LKK Auto Consultants Pte Ltd

1. Policy Particulars :- THIRD PARTY CLAIM

ADJUSTMENT ON REPAIR COST FOR VEHICLE NO. SHD 3054J

PHOTOGRAPHS FOR VEHICLE NO. SHD 3054J

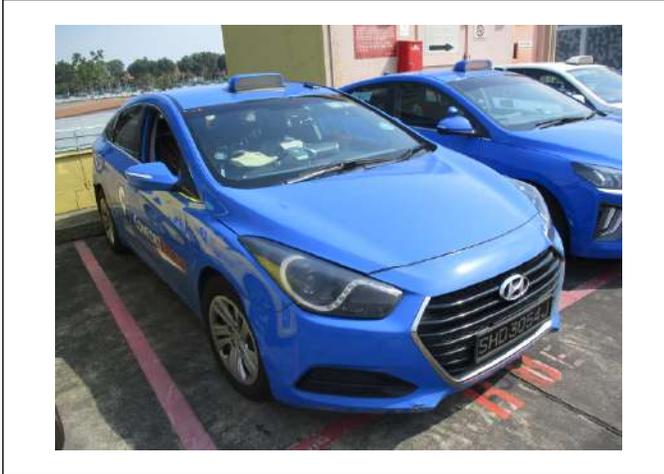
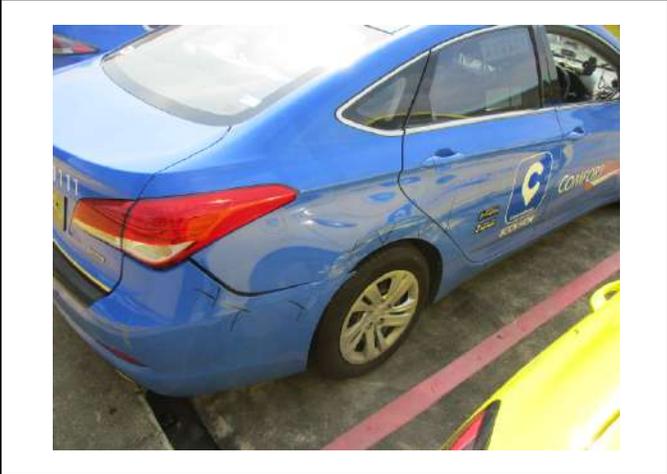
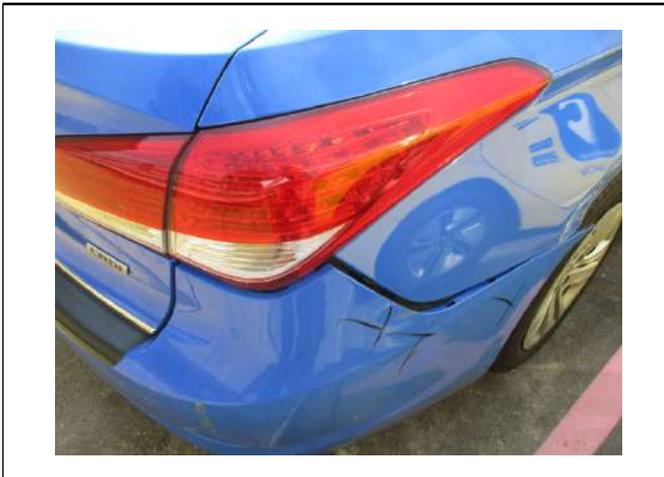
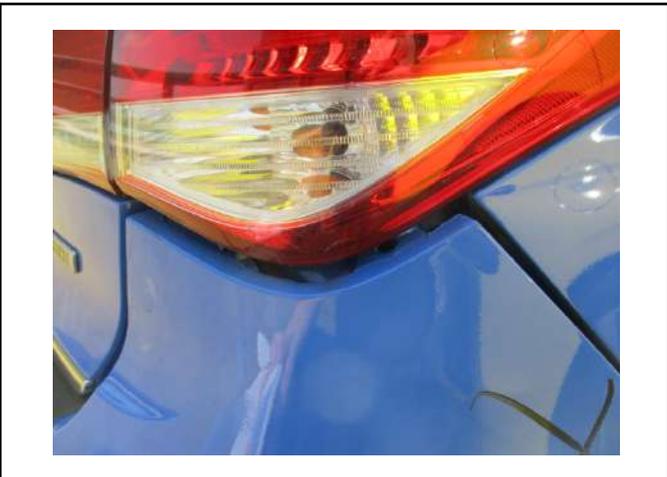
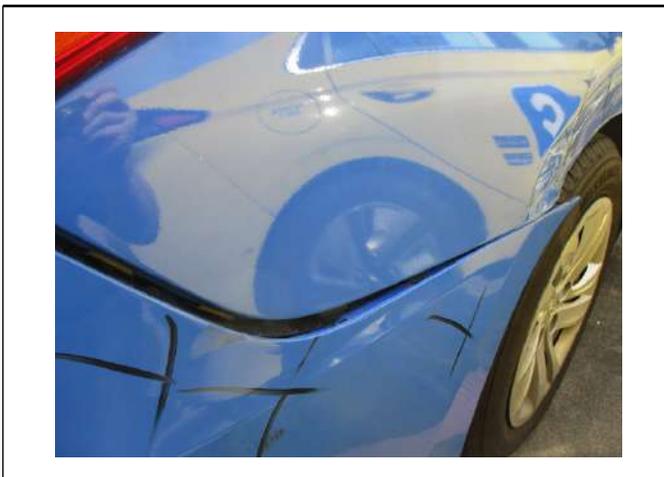
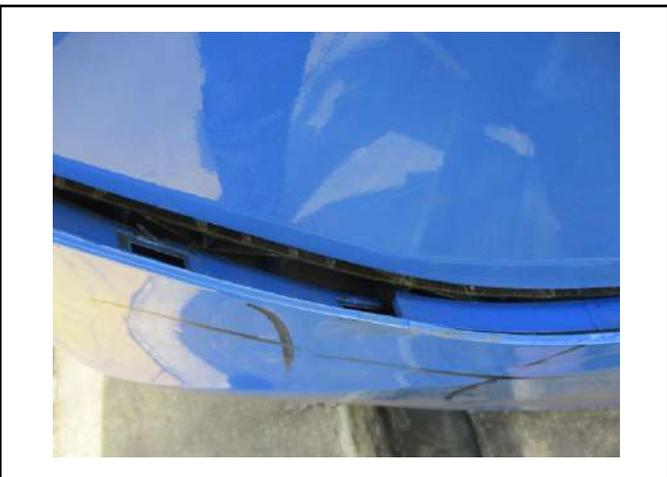
INSPECTION

THE VEHICLE SUSTAINED DAMAGES AT THE O/S BODY.THE UNDERCARRIAGE AFFECTED DUE TO COLLISION.
