Your Ref: TP/IP/05515/2021  
Our Ref : CI/TPD21002927/P

4<sup>th</sup> March 2021

**MECHANICAL INSPECTION REPORT OF MOTOR CAR SJP 5329S**

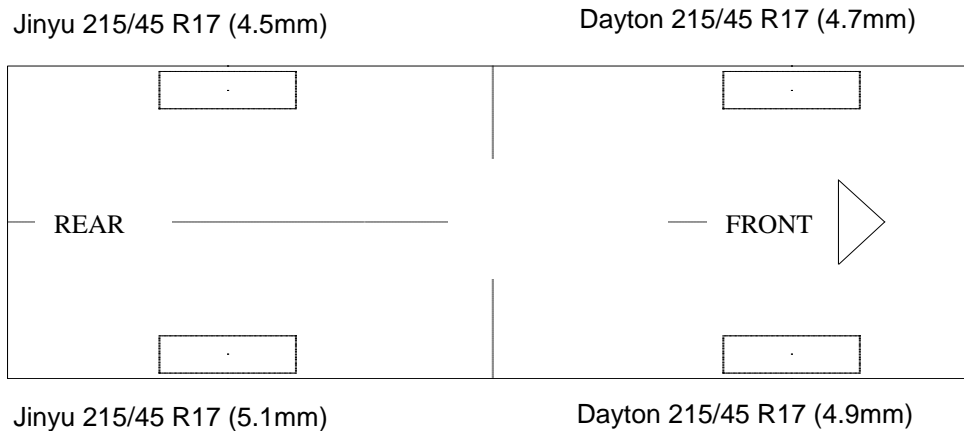
6. The front left tyre was observed to slip off from the Motor Car wheel rim as a result of the accident. However the condition of the Motor car's other 3 tyres was observed to be in serviceable condition. I did not find any tear, cut or burst mark(s) on the outer and the inner sidewalls as well as across the tread of the 4 tyres. The 3 tyres were also observed to be sufficiently inflated for vehicular operation. The tyre brand, tyre size and remaining tread depth of the 4 tyres were recorded as follows:-

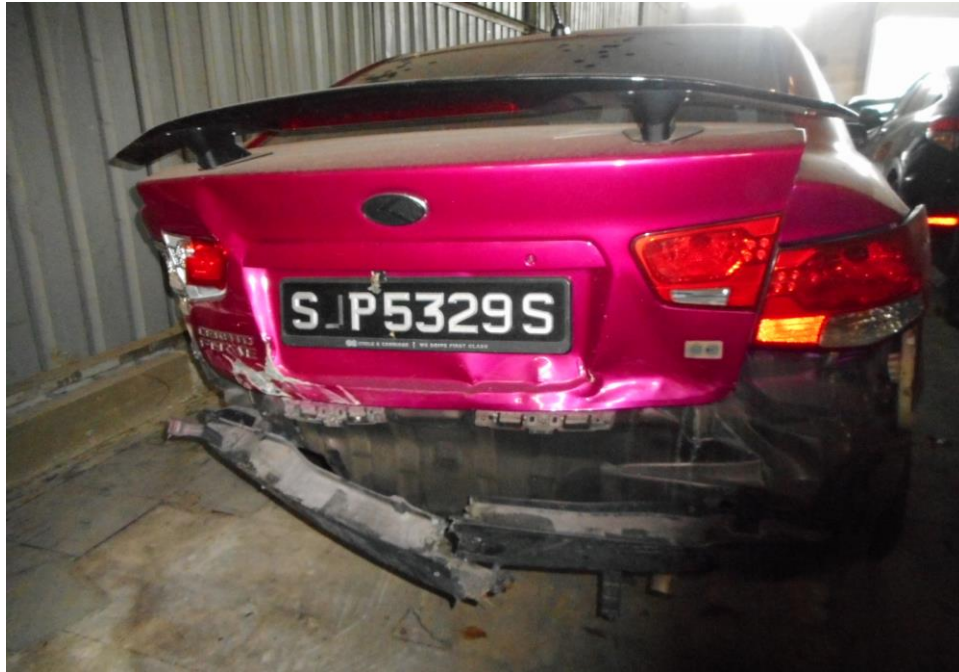
**Photo 1** shows a general view of the Motor Car's rear body at the time of my inspection. The rear portion of the Motor Car was observed to have sustained damaged as a result of the accident.

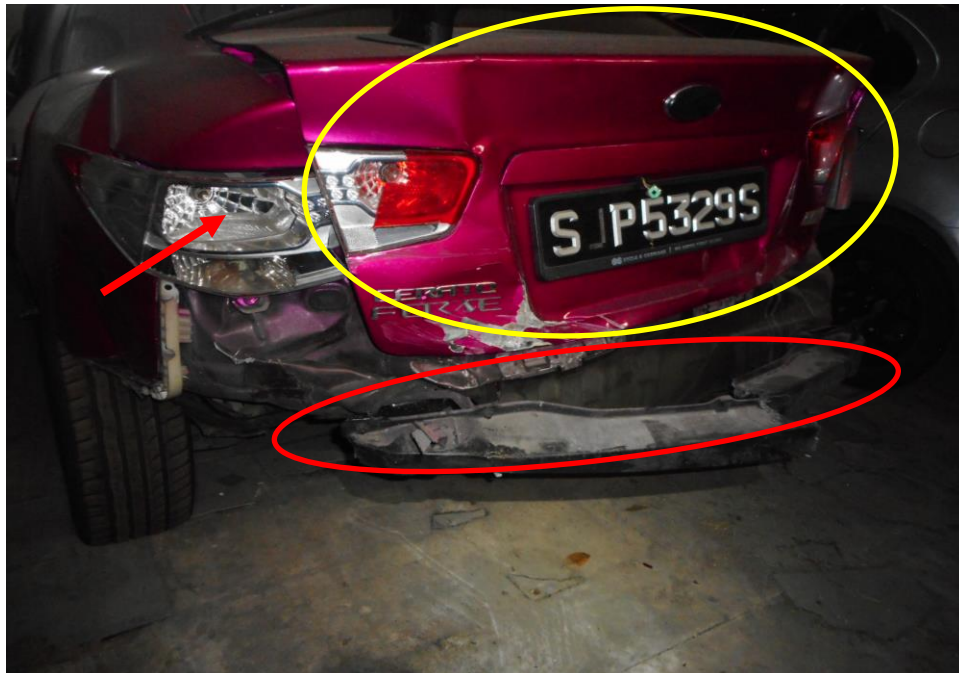
**Photo 2** shows a general view of the Motor Car's rear body at the time of my inspection. Its rear bumper (red circle), rear bonnet (yellow circle) and its left right brake lamp (arrowed) was amongst the body parts that were also damaged as a result of the accident.

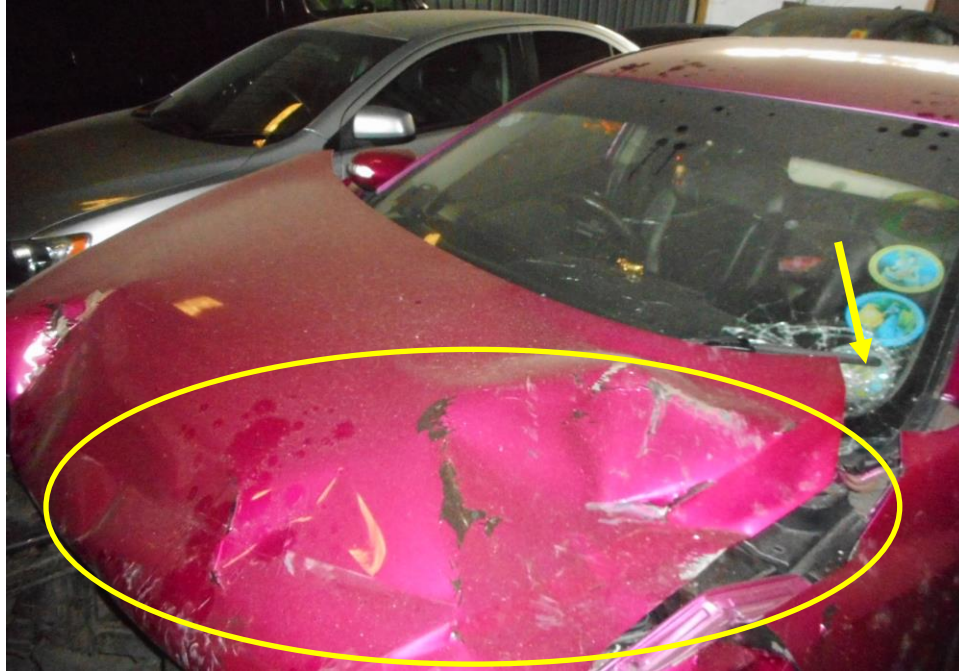
**Photo 3** shows a general view of the Motor Car's front body at the time of my inspection. Its front windscreen (arrowed) and front bonnet (yellow circle) was amongst the body parts and various components in the engine compartments were also damaged as a result of the accident.

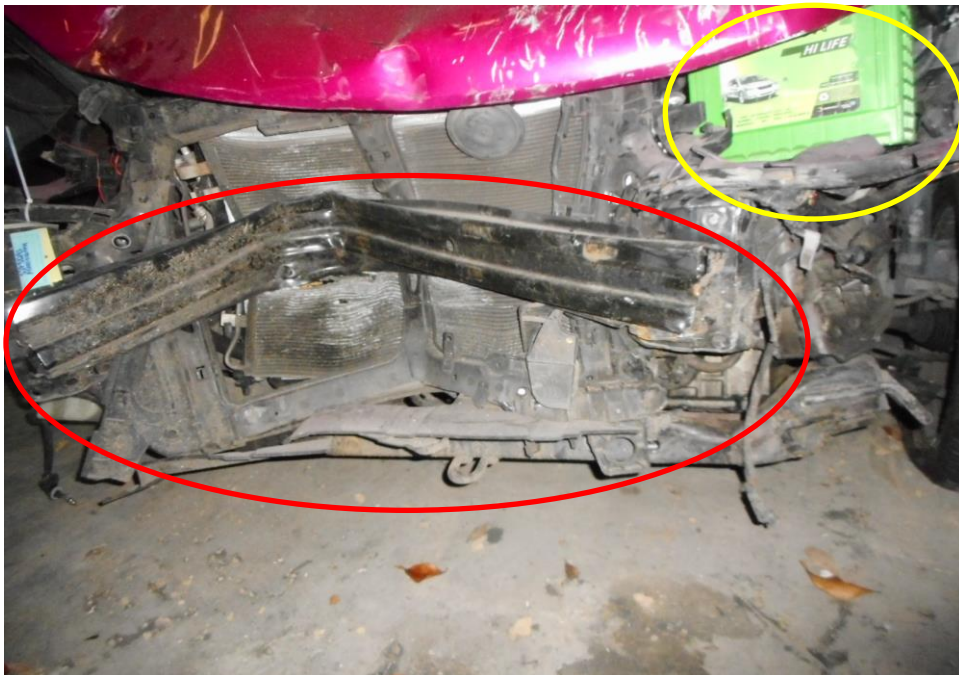
**Photo 4** shows the close up view of the Motor Car's front body at the time of my inspection. The Motor car was observed to have sustained damage at its front portion. Its battery (yellow circle), front bumper and body reinforcement panel (red circle) was amongst the various components in the engine compartments were also damaged as a result of the accident.

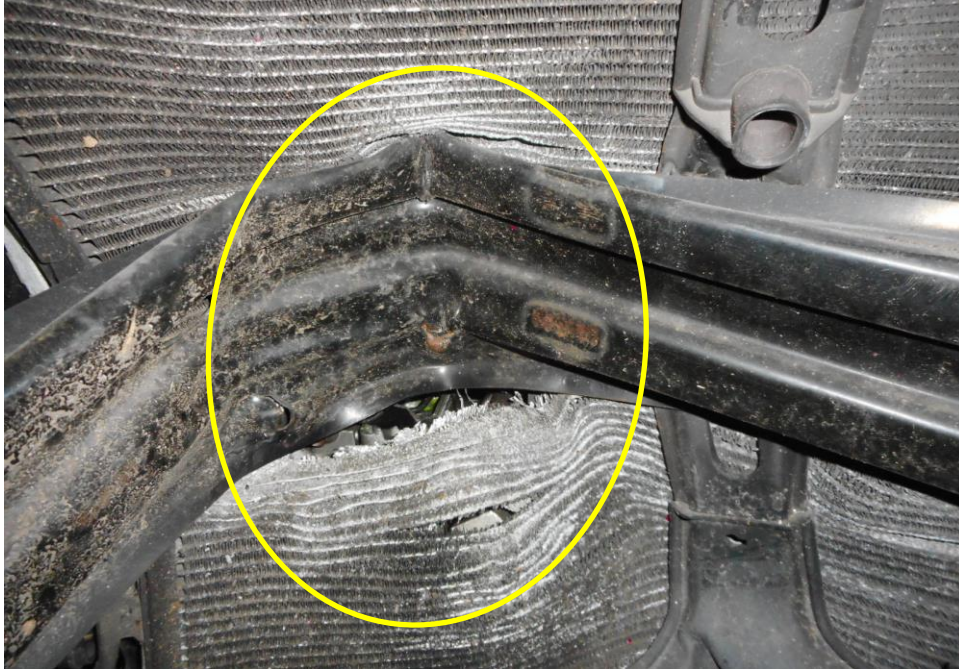
**Photo 5** shows the close up view of the Motor Car's front body at the time of my inspection. The Motor car was observed to have sustained damage at its front portion. Its engine radiator (circled) was amongst the various components in the engine compartments were also damaged as a result of the accident.

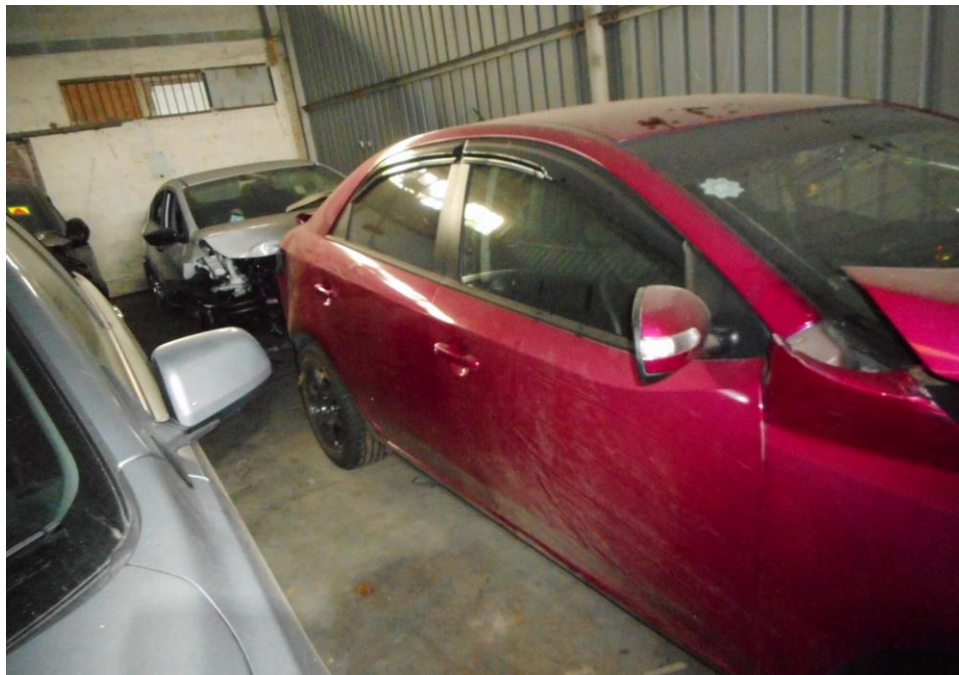
**Photo 6** shows the general view of the Motor Car's right body at the time of my inspection. The Motor car was not affected by the accident.

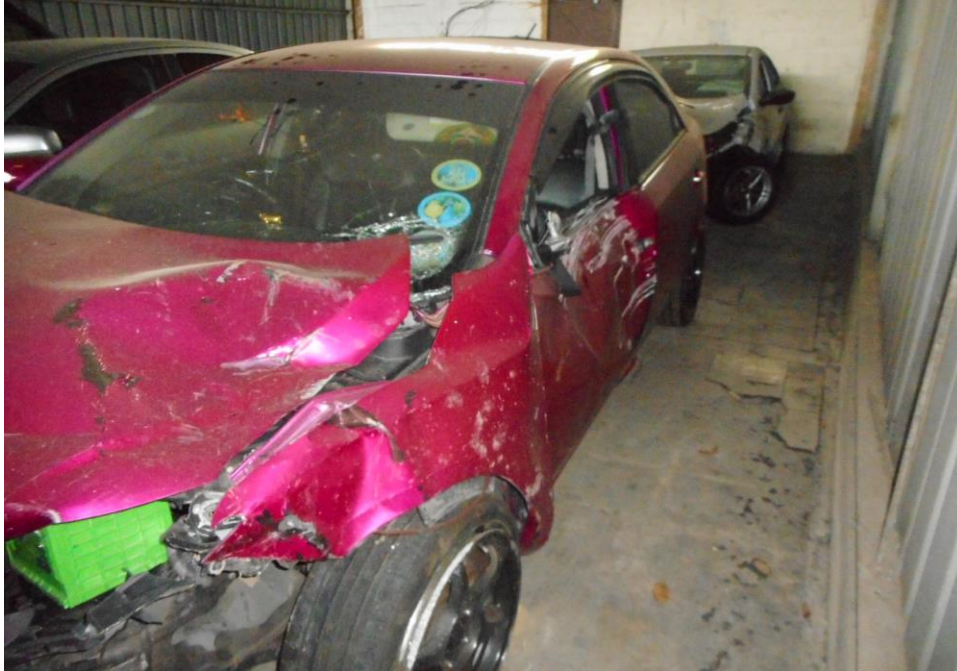
**Photo 7** shows the general view of the Motor Car's left body at the time of my inspection. The Motor car was observed to have sustained damage at its left portion. Its left body panel was damaged as a result of the accident.

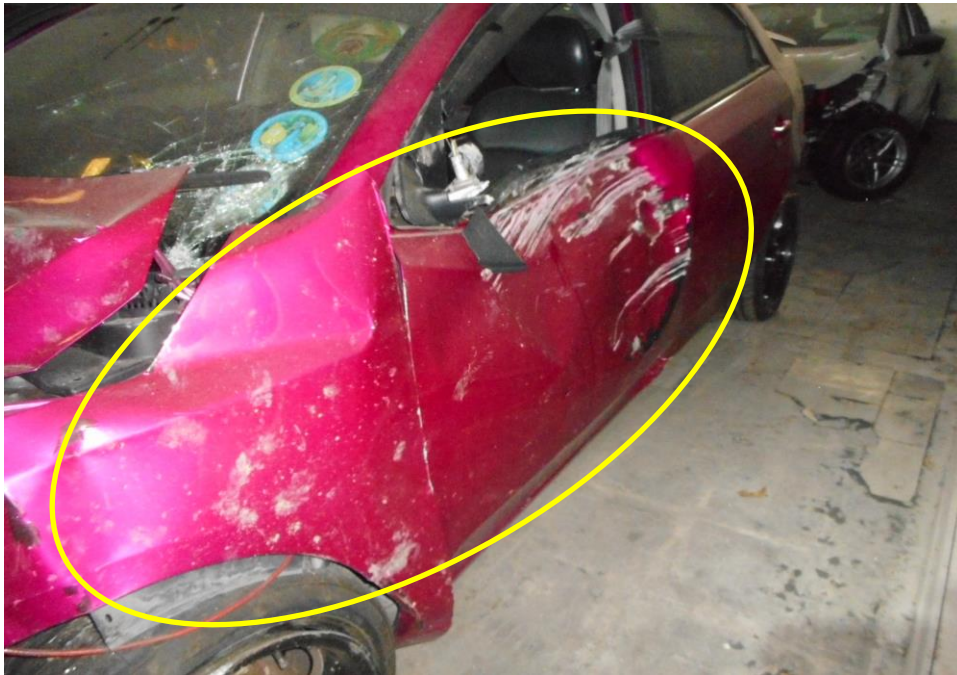
**Photo 8** shows the close up view of the Motor Car's left body at the time of my inspection. The Motor car was observed to have sustained damage at its left portion. Its left body panel (circled) was damaged as a result of the accident.

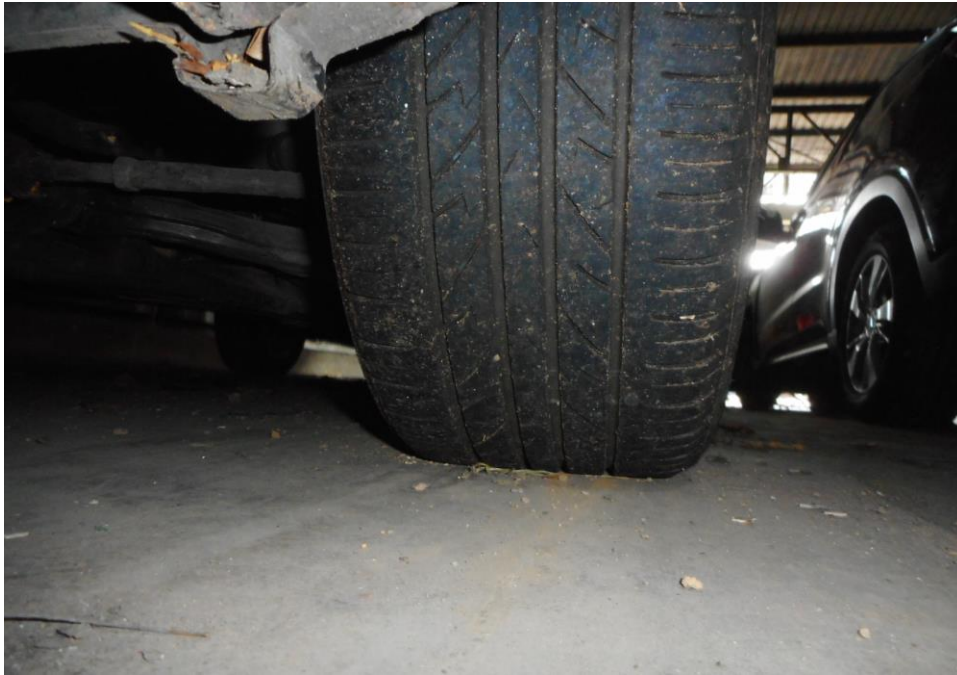
**Photo 9** shows the condition of the front right tyre of the Motor Car, which was observed to be in serviceable condition with remaining tread depth of approximately 4.9mm. The tyre was also observed to be sufficiently inflated for vehicular operation with no tear, cut or burst mark(s).

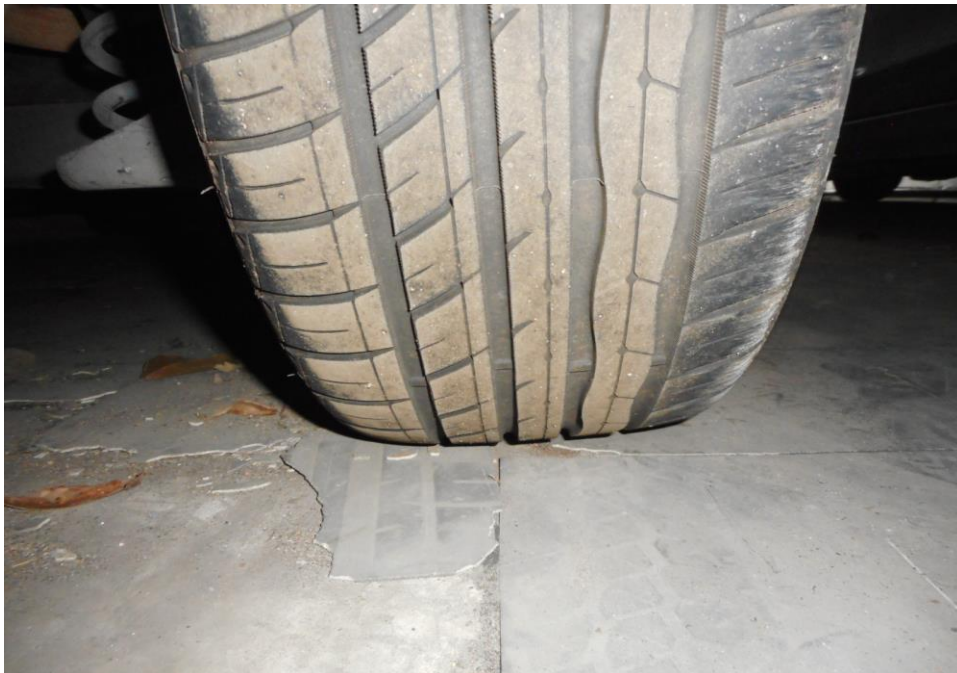
**Photo 10** shows the condition of the rear right tyre of the Motor Car, which was observed to be in serviceable condition with remaining tread depth of approximately 5.1mm. The tyre was also observed to be sufficiently inflated for vehicular operation with no tear, cut or burst mark(s).

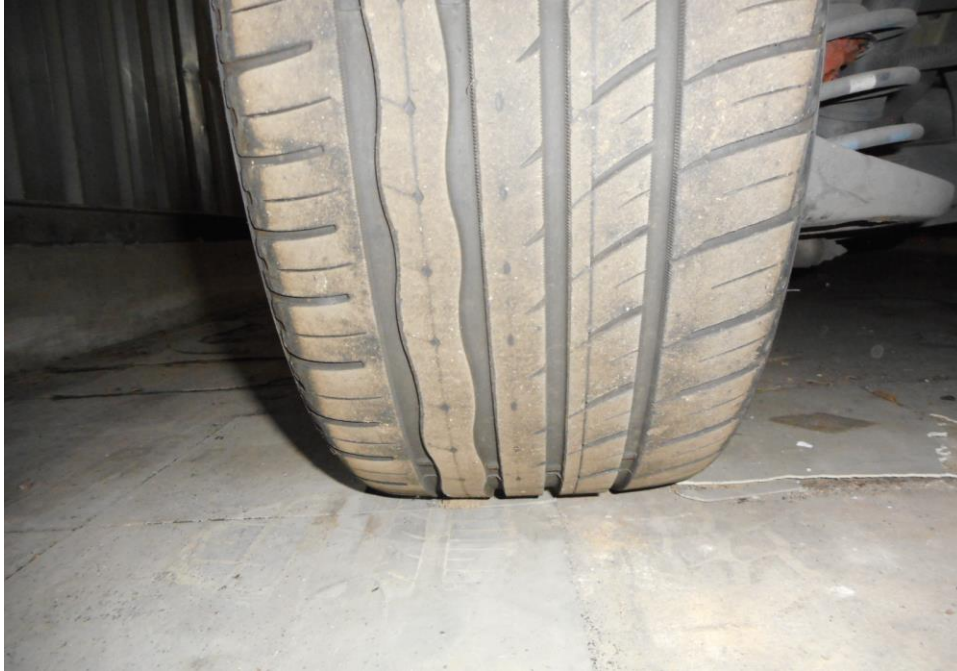
**Photo 11** shows the condition of the rear left tyre of the Motor Car, which was observed to be in serviceable condition with remaining tread depth of approximately 4.5mm. The tyre was also observed to be sufficiently inflated for vehicular operation with no tear, cut or burst mark(s).

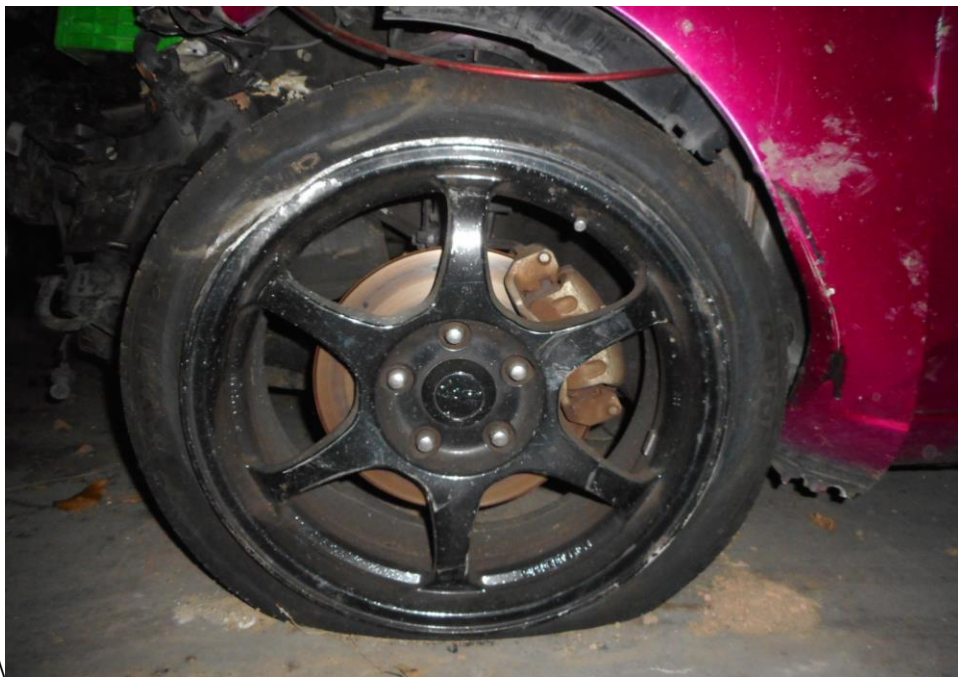
**Photo 12** shows the condition of the front left tyre of the Motor Car, which was observed to be in unserviceable condition with remaining tread depth of approximately 4.7mm. The tyre was also observed to slip off the wheel rim and deflated as a result of the accident.

19. The front left tyre was slip off from the wheel rim as a result of the accident. However, all the other 3 tyres of the Motor Car were also found to be in serviceable condition. I did not find any tear, cut or burst mark(s) on the outer and the inner sidewalls as well as across the tread of the 4 tyres. All the other 3 tyres were observed to be sufficiently inflated for vehicular operation. All 4 tyres were observed with remaining tread depth of approximately 4.5mm to 5.1mm.

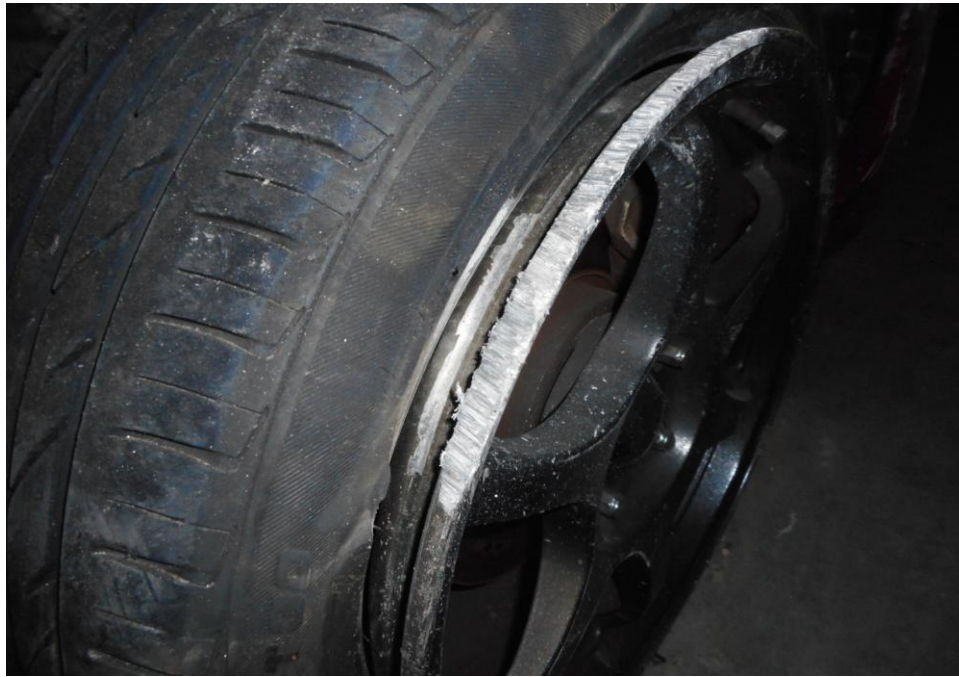
7. The front left wheel rim was observed to be damaged and tyre was slip off as a result of the accident. However, the other 3 tyres were observed to be wrapped around alloy wheel rims that were found to be without any damage. See photo 1 – 13 below.

**Photo 13** shows the condition of the front left tyre and rim of the Motor Car, the wheel rim was observed to slip off the wheel rim as a result of the accident

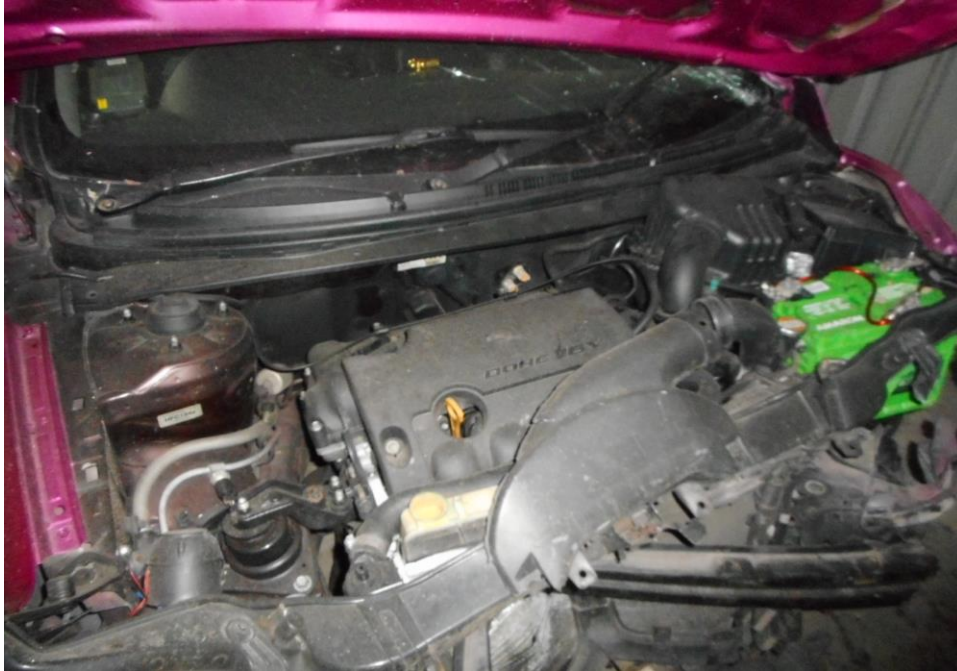
**Photo 14** shows a general view of the Motor Car's engine compartment. The various parts and components inside the engine compartment were unaffected by the accident. There was also no sign(s) or indication(s) of fluid leakage and/or fluid stain within the engine compartment.

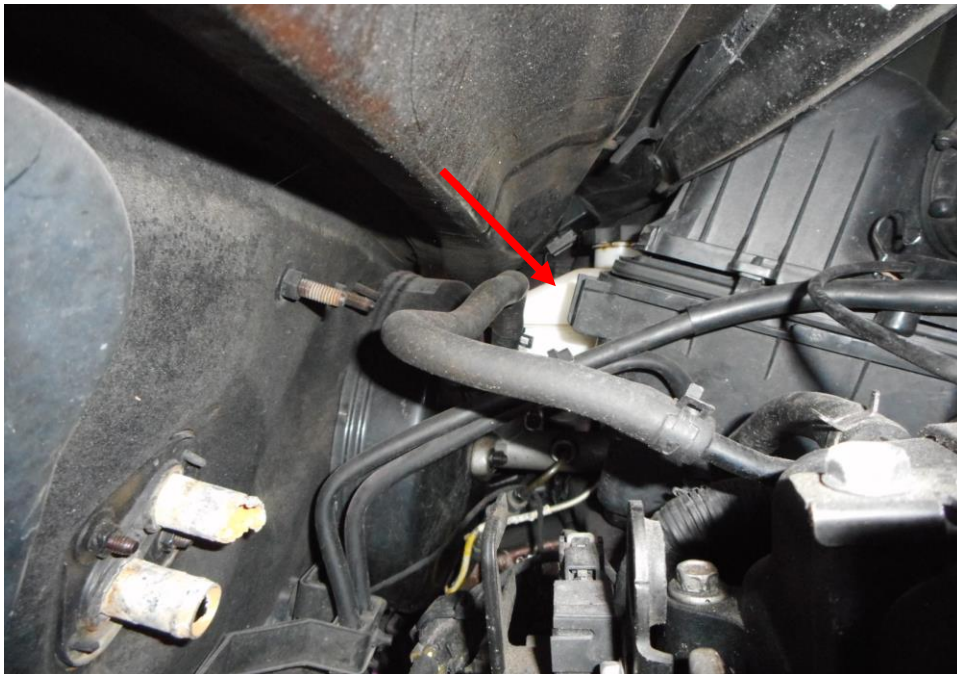
**Photo 15** shows the brake fluid reservoir of the Motor Car at the time of my inspection. The brake fluid reservoir was observed to be block as a result of the accident.

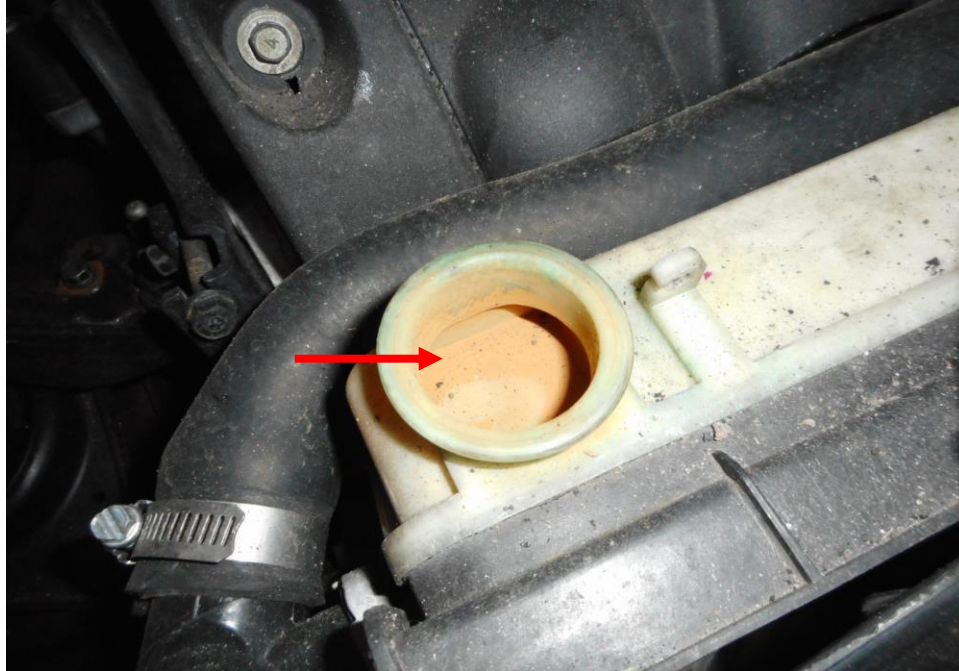
8. Upon examination of the engine compartment of the Motor Car, I had observed all the parts and components inside the engine compartment to be intact and unaffected by the accident. The engine oil was found to be of sufficient level for operating purposes. Visually, there was also no contamination found to these fluid. However, the brake fluid was not able to be inspected as it was blocked. The engine coolant was observed to be insufficient as the radiator was damaged and coolant had leak out as a result of the accident.

**Photo 16** shows checks being carried out to the engine coolant of the Motor Car at the time of my inspection. The engine coolant was observed to be of insufficient level (arrowed) likely due to the damaged to the front radiator which caused the leakage of coolant.

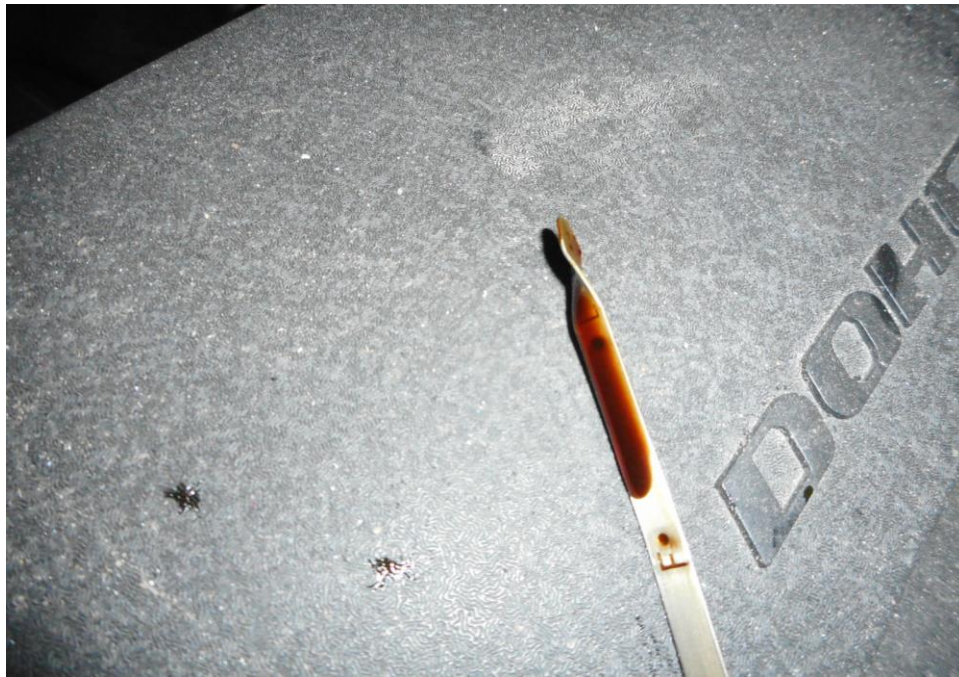
**Photo 17** shows the engine oil dip stick of the Motor Car at the time of my inspection. The engine oil was observed to be of sufficient level and without any visible contamination.

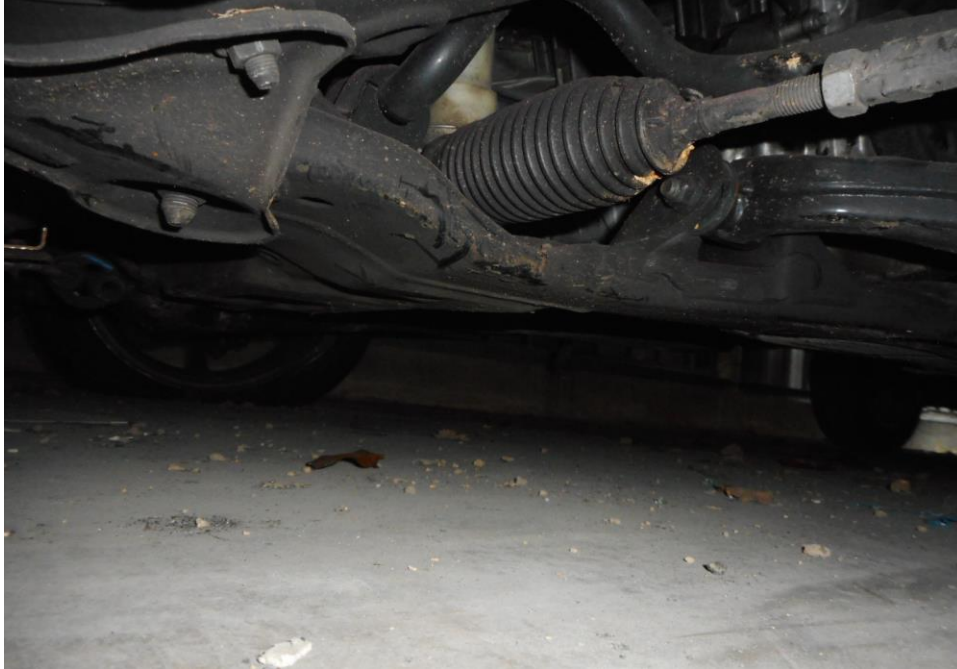
**Photo 18** shows the undercarriage of the Motor Car, at the area where the engine housing and transmission housing are located. I did not find any sign(s) or indication(s) of fluid leak and/or fluid stain(s) on the underside of the Motor Car.

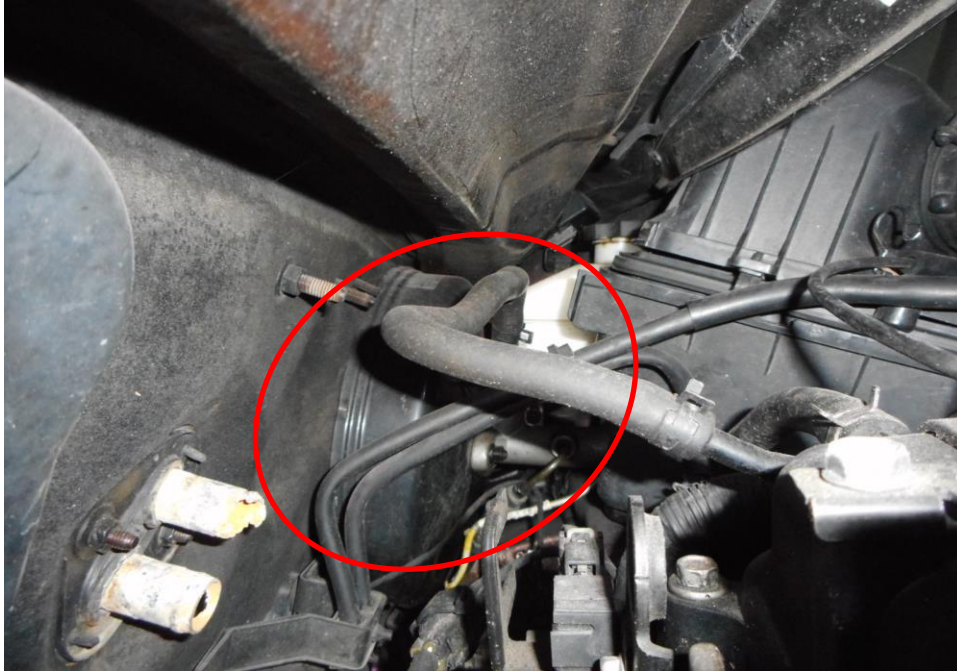
12. Static brake tests conducted on the Motor Car revealed abnormality. The brake booster do not responded well to the various tests conducted. There was abnormal movement of the brake pedal when it was depressed. As the brake booster was crush into stationary position and was not able to work properly as normal of providing pressure/vacuum in the braking system of the Motor Car. The abnormal movement to the brake pedal was likely cause by the accident. As the brake booster was found to be damaged as the induced impact from the accident to the front engine comparmtent had crush the brake booster into stationary position. See photo 19 below.

**Photo 19** shows the brake booster of the Motor Car at the time of my inspection. The brake booster (circled) was observed to be crushed as a result of the induced impact from accident.

17. For this particular case, I was unable to determine whether there was any possible mechanical failure to the Motor Car that may have contributed to the accident. The extent of damage that it had sustained had prevented me from carrying out any operational test(s) and/or static test(s) to its engine system, transmission system, steering system and suspension system.
18. The static brake test was able to be conducted and in general our visual inspection of the mechanical components of the Motor Car's braking system appear to suggest that its braking was in serviceable condition at the material time of accident and there was no leakage found at the braking and steering components of the Motor Car, the abnormal found when depressing the brake pedal was likely due to the crushed brake booster at the engine compartment of the Motor Car as a result of the accident.

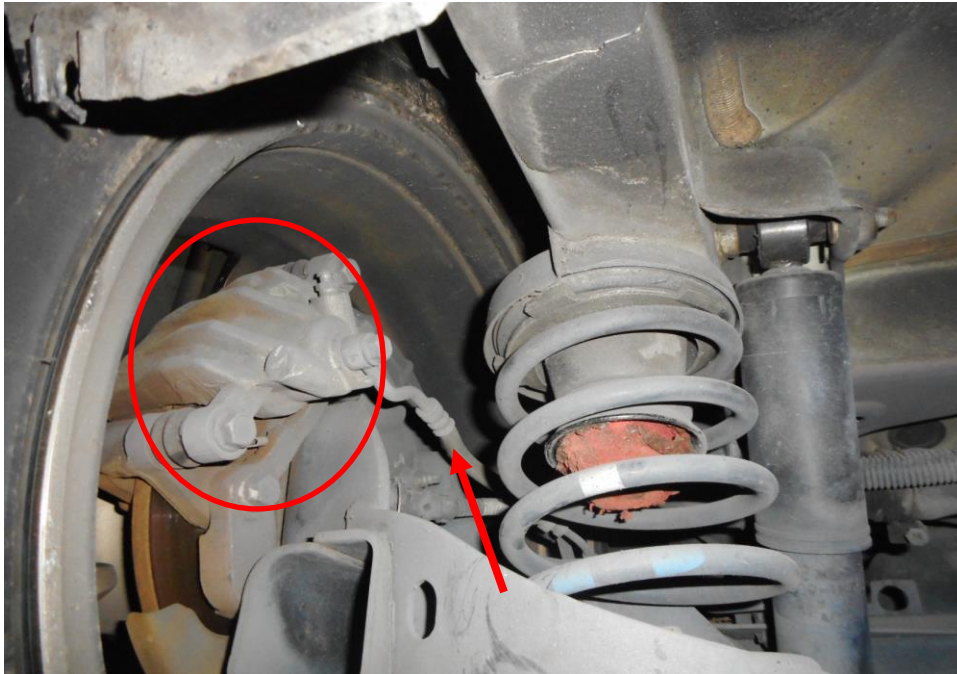
**Photo 20** shows the brake caplier (circled) and brake hose/pipe (arrowed) at the rear left wheel of the Motor Car and it was observed to be intact

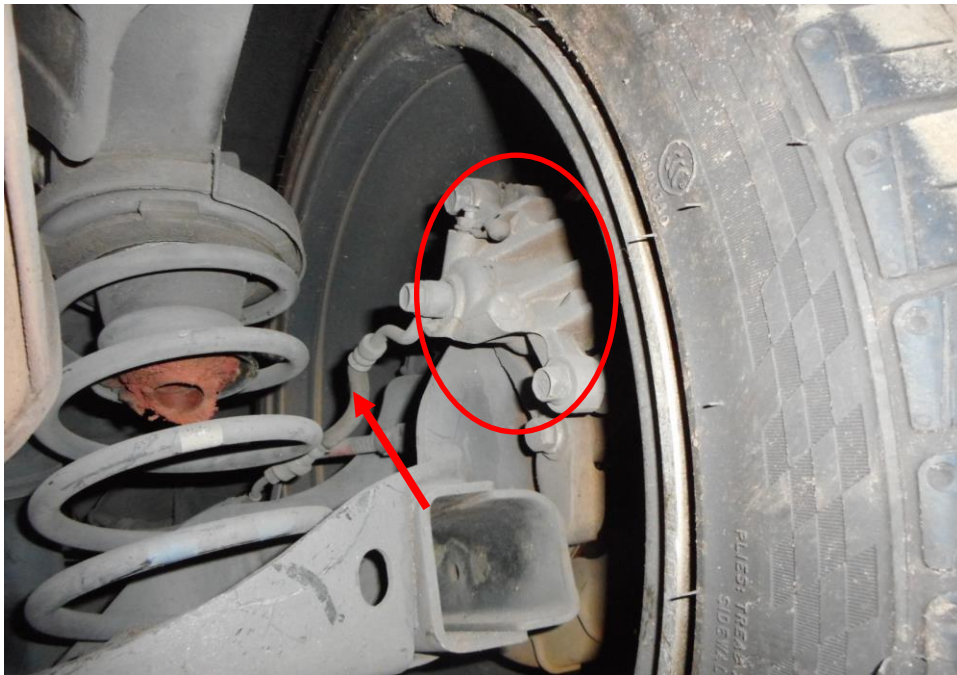
**Photo 21** shows the brake caplier (circled) brake hose/pipe (arrowed) at the rear right wheel of the Motor Car and it was observed to be intact

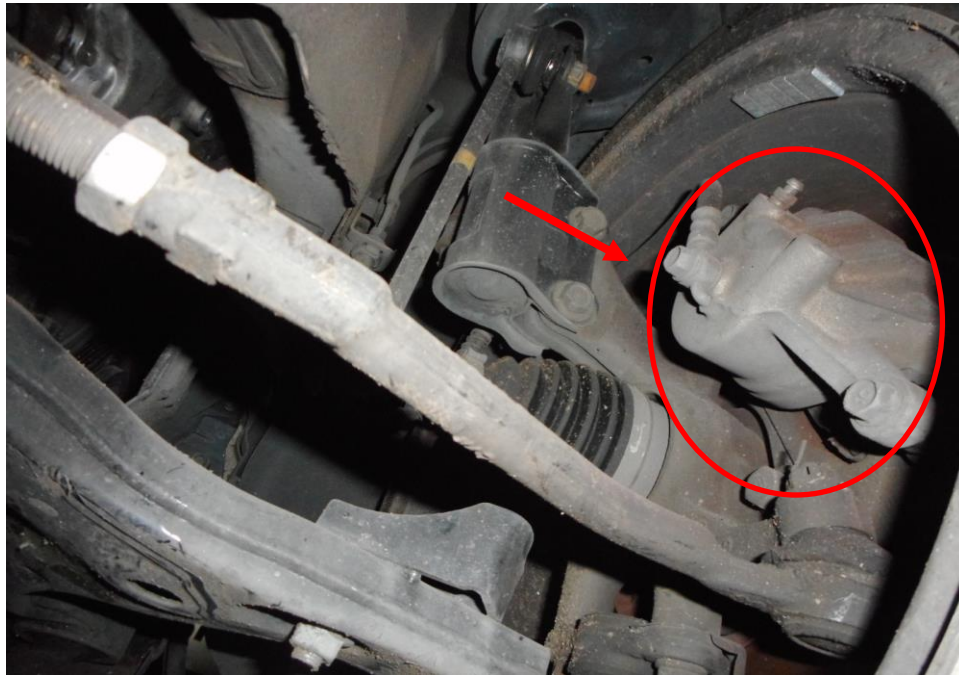
**Photo 22** shows the brake hose/pipe (arrowed) at the front right wheel of the Motor Car. No leakage of brake fluid was observed. Visual examination of the various components of the braking system like the brake caliper (circled) had revealed to be intact and without visible damage at the time of accident. There was also no sign of fluid stain(s) observed on the various undercarriage components.

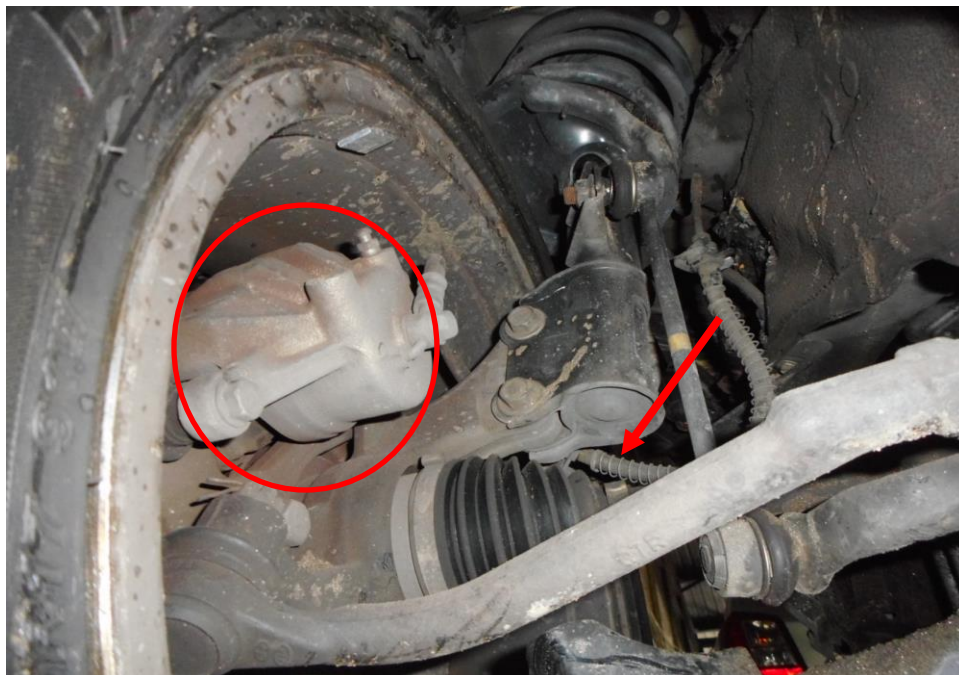
**Photo 23** shows the brake hose/pipe (arrowed) at the front left wheel of the Motor Car. No leakage of brake fluid was observed. Visual examination of the various components of the braking system like the brake caliper (circled) had revealed all to be intact and without visible damage at the time of accident. There was also no sign of fluid stain(s) observed on the various undercarriage components.

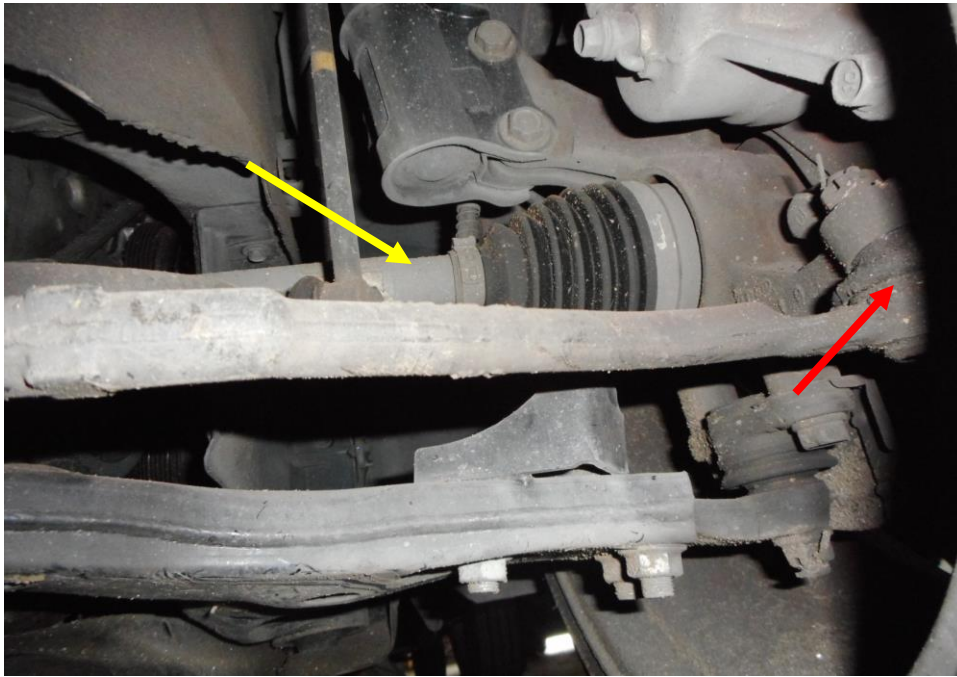
**Photo 24** shows the various undercarriage components at the front right wheel of the Motor Car, in particular the steering tie rod end (arrowed) and drive shaft (yellow arrow). The various steering components were all found to be intact, there was no sign of fluid stain(s) observed on the various undercarriage components.

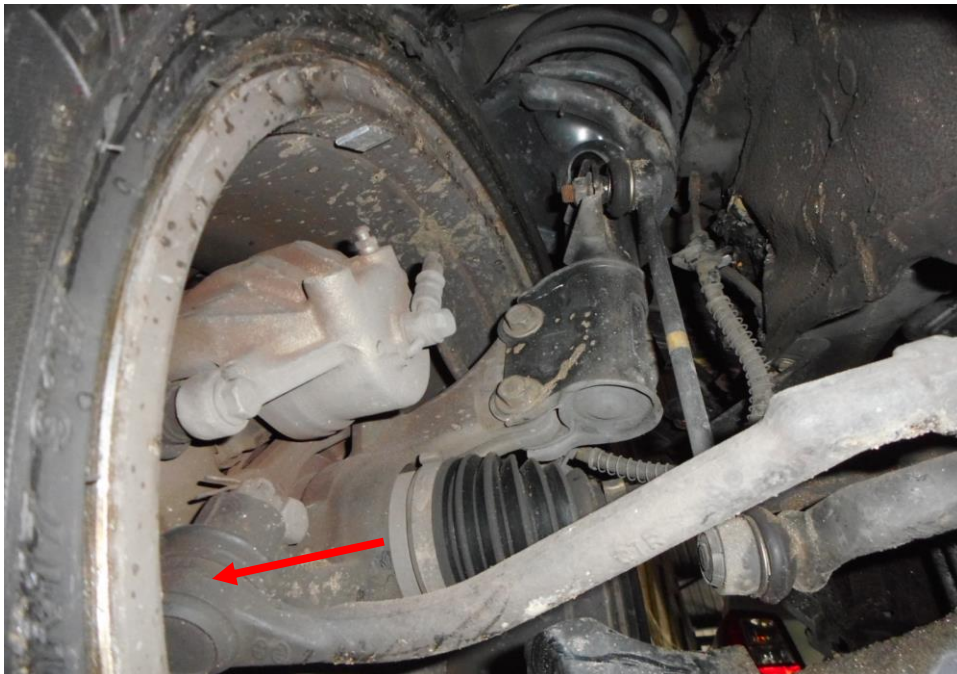
**Photo 25** shows the various undercarriage components at the front left wheel of the Motor Car, in particular the steering tie rod end (arrowed). The various steering components were all found to be intact, there was no sign of fluid stain(s) observed on the various undercarriage components.
