Your Ref: TP/IP/06341/2021
Our Ref : CI/TPD21002928/P

18th March 2021

MECHANICAL INSPECTION REPORT OF MOTOR VAN GW 9536H

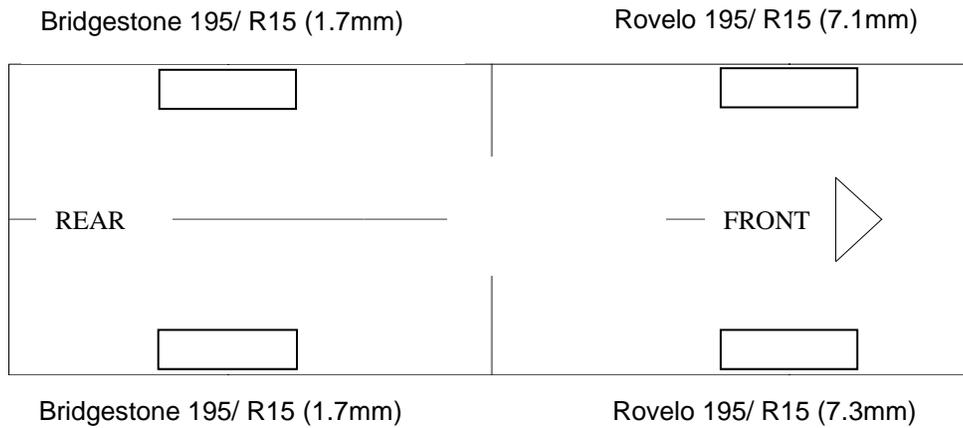
6. The 4 tyres of the Motor Van were observed to be in serviceable condition and sufficiently inflated for vehicular operation. I did not find any tear, cut or burst mark(s) on the outer and the inner sidewalls as well as across the tread of the 4 tyres. The tyre brand, tyre size and remaining tread depth of the 4 tyres of the Motor Van were recorded as follows:-

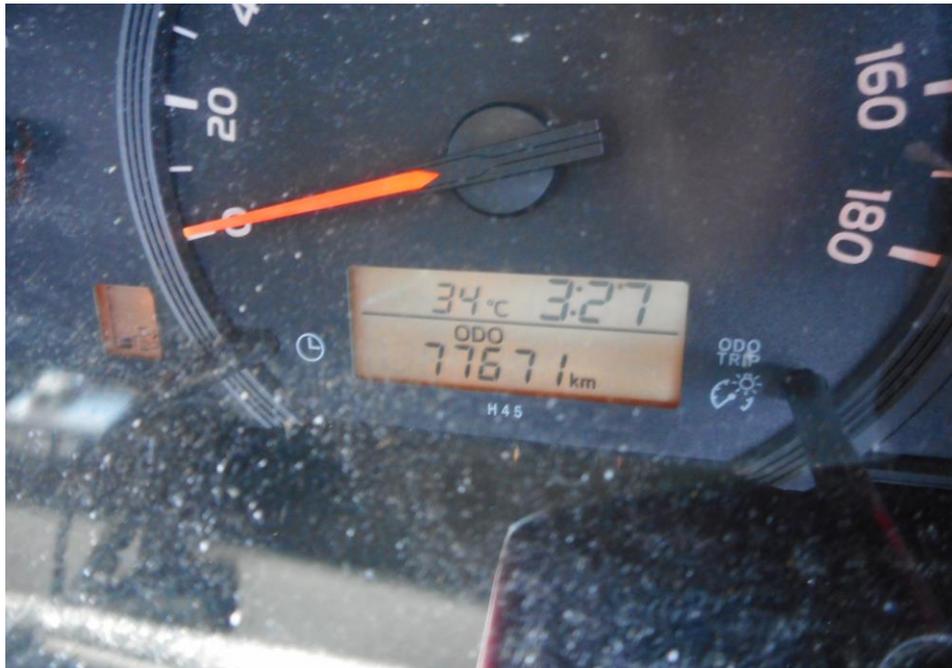
Photo 1 shows a general view of the instrument cluster of the Motor Van at the time of my inspection. The mileage of the Motor Van was 77,671 km

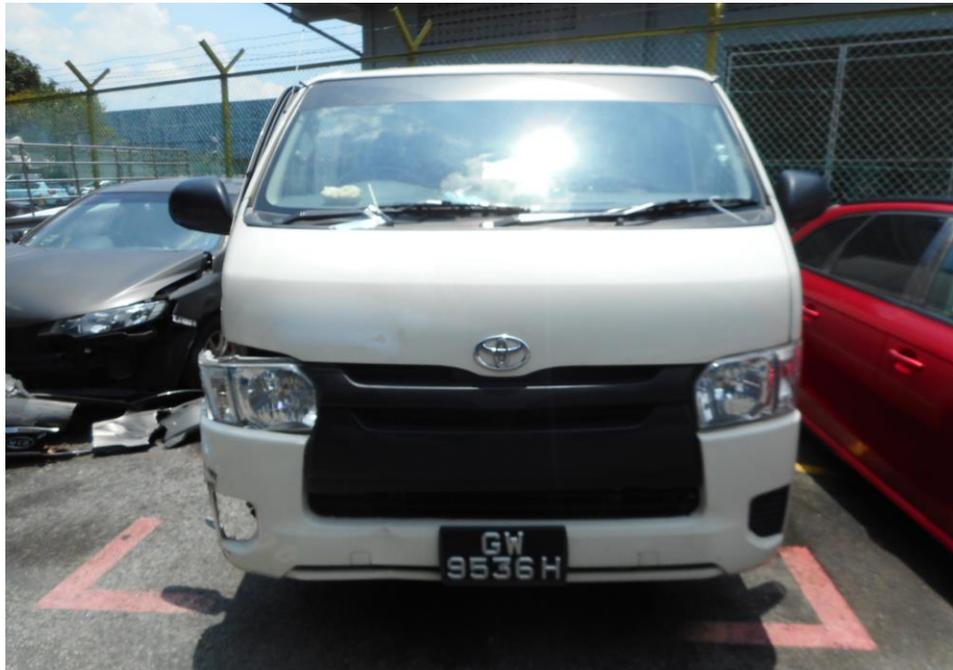
4. The mileage of the Motor Van at the time of my inspection was 77,671km.
5. The Motor Van was observed to sustained damage at its front and right portion. Its front right headlamp, front bumper and right door were damage at the time of my inspection.

Photo 2 shows a general view of the Motor Van's frontal portion at the time of my inspection. It appeared to have sustained damage at its front and right portion. Its front right headlamp, front bumper and right door were damage at the time of my inspection.

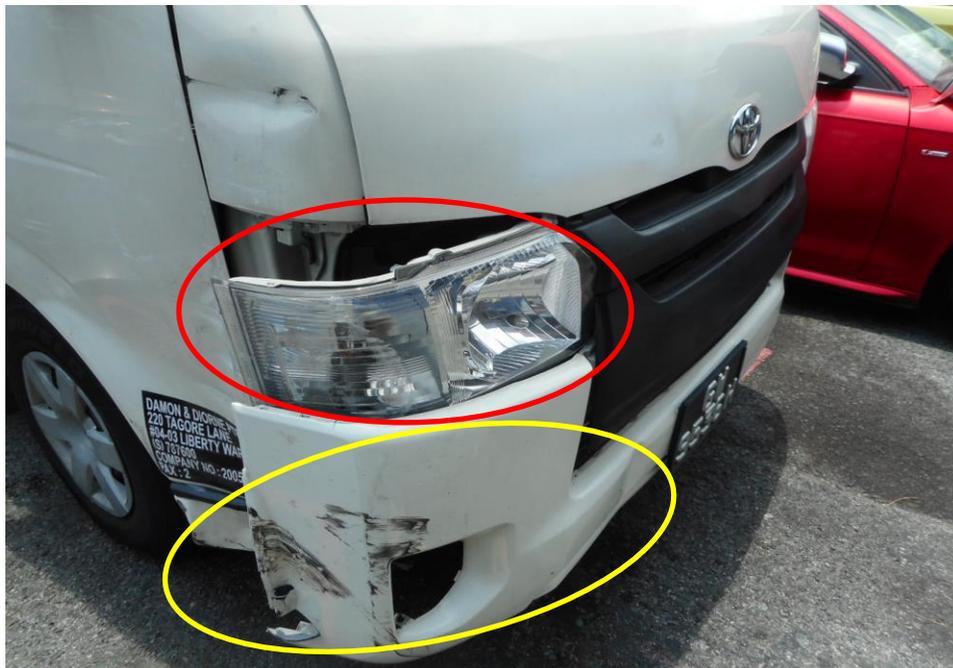
Photo 3 shows a close up view of the Motor Van's front portion at the time of my inspection. Its front right headlamp (red circle) and front bumper (yellow circle) was damage at the time of my inspection as a result of the accident.

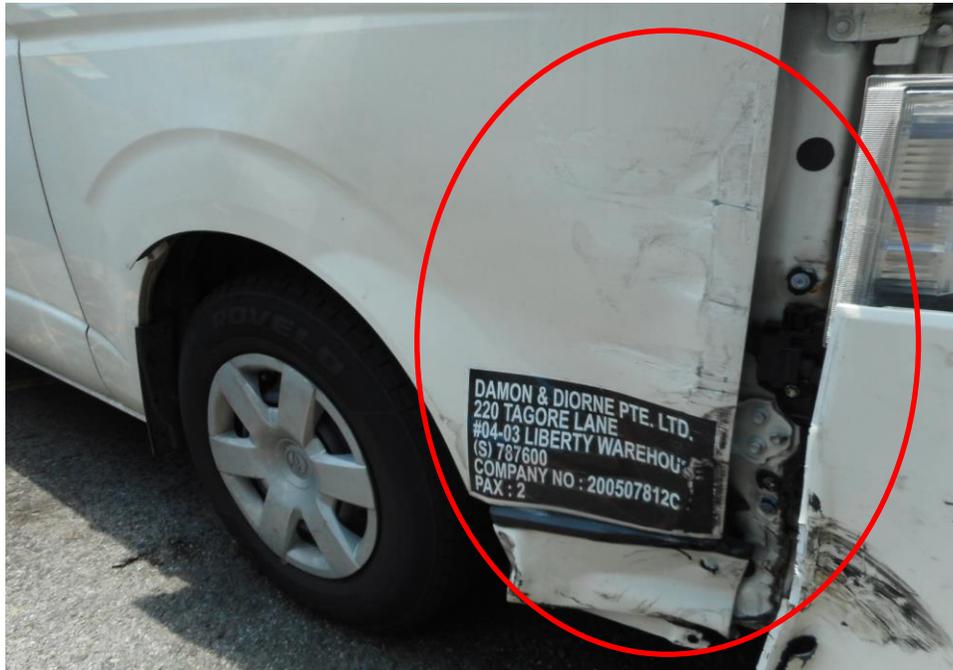
Photo 4 shows a close up view of the Motor Van's right portion at the time of my inspection. Its right door (red circle) was damage at the time of my inspection as a result of the accident.

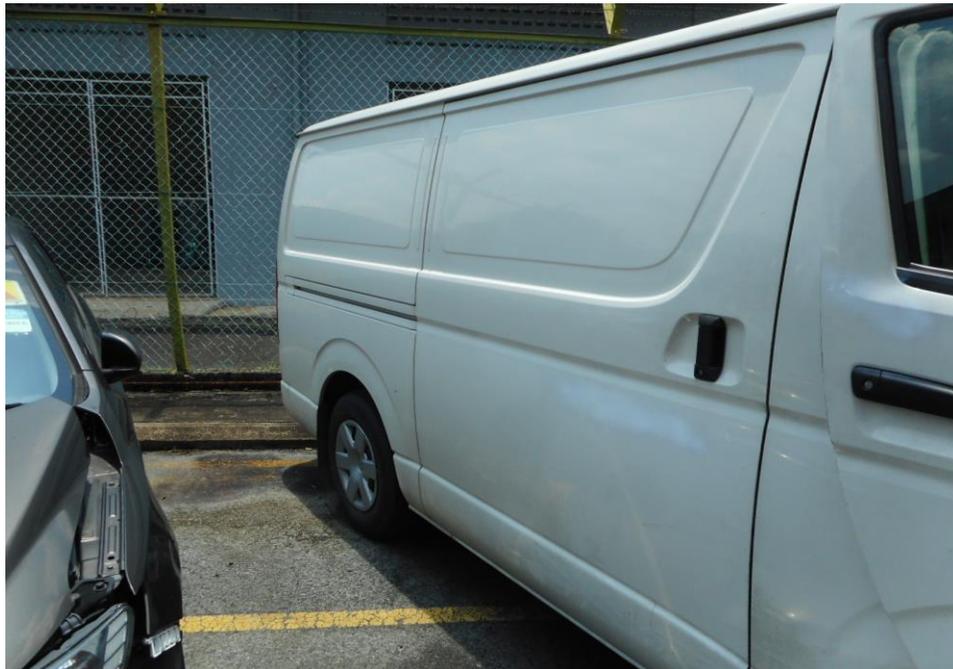
Photo 5 shows a general view of the right body of the Motor Van at the time of my inspection. The Motor Van was observed to be intact and unaffected by the accident.

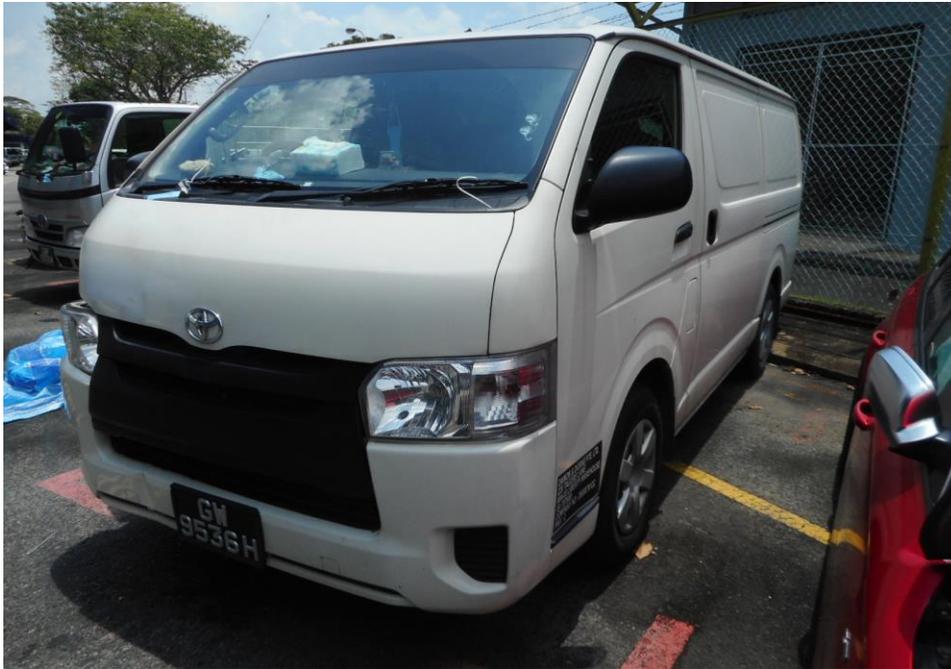
Photo 6 shows a general view of the left body of the Motor Van at the time of my inspection. The Motor Van was observed to be intact and unaffected by the accident.

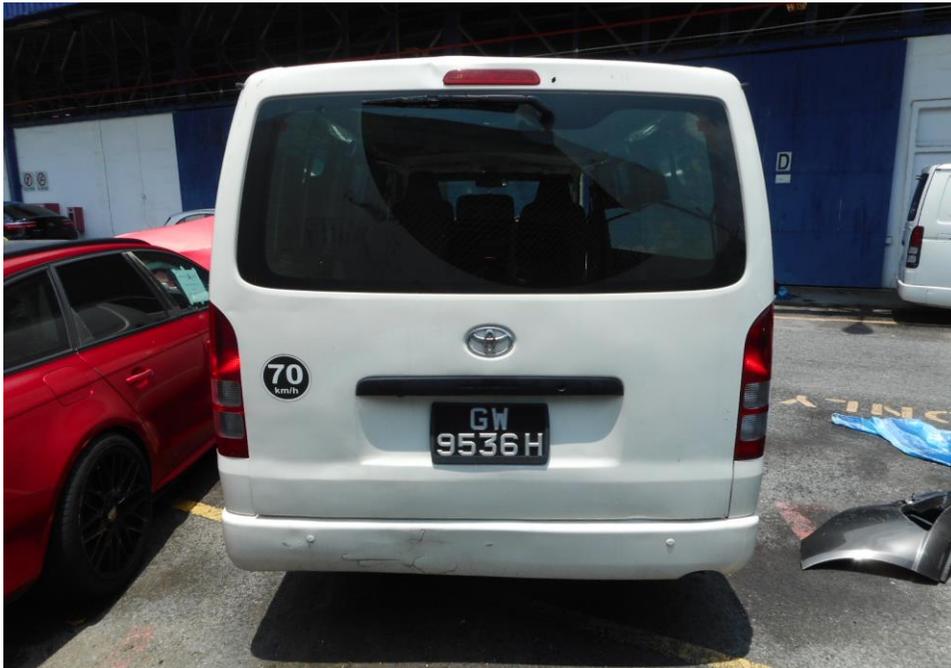
Photo 7 shows a general view of the rear body of the Motor Van at the time of my inspection. The Motor Van was observed to be intact and unaffected by the accident.

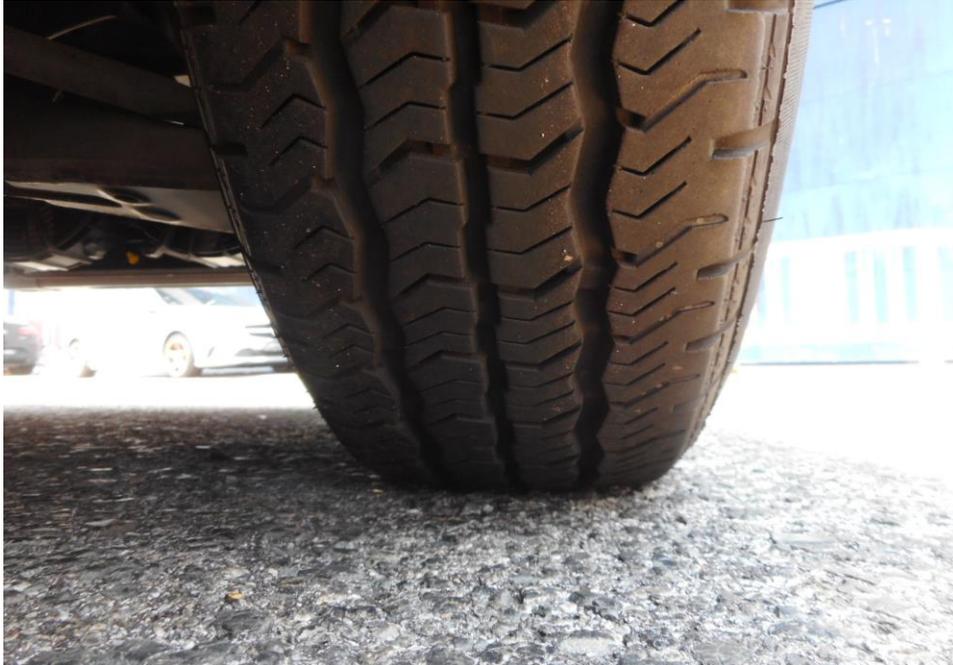
Photo 8 shows the condition of the front right tyre of the Motor Van, which was observed to be in serviceable condition with remaining tread depth of approximately 7.3mm. The tyre, which was wrapped around standard steel wheel rim, was also observed to be sufficiently inflated for vehicular operation. There was no tear, cut or burst mark(s) on the outer and the inner sidewalls as well as across the tread of the 4 tyres that were fitted on the Motor Van.

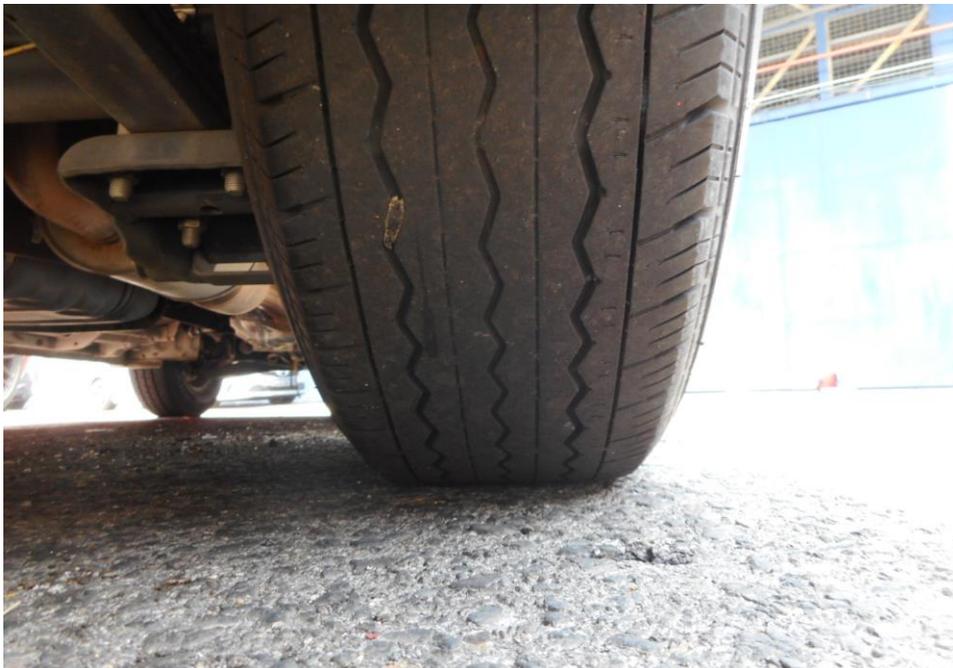
Photo 9 shows the condition of the rear right tyre of the Motor Van, which was observed to be in serviceable condition with remaining tread depth of approximately 1.7mm. The tyre, which was wrapped around standard steel wheel rim, it was observed to be sufficiently inflated for vehicular operation.

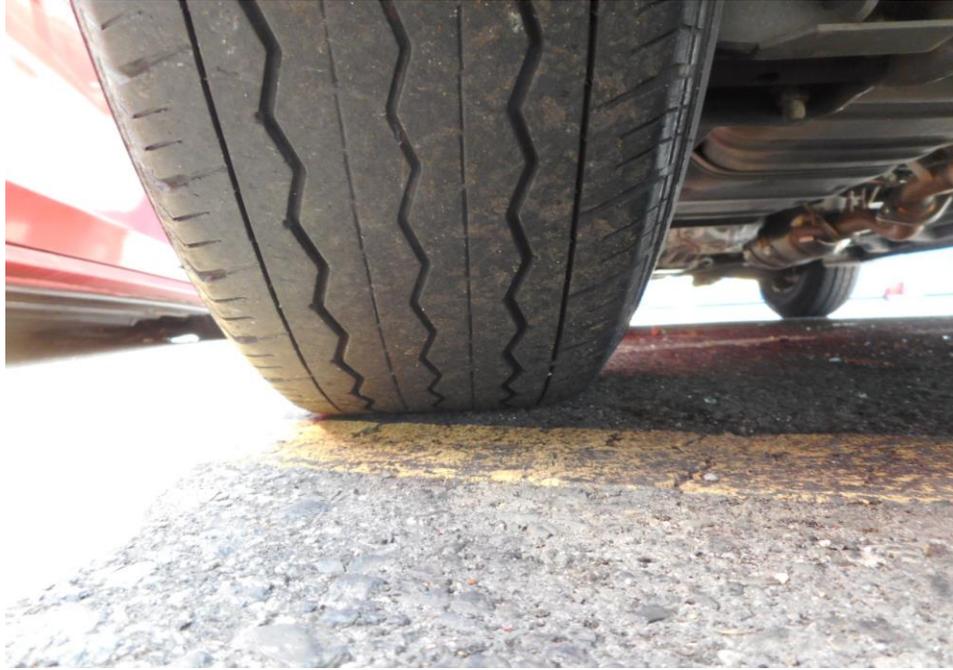
Photo 10 shows the condition of the rear left tyres of the Motor Van, which was observed to be in serviceable condition with remaining tread depth of approximately 1.7mm. The tyres, which were wrapped around standard steel wheel rim, were also observed to be sufficiently inflated for vehicular operation. There was also no damage found on all 4 steel wheel rims of the Motor Van.

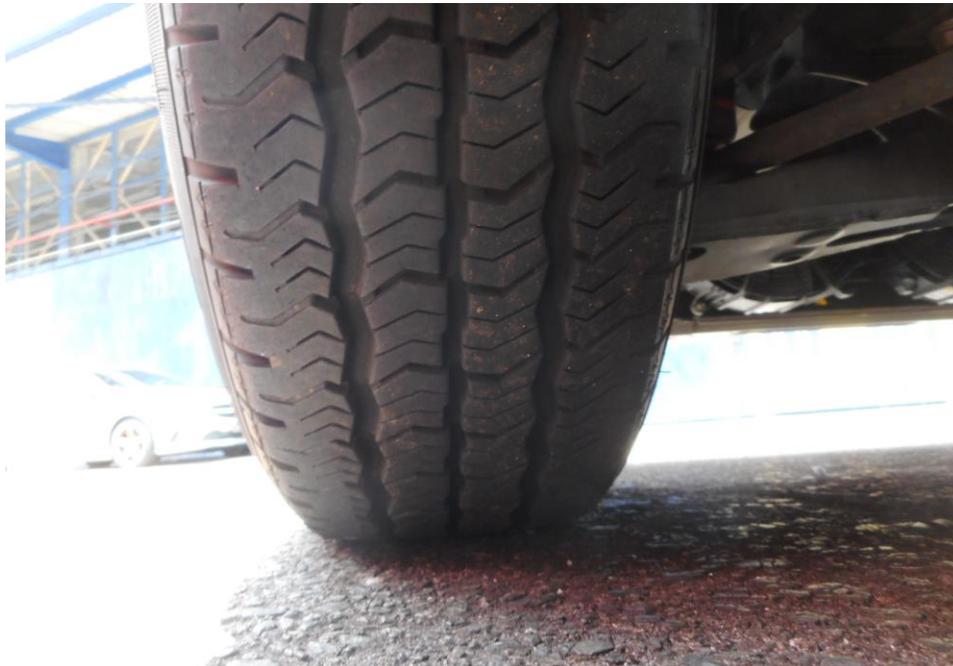
Photo 11 shows the condition of the rear right tyres of the Motor Van, which were observed to be in serviceable condition with remaining tread depth of approximately 7.1mm. There was also no tear, cut or burst mark(s) on the outer and the inner sidewalls as well as across the tread of the 4 tyres that were fitted on the Motor Van.

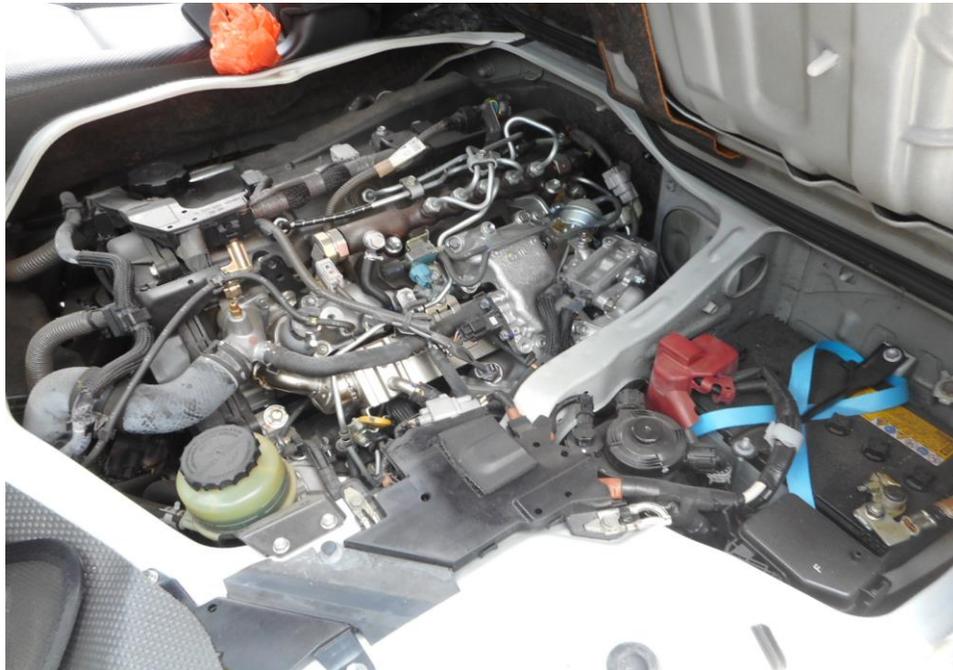
Photo 12 shows a general view of the Motor Van's engine compartment, which was accessed by lifting the front cabin of the Motor Van. The various parts and components inside the engine compartment were unaffected by the accident. There was also no sign(s) or indication(s) of fresh fluid leakage and/or fluid stain within the engine compartment

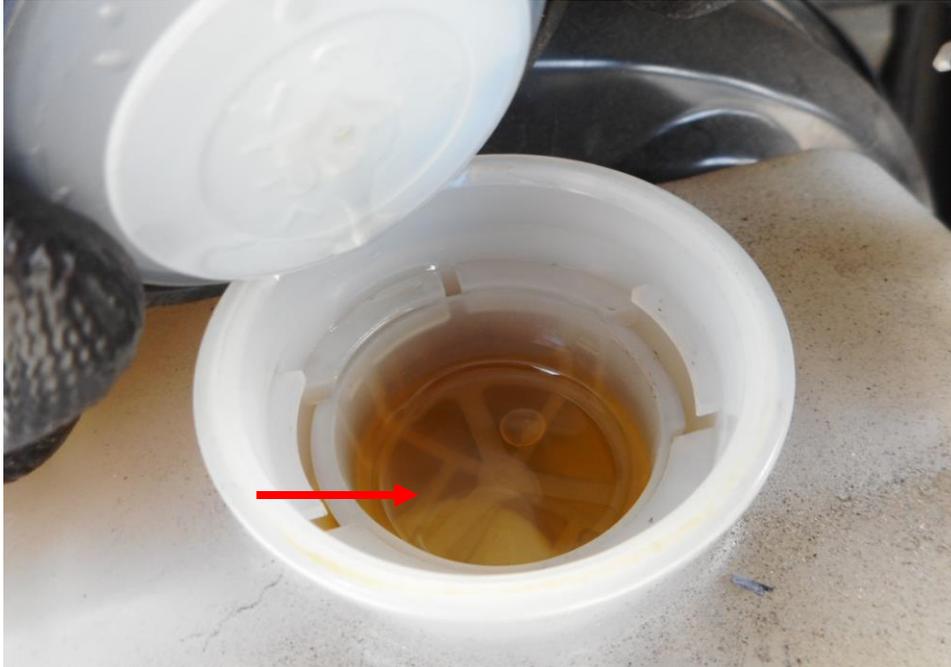
Photo 13 shows the brake fluid reservoir of the Motor Van at the time of my inspection. The brake fluid was observed to be of sufficient level (arrowed) and without any visible contamination.

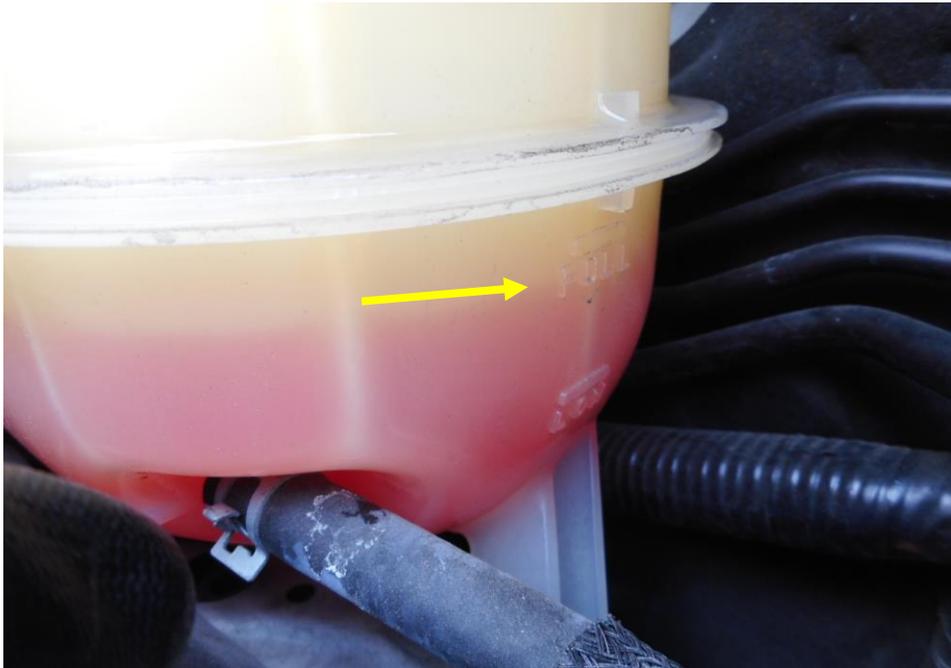
Photo 14 shows the engine coolant reservoir of the Motor Van at the time of my inspection. The engine coolant was observed to be of sufficient level (arrowed) and without any visible contamination.

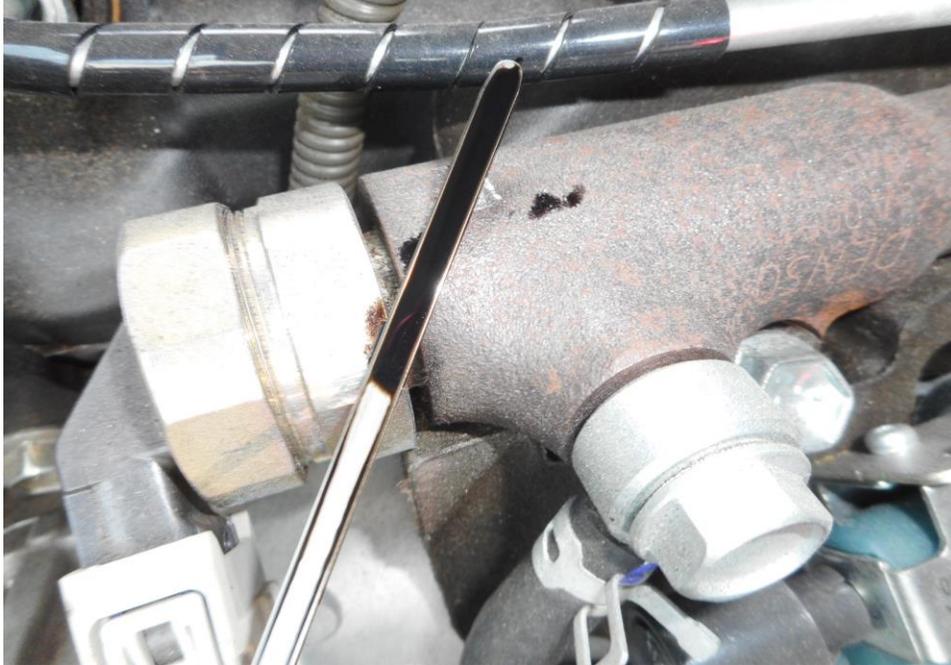
Photo 15 shows the engine oil dip stick of the Motor Van at the time of my inspection. The engine oil was observed to be of sufficient level and without any visible contamination.

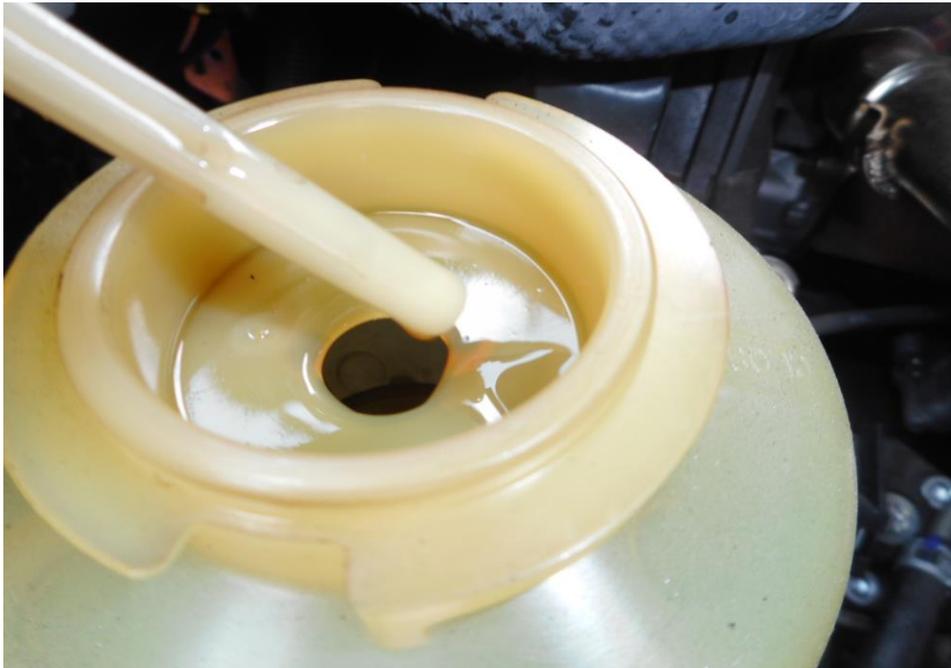
Photo 16 shows the power steering fluid reservoir of the Motor Van at the time of my inspection. The power steering fluid was observed to be of sufficient level (arrowed) and without any visible contamination.

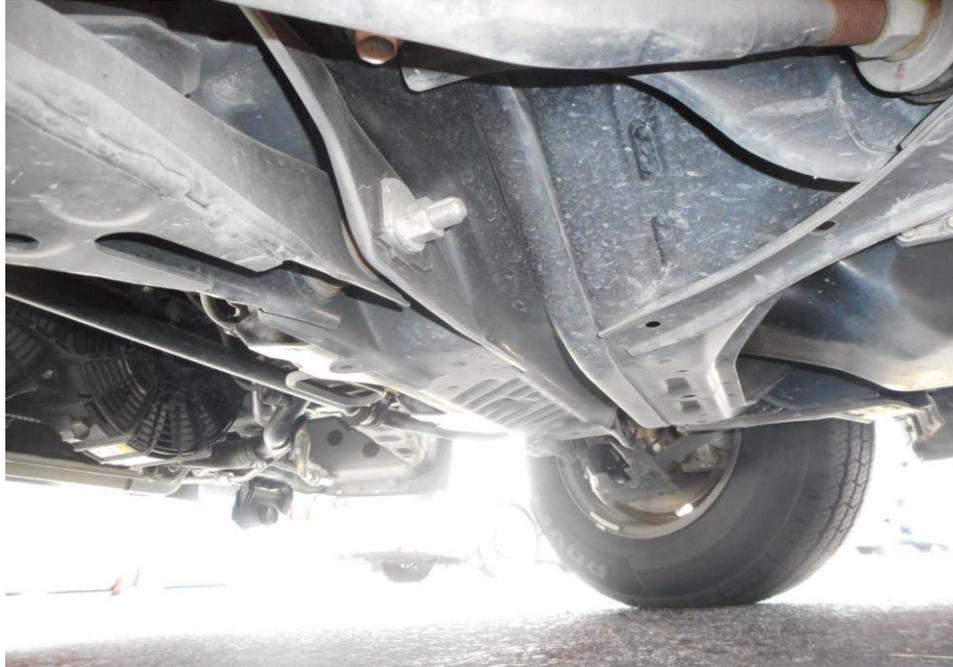
Photo 17 shows the undercarriage of the Motor Van, at the area where the engine housing and transmission housing are located. I did not find any sign(s) or indication(s) of fluid leak and/or fluid stain(s) on the underside of the Motor Van.

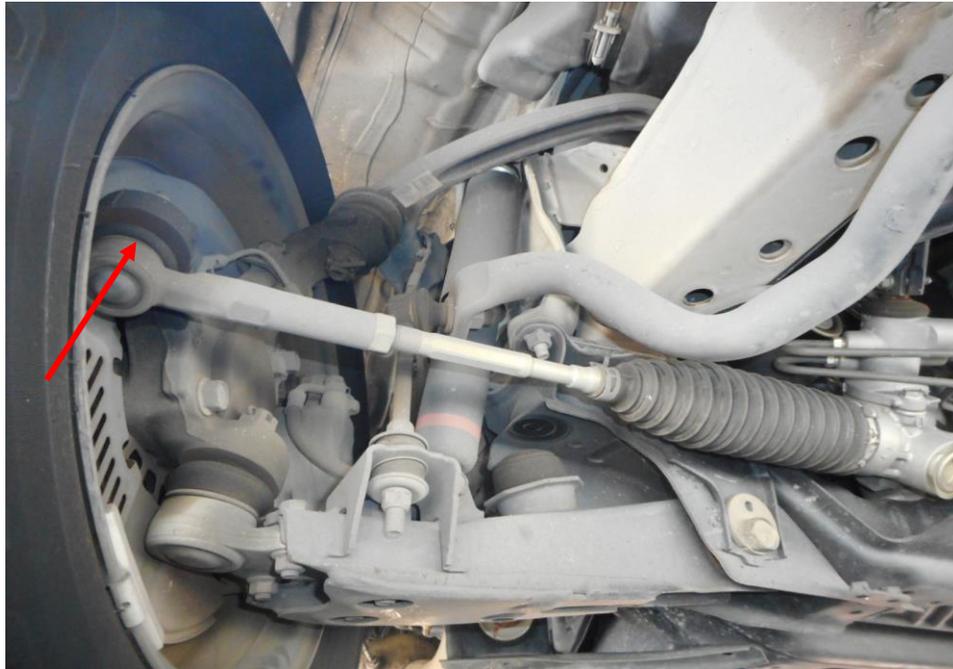
Photo 18 shows the various undercarriage components at the front right wheel of the Motor Van, in particular the steering tie rod end (arrowed). The various steering components were all found to be intact, suggesting that the steering system of the Motor Van was likely to be in serviceable condition at the material time of accident. There was also no sign of fluid stain(s) observed on the various undercarriage components.

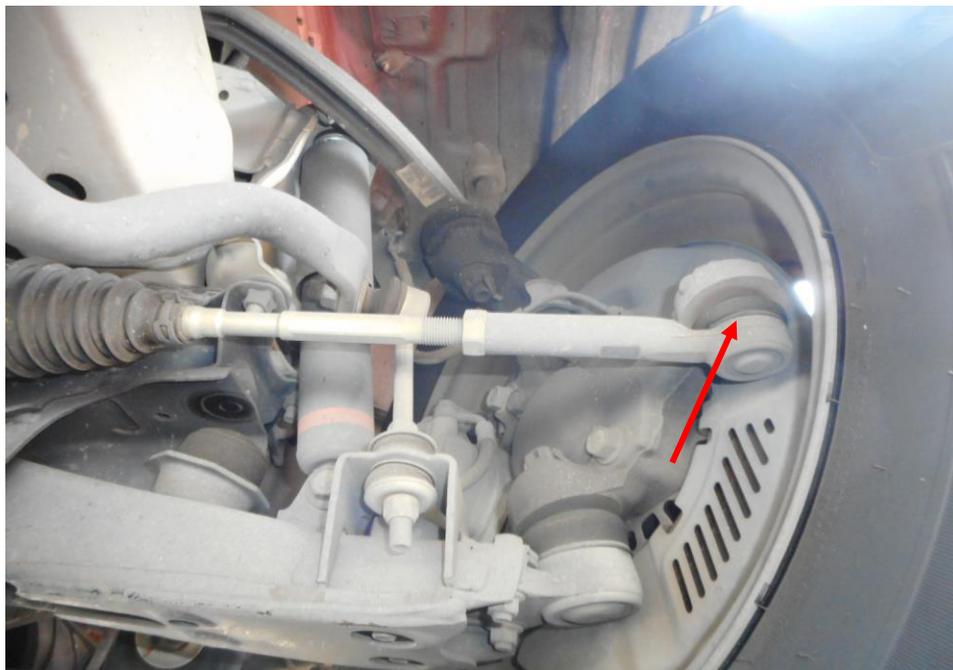
Photo 19 shows the various undercarriage components at the front left wheel of the Motor Van, in particular the steering tie rod end (arrowed). The various undercarriage components of the Motor Van were all found to be intact without any visible damage. There was also no sign of fluid stain(s) observed on the various undercarriage components.

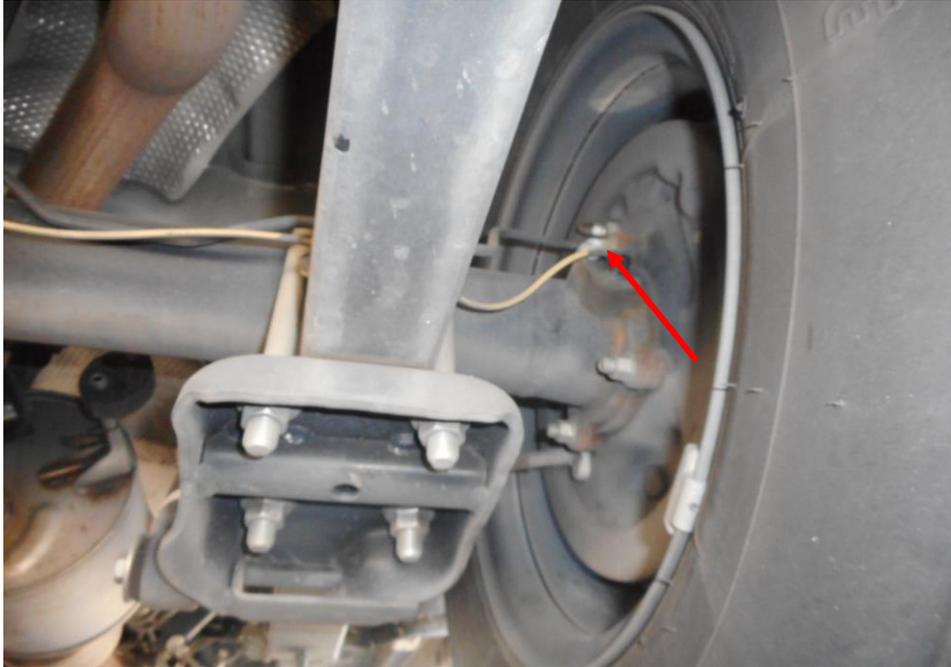
Photo 20 shows the brake pipe (arrowed) at the rear right wheel of the Motor Van. I did not observe any leakage of brake fluid at the time of my inspection of the Motor Van. My static tests of the Motor Van's braking system, along with my visual examination of the various mechanical components in the braking system, had indicated that there was no internal leakage of pressure/vacuum. Hence the braking system of the Motor Van was likely to be in serviceable condition at the material time of accident.

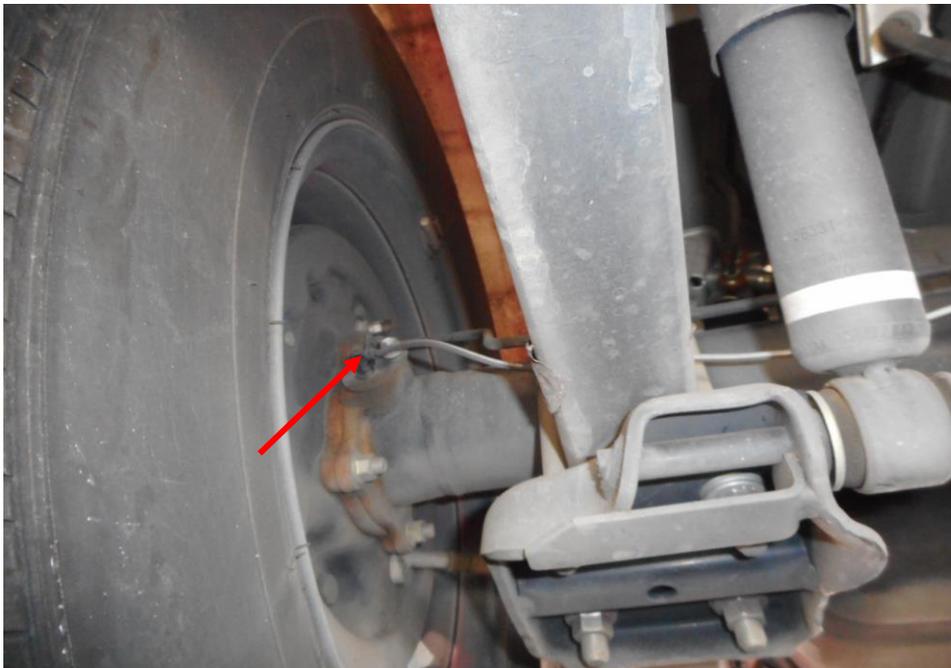
Photo 21 shows the brake pipe (arrowed) at the rear left wheel of the Motor Van. I did not observe any leakage of brake fluid at the time of my inspection of the Motor Van. My static tests of the Motor Van's braking system, along with my visual examination of the various mechanical components in the braking system had indicated that there was no internal leakage of pressure/vacuum. Hence the braking system of the Motor Van was likely to be in serviceable condition at the material time of accident.

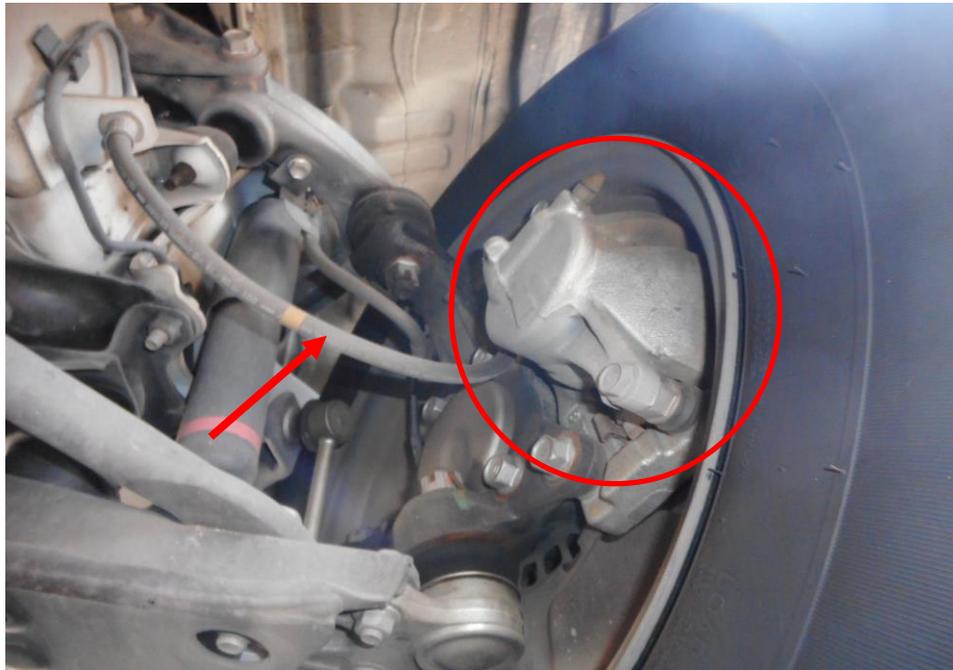
Photo 22 shows the brake hose/pipe (arrowed) at the front right wheel of the Motor Van. No leakage of brake fluid was observed. Visual examination of the various components of the braking system like the brake caliper (circled), brake booster, brake pedal etc had revealed all to be intact and without visible damage at the time of accident. There was also no sign of fluid stain(s) observed on the various undercarriage components.

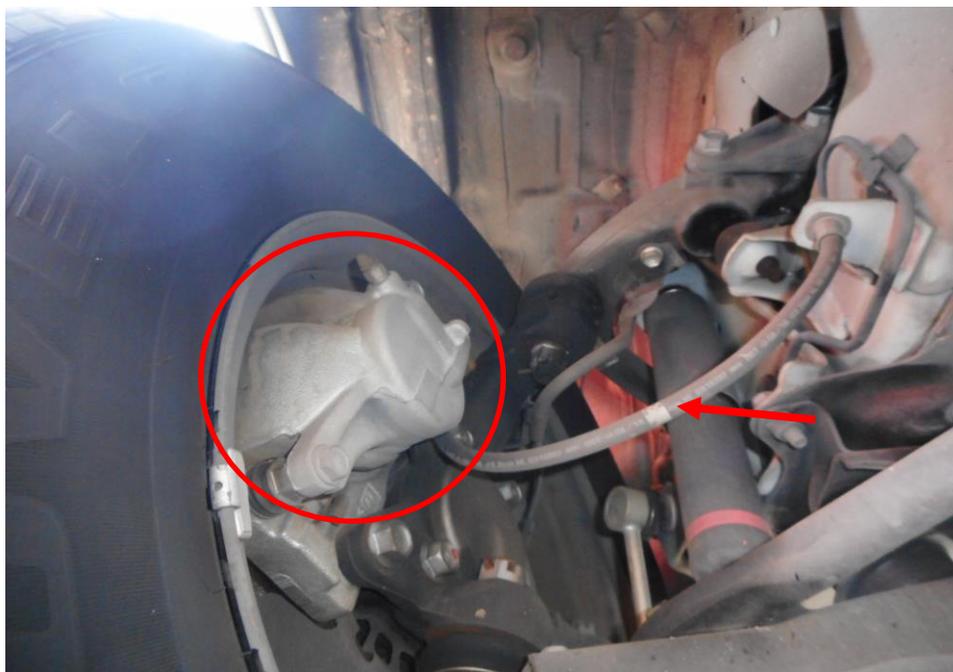
Photo 23 shows the brake hose/pipe (arrowed) at the front left wheel of the Motor Van. No leakage of brake fluid was observed. Visual examination of the various components of the braking system like the brake caliper (circled), brake booster, brake pedal etc had revealed all to be intact and without visible damage at the time of accident. There was also no sign of fluid stain(s) observed on the various undercarriage components.

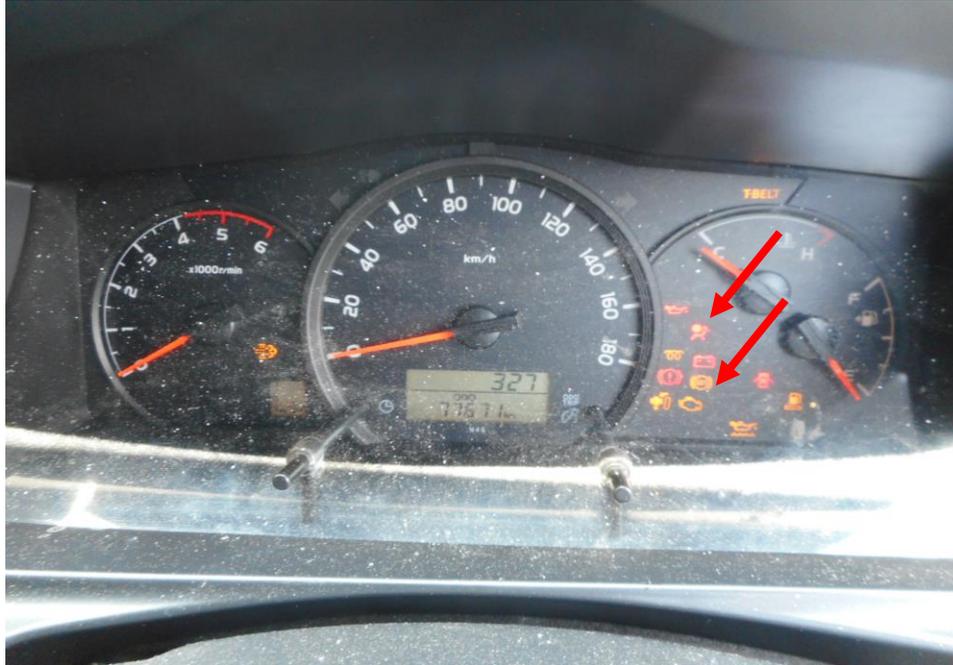
Photo 25 shows the warning light for Anti-Lock Brake System (ABS) and Supplemental Restraint System (SRS) (arrowed) appearing on the instrument panel of the Motor Van during the self-test of its various electronic operating systems when its engine was cranked.

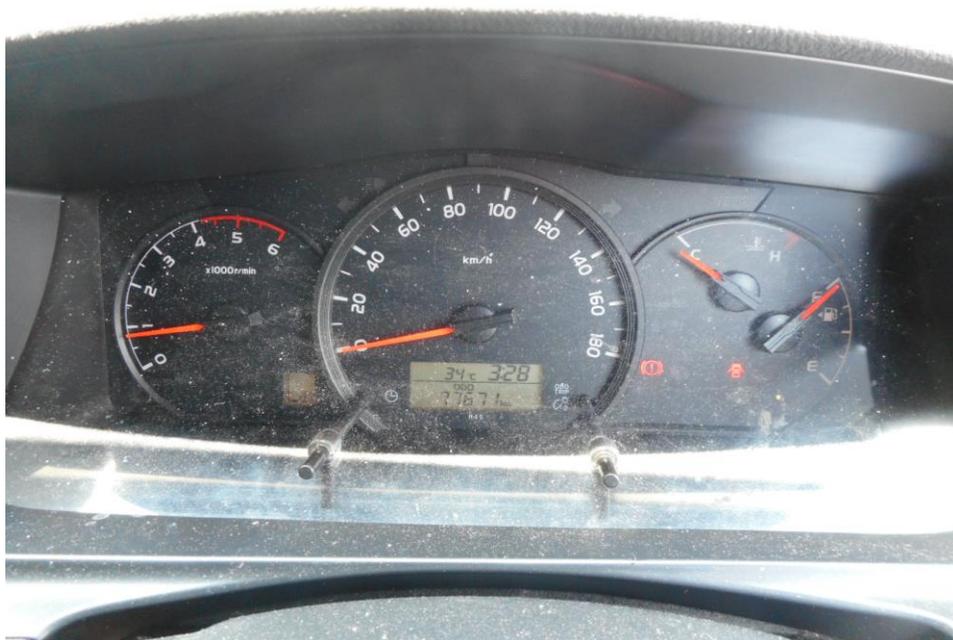
Photo 26 shows no warning lights illuminated on the instrument panel of the Motor Van after the engine was cranked. This would suggest that there was no abnormality to the electronic operating system of the Motor Van, like the ABS, and SRS etc.
