You're Ref: TP/IP/04943/2021  
Our Ref: CI/TPD21002929/P

18<sup>th</sup> March 2021

**MECHANICAL INSPECTION REPORT OF MOTOR CAR SJM 3716L**

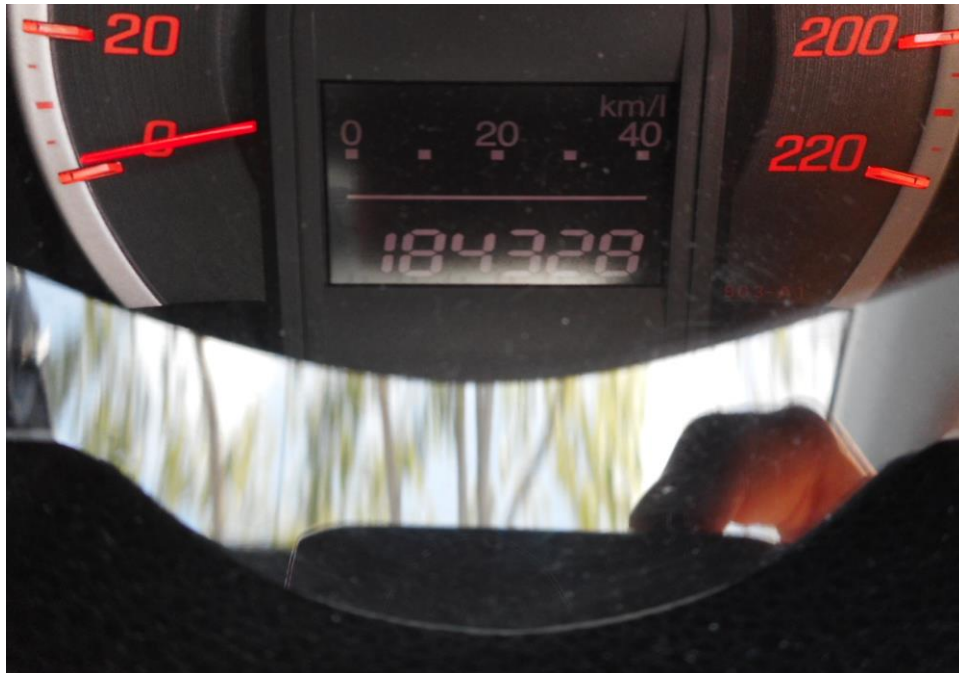
**Photo 1** shows the mileage of the Motor Car at the time of my inspection. The mileage observed was 184,328km.

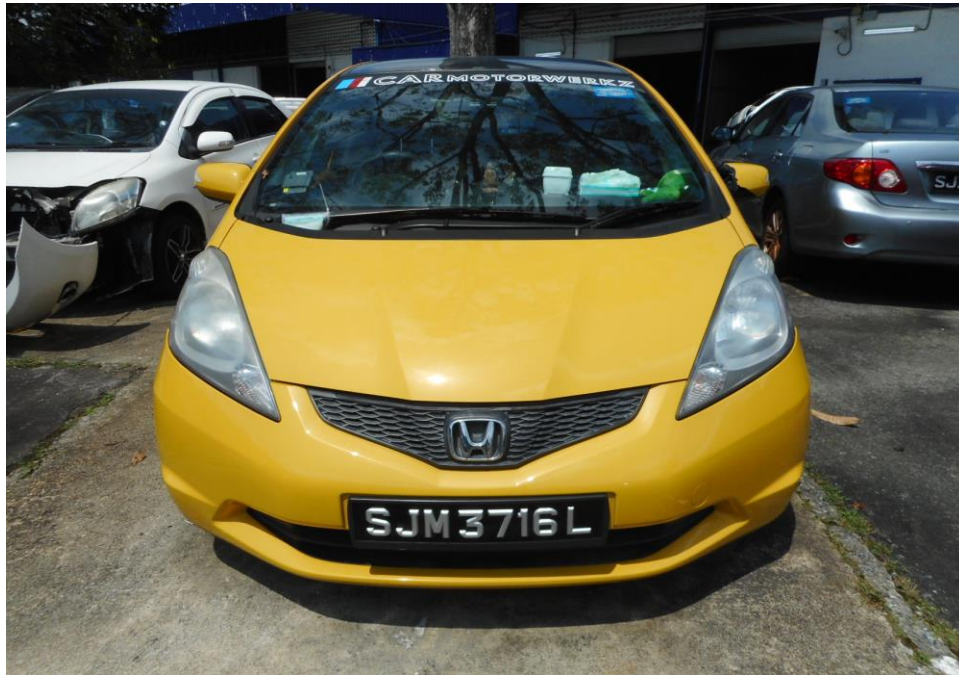
**Photo 2** shows a general view of the Motor Car's front body at the time of my inspection. The front portion of the Motor Car was observed to have been unaffected by the accident.

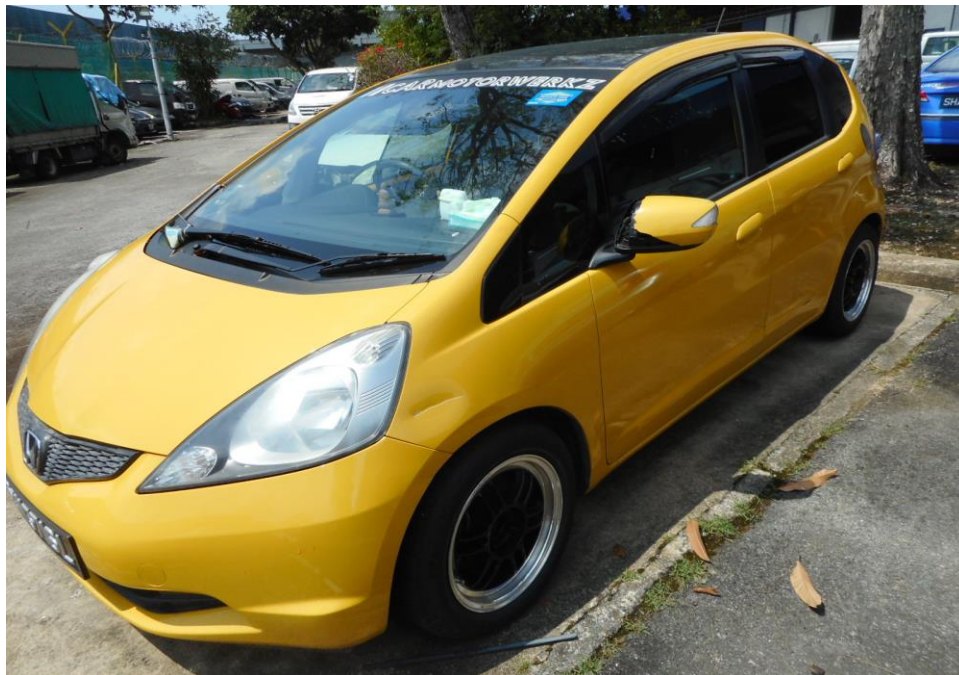
4. The mileage of the Motor Car at the time of my inspection was 184,328km.
5. The Motor Car was observed to have sustained damage at its left portion. Its front left rear view mirror was the body part that were damaged as a result of the accident.

**Photo 3** shows a general view of the Motor Car's left body at the time of my inspection. The left portion of the Motor Car was observed to have sustained damage. Its front left rear view mirror was the body part that were damaged as a result of the accident.

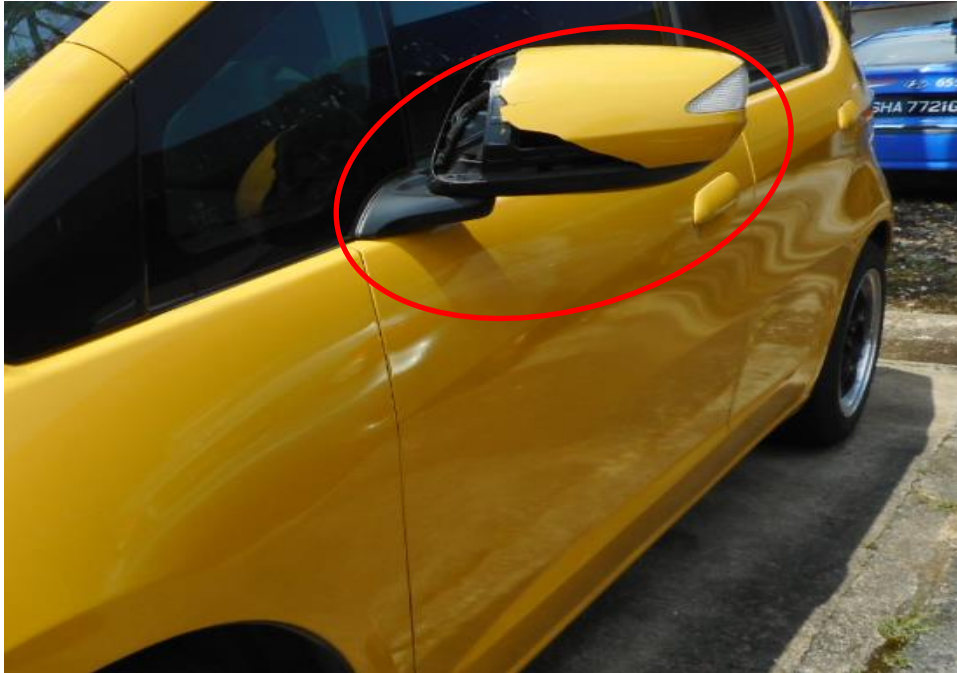
**Photo 4** shows the close up view of the Motor Car's front body at the time of my inspection. The Motor Car was observed to have sustained damage at its front left rear view mirror (circled) as a result of the accident.

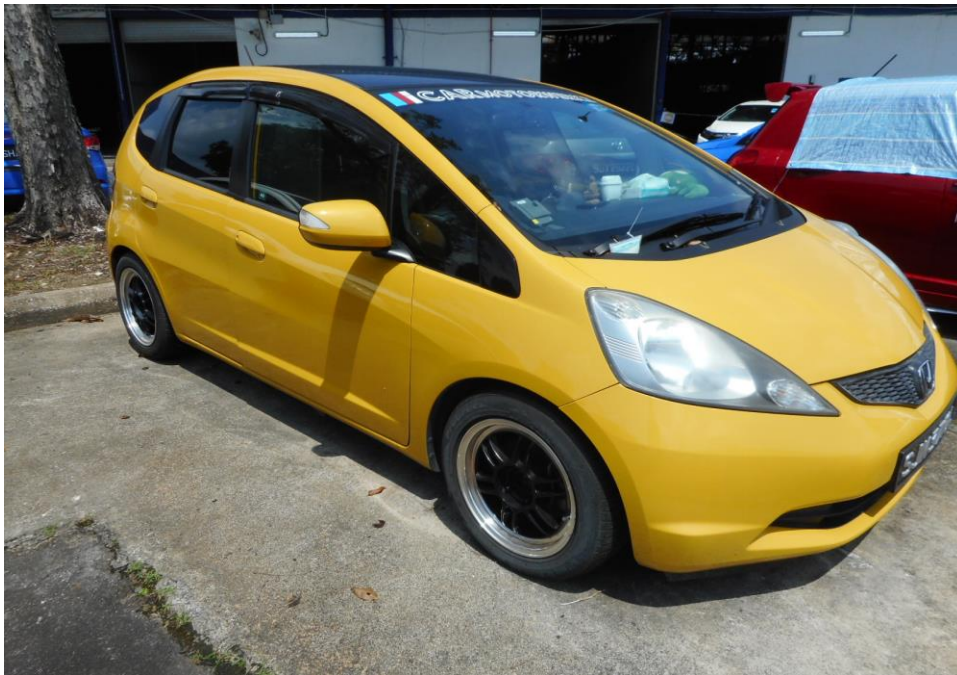
**Photo 5** shows a general view of the Motor Car's right body at the time of my inspection. The right portion of the Motor Car was observed to have been unaffected by the accident.

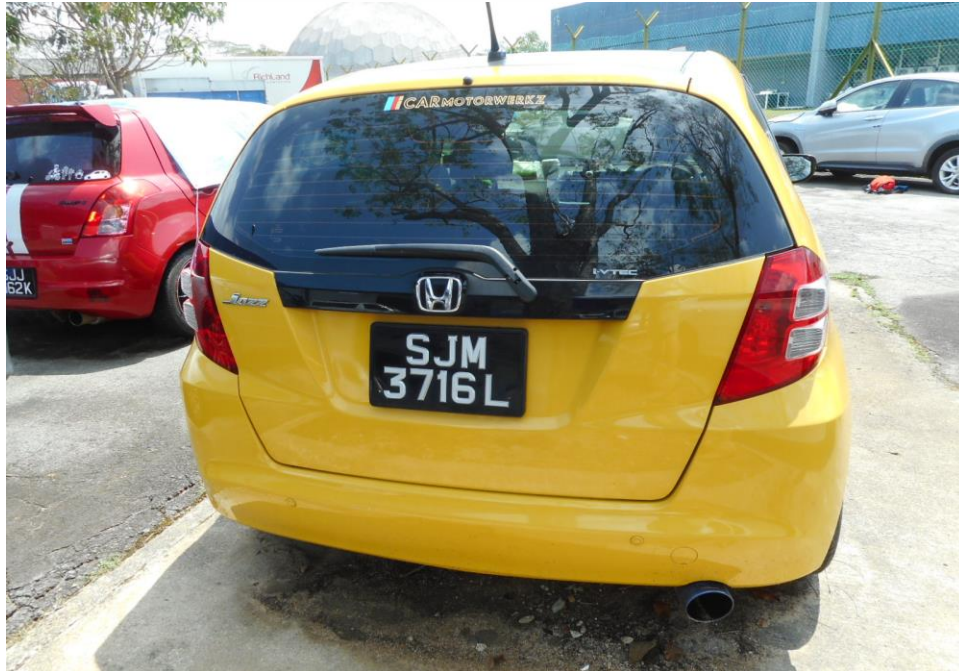
**Photo 6** shows the general view of the Motor Car's rear body at the time of my inspection. The Motor Car rear was observed to be unaffected by the accident.

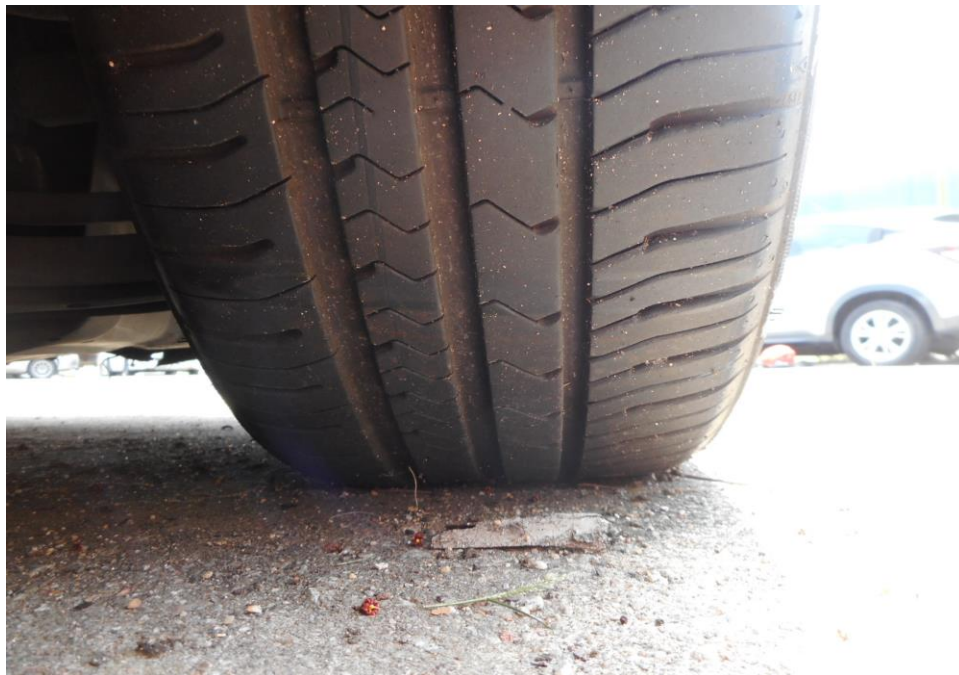
**Photo 7** shows the condition of the front right tyre of the Motor Car, which was observed to be in serviceable condition with remaining tread depth of approximately 6.5mm. The tyre was sufficiently inflated for vehicular operation with no tear, cut or burst mark(s) on the outer and the inner sidewalls as well as across the tread. The 4 tyres of the Motor Car were wrapped around standard steel wheel rims without any damage.

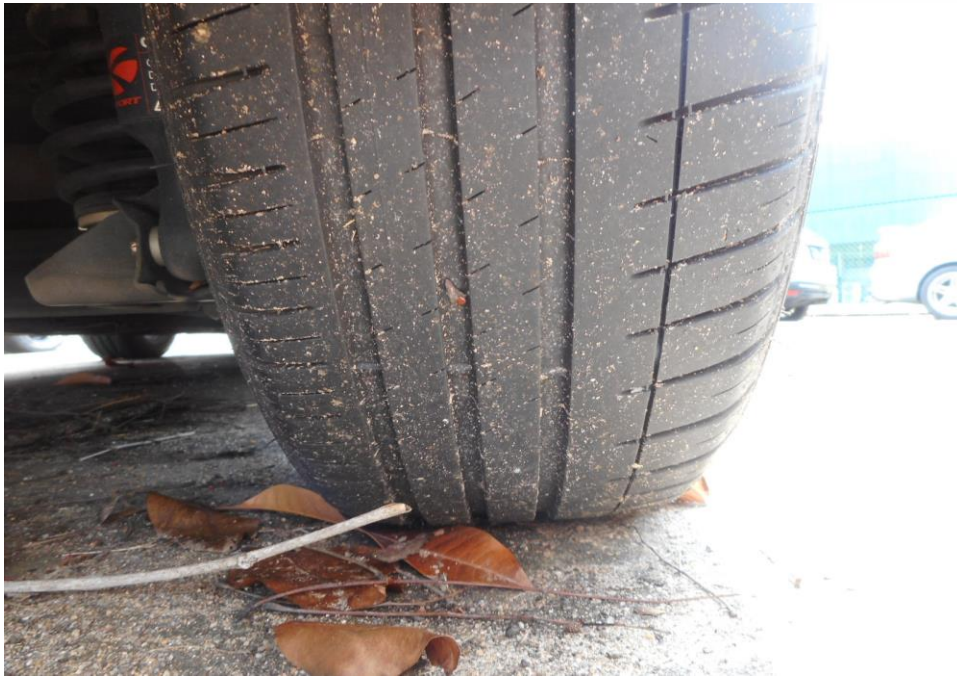
**Photo 8** shows the condition of the rear right tyre of the Motor Car, which was observed to be in serviceable condition with remaining tread depth of approximately 4.3mm. The tyre was also observed to be sufficiently inflated for vehicular operation with no tear, cut or burst mark(s).

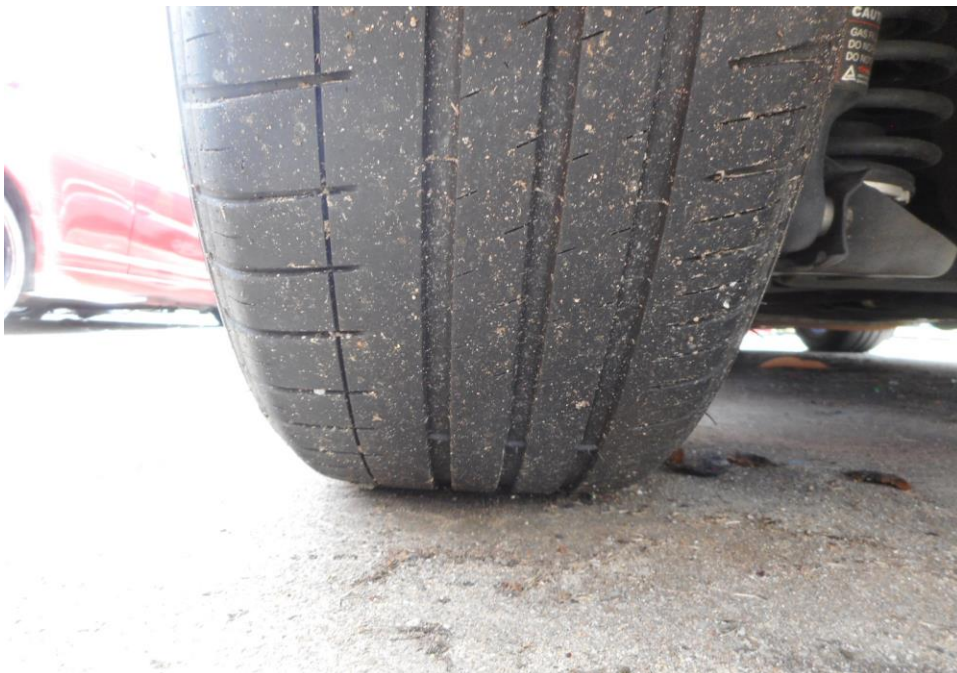
**Photo 9** shows the condition of the rear left tyre of the Motor Car, which was observed to be in serviceable condition with remaining tread depth of approximately 3.7mm. The tyre, which was wrapped around steel wheel rim, was also observed to be sufficiently inflated for vehicular operation. The 4 tyres of the Motor Car were wrapped around standard steel wheel rims.

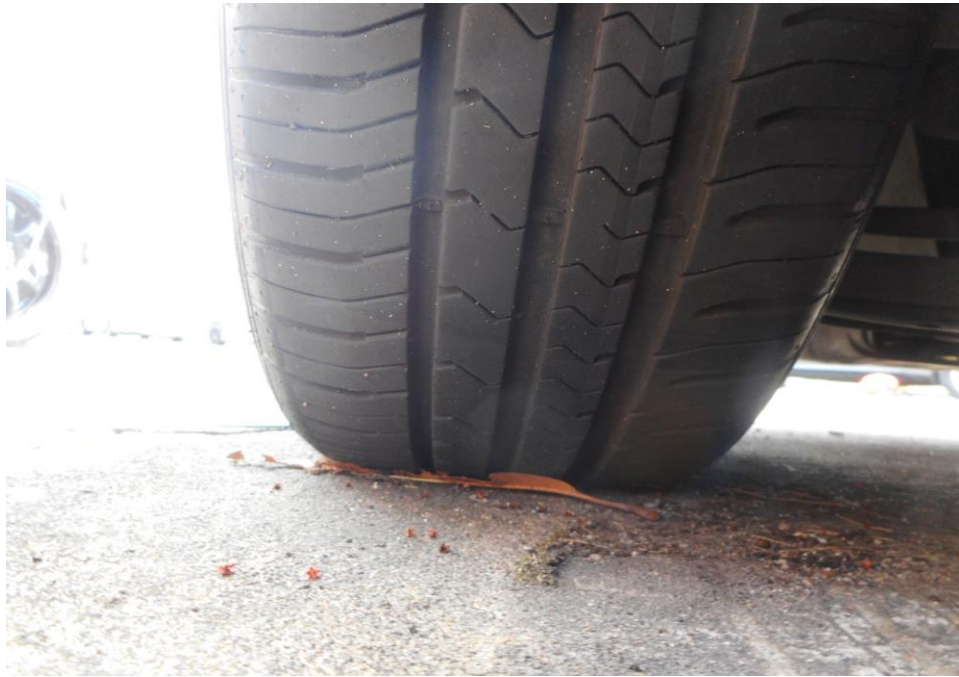
**Photo 10** shows the condition of the front left tyre of the Motor Car, which was observed to be in serviceable condition with remaining tread depth of approximately 3.9mm. There was also no tear, cut or burst mark(s) on the outer and the inner sidewalls as well as across the tread of the Motor Car's 4 tyres.

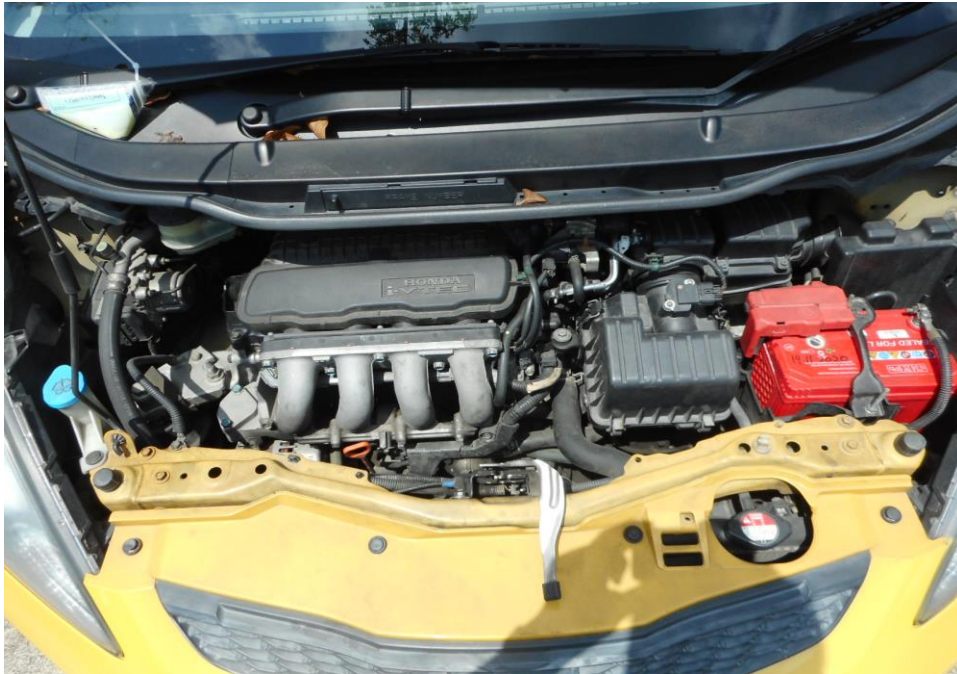
**Photo 11** shows a general view of the Motor Car's engine compartment. The various parts and components inside the engine compartment were unaffected by the accident. There was also no sign(s) or indication(s) of fluid leakage and/or fluid stain within the engine compartment.

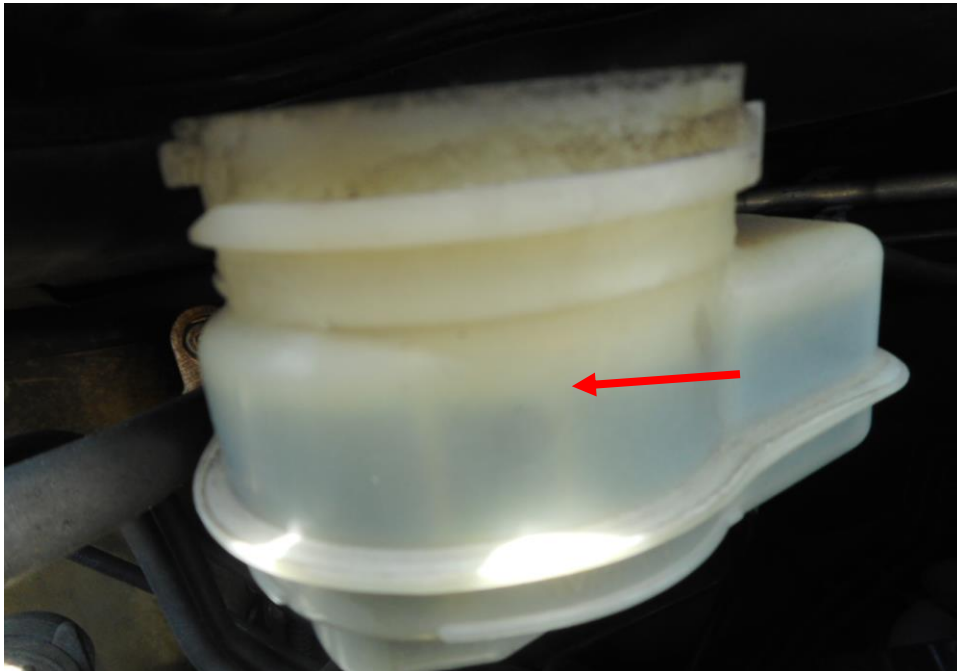
**Photo 12** shows the brake fluid reservoir of the Motor Car at the time of my inspection. The brake fluid was observed to be of sufficient level (arrowed) and without any visible contamination.

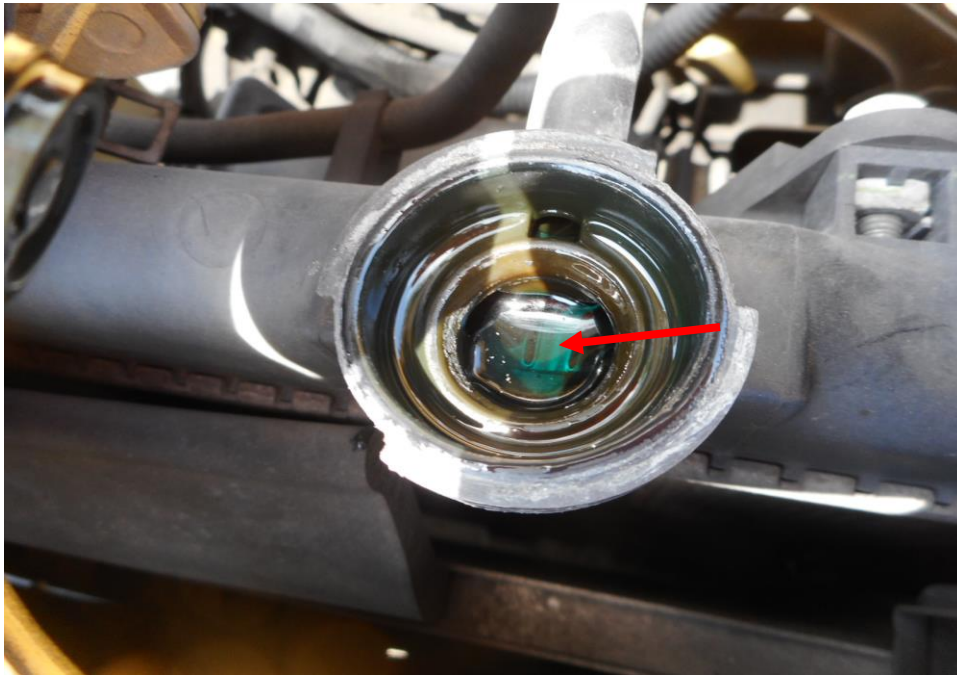
**Photo 13** shows checks being carried out to the engine coolant of the Motor Car at the time of my inspection. The engine coolant was observed to be of sufficient level (arrowed) and without any visible contamination.

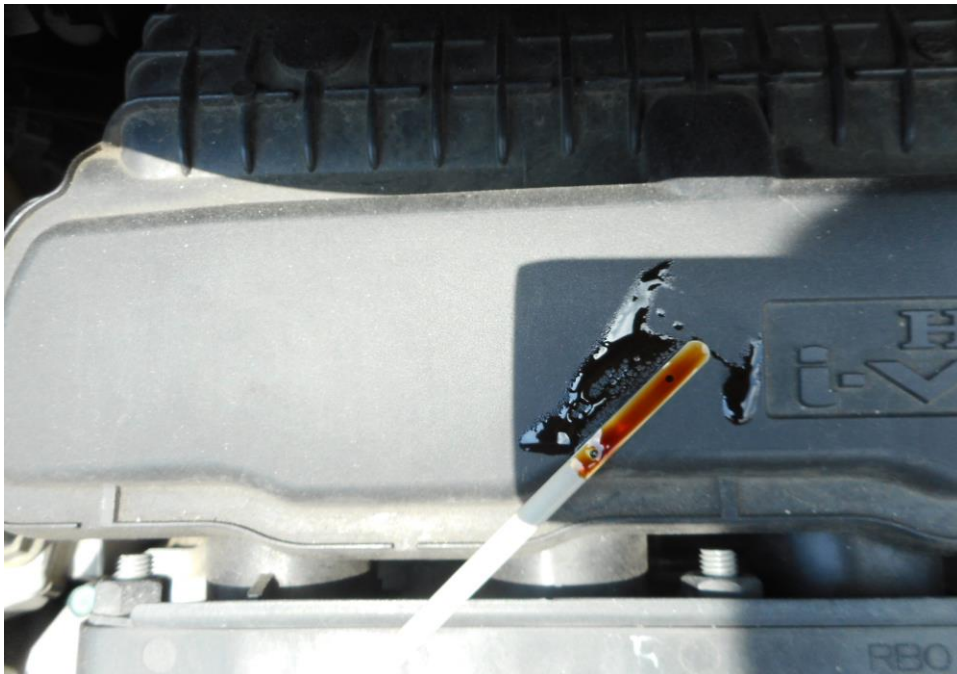
**Photo 14** shows the engine oil dip stick of the Motor Car at the time of my inspection. The engine oil was observed to be of sufficient level and without any visible contamination.

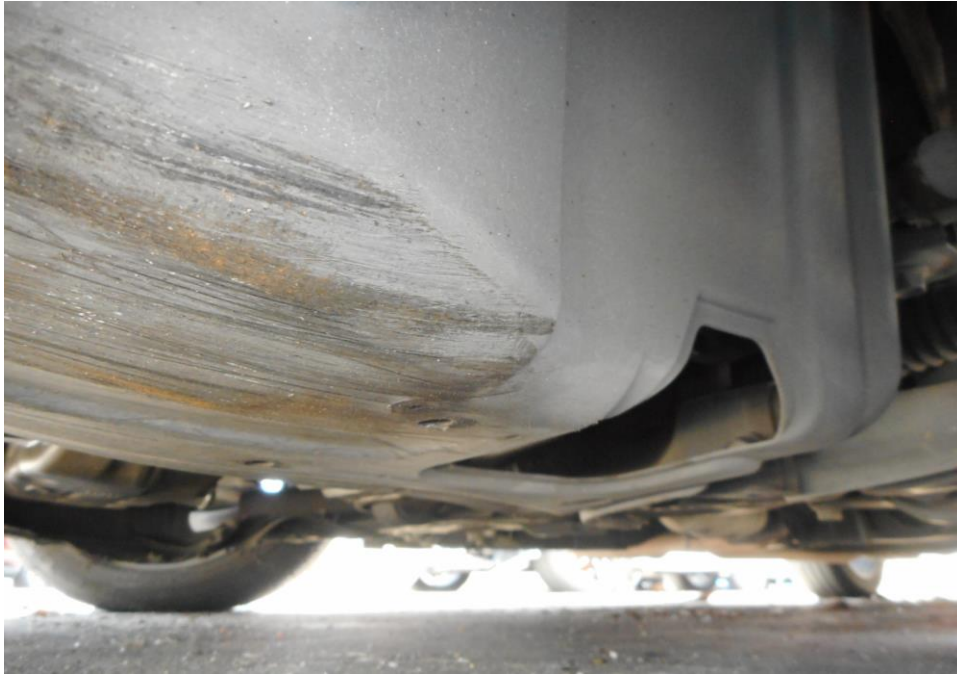
**Photo 15** shows the undercarriage of the Motor Car, at the area where the engine housing and transmission housing are located. I did not find any sign(s) or indication(s) of fluid leak and/or fluid stain(s) on the underside of the Motor Car.

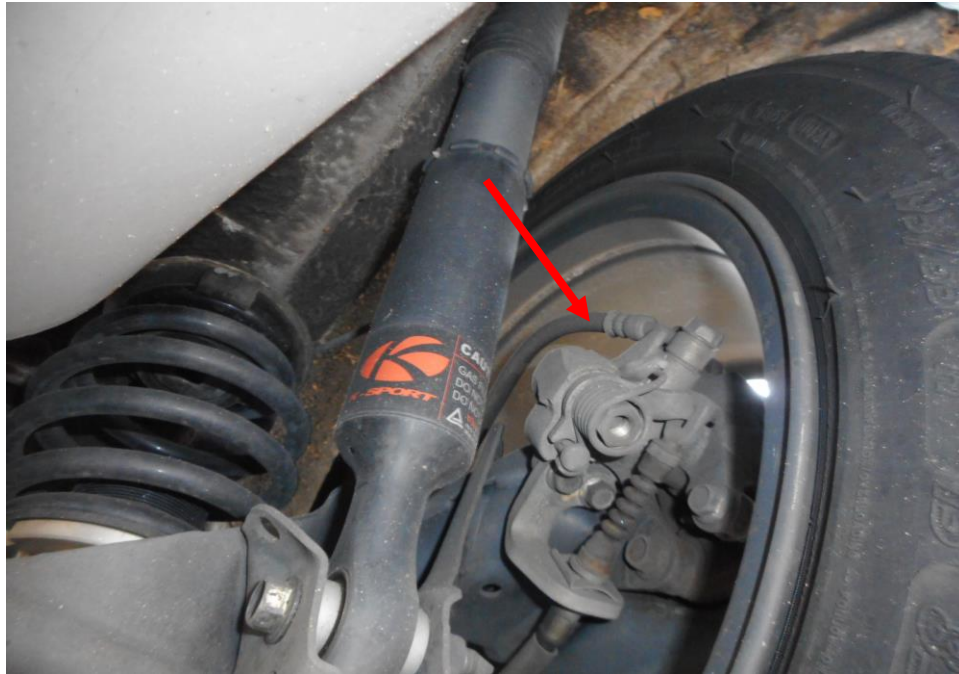
**Photo 16** shows the brake hose/pipe (arrowed) at the rear right wheel of the Motor Car. No leakage of brake fluid was observed. Visual examination of the various components of the braking system like the drum brake, brake booster, brake pedal etc. had revealed all to be intact and without visible damage.

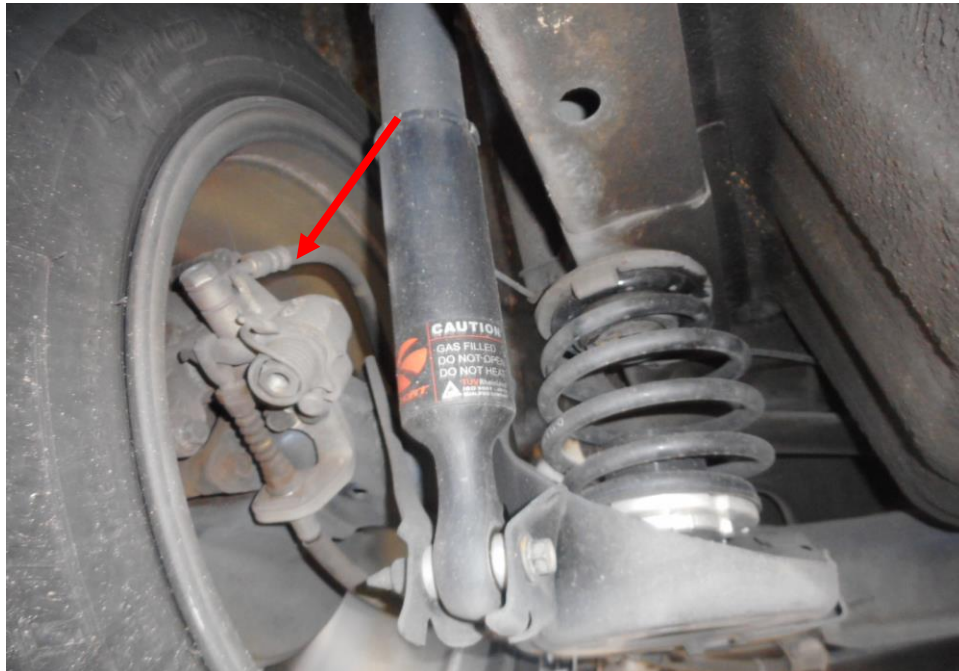
**Photo 17** shows the brake hose/pipe (arrowed) at the rear left wheel of the Motor Car. I did not observe any leakage of brake fluid at the time of my inspection of the Motor Car. Static tests of the Motor Car's braking system had indicated that there was no internal leakage of pressure/vacuum. The undercarriage components of the Motor Car were also all found to be intact and without any visible damage.

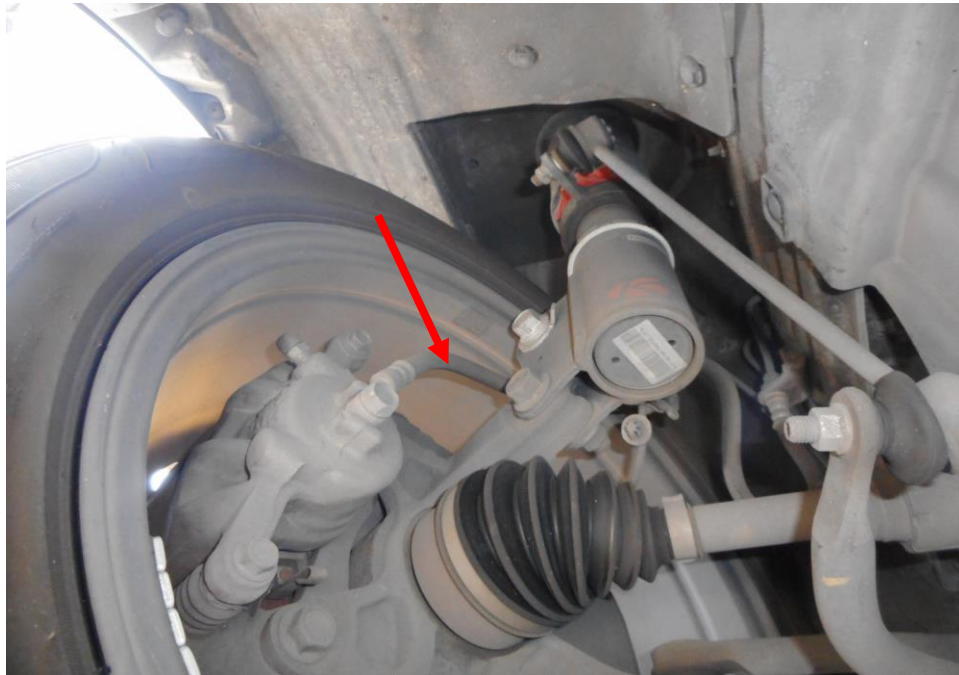
**Photo 18** shows the brake hose/pipe (arrowed) at the front right wheel of the Motor Car. I did not observe any leakage of brake fluid at the time of my inspection of the Motor Car. Static tests of the Motor Car's braking system had indicated that there was no internal leakage of pressure/vacuum. The undercarriage components of the Motor Car were also all found to be intact and without any visible damage.

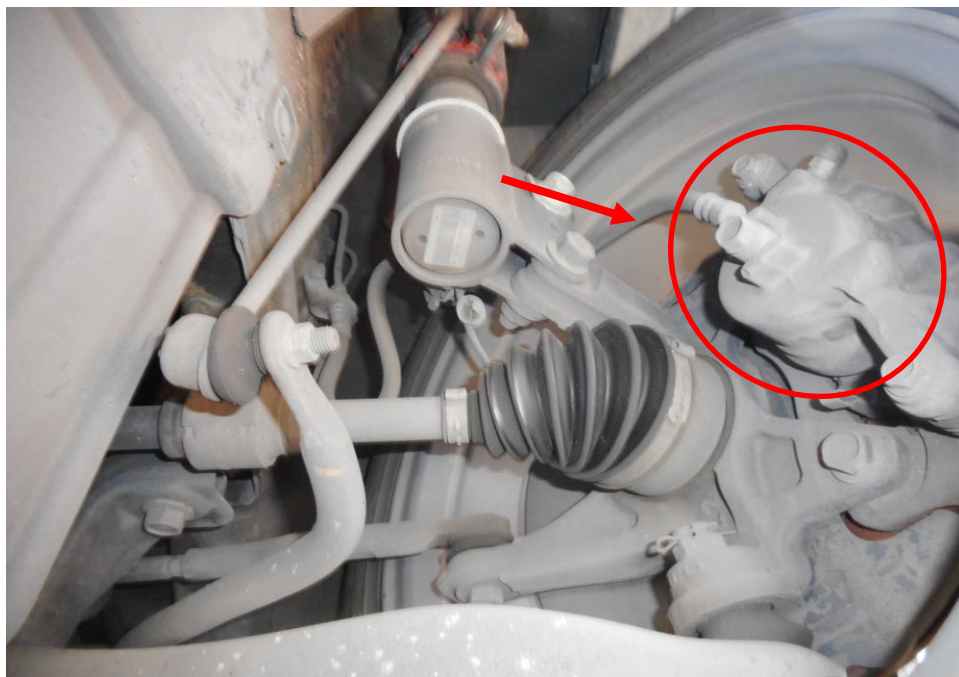
**Photo 19** shows the brake hose/pipe (arrowed) at the front left wheel of the Motor Car. No leakage of brake fluid was observed. Visual examination of the various components of the braking system like the brake caliper (circled), brake booster, brake pedal etc had revealed all to be intact and without visible damage.

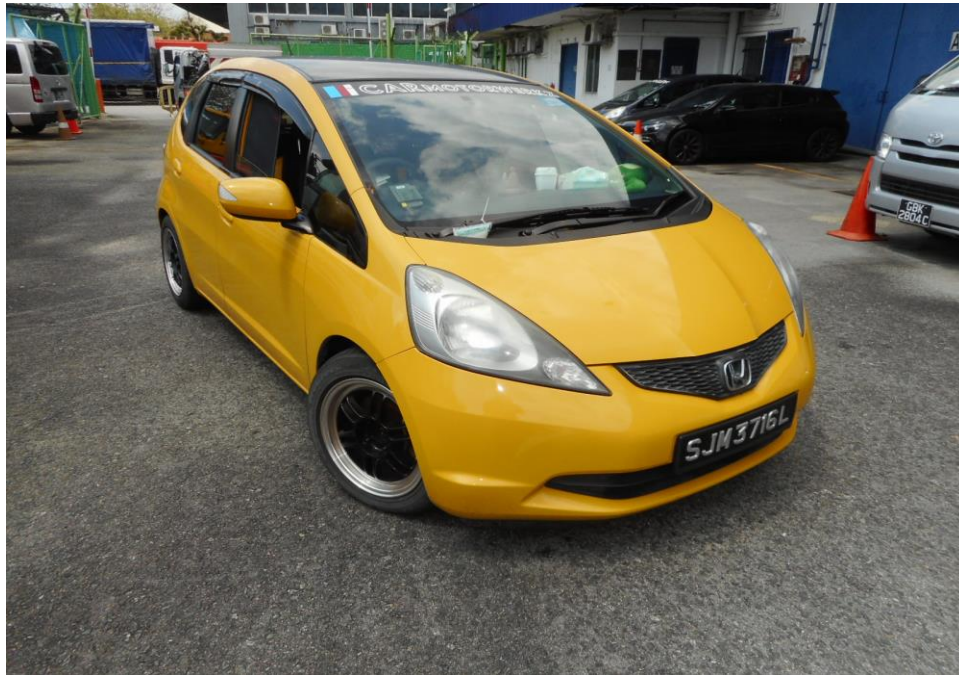
**Photo 20** shows the front right wheel of the Motor Car turned to its full left. During my steering system test, I did not experience any abnormal free play and/or resistance when I had turned the steering wheel towards the left and right. This would suggest that the steering system of the Motor Car was likely to be in serviceable condition at the material time of accident.

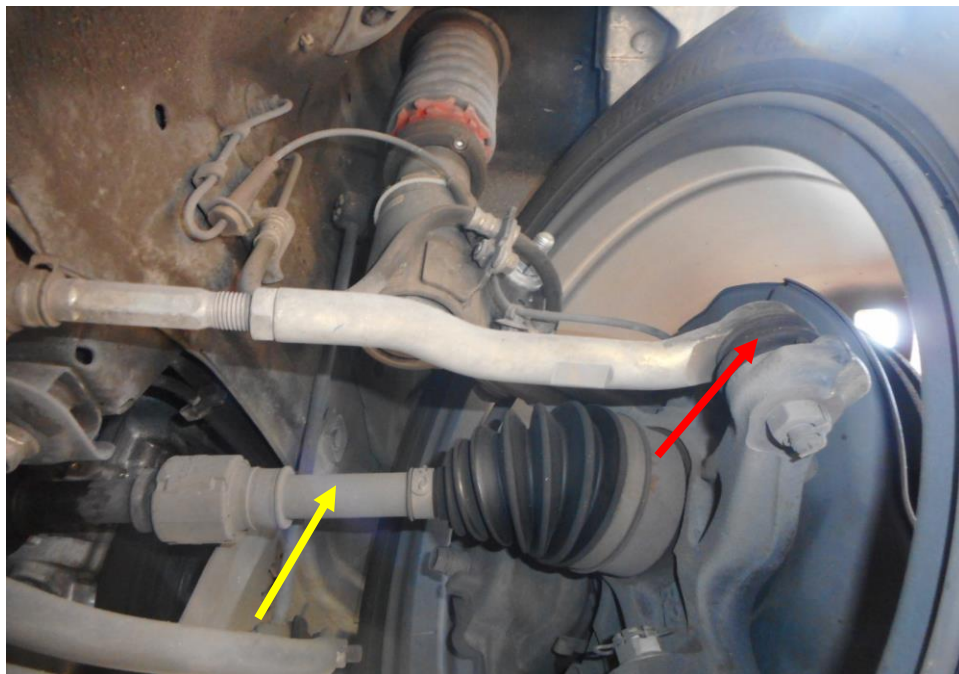
**Photo 21** shows the various undercarriage components at the front right wheel of the Motor Car, in particular the steering tie rod (red arrow) and drive shaft (yellow arrow). The various steering components were all found to be intact, suggesting that the steering system of the Motor Car was likely to be in serviceable condition at the material time of accident. There was also no sign of fluid stain observed on the various undercarriage components at the front right wheel of the Motor Car.

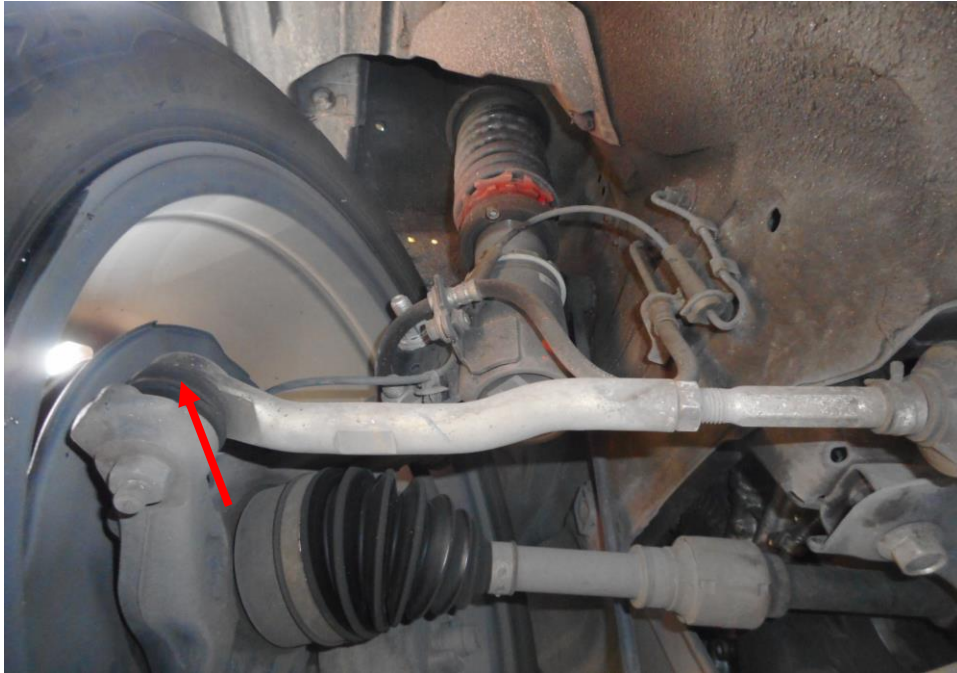
**Photo 22** shows the various undercarriage components at the front left wheel of the Motor Car, which had included the steering tie rod (red arrow). The various undercarriage components of the Motor Car were all found to be intact without any visible damage.

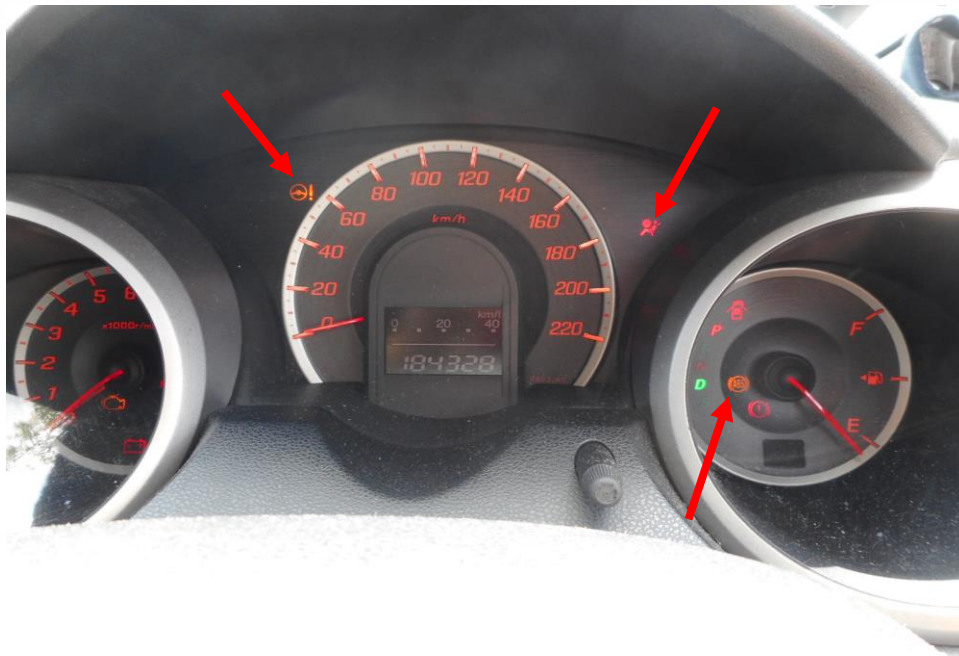
**Photo 23** shows the warning light for Anti-Lock Brake System (ABS) and Power Steering System (EPS) and Supplemental Restraint System (SRS) (arrowed) appearing on the instrument panel of the Motor Car during the self-test of its various electronic operating systems when its engine was cranked.

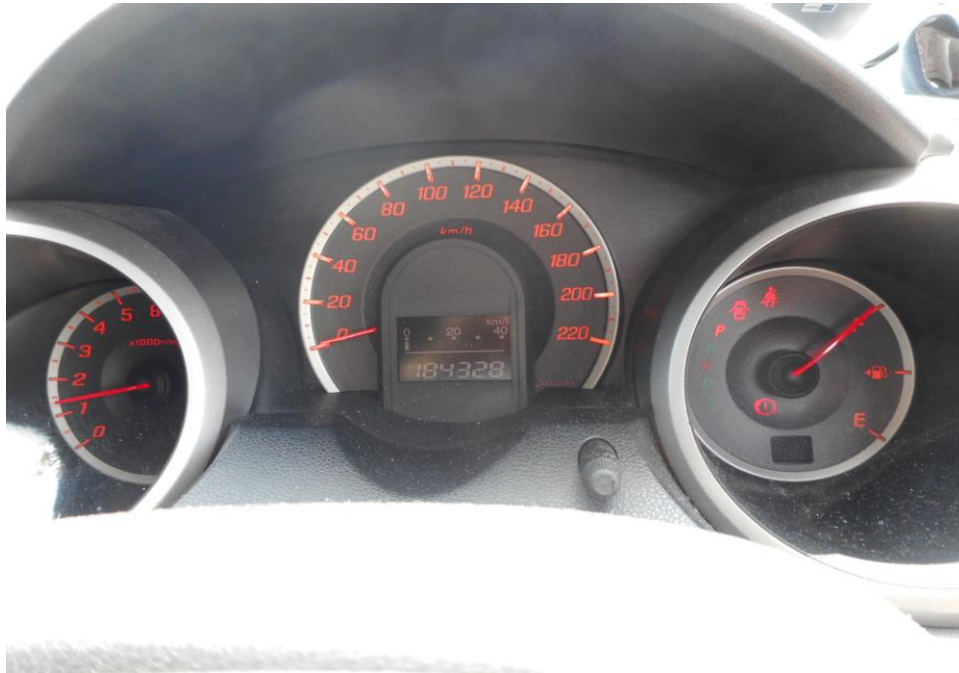
**Photo 24** shows no warning lights illuminated on the instrument panel of the Motor Car after the engine was cranked. This would suggest that there was no abnormality to the electronic operating system of the Motor Car, like the ABS, EPS and SRS etc.
