You're Ref: TP/IP/01915/2021
Our Ref: CI/TPD21002930/P

Fatal Accident Investigation Team

MECHANICAL INSPECTION REPORT OF MOTOR CAR SMK 7187L

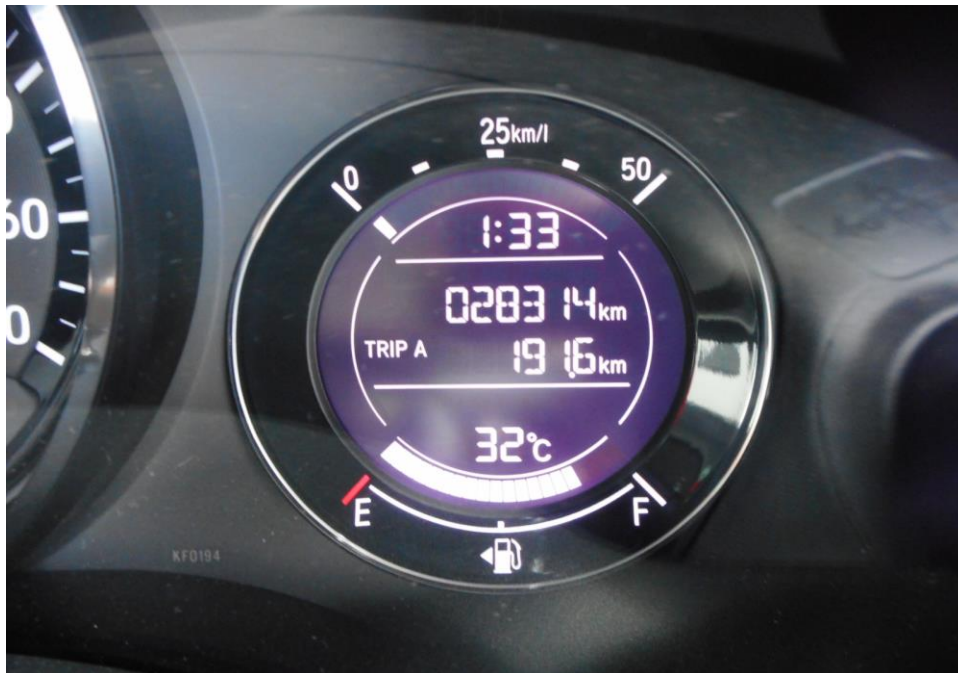
Photo 1 shows the mileage of the Motor Car at the time of my inspection. The mileage observed was 28,314km.

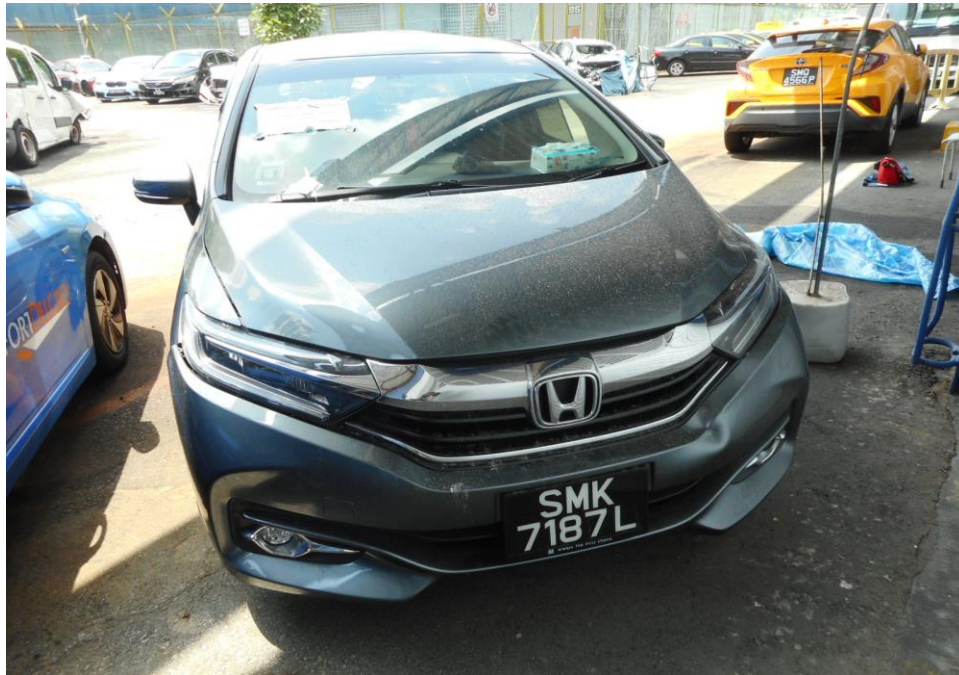
Photo 2 shows a general view of the Motor Car's front body at the time of my inspection. The front portion of the Motor Car was observed to have sustained damage. Its front bumper was the body part that were damaged as a result of the accident.

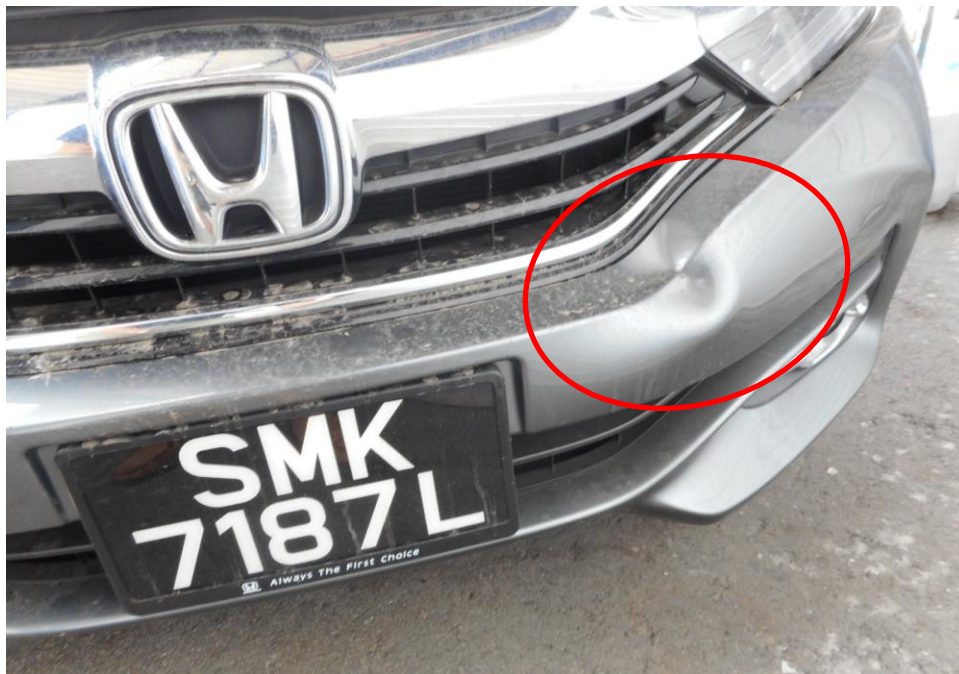
Photo 3 shows the close up view of the Motor Car's front body at the time of my inspection. The Motor Car was observed to have sustained damage at its front bumper (circled) as a result of the accident.

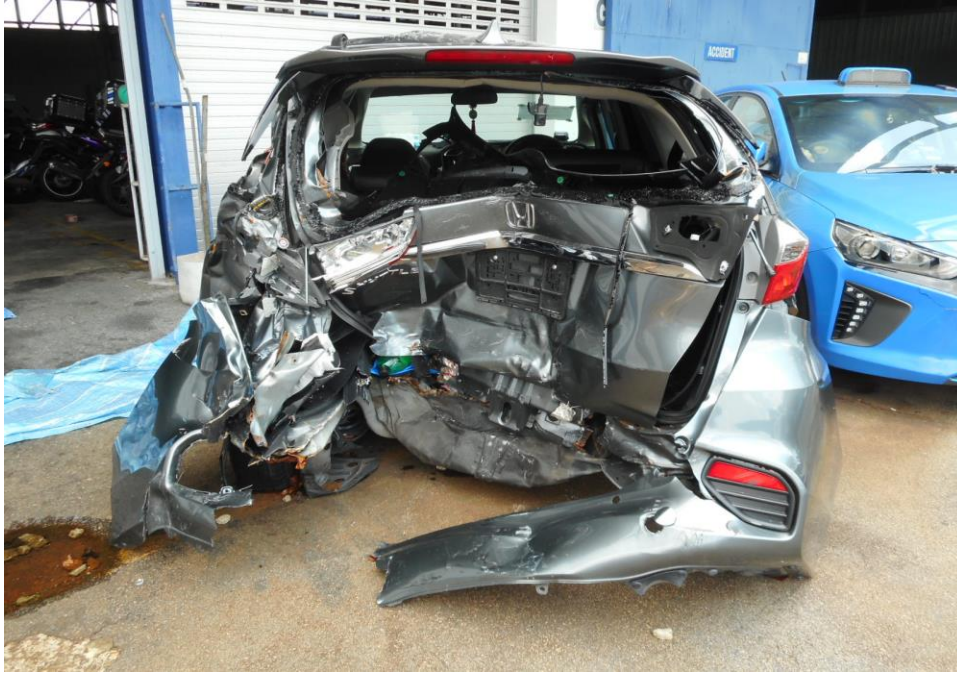
Photo 4 shows a general view of the Motor Car's rear body at the time of my inspection. The rear portion of the Motor Car was observed to have sustained damage. Its rear windscreen, rear boot and rear bumper was the body parts that were damaged as a result of the accident.

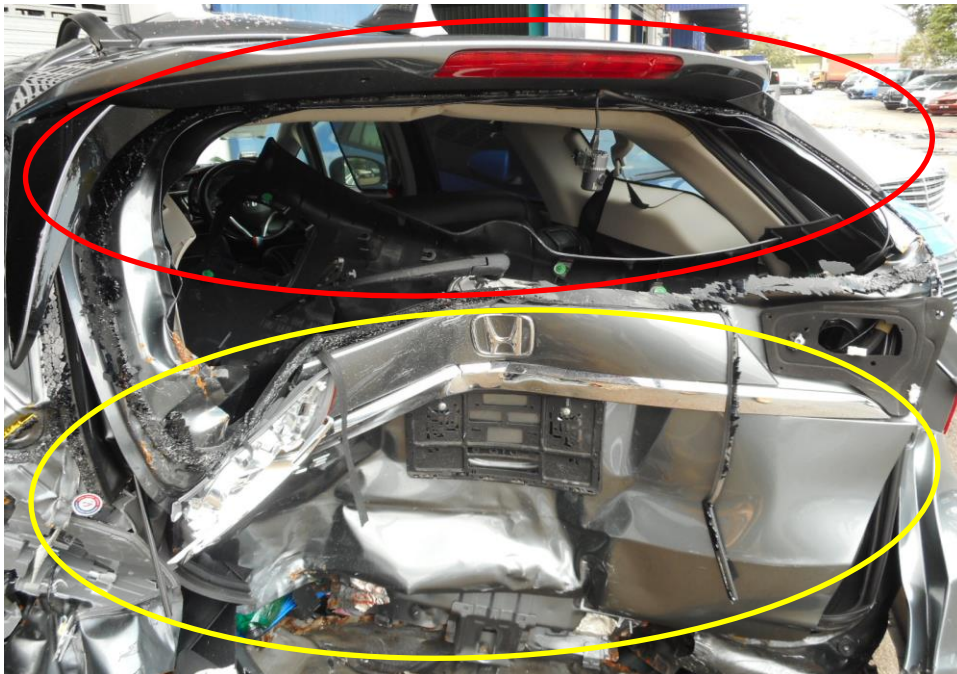
Photo 5 shows a close up view of the Motor Car's rear body at the time of my inspection. The rear portion of the Motor Car was observed to have sustained damage. Its rear windscreen (red circle) and rear boot (yellow circle) was the body parts that were damaged as a result of the accident.

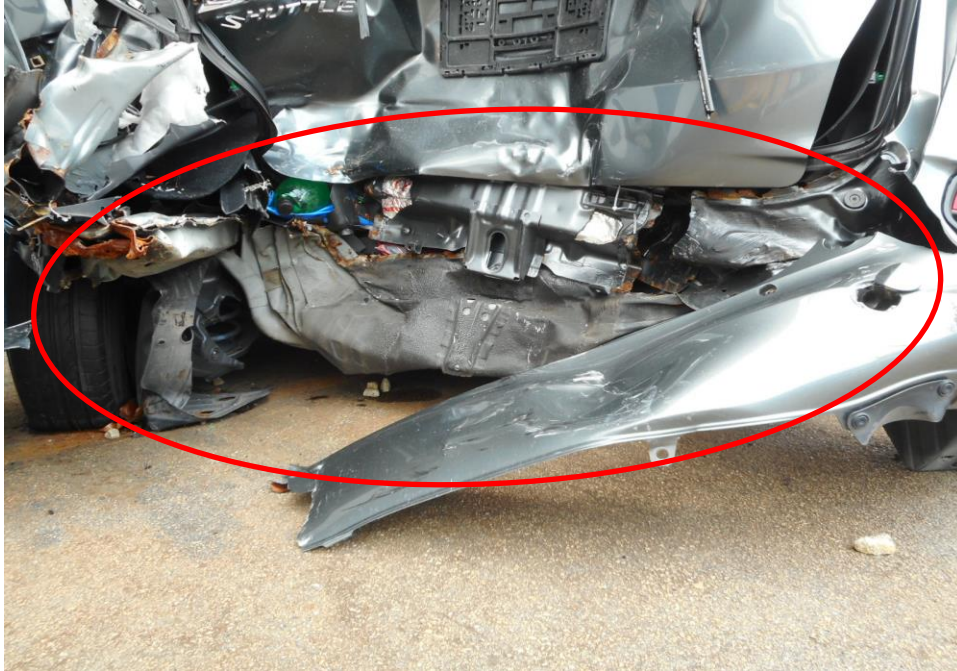
Photo 6 shows a close up view of the Motor Car's rear body at the time of my inspection. The rear portion of the Motor Car was observed to have sustained damage. Its rear bumper was the body part that were damaged as a result of the accident.

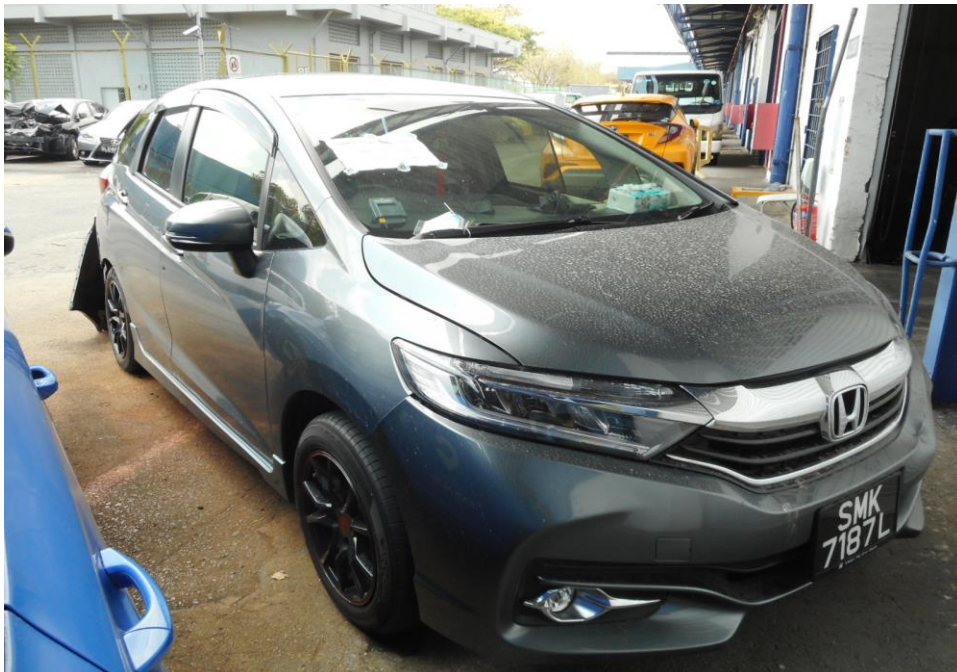
Photo 7 shows a general view of the Motor Car's right body at the time of my inspection. The right portion of the Motor Car was observed to have been unaffected by the accident.

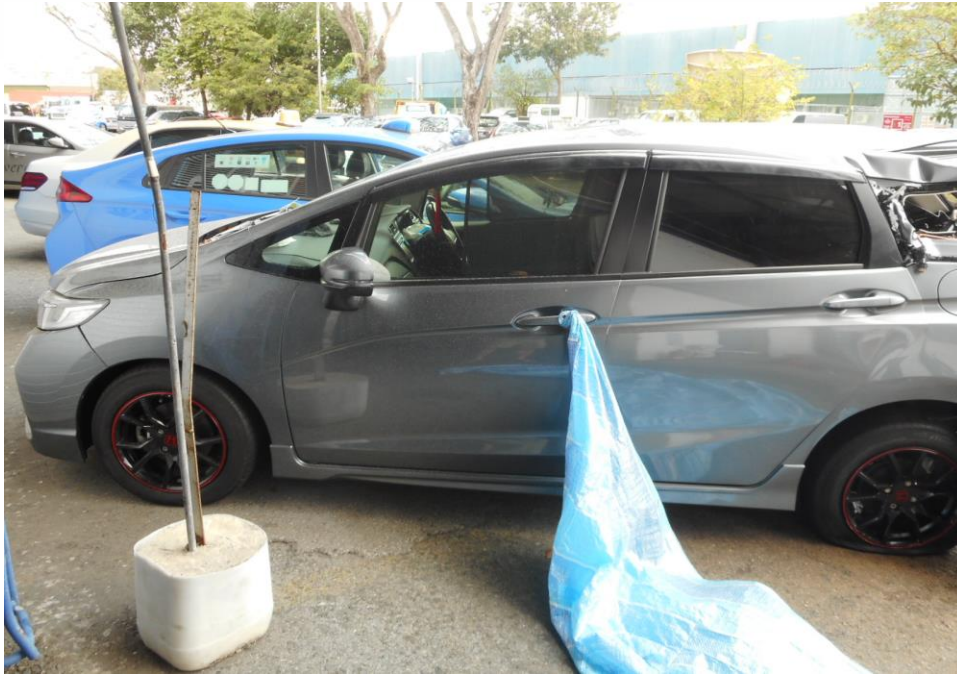
Photo 8 shows a general view of the Motor Car's left body at the time of my inspection. The left portion of the Motor Car was observed to have been unaffected by the accident.

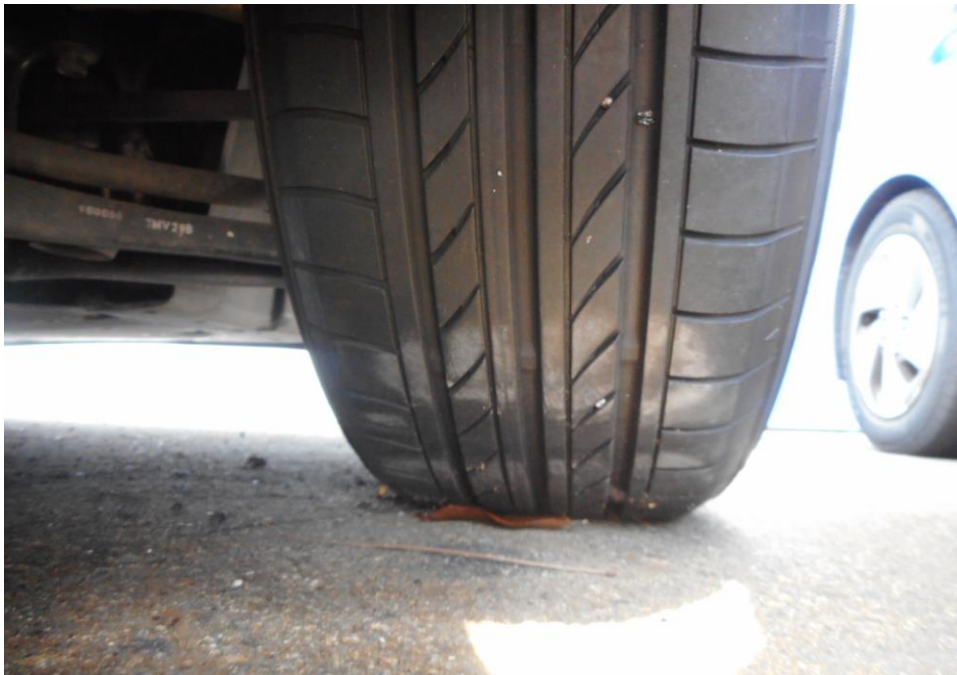
Photo 9 shows the condition of the front right tyre of the Motor Car, which was observed to be in serviceable condition with remaining tread depth of approximately 4.7mm. The tyre was sufficiently inflated for vehicular operation with no tear, cut or burst mark(s) on the outer and the inner sidewalls as well as across the tread. The 3 tyres of the Motor Car were wrapped around standard alloy wheel rims without any damage.

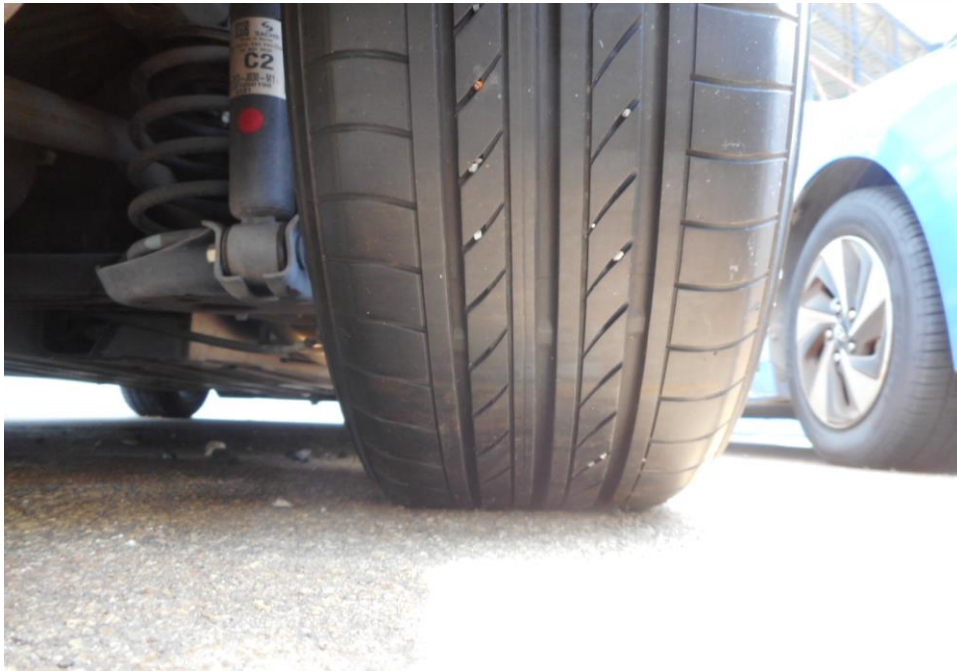
Photo 10 shows the condition of the rear right tyre of the Motor Car, which was observed to be in serviceable condition with remaining tread depth of approximately 3.9mm. The tyre was also observed to be sufficiently inflated for vehicular operation with no tear, cut or burst mark(s).

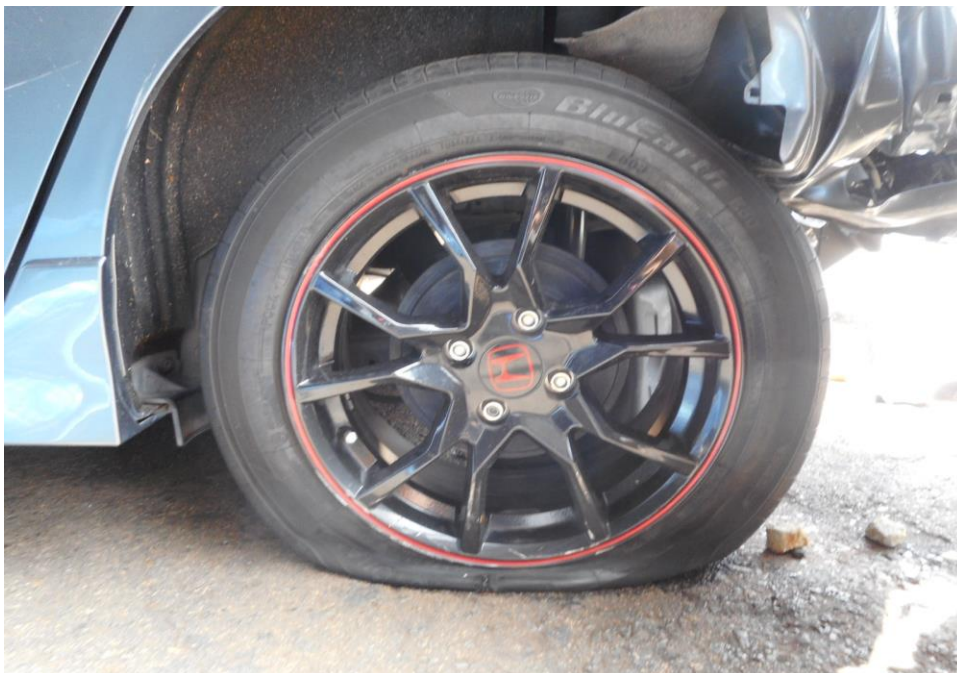
Photo 11 shows the condition of the rear left tyre of the Motor Car, which was observed to be cut and deflated as a result of the accident, with remaining tread depth of approximately 4.2mm.

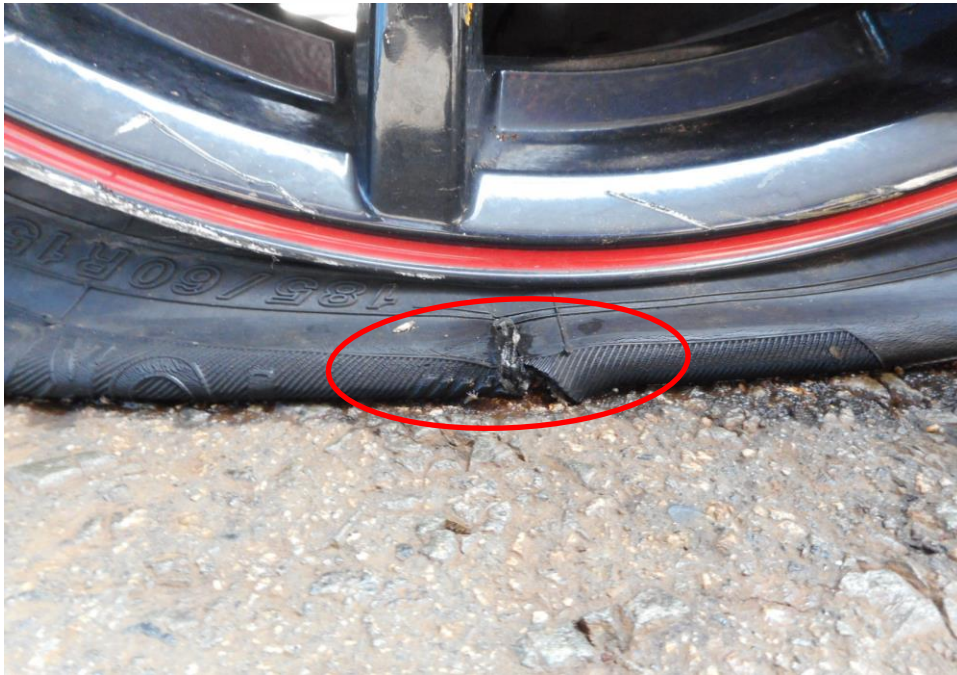
Photo 12 shows the close up condition of the rear left tyre of the Motor Car, which was observed to be cut and deflated (circled) as a result of the accident.

19. The rear left tyre was observed to be cut and deflated as a result of the accident. However, the other 3 tyres of the Motor Car were also found to be in serviceable condition. I did not find any tear, cut or burst mark(s) on the outer and the inner sidewalls as well as across the tread of the 3 tyres. The 4 tyres were observed with remaining tread depth of approximately 3.9mm to 4.7mm.

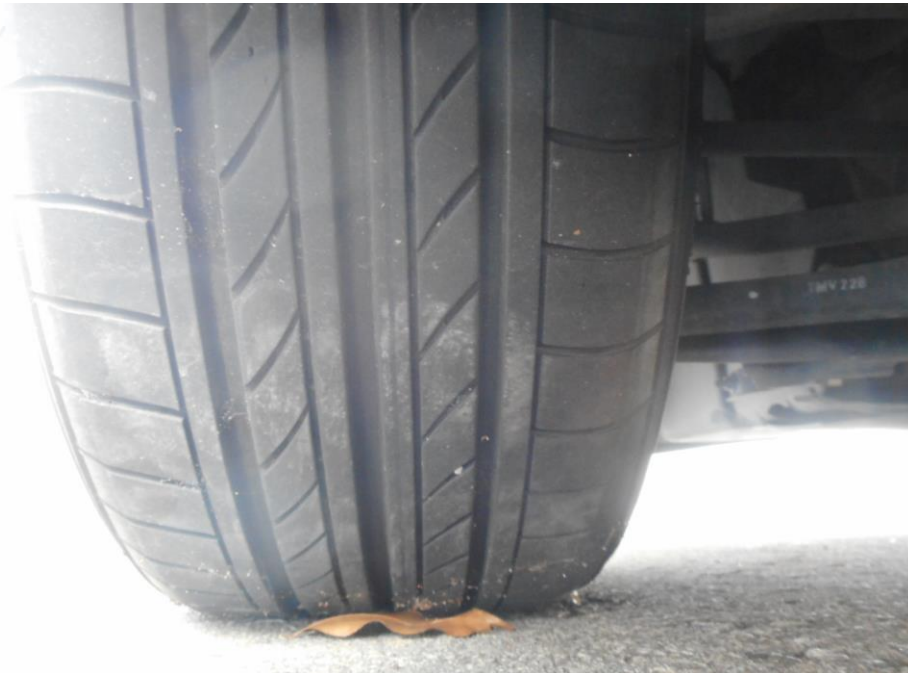
Photo 13 shows the condition of the front left tyre of the Motor Car, which was observed to be in serviceable condition with remaining tread depth of approximately 3.2mm. There was also no tear, cut or burst mark(s) on the outer and the inner sidewalls as well as across the tread of the Motor Car's 3 tyres.

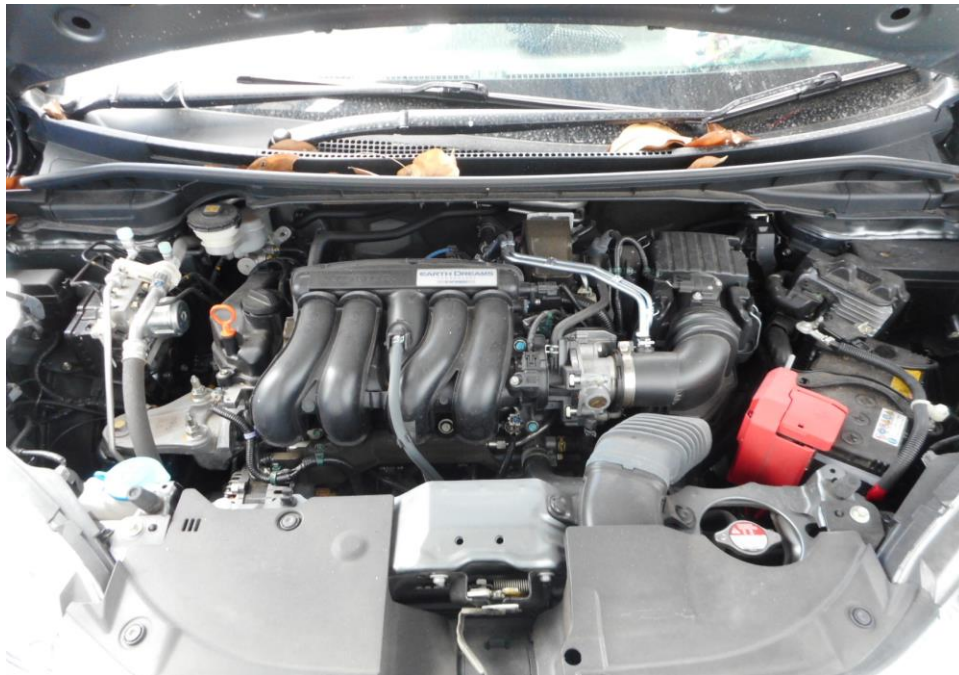
Photo 14 shows a general view of the Motor Car's engine compartment. The various parts and components inside the engine compartment were unaffected by the accident. There was also no sign(s) or indication(s) of fluid leakage and/or fluid stain within the engine compartment.

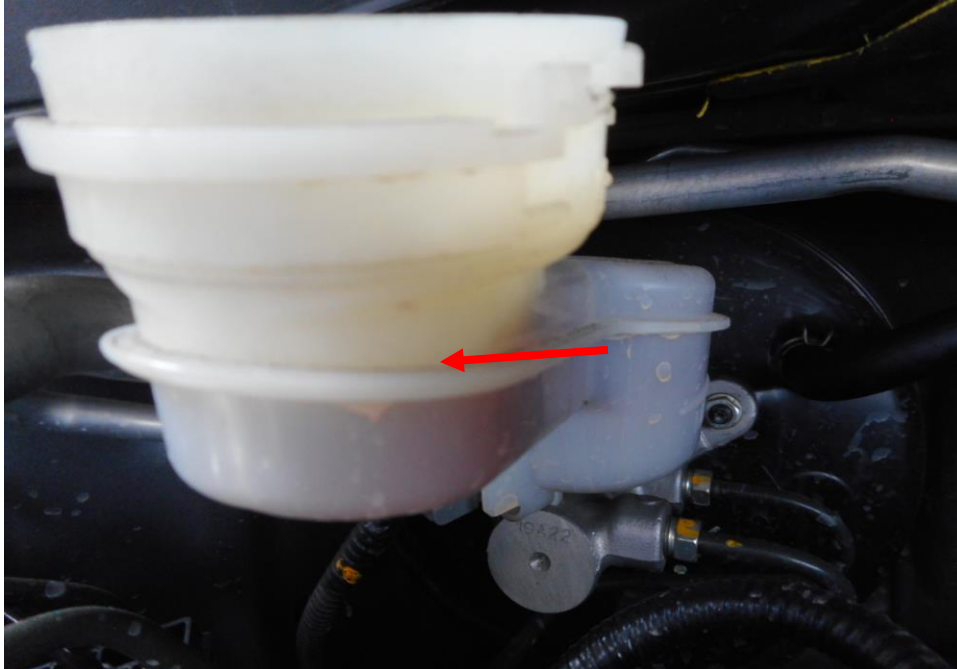
Photo 15 shows the brake fluid reservoir of the Motor Car at the time of my inspection. The brake fluid was observed to be of sufficient level (arrowed) and without any visible contamination.

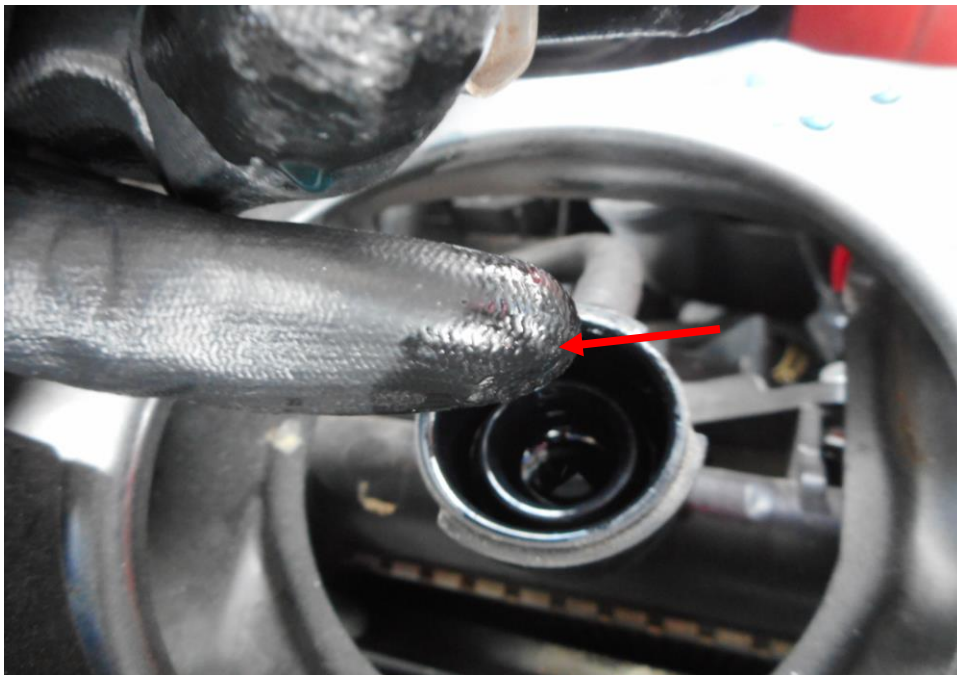
Photo 16 shows checks being carried out to the engine coolant of the Motor Car at the time of my inspection. The engine coolant was observed to be of sufficient level (arrowed) and without any visible contamination.

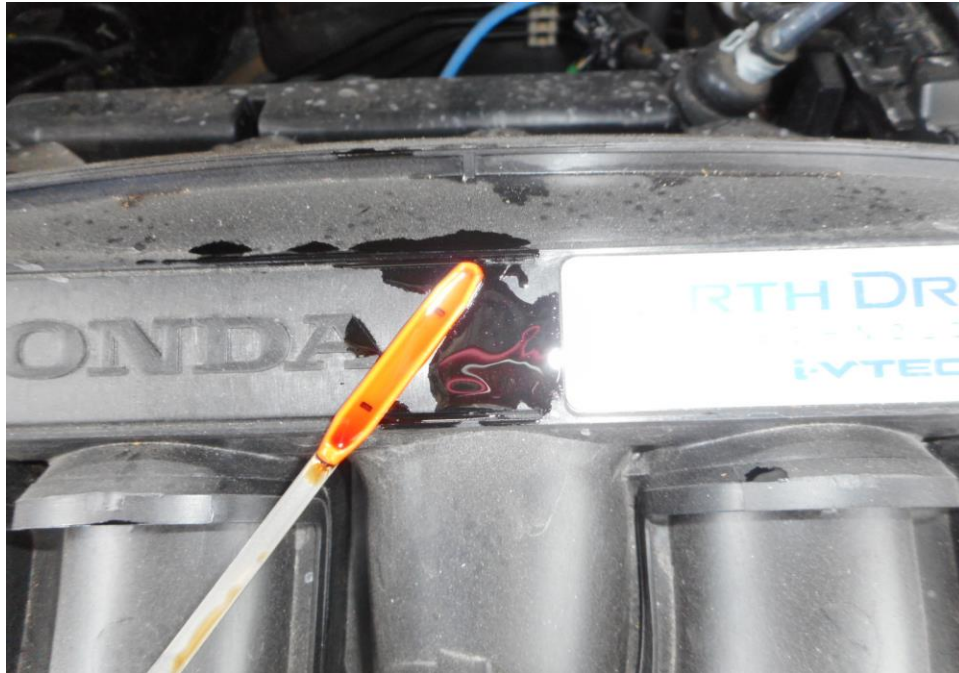
Photo 17 shows the engine oil dip stick of the Motor Car at the time of my inspection. The engine oil was observed to be of sufficient level and without any visible contamination.

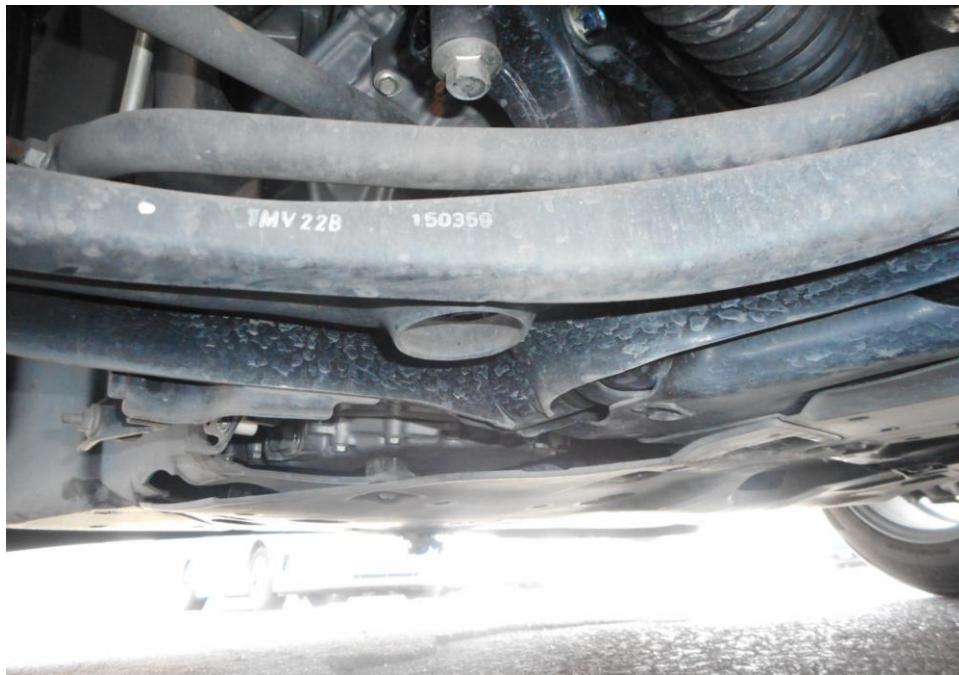
Photo 18 shows the undercarriage of the Motor Car, at the area where the engine housing and transmission housing are located. I did not find any sign(s) or indication(s) of fluid leak and/or fluid stain(s) on the underside of the Motor Car.

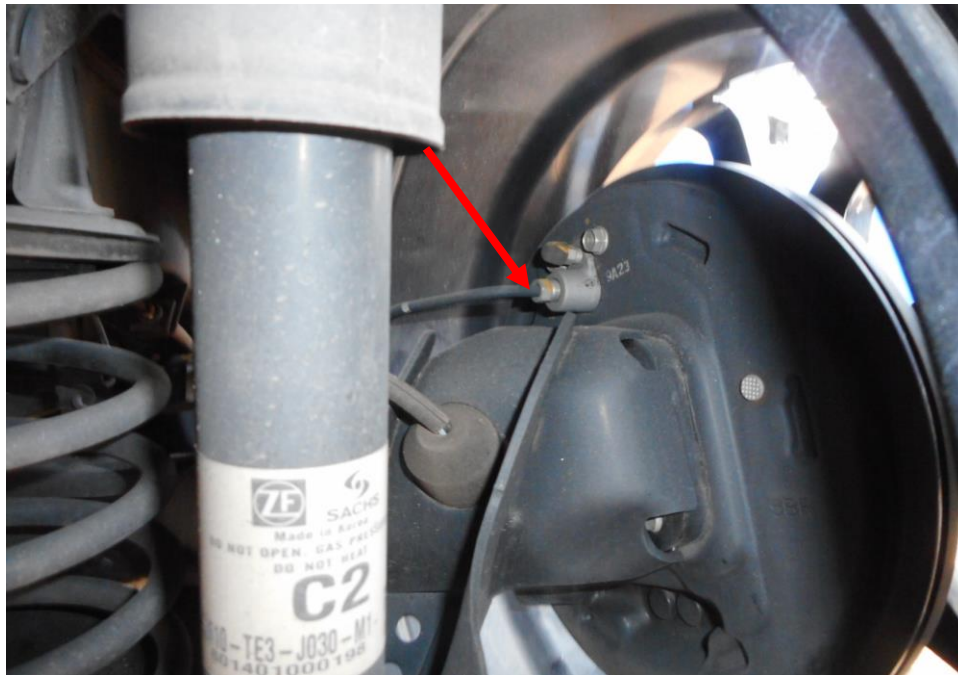
Photo 19 shows the brake hose/pipe (arrowed) at the rear right wheel of the Motor Car. No leakage of brake fluid was observed. Visual examination of the various components of the braking system like the drum brake, brake booster, brake pedal etc. had revealed all to be intact and without visible damage.

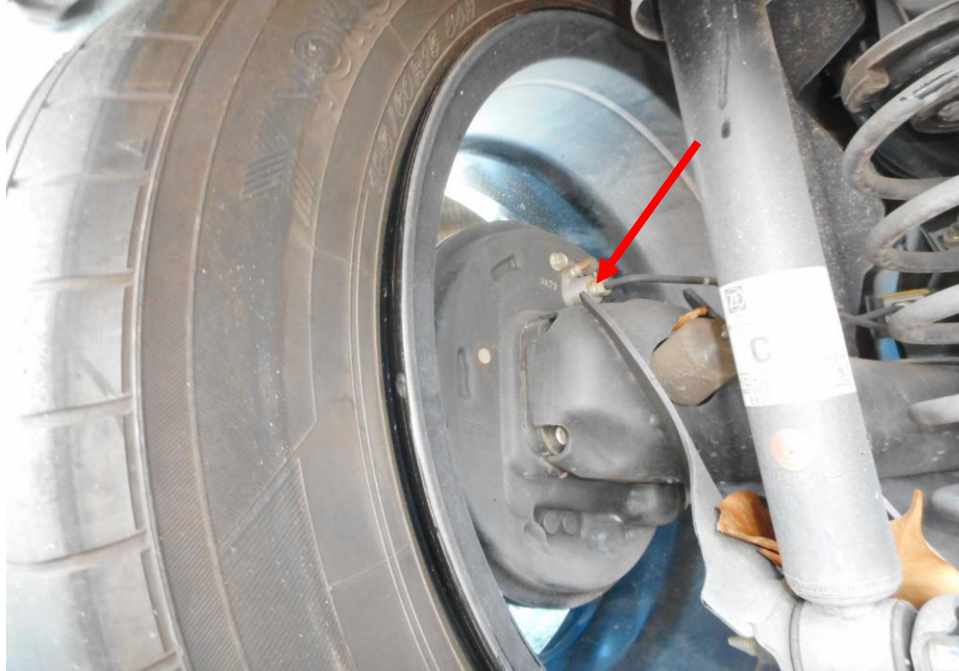
Photo 20 shows the brake hose/pipe (arrowed) at the rear left wheel of the Motor Car. I did not observe any leakage of brake fluid at the time of my inspection of the Motor Car. Static tests of the Motor Car's braking system had indicated that there was no internal leakage of pressure/vacuum. The undercarriage components of the Motor Car were also all found to be intact and without any visible damage.

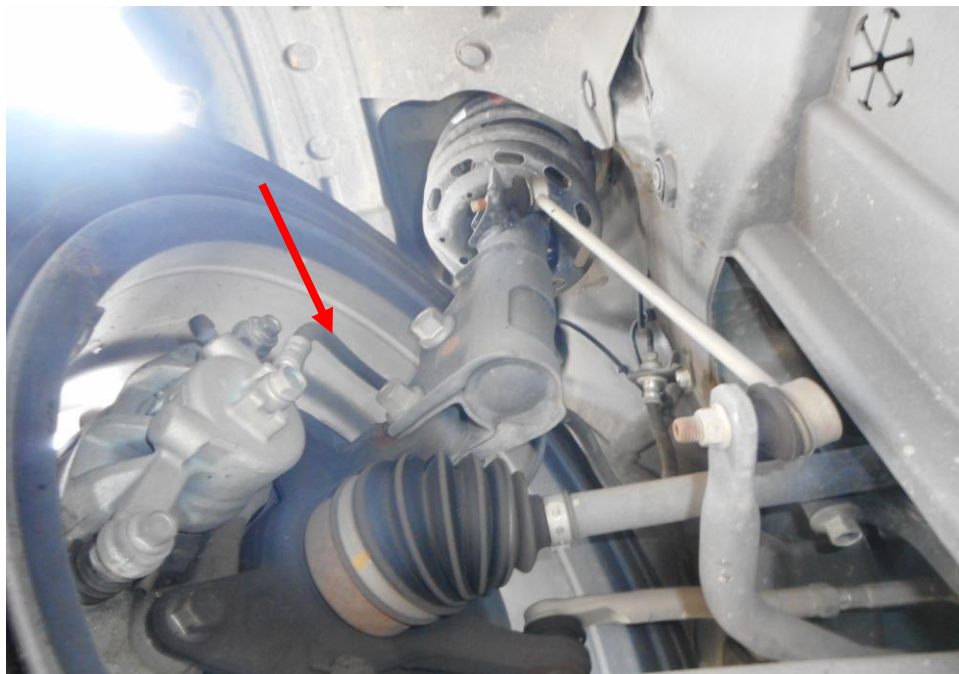
Photo 21 shows the brake hose/pipe (arrowed) at the front right wheel of the Motor Car. I did not observe any leakage of brake fluid at the time of my inspection of the Motor Car. Static tests of the Motor Car's braking system had indicated that there was no internal leakage of pressure/vacuum. The undercarriage components of the Motor Car were also all found to be intact and without any visible damage.

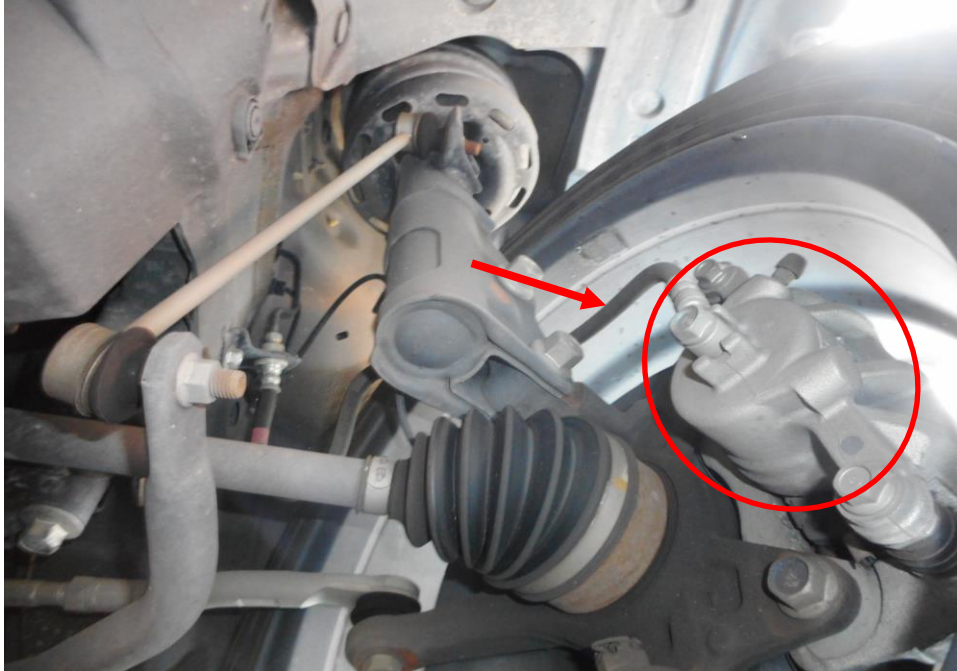
Photo 22 shows the brake hose/pipe (arrowed) at the front left wheel of the Motor Car. No leakage of brake fluid was observed. Visual examination of the various components of the braking system like the brake caliper (circled), brake booster, brake pedal etc had revealed all to be intact and without visible damage.

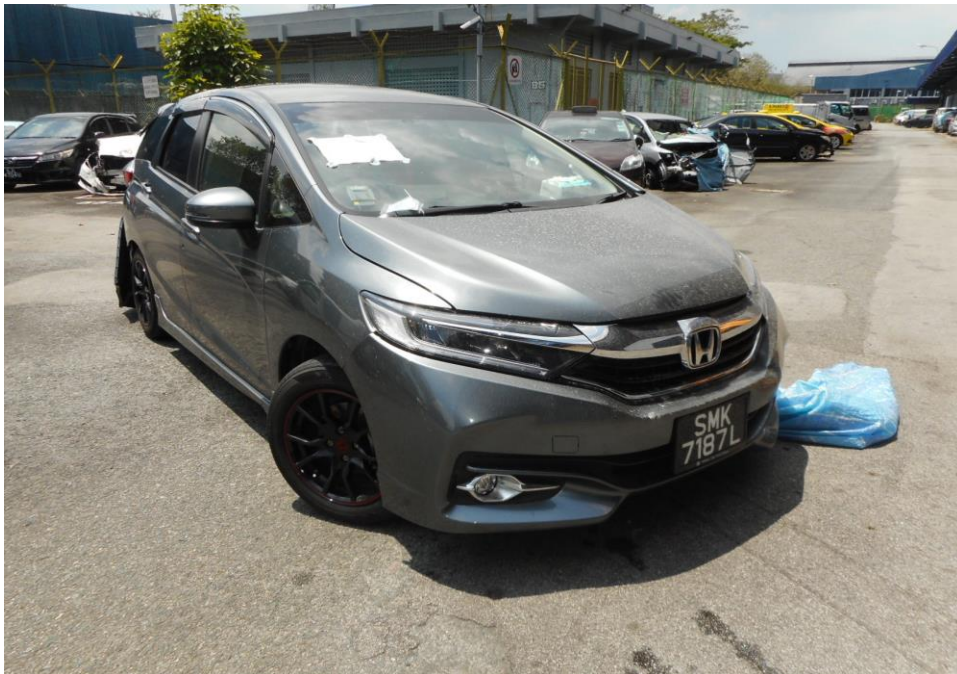
Photo 23 shows the front right wheel of the Motor Car turned to its full left. During my steering system test, I did not experience any abnormal free play and/or resistance when I had turned the steering wheel towards the left and right. This would suggest that the steering system of the Motor Car was likely to be in serviceable condition at the material time of accident.

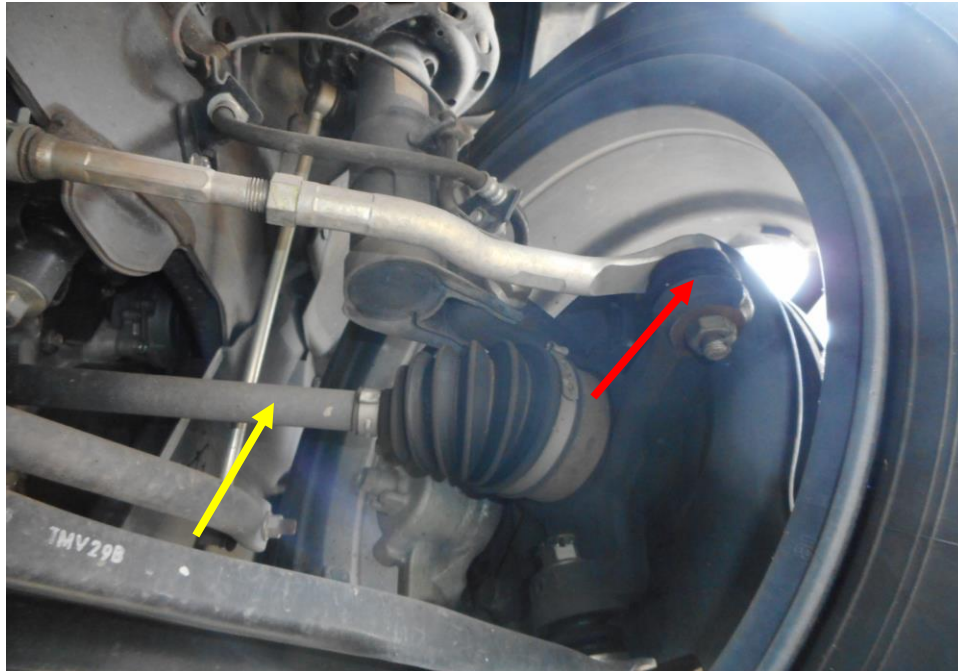
Photo 24 shows the various undercarriage components at the front right wheel of the Motor Car, in particular the steering tie rod (red arrow) and drive shaft (yellow arrow). The various steering components were all found to be intact, suggesting that the steering system of the Motor Car was likely to be in serviceable condition at the material time of accident. There was also no sign of fluid stain observed on the various undercarriage components at the front right wheel of the Motor Car.

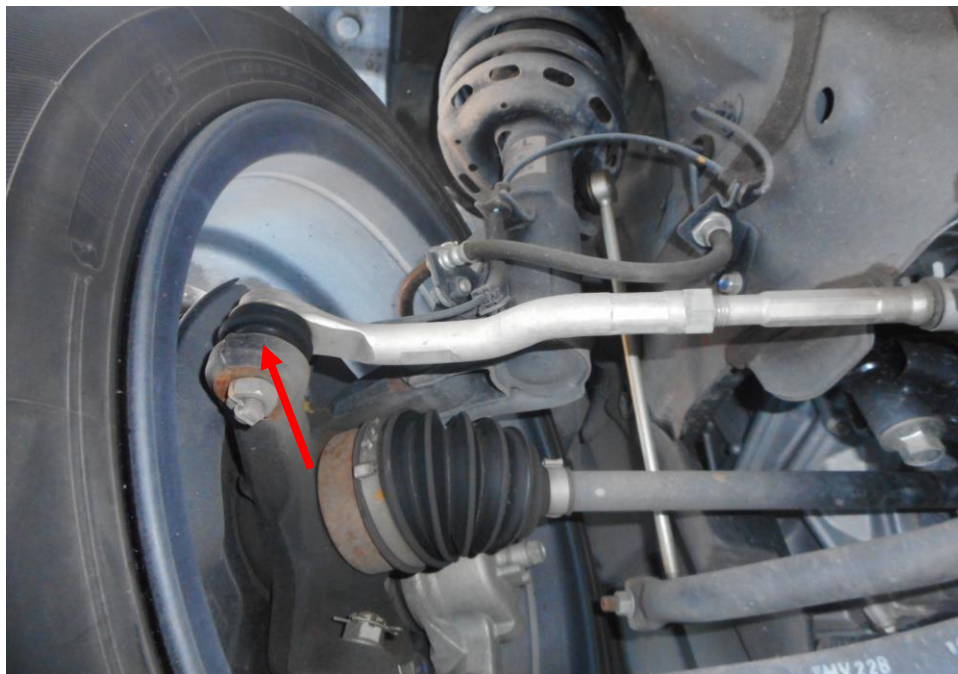
Photo 25 shows the various undercarriage components at the front left wheel of the Motor Car, which had included the steering tie rod (red arrow). The various undercarriage components of the Motor Car were all found to be intact without any visible damage.

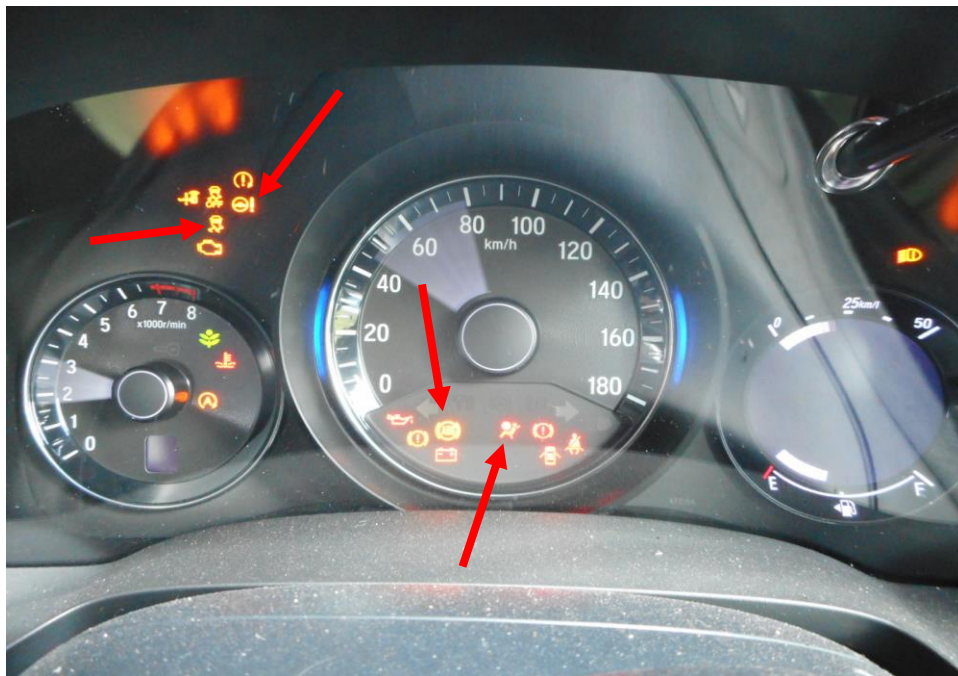
Photo 26 shows the warning light for Anti-Lock Brake System (ABS) and Power Steering System (EPS) and Supplemental Restraint System (SRS) (arrowed) appearing on the instrument panel of the Motor Car during the self-test of its various electronic operating systems when its engine was cranked.

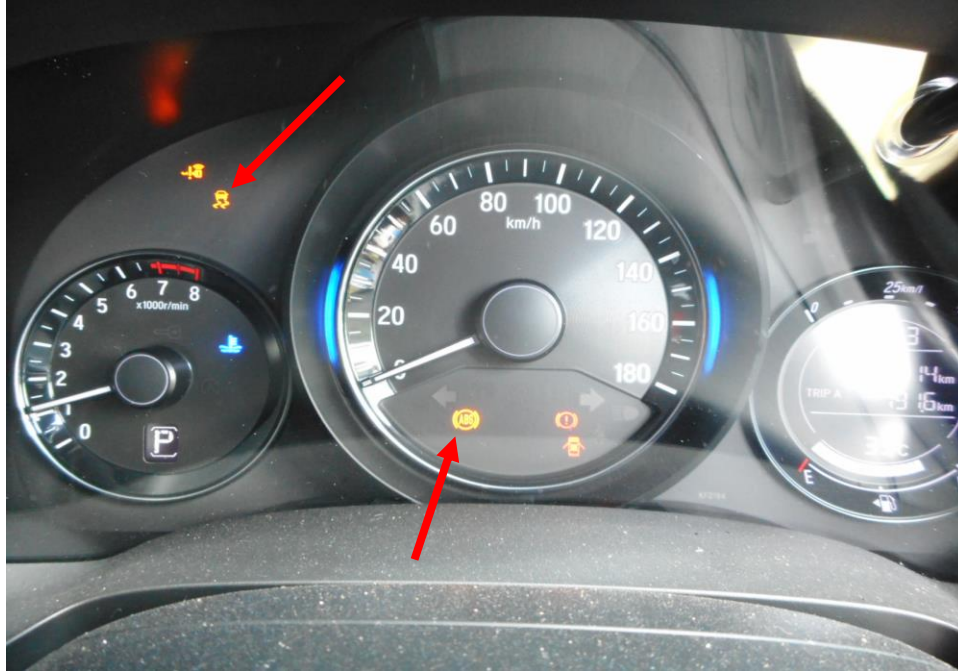
Photo 27 shows only the ABS and TC warning lights remained illuminated on the instrument panel of the Motor Car after the engine was cranked. This was likely due to the damaged rear left tyre as a result of the accident.
