Your Ref: TP/IP/01915/2021  
Our Ref : CI/TPD21002932/P

**Fatal Accident Investigation Team**

**MECHANICAL INSPECTION REPORT OF MINI BUS PA 8287S**

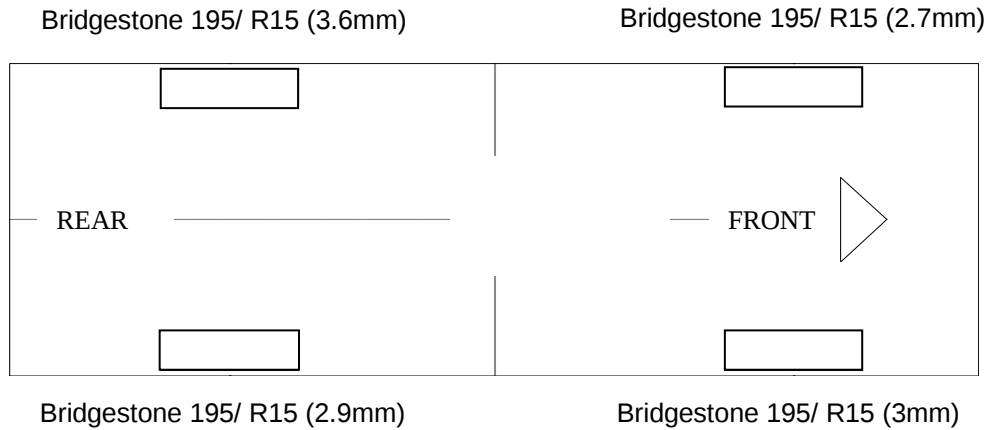
6. The 4 tyres of the Mini Bus were observed to be in serviceable condition and sufficiently inflated for vehicular operation. I did not find any tear, cut or burst mark(s) on the outer and the inner sidewalls as well as across the tread of the 4 tyres. The tyre brand, tyre size and remaining tread depth of the 4 tyres of the Mini Bus were recorded as follows:-

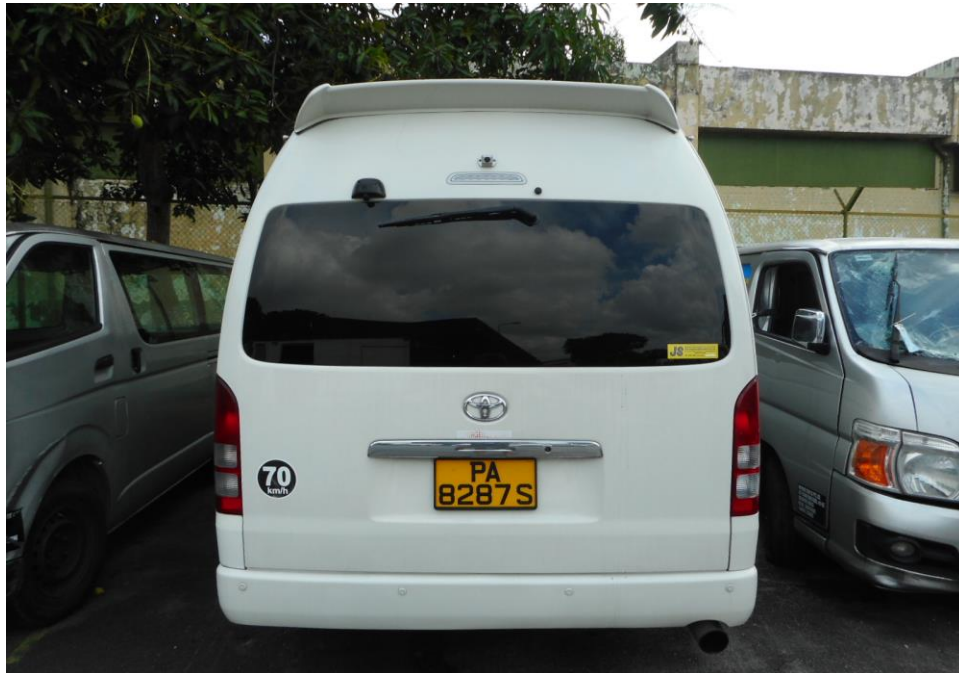
**Photo 1** shows general view of the Mini Bus's rear portion at the time of my inspection. The Mini Bus rear portion was observed to be intact and unaffected by the accident.

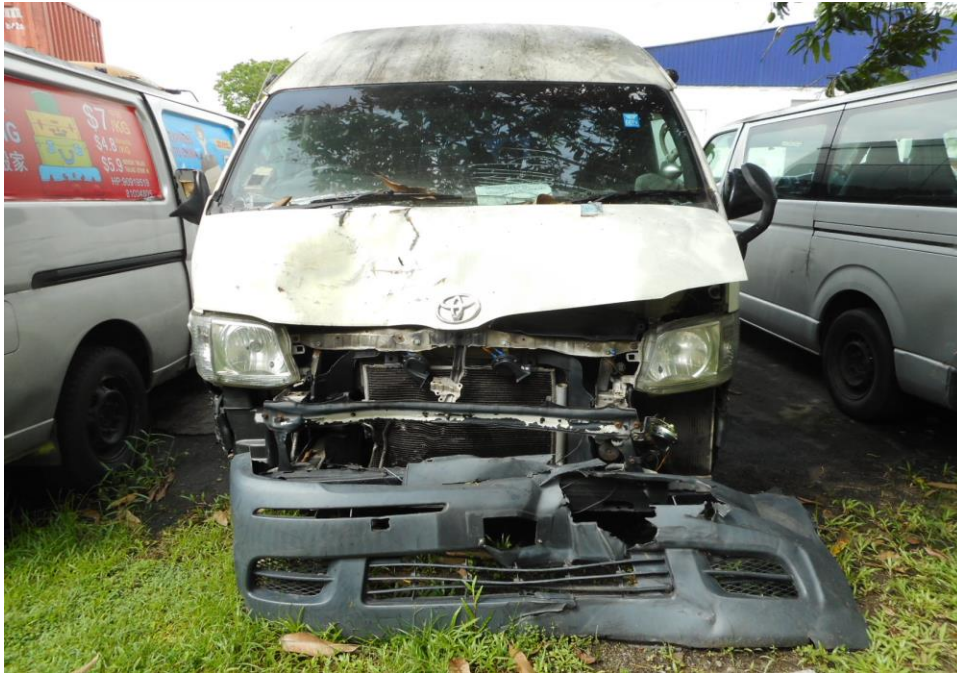
4. The mileage of the Mini Bus at the time of my inspection was not recorded as the engine was unable to be jumpstarted up despite multiple attempts in jumpstarting it.
5. The Mini Bus appeared to have sustained damage at its front portion. Its front windscreen, front body panel, front bumper and engine components were damaged at the time of my inspection as result of the accident.

**Photo 2** shows a general view of the Mini Bus's frontal portion at the time of my inspection. The Mini Bus front portion was observed to have sustained damage at its front windscreen, front body panel, front bumper and engine components were damage at the time of my inspection as result of the accident.

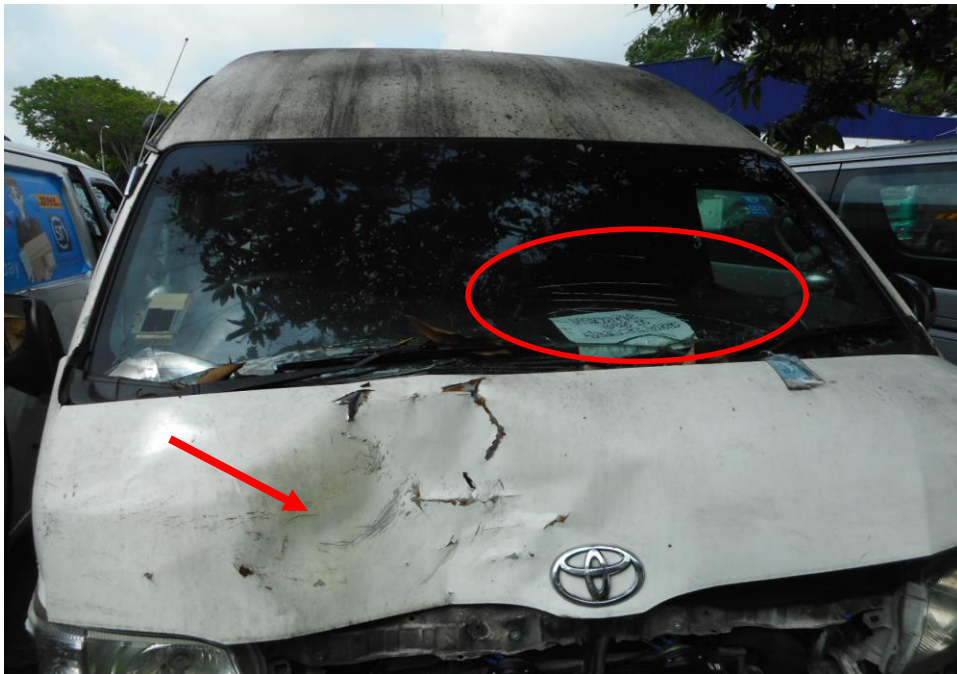
**Photo 3** shows a general view of the Mini Bus's frontal portion at the time of my inspection. The Mini Bus front portion was observed to have sustained damage at its front windscreen (circled) and front body panel (arrowed) at the time of my inspection as result of the accident.

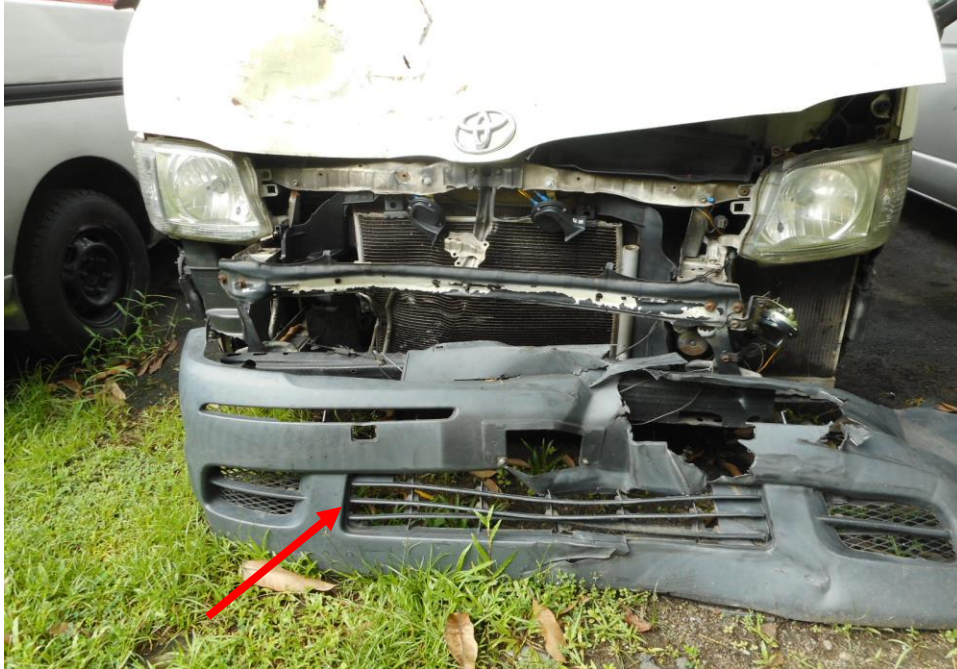
**Photo 4** shows a general view of the Mini Bus's frontal portion at the time of my inspection. The Mini Bus front portion was observed to have sustained damage at its front bumper (arrowed) at the time of my inspection as result of the accident.

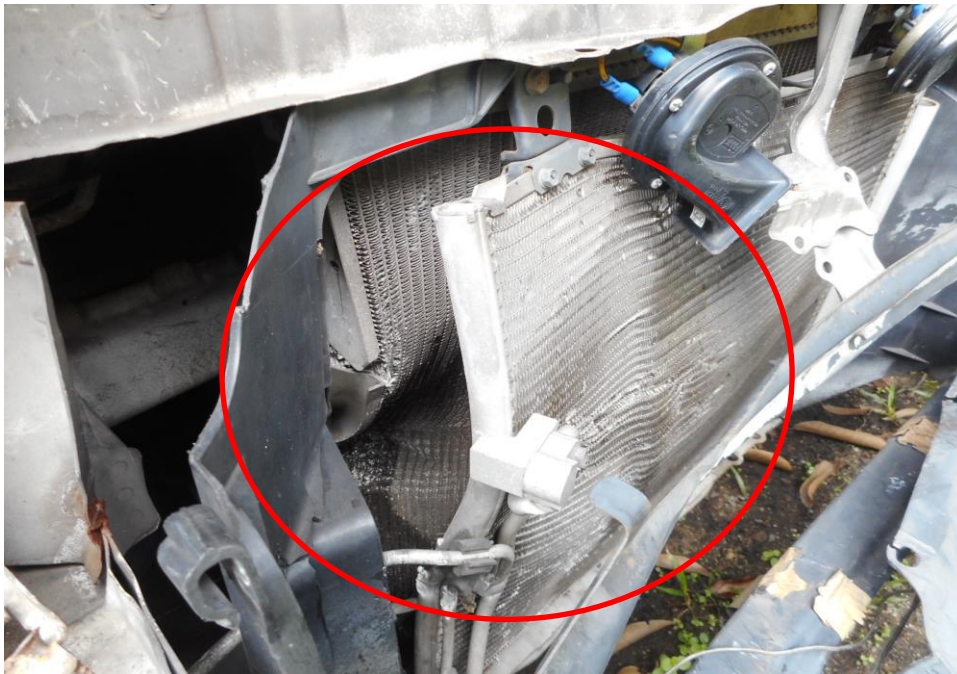
**Photo 5** shows a general view of the Mini Bus's frontal portion at the time of my inspection. The Mini Bus front portion was observed to have sustained damage at its front engine radiator (circled) at the time of my inspection as result of the accident.

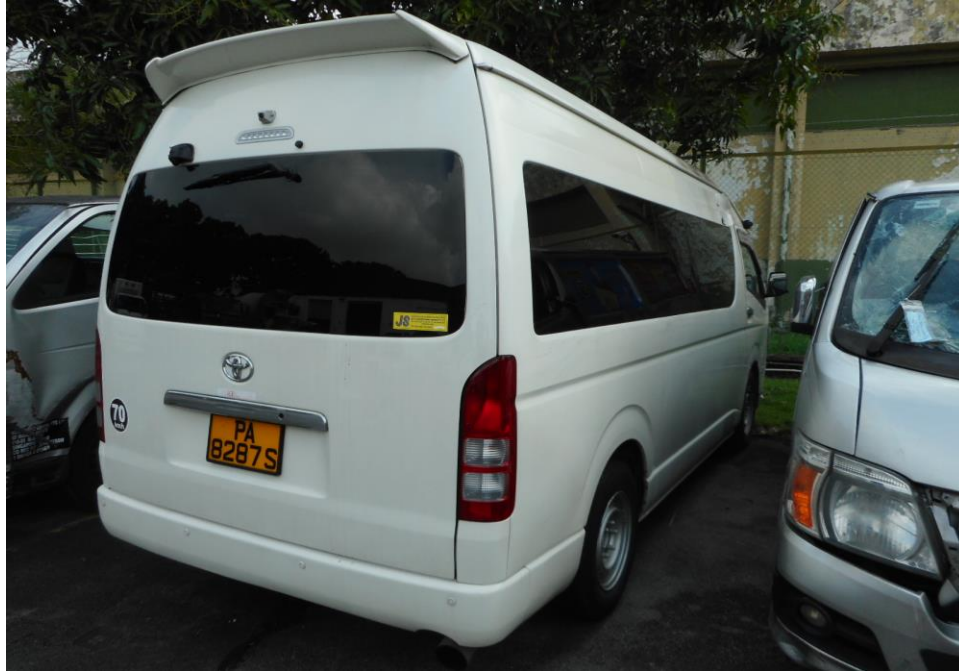
**Photo 6** shows general view of the Mini Bus's right portion at the time of my inspection. The Mini Bus was observed to be intact and unaffected by the accident.

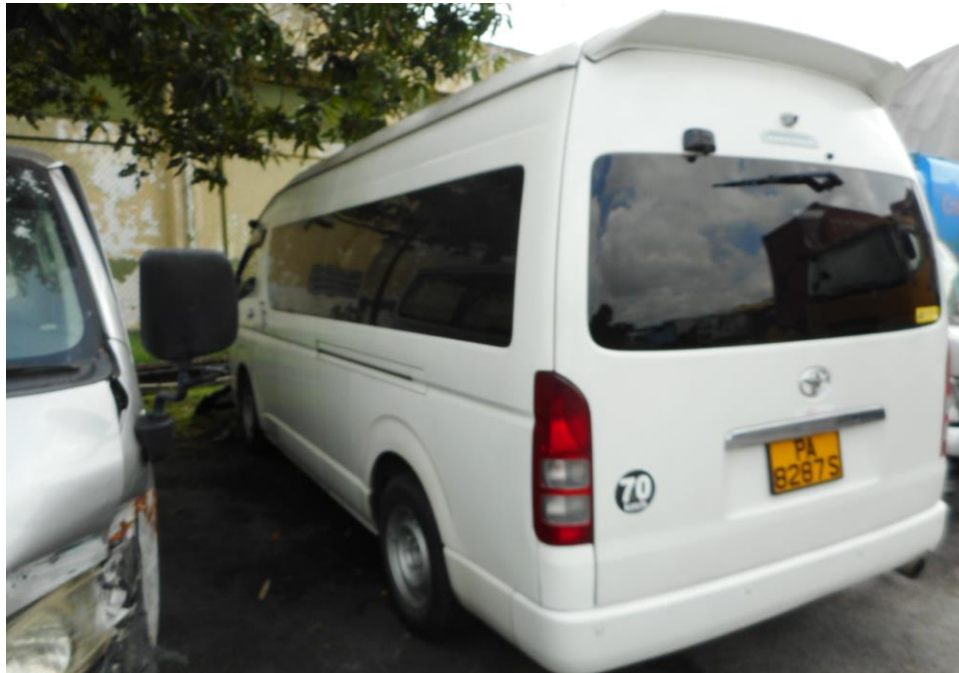
**Photo 7** shows a general view of the left body of the Mini Bus at the time of my inspection. The Mini Bus was observed to be intact and unaffected by the accident.

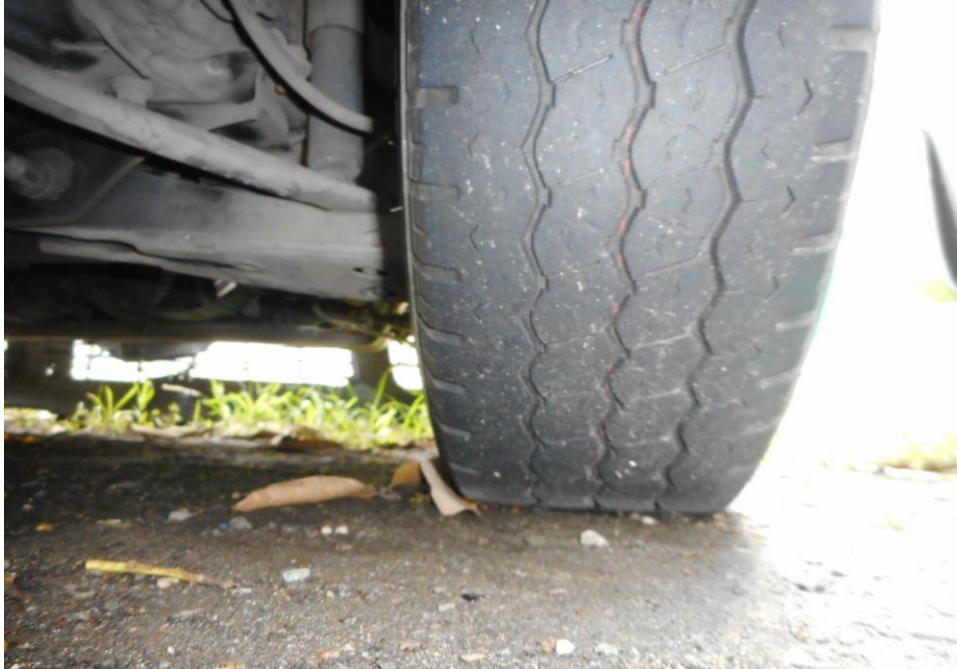
**Photo 8** shows the condition of the front right tyre of the Mini Bus, which was observed to be in serviceable condition with remaining tread depth of approximately 3mm. The tyre, which was wrapped around standard steel wheel rim, was also observed to be sufficiently inflated for vehicular operation. There was no tear, cut or burst mark(s) on the outer and the inner sidewalls as well as across the tread of the 4 tyres that were fitted on the Mini Bus.

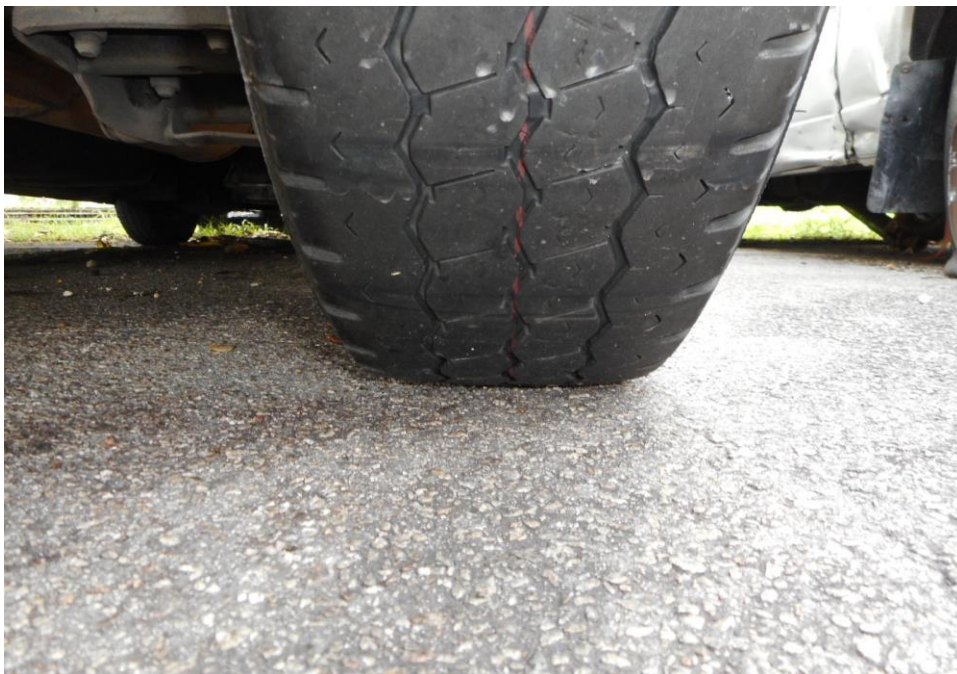
**Photo 9** shows the condition of the rear right tyre of the Mini Bus, which was observed to be in serviceable condition with remaining tread depth of approximately 2.9mm. The tyre, which was wrapped around standard steel wheel rim, it was observed to be sufficiently inflated for vehicular operation.

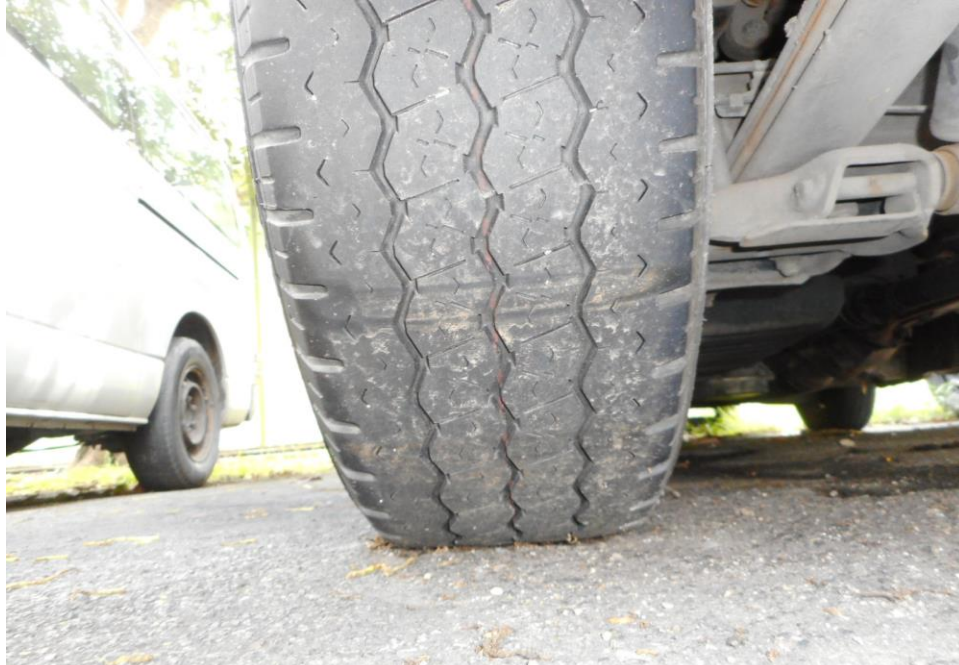
**Photo 10** shows the condition of the rear left tyres of the Mini Bus, which was observed to be in serviceable condition with remaining tread depth of approximately 3.6mm. The tyres, which were wrapped around standard steel wheel rim, were also observed to be sufficiently inflated for vehicular operation. There was also no damage found on all 4 steel wheel rims of the Mini Bus.

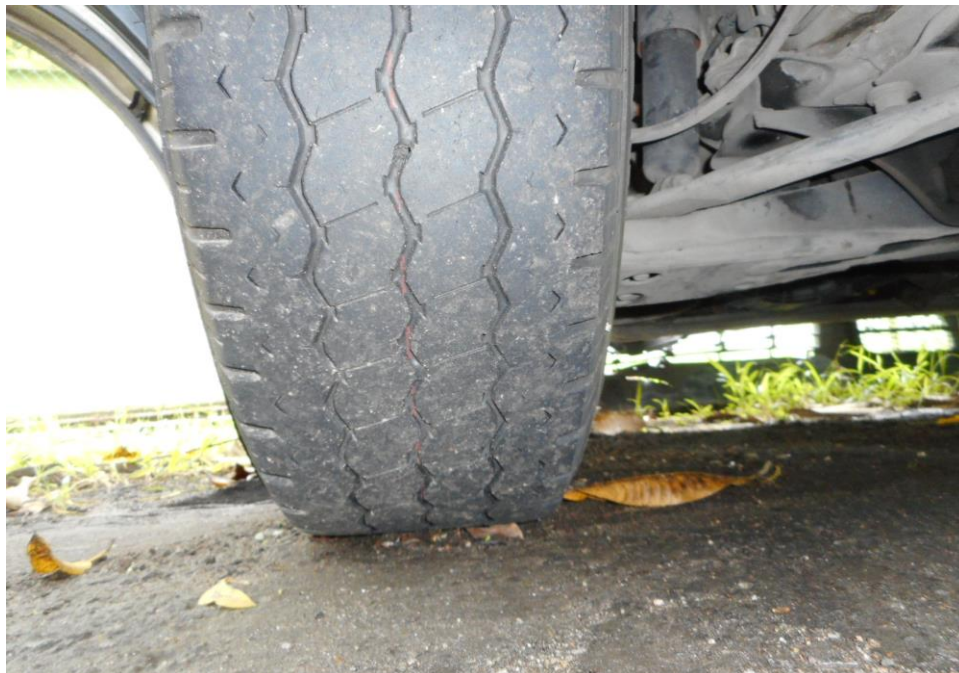
**Photo 11** shows the condition of the rear right tyres of the Mini Bus, which were observed to be in serviceable condition with remaining, tread depth of approximately 2.7mm. There was also no tear, cut or burst mark(s) on the outer and the inner sidewalls as well as across the tread of the 4 tyres that were fitted on the Mini Bus.

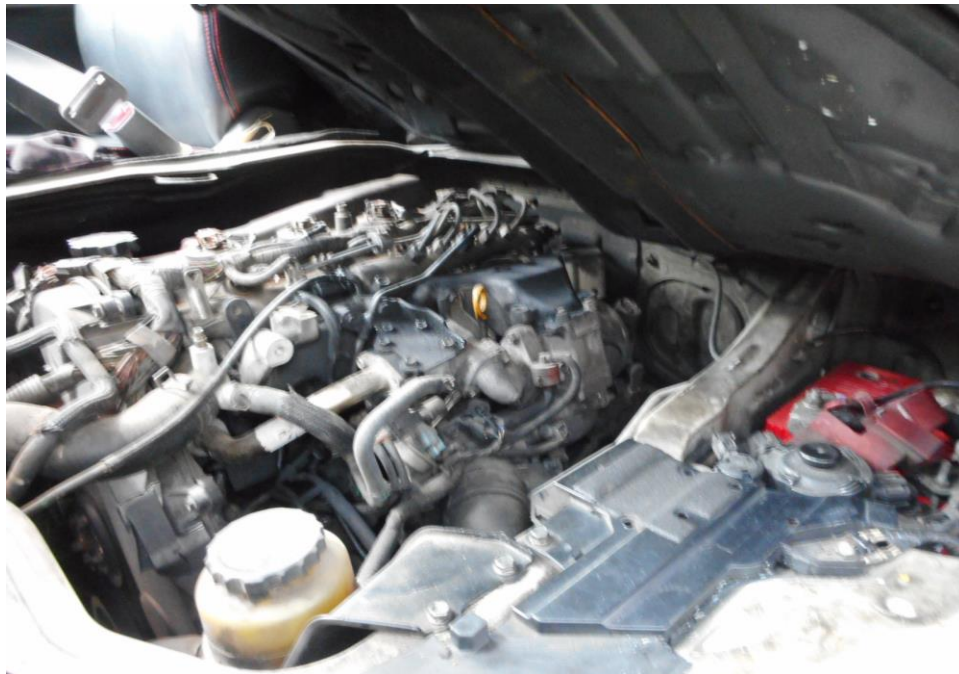
**Photo 12** shows a general view of the Mini Bus's engine compartment, which was accessed by lifting the front cabin of the Mini Bus. The various parts and components inside the engine compartment were unaffected by the accident. There was also no sign(s) or indication(s) of fresh fluid leakage and/or fluid stain within the engine compartment

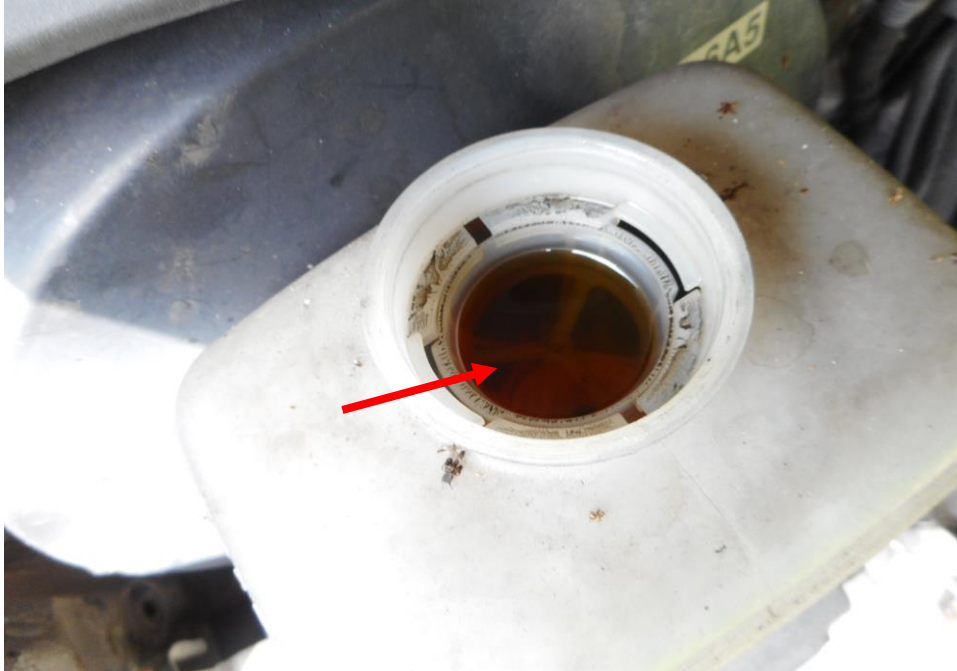
**Photo 13** shows the brake fluid reservoir of the Mini Bus at the time of my inspection. The brake fluid was observed to be of sufficient level (arrowed) and without any visible contamination.

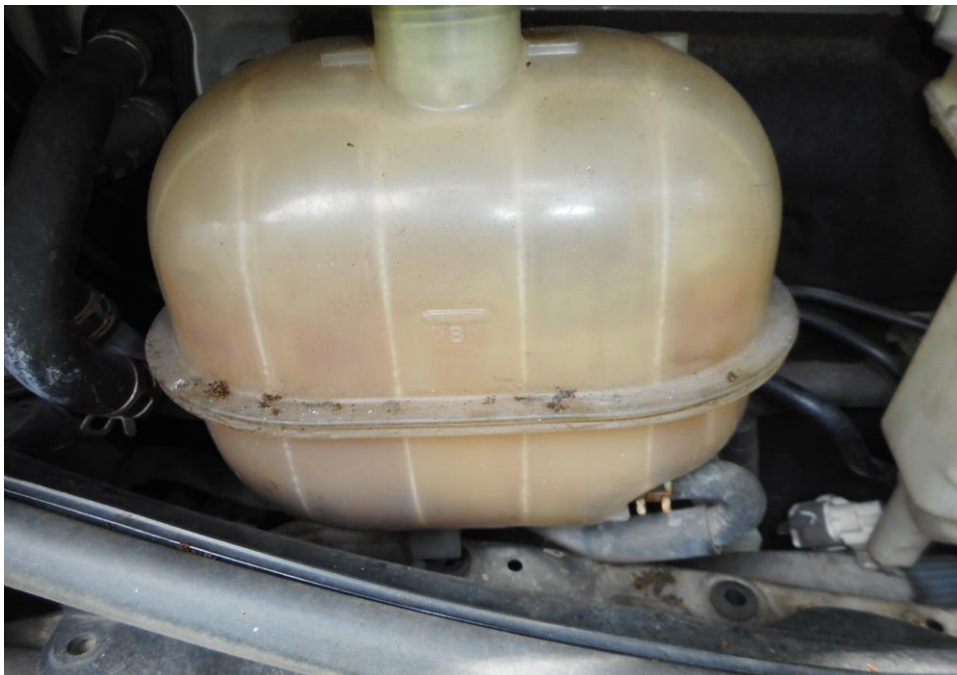
8. Upon examination of the Mini Bus's engine compartment, I had observed all the parts and components inside the engine compartment to be intact and unaffected by the accident. The brake fluid, power steering fluid and engine oil were all found to be of sufficient level for operating purposes. Visually, there was also no contamination found to these fluids. However, the engine coolant was observed to be insufficient due to the damaged to the radiator that caused a leakage of engine coolant as a result of the accident.

**Photo 14** shows the engine coolant reservoir of the Mini Bus at the time of my inspection. The engine coolant was observed to be insufficient level as the damaged sustained from the accident had caused a leakage of engine coolant from the radiator.

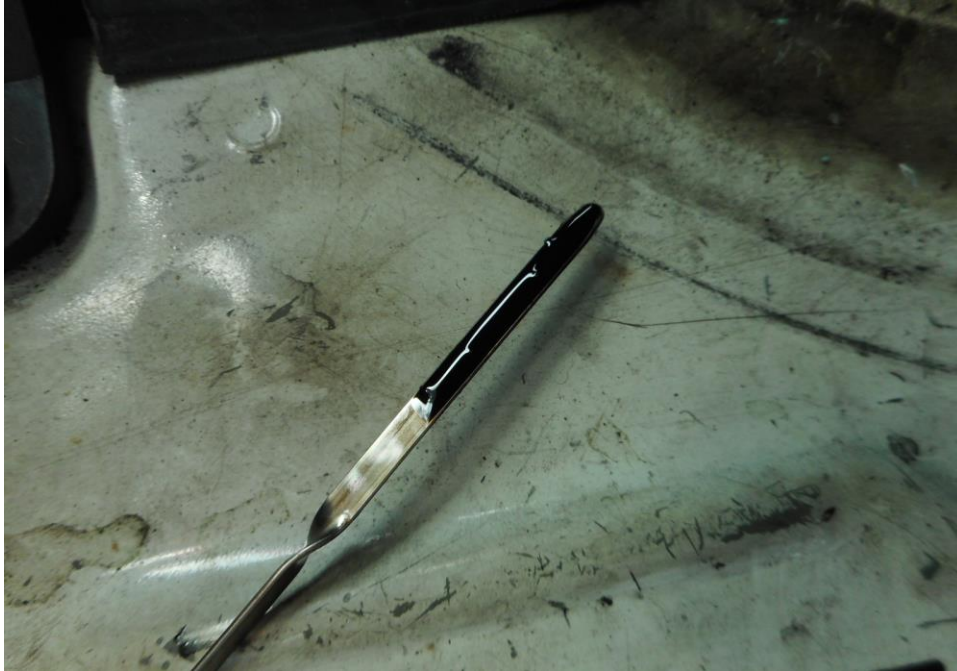
**Photo 15** shows the engine oil dip stick of the Mini Bus at the time of my inspection. The engine oil was observed to be of sufficient level and without any visible contamination.

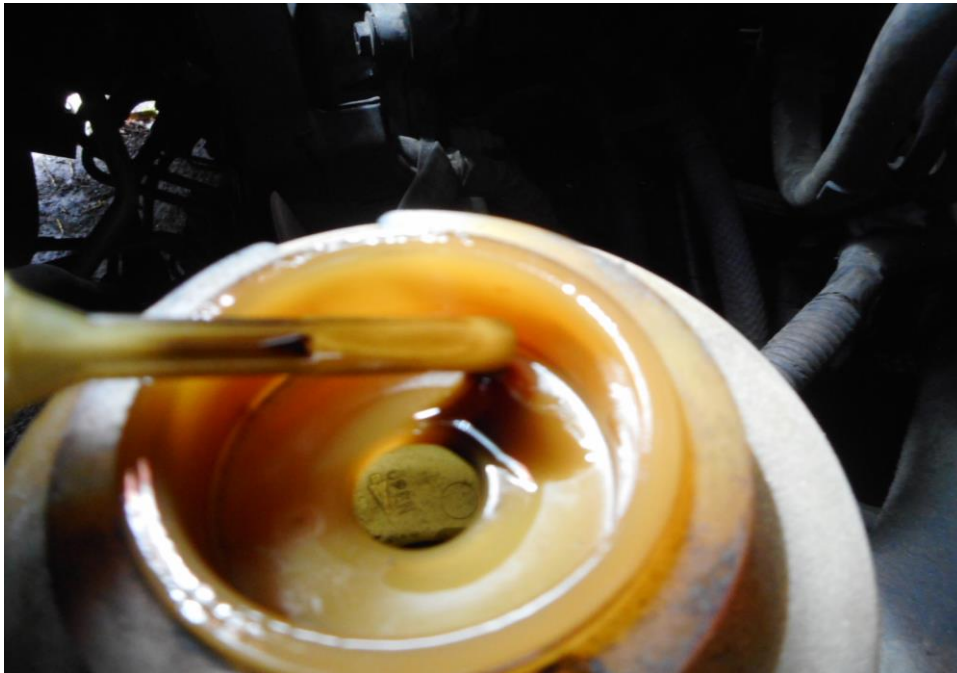
**Photo 16** shows the power steering fluid reservoir of the Mini Bus at the time of my inspection. The power steering fluid was observed to be of sufficient level and without any visible contamination.

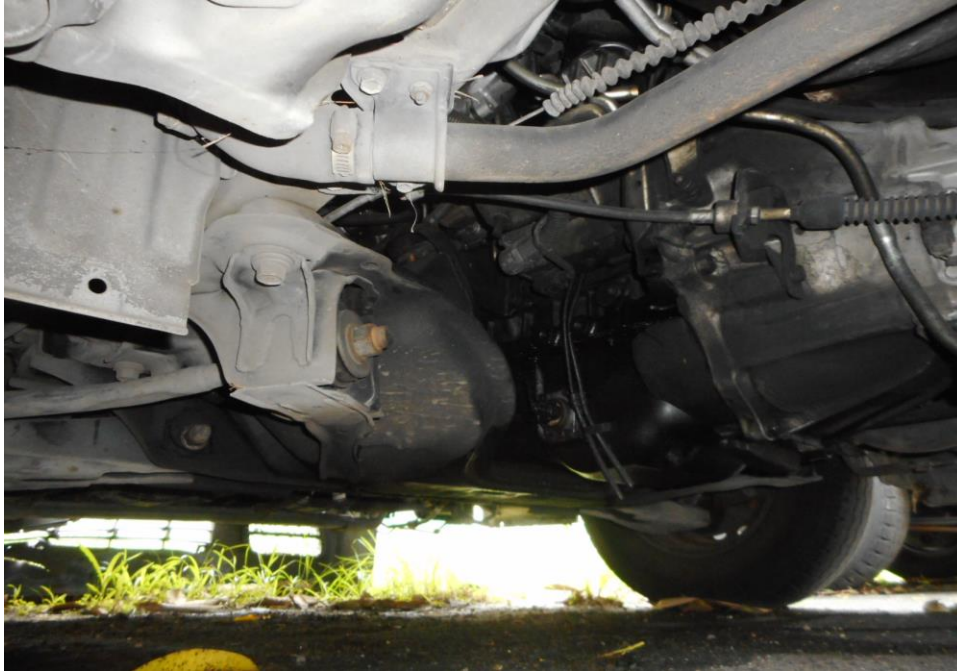
**Photo 17** shows the undercarriage of the Mini Bus, at the area where the engine housing and transmission housing are located. I did not find any sign(s) or indication(s) of fluid leak and/or fluid stain(s) on the underside of the Mini Bus.

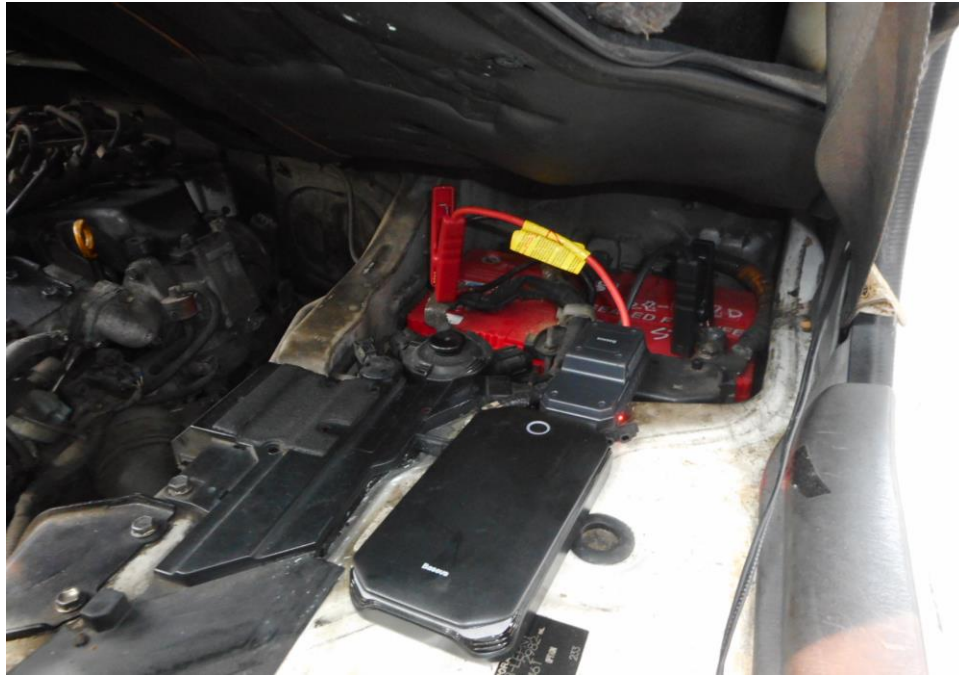
**Photo 18** shows the jumpstarting process of the Mini Bus's engine. The engine of the Mini Bus was unable to be jumpstarted up despite multiple attempts in starting it.

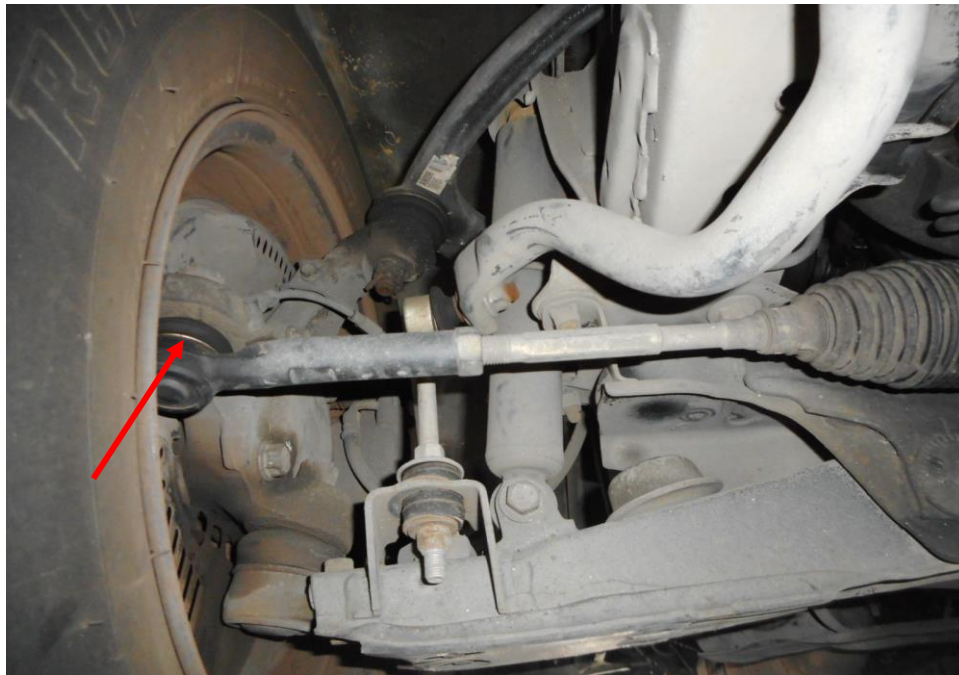
**Photo 19** shows the various undercarriage components at the front right wheel of the Mini Bus, in particular the steering tie rod end (arrowed). The various steering components were all found to be intact, suggesting that the steering system of the Mini Bus was likely to be in serviceable condition at the material time of accident. There was also no sign of fluid stain(s) observed on the various undercarriage components.

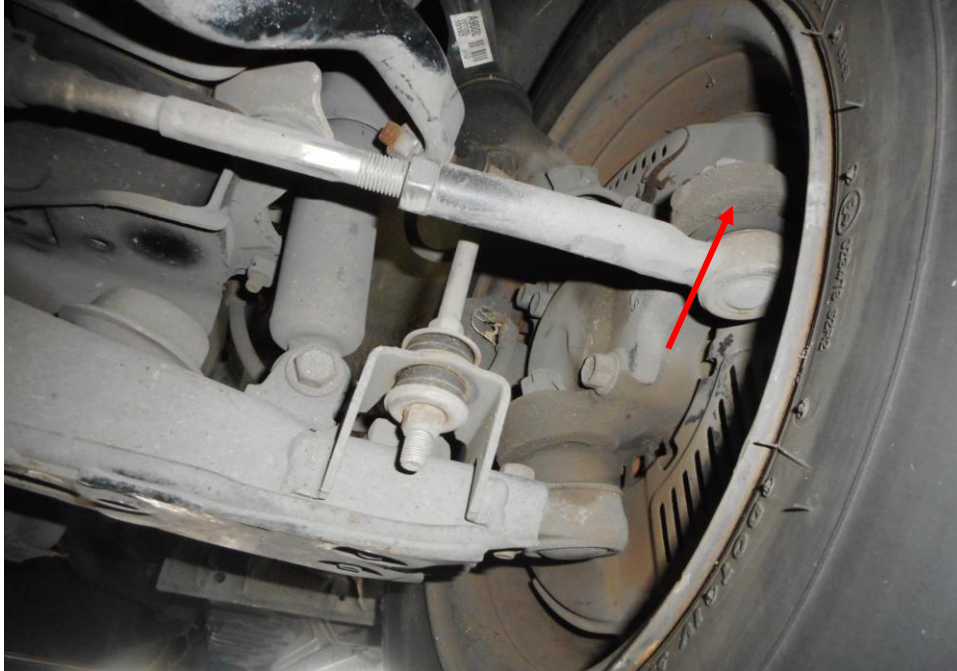
**Photo 20** shows the various undercarriage components at the front left wheel of the Mini Bus, in particular the steering tie rod end (arrowed). The various undercarriage components of the Mini Bus were all found to be intact without any visible damage. There was also no sign of fluid stain(s) observed on the various undercarriage components.

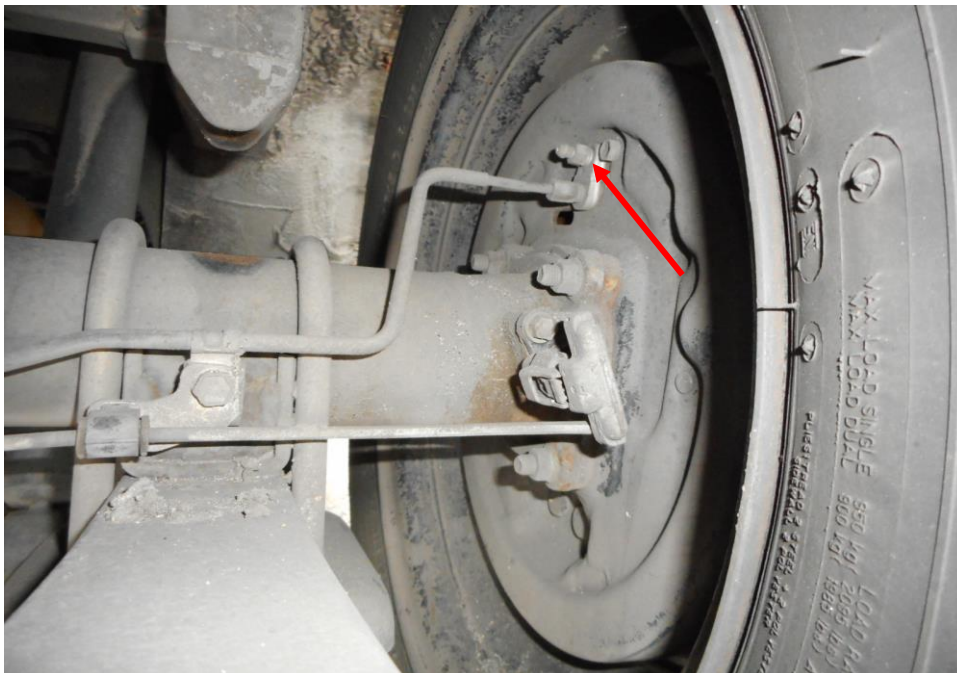
**Photo 21** shows the brake pipe (arrowed) at the rear right wheel of the Mini Bus. I did not observe any leakage of brake fluid at the time of my inspection of the Mini Bus. My static tests of the Mini Bus's braking system, along with my visual examination of the various mechanical components in the braking system, had indicated that there was no internal leakage of pressure/vacuum. Hence the braking system of the Mini Bus was likely to be in serviceable condition at the material time of accident.

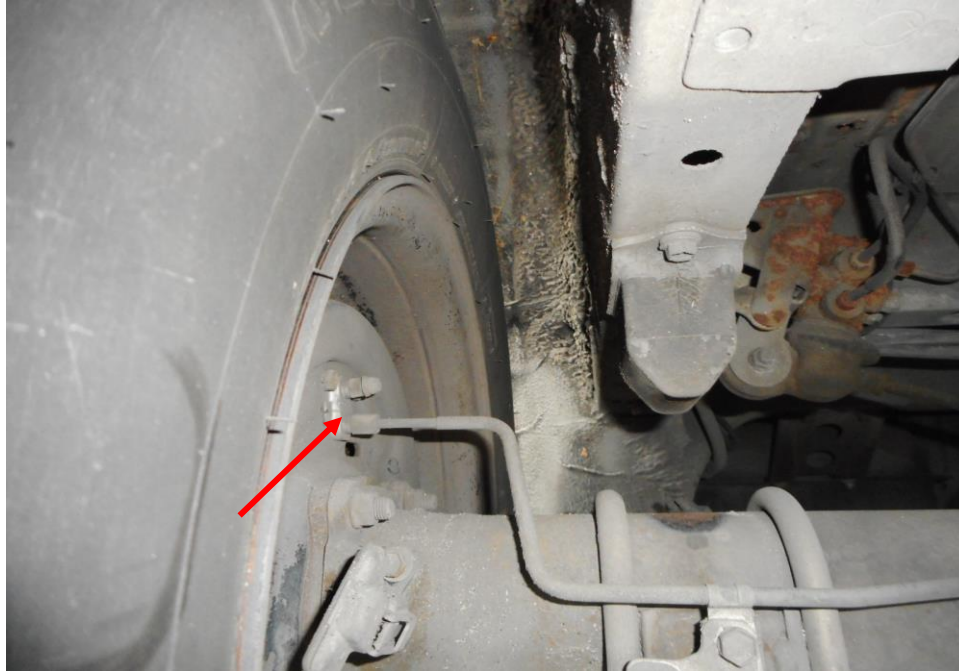
**Photo 22** shows the brake pipe (arrowed) at the rear left wheel of the Mini Bus. I did not observe any leakage of brake fluid at the time of my inspection of the Mini Bus. My static tests of the Mini Bus's braking system, along with my visual examination of the various mechanical components in the braking system had indicated that there was no internal leakage of pressure/vacuum. Hence the braking system of the Mini Bus was likely to be in serviceable condition at the material time of accident.

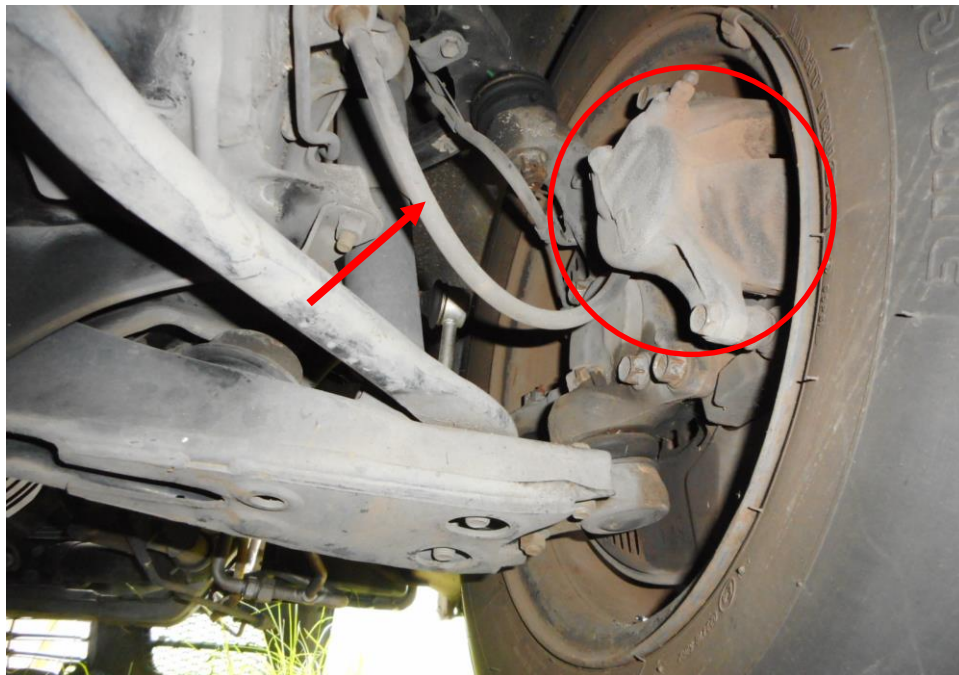
**Photo 23** shows the brake hose/pipe (arrowed) at the front right wheel of the Mini Bus. No leakage of brake fluid was observed. Visual examination of the various components of the braking system like the brake caliper (circled), brake booster, brake pedal etc had revealed all to be intact and without visible damage at the time of accident. There was also no sign of fluid stain(s) observed on the various undercarriage components.

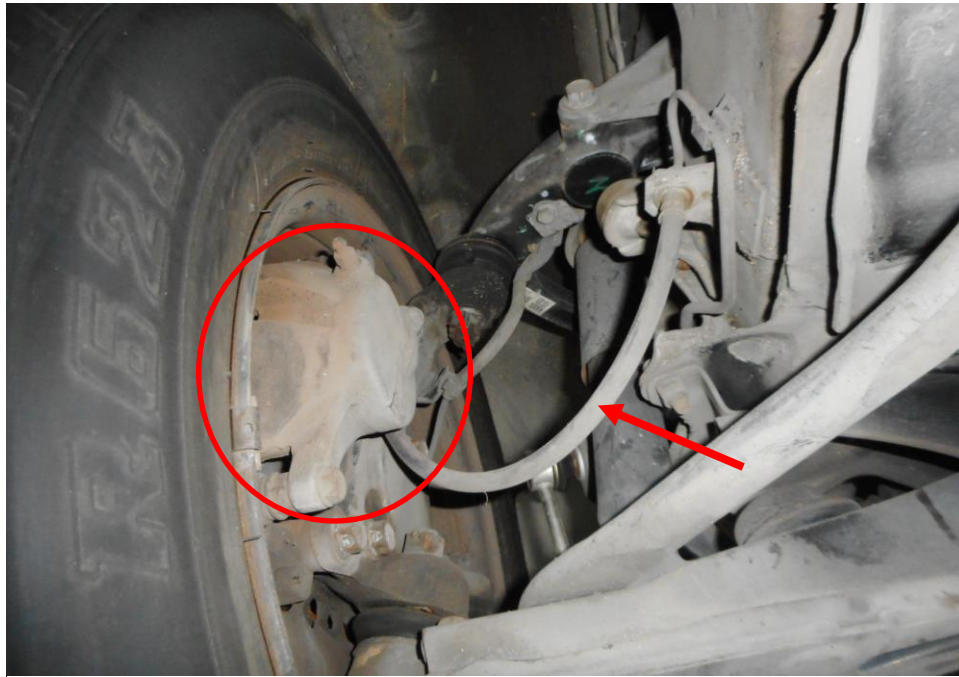
**Photo 24** shows the brake hose/pipe (arrowed) at the front left wheel of the Mini Bus. No leakage of brake fluid was observed. Visual examination of the various components of the braking system like the brake caliper (circled), brake booster, brake pedal etc had revealed all to be intact and without visible damage at the time of accident. There was also no sign of fluid stain(s) observed on the various undercarriage components.
