Your Ref: TP/IP/02181/2021  
Our Ref : CI/TPD21002933/P

**Fatal Accident Investigation Team**

**MECHANICAL INSPECTION REPORT OF MOTOR LORRY GBB 4350D**

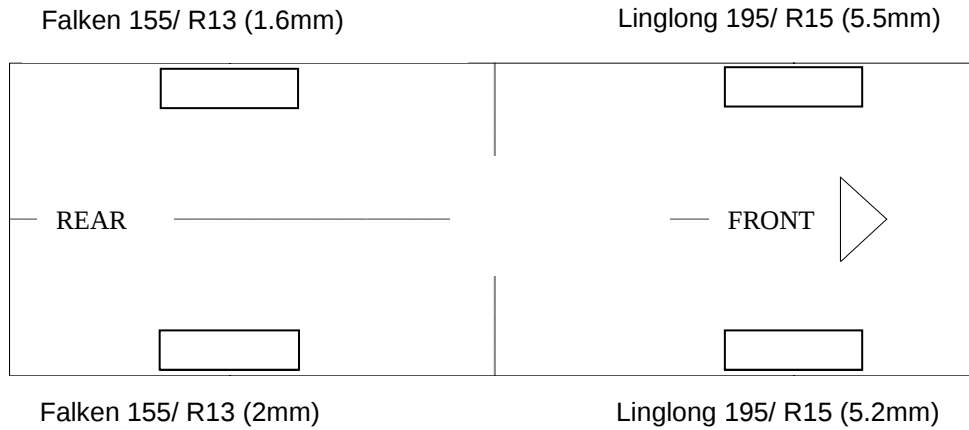
6. The 4 tyres of the Motor Lorry were observed to be in serviceable condition and sufficiently inflated for vehicular operation. I did not find any tear, cut or burst mark(s) on the outer and the inner sidewalls as well as across the tread of the 4 tyres. The tyre brand, tyre size and remaining tread depth of the 4 tyres of the Motor Lorry were recorded as follows:-

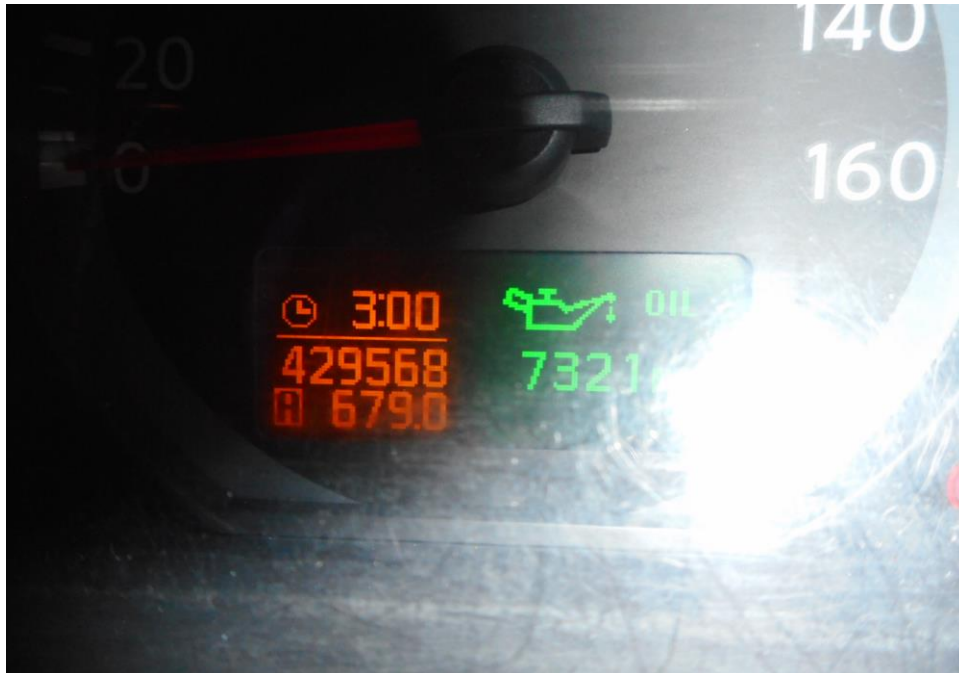
**Photo 1** shows a general view of the instrument cluster of the Motor Lorry at the time of my inspection. The mileage of the Motor Lorry was 429,568 km

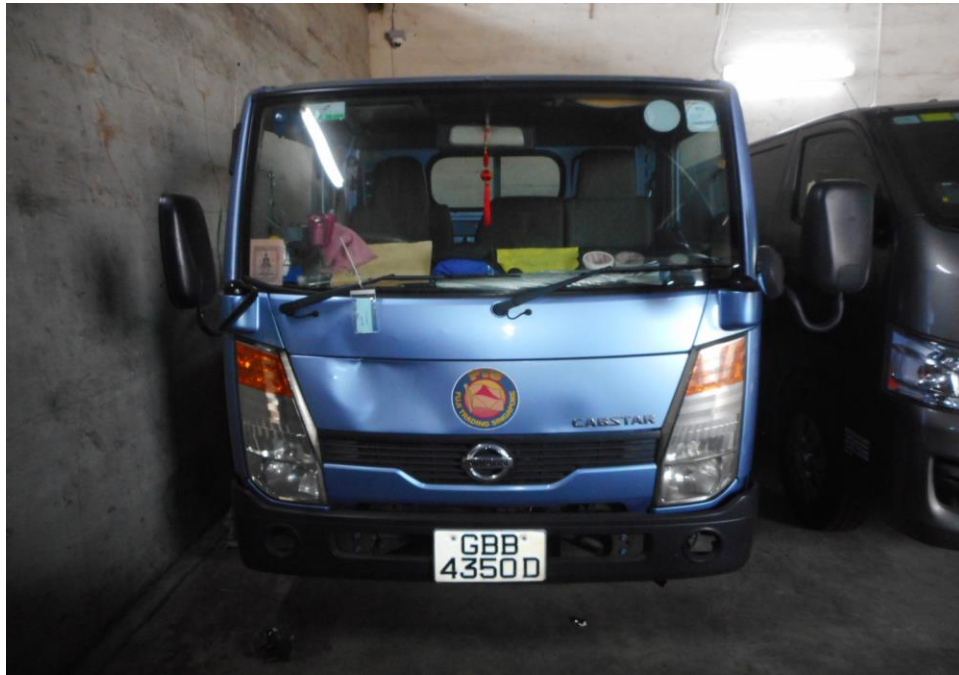
4. The mileage of the Motor Lorry at the time of my inspection was 429,568km.
5. The Motor Lorry appeared to have sustained damage at its frontal portion. Its front body panel and front windscreen were damaged at the time of my inspection.

**Photo 2** shows a general view of the Motor Lorry's frontal portion at the time of my inspection. It appeared to have sustained damage at its frontal portion. Its front body panel and front windscreen were damage at the time of my inspection.

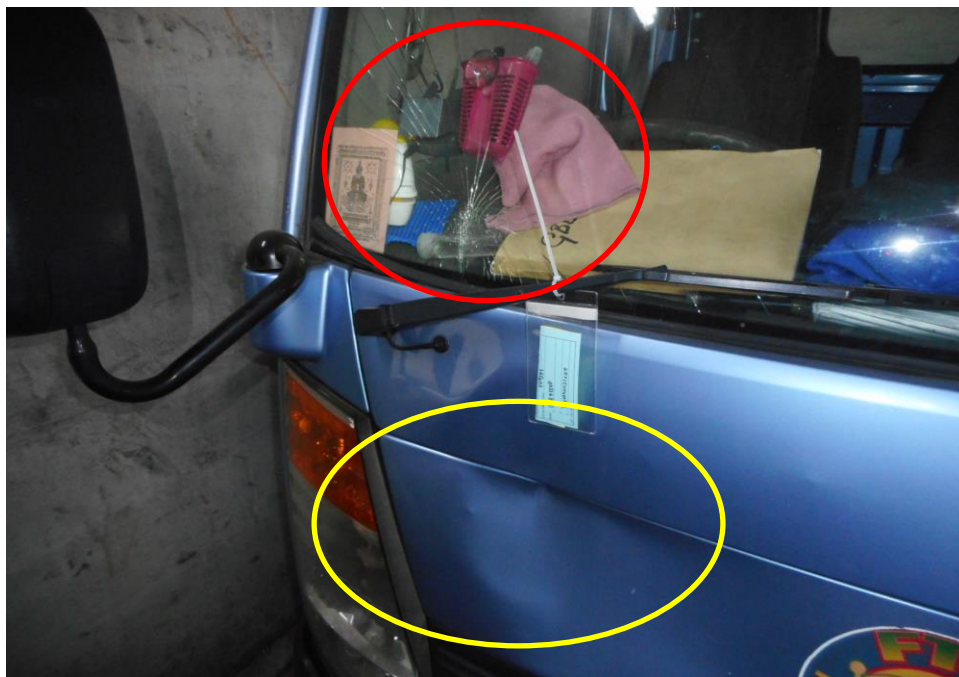
**Photo 3** shows a close up view of the Motor Lorry's frontal portion at the time of my inspection. It appeared to have sustained damage at its frontal portion. Its front body panel (yellow circle) and front windscreen (red circle) was damage at the time of my inspection as a result of the accident.

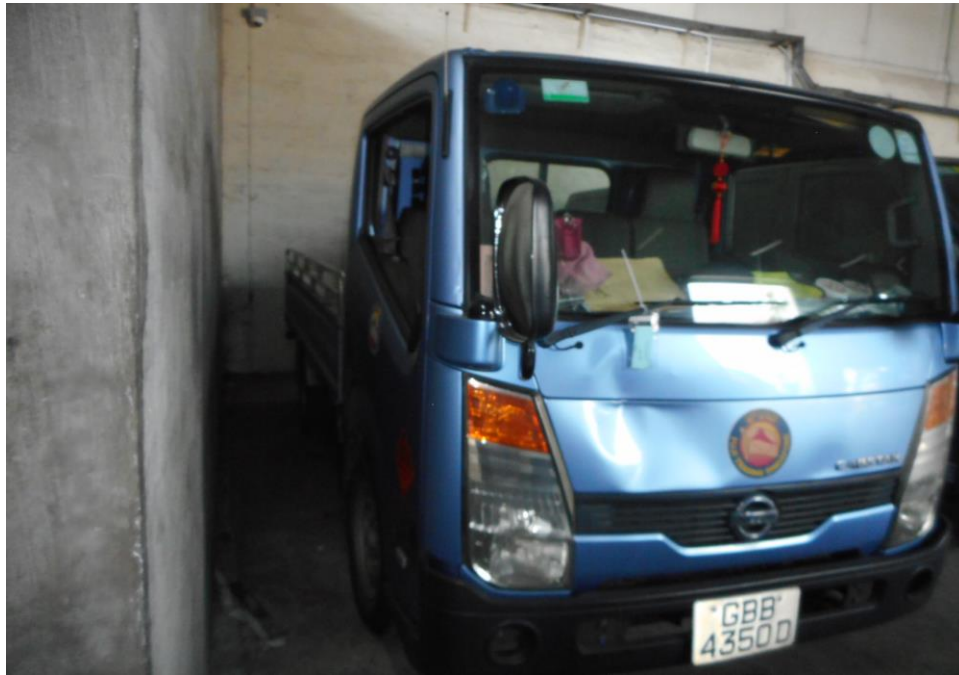
**Photo 4** shows a general view of the right body of the Motor Lorry at the time of my inspection. The Motor Lorry was observed to be intact and unaffected by the accident.

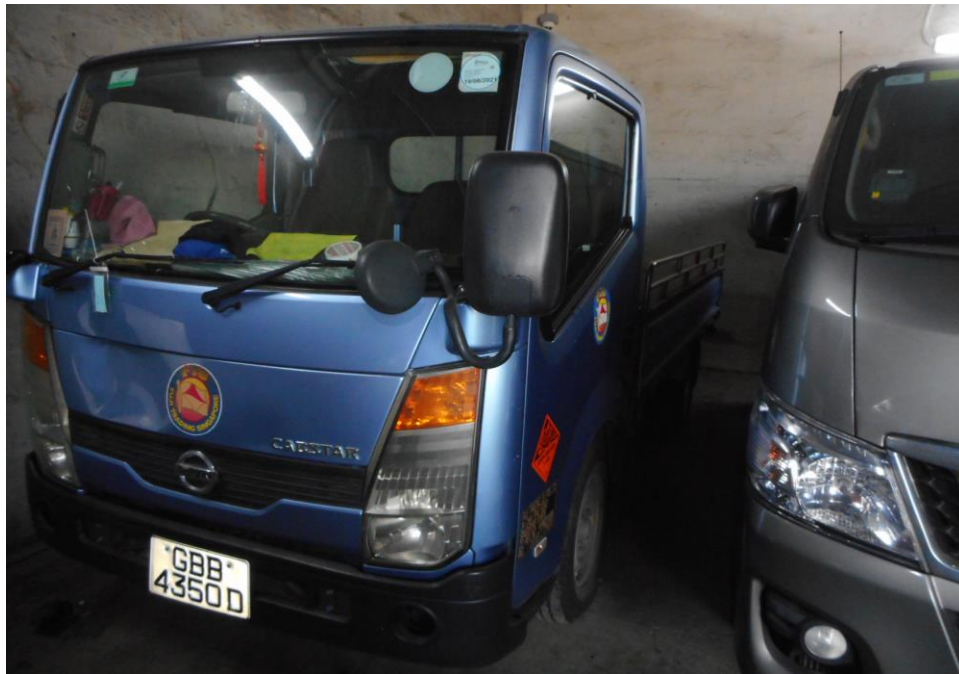
**Photo 5** shows a general view of the left body of the Motor Lorry at the time of my inspection. The Motor Lorry was observed to be intact and unaffected by the accident.

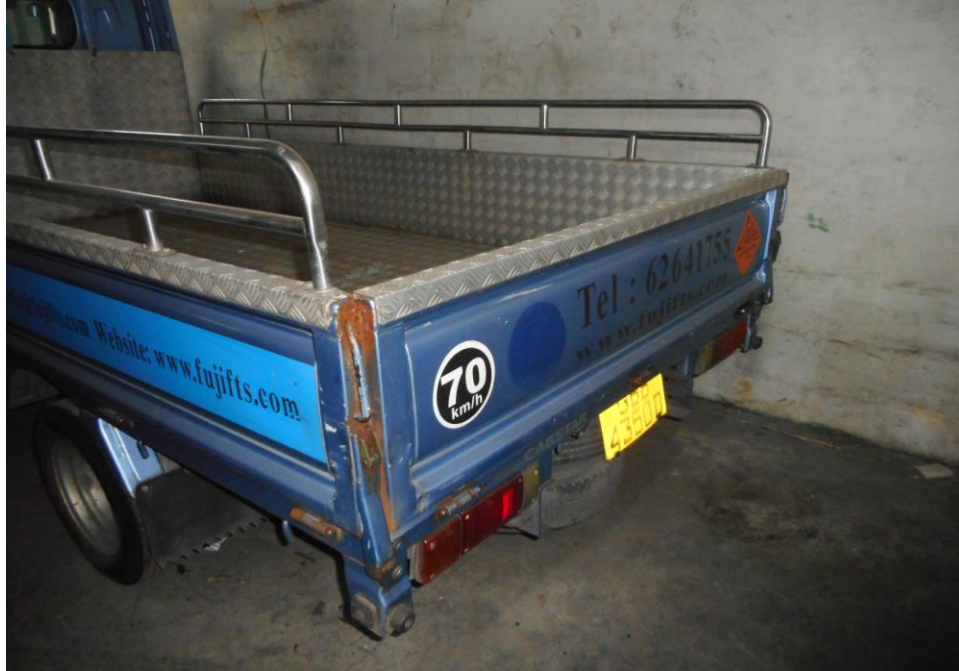
**Photo 6** shows a general view of the rear body of the Motor Lorry at the time of my inspection. The Motor Lorry was observed to be intact and unaffected by the accident.

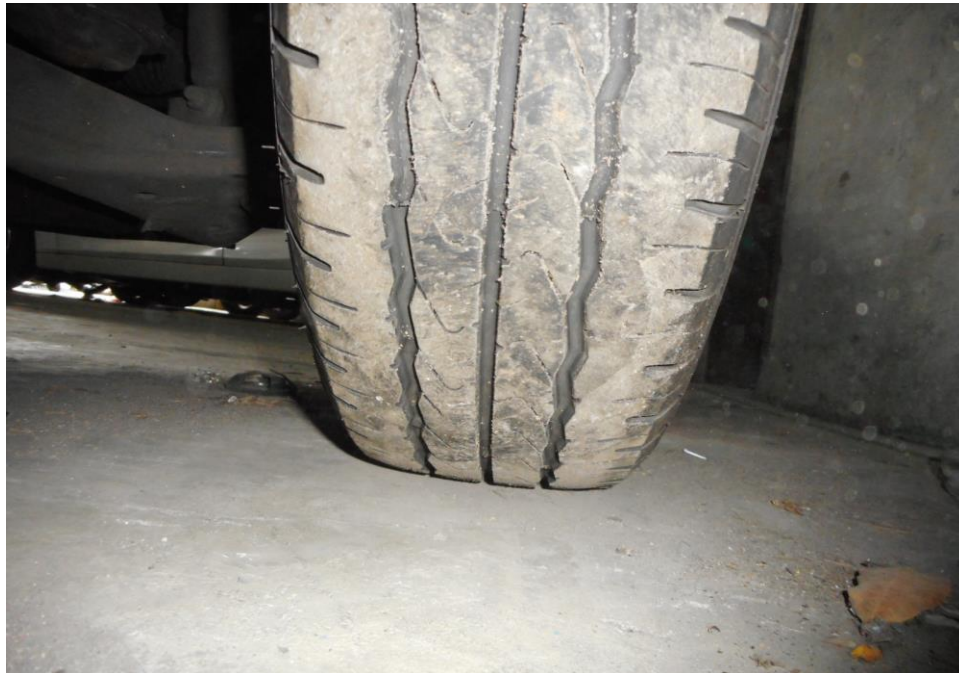
**Photo 7** shows the condition of the front right tyre of the Motor Lorry, which was observed to be in serviceable condition with remaining tread depth of approximately 5.2mm. The tyre, which was wrapped around standard steel wheel rim, was also observed to be sufficiently inflated for vehicular operation. There was no tear, cut or burst mark(s) on the outer and the inner sidewalls as well as across the tread of the 4 tyres that were fitted on the Motor Lorry.

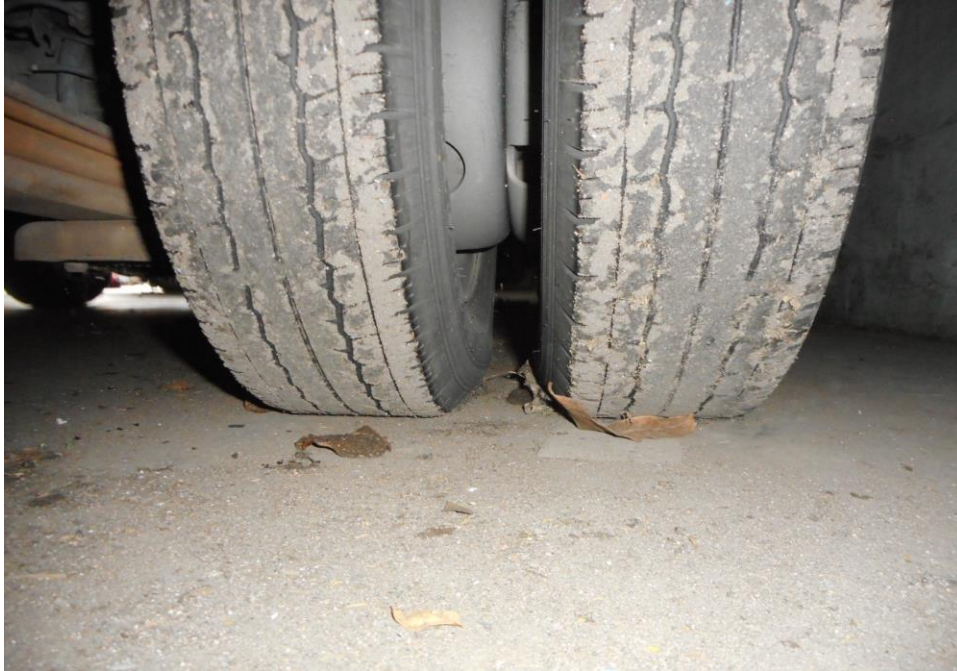
**Photo 8** shows the condition of the rear right tyre of the Motor Lorry, which was observed to be in serviceable condition with remaining tread depth of approximately 2mm. The tyre, which was wrapped around standard steel wheel rim, it was observed to be sufficiently inflated for vehicular operation.

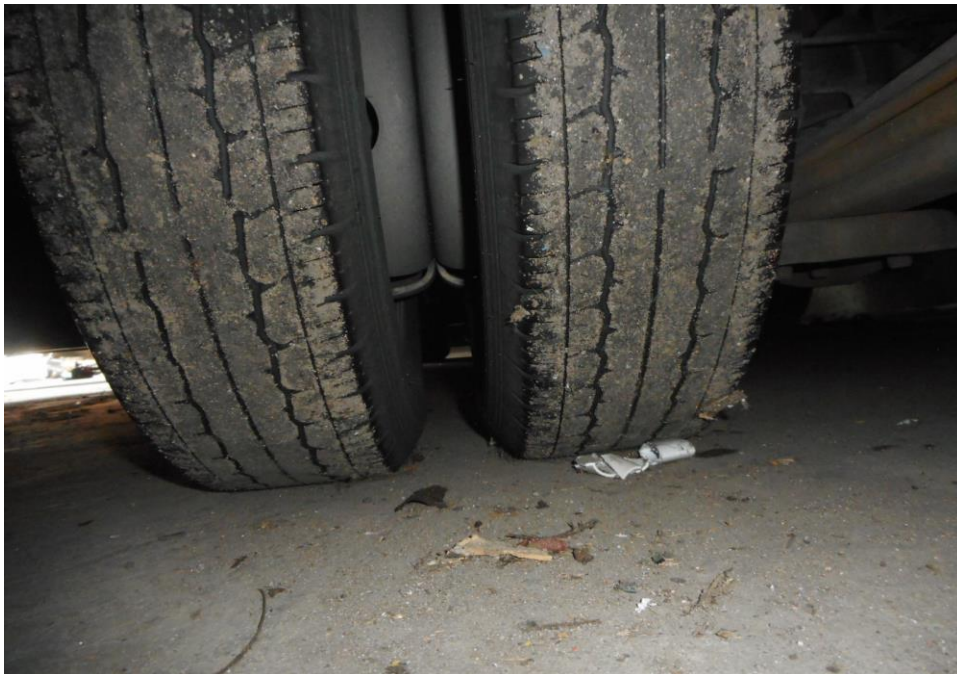
**Photo 9** shows the condition of the rear left tyres of the Motor Lorry, which was observed to be in serviceable condition with remaining tread depth of approximately 1.6mm. The tyres, which were wrapped around standard steel wheel rim, were also observed to be sufficiently inflated for vehicular operation. There was also no damage found on all 4 steel wheel rims of the Motor Lorry.

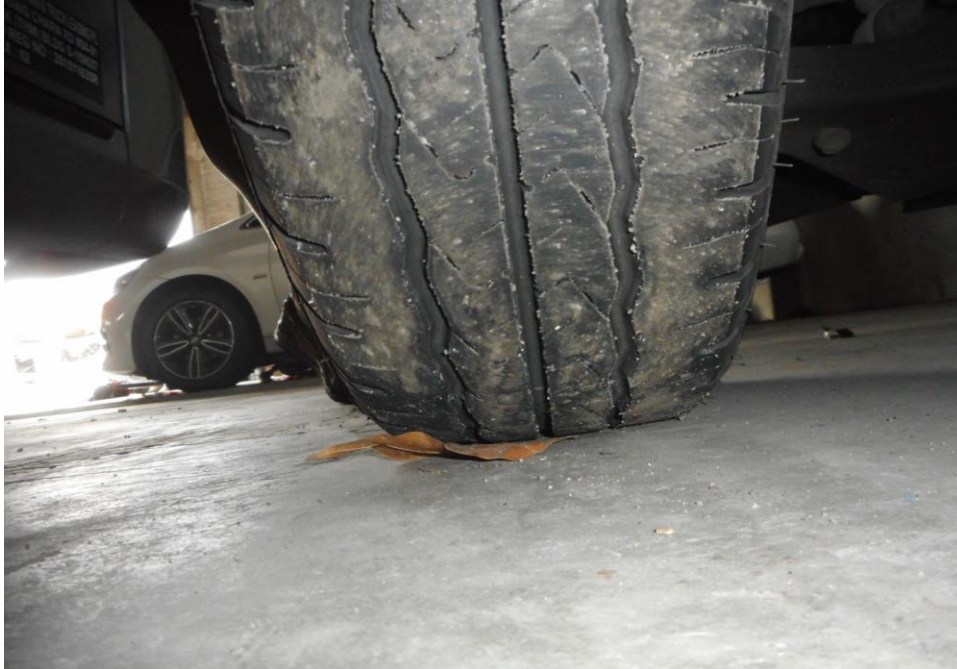
**Photo 10** shows the condition of the rear right tyres of the Motor Lorry, which were observed to be in serviceable condition with remaining, tread depth of approximately 5.5mm. There was also no tear, cut or burst mark(s) on the outer and the inner sidewalls as well as across the tread of the 4 tyres that were fitted on the Motor Lorry.

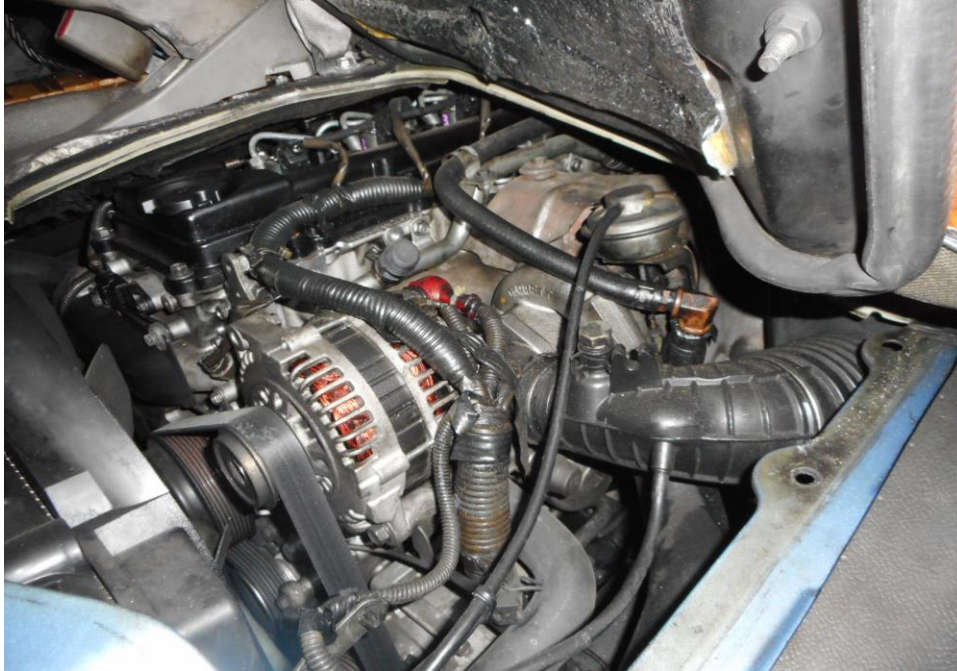
**Photo 11** shows a general view of the Motor Lorry's engine compartment, which was accessed by lifting the front cabin of the Motor Lorry. The various parts and components inside the engine compartment were unaffected by the accident. There was also no sign(s) or indication(s) of fresh fluid leakage and/or fluid stain within the engine compartment

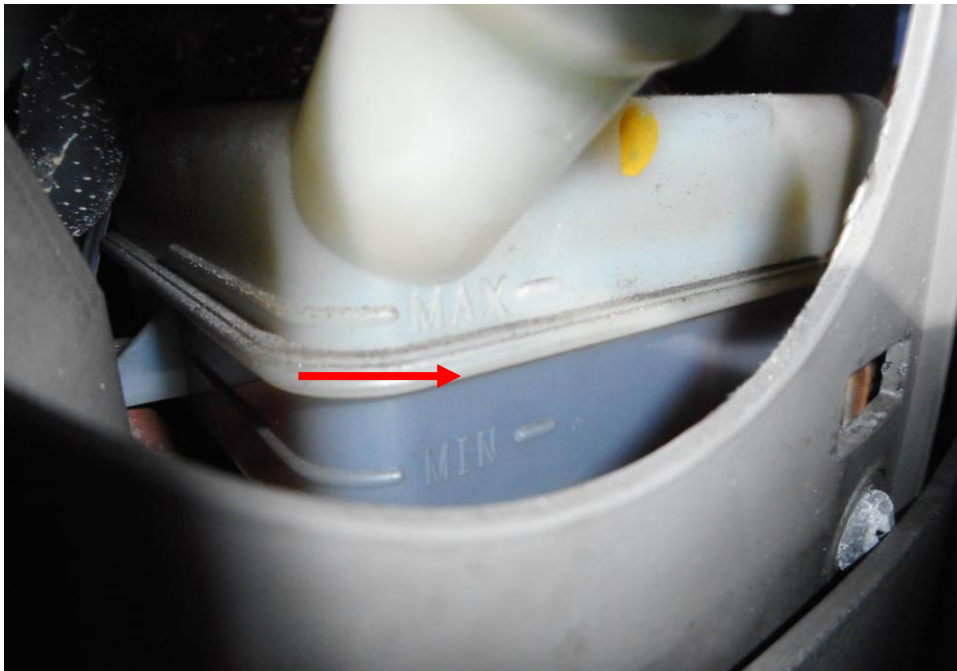
**Photo 12** shows the brake fluid reservoir of the Motor Lorry at the time of my inspection. The brake fluid was observed to be of sufficient level (arrowed) and without any visible contamination.

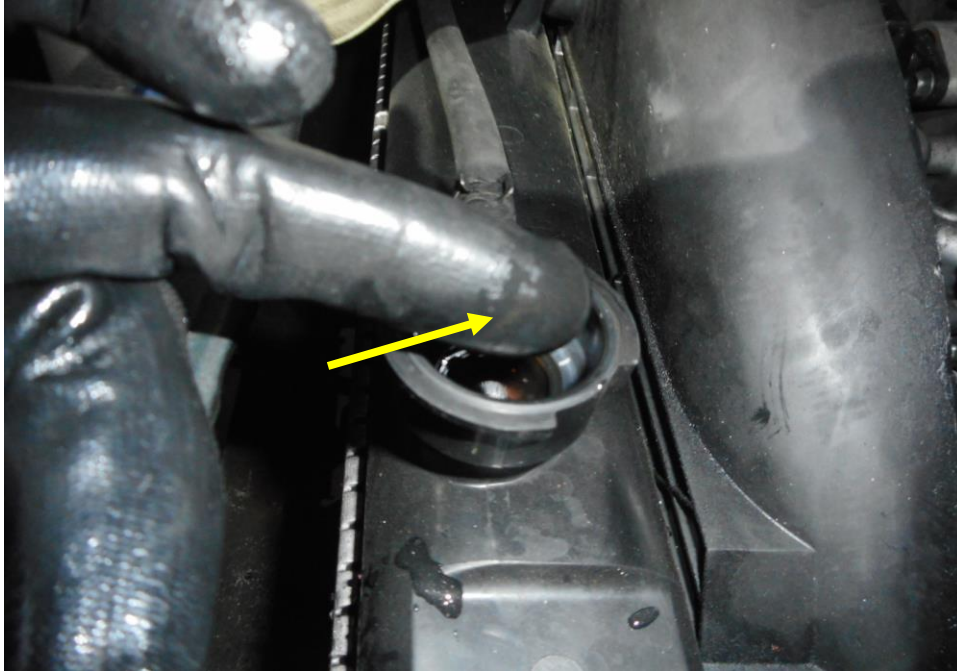
**Photo 13** shows the engine coolant reservoir of the Motor Lorry at the time of my inspection. The engine coolant was observed to be of sufficient level (arrowed) and without any visible contamination.

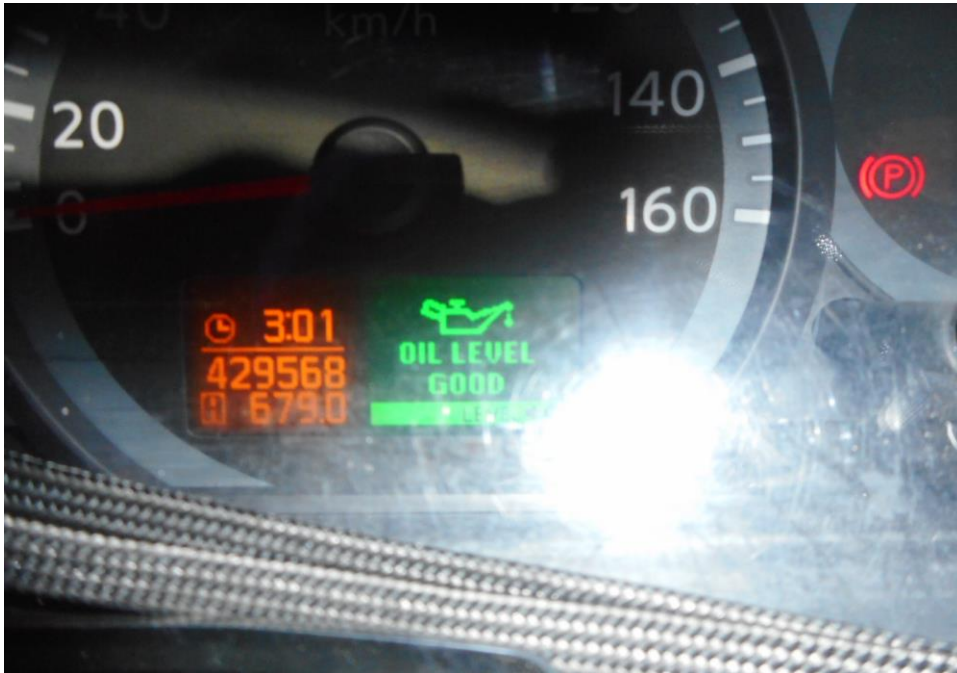
**Photo 14** shows the engine oil display panel of the Motor Lorry at the time of my inspection. The engine oil was observed to be of sufficient level and without any contamination.

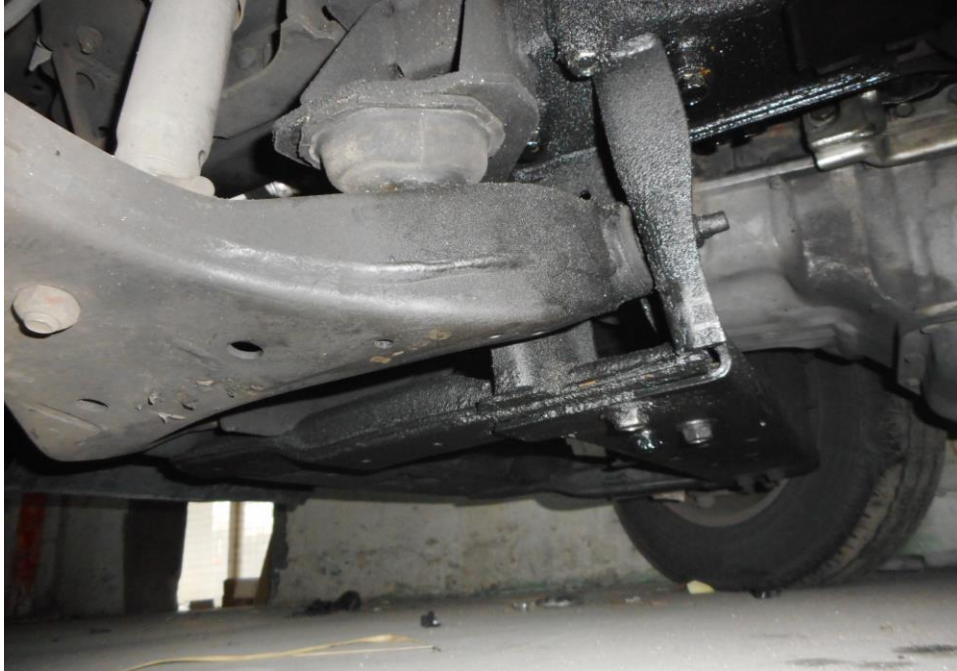
**Photo 15** shows the undercarriage of the Motor Lorry, at the area where the engine housing and transmission housing are located. I did not find any sign(s) or indication(s) of fluid leak and/or fluid stain(s) on the underside of the Motor Lorry.

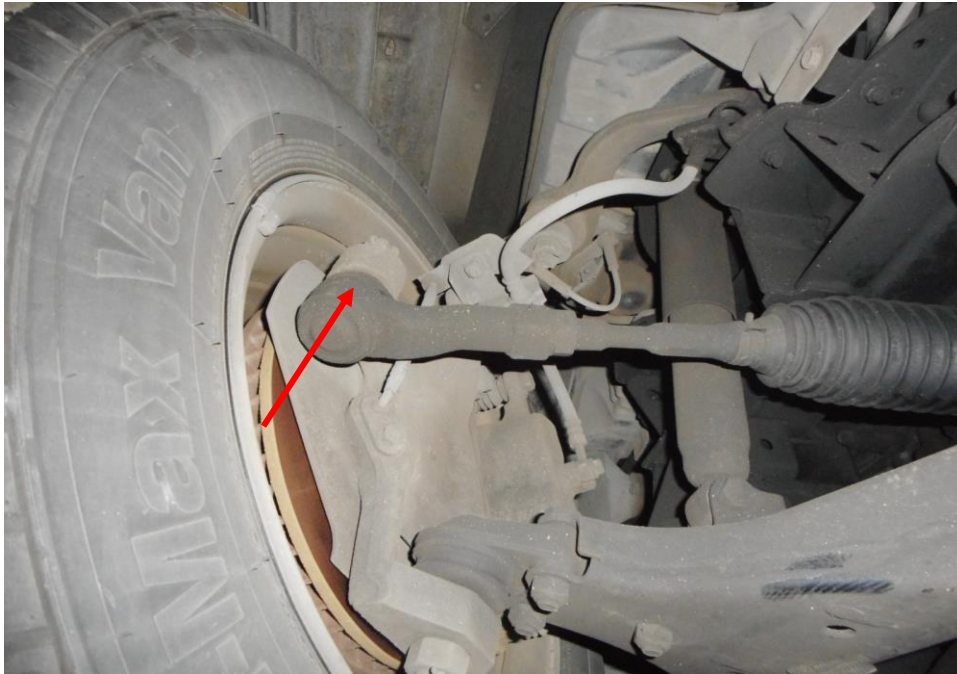
**Photo 16** shows the various undercarriage components at the front right wheel of the Motor Lorry, in particular the steering tie rod end (arrowed). The various steering components were all found to be intact, suggesting that the steering system of the Motor Lorry was likely to be in serviceable condition at the material time of accident. There was also no sign of fluid stain(s) observed on the various undercarriage components.

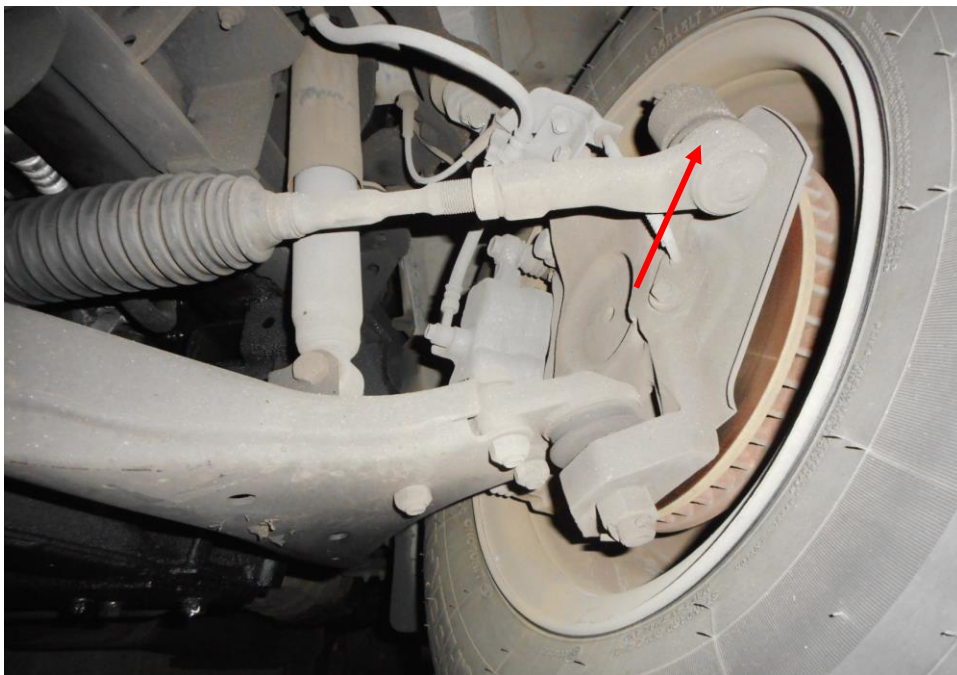
**Photo 17** shows the various undercarriage components at the front left wheel of the Motor Lorry, in particular the steering tie rod end (arrowed). The various undercarriage components of the Motor Lorry were all found to be intact without any visible damage. There was also no sign of fluid stain(s) observed on the various undercarriage components.

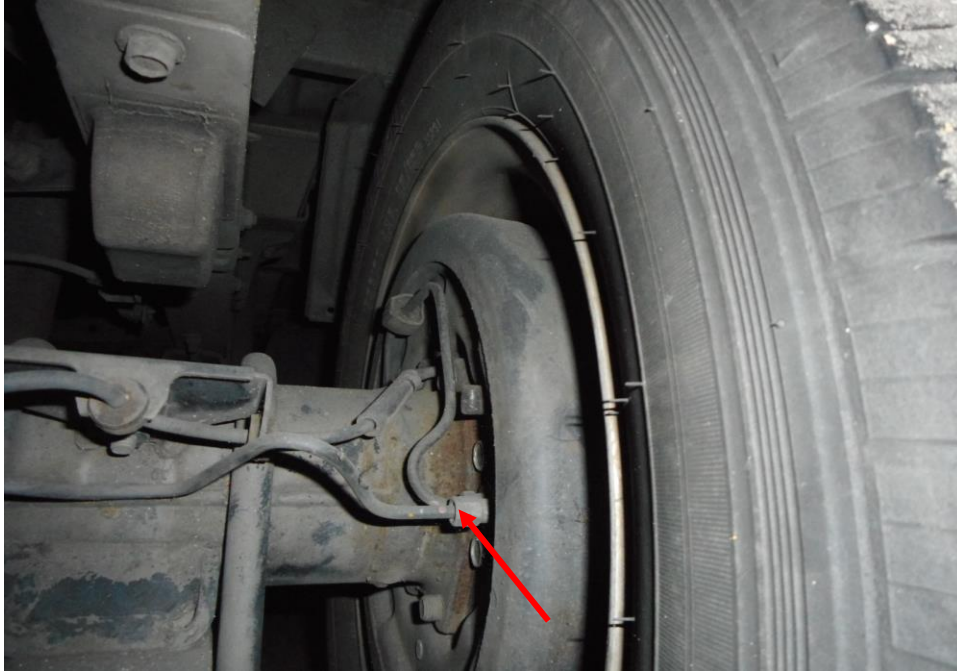
**Photo 18** shows the brake pipe (arrowed) at the rear right wheel of the Motor Lorry. I did not observe any leakage of brake fluid at the time of my inspection of the Motor Lorry. My static tests of the Motor Lorry's braking system, along with my visual examination of the various mechanical components in the braking system, had indicated that there was no internal leakage of pressure/vacuum. Hence the braking system of the Motor Lorry was likely to be in serviceable condition at the material time of accident.

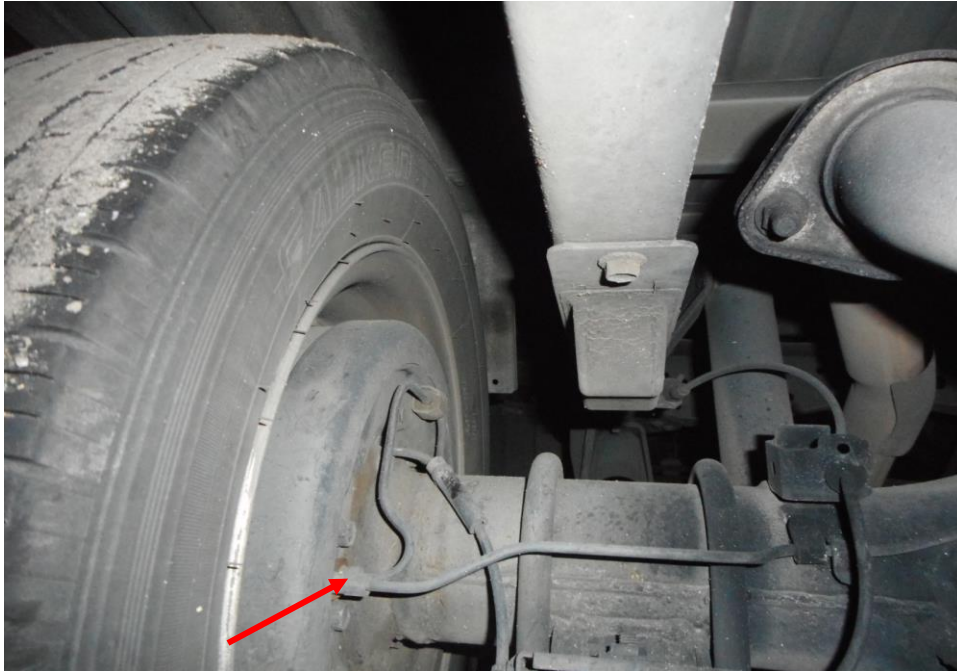
**Photo 19** shows the brake pipe (arrowed) at the rear left wheel of the Motor Lorry. I did not observe any leakage of brake fluid at the time of my inspection of the Motor Lorry. My static tests of the Motor Lorry's braking system, along with my visual examination of the various mechanical components in the braking system had indicated that there was no internal leakage of pressure/vacuum. Hence the braking system of the Motor Lorry was likely to be in serviceable condition at the material time of accident.

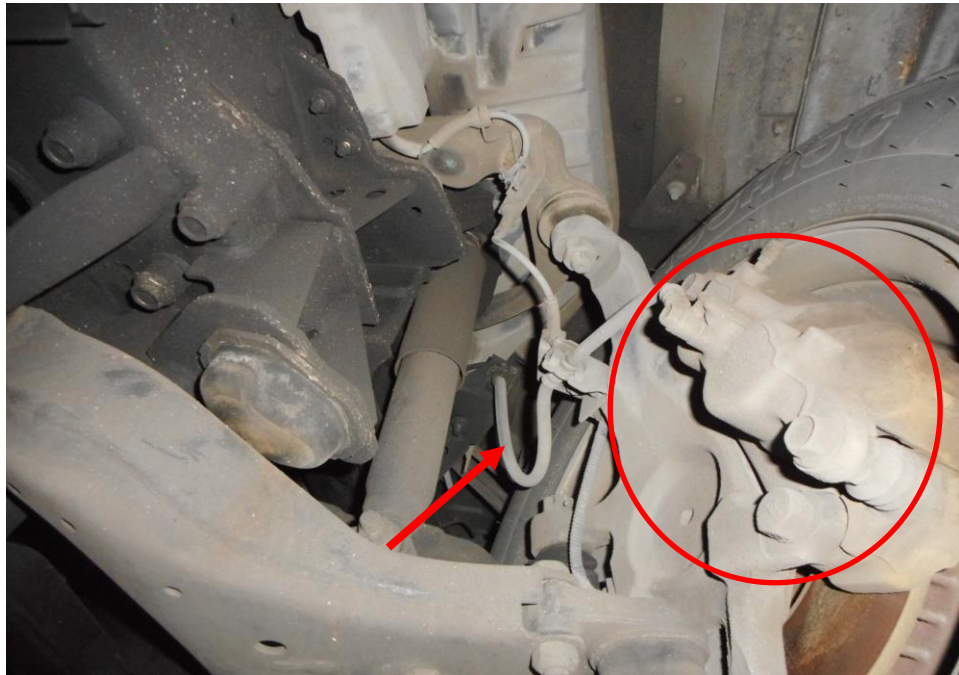
**Photo 20** shows the brake hose/pipe (arrowed) at the front right wheel of the Motor Lorry. No leakage of brake fluid was observed. Visual examination of the various components of the braking system like the brake caliper (circled), brake booster, brake pedal etc had revealed all to be intact and without visible damage at the time of accident. There was also no sign of fluid stain(s) observed on the various undercarriage components.

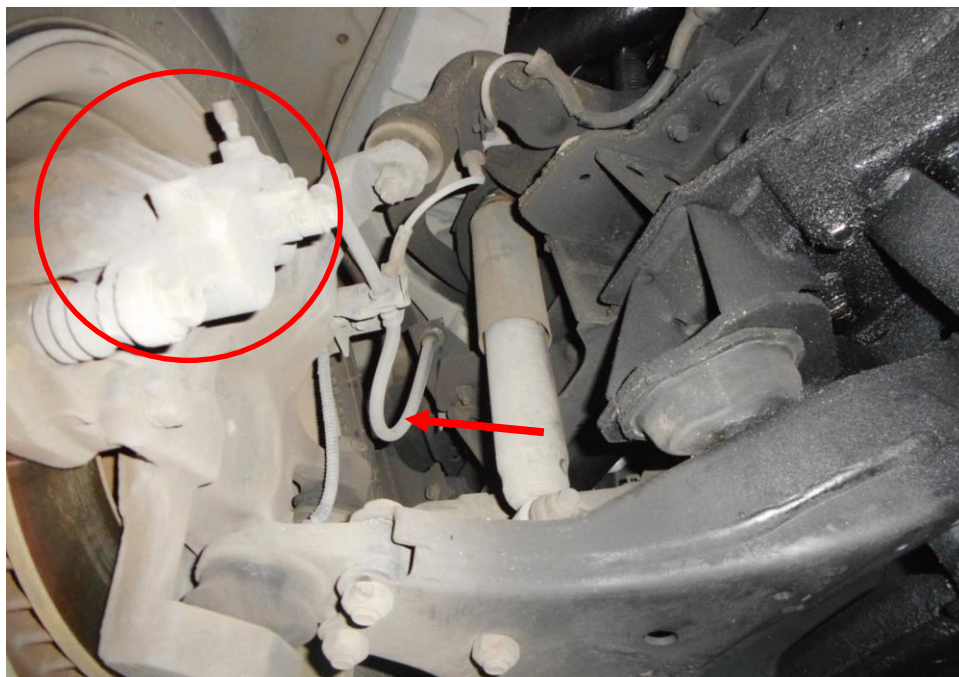
**Photo 21** shows the brake hose/pipe (arrowed) at the front left wheel of the Motor Lorry. No leakage of brake fluid was observed. Visual examination of the various components of the braking system like the brake caliper (circled), brake booster, brake pedal etc had revealed all to be intact and without visible damage at the time of accident. There was also no sign of fluid stain(s) observed on the various undercarriage components.

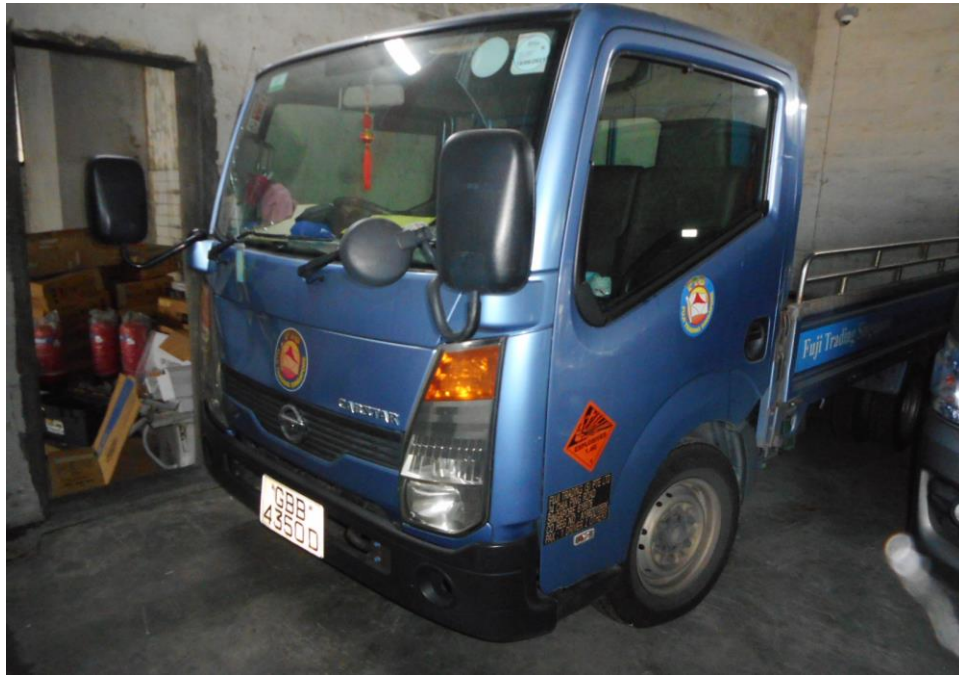
**Photo 22** shows the front left wheel of the Motor Lorry turned to its right. During my steering system test, I did not experience any abnormal free play and/or resistance when I had turned the steering wheel towards full left and full right. This would suggest that the steering system of the Motor Lorry was likely to be in serviceable condition at the material time of accident.

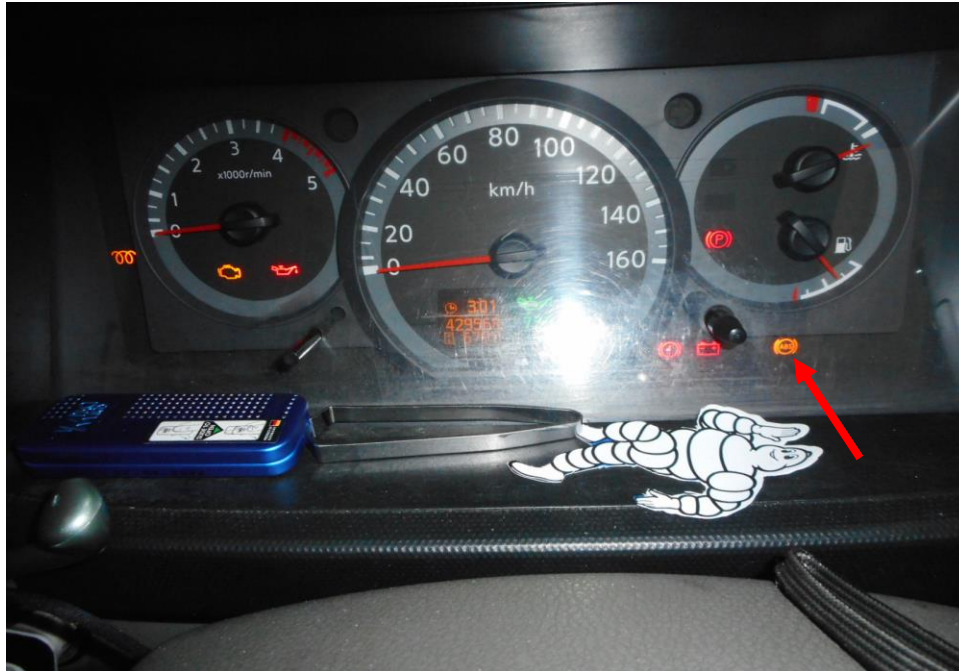
**Photo 23** shows the warning light for Anti-Lock Brake System (ABS) (arrowed) appearing on the instrument panel of the Motor Lorry during the self-test of its various electronic operating systems when its engine was cranked.

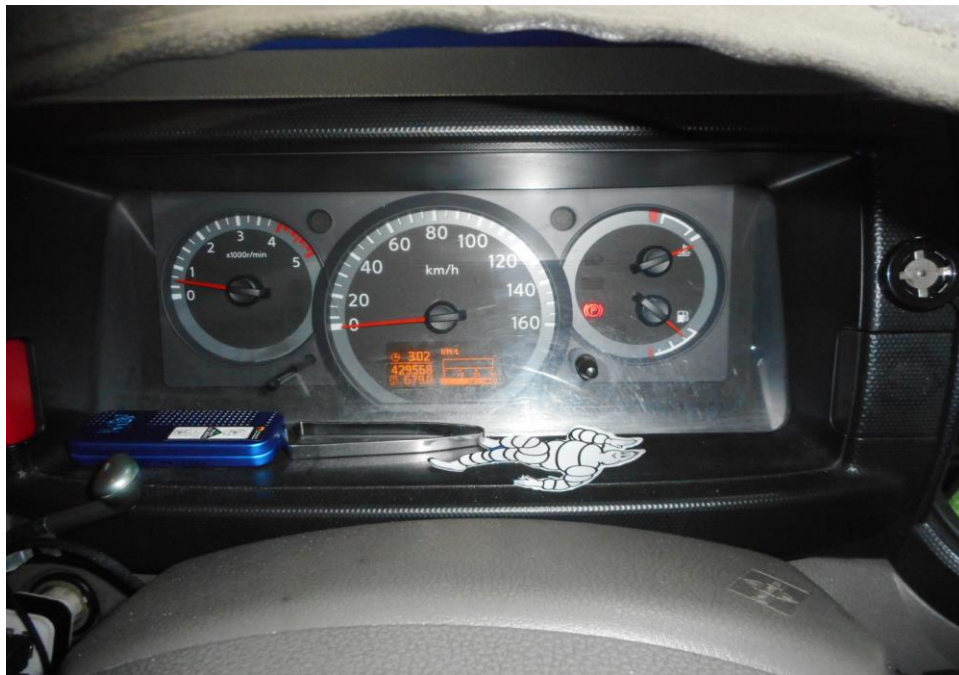
**Photo 24** shows no warning lights illuminated on the instrument panel of the Motor Lorry after the engine was cranked. This would suggest that there was no abnormality to the electronic operating system of the Motor Lorry, like the ABS, etc.
