Your Ref: TP/IP/50171/2020
Our Ref : CI/TPD21002934/P

19th April 2021

MECHANICAL INSPECTION REPORT OF TRAILER XE 3670K

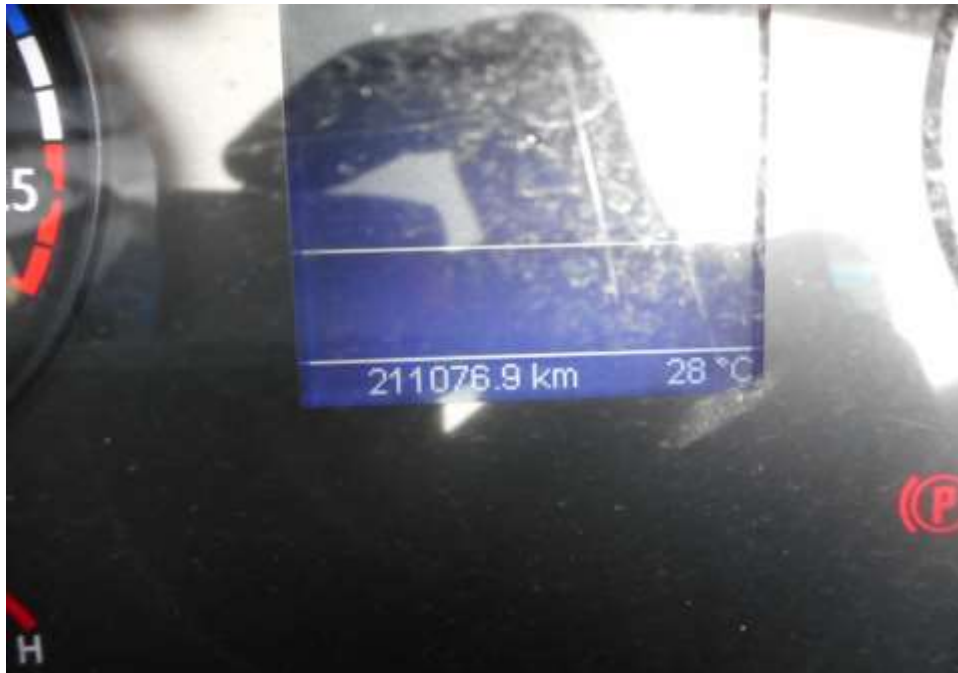
Photo 1 shows a general view of the instrument cluster of the Trailer at the time of my inspection. The mileage of the Trailer was 211,076 km

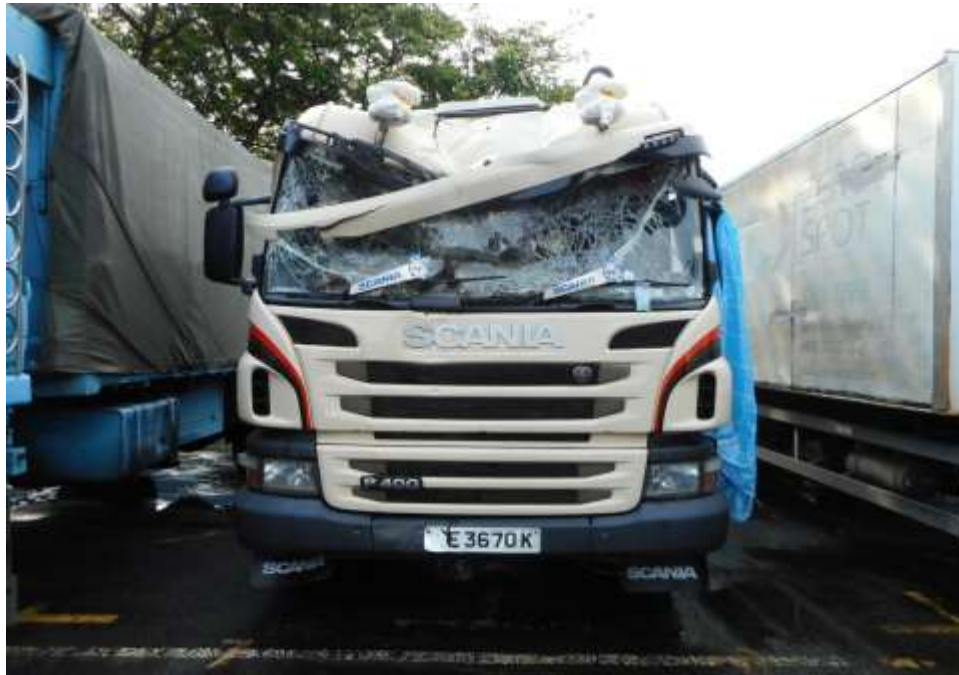
4. The mileage of the Trailer at the time of my inspection was 211,076km.
5. The Trailer appeared to have sustained damage at its front and rear portion. Its front windscreen, front cabin panel and rear left mud guard were damage at the time of my inspection.

Photo 2 shows a general view of the Trailer's frontal portion at the time of my inspection. It appeared to have sustained damage at its front and rear portion. Its front windscreen, front cabin panel and rear left mud guard were damage at the time of my inspection.

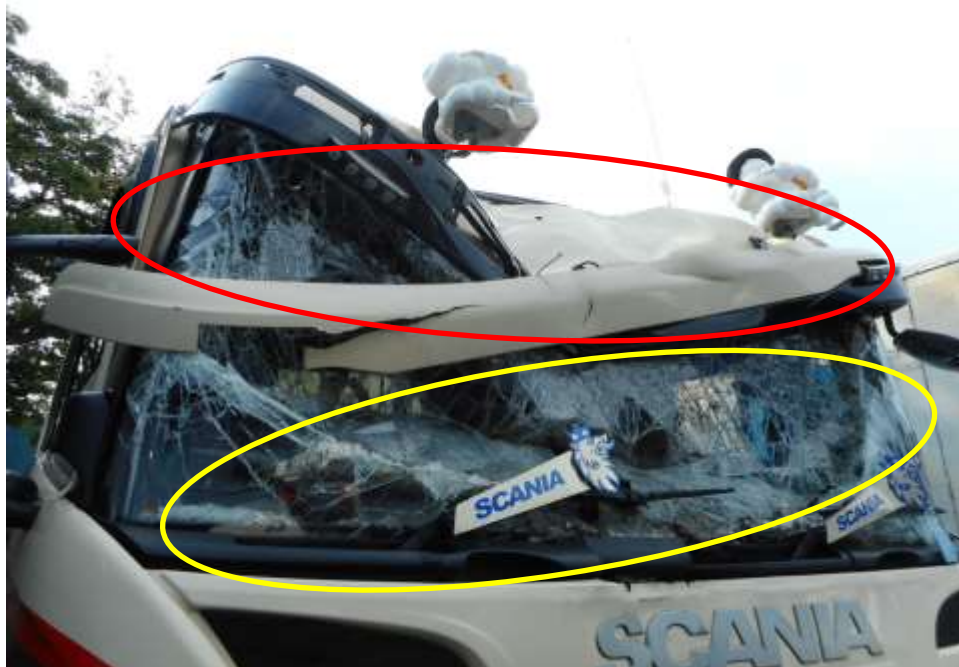
Photo 3 shows a close up view of the Trailer's front portion at the time of my inspection. It appeared to have sustained damage at its front portion. Its front windscreen (yellow circle) and front cabin panel (red circle) was damage at the time of my inspection as a result of the accident.

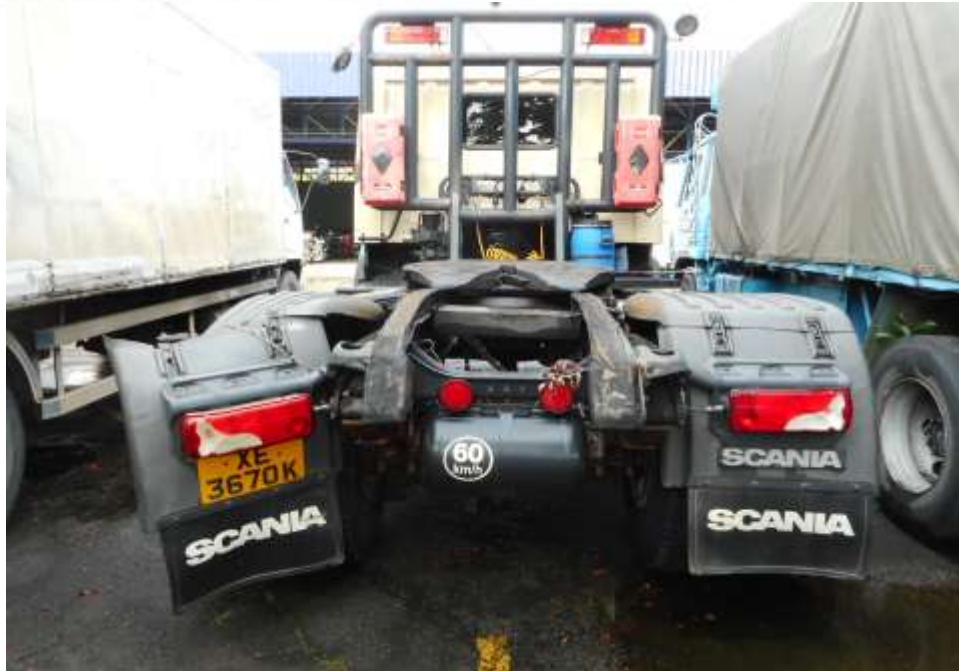
Photo 4 shows a general view of the Trailer's rear portion at the time of my inspection. It appeared to have sustained damage at its rear portion. Its rear mud guard was damage at the time of my inspection as a result of the accident.

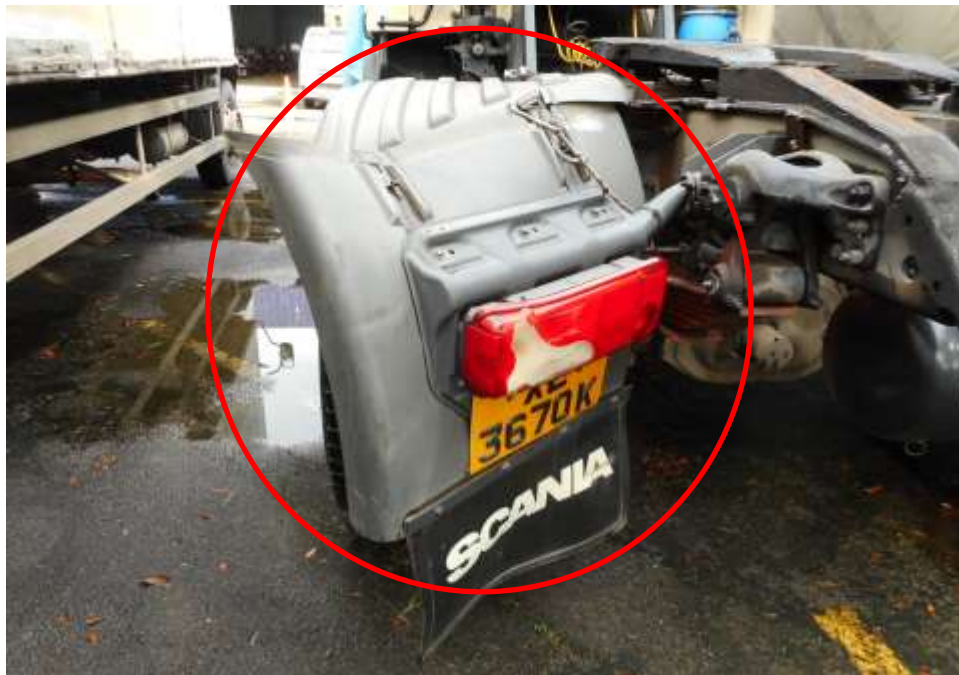
Photo 5 shows a close up view of the Trailer's rear portion at the time of my inspection. It appeared to have sustained damage at its rear portion. Its rear mud guard (circled) was damage at the time of my inspection as a result of the accident.

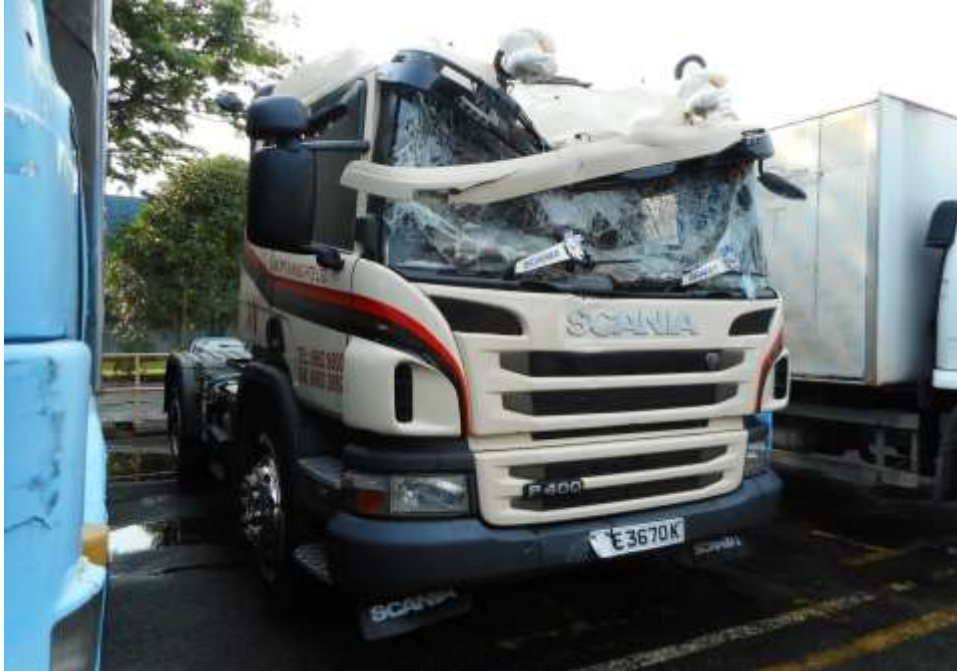
Photo 6 shows a general view of the Trailer's right portion at the time of my inspection. The Trailer's right portion was observed to be intact and unaffected by the accident.

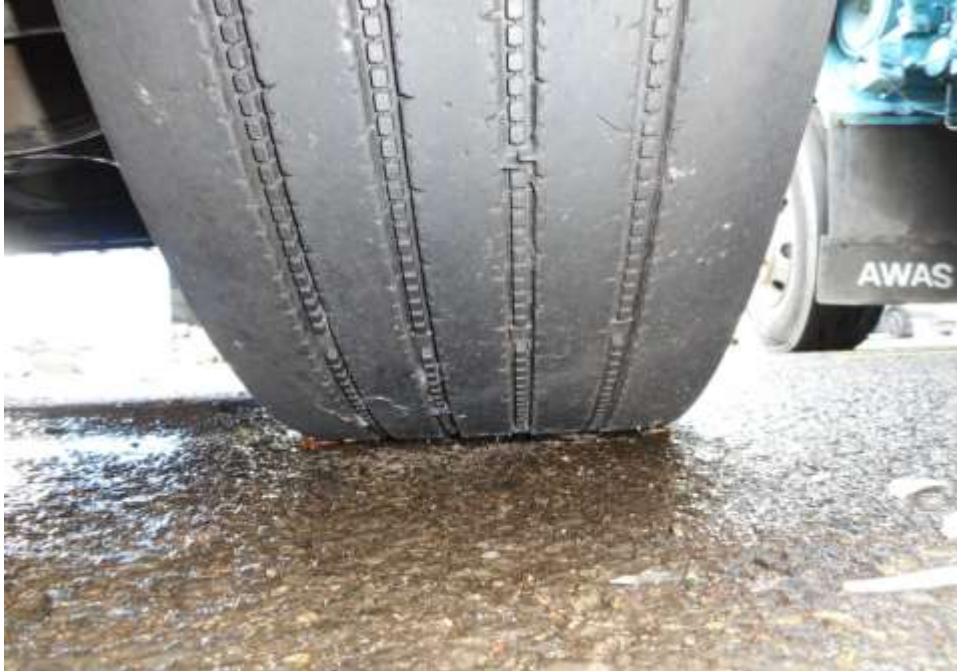
Photo 8 shows the condition of the front right tyre of the Trailer, which was observed to be in serviceable condition with remaining tread depth of approximately 5.6mm. The tyre, which was wrapped around standard steel wheel rim, was also observed to be sufficiently inflated for vehicular operation. There was no tear, cut or burst mark(s) on the outer and the inner sidewalls as well as across the tread of the 6 tyres that were fitted on the Trailer.

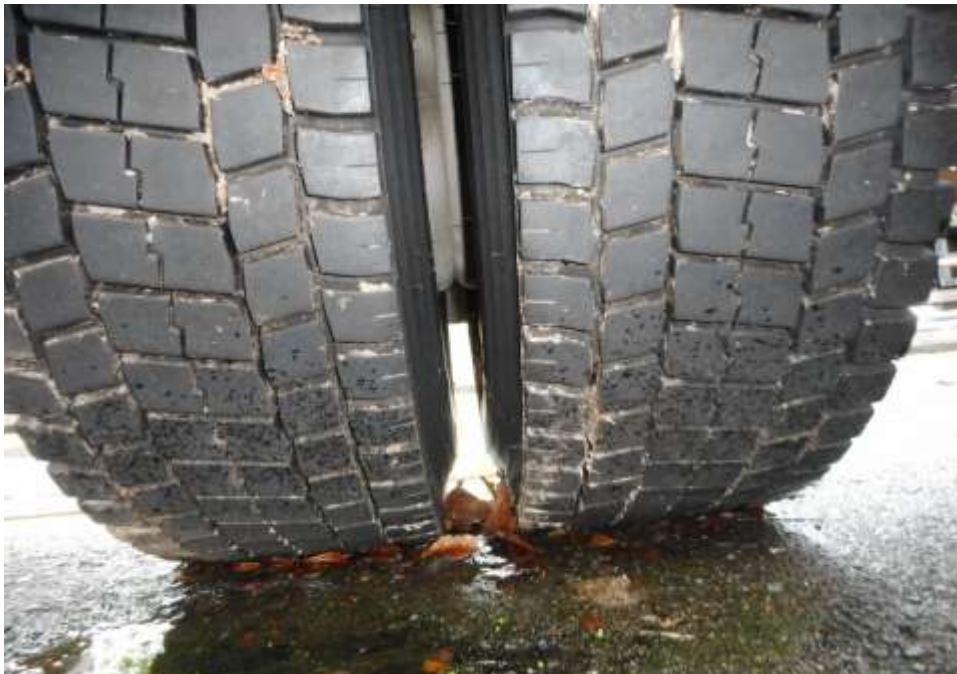
Photo 9 shows the condition of the rear right tyre of the Trailer, which was observed to be in serviceable condition with remaining tread depth of approximately 13.5mm. The tyre, which was wrapped around standard steel wheel rim, it was observed to be sufficiently inflated for vehicular operation.

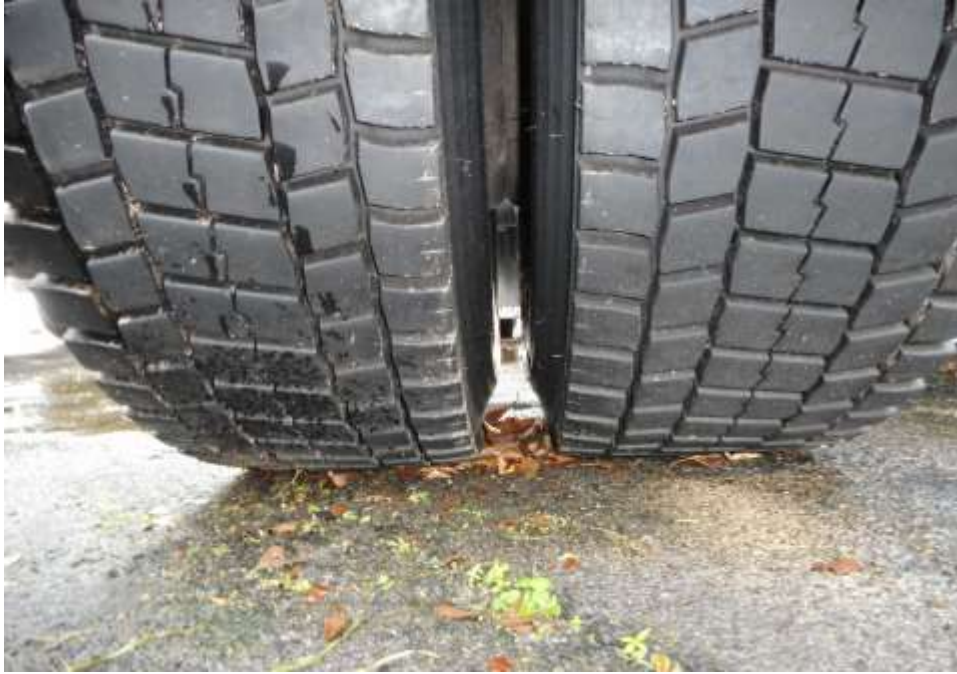
Photo 10 shows the condition of the rear left tyres of the Trailer, which was observed to be in serviceable condition with remaining tread depth of approximately 11.6mm. The tyres, which were wrapped around standard steel wheel rim, were also observed to be sufficiently inflated for vehicular operation. There was also no damage found on all 6 steel wheel rims of the Trailer.

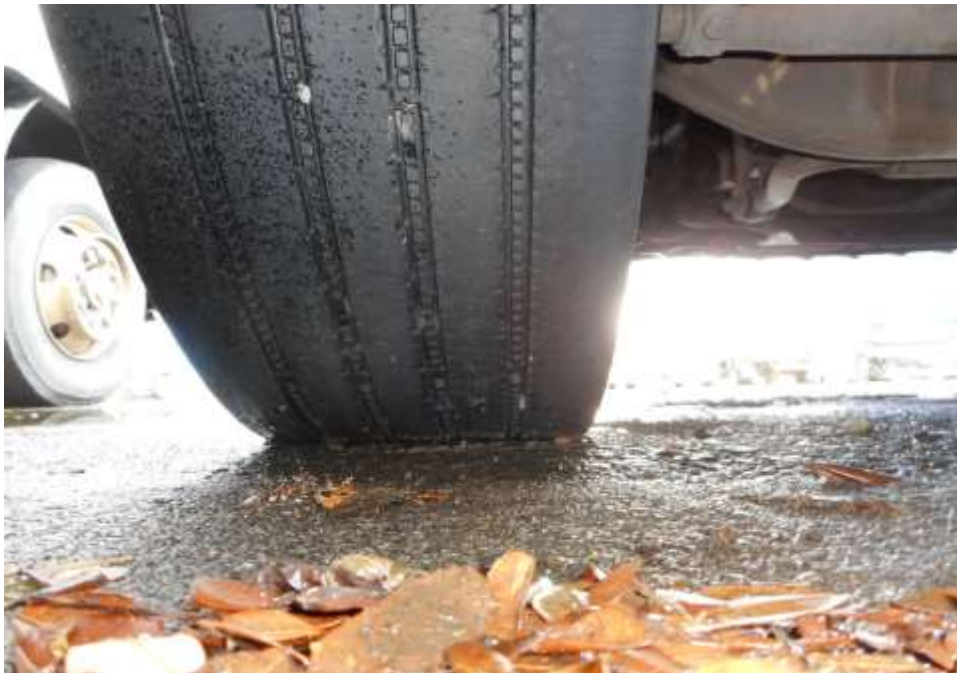
Photo 11 shows the condition of the rear right tyres of the Trailer, which were observed to be in serviceable condition with remaining, tread depth of approximately 6mm. There was also no tear, cut or burst mark(s) on the outer and the inner sidewalls as well as across the tread of the 6 tyres that were fitted on the Trailer.

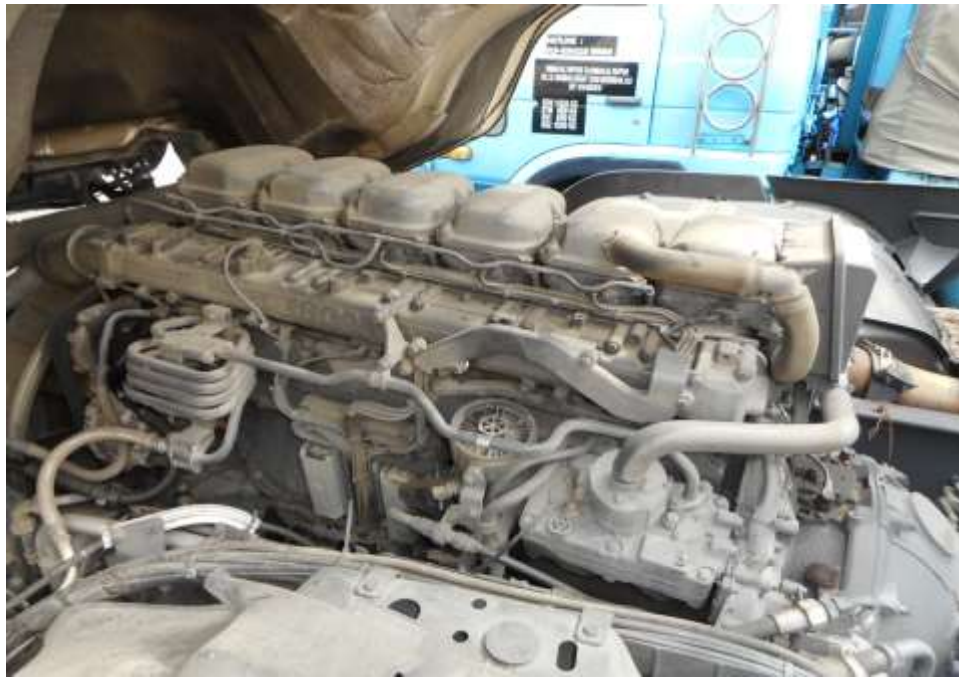
Photo 12 shows a general view of the Trailer's engine compartment, which was accessed by lifting the front cabin of the Trailer. The various parts and components inside the engine compartment were unaffected by the accident. There was also no sign(s) or indication(s) of fresh fluid leakage and/or fluid stain within the engine compartment

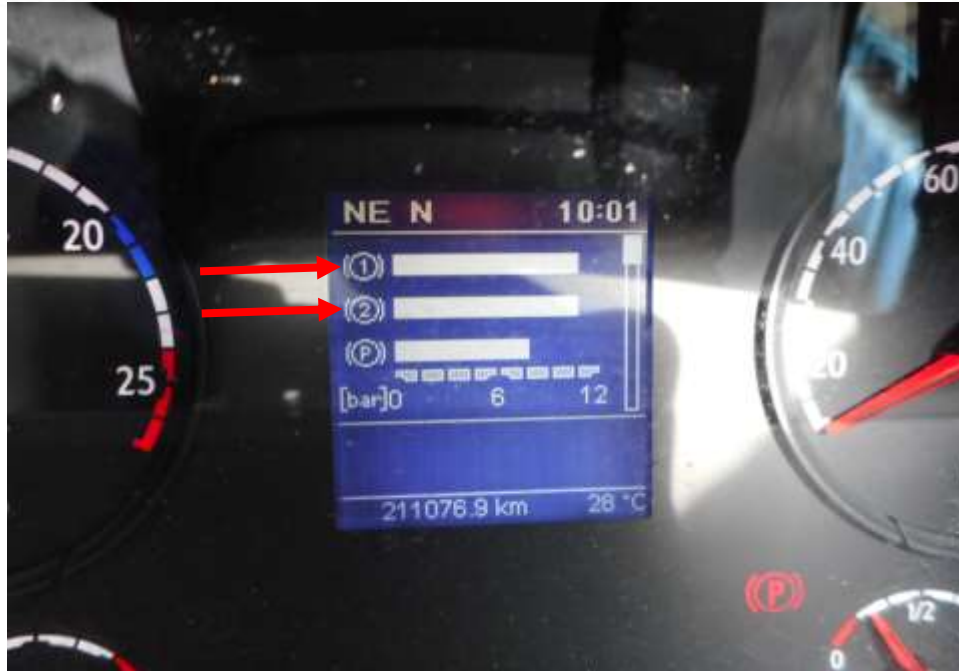
Photo 13 shows the air in the air brake cylinder of the Motor Bus at the time of my inspection. The air in the cylinder was observed to be of sufficient level & serviceable at the time of the accident.

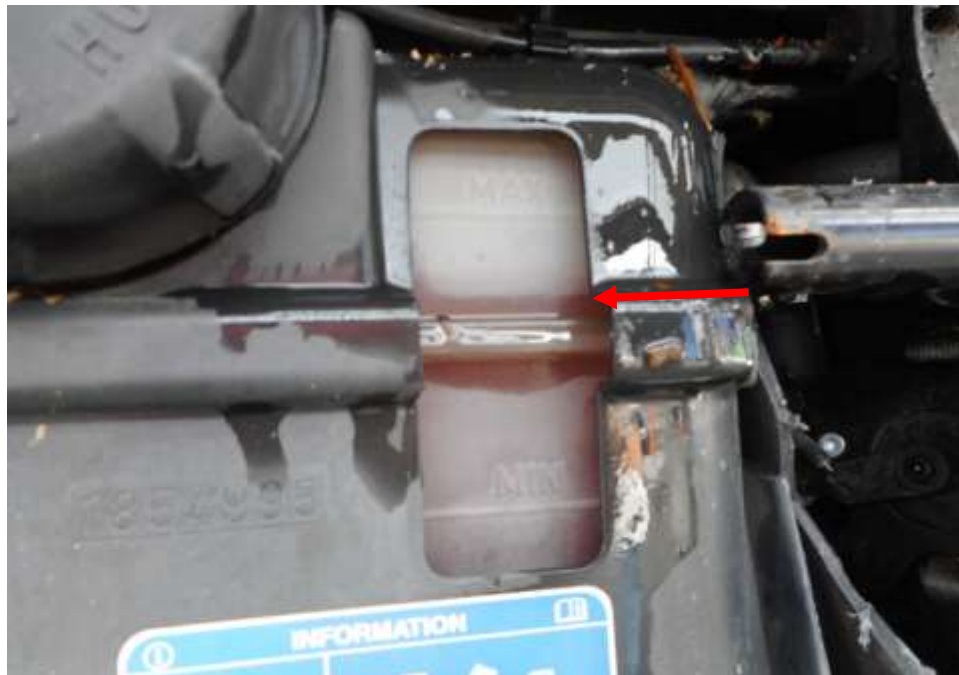
Photo 14 shows the engine coolant reservoir of the Trailer at the time of my inspection. The engine coolant was observed to be of sufficient level (arrowed) and without any visible contamination.

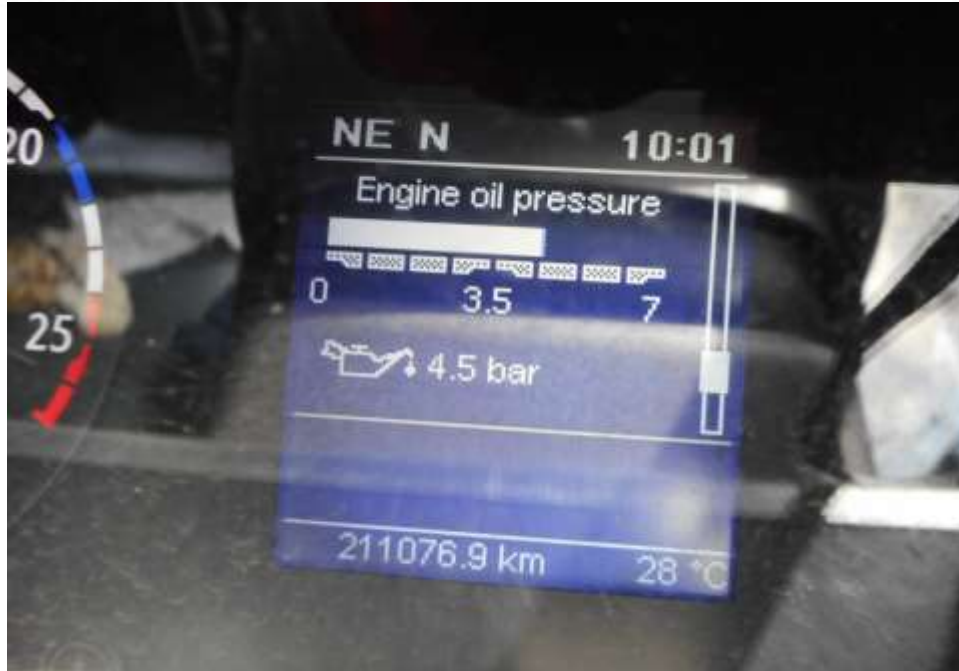
Photo 15 shows the engine oil measurement of the Trailer at the time of my inspection. The engine oil was observed to be of sufficient level and without any visible contamination.

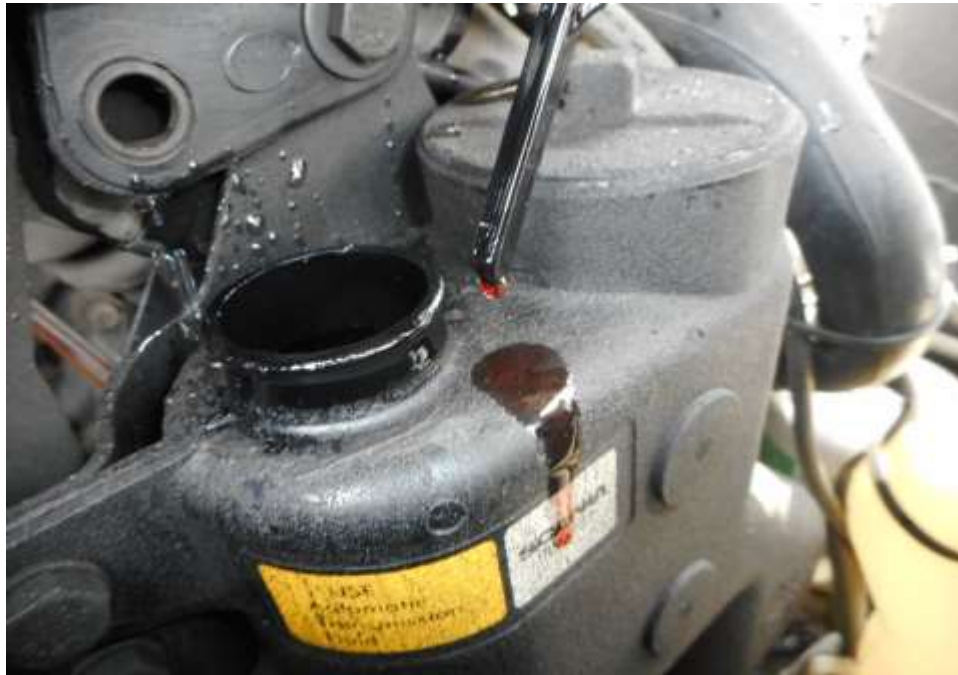
Photo 16 shows the power steering fluid reservoir of the Trailer at the time of my inspection. The power steering fluid was observed to be of sufficient level and without any visible contamination.

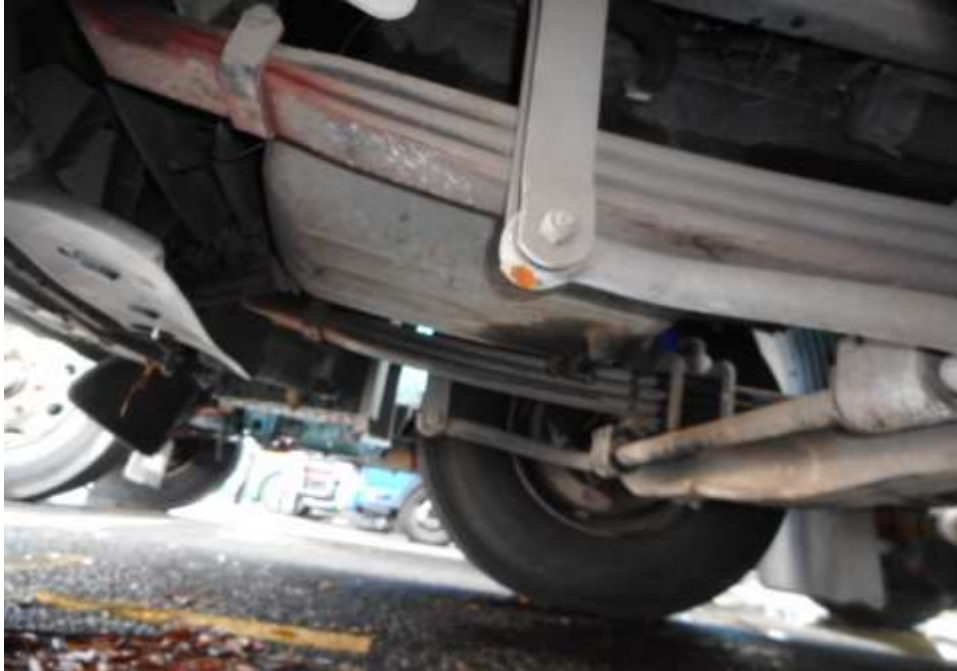
Photo 17 shows the undercarriage of the Trailer, at the area where the engine housing and transmission housing are located. I did not find any sign(s) or indication(s) of fluid leak and/or fluid stain(s) on the underside of the Trailer.

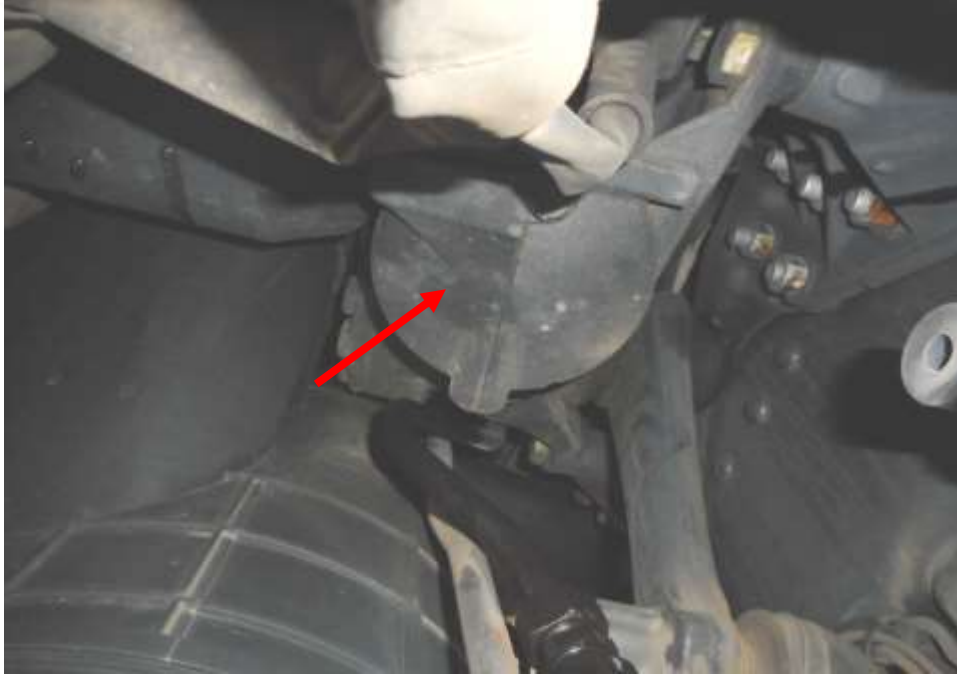
Photo 18 shows the steering box component (arrowed) at the undercarriage of the Trailer was found to be intact without any visible damage. There was also no sign of fluid stain(s) observed on the various undercarriage components.

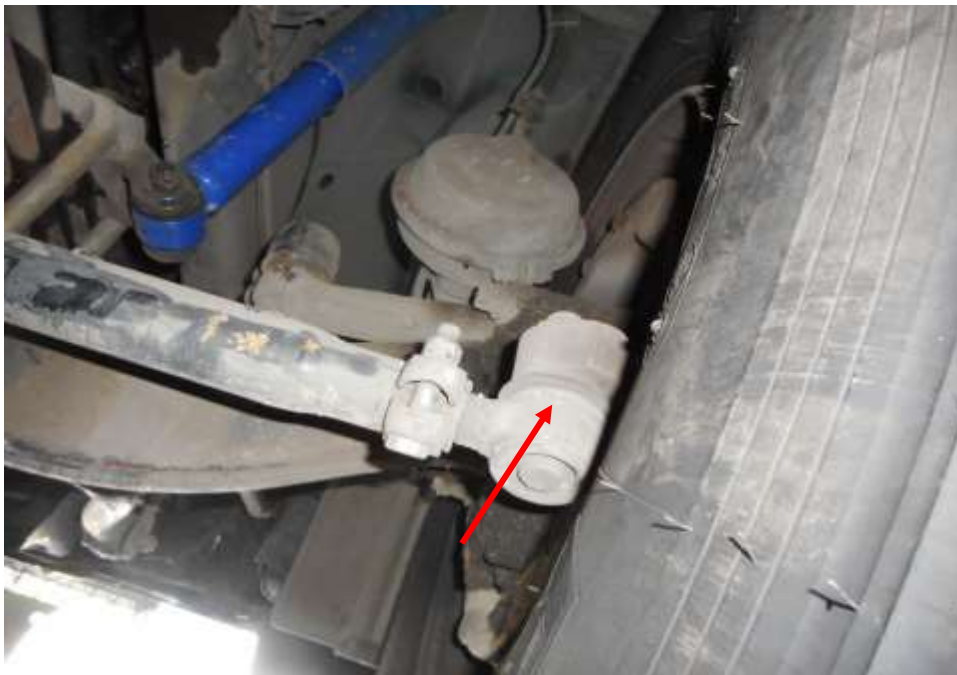
Photo 19 shows the various undercarriage components at the front right wheel of the Trailer, in particular the steering tie rod end (arrowed). The various steering components were all found to be intact, suggesting that the steering system of the Trailer was likely to be in serviceable condition at the material time of accident. There was also no sign of fluid stain(s) observed on the various undercarriage components.

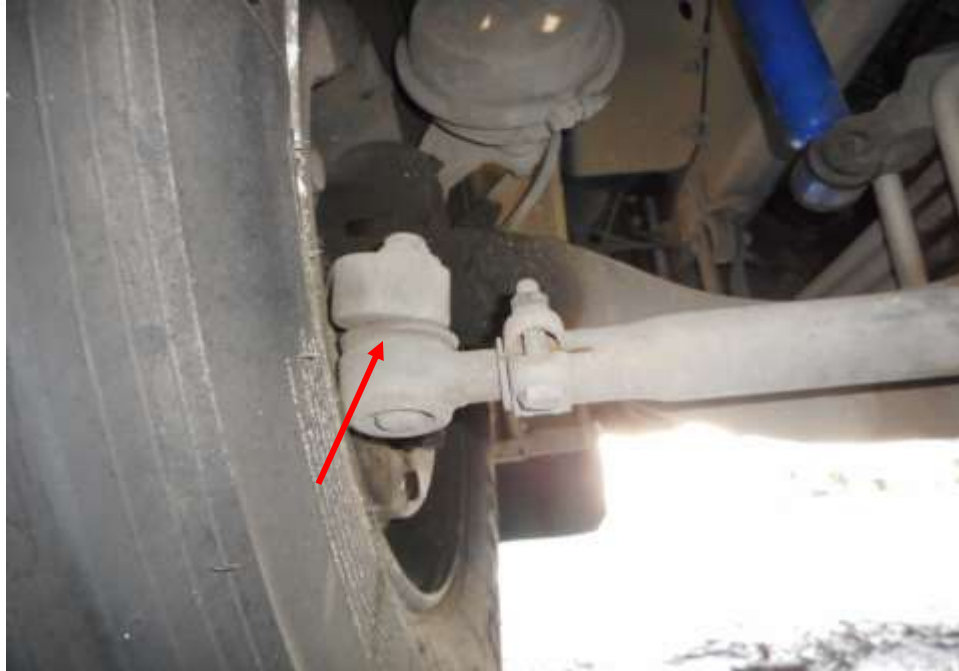
Photo 20 shows the various undercarriage components at the front left wheel of the Trailer, in particular the steering tie rod end (arrowed). The various undercarriage components of the Trailer were all found to be intact without any visible damage. There was also no sign of fluid stain(s) observed on the various undercarriage components.

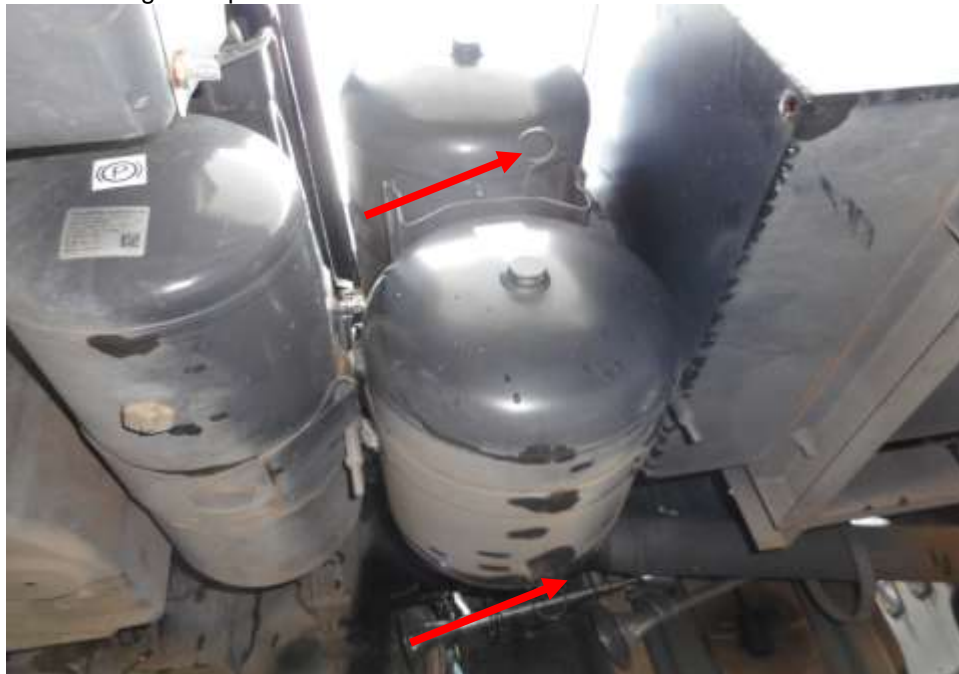
Photo 21 shows the air brake cylinders (arrowed) at the undercarriage of the Trailer. I did not observe any leakage of air brake fluid at the time of my inspection of the Trailer. My static tests of the Trailer's braking system, along with my visual examination of the various mechanical components in the braking system had indicated that there was no internal leakage of pressure/vacuum. Hence the braking system of the v was likely to be in serviceable condition at the material time of accident.

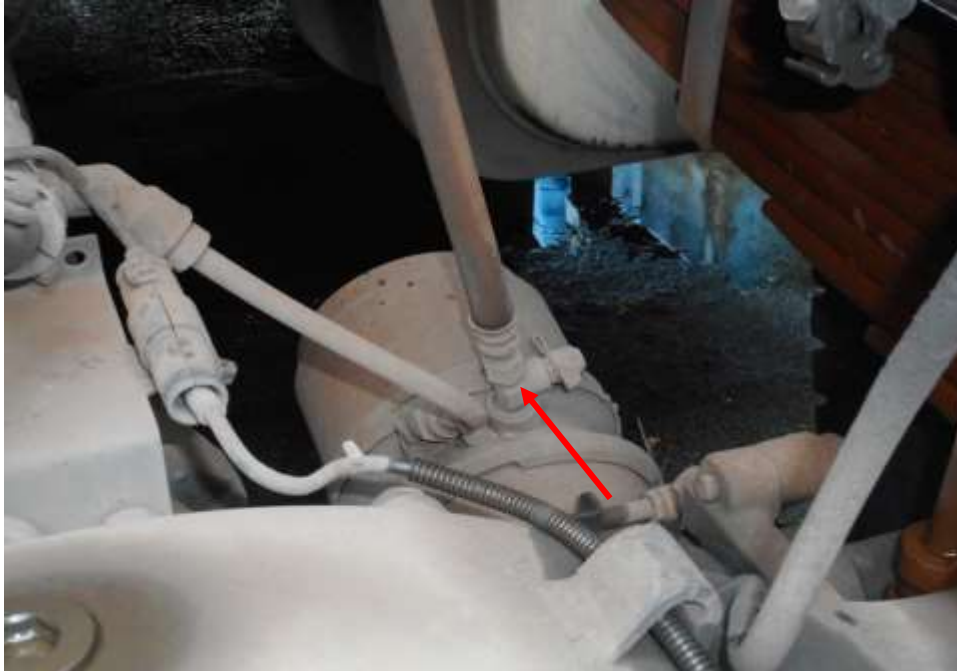
Photo 22 shows the brake pipe (arrowed) at the rear right wheel of the Trailer. I did not observe any leakage of brake fluid at the time of my inspection of the Trailer. My static tests of the Trailer's braking system, along with my visual examination of the various mechanical components in the braking system, had indicated that there was no internal leakage of pressure/vacuum. Hence the braking system of the Trailer was likely to be in serviceable condition at the material time of accident.

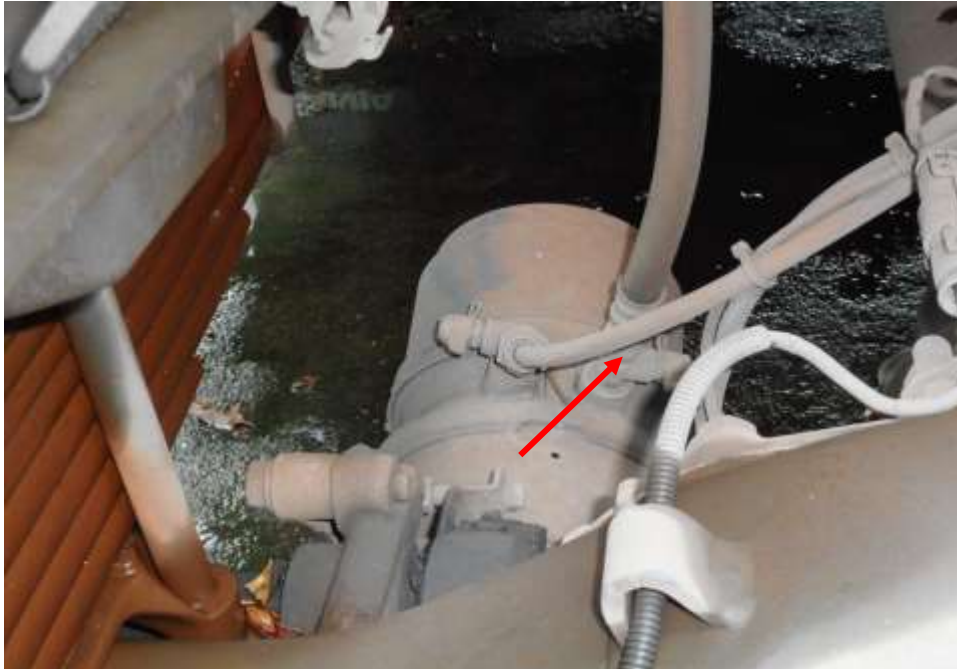
Photo 23 shows the brake pipe (arrowed) at the rear left wheel of the Trailer. I did not observe any leakage of brake fluid at the time of my inspection of the Trailer. My static tests of the Trailer's braking system, along with my visual examination of the various mechanical components in the braking system had indicated that there was no internal leakage of pressure/vacuum. Hence the braking system of the Trailer was likely to be in serviceable condition at the material time of accident.

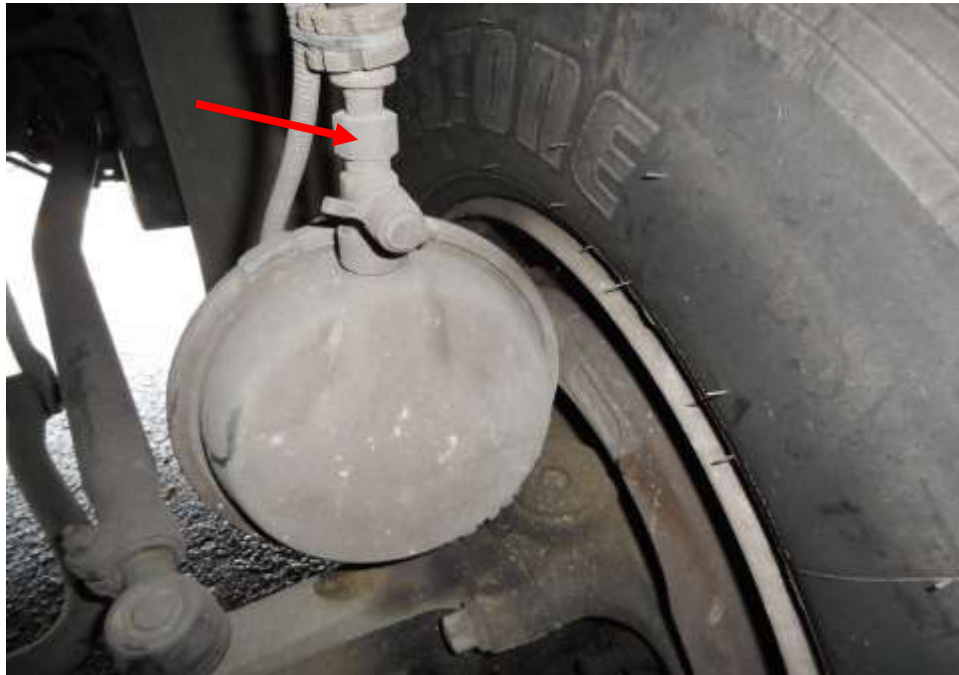
Photo 24 shows the brake hose/pipe (arrowed) at the front right wheel of the Trailer. My static tests of the Motor Bus's braking system, along with my visual examination of the various mechanical components in the braking system had indicated that there was no internal leakage of pressure/vacuum. Hence the braking system of the Motor Bus was likely to be in serviceable condition at the material time of accident.

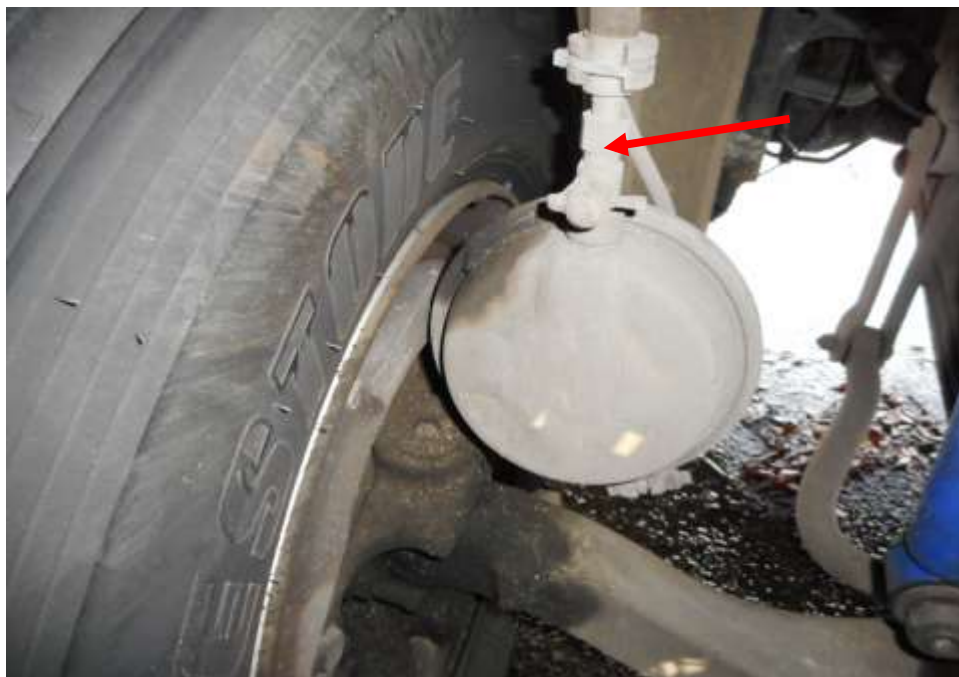
Photo 25 shows the brake hose/pipe (arrowed) at the front left wheel of the Trailer. My static tests of the Motor Bus's braking system, along with my visual examination of the various mechanical components in the braking system had indicated that there was no internal leakage of pressure/vacuum. Hence the braking system of the Motor Bus was likely to be in serviceable condition at the material time of accident.

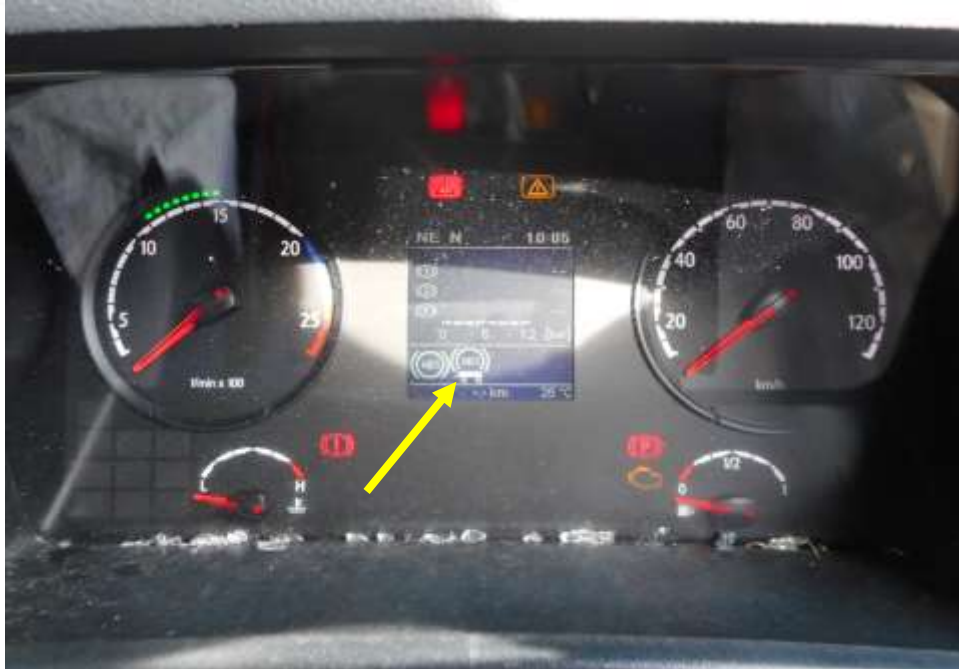
Photo 27 shows the warning light for Anti-Lock Brake System (ABS) (arrowed) appearing on the instrument panel of the Trailer during the self-test of its various electronic operating systems when its engine was cranked.

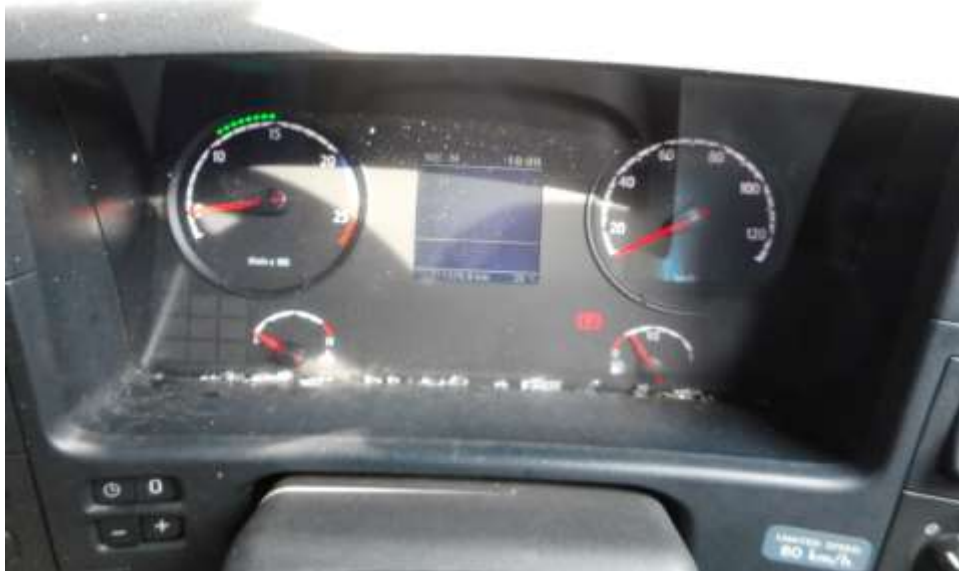
Photo 28 shows no warning lights illuminated on the instrument panel of the Trailer after the engine was cranked. This would suggest that there was no abnormality to the various electronic operating systems of the Trailer, like the ABS.
