**Fatal Accident Investigation Team**

**MECHANICAL INSPECTION REPORT OF LORRY YP 6810J**

1. I refer to your request on 25<sup>th</sup> February 2021 to conduct a visual inspection of a Lorry bearing registration number YP 6810J (herein referred to as "**Lorry**"), which was involved in a fatal road traffic accident on 8<sup>th</sup> February 2021
2. The objective of this inspection is to determine if there was any possible mechanical failure to the Lorry that may have contributed to the accident.
3. Following the request, I had carried out a visual inspection of the Lorry on 25<sup>th</sup> June 2021 at the premises of Traffic Police vehicle pound, 517 Airport Road Singapore 539942. I now set out below my observations and comments with respect to this inspection.

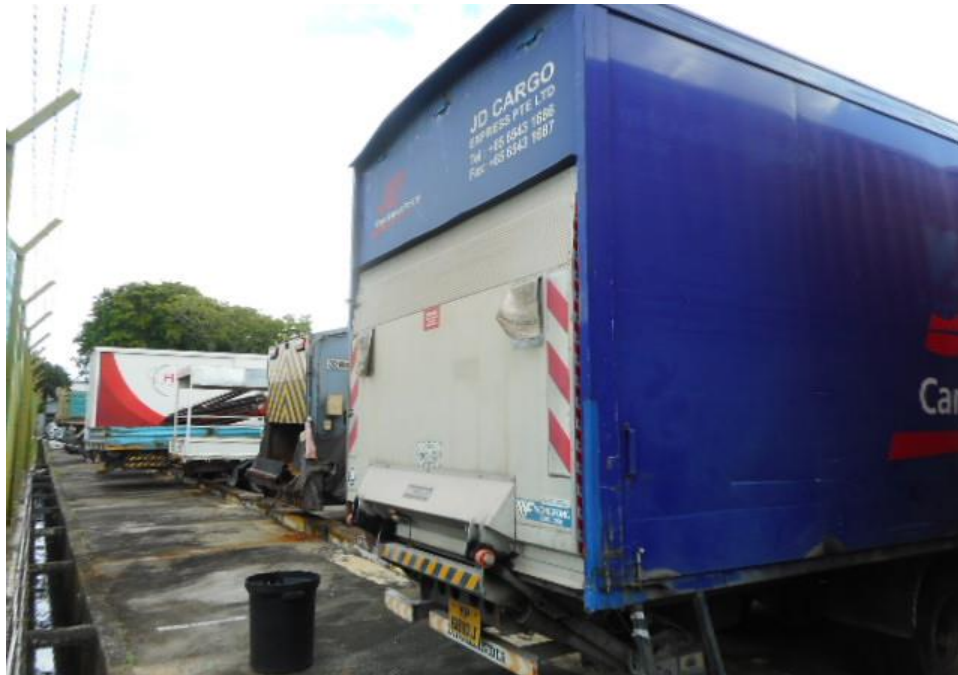
4. The mileage of the Lorry at the time of my inspection was not recorded.
5. The Lorry was observed to have sustained damage at its rear portion. Its rear right brake lamp was damaged as a result of the accident.

**Photo 1** shows a general view of the rear body of the Lorry at the time of my inspection. The Lorry was observed to be sustained damage and affected by the accident.

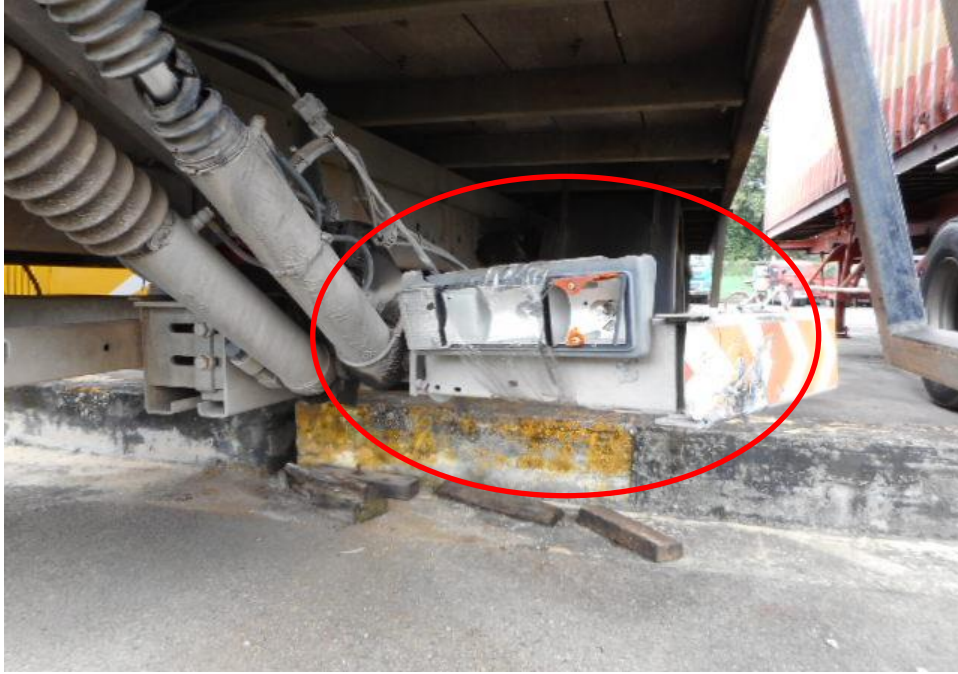
**Photo 2** shows a close up view of the rear body of the Lorry at the time of my inspection. The Lorry was observed to have sustained damage at its rear right brake lamp (circled) as a result of the accident.

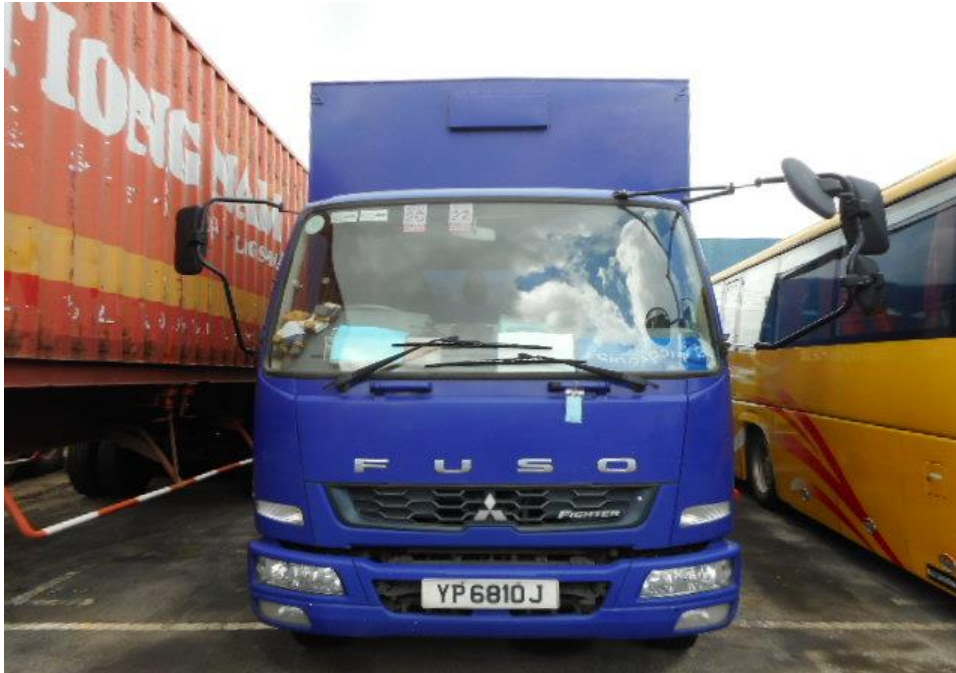
**Photo 3** shows a general view of the Lorry's frontal portion at the time of my inspection. The Lorry was observed to be intact and unaffected by the accident.

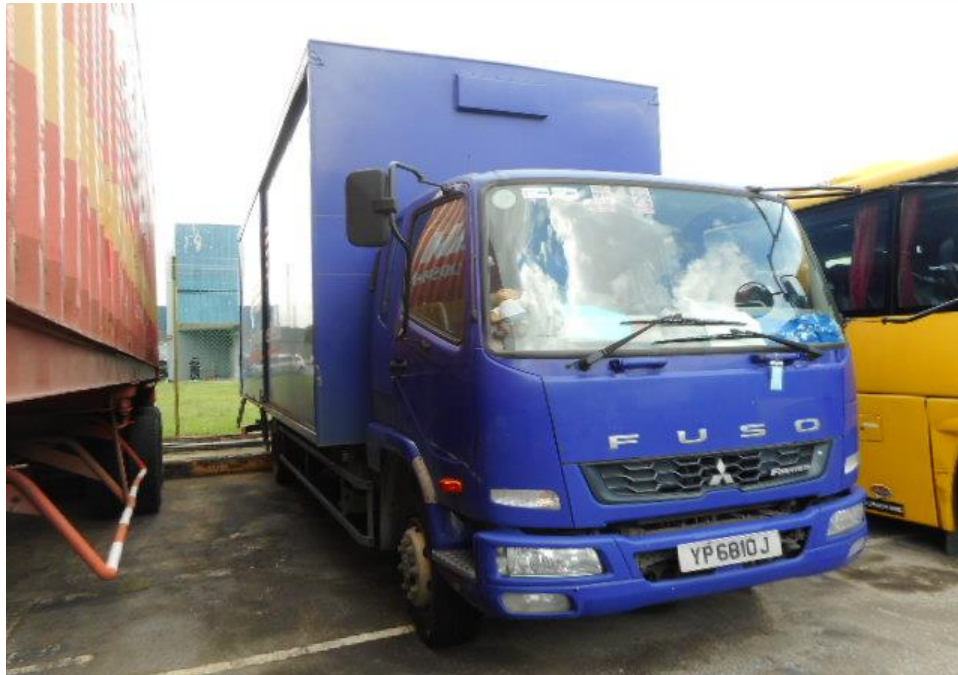
**Photo 4** shows a general view of the right body of the Lorry at the time of my inspection. The Lorry was observed to be intact and unaffected by the accident.

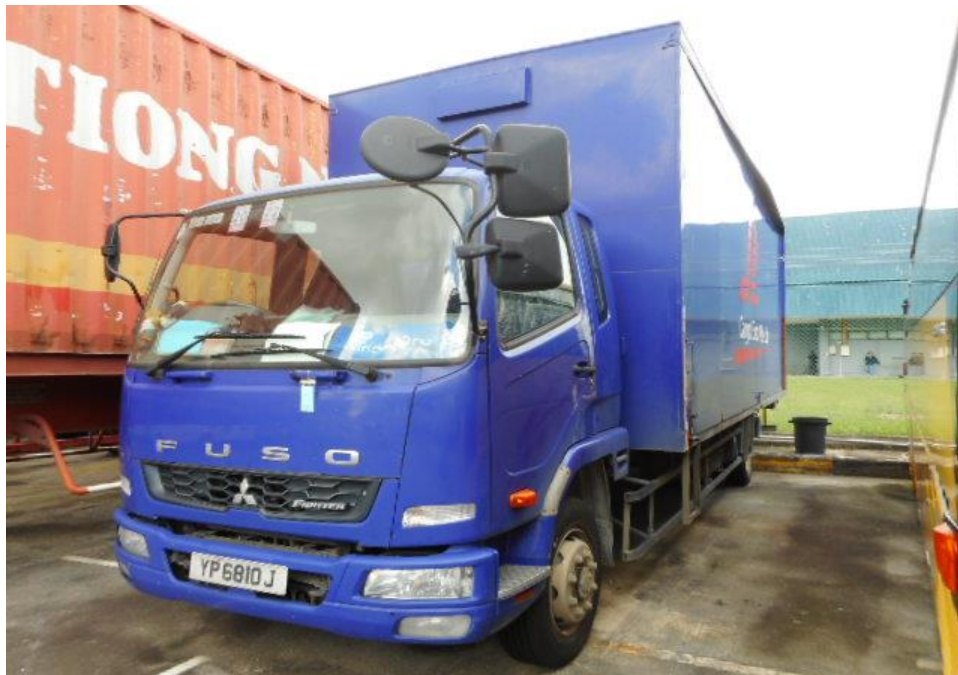
**Photo 5** shows a general view of the left body of the Lorry at the time of my inspection. The Lorry was observed to be intact and unaffected by the accident.

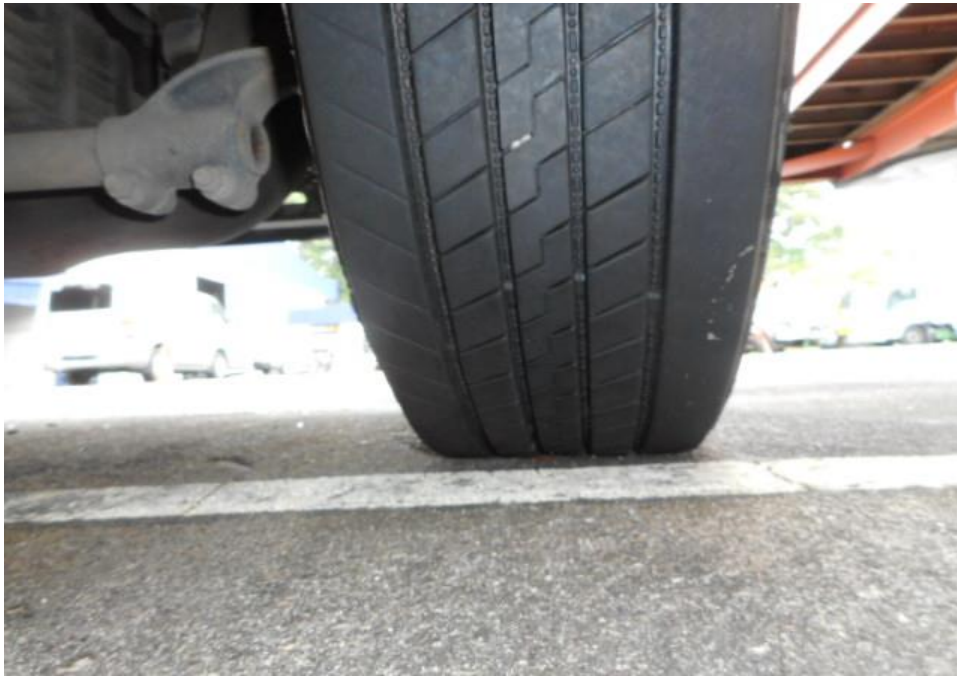
**Photo 6** shows the condition of the front right tyre of the Lorry, which was observed to be in serviceable condition with remaining tread depth of approximately 9.4mm. The tyre, which was wrapped around standard steel wheel rim, was also observed to be sufficiently inflated for vehicular operation. There was no tear, cut or burst mark(s) on the outer and the inner sidewalls as well as across the tread of the 6 tyres that were fitted on the Lorry.

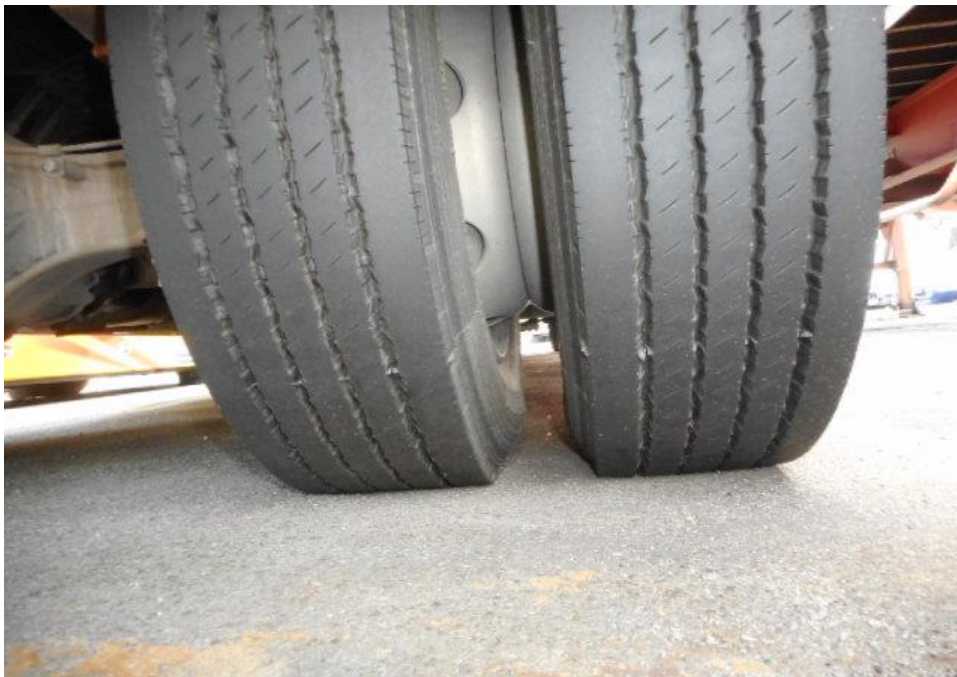
**Photo 7** shows the condition of the rear right tyres of the Lorry, which was observed to be in serviceable condition with remaining tread depth of approximately 8.9mm. The tyre, which was wrapped around standard steel wheel rim, was also observed to be sufficiently inflated for vehicular operation. There was no tear, cut or burst mark(s) on the outer and the inner sidewalls as well as across the tread of the 6 tyres that were fitted on the Lorry.

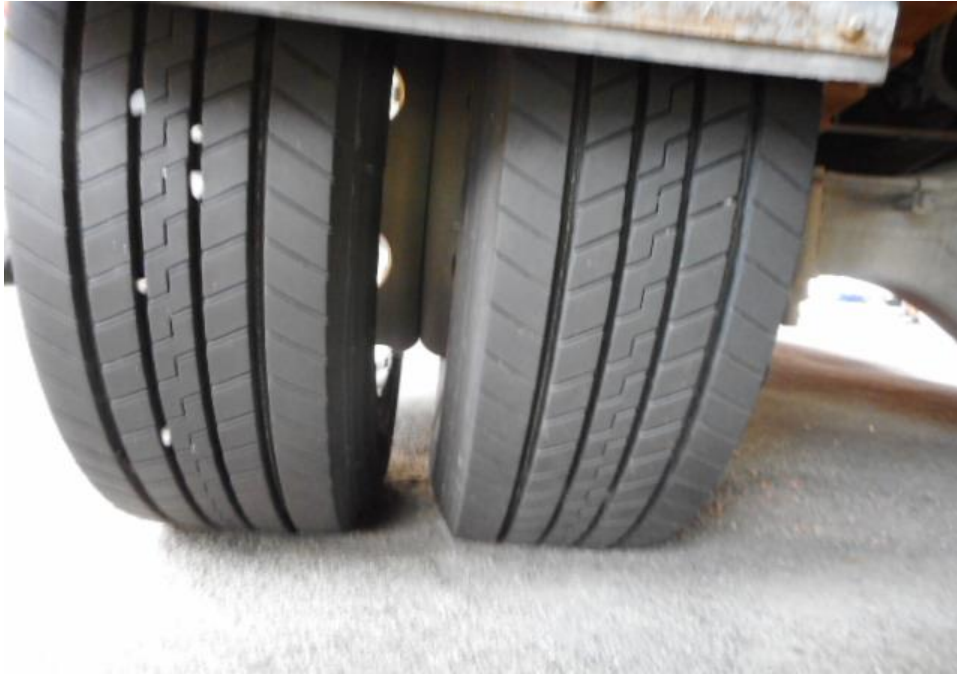
**Photo 8** the condition of the rear left tyres of the Lorry, which was observed to be in serviceable condition with remaining, tread depth of approximately 9.1mm. The tyres, which were wrapped around standard steel wheel rim, were also observed to be sufficiently inflated for vehicular operation. There was also no damage found on all 6 steel wheel rims of the Lorry.

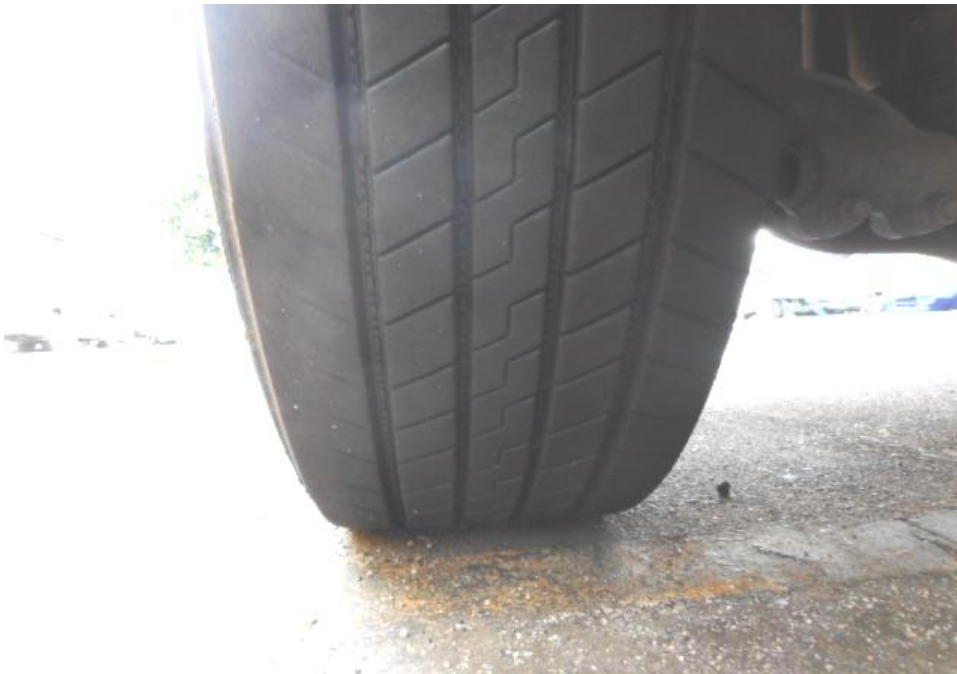
**Photo 9** shows the condition of the front left tyre of the Lorry, which were observed to be in serviceable condition with remaining, tread depth of approximately 10.4mm. There was also no tear, cut or burst mark(s) on the outer and the inner sidewalls as well as across the tread of the 6 tyres that were fitted on the Lorry.

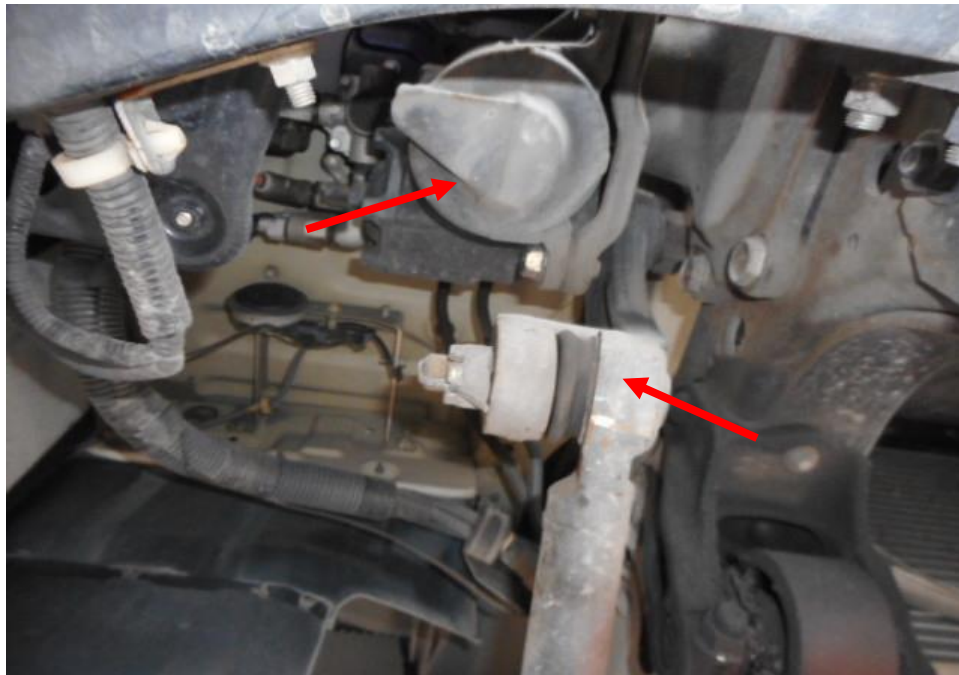
**Photo 10** shows the front underside of the Lorry. I was not able to conduct any test(s) on the steering system of the Lorry as the engine of the Lorry could not be started. My visual checks on the various mechanical components of the steering system like the steering box, steering shaft and steering linkages (arrowed) amongst others revealed all to be intact and in good condition.

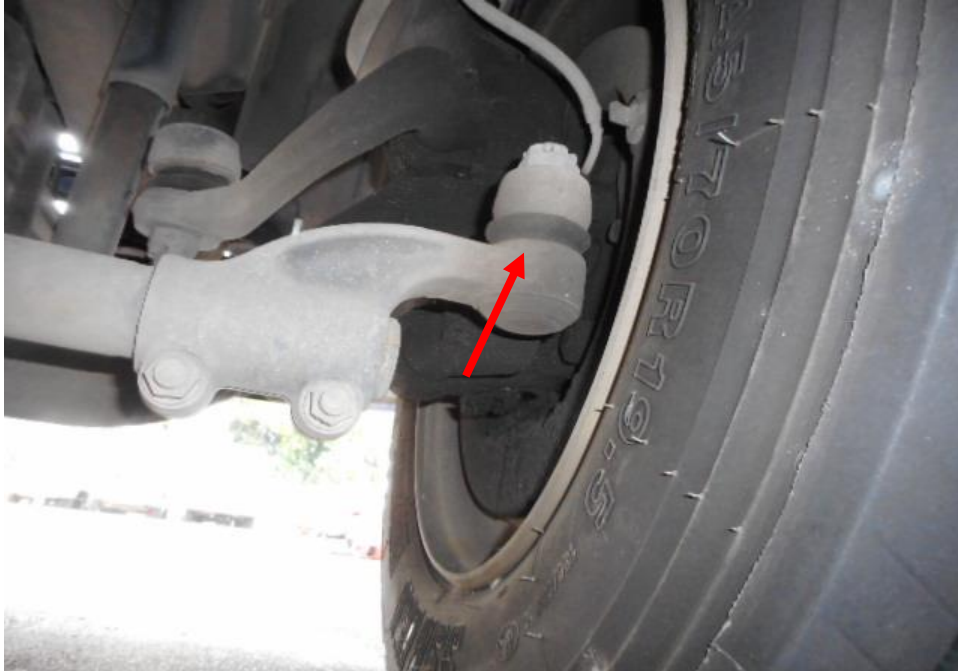
**Photo 11** shows the undercarriage components at the front right wheel of the Lorry. The various undercarriage components of the Lorry were all observed to be intact and without any visible damage. This had included the steering rack and steering ball joints (arrowed) of the Lorry. Visual examinations of the mechanical components of the steering system appear to indicate that the Lorry's steering system was in serviceable condition.

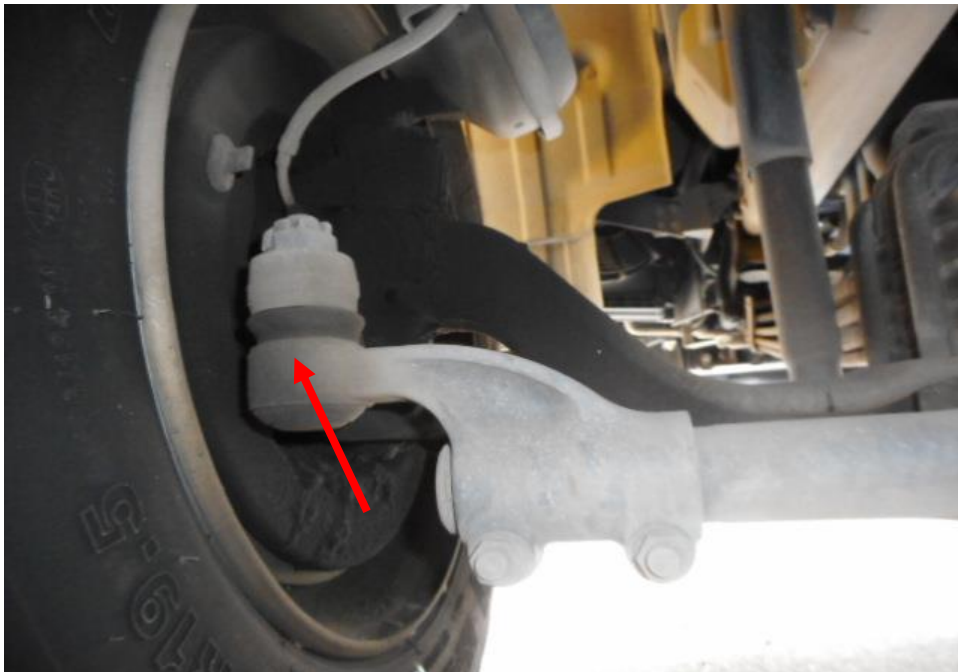
**Photo 12** shows the undercarriage components at the front left wheel of the Lorry. The various undercarriage components of the Lorry were all observed to be intact and without any visible damage. This had included the steering rack and steering ball joints (arrowed) of the Lorry, which were observed to be securely attached to the front left wheel and front right wheel.

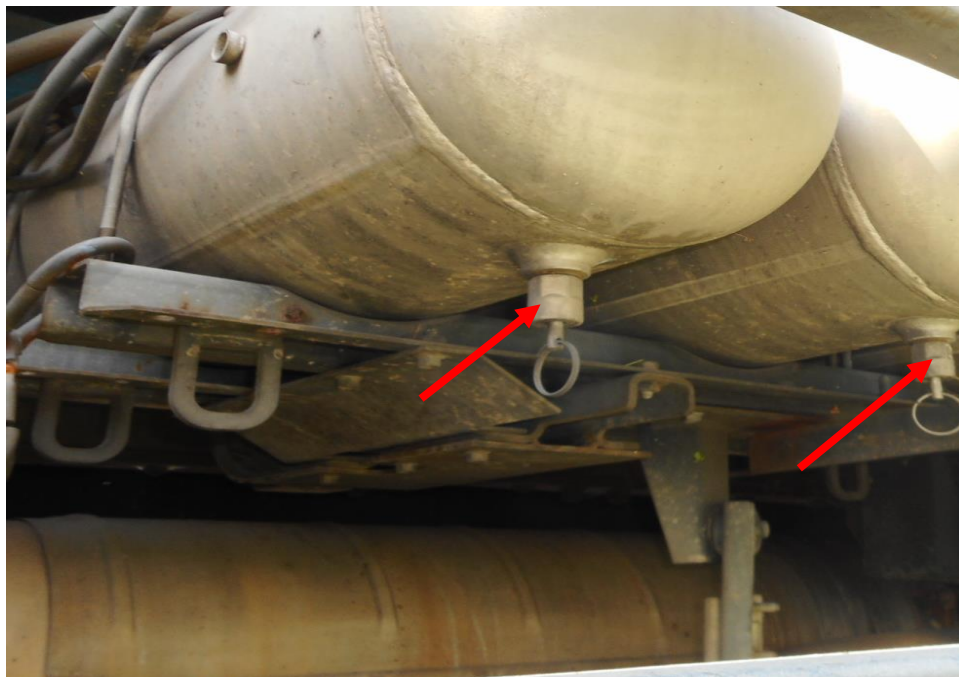
12. Since the engine of the Lorry could not be started, I was hence not able to carry out test(s) on whether there was any leakage of compressed air that could have affected the braking efficiency of the Lorry. However, the air pipes, air tanks and connecting valves had all appear to be in good general condition and securely fitted upon my visual examination of these parts.

**Photo 13** shows a general view of the air tank, valves, pipes and hoses, which are some of the components for the air-assisted braking system of the Lorry. I was however not able to carry out any operational test(s) to the braking system of the Lorry as its engine was unable to be started.

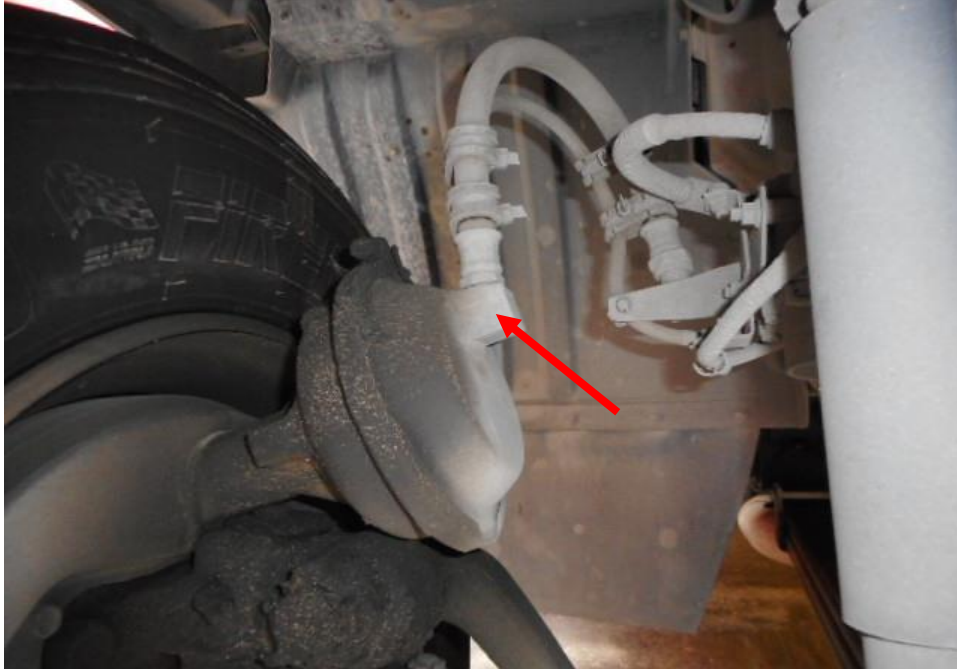
**Photo 14** shows the brake air cylinder and air pipes (arrowed) at the front left wheel of the Lorry. My visual inspection of the mechanical components of the Lorry's braking system appear to suggest that its braking system was in serviceable condition at the material time of accident.

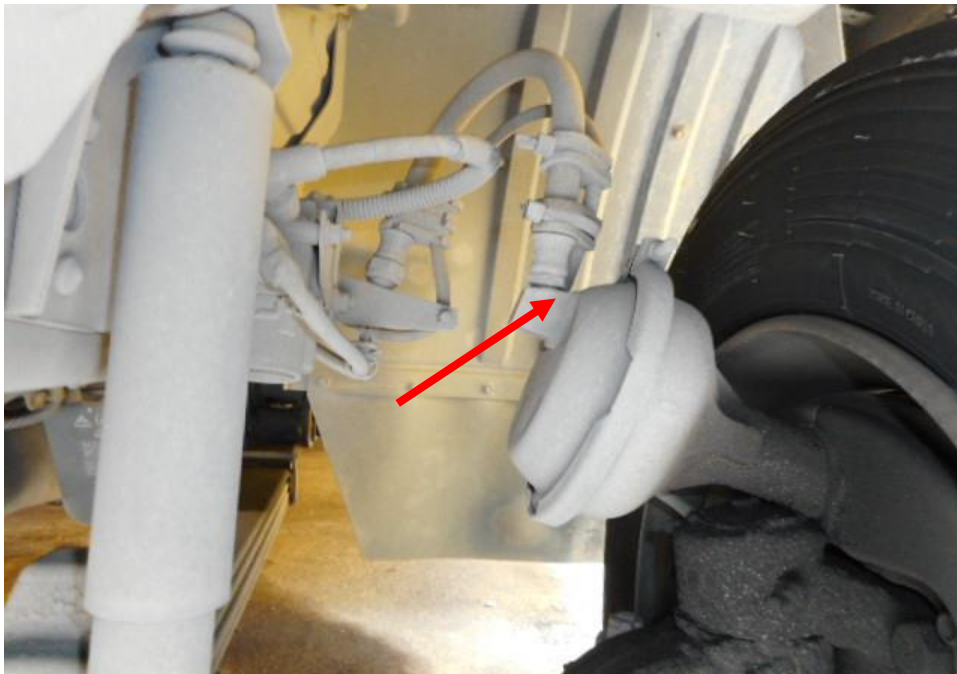
**Photo 15** shows the brake air cylinder and air pipes (arrowed) at the front right wheel of the Lorry. My visual inspection of the mechanical components of the Lorry's braking system appear to suggest that its braking system was in serviceable condition at the material time of accident.

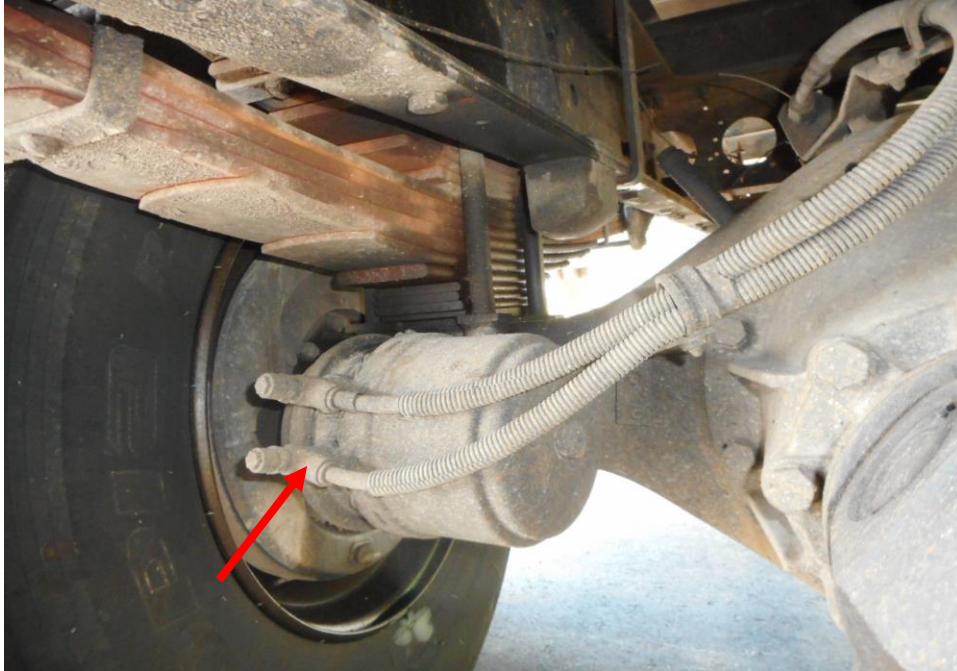
**Photo 16** shows the brake air cylinder and air pipes (arrowed) at the rear left wheel of the Lorry. My visual inspection of the mechanical components of the Lorry's braking system appear to suggest that its braking system was in serviceable condition at the material time of accident.

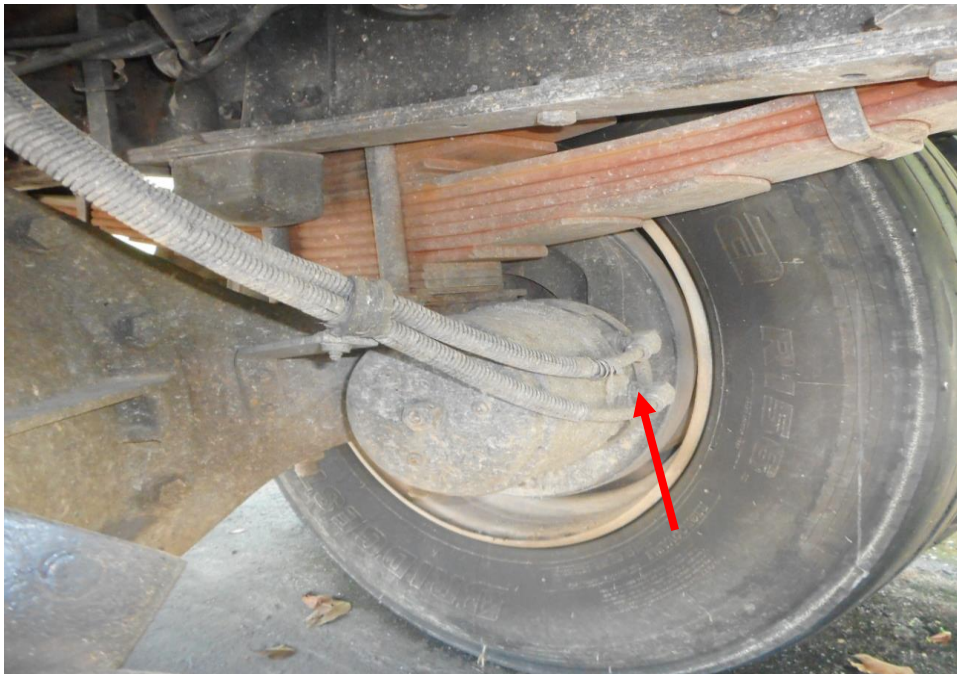
**Photo 17** shows the brake air cylinder and air pipes (arrowed) at the front right wheel of the Lorry. My visual inspection of the mechanical components of the Lorry's braking system appear to suggest that its braking system was in serviceable condition at the material time of accident.
