Your Ref: Porsche Marcan
(chassis number WP1ZZZ95ZLLB00142)
Our Ref : CI/TP21003014/D

08 March 2021

INSPECTION REPORT OF AN UNREGISTERD PORSCHE MARCAN MOTOR CAR WITH CHASSIS NUMBER WP1ZZZ95ZLLB00142

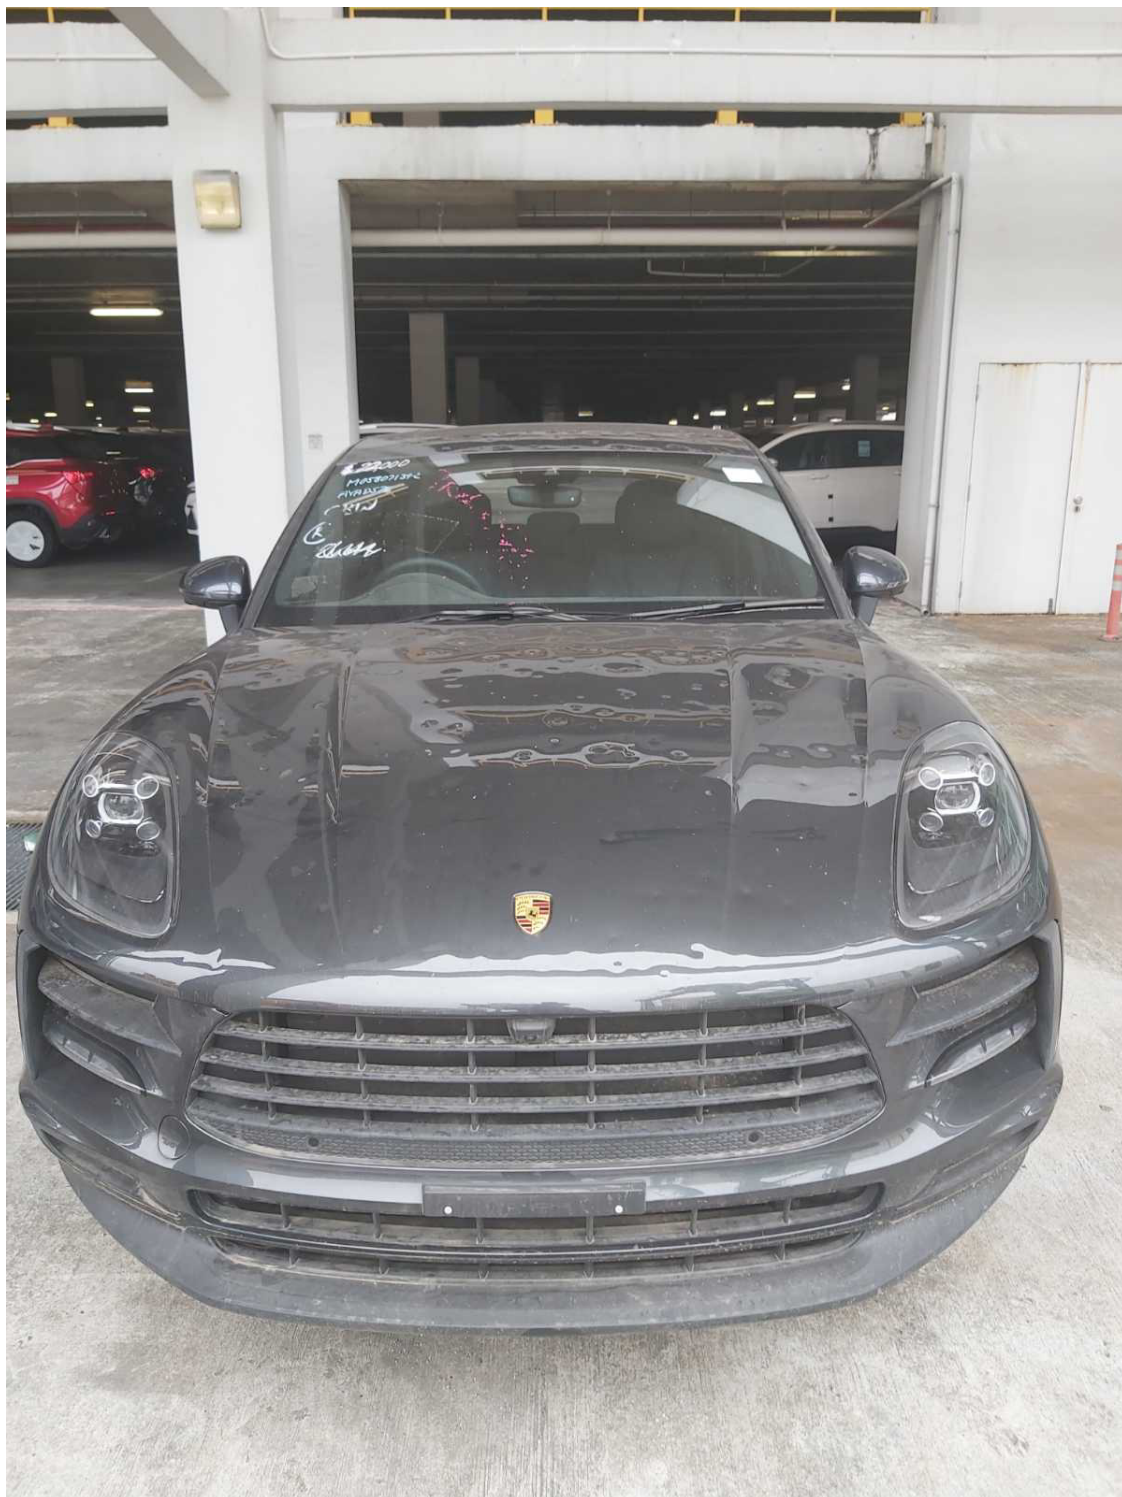
Photo 1 shows the frontal body of the Motor Car prior to any repairs being carried out (photograph provided to me). The Motor Car was observed to have sustained damage of indentation nature to multiple exterior body parts like its front bonnet. As seen from the photograph, there were multiple relatively minor indentations on the front bonnet.

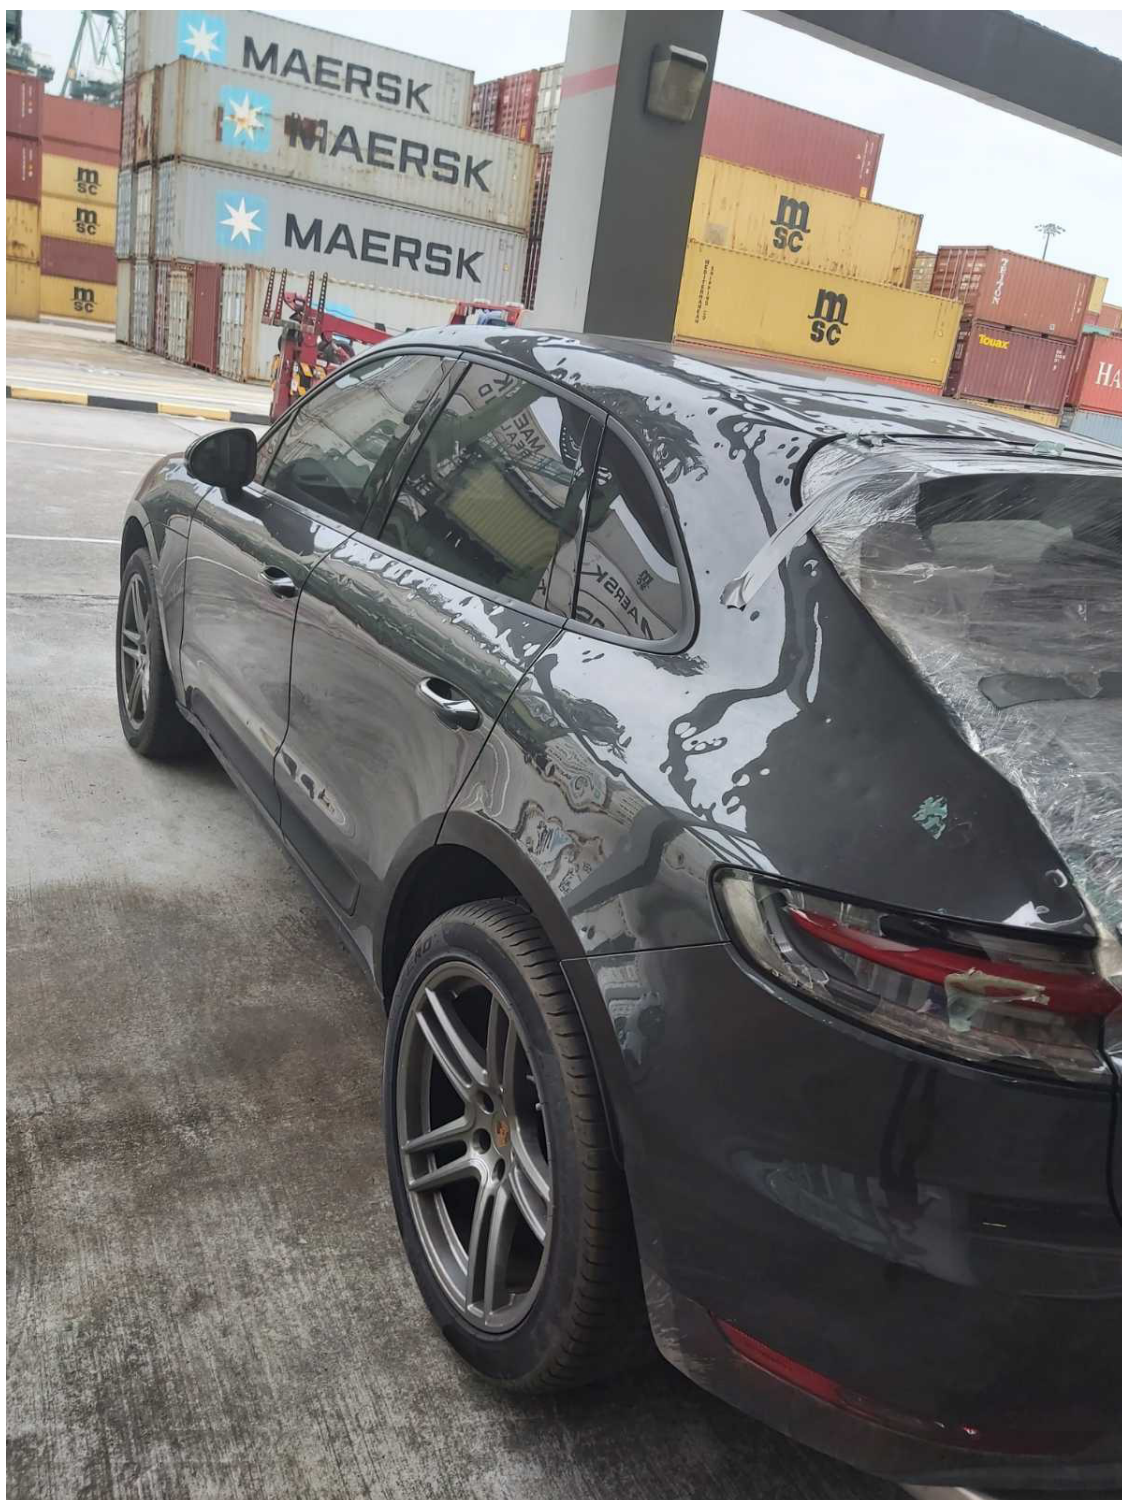
Photo 2 shows the rear left body of the Motor Car prior to any repairs being carried out (photograph provided to me). The Motor Car was observed to have sustained damage of indentation nature to multiple exterior body parts like its rear left fender and rear left door. As seen from the photographs provided, the indentations were relatively minor. The rear left taillamp was also observed to be broken.

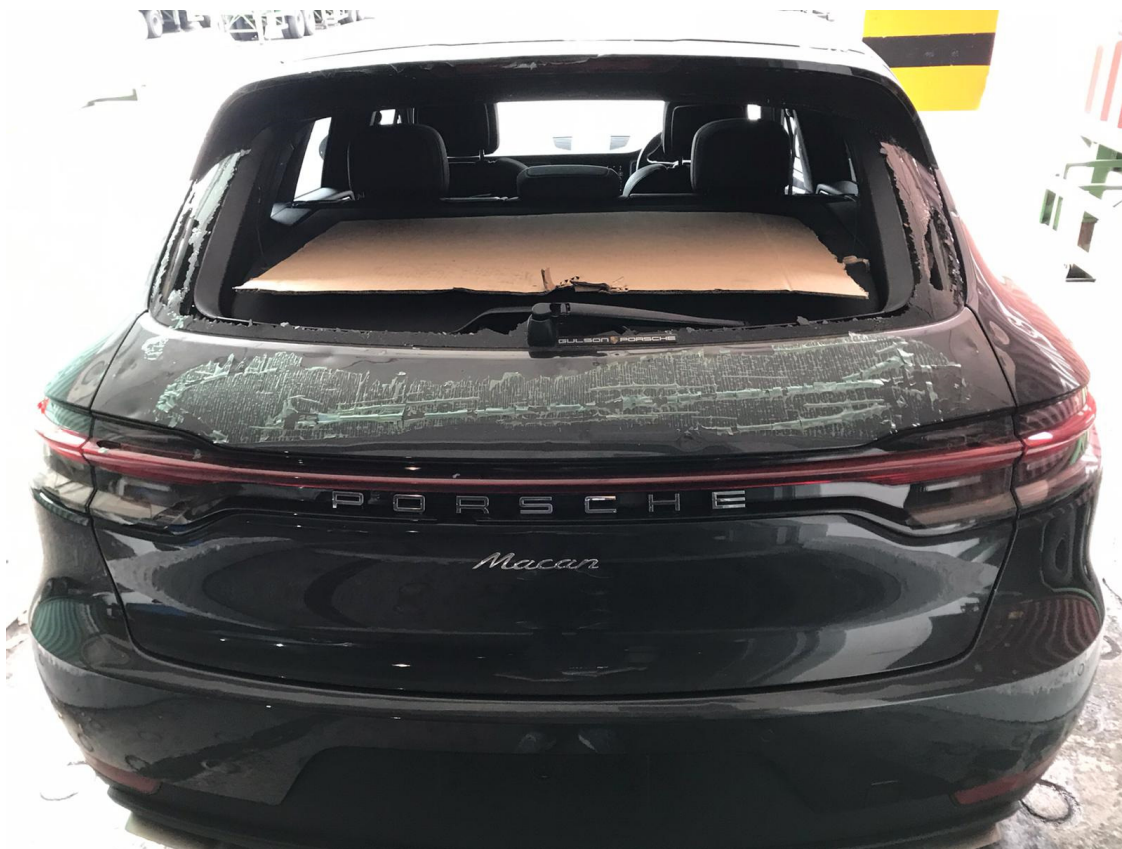
Photo 3 shows the rear body of the Motor Car prior to any repairs being carried out (photograph provided to me). The Motor Car was observed to have sustained damage of indentation nature to multiple exterior body parts like its rear tailgate. As seen from the photographs provided, the indentations were relatively minor. The rear windscreen glass was also observed to be broken.

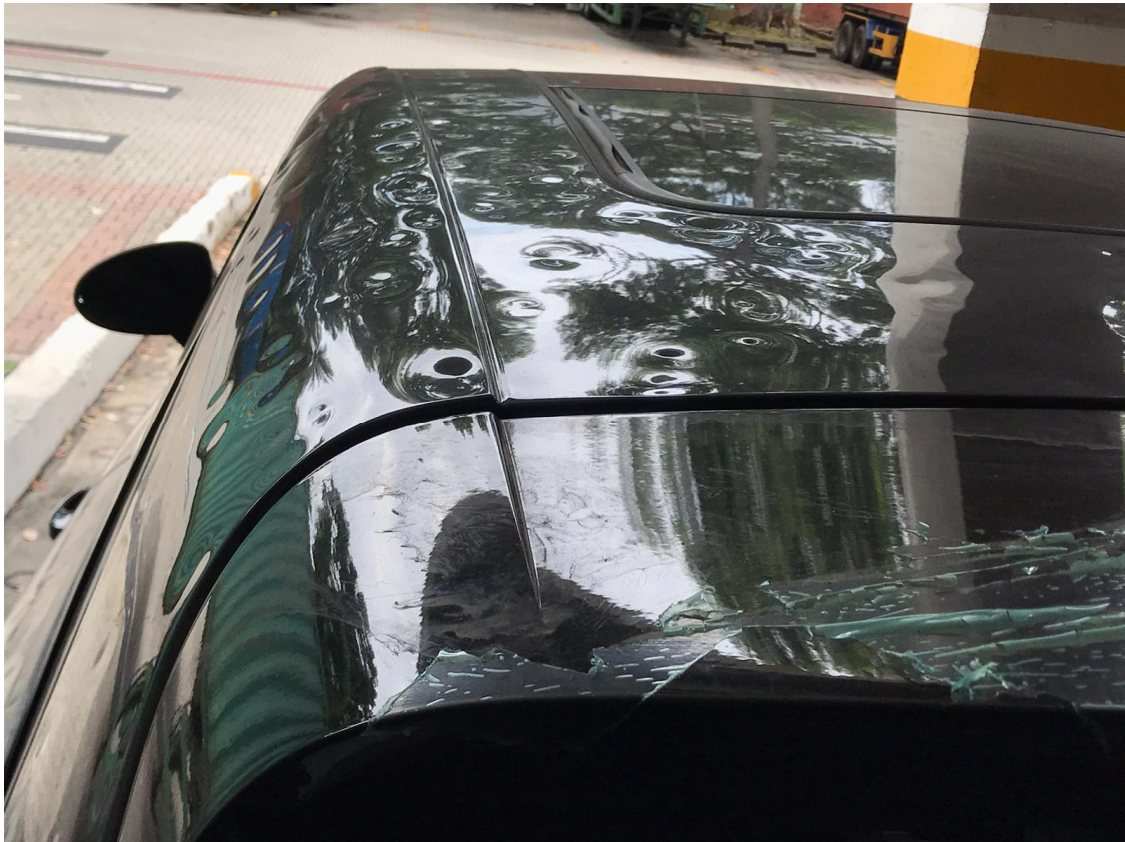
Photo 4 shows the roof panel of the Motor Car prior to any repairs being carried out (photograph provided to me). Relatively minor indentation damage was seen on the roof panel. The sunroof, as seen from the photograph, was unaffected.

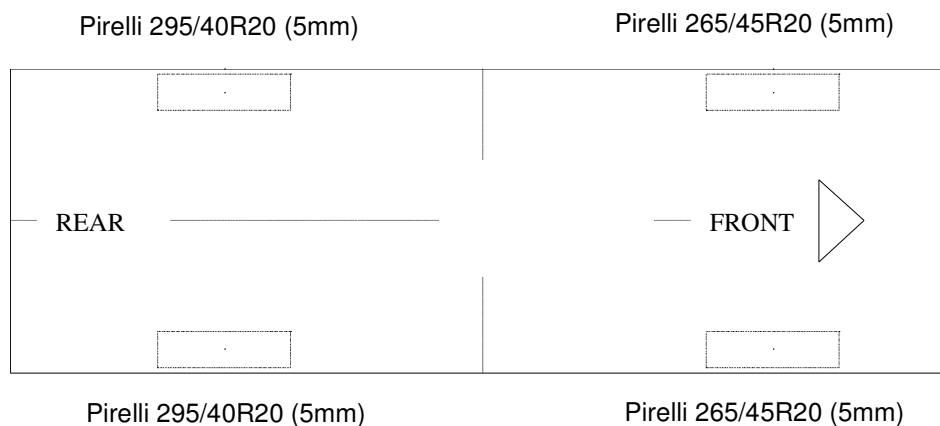
8. It was fitted with 20inch sport wheel rims that were wrapped with tyres that were observed to be of serviceable condition. The tyres were also sufficiently inflated for vehicular operation. The tyre brand, tyre size and approximate remaining tread depth of the 4 tyres of the Motor Car were recorded as follows: -

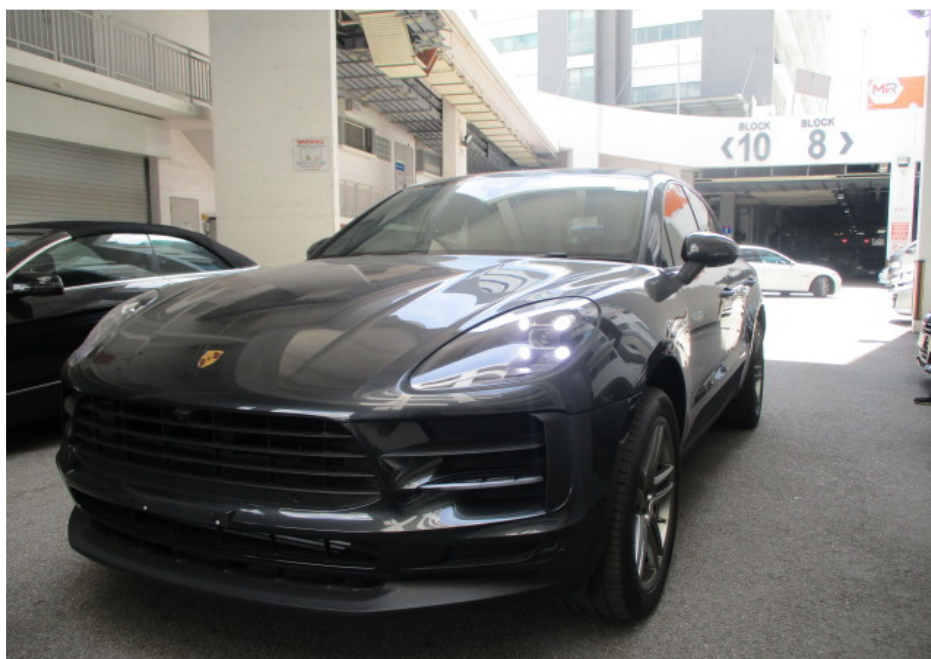
Photo 5 shows a general view of the front left body of the Motor Car at the time of my inspection. The Motor Car was observed to be in a relatively good general condition with no loose exterior fittings observed. The exterior body parts at the frontal body of the Motor Car were visually examined and it was observed that the repair/restoration works carried out to the damaged area of the Motor Car (refer to photograph 1 above) were reasonably adequate and in order.

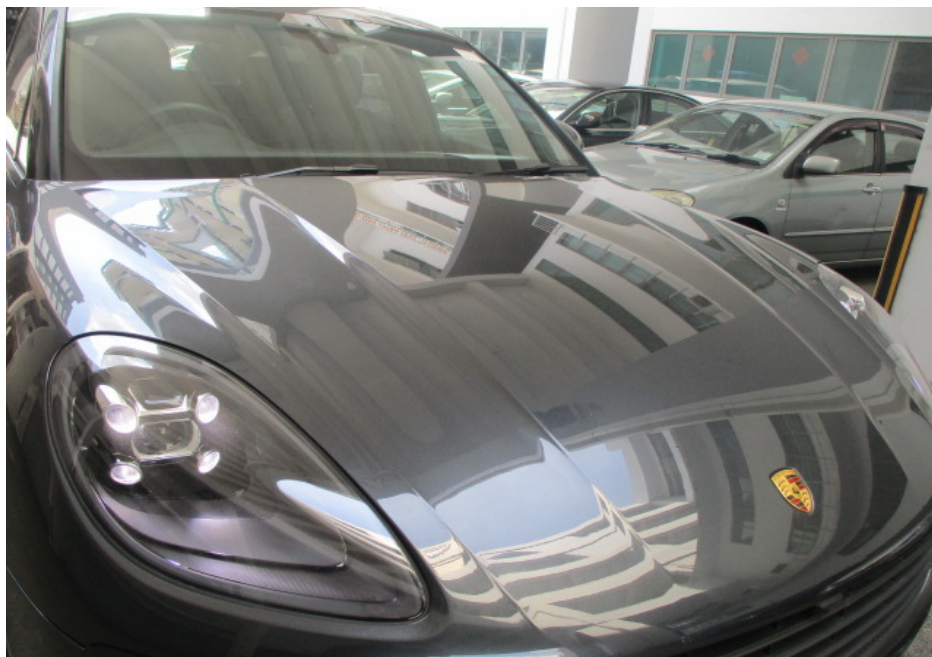
Photo 6 shows a closer view of the Motor Car's front bonnet at the time of my inspection. The Motor Car was observed to be in a relatively good general condition with no loose exterior fittings observed. The exterior body parts at the frontal body of the Motor Car were visually examined and it was observed that the repair/restoration works carried out to the damaged area of the Motor Car (refer to photograph 1 above) were reasonably adequate and in order.

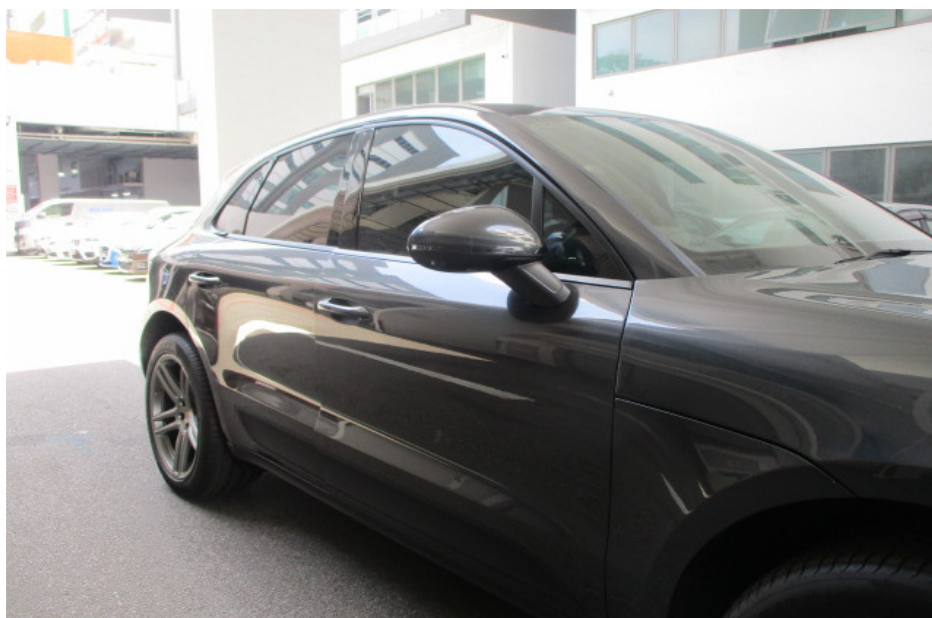
Photo 7 shows a general view of the right body of the Motor Car at the time of my inspection. The Motor Car was observed to be in a relatively good general condition with no loose exterior fittings observed. The exterior body parts of the Motor Car were visually examined, and it was observed that the repair/restoration works carried out to the damaged area of the Motor Car (refer to photograph 1 - 4 above) were reasonably adequate and in order.

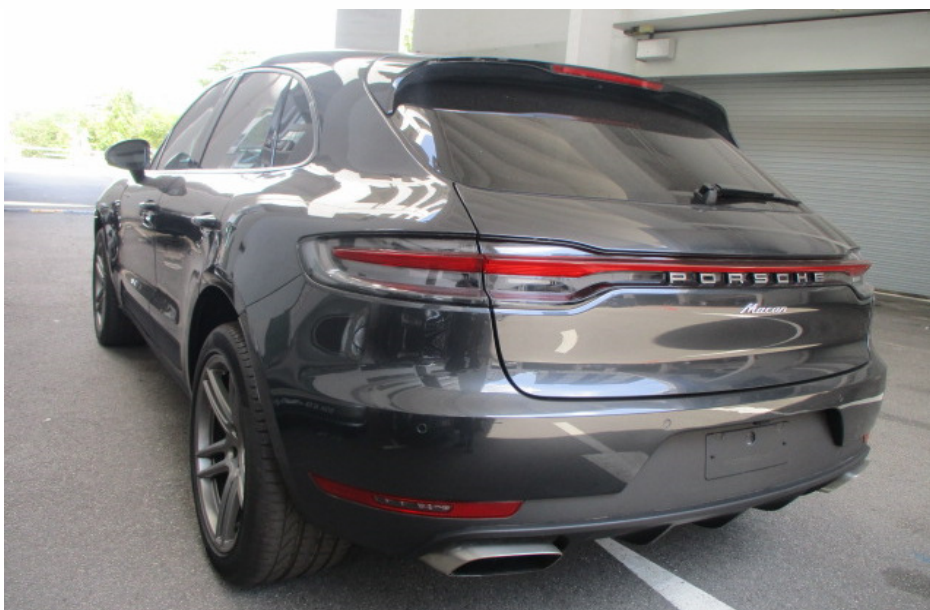
Photo 8 shows a general view of the rear left body of the Motor Car at the time of my inspection. The Motor Car was observed to be in a relatively good general condition with no loose exterior fittings observed. The exterior body parts at the rear body of the Motor Car were visually examined and it was observed that the repair/restoration works carried out to the damaged area of the Motor Car (refer to photograph 2 & 3 above) were reasonably adequate and in order.

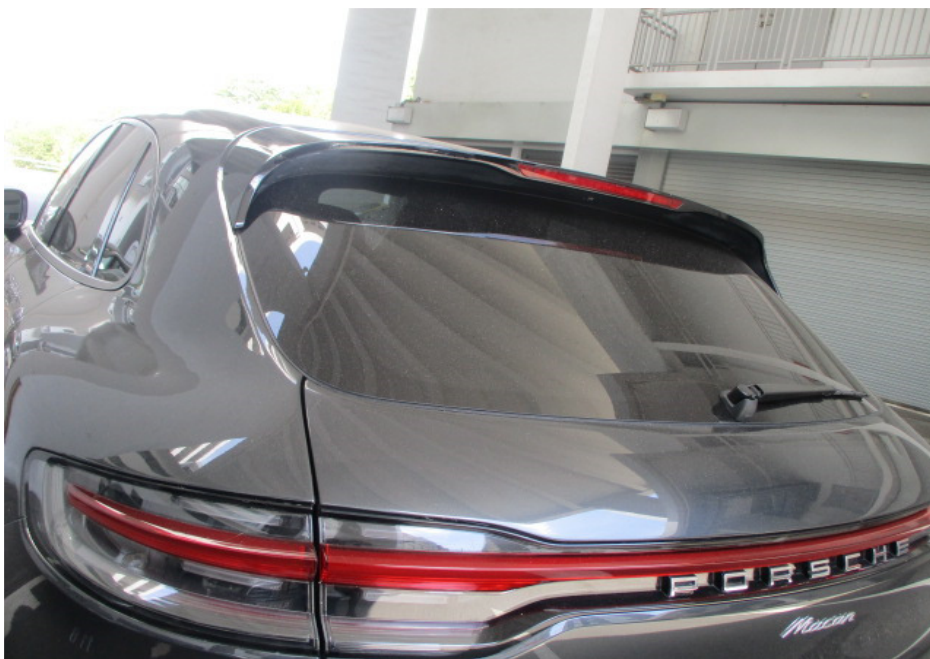
Photo 9 shows a closer view of the rear left fender, rear tailgate, rear windscreen glass and rear left taillamp of the Motor Car. The Motor Car was observed to be in a relatively good general condition with no loose exterior fittings observed. The exterior body parts at the rear body of the Motor Car were visually examined and it was observed that the repair/restoration works carried out to the damaged area of the Motor Car (refer to photograph 2 & 3 above) were reasonably adequate and in order.

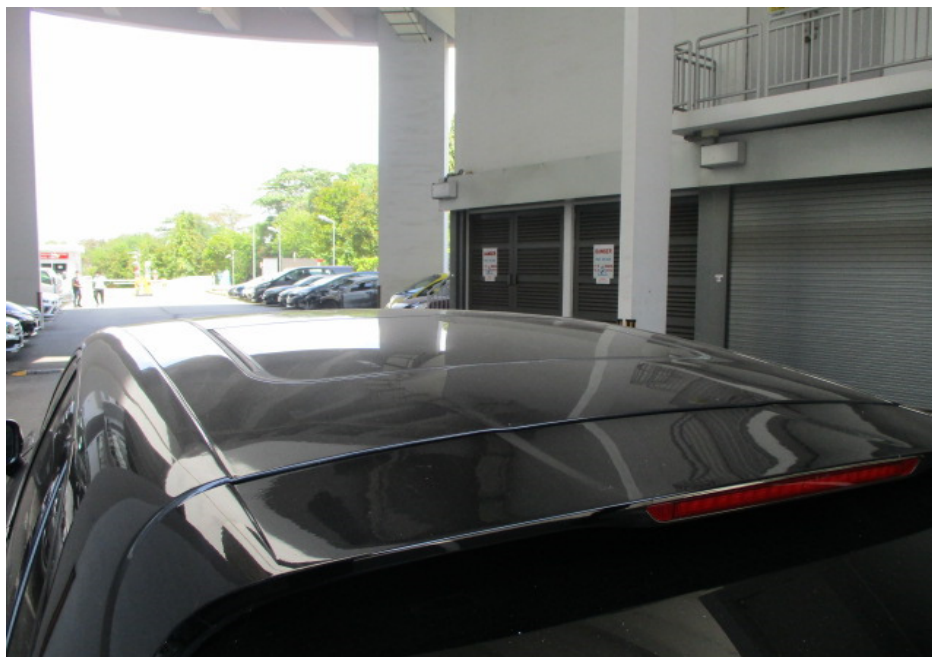
Photo 10 shows a general view of the Motor Car's roof panel at the time of my inspection. The Motor Car was observed to be in a relatively good general condition with no loose exterior fittings observed. The exterior body parts at the rear body of the Motor Car were visually examined and it was observed that the repair/restoration works carried out to the damaged area of the Motor Car (refer to photograph 4 above) were reasonably adequate and in order.

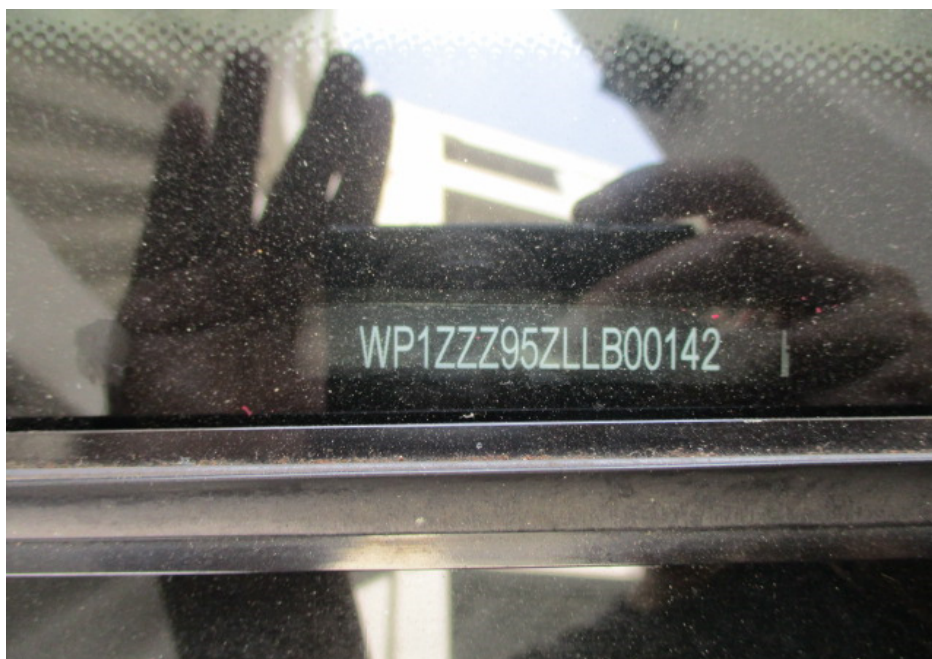
Photo 11 shows the chassis number of the Motor Car. The chassis number recorded was WP1ZZZ95ZLLB00142.

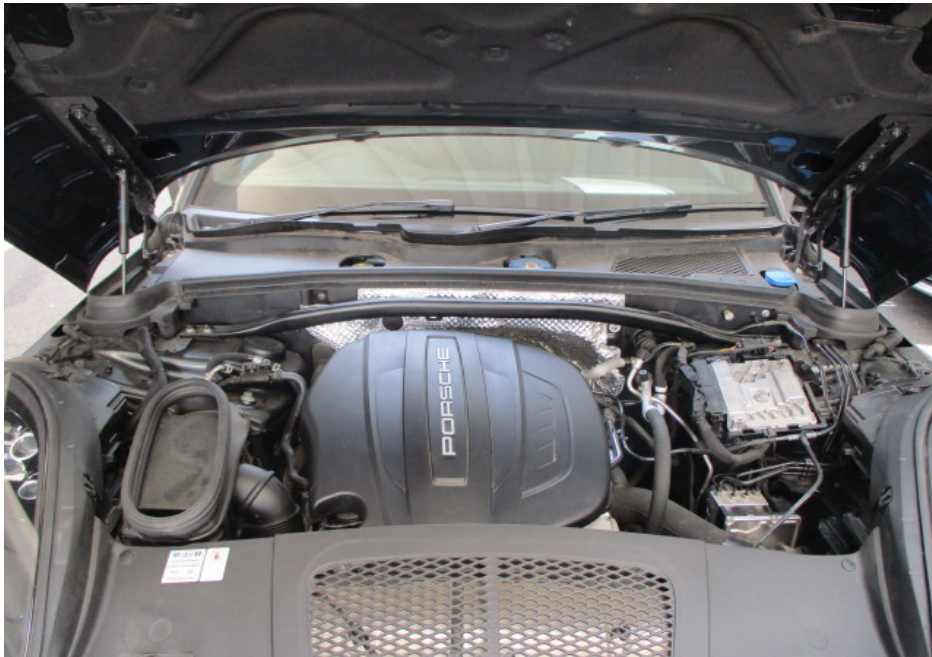
Photo 12 shows a general view of the engine compartment of the Motor Car at the time of my inspection. The various parts and components inside the engine compartment were all observed to be intact and properly fitted. There was also no sign(s) or indication(s) of fluid leak and/or fluid stain found inside the engine compartment.

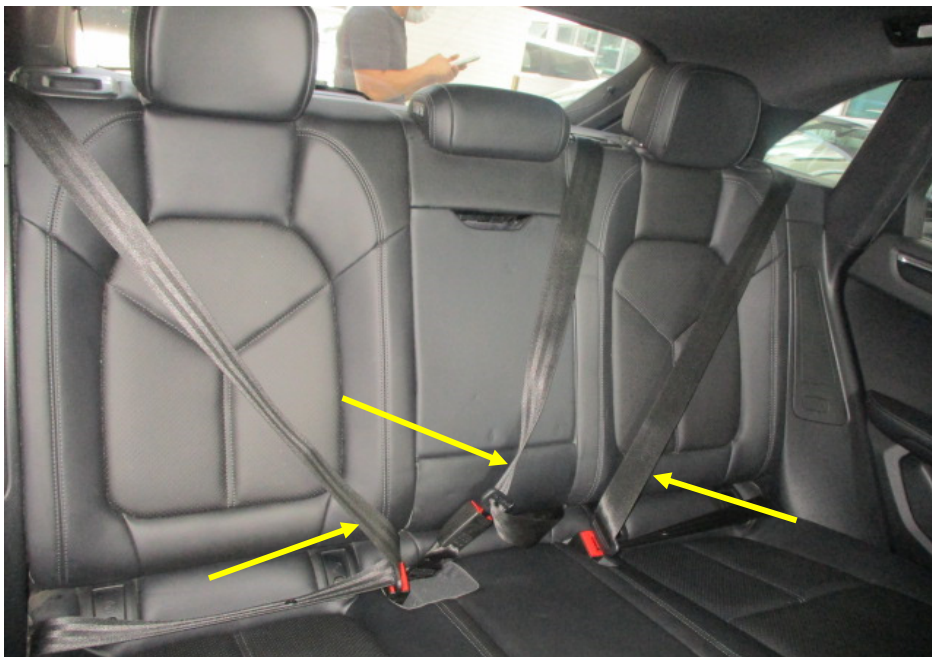
Photo 13 shows the rear seats of the Motor Car. All the seats of the Motor Car were secured via seat rails to the floorboard. They were also fitted with a retractable seat belt reel and a pre-tensioner. The seat belts (arrowed) were tested and were able to be fastened into the respective pre-tensions that were fitted on the side of each individual seat.

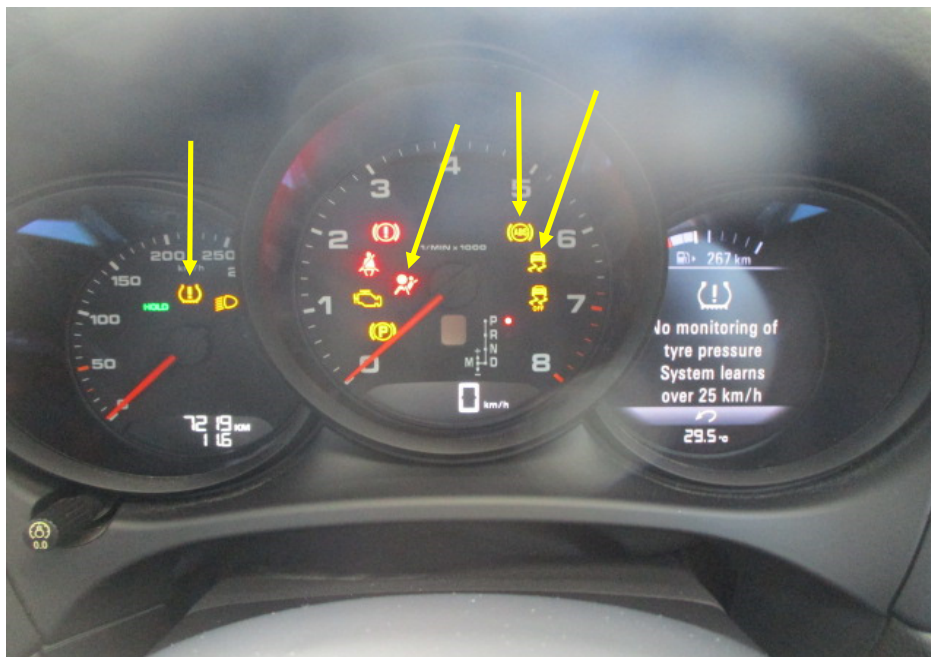
Photo 14 shows the warning lights for the various electronic safety features appearing on the instrument panel of the Motor Car during its self-test when the engine is cranked, in particular the ABS, SRS, TPM and TCS lights (arrowed).

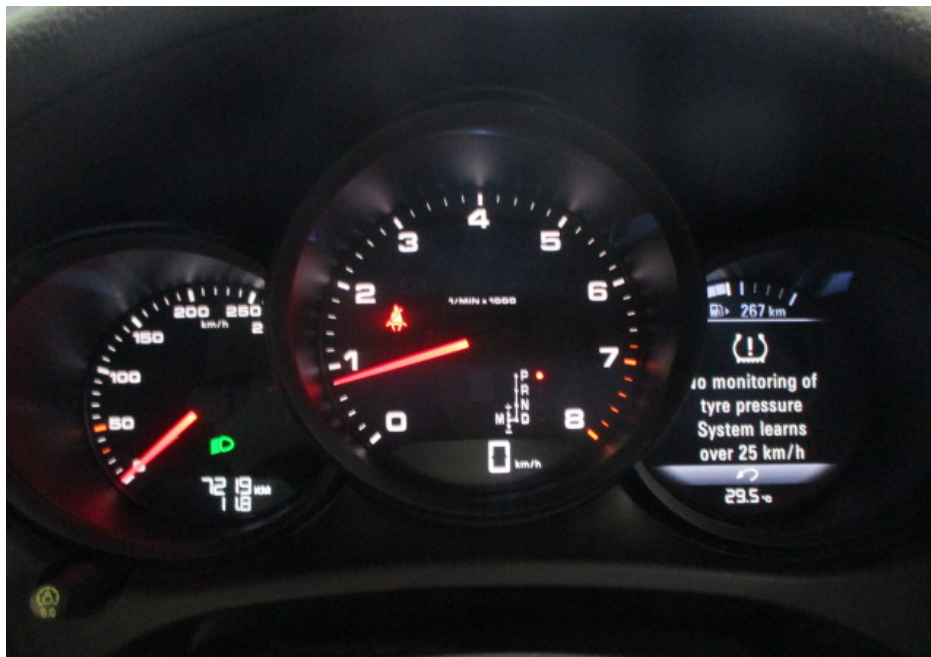
Photo 15 shows the respective warning lights no longer illuminated, indicating that there is no fault detected to the ABS, SRS, TPM and TCS systems of the Motor Car during the self-test. These electronic systems were hence in working condition at the time of my inspection.

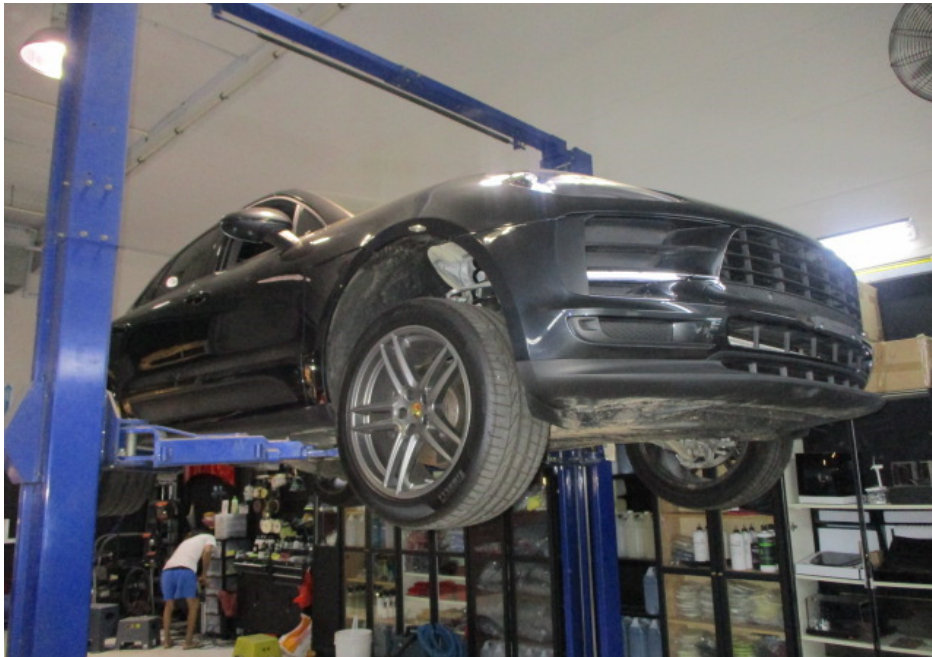
Photo 16 shows the Motor Car hoisted up for checks on its undercarriage. There was no sign(s) or indication(s) of fluid leakage and/or fluid stain(s) on the underside of the Motor Car. The undercarriage components of the Motor Car were also all observed to be intact and secured in an appropriate manner.

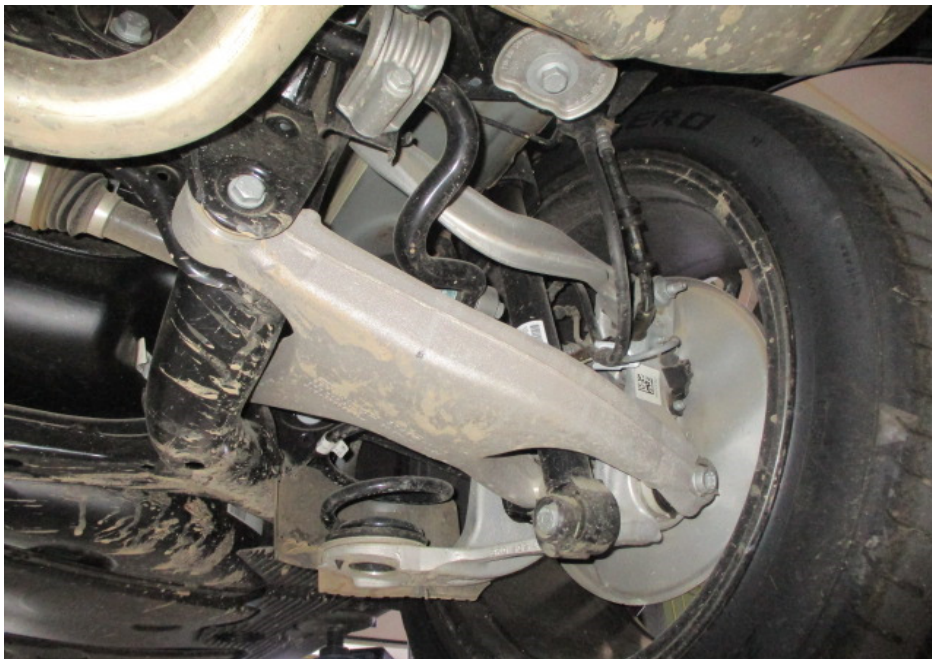
Photo 17 shows a general view of the control arms and linkages at the rear right wheel of the Motor Car. I did not observe any fluid leak and/or fluid stain on the underside of the Motor Car. All the Motor Car's undercarriage components were observed to be intact and secured in an appropriate manner.

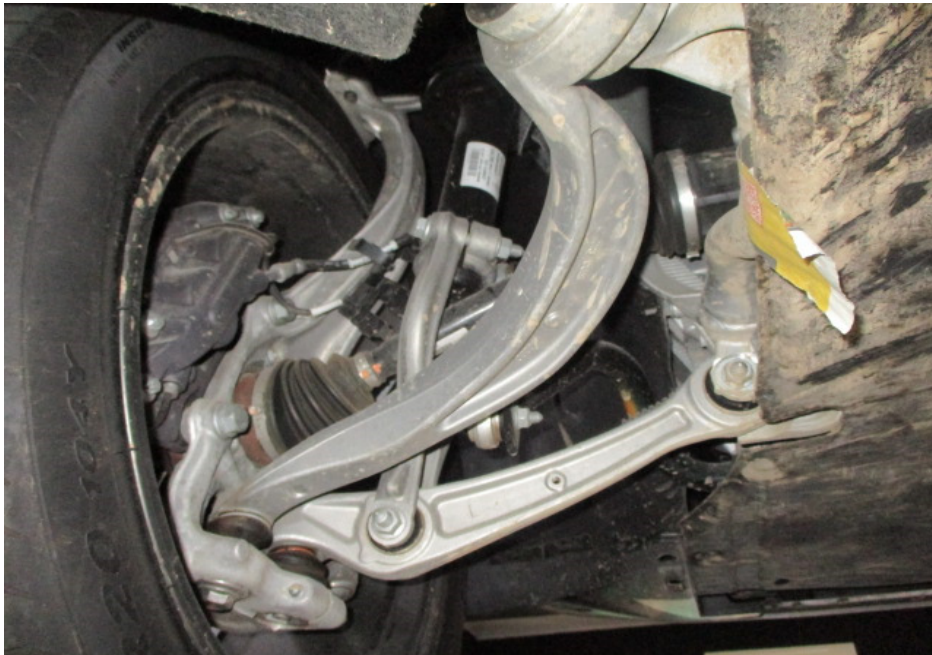
Photo 18 shows the various undercarriage components at the front left wheel of the Motor Car. The mechanical components, control arms and linkages were all found to be intact and secured in an appropriate manner.

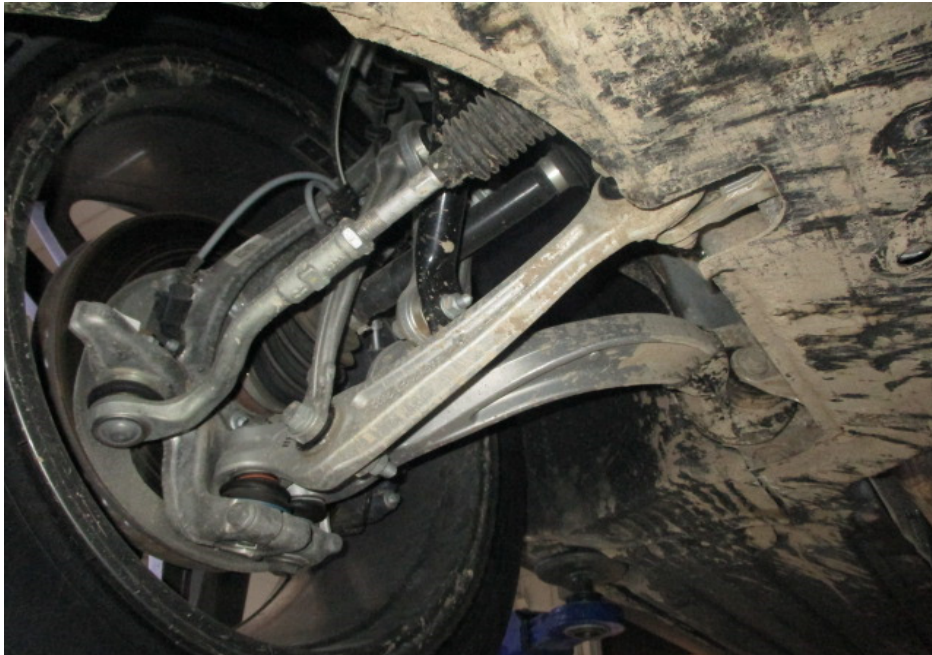
Photo 19 shows the various undercarriage components at the front right wheel of the Motor Car. The mechanical components, control arms and linkages were all found to be intact and secured in an appropriate manner. I also did not observe any fluid leak and/or fluid stain on the underside of the Motor Car.

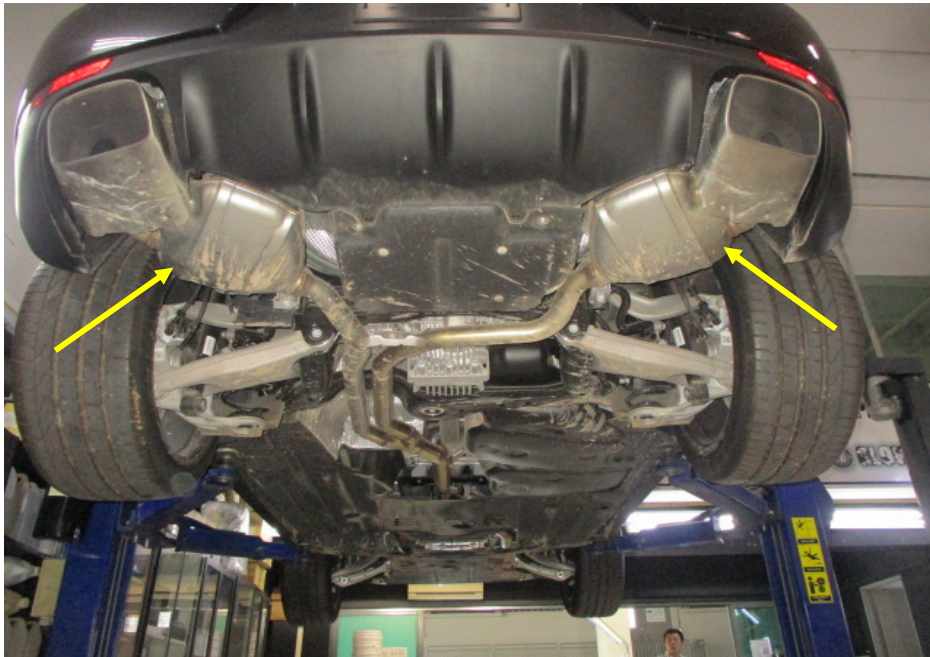
Photo 20 shows the Motor Car's rear mufflers (arrowed). My examination of the Motor Car's exhaust system revealed no sign(s) or indication(s) of any cut or weld marks along its exhaust pipes and on its catalytic converter.

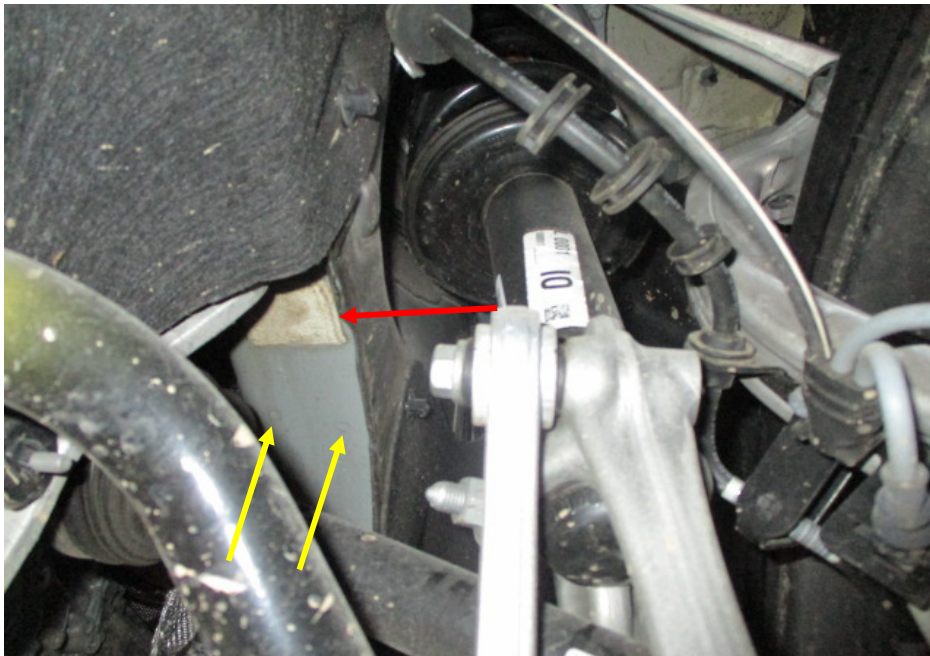
Photo 21 shows the chassis/structural body at the underside front left of the Motor Car. I did not find any weld marks other than original spot weld marks (yellow arrow) on the chassis/structural body of the Motor Car. The original factory sealant (red arrow) at the joints along the chassis/structural body was also untouched, indicating no work was done on the chassis/structural body of the Motor Car and that the chassis/structural body was originally fitted.

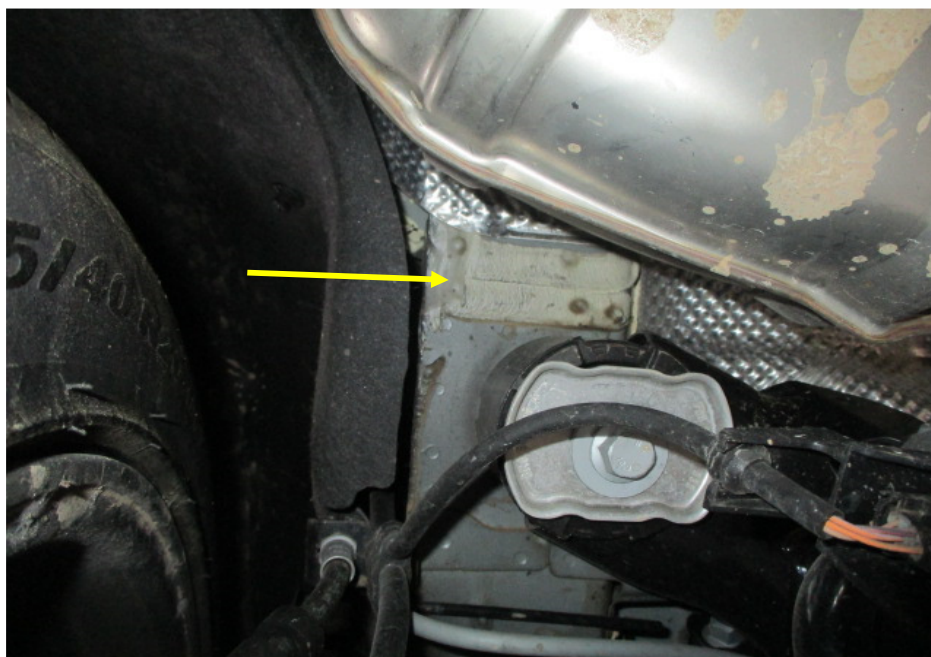
Photo 22 shows the chassis/structural body at the underside rear left of the Motor Car. I did not find any weld marks other than original spot weld marks on the chassis/structural body of the Motor Car. The original factory sealant (arrowed) at the joints along the chassis/structural body was also untouched. In general, I had found no work was carried out on the chassis/structural body of the Motor Car. The chassis/structural body of the Motor Car was originally fitted.

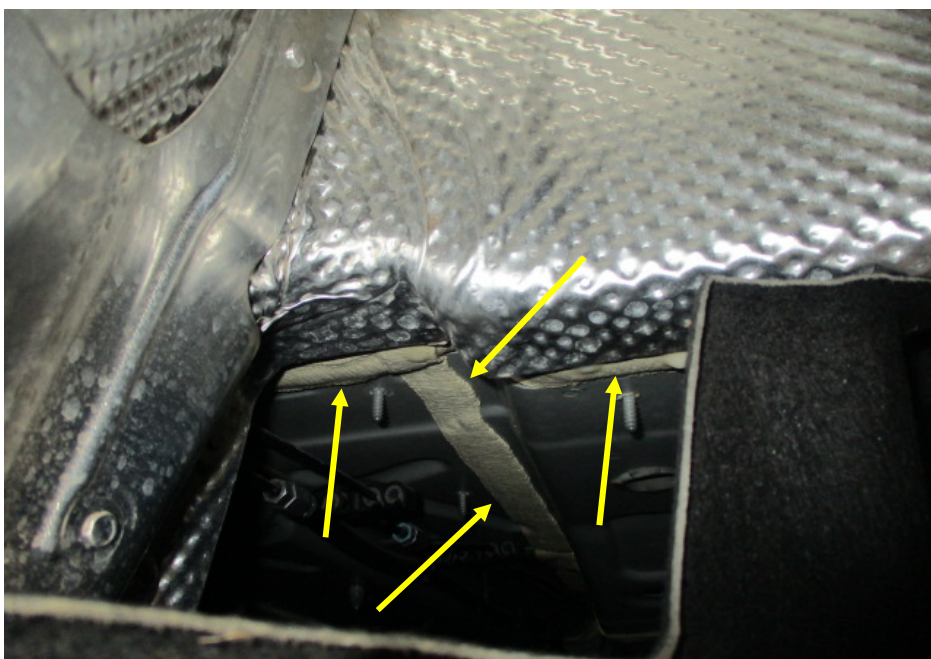
Photo 23 shows the floorboard at the underside left centre of the Motor Car. The original factory sealant (arrowed) at the joints along the floorboard (non-detachable body panel) was untouched, indicating no work was done on the floorboard of the Motor Car. In general, I had found all the non-detachable body panels of the Motor Car to be originally fitted at the time of my inspection.

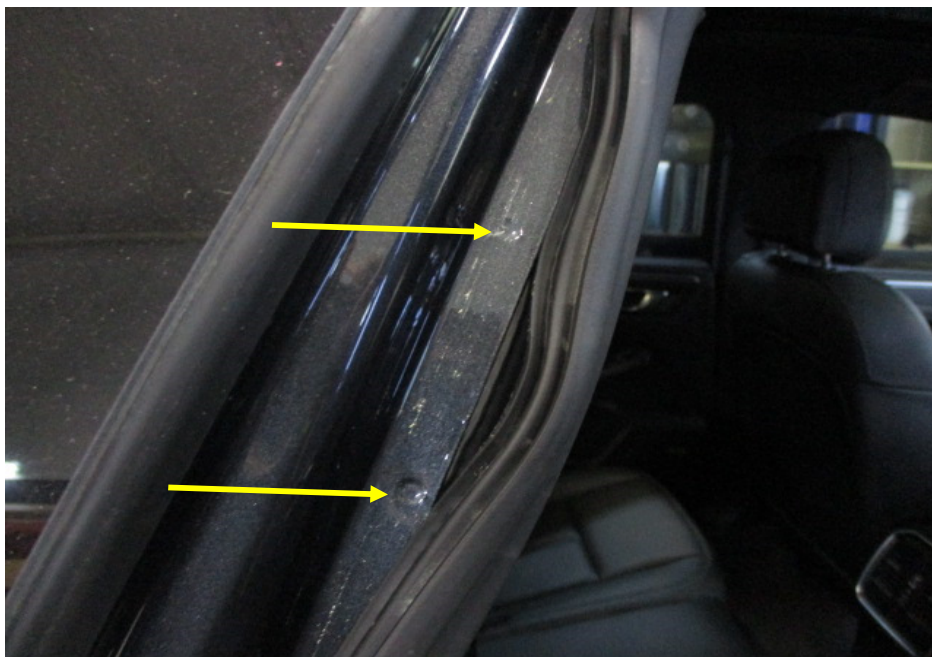
Photo 24 shows the right side “C” pillar of the Motor Car. I did not find any weld marks other than original spot weld marks (arrowed) on the right side “C” pillar of the Motor Car, which indicates that there was no re-welding works carried out. In general, I had found all the non-detachable body panels of the Motor Car to be originally fitted at the time of my inspection.
