Your Ref: Maserati Levante  
(chassis number ZN6XU61C00X321847)  
Our Ref : CI/TP21003016/D

08 March 2021

**INSPECTION REPORT OF AN UNREGISTERD MASERATI LEVANTE MOTOR CAR WITH CHASSIS NUMBER ZN6XU61C00X321847**

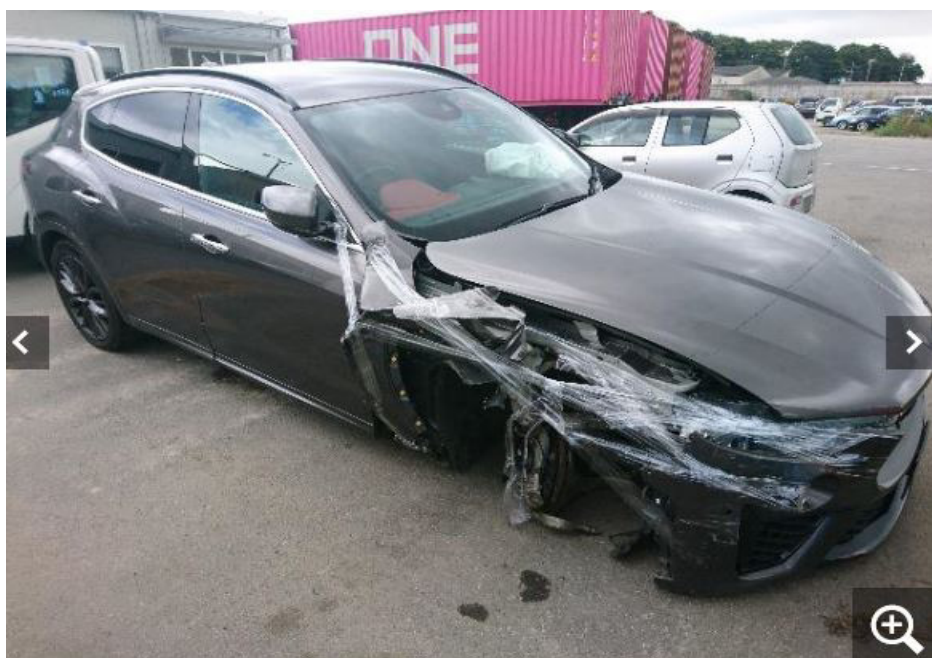
**Photo 1** shows the front right body of the Motor Car (photograph provided to me). The Motor Car was observed to have sustained damage at its front right portion. The front bumper, front bumper right lower grille, front right headlamp, front right fender, front right fender inner panel, front right fender inner shield, front right fender wheel arc garnish, front right wheel rim and front bonnet were amongst the body parts that were observed to have been damaged. The front right undercarriage parts were also observed to be damaged.

22. The body parts at the front right portion and undercarriage parts at the front right of the Motor Car were visually examined and it was noted that the repair/restoration works carried out to the damaged area of the Motor Car (refer to photograph 1 above) were reasonably adequate and in order.

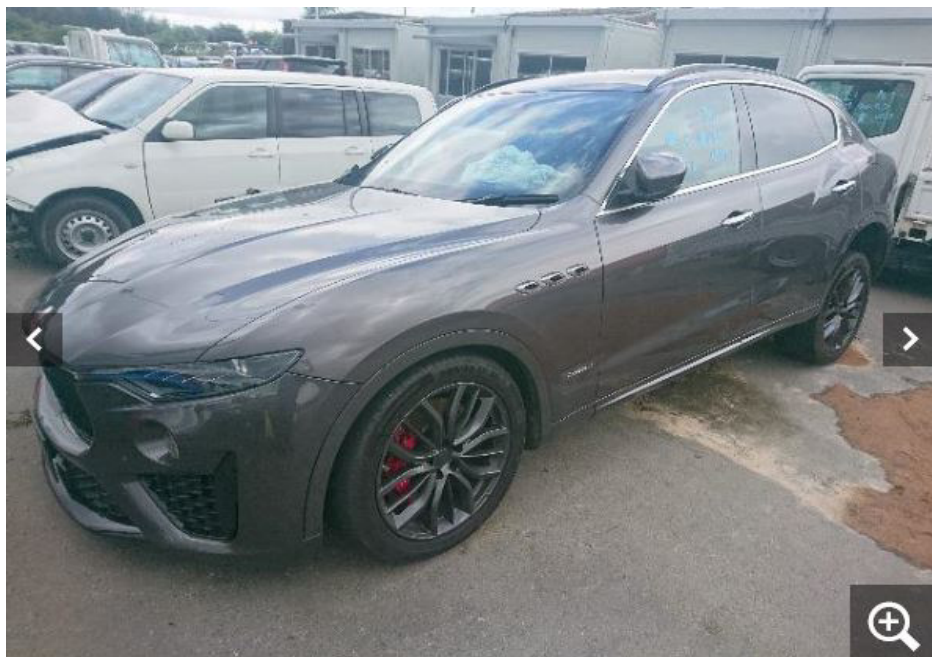
**Photo 2** shows the front left body of the Motor Car (photograph provided to me). Apart for the front right portion, there was no physical damage seen to other areas of the Motor Car.

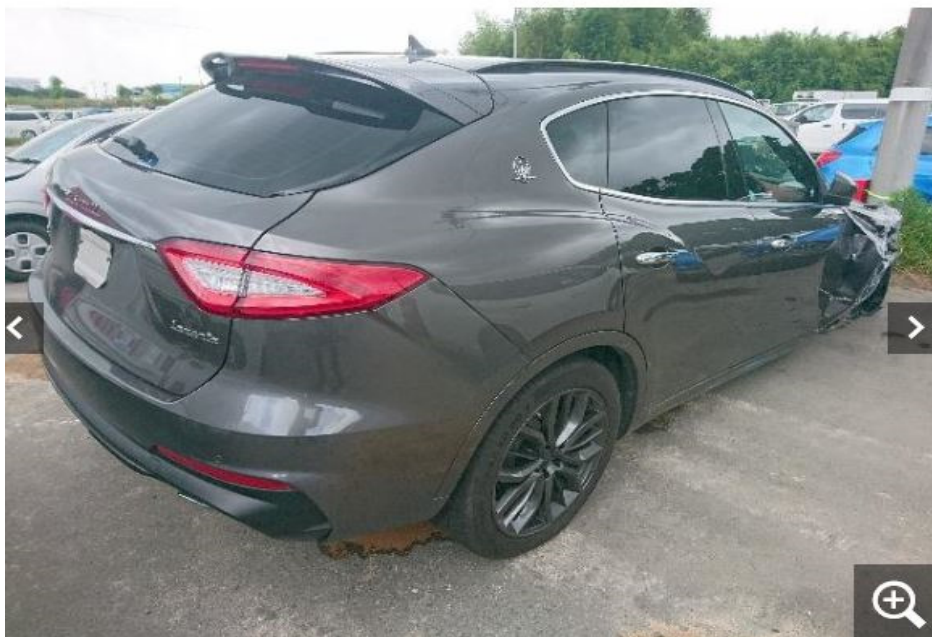
**Photo 3** shows the rear right body of the Motor Car (photograph provided to me). Apart for the front right portion, there was no physical damage seen to other areas of the Motor Car.

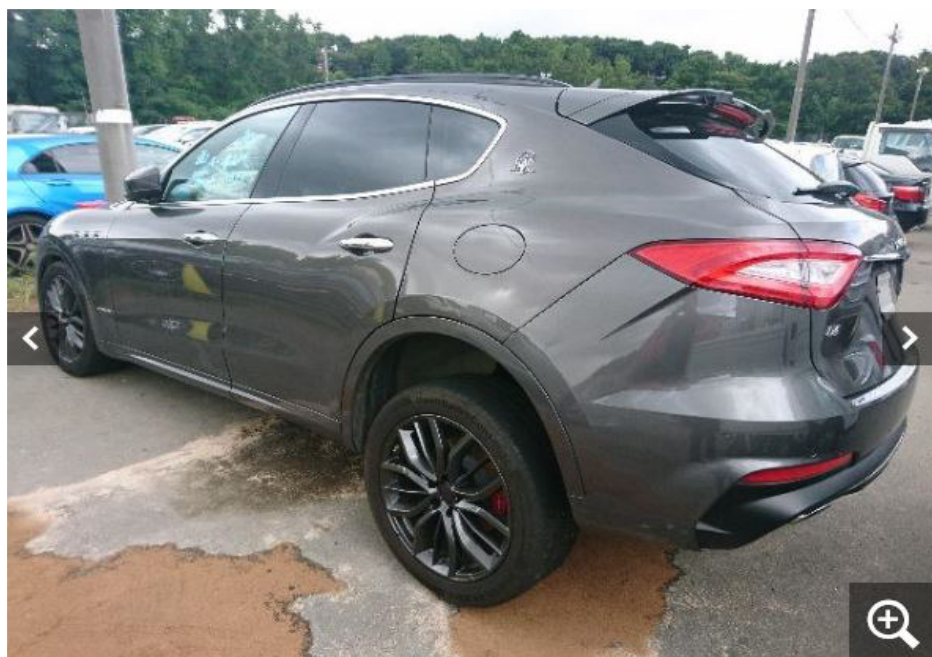
**Photo 4** shows the rear left body of the Motor Car (photograph provided to me). Apart for the front right portion, there was no physical damage seen to other areas of the Motor Car.

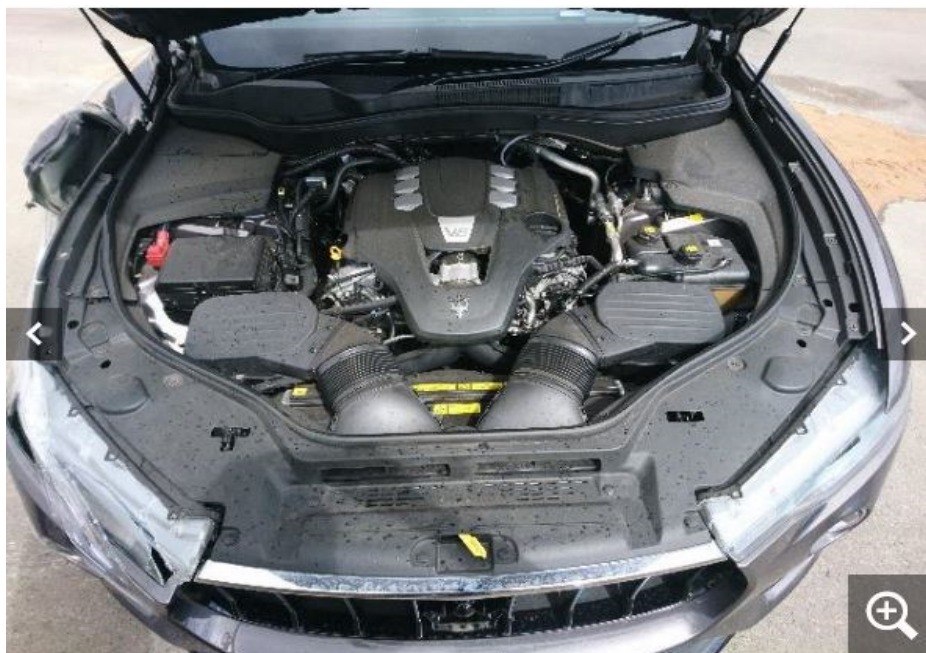
**Photo 5** shows a general view of the engine compartment of the Motor Car (photograph provided to me). Parts within the engine compartment were unaffected as seen from the photograph that was provided.

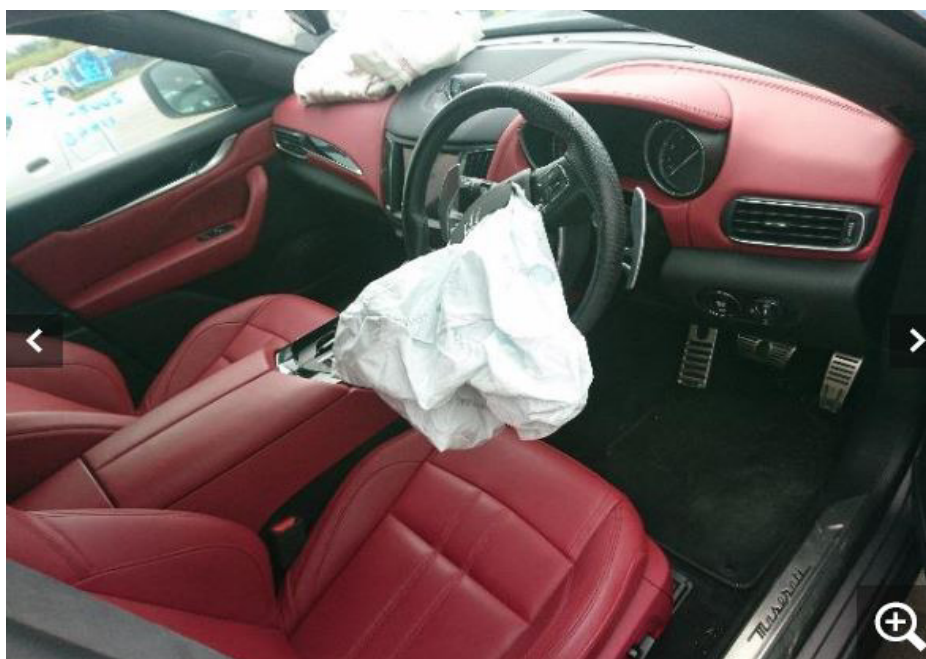
**Photo 6** shows a general view of the interior compartment of the Motor Car (photograph provided to me). The driver's airbag and front left passenger airbag were activated as seen from the photograph that was provided.

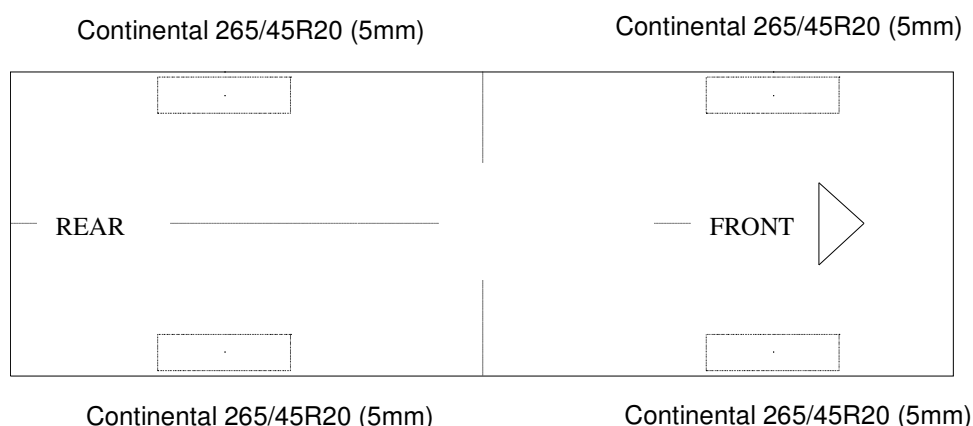
8. It was fitted with 20inch sport wheel rims that were wrapped with tyres that were observed to be of serviceable condition. The tyres were also sufficiently inflated for vehicular operation. The tyre brand, tyre size and approximate remaining tread depth of the 4 tyres of the Motor Car were recorded as follows: -

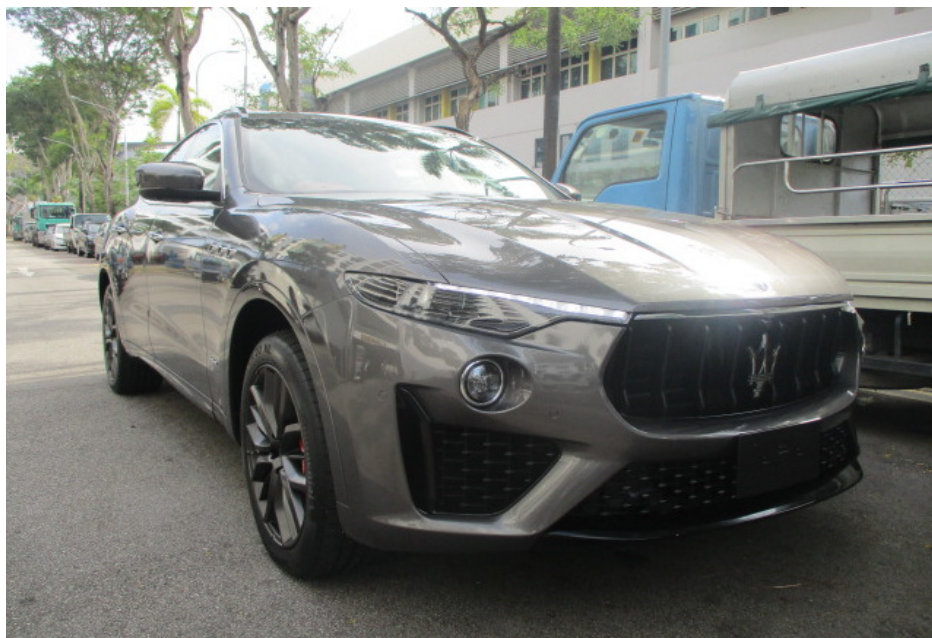
**Photo 7** shows a general view of the front right body of the Motor Car at the time of my inspection. The Motor Car was observed to be in a relatively good general condition with no loose exterior fittings observed. The body parts at the front right portion of the Motor Car were visually examined and it was observed that the repair/restoration works carried out to the damaged area of the Motor Car (refer to photograph 1 above) were reasonably adequate and in order.

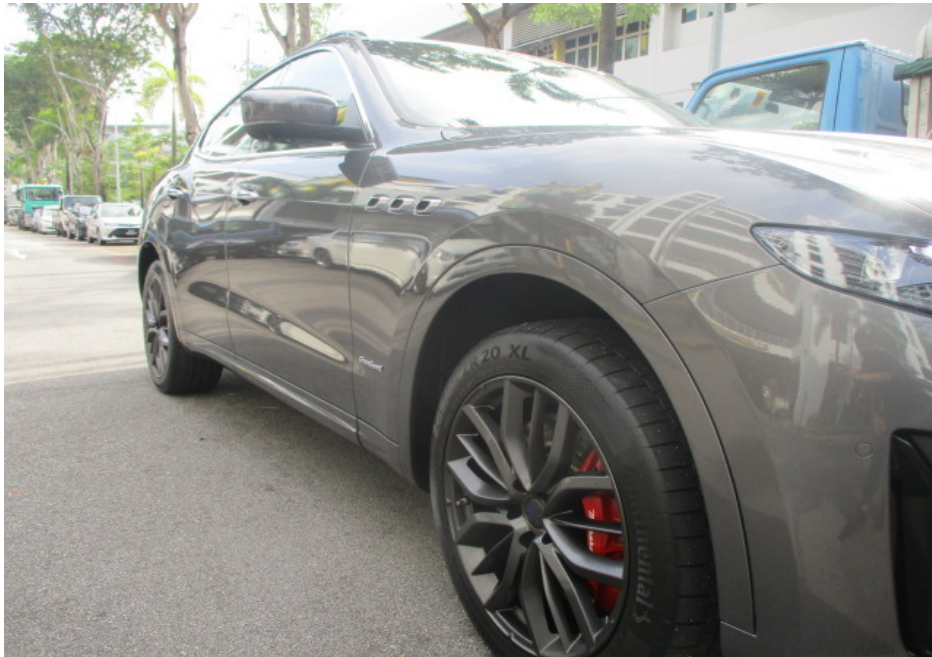
**Photo 8** shows a closer view of the front bumper, front right headlamp, front right fender wheel arc garnish and front right wheel of the Motor Car at the time of my inspection. The body parts at the front right portion of the Motor Car were visually examined and it was observed that the repair/restoration works carried out to the damaged area of the Motor Car (refer to photograph 1 above) were reasonably adequate and in order.

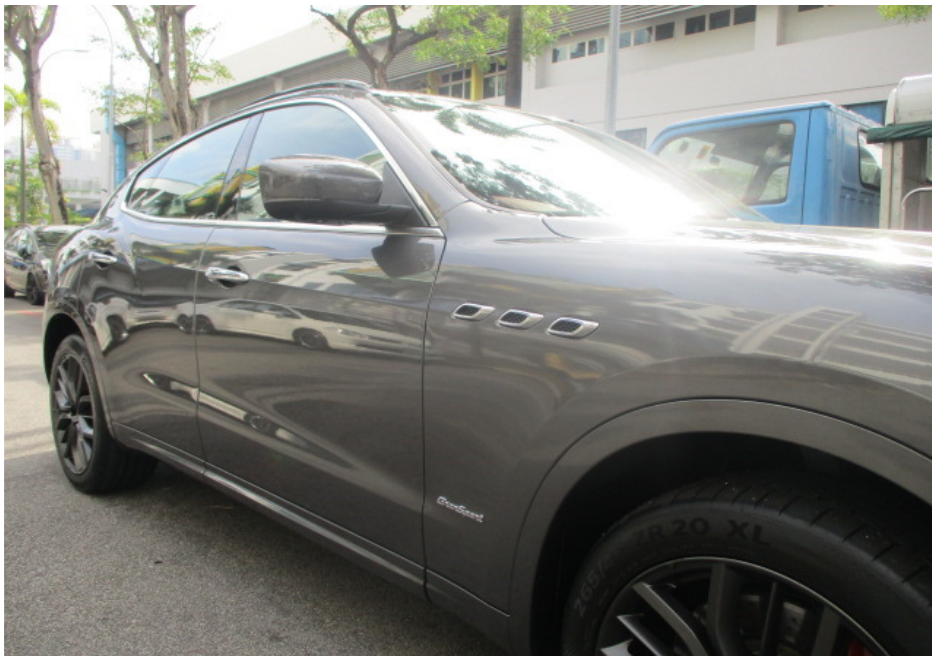
**Photo 9** shows a closer view of the front right fender and front right door of the Motor Car at the time of my inspection. The body parts at the front right portion of the Motor Car were visually examined and it was observed that the repair/restoration works carried out to the damaged area of the Motor Car (refer to photograph 1 above) were reasonably adequate and in order.

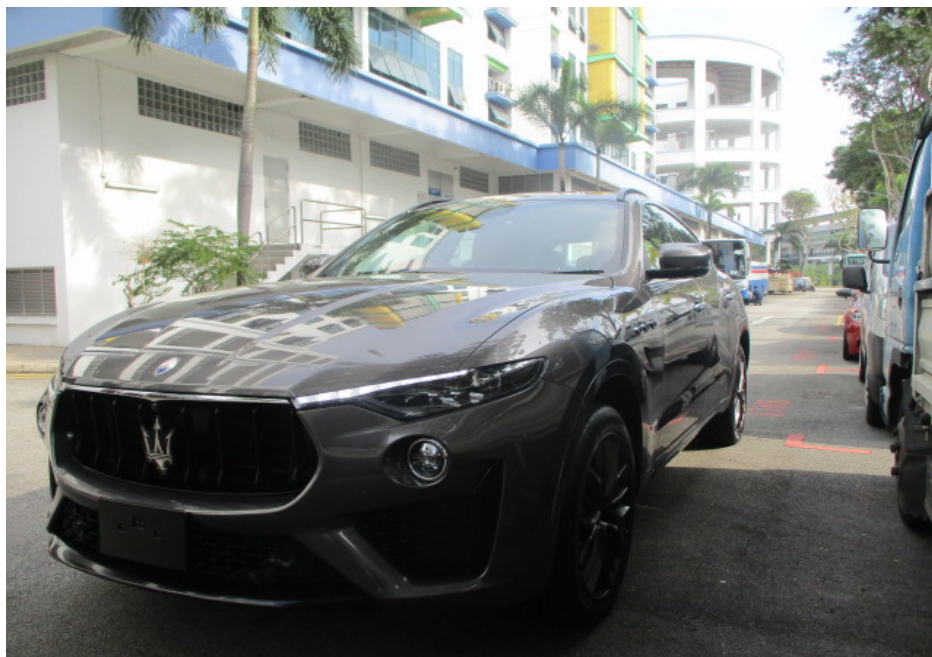
**Photo 10** shows a general view of the front left body of the Motor Car at the time of my inspection. The Motor Car was observed to be in a relatively good general condition with no loose exterior fittings observed. The mileage of the Motor Car recorded at the time of my inspection was 22,373km.

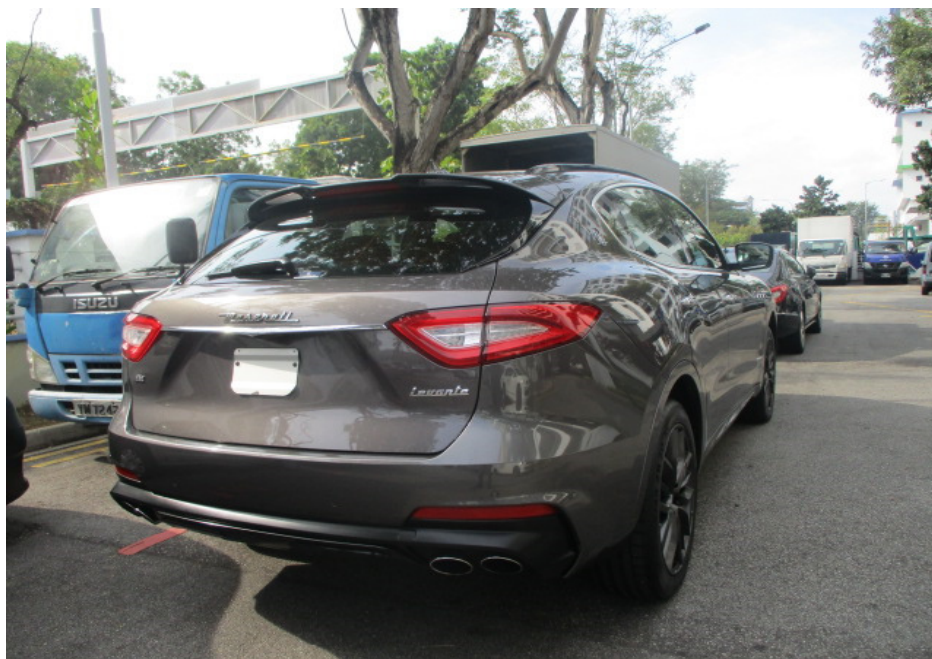
**Photo 11** shows a general view of the rear right body of the Motor Car at the time of my inspection. The Motor Car was observed to be in a relatively good general condition with no loose exterior fittings observed. The mileage of the Motor Car recorded at the time of my inspection was 22,373km.

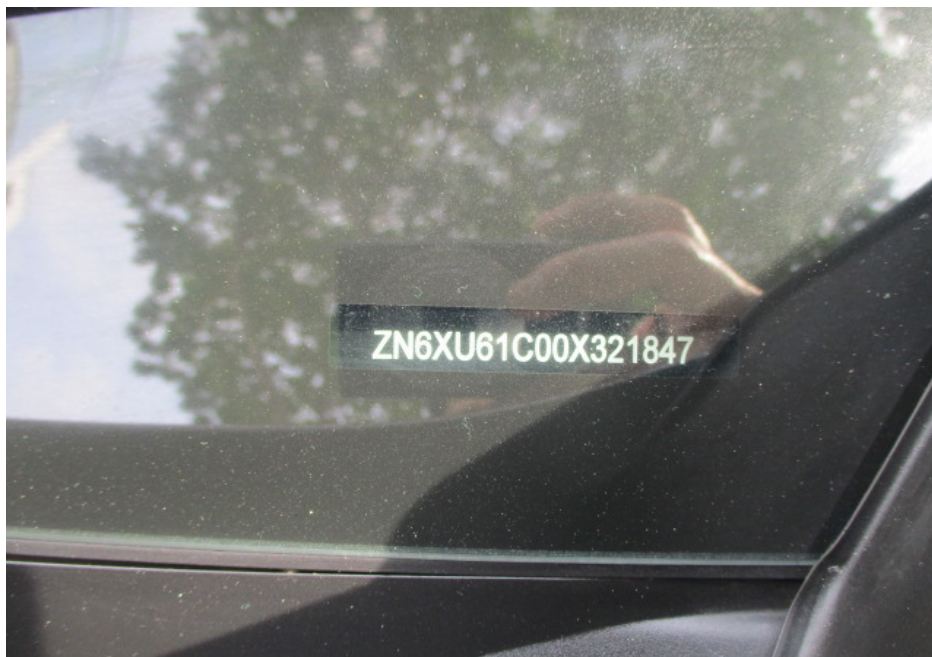
**Photo 12** shows the chassis number of the Motor Car. The chassis number recorded was ZN6XU61C00X321847.

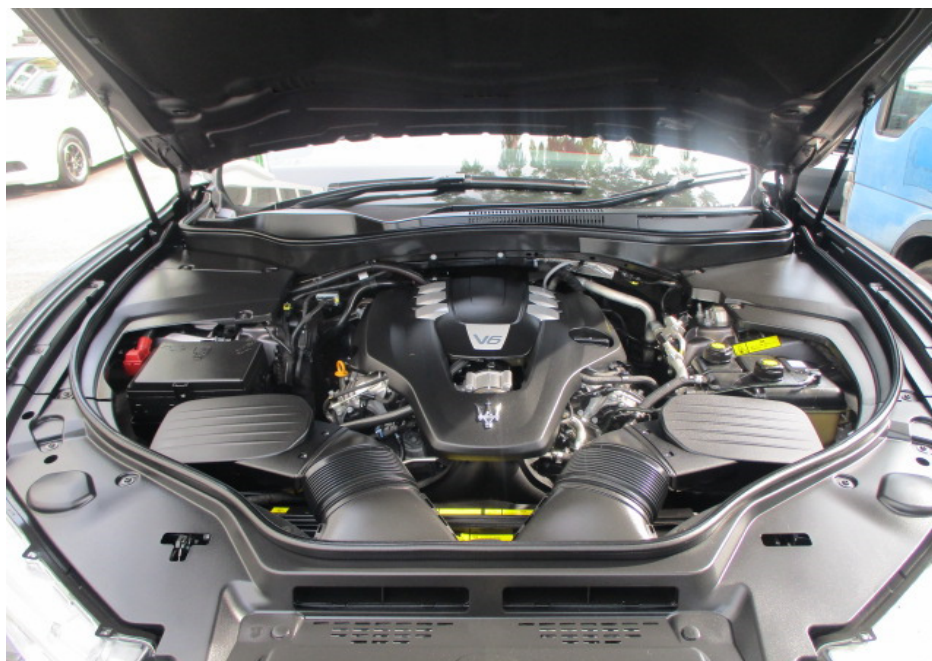
14. My examination of the engine compartment of the Motor Car revealed that the various parts and components inside the engine compartment were all intact and properly fitted. The engine oil, brake fluid and engine coolant were all found to be of sufficient level for operating purposes. Visually, there was also no contamination found to these fluids.

**Photo 13** shows a general view of the engine compartment of the Motor Car at the time of my inspection. The various parts and components inside the engine compartment were all observed to be intact and properly fitted. There was also no sign(s) or indication(s) of fluid leak and/or fluid stain found inside the engine compartment.

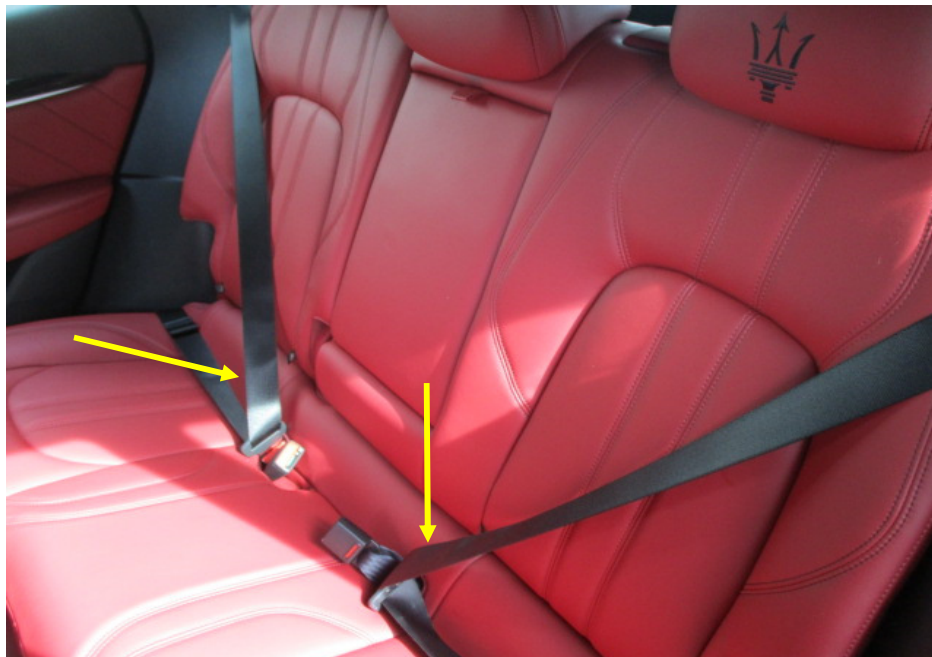
12. The seats of the Motor Car were found to be secured to the floorboard of the Motor Car via seat rails bolted onto the floorboard. Retractable seat belt reels and pre-tensioners were fitted on all seats of the Motor Car. The seat belts were tested and were able to be fastened securely into the respective pre-tensioners that were fixed to the side of all the seats.

**Photo 14** shows the rear seats of the Motor Car. All the seats of the Motor Car were secured via seat rails to the floorboard. They were also fitted with a retractable seat belt reel and a pre-tensioner. The seat belts (arrowed) were tested and were able to be fastened into the respective pre-tensions that were fitted on the side of each individual seat.

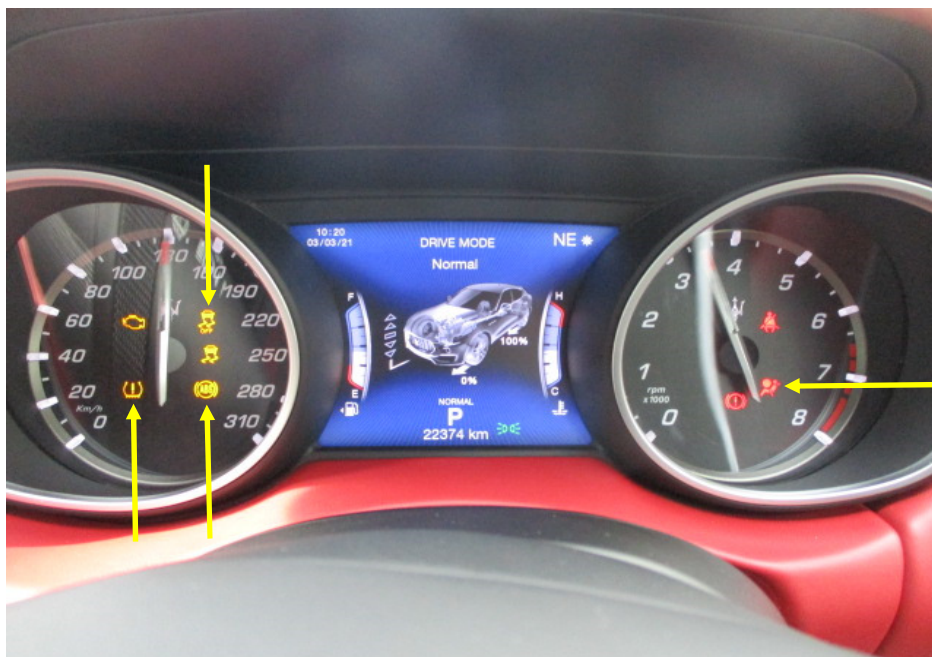
**Photo 15** shows the warning lights for the various electronic safety features appearing on the instrument panel of the Motor Car during its self-test when the engine is cranked, in particular the ABS, SRS, TPM and TCS lights (arrowed).

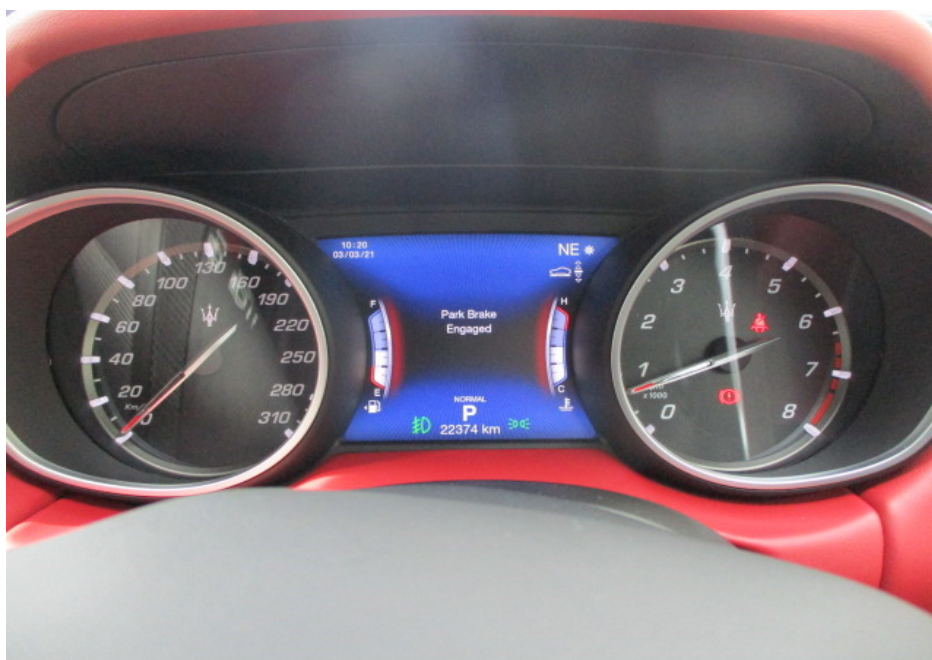
13. The Motor Car's automatic self-test of the functionality of its various electronic safety features like the Anti-Lock Brake System (ABS), Supplemental Restraint System (SRS), Tyre Pressure Monitor (TPM) and Traction Control System (TCS) during cranking of the engine had indicated that these electronic systems were in working condition. This was determined from the respective warning lights disappearing from the instrument panel after the self-test.

**Photo 16** shows the respective warning lights no longer illuminated, indicating that there is no fault detected to the ABS, SRS, TPM and TCS systems of the Motor Car during the self-test. These electronic systems were hence in working condition at the time of my inspection.

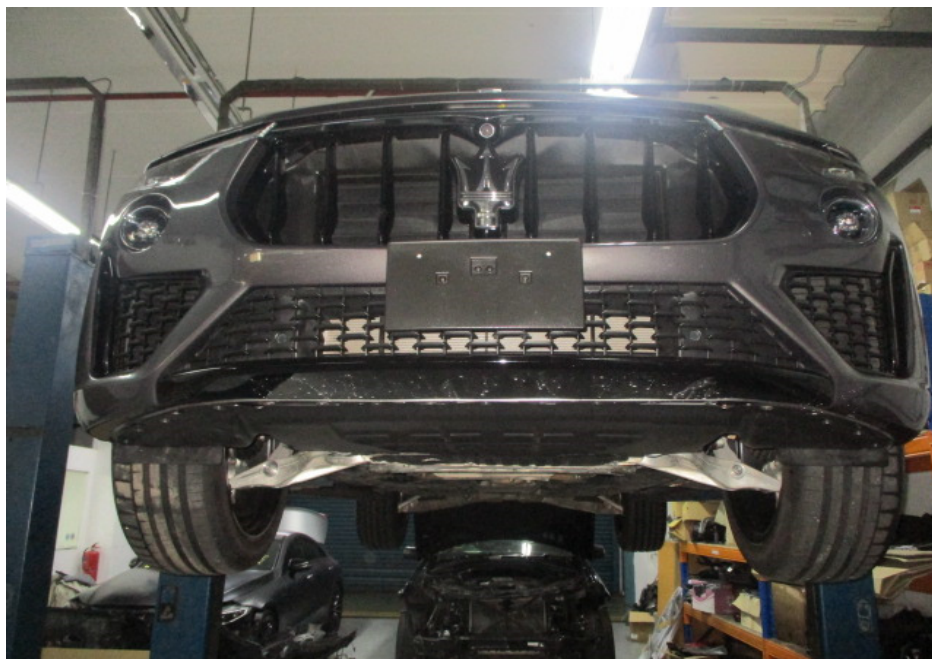
15. My checks on the underside of the Motor Car revealed no sign(s) or indication(s) of fluid leakage and/or fluid stain(s). The engine block and automatic transmission assembly were both secured properly. All undercarriage components of the Motor Car were also observed to be intact and secured in an appropriate manner.

**Photo 17** shows the Motor Car hoisted up for checks on its undercarriage. There was no sign(s) or indication(s) of fluid leakage and/or fluid stain(s) on the underside of the Motor Car. The undercarriage components of the Motor Car were also all observed to be intact and secured in an appropriate manner.

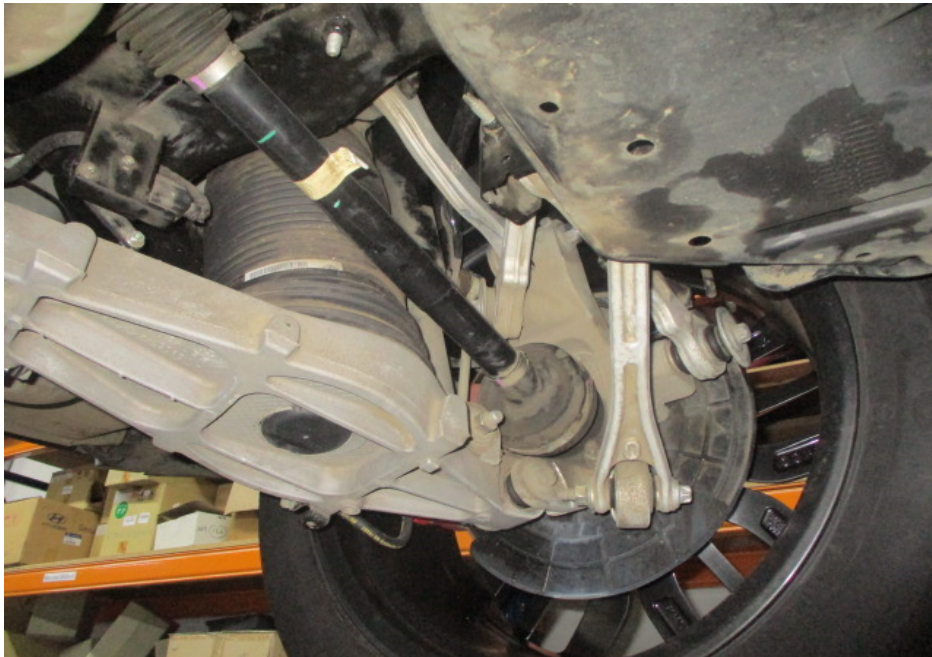
**Photo 18** shows a general view of the control arms and linkages at the rear left wheel of the Motor Car. I did not observe any fluid leak and/or fluid stain on the underside of the Motor Car. All of the Motor Car's undercarriage components were observed to be intact and secured in an appropriate manner.

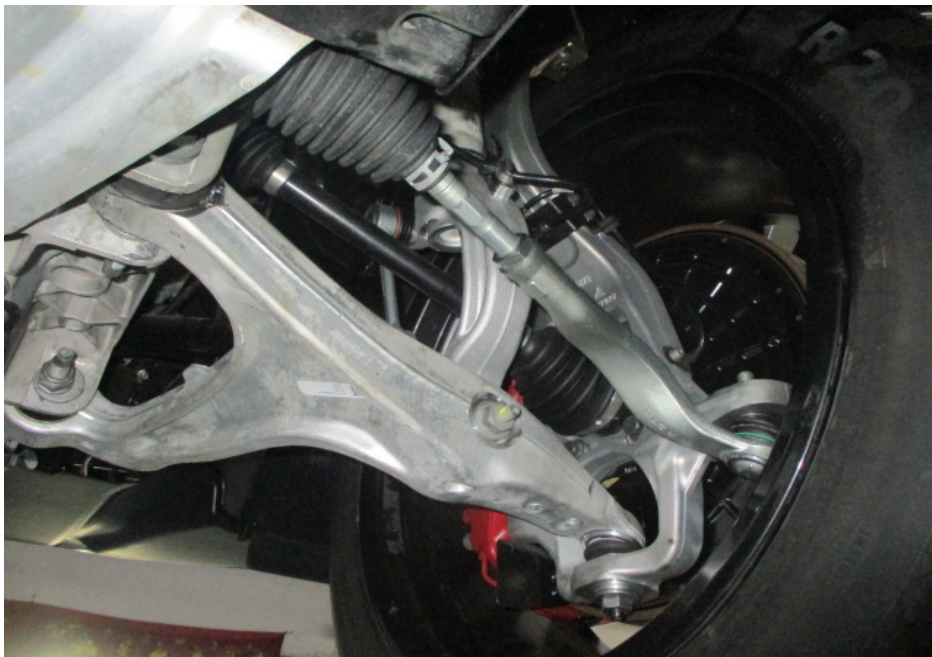
**Photo 19** shows the various undercarriage components at the front right wheel of the Motor Car. The mechanical components, control arms and linkages were all found to be intact and secured in an appropriate manner.

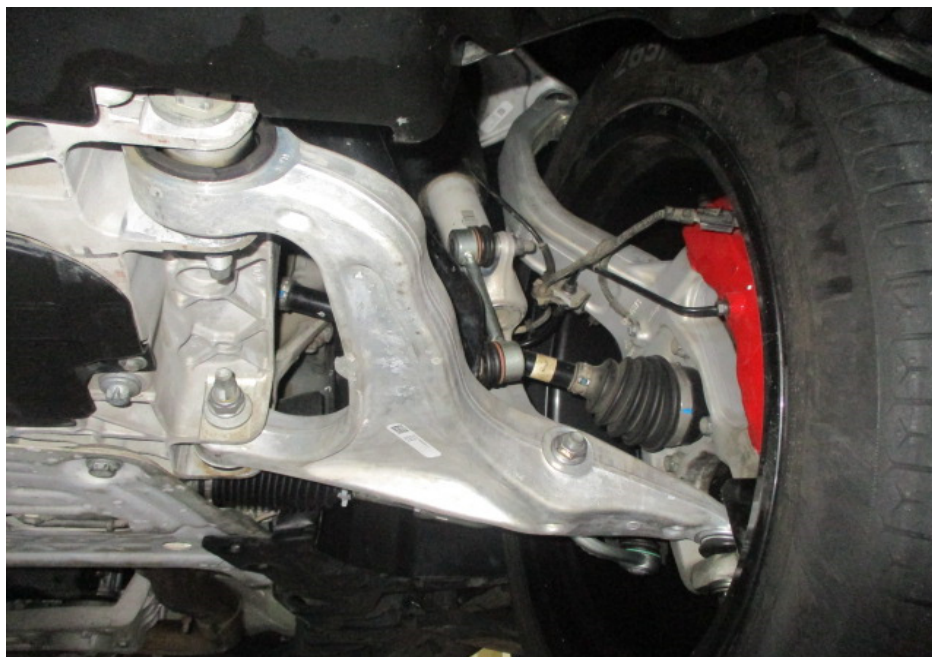
**Photo 20** shows the various undercarriage components at the front left wheel of the Motor Car. The mechanical components, control arms and linkages were all found to be intact and secured in an appropriate manner. I also did not observe any fluid leak and/or fluid stain on the underside of the Motor Car.

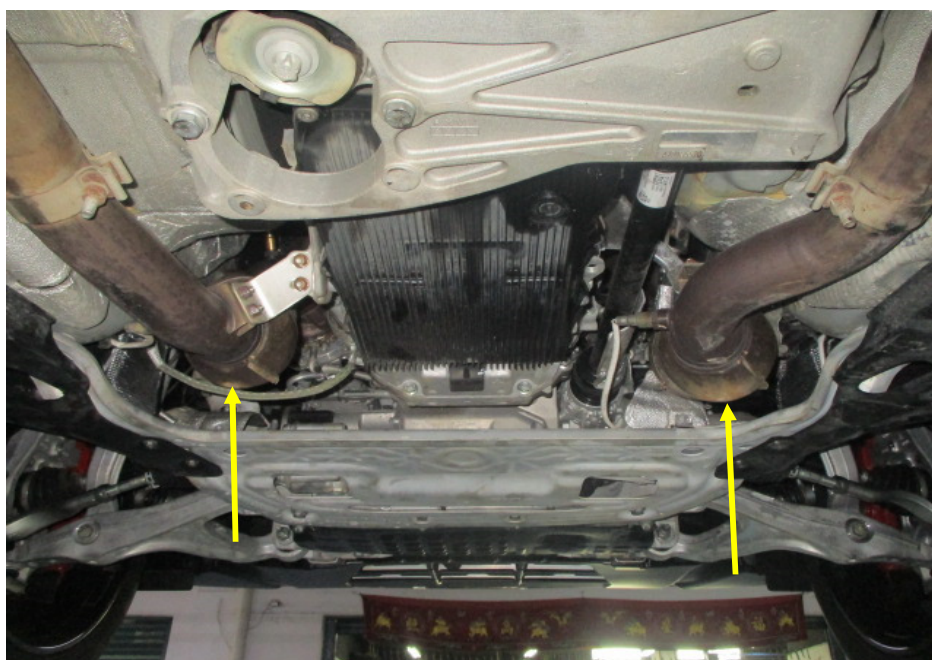
**Photo 21** shows the Motor Car's catalytic converters (arrowed). My examination of the Motor Car's exhaust system revealed no sign(s) or indication(s) of any cut or weld marks along its exhaust pipes and on its rear mufflers.

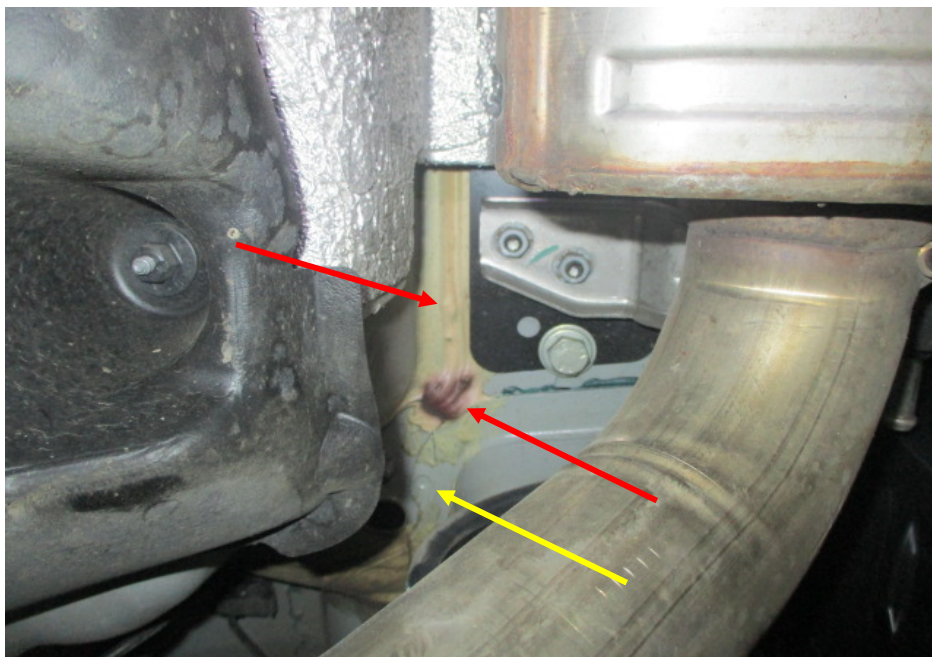
11. Visually, I did not find any weld marks, other than the original spot weld marks, on the chassis/structural body of the Motor Car. The original factory sealant at the joints along the chassis/structural body was also untouched, again indicating that no replacement of the chassis/structural body was carried out; and that the chassis/structural body was originally fitted.

**Photo 22** shows the chassis/structural body at the underside rear right of the Motor Car. I did not find any weld marks other than original spot weld marks (yellow arrow) on the chassis/structural body of the Motor Car. The original factory sealant (red arrow) at the joints along the chassis/structural body was also untouched, indicating no work was done on the chassis/structural body of the Motor Car and that the chassis/structural body was originally fitted.

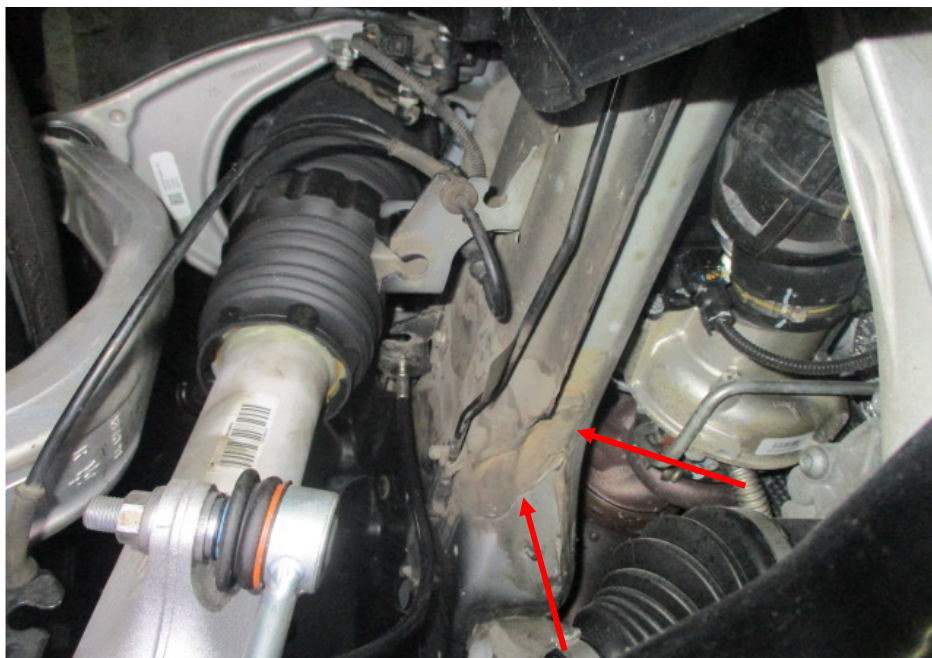
**Photo 23** shows the chassis/structural body at the underside front right of the Motor Car. The original factory sealant (arrowed) at the joints along the chassis/structural body was observed to be untouched. In general, I had found no work was carried out on the chassis/structural body of the Motor Car. The chassis/structural body of the Motor Car was originally fitted.

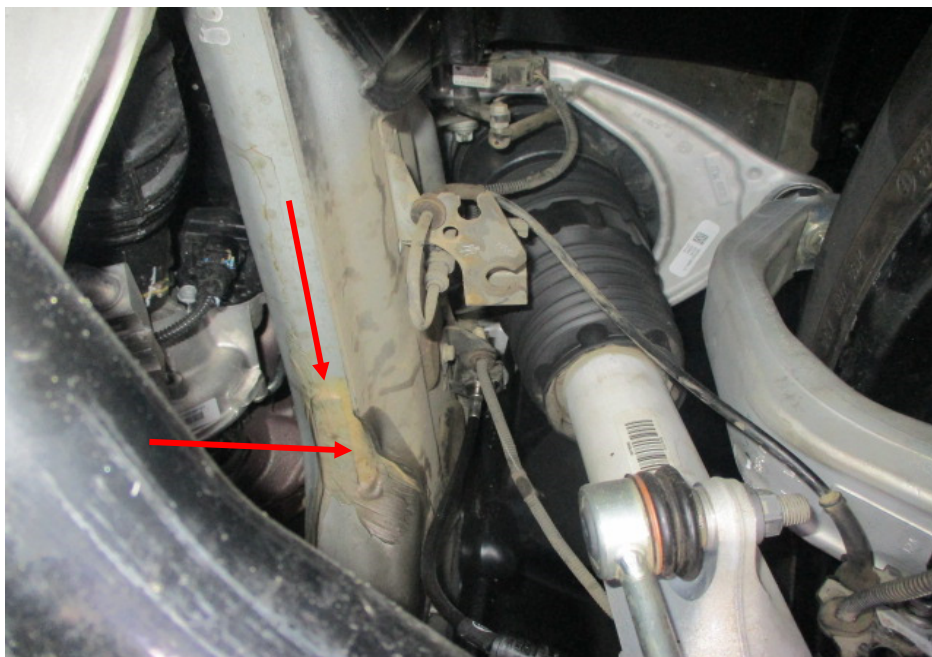
**Photo 24** shows the chassis/structural body at the underside front left of the Motor Car. The original factory sealant (arrowed) at the joints along the chassis/structural body was observed to be untouched. In general, I had found no work was carried out on the chassis/structural body of the Motor Car. The chassis/structural body of the Motor Ca was originally fitted.

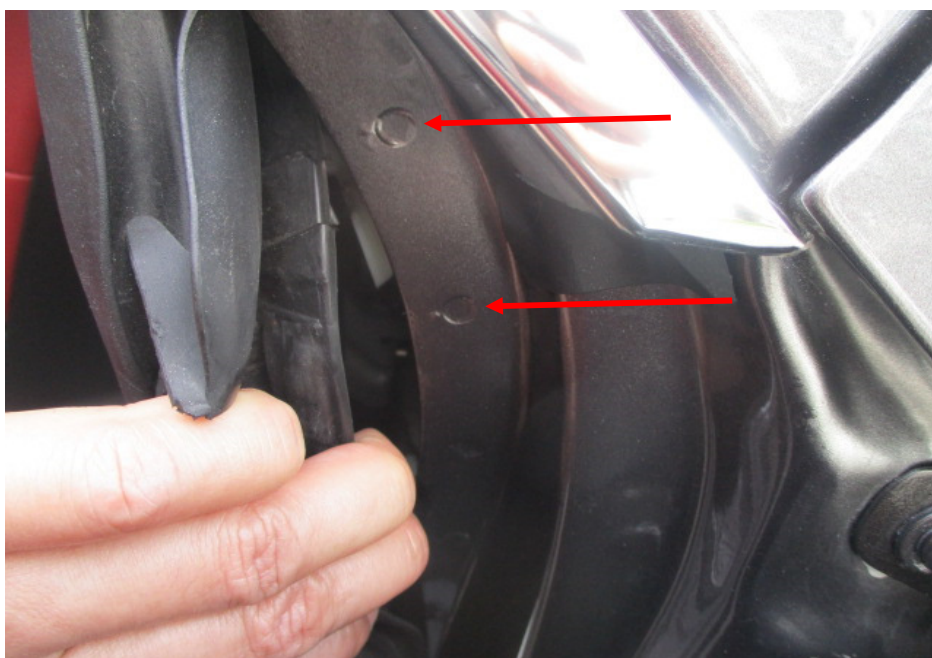
**Photo 25** shows the right side "A" pillar of the Motor Car. I did not find any weld marks other than original spot weld marks (arrowed) on the right side "A" pillar of the Motor Car which, indicates that there was no re-welding works carried out. In general, I had found all the non-detachable body panels of the Motor Car to be originally fitted at the time of my inspection.

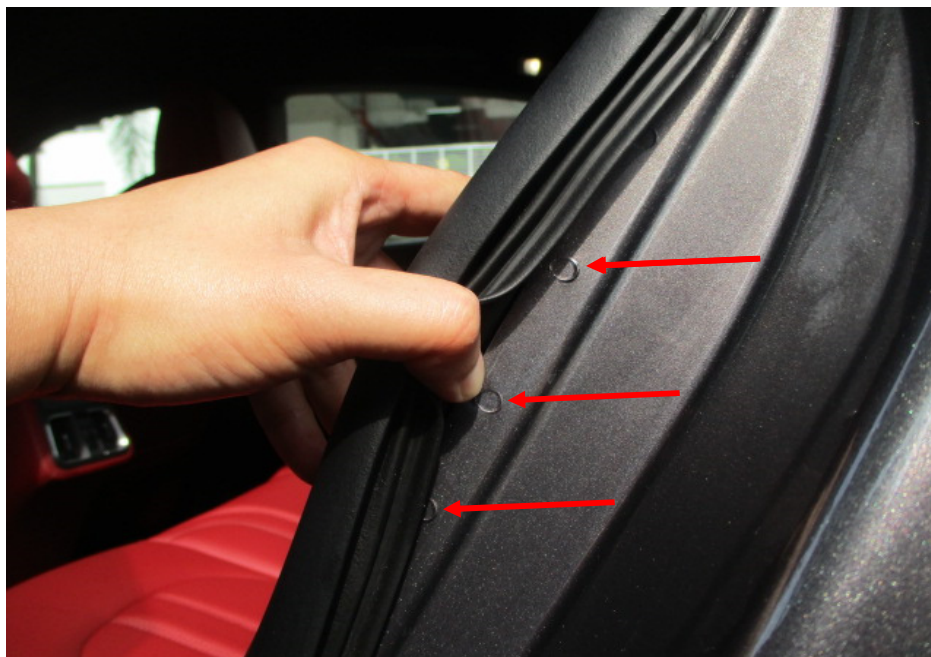
**Photo 26** shows the left side "C" pillar of the Motor Car. I did not find any weld marks other than original spot weld marks (arrowed) on the left side "C" pillar of the Motor Car which, indicates that there was no re-welding works carried out. In general, I had found all the non-detachable body panels of the Motor Car to be originally fitted at the time of my inspection.
