# LKK Auto Consultants Pte Ltd

## ADJUSTMENT ON REPAIR COST FOR VEHICLE NO. GBH 8937D

PHOTOGRAPHS FOR VEHICLE NO. GBH 8937D

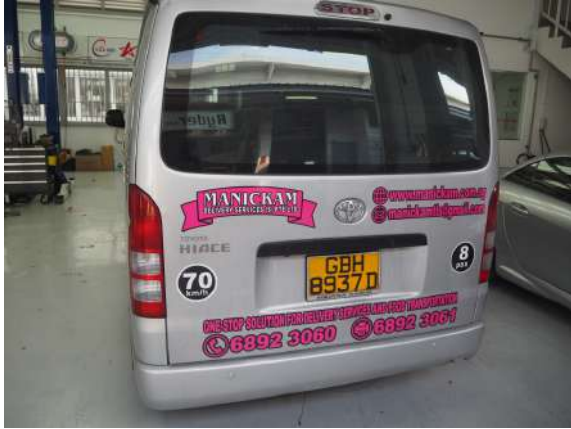
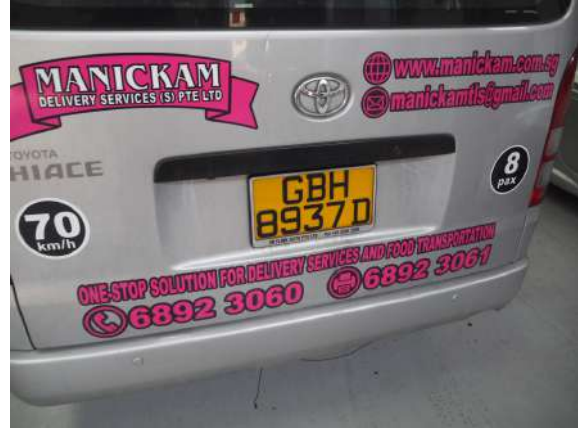
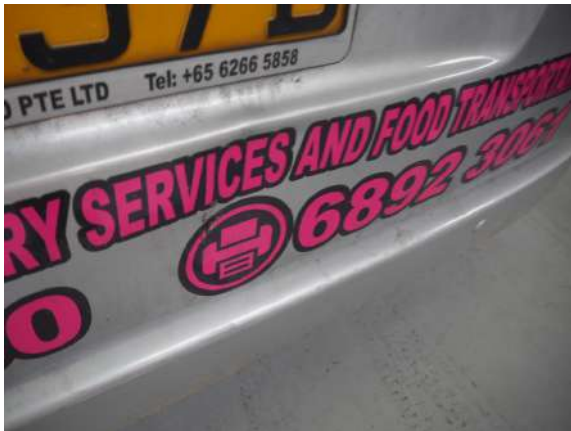
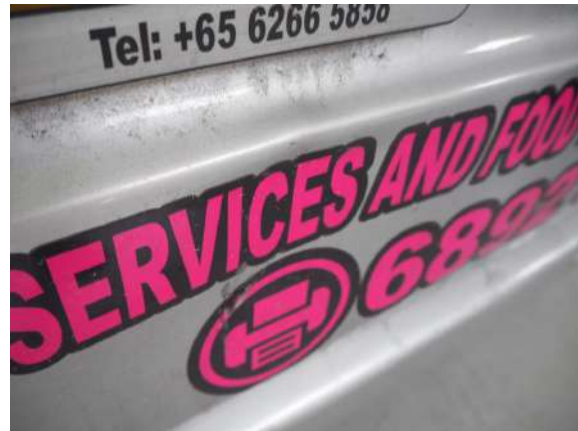
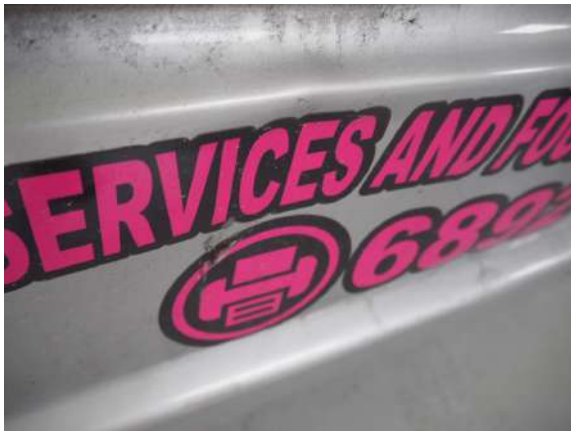
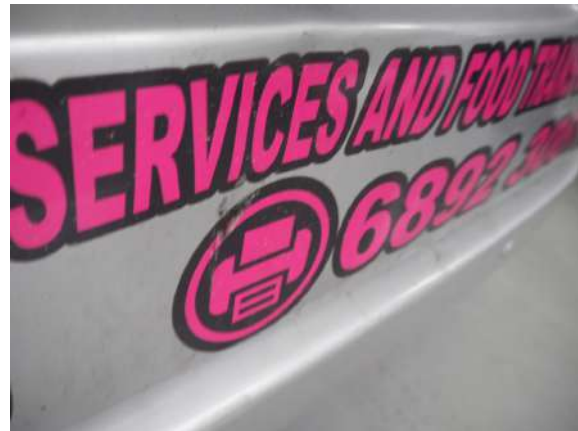
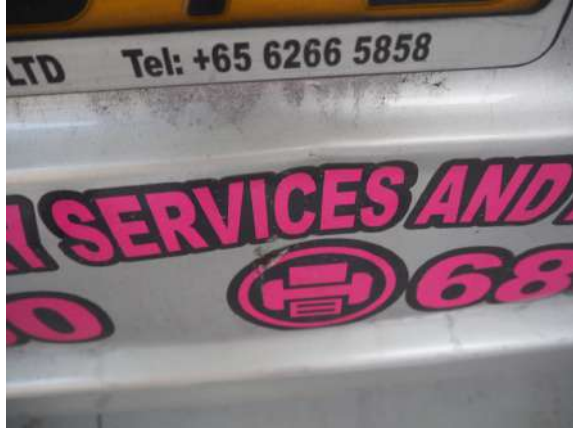
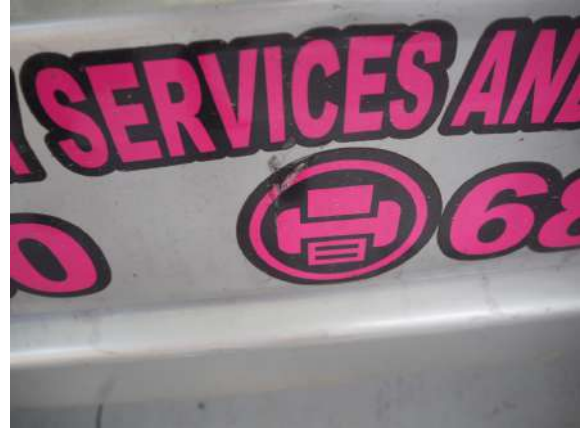
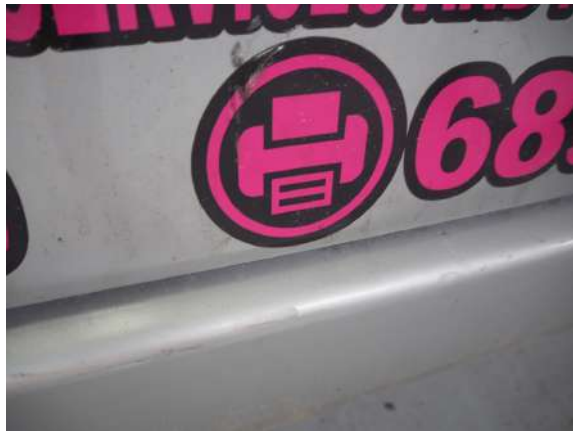
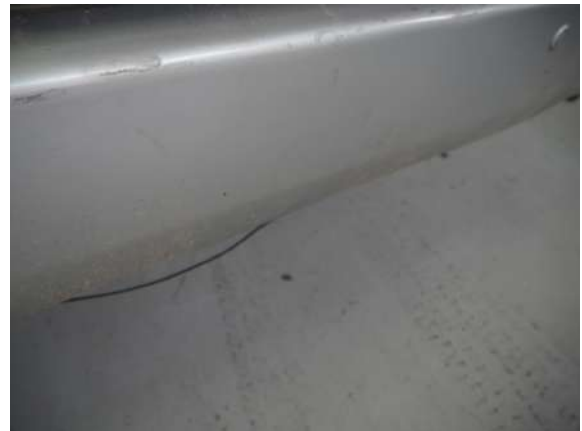
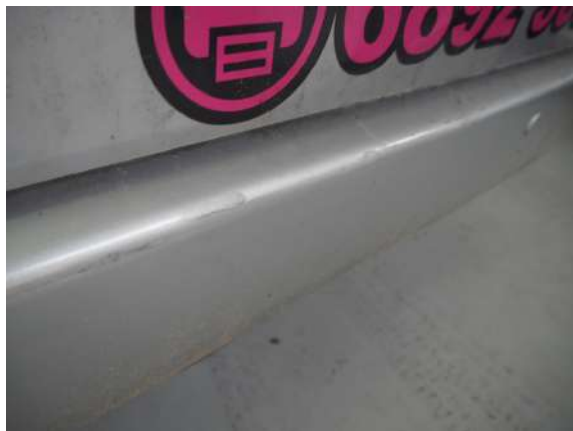
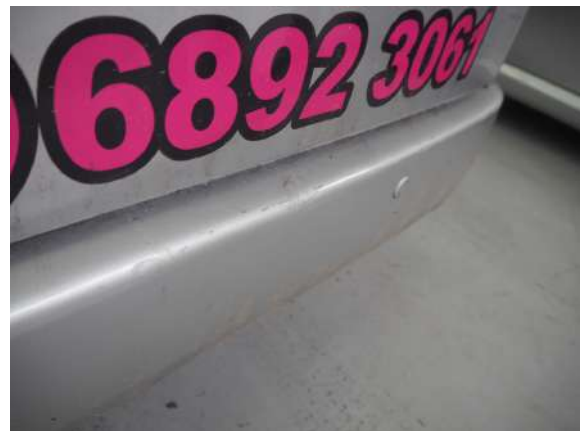
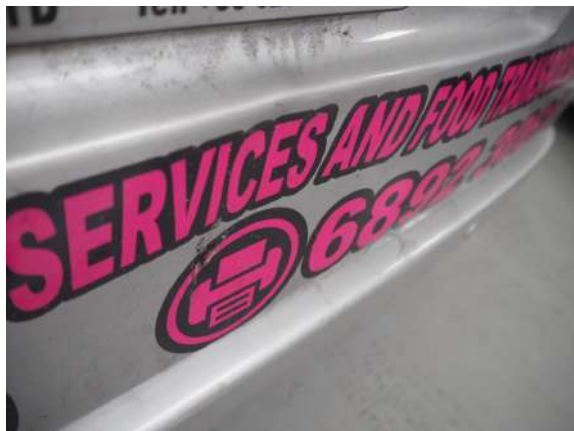
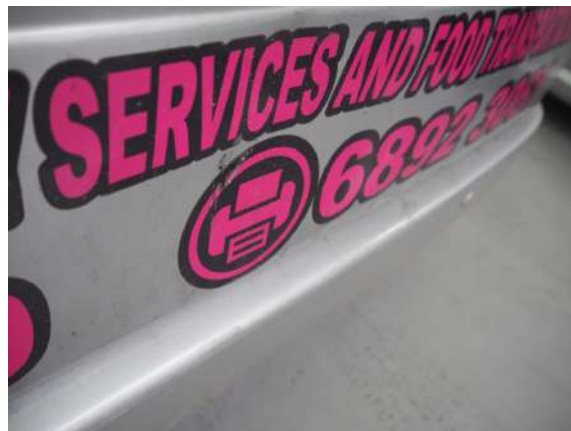
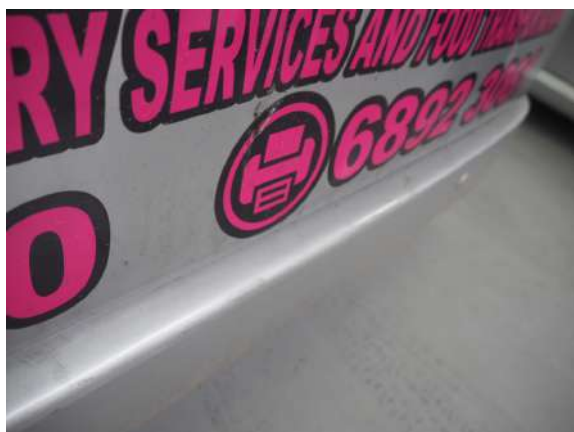
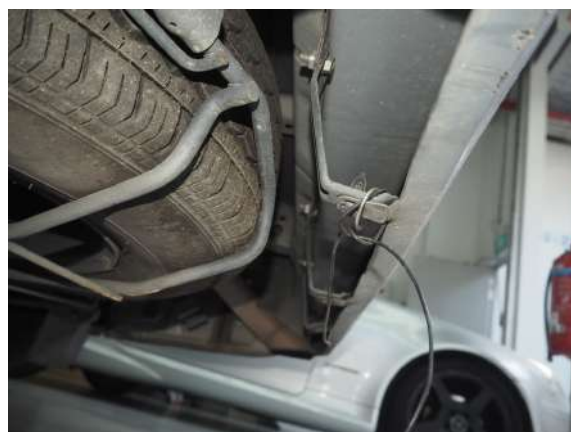
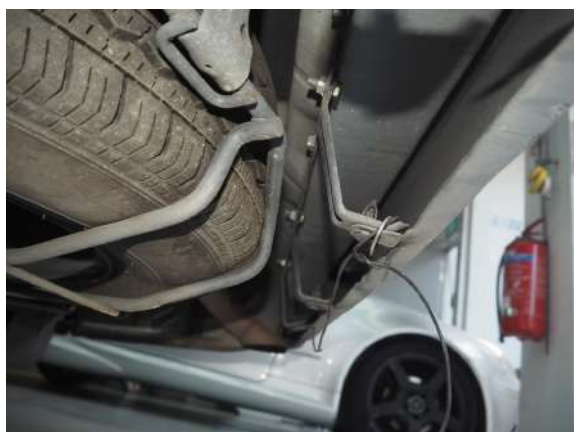
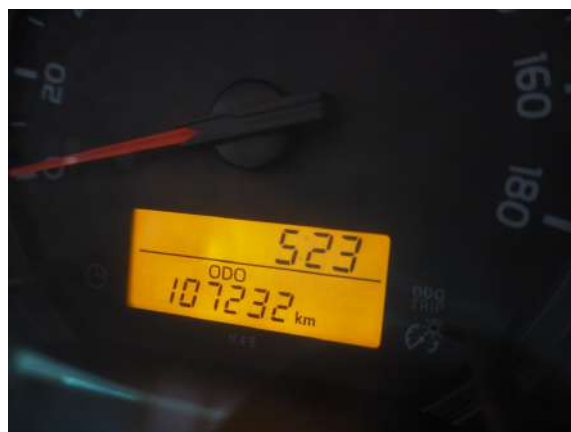
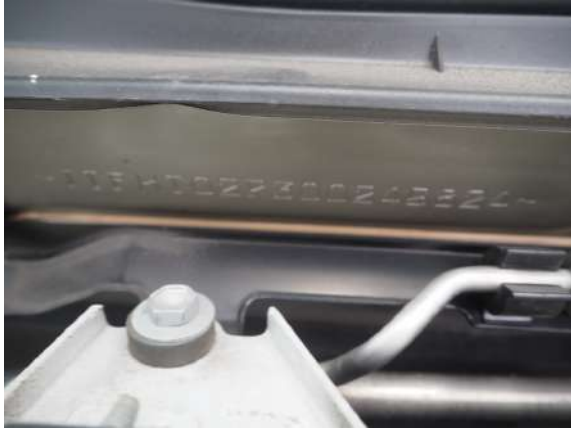
INSPECTION

| Affiliated to Federation Internationale Des Experts En Automobile | | | | |
|---|---|---|---|--|
| THE VEHICLE SUSTAINED DAMAGES AT THE REAR PORTION.<br><br>DAMAGES SEE DETAILS. | | | | |
