Our Reference : KAAS/TA/6148/2500/TP/12.20  
Date : 16 January 2021

## VEHICLE APPRAISAL REPORT

| Registration No. | : SMR 2500L | Chassis Frame No. | : ZC53S-117547 |
| Make / Model | : Suzuki Swift M-Hybrid 1.2 RS CVT | Engine No. ( Logcard ) | : K12C5591440 |

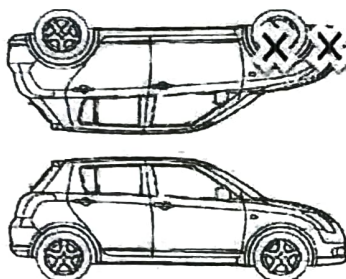
Damages sustained were consistent with the subject vehicle being involved in a collision with another vehicle and the impact was delivered **Diagonally to the LH Front from rear to front; left to right;** portion of the vehicle.

The general area of damages is at the **LH Front portion**  
( Please refer to the parts list and photographs as attached for more information )
