## VEHICLE APPRAISAL REPORT

Name of Workshop : Apex Motoring  
Place of inspection : 25 Kaki Bukit Road 4 #01-55, Synergy @ Kaki Bukit, Singapore 417800  
Date of Assignment : 19 December 2020  
Date of Accident : 15 December 2020  
Date of Inspection : 19 December 2020

| Registration No. | : SMR 2500L | Chassis Frame No. | : ZC53S-117547 |
| Make / Model | : Suzuki Swift M-Hybrid 1.2 RS CVT | Engine No. ( Logcard ) | : K12C5591440 |

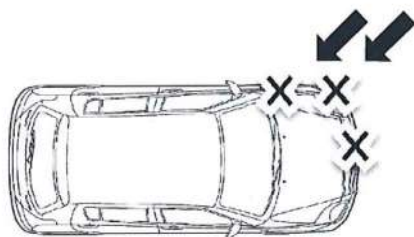
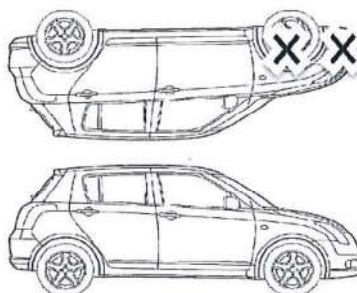
Damages sustained were consistent with the subject vehicle being involved in a collision with another vehicle and the impact was delivered **Diagonally to the LH Front from rear to front; left to right;** portion of the vehicle.

The general area of damages is at the **LH Front portion**  
( Please refer to the parts list and photographs as attached for more information )
