Your Ref: Mercedes Benz E300 Coupe  
(chassis number WDD2383832F121310)

Our Ref : CI/TP21003295/D

**Global Carz Pte Ltd**

**INSPECTION REPORT OF AN UNREGISTERED MERCEDES BENZ E300  
COUPE MOTOR CAR WITH CHASSIS NUMBER WDD2383832F121310**

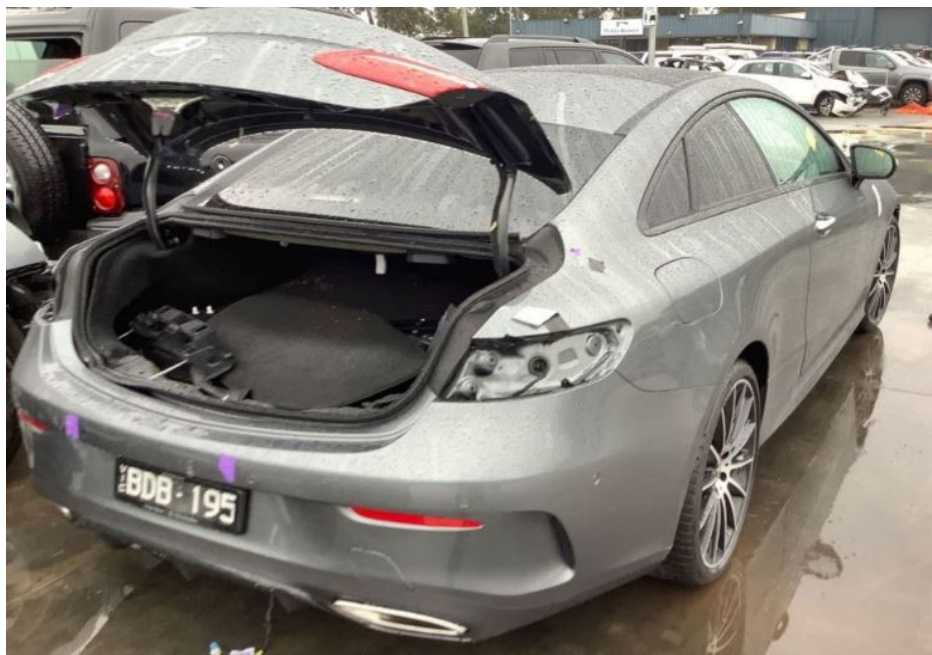
**Photo 1** shows the rear right body of the Motor Car prior to any repairs being carried out (photograph provided to me). The Motor Car was observed to have sustained damages at its rear portion. The rear bootlid weatherstrip and various inner trims within the rear boot compartment were observed to be damaged. The rear right taillamp was either dislodged, removed or damaged.

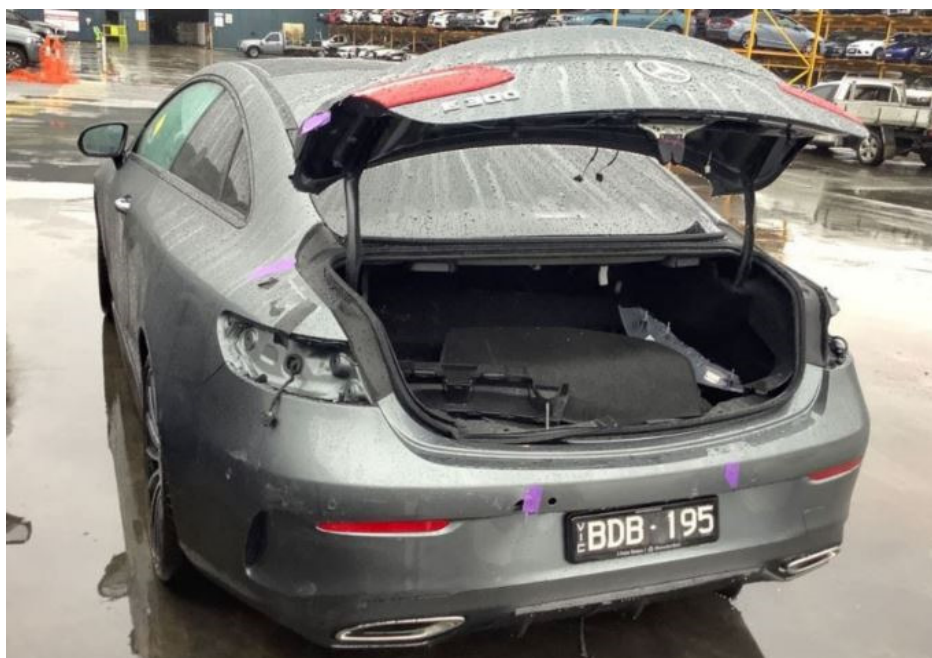
**Photo 2** shows the rear left body of the Motor Car prior to any repairs being carried out (photograph provided to me). The Motor Car was observed to have sustained damages at its rear portion. The rear bumper, rear end panel and various inner trims within the rear boot compartment were observed to be damaged. The rear left taillamp was either dislodged, removed or damaged.

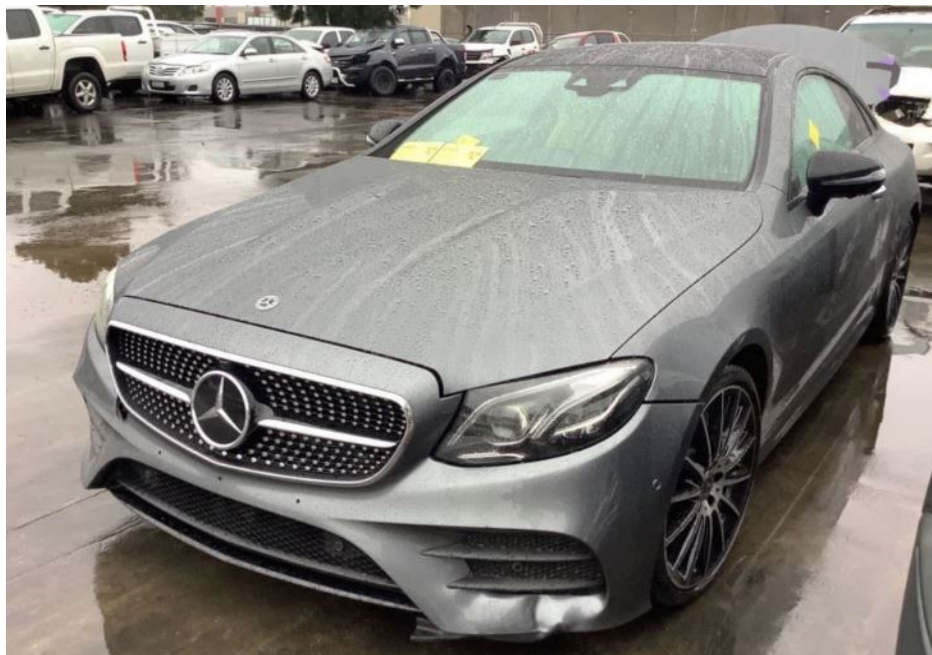
**Photo 3** shows the front left body of the Motor Car prior to any repairs being carried out (photograph provided to me). The front bumper was observed to be dented at its left lower portion. The orientation of the front left wheel appears to be more towards the right as compared to the front right wheel (refer to photograph 4 below), suggesting possible damage to the front undercarriage of the Motor Car.

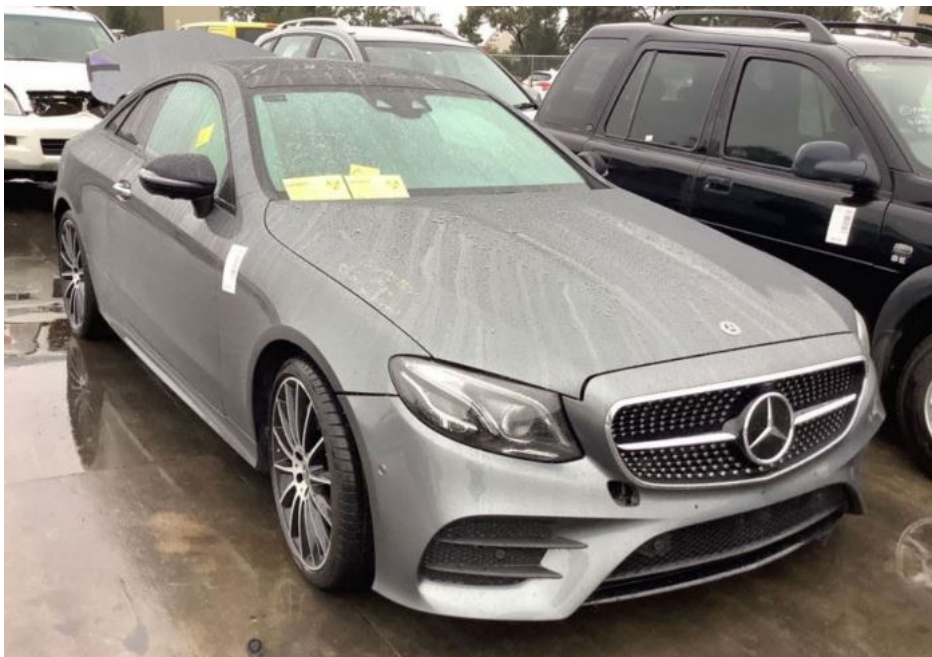
**Photo 4** shows the front right body of the Motor Car prior to any repairs being carried out (photograph provided to me). The orientation of the front right wheel as compared to the front right wheel (refer to photograph 3 above) suggest possible damage to the front undercarriage of the Motor Car.

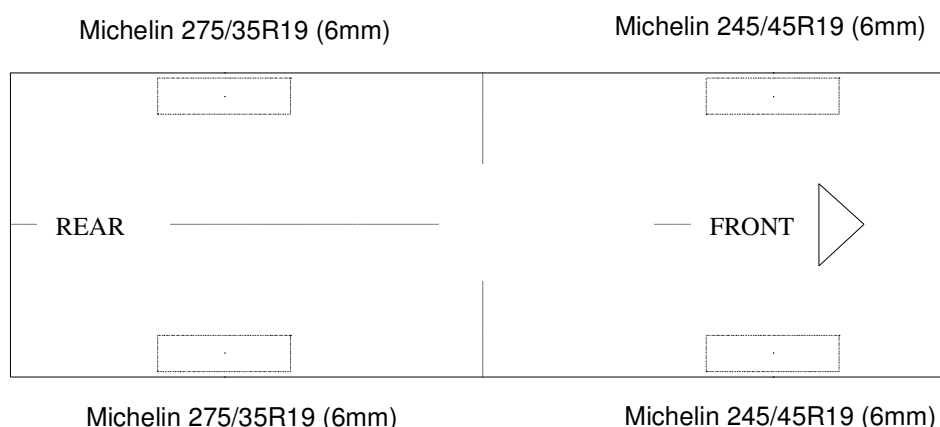
8. It was fitted with 19inch sport wheel rims that were wrapped with tyres that were observed to be of serviceable condition. The tyres were also sufficiently inflated for vehicular operation. The tyre brand, tyre size and approximate remaining tread depth of the 4 tyres of the Motor Car were recorded as follows: -

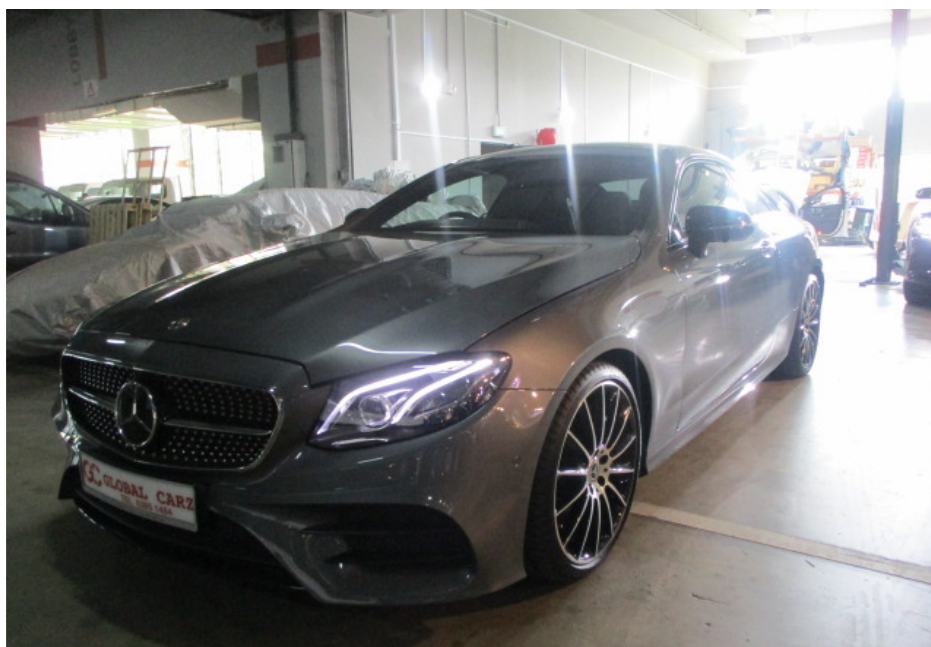
**Photo 5** shows a general view of the front left body of the Motor Car at the time of my inspection. The Motor Car was observed to be in a relatively good general condition with no loose exterior fittings observed. The body parts at the front left portion of the Motor Car were visually examined and it was observed that the repair/restoration works carried out to the damaged area of the Motor Car (refer to photograph 3 above) were reasonably adequate and in order.

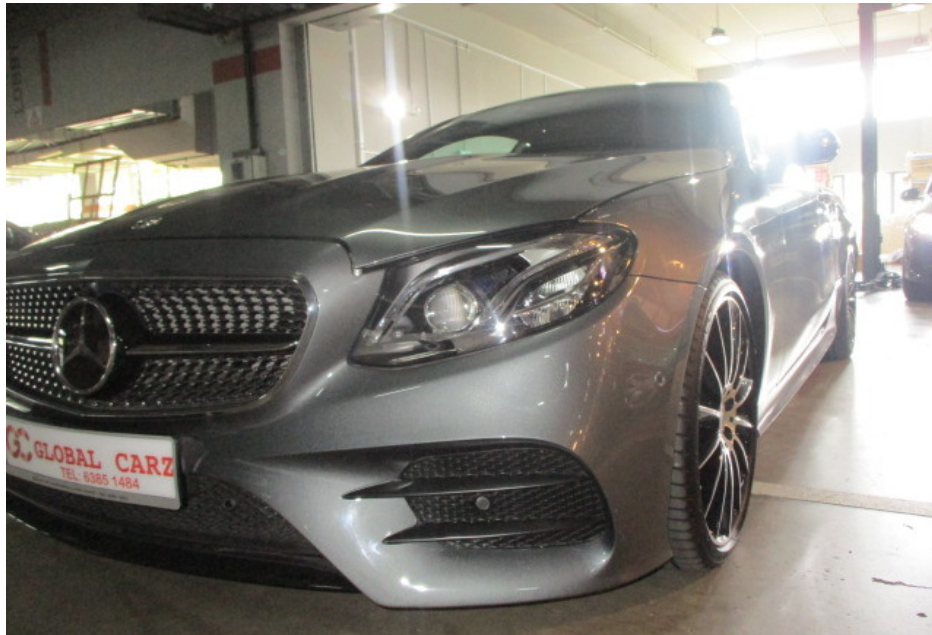
**Photo 6** shows a closer view of the Motor Car's front bumper, at the left lower portion. The Motor Car was observed to be in a relatively good general condition with no loose exterior fittings observed. The body parts at the front left portion of the Motor Car were visually examined and it was observed that the repair/restoration works carried out to the damaged area of the Motor Car (refer to photograph 3 above) were reasonably adequate and in order.

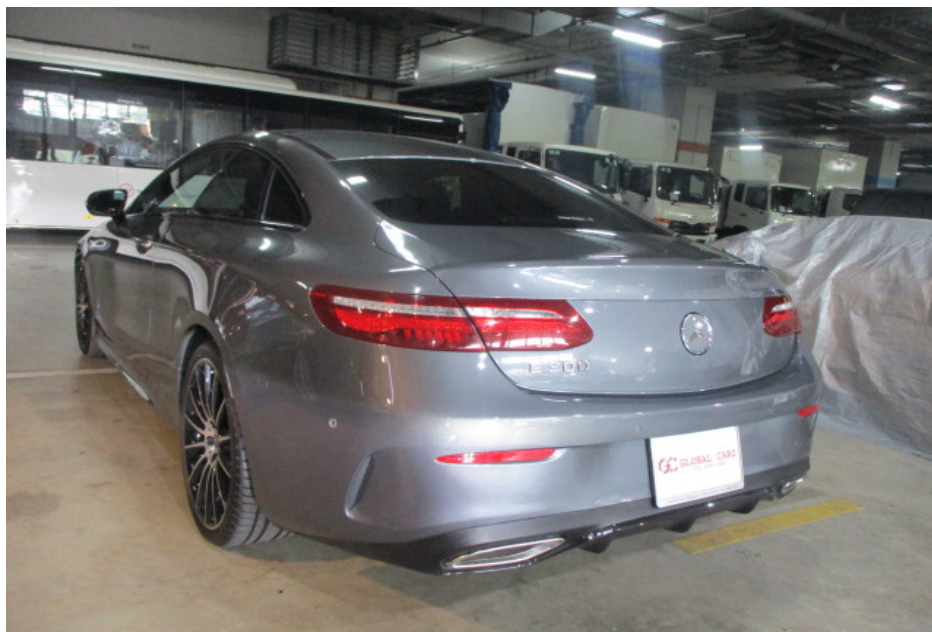
**Photo 7** shows a general view of the rear left body of the Motor Car at the time of my inspection. The Motor Car was observed to be in a relatively good general condition with no loose exterior fittings observed. The body parts at the rear portion of the Motor Car were visually examined, and it was observed that the repair/restoration works carried out to the damaged area of the Motor Car (refer to photograph 1 & 2 above) were reasonably adequate and in order.

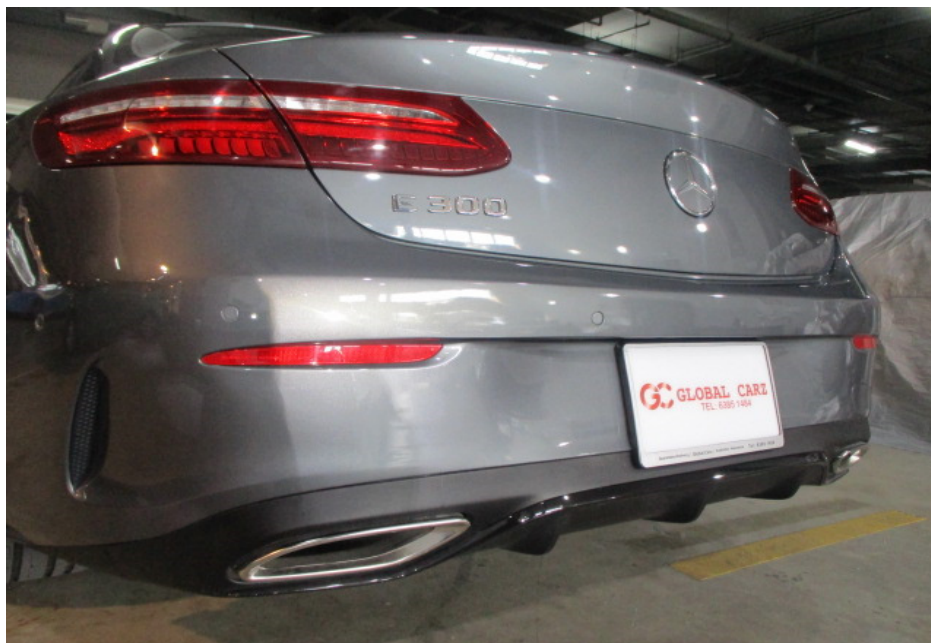
**Photo 8** shows a closer view of the Motor Car's rear bumper, rear bootlid and rear taillamp. The Motor Car was observed to be in a relatively good general condition with no loose exterior fittings observed. The body parts at the rear portion of the Motor Car were visually examined and it was observed that the repair/restoration works carried out to the damaged area of the Motor Car (refer to photograph 1 & 2 above) were reasonably adequate and in order.

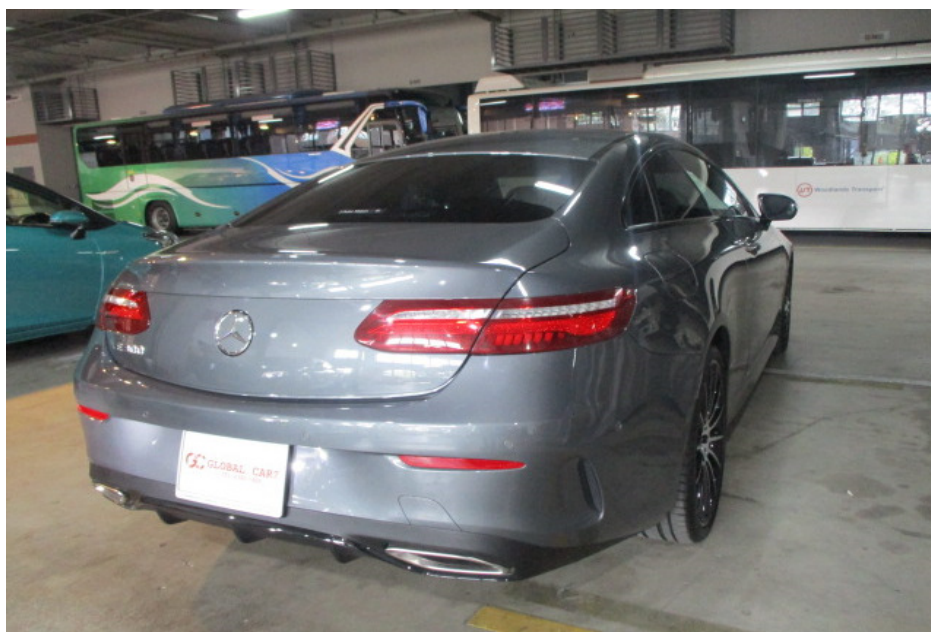
**Photo 9** shows a general view of the rear right body of the Motor Car at the time of my inspection. The Motor Car was observed to be in a relatively good general condition with no loose exterior fittings observed. The exterior body parts at the rear body of the Motor Car were visually examined and it was observed that the repair/restoration works carried out to the damaged area of the Motor Car (refer to photograph 1 & 2 above) were reasonably adequate and in order.

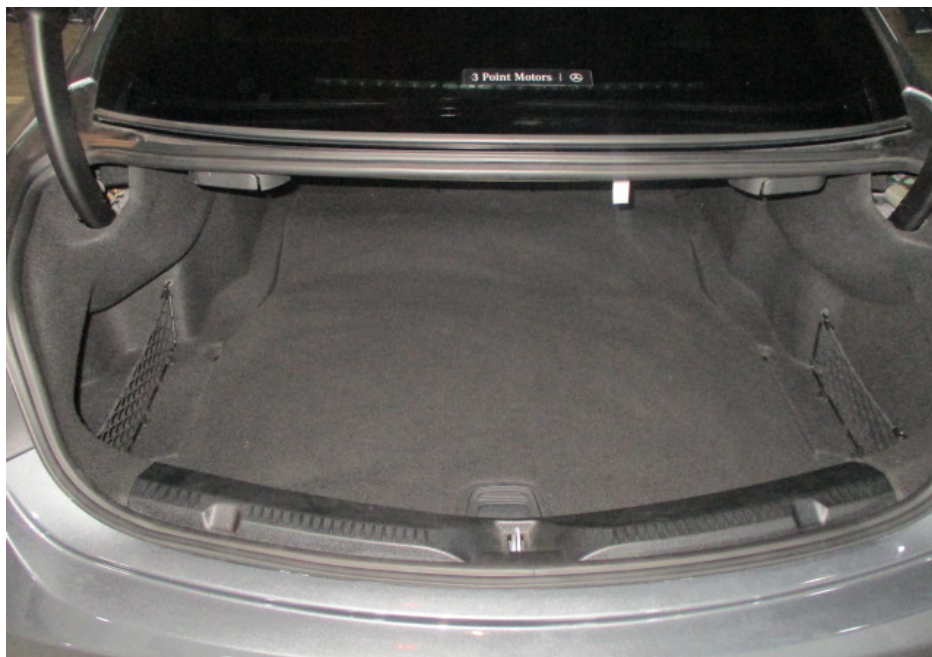
**Photo 10** shows a general view of the various inner trims within the rear boot compartment of the Motor Car at the time of my inspection. Parts within the rear boot compartment were visually examined and it was observed that the repair/restoration works carried out to the damaged area of the Motor Car (refer to photograph 1 & 2 above) were reasonably adequate and in order.

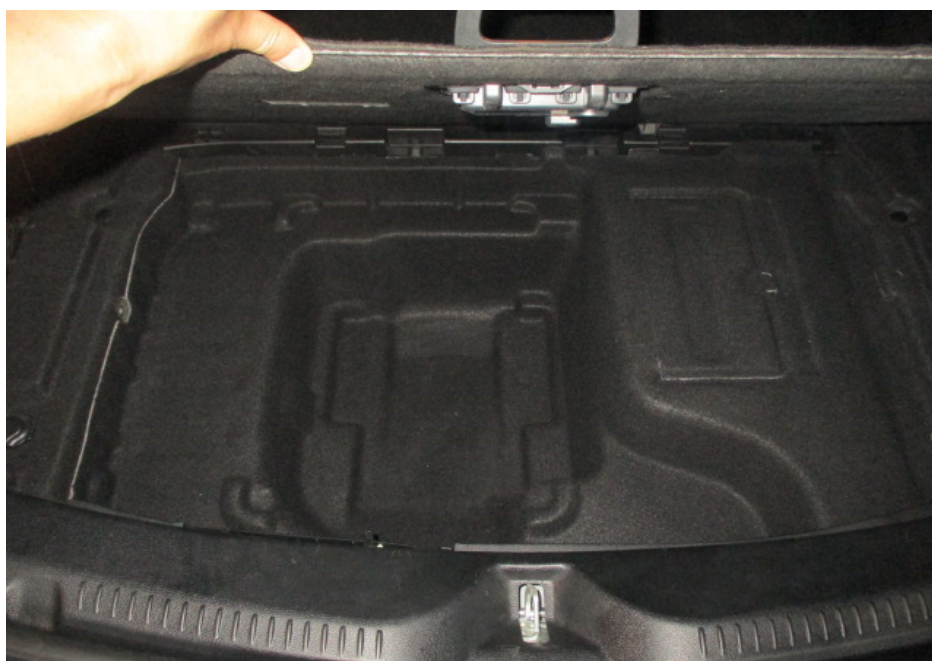
**Photo 11** shows the rear boot compartment of the Motor Car at the time of my inspection. Parts within the rear boot compartment were visually examined and it was observed that the repair/restoration works carried out to the damaged area of the Motor Car (refer photograph to 1 & 2 above) were reasonably adequate and in order.

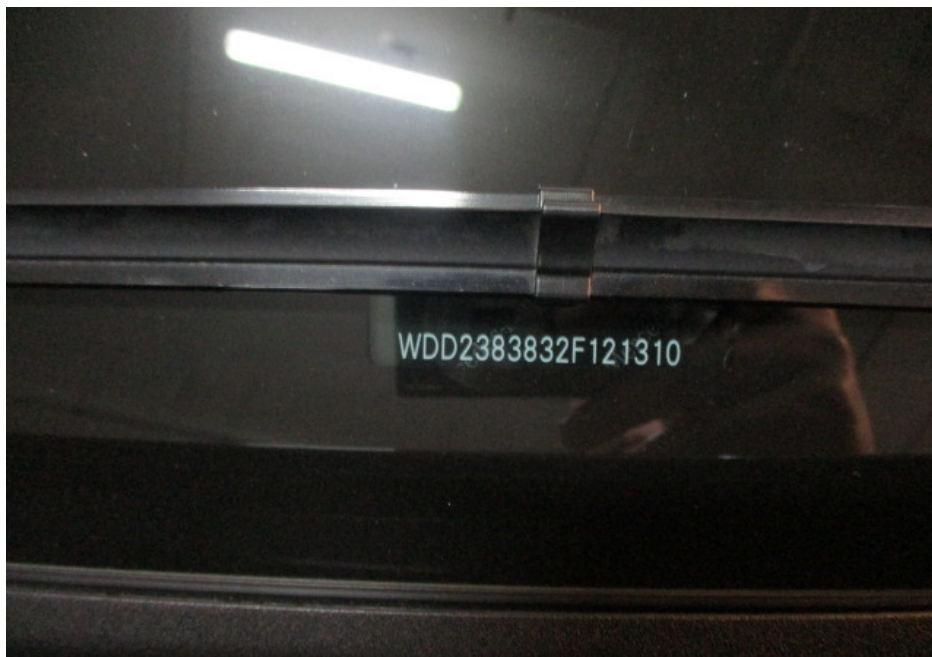
**Photo 12** shows the chassis number of the Motor Car. The chassis number recorded was WDD2383832F121310.

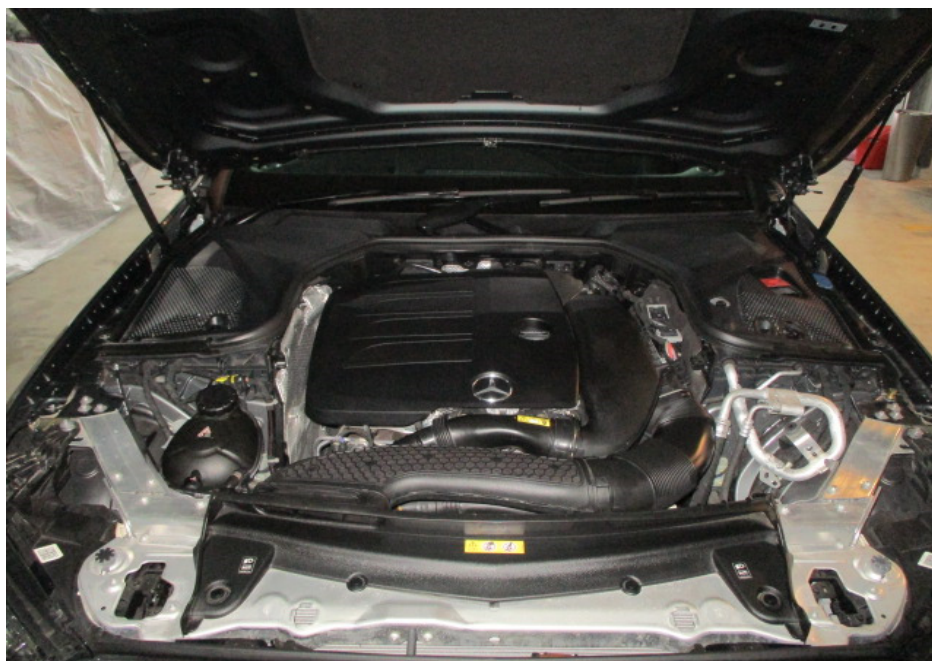
**Photo 13** shows a general view of the engine compartment of the Motor Car at the time of my inspection. The various parts and components inside the engine compartment were all observed to be intact and properly fitted. There was also no sign(s) or indication(s) of fluid leak and/or fluid stain found inside the engine compartment.

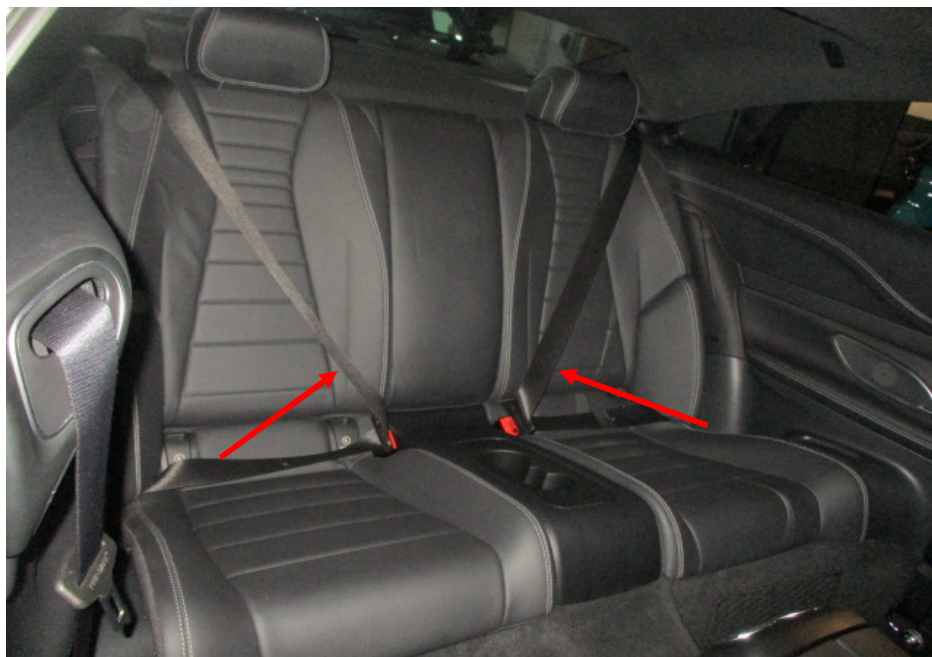
**Photo 14** shows the rear seats of the Motor Car. All the seats of the Motor Car were secured via seat rails to the floorboard. They were also fitted with a retractable seat belt reel and a pre-tensioner. The seat belts (arrowed) were tested and were able to be fastened into the respective pre-tensions that were fitted on the side of each individual seat.

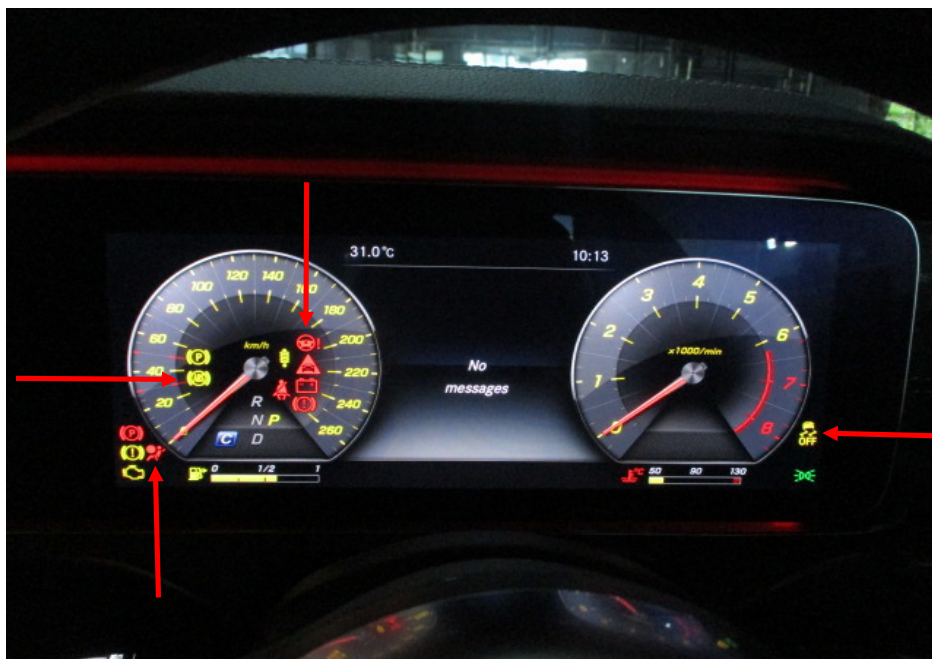
**Photo 15** shows the warning lights for the various electronic safety features appearing on the instrument panel of the Motor Car during its self-test when the engine is cranked, in particular the ABS, SRS, EPS and TCS lights (arrowed).

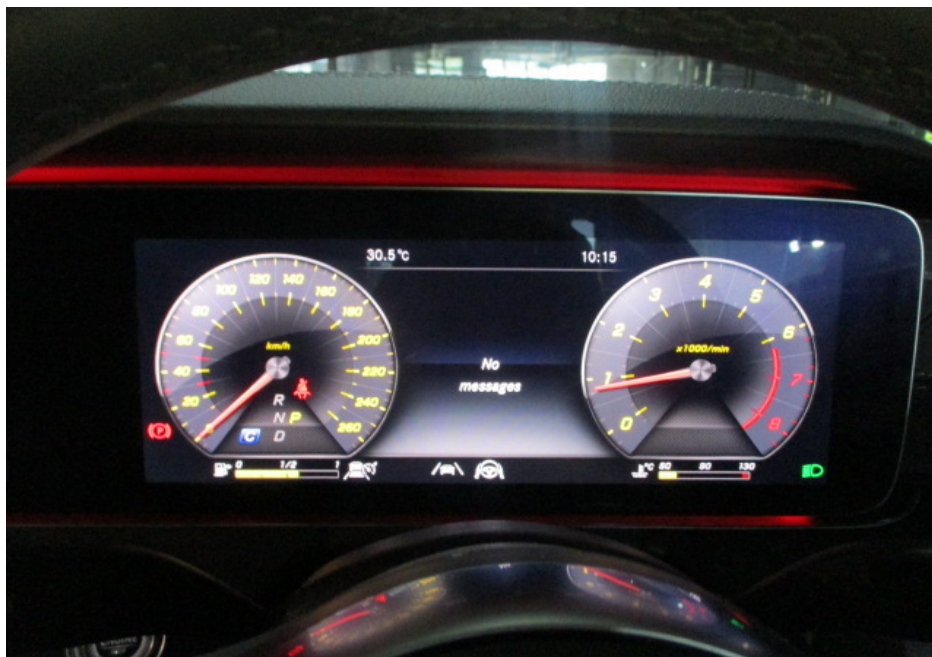
**Photo 16** shows the respective warning lights no longer illuminated, indicating that there is no fault detected to the ABS, SRS, EPS and TCS systems of the Motor Car during the self-test. These electronic systems were hence in working condition at the time of my inspection.

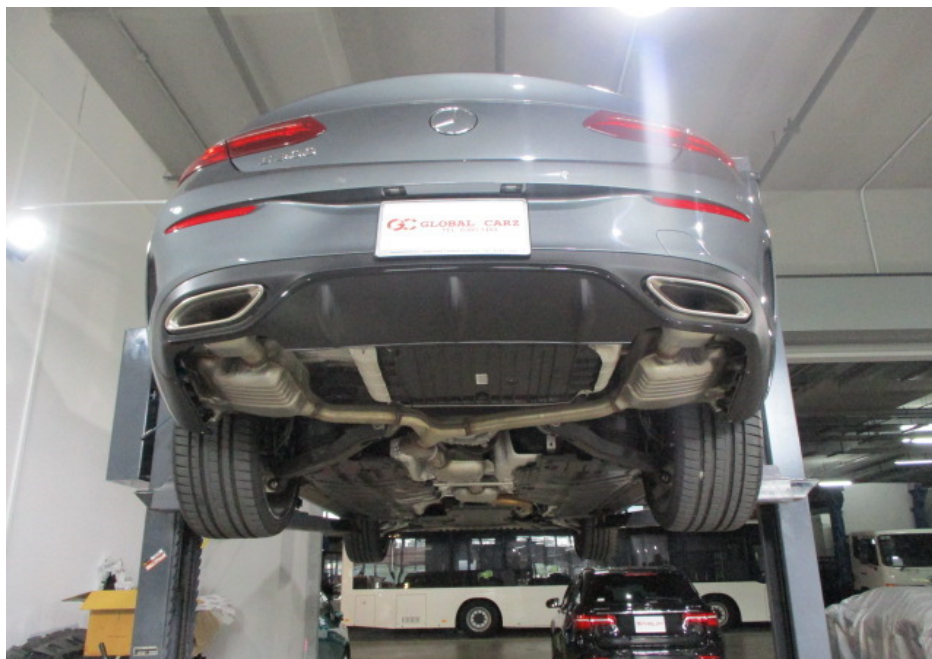
**Photo 17** shows the Motor Car hoisted up for checks on its undercarriage. There was no sign(s) or indication(s) of fluid leakage and/or fluid stain(s) on the underside of the Motor Car. The undercarriage components of the Motor Car were also all observed to be intact and secured in an appropriate manner.

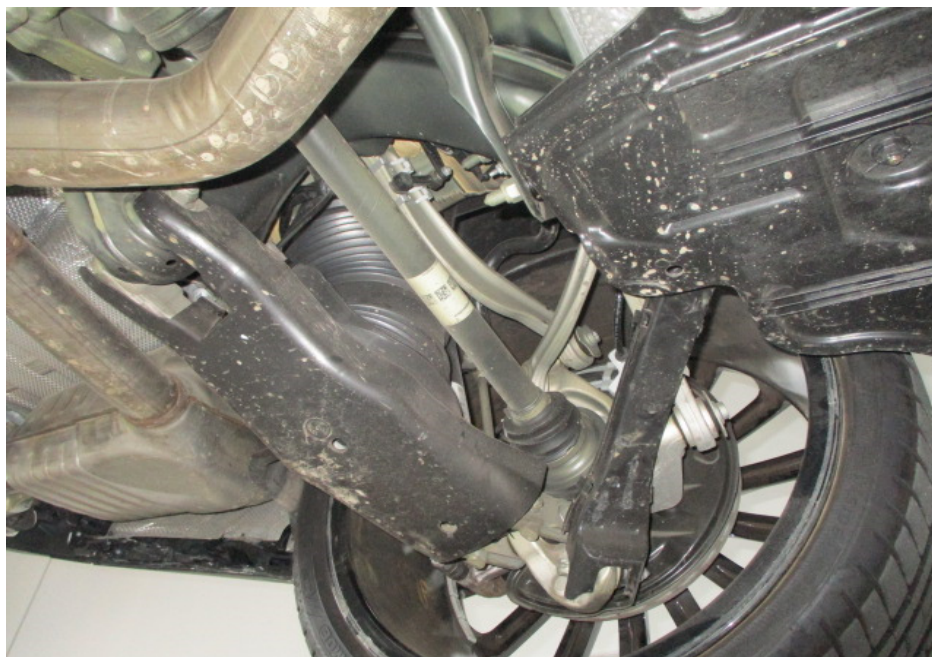
**Photo 18** shows a general view of the control arms and linkages at the rear left wheel of the Motor Car. I did not observe any fluid leak and/or fluid stain on the underside of the Motor Car. All the Motor Car's undercarriage components were observed to be intact and secured in an appropriate manner.

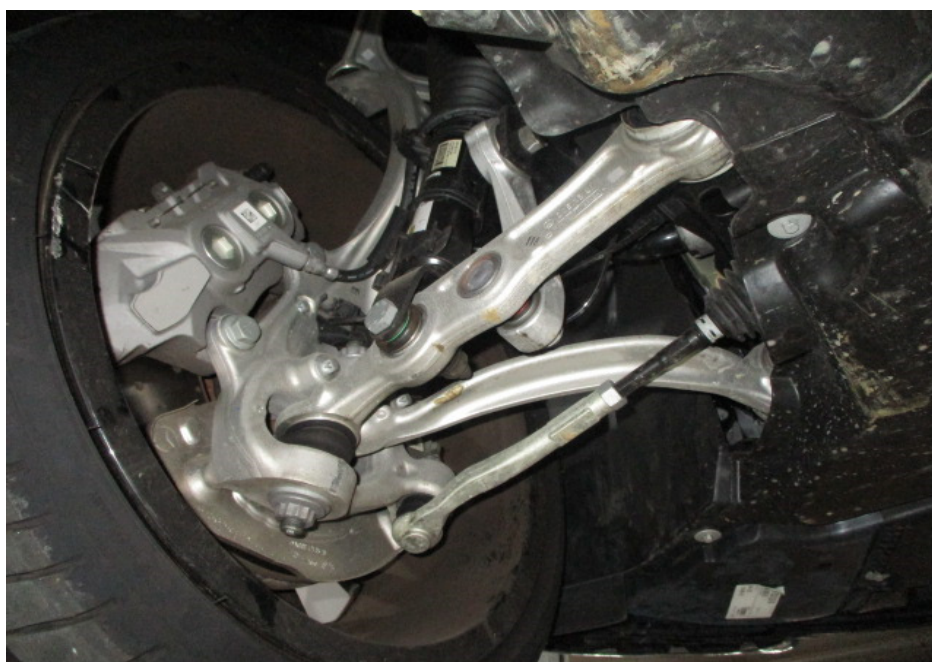
**Photo 19** shows the various undercarriage components at the front left wheel of the Motor Car. The mechanical components, control arms and linkages were all found to be intact and secured in an appropriate manner.

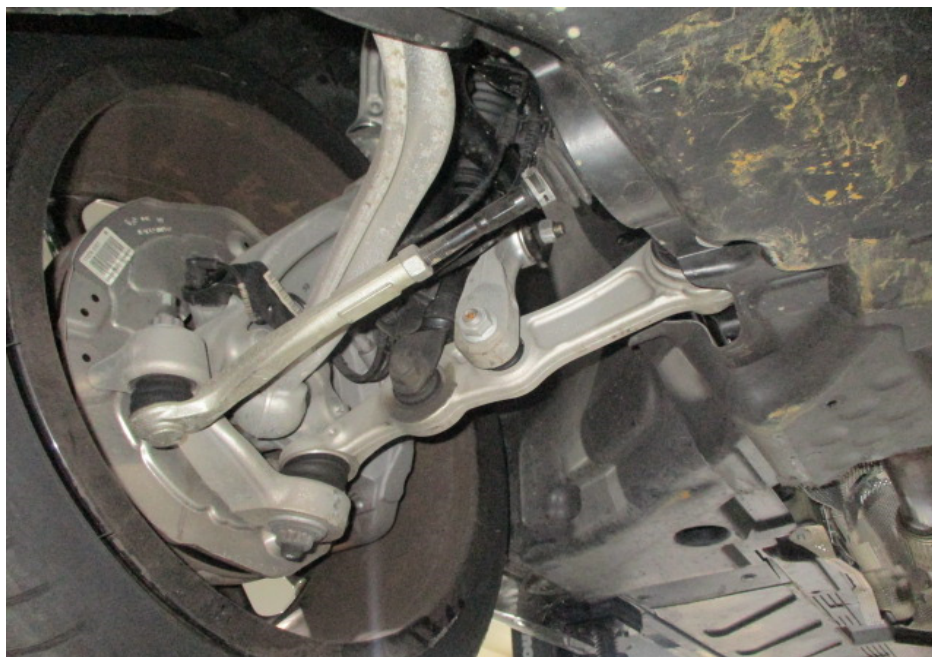
**Photo 20** shows the various undercarriage components at the front right wheel of the Motor Car. The mechanical components, control arms and linkages were all found to be intact and secured in an appropriate manner. I also did not observe any fluid leak and/or fluid stain on the underside of the Motor Car.

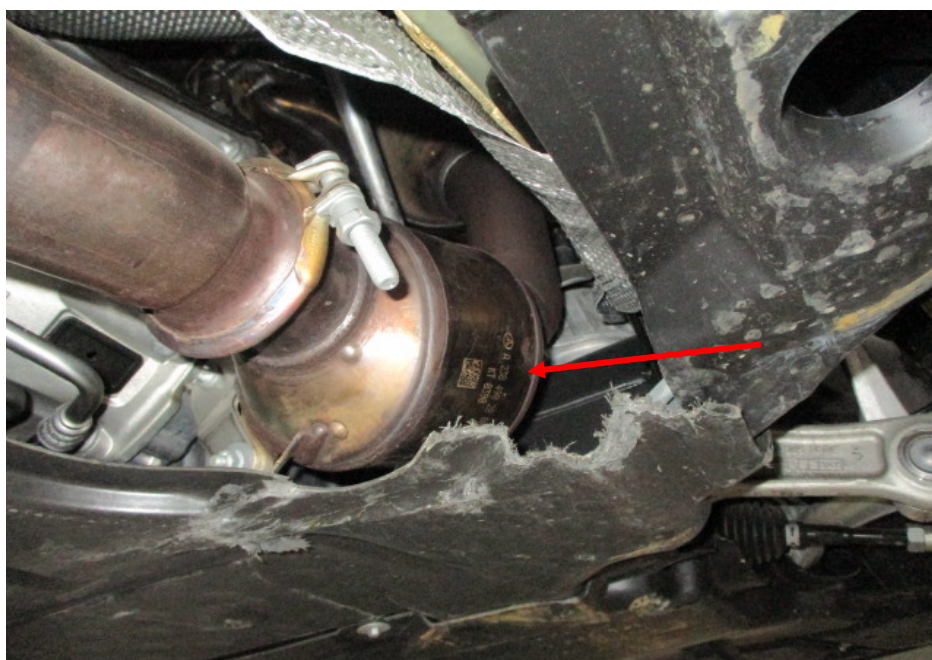
**Photo 21** shows the Motor Car's catalytic converter (arrowed). My examination of the Motor Car's exhaust system revealed no sign(s) or indication(s) of any cut or weld marks along its exhaust pipes and on its rear mufflers.

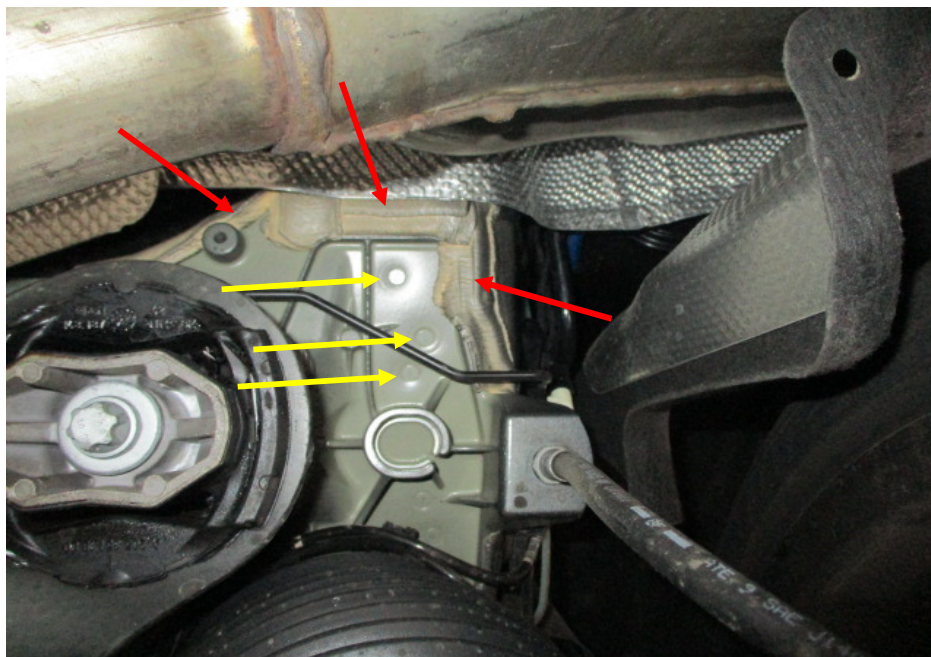
**Photo 22** shows the chassis/structural body at the underside rear right of the Motor Car. I did not find any weld marks other than original spot weld marks (yellow arrow) on the chassis/structural body of the Motor Car. The original factory sealant (red arrow) at the joints along the chassis/structural body was untouched, indicating no work was done on the chassis/structural body of the Motor Car and that the chassis/structural body was originally fitted.

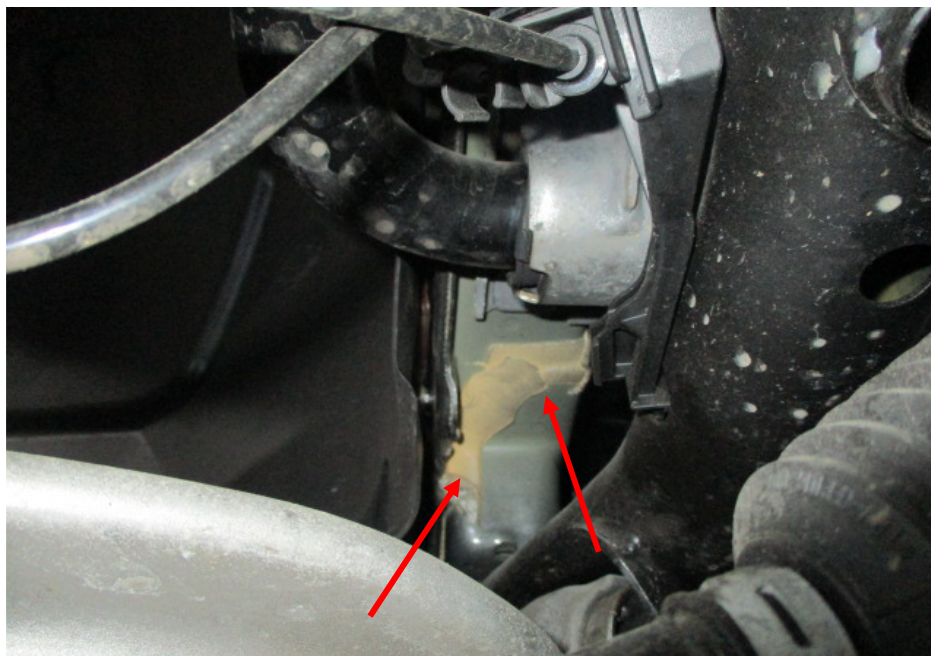
**Photo 23** shows the chassis/structural body at the underside front left of the Motor Car. The original factory sealant (arrowed) at the joints along the chassis/structural body was observed to be untouched. In general, I had found no work was carried out on the chassis/structural body of the Motor Car. The chassis/structural body of the Motor Car was originally fitted.

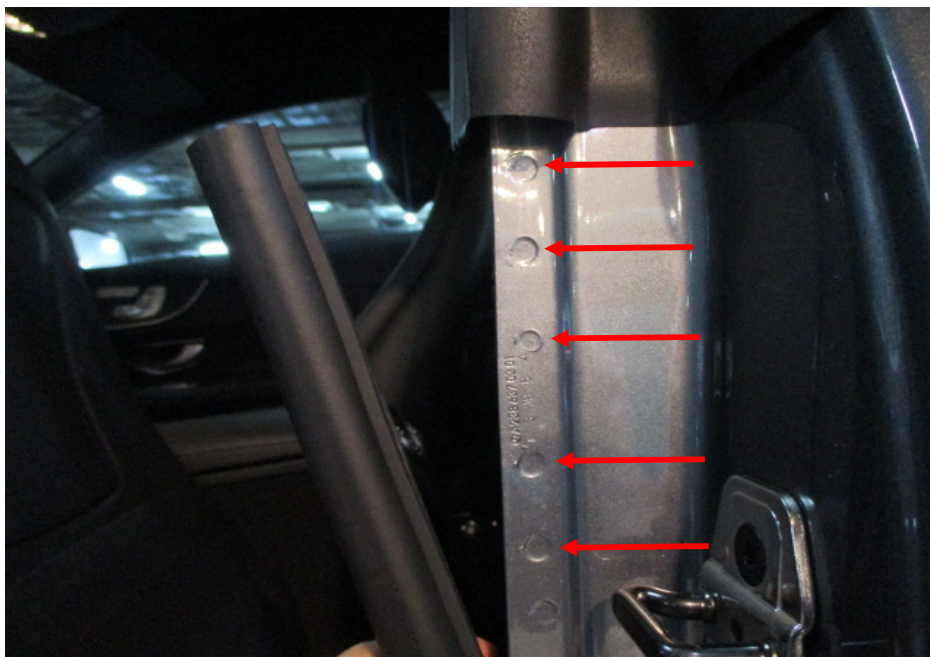
**Photo 24** shows the left side rear body panel of the Motor Car. I did not find any weld marks other than original spot weld marks (arrowed) on the left side rear body panel of the Motor Car which, indicates that there was no re-welding works carried out. In general, I had found all the non-detachable body panels of the Motor Car to be originally fitted at the time of my inspection.
