Your Ref: Mercedes Benz GLC 63s  
(chassis number WDC2539892F427299)  
Our Ref : CI/TP21003318/D

14 March 2021

**INSPECTION REPORT OF AN UNREGISTERD MERCEDES BENZ GLC 63s  
MOTOR CAR WITH CHASSIS NUMBER WDC2539892F427299**

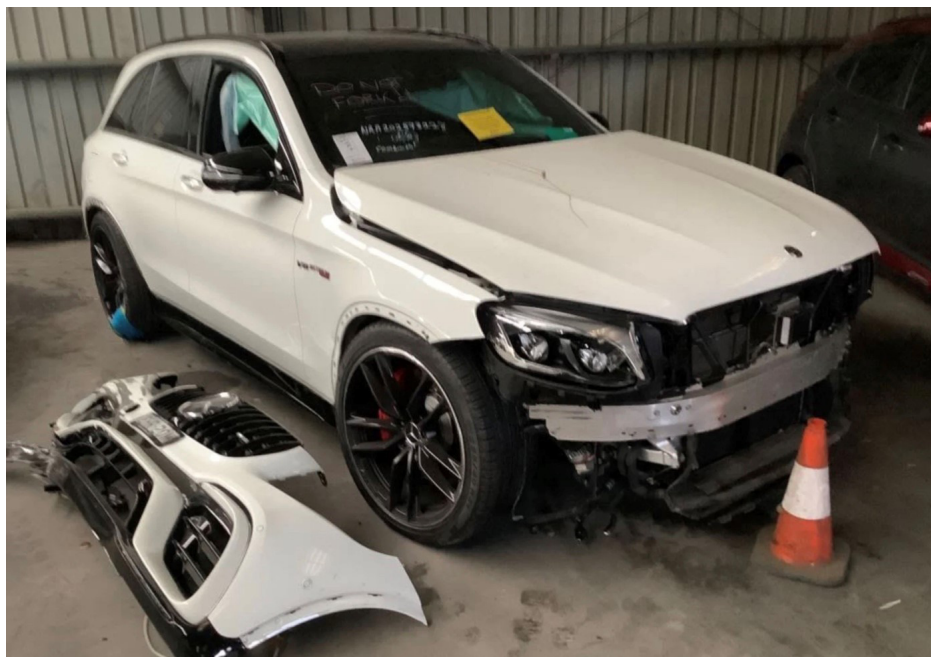
**Photo 1** shows the front right body of the Motor Car (photograph provided to me). The Motor Car was observed to have sustained damage at its front right portion. Body parts damaged include the front bumper, front bumper right lower grille, front bumper centre lower grille, front bumper lower lip, front bumper reinforcement, front right headlamp, front bonnet, front right fender, front right fender inner shield and front right fender wheel arc garnish amongst others.

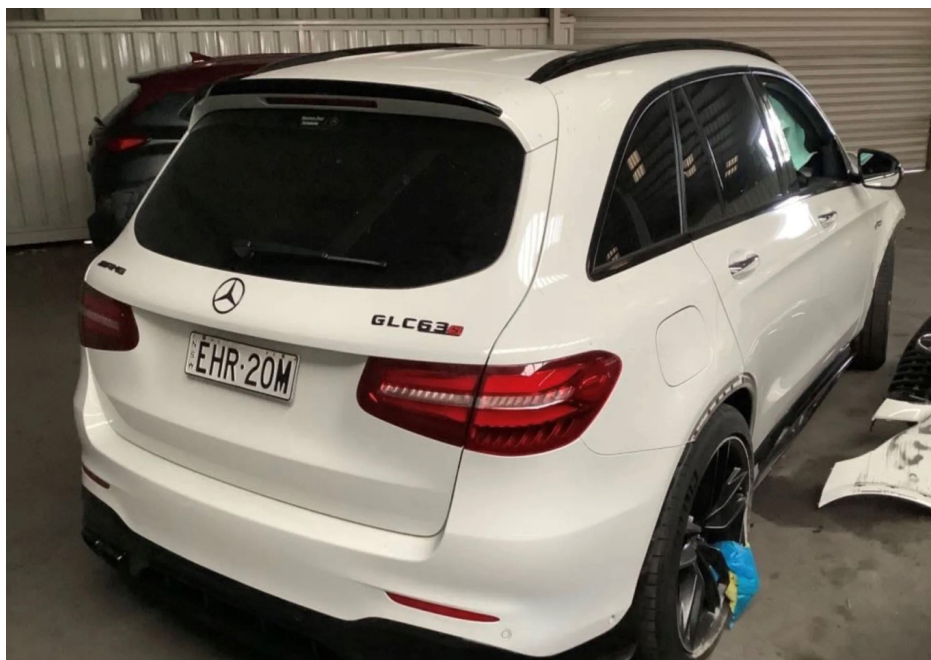
**Photo 2** shows the rear right body of the Motor Car (photograph provided to me). Damage was seen to the rear right wheel rim. The rear right fender wheel arc garnish was observed to be either dislodged, removed or damaged.

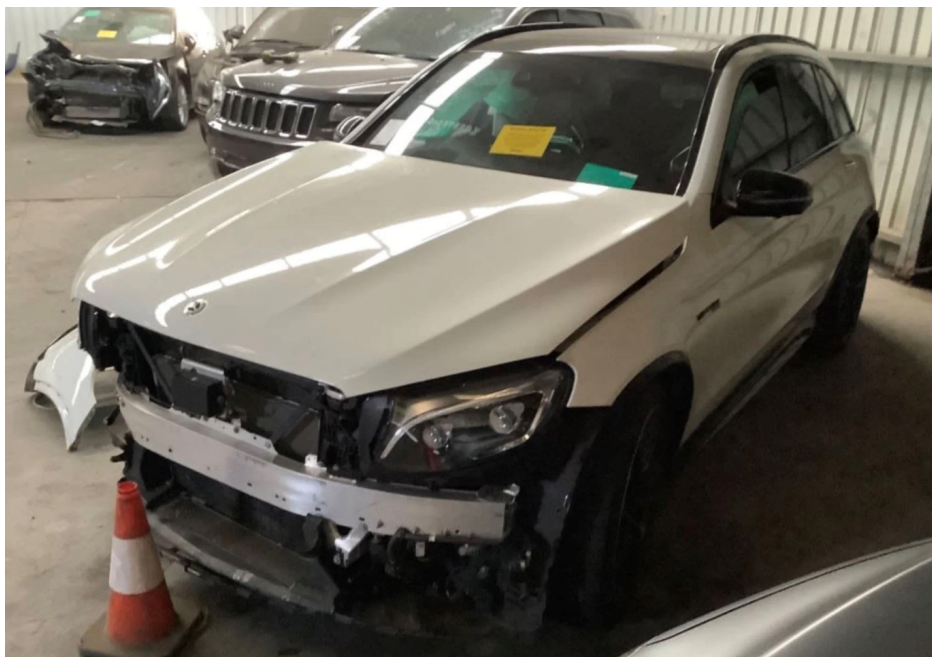
**Photo 3** shows the front left body of the Motor Car (photograph provided to me). The left portion of the Motor Car appears to be without any damage as seen from the photograph that were provided to me.

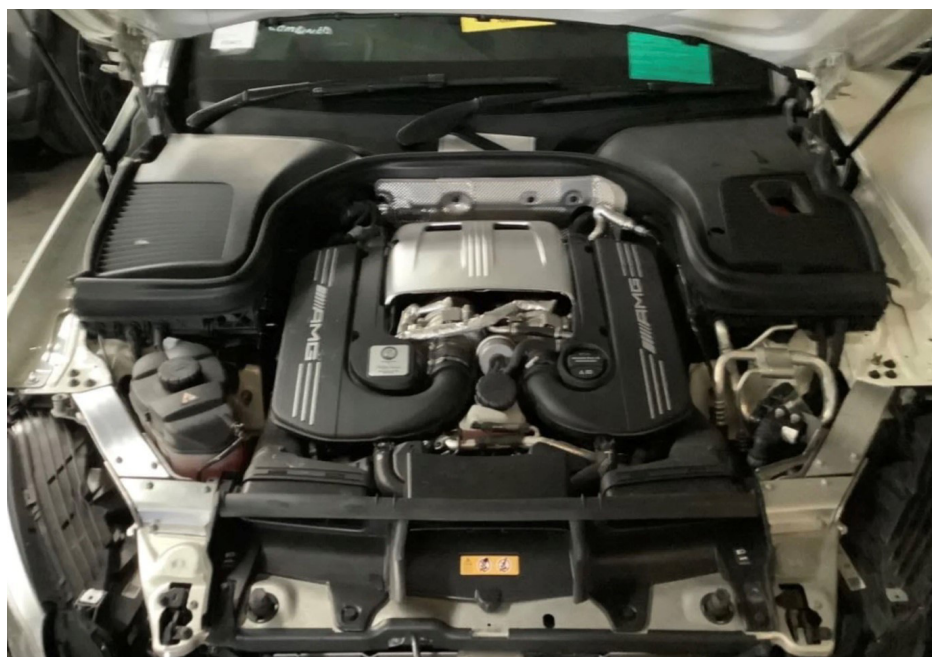
**Photo 3** shows the engine compartment of the Motor Car (photograph provided to me). Parts within the engine compartment were unaffected.

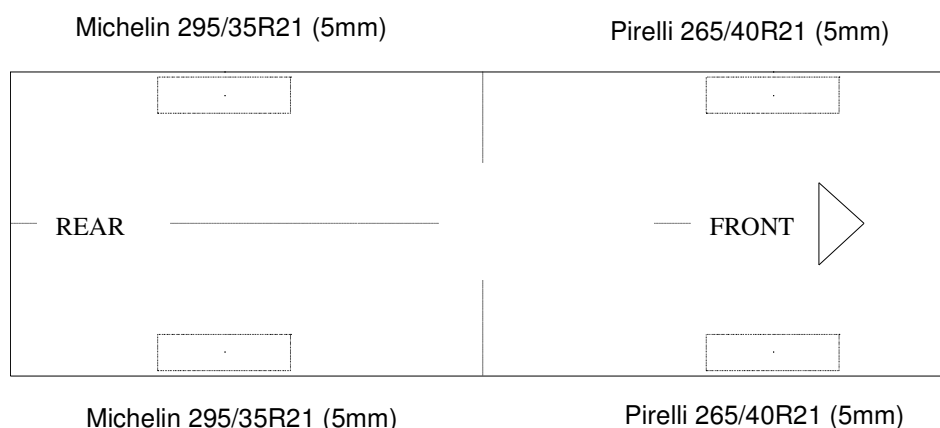
8. It was fitted with 21inch sport wheel rims that were wrapped with tyres that were observed to be of serviceable condition. The tyres were also sufficiently inflated for vehicular operation. The tyre brand, tyre size and approximate remaining tread depth of the 4 tyres of the Motor Car were recorded as follows: -

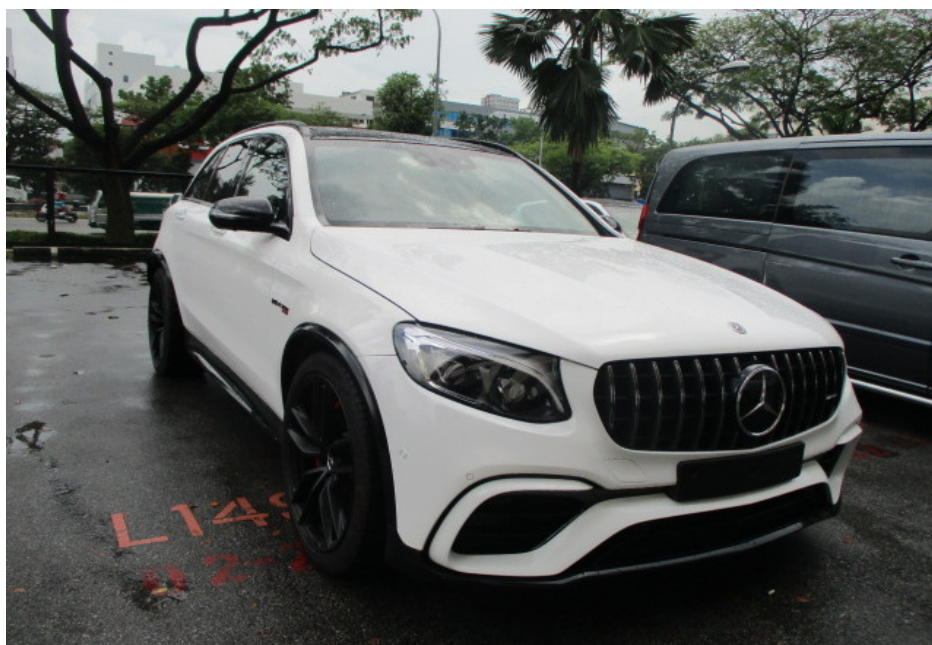
**Photo 5** shows a general view of the front right body of the Motor Car at the time of my inspection. The Motor Car was observed to be in a relatively good general condition with no loose exterior fittings observed. The body parts at the front right portion of the Motor Car were visually examined and it was observed that the repair/restoration works carried out to the damaged area of the Motor Car (refer to photograph 1 above) were reasonably adequate and in order.

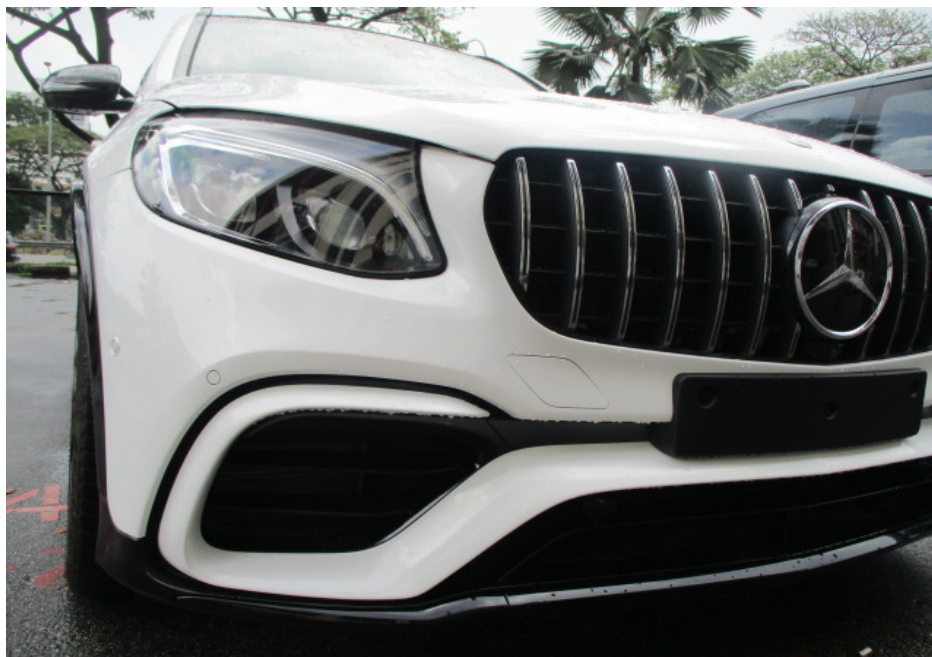
**Photo 6** shows a closer view of the Motor Car's front bumper, front bumper right lower grille, front bumper lower lip and front right headlamp. The body parts at the front right portion of the Motor Car were visually examined and it was observed that the repair/restoration works carried out to the damaged area of the Motor Car (refer to photograph 1 above) were reasonably adequate and in order.

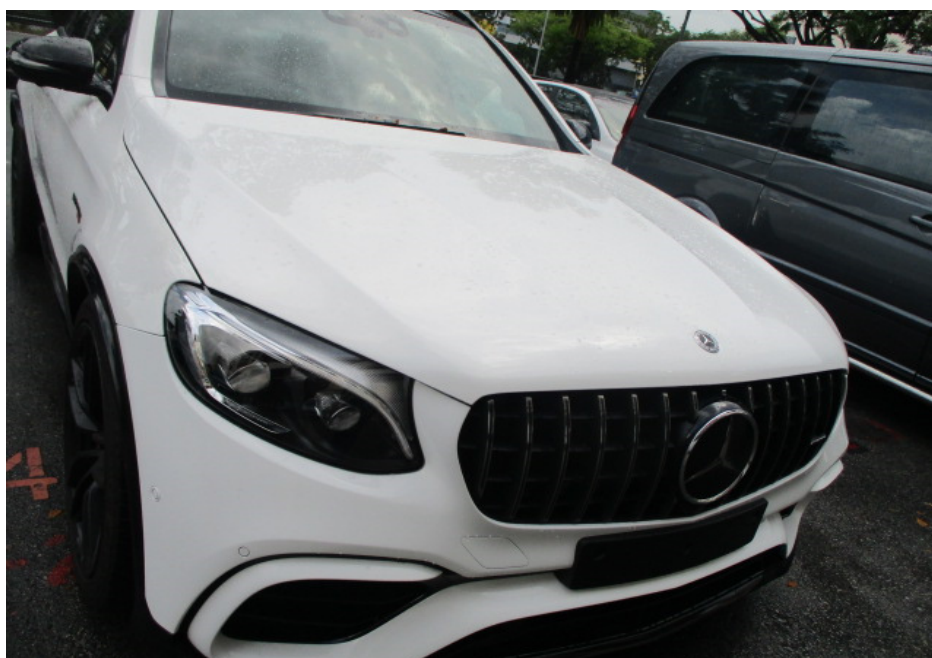
**Photo 7** shows a closer view of the front bonnet, front right headlamp and front right fender of the Motor Car at the time of my inspection. The body parts at the front right portion of the Motor Car were visually examined and it was observed that the repair/restoration works carried out to the damaged area of the Motor Car (refer to photograph 1 above) were reasonably adequate and in order.

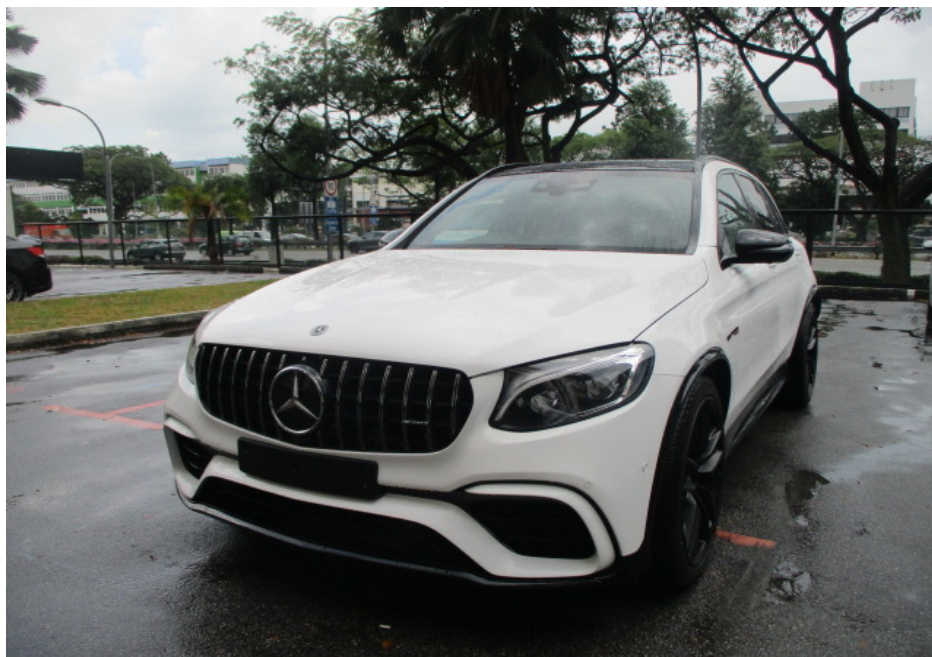
**Photo 8** shows a general view of the front left body of the Motor Car at the time of my inspection. The Motor Car was observed to be in a relatively good general condition with no loose exterior fittings observed. The mileage of the Motor Car recorded at the time of my inspection was 31,247km.

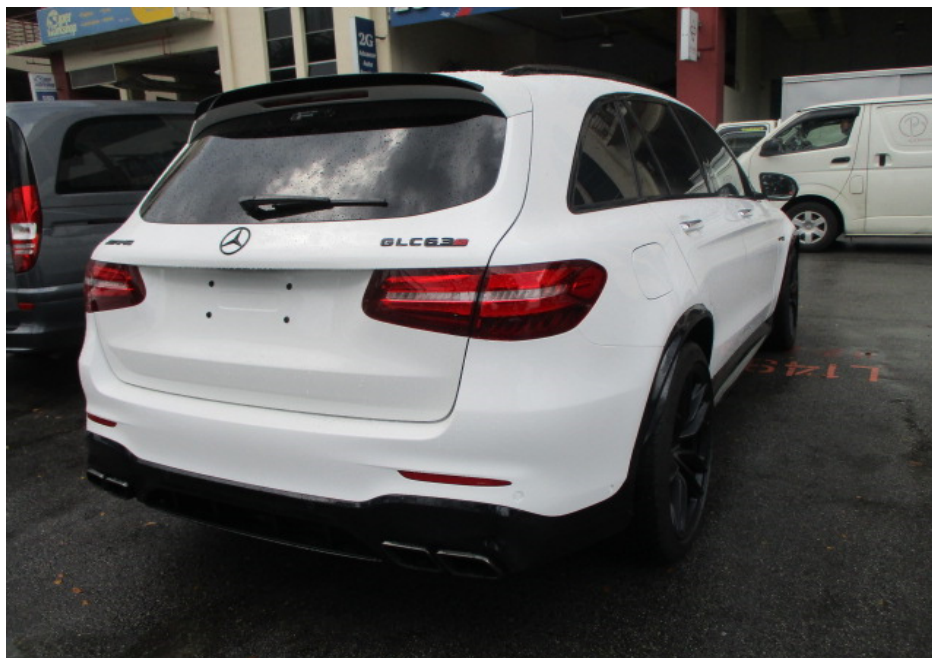
**Photo 9** shows a general view of the rear right body of the Motor Car at the time of my inspection. The damaged parts at the rear right portion of the Motor Car, in particular the rear right wheel rim and rear right fender wheel arc garnish were visually examined, and it was observed that the repair/restoration works carried out to the damaged area of the Motor Car (refer to photograph 2 above) were reasonably adequate and in order.

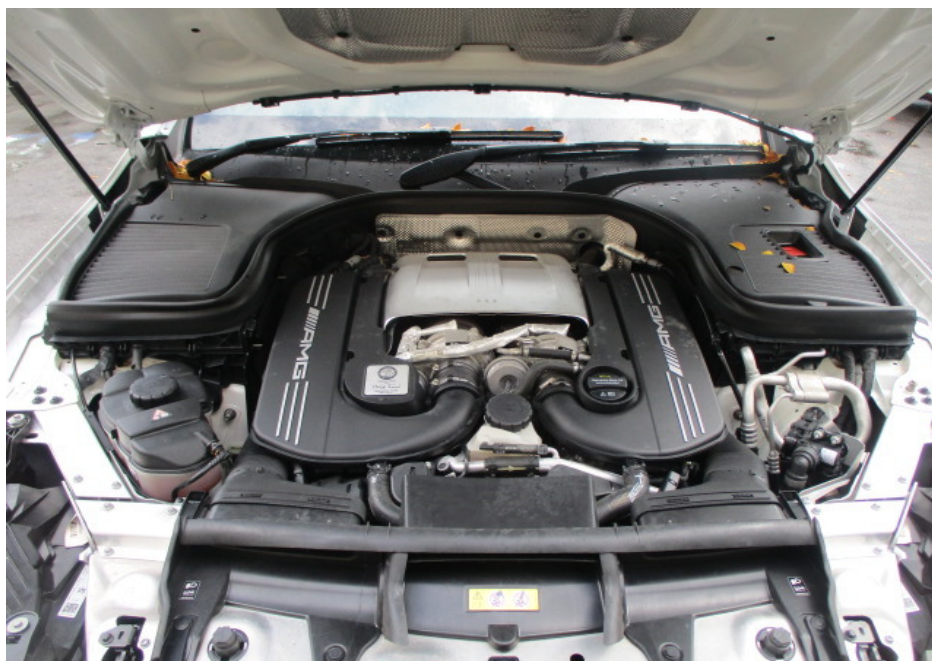
**Photo 11** shows a general view of the engine compartment of the Motor Car at the time of my inspection. The various parts and components inside the engine compartment were all observed to be intact and properly fitted. There was also no sign(s) or indication(s) of fluid leak and/or fluid stain found inside the engine compartment.

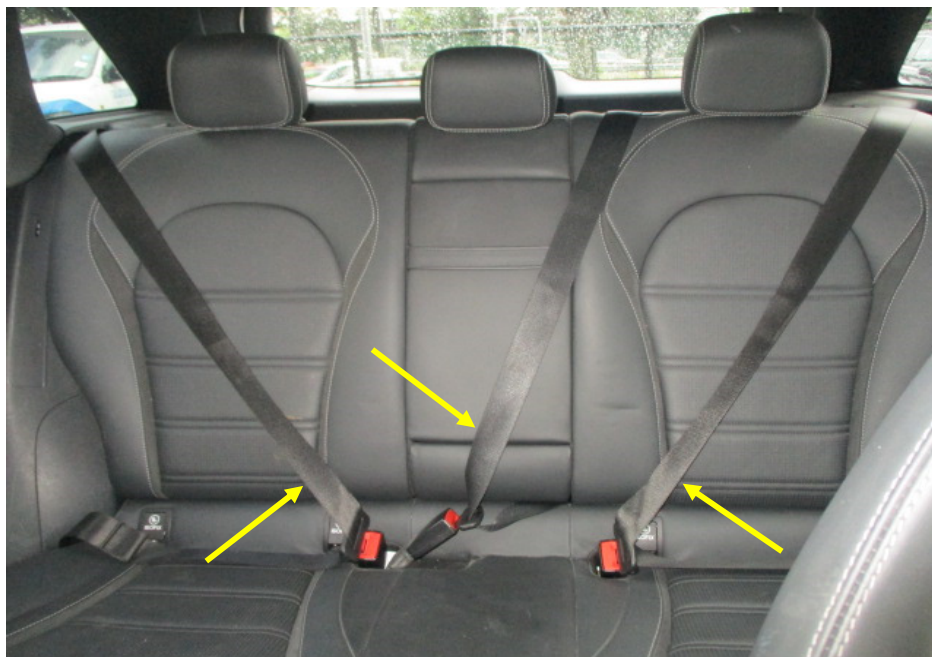
**Photo 12** shows the rear seats of the Motor Car. All the seats of the Motor Car were secured via seat rails to the floorboard. They were also fitted with a retractable seat belt reel and a pre-tensioner. The seat belts (arrowed) were tested and were able to be fastened into the respective pre-tensions that were fitted on the side of each individual seat.

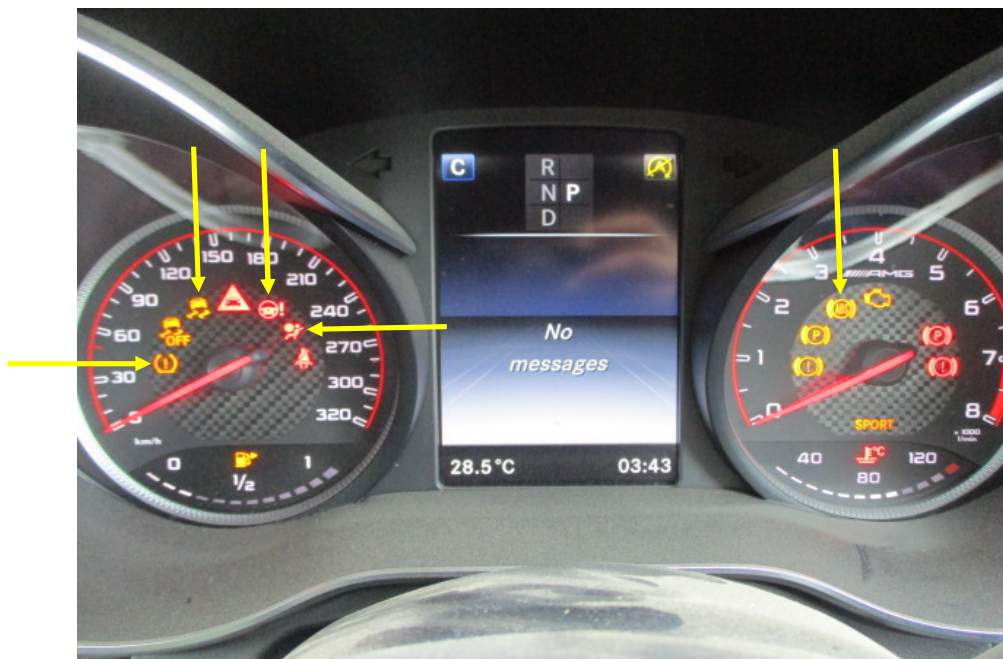
**Photo 13** shows the warning lights for the various electronic safety features appearing on the instrument panel of the Motor Car during its self-test when the engine is cranked, in particular the ABS, SRS, EPS, TPM and TCS lights (arrowed).

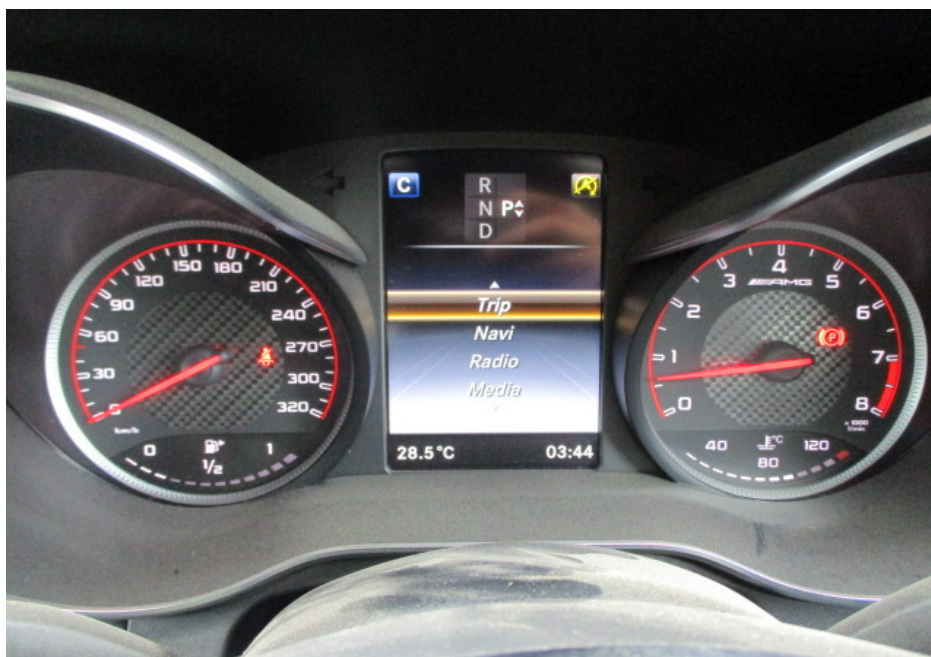
**Photo 14** shows the respective warning lights no longer illuminated, indicating that there is no fault detected to the ABS, SRS, EPS, TPM and TCS systems of the Motor Car during the self-test. These electronic systems were hence in working condition at the time of my inspection.

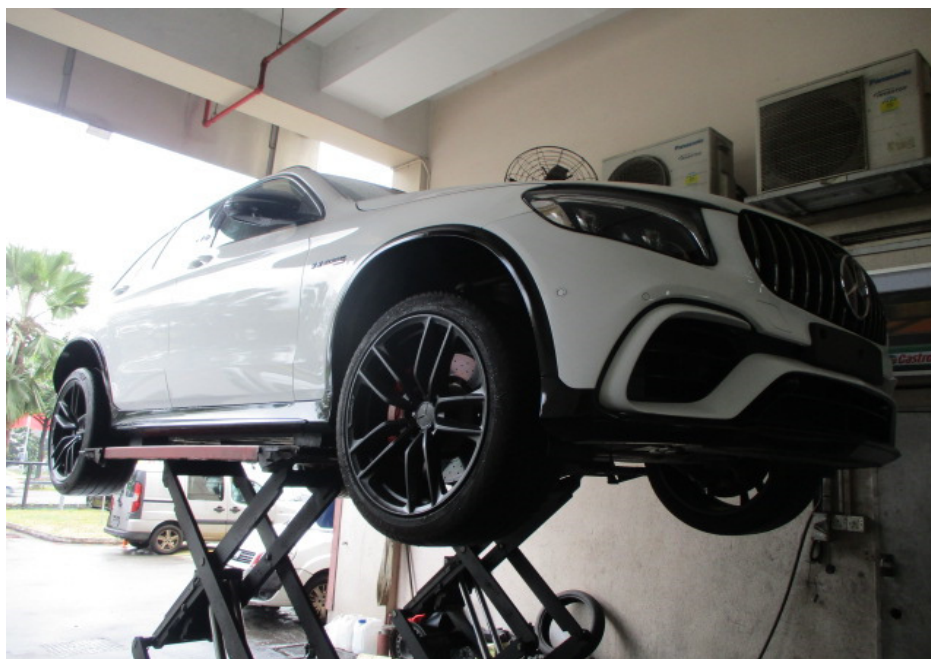
**Photo 15** shows the Motor Car hoisted up for checks on its undercarriage. There was no sign(s) or indication(s) of fluid leakage and/or fluid stain(s) on the underside of the Motor Car. The undercarriage components of the Motor Car were also all observed to be intact and secured in an appropriate manner.

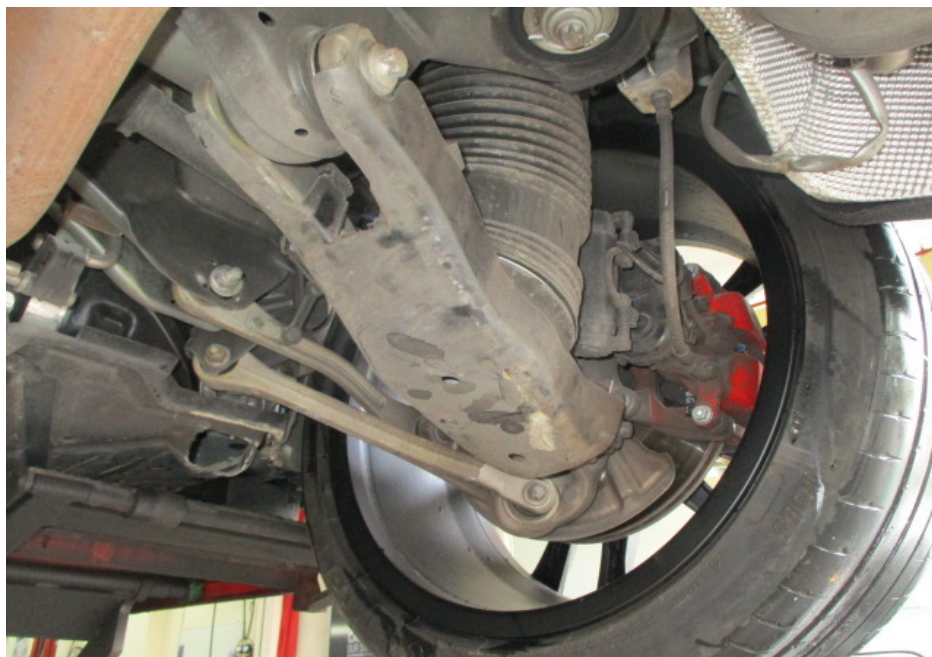
**Photo 16** shows a general view of the control arms and linkages at the rear right wheel of the Motor Car. I did not observe any fluid leak and/or fluid stain on the underside of the Motor Car. All of the Motor Car's undercarriage components were observed to be intact and secured in an appropriate manner.

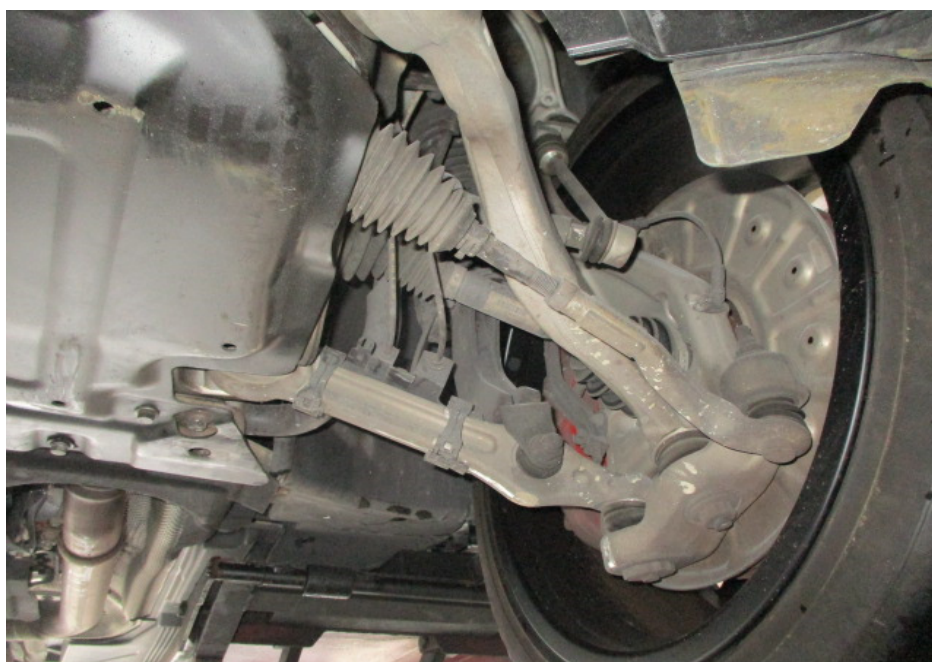
**Photo 17** shows the various undercarriage components at the front left wheel of the Motor Car. The mechanical components, control arms and linkages were all found to be intact and secured in an appropriate manner.

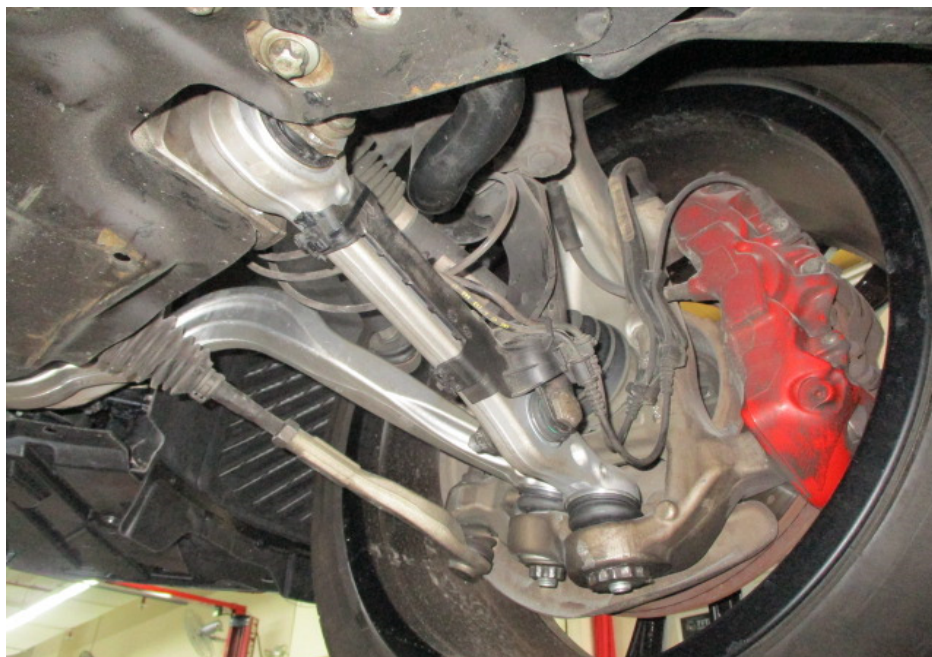
**Photo 18** shows the various undercarriage components at the front right wheel of the Motor Car. The mechanical components, control arms and linkages were all found to be intact and secured in an appropriate manner. I also did not observe any fluid leak and/or fluid stain on the underside of the Motor Car.

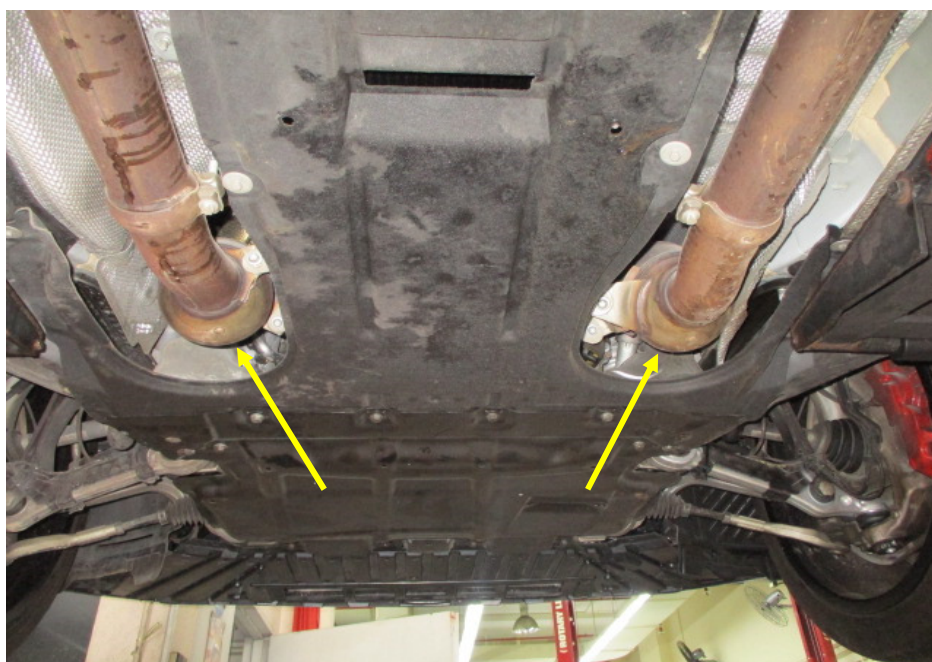
**Photo 19** shows the Motor Car's catalytic converters (arrowed). My examination of the Motor Car's exhaust system revealed no sign(s) or indication(s) of any cut or weld marks along its exhaust pipes and on its mufflers.

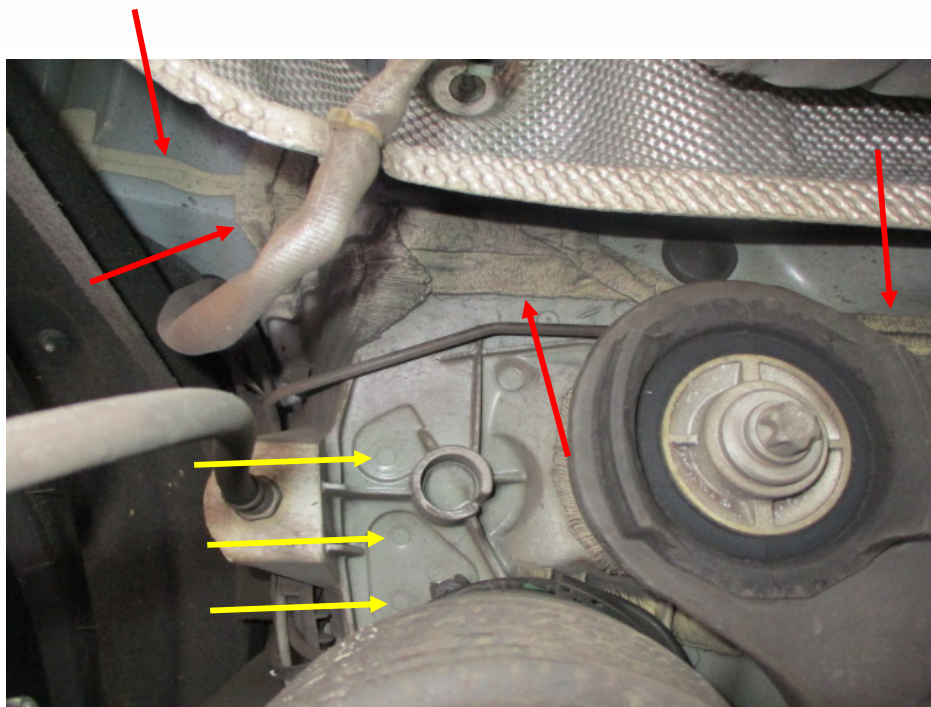
**Photo 20** shows the chassis/structural body at the underside rear left of the Motor Car. I did not find any weld marks other than original spot weld marks (yellow arrow) on the chassis/structural body of the Motor Car. The original factory sealant (red arrow) at the joints along the chassis/structural body was untouched, indicating no work was done on the chassis/structural body of the Motor Car and that the chassis/structural body was originally fitted.

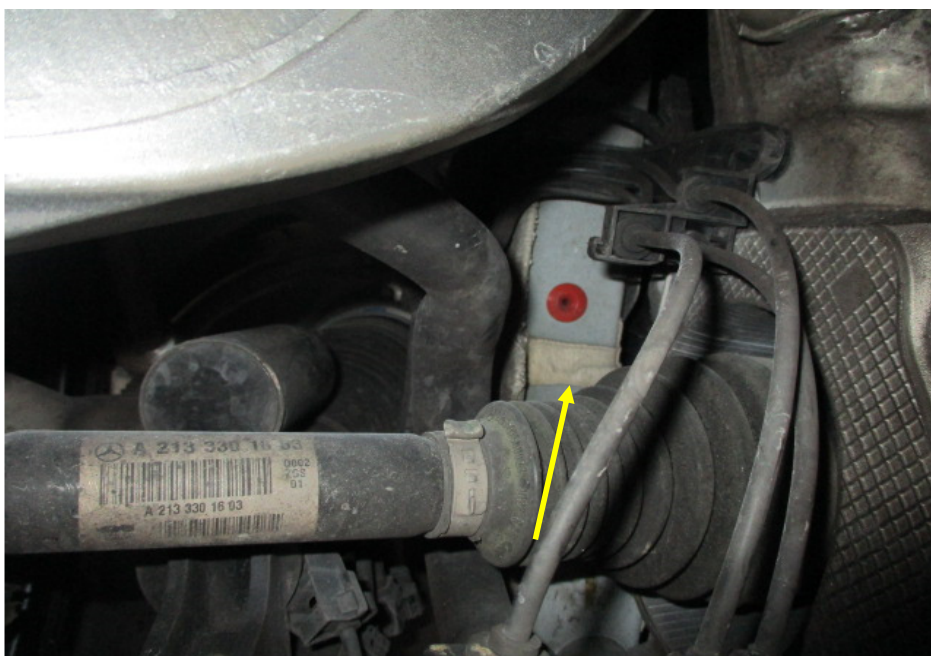
**Photo 21** shows the chassis/structural body at the underside front right of the Motor Car. The original factory sealant (arrowed) at the joints along the chassis/structural body was observed to be untouched. In general, I had found no work was carried out on the chassis/structural body of the Motor Car. The chassis/structural body of the Motor Car was originally fitted.

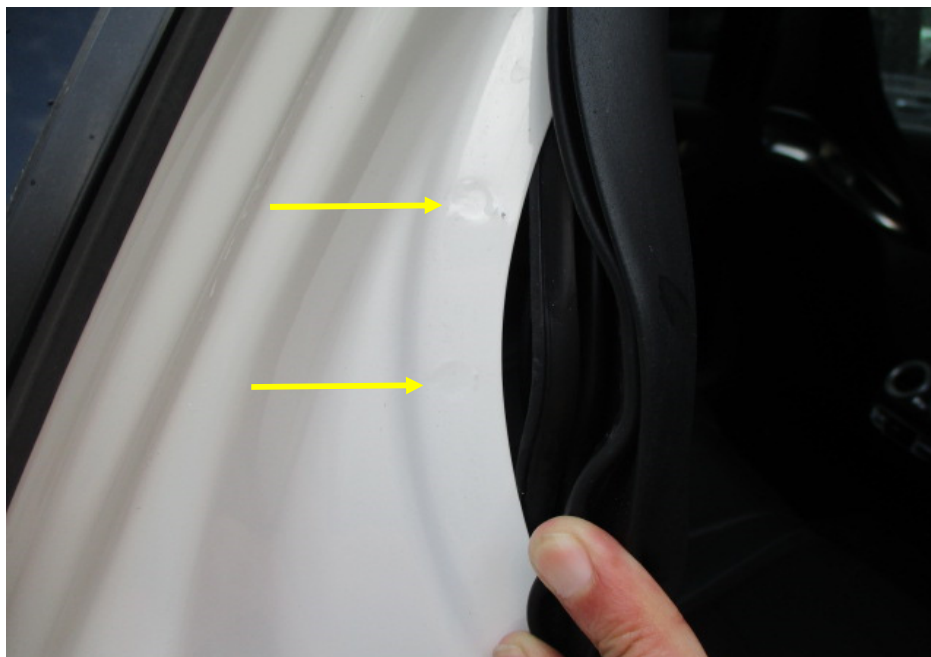
**Photo 22** shows the right side "C" pillar of the Motor Car. I did not find any weld marks other than original spot weld marks (arrowed) on the right side "C" pillar of the Motor Car which, indicates that there was no re-welding works carried out. In general, I had found all the non-detachable body panels of the Motor Car to be originally fitted at the time of my inspection.
