# Precise Appraiser Pte Ltd

## VEHICLE DAMAGE ASSESSMENT REPORT

| Ref No | : 2020/0140 | Date of Report | : 13/8/2020 |
| Third party vehicle | : SMC8312C | Date of Accident | : 12/8/2020 |

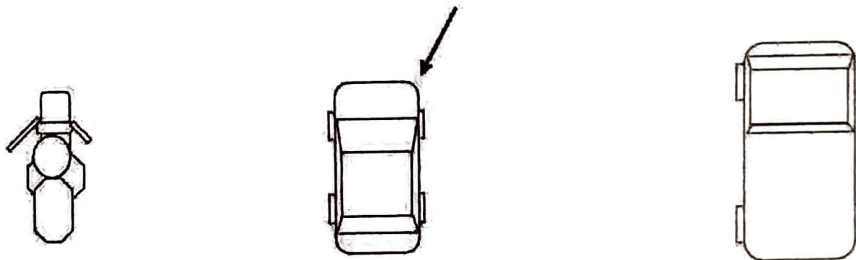
At the time of inspection, this vehicle sustained damages to the **Front Rh Portion**.

Front bumper deformed/ deep cut, front rh fender warp, bonnet dented, rh headlamp grazed etc.
