Your Ref: Mercedes Benz E300
(chassis number WDD2130482A454788)
Our Ref : CI/TP21003429/D

17 March 2021

**INSPECTION REPORT OF AN UNREGISTERD MERCEDES BENZ E300
MOTOR CAR WITH CHASSIS NUMBER WDD2130482A454788**

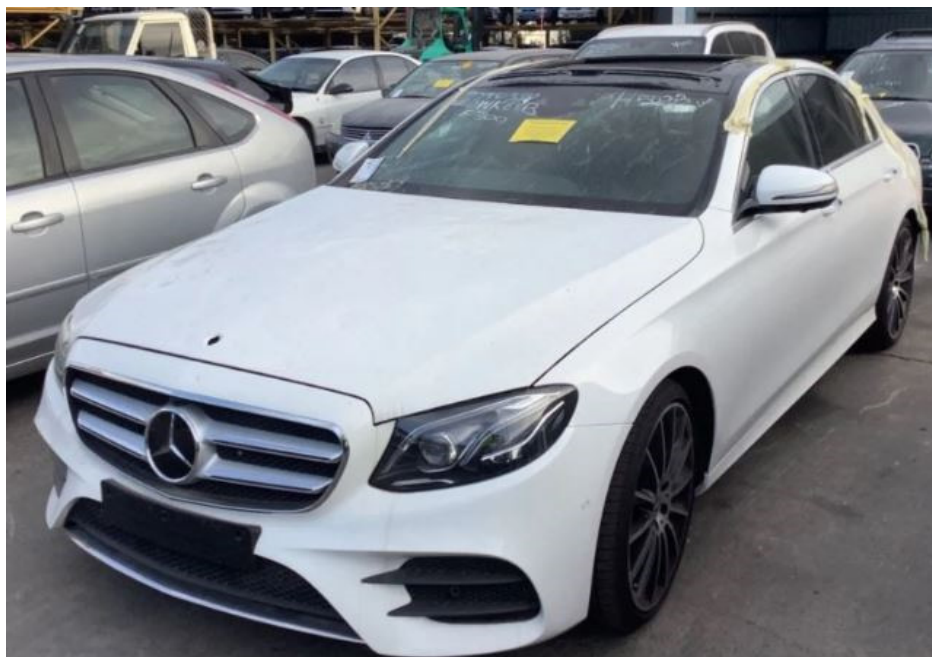
3. The photographs provided to me had showed damage of indentation nature to multiple exterior body parts of the Motor Car. The indentations were observed to be relatively minor and had affected exterior body parts like the front bonnet and rear bootlid amongst others. The rear windscreen glass, panoramic sunroof and rear right taillamp were also observed to be broken. See photo 1 – 4 below.

Photo 1 shows the front left body of the Motor Car prior to any repairs being carried out (photograph provided to me). The Motor Car was observed to have sustained damages of indentation nature to multiple exterior body parts like its front bonnet. The panoramic sunroof was also observed to be damaged.

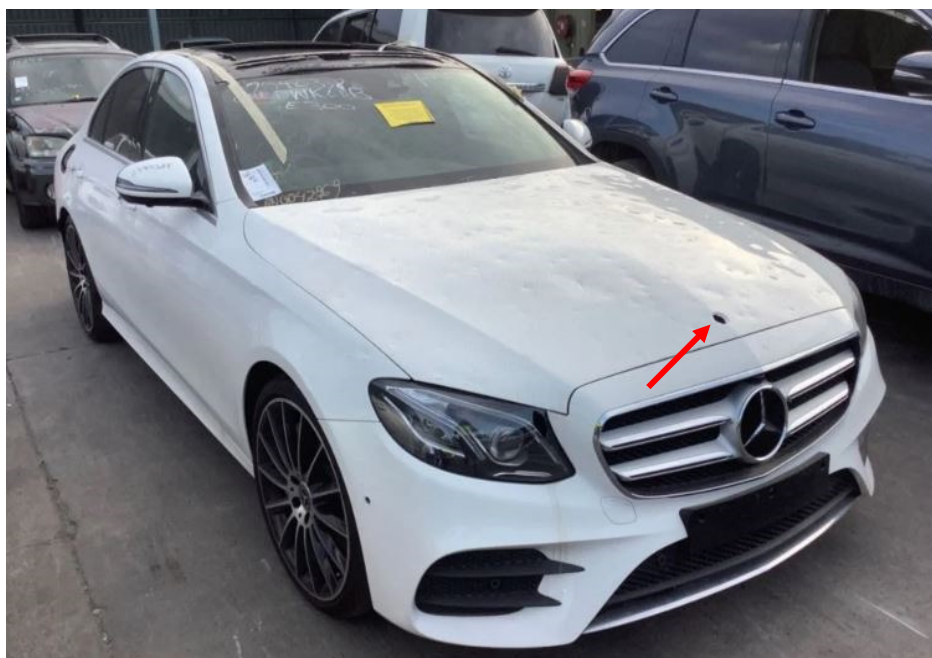
Photo 2 shows the front right body of the Motor Car prior to any repairs being carried out (photograph provided to me). The Motor Car was observed to have sustained damages of indentation nature to multiple exterior body parts like its front bonnet. As seen from the photograph, there were multiple relatively minor indentations on the front bonnet. The front bonnet emblem (arrowed) was observed to be either dislodged, removed or damaged.

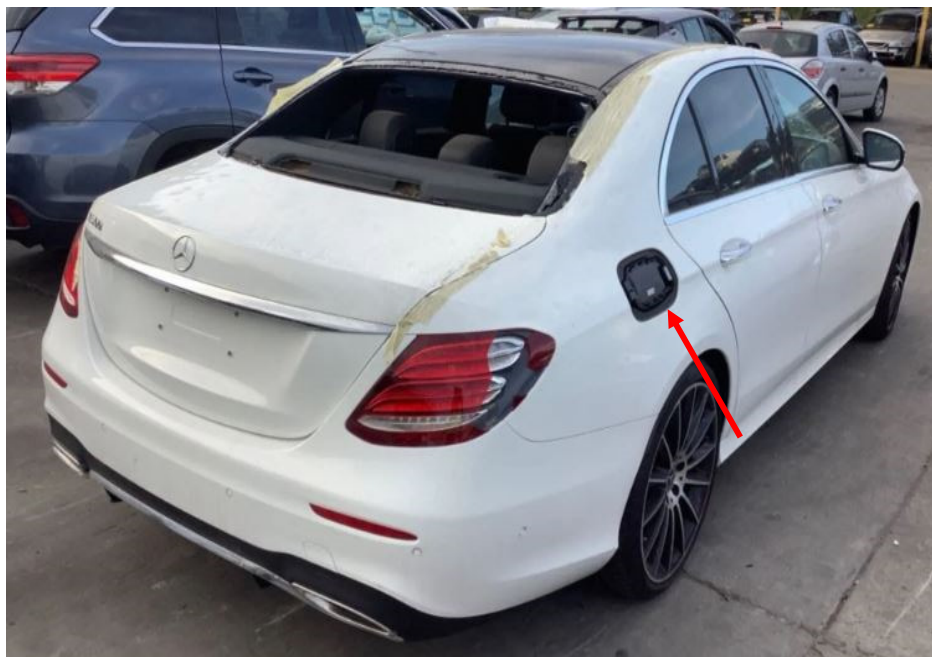
Photo 3 shows the rear right body of the Motor Car prior to any repairs being carried out (photograph provided to me). Relatively minor indentation damage was seen on the rear bootlid. The rear right taillamp was also observed to be broken. The fuel filler cover (arrowed) was observed to be either dislodged, removed or damaged.

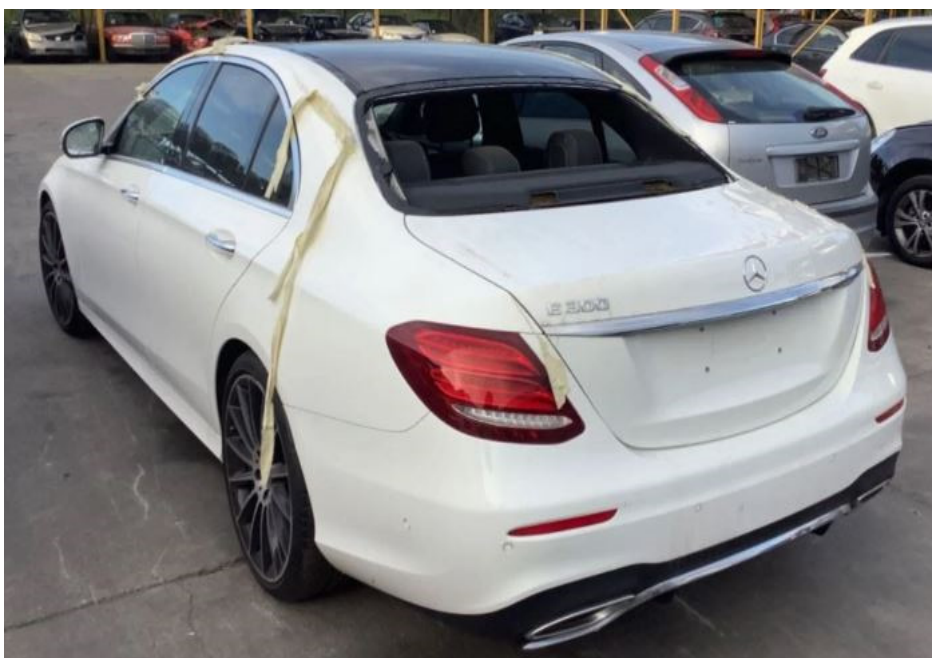
Photo 4 shows the rear left body of the Motor Car prior to any repairs being carried out (photograph provided to me). The Motor Car was observed to have sustained damages of indentation nature to multiple exterior body parts like its rear bootlid amongst others. The rear windscreen was also observed to be broken.

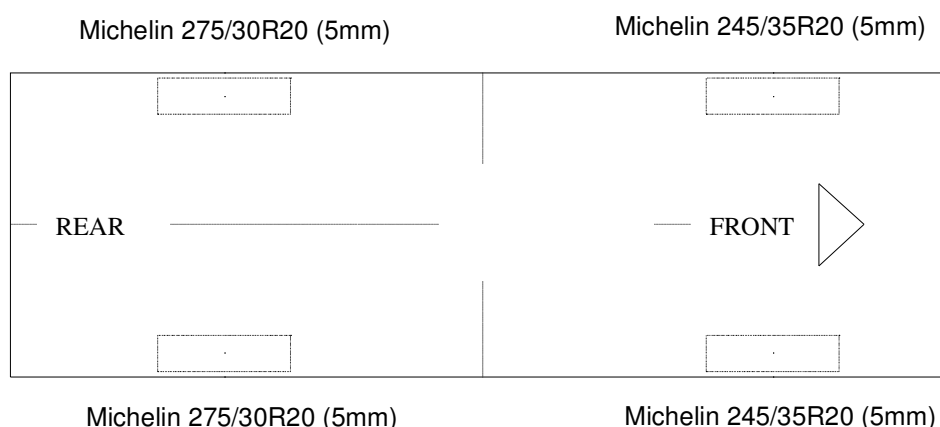
7. It was fitted with 20inch sport wheel rims that were wrapped with tyres that were observed to be of serviceable condition. The tyres were also sufficiently inflated for vehicular operation. The tyre brand, tyre size and approximate remaining tread depth of the 4 tyres of the Motor Car were recorded as follows: -

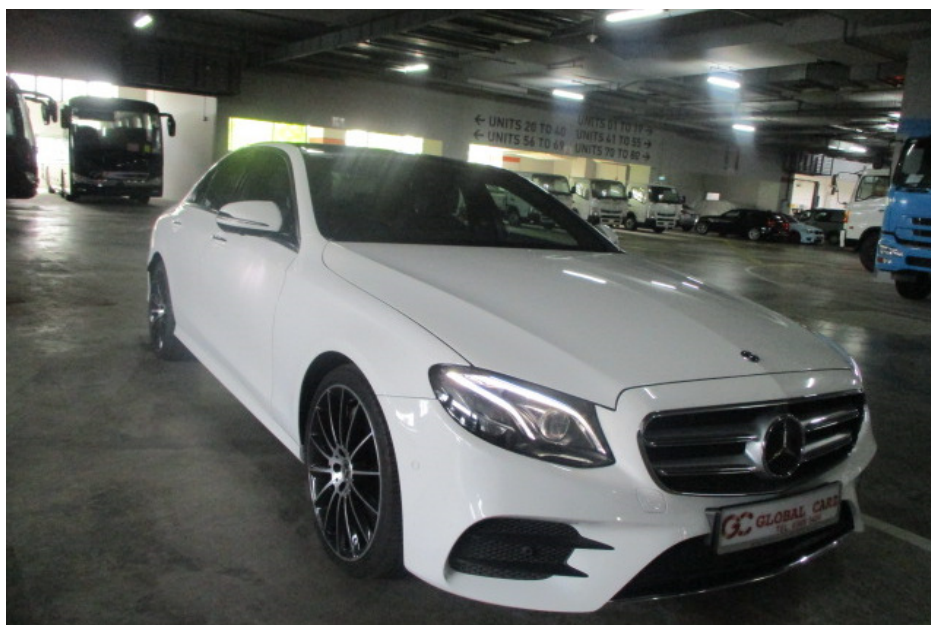
Photo 5 shows a general view of the front right body of the Motor Car at the time of my inspection. The Motor Car was observed to be in a relatively good general condition with no loose exterior fittings observed. The exterior body parts at the frontal portion of the Motor Car, like the front bumper, front bonnet and front fenders, were visually examined and it was observed that the repair/restoration works carried out to the damaged area of the Motor Car (refer to photograph 1 & 2 above) were reasonably adequate and in order.

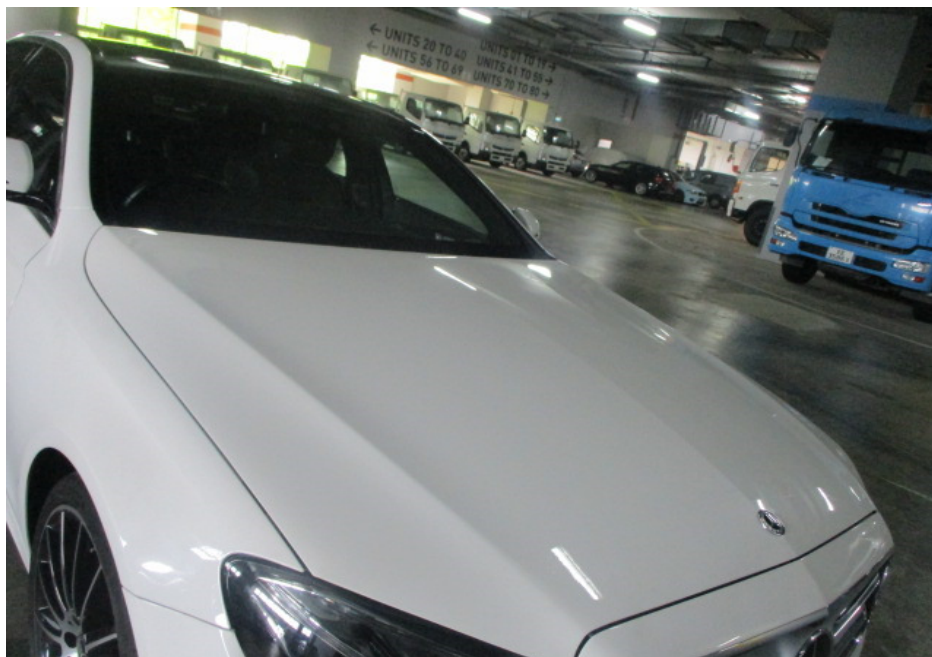
Photo 6 shows a closer view of the Motor Car's front bonnet at the time of my inspection. In general, I had found that the repair/restoration works carried out to the damaged area of the Motor Car (refer to photograph 1 & 2 above) were reasonably adequate and in order.

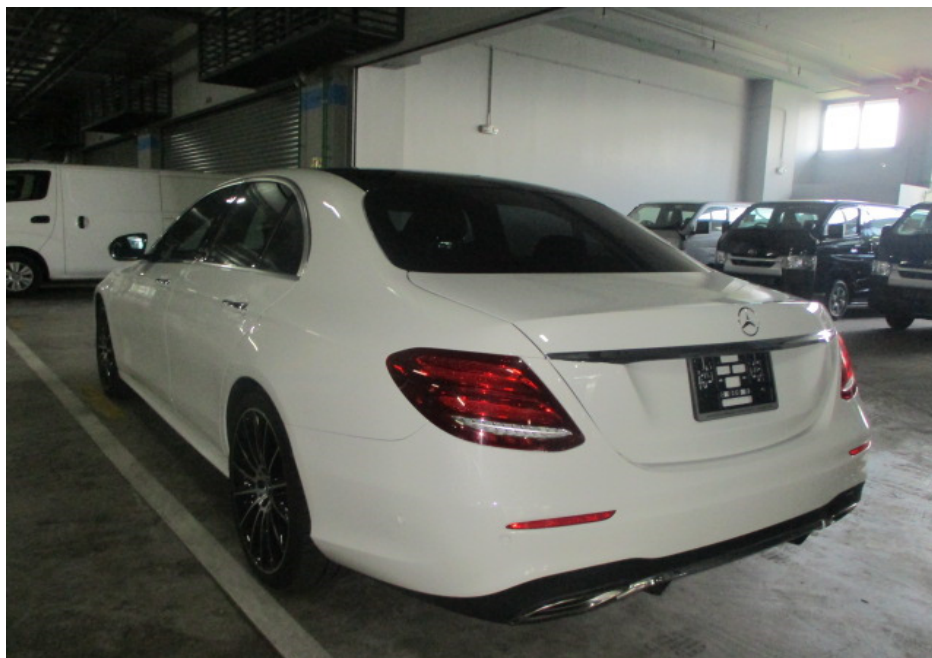
Photo 7 shows a general view of the rear left body of the Motor Car at the time of my inspection. The Motor Car was observed to be in a relatively good general condition with no loose exterior fittings observed. The exterior body parts at the rear portion of the Motor Car were visually examined, and it was observed that the repair/restoration works carried out to the damaged area of the Motor Car (refer to photograph 3 & 4 above) were reasonably adequate and in order.

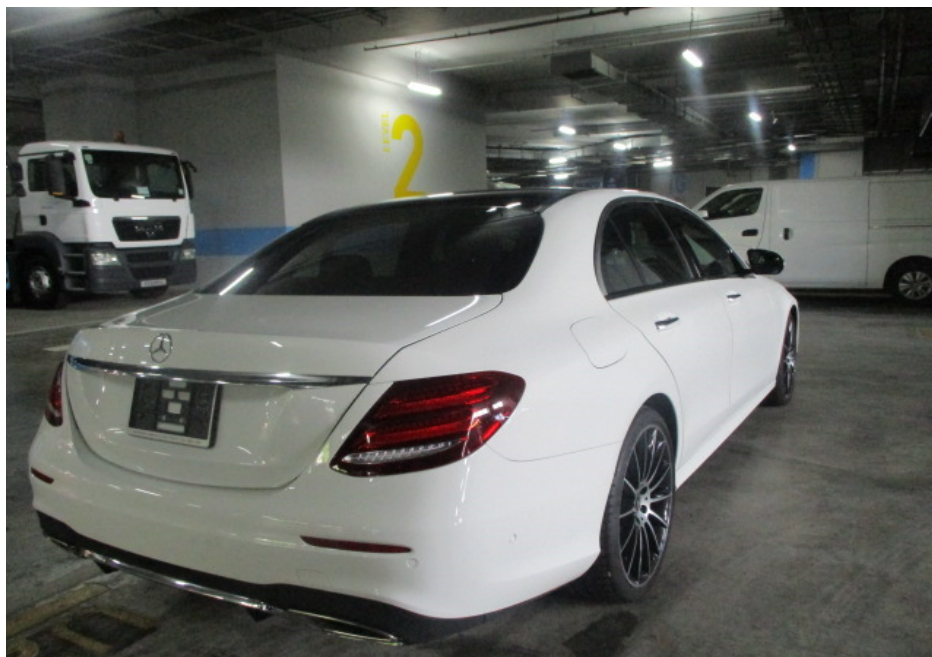
Photo 8 shows a general view of the rear right body of the Motor Car at the time of my inspection. The exterior body parts at the rear portion of the Motor Car, like the rear bumper, rear bootlid and rear fenders, were visually examined and it was observed that the repair/restoration works carried out to the damaged area of the Motor Car (refer to photograph 3 & 4 above) were reasonably adequate and in order.

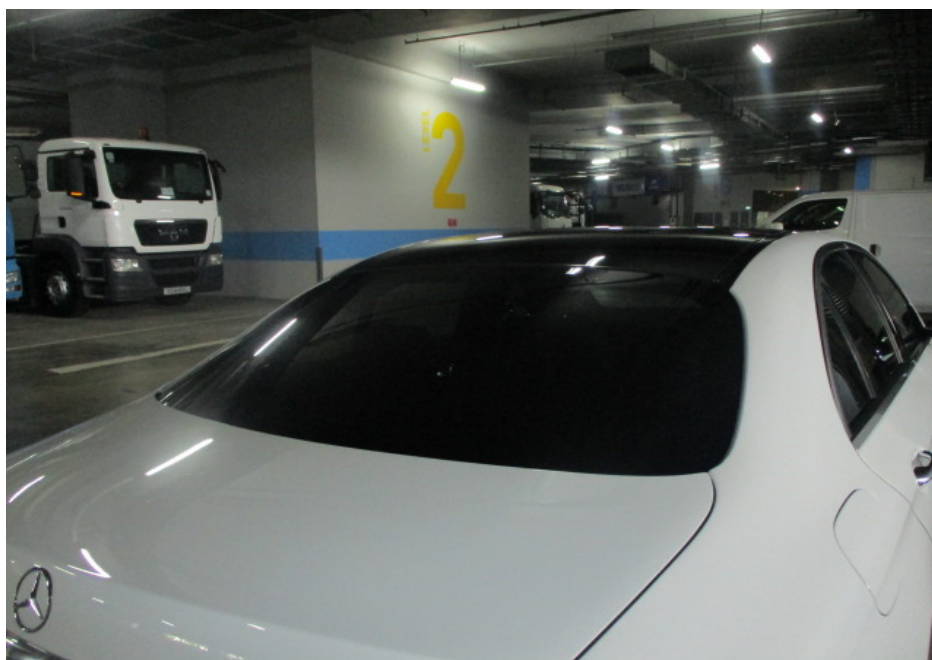
Photo 9 shows a closer view of the Motor Car's rear bootlid and rear windscreen at the time of my inspection. In general, I had found that the repair/restoration works carried out to the damaged area of the Motor Car (refer to photograph 3 to 4 above) were reasonably adequate and in order.

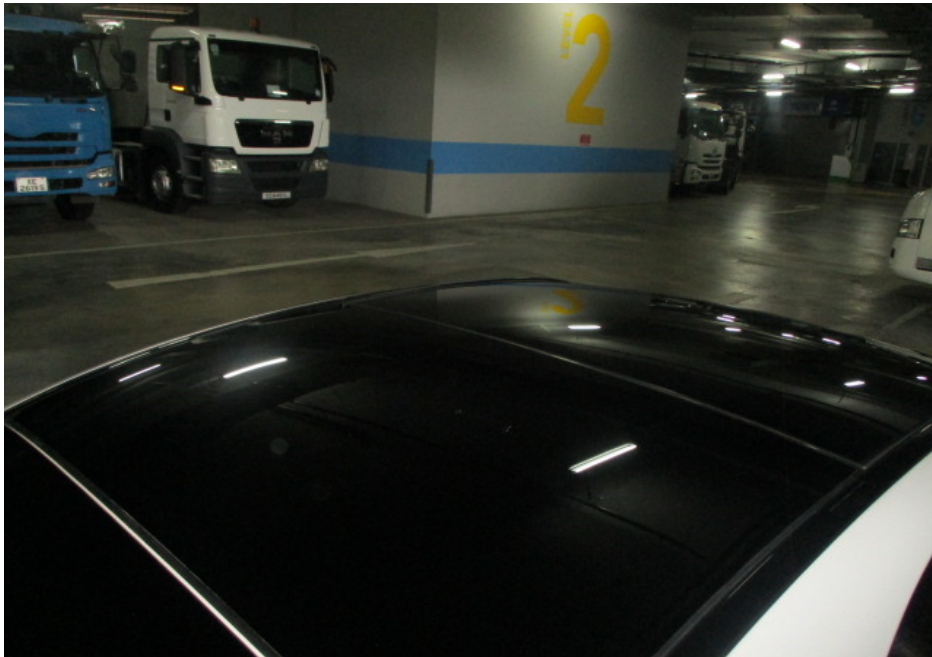
Photo 10 shows the roof panel and panoramic sunroof of the Motor Car at the time of my inspection. In general, I had found that the repair/restoration works carried out to the damaged area of the Motor Car (refer to photograph 1 to 4 above) were reasonably adequate and in order.

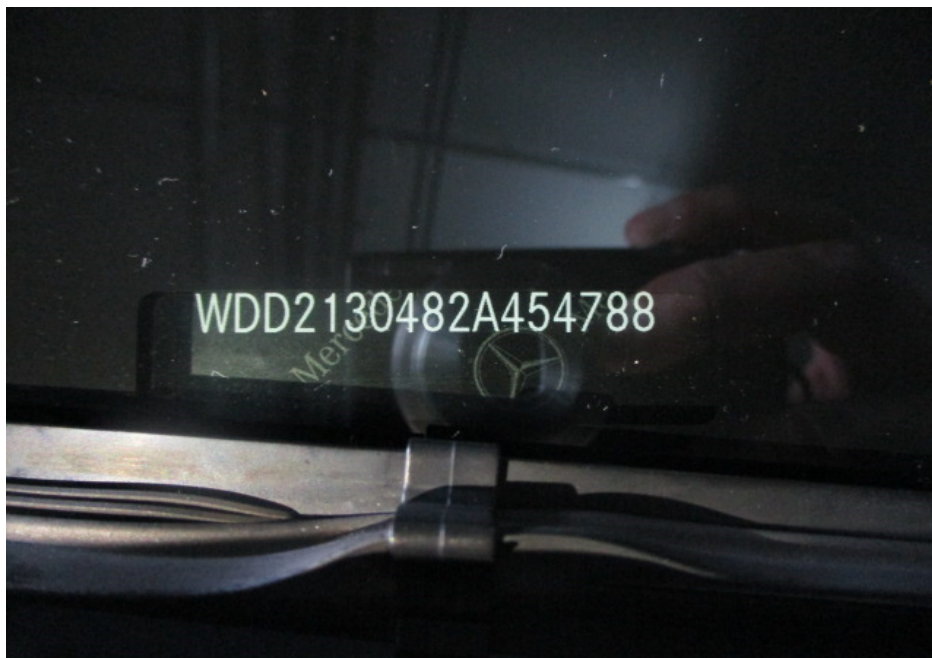
Photo 11 shows the chassis number of the Motor Car. The chassis number recorded was WDD2130482A454788.

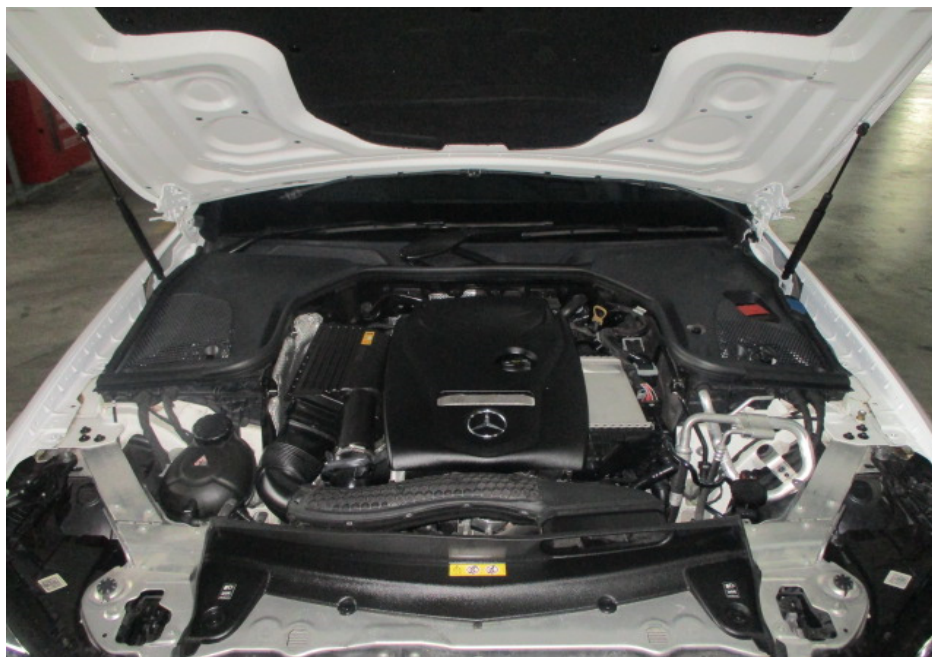
13. My examination of the engine compartment of the Motor Car revealed that the various parts and components inside the engine compartment were all intact and properly fitted. The engine oil, brake fluid and engine coolant were all found to be of sufficient level for operating purposes. Visually, there was also no contamination found to these fluids.

Photo 12 shows a general view of the engine compartment of the Motor Car at the time of my inspection. The various parts and components inside the engine compartment were all observed to be intact and properly fitted. There was also no sign(s) or indication(s) of fluid leak and/or fluid stain found inside the engine compartment.

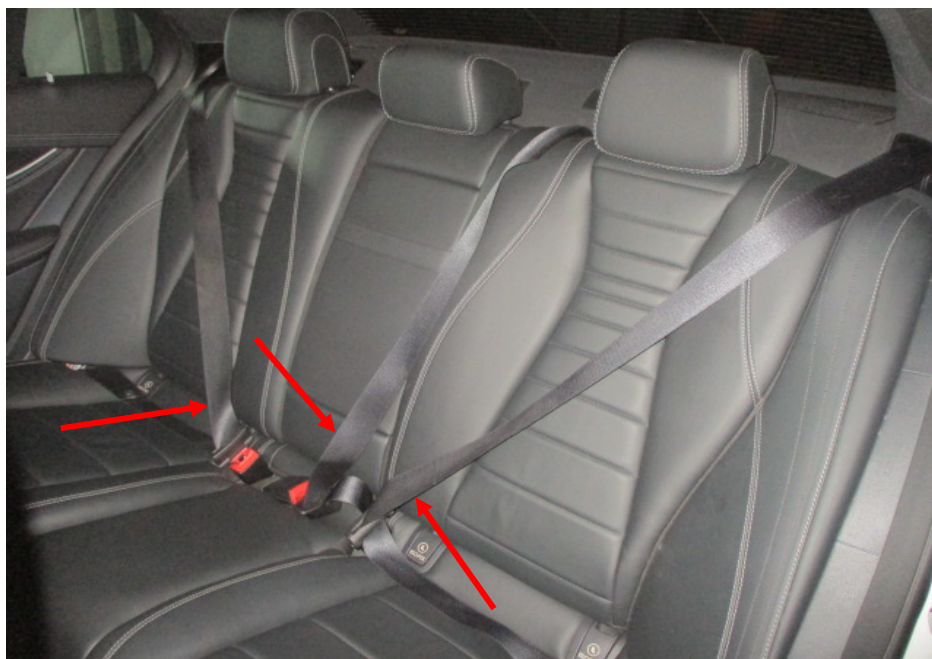
11. The seats of the Motor Car were found to be secured to the floorboard of the Motor Car via seat rails bolted onto the floorboard. Retractable seat belt reels and pre-tensioners were fitted on all seats of the Motor Car. The seat belts were tested and were able to be fastened securely into the respective pre-tensioners that were fixed to the side of all the seats.

Photo 13 shows the rear seats of the Motor Car. All the seats of the Motor Car were secured via seat rails to the floorboard. They were also fitted with a retractable seat belt reel and a pre-tensioner. The seat belts (arrowed) were tested and were able to be fastened into the respective pre-tensions that were fitted on the side of each individual seat.

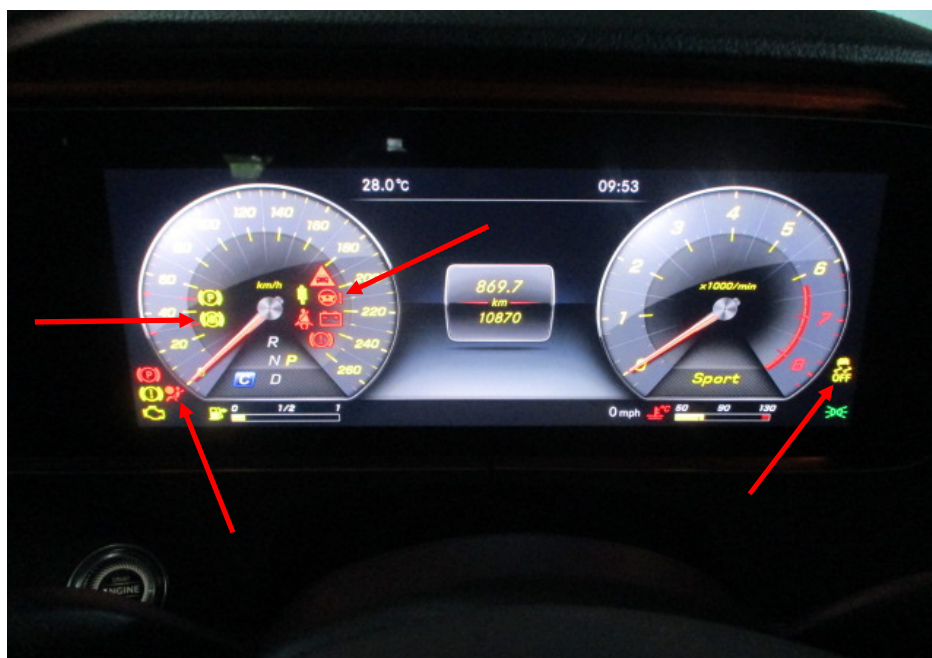
Photo 14 shows the warning lights for the various electronic safety features appearing on the instrument panel of the Motor Car during its self-test when the engine is cranked, in particular the ABS, SRS, EPS and TCS lights (arrowed).

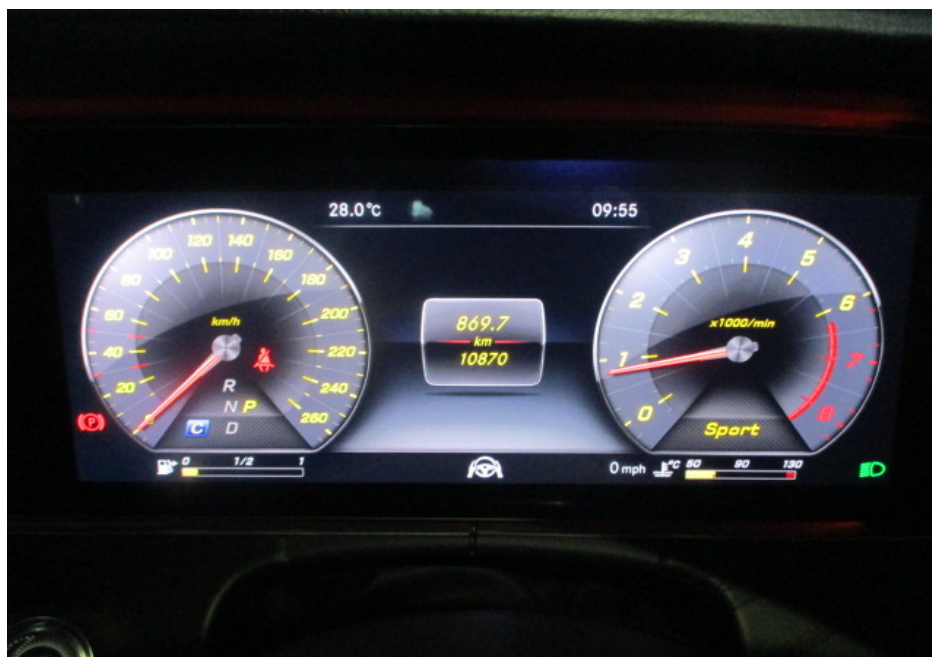
12. The Motor Car's automatic self-test of the functionality of its various electronic safety features like the Anti-Lock Brake System (ABS), Supplemental Restraint System (SRS), Electric Power Steering (EPS) and Traction Control System (TCS) during cranking of the engine had indicated that these electronic systems were in working condition. This was determined from the respective warning lights disappearing from the instrument panel after the self-test.

Photo 15 shows the respective warning lights no longer illuminated, indicating that there is no fault detected to the ABS, SRS, EPS and TCS systems of the Motor Car during the self-test. These electronic systems were hence in working condition at the time of my inspection.

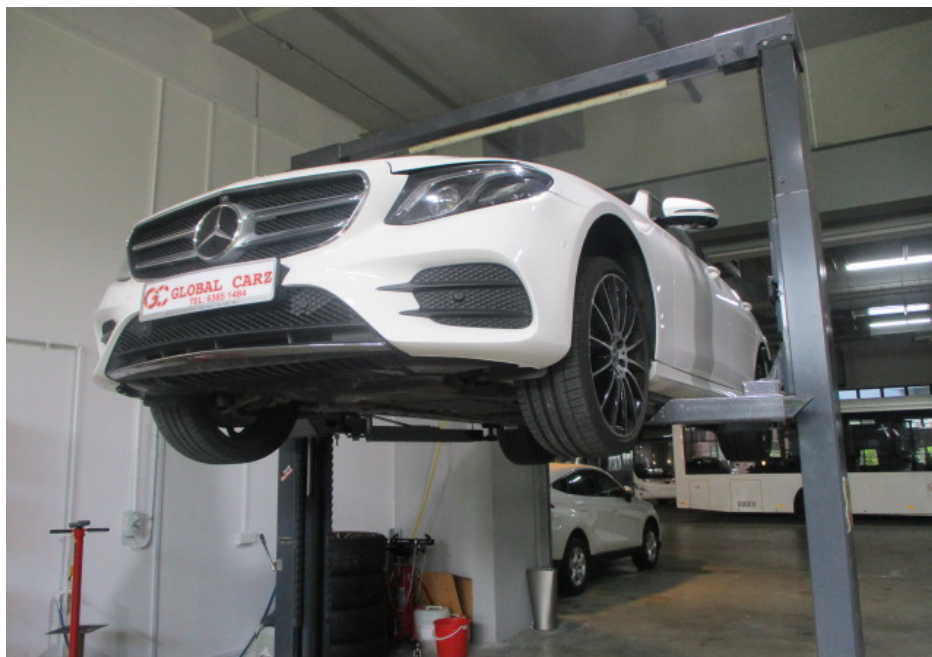
14. My checks on the underside of the Motor Car revealed no sign(s) or indication(s) of fluid leakage and/or fluid stain(s). The engine block and automatic transmission assembly were both secured properly. They were not mounted onto the chassis/structural body or any integral body part of the Motor Car. All undercarriage components of the Motor Car were also observed to be intact and secured in an appropriate manner.

Photo 16 shows the Motor Car hoisted up for checks on its undercarriage. There was no sign(s) or indication(s) of fluid leakage and/or fluid stain(s) on the underside of the Motor Car. The undercarriage components of the Motor Car were also all observed to be intact and secured in an appropriate manner.

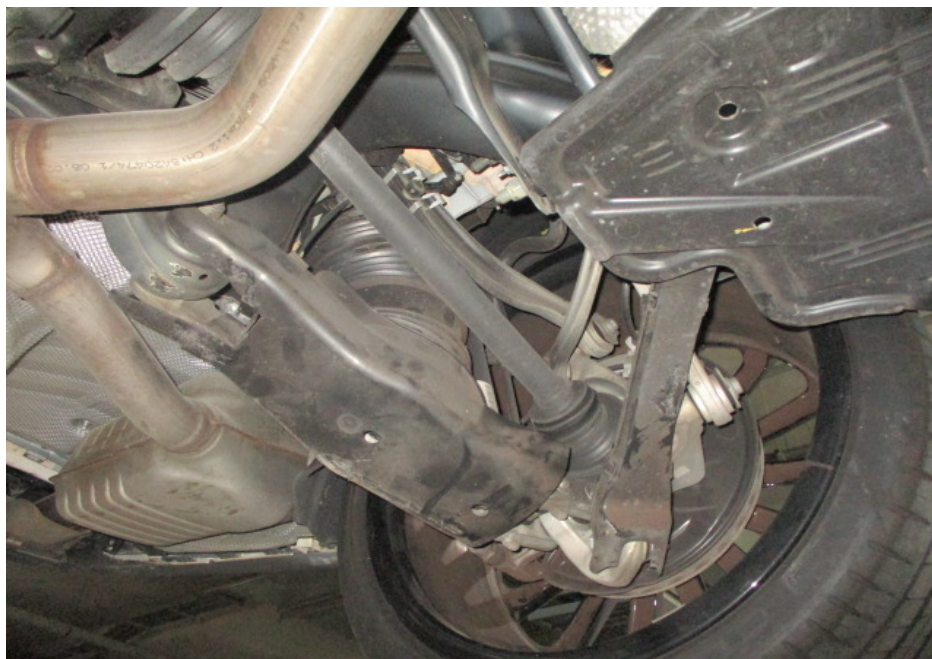
Photo 17 shows a general view of the control arms and linkages at the rear left wheel of the Motor Car. I did not observe any fluid leak and/or fluid stain on the underside of the Motor Car. All the Motor Car's undercarriage components were observed to be intact and secured in an appropriate manner.

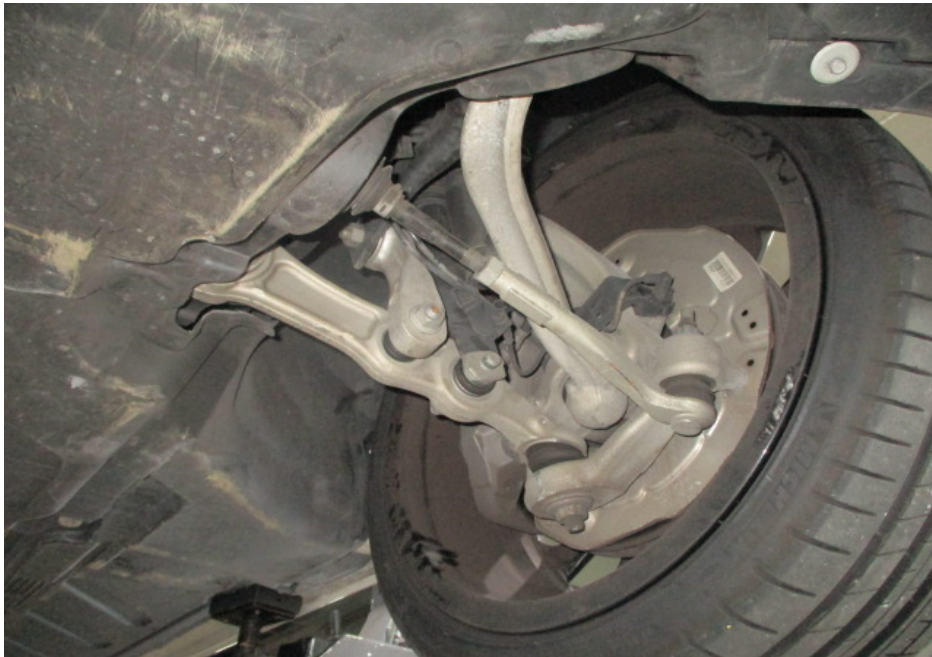
Photo 18 shows the various undercarriage components at the front left wheel of the Motor Car. The mechanical components, control arms and linkages were all found to be intact and secured in an appropriate manner.

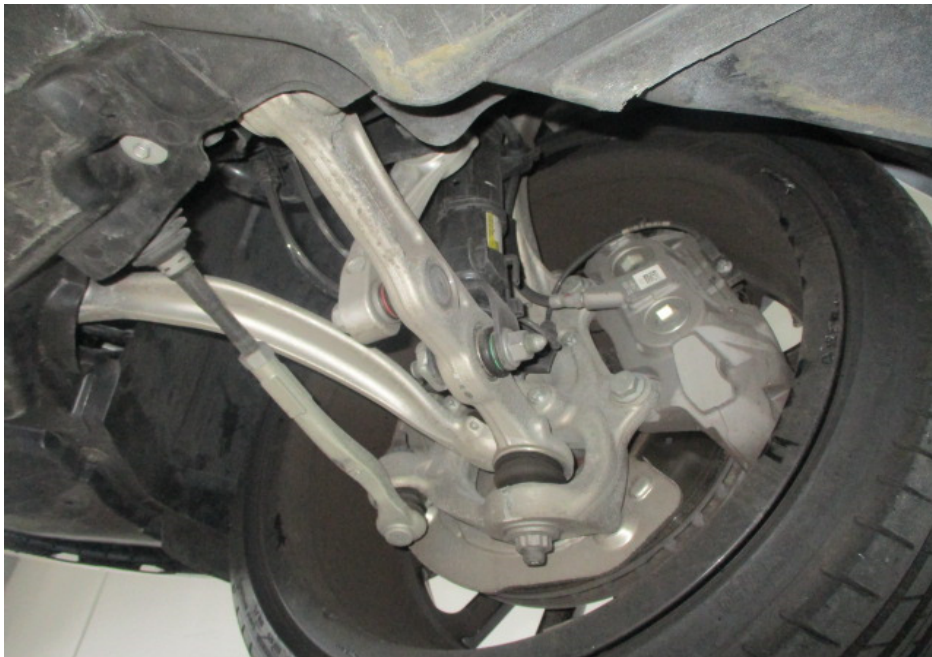
Photo 19 shows the various undercarriage components at the front right wheel of the Motor Car. The mechanical components, control arms and linkages were all found to be intact and secured in an appropriate manner. I also did not observe any fluid leak and/or fluid stain on the underside of the Motor Car.

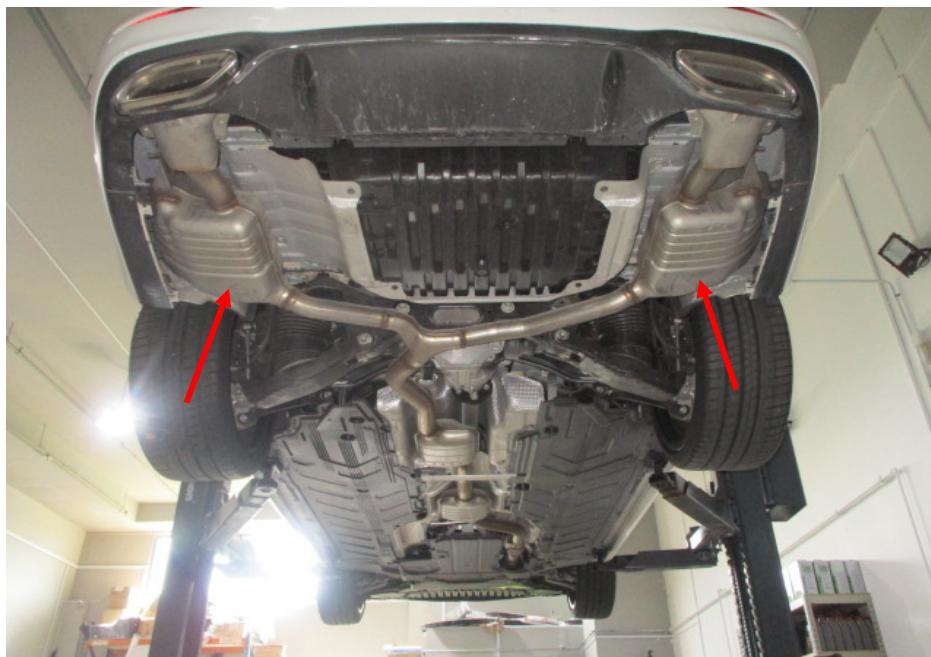
Photo 20 shows the Motor Car's rear exhaust mufflers (arrowed). My examination of the Motor Car's exhaust system revealed no sign(s) or indication(s) of any cut or weld marks along its exhaust pipes and on its catalytic converter.

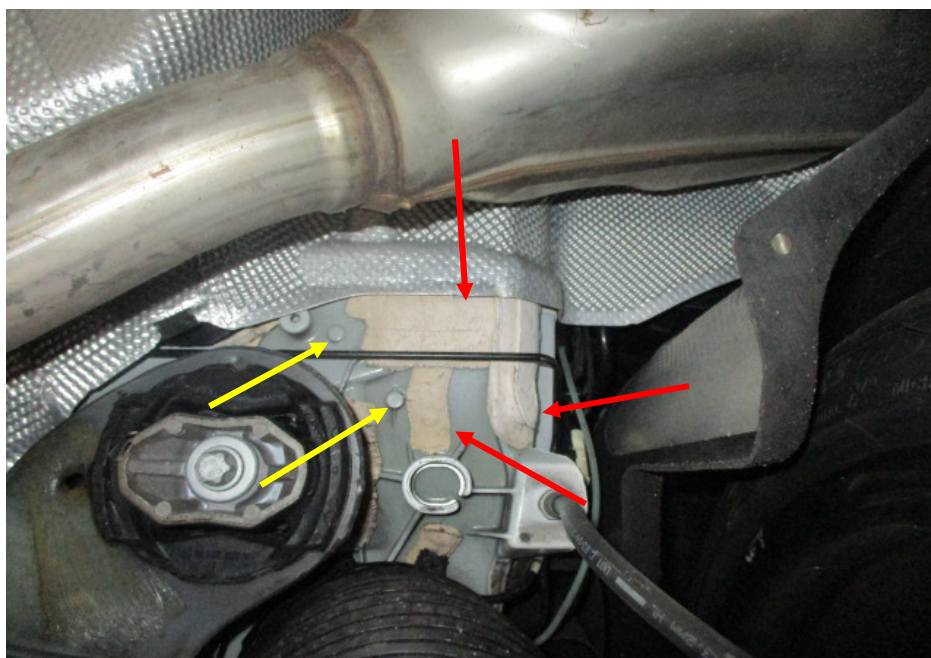
10. Visually, I did not find any weld marks, other than the original spot weld marks, on the chassis/structural body of the Motor Car. The original factory sealant at the joints along the chassis/structural body was also untouched, indicating that no replacement of the chassis/structural body was carried out; and that the chassis/structural body was originally fitted.

Photo 21 shows the chassis/structural body at the underside rear right of the Motor Car. I did not find any weld marks other than original spot weld marks (yellow arrow) on the chassis/structural body of the Motor Car. The original factory sealant (red arrow) at the joints along the chassis/structural body was untouched, indicating no work was done on the chassis/structural body of the Motor Car and that the chassis/structural body was originally fitted.

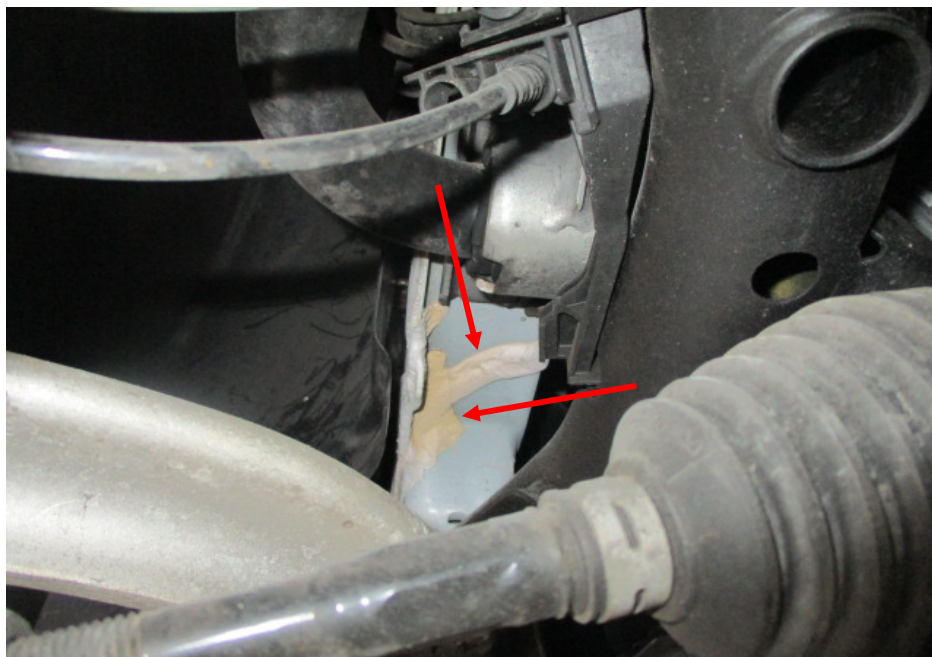
Photo 22 shows the chassis/structural body at the underside front left of the Motor Car. The original factory sealant (arrowed) at the joints along the chassis/structural body was observed to be untouched. In general, I had found no work was carried out on the chassis/structural body of the Motor Car. The chassis/structural body of the Motor Car was originally fitted.

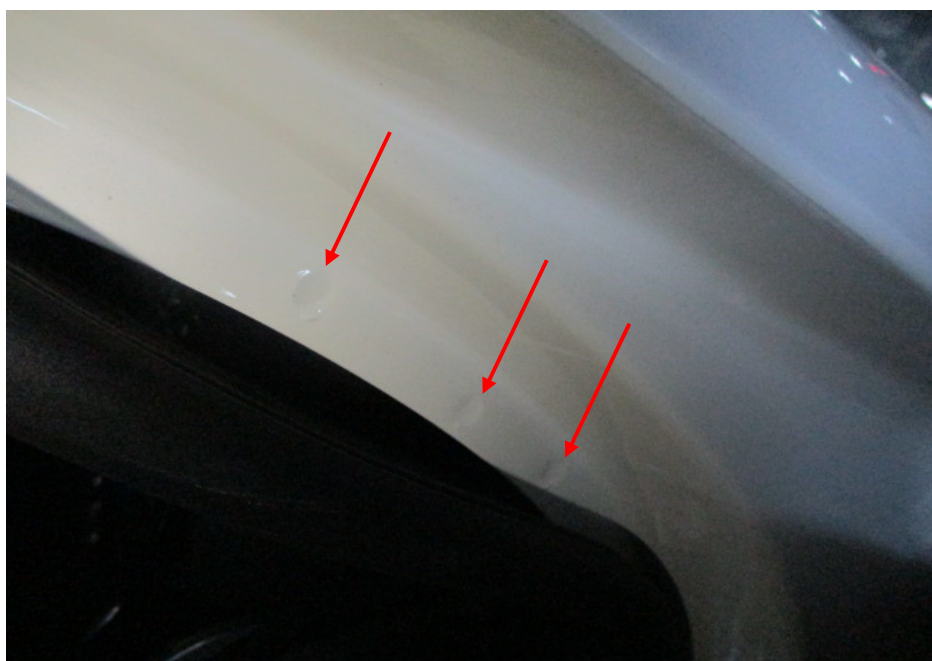
9. Checks on the non-detachable body panels like the rear fenders, floorboard, roof panel, pillars and rocker panels amongst others, revealed that these body panels were spot welded onto the chassis/structural body of the Motor Car. The original factory sealant at the joints of the non-detachable body panels was all untouched indicating no replacement of the non-detachable body panels was carried out; and that these body panels were all originally fitted.

Photo 23 shows the right side "A" pillar of the Motor Car. I did not find any weld marks other than original spot weld marks (arrowed) on the right side "A" pillar of the Motor Car which, indicates that there was no re-welding works carried out. In general, I had found all the non-detachable body panels of the Motor Car to be originally fitted at the time of my inspection.

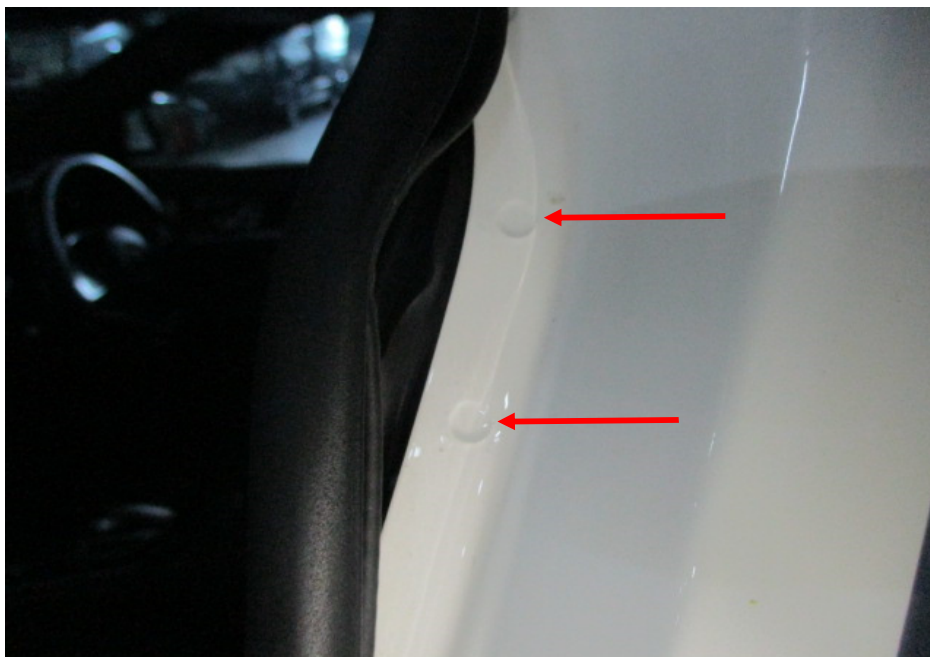
Photo 24 shows the left side "B" pillar of the Motor Car. I did not find any weld marks other than original spot weld marks (arrowed) on the left side "B" pillar of the Motor Car which, indicates that there was no re-welding works carried out. In general, I had found all the non-detachable body panels of the Motor Car to be originally fitted at the time of my inspection.
