Your Ref: TP/IP/56637/2020
Our Ref : CI/TPD21003521/N

Fatal Accident Investigation Team

INSPECTION REPORT OF MOTORCYCLE FBM 7616K

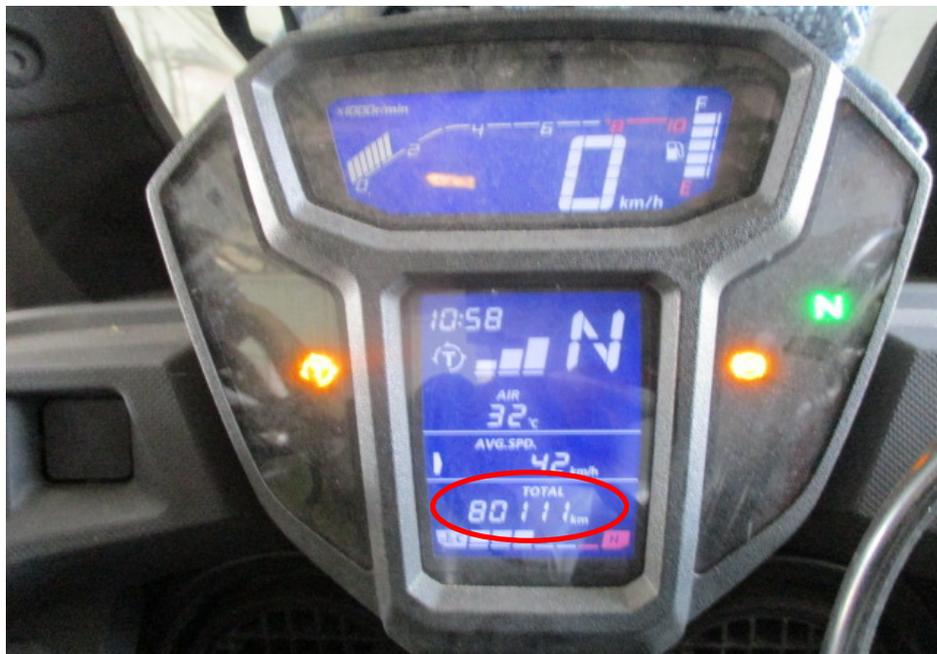
Photo 1 shows the speedometer gauge of the Motorcycle where the mileage recorded at the time of our inspection was 80, 111km (circled).

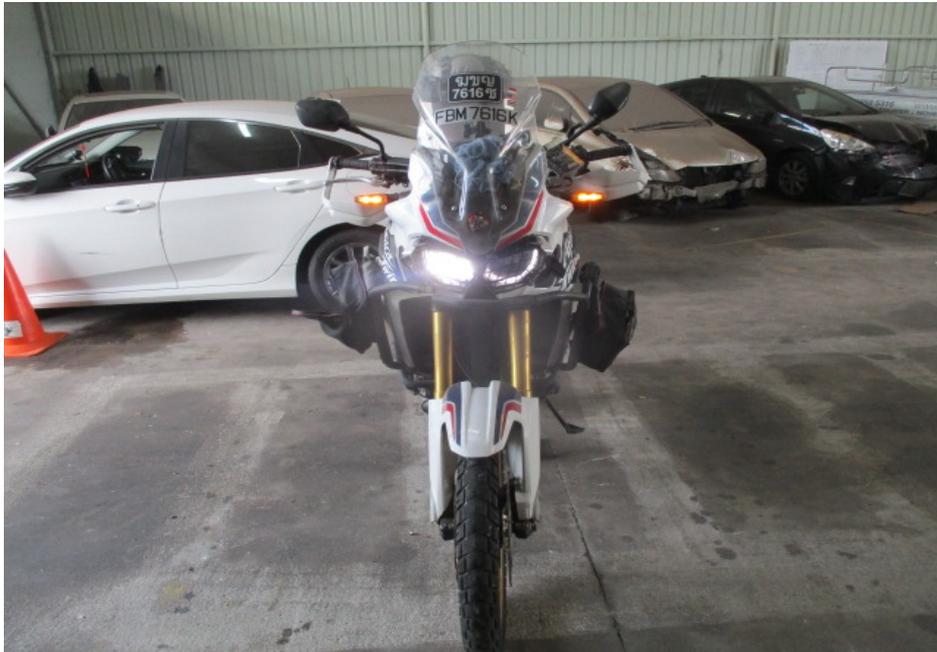
Photo 2 shows a general view of the frontal portion of the Motorcycle at the time of our inspection. The Motorcycle was observed to have sustained damages all around.

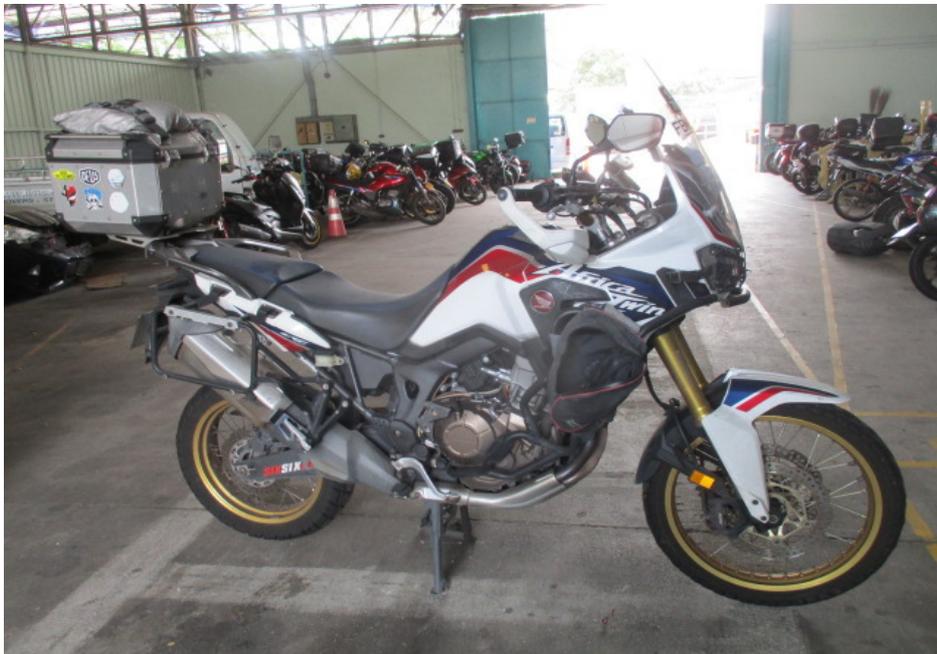
Photo 3 shows a general view of the right body of the Motorcycle at the time of our inspection. The Motorcycle was observed to have sustained damages all around.

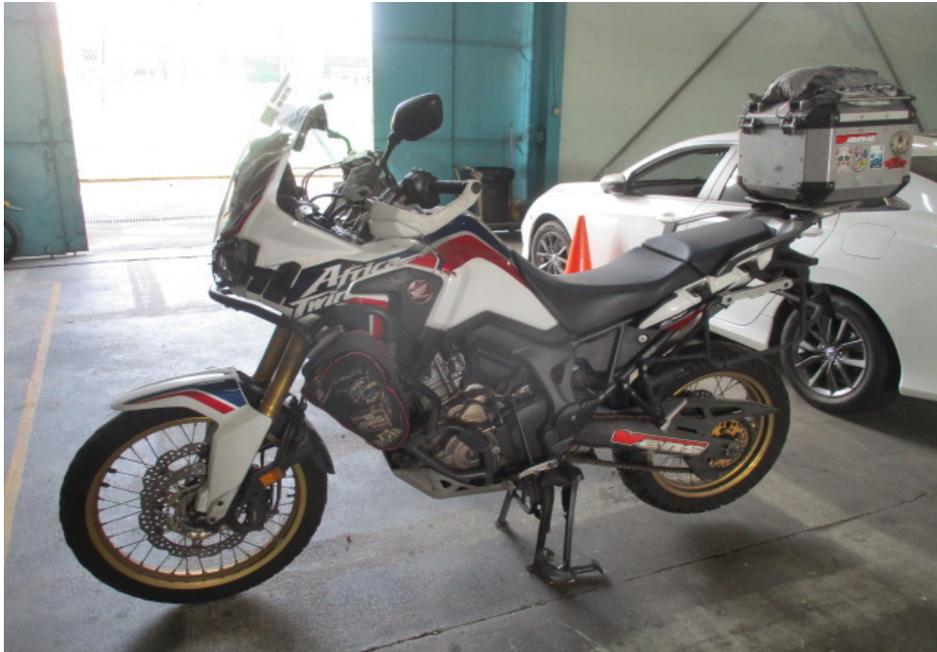
Photo 4 shows a general view of the left body of the Motorcycle at the time of our inspection. The Motorcycle was observed to have sustained damages all around. The body parts that were found to have been damaged include its head cowling, right pillion foot peg, left tank cover, front brake lever guard, front brake lever, right side mirror, right side pannier rack, left front footrest, right engine crashbar, exhaust muffler and top box, amongst others.

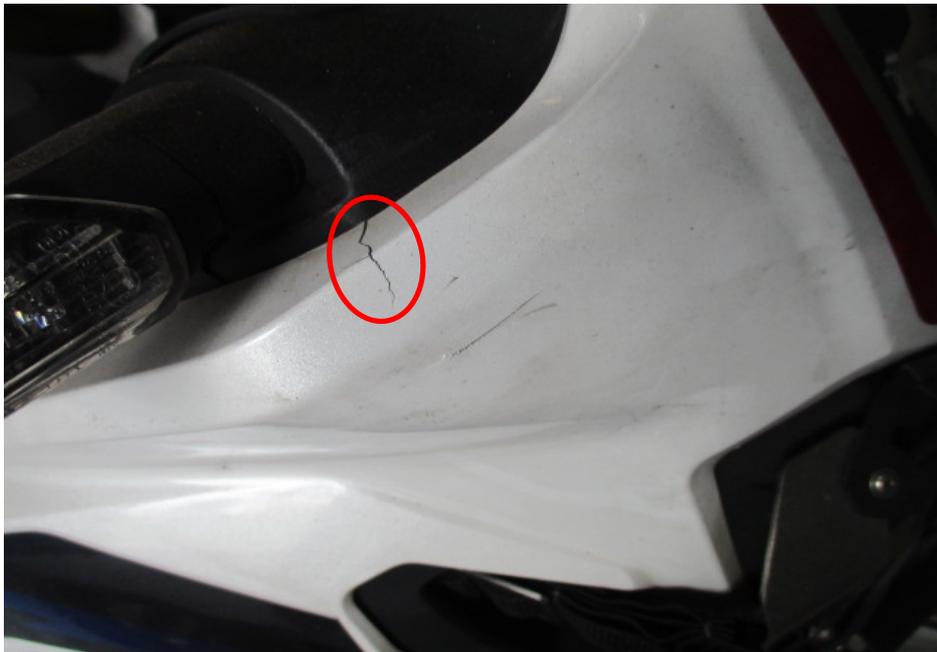
Photo 5 shows a close up view of the cracked head cowl of the Motorcycle as a result of the accident (circled).

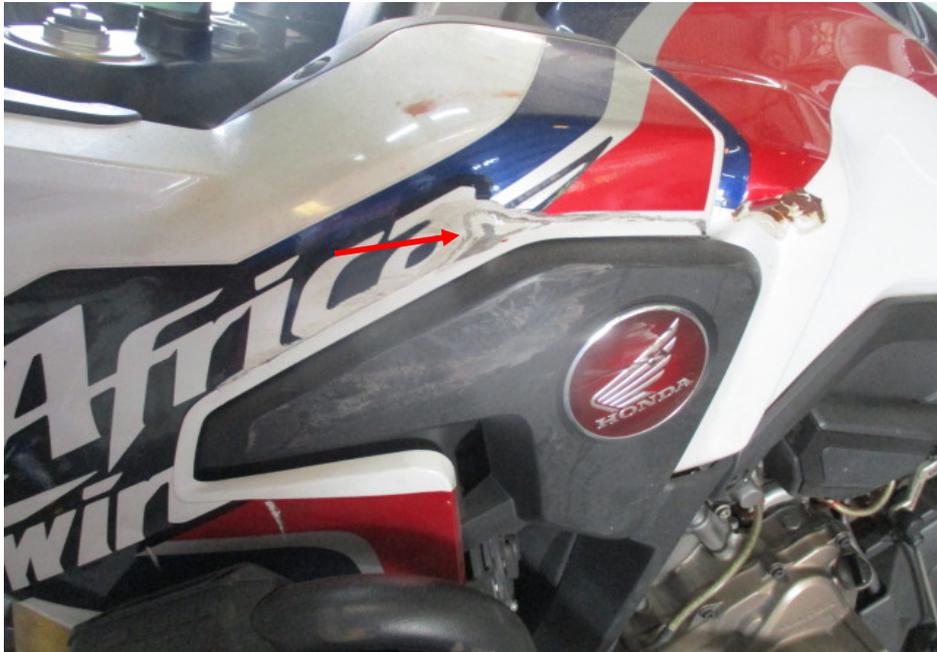
Photo 6 shows a closer view of the left tank cover which was amongst the body parts at the front body of the Motorcycle that had sustained damage as a result of the accident (arrowed).

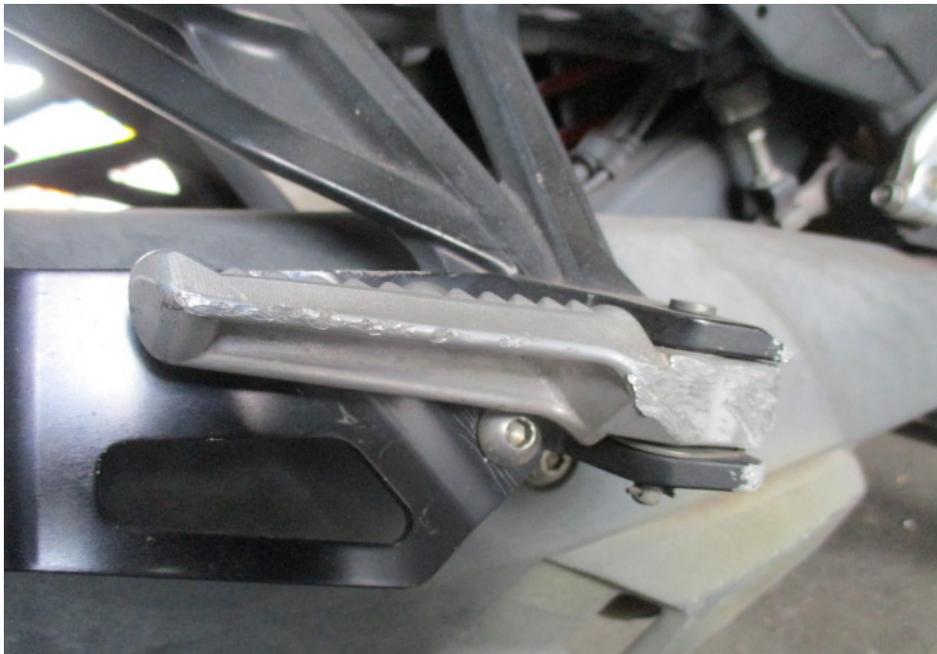
Photo 7 shows a closer view of the right pillion foot peg of the Motorcycle that had sustained damages of grazing nature as a result of the accident.

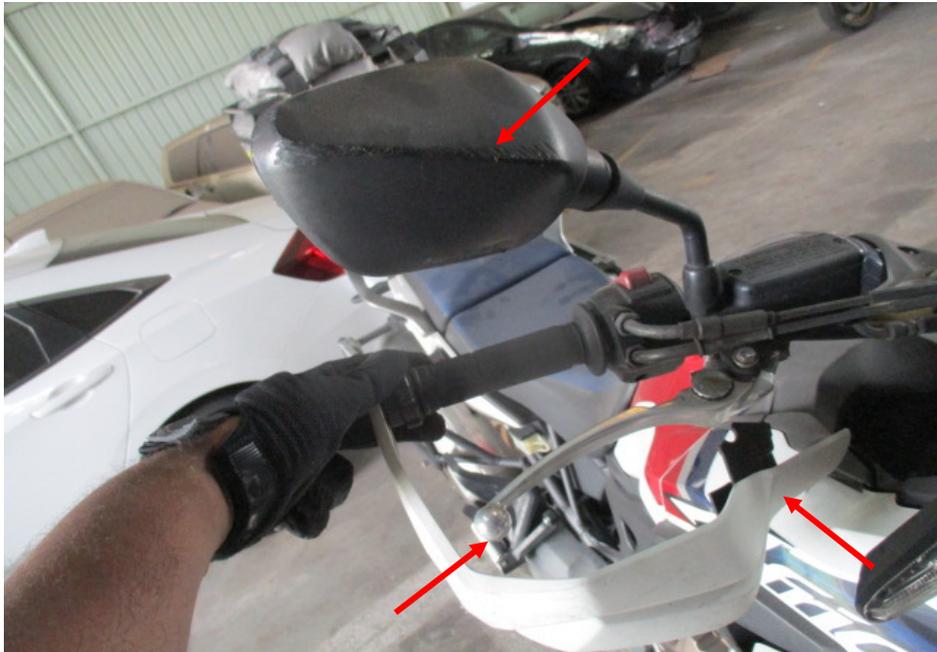
Photo 8 shows a closer view of the front brake lever guard, front brake lever and right side mirror (arrowed) which were amongst the body parts of the Motorcycle that had sustained damage as a result of the accident.

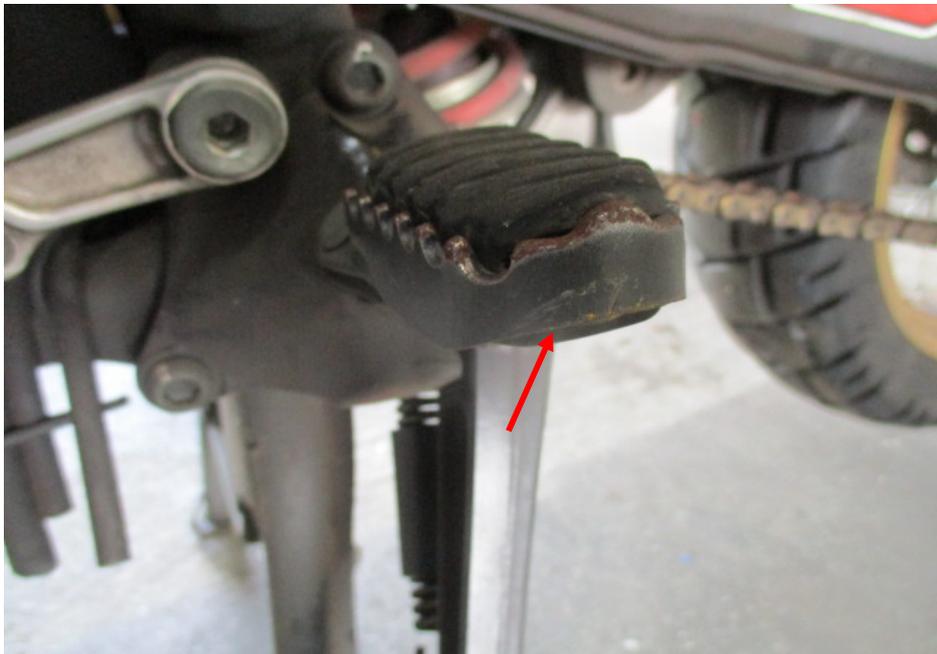
Photo 9 shows a closer view of the left front footrest (arrowed) which was amongst the body parts of the Motorcycle that had sustained damage as a result of the accident.

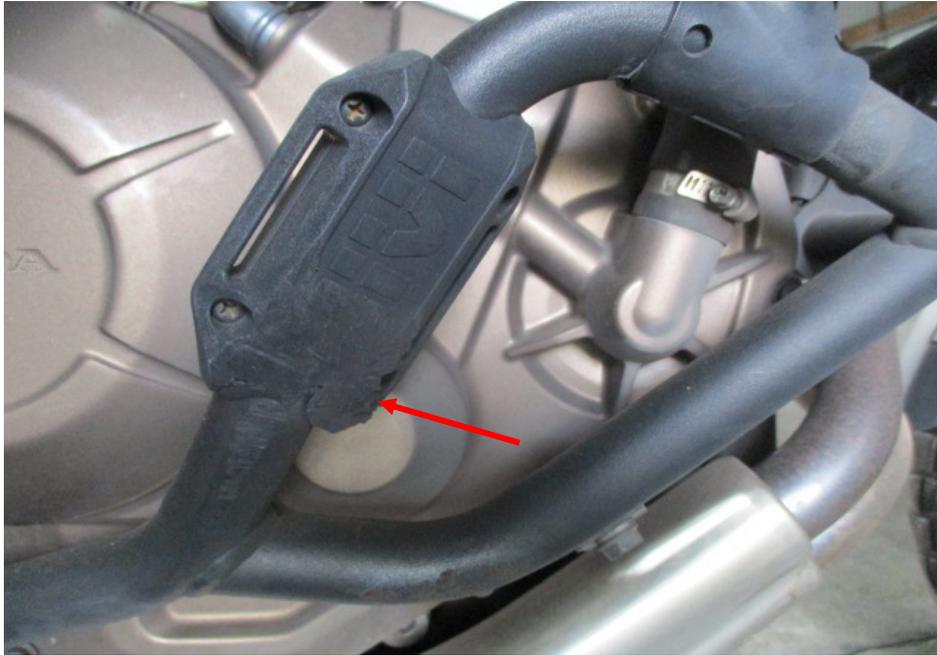
Photo 10 shows a closer view of the right engine crash bar which was amongst the body parts of the Motorcycle that had sustained damages of grazing nature as a result of the accident (arrowed).

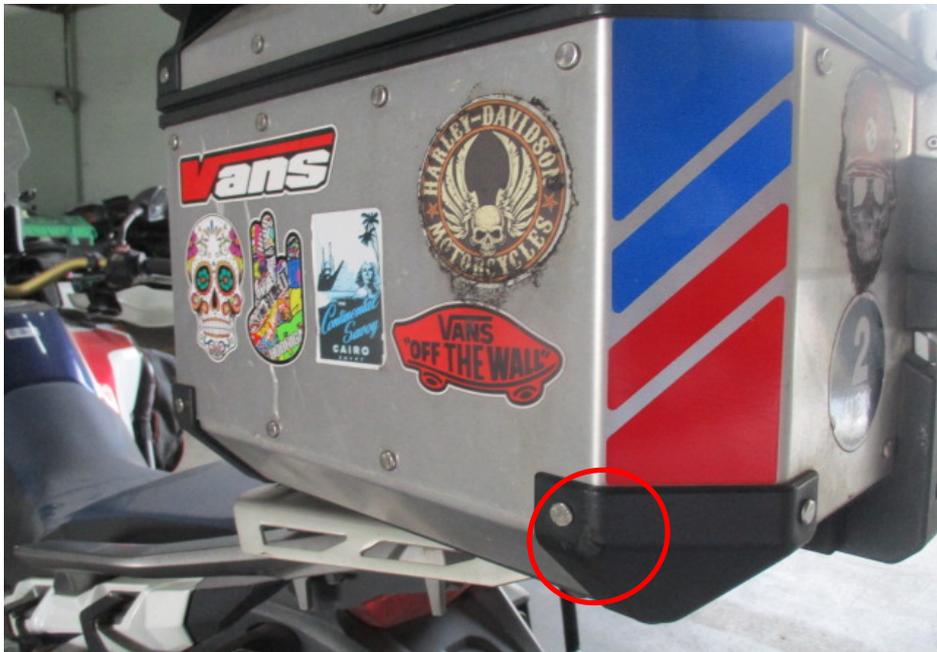
Photo 11 shows a closer view of the top box which was amongst the body parts of the Motorcycle that had sustained damages of grazing nature as a result of the accident (circled).

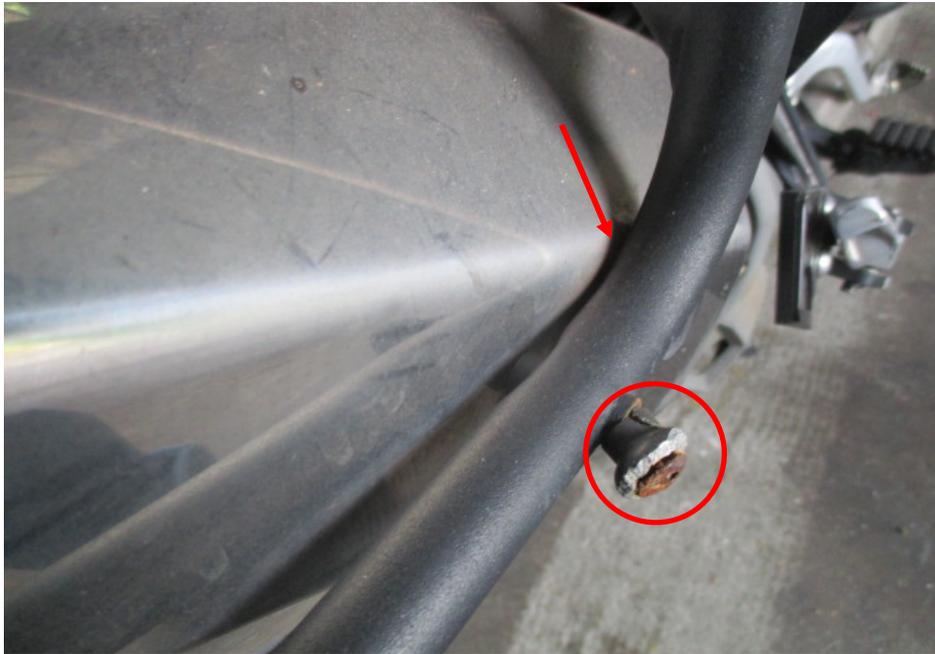
Photo 12 shows a closer view of the damaged exhaust muffler (arrowed) and right side pannier rack (circled) of the Motorcycle as a result of the accident.

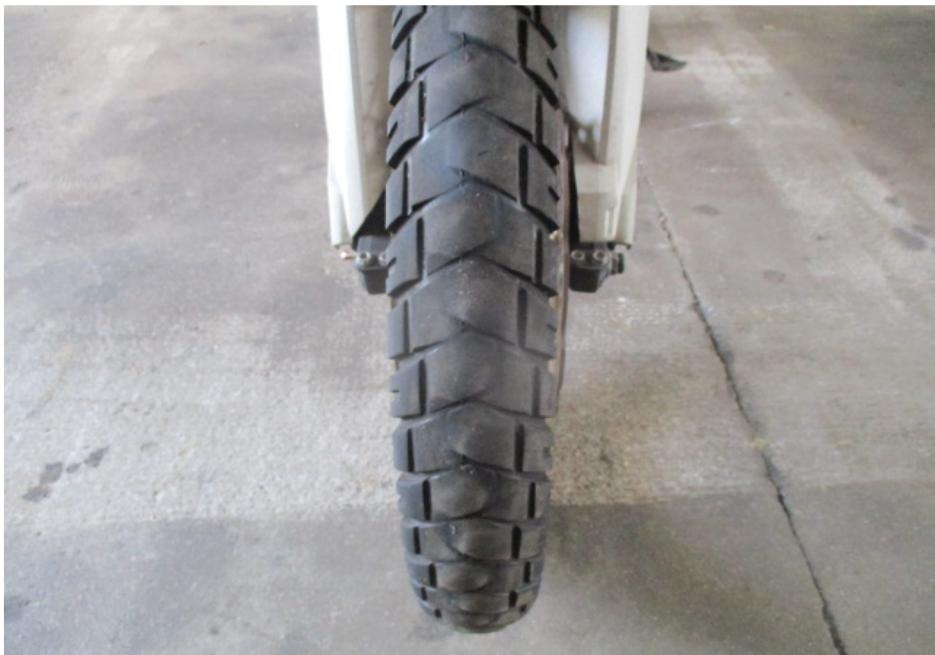
Photo 13 shows the condition of the Motorcycle's front tyre. The front tyre was observed to be in serviceable condition with remaining tread depth of approximately 3mm. There was no tear, burst mark(s) and/or punctured hole(s) on the sidewalls as well as across the tread of the front tyre.

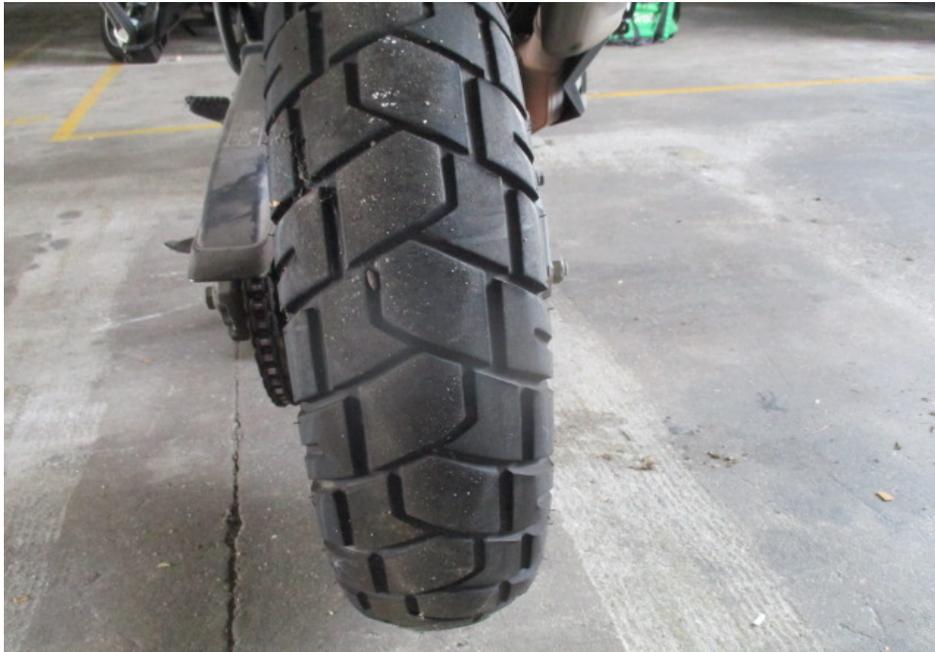
Photo 14 shows the condition of the Motorcycle's rear tyre. The rear tyre was observed to be in serviceable condition with remaining tread depth of approximately 4mm. The tyre was also observed to be sufficiently inflated for vehicular operation. We did not observe any tear, burst mark(s) and/or punctured hole(s) on the sidewalls as well as across the tread of the rear tyre.

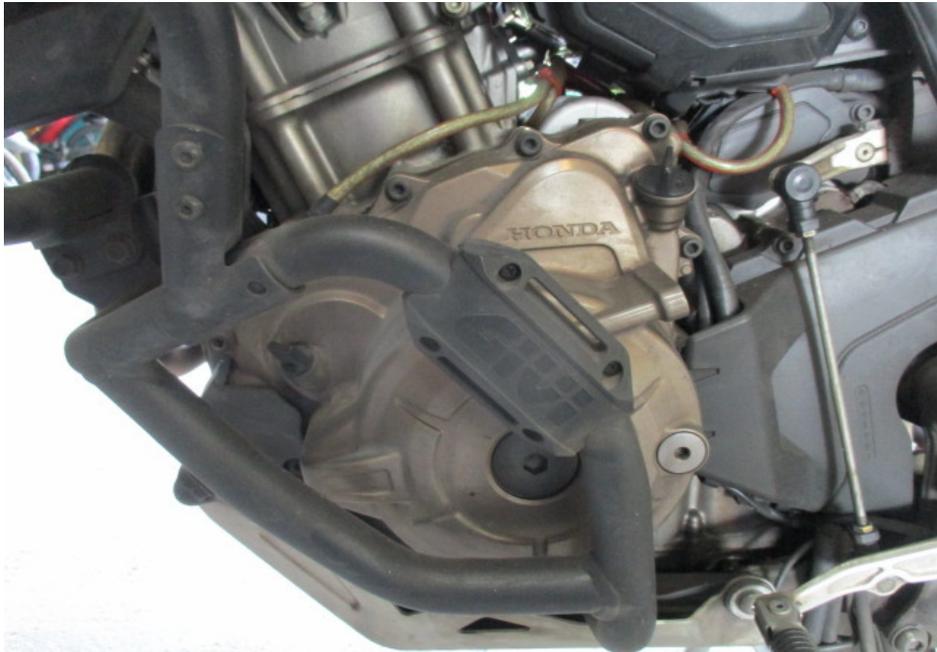
Photo 15 shows the left side of the engine of the Motorcycle at the time of our inspection. The various engine related parts and components were found to be intact with no visible damage. There was also no sign(s) or indication(s) of fluid leak observed around the left engine area of the Motorcycle.

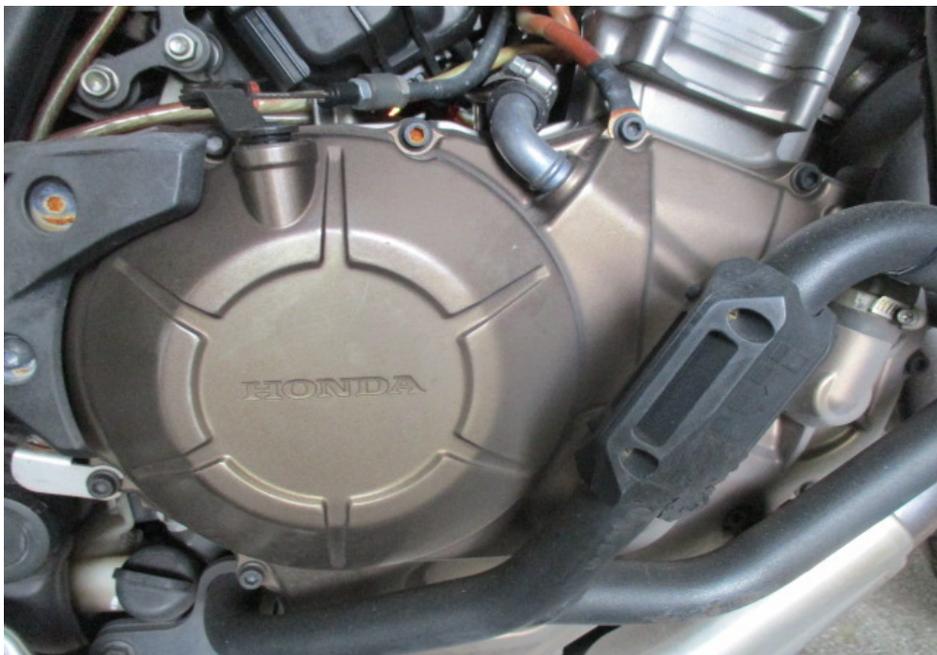
Photo 16 shows the right side of the engine of the Motorcycle at the time of our inspection. The various engine related parts and components were found to be intact with no visible damage. There was also no sign(s) or indication(s) of fluid leak observed around the right engine area of the Motorcycle.

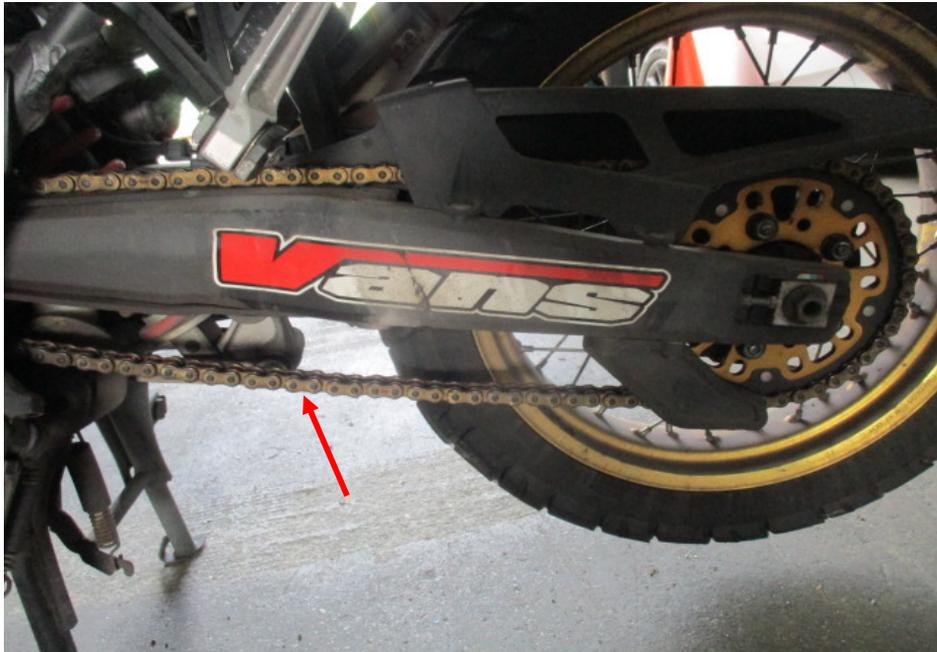
Photo 17 shows the general view of the gear train (arrowed) of the Motorcycle, which was observed to be intact with no misalignment. It was also adequately lubricated for operating purposes.

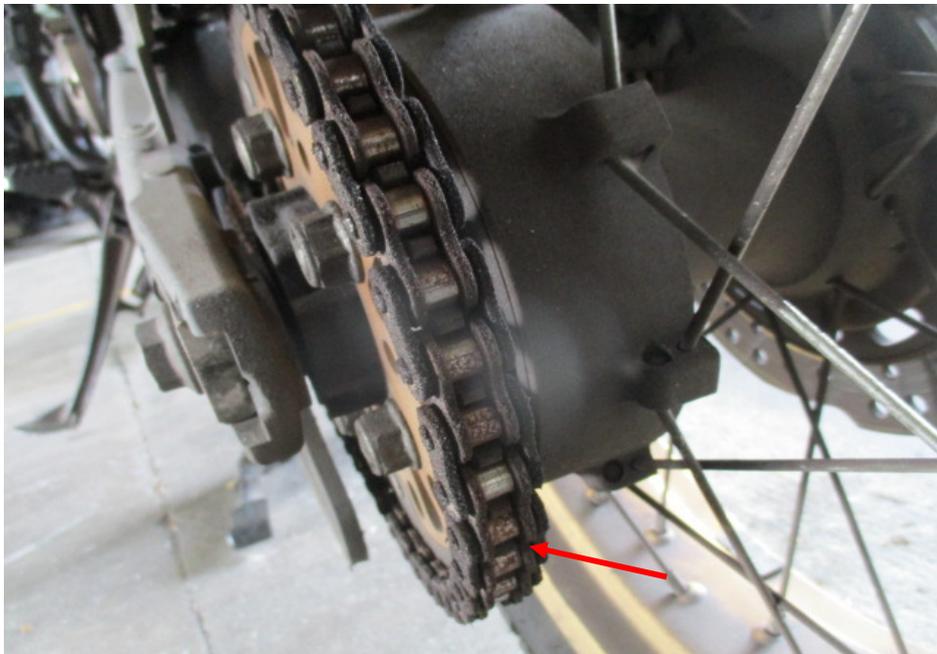
Photo 18 shows a closer view of the gear train (arrowed) of the Motorcycle, which was observed to be intact with no misalignment. It was also adequately lubricated for operating purposes.

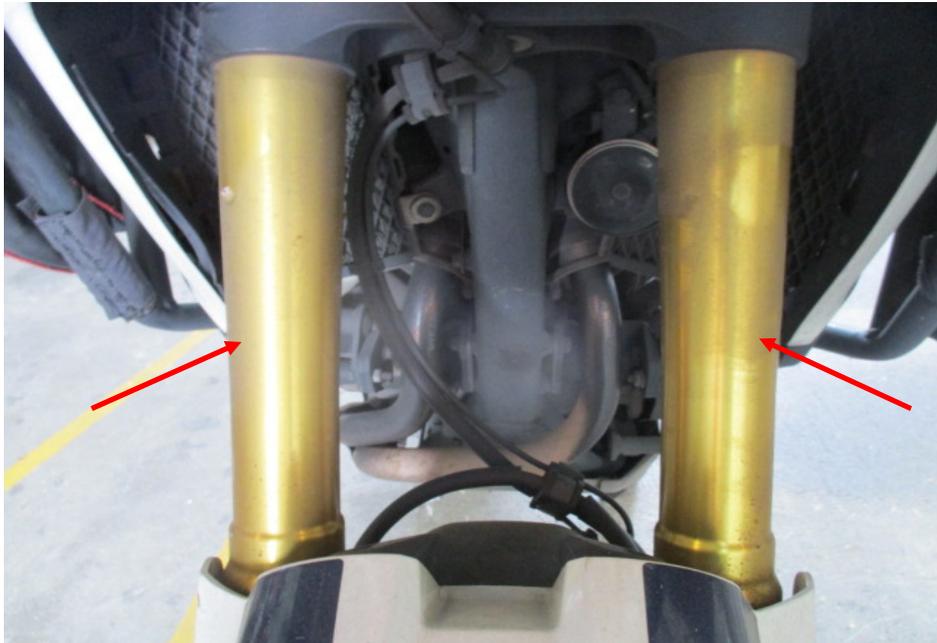
Photo 19 shows the front fork (arrowed) of the Motorcycle. The front fork and fork bracket of the Motorcycle were both found to be intact and undamaged. Turning the Motorcycle's handle bar towards the left and right did not produce any abnormal free play and/or resistance. The steering system of the Motorcycle was in serviceable condition at the time of our inspection.

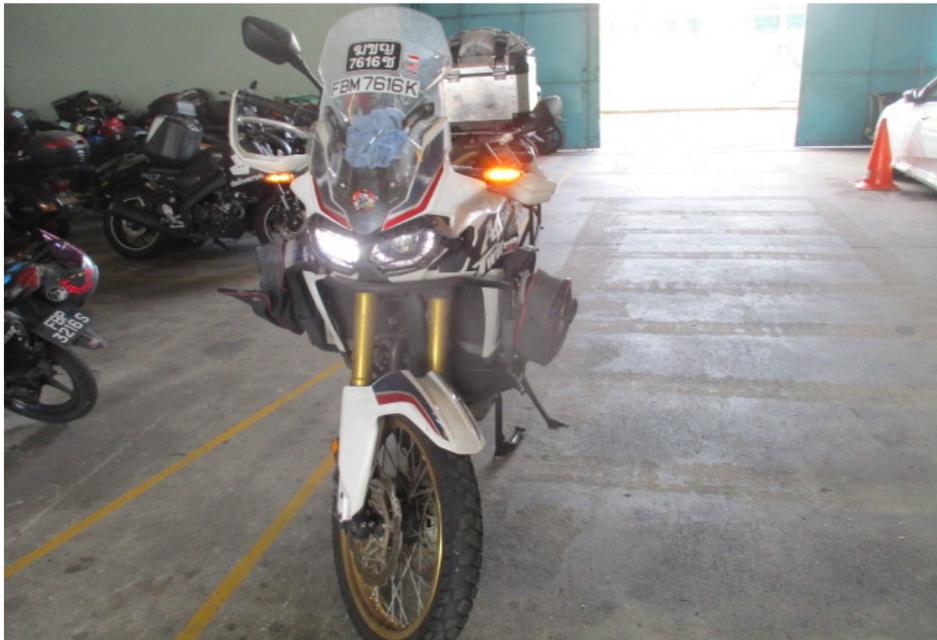
Photo 20 shows the front wheel of the Motorcycle turned towards its full left. Turning the Motorcycle's handle bar towards the left and right did not produce any abnormal free play and/or resistance. This would indicate that the steering system of the Motorcycle was in serviceable condition at the time of our inspection.

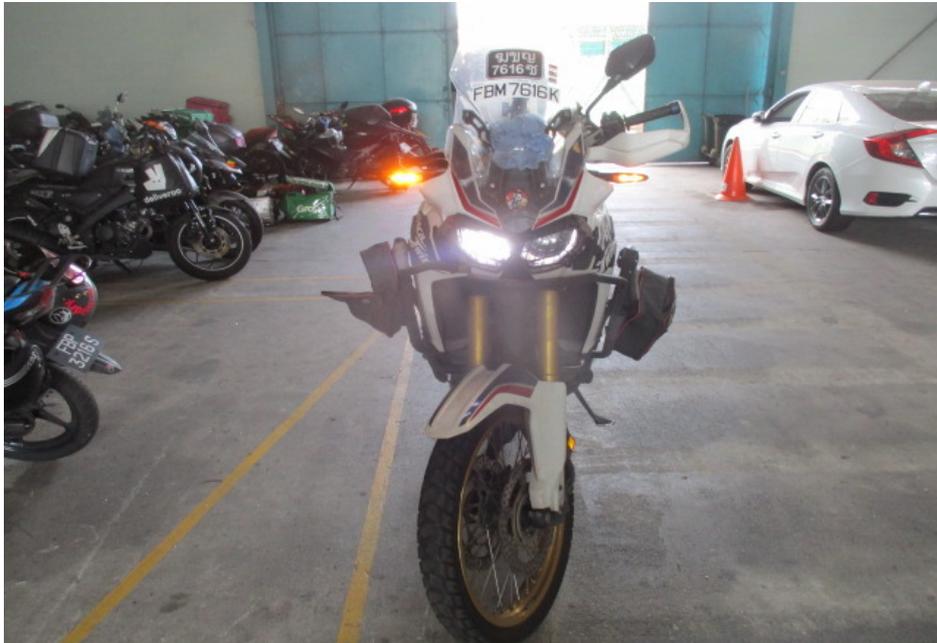
Photo 21 shows the front wheel of the Motorcycle turned towards its full right. Turning the Motorcycle's handle bar towards the left and right did not produce any abnormal free play and/or resistance. This would indicate that the steering system of the Motorcycle was in serviceable condition at the time of our inspection.

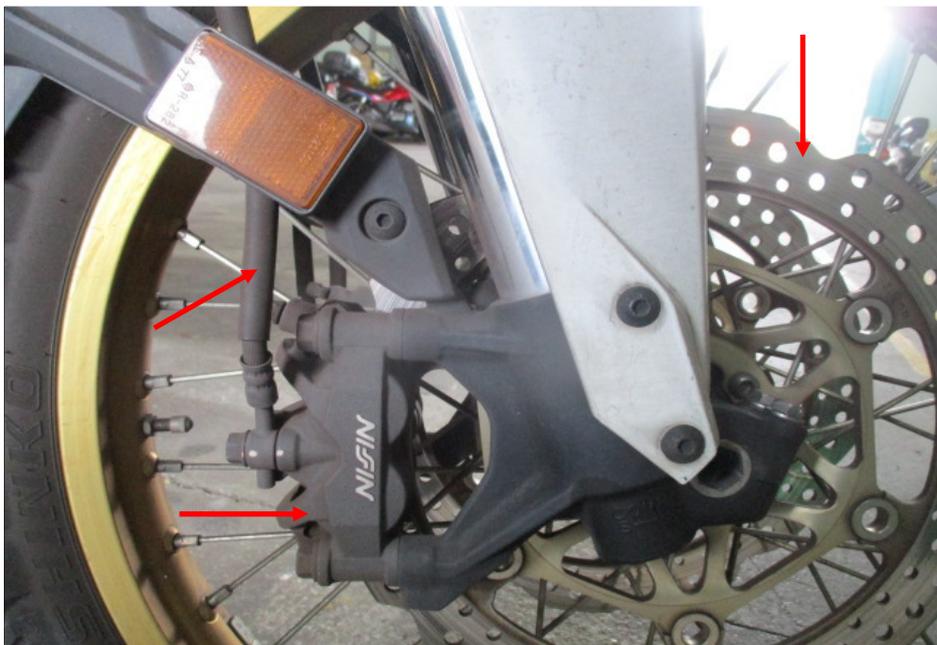
Photo 22 shows a close up view of the front brake caliper, front brake disc and front brake hose (arrowed) at the right side of the Motorcycle's front wheel, which are all part of the components in the hydraulic front brake system of the Motorcycle. Our visual checks of these various components had revealed all to be intact with no visible damage. No leakage of brake fluid was also observed.

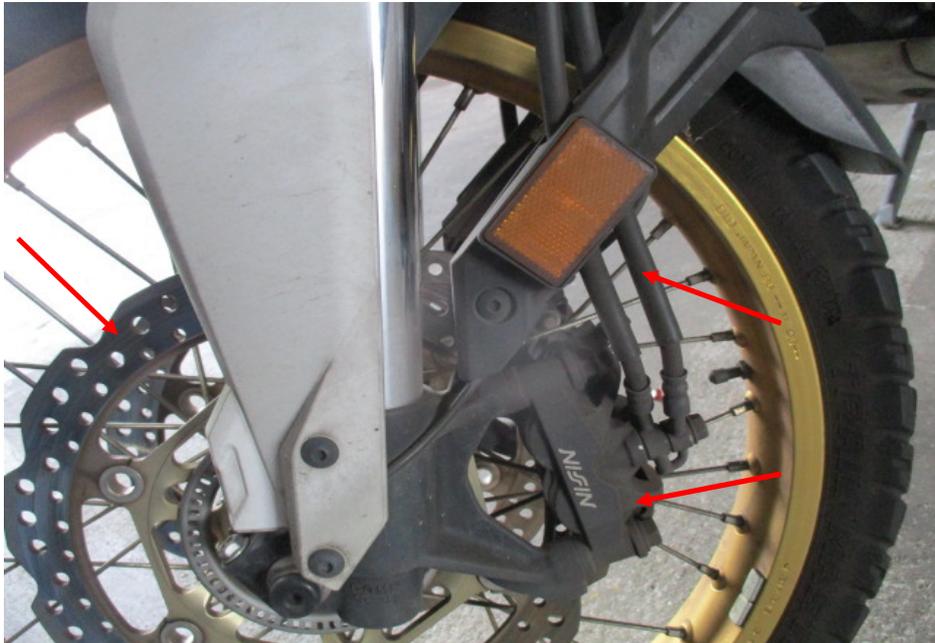
Photo 23 shows a close up view of the front brake caliper, front brake disc and front brake hose (arrowed) at the left side of the Motorcycle's front wheel, which are all part of the components in the hydraulic front brake system of the Motorcycle. Our visual checks of these various components had revealed all to be intact with no visible damage. No leakage of brake fluid was also observed.

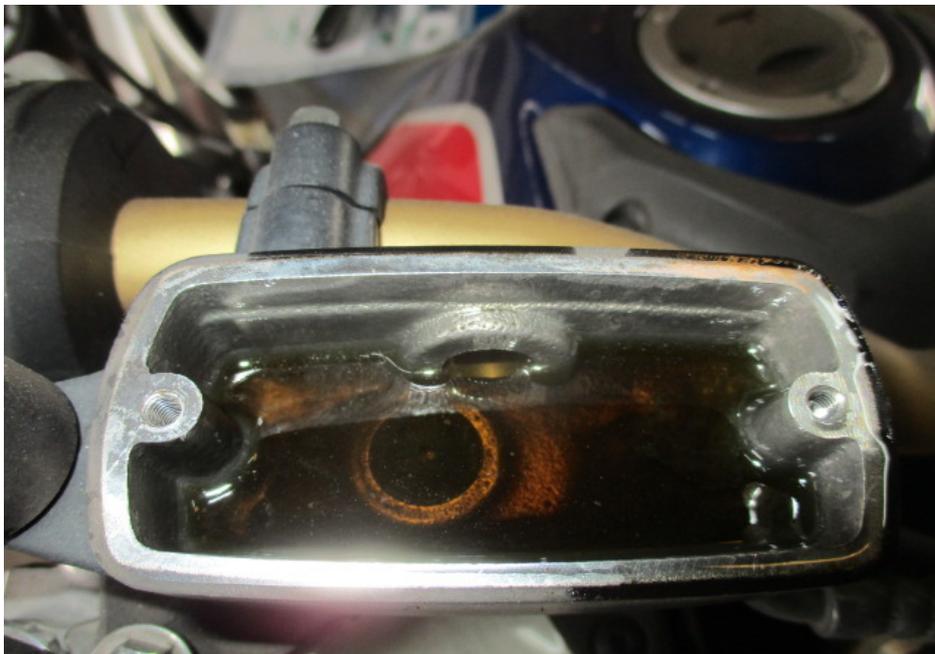
Photo 24 shows the brake fluid reservoir for the front brake of the Motorcycle. The brake fluid was observed to be of sufficient level for operational purposes and without any contamination.

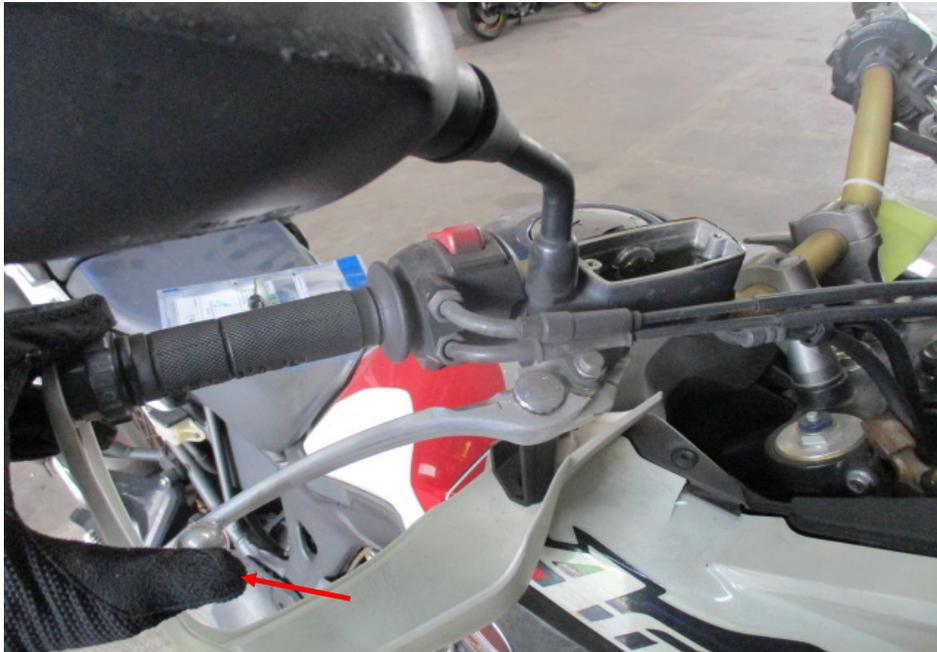
Photo 25 shows the front brake lever being depressed. There was some resistance felt (spongy like feel) upon pressing the front brake lever (arrowed). This would indicate that there is no leakage of pressure/vacuum in the brake system.

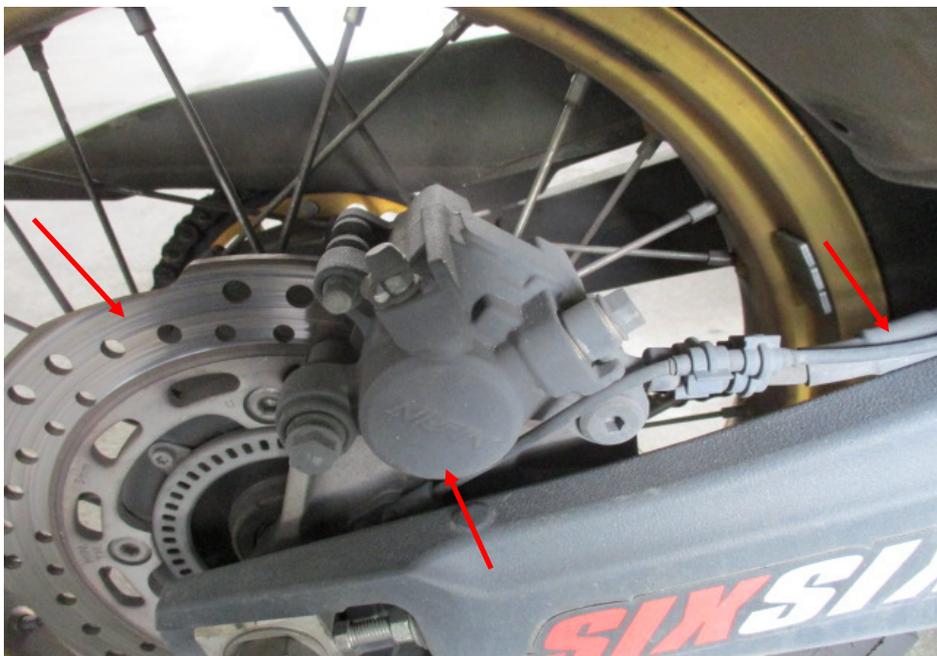
Photo 26 shows a close up view of the rear brake caliper, rear brake disc and rear brake hose (arrowed) of the Motorcycle, which are all part of the components in the hydraulic rear brake system of the Motorcycle. Our visual checks of these various components had revealed all to be intact with no visible damage. No leakage of brake fluid was also observed.
