Your Ref: TP/IP/56643/2020
Our Ref : CI/TPD21003522/N

Fatal Accident Investigation Team

MECHANICAL INSPECTION REPORT OF MOTORCYCLE FBG 2194A

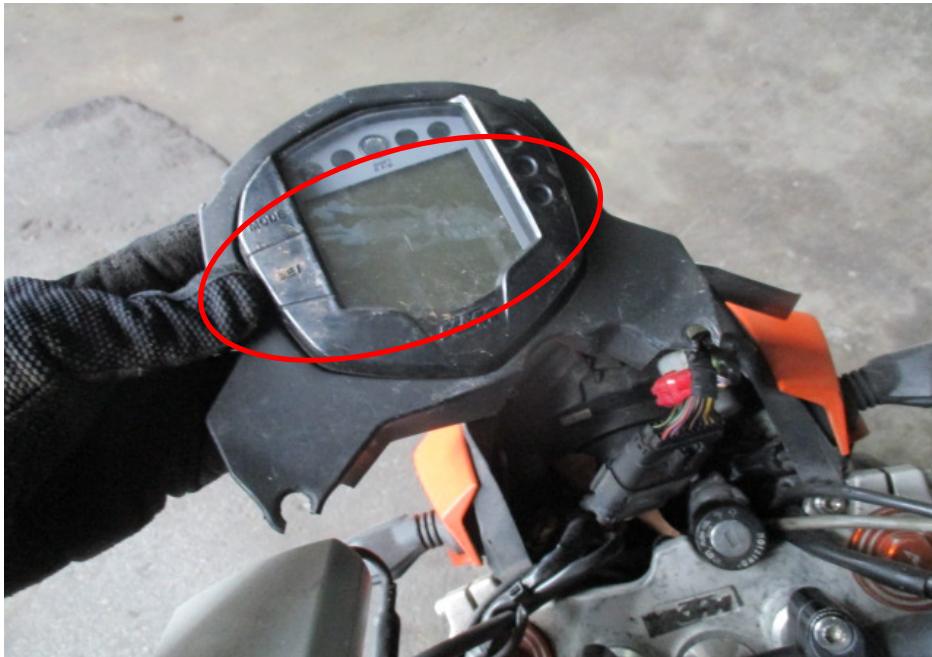
Photo 1 shows the mileage of the Motorcycle which could not be recorded at the time of our inspection due to the damaged speedometer gauge (circled).

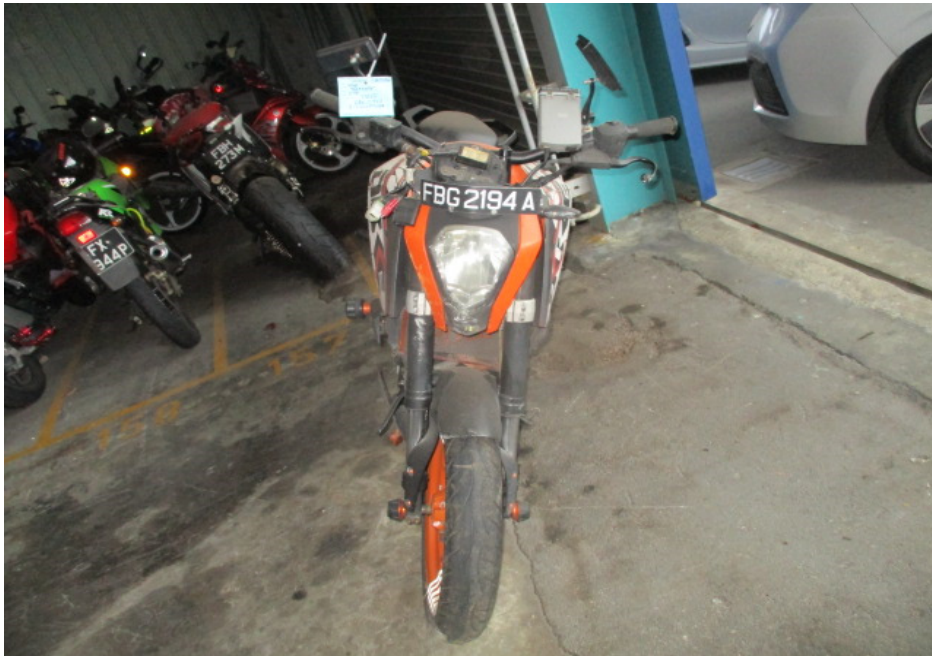
Photo 2 shows a general view of the frontal portion of the Motorcycle at the time of our inspection. The Motorcycle had sustained damages all around.

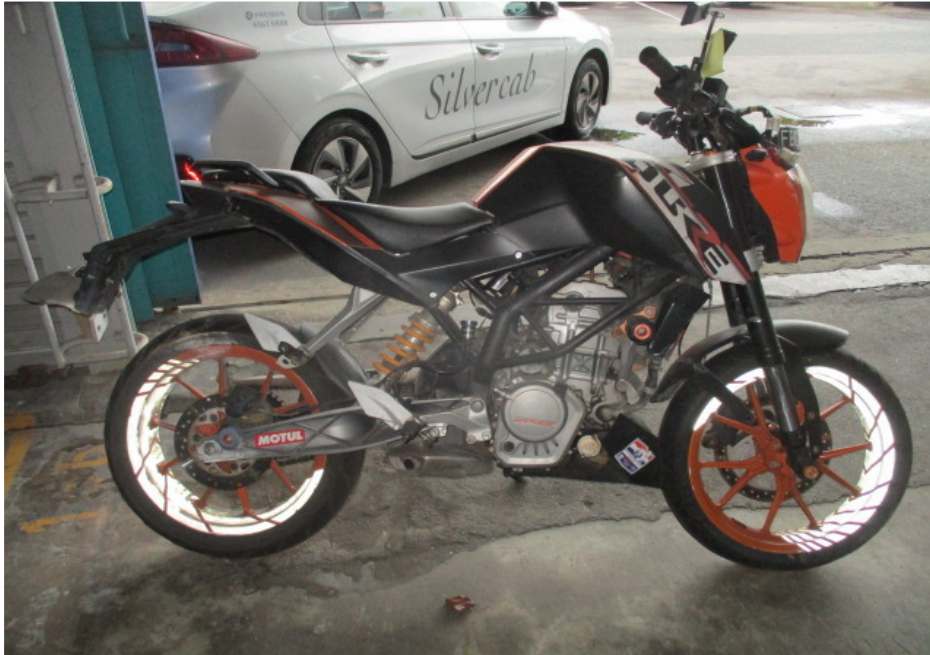
Photo 3 shows a general view of the right body of the Motorcycle at the time of our inspection. The Motorcycle had sustained damages all around. Body parts that were found to have been damaged include its headlight assembly, speedometer gauge, front fork assembly, front mudguard, left tank cover, side mirrors, front brake lever, clutch lever, handlebar ends, rear brake pedal, belly pan and right radiator cover, among others.

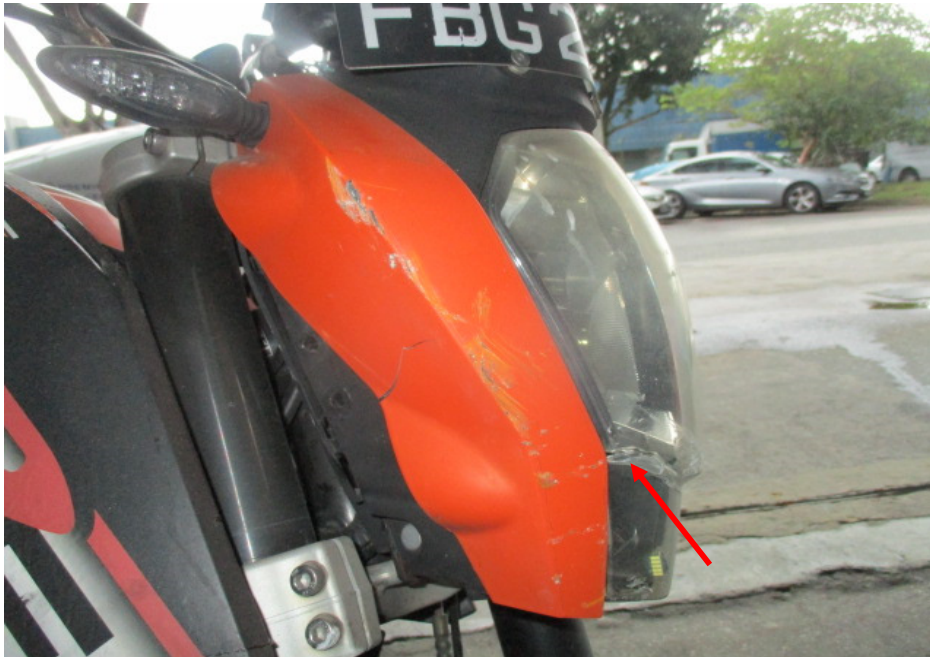
Photo 4 shows a closer view of the cracked headlight assembly of the Motorcycle as a result of the accident (arrowed).

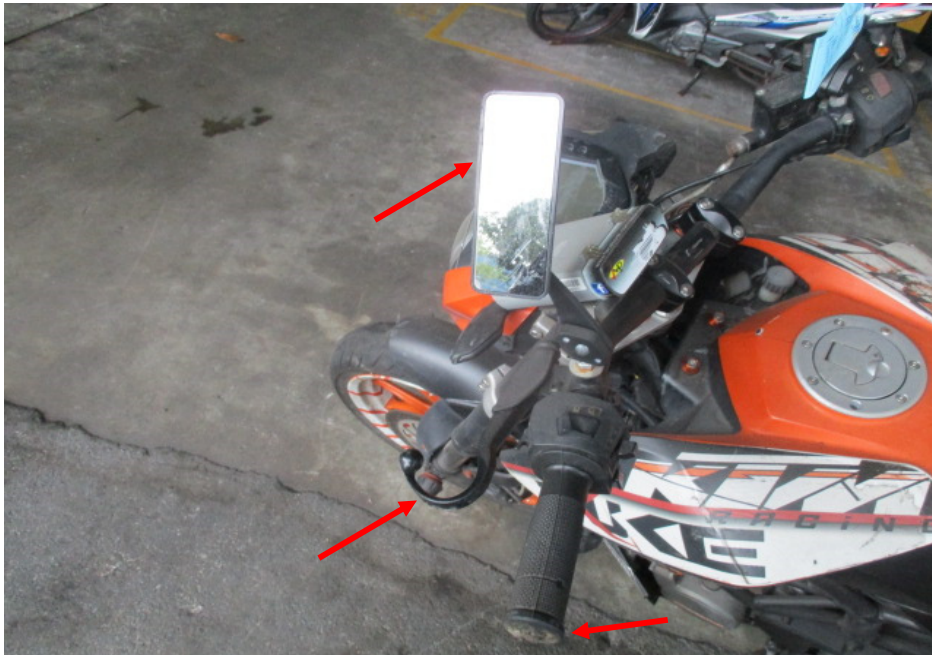
Photo 5 shows a closer view of the clutch lever, left side mirror and left handlebar end (arrowed) of the Motorcycle. These parts were amongst the body parts of the Motorcycle which were damaged as a result of the accident.

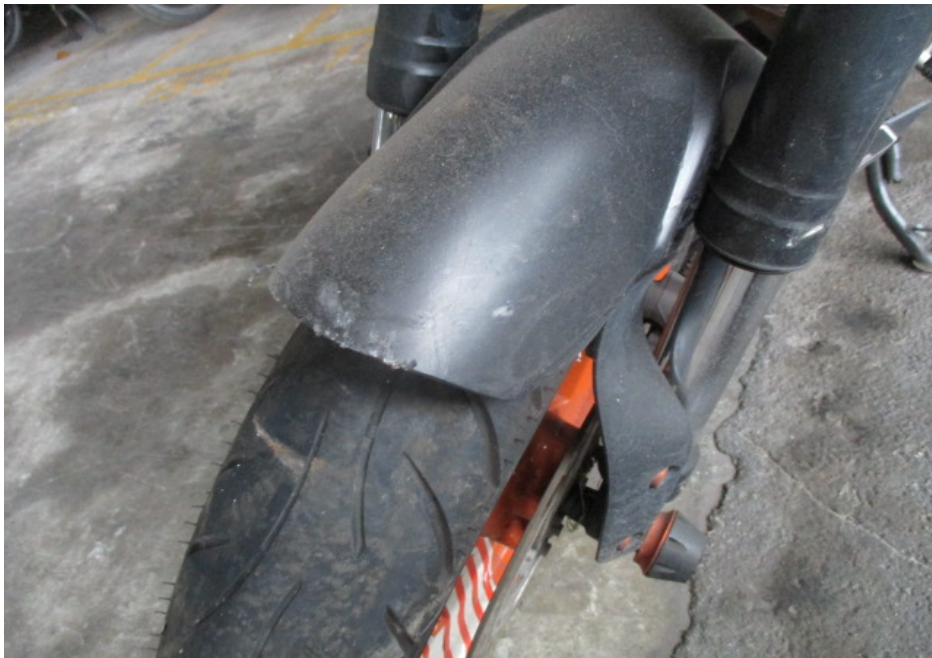
Photo 6 shows a closer view of the front mudguard, which was amongst the body parts of the Motorcycle that had sustained damage as a result of the accident.

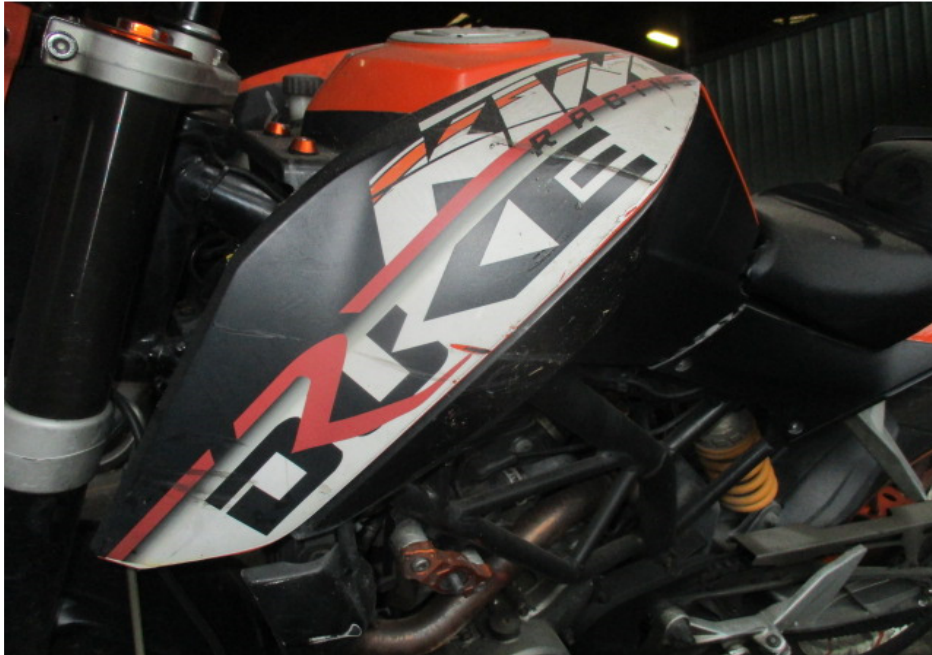
Photo 7 shows a closer view of the left tank cover which was amongst the body parts of the Motorcycle that had sustained damages as a result of the accident.

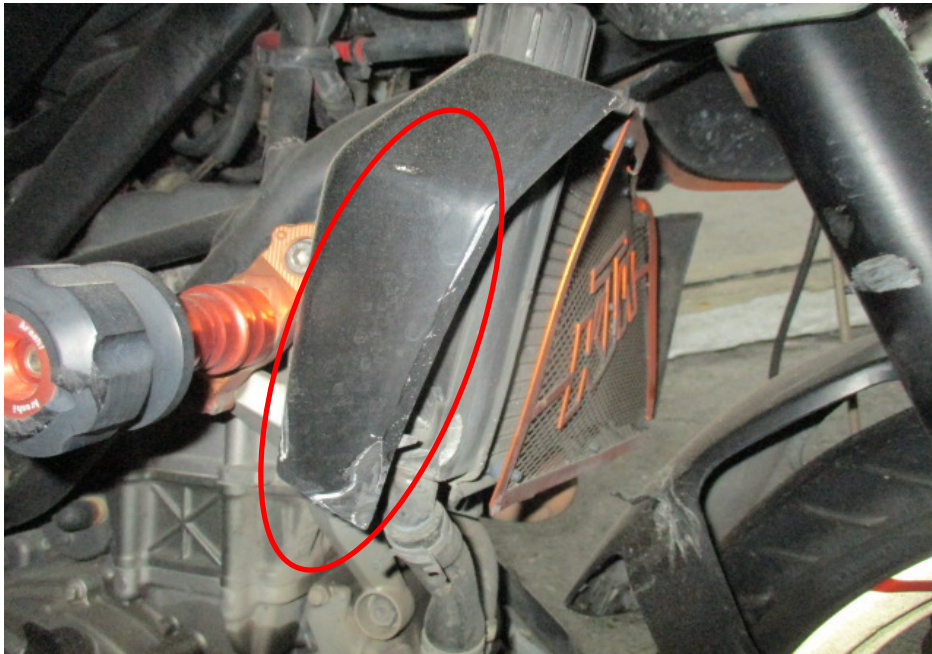
Photo 8 shows a closer view of the right radiator cover which was amongst the body parts at the rear body of the Motorcycle that had sustained damages as a result of the accident (circled).

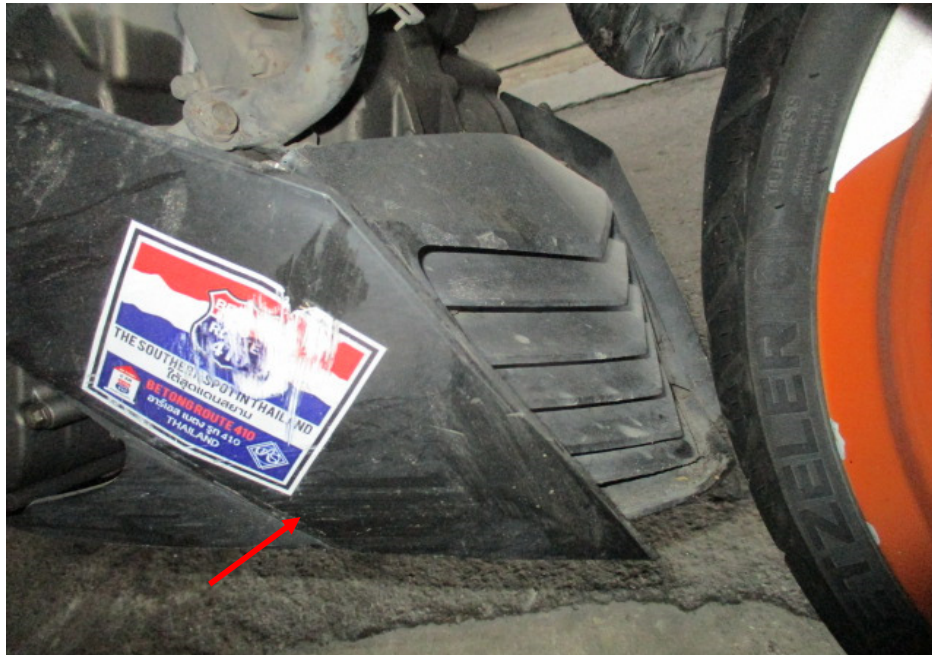
Photo 9 shows a closer view of the belly pan which was amongst the body parts at the front body of the Motorcycle that had sustained damages as a result of the accident (arrowed).

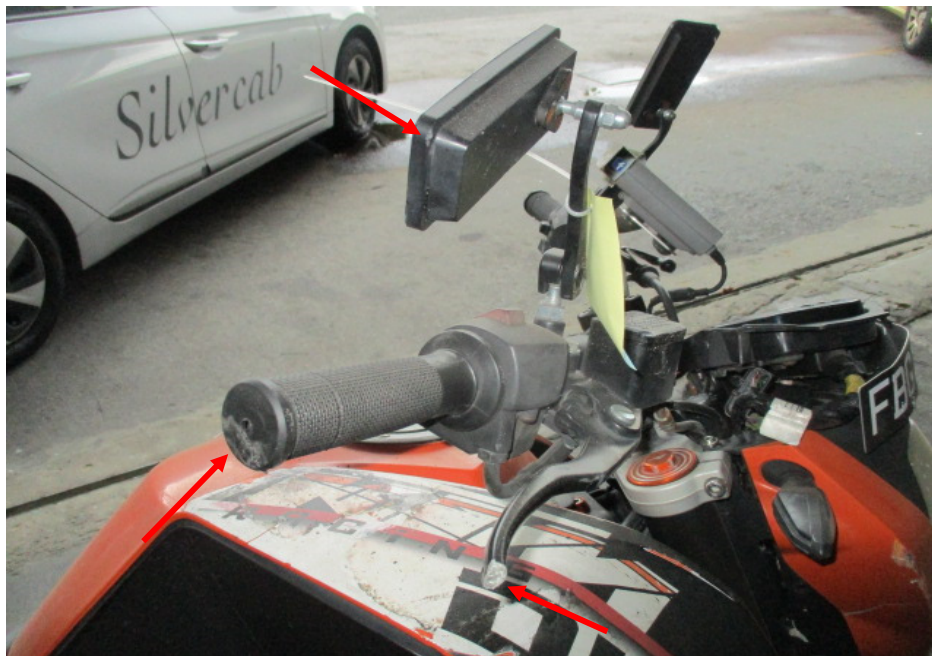
Photo 10 shows a closer view of the right side mirror and right handlebar end and front brake lever (arrowed), which were amongst the body parts of the Motorcycle that had sustained damage as a result of the accident.

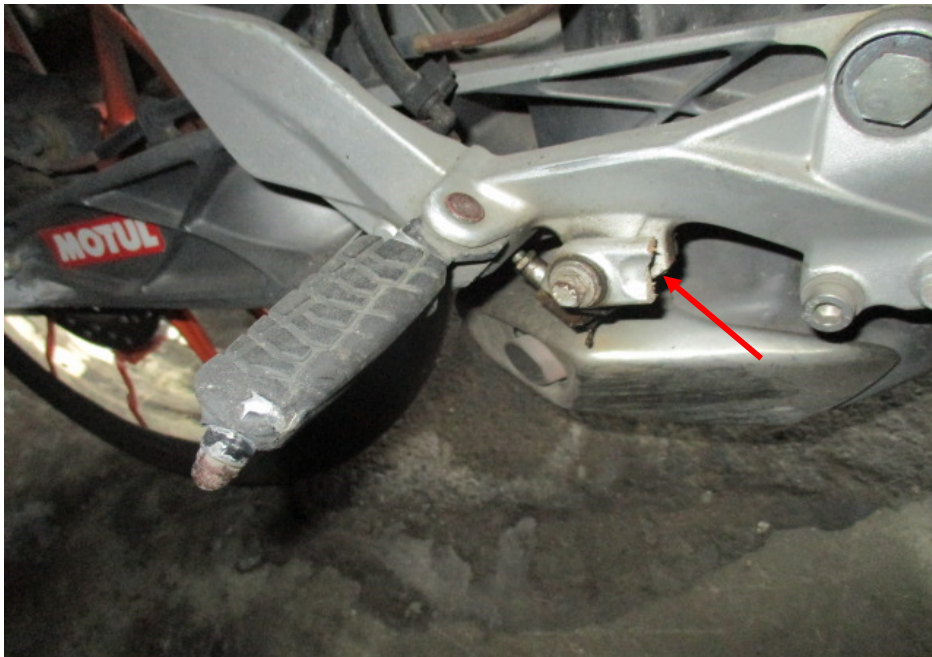
Photo 11 shows the broken rear brake pedal of the Motorcycle as a result of the accident (arrowed).

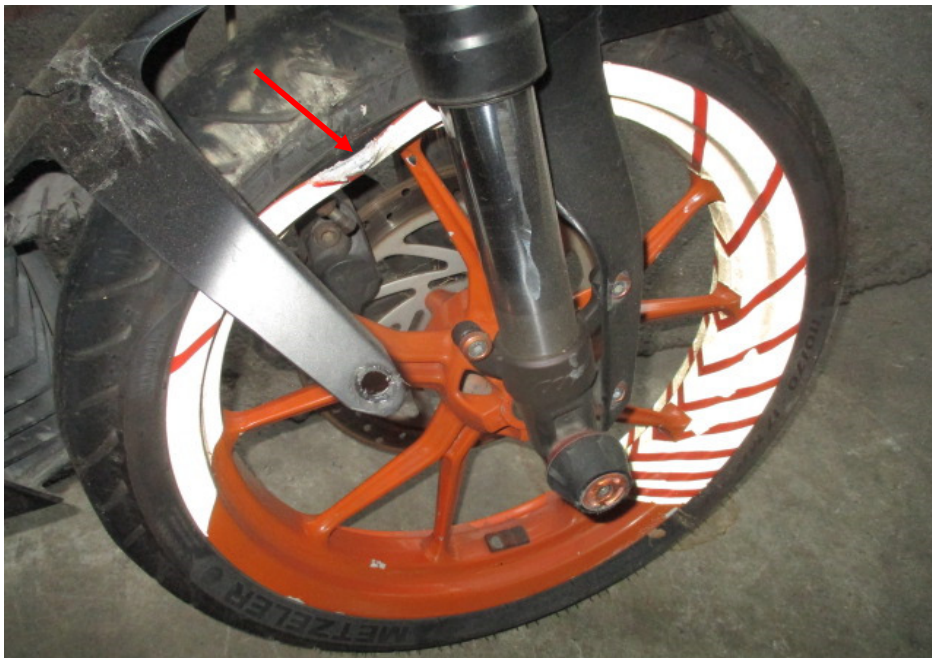
8. The 2 tyres were wrapped around alloy wheel rims. At the time of our inspection, we did not observe any visible damage on the rear wheel rim of the Motorcycle. However we did observe that the front wheel rim was bent. See photos 1 – 14 below.

Photo 12 shows the bent front wheel rim of the Motorcycle as a result of the accident at the time of our inspection (arrowed).

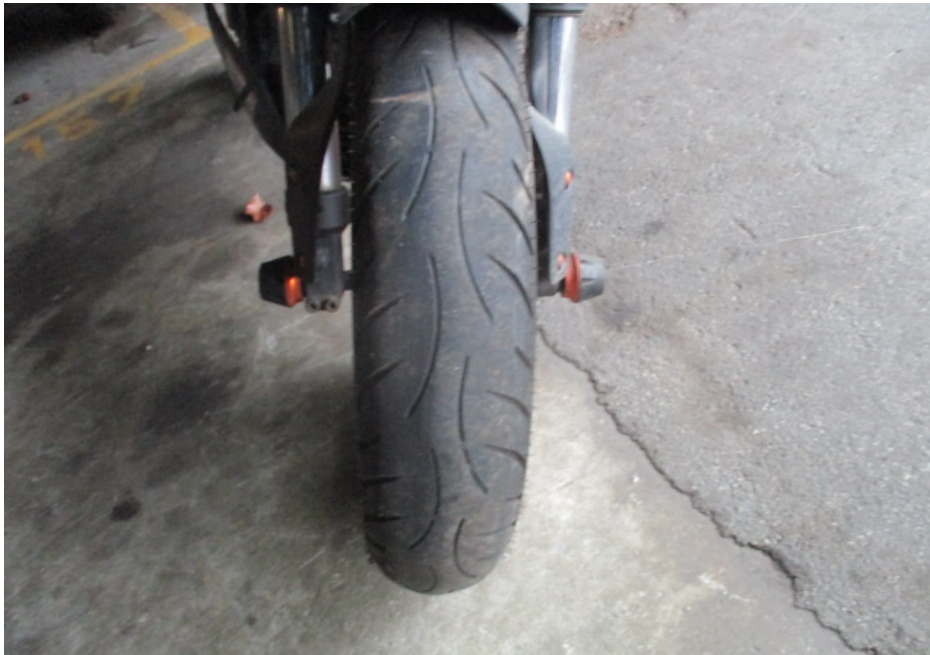
Photo 13 shows the front tyre of the Motorcycle at the time of our inspection. The front tyre was observed to be in serviceable condition with remaining tread depth of approximately 3mm. The pattern of the tread was also clearly visible. There was no tear, burst mark(s) and/or punctured hole(s) on the sidewalls as well as across the tread of the front tyre.

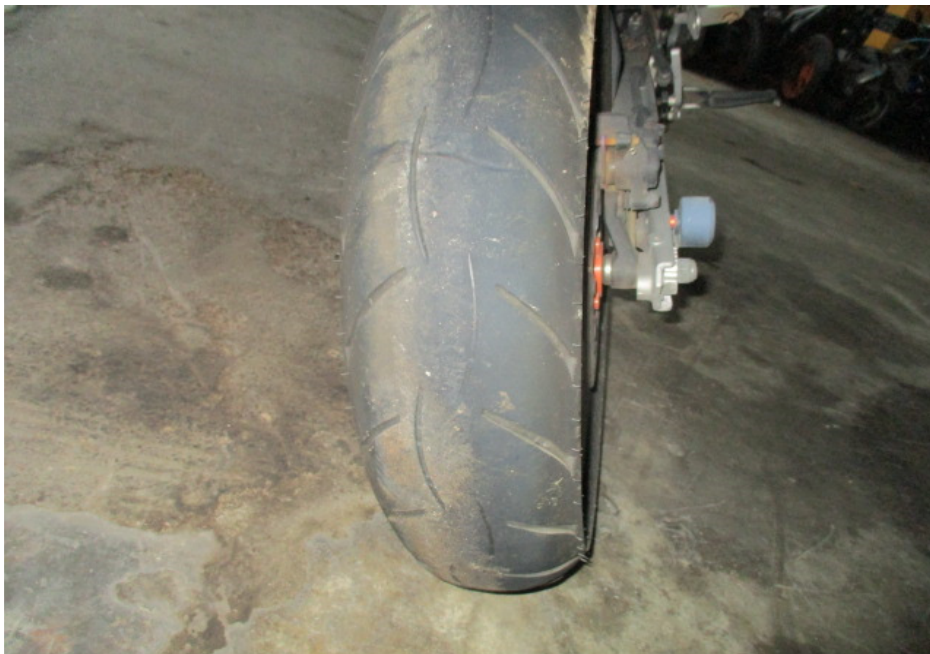
Photo 14 shows the condition of the Motorcycle's rear tyre. The rear tyre was observed to be in serviceable condition with remaining tread depth of approximately 3mm. The tyre was also observed to be sufficiently inflated for vehicular operation. We did not observe any tear, burst mark(s) and/or punctured hole(s) on the sidewalls as well as across the tread of the rear tyre.

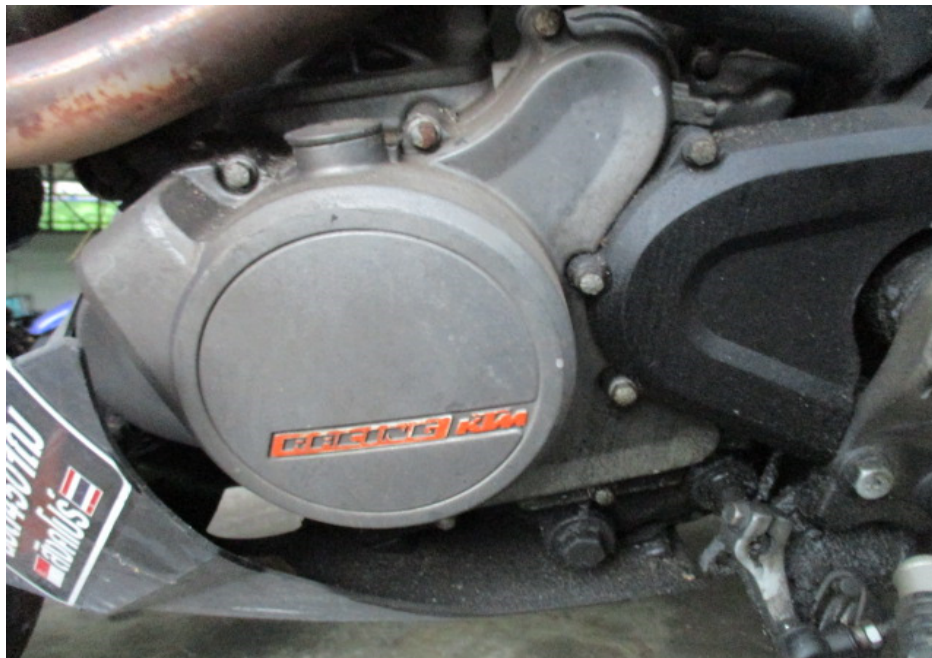
Photo 15 shows the left side of the engine of the Motorcycle at the time of our inspection. The various engine related parts and components were found to be intact with no visible damage. There was also no sign(s) or indication(s) of fluid leak observed around the left engine area of the Motorcycle.

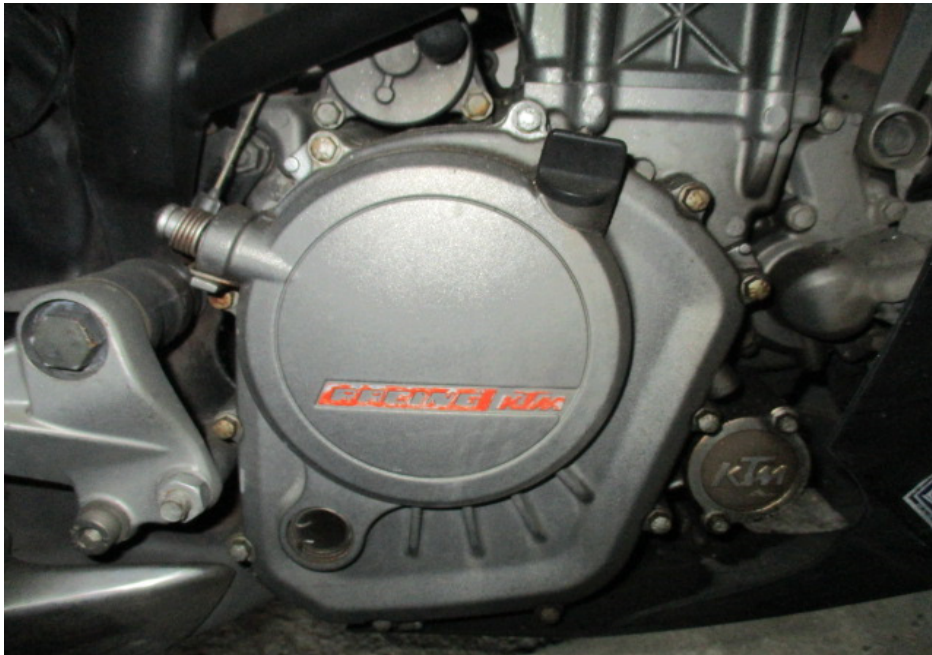
Photo 16 shows the right side of the engine of the Motorcycle at the time of our inspection. The various engine related parts and components were found to be intact with no visible damage. There was also no sign(s) or indication(s) of fluid leak observed around the right engine area of the Motorcycle.

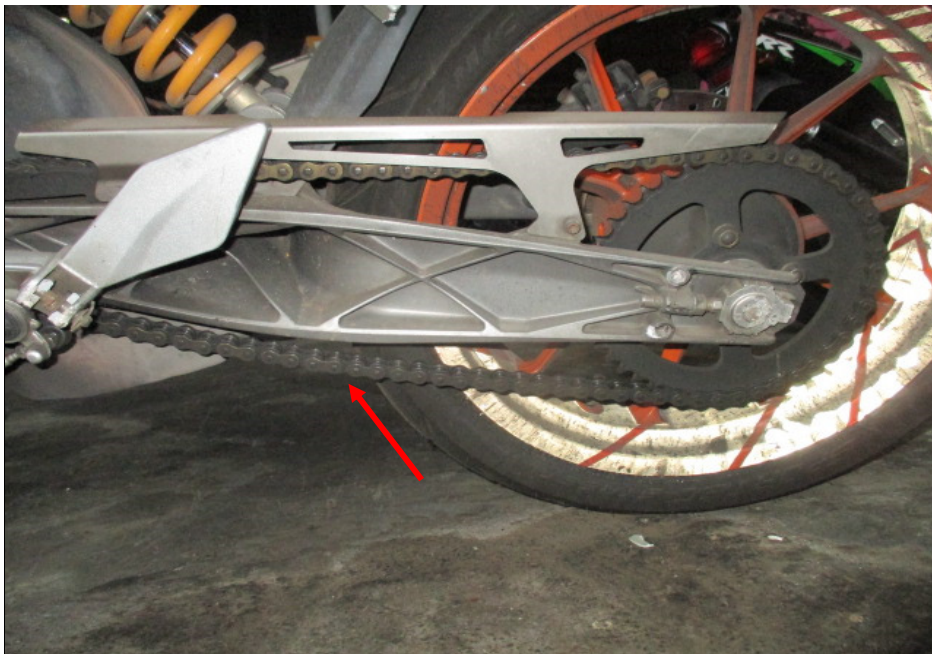
Photo 17 shows the gear chain (arrowed) of the Motorcycle, which was observed to be intact with no misalignment. It was also adequately lubricated for operating purposes. The gear chain rotates the rear wheel of the Motorcycle.

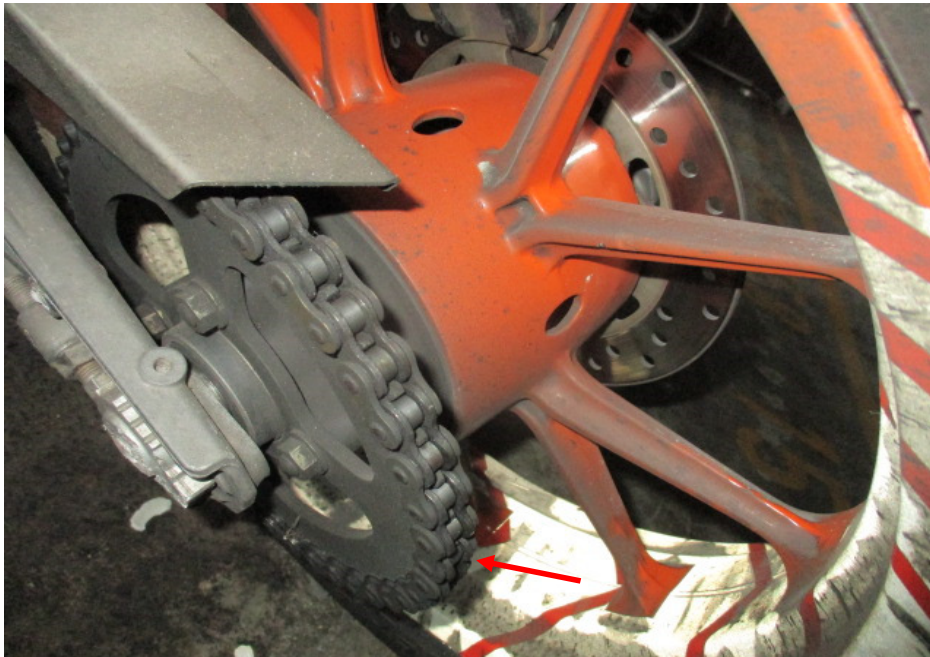
Photo 18 shows the closer view of the gear chain (arrowed) of the Motorcycle, which was observed to be intact with no misalignment. It was also adequately lubricated for operating purposes.

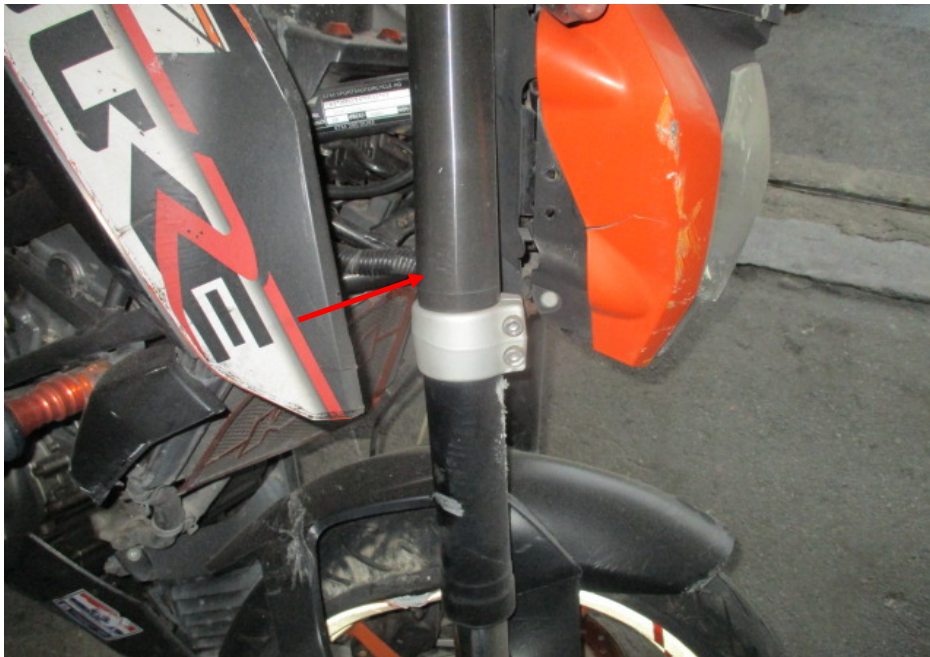
11. For this case, we were not able to conduct any test(s) on the steering system of the Motorcycle due to the damage of its front forks. The right front fork was found to be bent inwards as a result of the accident.

Photo 19 shows the front forks of the Motorcycle. The front right fork was observed to be bent inwards (arrowed) as a result of the accident. We were hence not able to conduct any tests on the steering system of the Motorcycle.

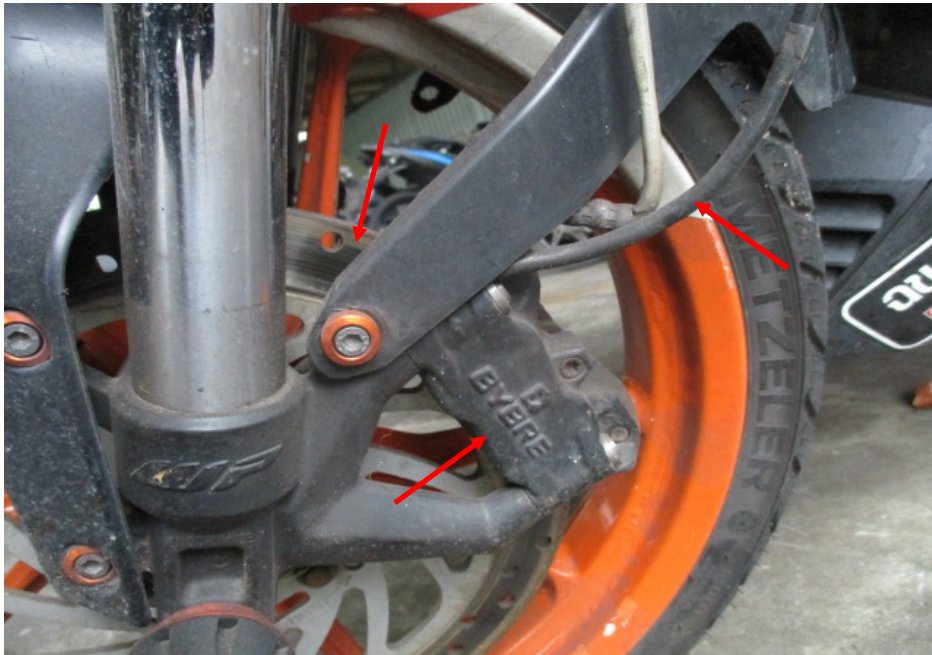
Photo 20 shows a close up view of the front brake caliper, front brake disc and front brake hose (arrowed) of the Motorcycle, which are all part of the components in the hydraulic front brake system of the Motorcycle. Our visual checks of these various components had revealed all to be intact with no visible damage. No leakage of brake fluid was also observed.

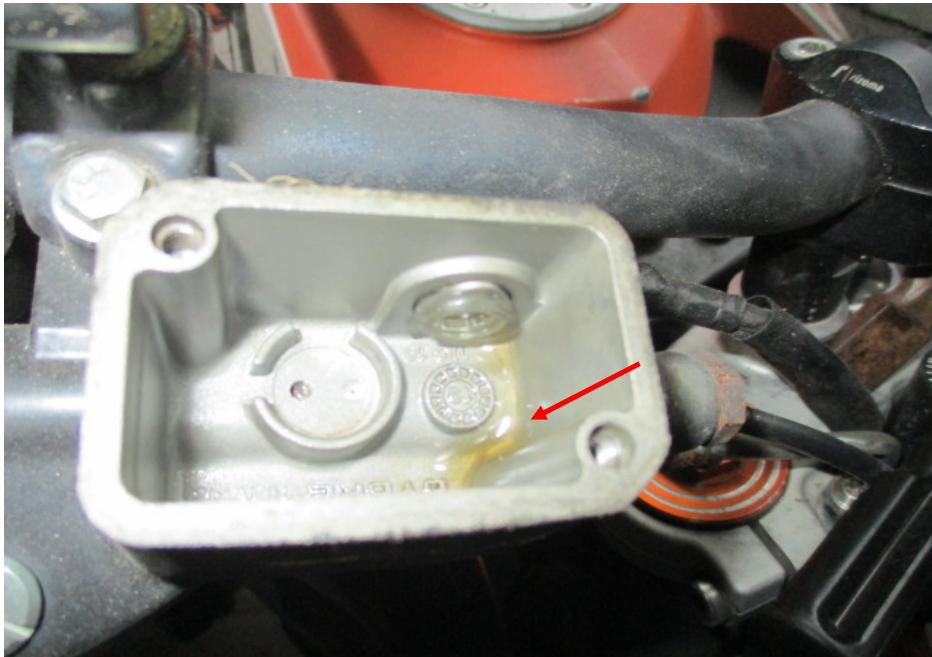
Photo 21 shows the brake fluid reservoir for the front brake of the Motorcycle. The brake fluid was found to be of insufficient level for operating purposes (arrowed).

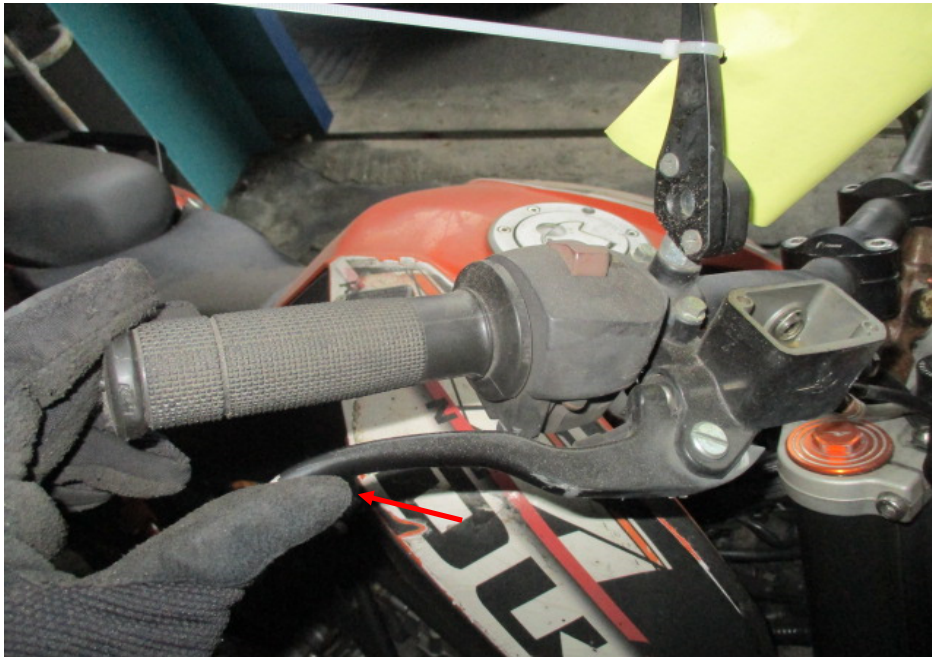
14. Static brake tests conducted on the Motorcycle had appear to indicate that the front braking system of the Motorcycle was in serviceable condition. There was some resistance felt (spongy like feel) upon pressing the brake lever. This would indicate that there was no leakage of pressure/vacuum in the front brake system.
15. Static brake tests could not be conducted on the Motorcycle's rear braking system due to a broken rear brake pedal.
16. For this case, we were not able to carry out any operational tests to the steering system and braking system of the Motorcycle due to the damage of its front forks, which had rendered the Motorcycle immobile for the operational tests. We were not able to push the Motorcycle manually forward and backward, simulating movement of the Motorcycle, for the operational tests. See photos 19 – 24 below.

Photo 22 shows the front brake lever being depressed. There was some resistance felt (spongy like feel) upon pressing the front brake lever (arrowed). This would indicate that there is no leakage of pressure/vacuum in the brake system.

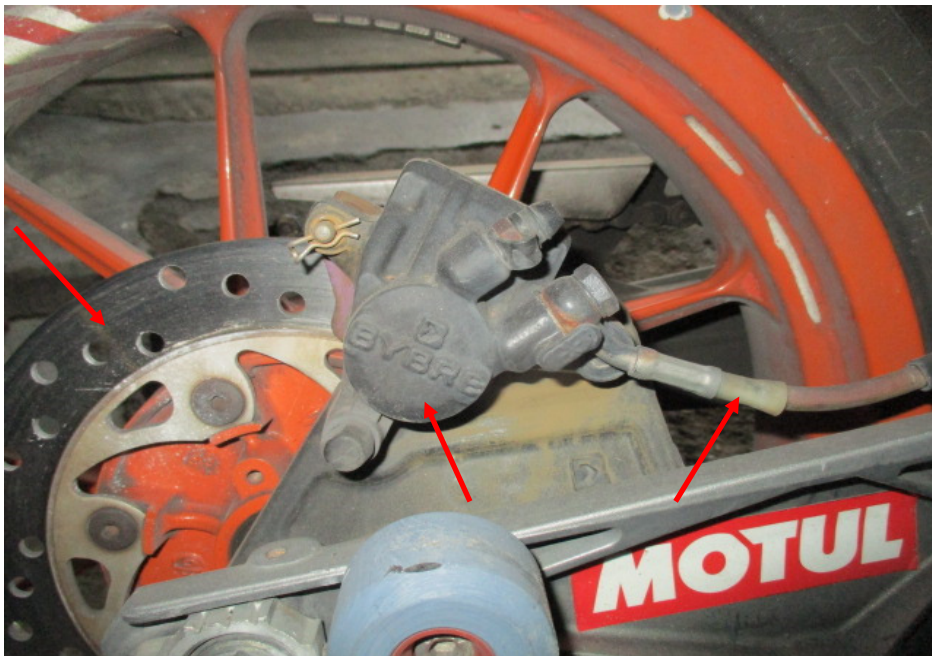
Photo 23 shows a close up view of the rear brake caliper, rear brake disc and rear brake hose (arrowed) of the Motorcycle, which are all part of the components in the hydraulic rear brake system of the Motorcycle. Our visual checks of these various components had revealed all to be intact with no visible damage. No leakage of brake fluid was also observed.

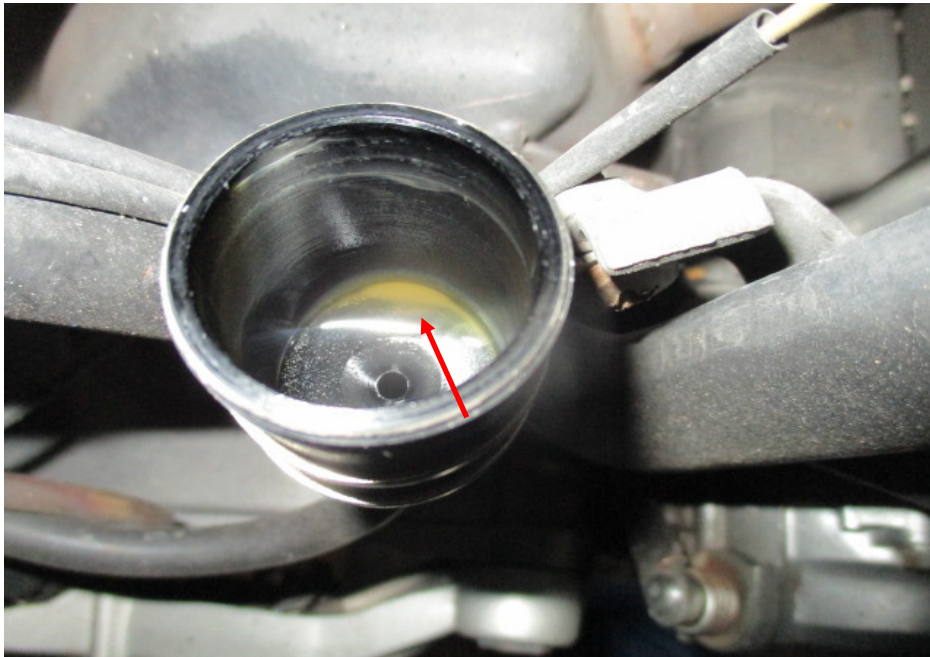
Photo 24 shows the brake fluid reservoir for the rear brake of the Motorcycle. The brake fluid was found to be of insufficient level for operating purposes (arrowed).
