LKK Auto Consultants Pte Ltd

Vehicle No. SGU 8845H
Insured Veh. SGG 1889B
Claim No. 20/21/21/VP05/024335
Policy No. Z/20/VP05026557
Accident Date 14/03/2021
Inspection Date 18/03/2021

ADJUSTMENT ON REPAIR COST FOR VEHICLE NO. SGU 8845H

PHOTOGRAPHS FOR VEHICLE NO. SGU 8845H

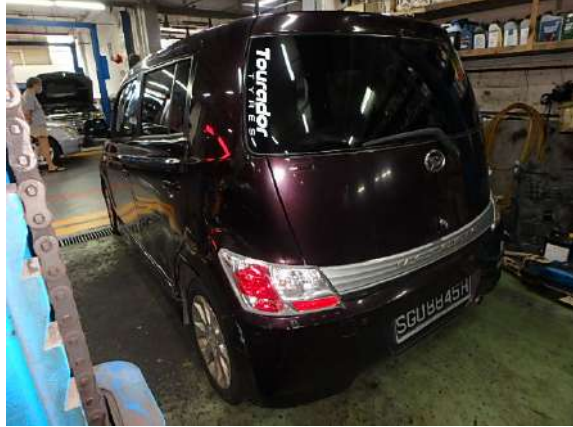
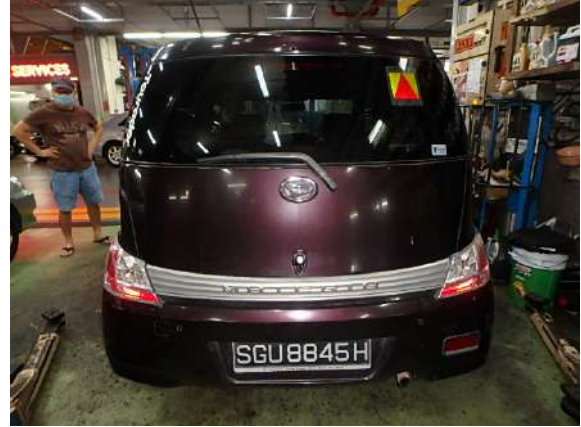
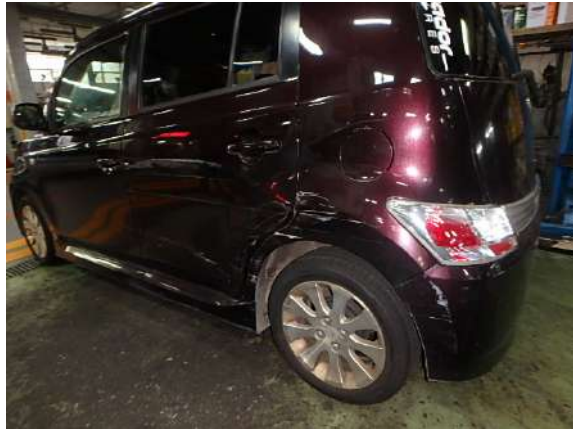
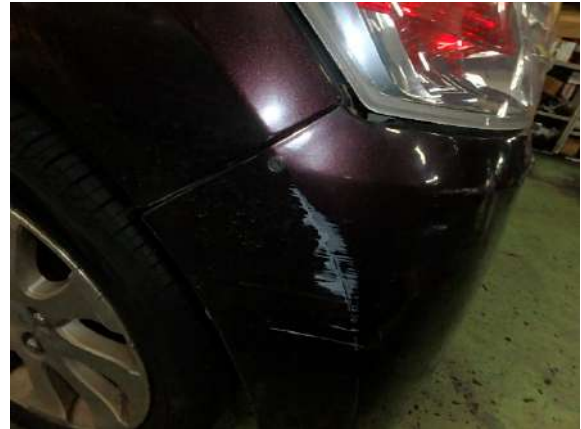
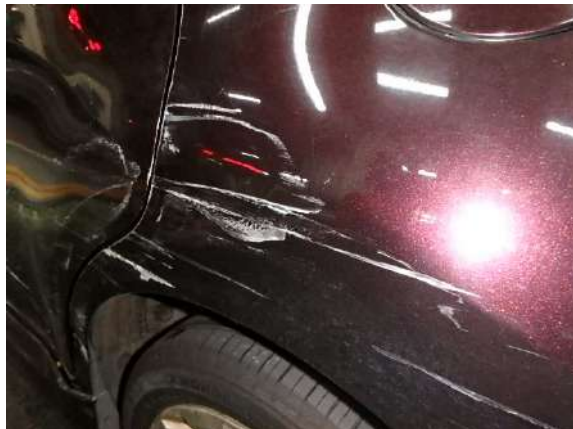
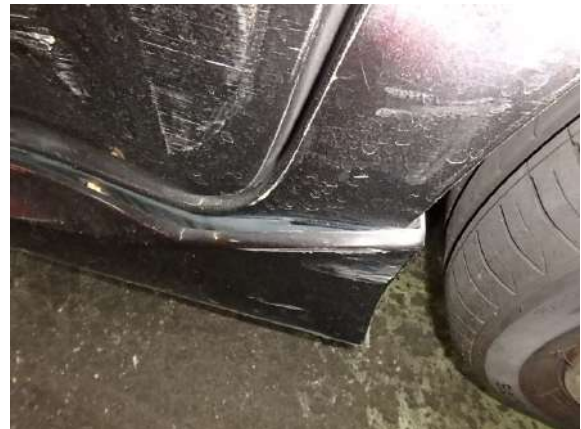
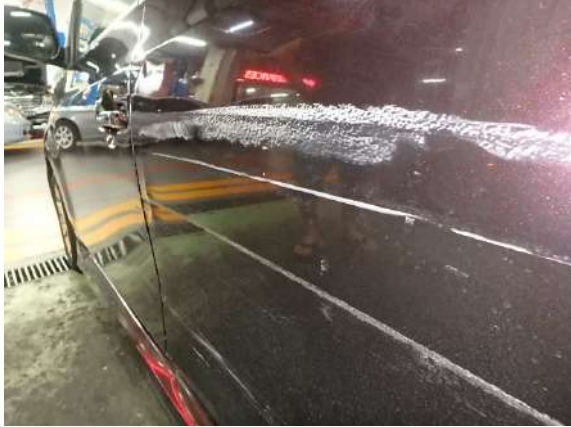
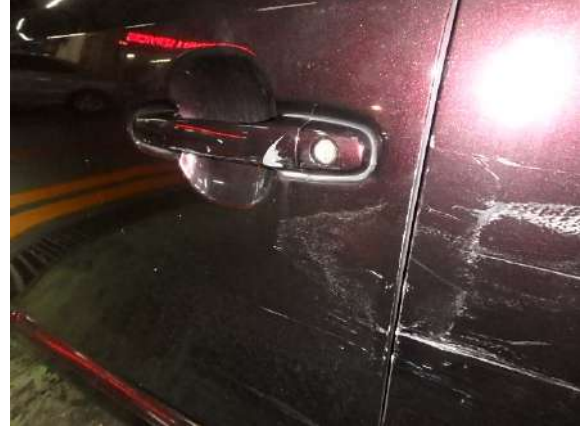
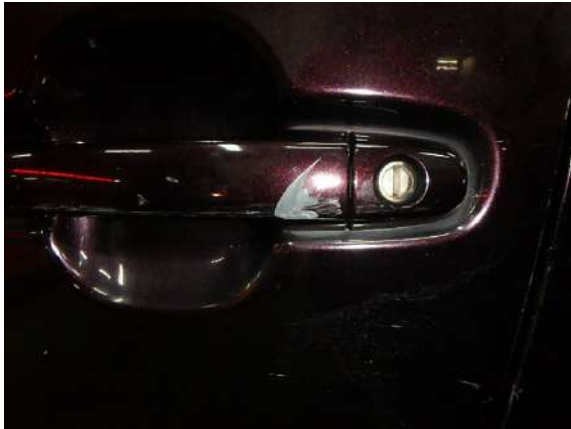
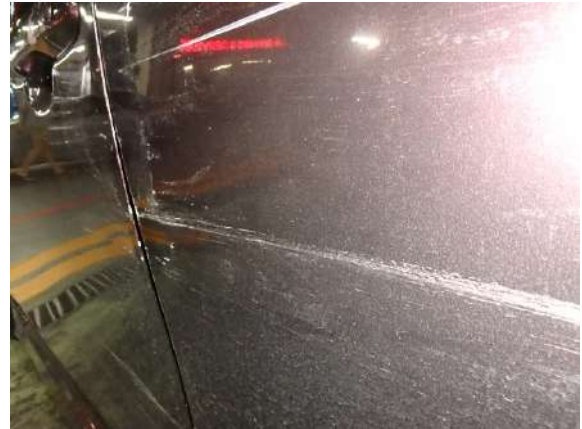
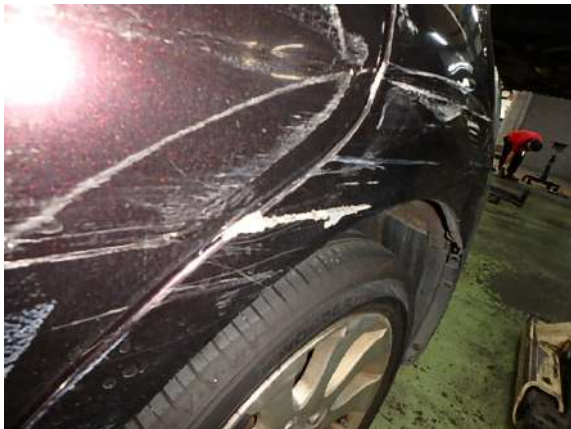
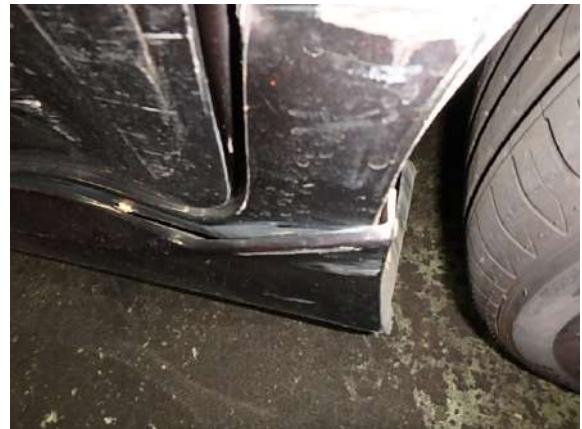
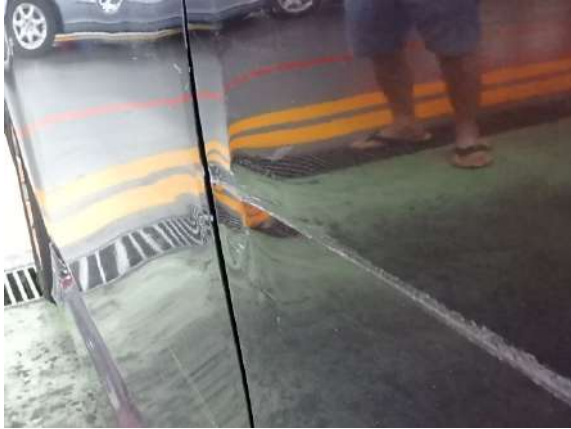
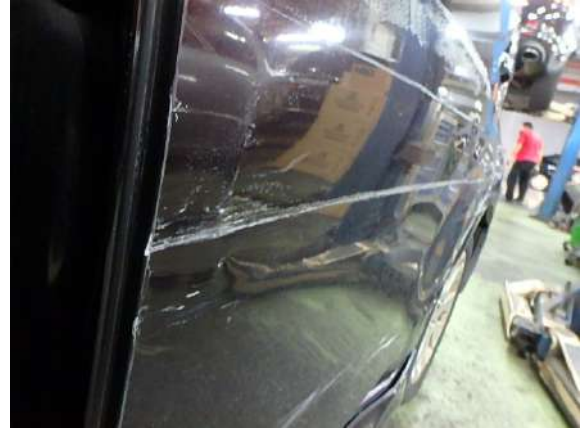
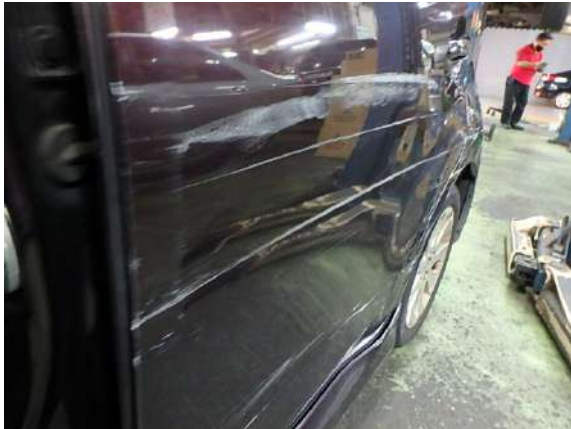
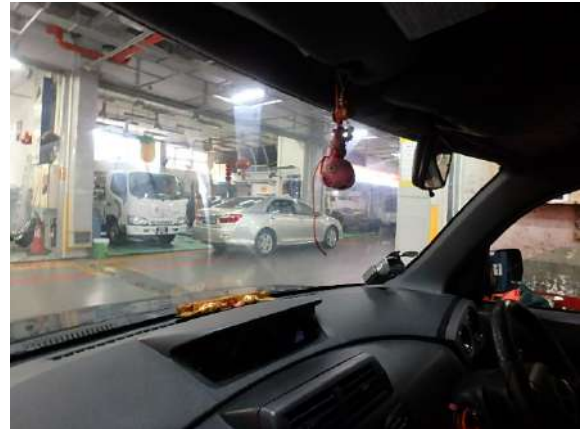
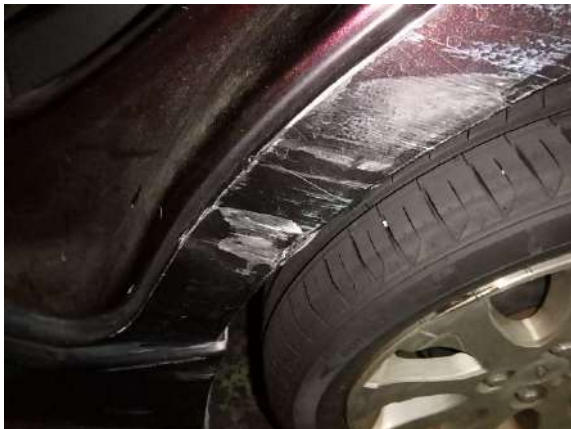
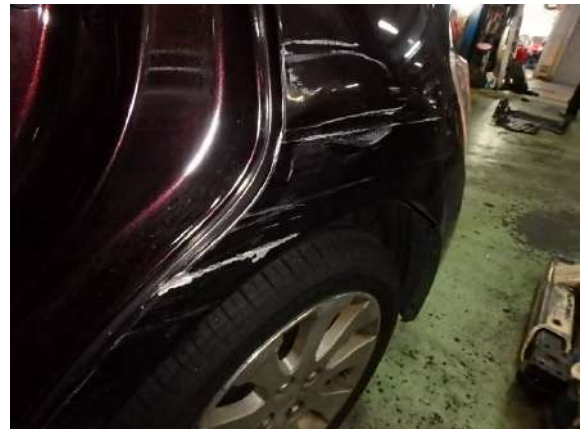
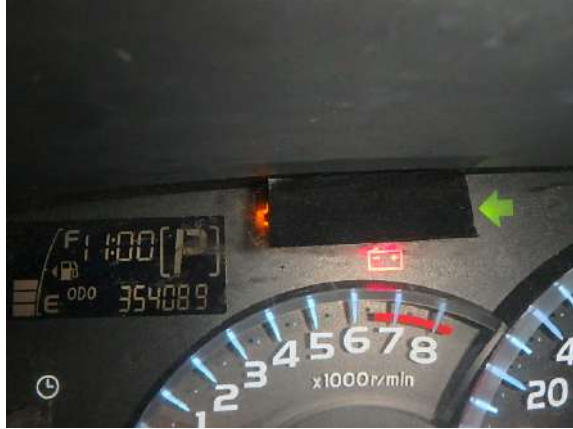
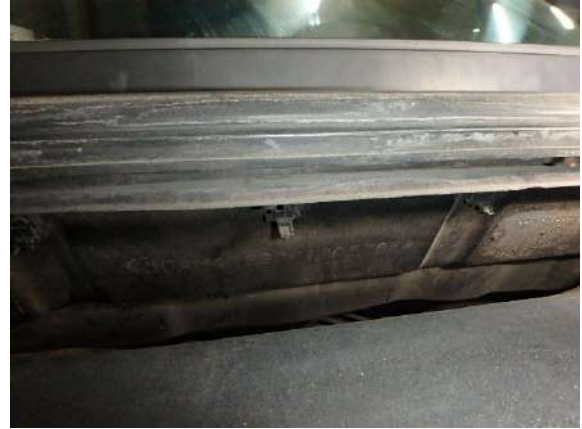
INSPECTION

4. Description of Damages				
THE VEHICLE SUSTAINED DAMAGES AT THE N/S REAR BODY. DAMAGES SEE DETAILS.				
5. General Information				
Accident Date	14/03/2021	Inspection Date	18/03/2021	
Survey held at	AH LIM MOTOR COMPANY NO 10 ANG MO KIO IND PK 2A #01-09 AMK AUTOPOINT SINGAPORE 568047			
5a. Remarks

RECOMMENDED COST OF LUMP SUM REPAIRS (TO ITS PRE-ACCIDENT CONDITION)			2,000.00
---	--	--	-----------------
