AUTOMOBILE ASSESSMENT REPORT

Our Reference: 1120/AP706
Date: 30-Nov-2020

ASSESSMENT OF VEHICLE NO. SJN 3238 U

DATE OF LOSS: 10-Nov-2020

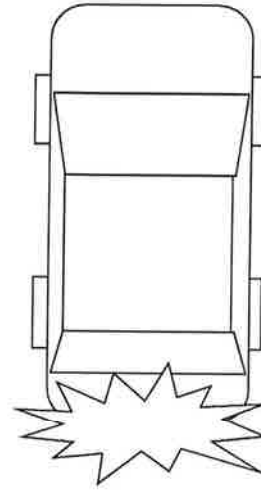
At the time of the inspection, the vehicle sustained damages to the REAR portion.
