You're Ref: TP/IP/08593/20201  
Our Ref: CI/TPD21003579/P

**General Investigation Team**

**MECHANICAL INSPECTION REPORT OF MOTOR CAR SLL 2295Y**

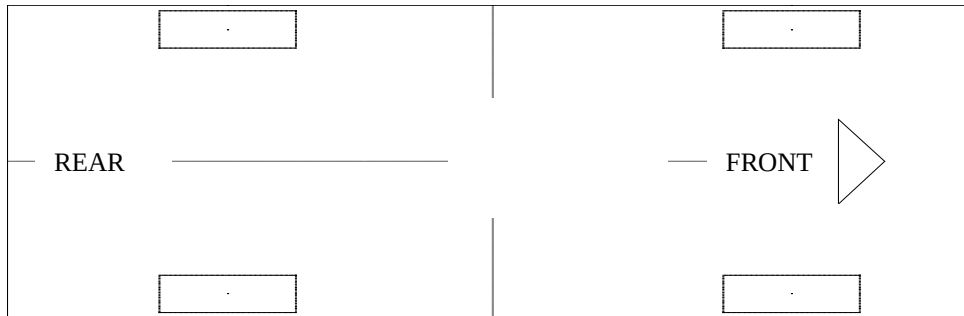
6. The condition of the Motor Car's 4 tyres was observed to be in serviceable condition. I did not find any tear, cut or burst mark(s) on the outer and the inner sidewalls as well as across the tread of the 4 tyres. The 4 tyres were also observed to be sufficiently inflated for vehicular operation. The tyre brand, tyre size and remaining tread depth of the 4 tyres were recorded as follows:-

Yokohama 185/60R15 (3.4mm)

Yokohama 185/60R15 (3.7mm)

Yokohama 185/60R15 (3.8mm)

Yokohama 185/60R15 (5.1mm)

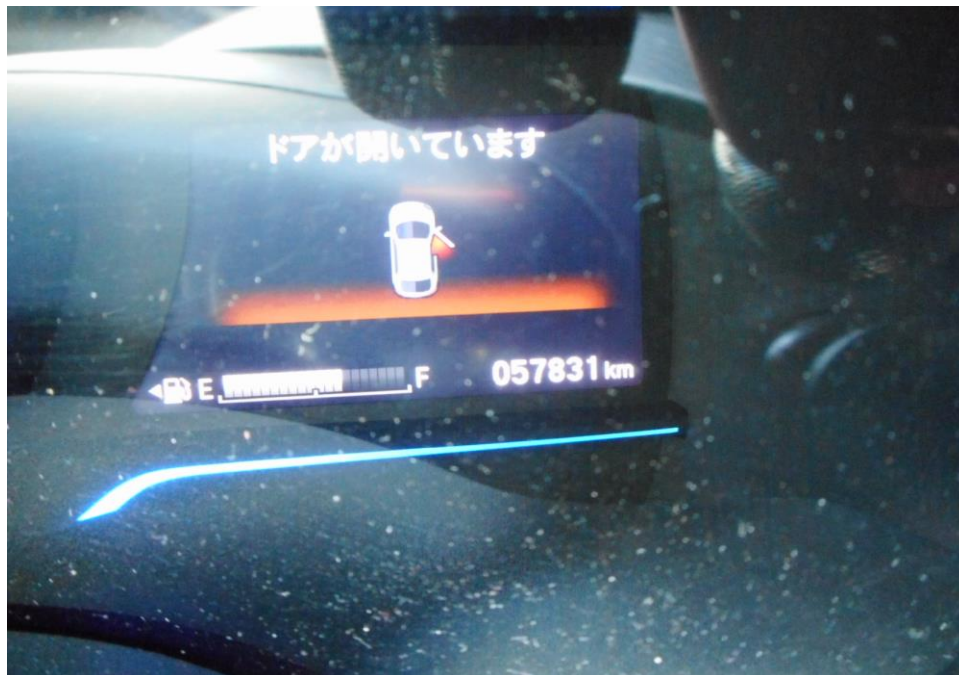
**Photo 1** shows the mileage of the Motor Car at the time of my inspection. The mileage observed was 57,831km.

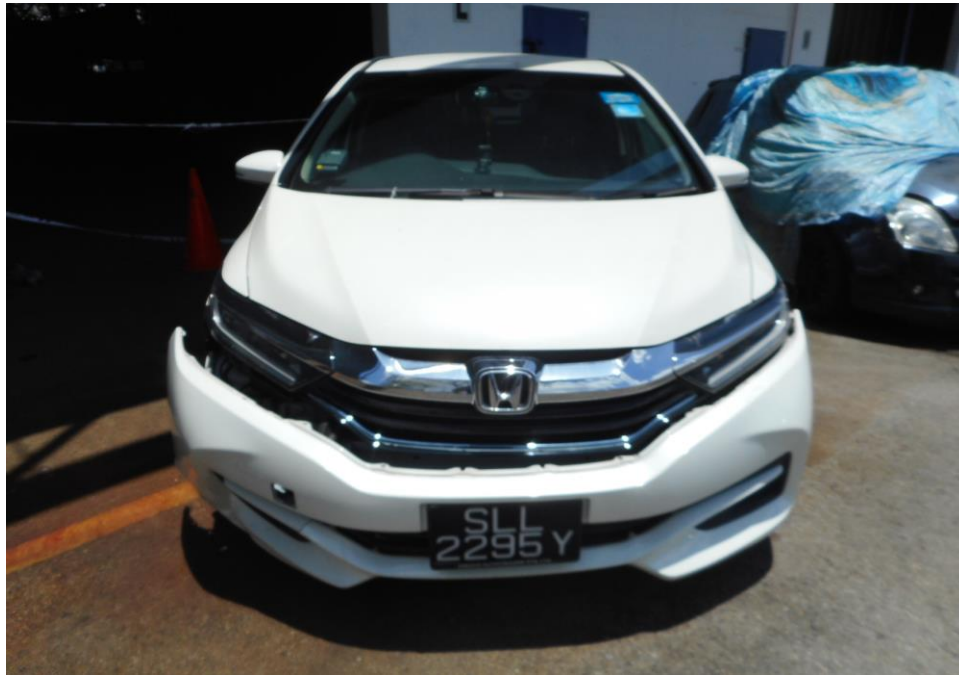
**Photo 2** shows a general view of the Motor Car's front body at the time of my inspection. The front portion of the Motor Car was observed to have sustained damage. Its front bumper was the body part that were damaged as a result of the accident.

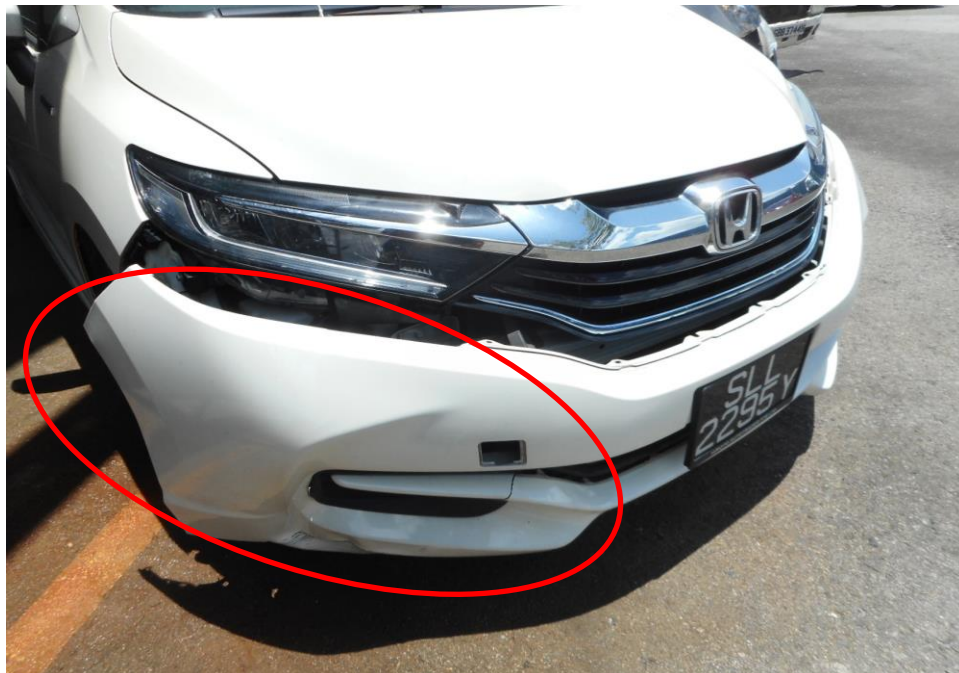
**Photo 3** shows the close up view of the Motor Car's front body at the time of my inspection. The Motor Car was observed to have sustained damage at its front bumper (circled) as a result of the accident.

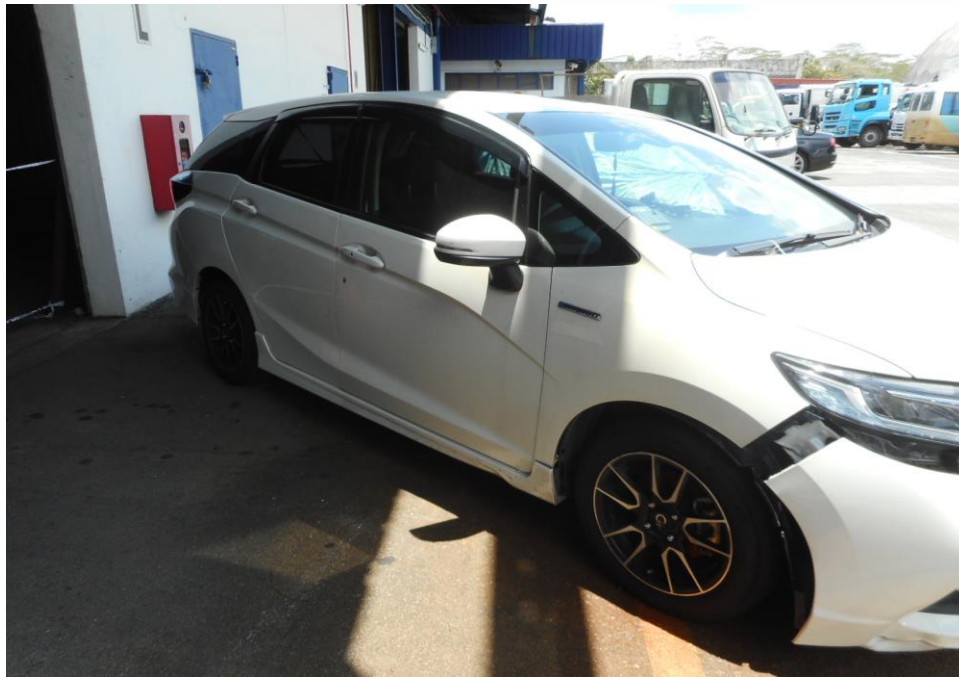
**Photo 4** shows a general view of the Motor Car's right body at the time of my inspection. The right portion of the Motor Car was observed to have been unaffected by the accident.

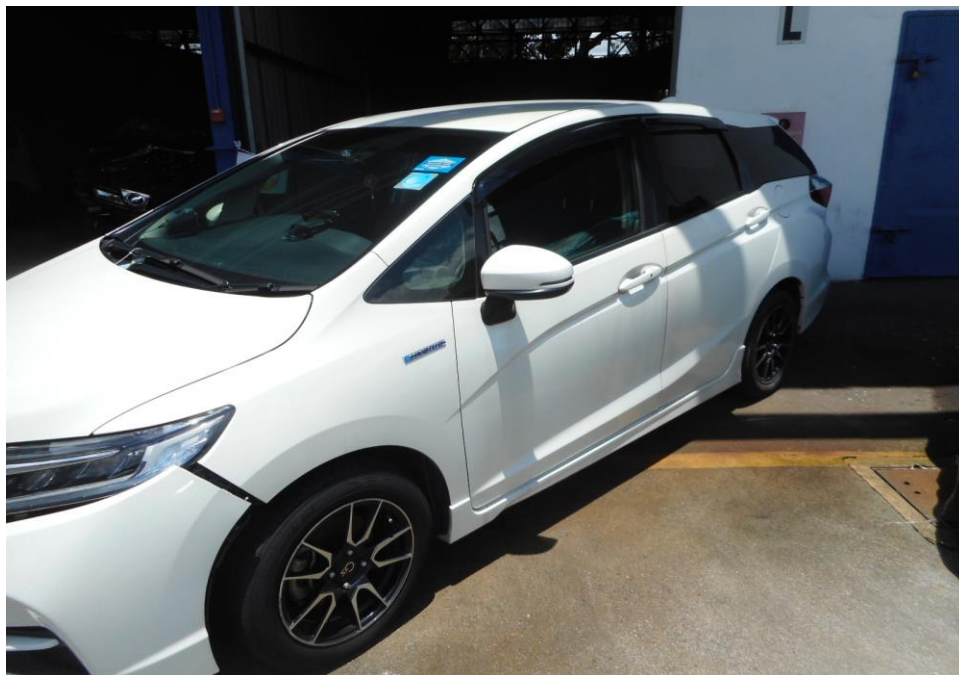
**Photo 5** shows a general view of the Motor Car's left body at the time of my inspection. The left portion of the Motor Car was observed to have been unaffected by the accident.

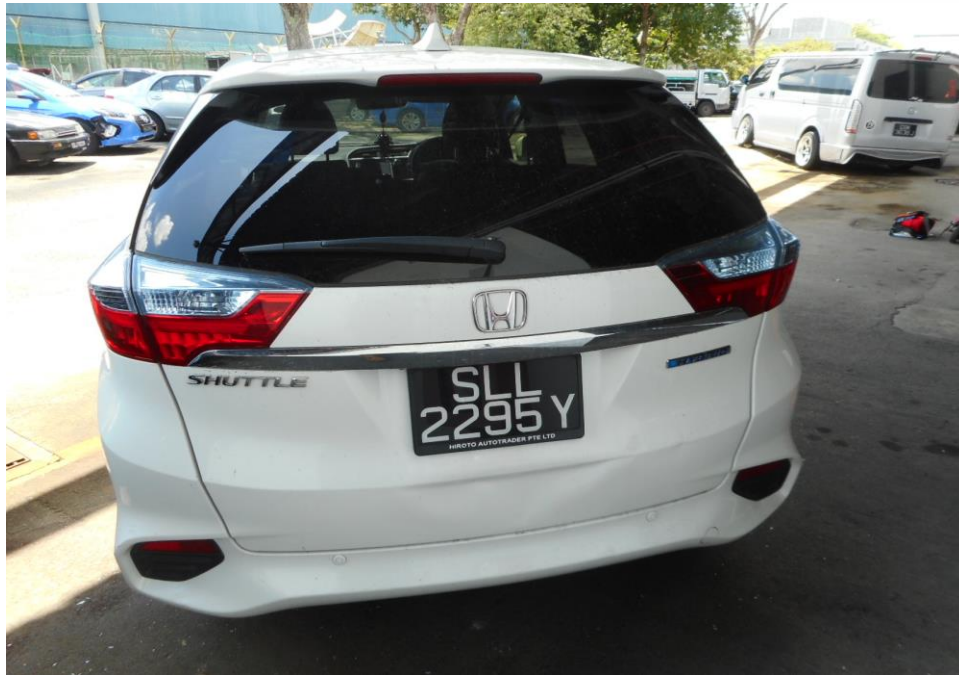
**Photo 6** shows the general view of the Motor Car's rear body at the time of my inspection. The Motor Car rear was observed to be unaffected by the accident.

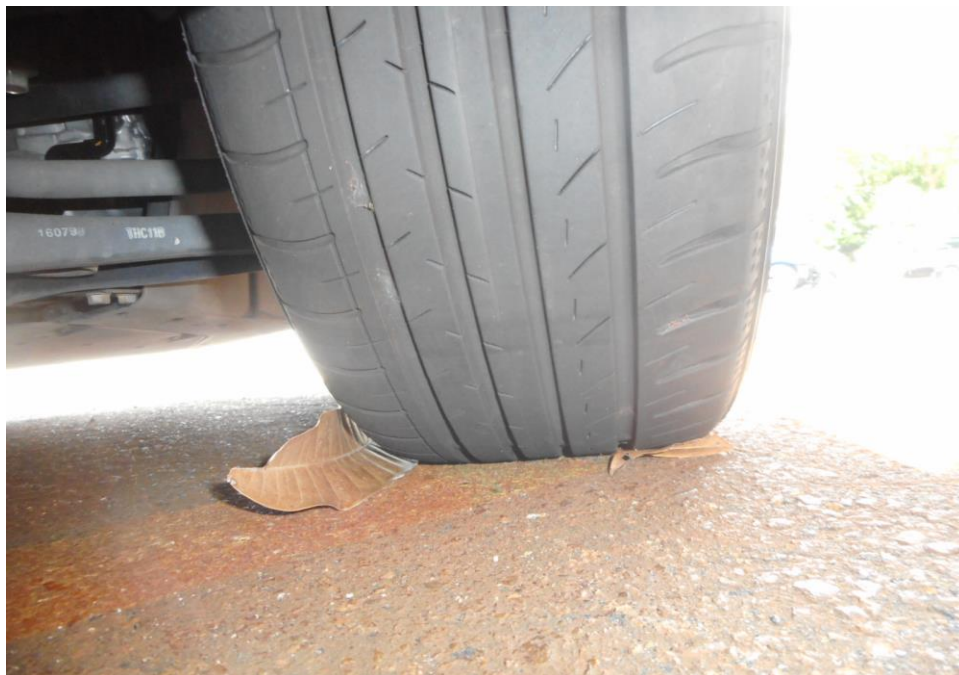
**Photo 7** shows the condition of the front right tyre of the Motor Car, which was observed to be in serviceable condition with remaining tread depth of approximately 5.1mm. The tyre was sufficiently inflated for vehicular operation with no tear, cut or burst mark(s) on the outer and the inner sidewalls as well as across the tread. The 4 tyres of the Motor Car were wrapped around standard steel wheel rims without any damage.

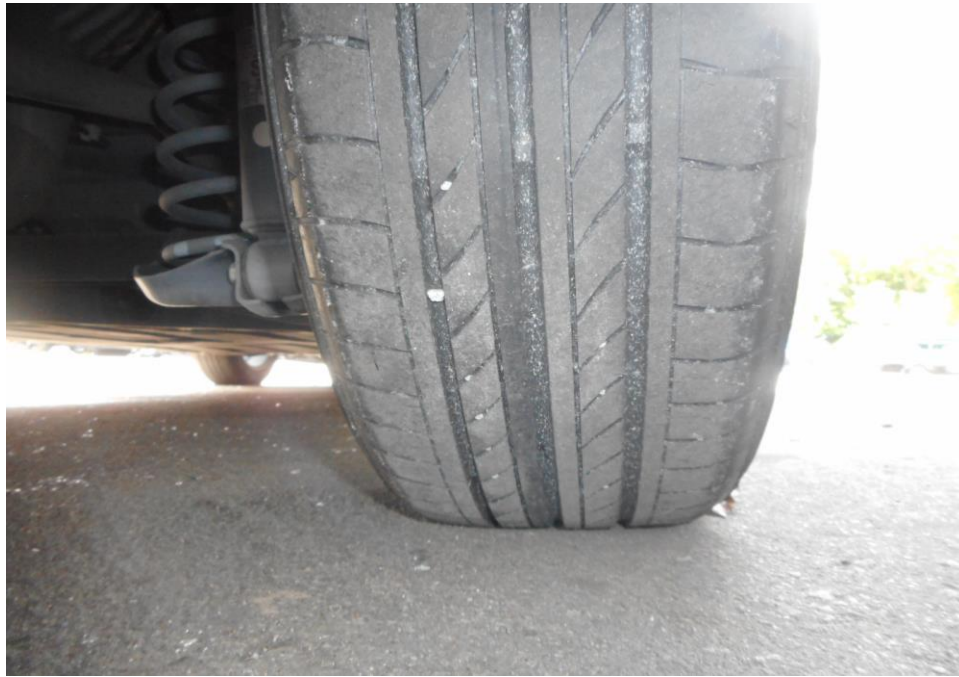
**Photo 8** shows the condition of the rear right tyre of the Motor Car, which was observed to be in serviceable condition with remaining tread depth of approximately 3.8mm. The tyre was also observed to be sufficiently inflated for vehicular operation with no tear, cut or burst mark(s).

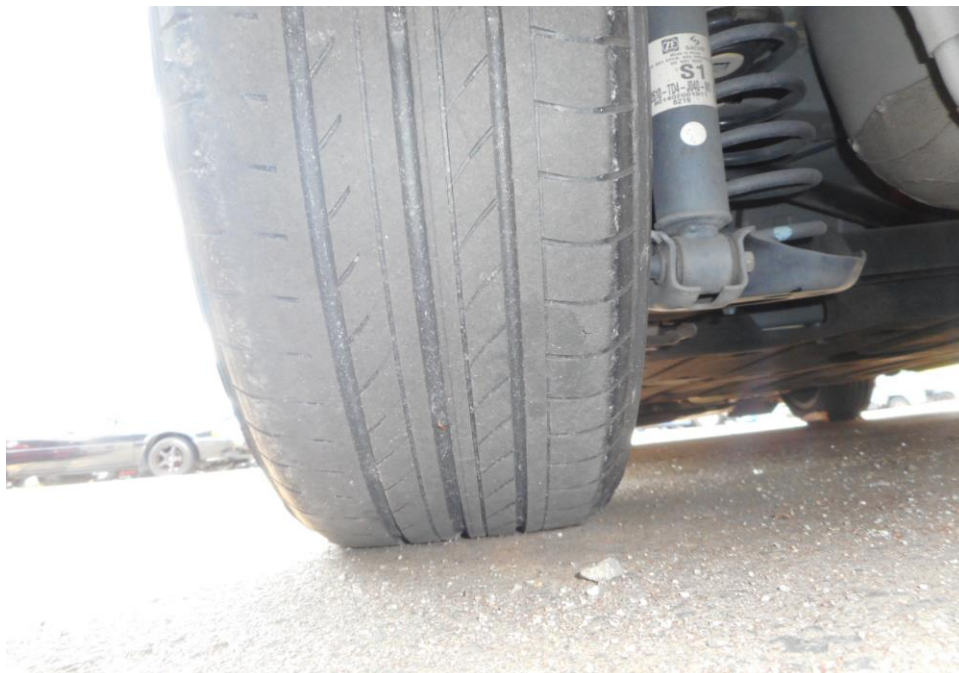
**Photo 9** shows the condition of the rear left tyre of the Motor Car, which was observed to be in serviceable condition with remaining tread depth of approximately 3.4mm. The tyre, which was wrapped around steel wheel rim, was also observed to be sufficiently inflated for vehicular operation. The 4 tyres of the Motor Car were wrapped around standard steel wheel rims.

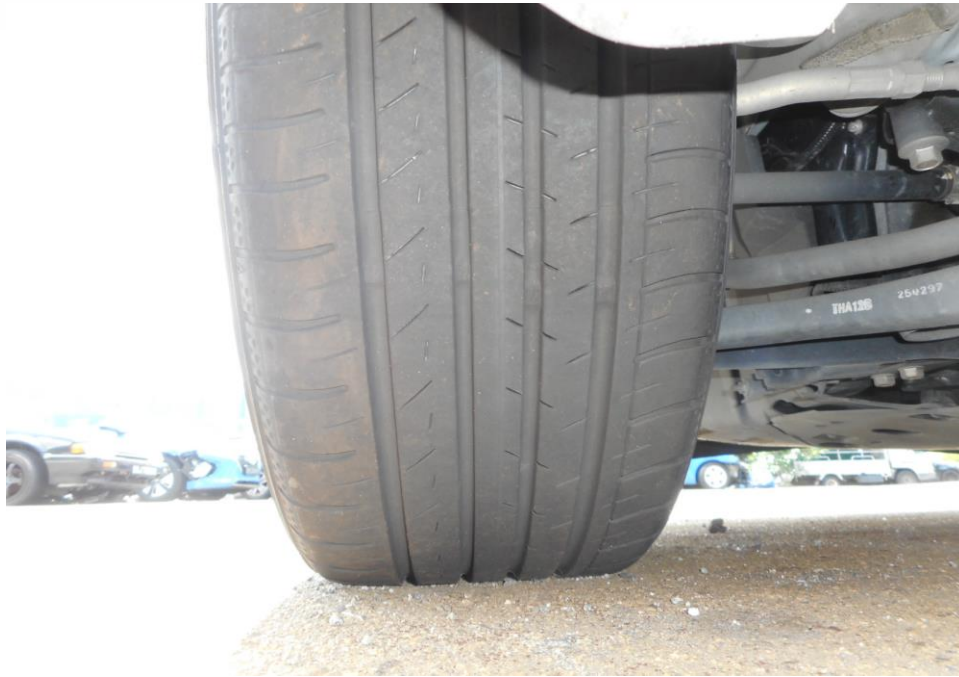
**Photo 10** shows the condition of the front left tyre of the Motor Car, which was observed to be in serviceable condition with remaining tread depth of approximately 3.7mm. There was also no tear, cut or burst mark(s) on the outer and the inner sidewalls as well as across the tread of the Motor Car's 4 tyres.

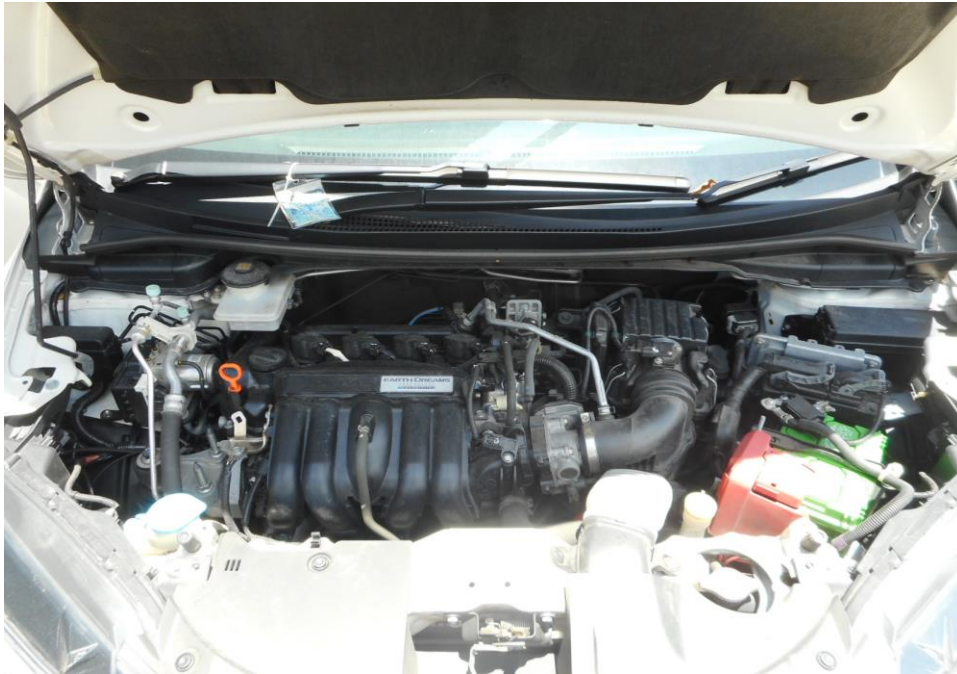
**Photo 11** shows a general view of the Motor Car's engine compartment. The various parts and components inside the engine compartment were unaffected by the accident. There was also no sign(s) or indication(s) of fluid leakage and/or fluid stain within the engine compartment.

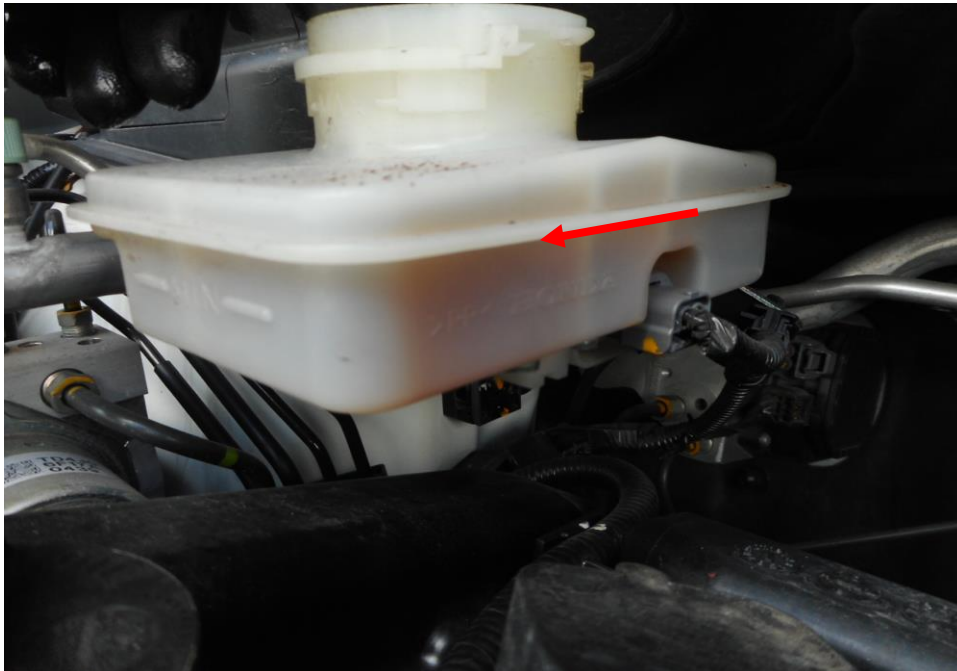
**Photo 12** shows the brake fluid reservoir of the Motor Car at the time of my inspection. The brake fluid was observed to be of sufficient level (arrowed) and without any visible contamination.

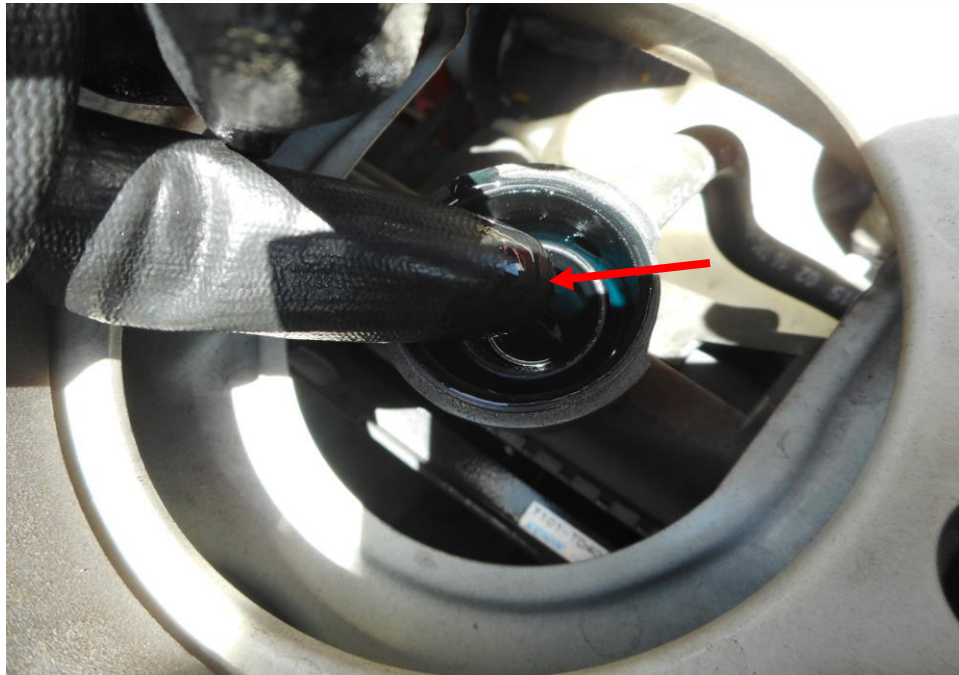
**Photo 13** shows checks being carried out to the engine coolant of the Motor Car at the time of my inspection. The engine coolant was observed to be of sufficient level (arrowed) and without any visible contamination.

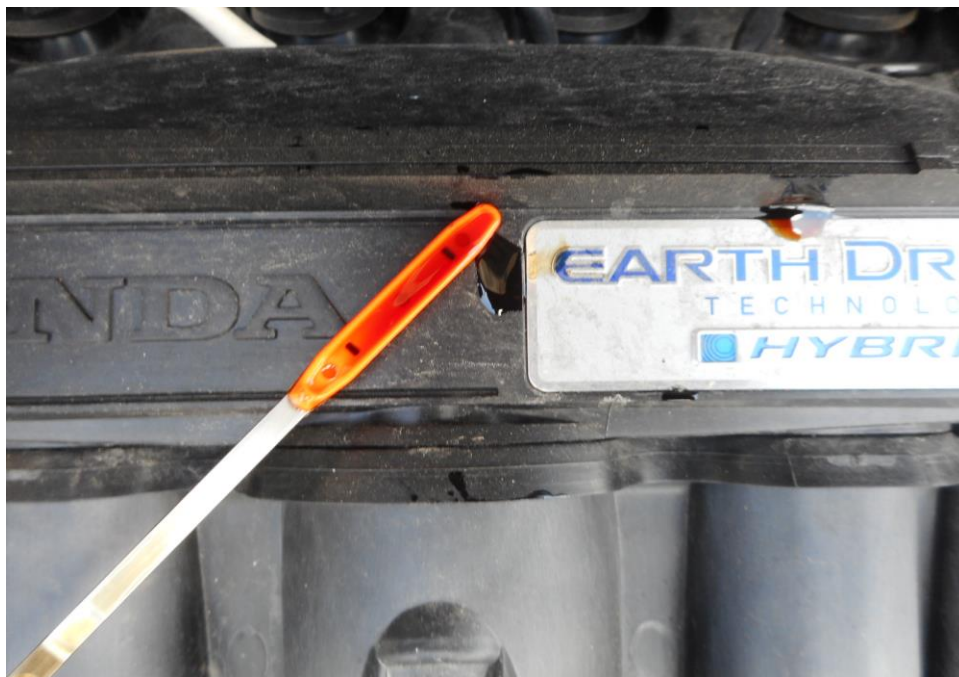
**Photo 14** shows the engine oil dip stick of the Motor Car at the time of my inspection. The engine oil was observed to be of sufficient level and without any visible contamination.

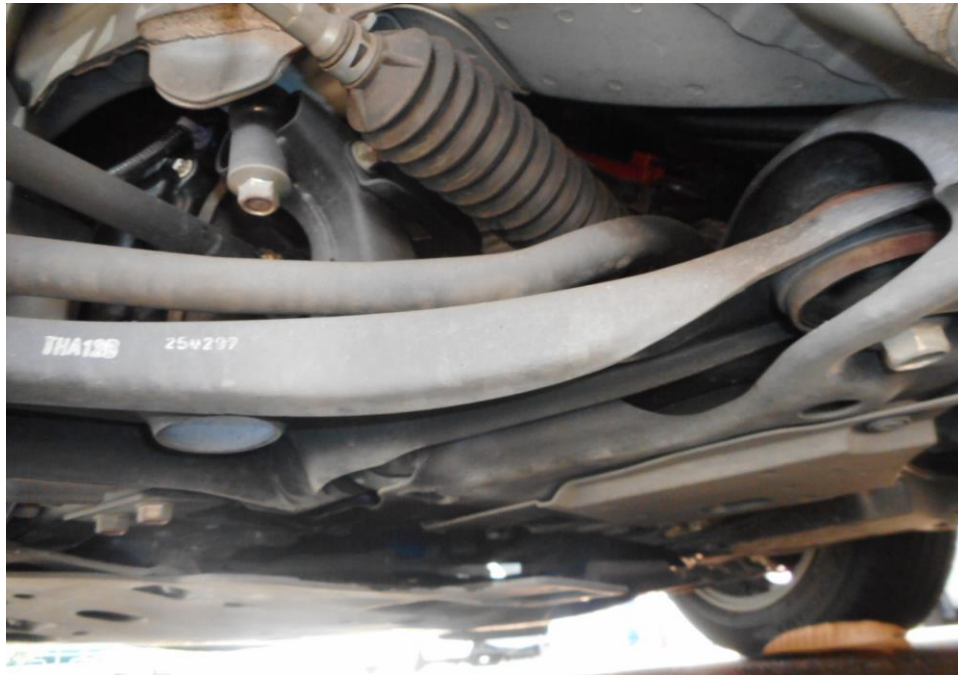
**Photo 15** shows the undercarriage of the Motor Car, at the area where the engine housing and transmission housing are located. I did not find any sign(s) or indication(s) of fluid leak and/or fluid stain(s) on the underside of the Motor Car.

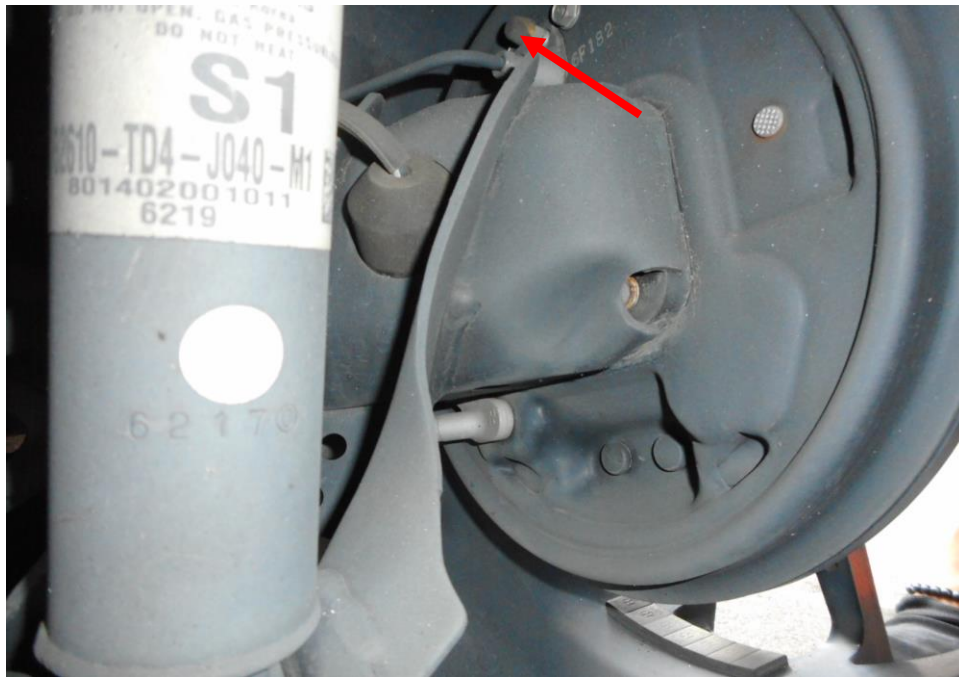
**Photo 16** shows the brake hose/pipe (arrowed) at the rear right wheel of the Motor Car. No leakage of brake fluid was observed. Visual examination of the various components of the braking system like the drum brake, brake booster, brake pedal etc. had revealed all to be intact and without visible damage.

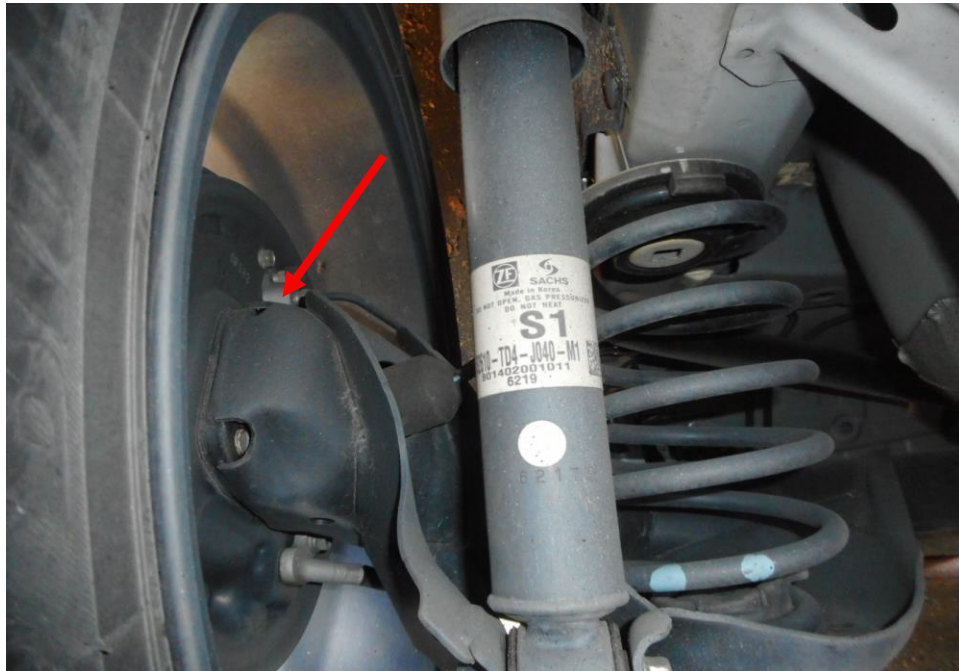
**Photo 17** shows the brake hose/pipe (arrowed) at the rear left wheel of the Motor Car. I did not observe any leakage of brake fluid at the time of my inspection of the Motor Car. Static tests of the Motor Car's braking system had indicated that there was no internal leakage of pressure/vacuum. The undercarriage components of the Motor Car were also all found to be intact and without any visible damage.

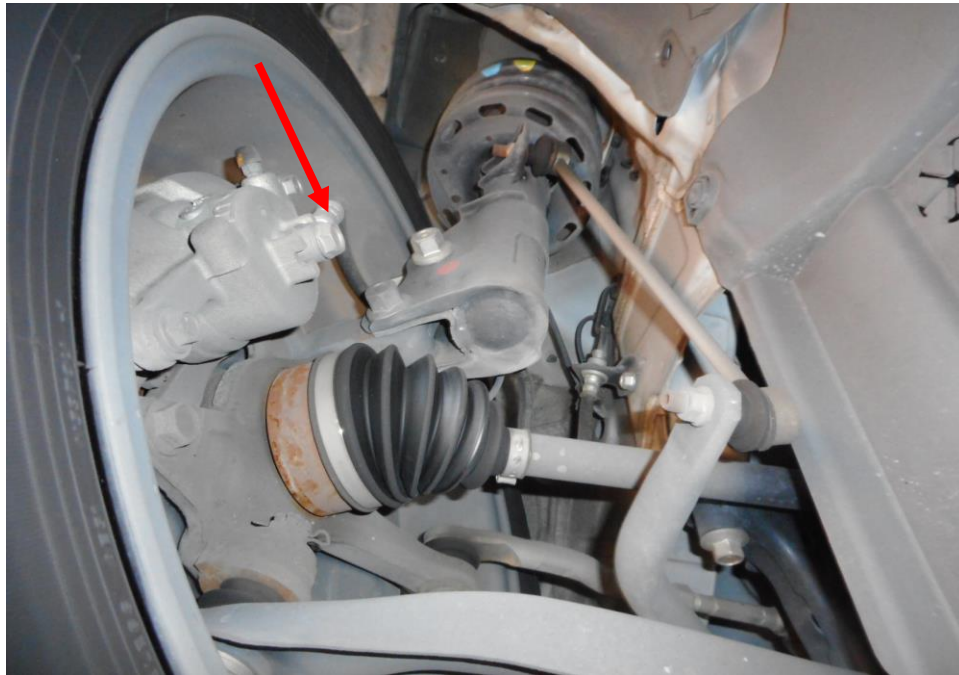
**Photo 18** shows the brake hose/pipe (arrowed) at the front right wheel of the Motor Car. I did not observe any leakage of brake fluid at the time of my inspection of the Motor Car. Static tests of the Motor Car's braking system had indicated that there was no internal leakage of pressure/vacuum. The undercarriage components of the Motor Car were also all found to be intact and without any visible damage.

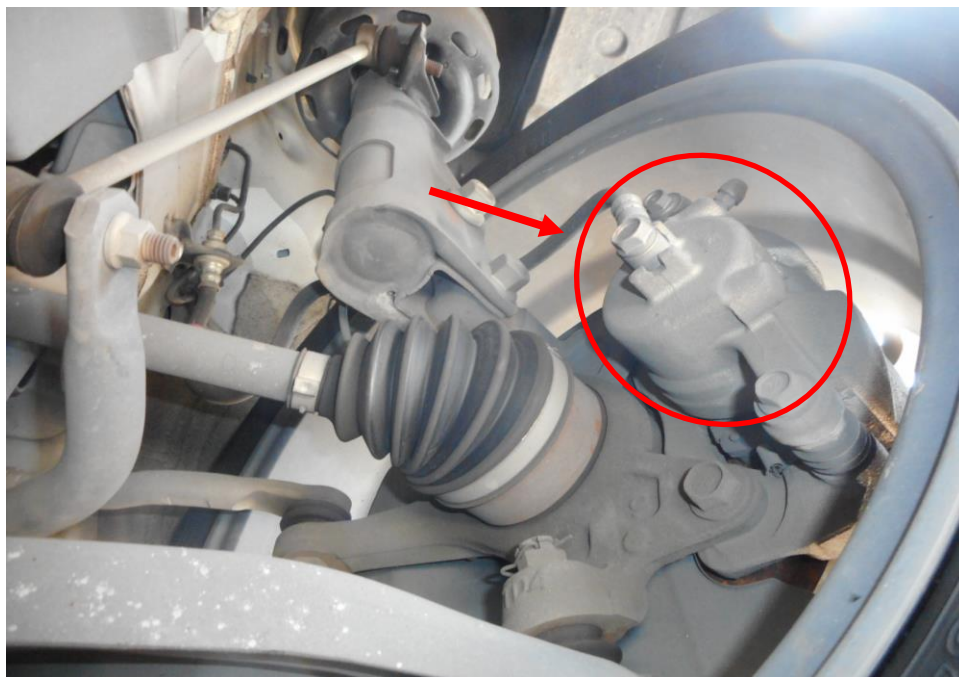
**Photo 19** shows the brake hose/pipe (arrowed) at the front left wheel of the Motor Car. No leakage of brake fluid was observed. Visual examination of the various components of the braking system like the brake caliper (circled), brake booster, brake pedal etc had revealed all to be intact and without visible damage.

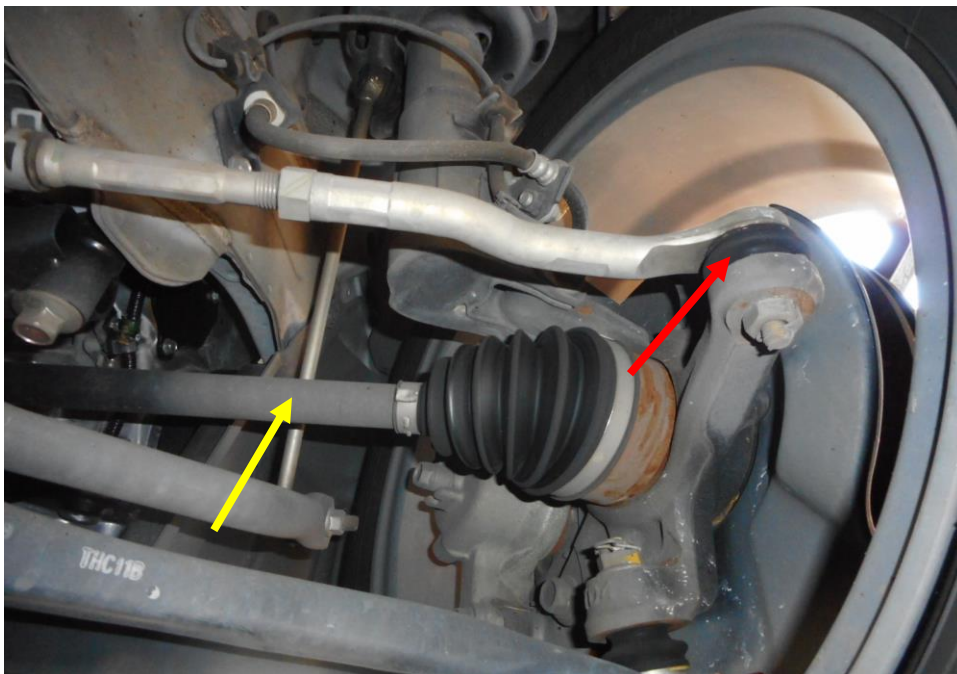
**Photo 21** shows the various undercarriage components at the front right wheel of the Motor Car, in particular the steering tie rod (red arrow) and drive shaft (yellow arrow). The various steering components were all found to be intact, suggesting that the steering system of the Motor Car was likely to be in serviceable condition at the material time of accident. There was also no sign of fluid stain observed on the various undercarriage components at the front right wheel of the Motor Car.

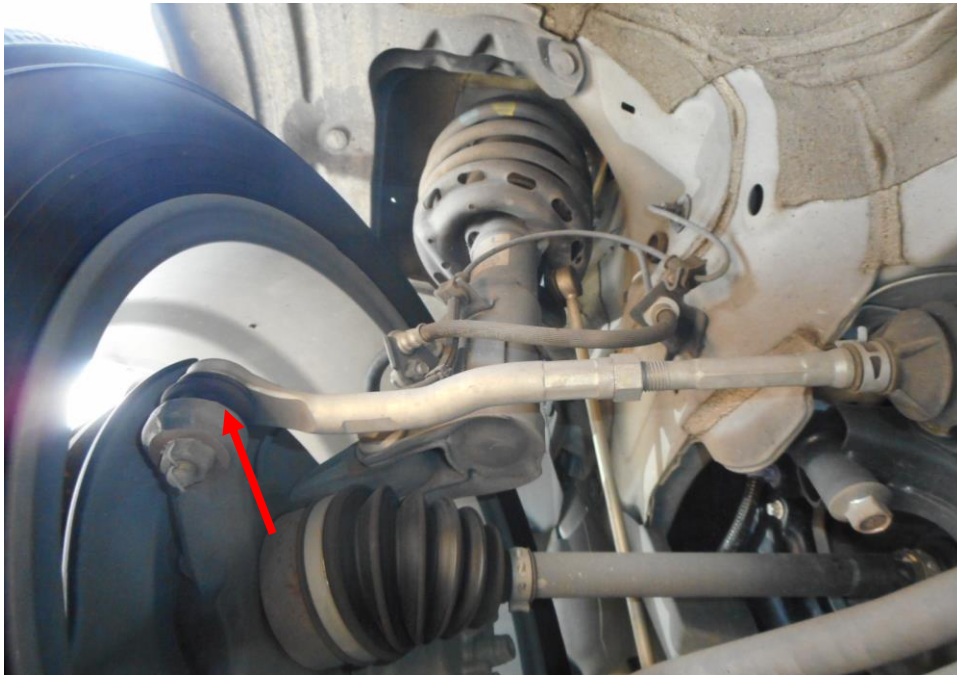
**Photo 22** shows the various undercarriage components at the front left wheel of the Motor Car, which had included the steering tie rod (red arrow). The various undercarriage components of the Motor Car were all found to be intact without any visible damage.

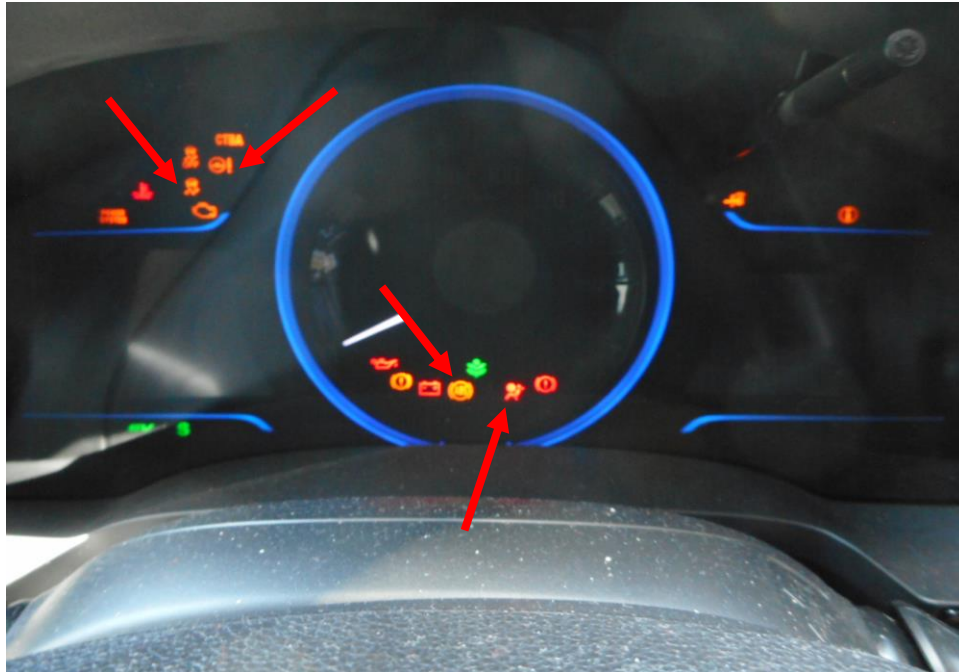
**Photo 23** shows the warning light for Anti-Lock Brake System (ABS) and Power Steering System (EPS), Supplemental Restraint System (SRS) and Traction Control (TC) (arrowed) appearing on the instrument panel of the Motor Car during the self-test of its various electronic operating systems when its engine was cranked.

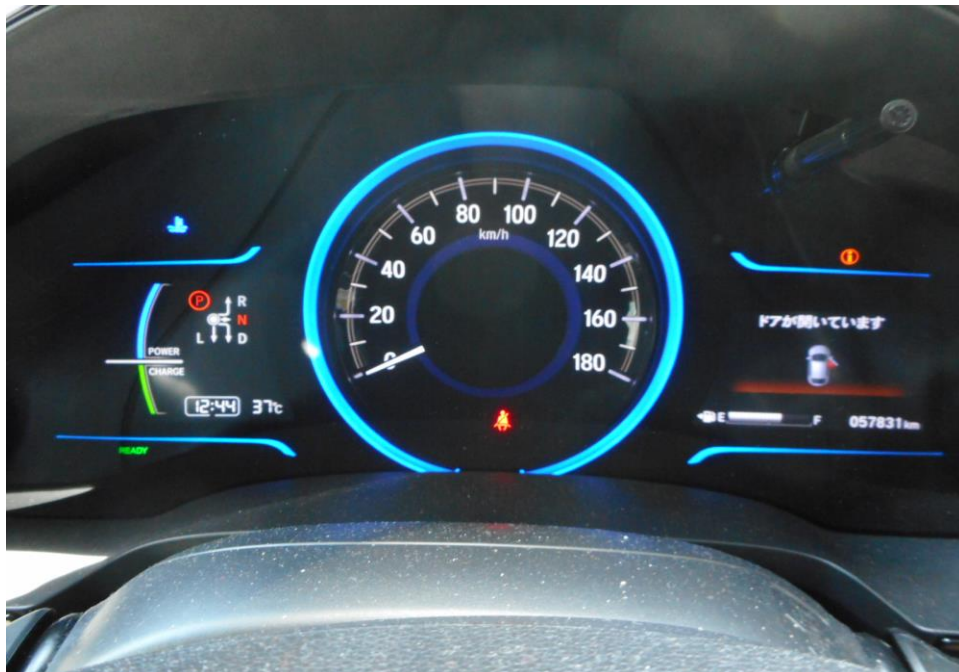
**Photo 24** shows no warning lights illuminated on the instrument panel of the Motor Car after the engine was cranked. This would suggest that there was no abnormality to the electronic operating system of the Motor Car, like the ABS, EPS, SRS, and TC etc.
