You're Ref: TP/IP/06549/2021  
Our Ref: CI/TPD21003582/P

24<sup>th</sup> March 2021

**MECHANICAL INSPECTION REPORT OF MOTOR CAR SMC 8216Y**

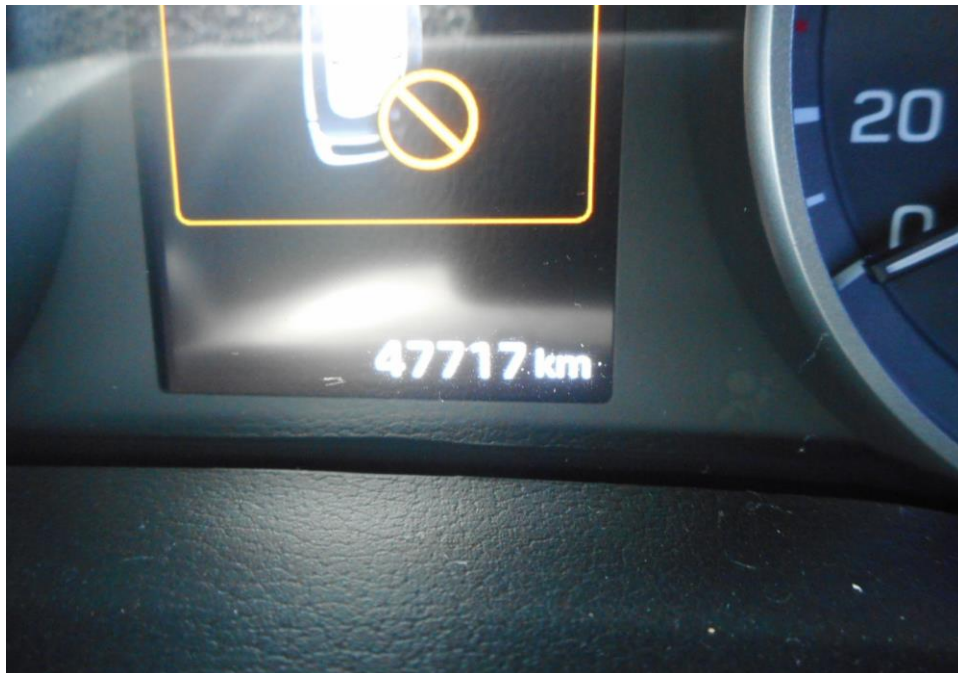
**Photo 1** shows the mileage of the Motor Car at the time of my inspection. The mileage observed was 47,717km.

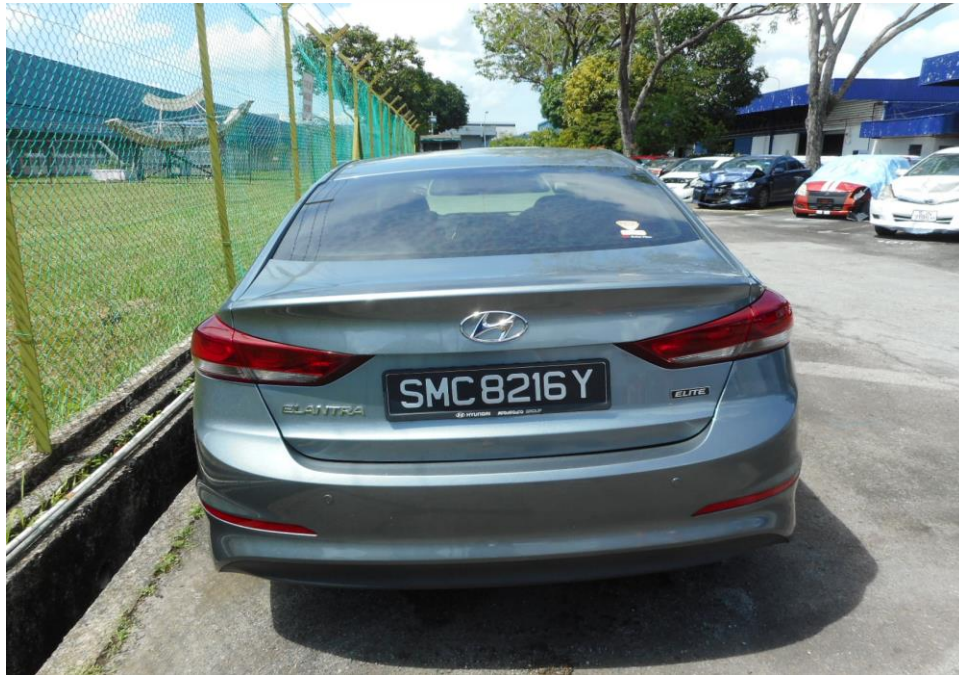
**Photo 2** shows the general view of the Motor Car's rear body at the time of my inspection. The Motor Car rear was observed to be unaffected by the accident.

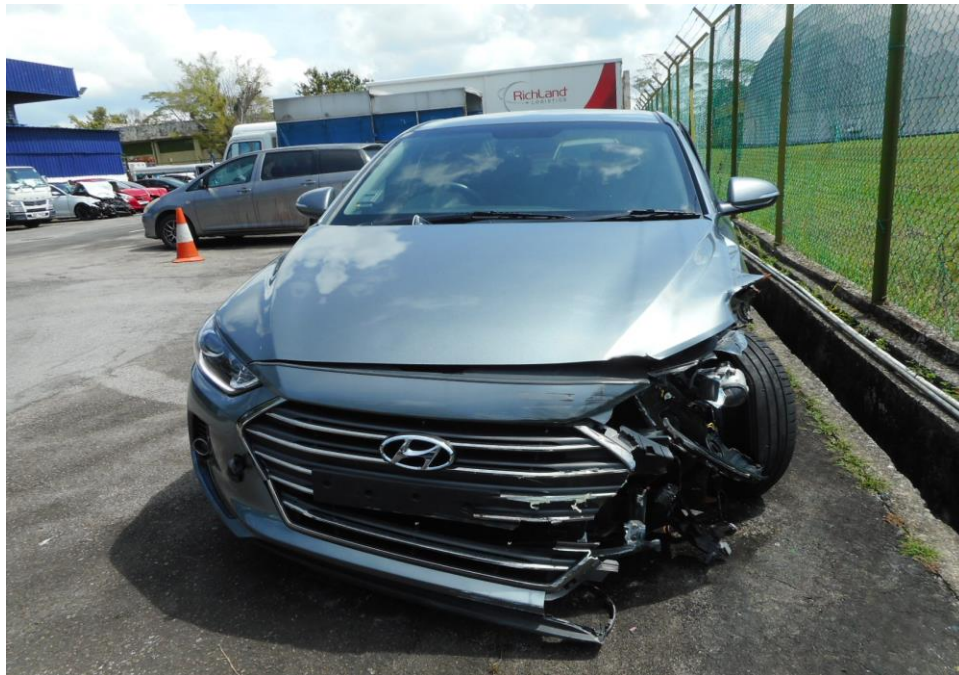
**Photo 3** shows a general view of the Motor Car's front body at the time of my inspection. The front portion of the Motor Car was observed to have sustained damage. Its front bonnet, front bumper and front left headlamp was the body parts that were damaged as a result of the accident.

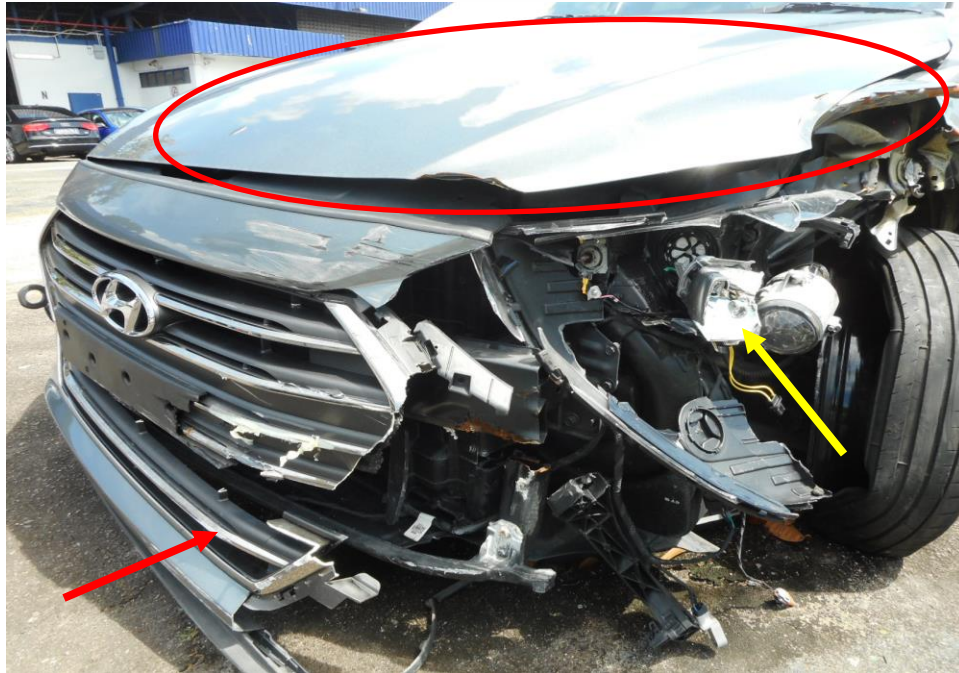
**Photo 4** shows the close up view of the Motor Car's front body at the time of my inspection. The Motor Car was observed to have sustained damage at its front bonnet (red circle), front bumper (red arrow) and front left headlamp (yellow arrow) as a result of the accident.

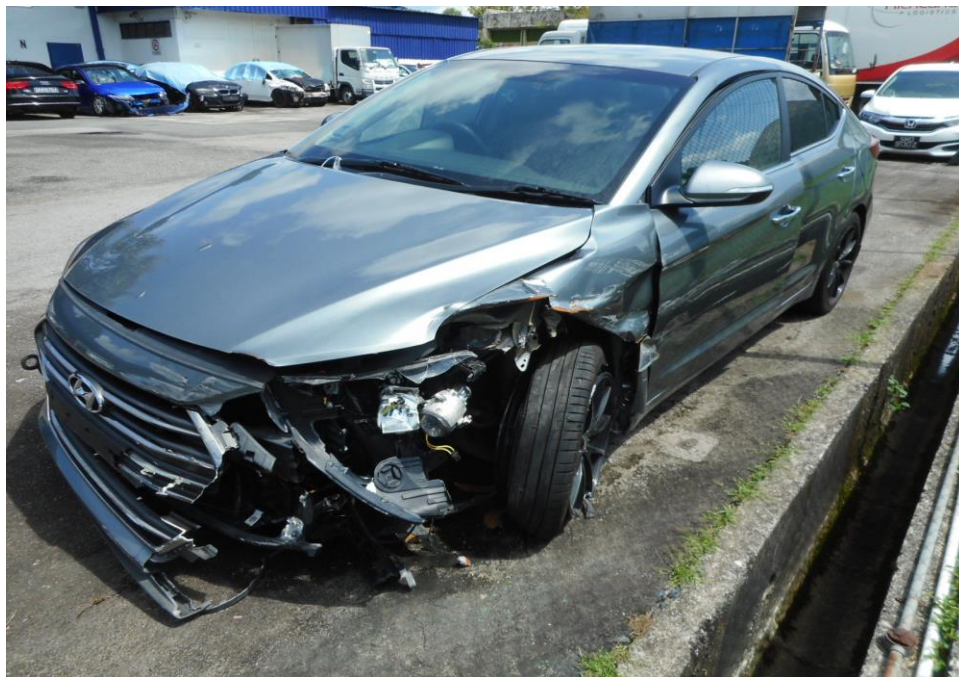
**Photo 5** shows a general view of the Motor Car's left body at the time of my inspection. The left portion of the Motor Car was observed to have sustained damage at its left fender and left door as a result of the accident.

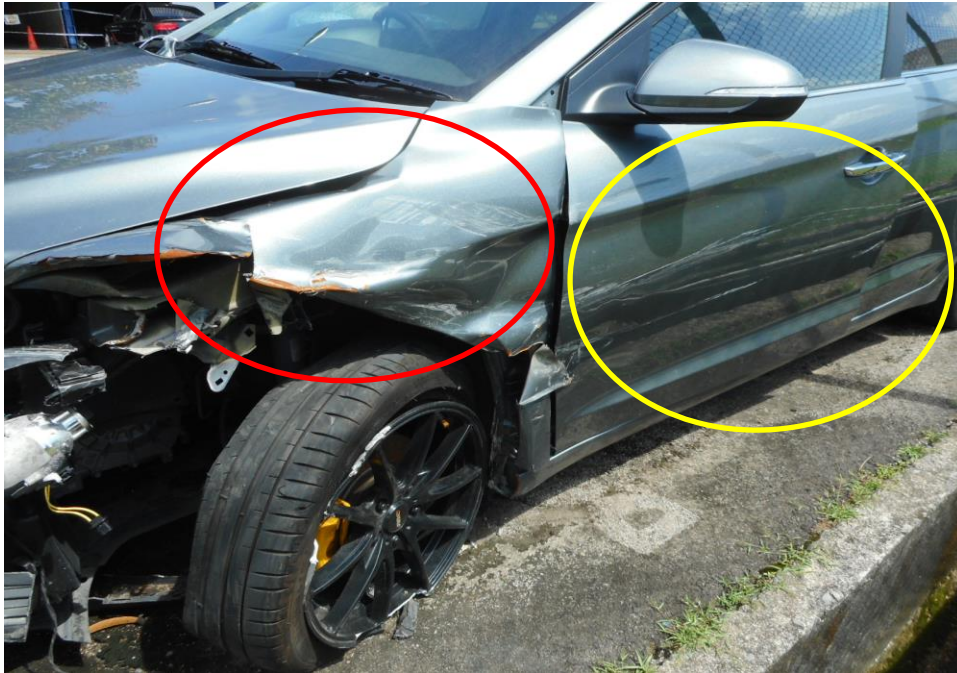
**Photo 6** shows a close up view of the Motor Car's left body at the time of my inspection. The left portion of the Motor Car was observed to have sustained damage at its left fender (red circle) and left door (yellow circle) as a result of the accident.

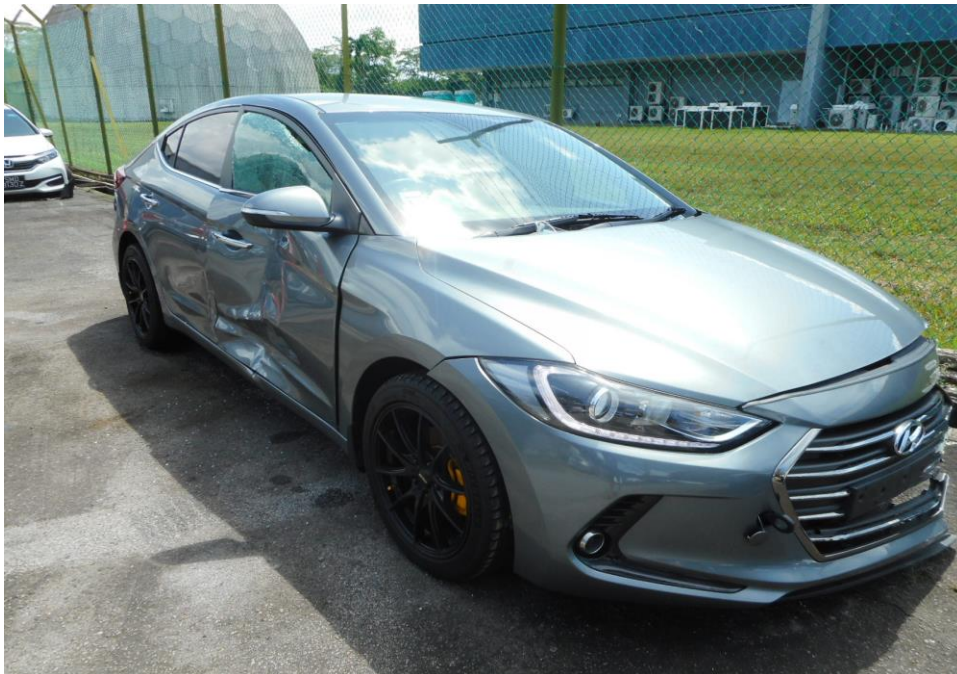
**Photo 7** shows a general view of the Motor Car's right body at the time of my inspection. The right portion of the Motor Car was observed to have sustained damage at its right door as a result of the accident.

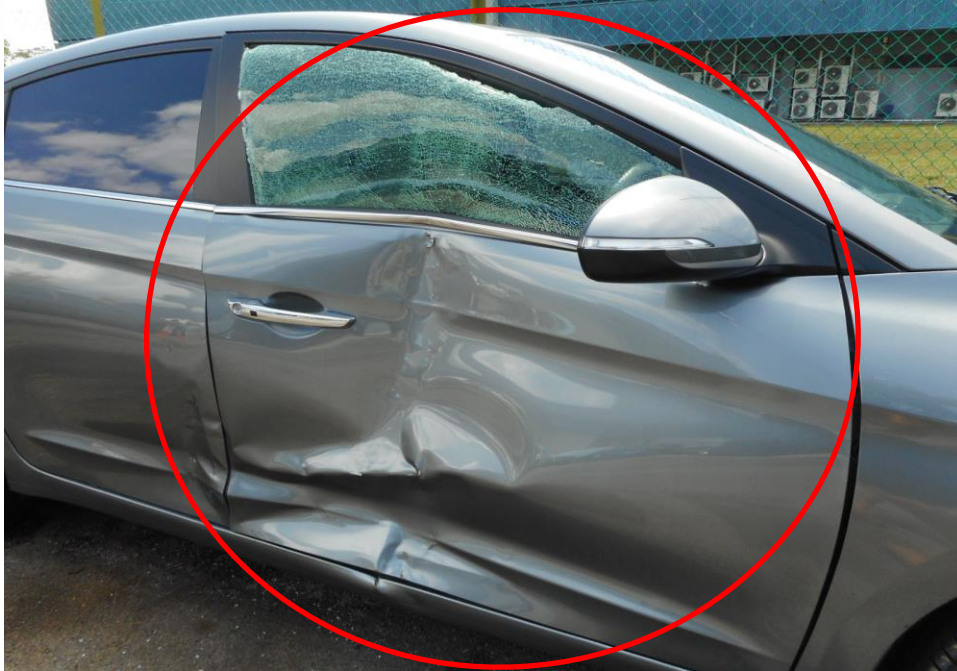
**Photo 8** shows a close up view of the Motor Car's right body at the time of my inspection. The right portion of the Motor Car was observed to have sustained damage at its right door (circled) as a result of the accident.

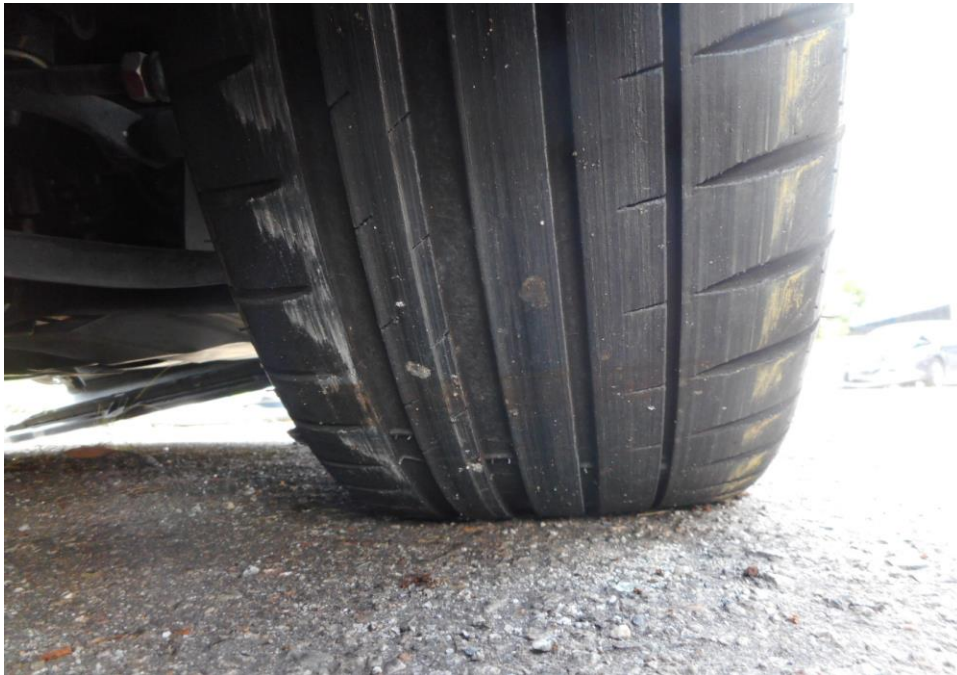
**Photo 9** shows the condition of the front right tyre of the Motor Car, which was observed to be in serviceable condition with remaining tread depth of approximately 4.6mm.

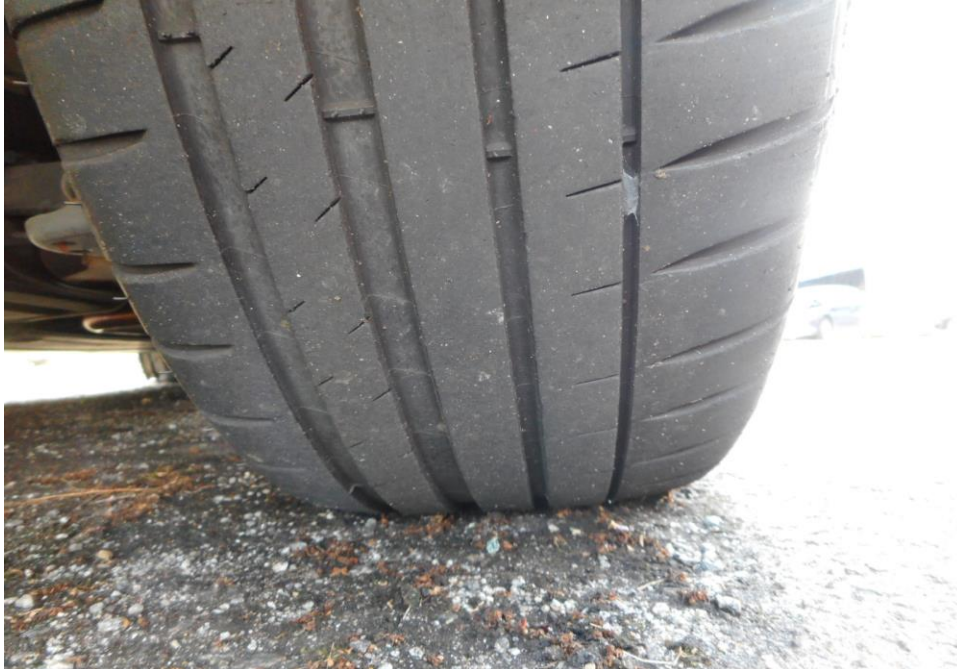
**Photo 10** shows the condition of the rear right tyre of the Motor Car, which was observed to be in serviceable condition with remaining tread depth of approximately 4.9mm.

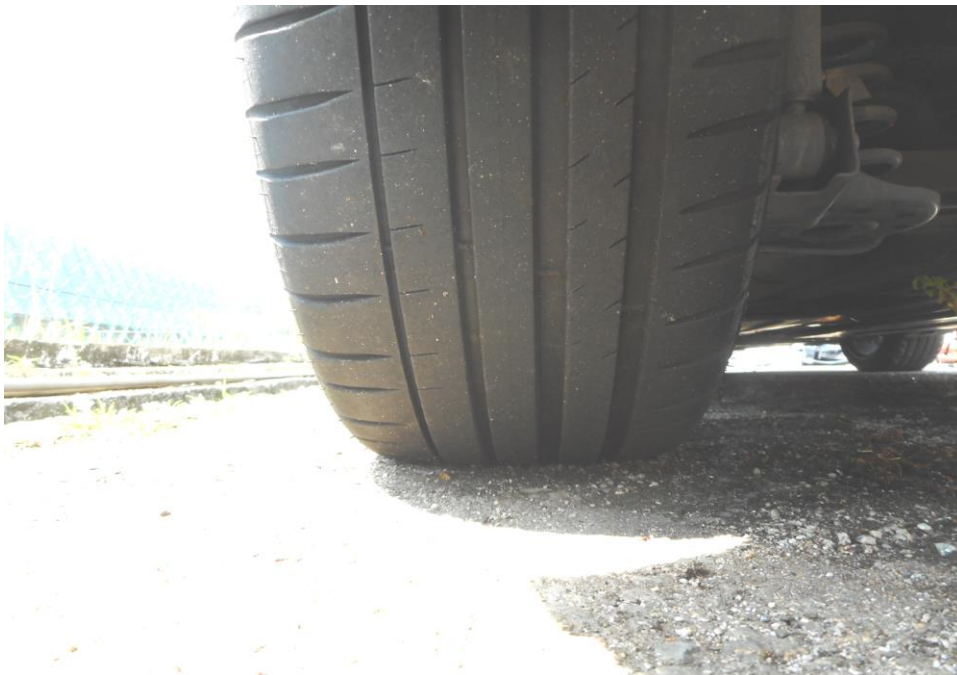
**Photo 11** shows the condition of the rear left tyre of the Motor Car, which was observed to be in serviceable condition with remaining tread depth of approximately 4.9mm. The tyre, which was wrapped around steel wheel rim, was also observed to be sufficiently inflated for vehicular operation.

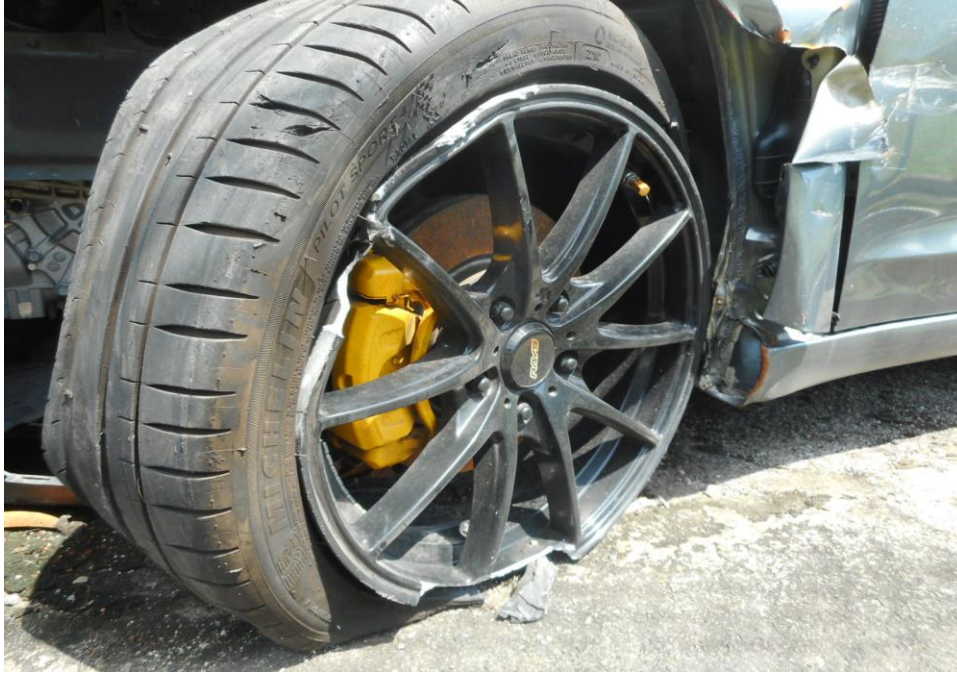
**Photo 12** shows the condition of the front left tyre of the Motor Car, which was observed to be in unserviceable condition with remaining tread depth of approximately 4.6mm. The tyre was observed to have slipped of the damaged wheel rim and deflated as a result of the accident.

18. The front left tyre was deflated and cut as a result of the accident. However, the other 3 tyres was found to be in serviceable condition. I did not find any tear, cut or burst mark(s) on the outer and the inner sidewalls as well as across the tread of the 3 tyres. The 4 tyres were also observed with remaining tread depth of approximately 4.6mm to 4.9mm.

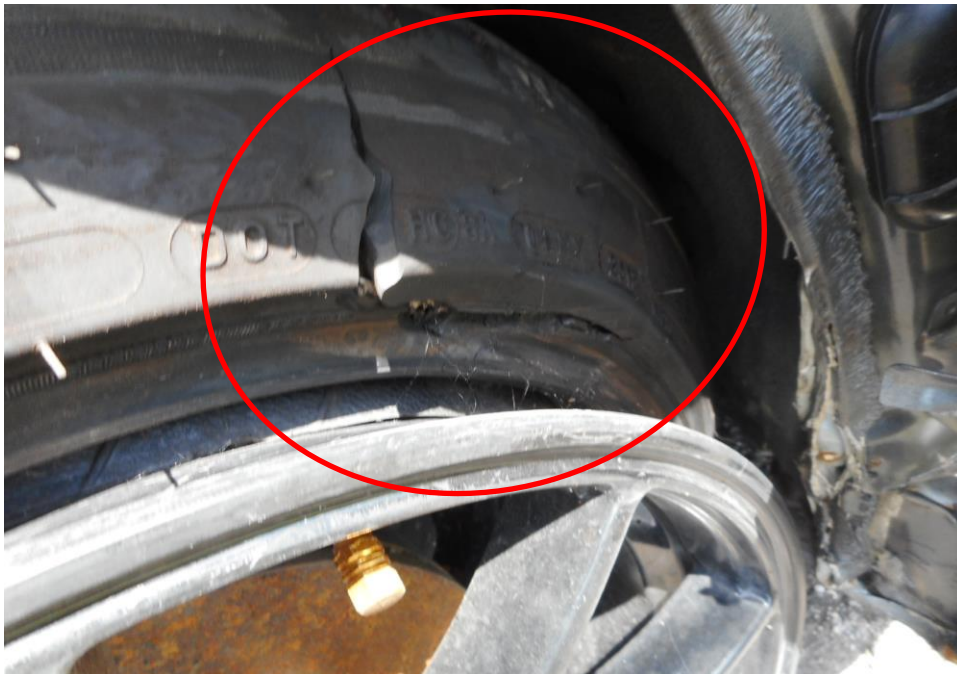
**Photo 13** shows the close up condition of the front right tyre of the Motor Car, which was observed to be in unserviceable condition. The tyre was observed to be cut and slipped of the damaged wheel rim (circled) and deflated as a result of the accident.

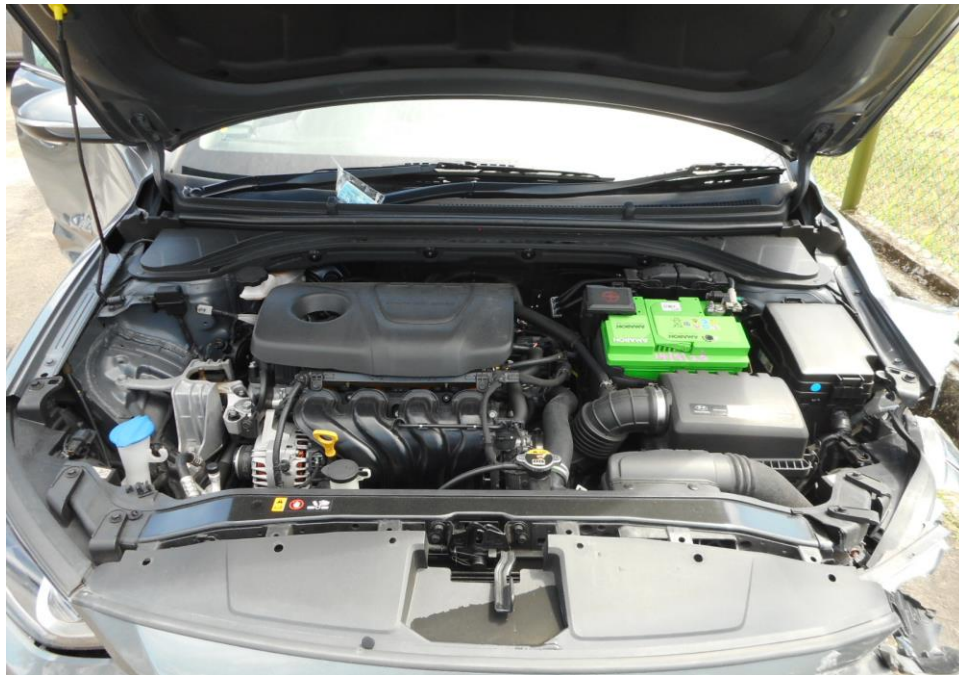
**Photo 14** shows a general view of the Motor Car's engine compartment. The various parts and components inside the engine compartment were unaffected by the accident. There was also no sign(s) or indication(s) of fluid leakage and/or fluid stain within the engine compartment.

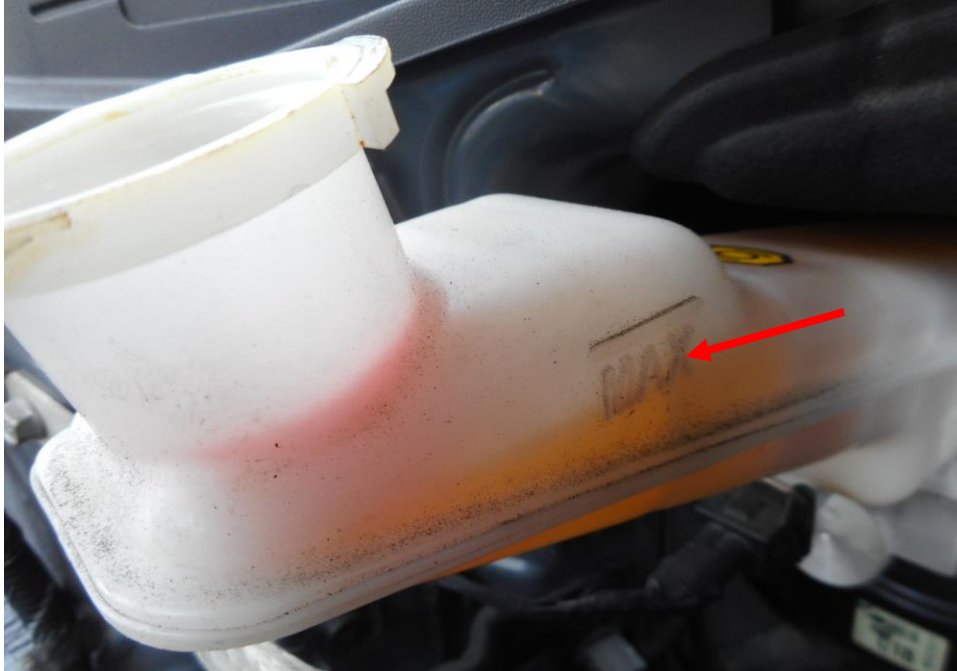
**Photo 15** shows the brake fluid reservoir of the Motor Car at the time of my inspection. The brake fluid was observed to be of sufficient level (arrowed) and without any visible contamination.

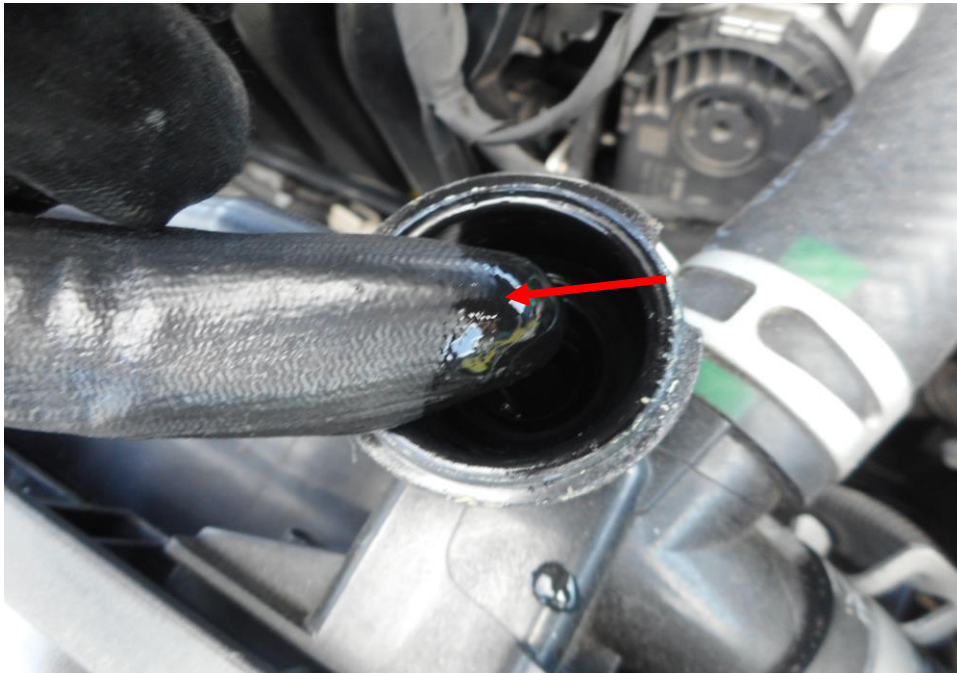
**Photo 16** shows checks being carried out to the engine coolant of the Motor Car at the time of my inspection. The engine coolant was observed to be of sufficient level (arrowed) and without any visible contamination.

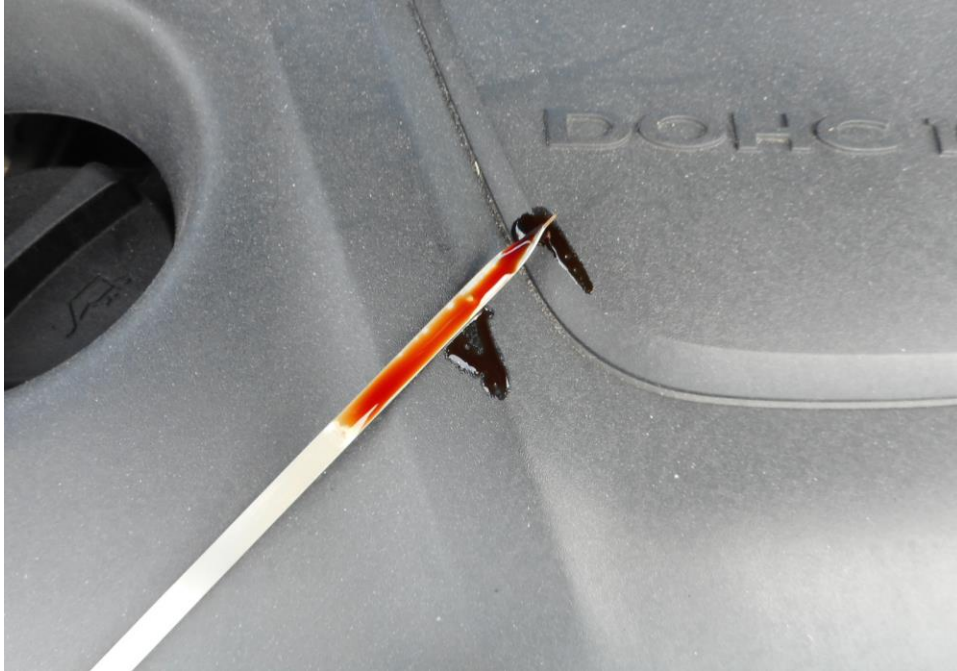
**Photo 17** shows the engine oil dipstick of the Motor Car at the time of my inspection. The engine oil was observed to be of sufficient level and without any visible contamination.

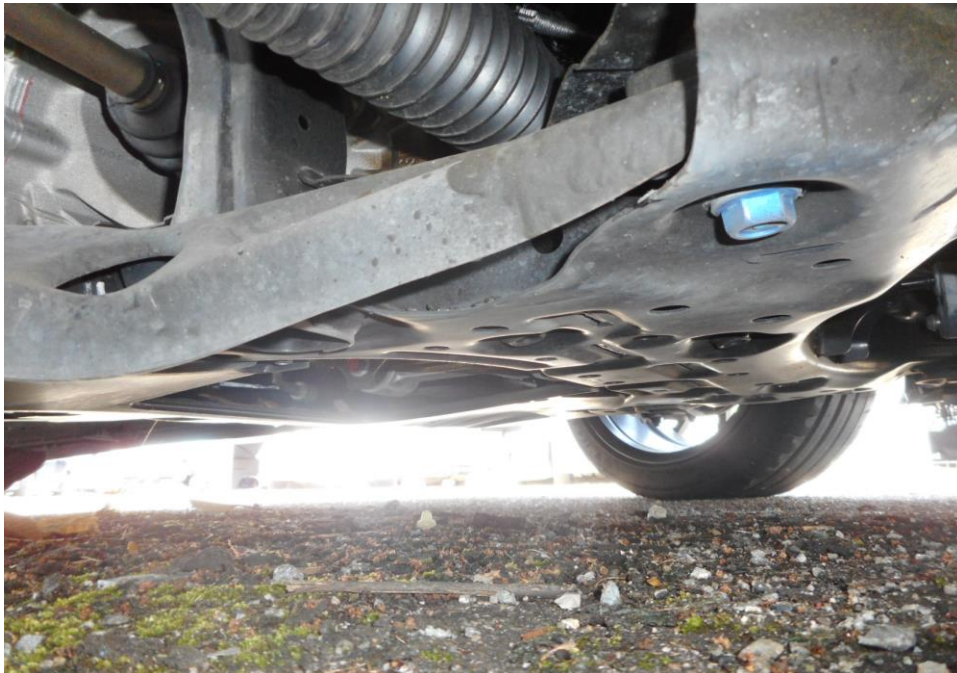
**Photo 18** shows the undercarriage of the Motor Car, at the area where the engine housing and transmission housing are located. I did not find any sign(s) or indication(s) of fluid leak and/or fluid stain(s) on the underside of the Motor Car.

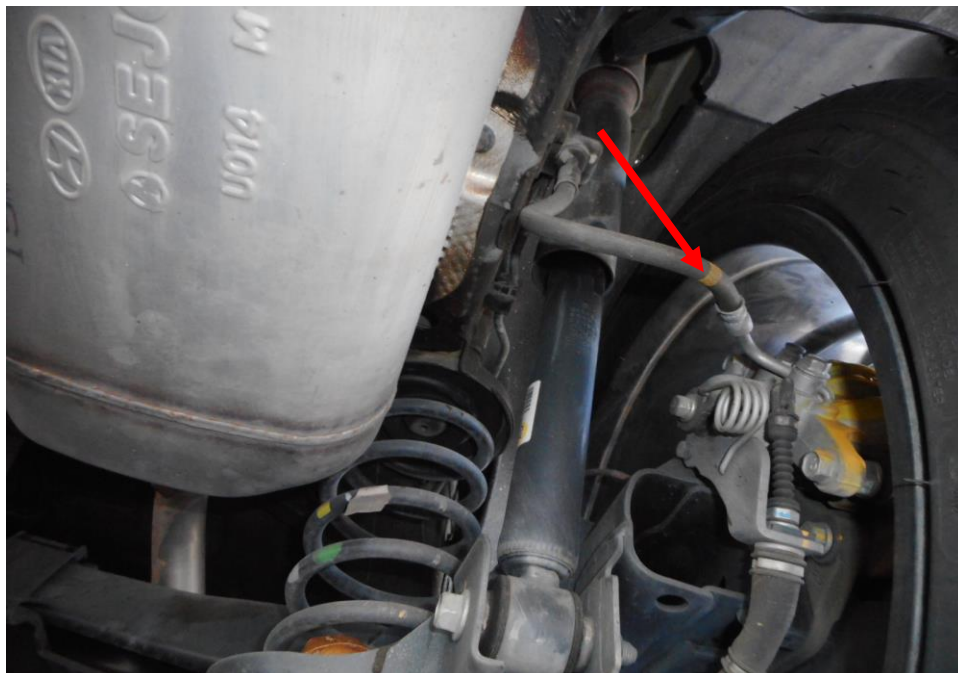
**Photo 19** shows the brake hose/pipe (arrowed) at the rear right wheel of the Motor Car. No leakage of brake fluid was observed. Visual examination of the various components of the braking system like the drum brake, brake booster, brake pedal etc. had revealed all to be intact and without visible damage.

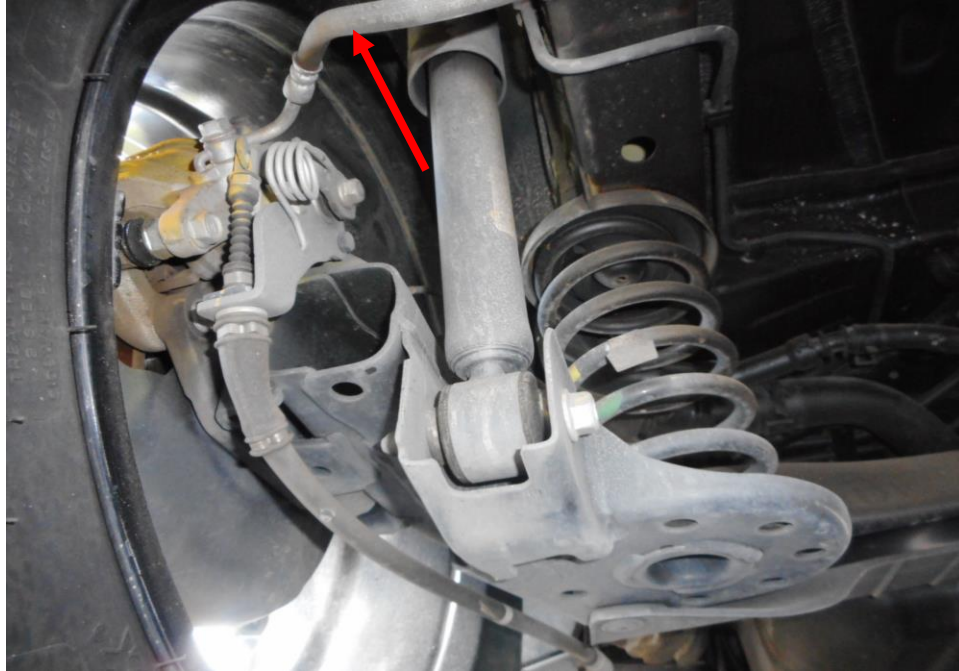
**Photo 20** shows the brake hose/pipe (arrowed) at the rear left wheel of the Motor Car. I did not observe any leakage of brake fluid at the time of my inspection of the Motor Car. Static tests of the Motor Car's braking system had indicated that there was no internal leakage of pressure/vacuum. The undercarriage components of the Motor Car were also all found to be intact and without any visible damage.

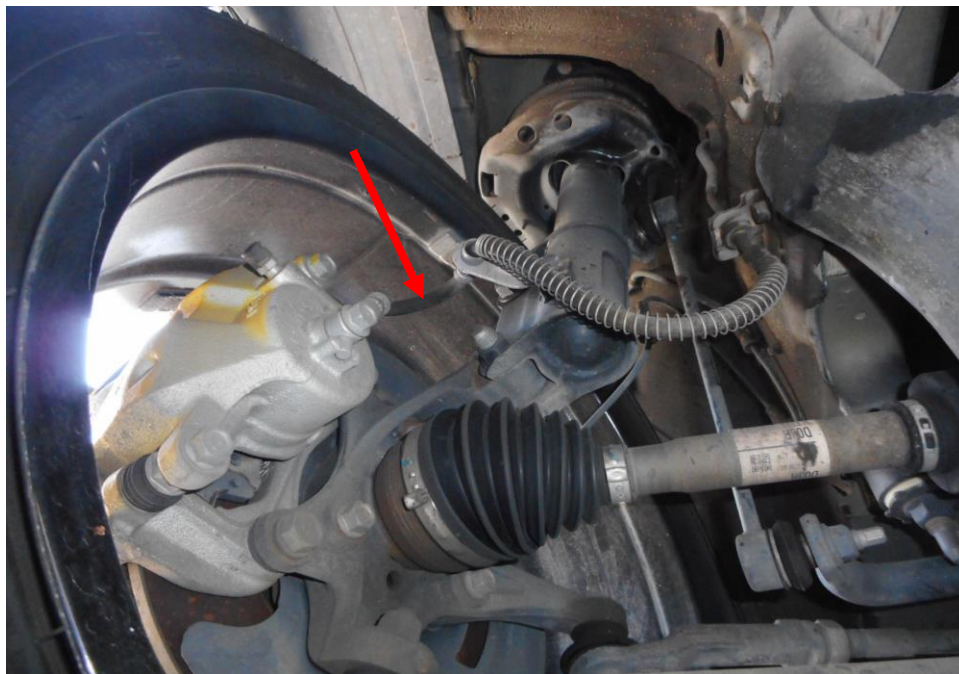
**Photo 21** shows the brake hose/pipe (arrowed) at the front right wheel of the Motor Car. I did not observe any leakage of brake fluid at the time of my inspection of the Motor Car. Static tests of the Motor Car's braking system had indicated that there was no internal leakage of pressure/vacuum. The undercarriage components of the Motor Car were also all found to be intact and without any visible damage.

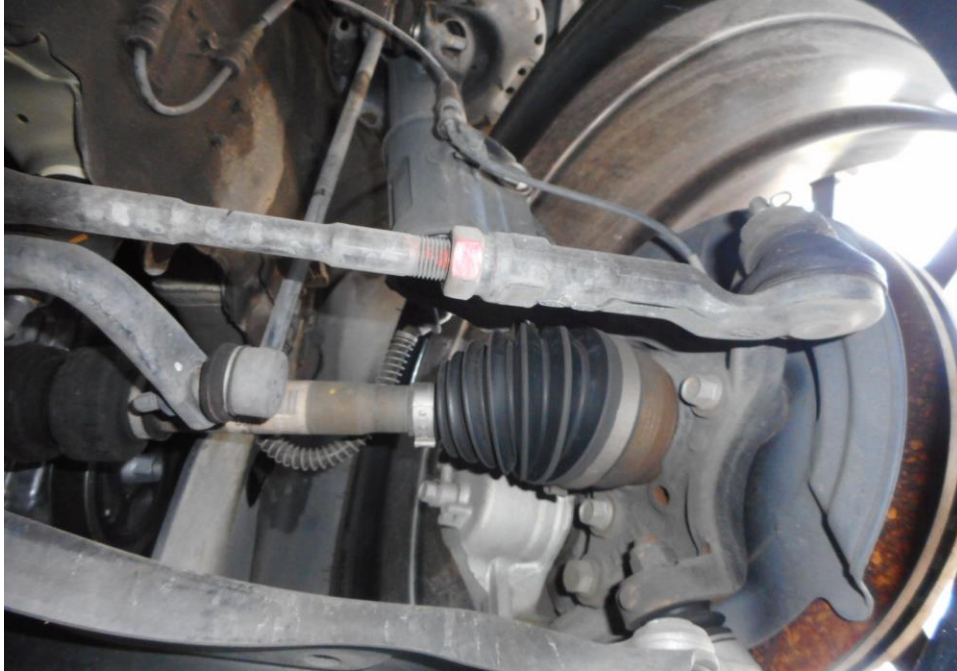
**Photo 22** shows the various undercarriage components at the front right wheel of the Motor Car, which had included the steering tie rod (red arrowed) and the driveshaft (yellow arrowed). The various undercarriage components of the Motor Car were all found to be intact without any visible damage.

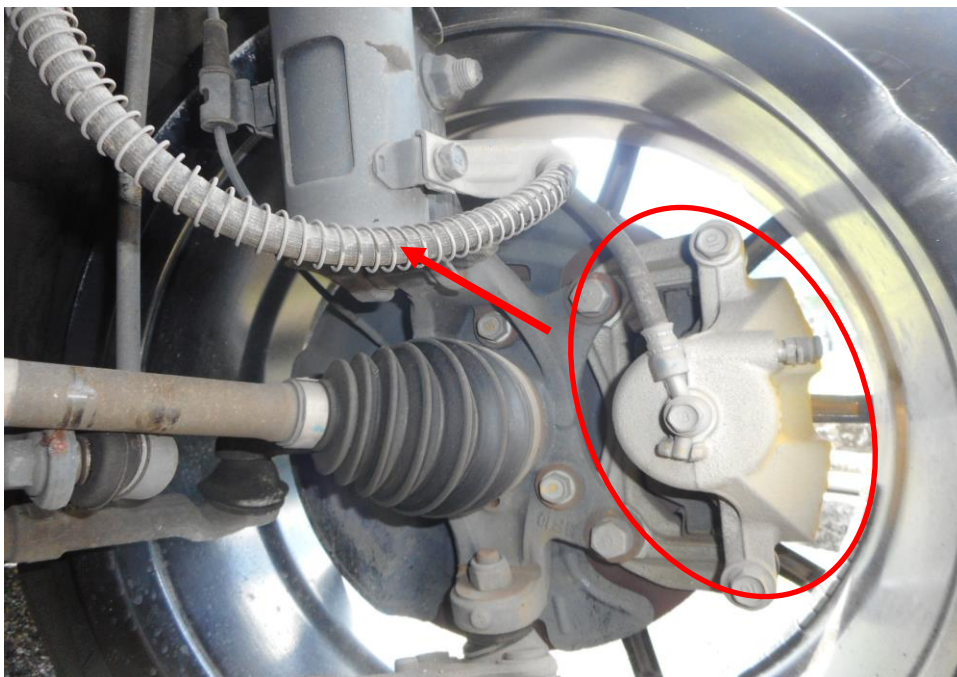
**Photo 23** shows the brake hose/pipe (arrowed) at the front left wheel of the Motor Car. No leakage of brake fluid was observed. Visual examination of the various components of the braking system like the brake caliper (circled), brake booster, brake pedal etc had revealed all to be intact and without visible damage.

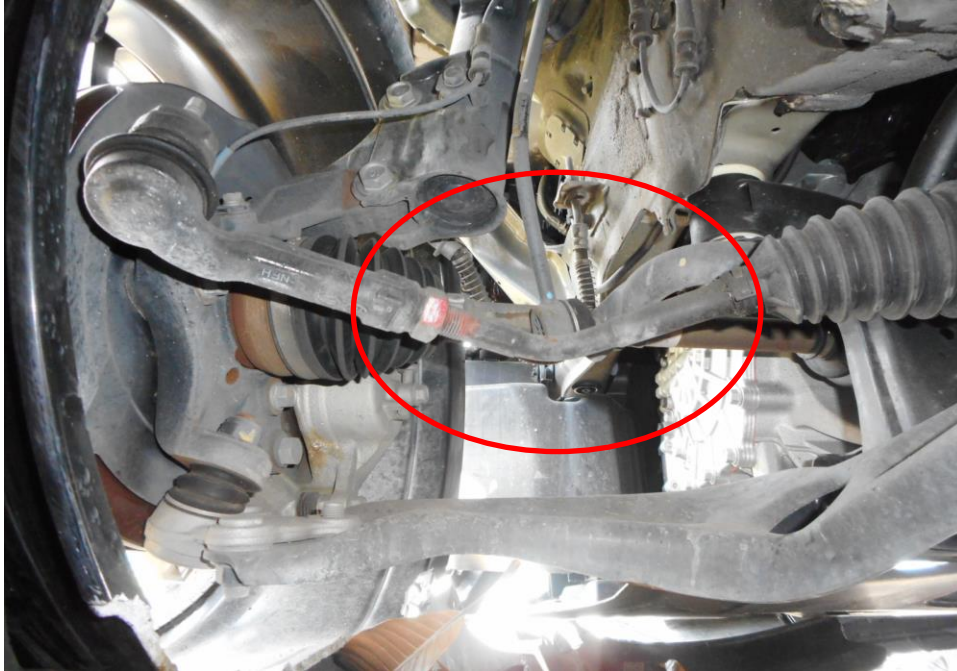
**Photo 24** shows the various undercarriage components at the front left wheel of the Motor Car, in particular the steering tie rod was observed to have sustained damaged as a result of the accident (circled).

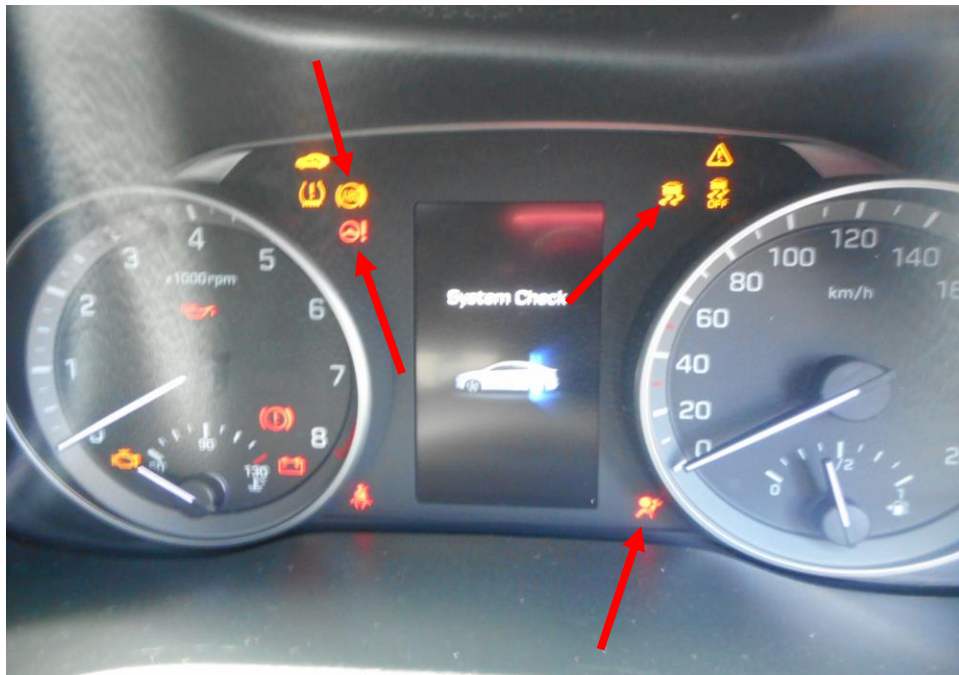
**Photo 25** shows the warning light for Anti-Lock Brake System (ABS) and Power Steering System (EPS), Supplemental Restraint System (SRS) and Traction Control (TC) (arrowed) appearing on the instrument panel of the Motor Car during the self-test of its various electronic operating systems when its engine was cranked.

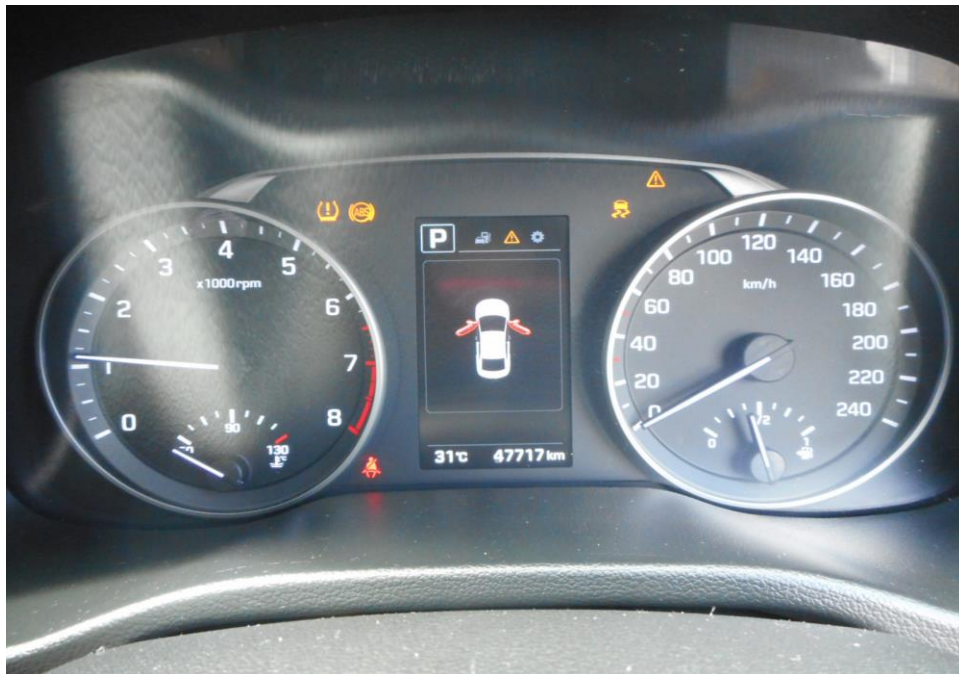
**Photo 26** shows only the ABS and TC warning lights illuminated on the instrument panel of the Motor Car after the engine was cranked. This was caused by the damaged front left tyre and rim as a result of the accident.
