Your Ref: TP/IP/55797/2021
Our Ref : CI/TPD21003583/P

31st March 2021

MECHANICAL INSPECTION REPORT OF MOTOR CAR SLL 9438G

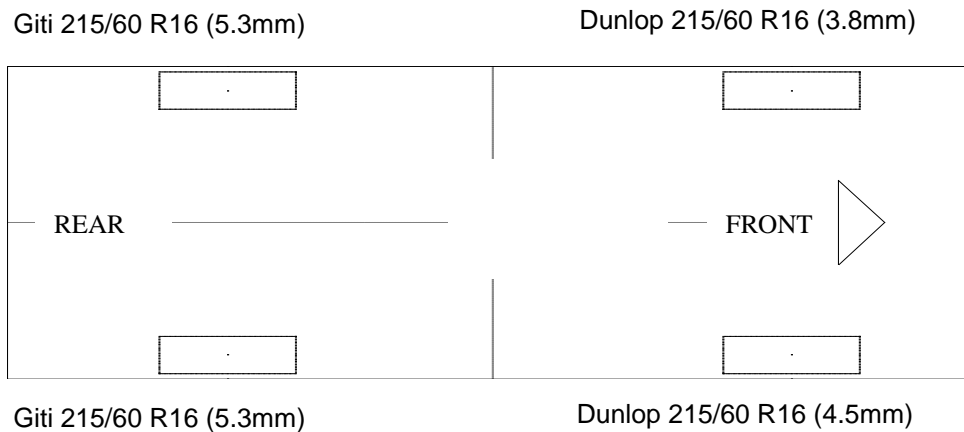
6. The 4 tyres of the Motor Car were observed to be in serviceable condition and sufficiently inflated for vehicular operation. I did not find any tear, cut or burst mark(s) on the outer and the inner sidewalls as well as across the tread of the 4 tyres. The tyre brand, tyre size and remaining tread depth of the 4 tyres of the Motor Car were recorded as follows:-

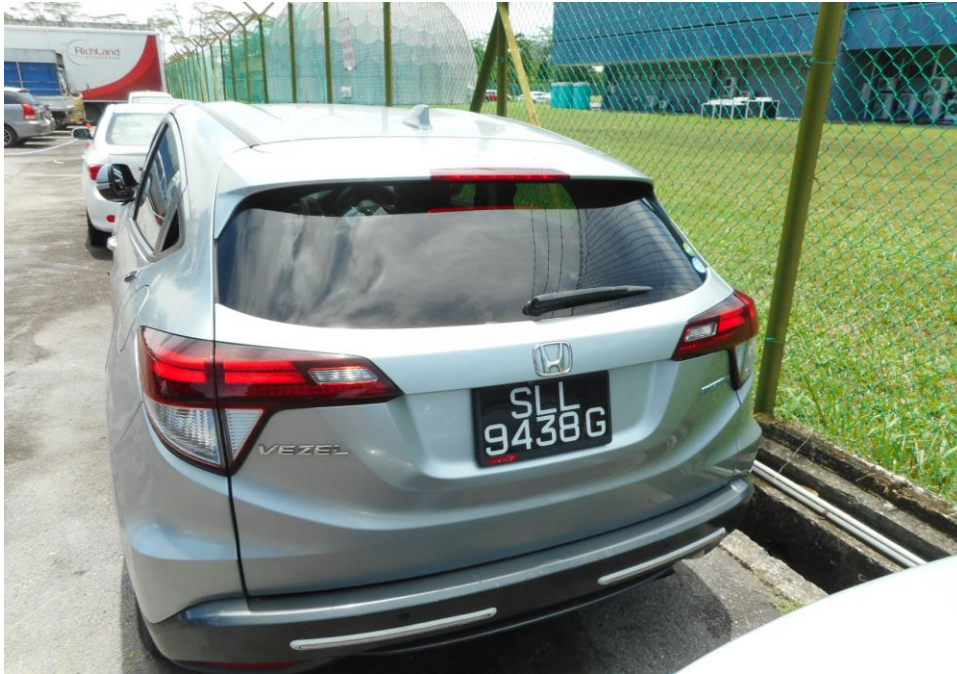
Photo 1 shows a general view of the Motor Car's rear body at the time of my inspection. The rear portion of the Motor Car was observed to have been undamaged by the accident.

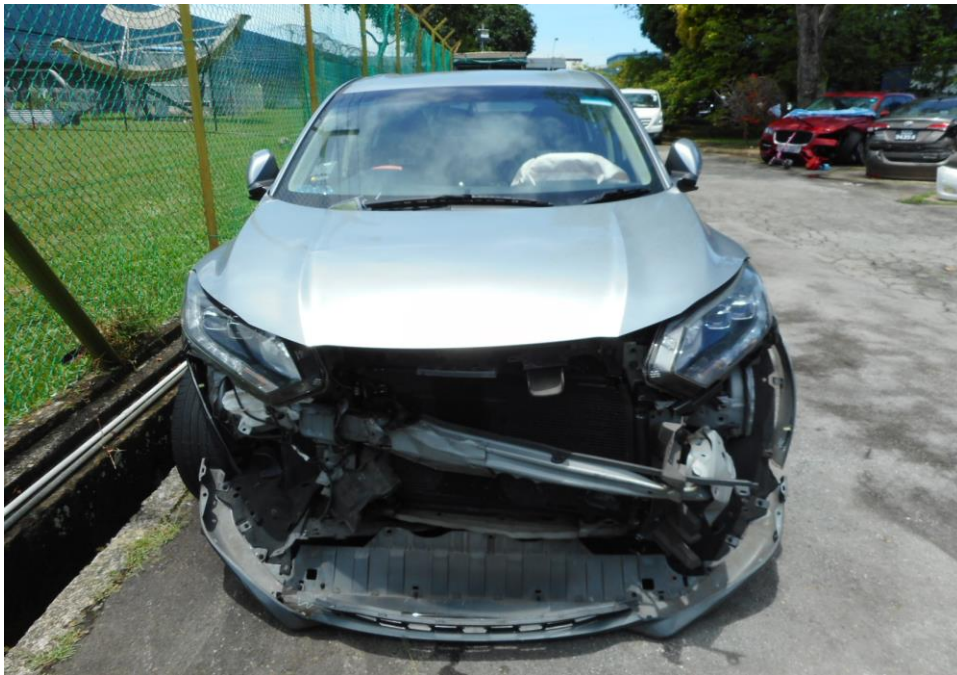
4. The mileage of the Motor Car at the time of my inspection was 283,190km.
5. The Motor car was observed to have sustained damage at its front portion. Its front bonnet, front right headlamp, front bumper, front right fender was amongst the body parts and various components in the engine compartments were also damaged as a result of the accident. The Supplemental Restraint System (SRS) was activated as a result of the accident.

Photo 2 shows a general view of the Motor Car's front body at the time of my inspection. The Motor car was observed to have sustained damage at its front portion. Its front bonnet, front right headlamp, front bumper, front right fender was amongst the body parts and various components in the engine compartments were also damaged as a result of the accident.

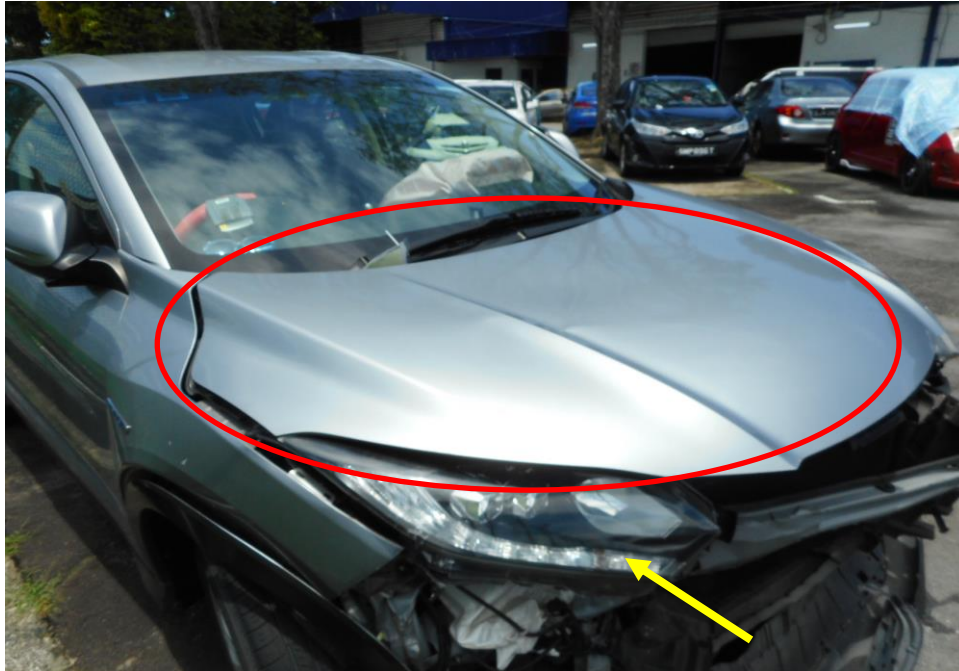
Photo 2 shows the close up view of the Motor Car's front body at the time of my inspection. The Motor car was observed to have sustained damage at its front portion. Its front bonnet (circled) and front right headlamp (arrowed) was amongst the body parts and various components in the engine compartments were also damaged as a result of the accident.

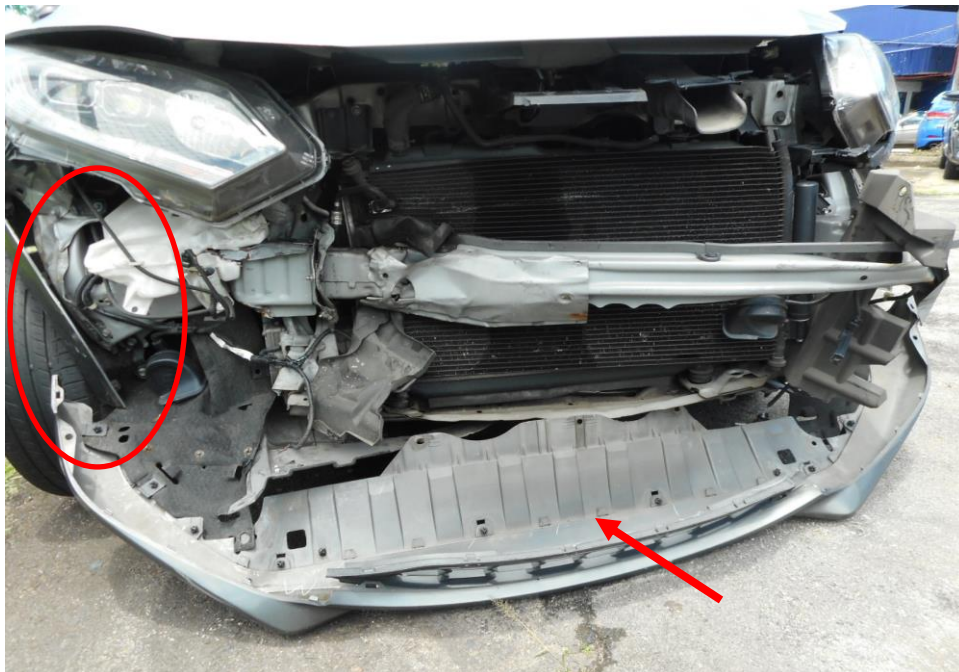
Photo 3 shows the general view of the Motor Car's front body at the time of my inspection. The Motor car was observed to have sustained damage at its front portion. Its front bumper (arrowed) was amongst the body parts and various components in the engine compartments were also damaged as a result of the accident.

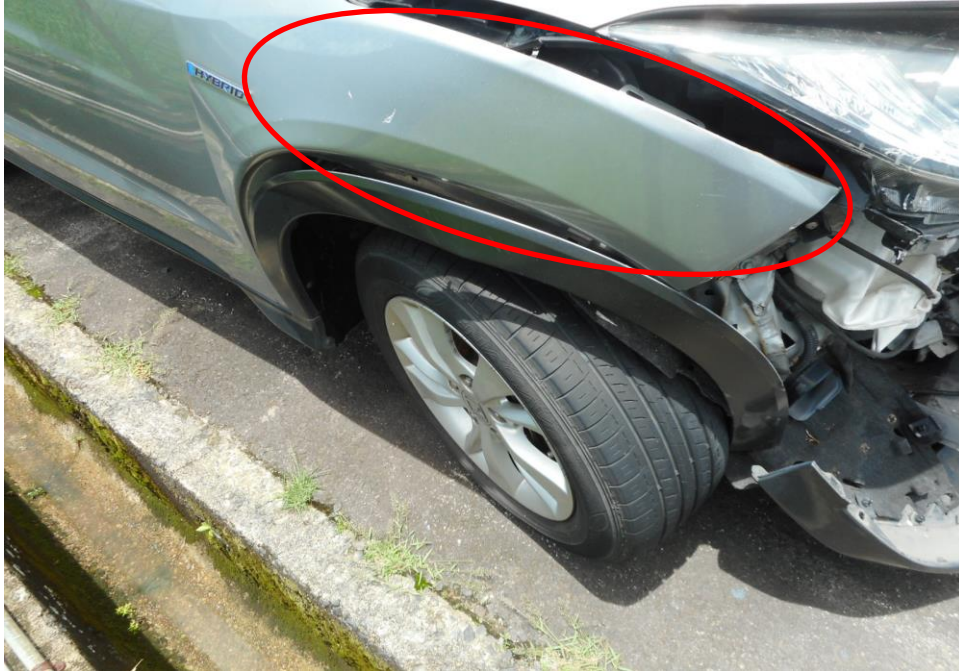
Photo 4 shows the general view of the Motor Car's front body at the time of my inspection. The Motor car was observed to have sustained damage at its front portion. Its front right fender (circled) was amongst the body parts and various components in the engine compartments were also damaged as a result of the accident.

12. Static test on the steering system of the Motor Car also revealed no abnormality to the steering system. I did experience abnormal resistance when turning the steering wheel left and right to full lock positions as the damaged front right fender from the accident had blocked the turning of the steering wheel. However, my visual examination of the various steering components which had included the steering rack and pinion, tie rods, tie rod ends and ball joints revealed that these components were all generally in good condition. See photo 18 - 23 below.

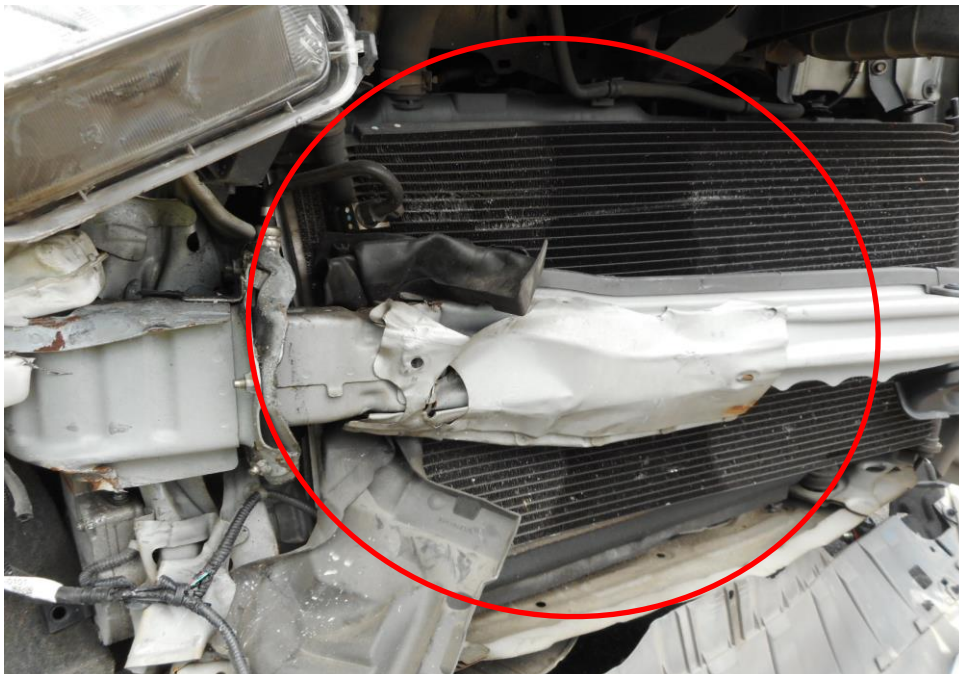
Photo 5 shows the close up view of the Motor Car's front body at the time of my inspection. The Motor car was observed to have sustained damage at its front portion. Its engine radiator (circled) was amongst the various components in the engine compartments were also damaged as a result of the accident.

15. Operational test to primarily determine whether there was any abnormality to the engine system, transmission system and braking system of the Motor Car could not be conducted given the extent of damage that it had sustained to the engine radiator and the front right fender. (unable to move)

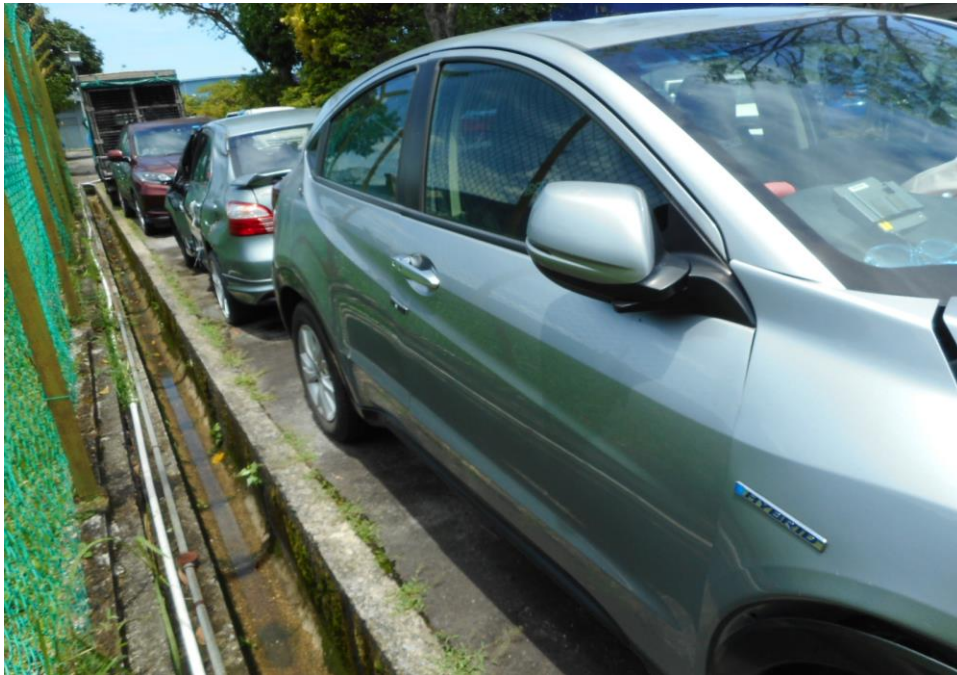
Photo 6 shows a general view of the Motor Car's right body at the time of my inspection. The right portion of the Motor Car was observed to have been undamaged by the accident.

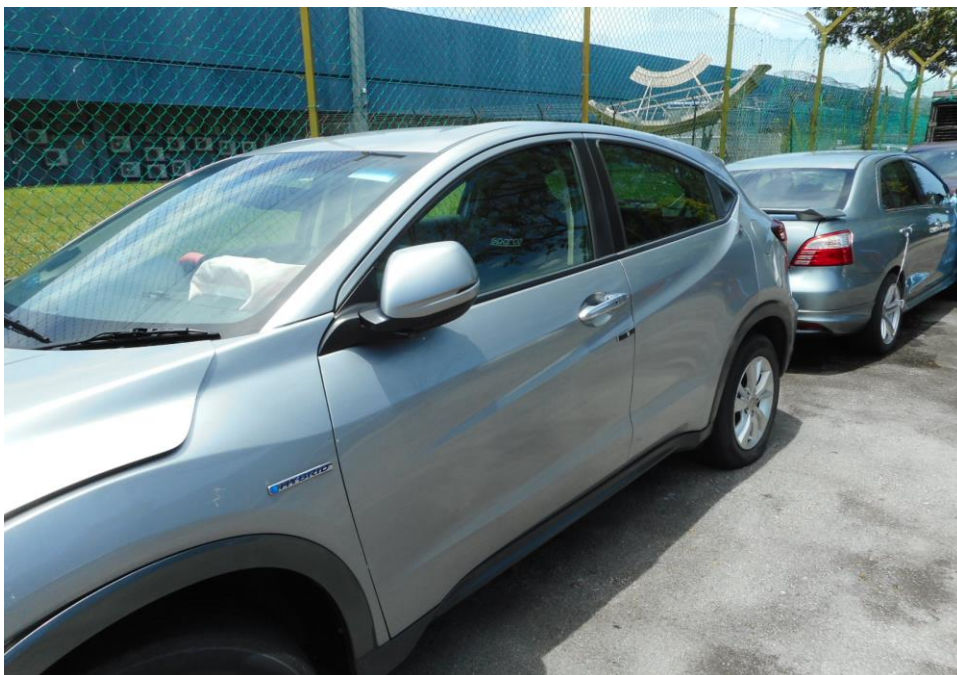
Photo 7 shows a general view of the Motor Car's left body at the time of my inspection. The left portion of the Motor Car was observed to have been undamaged by the accident.

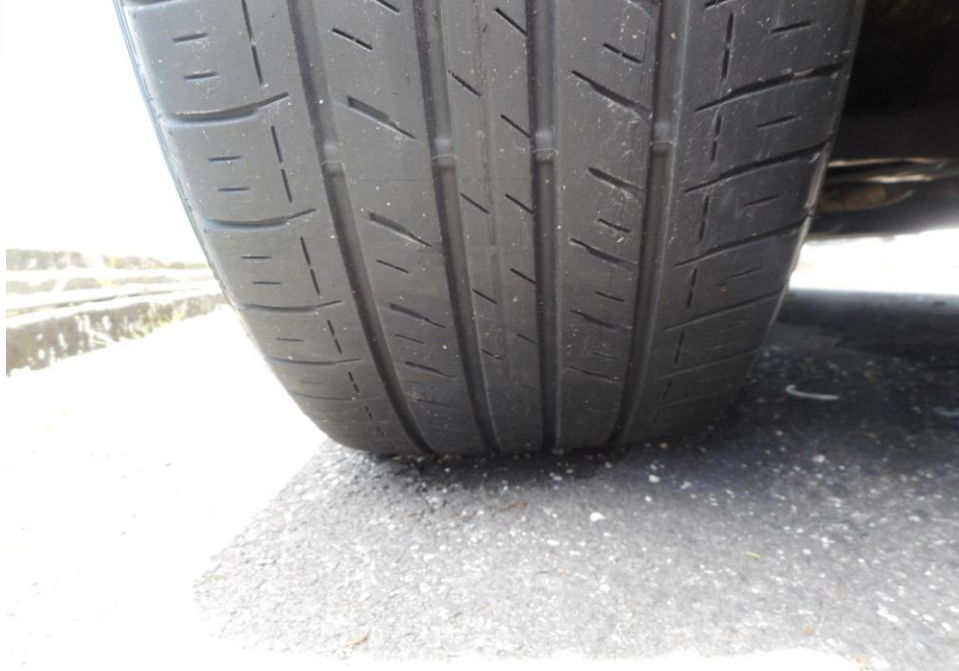
Photo 8 shows the condition of the front right tyre of the Motor Car, which was observed to be in serviceable condition with remaining tread depth of approximately 4.5mm. The tyre was also observed to be sufficiently inflated for vehicular operation with no tear, cut or burst mark(s).

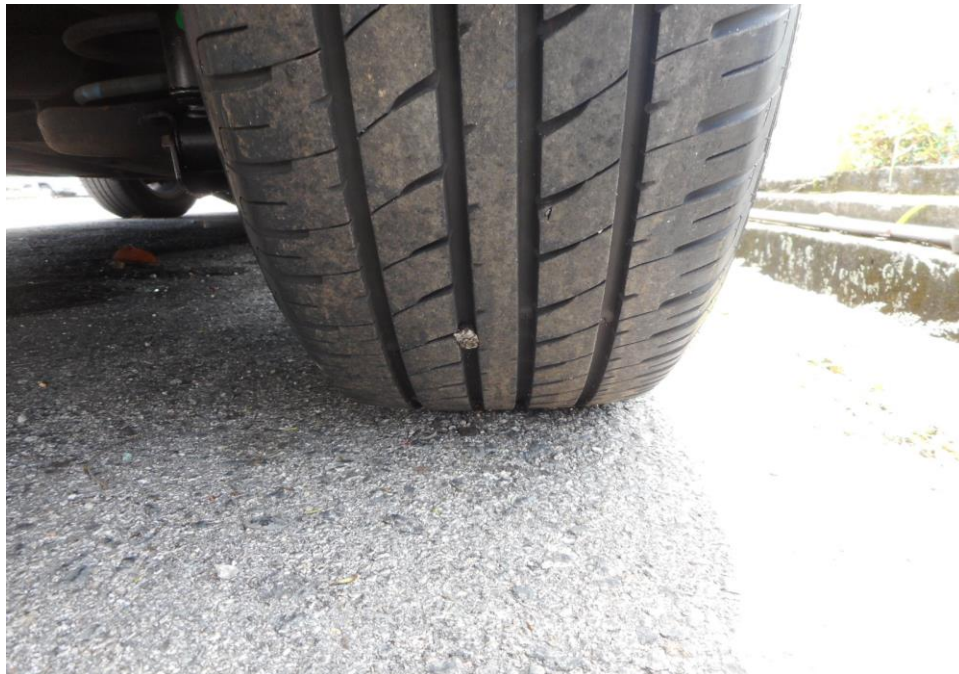
Photo 9 shows the condition of the rear right tyre of the Motor Car, which was observed to be in serviceable condition with remaining tread depth of approximately 5.3mm. The tyre was also observed to be sufficiently inflated for vehicular operation with no tear, cut or burst mark(s).

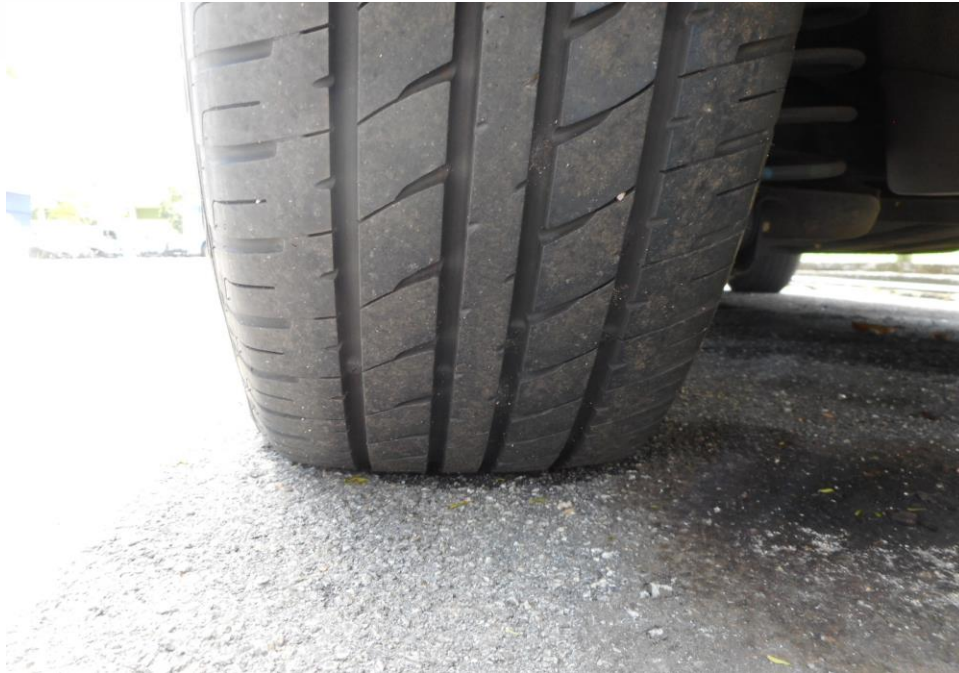
Photo 10 shows the condition of the rear left tyre of the Motor Car, which was observed to be in serviceable condition with remaining tread depth of approximately 5.3mm. The tyre was also observed to be sufficiently inflated for vehicular operation with no tear, cut or burst mark(s).

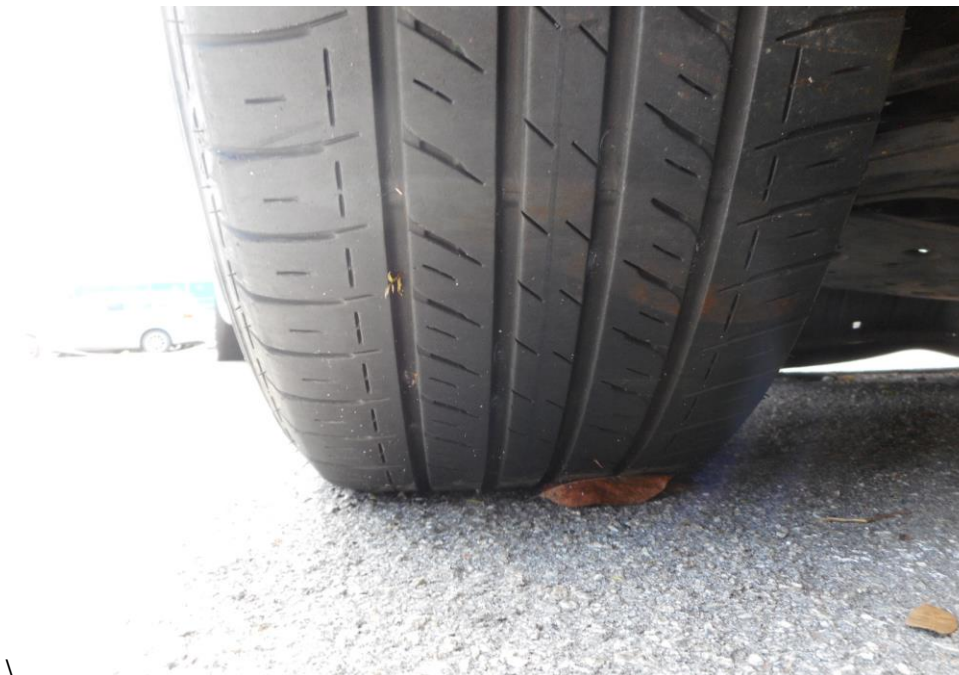
Photo 11 shows the condition of the front left tyre of the Motor Car, which was observed to be in serviceable condition with remaining tread depth of approximately 3.8mm. The tyre was also observed to be sufficiently inflated for vehicular operation with no tear, cut or burst mark(s).

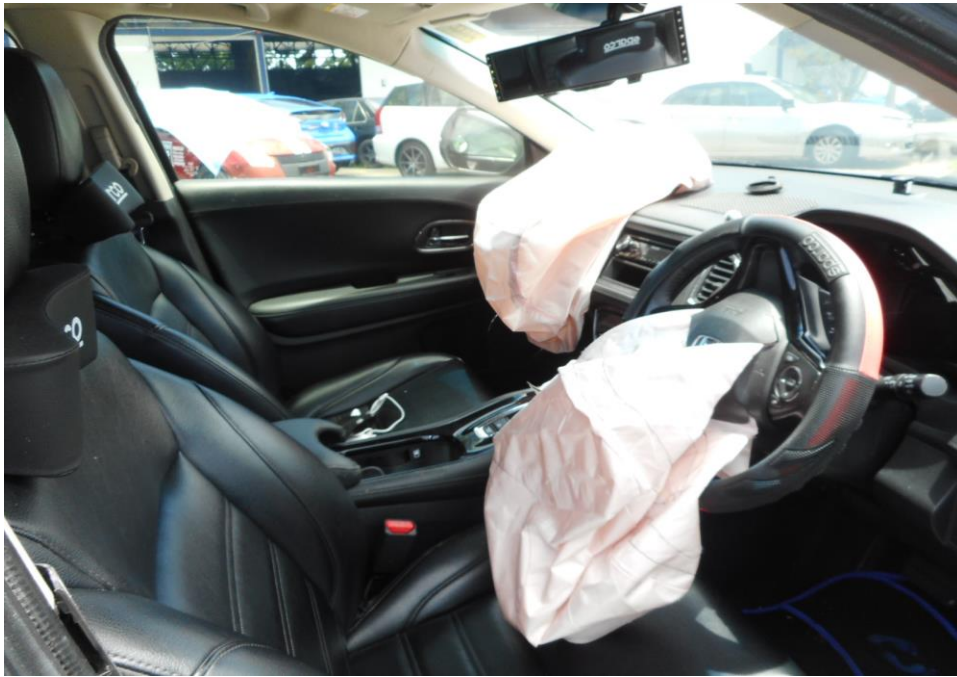
Photo 12 shows the deployment of the Supplemental Restraint System (SRS) airbag in the Motor Car as a result of the accident.

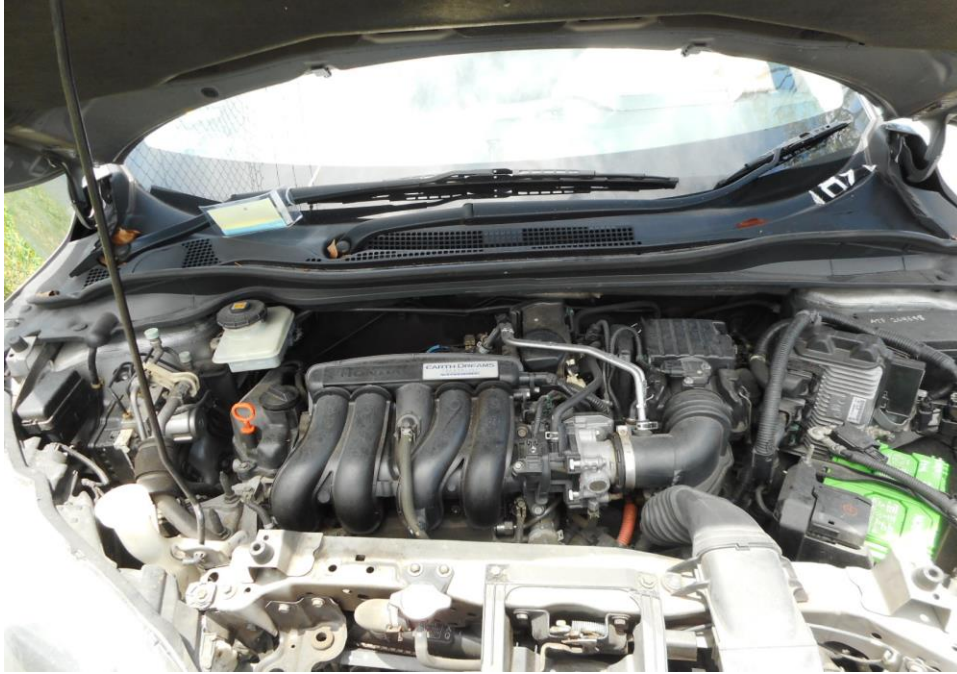
Photo 13 shows a general view of the Motor Car's engine compartment. The various parts and components inside the engine compartment were unaffected by the accident. There was also no sign(s) or indication(s) of fluid leakage and/or fluid stain within the engine compartment.

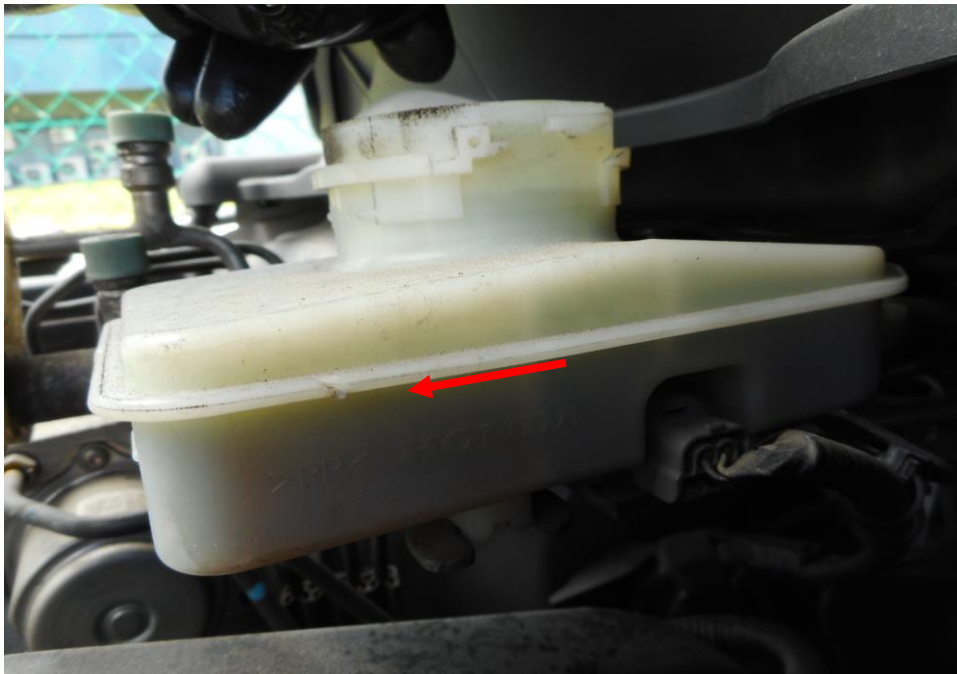
Photo 14 shows the brake fluid reservoir of the Motor Car at the time of my inspection. The brake fluid was observed to be of sufficient level (arrowed) and without any visible contamination.

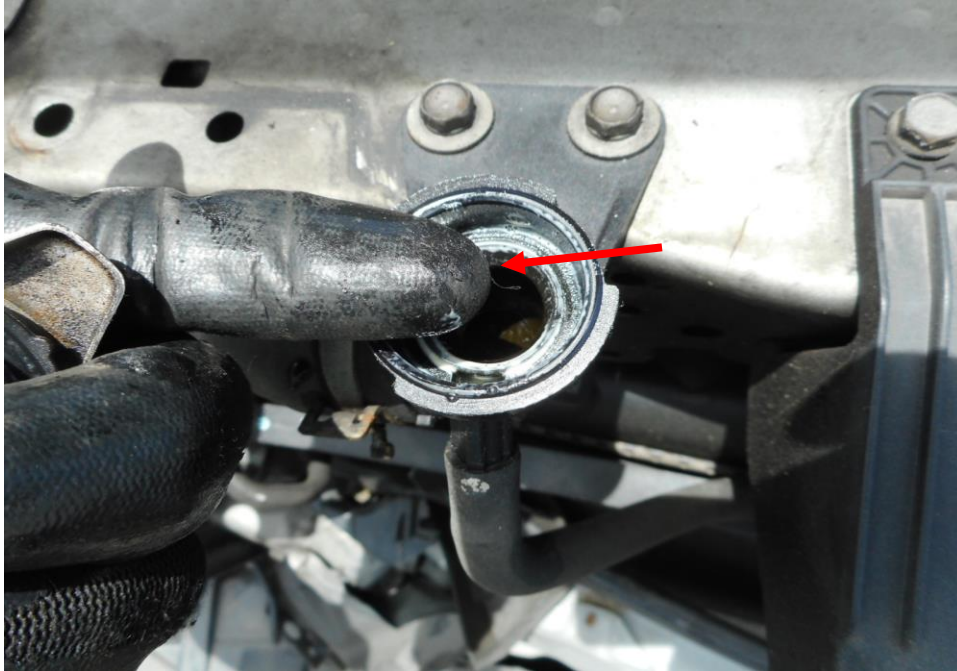
8. Upon examination of the engine compartment of the Motor Car, I had observed all the parts and components inside the engine compartment to be intact and unaffected by the accident. The brake fluid and engine oil were all found to be of sufficient level for operating purposes. Visually, there was also no contamination found to these fluids. However, the engine coolant was observed to be insufficient due to the result of the accident that had damaged the radiator and caused a leakage of engine coolant.

Photo 15 shows checks being carried out to the engine coolant of the Motor Car at the time of my inspection. The engine coolant was observed to be insufficient level (arrowed) as the result of the accident had damaged the engine radiator and caused the leakage of engine coolant.

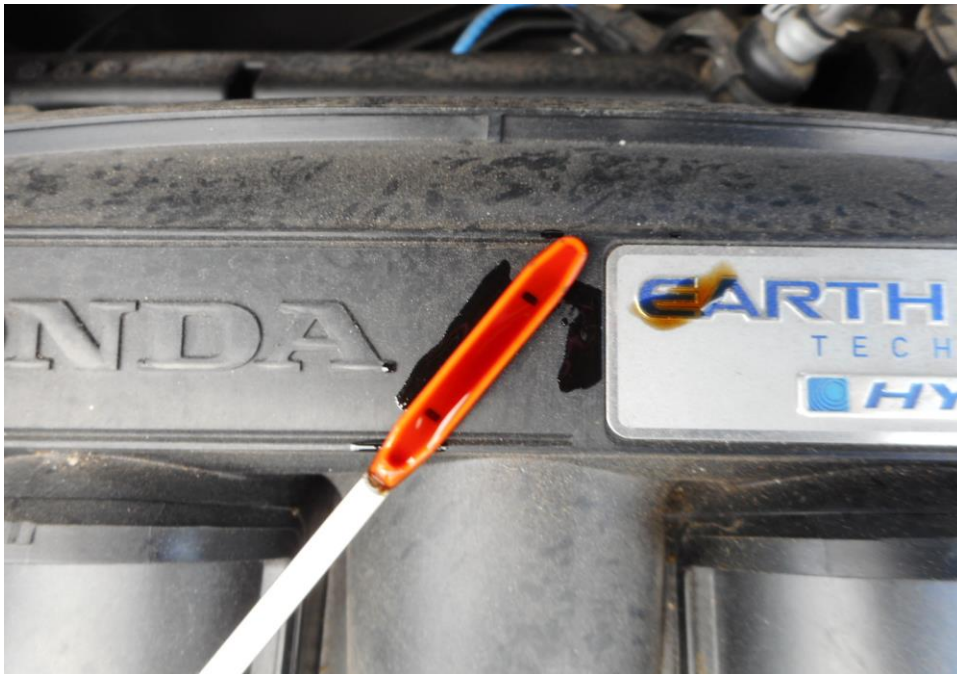
Photo 16 shows the engine oil dip stick of the Motor Car at the time of my inspection. The engine oil was observed to be of sufficient level and without any visible contamination.

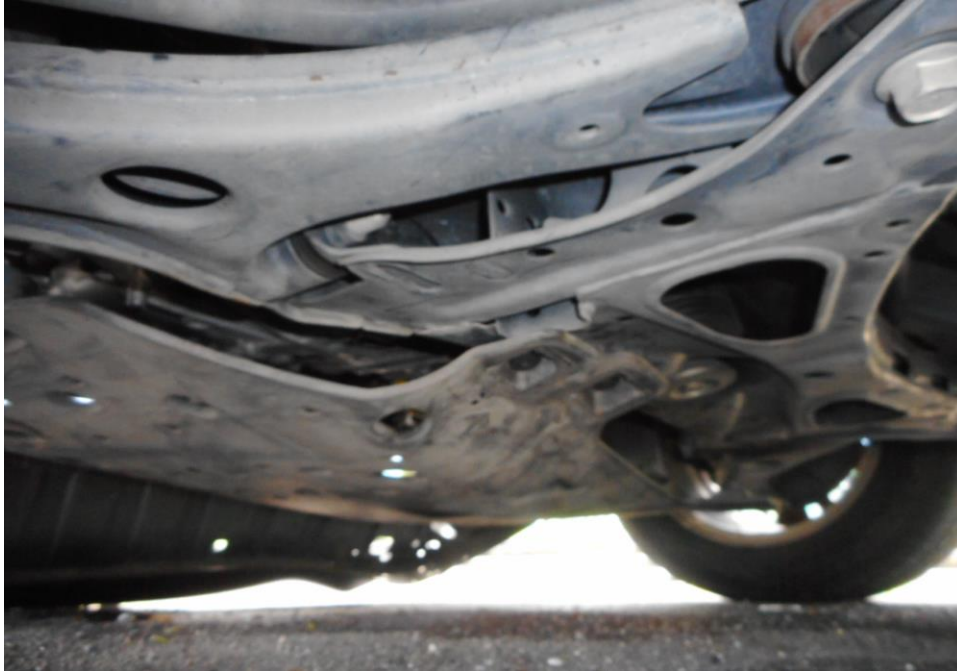
Photo 17 shows the undercarriage of the Motor Car, at the area where the engine housing and transmission housing are located. I did not find any sign(s) or indication(s) of fluid leak and/or fluid stain(s) on the underside of the Motor Car.

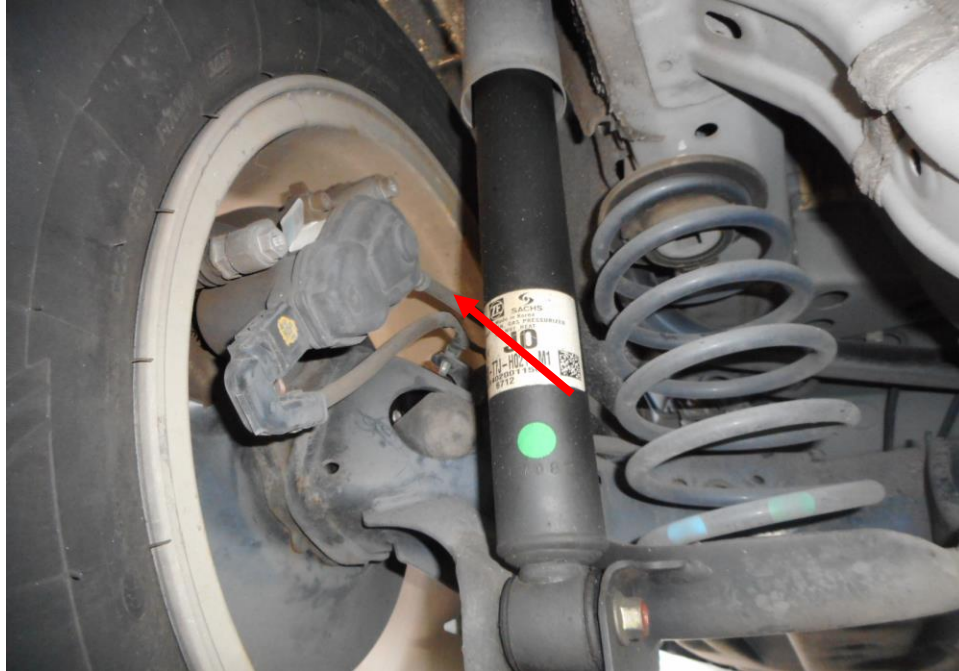
Photo 18 shows the brake hose/pipe (arrowed) at the rear left wheel of the Motor Car. I did not observe any leakage of brake fluid at the time of my inspection of the Motor Car. Static tests of the Motor Car's braking system had indicated that there was no internal leakage of pressure/vacuum. The undercarriage components of the Motor Car were also all found to be intact and without any visible damage.

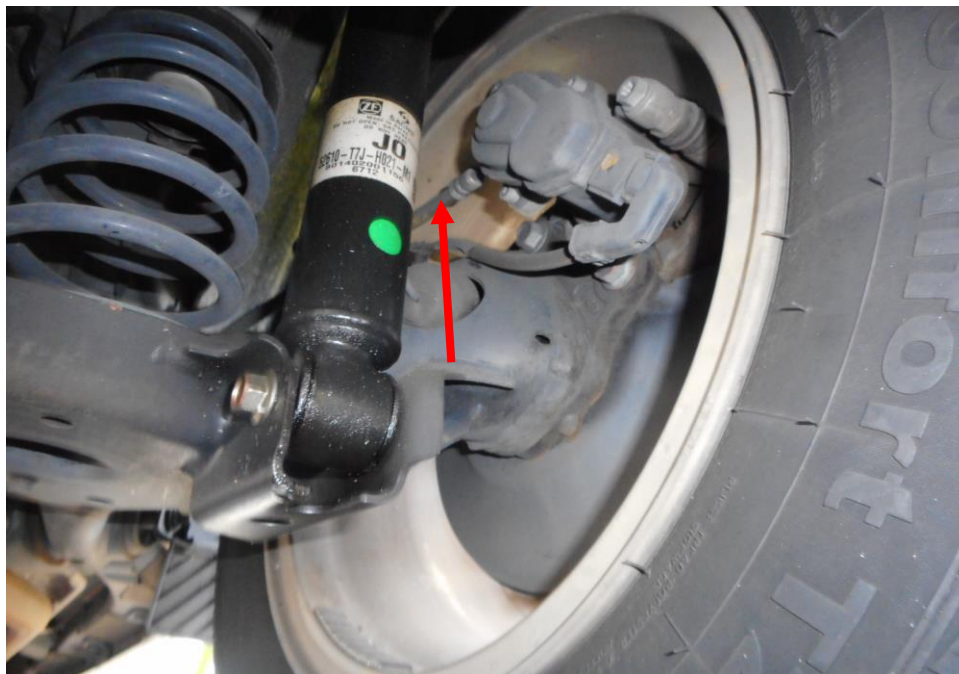
Photo 19 shows the brake hose/pipe (arrowed) at the front right wheel of the Motor Car. I did not observe any leakage of brake fluid at the time of my inspection of the Motor Car. Static tests of the Motor Car's braking system had indicated that there was no internal leakage of pressure/vacuum. The undercarriage components of the Motor Car were also all found to be intact and without any visible damage.

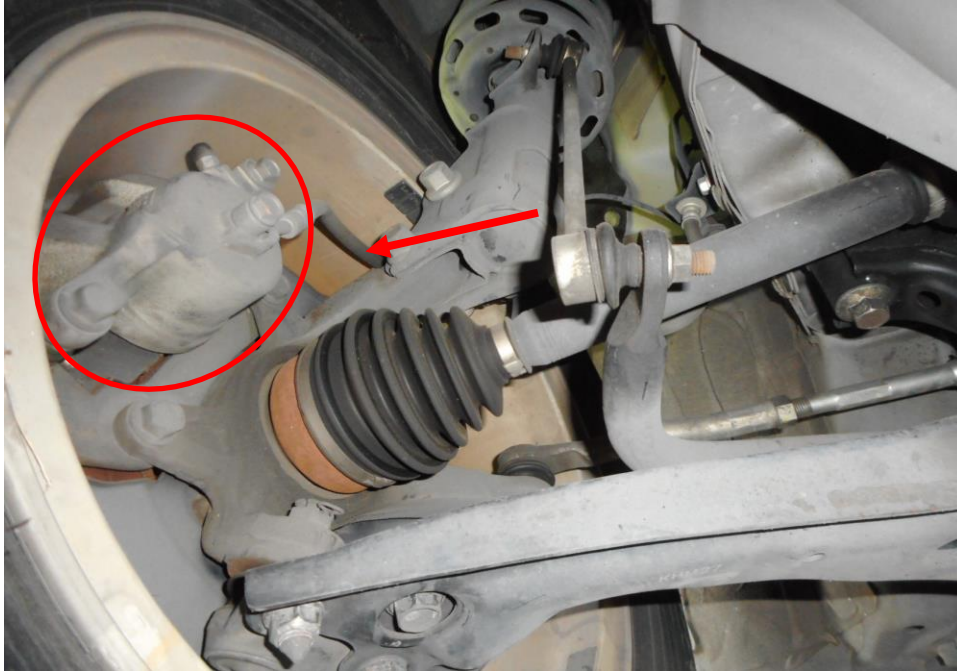
Photo 20 shows the brake hose/pipe (arrowed) at the front right wheel of the Motor Car. No leakage of brake fluid was observed. Visual examination of the various components of the braking system like the brake caliper (circled) brake pedal etc had revealed all to be intact and without visible damage at the time of accident. There was also no sign of fluid stain(s) observed on the various undercarriage components.

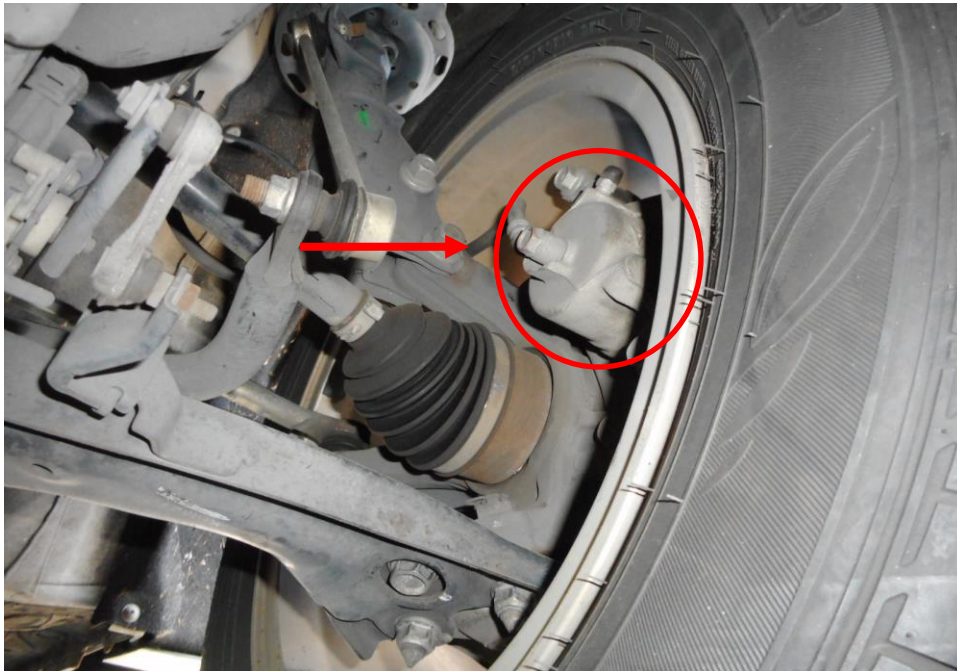
Photo 21 shows the brake hose/pipe (arrowed) at the front left wheel of the Motor Car. No leakage of brake fluid was observed. Visual examination of the various components of the braking system like the brake caliper (circled), brake pedal etc had revealed all to be intact and without visible damage at the time of accident. There was also no sign of fluid stain(s) observed on the various undercarriage components.

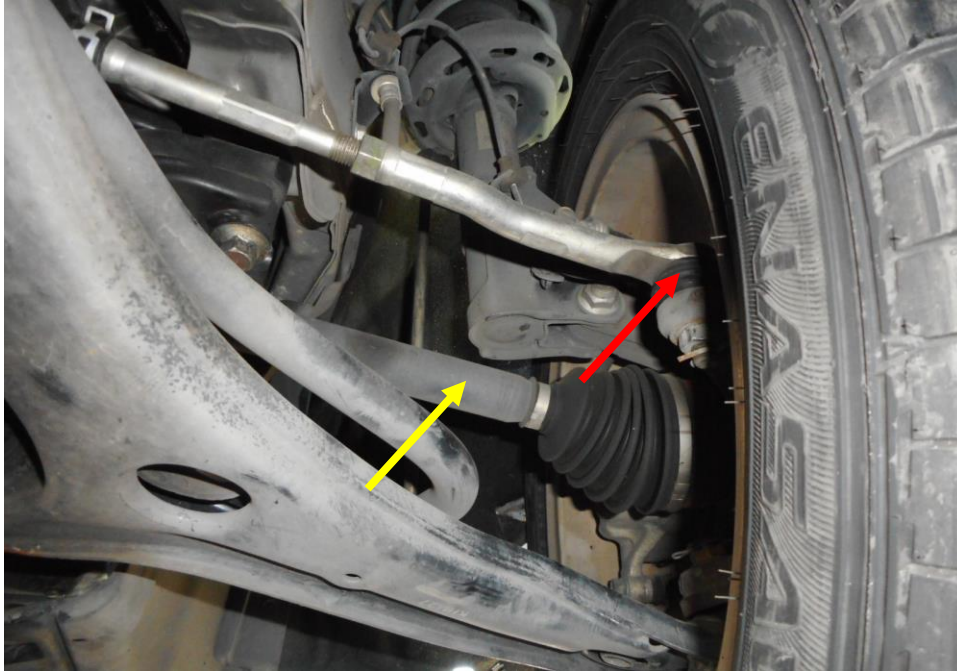
Photo 22 shows the various undercarriage components at the front right wheel of the Motor Car, in particular the steering tie rod end (arrowed) and drive shaft (yellow arrow). The various steering components were all found to be intact, suggesting that the steering system of the Motor Car was likely to be in serviceable condition at the material time of accident. There was also no sign of fluid stain(s) observed on the various undercarriage components.

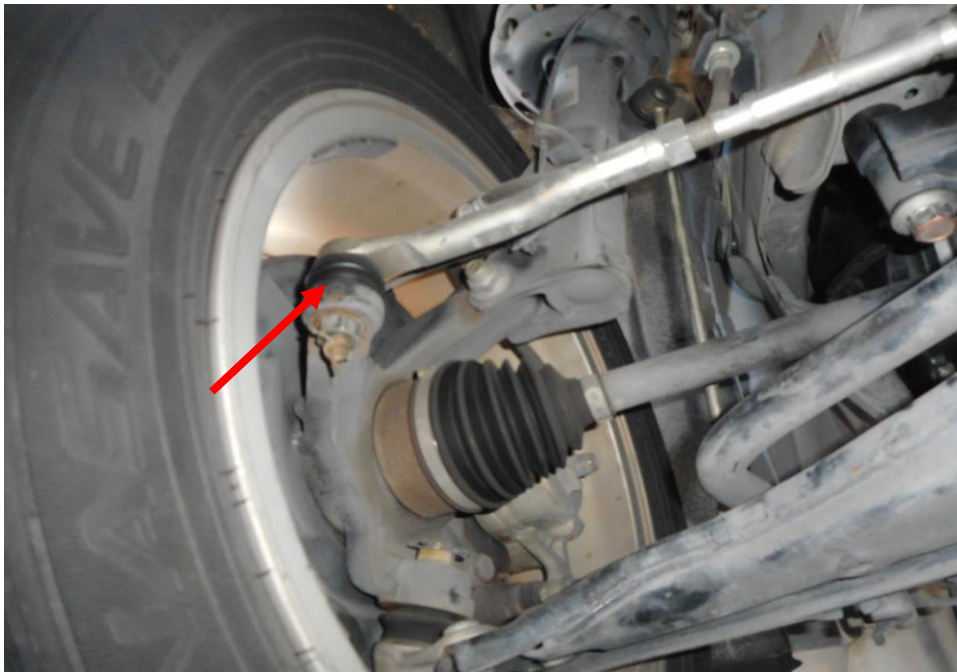
Photo 23 shows the various undercarriage components at the front left wheel of the Motor Car, in particular the steering tie rod end (arrowed). The various steering components were all found to be intact, suggesting that the steering system of the Motor Car was likely to be in serviceable condition at the material time of accident. There was also no sign of fluid stain(s) observed on the various undercarriage components.

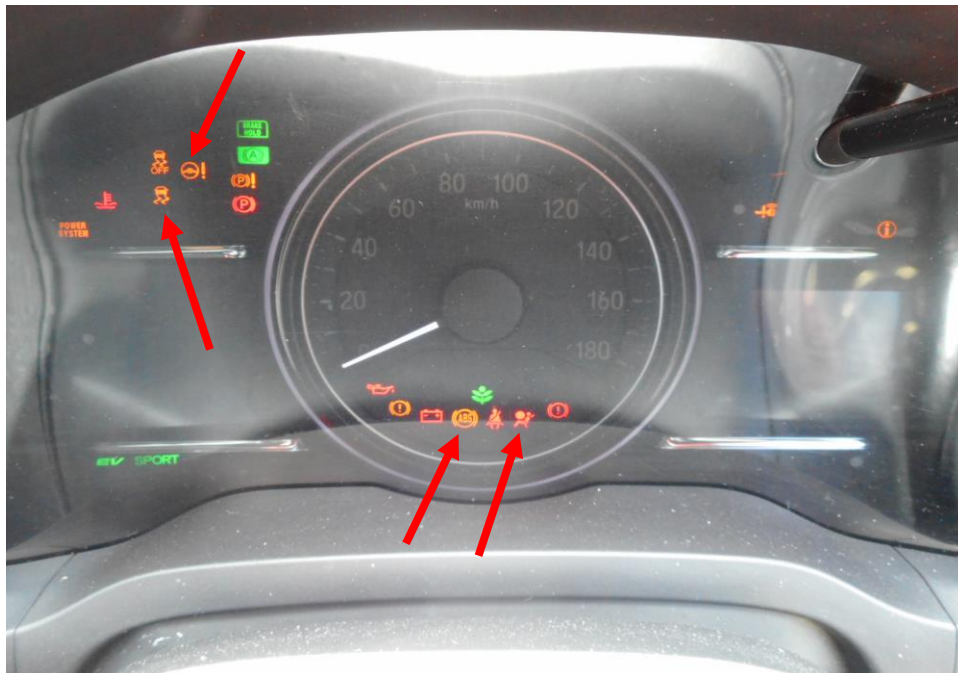
Photo 24 shows the warning light for Anti-Lock Brake System (ABS) and Power Steering System (EPS), Supplemental Restraint System (SRS) and Traction Control (TC) (arrowed) appearing on the instrument panel of the Motor Car during the self-test of its various electronic operating systems when its engine was cranked.

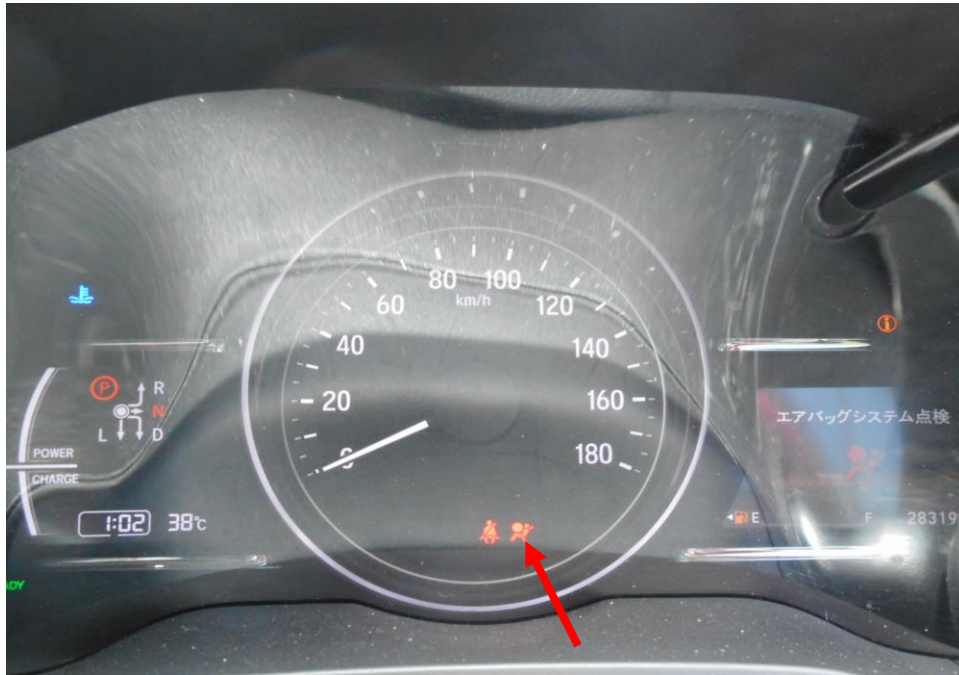
Photo 25 shows no warning lights illuminated on the instrument panel of the Motor Car after the engine was cranked. This would suggest that there was no abnormality to the electronic operating system of the Motor Car, like the ABS, EPS and TC etc. The Supplemental Restraint System (SRS) (arrowed) light remained on due to the deployment of the airbag as a result of the accident.

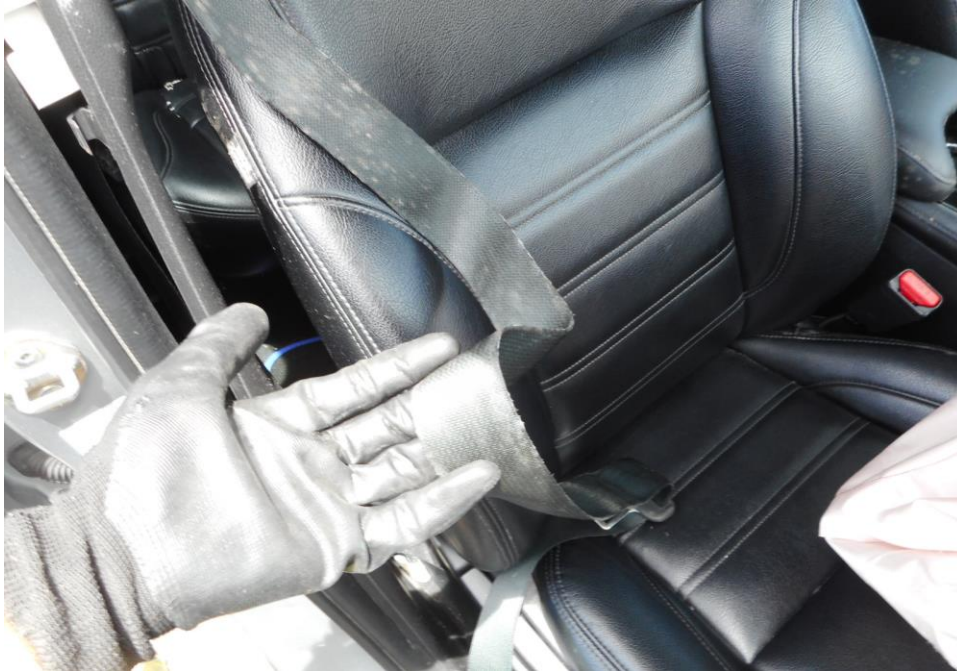
Photo 26 shows that the seat belt on the right seat was worn at the material time of accident as the safety pre-tensioners was activated at the moment of impact and caused the seat belt to be locked into the last position.

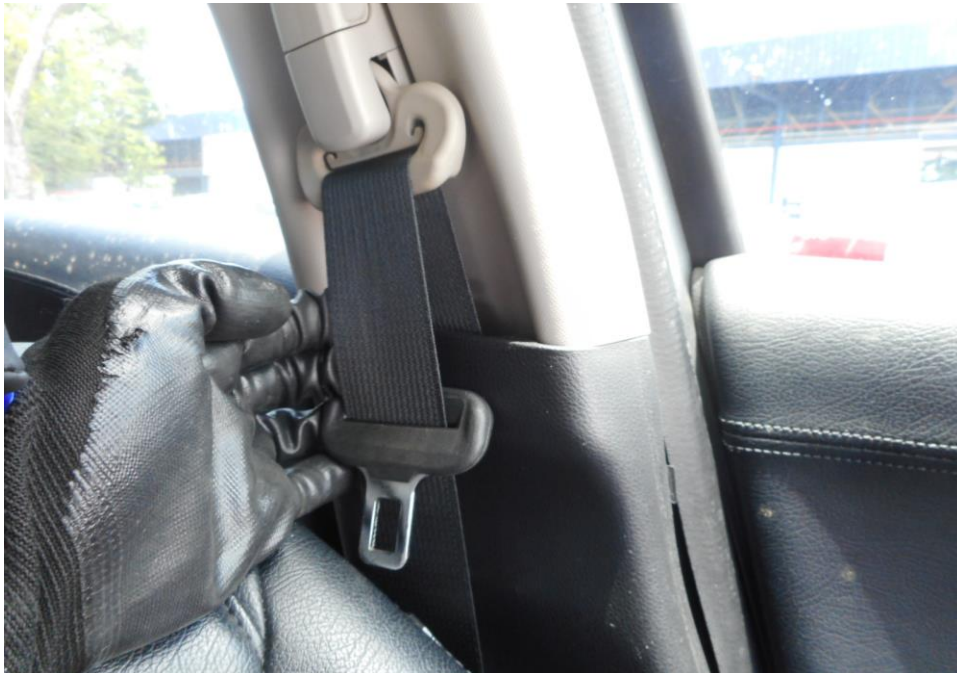
Photo 27 shows that the seat belt on the left seat was not worn at the material time of accident as the safety pre-tensioners was activated at the moment of impact and caused the seat belt to be locked into the last position.
