Your Ref: TP/IP/09045/2021  
Our Ref : CI/TPD21003584/P

23<sup>rd</sup> June 2021

**MECHANICAL INSPECTION REPORT OF MOTOR VAN GBD 4923R**

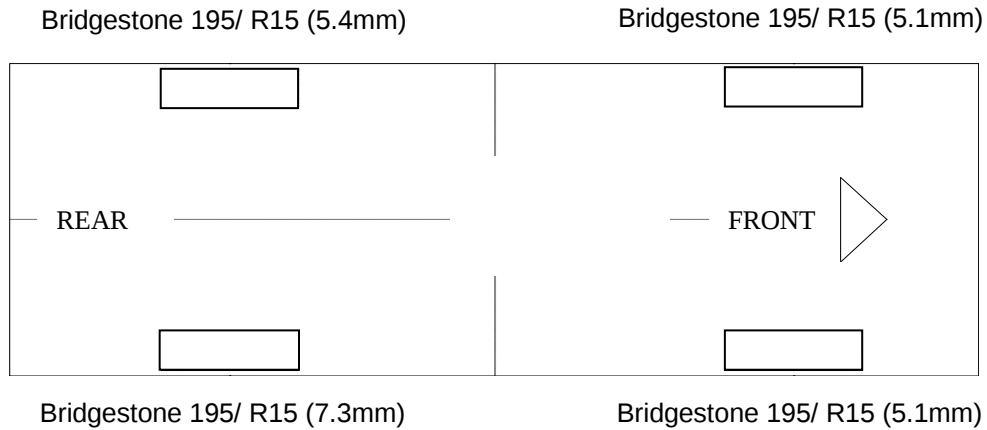
6. The 4 tyres of the Motor Van were observed to be in serviceable condition and sufficiently inflated for vehicular operation. I did not find any tear, cut or burst mark(s) on the outer and the inner sidewalls as well as across the tread of the 4 tyres. The tyre brand, tyre size and remaining tread depth of the 4 tyres of the Motor Van were recorded as follows:-

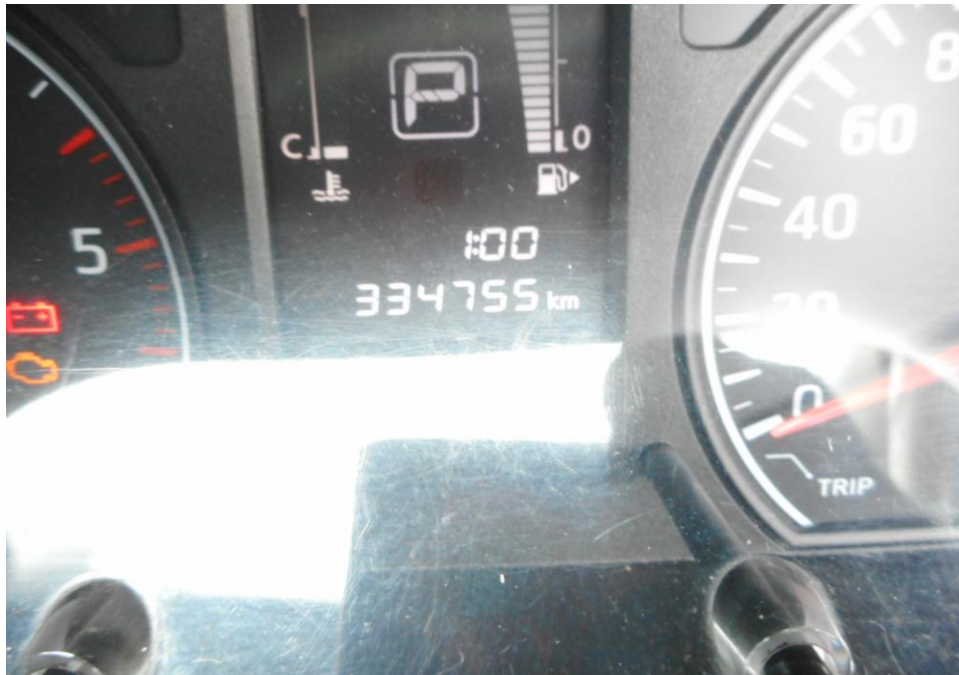
4. The mileage of the Motor Van at the time of my inspection was 334,755km.
5. The Motor Van appeared to have sustained damage at its frontal portion. Its front body panel were damage at the time of my inspection.

**Photo 1** shows a general view of the instrument cluster of the Motor Van at the time of my inspection. The mileage of the Motor Van was 334,755km

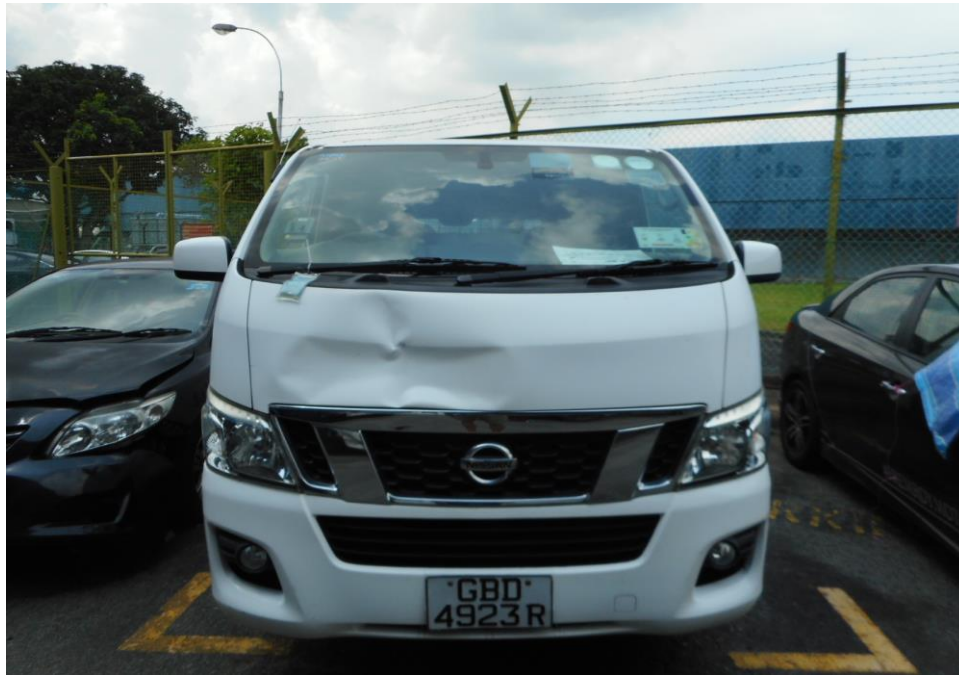
**Photo 2** shows a general view of the Motor Van's frontal portion at the time of my inspection. It appeared to have sustained damage at its frontal portion. Its front body panel were damage at the time of my inspection.

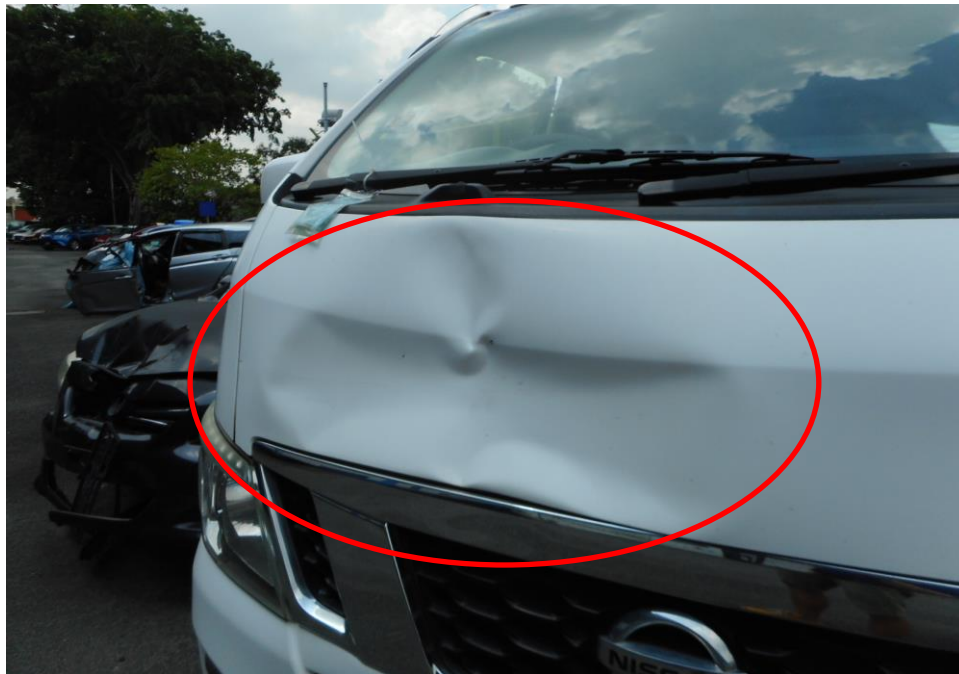
**Photo 3** shows a close up view of the Motor Van's frontal portion at the time of my inspection. It appeared to have sustained damage at its frontal portion. Its front body panel (circled) was damage at the time of my inspection as a result of the accident.

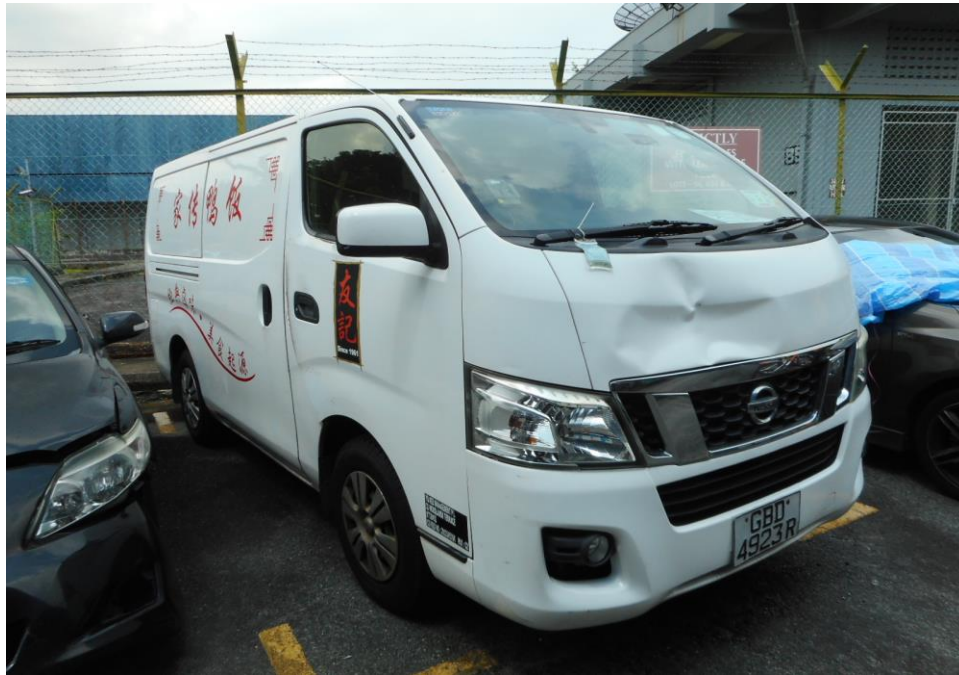
**Photo 4** shows a general view of the right body of the Motor Van at the time of my inspection. The Motor Van was observed to be intact and unaffected by the accident.

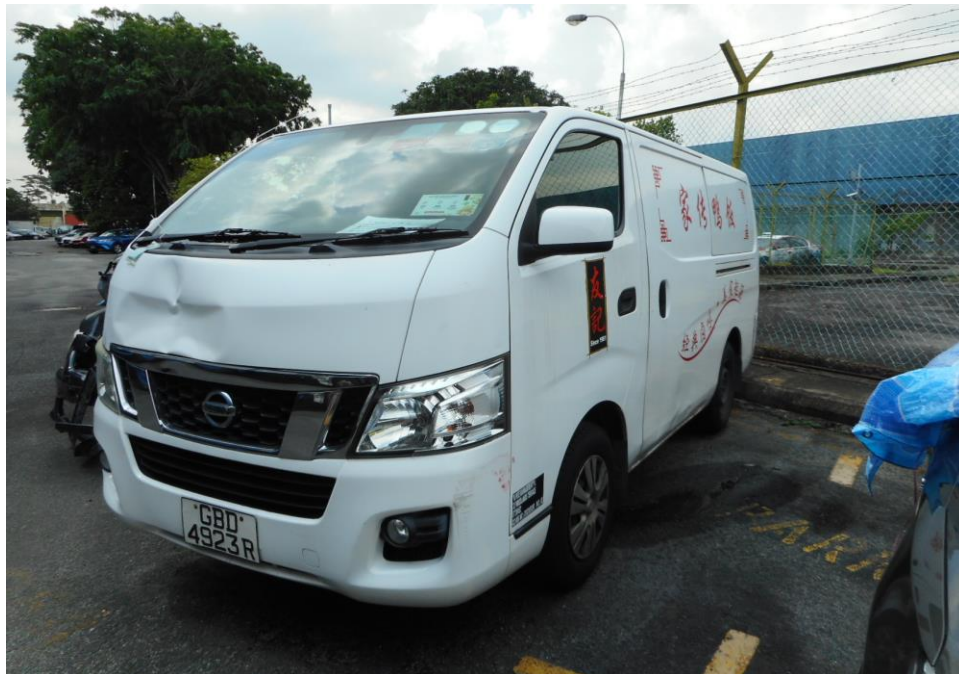
**Photo 5** shows a general view of the left body of the Motor Van at the time of my inspection. The Motor Van was observed to be intact and unaffected by the accident.

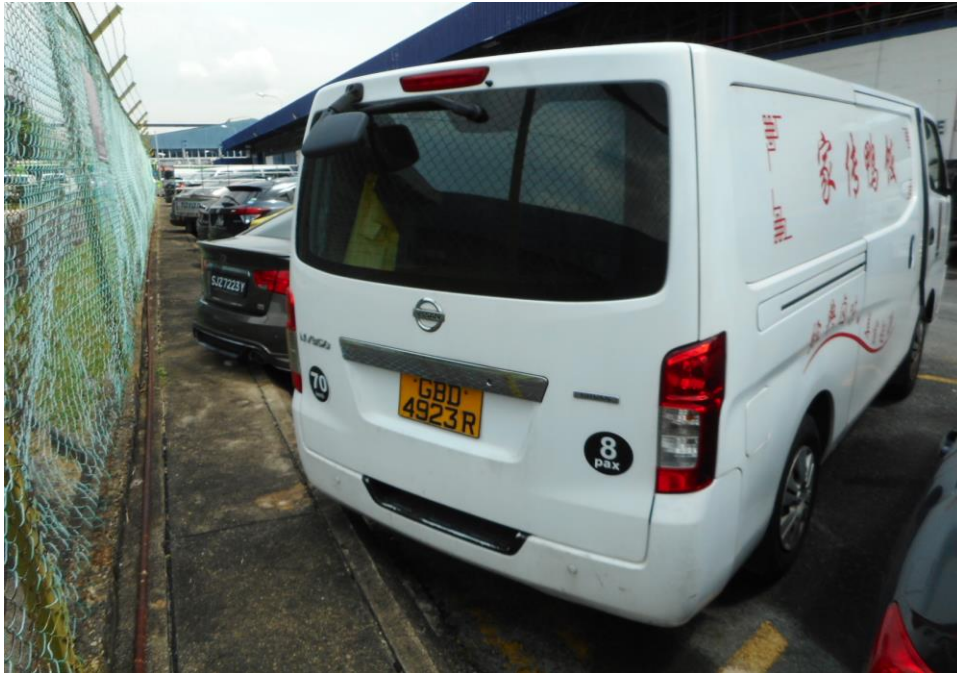
**Photo 6** shows a general view of the rear body of the Motor Van at the time of my inspection. The Motor Van was observed to be intact and unaffected by the accident.

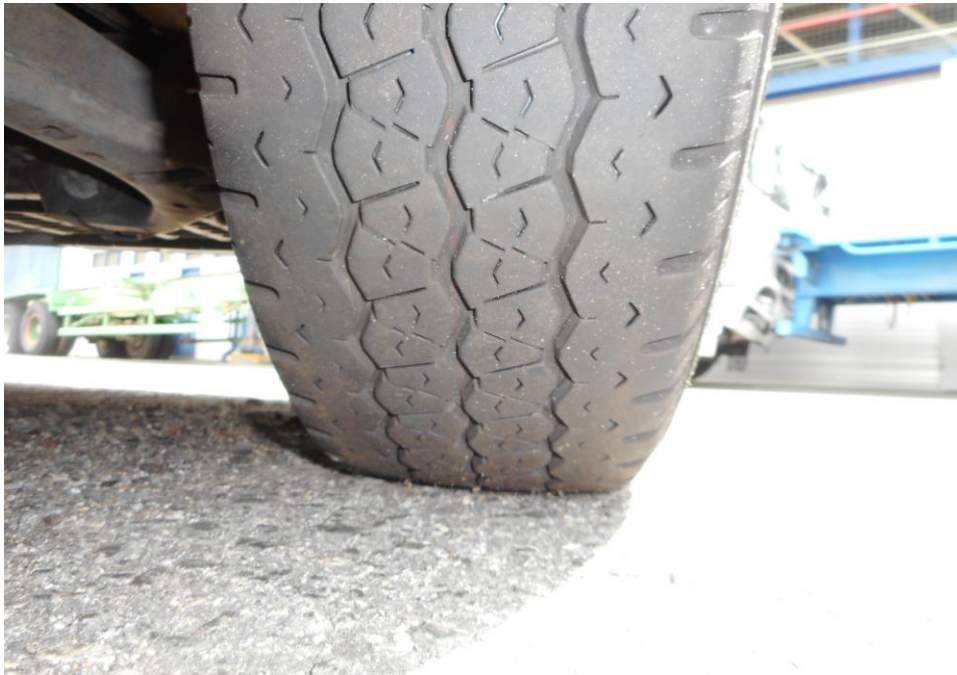
**Photo 7** shows the condition of the front right tyre of the Motor Van, which was observed to be in serviceable condition with remaining tread depth of approximately 5.1mm. The tyre, which was wrapped around standard steel wheel rim, was also observed to be sufficiently inflated for vehicular operation. There was no tear, cut or burst mark(s) on the outer and the inner sidewalls as well as across the tread of the 4 tyres that were fitted on the Motor Van.

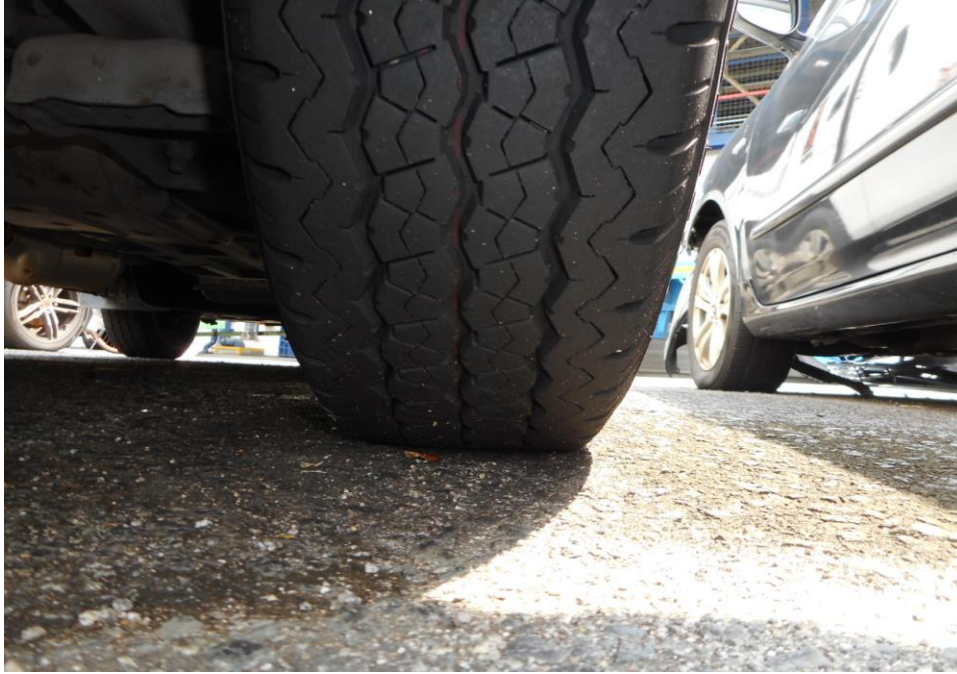
**Photo 8** shows the condition of the rear right tyre of the Motor Van, which was observed to be in serviceable condition with remaining tread depth of approximately 7.3mm. The tyre, which was wrapped around standard steel wheel rim, it was observed to be sufficiently inflated for vehicular operation.

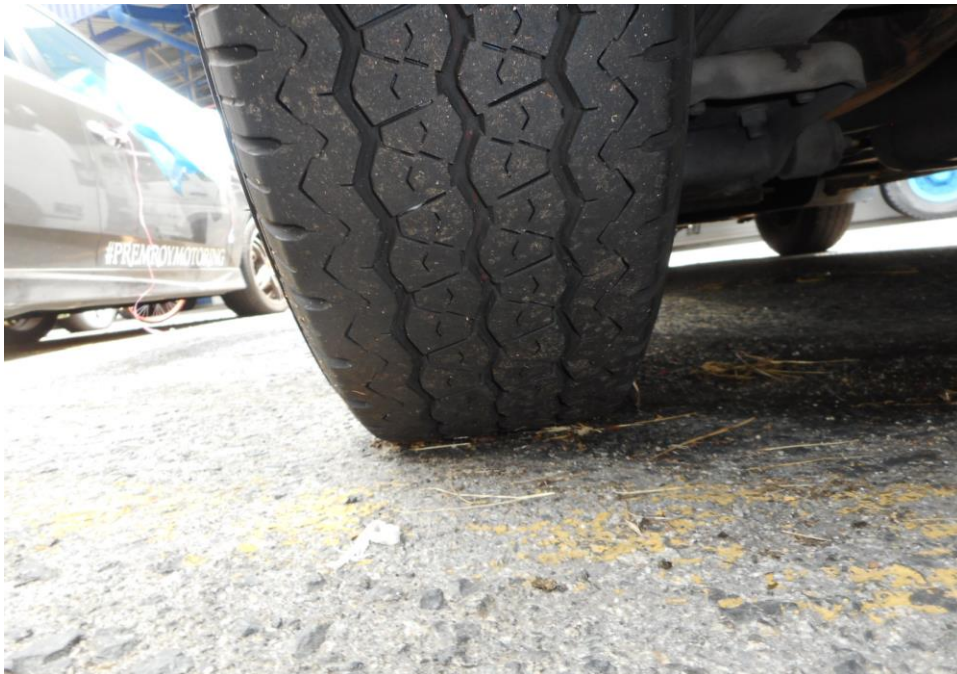
**Photo 9** shows the condition of the rear left tyres of the Motor Van, which was observed to be in serviceable condition with remaining tread depth of approximately 5.4mm. The tyres, which were wrapped around standard steel wheel rim, were also observed to be sufficiently inflated for vehicular operation. There was also no damage found on all 4 steel wheel rims of the Motor Van.

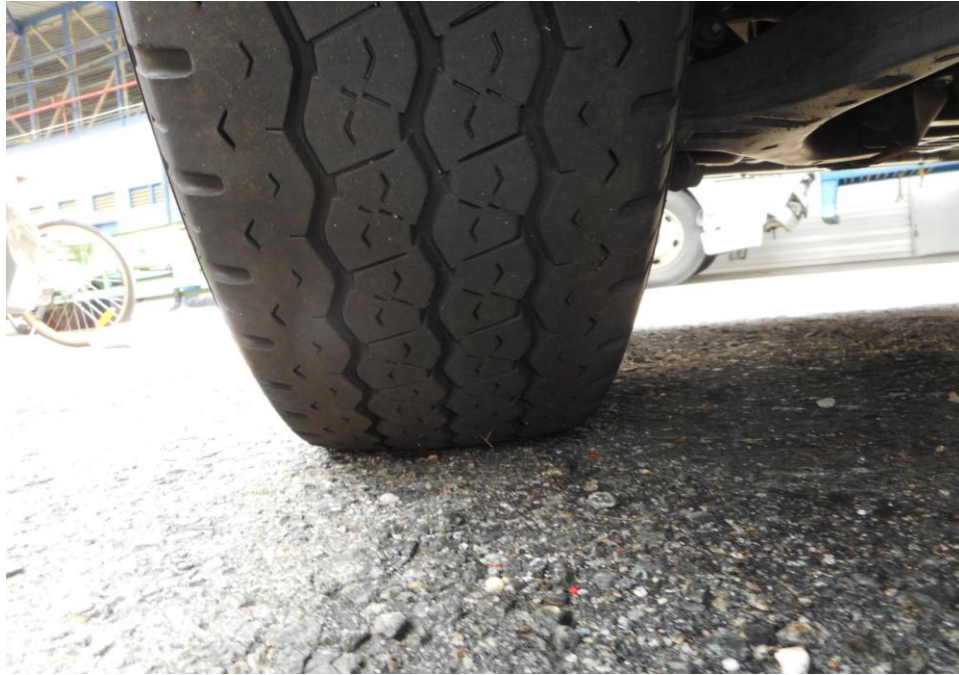
**Photo 10** shows the condition of the rear right tyres of the Motor Van, which were observed to be in serviceable condition with remaining, tread depth of approximately 5.1mm. There was also no tear, cut or burst mark(s) on the outer and the inner sidewalls as well as across the tread of the 4 tyres that were fitted on the Motor Van.

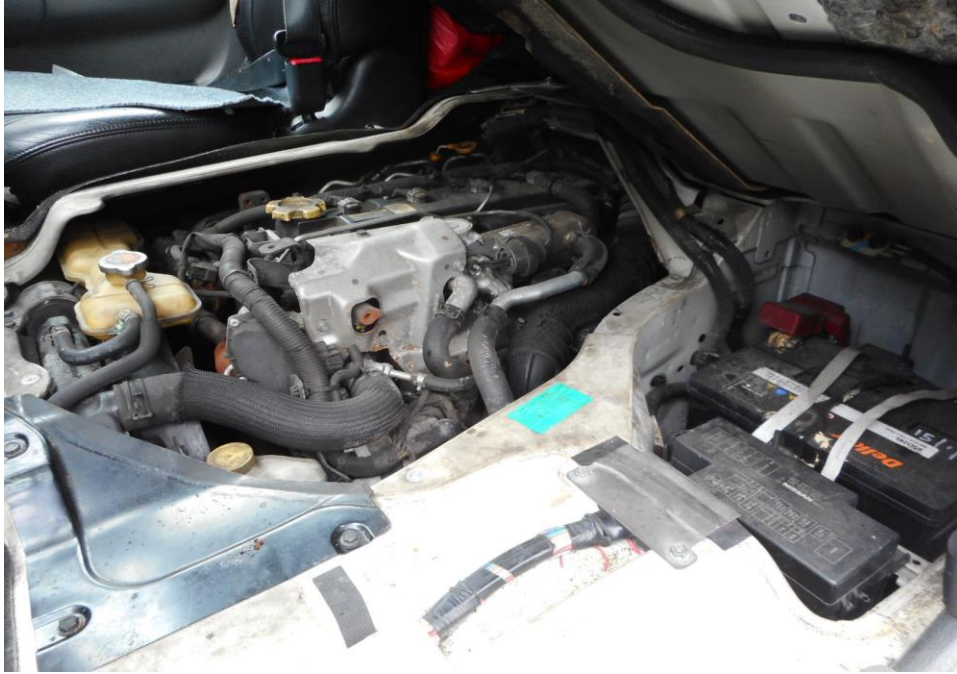
**Photo 11** shows a general view of the Motor Van's engine compartment, which was accessed by lifting the front cabin of the Motor Van. The various parts and components inside the engine compartment were unaffected by the accident. There was also no sign(s) or indication(s) of fresh fluid leakage and/or fluid stain within the engine compartment

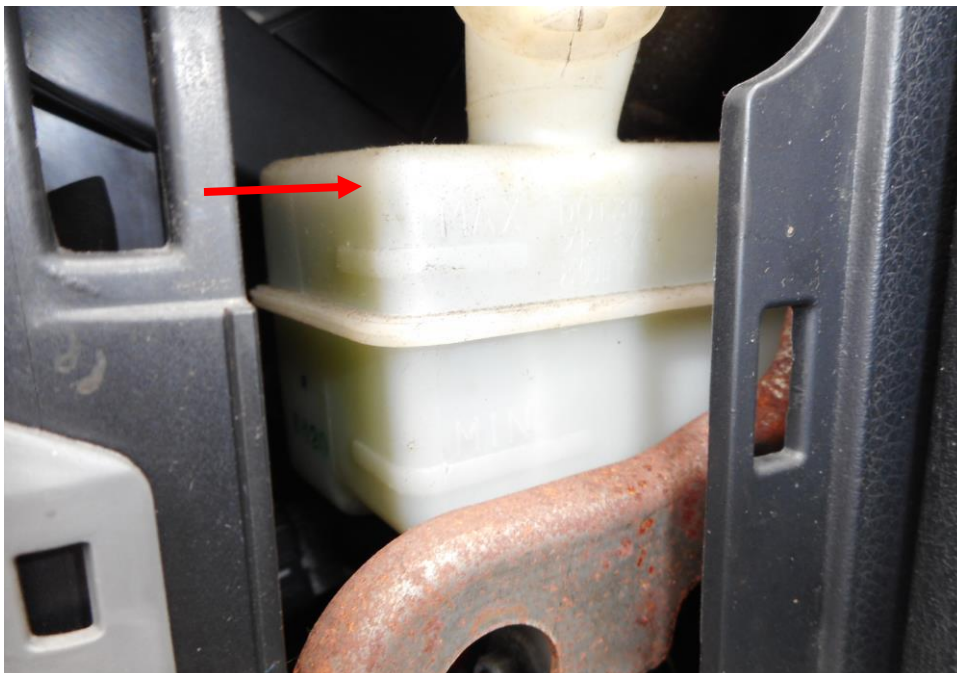
**Photo 12** shows the brake fluid reservoir of the Motor Van at the time of my inspection. The brake fluid was observed to be of sufficient level (arrowed) and without any visible contamination.

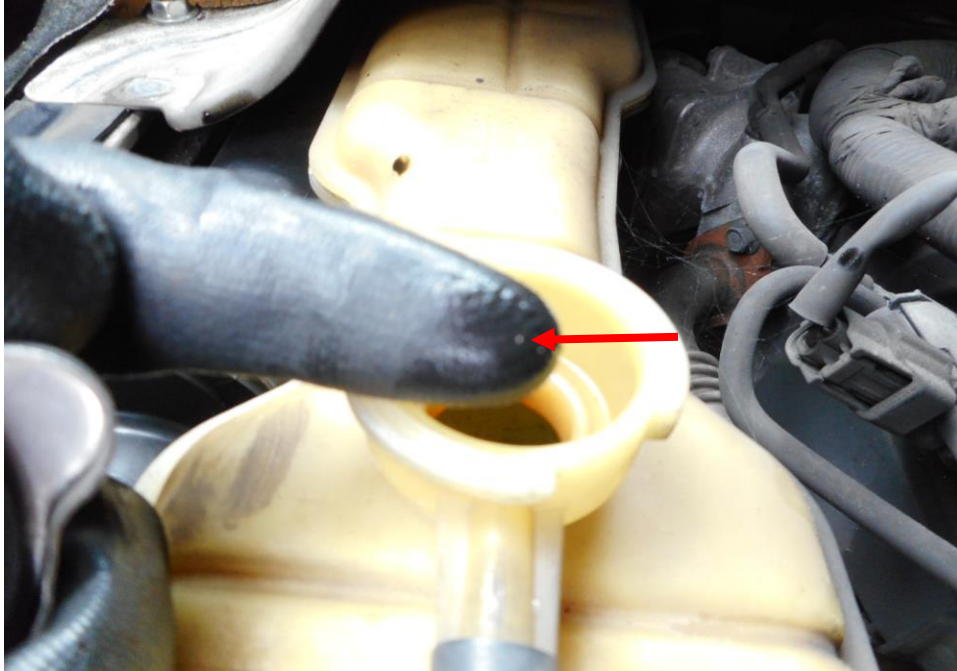
**Photo 13** shows the engine coolant reservoir of the Motor Van at the time of my inspection. The engine coolant was observed to be of sufficient level (arrowed) and without any visible contamination.

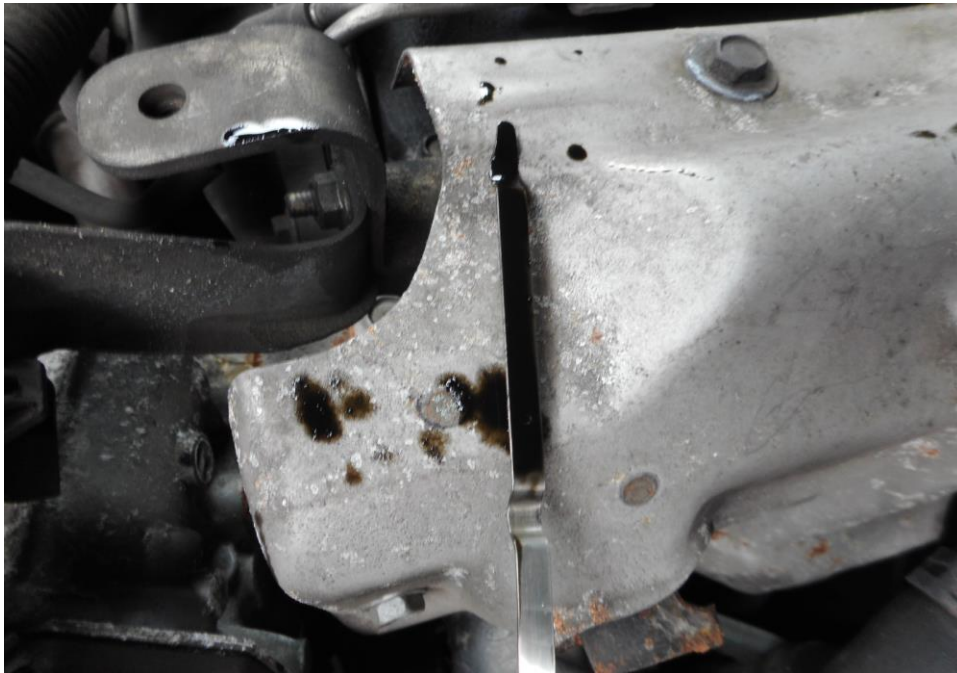
**Photo 14** shows the engine oil dip stick of the Motor Van at the time of my inspection. The engine oil was observed to be of sufficient level and without any visible contamination.

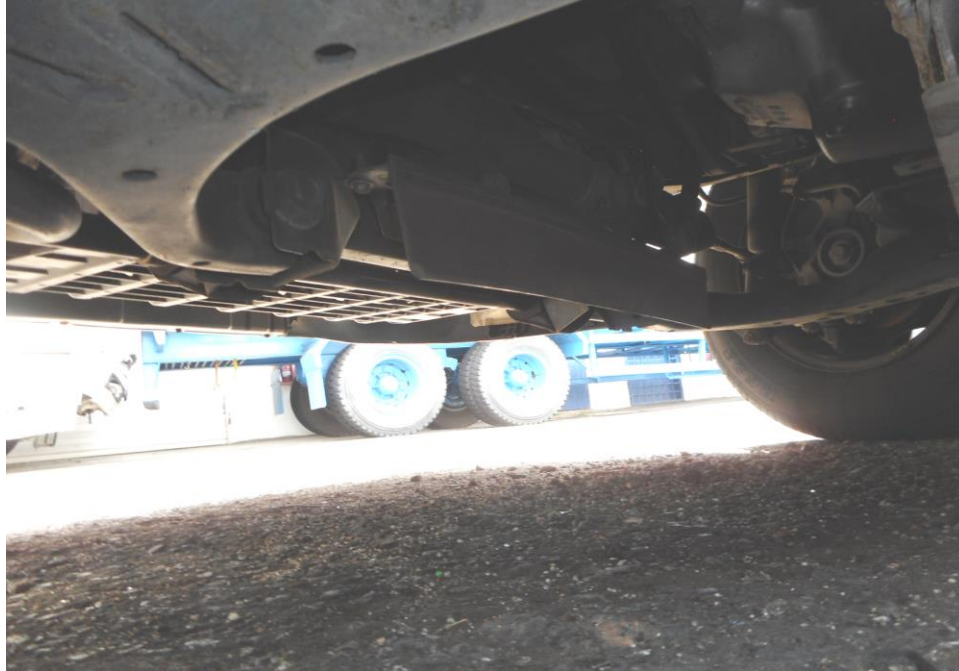
**Photo 15** shows the undercarriage of the Motor Van, at the area where the engine housing and transmission housing are located. . I did not find any sign(s) or indication(s) of fluid leak and/or fluid stain(s) on the underside of the Motor Van.

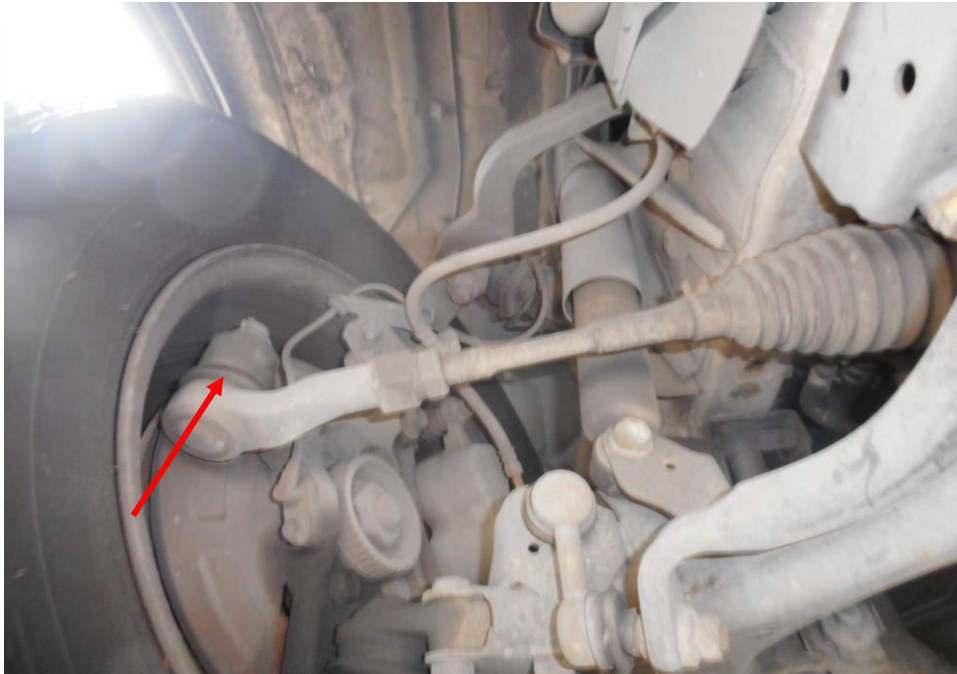
**Photo 16** shows the various undercarriage components at the front right wheel of the Motor Van, in particular the steering tie rod end (arrowed). The various steering components were all found to be intact, suggesting that the steering system of the Motor Van was likely to be in serviceable condition at the material time of accident. There was also no sign of fluid stain(s) observed on the various undercarriage components.

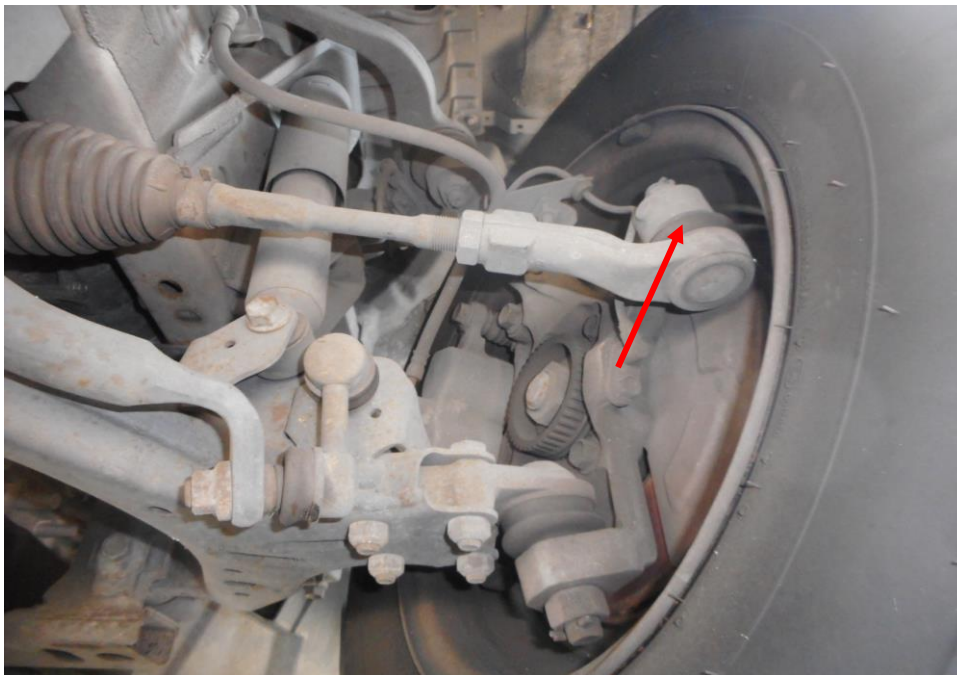
**Photo 17** shows the various undercarriage components at the front left wheel of the Motor Van, in particular the steering tie rod end (arrowed). The various undercarriage components of the Motor Van were all found to be intact without any visible damage. There was also no sign of fluid stain(s) observed on the various undercarriage components.

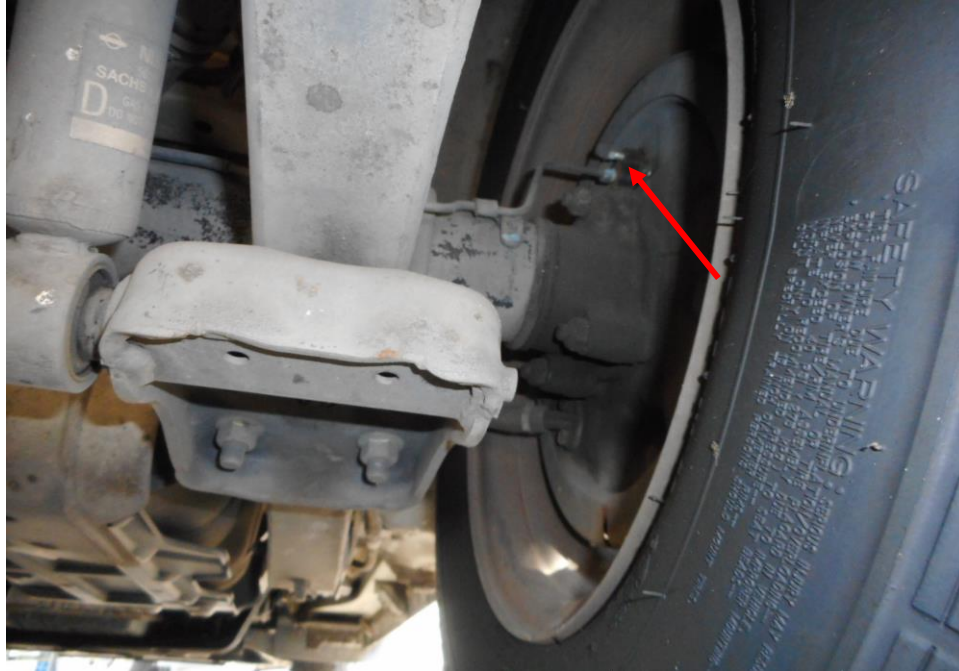
**Photo 18** shows the brake pipe (arrowed) at the rear right wheel of the Motor Van. I did not observe any leakage of brake fluid at the time of my inspection of the Motor Van. My static tests of the Motor Van's braking system, along with my visual examination of the various mechanical components in the braking system, had indicated that there was no internal leakage of pressure/vacuum. Hence the braking system of the Motor Van was likely to be in serviceable condition at the material time of accident.

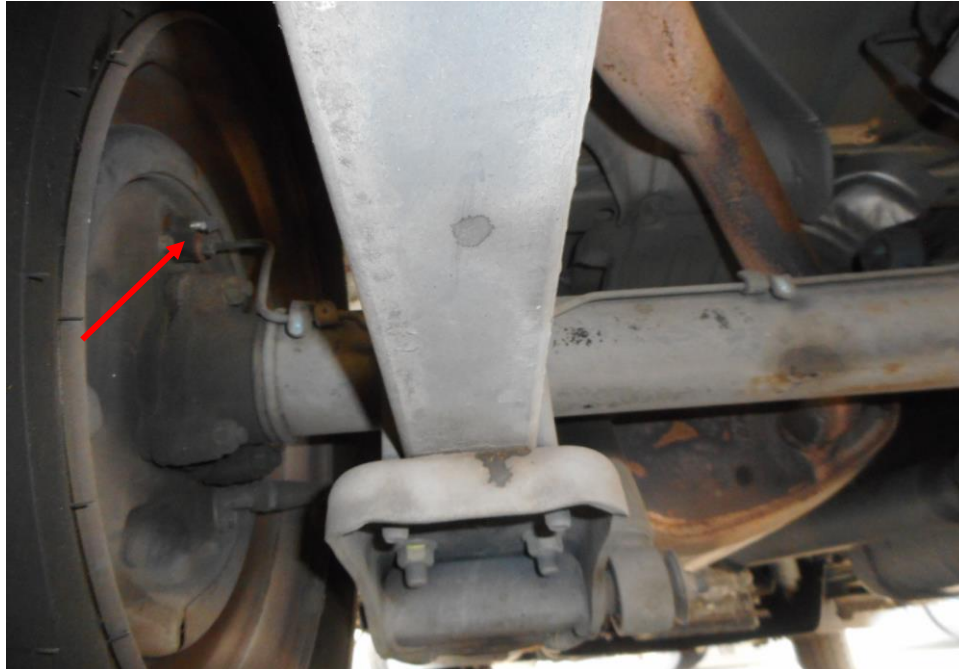
**Photo 19** shows the brake pipe (arrowed) at the rear left wheel of the Motor Van. I did not observe any leakage of brake fluid at the time of my inspection of the Motor Van. My static tests of the Motor Van's braking system, along with my visual examination of the various mechanical components in the braking system had indicated that there was no internal leakage of pressure/vacuum. Hence the braking system of the Motor Van was likely to be in serviceable condition at the material time of accident.

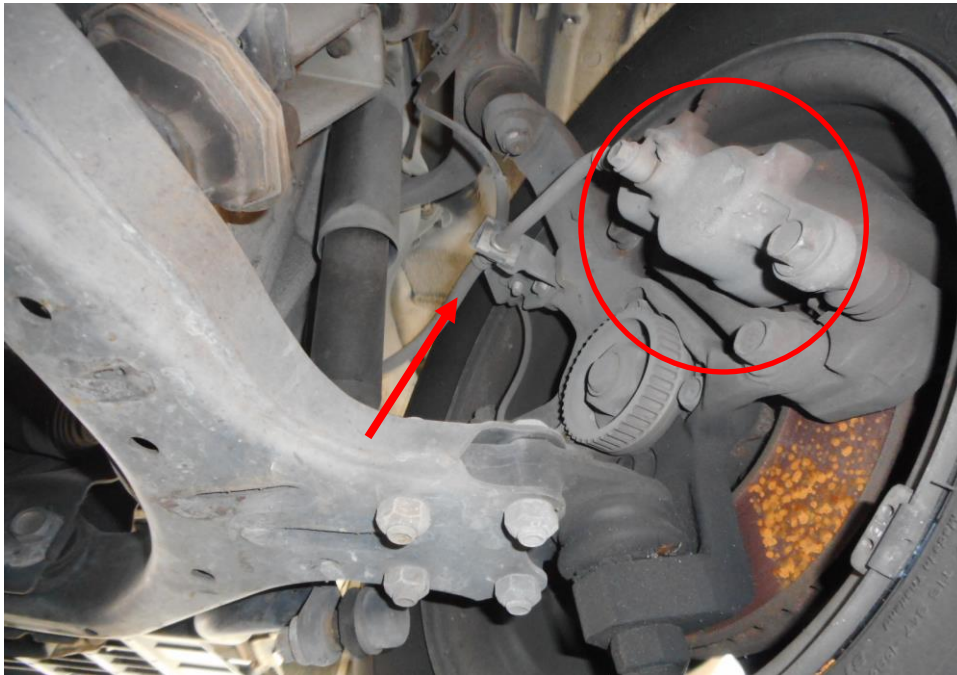
**Photo 20** shows the brake hose/pipe (arrowed) at the front right wheel of the Motor Van. No leakage of brake fluid was observed. Visual examination of the various components of the braking system like the brake caliper (circled), brake booster, brake pedal etc had revealed all to be intact and without visible damage at the time of accident. There was also no sign of fluid stain(s) observed on the various undercarriage components.

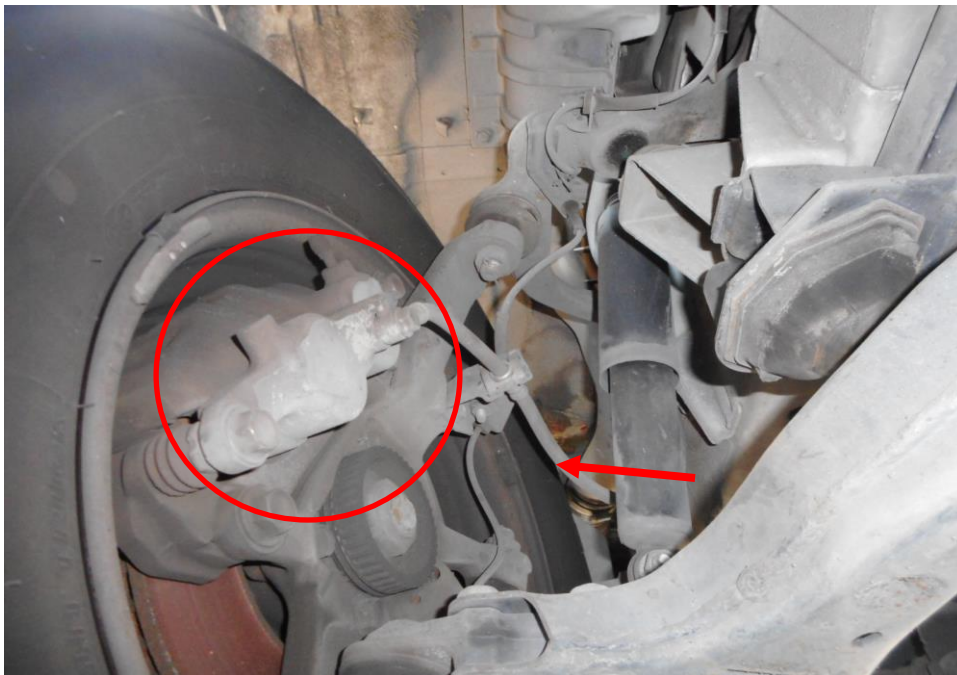
**Photo 21** shows the brake hose/pipe (arrowed) at the front left wheel of the Motor Van. No leakage of brake fluid was observed. Visual examination of the various components of the braking system like the brake caliper (circled), brake booster, brake pedal etc had revealed all to be intact and without visible damage at the time of accident. There was also no sign of fluid stain(s) observed on the various undercarriage components.

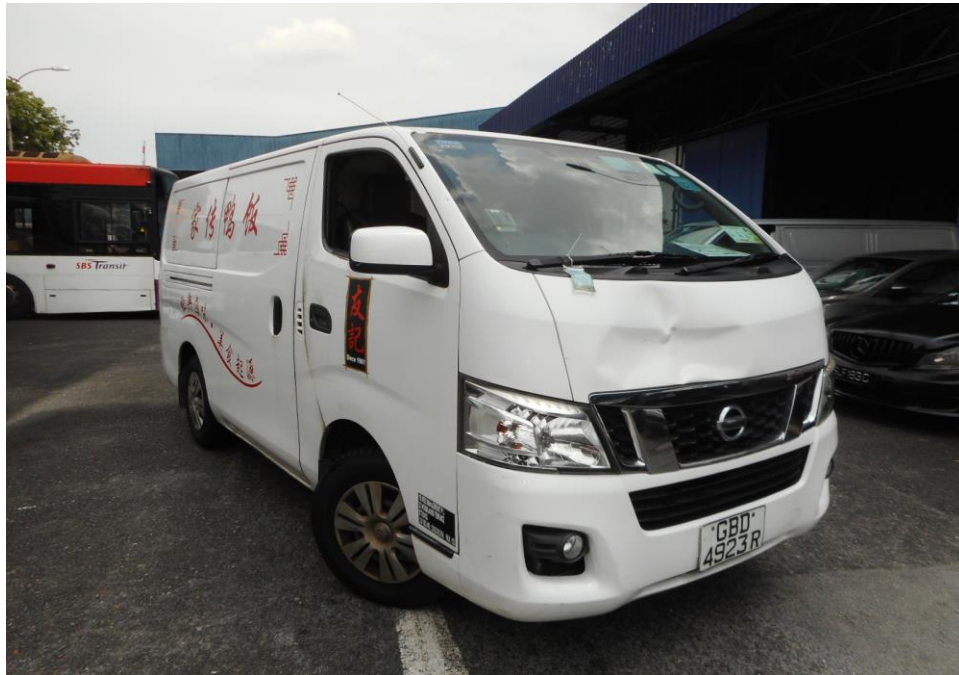
**Photo 22** shows the front right wheel of the Motor Van turned to its full left. During my steering system test, I did not experience any abnormal free play and/or resistance when I had turned the steering wheel towards full left and full right. This would suggest that the steering system of the Motor Van was likely to be in serviceable condition at the material time of accident.

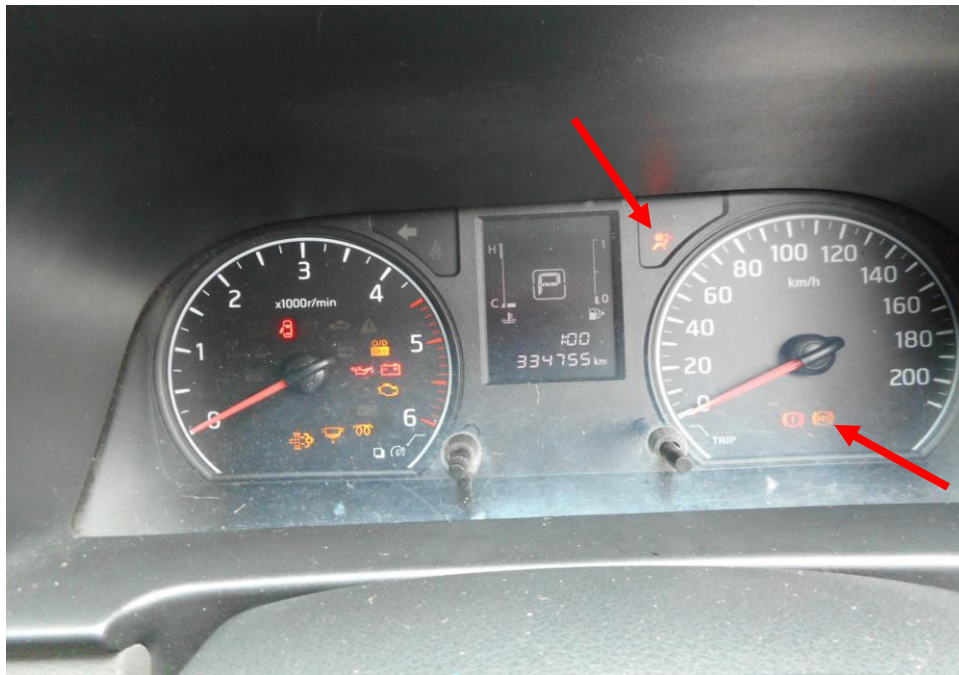
13. Motor Van's automatic self-test of the functionality of its electronic operating systems like the Anti-Lock Brake System (ABS) and Supplemental Restraint System (SRS) during cranking of the engine had indicated that the system were in working condition and without abnormality. This can be established from the warning lights disappearing from the instrument panel after the self-test. See photo 23 & 24 below.

**Photo 23** shows the warning light for Anti-Lock Brake System (ABS) and Supplemental Restraint System (SRS) (arrowed) appearing on the instrument panel of the Motor Van during the self-test of its various electronic operating systems when its engine was cranked.

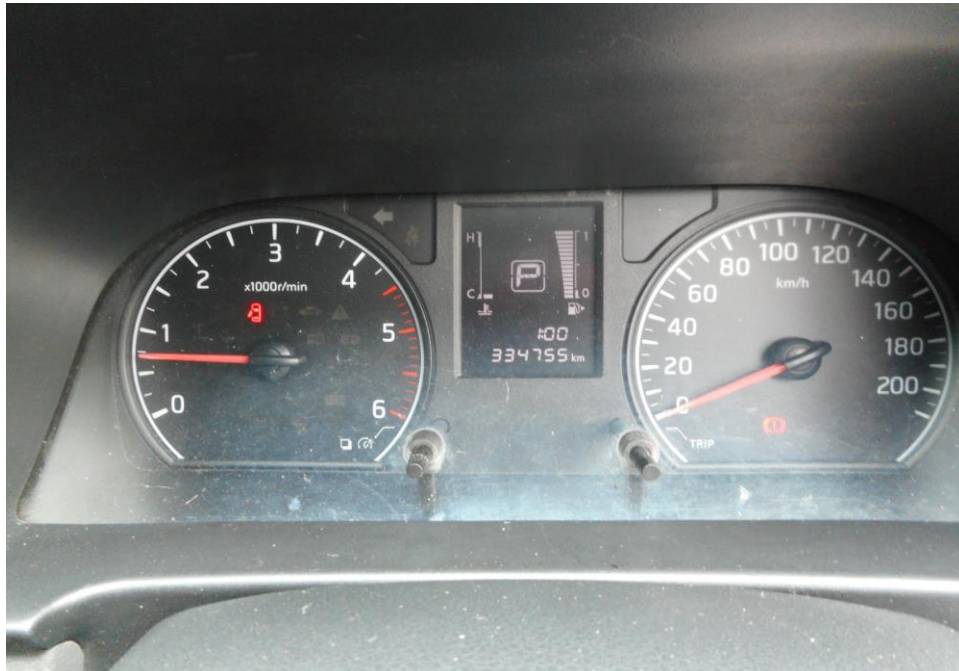
**Photo 24** shows no warning lights illuminated on the instrument panel of the Motor Van after the engine was cranked. This would suggest that there was no abnormality to the electronic operating system of the Motor Van, like the ABS and SRS etc.
