Your Ref: Mercedes Benz GLC 63s  
(chassis number WDC2539892F527280)  
Our Ref : CI/TP21003603/D

19 March 2021

**INSPECTION REPORT OF AN UNREGISTERD MERCEDES BENZ GLC 63s  
MOTOR CAR WITH CHASSIS NUMBER WDC2539892F527280**

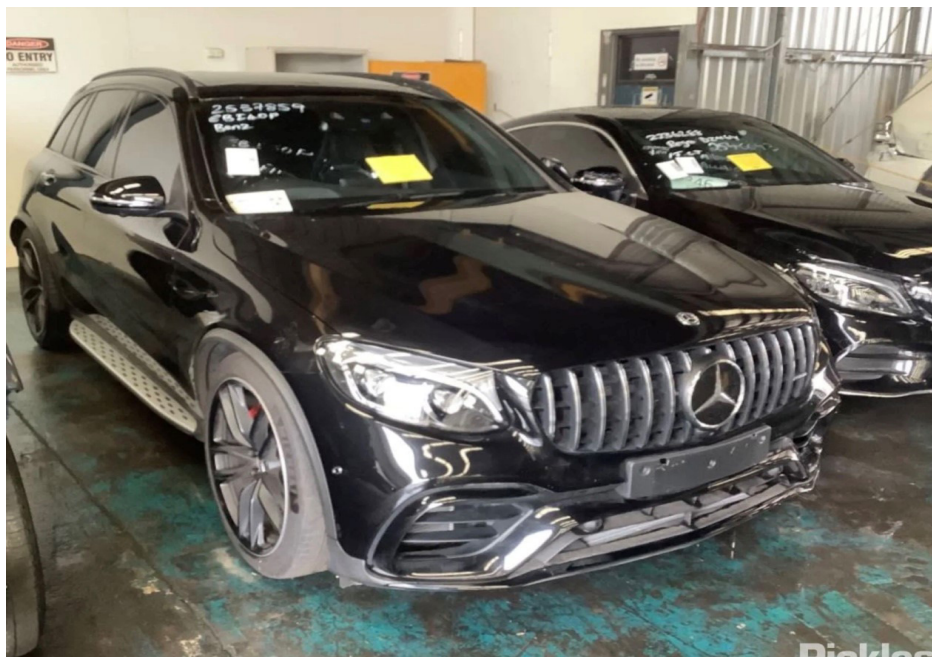
**Photo 1** shows the front right body of the Motor Car (photograph provided to me). There appears to be no visible damage to the Motor Car as seen from the photographs that were provided to me.

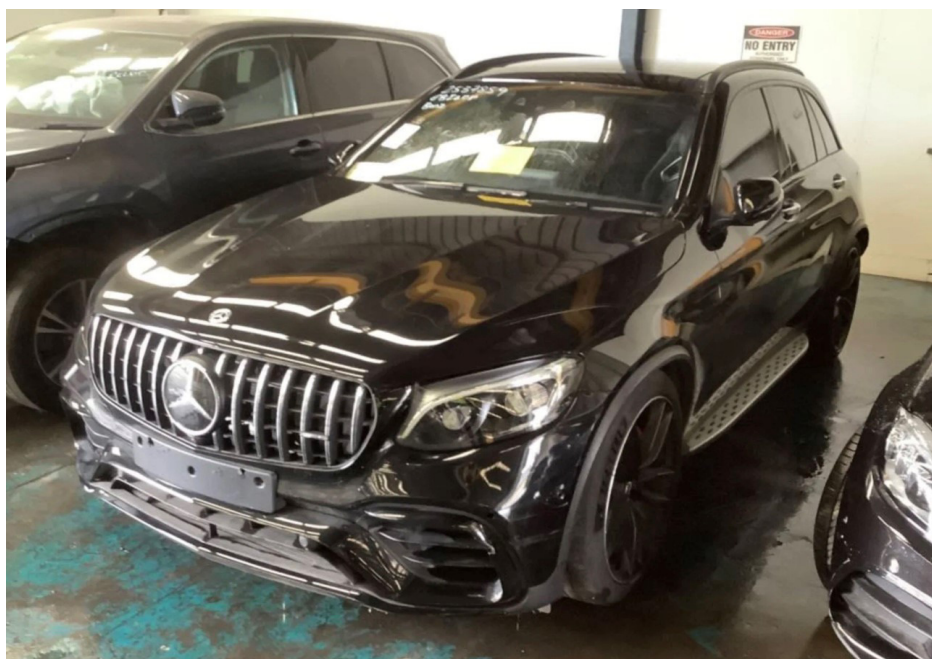
**Photo 2** shows the front left body of the Motor Car (photograph provided to me). There appears to be no visible damage to the Motor Car as seen from the photographs that were provided to me.

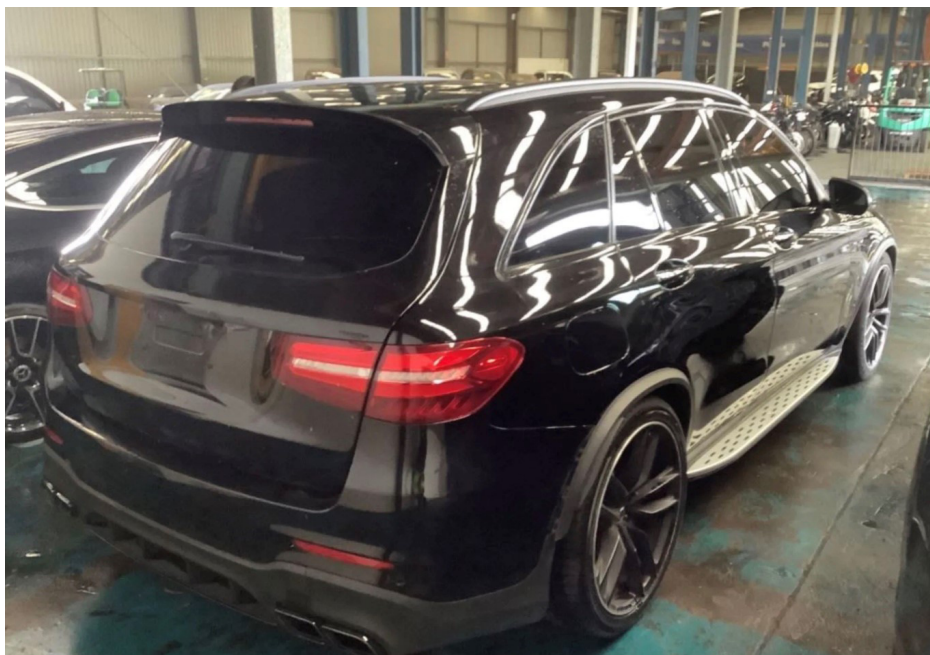
**Photo 3** shows the rear right body of the Motor Car (photograph provided to me). There appears to be no visible damage to the Motor Car as seen from the photographs that were provided to me.

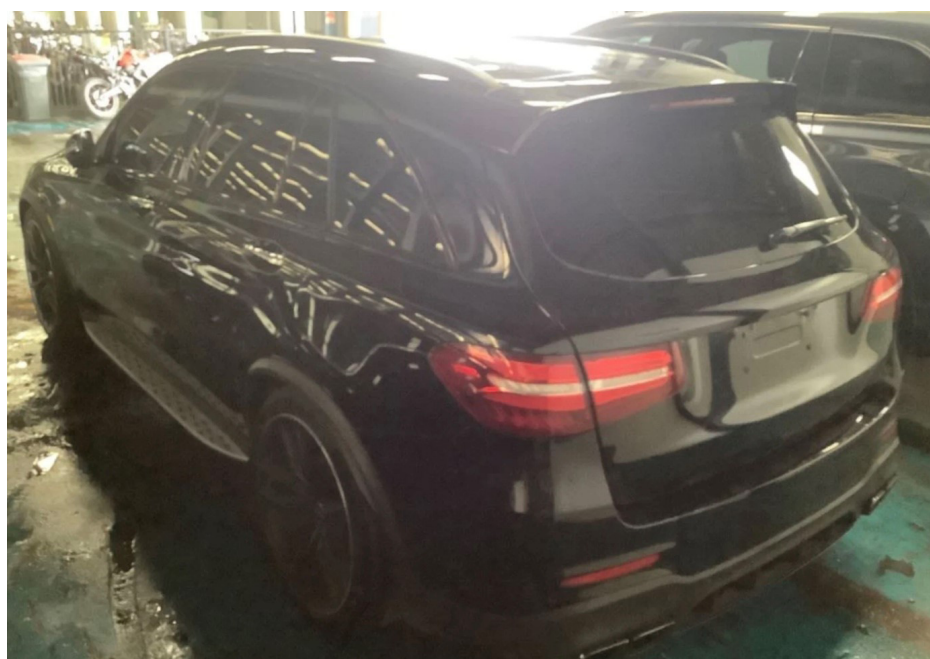
**Photo 4** shows the rear left body of the Motor Car (photograph provided to me). There appears to be no visible damage to the Motor Car as seen from the photographs that were provided to me.

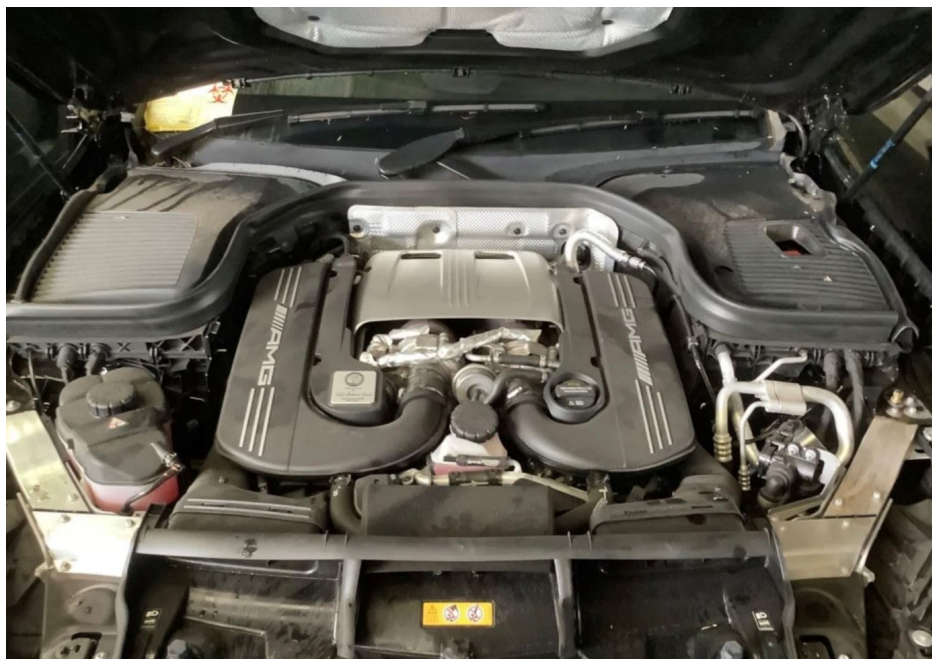
**Photo 5** shows the engine compartment of the Motor Car (photograph provided to me). Parts within the engine compartment were intact and without damage.

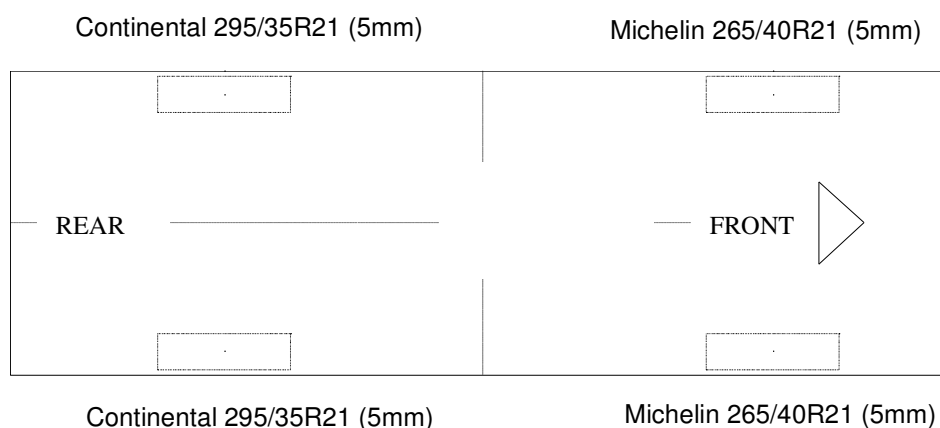
7. It was fitted with 21inch sport wheel rims that were wrapped with tyres that were observed to be of serviceable condition. The tyres were also sufficiently inflated for vehicular operation. The tyre brand, tyre size and approximate remaining tread depth of the 4 tyres of the Motor Car were recorded as follows: -

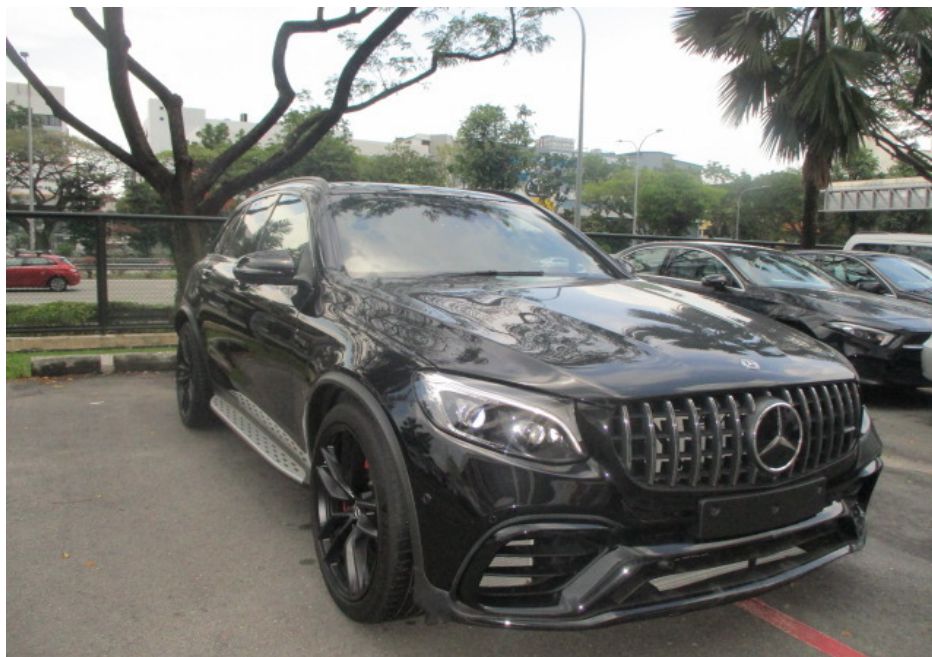
**Photo 6** shows a general view of the front right body of the Motor Car at the time of my inspection. The Motor Car was observed to be in a relatively good general condition with no loose exterior fittings observed. There was no visible damage observed to the Motor Car.

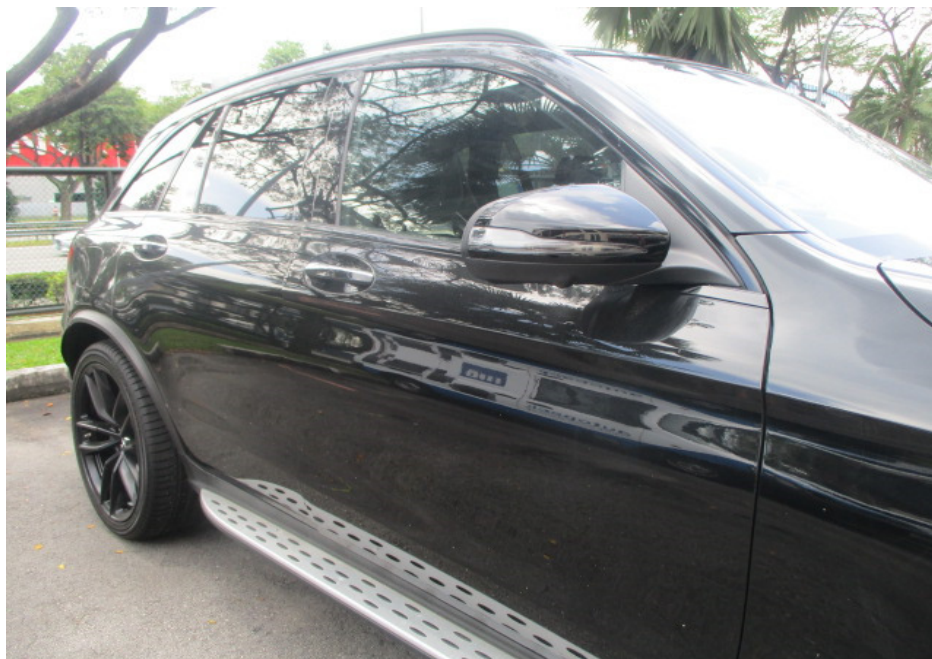
**Photo 7** shows a general view of the right side body of the Motor Car at the time of my inspection. The Motor Car was observed to be in a relatively good general condition with no loose exterior fittings observed. There was no visible damage observed to the Motor Car.

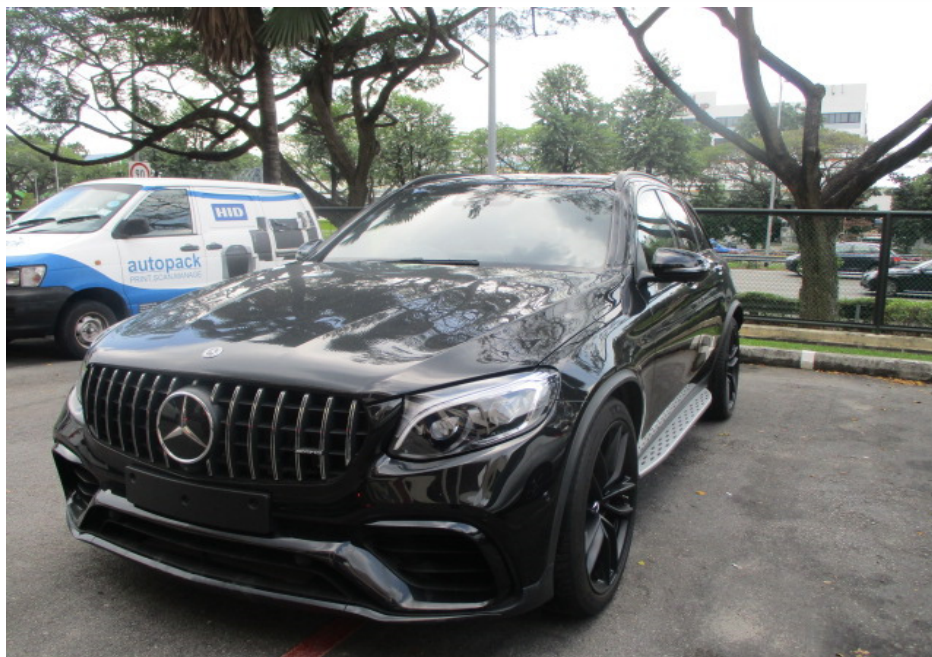
**Photo 8** shows a general view of the front left body of the Motor Car at the time of my inspection. The Motor Car was observed to be in a relatively good general condition with no loose exterior fittings observed. There was no visible damage observed to the Motor Car. The mileage of the Motor Car recorded at the time of my inspection was 3,709km.

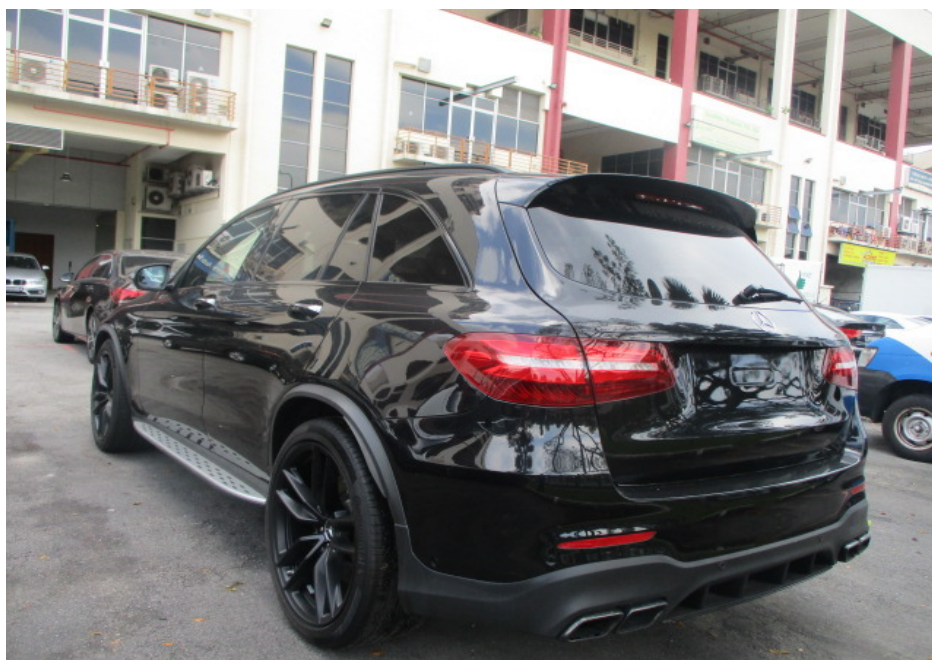
**Photo 9** shows a general view of the rear left body of the Motor Car at the time of my inspection. The Motor Car was observed to be in a relatively good general condition with no loose exterior fittings observed. There was no visible damage observed to the Motor Car.

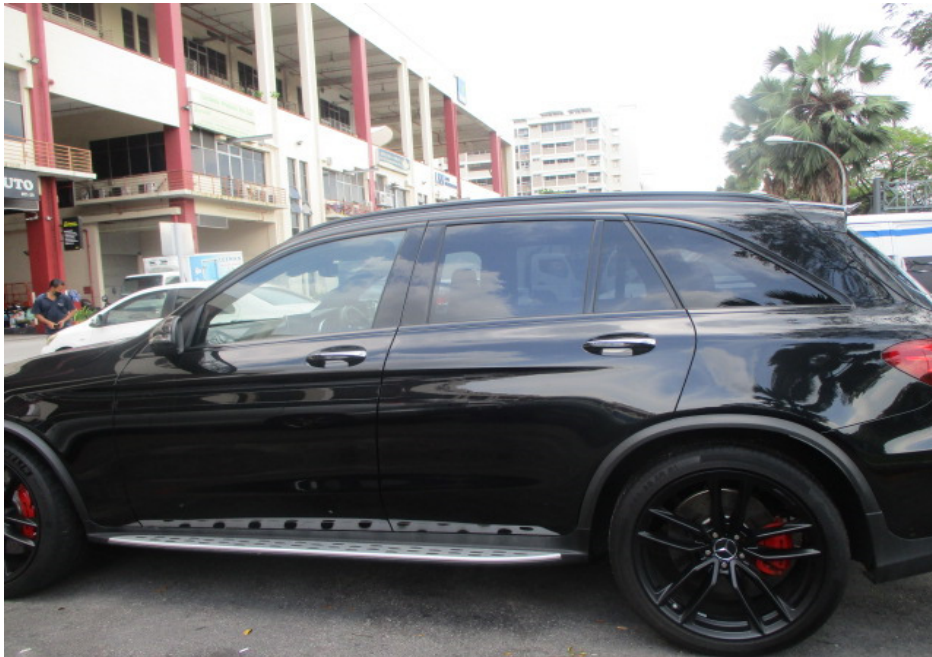
**Photo 10** shows a general view of the left side body of the Motor Car at the time of my inspection. The Motor Car was observed to be in a relatively good general condition with no loose exterior fittings observed. There was no visible damage observed to the Motor Car.

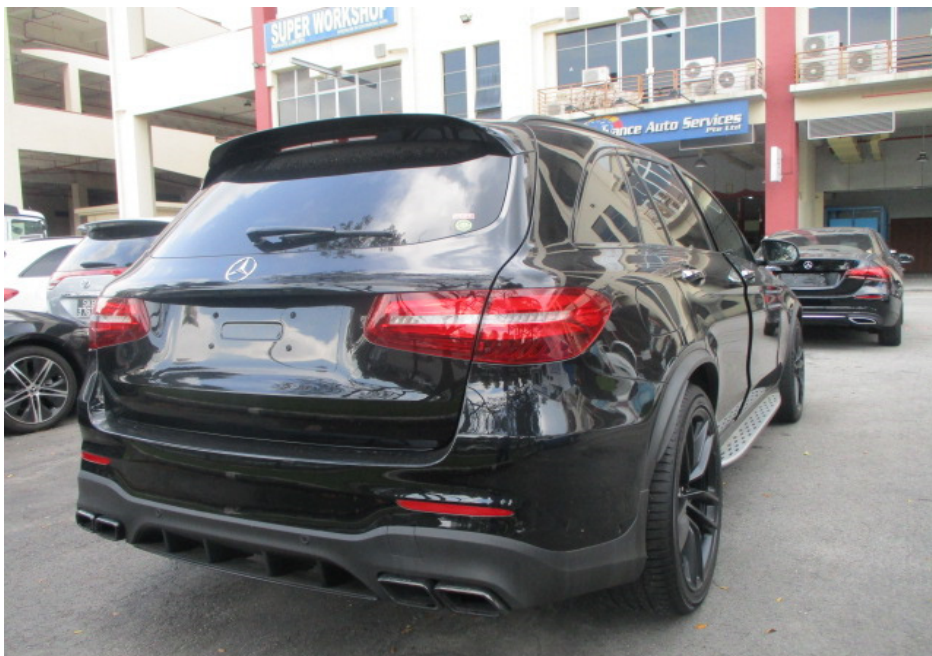
**Photo 11** shows a general view of the rear right body of the Motor Car at the time of my inspection. The Motor Car was observed to be in a relatively good general condition with no loose exterior fittings observed. There was no visible damage observed to the Motor Car. The mileage of the Motor Car recorded at the time of my inspection was 3,709km.

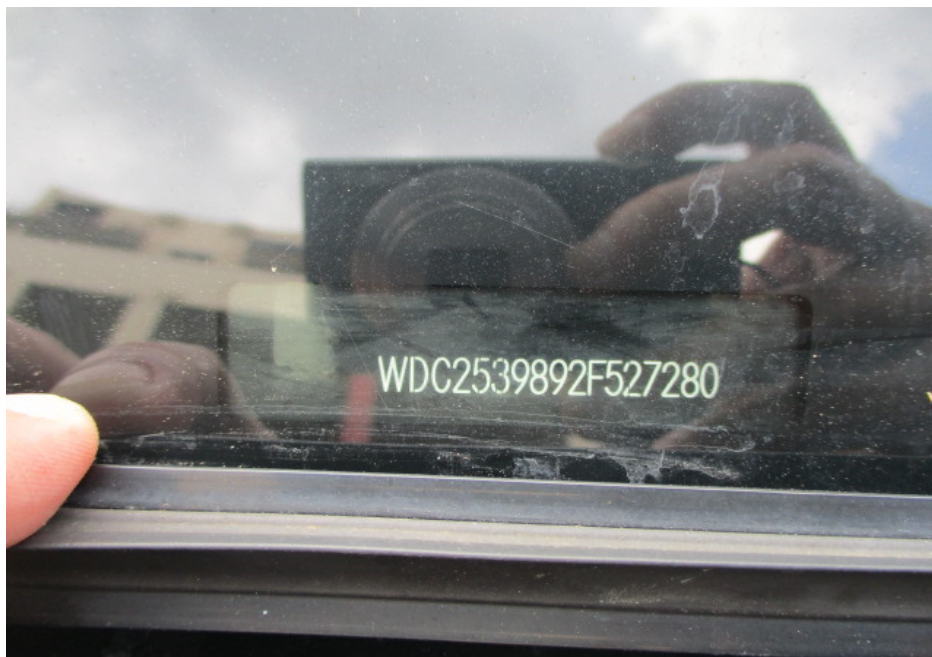
**Photo 12** shows the chassis number of the Motor Car. The chassis number recorded was WDC2539892F527280.

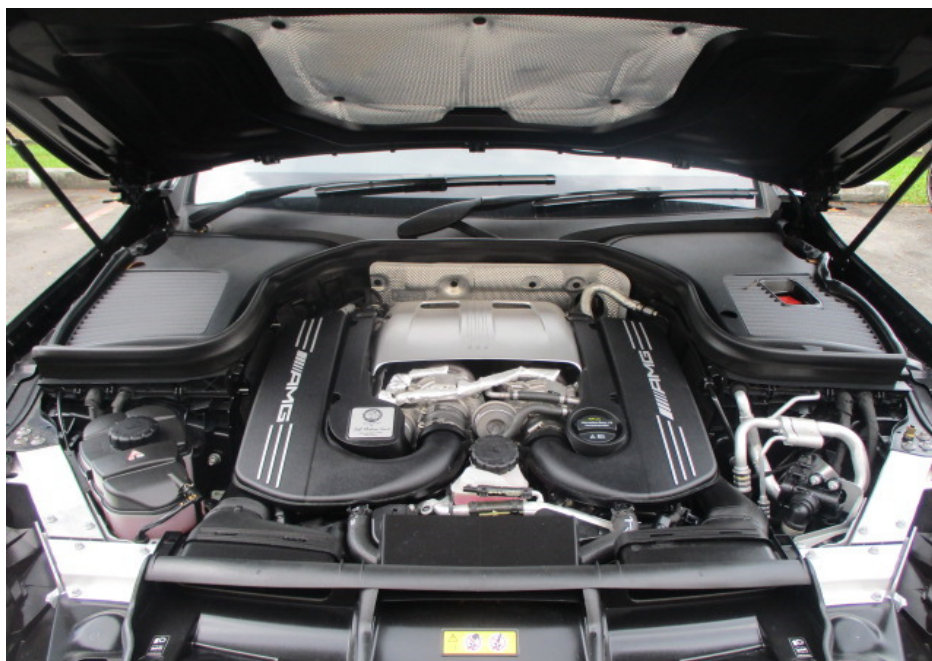
13. My examination of the engine compartment of the Motor Car revealed that the various parts and components inside the engine compartment were all intact and properly fitted. The engine oil, brake fluid and engine coolant were all found to be of sufficient level for operating purposes. Visually, there was also no contamination found to these fluids.
14. My checks on the underside of the Motor Car revealed no sign(s) or indication(s) of fluid leakage and/or fluid stain(s). The engine block and automatic transmission assembly were both secured properly. All undercarriage components of the Motor Car were also observed to be intact and secured in an appropriate manner.

**Photo 13** shows a general view of the engine compartment of the Motor Car at the time of my inspection. The various parts and components inside the engine compartment were all observed to be intact and properly fitted. There was also no sign(s) or indication(s) of fluid leak and/or fluid stain found inside the engine compartment.

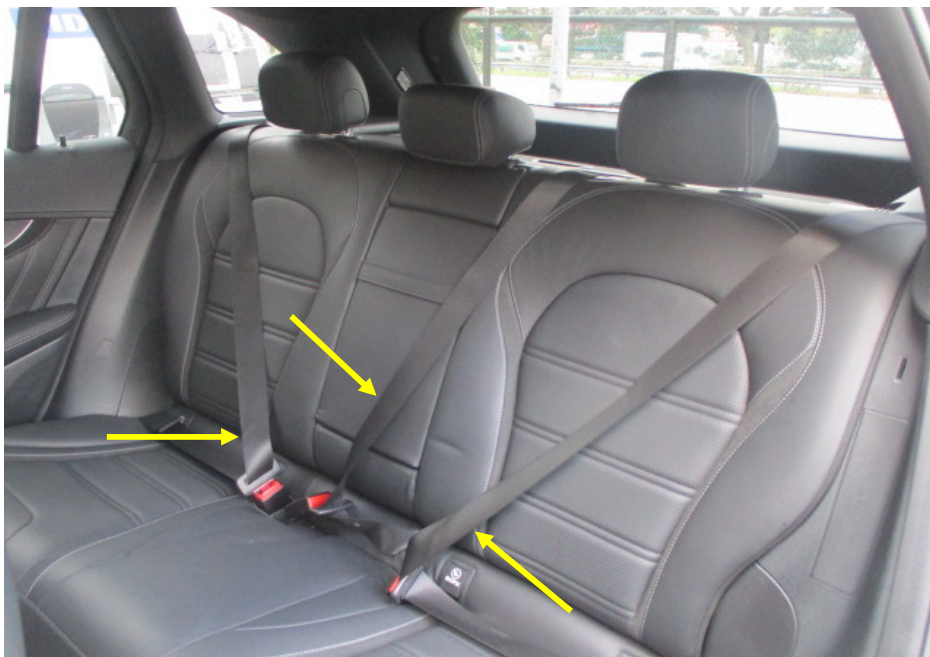
11. The seats of the Motor Car were found to be secured to the floorboard of the Motor Car via seat rails bolted onto the floorboard. Retractable seat belt reels and pre-tensioners were fitted on all seats of the Motor Car. The seat belts were tested and were able to be fastened securely into the respective pre-tensioners that were fixed to the side of all the seats.

**Photo 14** shows the rear seats of the Motor Car. All the seats of the Motor Car were secured via seat rails to the floorboard. They were also fitted with a retractable seat belt reel and a pre-tensioner. The seat belts (arrowed) were tested and were able to be fastened into the respective pre-tensions that were fitted on the side of each individual seat.

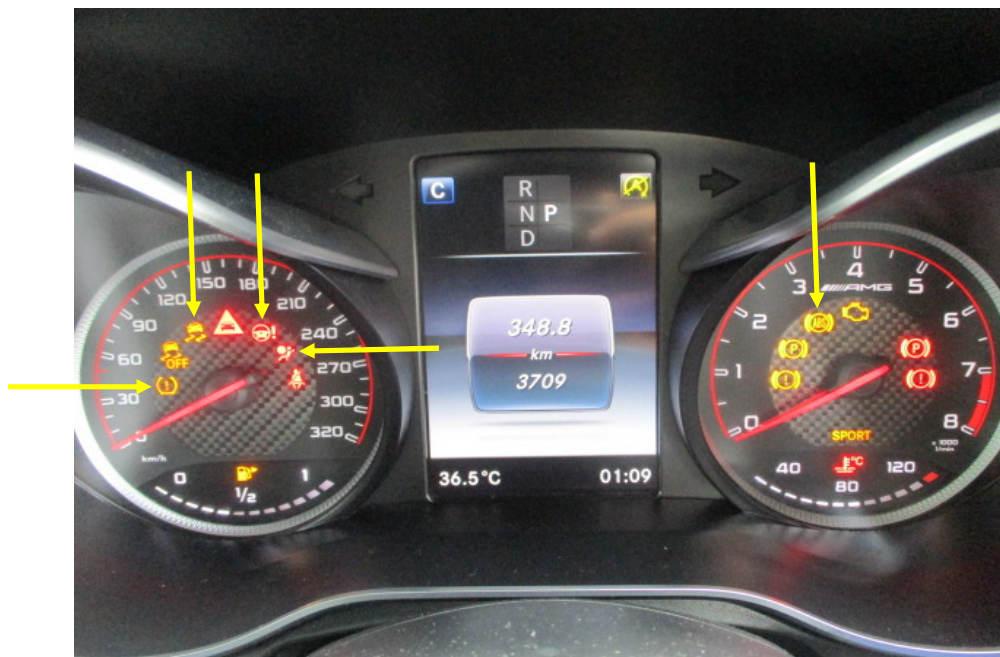
**Photo 15** shows the warning lights for the various electronic safety features appearing on the instrument panel of the Motor Car during its self-test when the engine is cranked, in particular the ABS, SRS, EPS, TPM and TCS lights (arrowed).

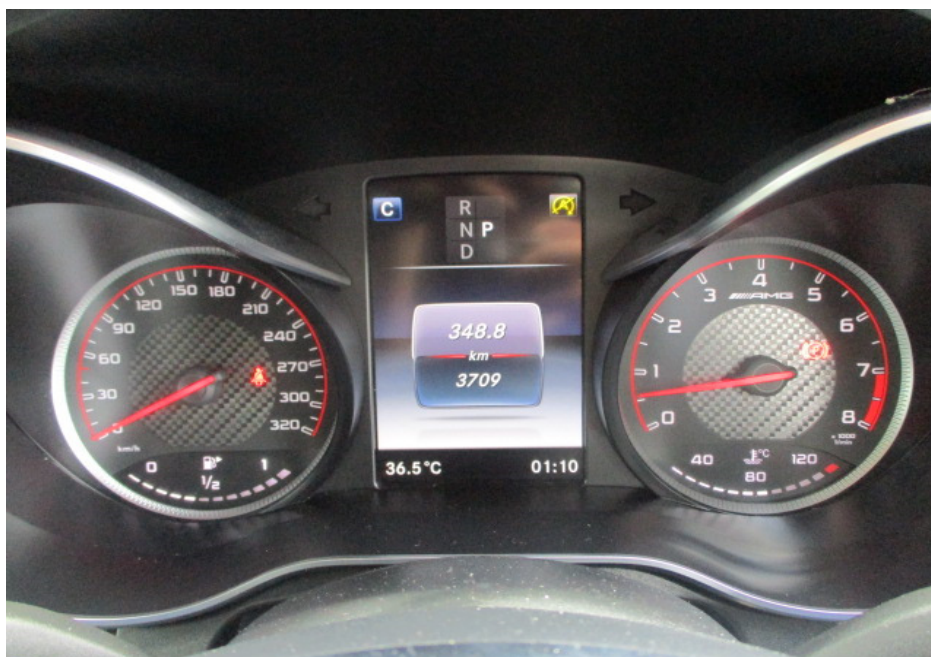
12. The Motor Car's automatic self-test of the functionality of its various electronic safety features like the Anti-Lock Brake System (ABS), Supplemental Restraint System (SRS), Electric Power Steering (EPS), Tyre Pressure Monitor (TPM) and Traction Control System (TCS) during cranking of the engine had indicated that these electronic systems were in working condition. This was determined from the respective warning lights disappearing from the instrument panel after the self-test.

**Photo 16** shows the respective warning lights no longer illuminated, indicating that there is no fault detected to the ABS, SRS, EPS, TPM and TCS systems of the Motor Car during the self-test. These electronic systems were hence in working condition at the time of my inspection.

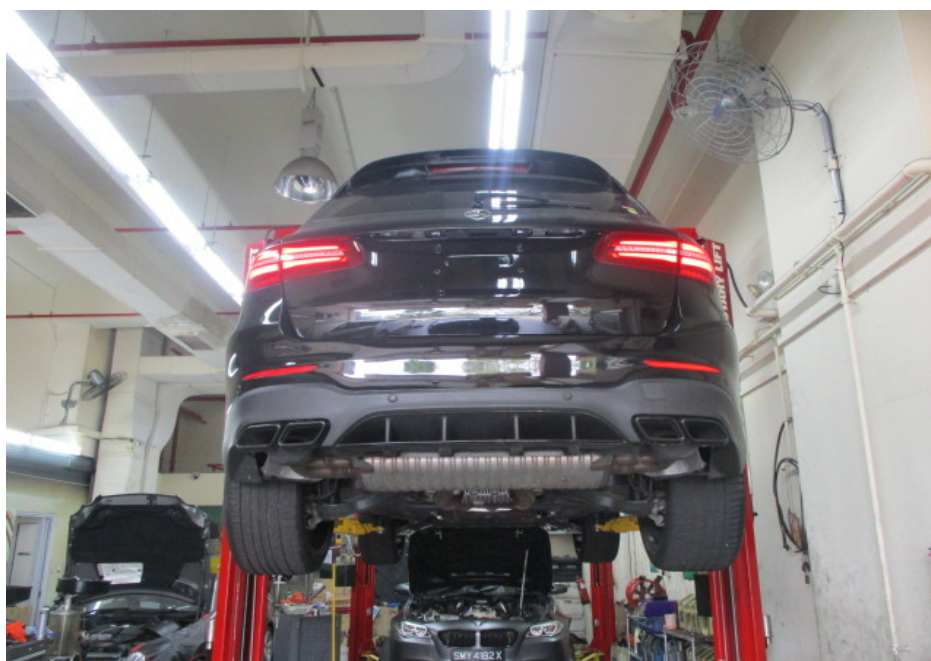
**Photo 17** shows the Motor Car hoisted up for checks on its undercarriage. There was no sign(s) or indication(s) of fluid leakage and/or fluid stain(s) on the underside of the Motor Car. The undercarriage components of the Motor Car were also all observed to be intact and secured in an appropriate manner.

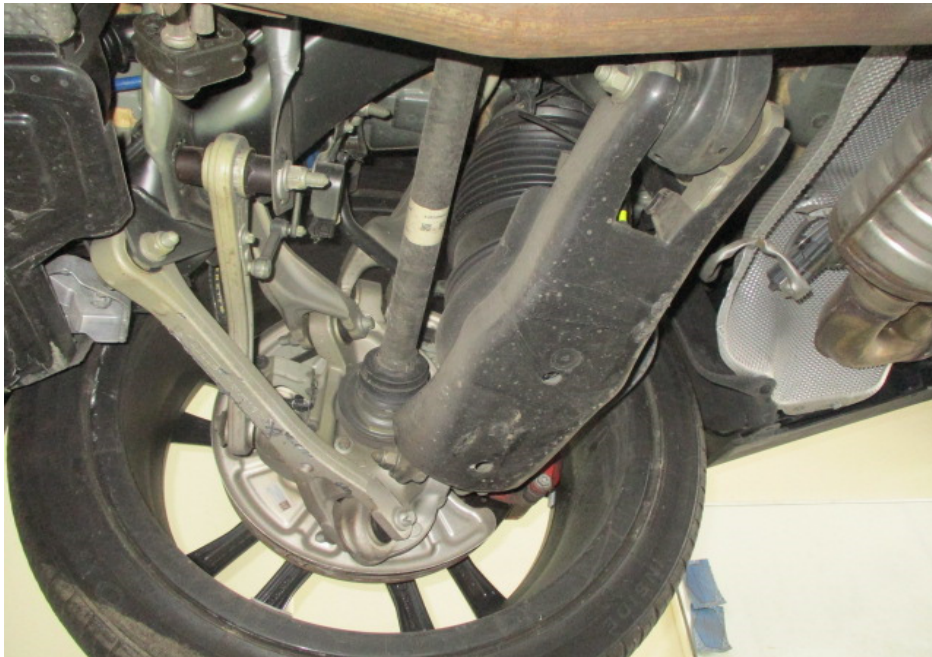
**Photo 18** shows a general view of the control arms and linkages at the rear right wheel of the Motor Car. I did not observe any fluid leak and/or fluid stain on the underside of the Motor Car. All of the Motor Car's undercarriage components were observed to be intact and secured in an appropriate manner.

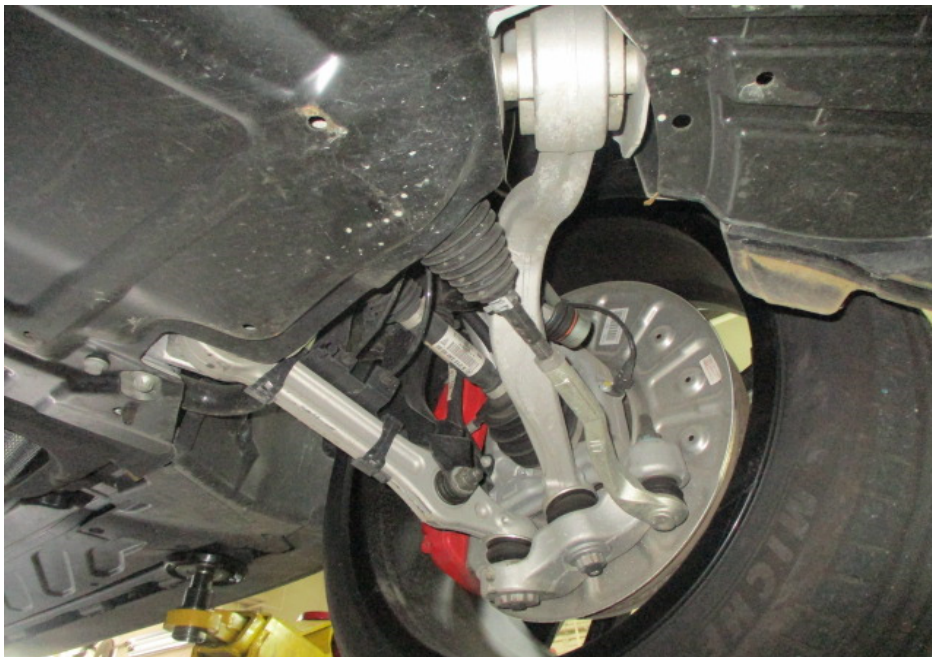
**Photo 19** shows the various undercarriage components at the front left wheel of the Motor Car. The mechanical components, control arms and linkages were all found to be intact and secured in an appropriate manner.

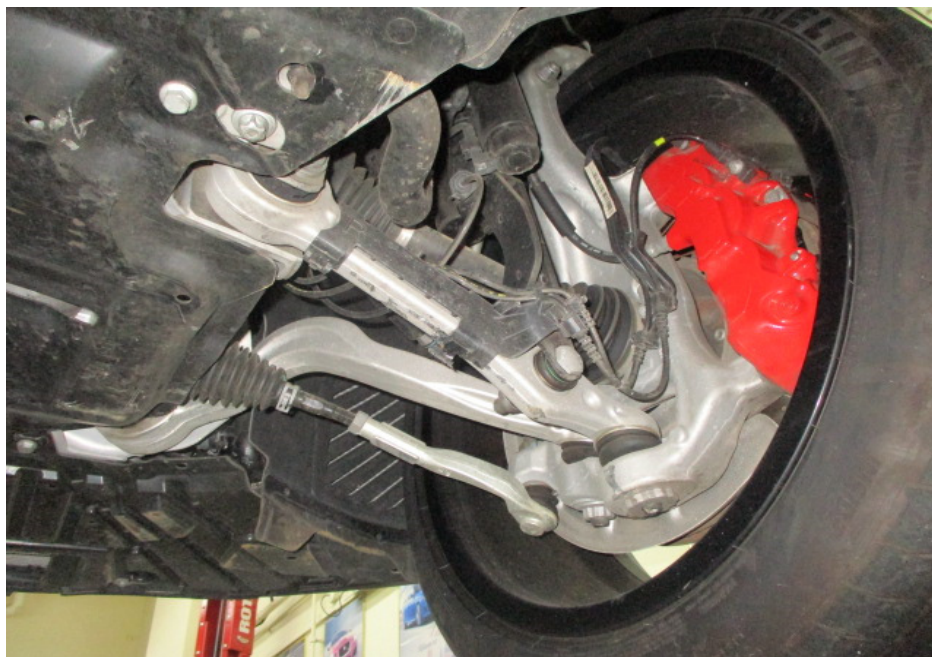
**Photo 20** shows the various undercarriage components at the front right wheel of the Motor Car. The mechanical components, control arms and linkages were all found to be intact and secured in an appropriate manner. I also did not observe any fluid leak and/or fluid stain on the underside of the Motor Car.

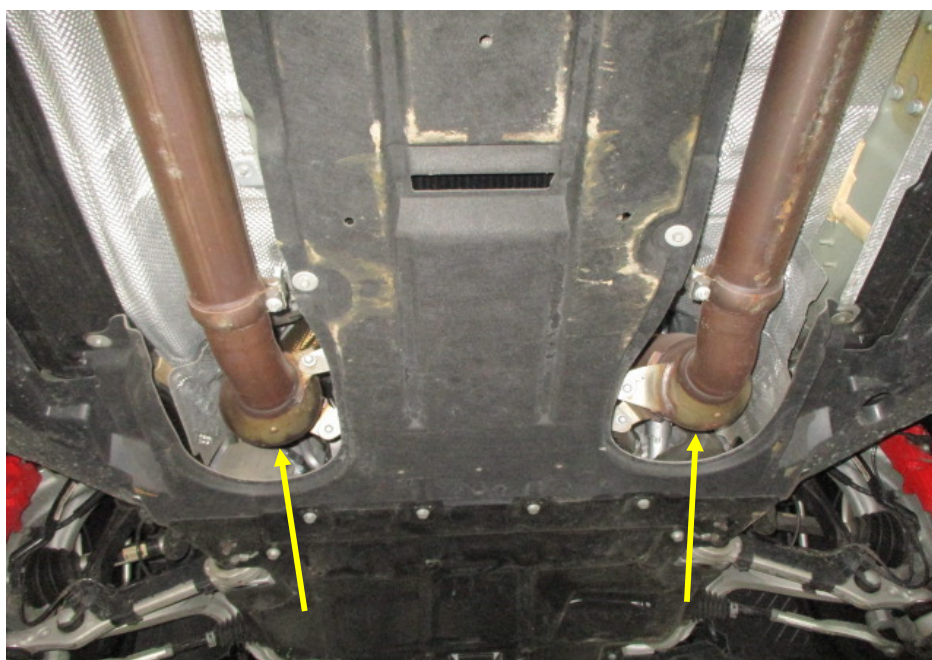
**Photo 21** shows the Motor Car's catalytic converters (arrowed). My examination of the Motor Car's exhaust system revealed no sign(s) or indication(s) of any cut or weld marks along its exhaust pipes and on its rear mufflers.

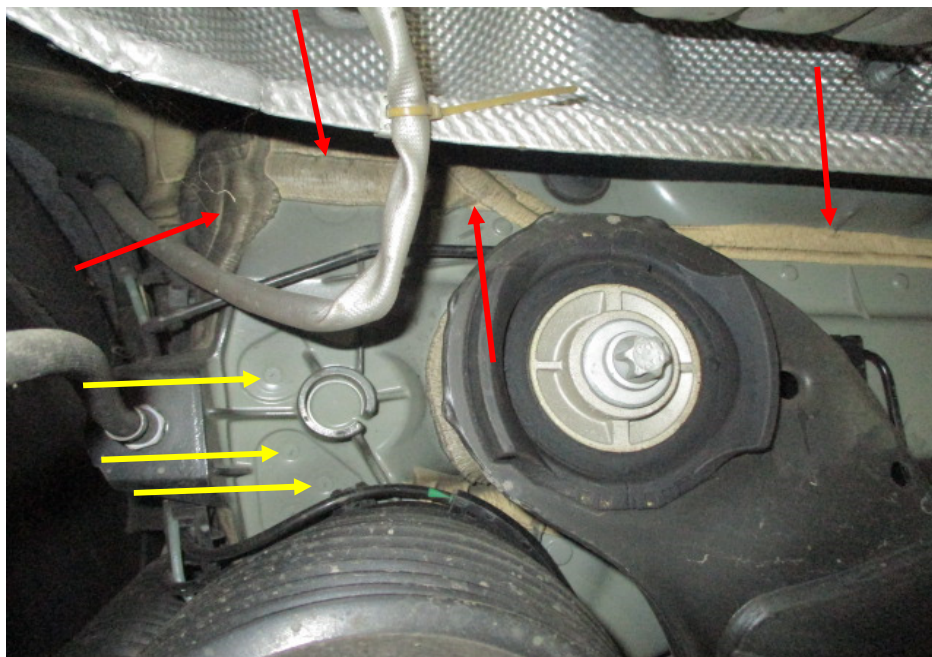
10. Visually, I did not find any weld marks, other than the original spot weld marks, on the chassis/structural body of the Motor Car. The original factory sealant at the joints along the chassis/structural body was also untouched, again indicating that no replacement of the chassis/structural body was carried out; and that the chassis/structural body was originally fitted.

**Photo 22** shows the chassis/structural body at the underside rear left of the Motor Car. I did not find any weld marks other than original spot weld marks (yellow arrow) on the chassis/structural body of the Motor Car. The original factory sealant (red arrow) at the joints along the chassis/structural body was untouched, indicating no work was done on the chassis/structural body of the Motor Car and that the chassis/structural body was originally fitted.

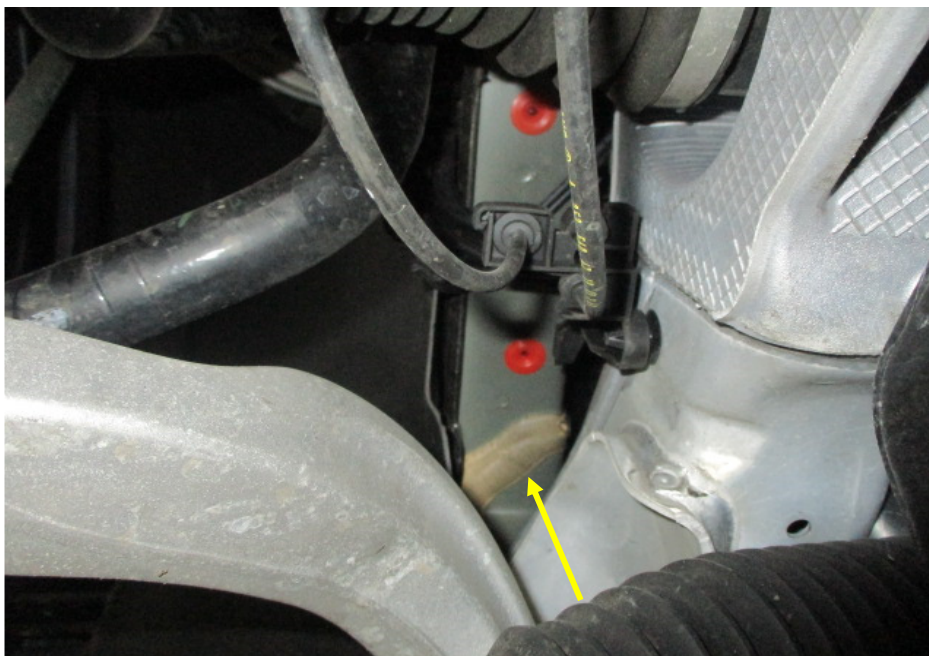
**Photo 23** shows the chassis/structural body at the underside front left of the Motor Car. The original factory sealant (arrowed) at the joints along the chassis/structural body was observed to be untouched. In general, I had found no work was carried out on the chassis/structural body of the Motor Car. The chassis/structural body of the Motor Car was originally fitted.

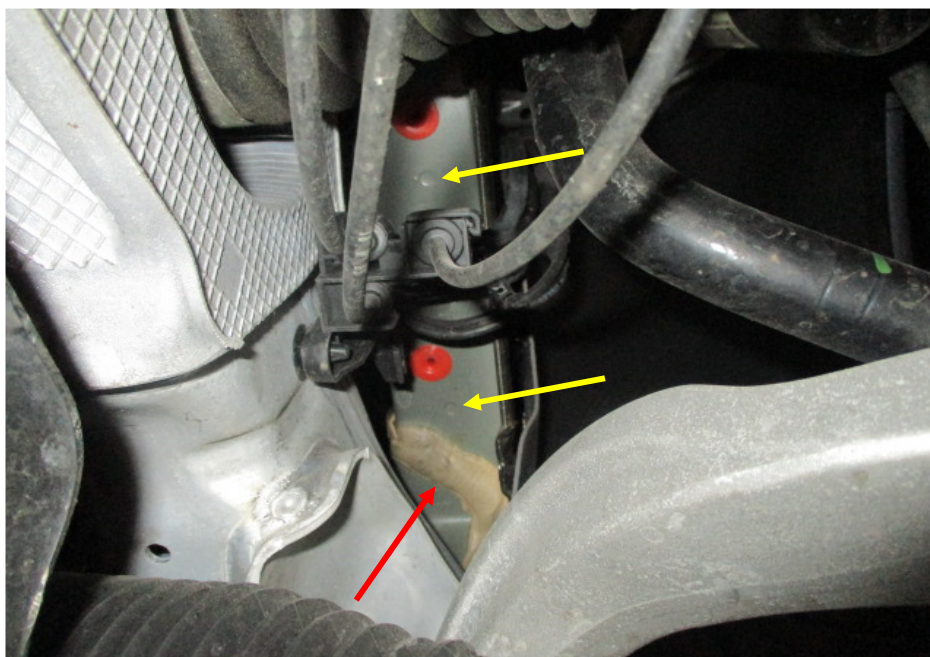
**Photo 24** shows the chassis/structural body at the underside front right of the Motor Car. I did not find any weld marks other than original spot weld marks (yellow arrow) on the chassis/structural body of the Motor Car. The original factory sealant (red arrow) at the joints along the chassis/structural body was untouched, indicating no work was done on the chassis/structural body of the Motor Car and that the chassis/structural body was originally fitted.

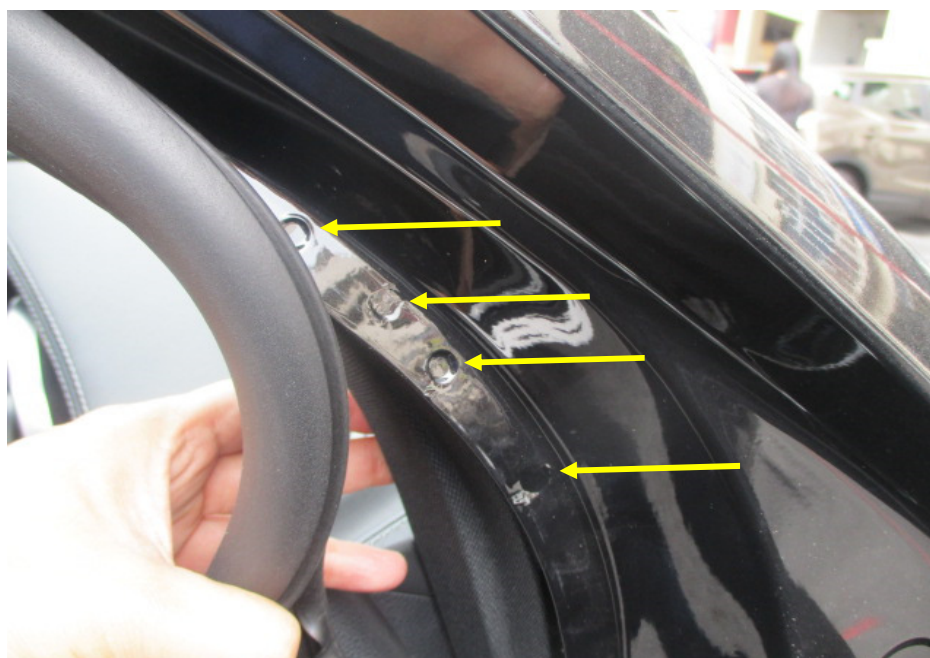
**Photo 25** shows the right side "A" pillar of the Motor Car. I did not find any weld marks other than original spot weld marks (arrowed) on the right side "A" pillar of the Motor Car which, indicates that there was no re-welding works carried out. In general, I had found all the non-detachable body panels of the Motor Car to be originally fitted at the time of my inspection.

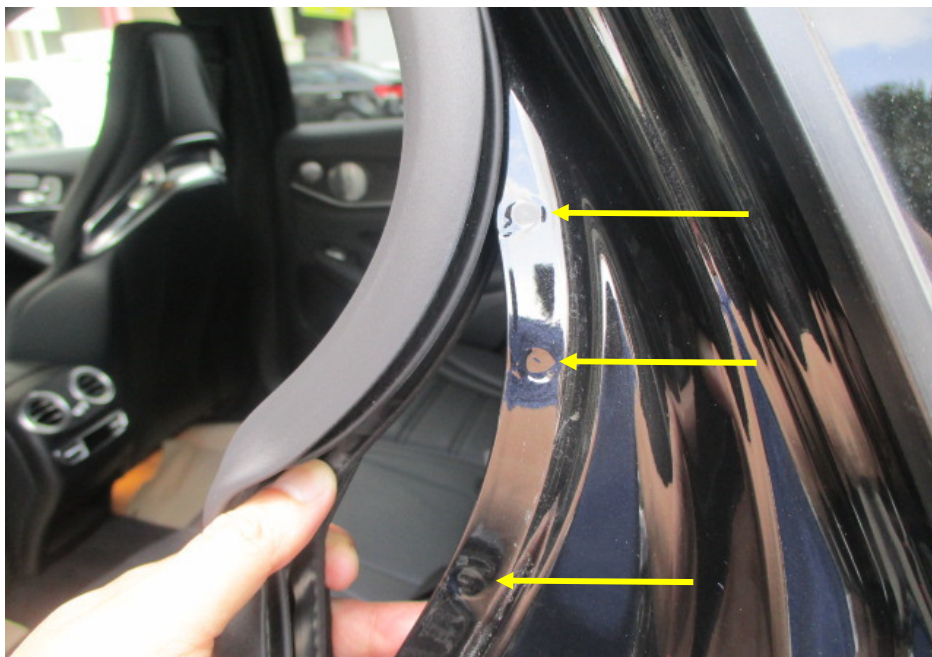
**Photo 26** shows the left side "C" pillar of the Motor Car. I did not find any weld marks other than original spot weld marks (arrowed) on the left side "C" pillar of the Motor Car which, indicates that there was no re-welding works carried out. In general, I had found all the non-detachable body panels of the Motor Car to be originally fitted at the time of my inspection.
