Your Ref: Mercedes Benz A200  
(chassis number WDD1771872W032829)  
Our Ref : CI/TP21003604/D

19 March 2021

**INSPECTION REPORT OF AN UNREGISTERED MERCEDES BENZ A200  
MOTOR CAR WITH CHASSIS NUMBER WDD1771872W032829**

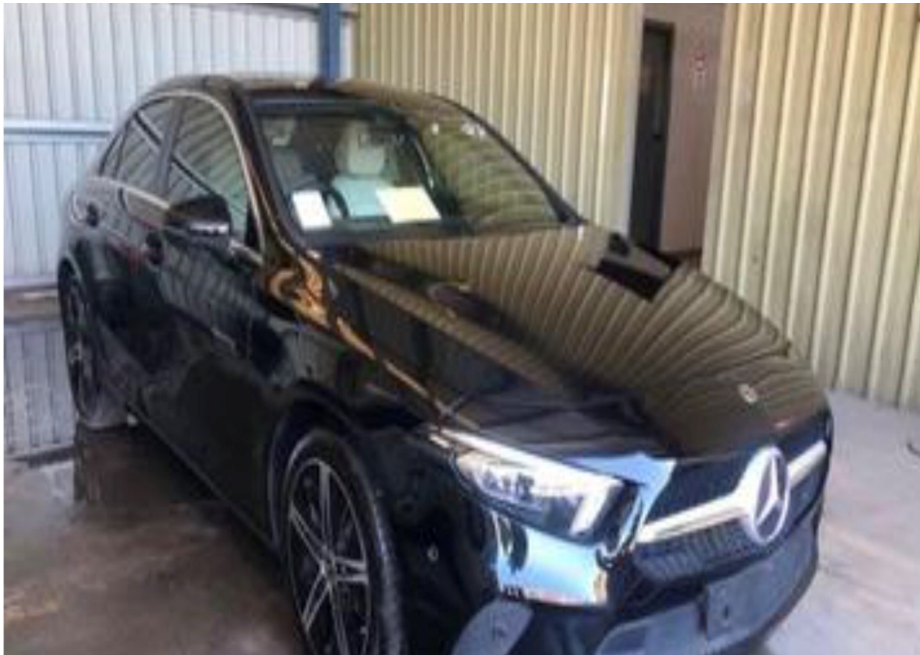
**Photo 1** shows the front right body of the Motor Car (photograph provided to me). There appears to be no visible damage to the Motor Car as seen from the photographs that were provided to me.

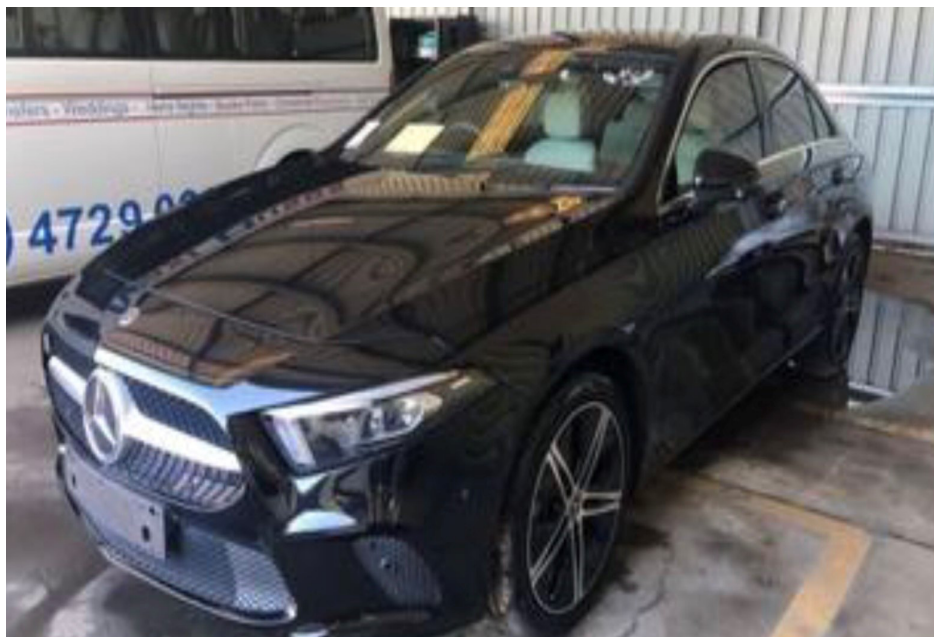
**Photo 2** shows the front left body of the Motor Car (photograph provided to me). There appears to be no visible damage to the Motor Car as seen from the photographs that were provided to me.

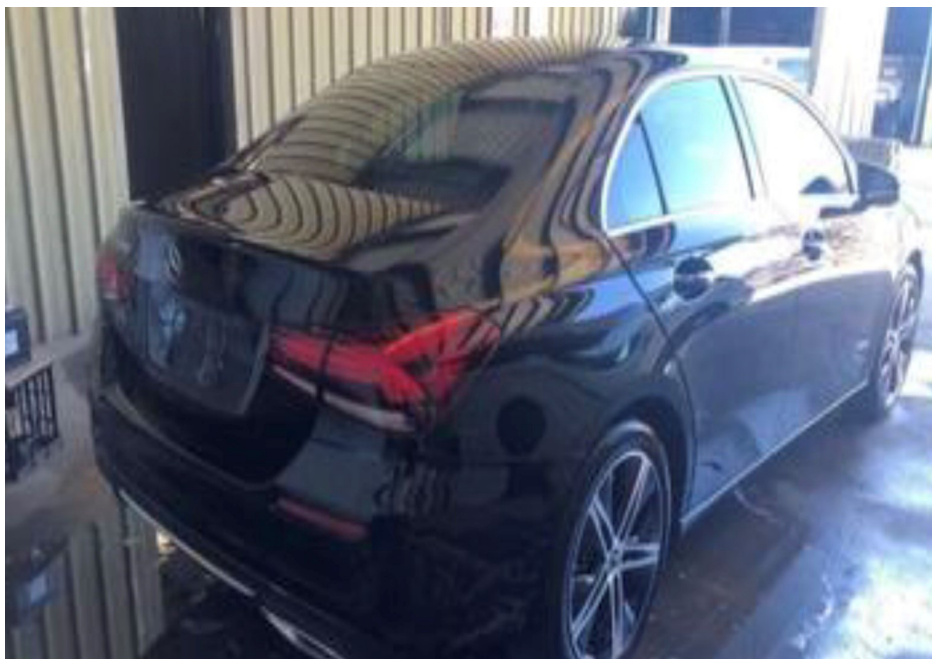
**Photo 3** shows the rear right body of the Motor Car (photograph provided to me). There appears to be no visible damage to the Motor Car as seen from the photographs that were provided to me.

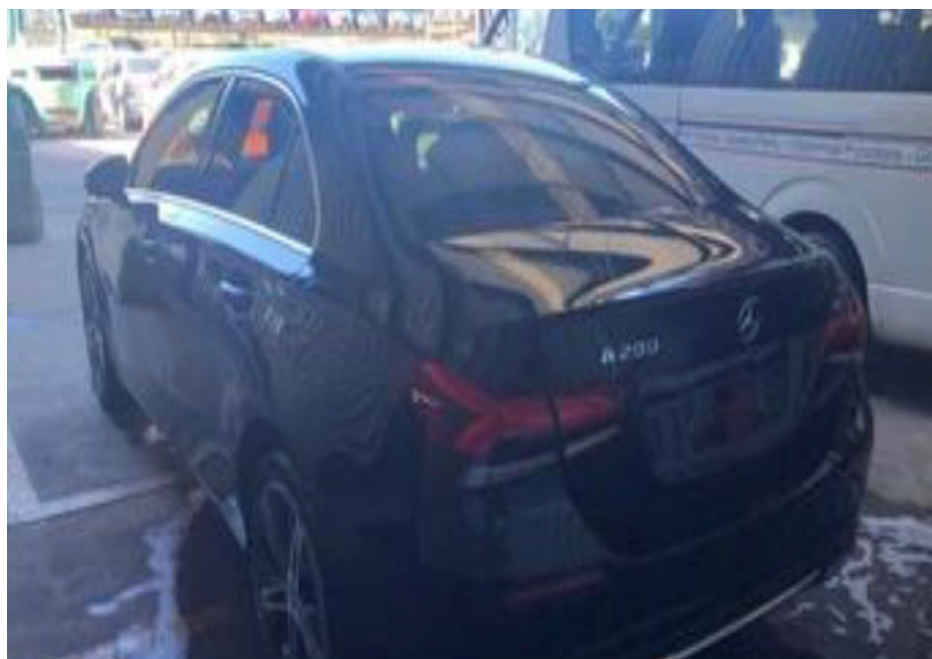
**Photo 4** shows the rear left body of the Motor Car (photograph provided to me). There appears to be no visible damage to the Motor Car as seen from the photographs that were provided to me.

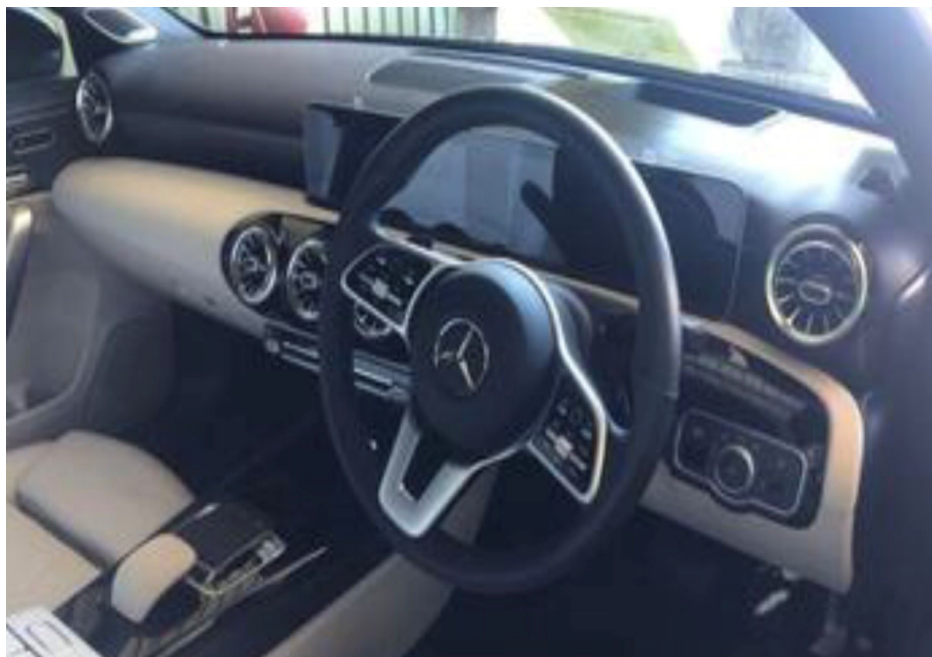
**Photo 5** shows the front dashboard of the Motor Car (photograph provided to me). There appears to be no visible damage to the Motor Car as seen from the photographs that were provided to me.

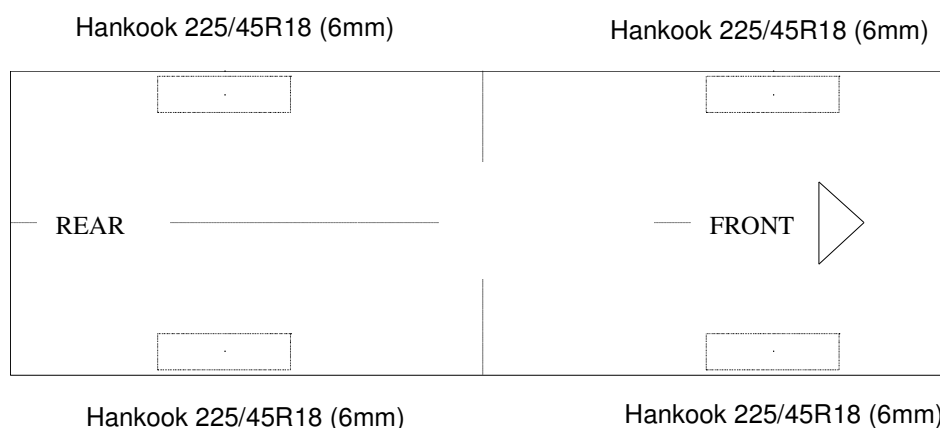
7. It was fitted with 18inch sport wheel rims that were wrapped with tyres that were observed to be of serviceable condition. The tyres were also sufficiently inflated for vehicular operation. The tyre brand, tyre size and approximate remaining tread depth of the 4 tyres of the Motor Car were recorded as follows: -

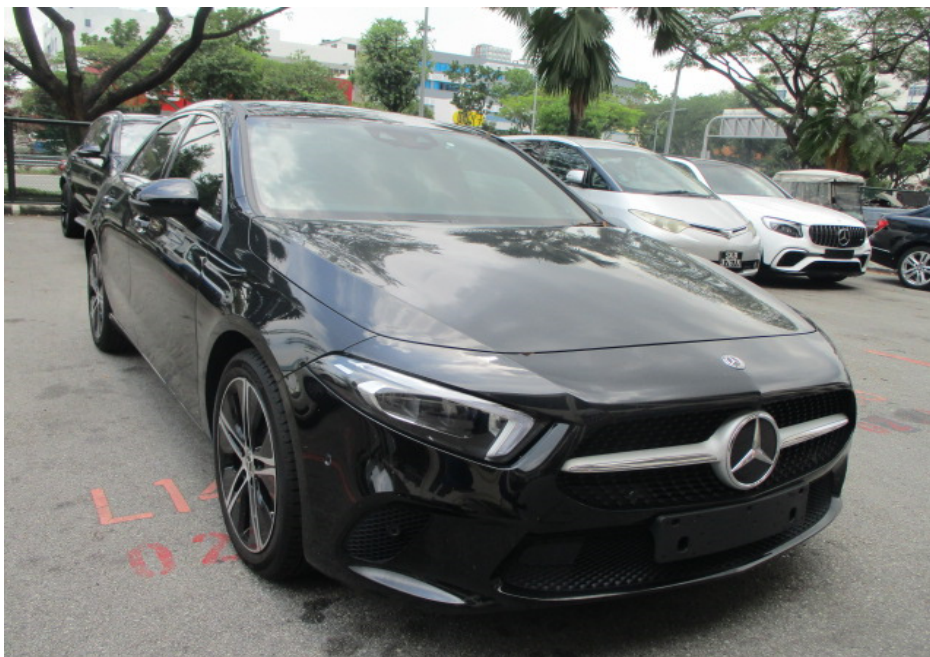
**Photo 6** shows a general view of the front right body of the Motor Car at the time of my inspection. The Motor Car was observed to be in a relatively good general condition with no loose exterior fittings observed. There was no visible damage observed to the Motor Car.

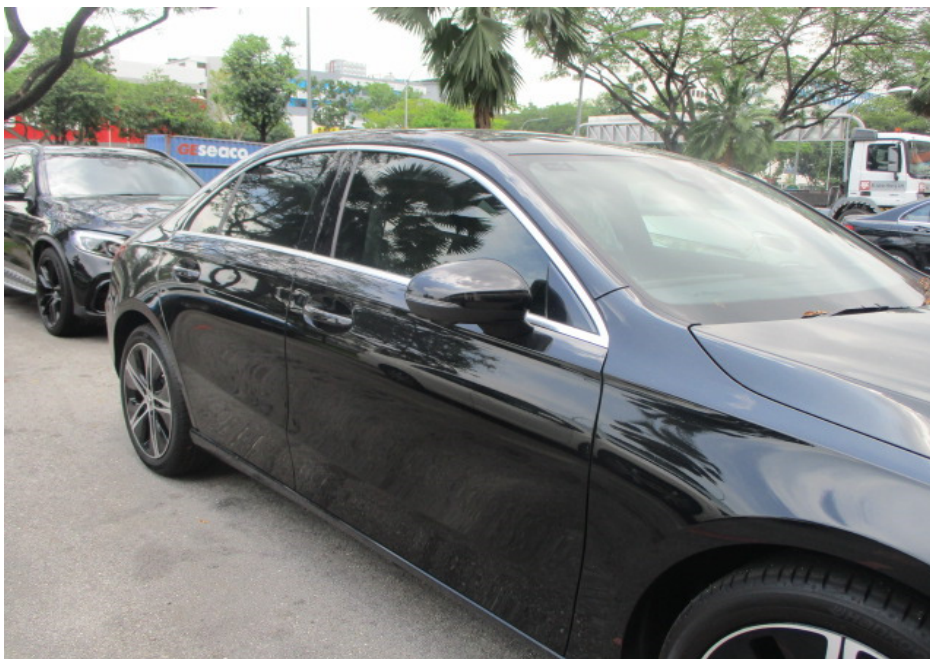
**Photo 7** shows a general view of the right side body of the Motor Car at the time of my inspection. The Motor Car was observed to be in a relatively good general condition with no loose exterior fittings observed. There was no visible damage observed to the Motor Car.

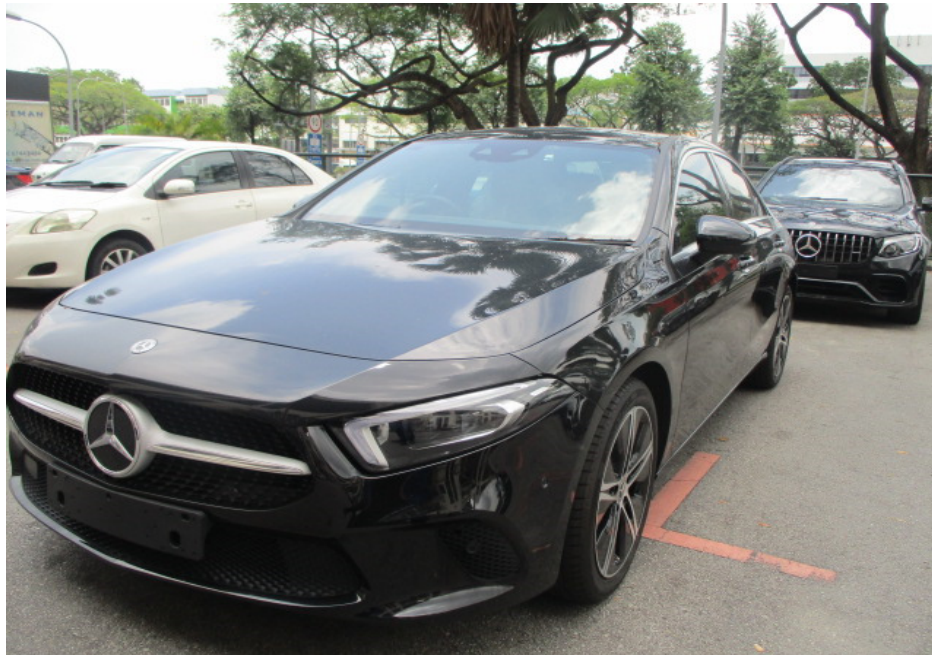
**Photo 8** shows a general view of the front left body of the Motor Car at the time of my inspection. The Motor Car was observed to be in a relatively good general condition with no loose exterior fittings observed. There was no visible damage observed to the Motor Car. The mileage of the Motor Car recorded at the time of my inspection was 2,920km.

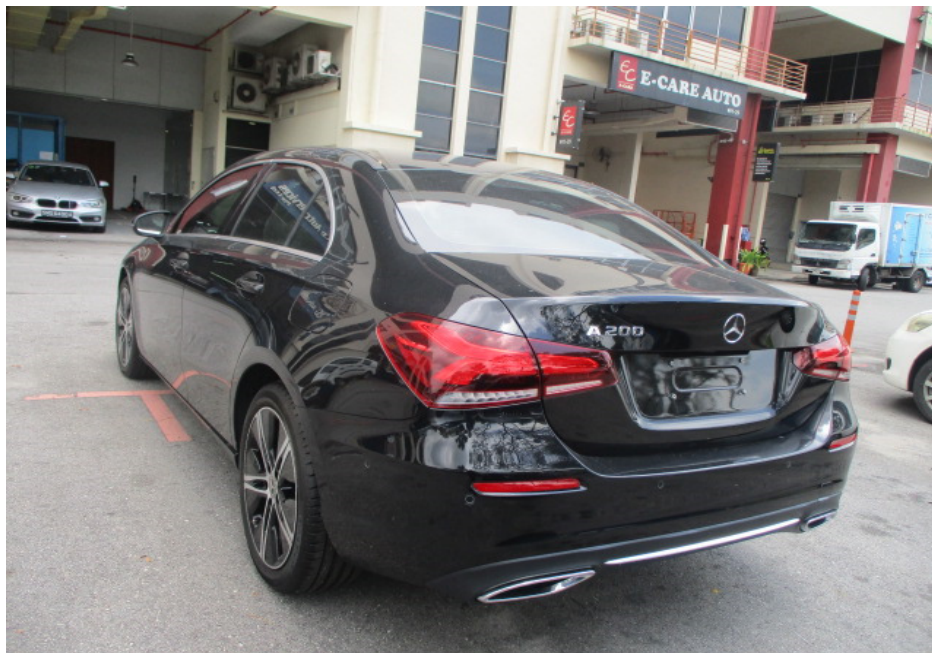
**Photo 9** shows a general view of the rear left body of the Motor Car at the time of my inspection. The Motor Car was observed to be in a relatively good general condition with no loose exterior fittings observed. There was no visible damage observed to the Motor Car.

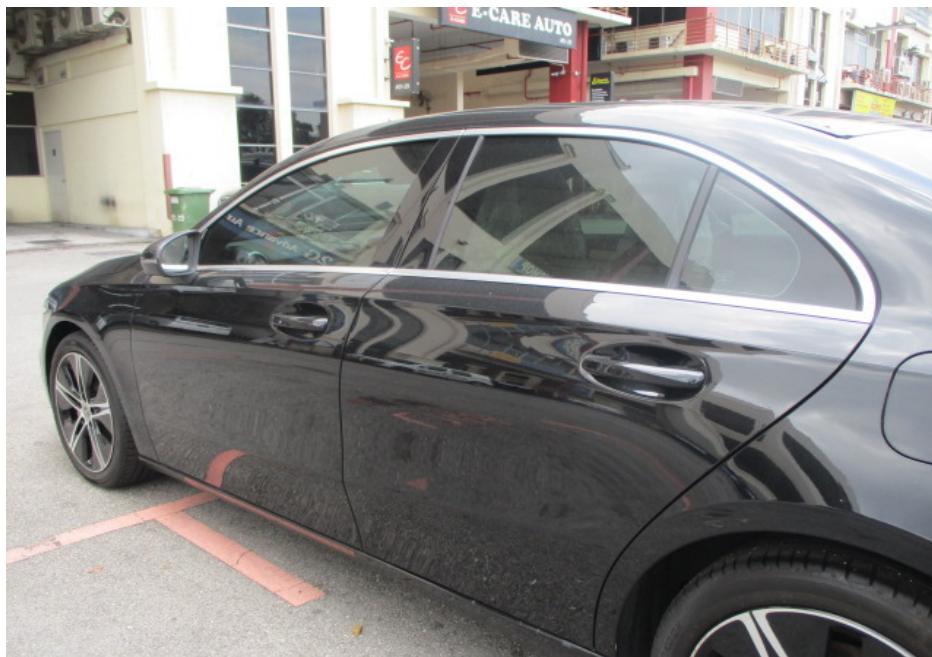
**Photo 10** shows a general view of the left side body of the Motor Car at the time of my inspection. The Motor Car was observed to be in a relatively good general condition with no loose exterior fittings observed. There was no visible damage observed to the Motor Car.

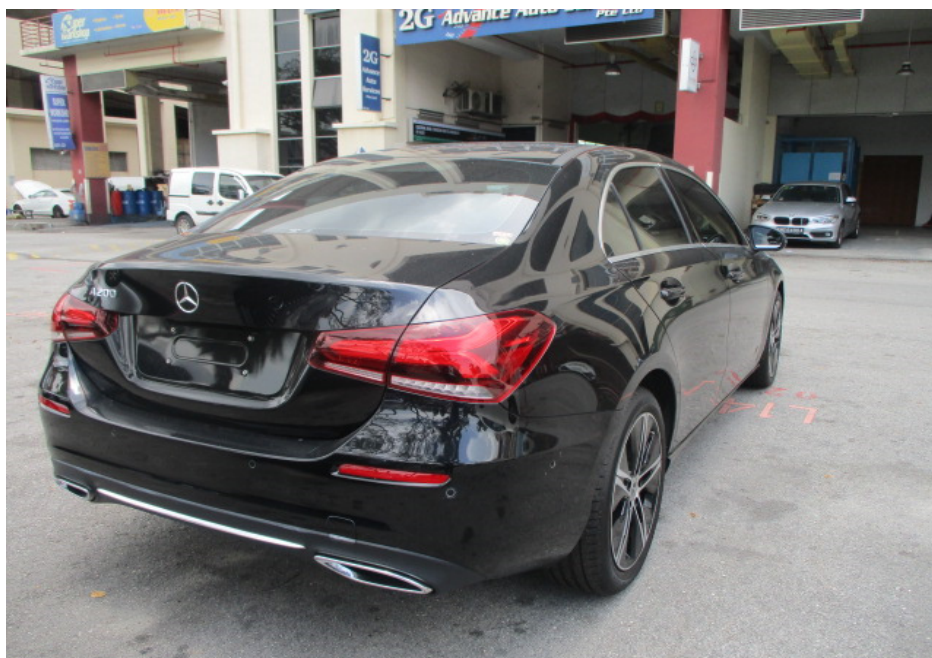
**Photo 11** shows a general view of the rear right body of the Motor Car at the time of my inspection. The Motor Car was observed to be in a relatively good general condition with no loose exterior fittings observed. There was no visible damage observed to the Motor Car. The mileage of the Motor Car recorded at the time of my inspection was 2,920km.

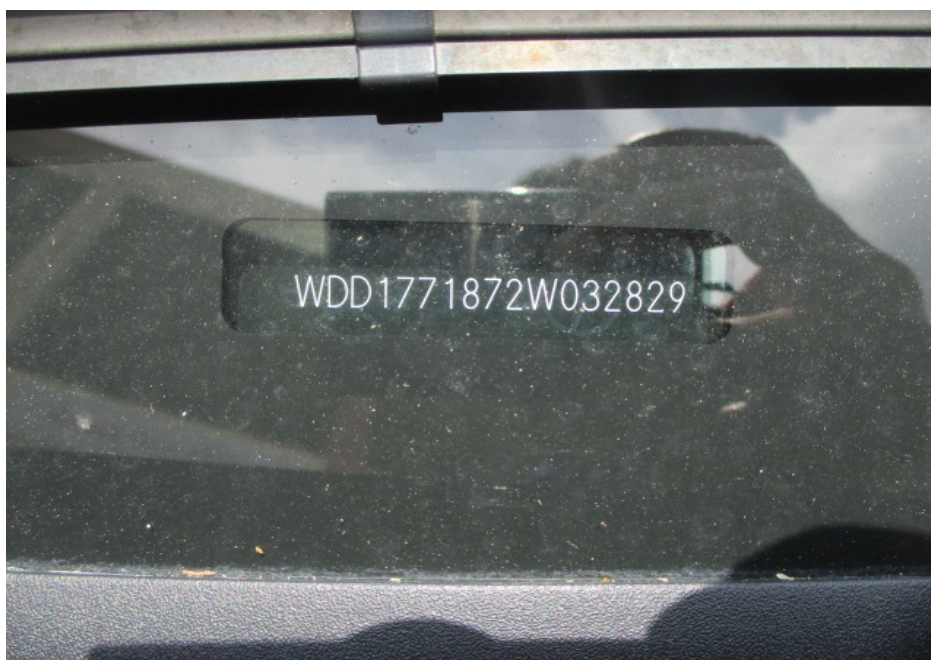
**Photo 12** shows the chassis number of the Motor Car. The chassis number recorded was WDD1771872W032829.

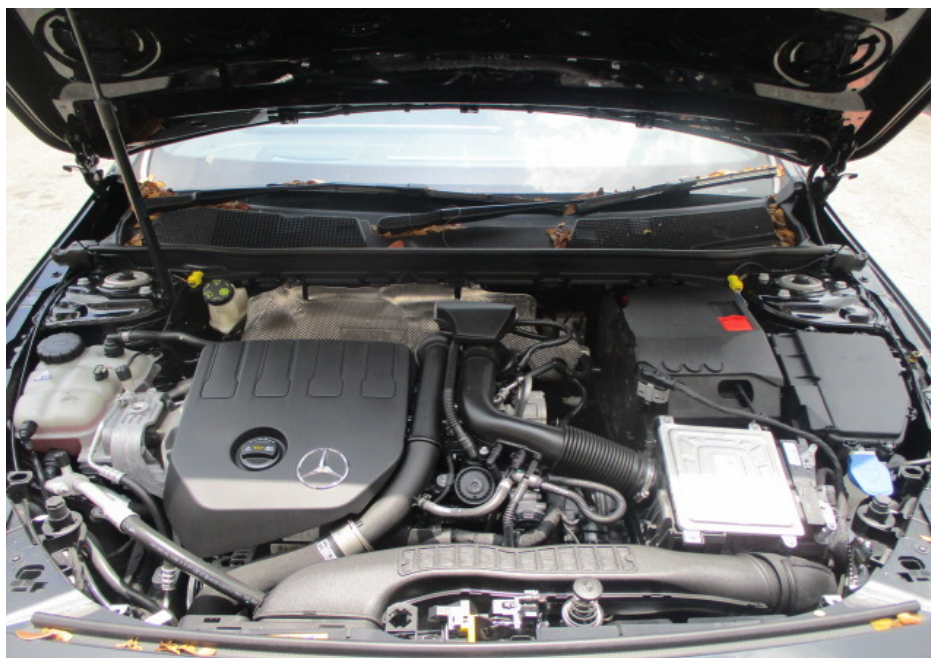
13. My examination of the engine compartment of the Motor Car revealed that the various parts and components inside the engine compartment were all intact and properly fitted. The engine oil, brake fluid and engine coolant were all found to be of sufficient level for operating purposes. Visually, there was also no contamination found to these fluids.
14. My checks on the underside of the Motor Car revealed no sign(s) or indication(s) of fluid leakage and/or fluid stain(s). The engine block and automatic transmission assembly were both secured properly. All undercarriage components of the Motor Car were also observed to be intact and secured in an appropriate manner.

**Photo 13** shows a general view of the engine compartment of the Motor Car at the time of my inspection. The various parts and components inside the engine compartment were all observed to be intact and properly fitted. There was also no sign(s) or indication(s) of fluid leak and/or fluid stain found inside the engine compartment.

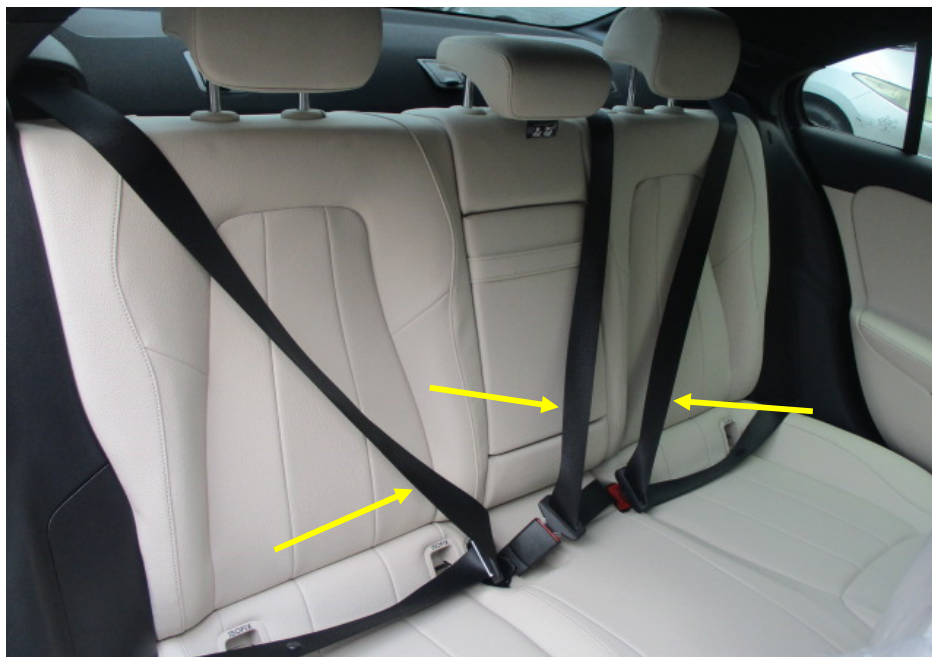
11. The seats of the Motor Car were found to be secured to the floorboard of the Motor Car via seat rails bolted onto the floorboard. Retractable seat belt reels and pre-tensioners were fitted on all seats of the Motor Car. The seat belts were tested and were able to be fastened securely into the respective pre-tensioners that were fixed to the side of all the seats.

**Photo 14** shows the rear seats of the Motor Car. All the seats of the Motor Car were secured via seat rails to the floorboard. They were also fitted with a retractable seat belt reel and a pre-tensioner. The seat belts (arrowed) were tested and were able to be fastened into the respective pre-tensions that were fitted on the side of each individual seat.

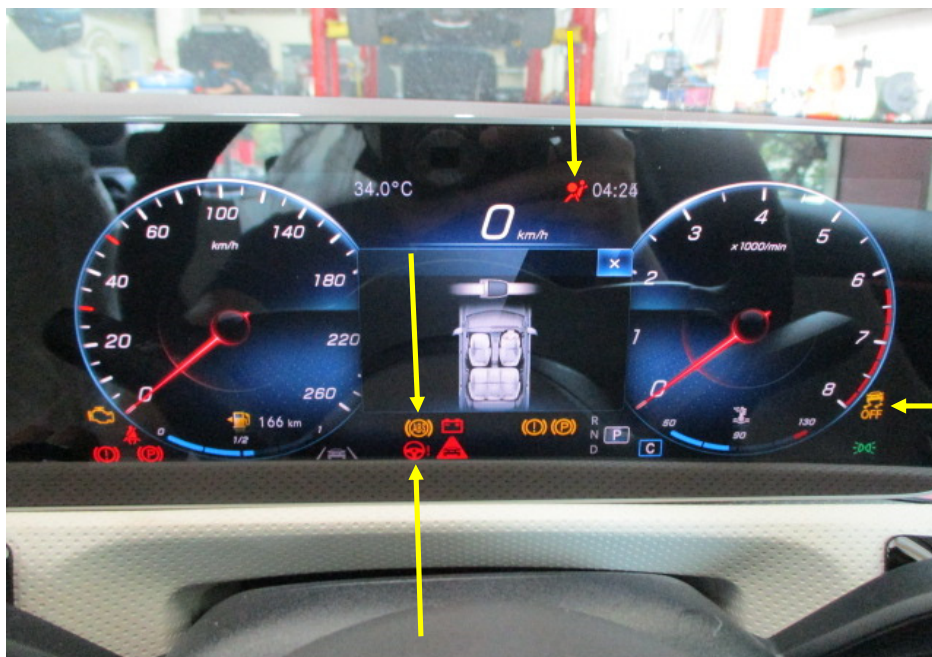
**Photo 15** shows the warning lights for the various electronic safety features appearing on the instrument panel of the Motor Car during its self-test when the engine is cranked, in particular the ABS, SRS, EPS and TCS lights (arrowed).

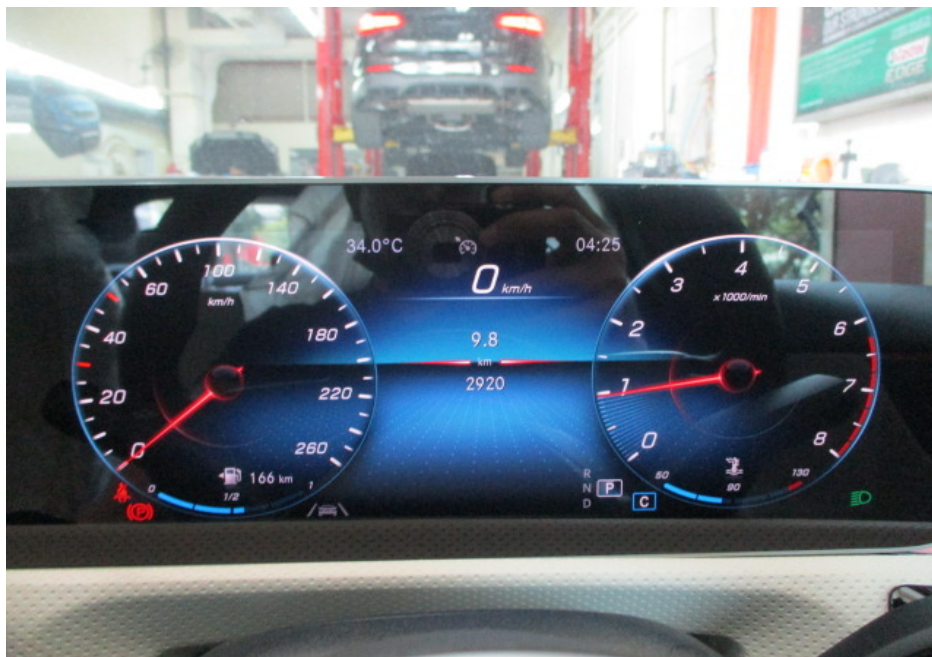
12. The Motor Car's automatic self-test of the functionality of its various electronic safety features like the Anti-Lock Brake System (ABS), Supplemental Restraint System (SRS), Electric Power Steering (EPS) and Traction Control System (TCS) during cranking of the engine had indicated that these electronic systems were in working condition. This was determined from the respective warning lights disappearing from the instrument panel after the self-test.

**Photo 16** shows the respective warning lights no longer illuminated, indicating that there is no fault detected to the ABS, SRS, EPS TCS systems of the Motor Car during the self-test. These electronic systems were hence in working condition at the time of my inspection.

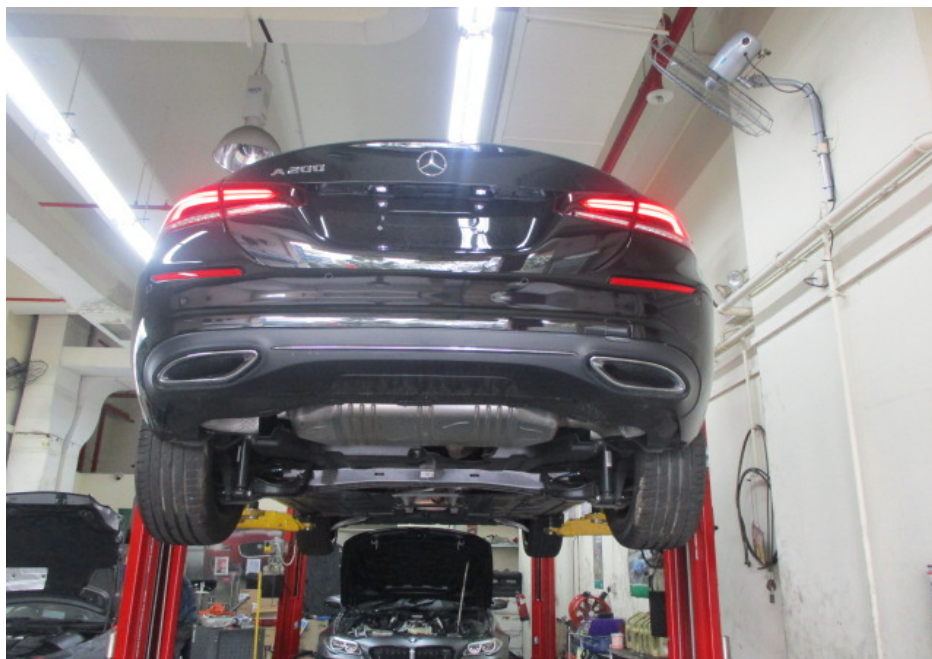
**Photo 17** shows the Motor Car hoisted up for checks on its undercarriage. There was no sign(s) or indication(s) of fluid leakage and/or fluid stain(s) on the underside of the Motor Car. The undercarriage components of the Motor Car were also all observed to be intact and secured in an appropriate manner.

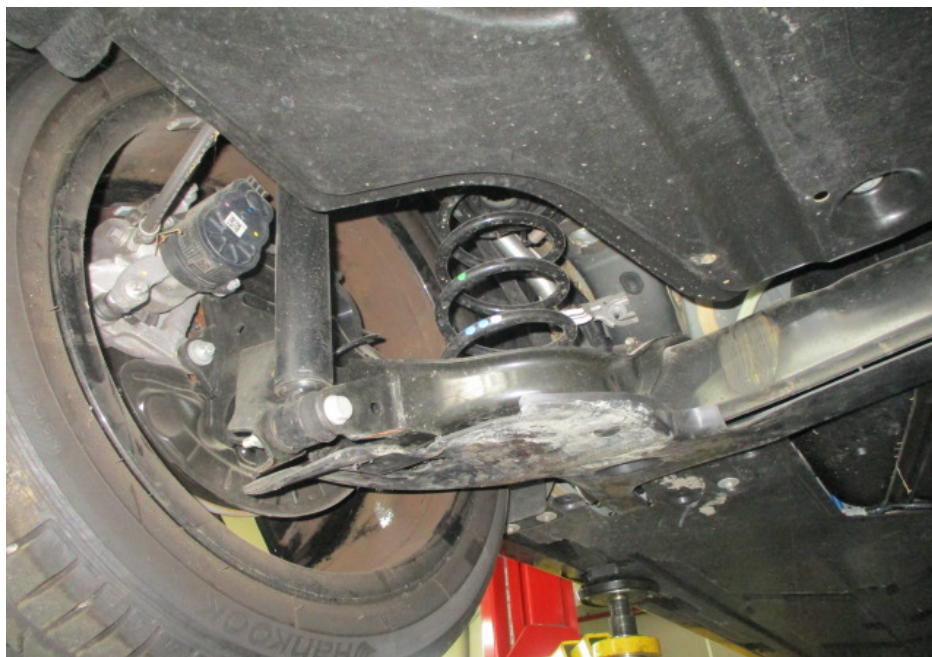
**Photo 18** shows a general view of the control arms and linkages at the rear left wheel of the Motor Car. I did not observe any fluid leak and/or fluid stain on the underside of the Motor Car. All of the Motor Car's undercarriage components were observed to be intact and secured in an appropriate manner.

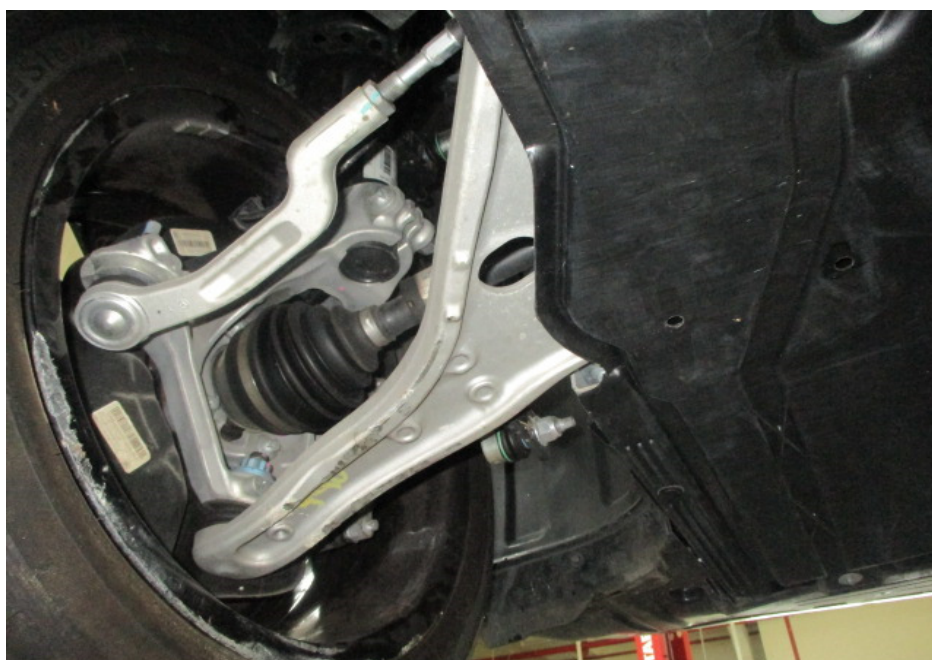
**Photo 19** shows the various undercarriage components at the front left wheel of the Motor Car. The mechanical components, control arms and linkages were all found to be intact and secured in an appropriate manner.

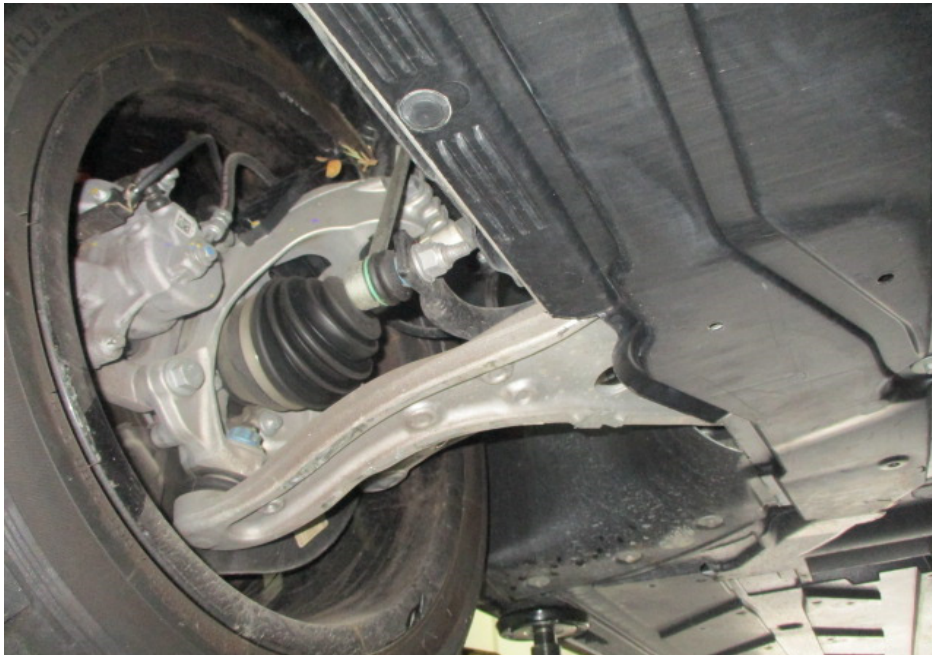
**Photo 20** shows the various undercarriage components at the front right wheel of the Motor Car. The mechanical components, control arms and linkages were all found to be intact and secured in an appropriate manner. I also did not observe any fluid leak and/or fluid stain on the underside of the Motor Car.

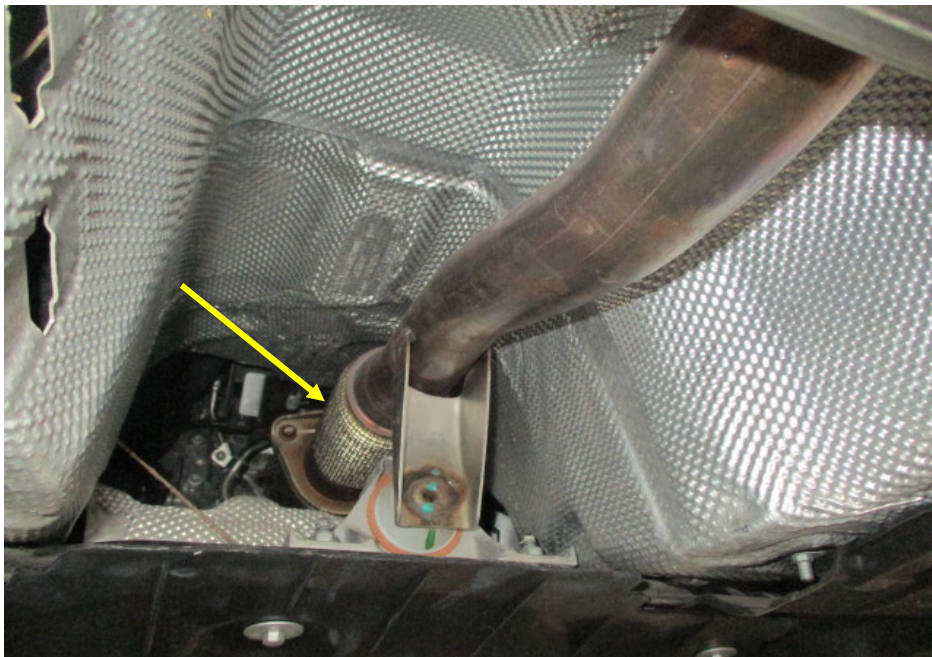
**Photo 21** shows the Motor Car's catalytic converter (arrowed). My examination of the Motor Car's exhaust system revealed no sign(s) or indication(s) of any cut or weld marks along its exhaust pipes and on its rear muffler.

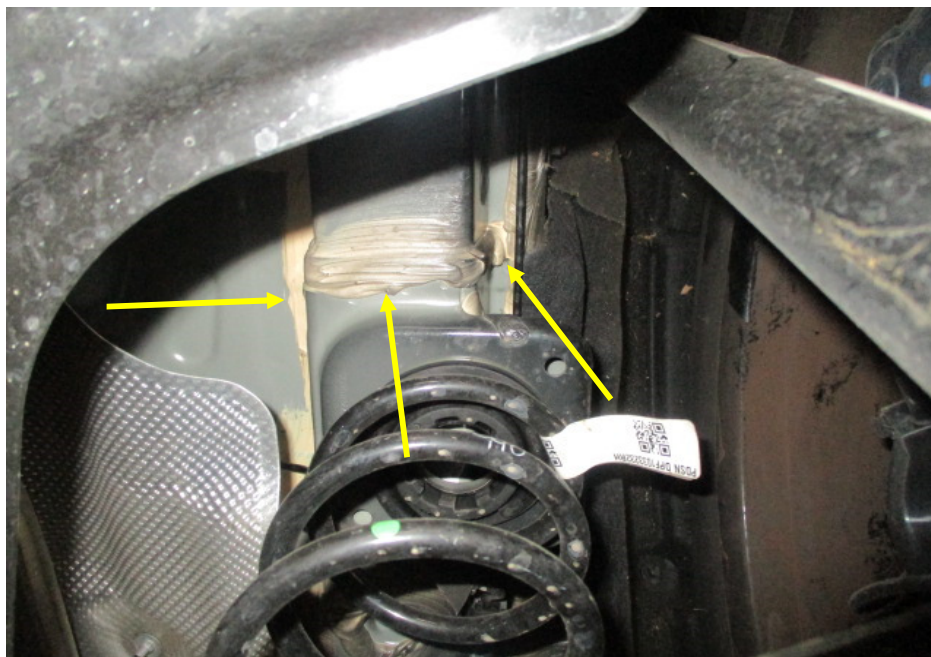
10. Visually, I did not find any weld marks, other than the original spot weld marks, on the chassis/structural body of the Motor Car. The original factory sealant at the joints along the chassis/structural body was also untouched, again indicating that no replacement of the chassis/structural body was carried out; and that the chassis/structural body was originally fitted.

**Photo 22** shows the chassis/structural body at the underside rear right of the Motor Car. I did not find any weld marks other than original spot weld marks on the chassis/structural body of the Motor Car. The original factory sealant (arrowed) at the joints along the chassis/structural body was untouched, indicating no work was done on the chassis/structural body of the Motor Car and that the chassis/structural body was originally fitted.

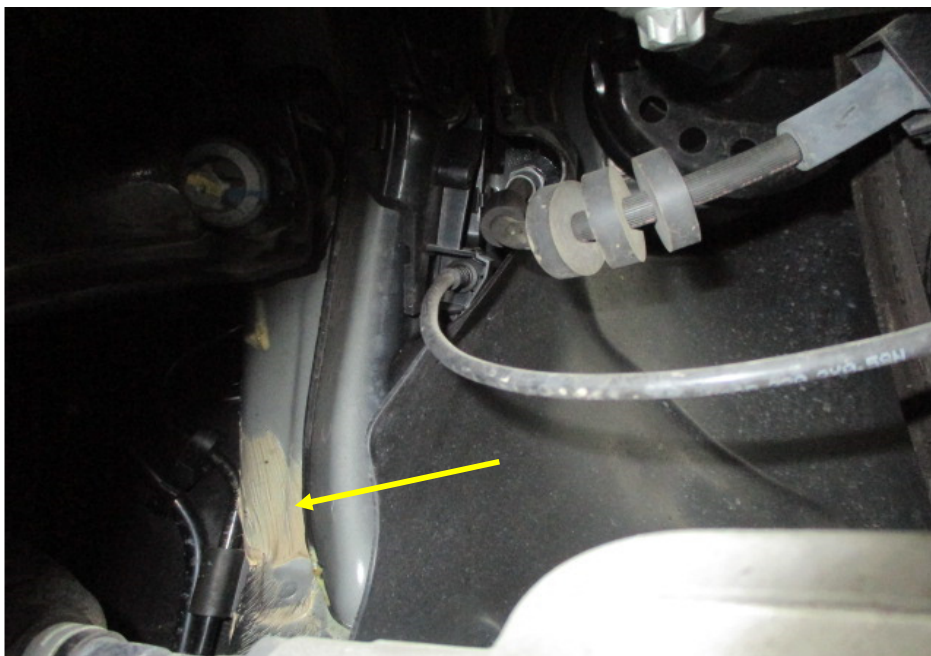
**Photo 23** shows the chassis/structural body at the underside front left of the Motor Car. The original factory sealant (arrowed) at the joints along the chassis/structural body was observed to be untouched. In general, I had found no work was carried out on the chassis/structural body of the Motor Car. The chassis/structural body of the Motor Car was originally fitted.

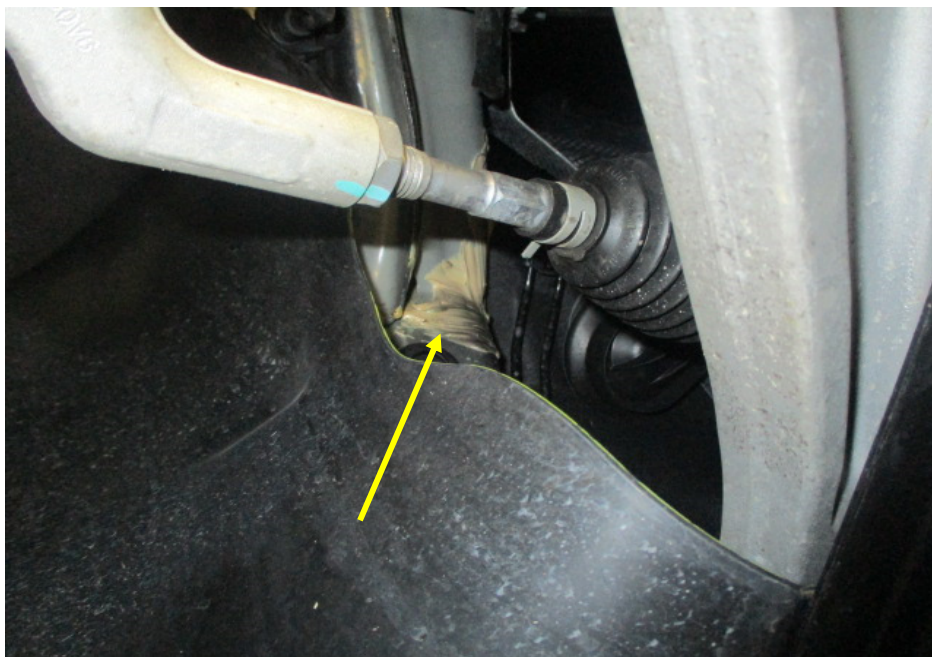
**Photo 24** shows the chassis/structural body at the underside front right of the Motor Car. I did not find any weld marks other than original spot weld marks on the chassis/structural body of the Motor Car. The original factory sealant (arrowed) at the joints along the chassis/structural body was untouched, indicating no work was done on the chassis/structural body of the Motor Car and that the chassis/structural body was originally fitted.

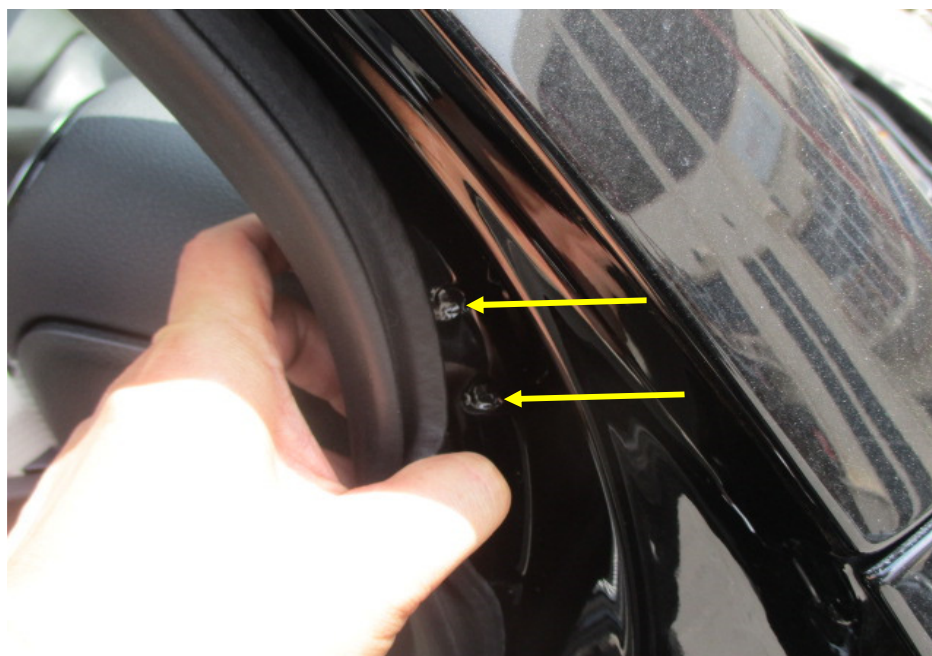
**Photo 25** shows the right side "A" pillar of the Motor Car. I did not find any weld marks other than original spot weld marks (arrowed) on the right side "A" pillar of the Motor Car which, indicates that there was no re-welding works carried out. In general, I had found all the non-detachable body panels of the Motor Car to be originally fitted at the time of my inspection.

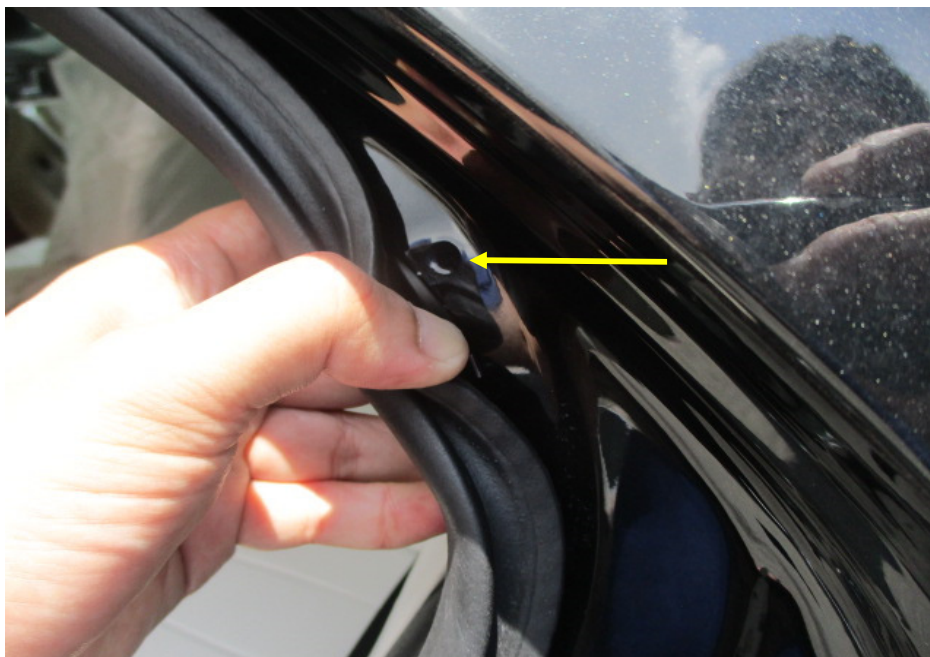
**Photo 26** shows the left side "C" pillar of the Motor Car. I did not find any weld marks other than original spot weld marks (arrowed) on the left side "C" pillar of the Motor Car which, indicates that there was no re-welding works carried out. In general, I had found all the non-detachable body panels of the Motor Car to be originally fitted at the time of my inspection.
