Your Ref: DMPC2100093H/CT  
Our Ref : CS4/ICS21003618/N

30 March 2021

### **TECHNICAL INVESTIGATION REPORT OF FIRE INCIDENT INVOLVING THE INSURED VEHICLE SKK 4937H ON 17 MARCH 2021**

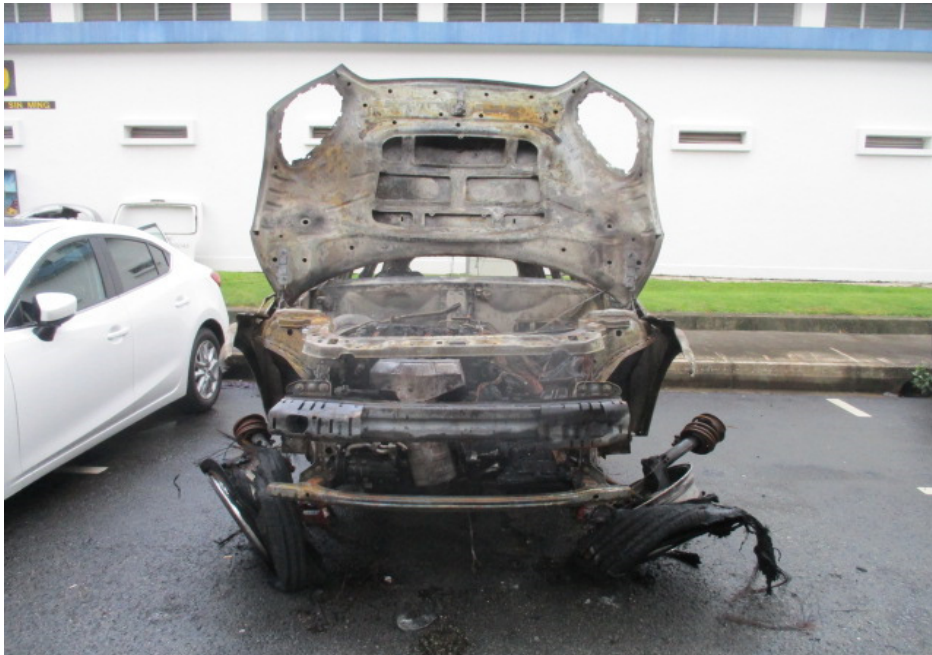
5. The Insured Vehicle was observed to have sustained severe fire damage all around. Its engine compartment and interior compartment were completely burnt. Rust had accumulated all over the Insured Vehicle as a result of exposure to environmental condition for a period of time. See photos 1 – 4 below.

**Photo 1** shows the general view of the frontal portion of the Insured Vehicle at the time of our inspection. The Insured Vehicle was observed to have sustained extensive fire damage all around. Its engine compartment and interior compartment were completely burnt. Rust had accumulated all over the Insured Vehicle as a result of exposure to environmental condition for a period of time.

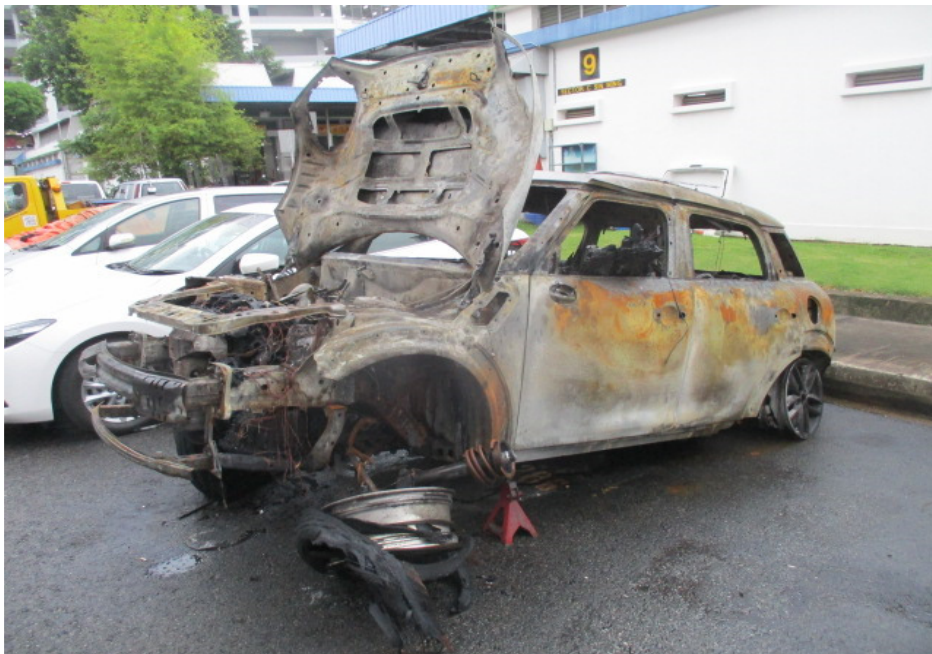
**Photo 2** shows the general view of the left body of the Insured Vehicle at the time of our inspection. The Insured Vehicle was observed to have sustained extensive fire damage all around. Rust had accumulated all over the Insured Vehicle as a result of exposure to environmental condition for a period of time.

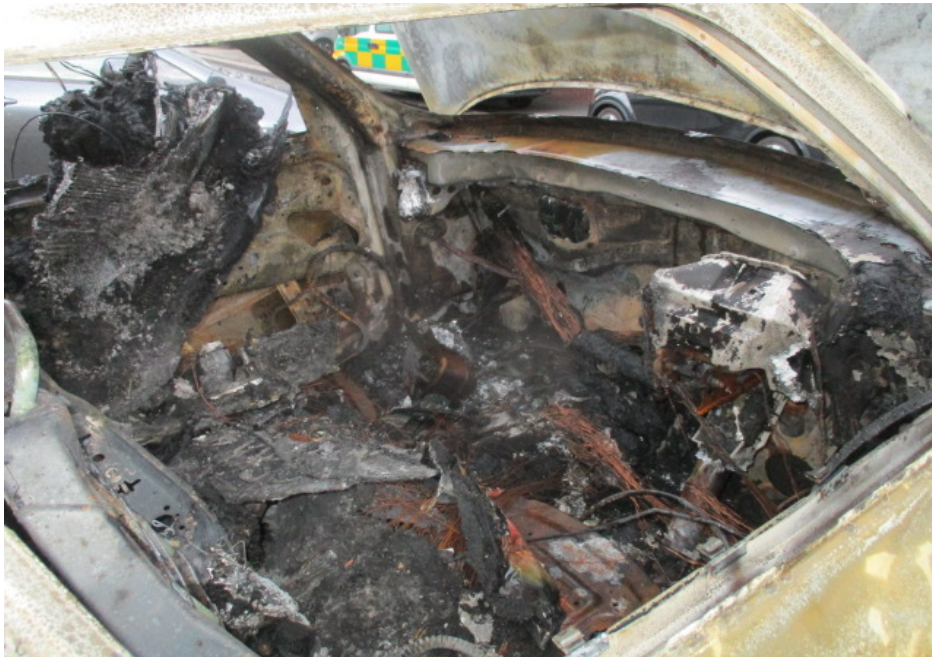
**Photo 3** shows the general view of the interior compartment of the Insured Vehicle at the time of our inspection. Its interior compartment was completely burnt.

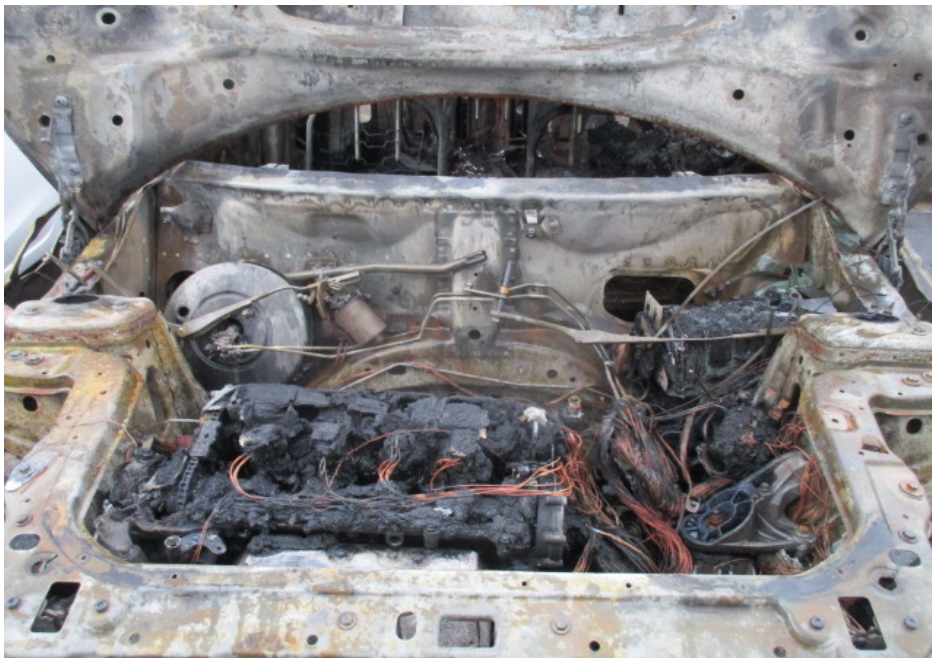
**Photo 4** shows the engine compartment of the Insured Vehicle at the time of our inspection. The entire engine compartment of the Insured Vehicle was observed to be severely burnt. Most of the parts inside the engine compartment were found to be burnt and/or melted as a result of the fire.

7. For this particular case, the fire appears to have originated within the engine compartment of the Insured Vehicle as this was the area where the damage of fire nature was most severe.

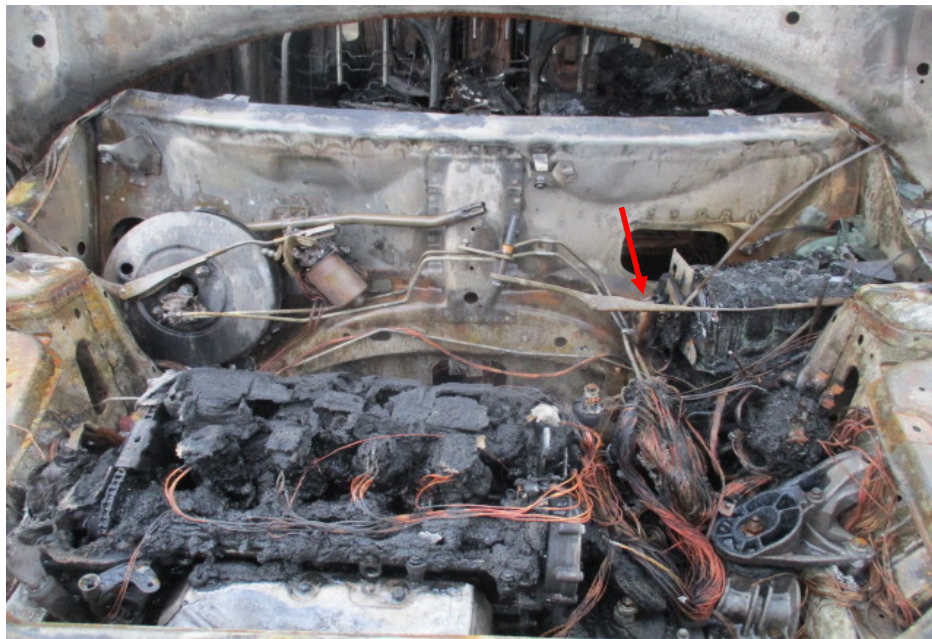
8. Upon closer examination of the rear portion of the engine compartment, which was where the fire to the Insured Vehicle had likely started, we had found faint traces of greenish residue on several stretches of wirings. These wirings were original factory fitted wirings that were around the rear portion of the engine compartment. The presence of greenish residue indicates internal heating of copper wires, a sign of an electrical short circuit occurring. The greenish residue is normally left behind from oxidation as a result of chemical reaction involving the copper wires. This physical evidence would appear to suggest that the cause of fire to the Insured Vehicle could have possibly been due to electrical in nature. See photos 5 - 7 below.

**Photo 5** shows the factory fitted wirings around the rear portion of the engine compartment which is near to the vicinity where the fire to the Insured Vehicle had likely started. We observed faint traces of greenish residue on some of these wirings (arrowed).

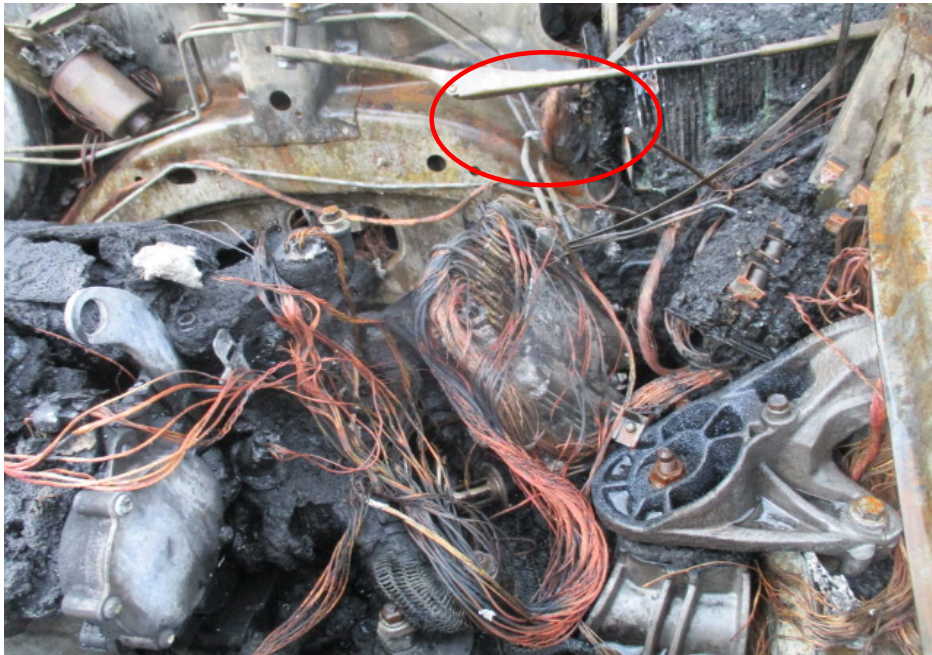
**Photo 6** shows a closer view of the wirings around the rear portion of the engine compartment. We observed faint traces of greenish residue on some of these wirings (circled). This seems to suggest the occurrence of an electrical short circuit.

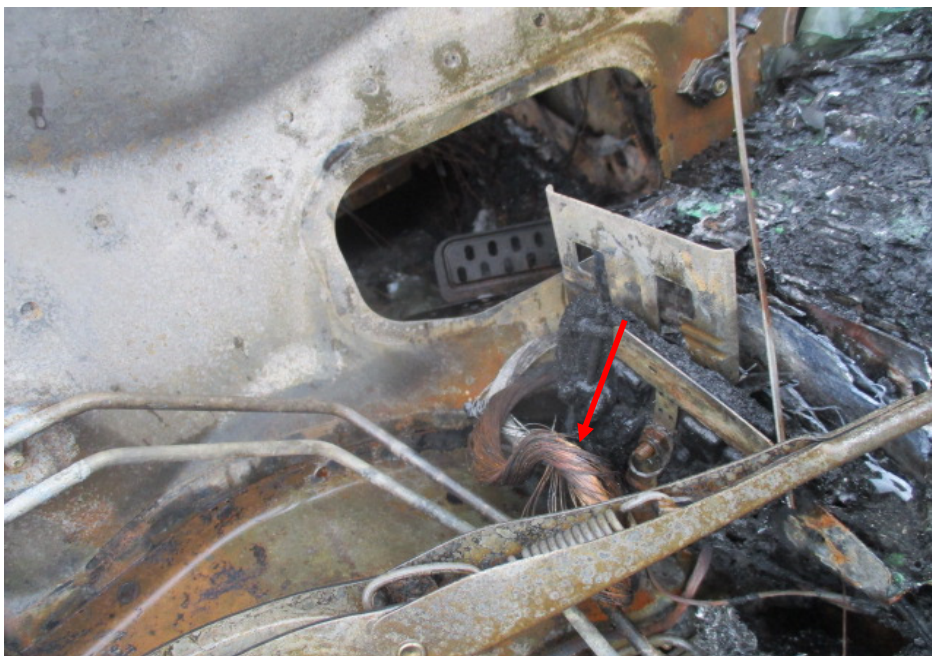
**Photo 7** shows a close up view of the faint greenish residue found on the wirings around the rear portion of the engine compartment (arrowed). The presence of greenish residue indicates internal heating of copper wires, a sign of an electrical short circuit.

21. The possibility of the fire being due to electrical in nature would then seem more likely given that engine overheating and external factors would both seem unlikely. The fire being due to electrical in nature is also supported by the condition of the wirings that were found in the engine compartment of the Insured Vehicle, which was earlier discussed in paragraph 8 above.

23. Having investigated and technically analysed the damages of burnt nature to the Insured Vehicle, we are of the view that the cause of fire to the Insured Vehicle was of electrical in nature. For this particular case, the fire had originated along the wirings inside the engine compartment, somewhere around the rear portion of the engine compartment. The wirings were original factory fitted wirings of the Insured Vehicle.

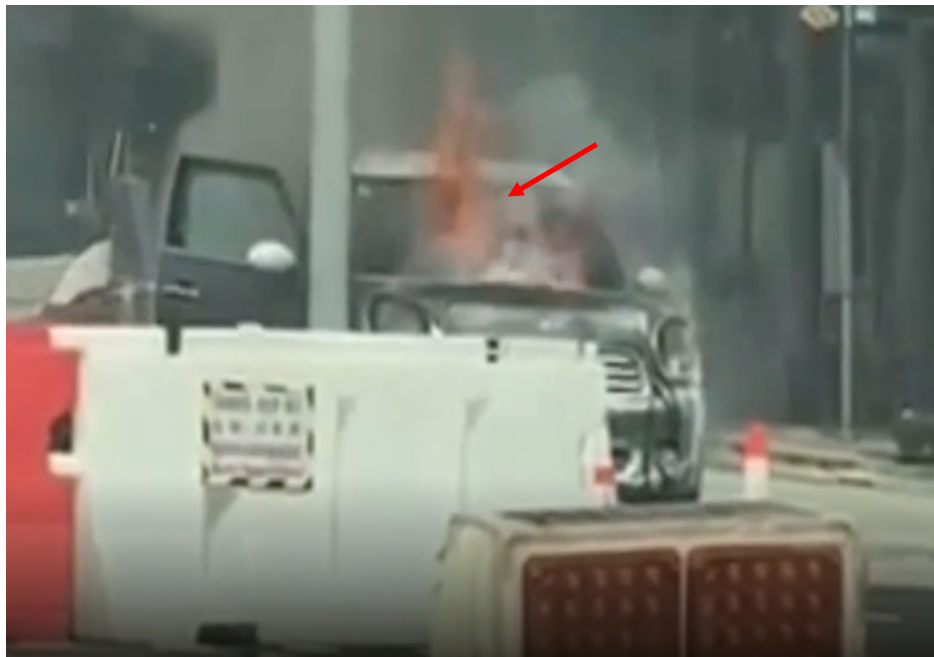
**Photo 12** shows the Insured Vehicle on fire before the arrival of the SCDF. In general, the information that could be gathered from this photograph had corresponded to the events that were related to us by Ms Akiko, which is the fire had started from the engine compartment of the Insured Vehicle (arrowed).

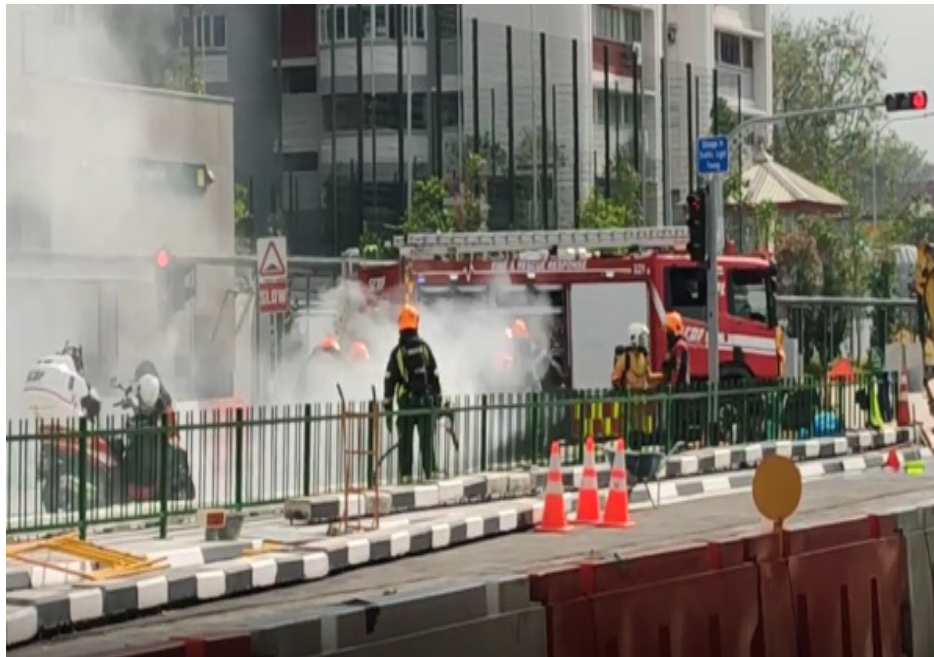
**Photo 13** shows firefighters putting out the fire to the Insured Vehicle.

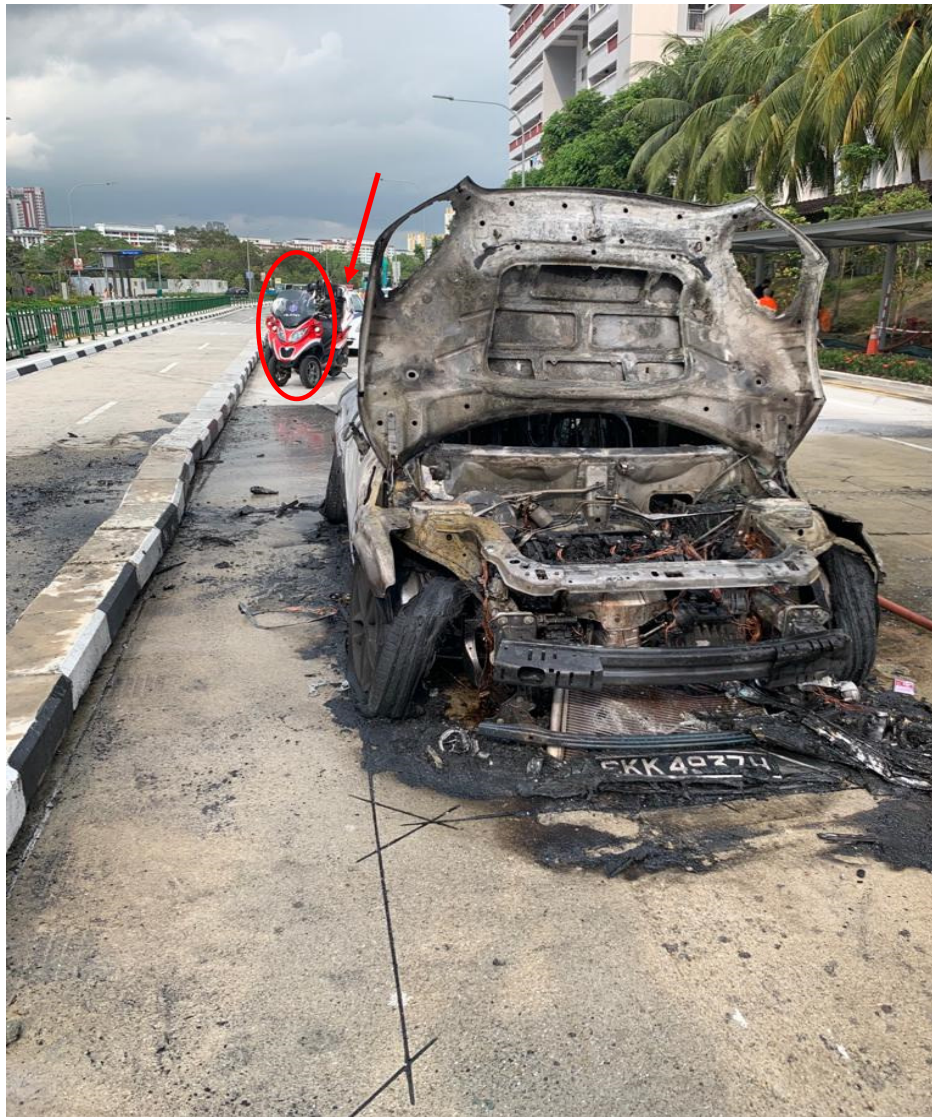
**Photo 14** shows the Insured Vehicle post- incident. In general, the information that could be gathered from this photograph had corresponded to the events that were related to us by Ms Akiko, which is the police (arrowed) and SCDF (circled) were present at the incident location.

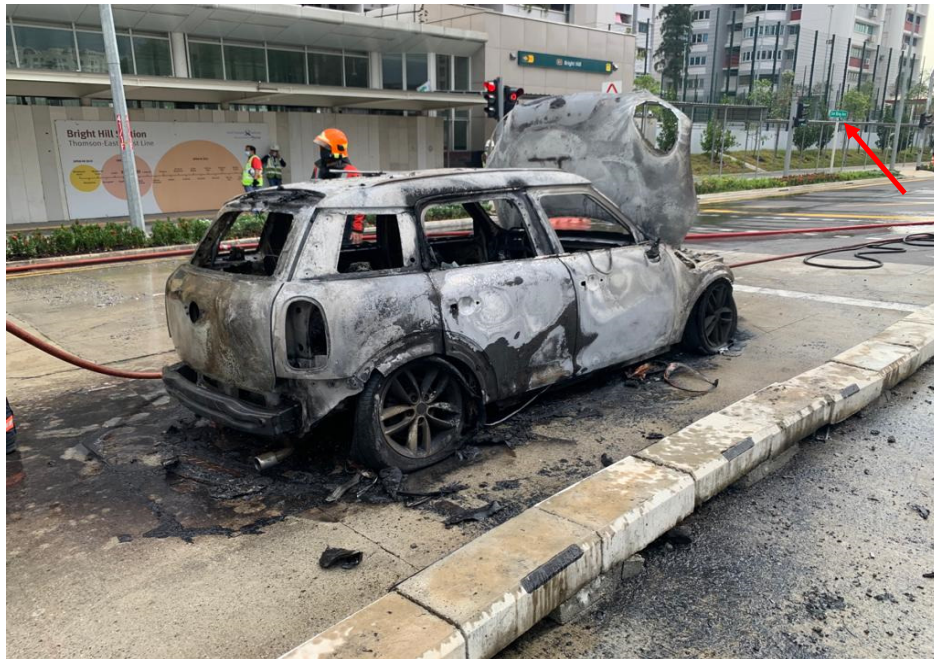
**Photo 15** shows the Insured Vehicle after the fire was put out. In general, the information that could be gathered from this photograph had corresponded to the events that were related to us by Ms Akiko, which is the incident had occurred along Sing Ming Avenue (arrowed) while she was waiting to turn right into Sin Ming Walk.

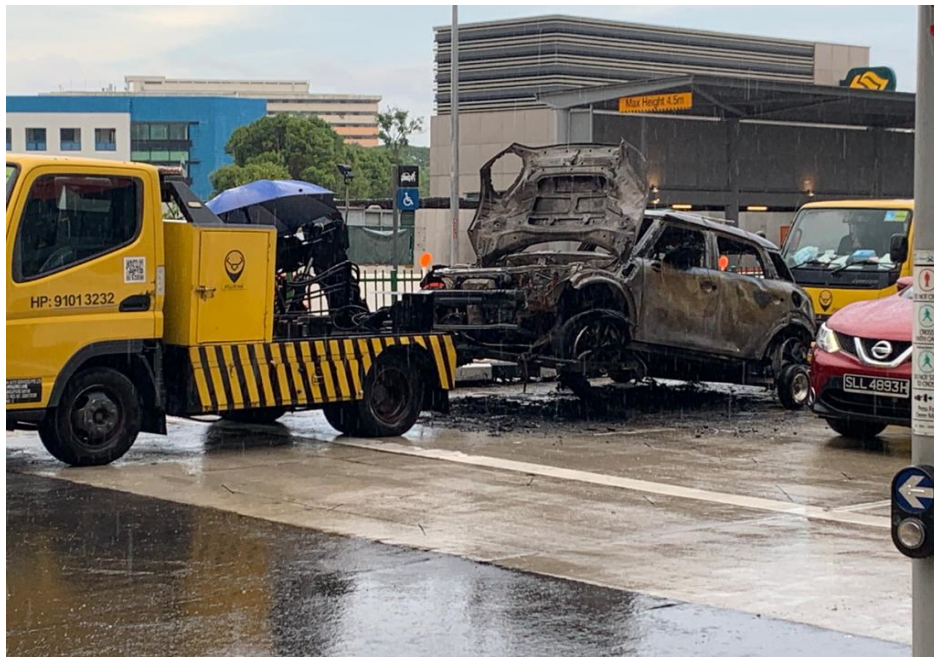
**Photo 16** shows the Insured Vehicle being prepped to be towed to BH post-incident.

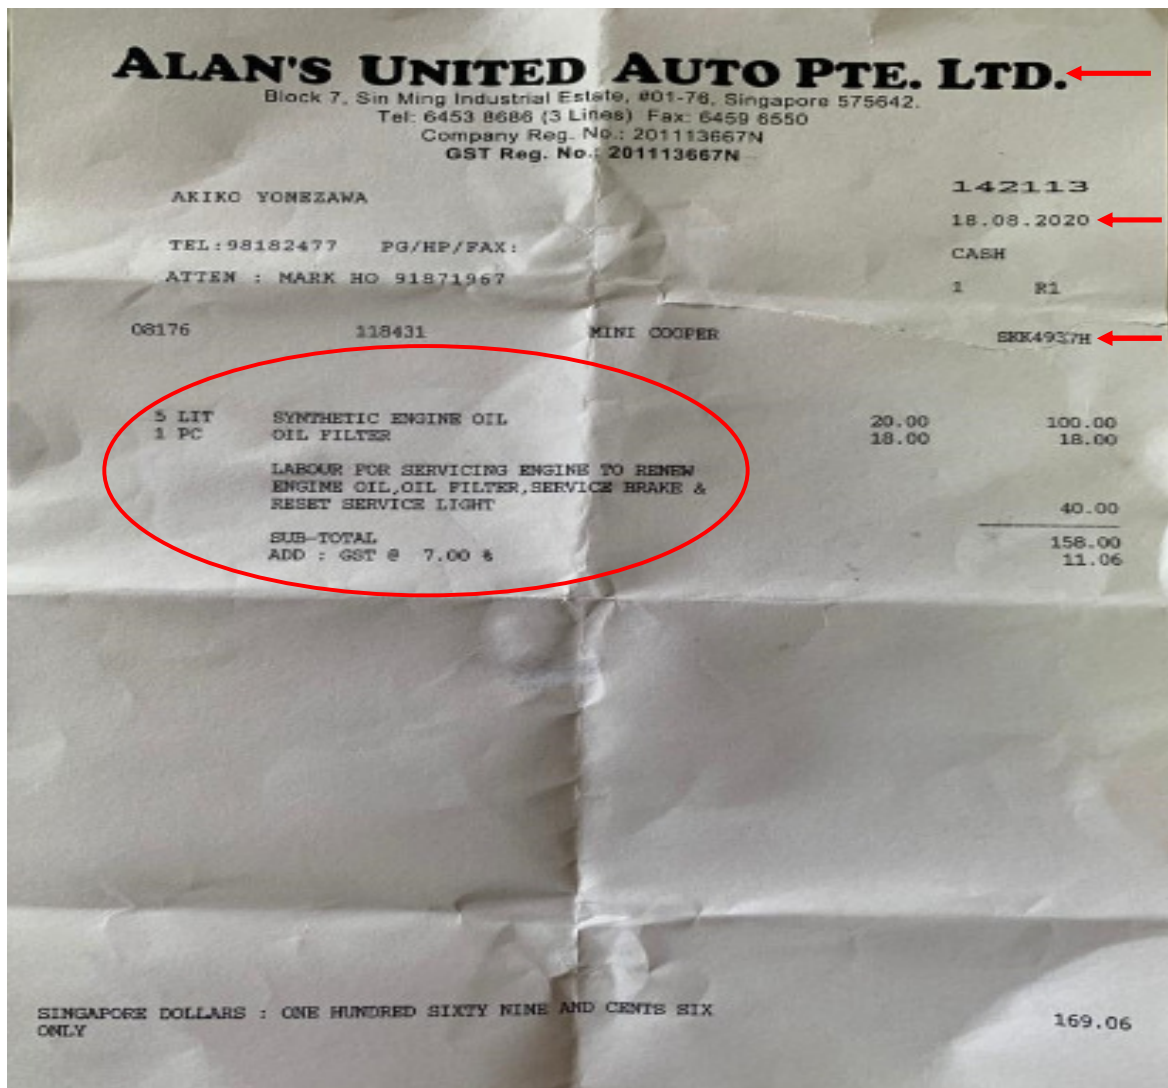
**Invoice 1** shows the last servicing package done on the Insured Vehicle on 18 August 2020 at Alan's United Auto Pte. Ltd. (arrowed) which included changing of engine oil and oil filter. The brakes were serviced and the service light was also reset (circled).

18. Based on the vehicle service record invoice provided, we are of the opinion that it is unlikely that the fire could have been caused by poor maintenance of the Insured Vehicle.
