Your Ref: SCK 8800L
Our Ref : CI/TP21003661/D

22 March 2021

AUTOMOBILE INSPECTION REPORT OF MOTOR CAR SCK 8800L

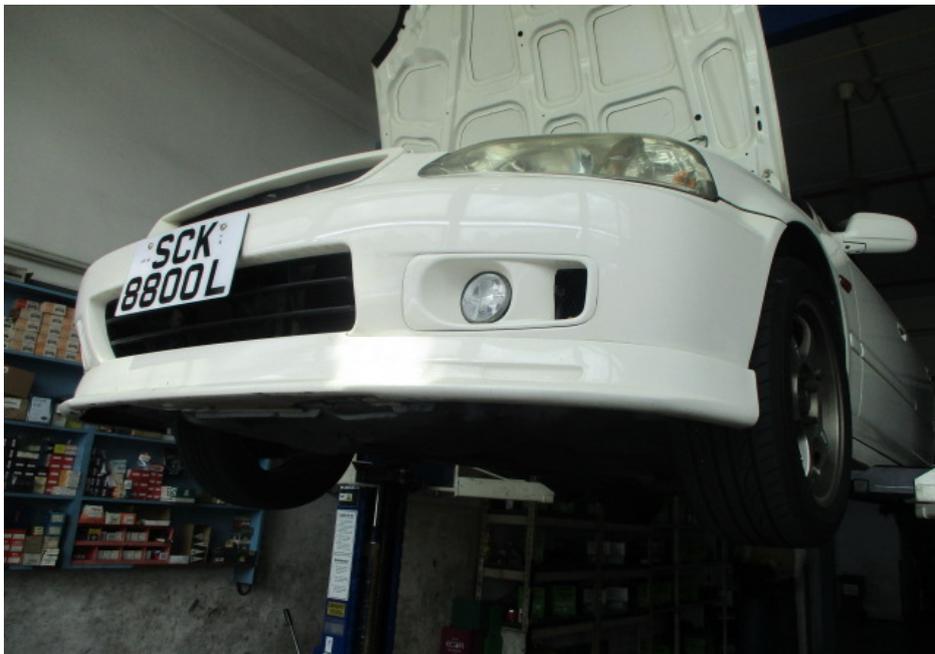
Photo 1 shows the Motor Car hoisted up at the time of my inspection. The mileage of the Motor Car recorded was 90,857km.

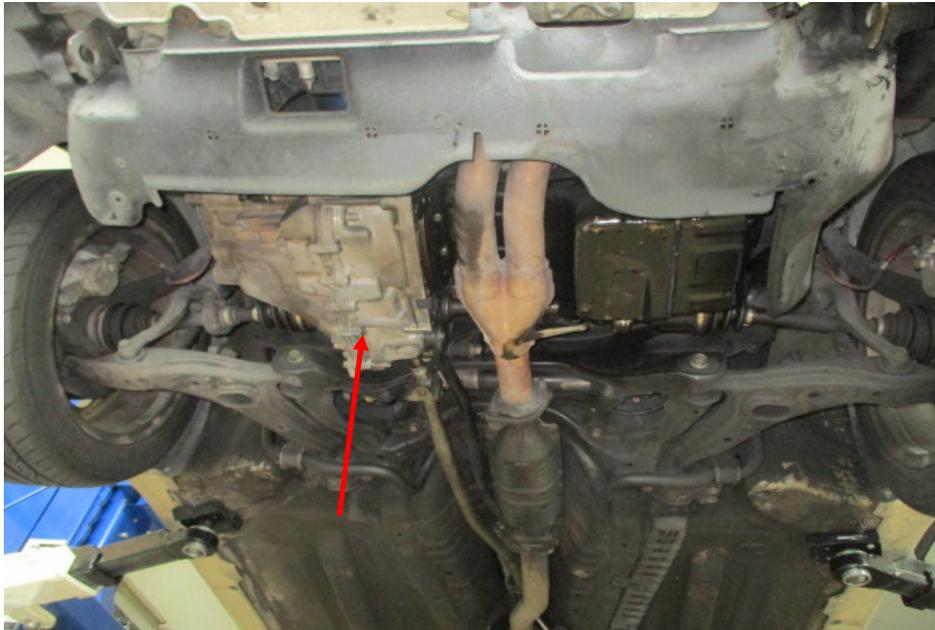
Photo 2 shows a general view of the transmission (arrowed) that was fitted on the Motor Car. The input side of the transmission is bolted to the crankshaft side of the engine block. The left and right drive shafts were observed to be securely fitted from the main shaft, located inside the transmission, to the front left wheel and front right wheel respectively. There was also no crack and/or hole observed on the transmission housing.

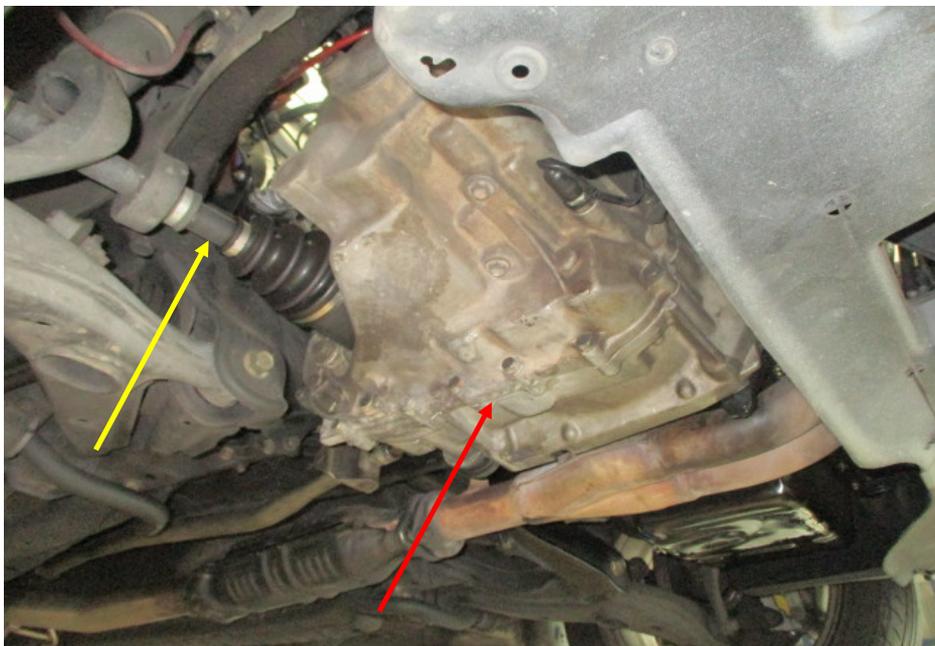
Photo 3 shows a general view of the transmission (red arrow) that was fitted on the Motor Car. There was also no crack and/or hole observed on the transmission housing. The left and right drive shafts were observed to be securely fitted from the main shaft, located inside the transmission, to the front left wheel and front right wheel respectively. The right drive shaft is highlighted by the yellow arrow.

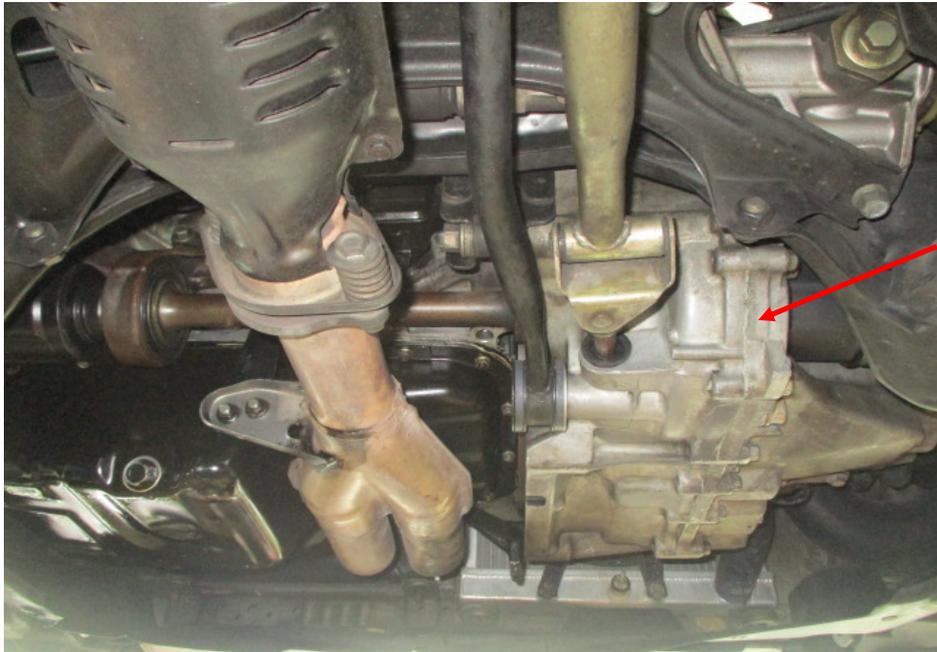
Photo 4 shows another view of the transmission (arrowed) that was fitted on the Motor Car, as viewed from the rear to front perspective of the Motor Car. There was also no crack and/or hole observed on the transmission housing.

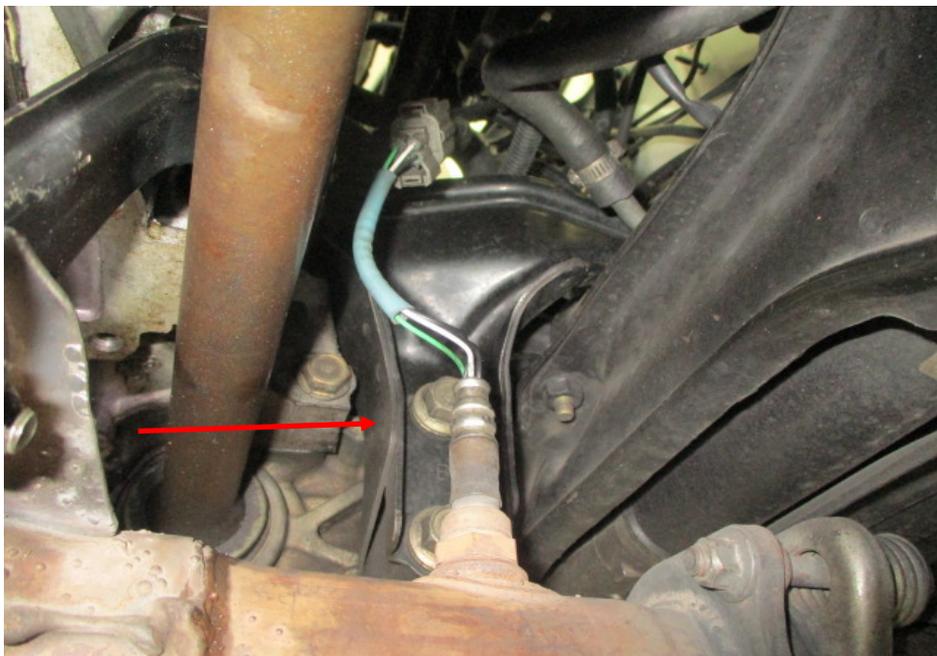
Photo 5 shows the bracket (arrowed) supporting the rear of the Motor Car's transmission. This bracket was mounted onto the engine cross member. The bracket was with rubber bushings that absorbs any vibrations arising from the rotation of the transmission gears, minimising any stress to the bracket and correspondingly also minimise any stress to the engine crossmember.

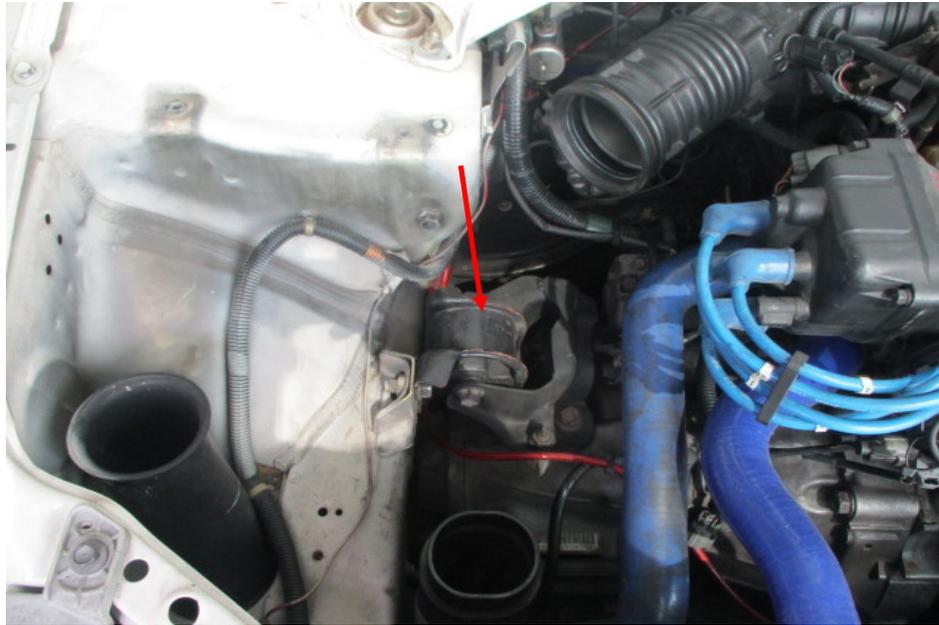
Photo 6 shows the bracket (arrowed) supporting the right side of the Motor Car's transmission. This bracket was mounted onto the right side front chassis, adjacent to the right side front wheel house. The bracket was with rubber bushings that absorbs any vibrations arising from the rotation of the transmission gears, minimising any stress to the bracket and correspondingly also minimise any stress to the right side front chassis member.

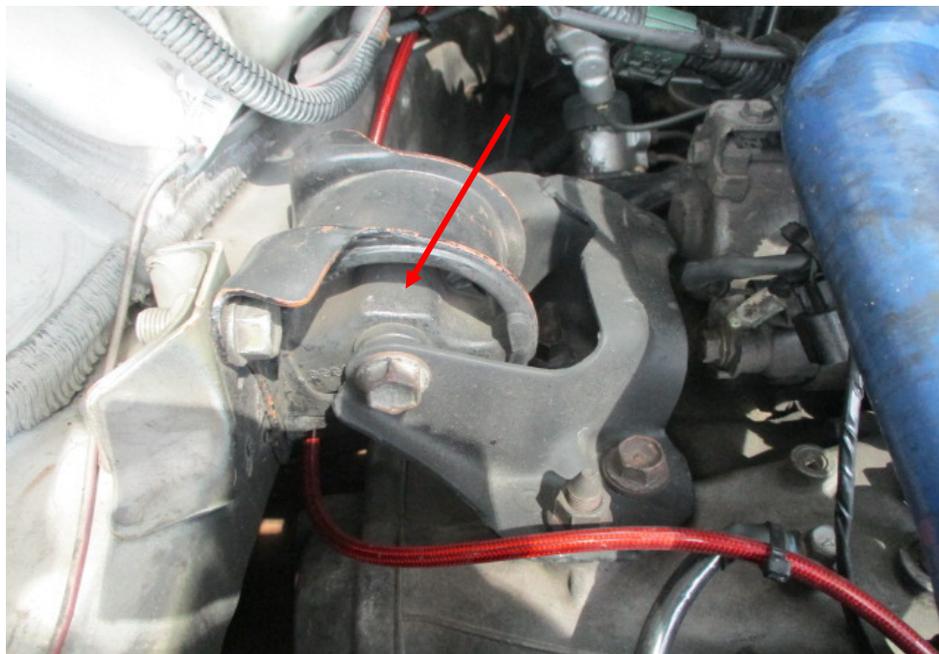
Photo 7 shows a closer view of the bracket supporting the right side of the Motor Car's transmission. This bracket was mounted onto the right side front chassis, adjacent to the right side front wheel house. The bracket was with rubber bushings (arrowed) that absorbs any vibrations arising from the rotation of the transmission gears, minimising any stress to the bracket and correspondingly also minimise any stress to the right side front chassis member.

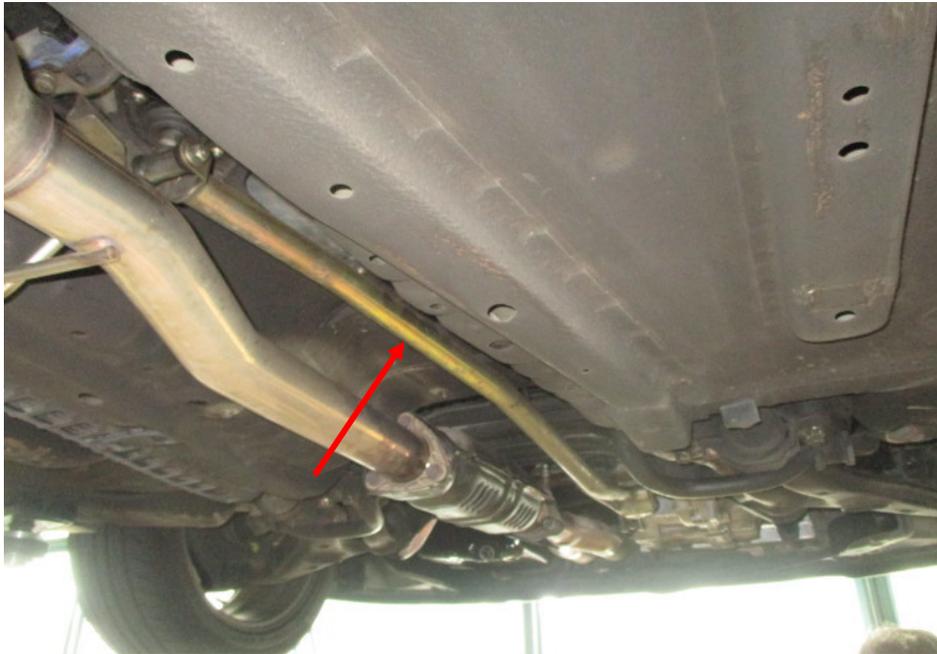
Photo 8 shows the gear selector fork (arrowed) from the transmission to the gear shifter of the Motor Car. The gear selector fork was observed to be securely fitted on the underside of the Motor Car. This gear selector fork connects to the gear shifter in the interior compartment of the Motor Car through the floorboard.

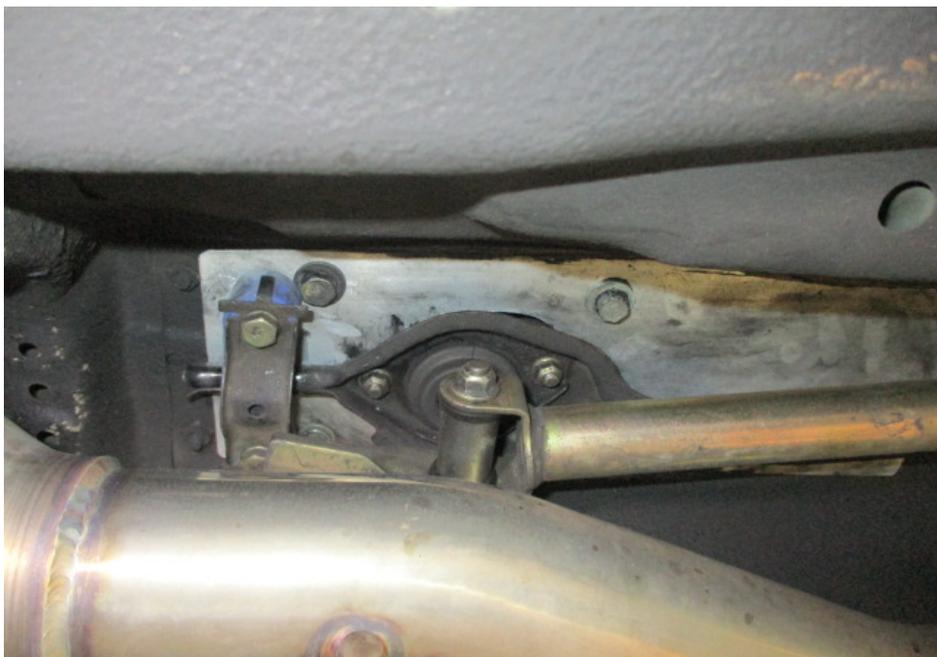
Photo 9 shows the gear selector fork, at the side where it connects to the gear shifter in the interior compartment of the Motor Car through the floorboard.

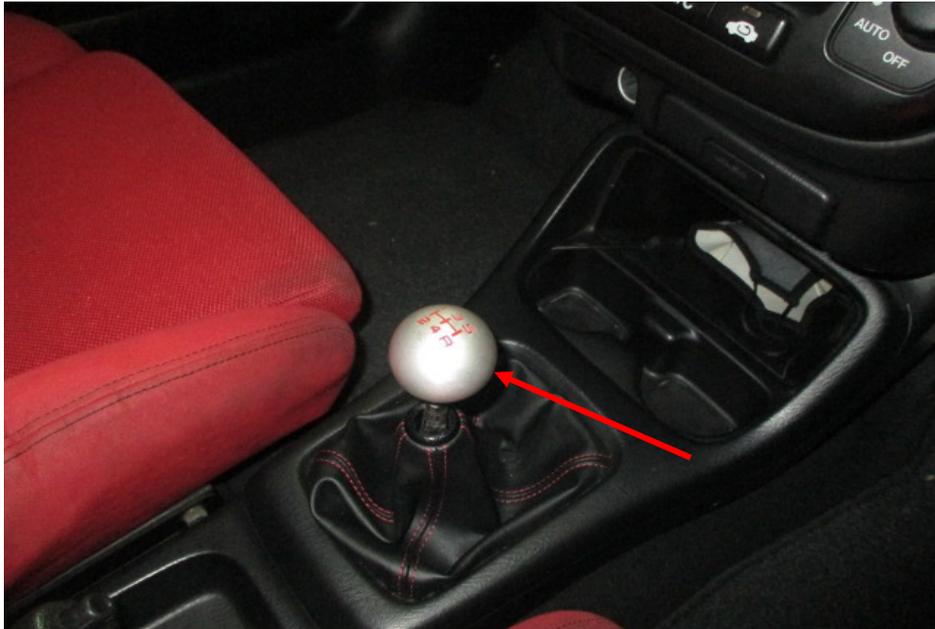
Photo 10 shows the gear shifter (arrowed) that was fitted on the Motor Car, for manually selecting the transmission gear to be engaged. The gear selector fork from the underside of the Motor Car (refer to photograph 8 & 9 above) connects to this gear shifter through the floorboard.

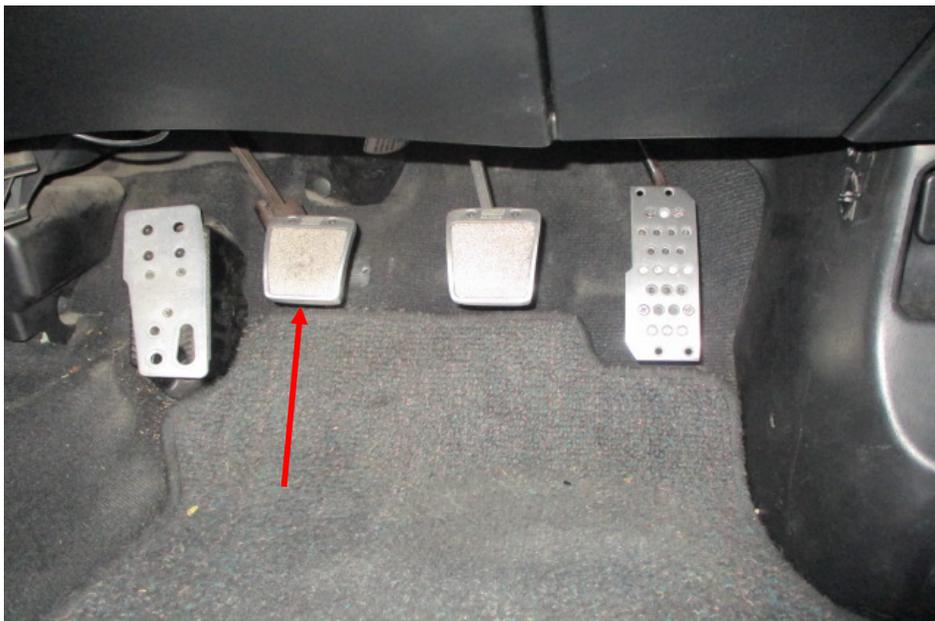
Photo 11 shows the clutch pedal (arrowed) of the Motor Car, for engaging and disengaging the transmission gears.

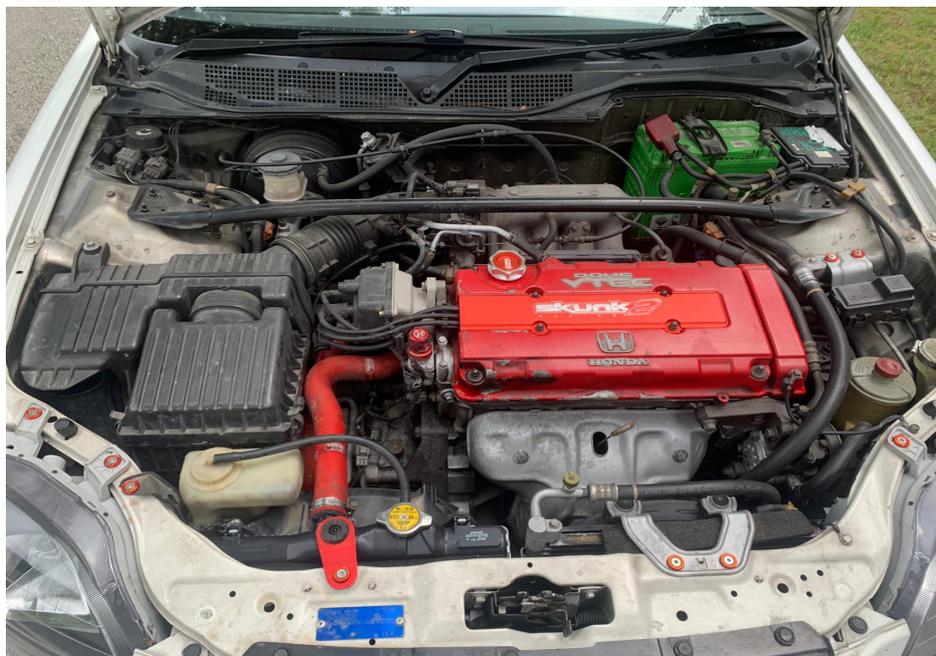
Photo 12 shows the engine bay of a similar make and model motor car that was fitted with an automatic transmission. This was for comparison of the mounting point of the right side bracket for the manual transmission that was fitted on the Motor Car.

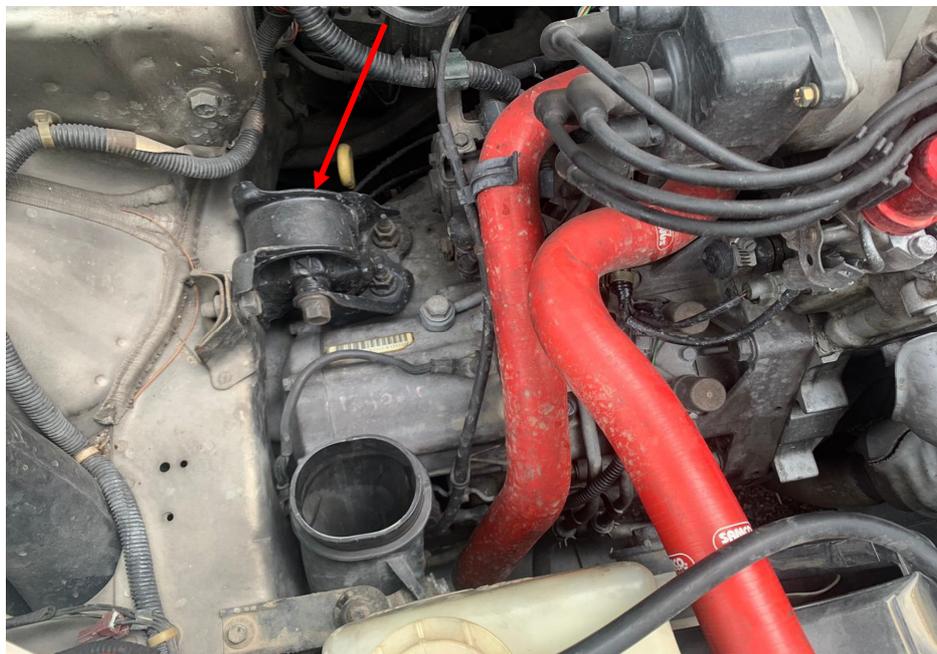
Photo 13 shows the bracket (arrowed) at the right side of the automatic transmission that was fitted on the similar make and model motor car. The mounting location was observed to be the same as the mounting location for the bracket at the right side of the manual transmission that was fitted on the Motor Car (refer to photograph 6 above).
