Your Ref: Mercedes Benz CLS 53  
(chassis number WDD2573612A032956)  
Our Ref : CI/TP21003664/D

**INSPECTION REPORT OF AN UNREGISTERD MERCEDES BENZ CLS 53  
MOTOR CAR WITH CHASSIS NUMBER WDD2573612A032956**

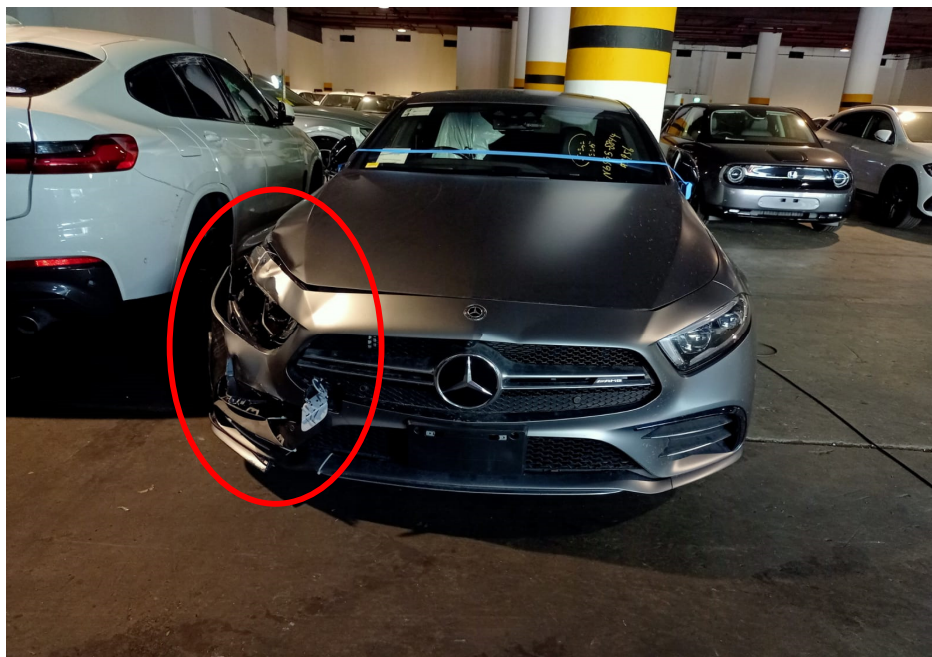
**Photo 1** shows the frontal body of the Motor Car (photograph provided to me). The Motor Car was observed to have sustained damage at its front right portion (circled). The front bumper, front right headlamp and front bonnet were amongst the parts that were observed to have been damaged.

22. The body parts at the front right portion of the Motor Car were visually examined and it was noted that the repair/restoration works carried out to the damaged area of the Motor Car (refer to photograph 1 & 2 above) were reasonably adequate and in order.

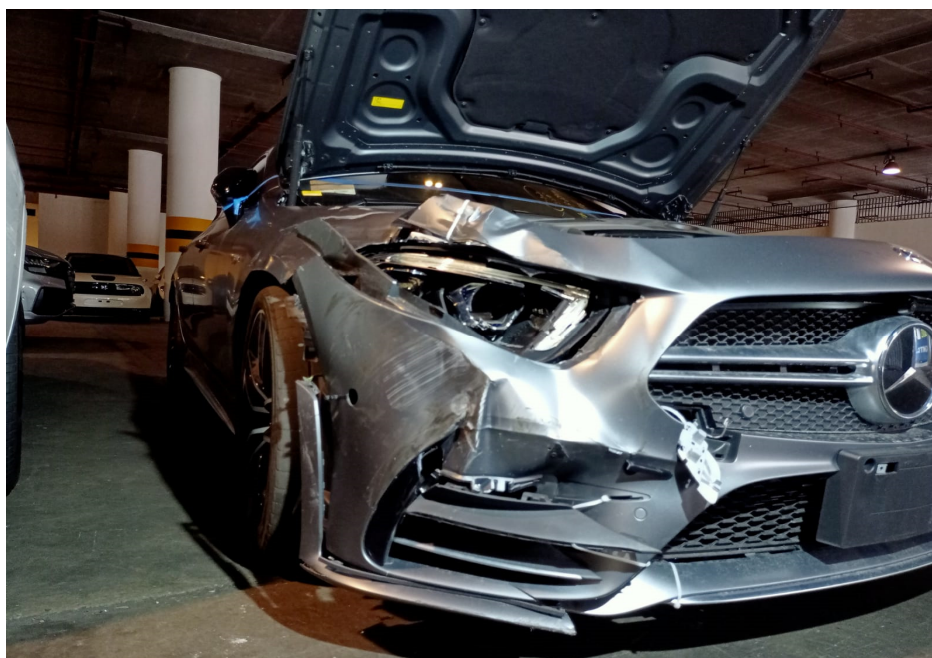
**Photo 2** shows a closer view of the damage at the front right portion of the Motor Car (photograph provided to me). The front bumper, front bumper right lower grille, front bumper right lower grille garnish, front bumper right lower lip, radiator grille, front right headlamp and front right fender were amongst the parts that were observed to have been damaged.

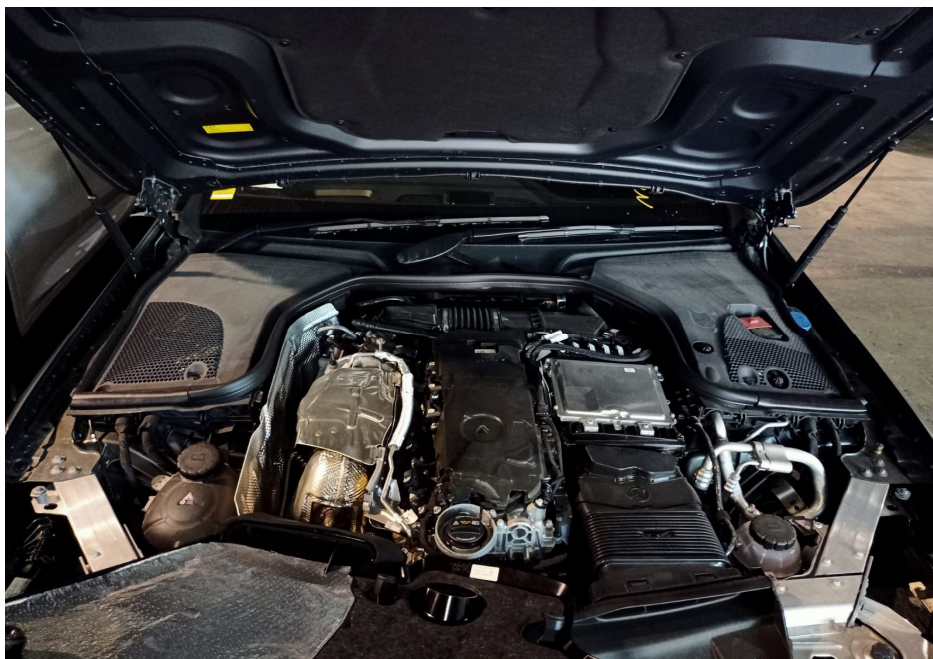
**Photo 3** shows the engine compartment of the Motor Car (photograph provided to me). Parts within the engine compartment were unaffected as seen from the photograph.

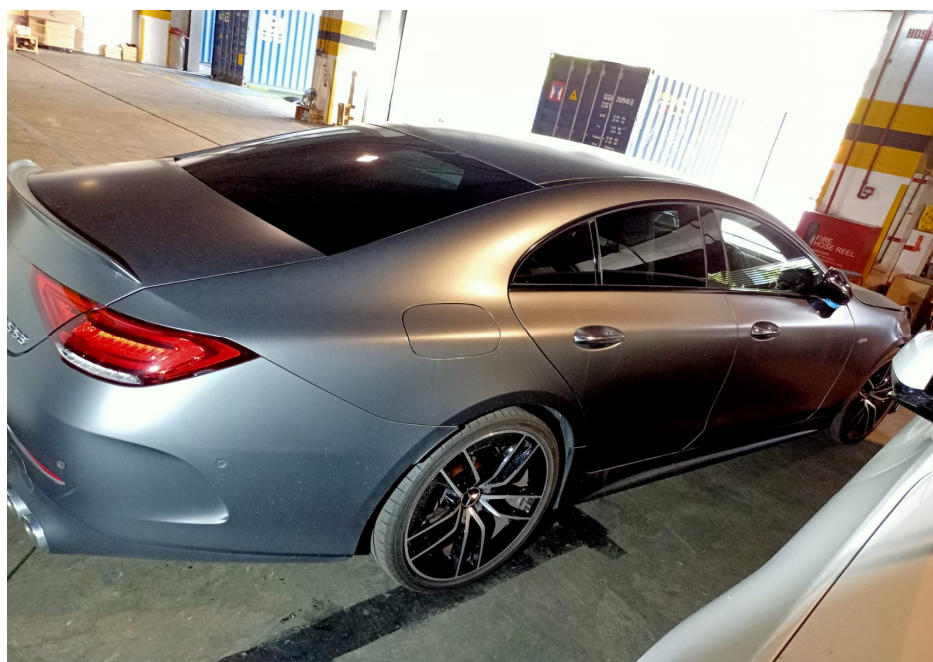
**Photo 4** shows the rear right body of the Motor Car (photograph provided to me). Apart for the front right portion, there was no physical damage seen to other areas of the Motor Car.

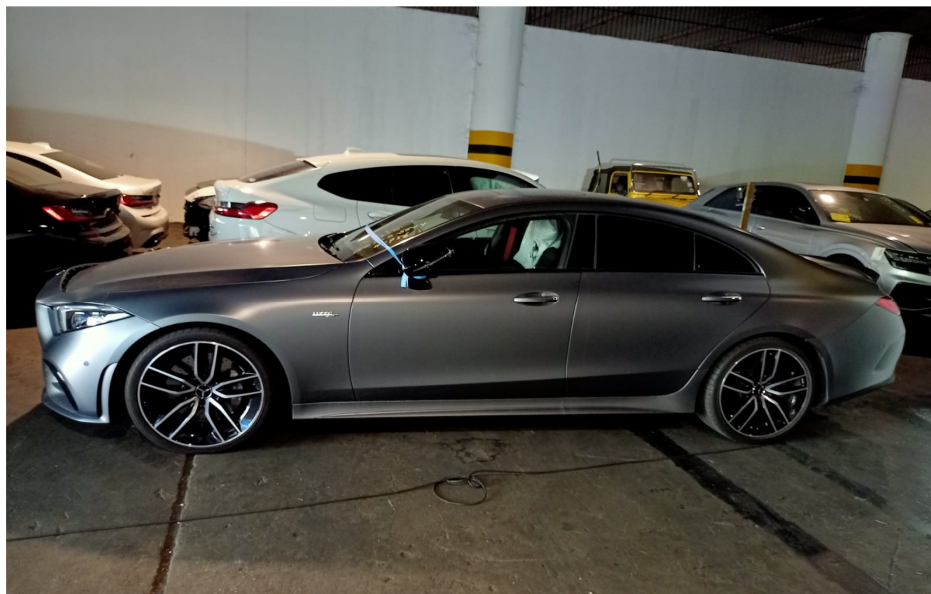
**Photo 5** shows the left body of the Motor Car (photograph provided to me). Apart for the front right portion, there was no physical damage seen to other areas of the Motor Car.

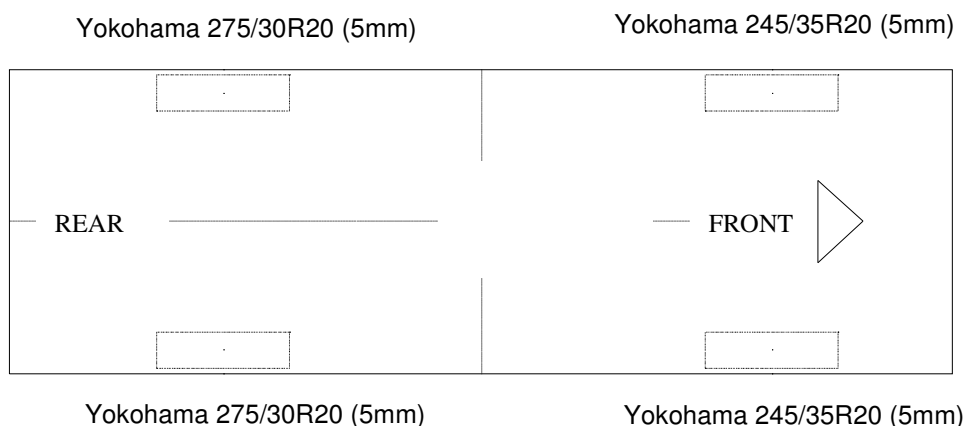
8. It was fitted with 20inch sport wheel rims that were wrapped with tyres that were observed to be of serviceable condition. The tyres were also sufficiently inflated for vehicular operation. The tyre brand, tyre size and approximate remaining tread depth of the 4 tyres of the Motor Car were recorded as follows: -

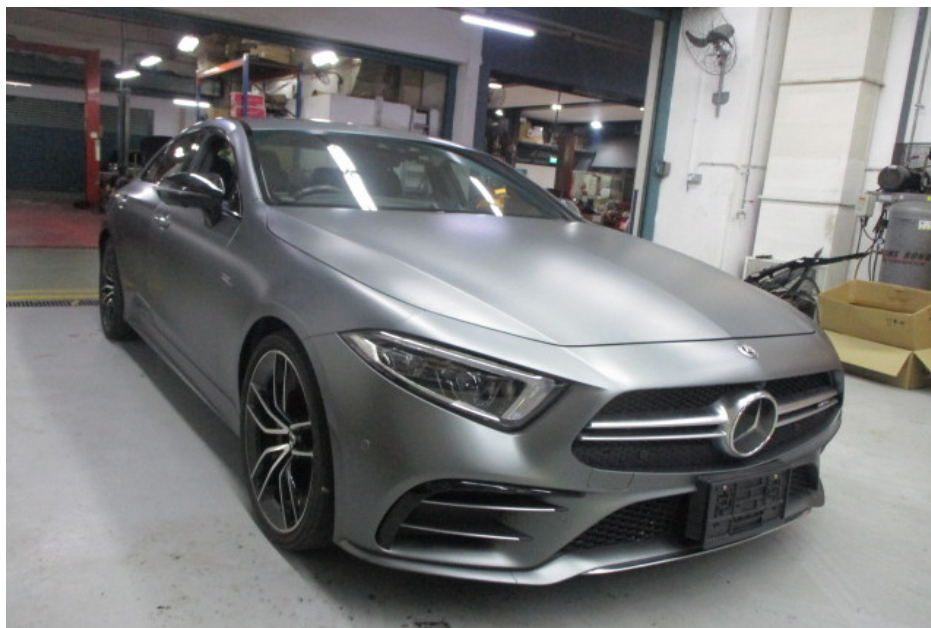
**Photo 6** shows a general view of the front right body of the Motor Car at the time of my inspection. The Motor Car was observed to be in a relatively good general condition with no loose exterior fittings observed. The body parts at the front right portion of the Motor Car were visually examined and it was observed that the repair/restoration works carried out to the damaged area of the Motor Car (refer to photograph 1 & 2 above) were reasonably adequate and in order.

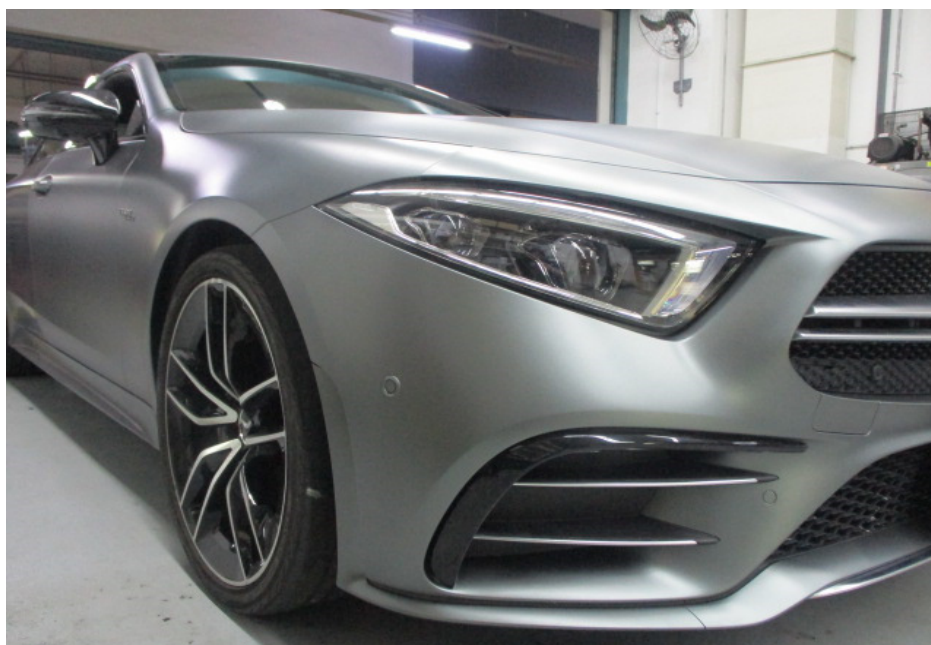
**Photo 7** shows a closer view of the front bumper, front bumper right lower grille, front bumper right lower grille garnish, front bumper right lower lip and front right fender of the Motor Car at the time of my inspection. The body parts at the front right portion of the Motor Car were visually examined and it was observed that the repair/restoration works carried out to the damaged area of the Motor Car (refer to photograph 1 & 2 above) were reasonably adequate and in order.

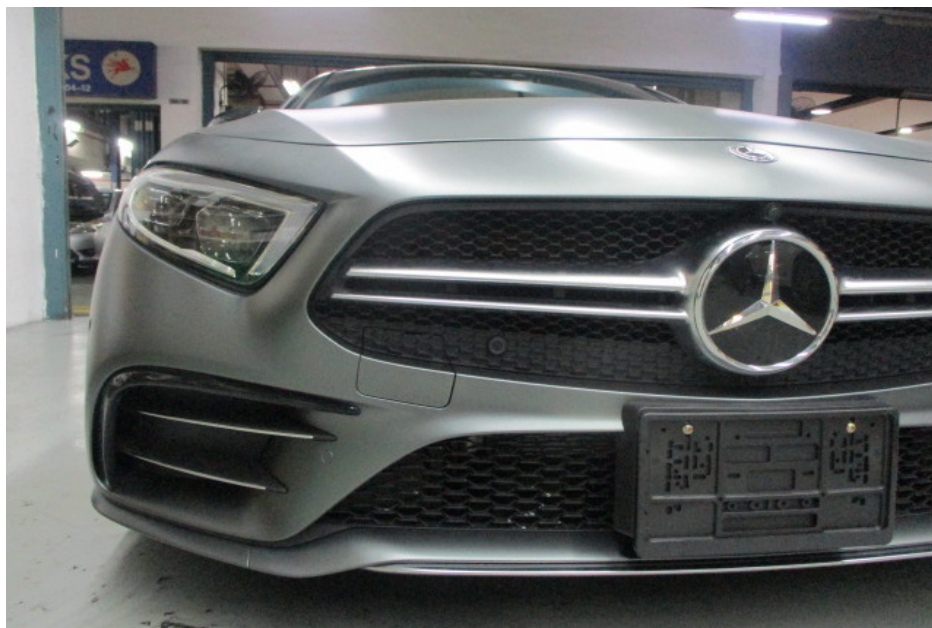
**Photo 8** shows a closer view of the front bumper, front bonnet, radiator grille and front left headlamp of the Motor Car at the time of my inspection. The body parts at the front right portion of the Motor Car were visually examined and it was observed that the repair/restoration works carried out to the damaged area of the Motor Car (refer to photograph 1 & 2 above) were reasonably adequate and in order.

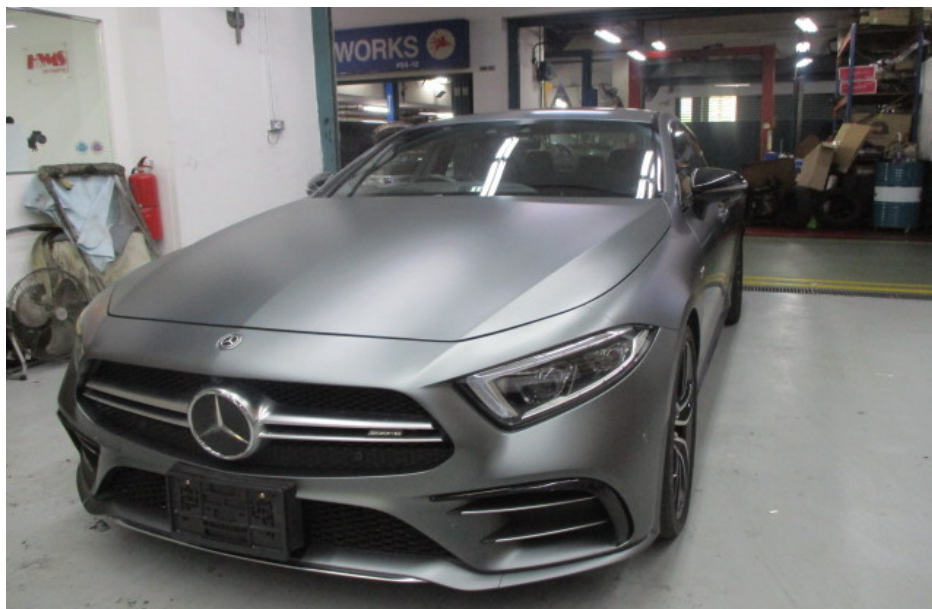
**Photo 9** shows a general view of the front left body of the Motor Car at the time of my inspection. The Motor Car was observed to be in a relatively good general condition with no loose exterior fittings observed. The body parts at the front right portion of the Motor Car were visually examined and it was observed that the repair/restoration works carried out to the damaged area of the Motor Car (refer to photograph 1 & 2 above) were reasonably adequate and in order.

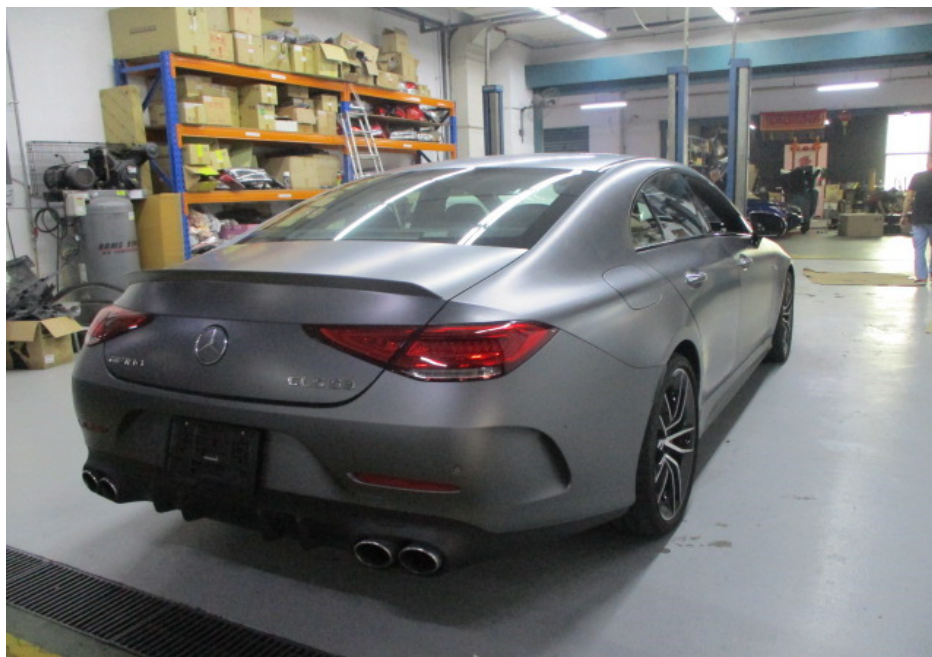
**Photo 10** shows a general view of the rear right body of the Motor Car at the time of my inspection. The Motor Car was observed to be in a relatively good general condition with no loose exterior fittings observed. The mileage of the Motor Car recorded at the time of my inspection was 21,593km.

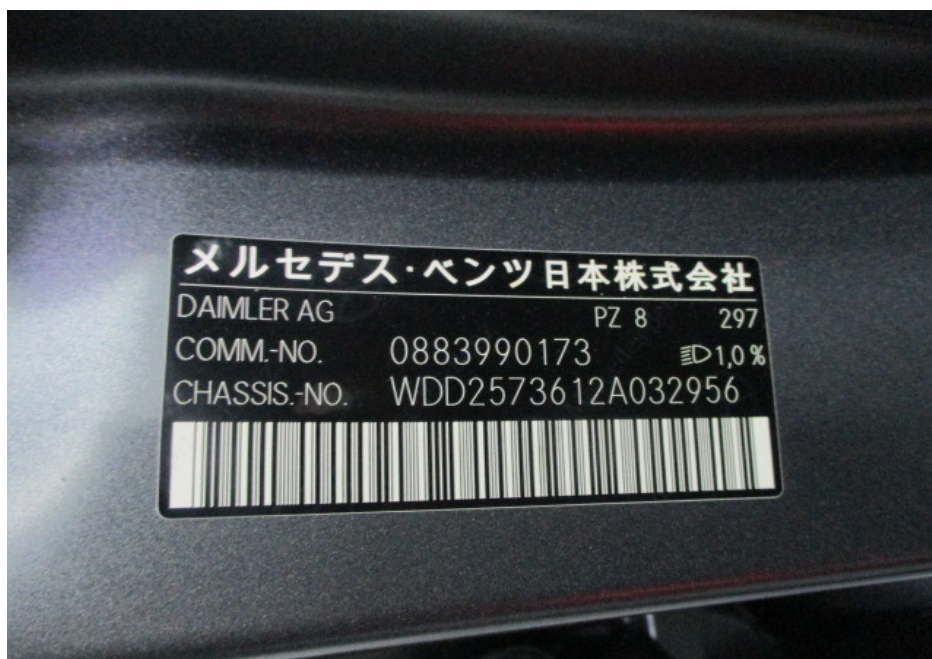
**Photo 11** shows the chassis number of the Motor Car. The chassis number recorded was WDD2573612A032956.

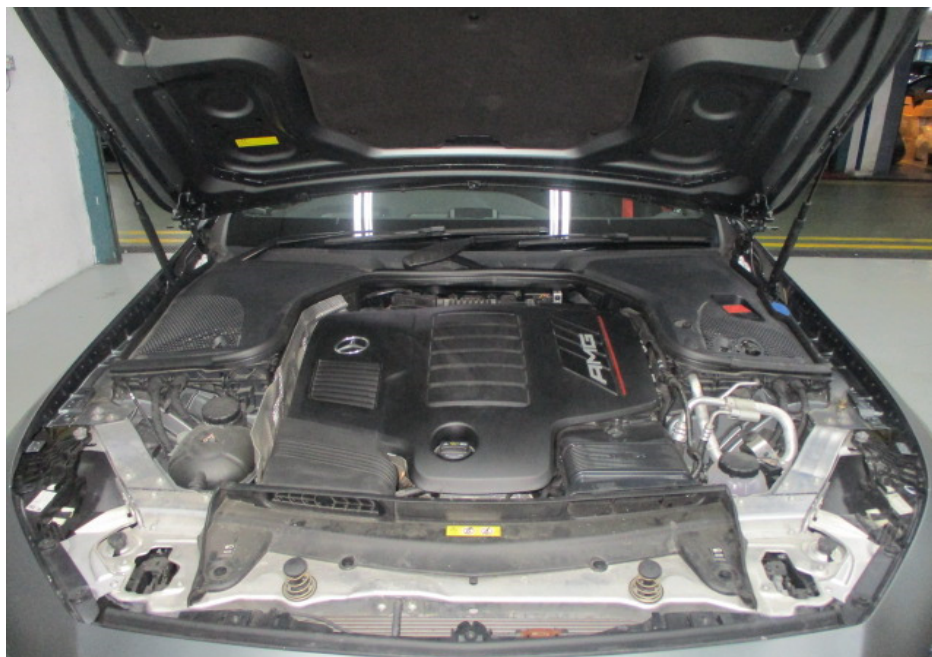
14. My examination of the engine compartment of the Motor Car revealed that the various parts and components inside the engine compartment were all intact and properly fitted. The engine oil, brake fluid and engine coolant were all found to be of sufficient level for operating purposes. Visually, there was also no contamination found to these fluids.
15. My checks on the underside of the Motor Car revealed no sign(s) or indication(s) of fluid leakage and/or fluid stain(s). The engine block and automatic transmission assembly were both secured properly. All undercarriage components of the Motor Car were also observed to be intact and secured in an appropriate manner.

**Photo 12** shows a general view of the engine compartment of the Motor Car at the time of my inspection. The various parts and components inside the engine compartment were all observed to be intact and properly fitted. There was also no sign(s) or indication(s) of fluid leak and/or fluid stain found inside the engine compartment.

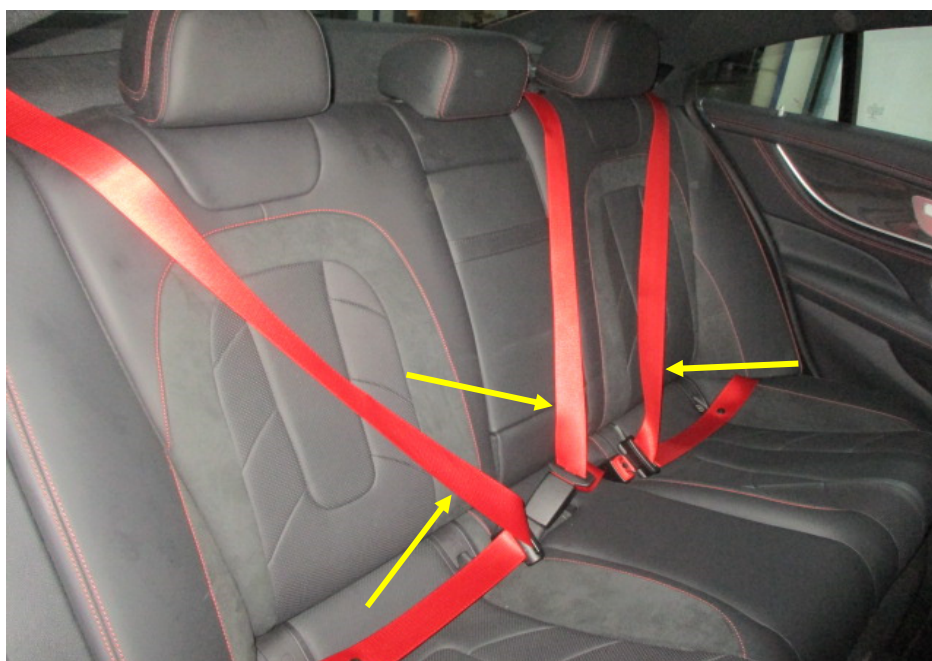
12. The seats of the Motor Car were found to be secured to the floorboard of the Motor Car via seat rails bolted onto the floorboard. Retractable seat belt reels and pre-tensioners were fitted on all seats of the Motor Car. The seat belts were tested and were able to be fastened securely into the respective pre-tensioners that were fixed to the side of all the seats.

**Photo 13** shows the rear seats of the Motor Car. All the seats of the Motor Car were secured via seat rails to the floorboard. They were also fitted with a retractable seat belt reel and a pre-tensioner. The seat belts (arrowed) were tested and were able to be fastened into the respective pre-tensions that were fitted on the side of each individual seat.

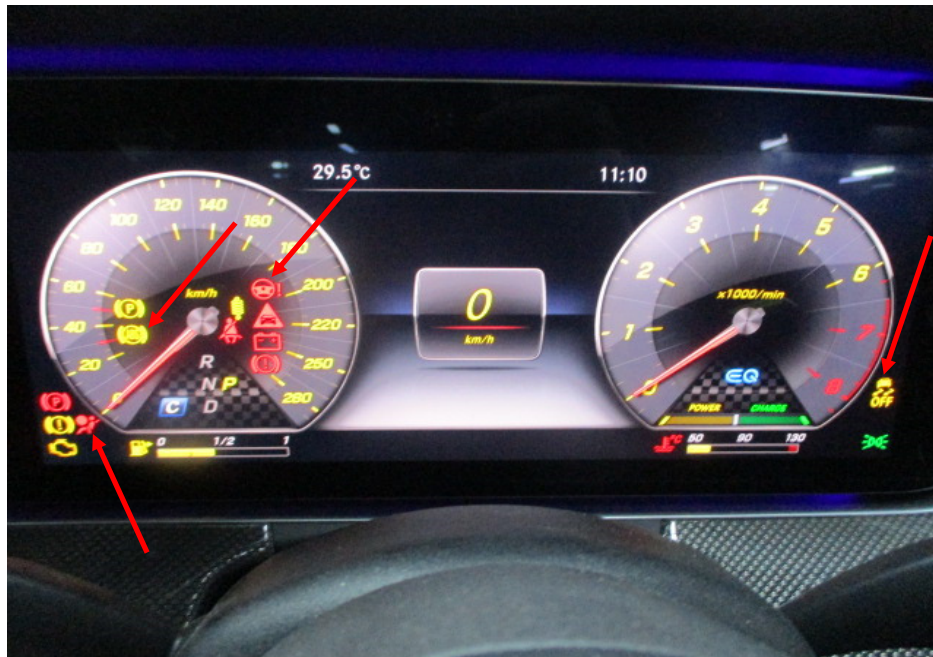
**Photo 14** shows the warning lights for the various electronic safety features appearing on the instrument panel of the Motor Car during its self-test when the engine is cranked, in particular the ABS, SRS, EPS and TCS lights (arrowed).

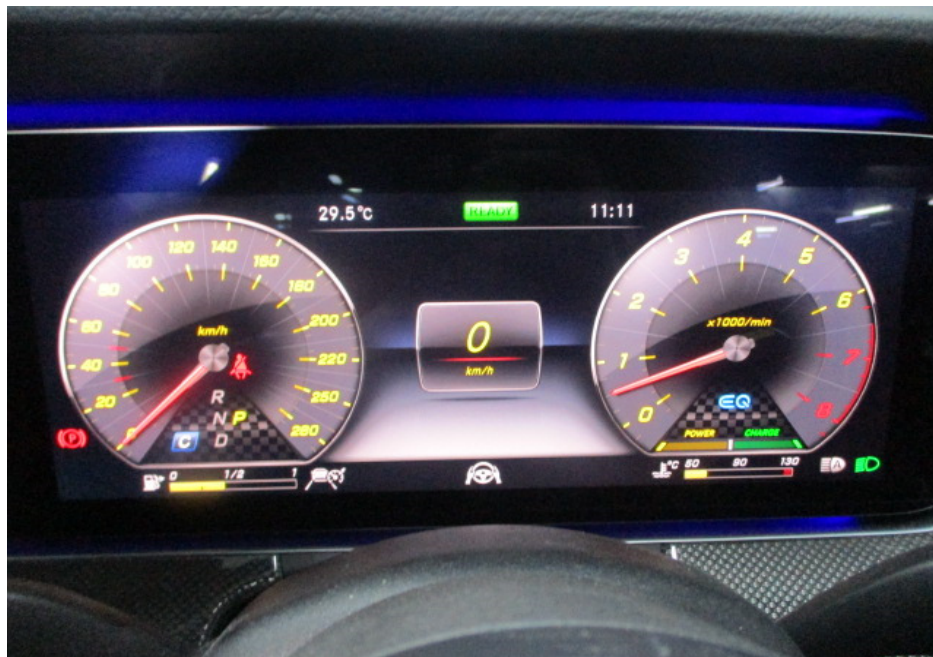
13. The Motor Car's automatic self-test of the functionality of its various electronic safety features like the Anti-Lock Brake System (ABS), Supplemental Restraint System (SRS), Electric Power Steering (EPS), Tyre Pressure Monitor (TPM) and Traction Control System (TCS) during cranking of the engine had indicated that these electronic systems were in working condition. This was determined from the respective warning lights disappearing from the instrument panel after the self-test.

**Photo 15** shows the respective warning lights no longer illuminated, indicating that there is no fault detected to the ABS, SRS, EPS and TCS systems of the Motor Car during the self-test. These electronic systems were hence in working condition at the time of my inspection.

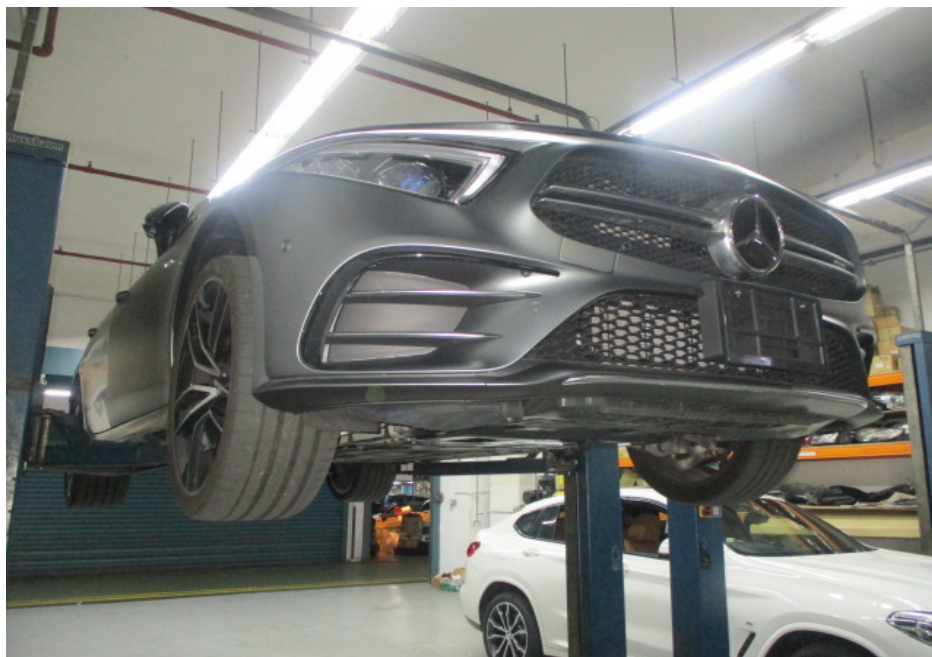
**Photo 16** shows the Motor Car hoisted up for checks on its undercarriage. There was no sign(s) or indication(s) of fluid leakage and/or fluid stain(s) on the underside of the Motor Car. The undercarriage components of the Motor Car were also all observed to be intact and secured in an appropriate manner.

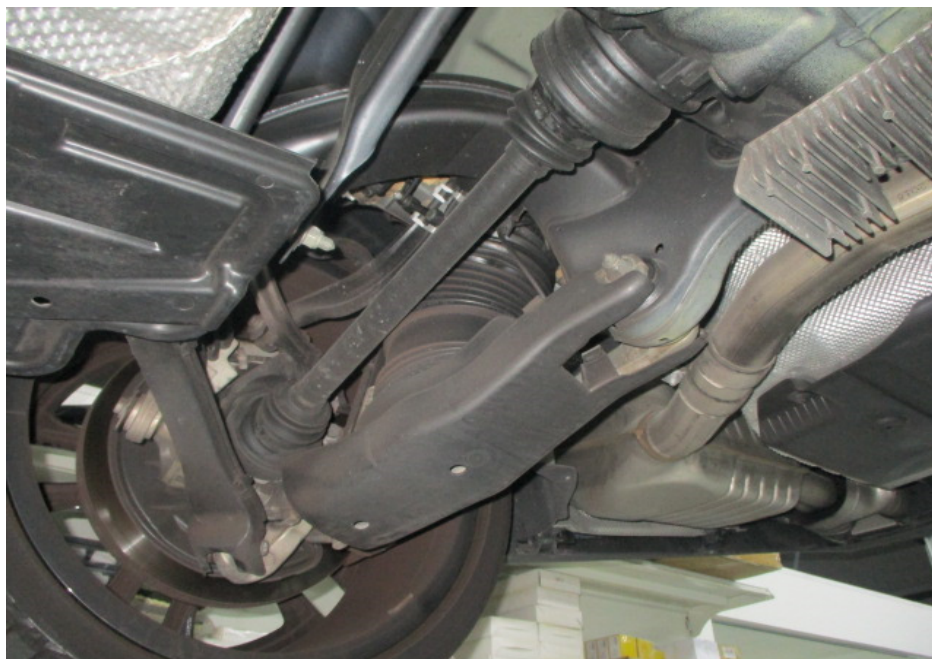
**Photo 17** shows a general view of the control arms and linkages at the rear right wheel of the Motor Car. I did not observe any fluid leak and/or fluid stain on the underside of the Motor Car. All of the Motor Car's undercarriage components were observed to be intact and secured in an appropriate manner.

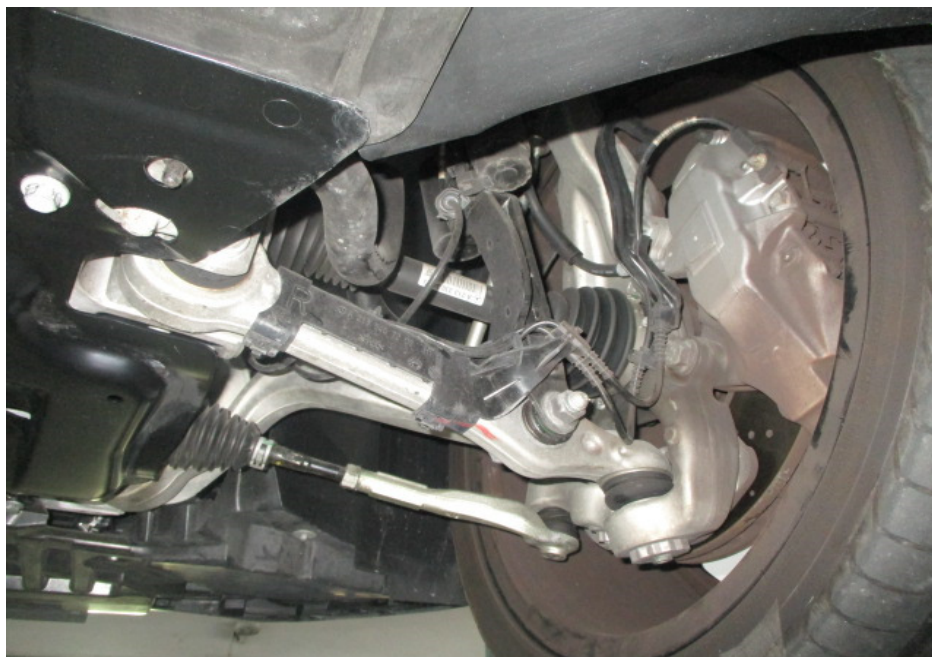
**Photo 18** shows the various undercarriage components at the front right wheel of the Motor Car. The mechanical components, control arms and linkages were all found to be intact and secured in an appropriate manner.

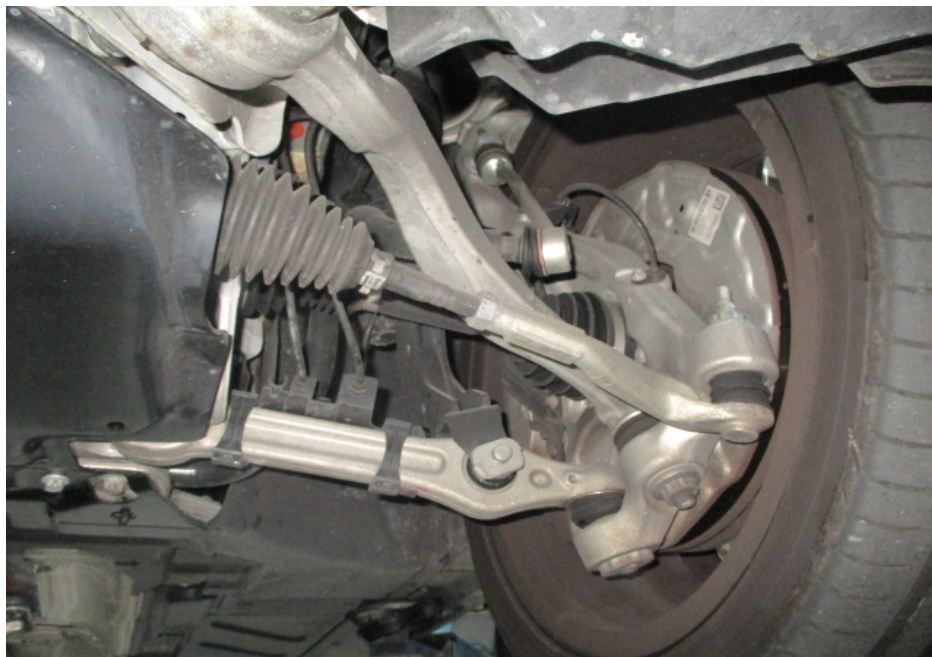
**Photo 19** shows the various undercarriage components at the front left wheel of the Motor Car. The mechanical components, control arms and linkages were all found to be intact and secured in an appropriate manner. I also did not observe any fluid leak and/or fluid stain on the underside of the Motor Car.

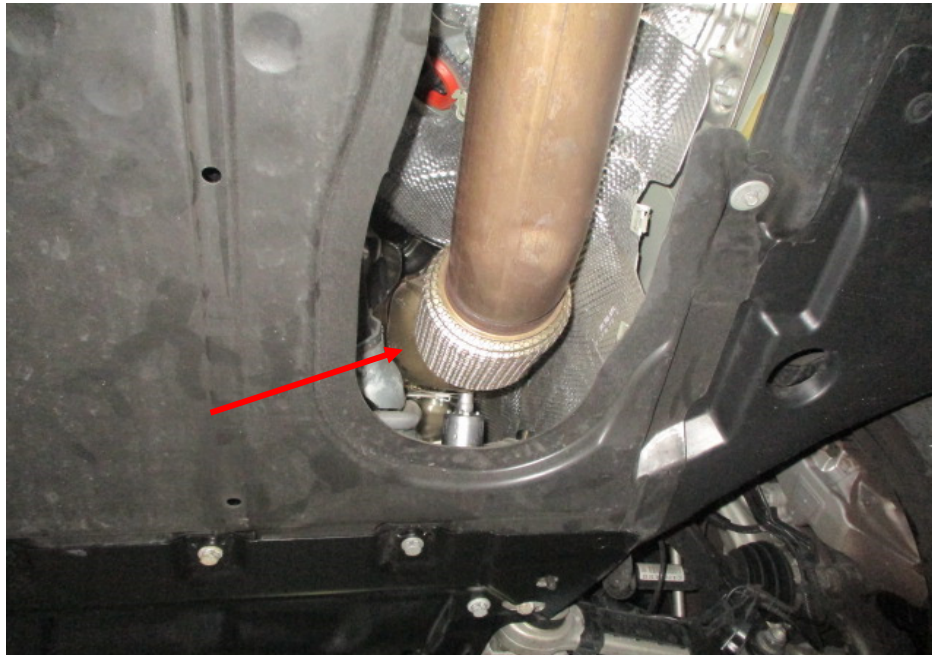
**Photo 20** shows the Motor Car's catalytic converter (arrowed). My examination of the Motor Car's exhaust system revealed no sign(s) or indication(s) of any cut or weld marks along its exhaust pipes and on its rear mufflers.

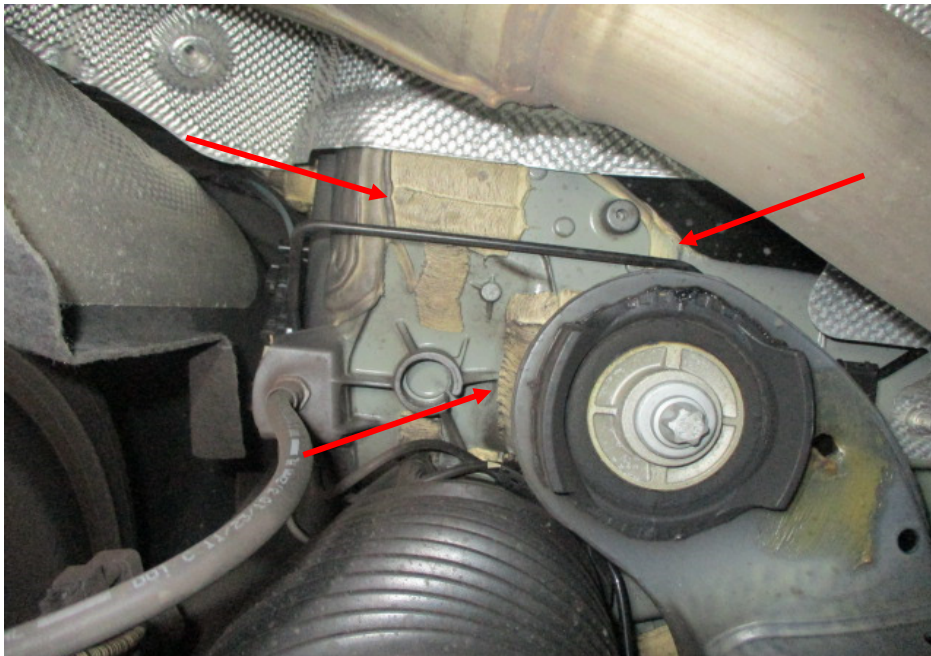
11. Visually, I did not find any weld marks, other than the original spot weld marks, on the chassis/structural body of the Motor Car. The original factory sealant at the joints along the chassis/structural body was also untouched, again indicating that no replacement of the chassis/structural body was carried out; and that the chassis/structural body was originally fitted.

**Photo 21** shows the chassis/structural body at the underside rear left of the Motor Car. I did not find any weld marks other than original spot weld marks on the chassis/structural body of the Motor Car. The original factory sealant (arrowed) at the joints along the chassis/structural body was also untouched, indicating no work was done on the chassis/structural body of the Motor Car and that the chassis/structural body was originally fitted.

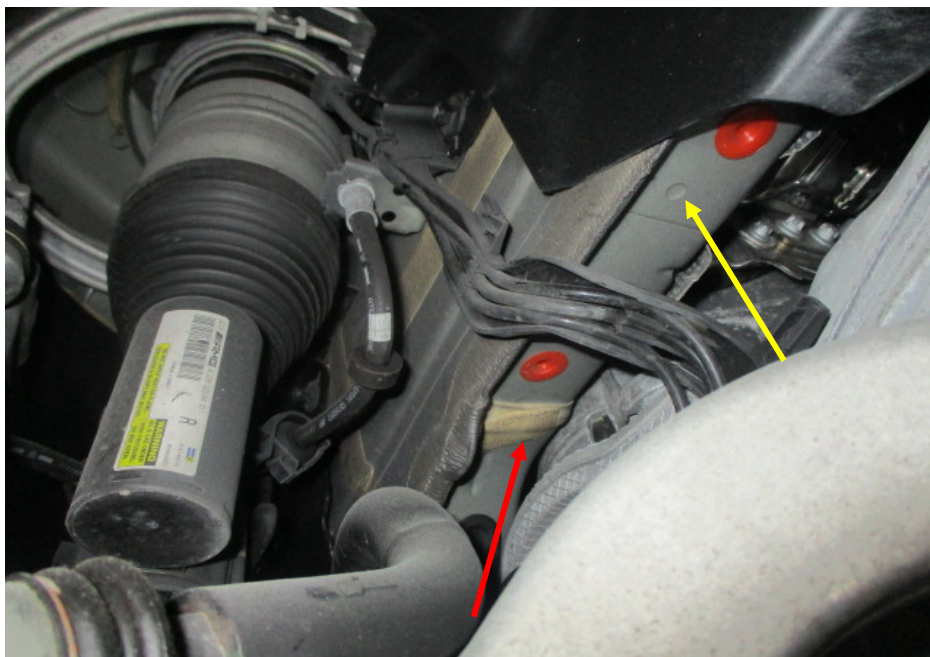
**Photo 22** shows the chassis/structural body at the underside front right of the Motor Car. I did not find any weld marks other than original spot weld marks (yellow arrow) on the chassis/structural body of the Motor Car. The original factory sealant (red arrow) at the joints along the chassis/structural body was also untouched, indicating no work was done on the chassis/structural body of the Motor Car and that the chassis/structural body was originally fitted.

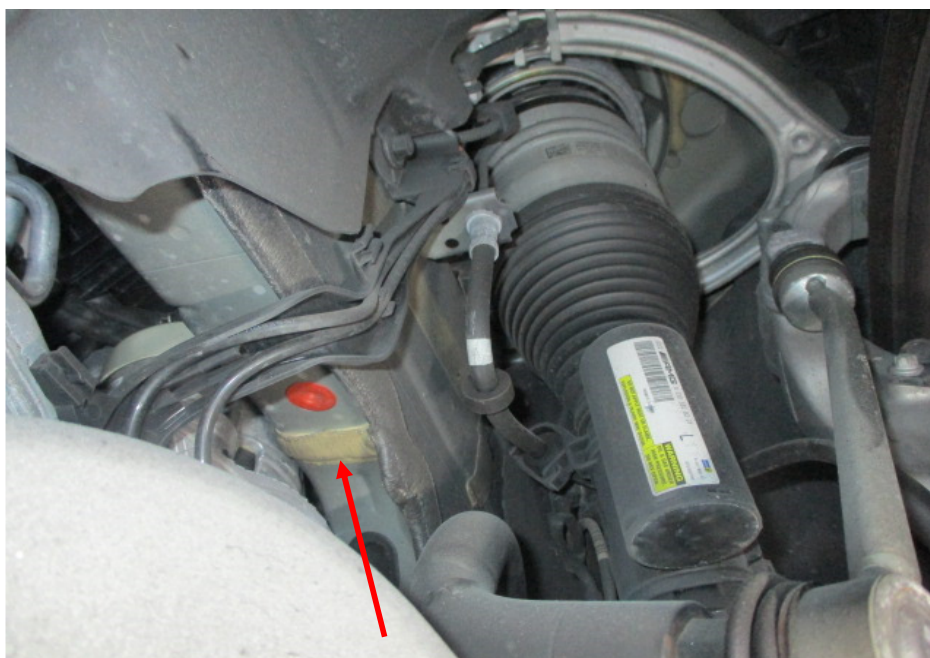
**Photo 23** shows the chassis/structural body at the underside front left of the Motor Car. The original factory sealant (arrowed) at the joints along the chassis/structural body was observed to be untouched. In general, I had found no work was carried out on the chassis/structural body of the Motor Car. The chassis/structural body of the Motor Car was originally fitted.

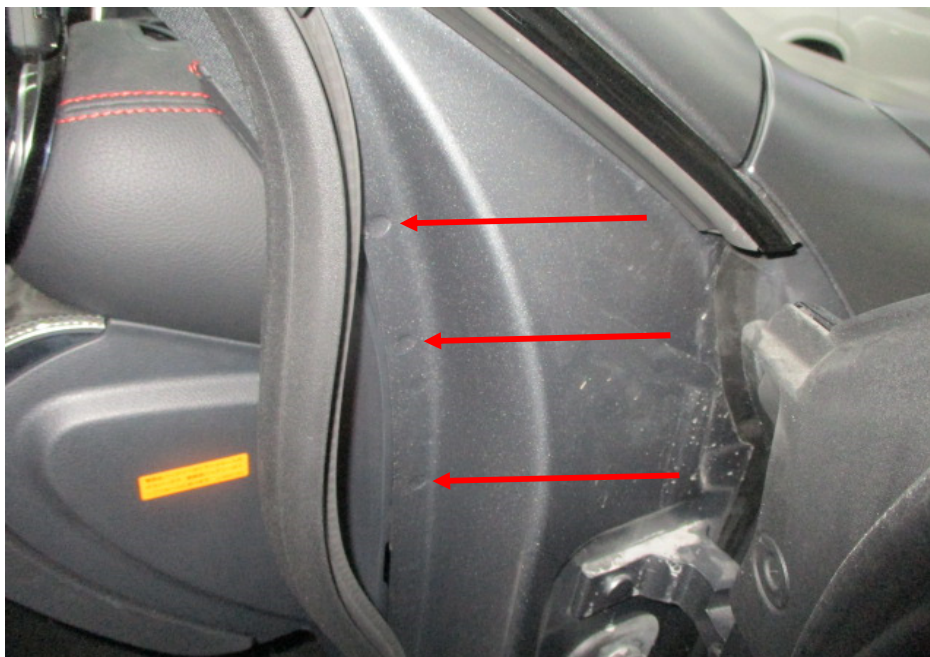
**Photo 24** shows the right side "A" pillar of the Motor Car. I did not find any weld marks other than original spot weld marks (arrowed) on the right side "A" pillar of the Motor Car which, indicates that there was no re-welding works carried out. In general, I had found all the non-detachable body panels of the Motor Car to be originally fitted at the time of my inspection.
