Your Ref: Audi A6

(chassis number WAUZZZF23KN060156)

Our Ref : CI/TP21003665/D

**INSPECTION REPORT OF AN UNREGISTERD AUDI A6 MOTOR CAR WITH CHASSIS NUMBER WAUZZZF23KN060156**

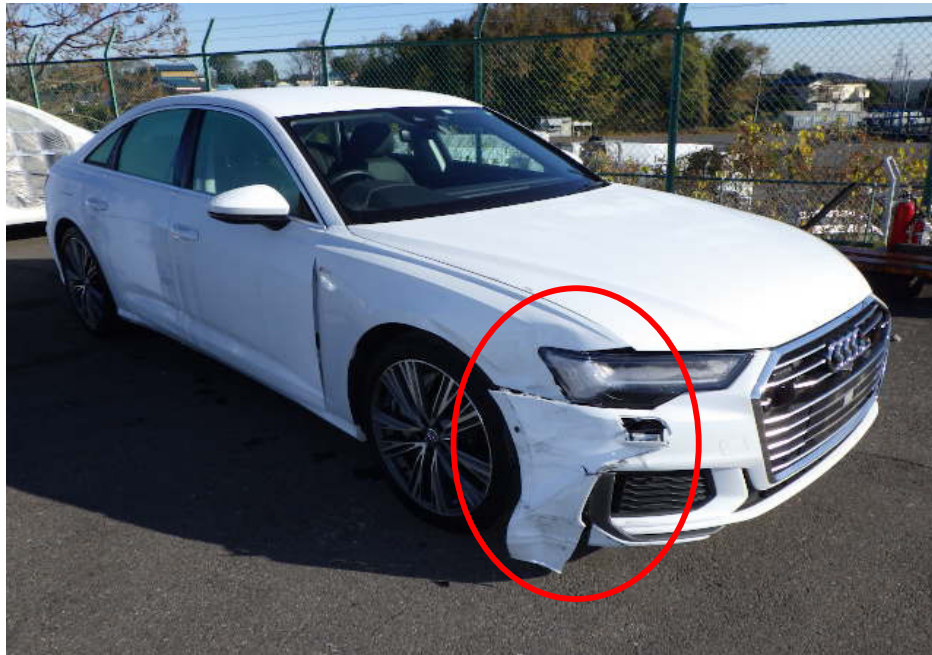
3. From the photographs provided to me, it was observed that the Motor Car had sustained damages at its front right portion. The front bumper, front bumper right lower garnish, front right fender, front right headlamp and front right headlamp washer cover were amongst the body parts of the Motor Car that were observed to have been damaged.
4. No physical damage was observed to other areas of the Motor Car. The airbags of the Motor Car were also not activated as seen from the photographs that were provided to me. See photo 1 – 4 below.

**Photo 1** shows the front right body of the Motor Car prior to any repairs being carried out (photograph provided to me). The Motor Car was observed to have sustained damages at its front right portion (circled). The front bumper, front bumper right lower garnish, front right fender, front right headlamp and front right headlamp washer cover were amongst the body parts that were observed to have been damaged.

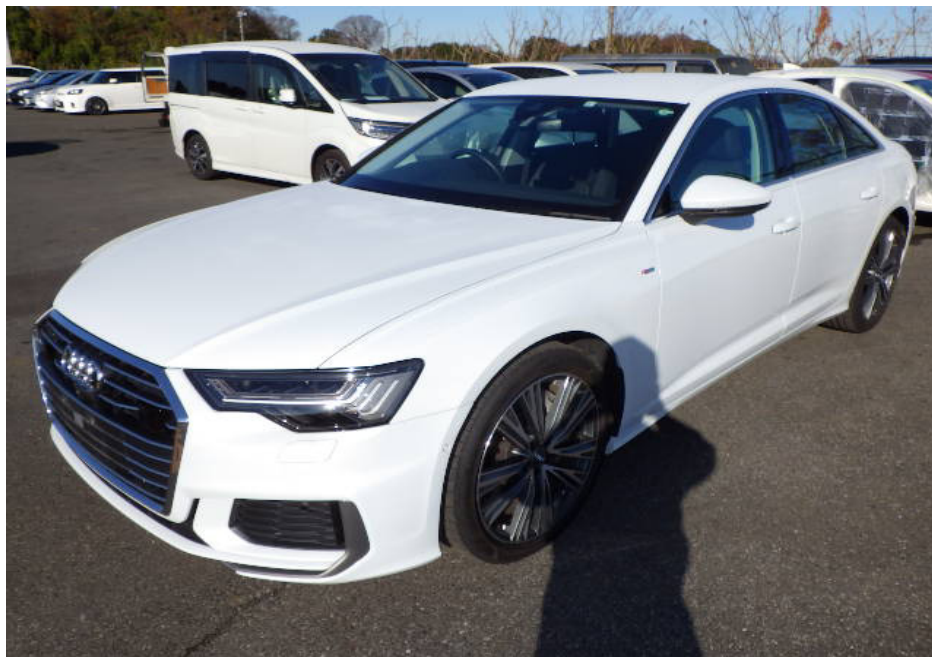
**Photo 2** shows the front left body of the Motor Car prior to any repairs being carried out (photograph provided to me). Apart for the front right portion, there was no physical damage seen to other areas of the Motor Car. The airbags of the Motor Car were also not activated.

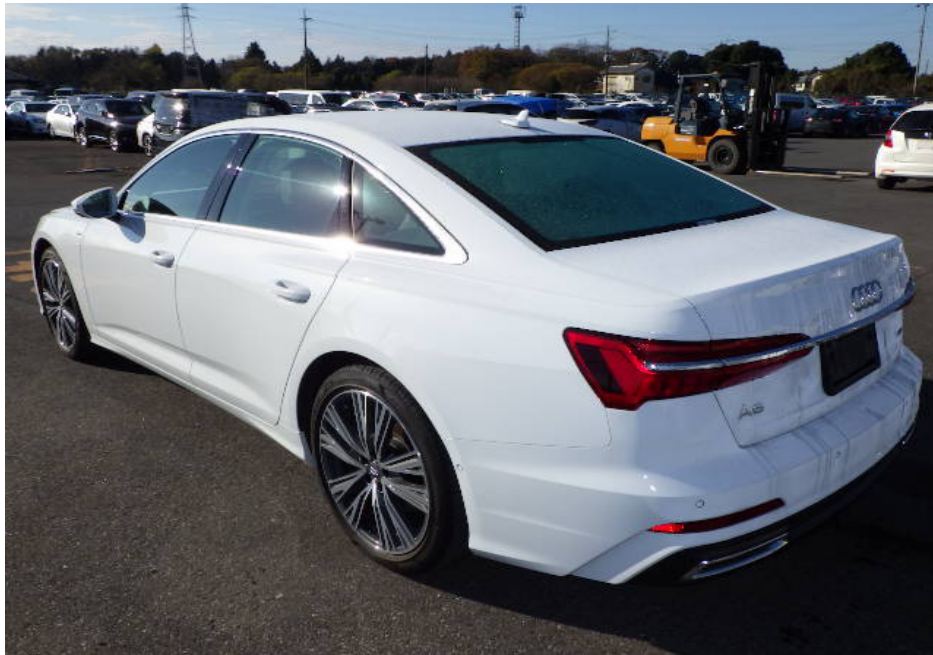
**Photo 3** shows the rear left body of the Motor Car prior to any repairs being carried out (photograph provided to me). Apart for the front right portion, there was no physical damage seen to other areas of the Motor Car. The airbags of the Motor Car were also not activated.

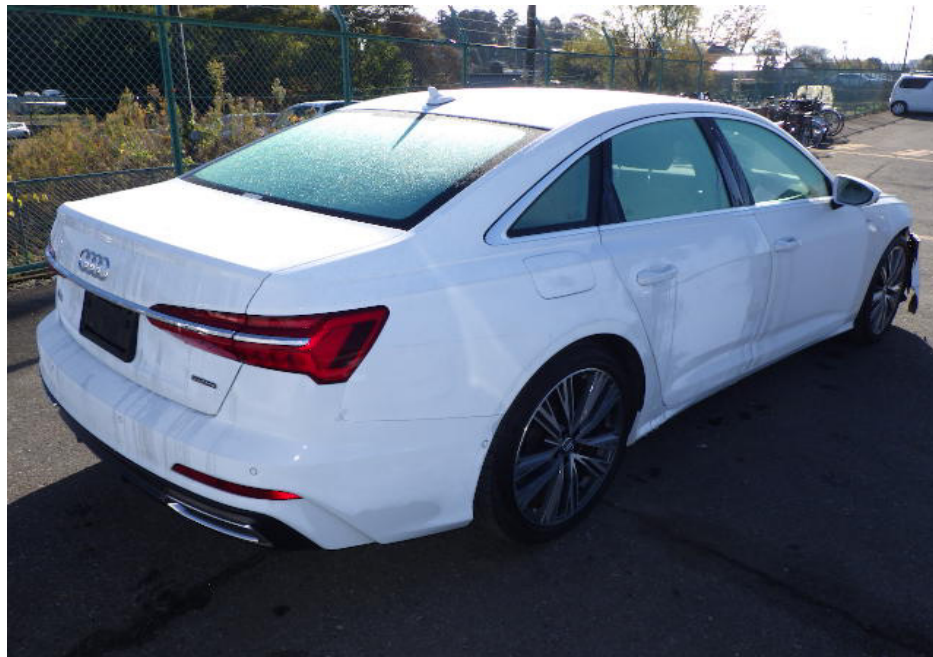
**Photo 4** shows the rear right body of the Motor Car prior to any repairs being carried out (photograph provided to me). Apart for the front right portion, there was no physical damage seen to other areas of the Motor Car. The airbags of the Motor Car were also not activated.

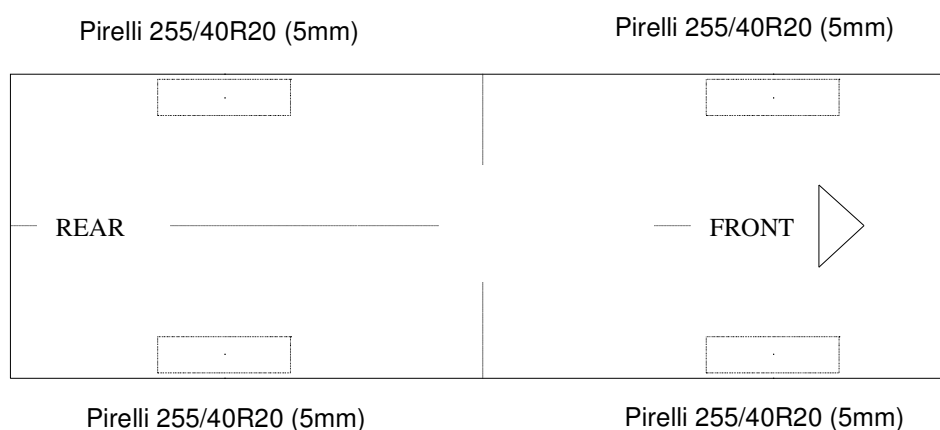
8. It was fitted with 20inch sport wheel rims that were wrapped with tyres that were observed to be of serviceable condition. The tyres were also sufficiently inflated for vehicular operation. The tyre brand, tyre size and approximate remaining tread depth of the 4 tyres of the Motor Car were recorded as follows: -

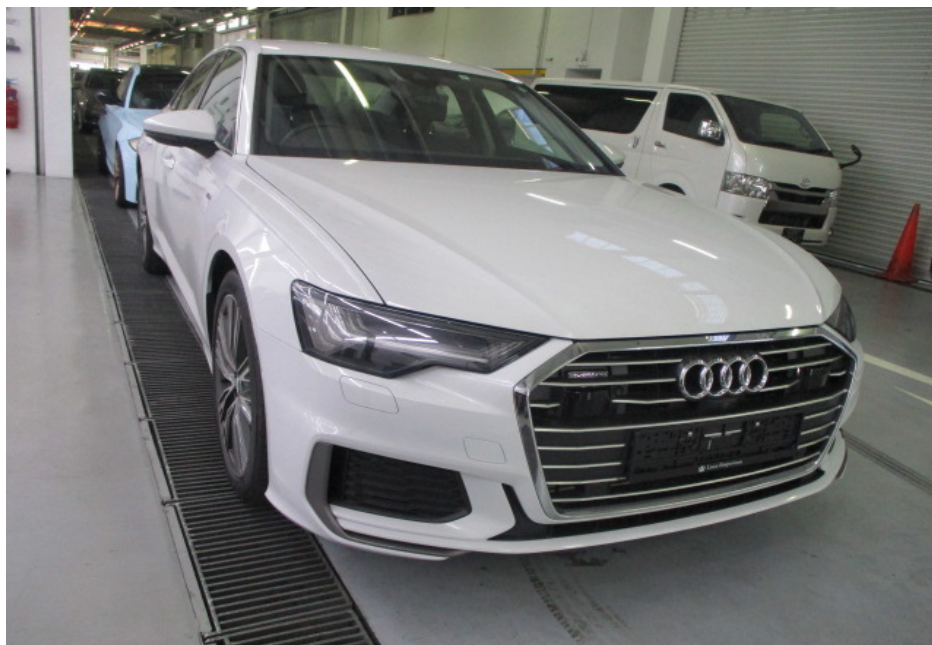
22. The body parts at the front right portion of the Motor Car were visually examined and it was noted that the repair/restoration works carried out to the damaged area of the Motor Car (refer to photograph 1 above) were adequate and in order.

**Photo 5** shows a general view of the front right body of the Motor Car at the time of my inspection. The Motor Car was observed to be in a relatively good general condition with no loose exterior fittings observed. The body parts at the front right portion of the Motor Car were visually examined and it was observed that the repair/restoration works carried out to the damaged area of the Motor Car (refer to photograph 1 above) were reasonably adequate and in order.

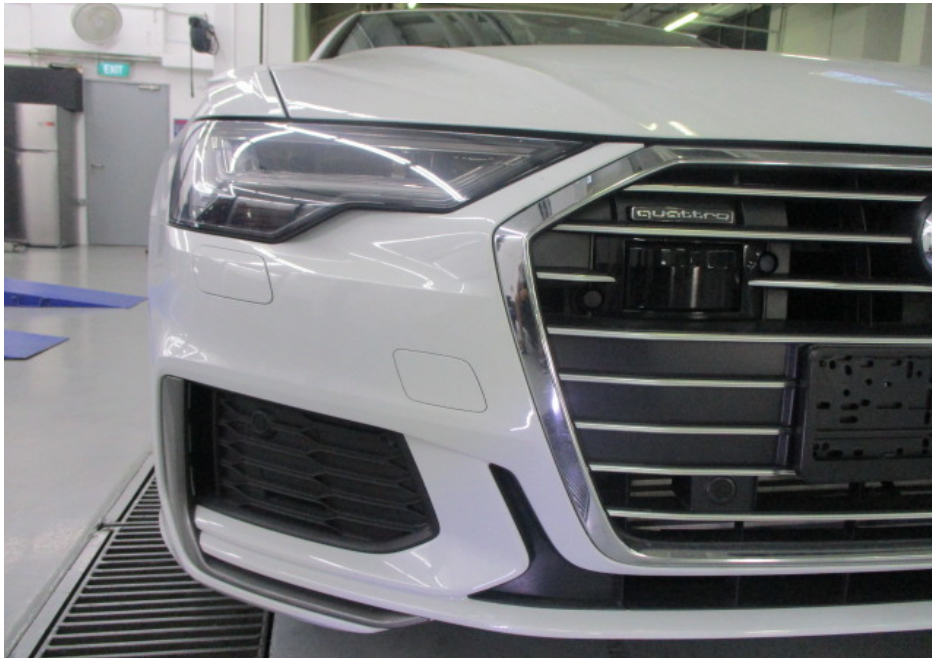
**Photo 6** shows a closer view of the front bumper, front bumper right lower garnish and front right headlamp of the Motor Car at the time of my inspection. The body parts at the front right portion of the Motor Car were visually examined and it was observed that the repair/restoration works carried out to the damaged area of the Motor Car (refer to photograph 1 above) were reasonably adequate and in order.

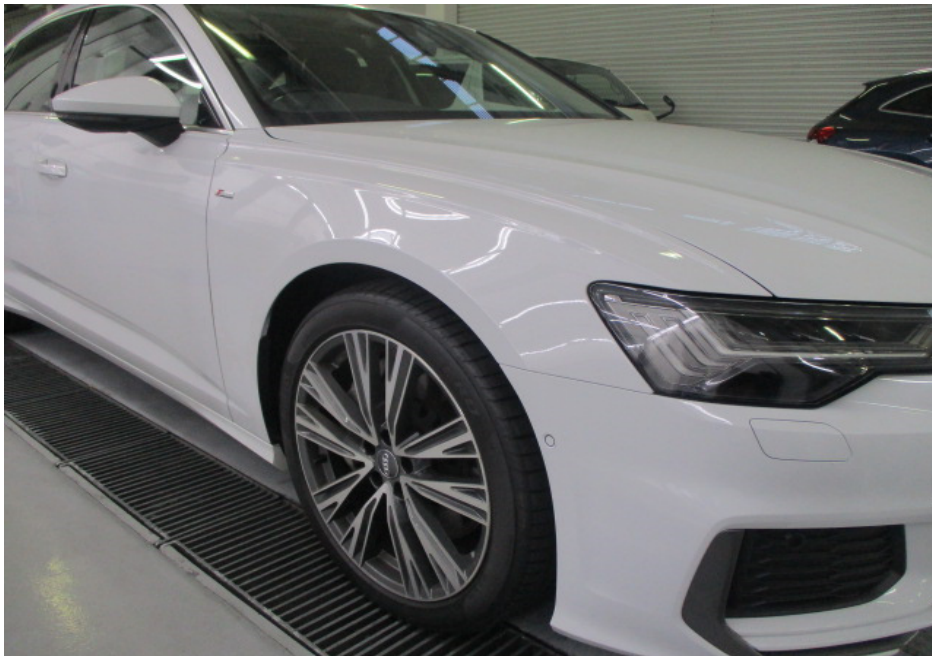
**Photo 7** shows a closer view of the front bumper, front right headlamp, front right headlamp washer cover and front right fender of the Motor Car. The body parts at the front right portion of the Motor Car were visually examined and it was observed that the repair/restoration works carried out to the damaged area of the Motor Car (refer to photograph 1 above) were reasonably adequate and in order.

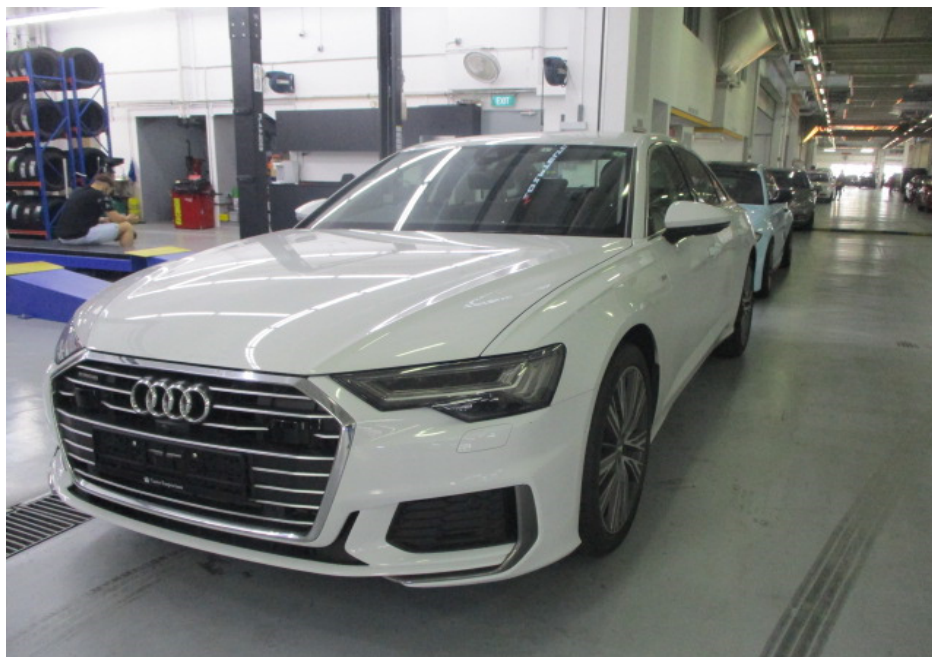
**Photo 8** shows a general view of the front left body of the Motor Car at the time of my inspection. The Motor Car was observed to be in a relatively good general condition with no loose exterior fittings observed. The mileage of the Motor Car recorded at the time of my inspection was 19,864km.

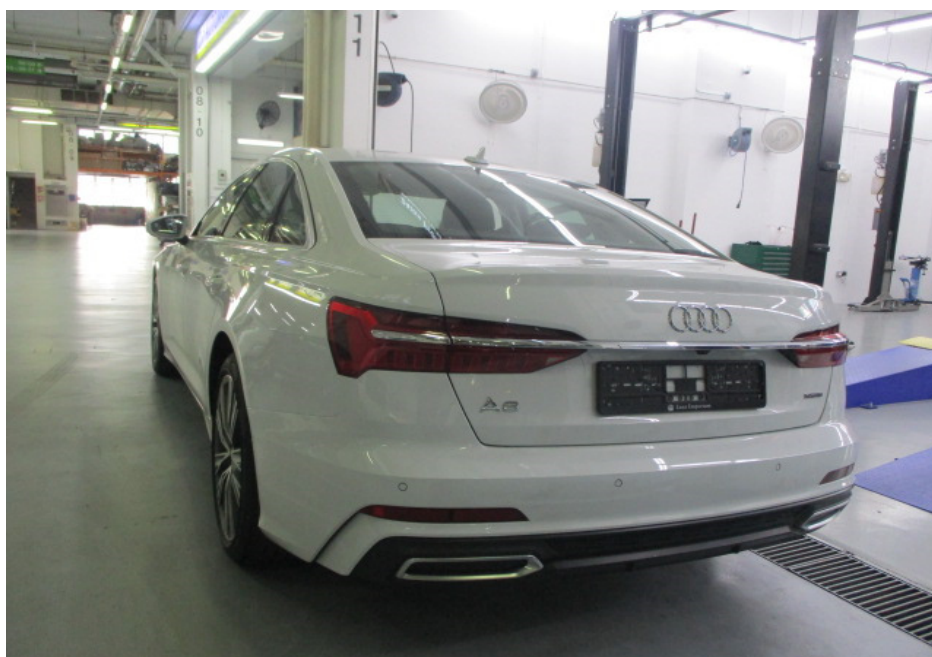
**Photo 9** shows a general view of the rear left body of the Motor Car at the time of my inspection. The Motor Car was observed to be in a relatively good general condition with no loose exterior fittings observed.

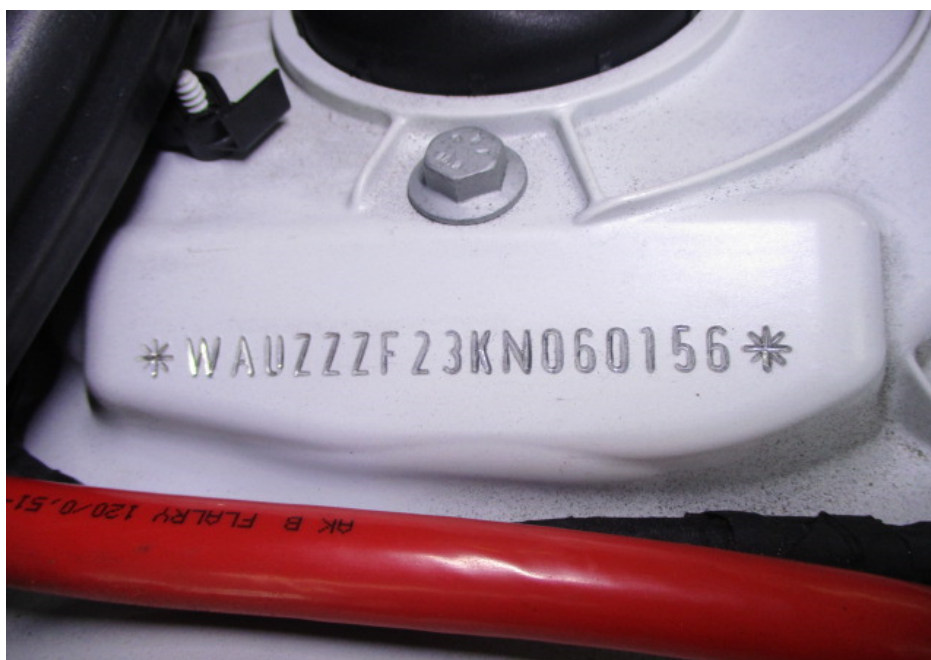
**Photo 10** shows the chassis number of the Motor Car. The chassis number recorded was WAUZZZF23KN060156.

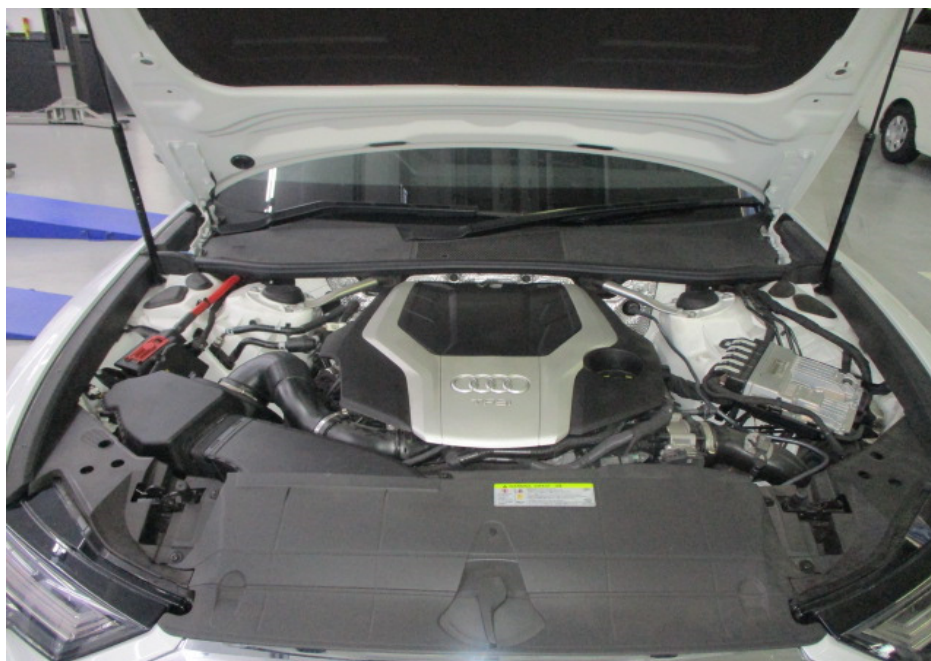
14. My examination of the engine compartment of the Motor Car revealed that the various parts and components inside the engine compartment were all intact and properly fitted. The engine oil, brake fluid and engine coolant were all found to be of sufficient level for operating purposes. Visually, there was also no contamination found to these fluids.

**Photo 11** shows a general view of the engine compartment of the Motor Car at the time of my inspection. The various parts and components inside the engine compartment were all observed to be intact and properly fitted. There was also no sign(s) or indication(s) of fluid leak and/or fluid stain found inside the engine compartment.

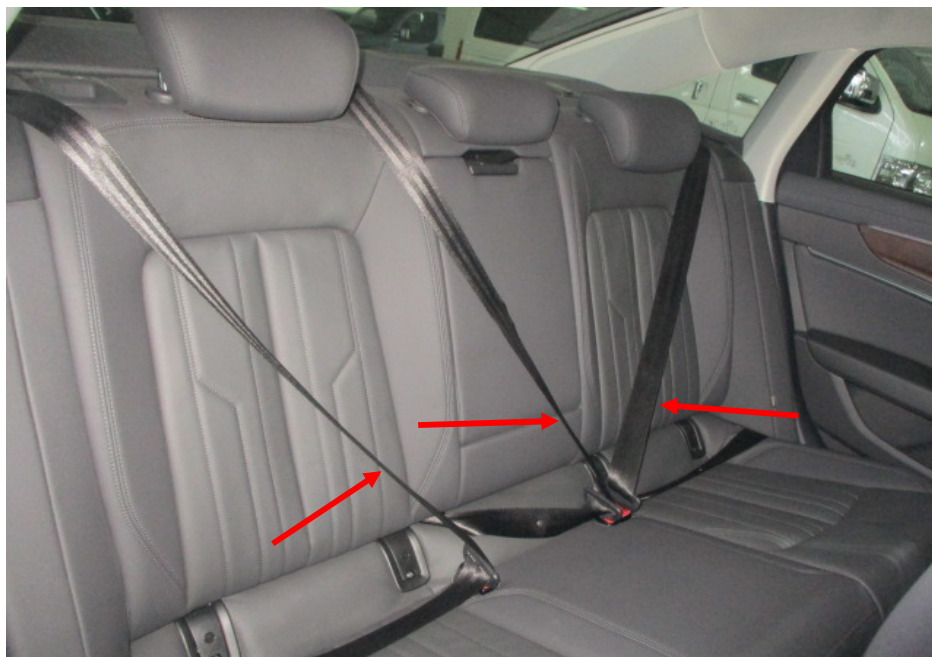
12. The seats of the Motor Car were found to be secured to the floorboard of the Motor Car via seat rails bolted onto the floorboard. Retractable seat belt reels and pre-tensioners were fitted on all seats of the Motor Car. The seat belts were tested and were able to be fastened securely into the respective pre-tensioners that were fixed to the side of all the seats.

**Photo 12** shows the rear seats of the Motor Car. All the seats of the Motor Car were secured via seat rails to the floorboard. They were also fitted with a retractable seat belt reel and a pre-tensioner. The seat belts (arrowed) were tested and were able to be fastened into the respective pre-tensions that were fitted on the side of each individual seat.

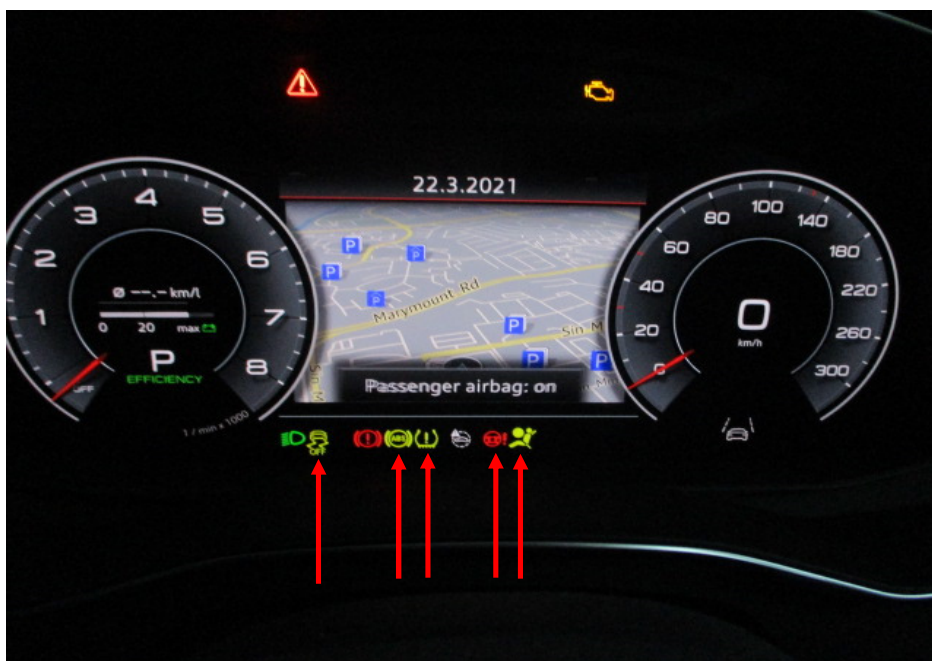
**Photo 13** shows the warning lights for the various electronic safety features appearing on the instrument panel of the Motor Car during its self-test when the engine is cranked, in particular the ABS, SRS, EPS, TPM and ESC lights (arrowed).

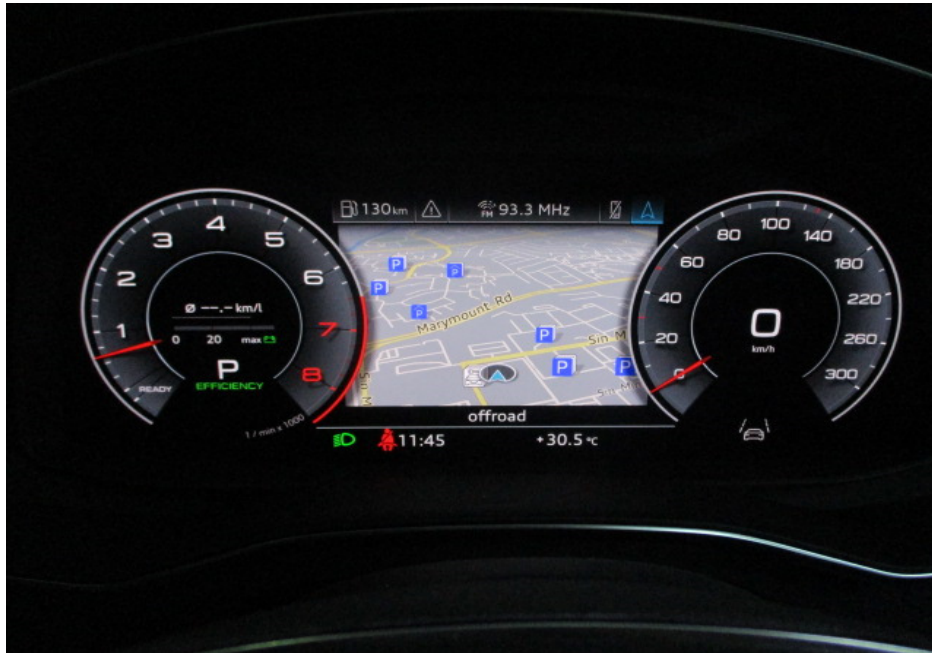
13. The Motor Car's automatic self-test of the functionality of its various electronic safety features like the Anti-Lock Brake System (ABS), Supplemental Restraint System (SRS), Electronic Power Steering (EPS), Tyre Pressure Monitor (TPM) and Electronic Stability Control (ESC) during cranking of the engine had indicated that these electronic systems were in working condition. This was determined from the respective warning lights disappearing from the instrument panel after the self-test.

**Photo 14** shows the respective warning lights no longer illuminated, indicating that there is no fault detected to the ABS, SRS, EPS, TPM and ESC systems of the Motor Car during the self-test. These electronic systems were hence in working condition at the time of my inspection.

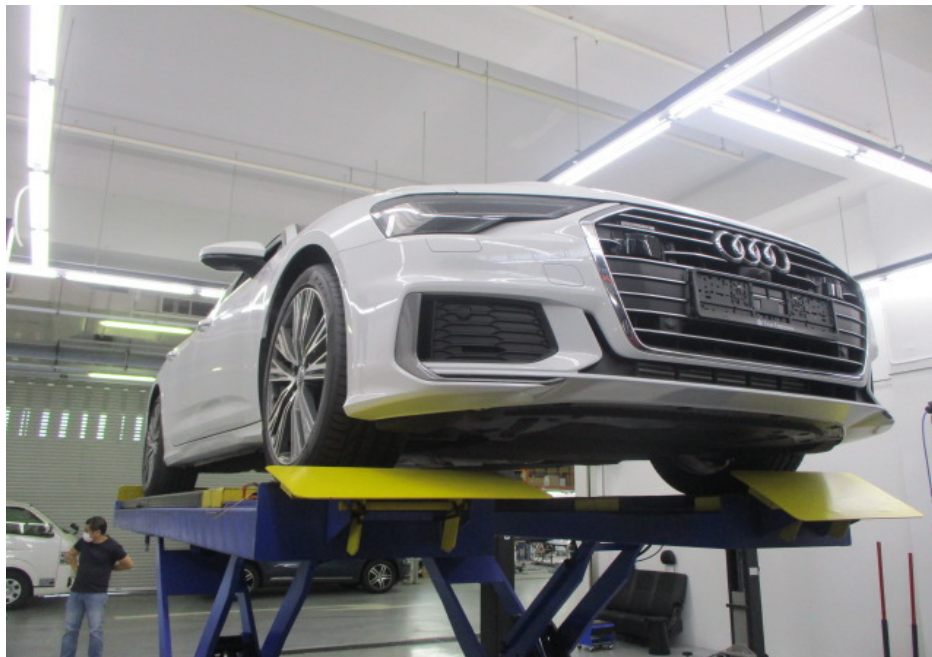
15. My checks on the underside of the Motor Car revealed no sign(s) or indication(s) of fluid leakage and/or fluid stain(s). The engine block and automatic transmission assembly were both secured properly. All undercarriage components of the Motor Car were also observed to be intact and secured in an appropriate manner.

**Photo 15** shows the Motor Car hoisted up for checks on its undercarriage. There was no sign(s) or indication(s) of fluid leakage and/or fluid stain(s) on the underside of the Motor Car. The undercarriage components of the Motor Car were also all observed to be intact and secured in an appropriate manner.

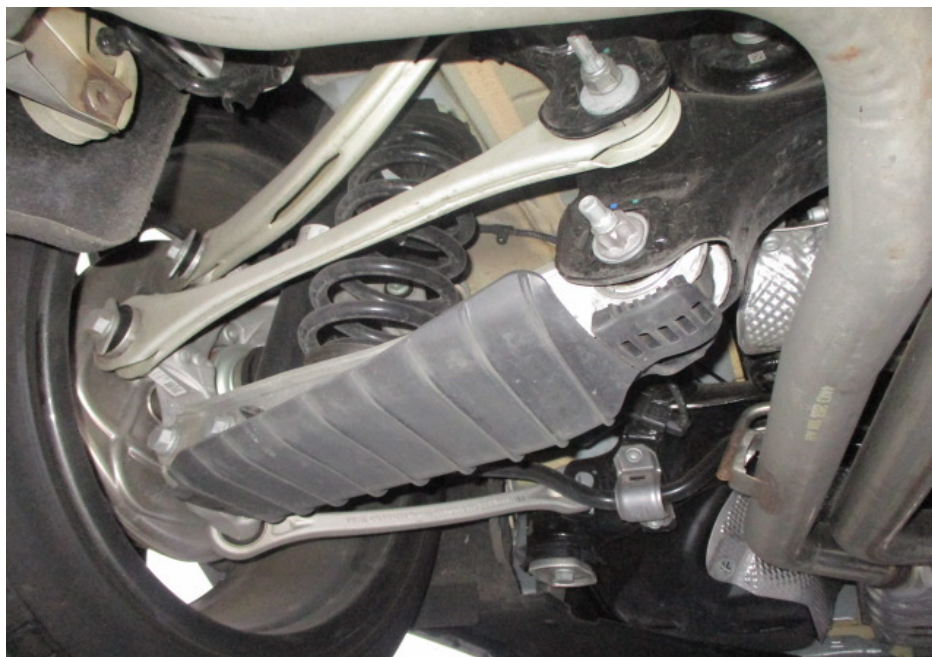
**Photo 16** shows a general view of the control arms and linkages at the rear left wheel of the Motor Car. I did not observe any fluid leak and/or fluid stain on the underside of the Motor Car. All of the Motor Car's undercarriage components were observed to be intact and secured in an appropriate manner.

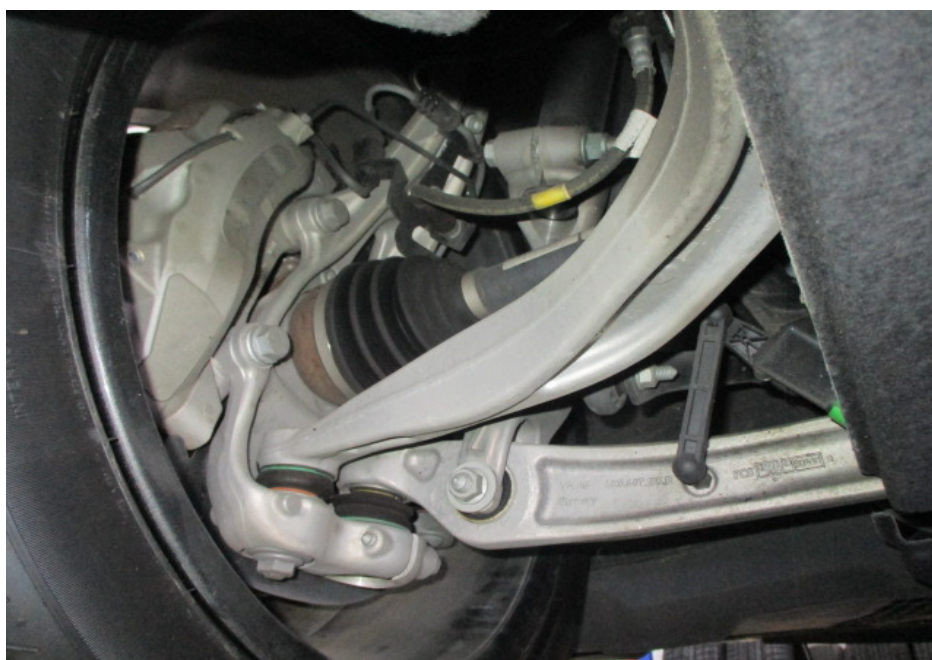
**Photo 17** shows the various undercarriage components at the front left wheel of the Motor Car. The mechanical components, control arms and linkages were all found to be intact and secured in an appropriate manner.

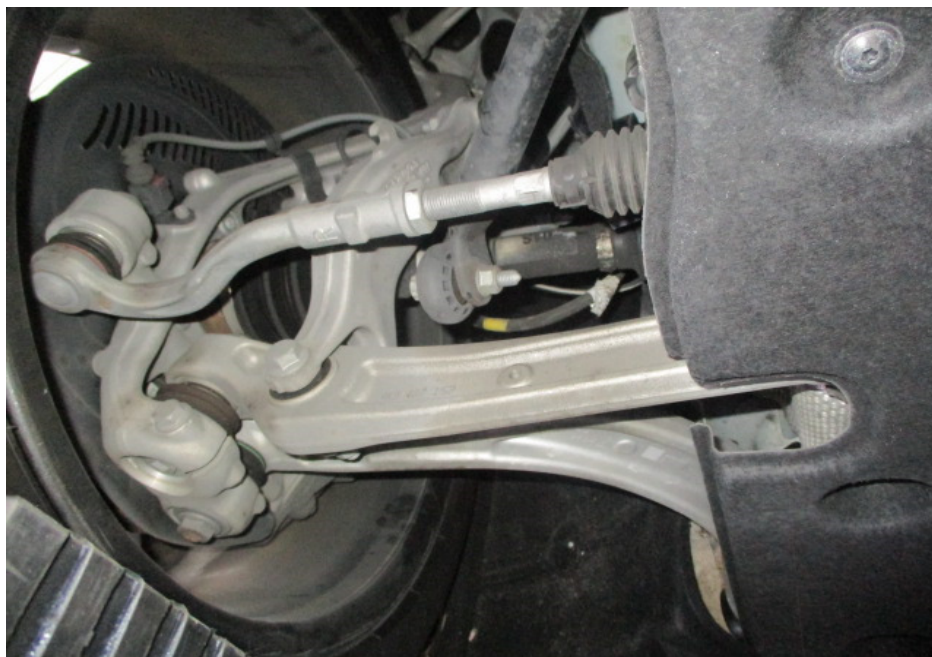
**Photo 18** shows the various undercarriage components at the front right wheel of the Motor Car. The mechanical components, control arms and linkages were all found to be intact and secured in an appropriate manner. I did not observe any fluid leak and/or fluid stain on the underside of the Motor Car.

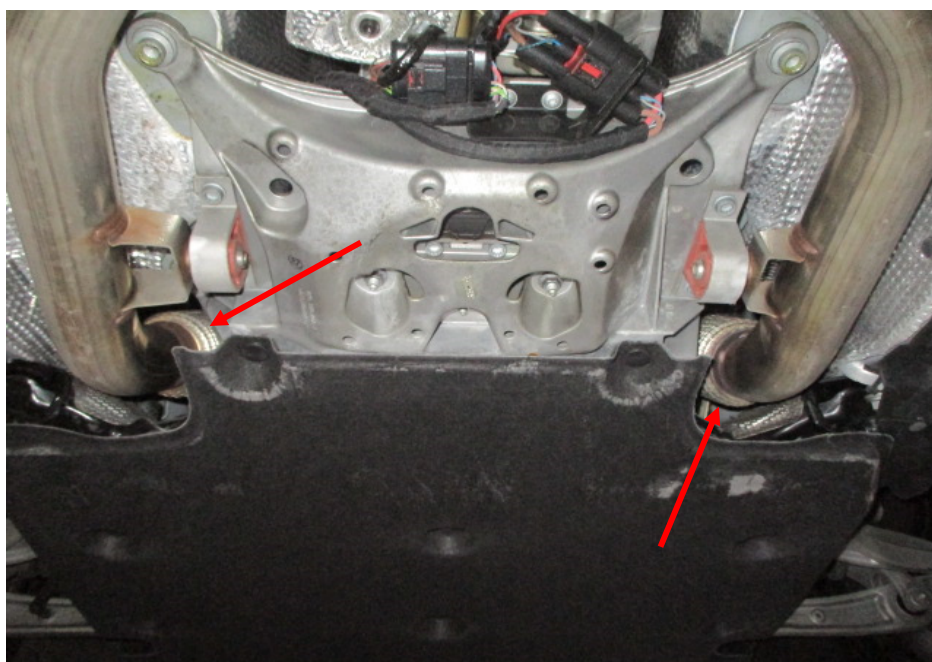
**Photo 19** shows the Motor Car's catalytic converters (arrowed). My examination of the Motor Car's exhaust system revealed no sign(s) or indication(s) of any cut or weld marks along its exhaust pipes and on its rear mufflers.

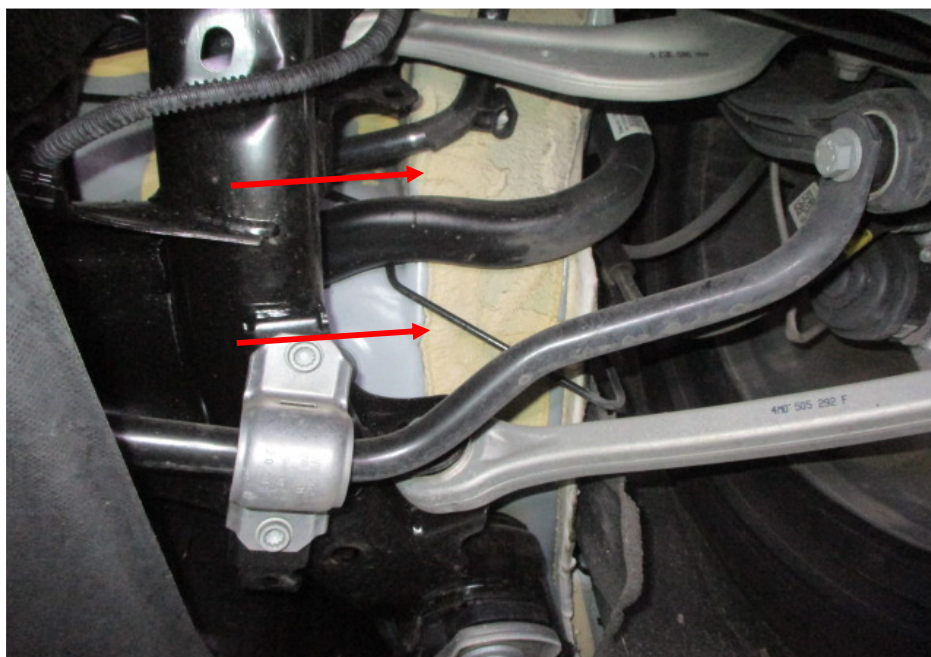
11. Visually, I did not find any weld marks, other than the original spot weld marks, on the chassis/structural body of the Motor Car. The original factory sealant at the joints along the chassis/structural body was also untouched, again indicating that no replacement of the chassis/structural body was carried out; and that the chassis/structural body was originally fitted.

**Photo 20** shows the chassis/structural body at the underside rear right of the Motor Car. Visually, I did not find any weld marks other than original spot weld marks on the chassis/structural body of the Motor Car. The original factory sealant (arrowed) at the joints along the chassis/structural body was also untouched, indicating no work was done on the chassis/structural body of the Motor Car and that the chassis/structural body was originally fitted.

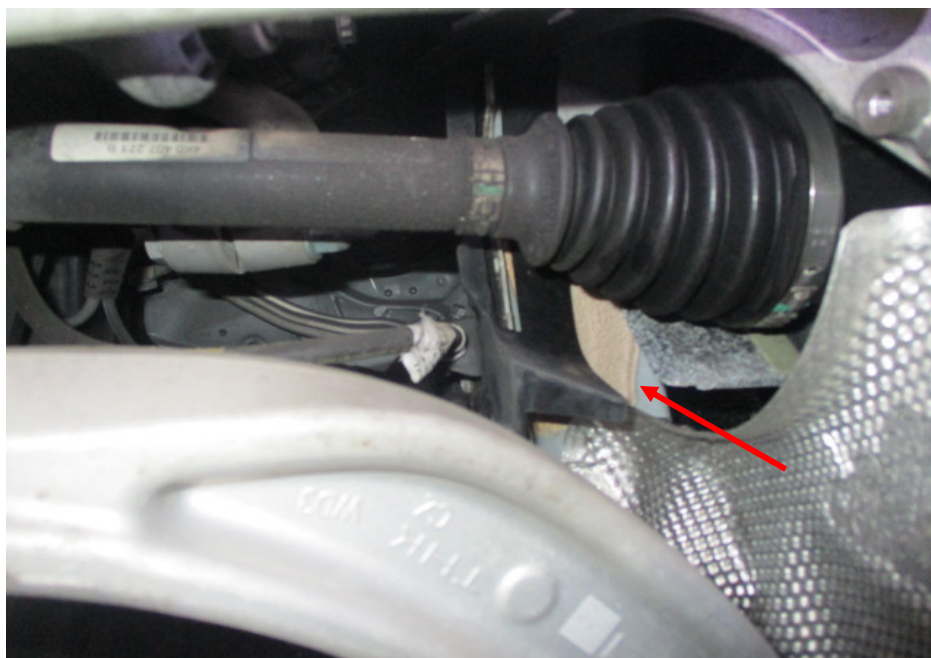
**Photo 21** shows the chassis/structural body at the underside front right of the Motor Car. The original factory sealant (arrowed) at the joints along the chassis/structural body was observed to be untouched. In general, I had found no work was carried out on the chassis/structural body of the Motor Car. The chassis/structural body of the Motor Car was originally fitted.

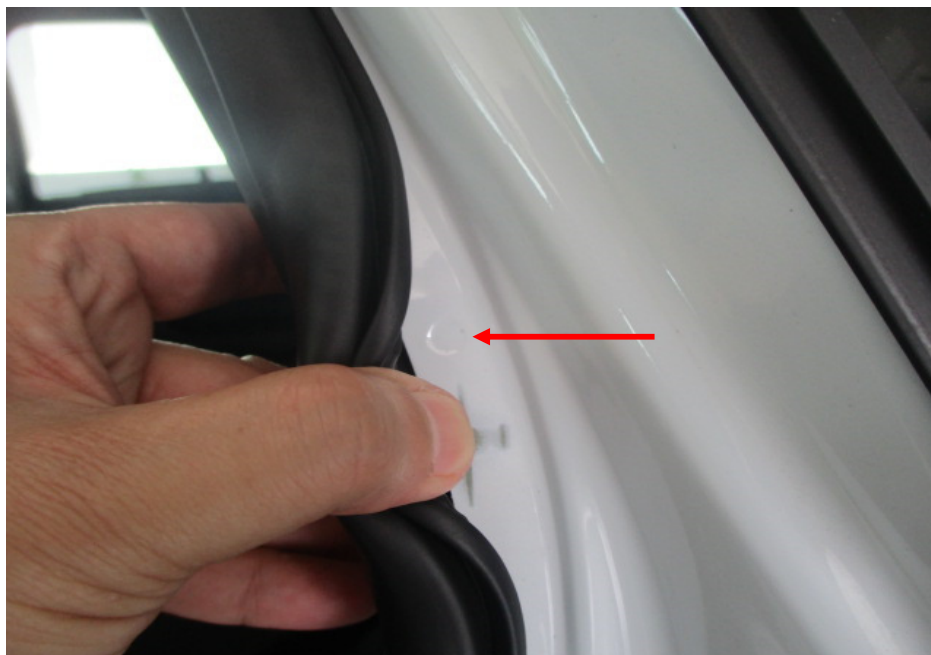
10. Checks on the non-detachable body panels like the rear fenders, floorboard, roof panel, pillars and rocker panels amongst others, revealed that these body panels were spot welded onto the chassis/structural body of the Motor Car. The original factory sealant at the joints of the non-detachable body panels was all untouched indicating no replacement of the non-detachable body panels was carried out; and that these body panels were all originally fitted except for the rear right fender, which was found to be replaced (refer to photograph 22 below).

**Photo 22** shows the rear left "C" pillar of the Motor Car. I did not find any weld marks other than original spot weld marks (arrowed) on the rear left "C" pillar of the Motor Car. In general, I had found all the non-detachable body panels of the Motor Car to be originally fitted.
