You're Ref: TP/IP/12963/2021  
Our Ref: CI/TPD21003844/P

25<sup>th</sup> March 2021

**MECHANICAL INSPECTION REPORT OF MOTOR CAR SHC 3540C**

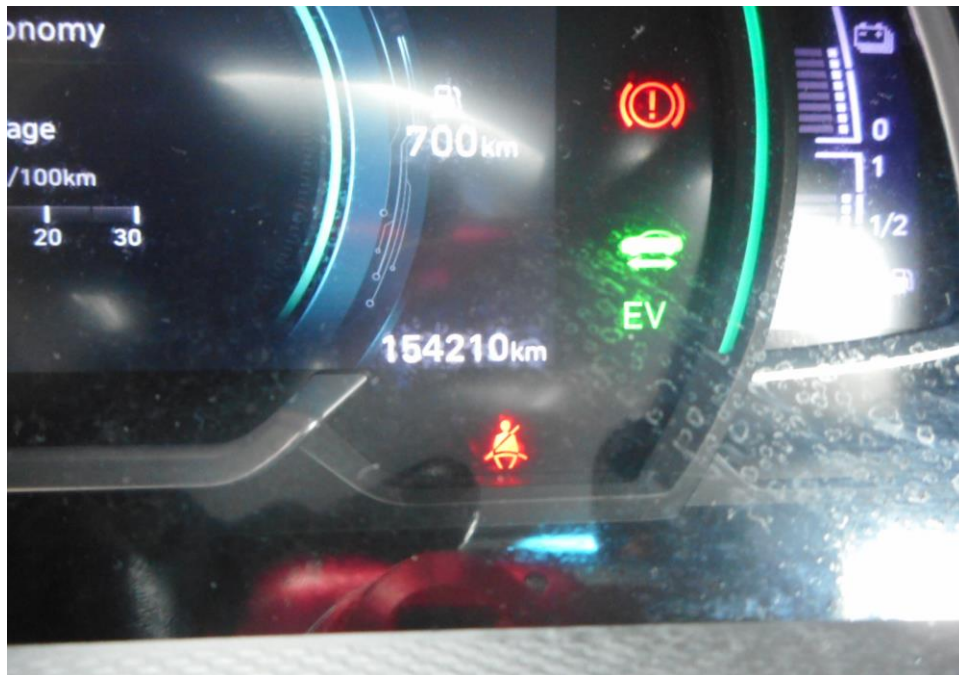
**Photo 1** shows the mileage of the Motor Car at the time of my inspection. The mileage observed was 154,210km.

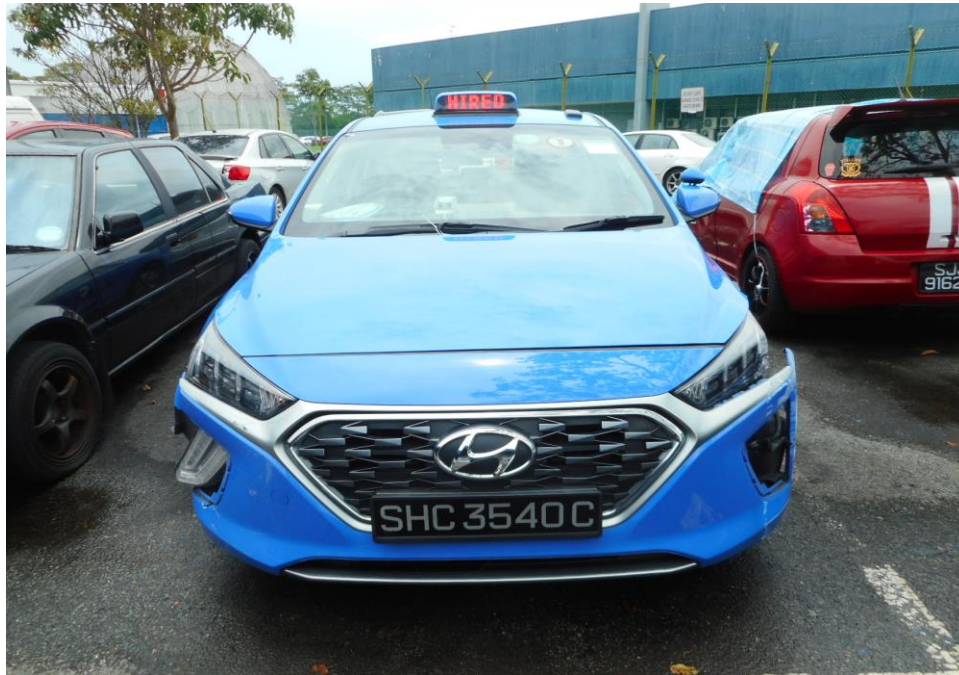
4. The mileage of the Motor Car at the time of my inspection was 154,210km.
5. The Motor Car was observed to have sustained damage at its front portion. Its front left headlamp, front bumper and front left fender was the body parts that were damaged as a result of the accident.

**Photo 2** shows a general view of the Motor Car's front body at the time of my inspection. The front portion of the Motor Car was observed to have sustained damage. Its front left headlamp, front bumper and front left fender was the body parts that were damaged as a result of the accident.

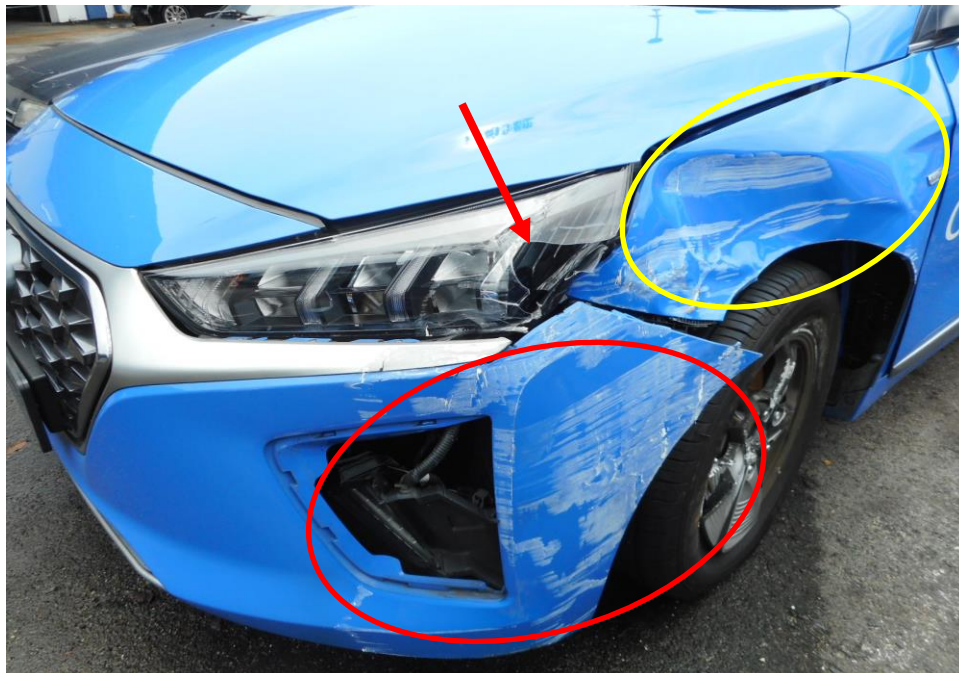
**Photo 3** shows the close up view of the Motor Car's front body at the time of my inspection. The Motor Car was observed to have sustained damage at its front left headlamp (arrowed), front bumper (red circle) and front left fender (yellow circle), as a result of the accident.

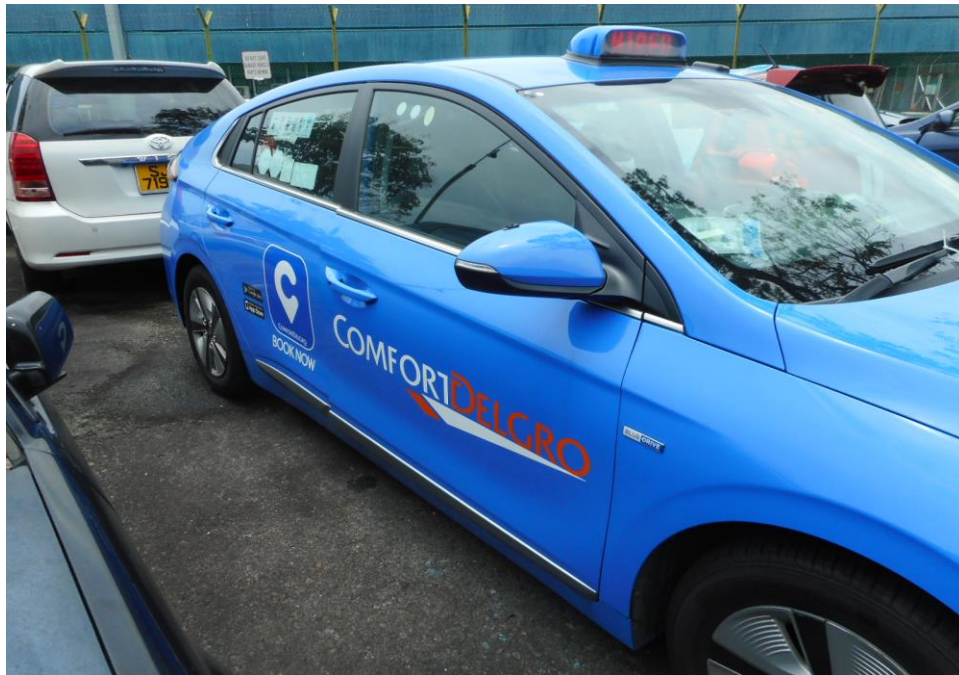
**Photo 4** shows a general view of the Motor Car's right body at the time of my inspection. The right portion of the Motor Car was observed to have been unaffected by the accident.

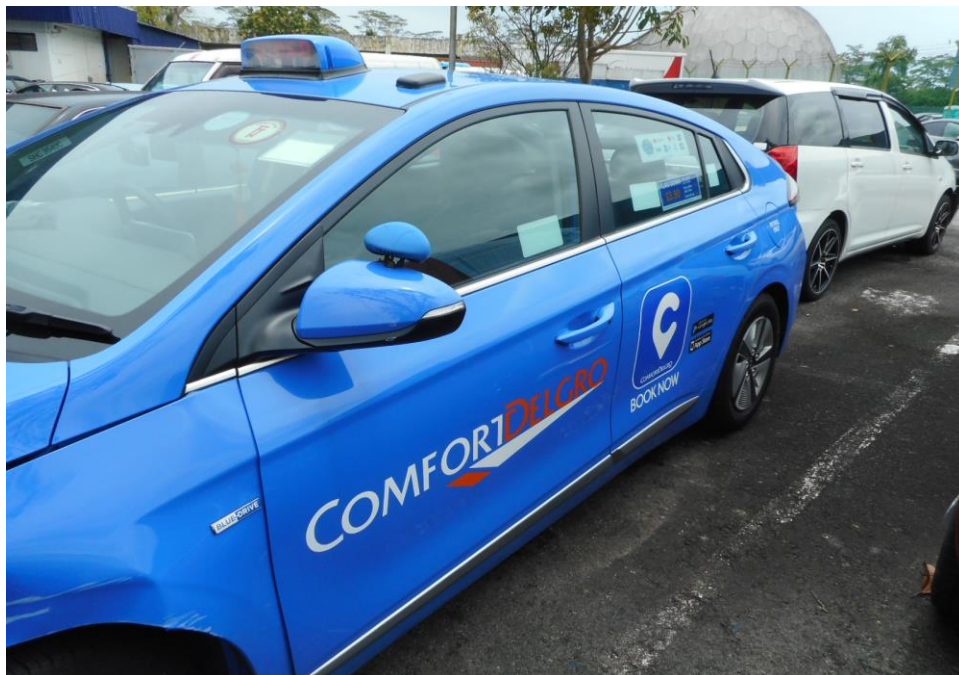
**Photo 5** shows a general view of the Motor Car's left body at the time of my inspection. The left portion of the Motor Car was observed to have been unaffected by the accident.

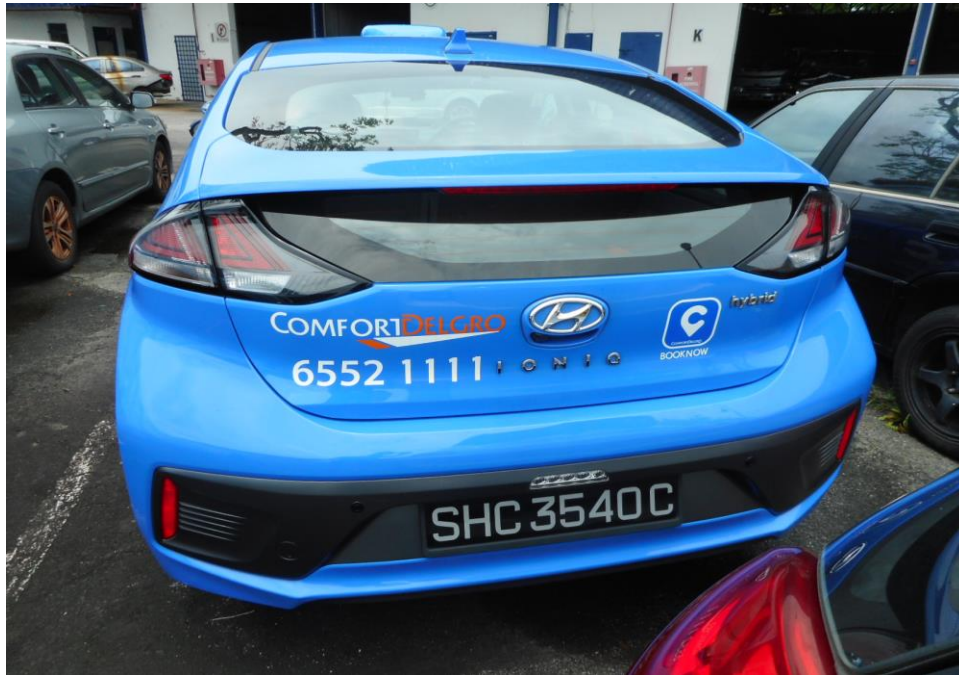
**Photo 6** shows the general view of the Motor Car's rear body at the time of my inspection. The Motor Car rear was observed to be unaffected by the accident.

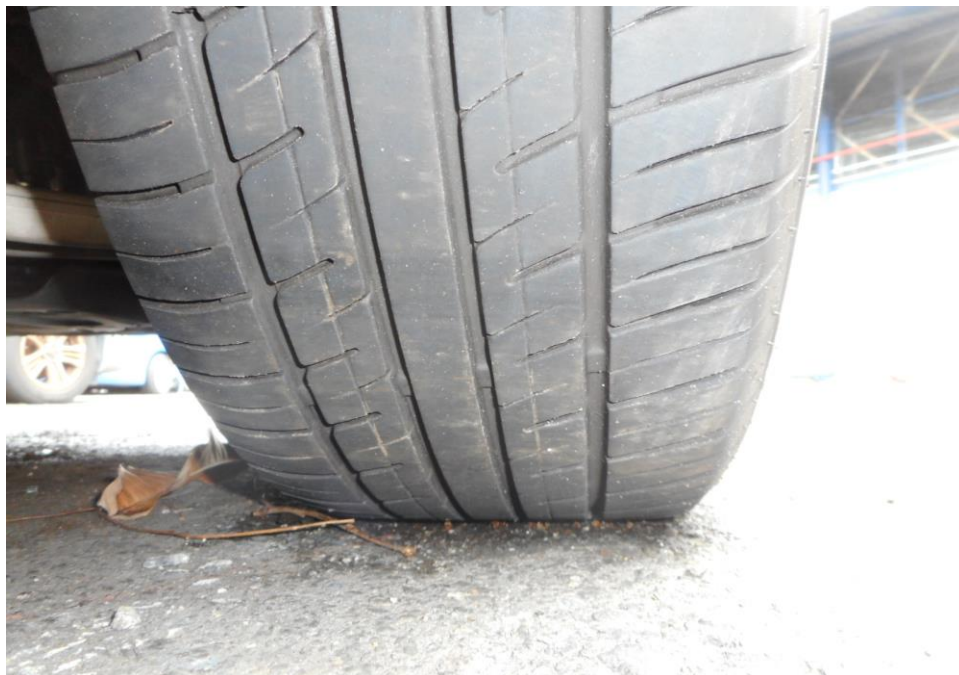
**Photo 7** shows the condition of the front right tyre of the Motor Car, which was observed to be in serviceable condition with remaining tread depth of approximately 4.9mm. The tyre was sufficiently inflated for vehicular operation with no tear, cut or burst mark(s) on the outer and the inner sidewalls as well as across the tread. The 4 tyres of the Motor Car were wrapped around standard steel wheel rims without any damage.

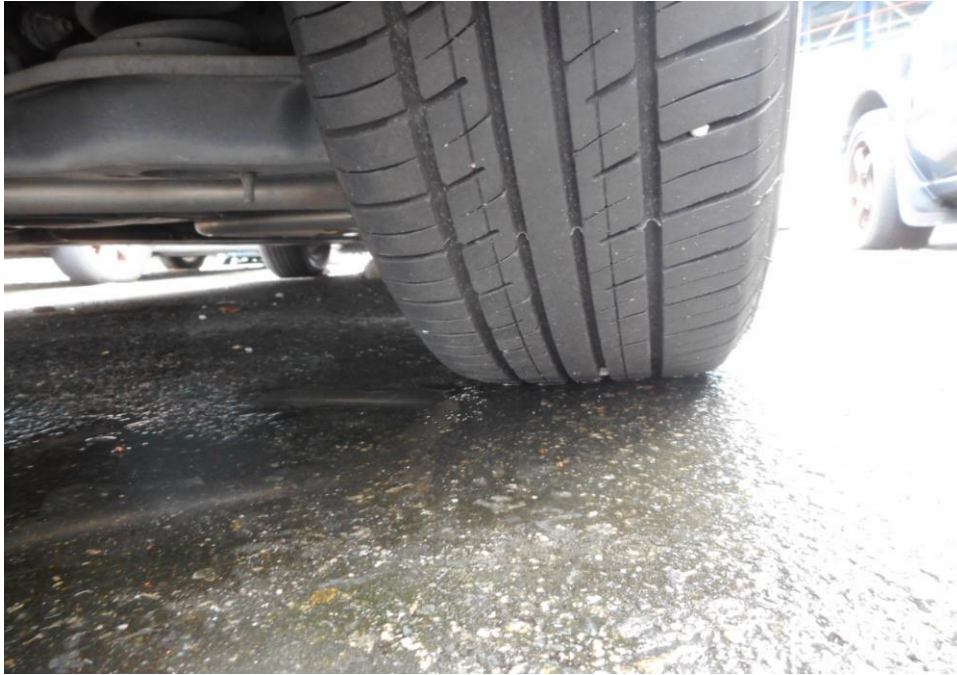
**Photo 8** shows the condition of the rear right tyre of the Motor Car, which was observed to be in serviceable condition with remaining tread depth of approximately 5.8mm. The tyre was also observed to be sufficiently inflated for vehicular operation with no tear, cut or burst mark(s).

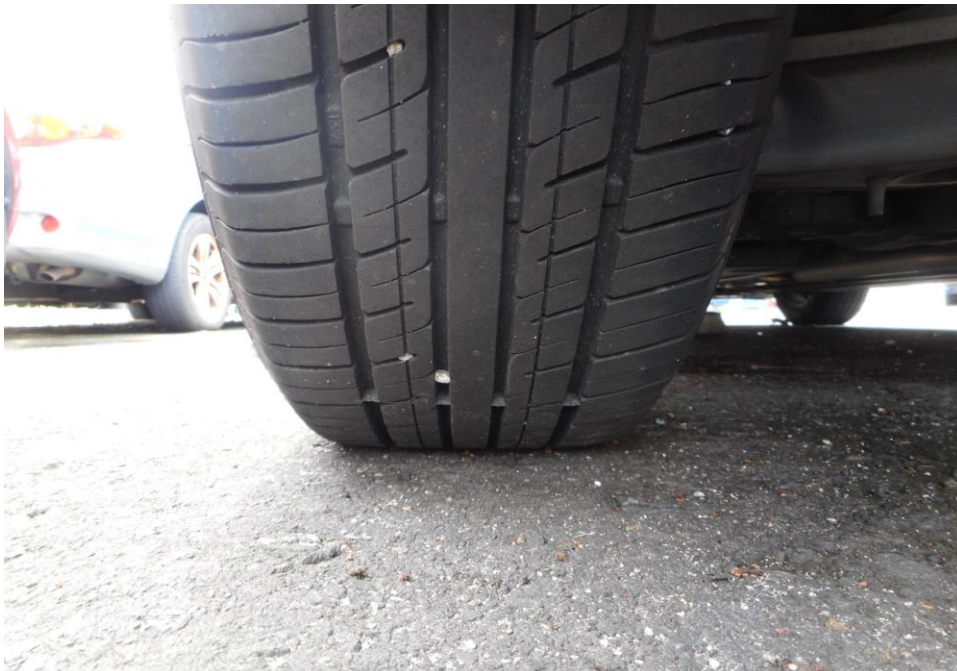
**Photo 9** shows the condition of the rear left tyre of the Motor Car, which was observed to be in serviceable condition with remaining tread depth of approximately 5.9mm. The tyre, which was wrapped around steel wheel rim, was also observed to be sufficiently inflated for vehicular operation. The 4 tyres of the Motor Car were wrapped around standard steel wheel rims.

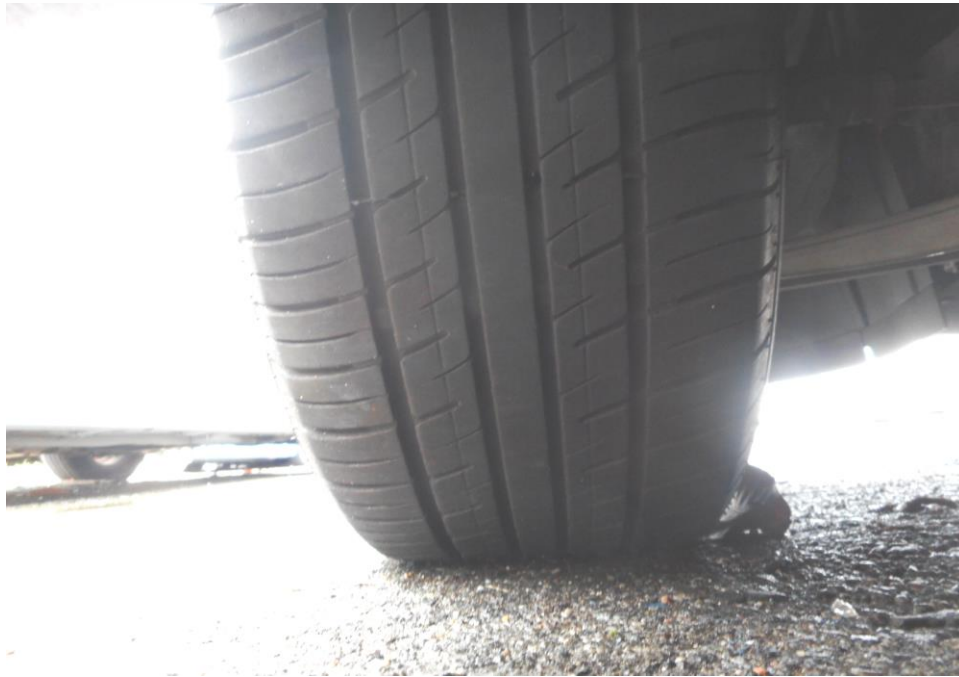
**Photo 10** shows the condition of the front left tyre of the Motor Car, which was observed to be in serviceable condition with remaining tread depth of approximately 4.9mm. There was also no tear, cut or burst mark(s) on the outer and the inner sidewalls as well as across the tread of the Motor Car's 4 tyres.

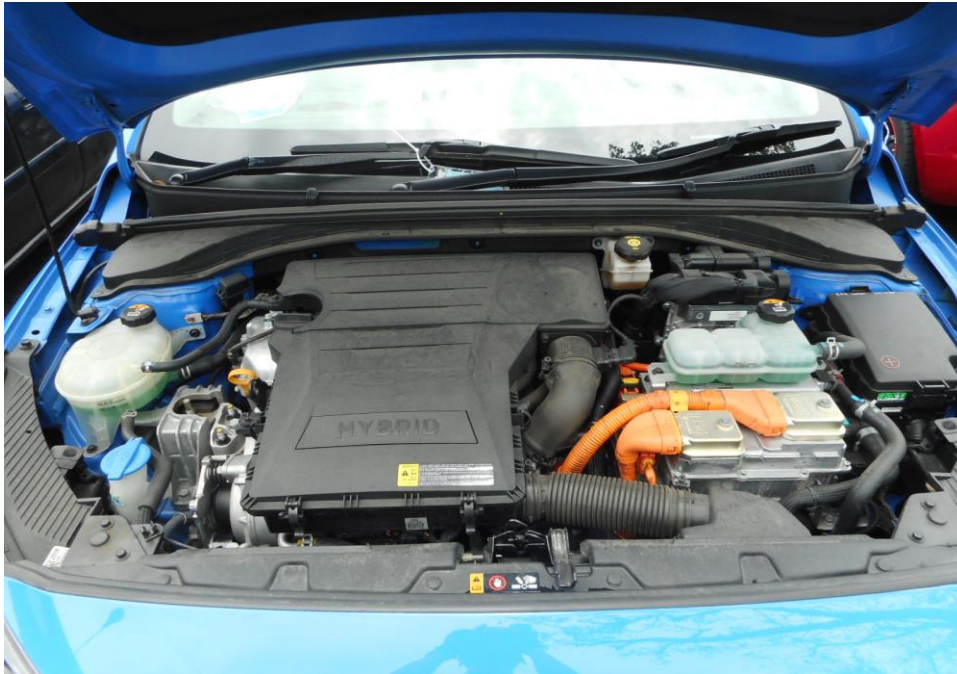
**Photo 11** shows a general view of the Motor Car's engine compartment. The various parts and components inside the engine compartment were unaffected by the accident. There was also no sign(s) or indication(s) of fluid leakage and/or fluid stain within the engine compartment.

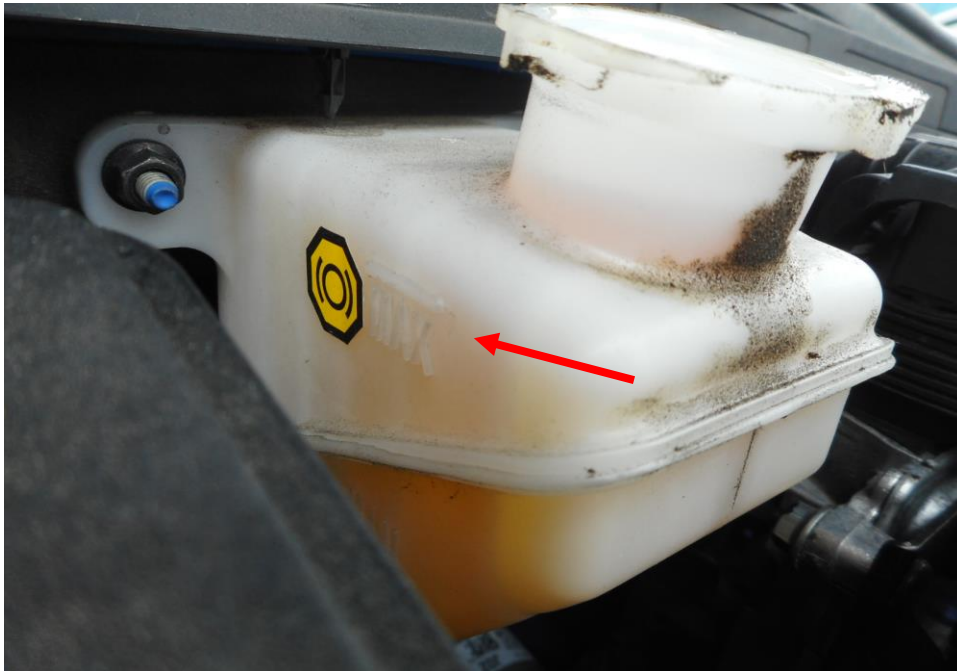
**Photo 12** shows the brake fluid reservoir of the Motor Car at the time of my inspection. The brake fluid was observed to be of sufficient level (arrowed) and without any visible contamination.

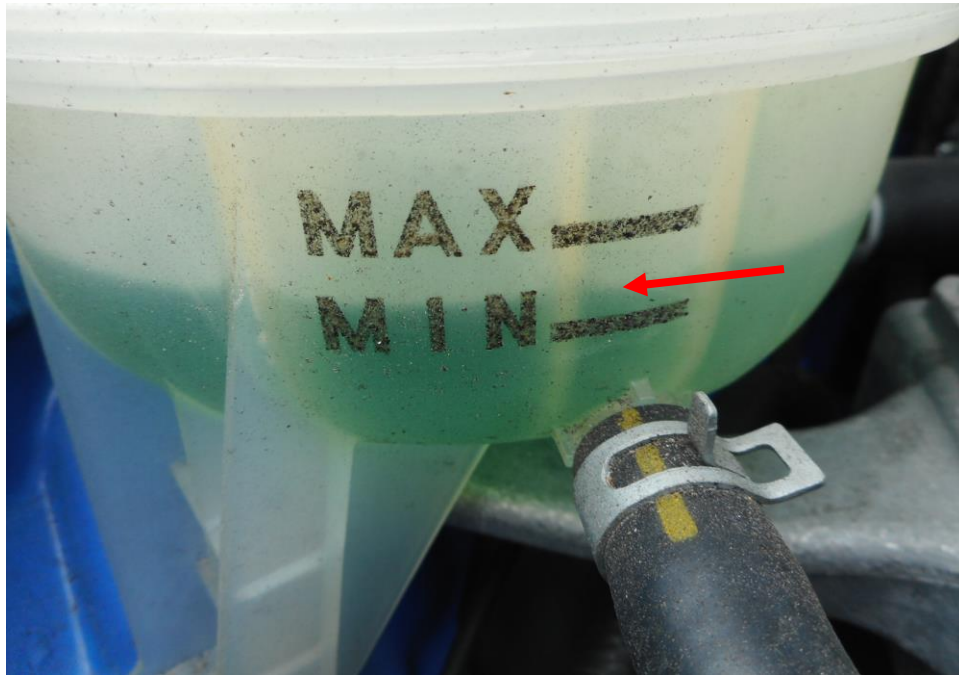
**Photo 13** shows checks being carried out to the engine coolant of the Motor Car at the time of my inspection. The engine coolant was observed to be of sufficient level (arrowed) and without any visible contamination.

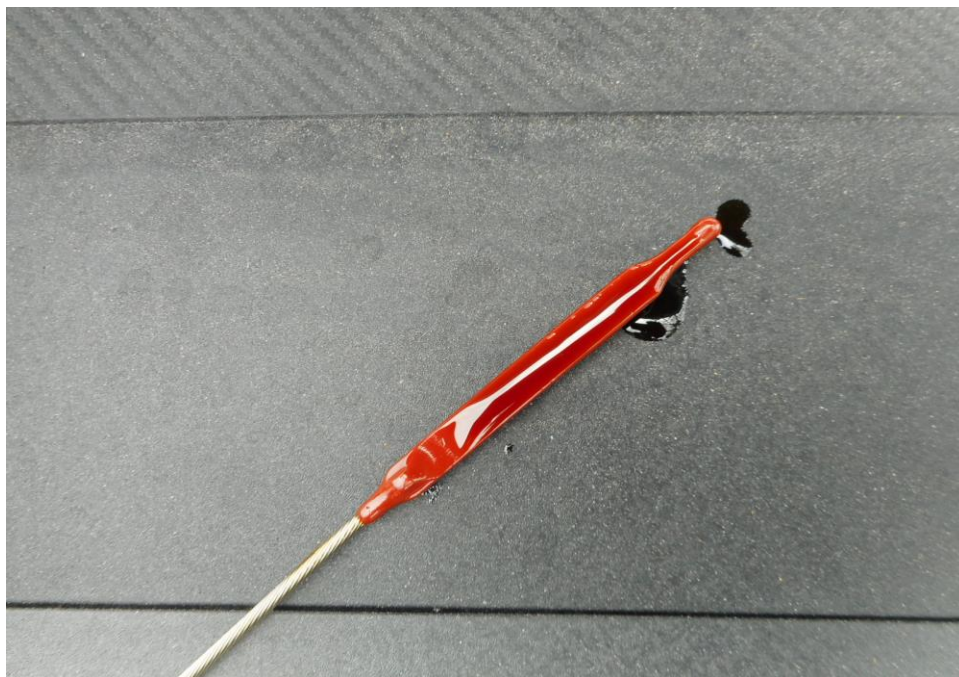
**Photo 14** shows the engine oil dip stick of the Motor Car at the time of my inspection. The engine oil was observed to be of sufficient level and without any visible contamination.

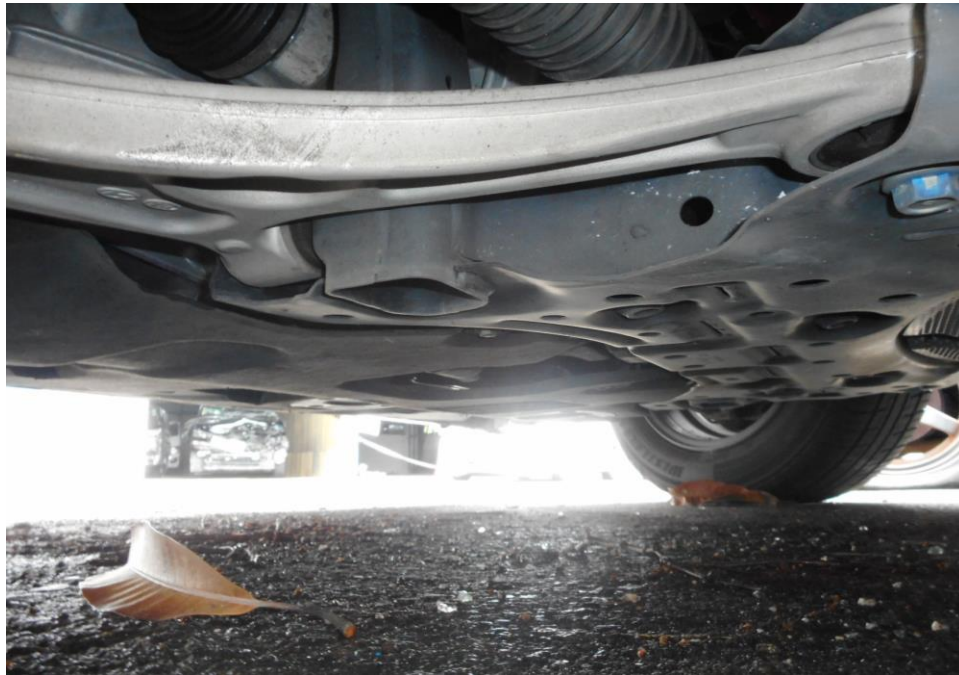
**Photo 15** shows the undercarriage of the Motor Car, at the area where the engine housing and transmission housing are located. I did not find any sign(s) or indication(s) of fluid leak and/or fluid stain(s) on the underside of the Motor Car.

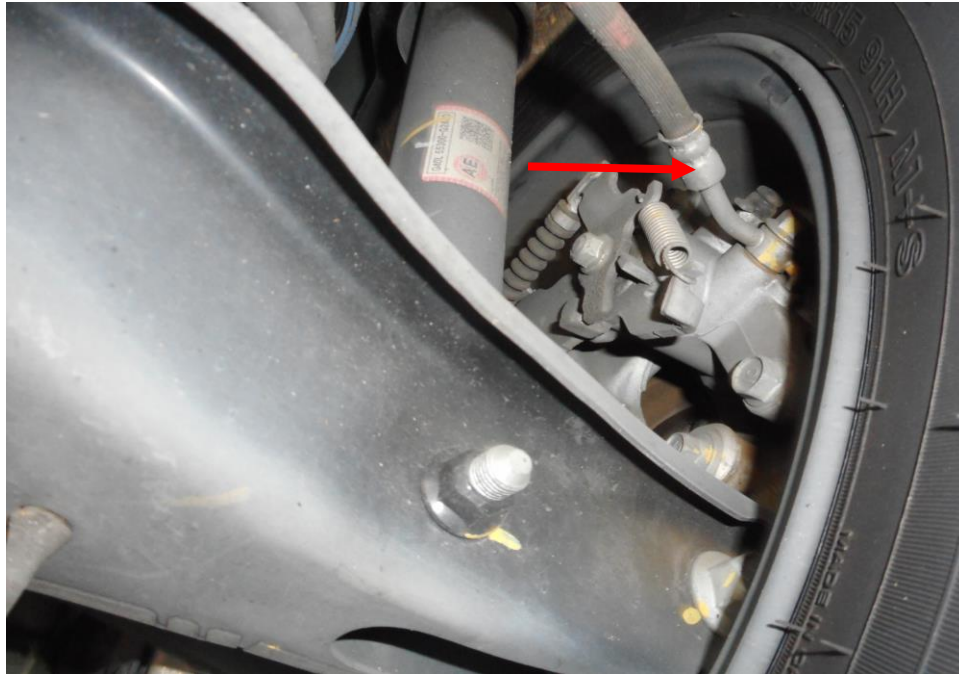
**Photo 16** shows the brake hose/pipe (arrowed) at the rear right wheel of the Motor Car. No leakage of brake fluid was observed. Visual examination of the various components of the braking system like the drum brake, brake booster, brake pedal etc. had revealed all to be intact and without visible damage.

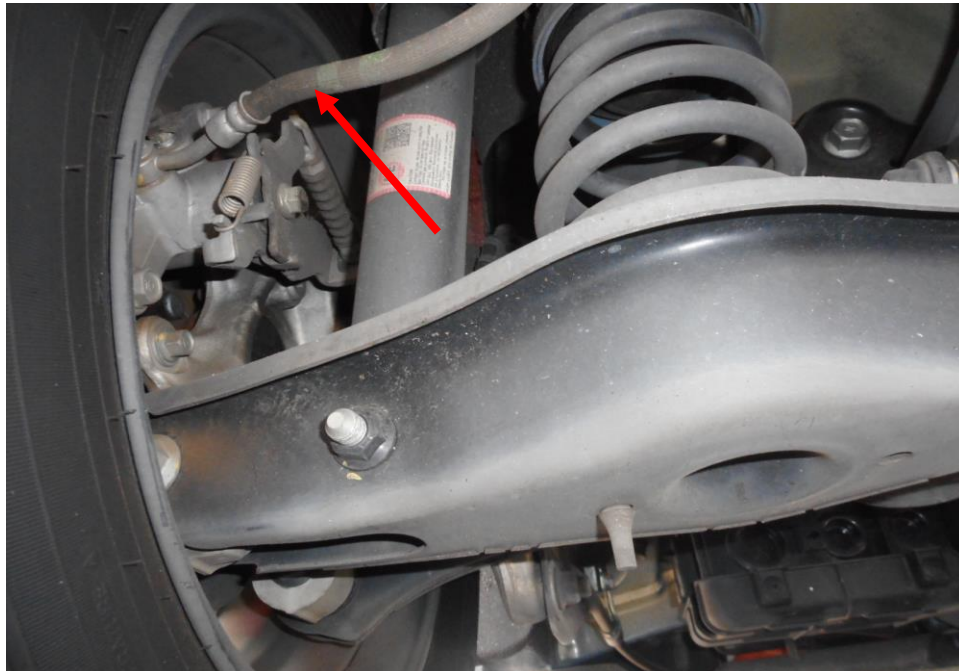
**Photo 17** shows the brake hose/pipe (arrowed) at the rear left wheel of the Motor Car. I did not observe any leakage of brake fluid at the time of my inspection of the Motor Car. Static tests of the Motor Car's braking system had indicated that there was no internal leakage of pressure/vacuum. The undercarriage components of the Motor Car were also all found to be intact and without any visible damage.

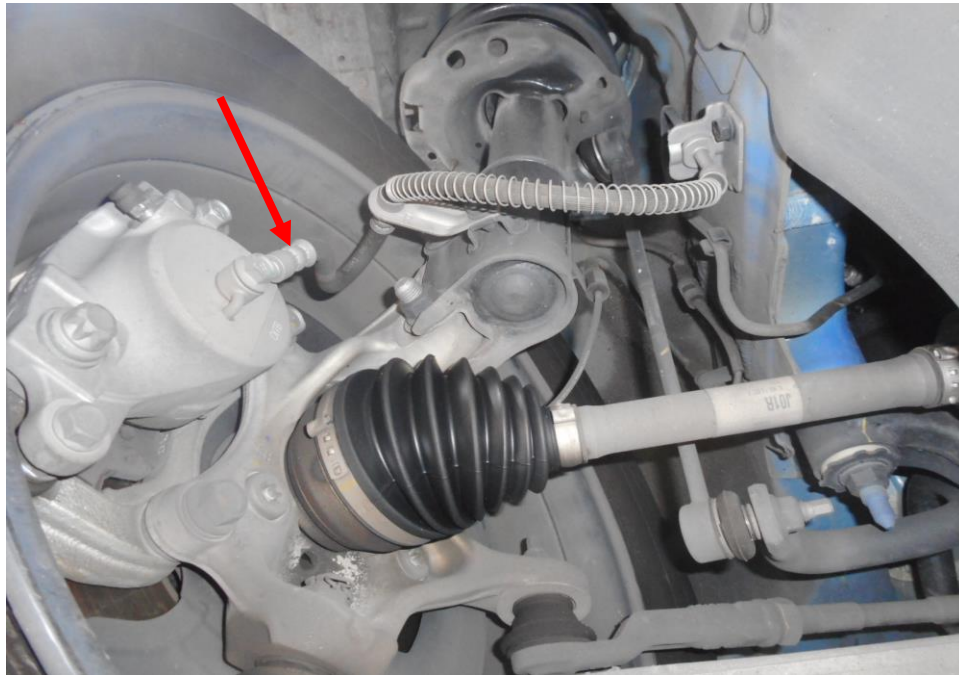
**Photo 18** shows the brake hose/pipe (arrowed) at the front right wheel of the Motor Car. I did not observe any leakage of brake fluid at the time of my inspection of the Motor Car. Static tests of the Motor Car's braking system had indicated that there was no internal leakage of pressure/vacuum. The undercarriage components of the Motor Car were also all found to be intact and without any visible damage.

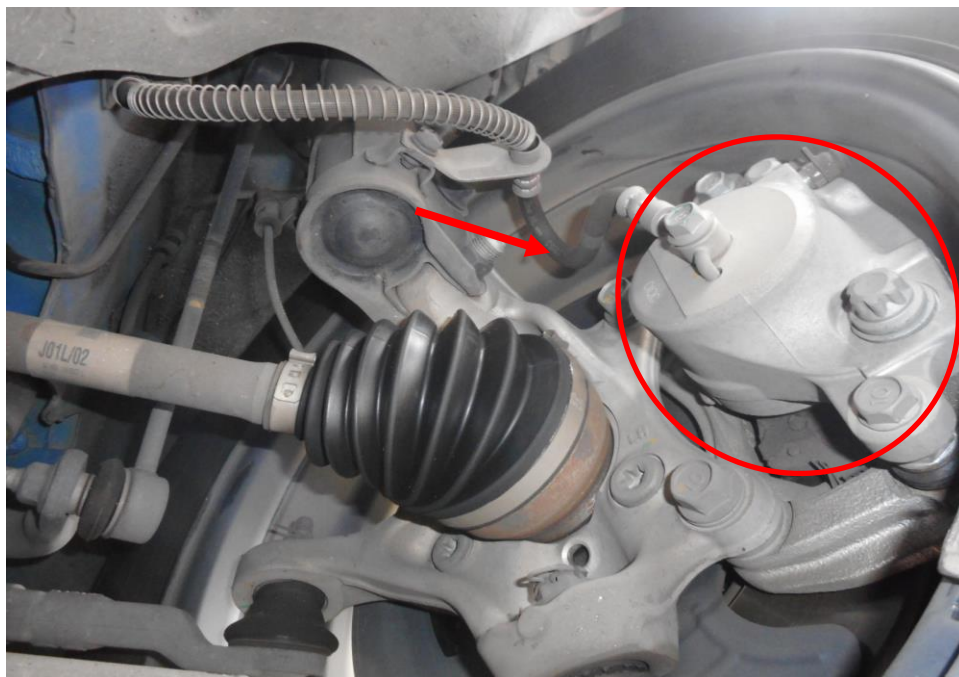
**Photo 19** shows the brake hose/pipe (arrowed) at the front left wheel of the Motor Car. No leakage of brake fluid was observed. Visual examination of the various components of the braking system like the brake caliper (circled), brake booster, brake pedal etc had revealed all to be intact and without visible damage.

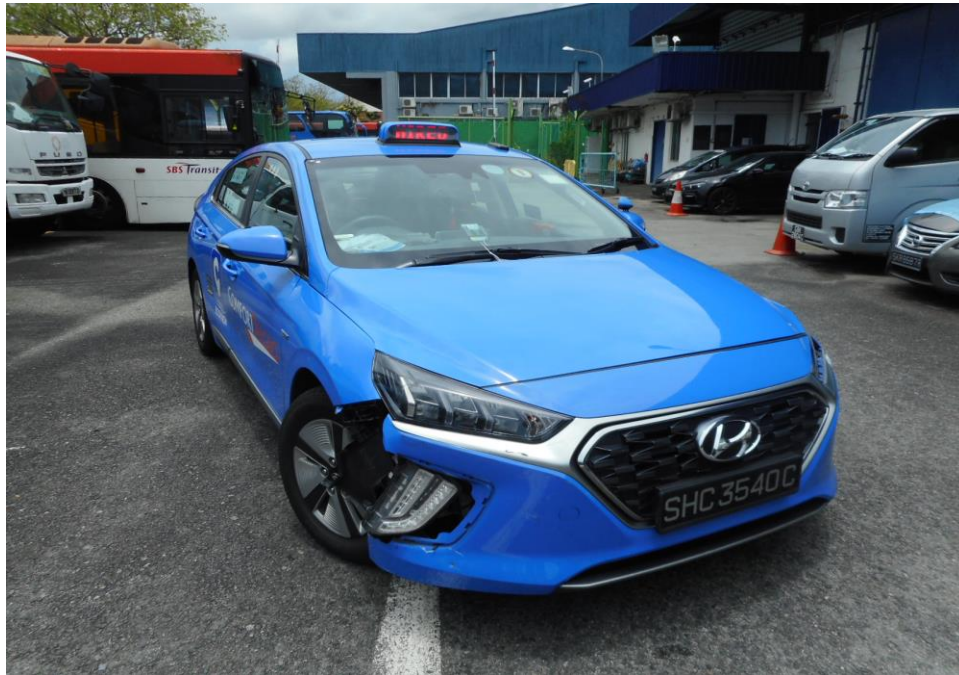
**Photo 20** shows the front right wheel of the Motor Car turned to its full left. During my steering system test, I did not experience any abnormal free play and/or resistance when I had turned the steering wheel towards the left and right. This would suggest that the steering system of the Motor Car was likely to be in serviceable condition at the material time of accident.

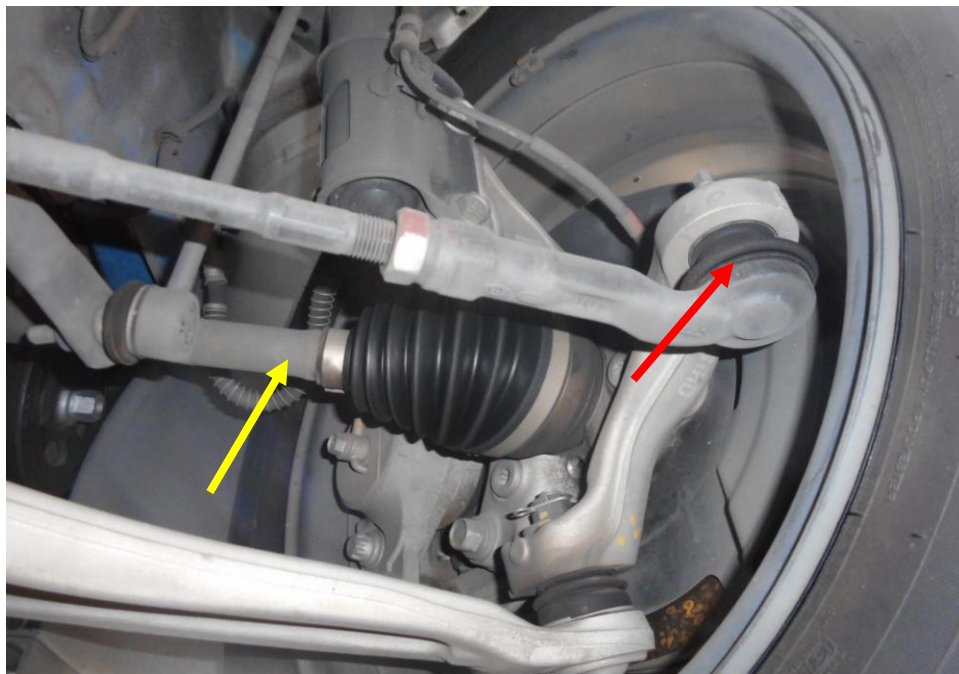
**Photo 21** shows the various undercarriage components at the front right wheel of the Motor Car, in particular the steering tie rod (red arrow) and drive shaft (yellow arrow). The various steering components were all found to be intact, suggesting that the steering system of the Motor Car was likely to be in serviceable condition at the material time of accident. There was also no sign of fluid stain observed on the various undercarriage components at the front right wheel of the Motor Car.

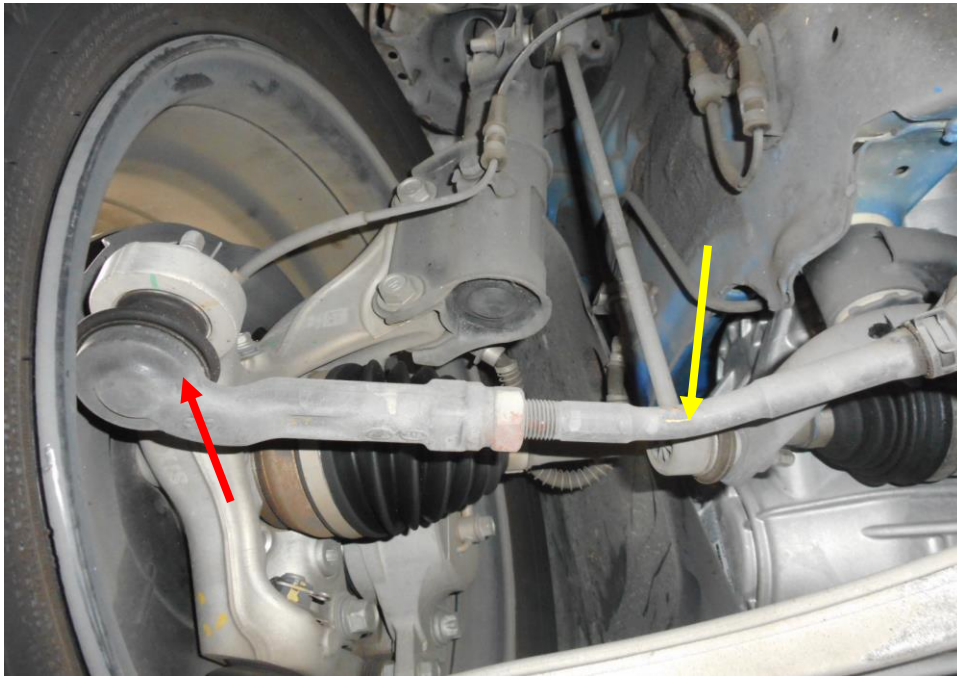
12. Static test on the steering system of the Motor Car also revealed no abnormality to the steering system. I did not experience any abnormal free play and/or other resistance when turning the steering wheel left and right to full lock positions. My visual examination of the various steering components which had included the steering rack and pinion, tie rods, tie rod ends and ball joints revealed that these components were all generally in good condition. However, the front left tie rod was observed to sustained damaged and was bent as a result as the accident. See photo 16 - 22 below.

**Photo 22** shows the various undercarriage components at the front left wheel of the Motor Car, which had included the steering tie rod (red arrow). The tie rod (yellow arrow) was observed to be damaged a bent as a result of the accident.

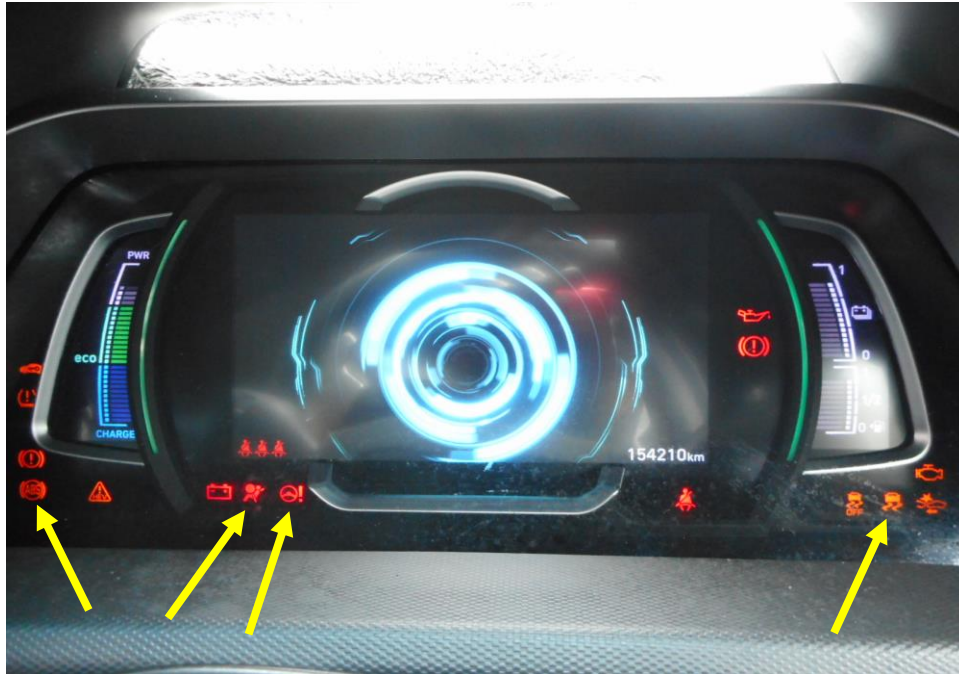
**Photo 23** shows the warning light for Anti-Lock Brake System (ABS) and Power Steering System (EPS), Supplemental Restraint System (SRS) and Traction Control (TC) (arrowed) appearing on the instrument panel of the Motor Car during the self-test of its various electronic operating systems when its engine was cranked.

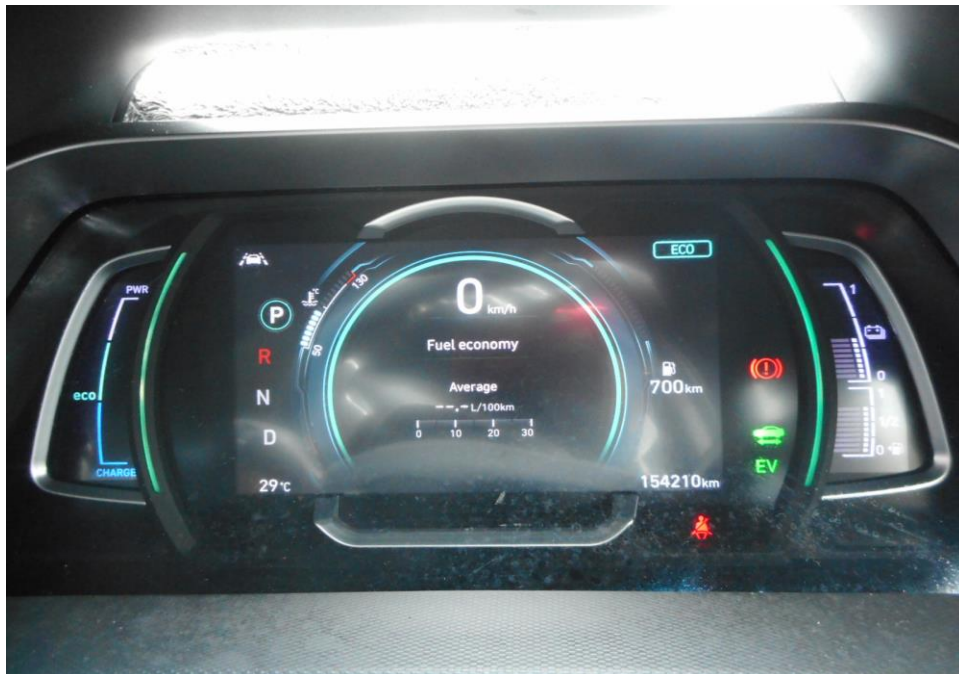
**Photo 24** shows no warning lights illuminated on the instrument panel of the Motor Car after the engine was cranked. This would suggest that there was no abnormality to the electronic operating system of the Motor Car, like the ABS, EPS, SRS, and TC etc.
