Your Ref: TP/IP/12719/2021  
Our Ref : CI/TPD21003845/P

26<sup>th</sup> March 2021

**MECHANICAL INSPECTION REPORT OF MOTOR LORRY YM 8290L**

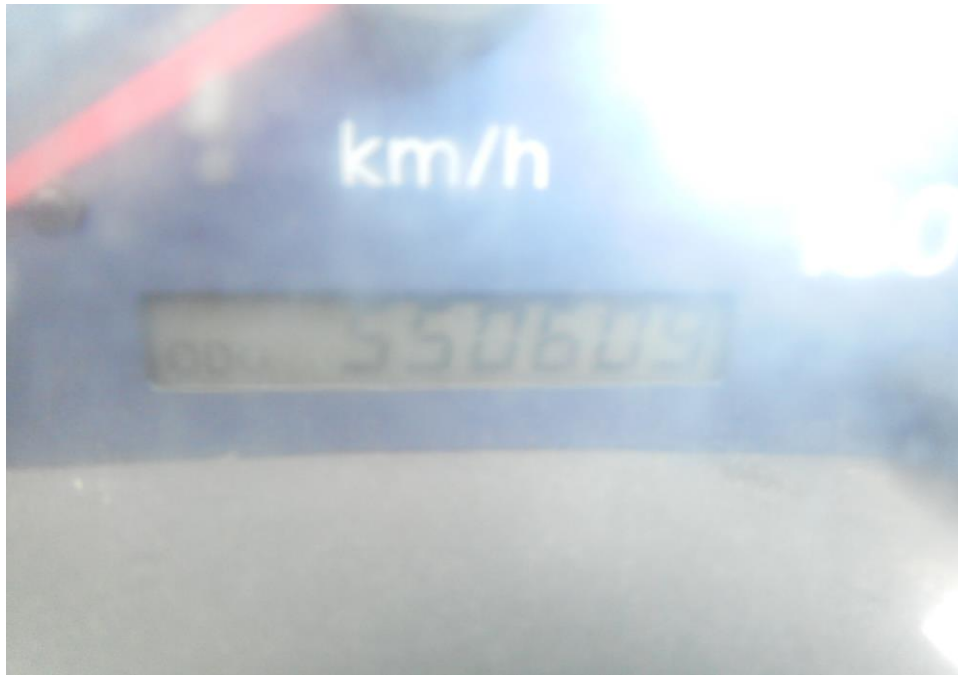
**Photo 1** shows a general view of the instrument cluster of the Motor Lorry at the time of my inspection. The mileage of the Motor Lorry was 550,609 km

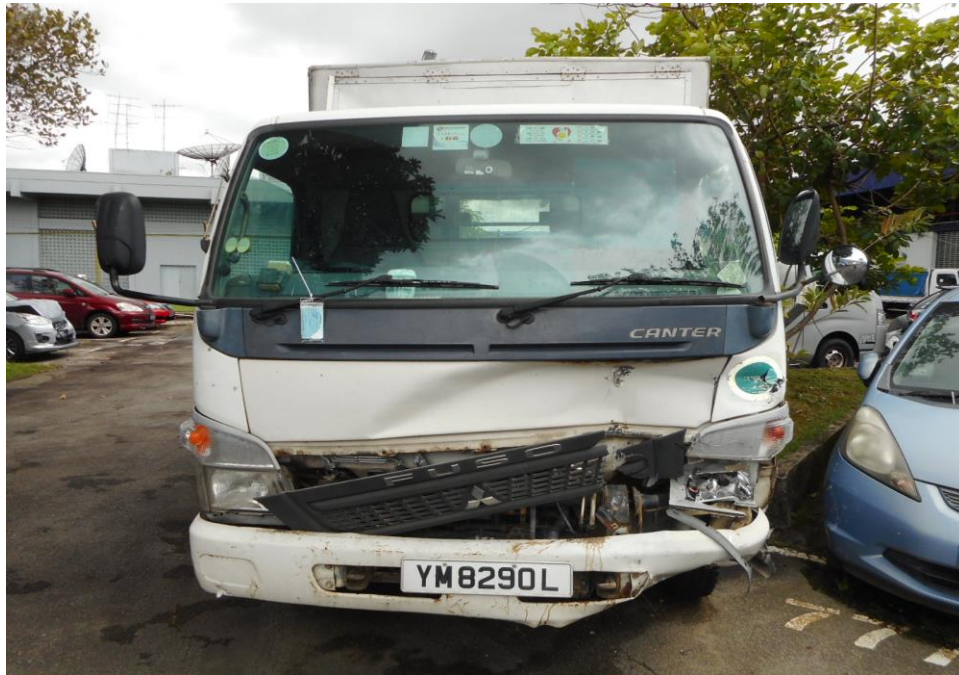
4. The mileage of the Motor Lorry at the time of my inspection was 550,609km.
5. The Motor Lorry appeared to have sustained damage at its frontal portion. Its front body panel, front bumper and front left headlamp were damaged at the time of my inspection.

**Photo 2** shows a general view of the Motor Lorry's frontal portion at the time of my inspection. It appeared to have sustained damage at its frontal portion. Its front body panel, front bumper and front left headlamp were damage at the time of my inspection as a result of the accident.

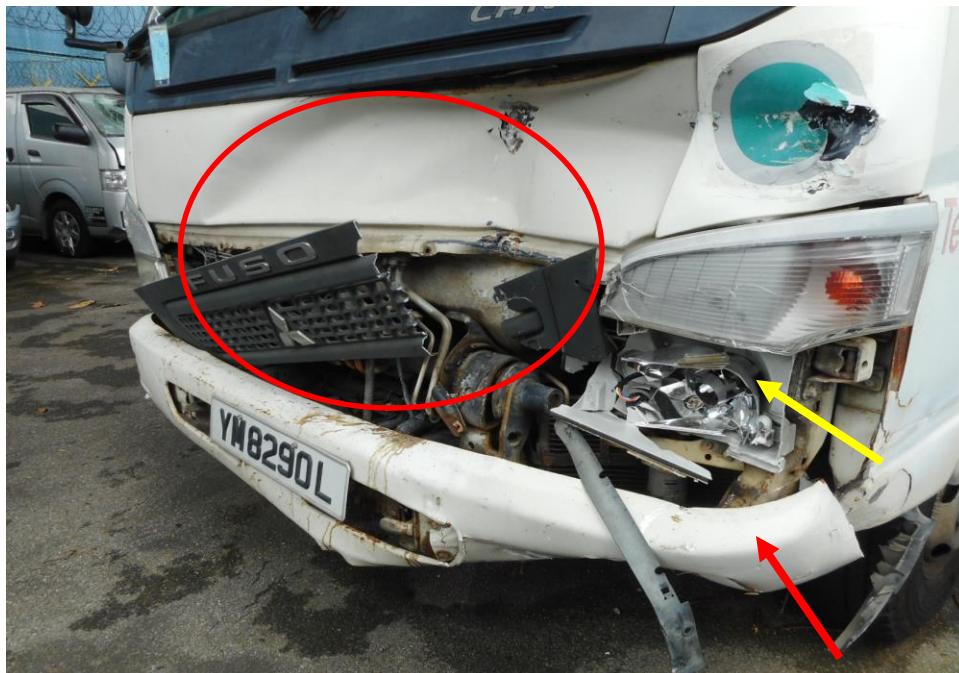
**Photo 3** shows a close up view of the Motor Lorry's frontal portion at the time of my inspection. It appeared to have sustained damage at its frontal portion. Its front body panel (circled), front bumper (red arrow) and front left headlamp (yellow arrow) were damage at the time of my inspection.as a result of the accident.

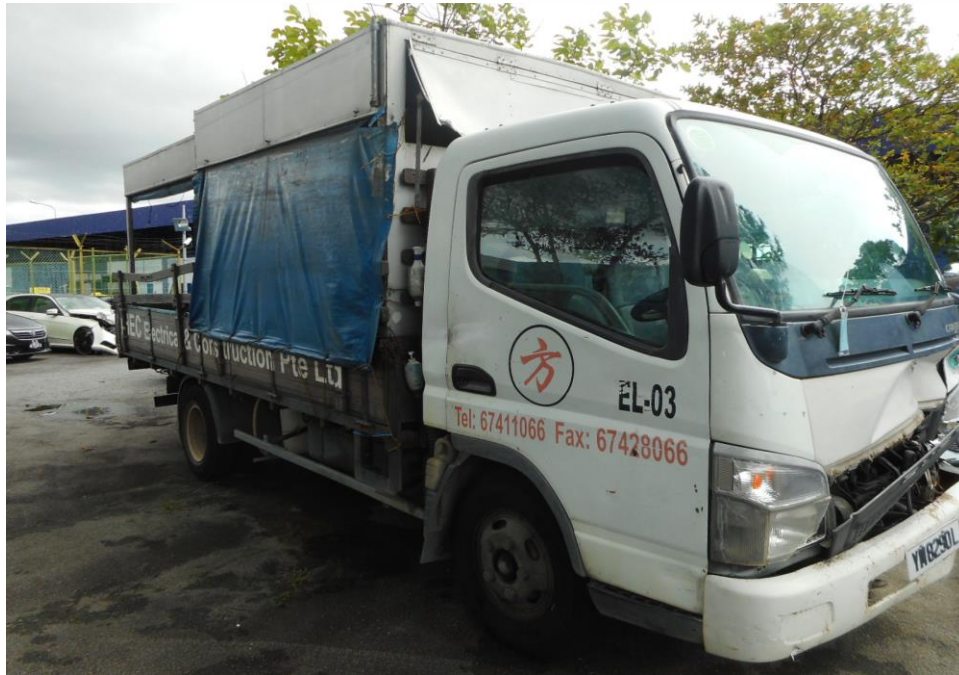
**Photo 4** shows a general view of the right body of the Motor Lorry at the time of my inspection. The Motor Lorry was observed to be intact and unaffected by the accident.

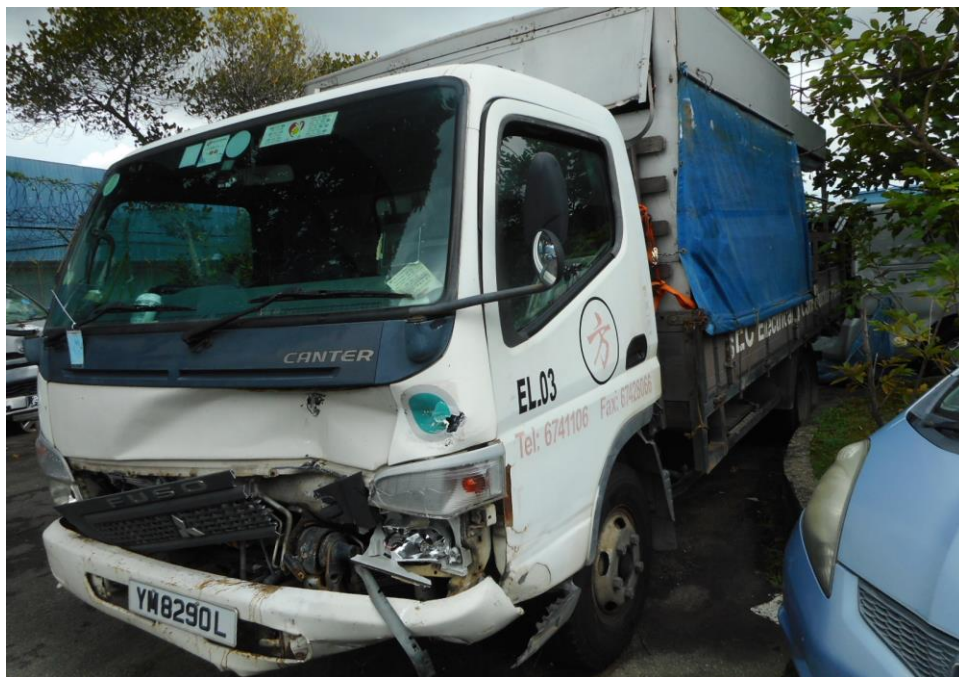
**Photo 5** shows a general view of the left body of the Motor Lorry at the time of my inspection. The Motor Lorry was observed to be intact and unaffected by the accident.

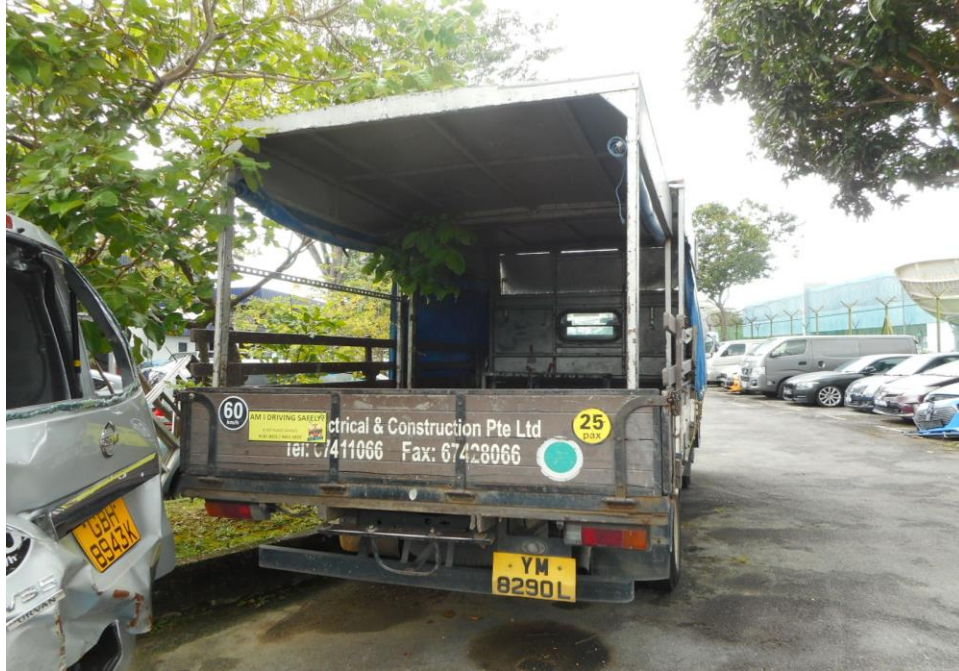
**Photo 6** shows a general view of the rear body of the Motor Lorry at the time of my inspection. The Motor Lorry was observed to be intact and unaffected by the accident.

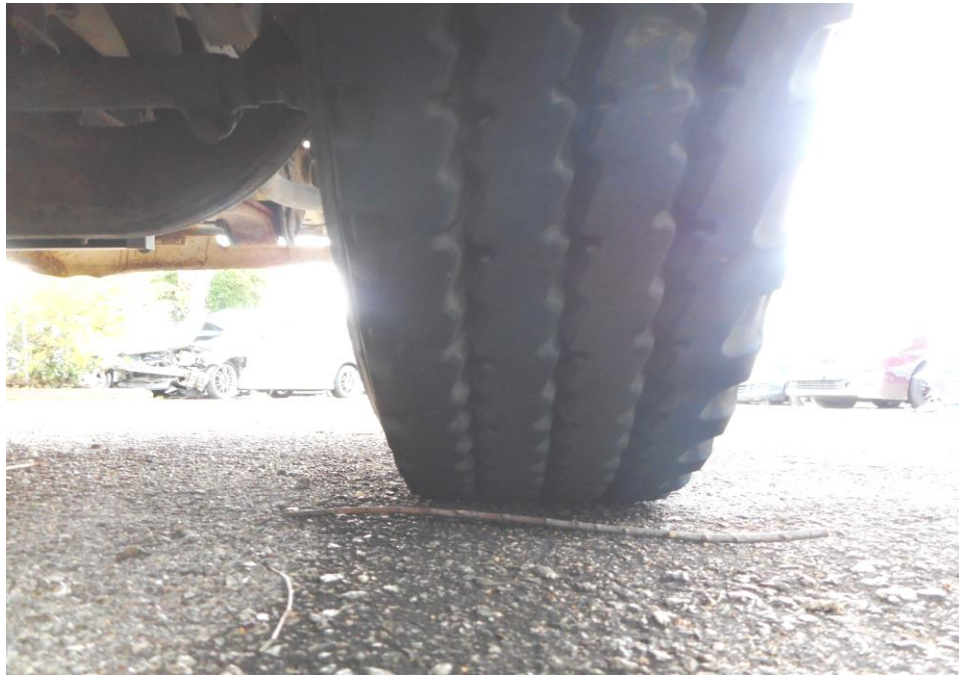
**Photo 7** shows the condition of the front right tyre of the Motor Lorry, which was observed to be in serviceable condition with remaining tread depth of approximately 11.4mm. The tyre, which was wrapped around standard steel wheel rim, was also observed to be sufficiently inflated for vehicular operation. There was no tear, cut or burst mark(s) on the outer and the inner sidewalls as well as across the tread of the 6 tyres that were fitted on the Motor Lorry.

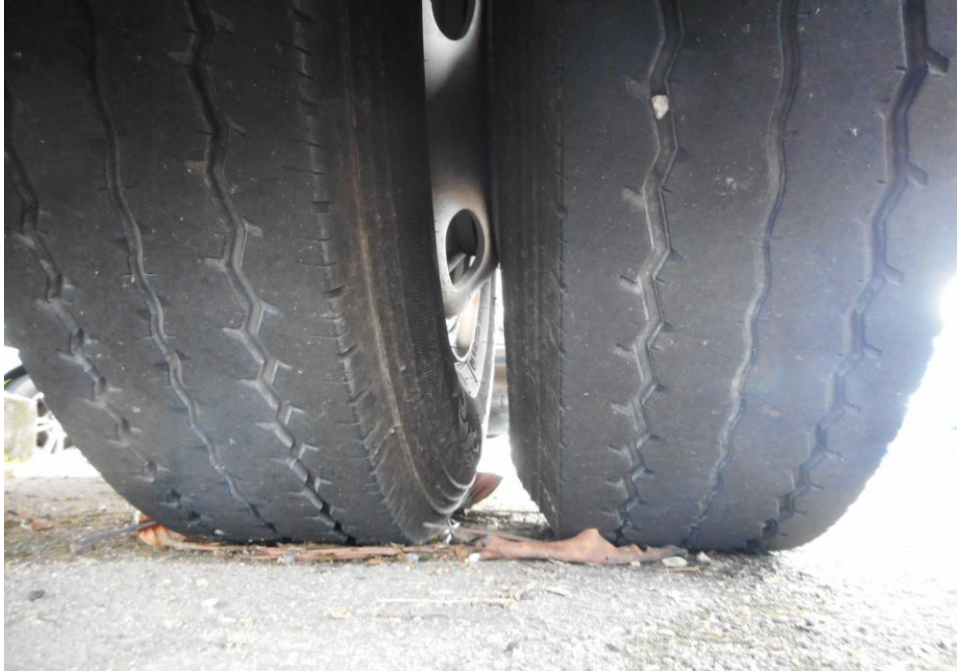
**Photo 8** shows the condition of the rear right tyre of the Motor Lorry, which was observed to be in serviceable condition with remaining tread depth of approximately 3.3mm. The tyre, which was wrapped around standard steel wheel rim, it was observed to be sufficiently inflated for vehicular operation.

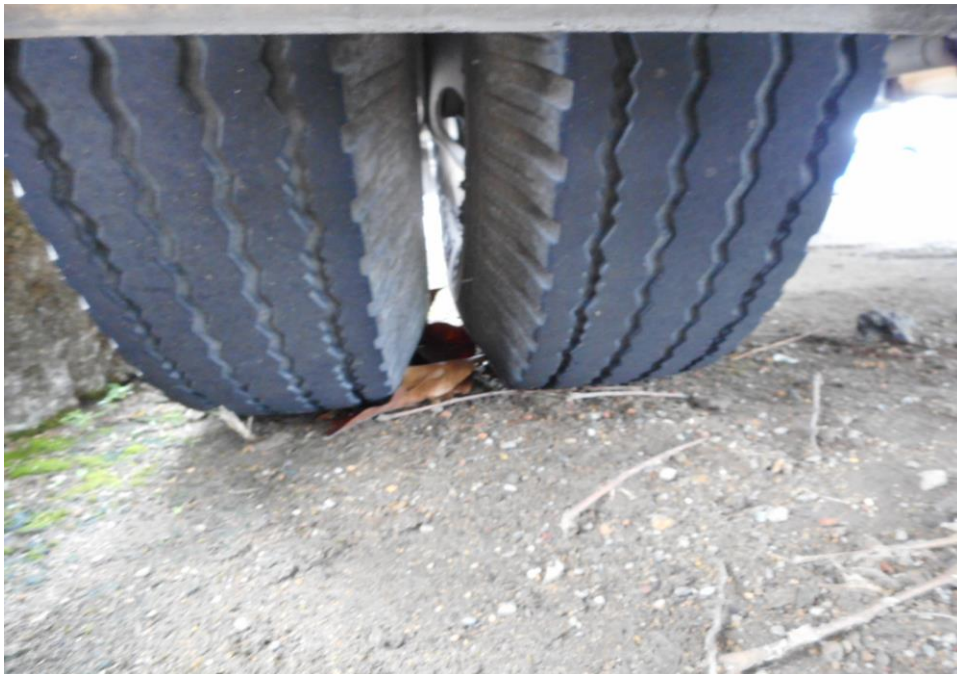
**Photo 9** shows the condition of the rear left tyres of the Motor Lorry, which was observed to be in serviceable condition with remaining tread depth of approximately 4.8mm. The tyres, which were wrapped around standard steel wheel rim, were also observed to be sufficiently inflated for vehicular operation. There was also no damage found on all 6 steel wheel rims of the Motor Lorry.

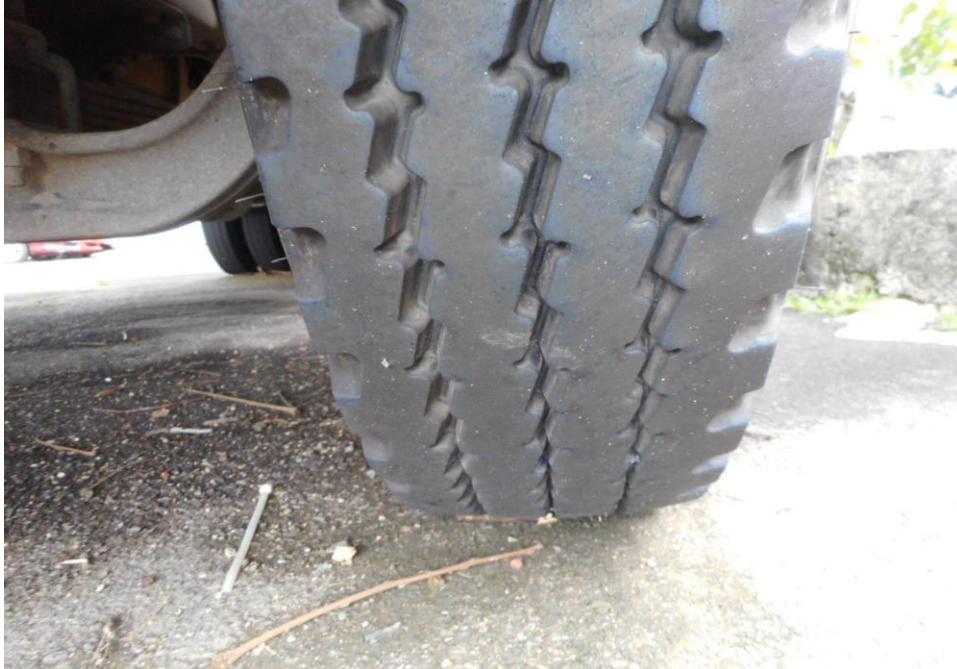
**Photo 10** shows the condition of the rear right tyres of the Motor Lorry, which were observed to be in serviceable condition with remaining, tread depth of approximately 11.4mm. There was also no tear, cut or burst mark(s) on the outer and the inner sidewalls as well as across the tread of the 6 tyres that were fitted on the Motor Lorry.

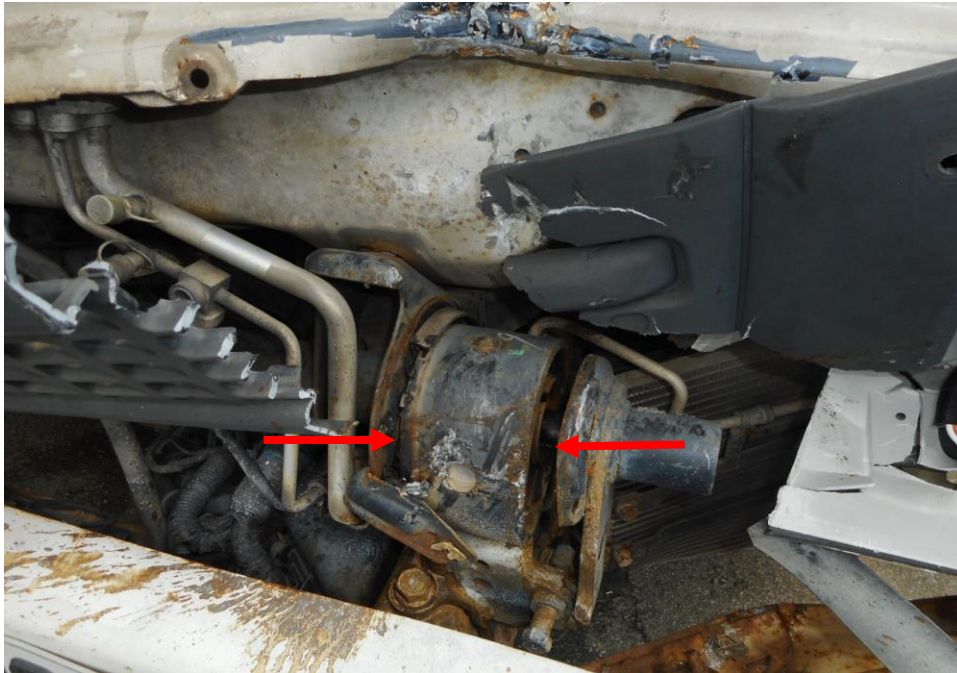
8. Upon examination of the Motor Lorry's engine compartment, we had observed that the parts, components and fluids could not be inspected as due to the damage induced has jam the cabin of the Motor Lorry which immobilized its opening and viewing, however we are able to observe the brake fluid reservoir of the Motor Lorry and it was observed to be of insufficient level.
9. My subsequent checks on the underside of the Motor Lorry also revealed no fluid stain. Visually, the various undercarriage components of the Motor Lorry were all observed to be intact and without any visible damage. See photo 11 – 13 below.

**Photo 11** shows the induced damage that had jam the cabin of the Motor Lorry's and immobilised the opening and viewing (arrowed) of the various parts and components inside the engine compartment, a result of the accident.

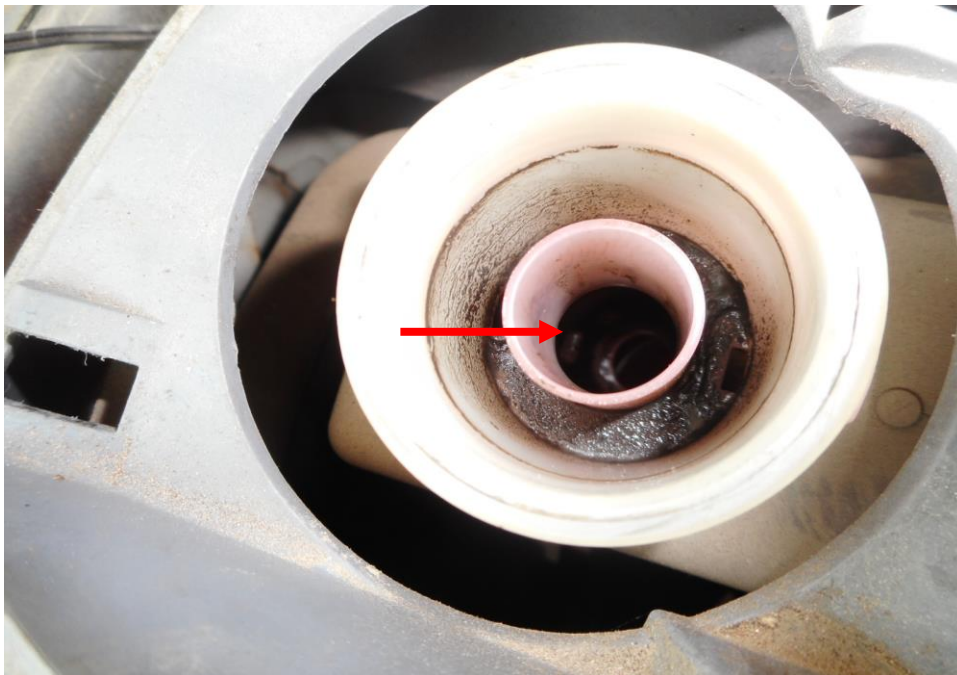
**Photo 12** shows the brake fluid reservoir of the Motor Lorry at the time of my inspection. The brake fluid was observed to be of sufficient level (arrowed).

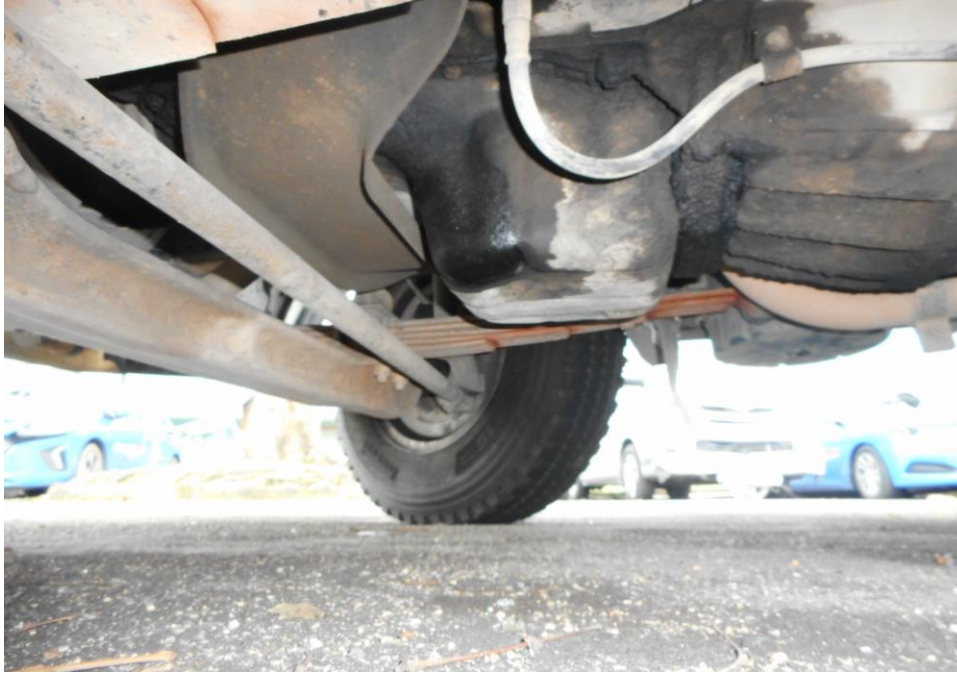
**Photo 13** shows the undercarriage of the Motor Lorry, at the area where the engine housing and transmission housing are located. I did observed old engine fluid stain(s) on the underside of the Motor Lorry.

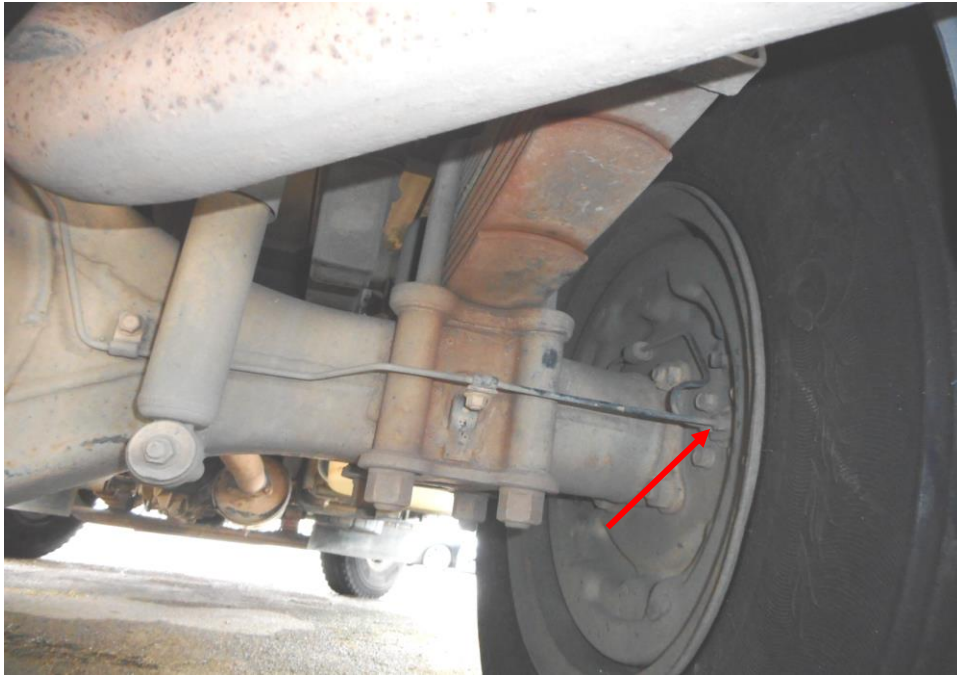
**Photo 14** shows the brake pipe (arrowed) at the rear right wheel of the Motor Lorry. I did not observe any leakage of brake fluid at the time of my inspection of the Motor Lorry.

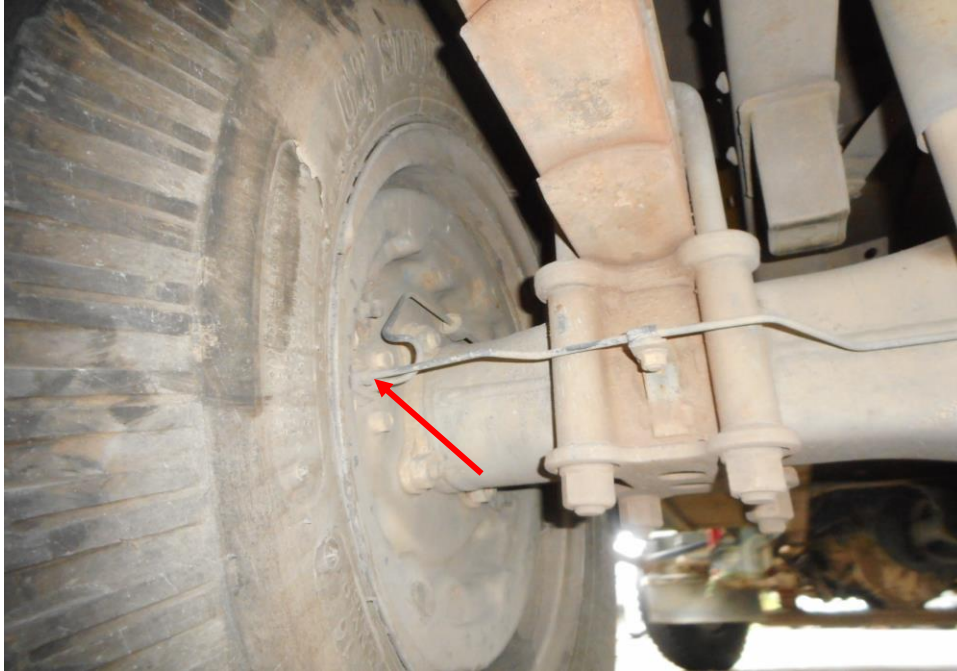
**Photo 15** shows the brake pipe (arrowed) at the rear left wheel of the Motor Lorry. I did not observe any leakage of brake fluid at the time of my inspection of the Motor Lorry.

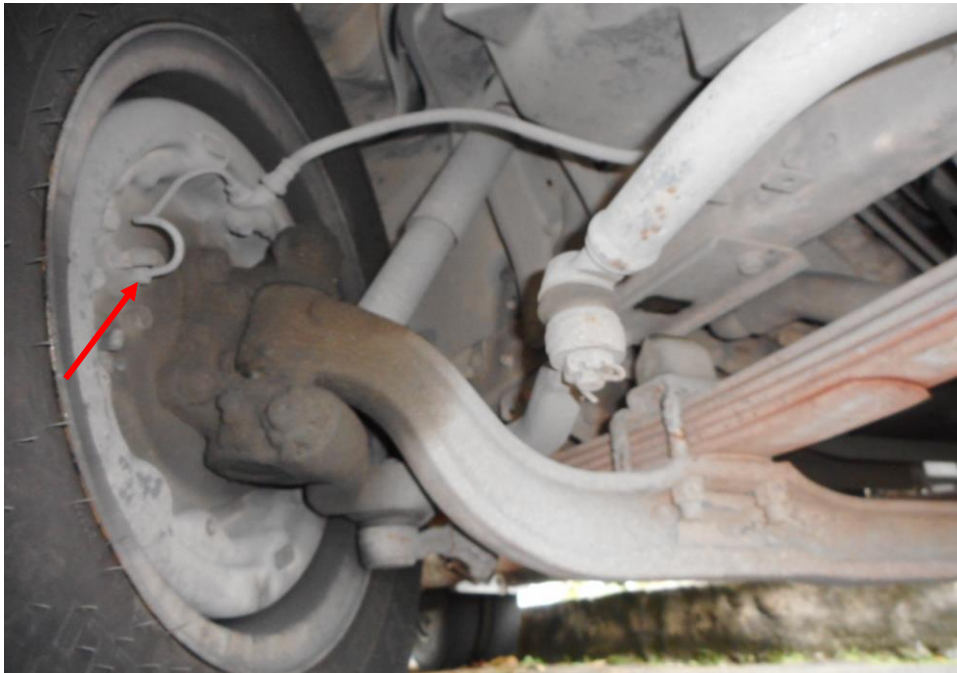
**Photo 16** shows the brake hose/pipe (arrowed) at the front right wheel of the Motor Lorry. No leakage of brake fluid was observed. Visual examination of the various components of the braking system like the brake drum (circled), brake pedal etc had revealed all to be intact and without visible damage at the time of accident. There was also no sign of fluid stain(s) observed on the various undercarriage components.

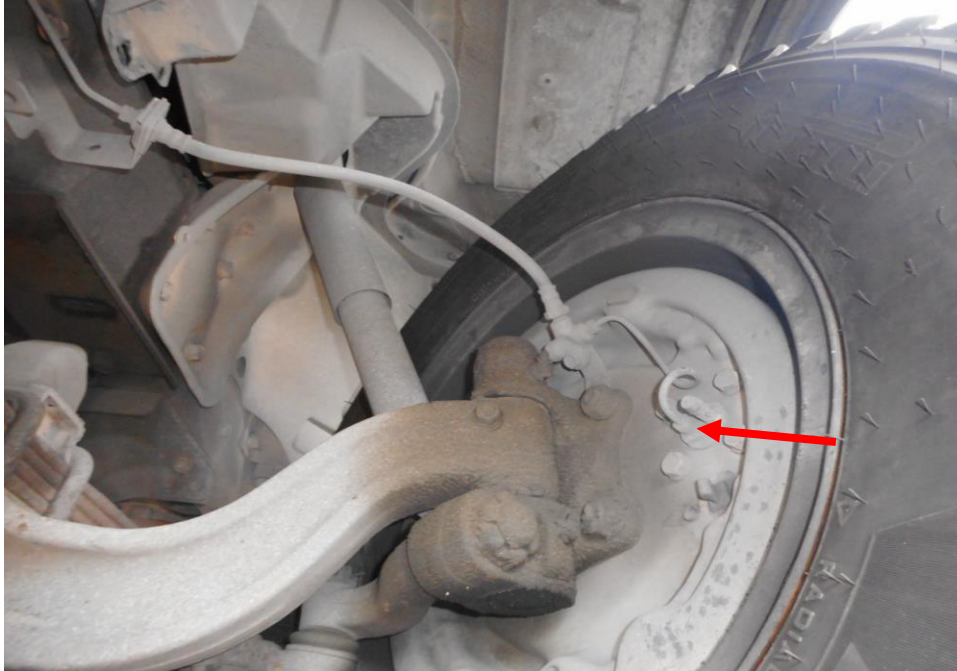
**Photo 17** shows the brake hose/pipe (arrowed) at the front left wheel of the Motor Lorry. No leakage of brake fluid was observed. Visual examination of the various components of the braking system like the brake drum (circled), brake pedal etc had revealed all to be intact and without visible damage at the time of accident. There was also no sign of fluid stain(s) observed on the various undercarriage components.

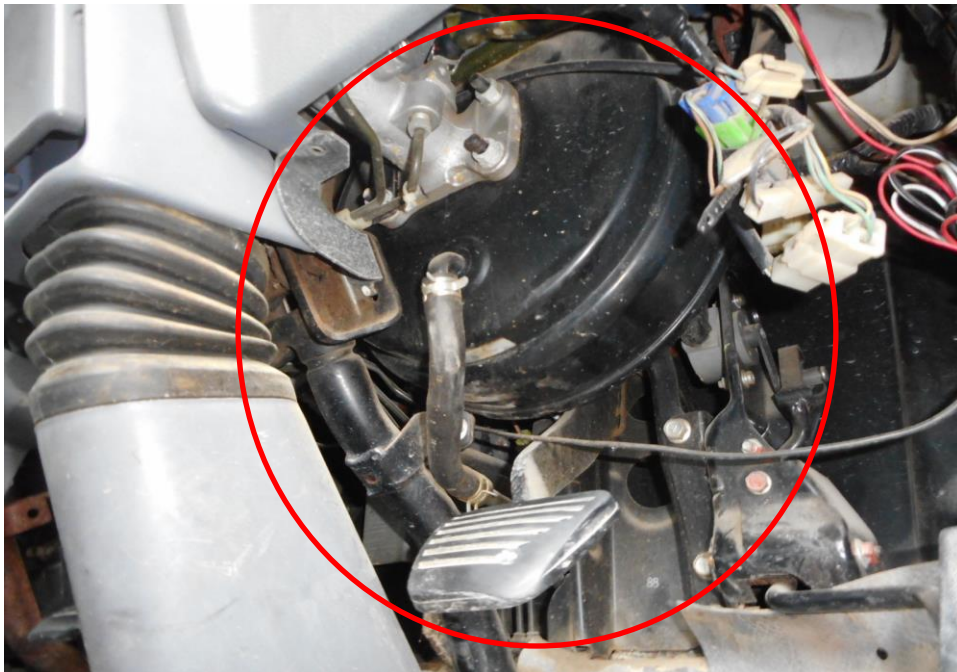
10. Static brake tests conducted on the Motor Lorry revealed abnormality. The brake booster do not responded well to the various tests conducted as there was abnormal movement of the brake pedal when it was depressed.
11. In general, the static brake tests had suggested that there was internal leakage of pressure/vacuum in the braking system of the Motor Lorry and braking system of the Motor Lorry was likely to be unserviceable condition at the material time. This was also taking into consideration that the brake fluid was of sufficient level, and also that there was no sign(s) of brake fluid leakage along the brake hoses and brake pipes. This was likely the cause that had resulted in the accident of the Motor Lorry.

**Photo 18** shows the brake booster (arrowed) of the Motor Lorry. No leakage of brake fluid was observed. Visual examination of the various components of the brake booster had revealed all to be intact and without visible damage at the time of inspection. There was also no sign of fluid stain(s) observed on the various undercarriage components.

17. We were able to determine that there was internal leakage of pressure/vacuum in the braking system of the Motor Lorry and the braking system of the Motor Lorry was likely to be unserviceable condition at the material time. As this was also taking into consideration that there was no damaged the exterior casing of the brake booster and brake fluid was of sufficient level, also that there was no sign(s) of brake fluid leakage along the brake hoses and brake pipes. This abnormality to the braking system of the Motor Lorry had likely caused the accident.

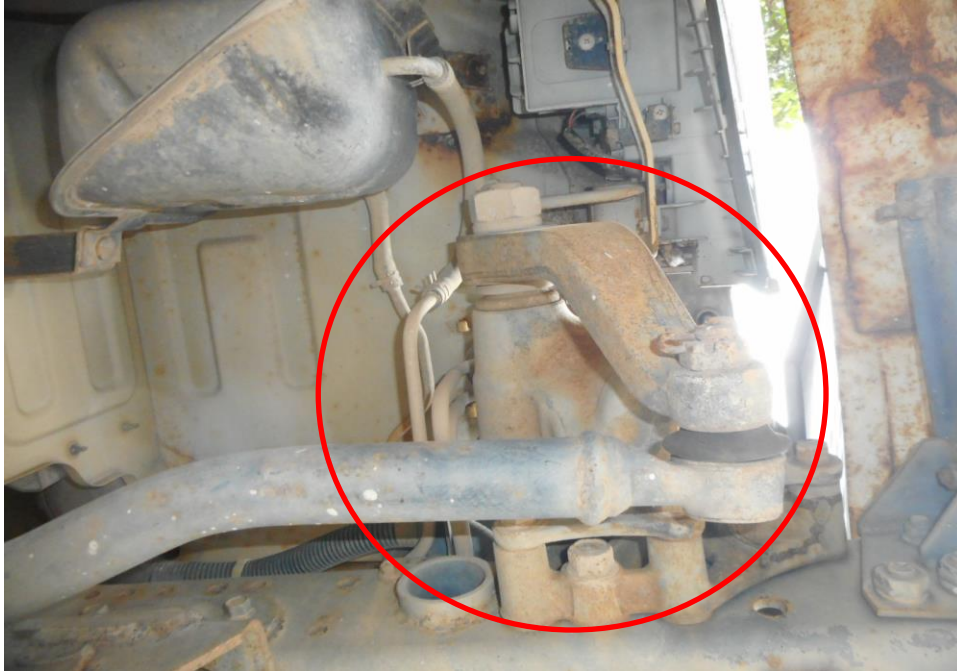
**Photo 19** shows a general view of the steering box (circled) of the Motor Lorry at the time of my inspection. The steering box was observed to be unaffected by the accident.

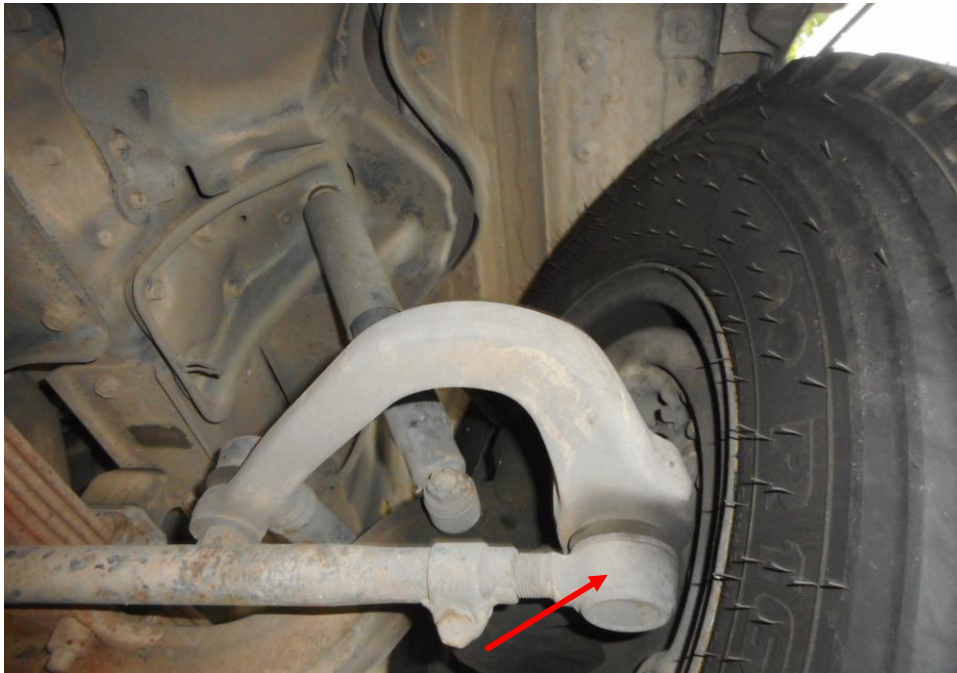
**Photo 20** shows the various undercarriage components at the front right wheel of the Motor Lorry, in particular the steering tie rod end (arrowed). The various steering components were all found to be intact, suggesting that the steering system of the Motor Lorry was likely to be in serviceable condition at the material time of accident. There was also no sign of fluid stain(s) observed on the various undercarriage components.

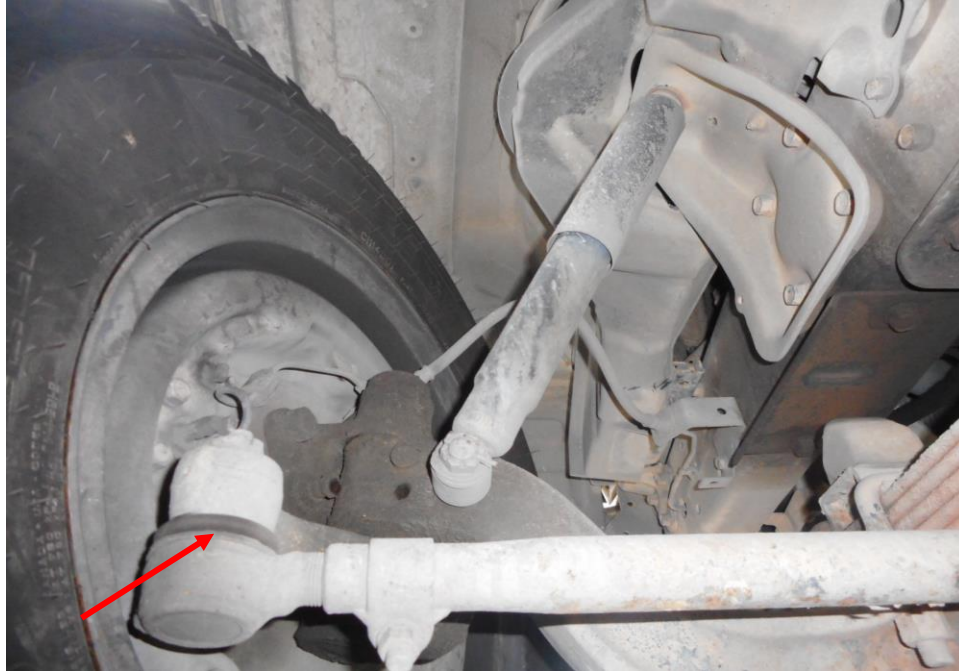
**Photo 21** shows the various undercarriage components at the front left wheel of the Motor Lorry, in particular the steering tie rod end (arrowed). The various undercarriage components of the Motor Lorry were all found to be intact without any visible damage. There was also no sign of fluid stain(s) observed on the various undercarriage components.
