You're Ref: TP/IP/08997/2021  
Our Ref: CI/TPD21003846/P

30<sup>th</sup> March 2021

**MECHANICAL INSPECTION REPORT OF MOTOR CAR SKC 4135Y**

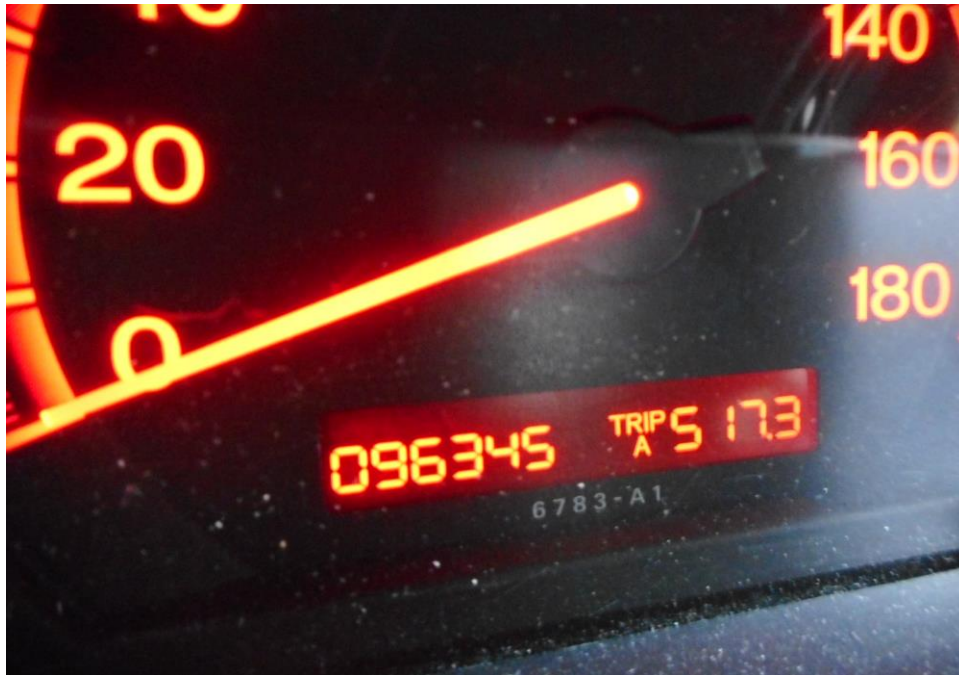
**Photo 1** shows the mileage of the Motor Car at the time of my inspection. The mileage observed was 96,345km.

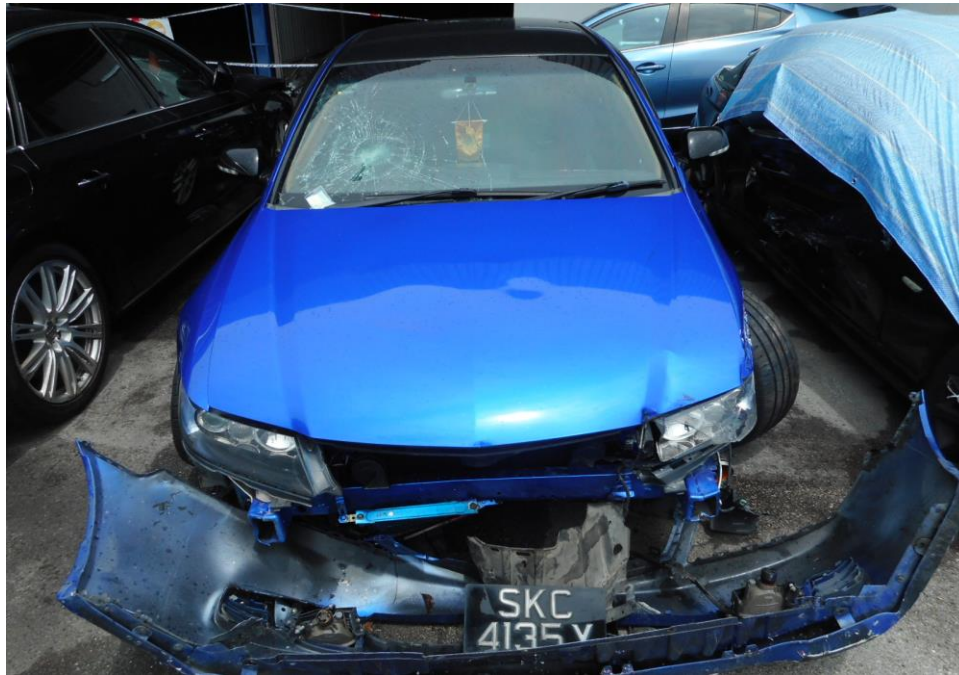
**Photo 2** shows a general view of the Motor Car's front body at the time of my inspection. The front windscreen, front bumper, front left headlamp, front left and right fender was the body parts and various engine components that were damaged as a result of the accident.

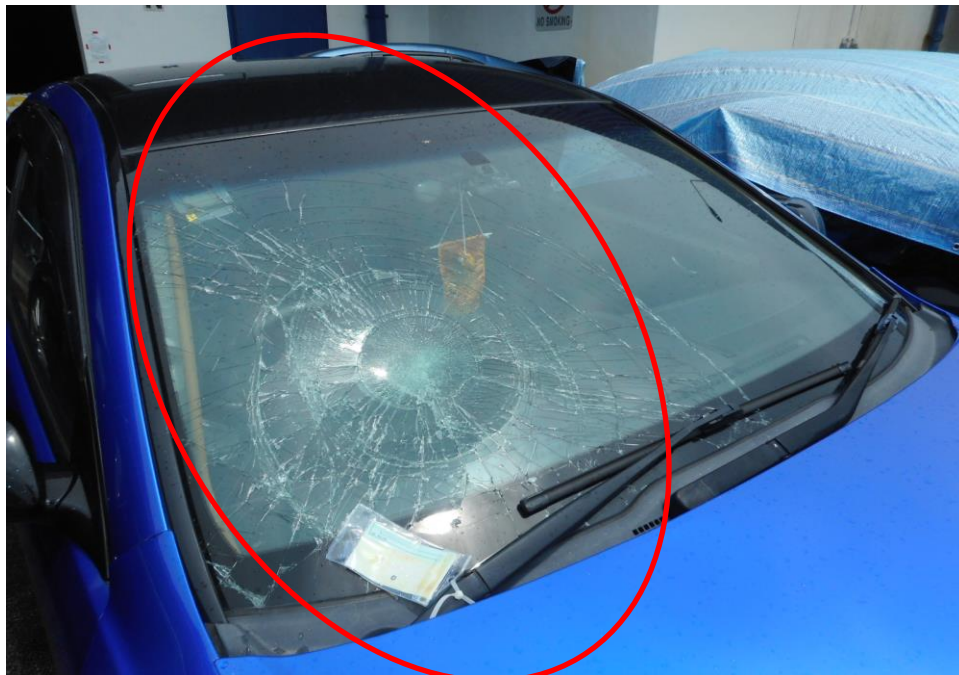
**Photo 3** shows the close up view of the Motor Car's front body at the time of my inspection. The Motor Car was observed to have sustained damage at its front windscreen (circled) as a result of the accident.

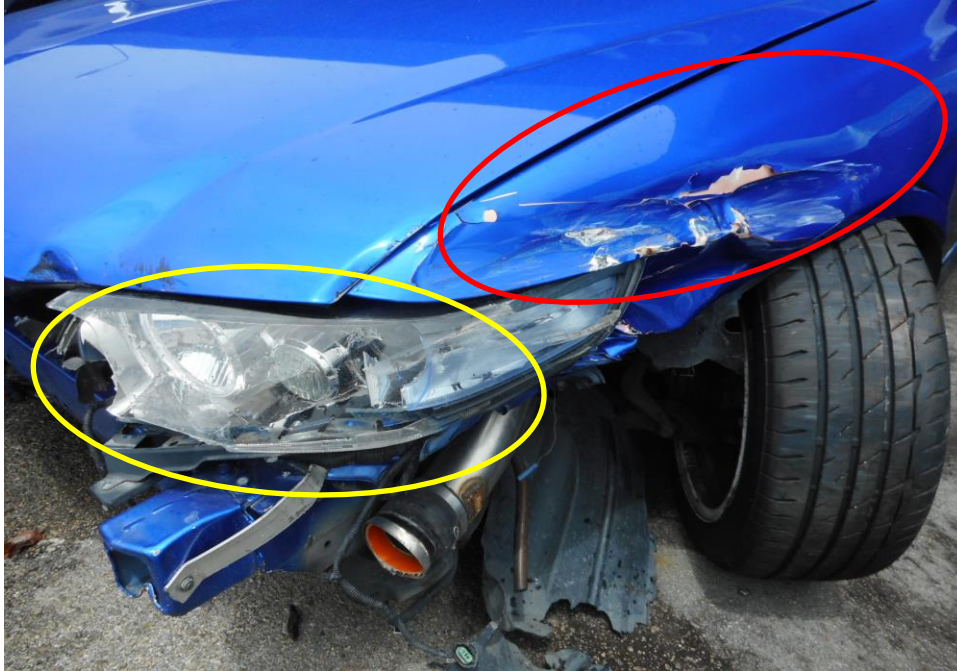
**Photo 4** shows the close up view of the Motor Car's front body at the time of my inspection. The Motor Car was observed to have sustained damage at its front left fender (red circle) and front left headlamp (yellow circle) as a result of the accident.

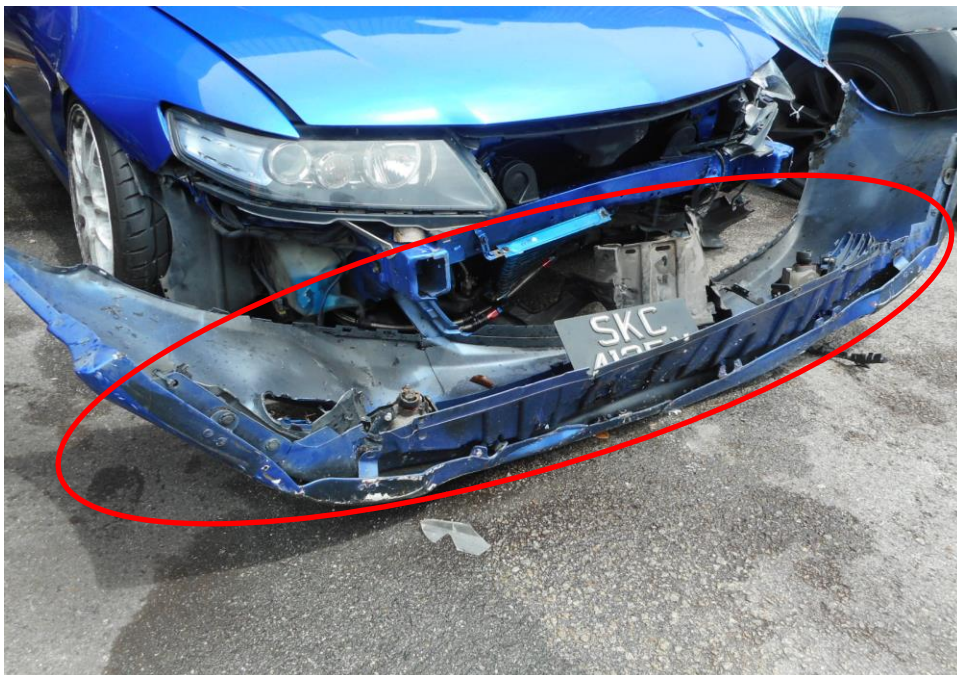
**Photo 5** shows the close up view of the Motor Car's front body at the time of my inspection. The Motor Car was observed to have sustained damage at its front bumper (circled) as a result of the accident.

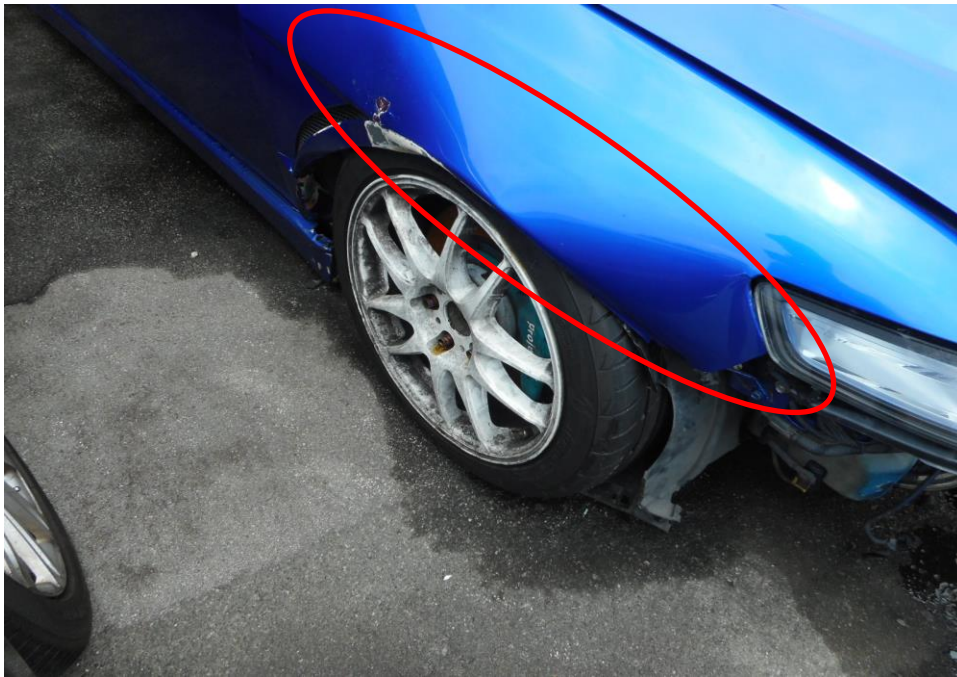
**Photo 6** shows the close up view of the Motor Car's front body at the time of my inspection. The Motor Car was observed to have sustained damage at its front right fender (circled) as a result of the accident.

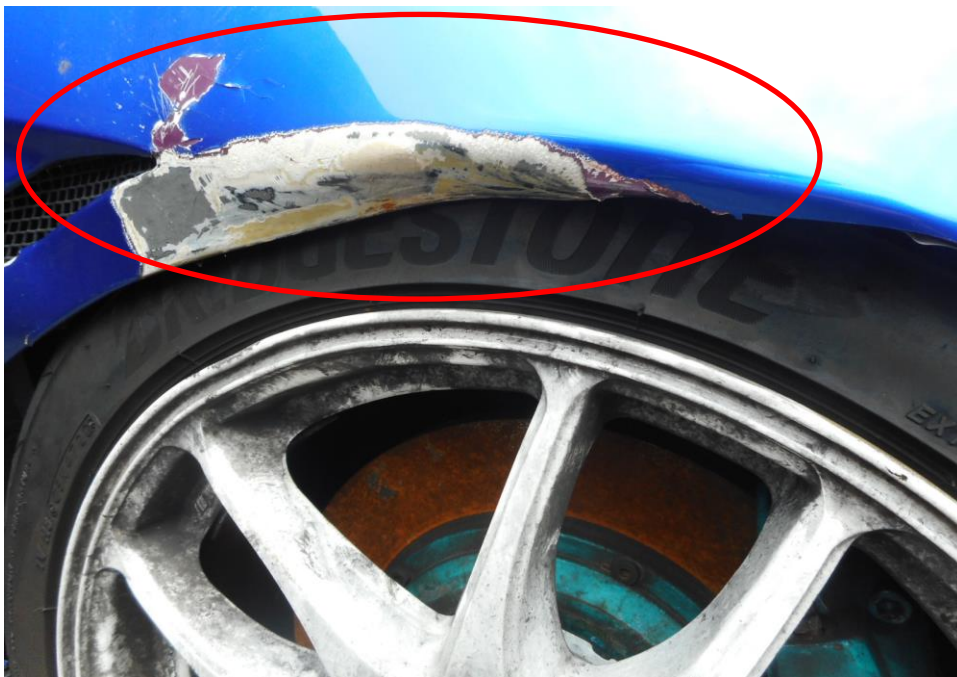
**Photo 7** shows the close up view of the Motor Car's front body at the time of my inspection. The Motor Car was observed to have sustained damage at its front right fender (circled) as a result of the accident.

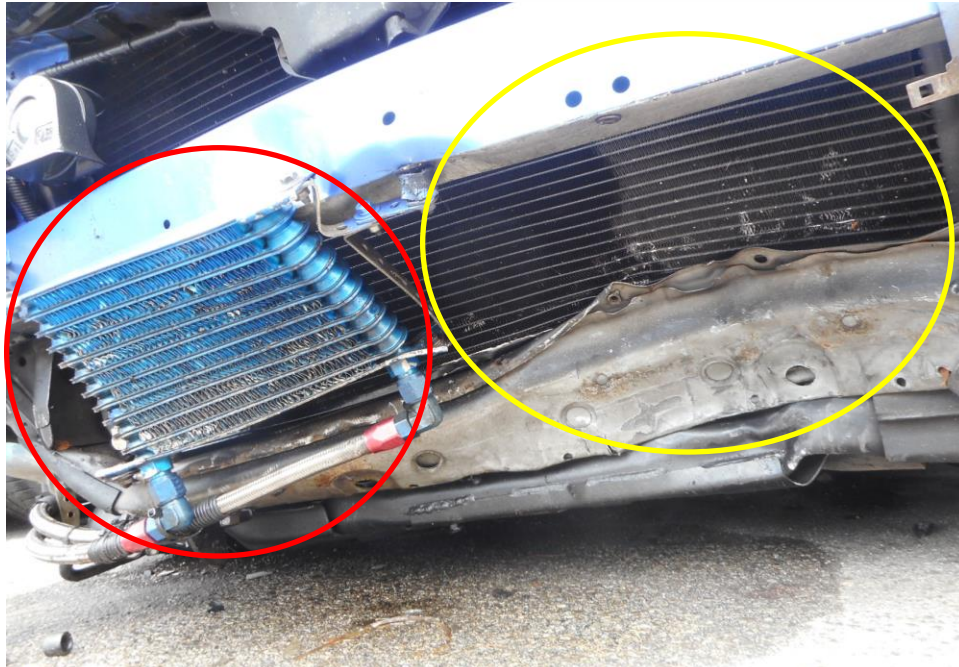
**Photo 8** shows the general view of the Motor Car's front engine at the time of my inspection. The Motor Car was observed to have sustained damage at its engine coolant radiator (yellow circled) and engine oil cooler (red circle) and there was engine oil leakage as a result of the accident.

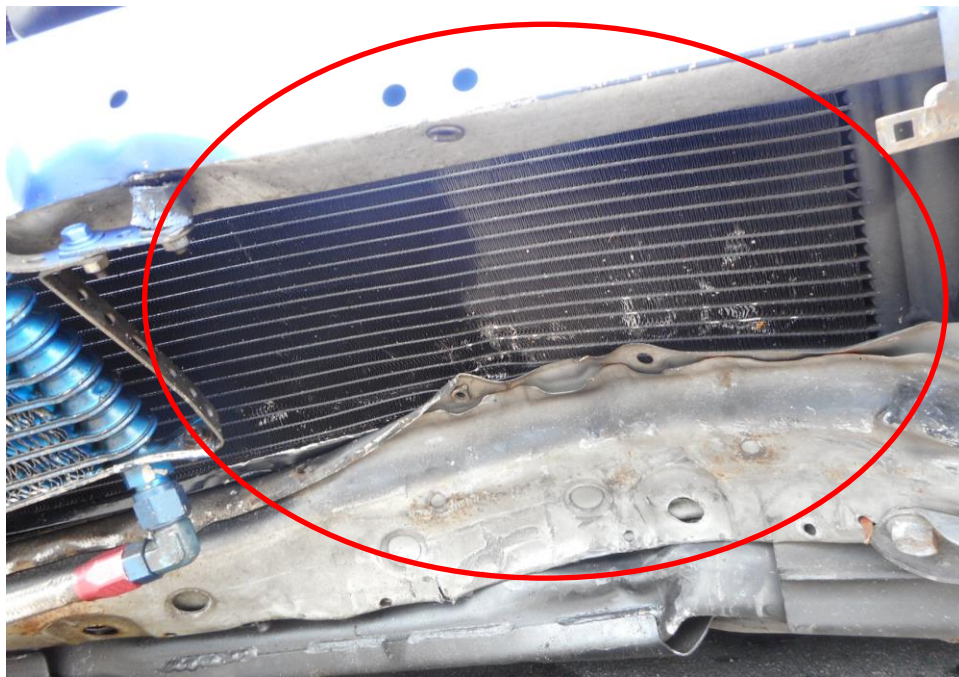
**Photo 9** shows the close up view of the Motor Car's front engine at the time of my inspection. The Motor Car was observed to have sustained damage at its engine coolant radiator (circled) as a result of the accident.

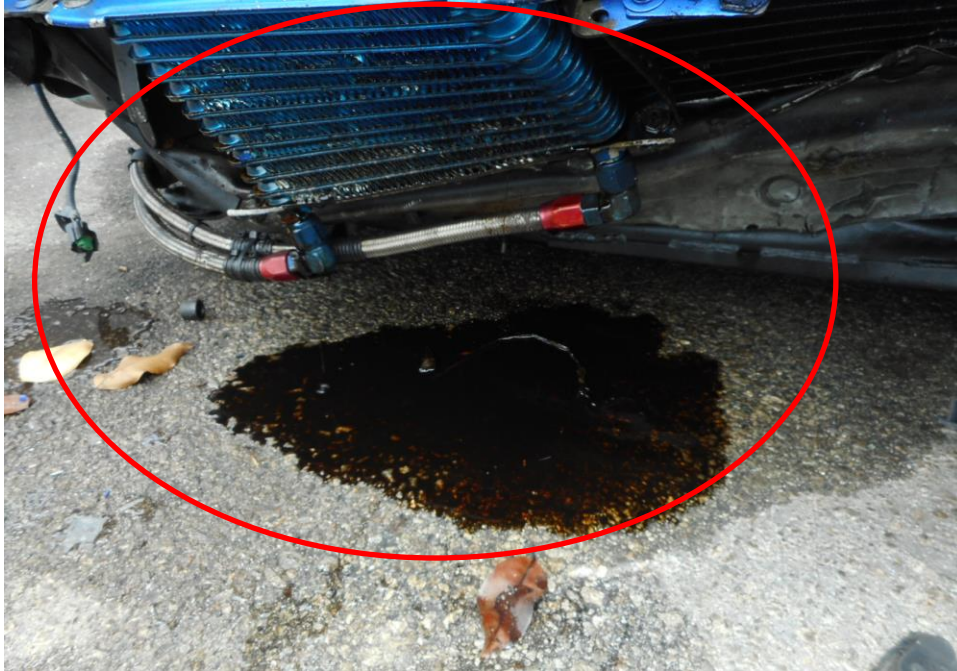
**Photo 10** shows the close up view of the Motor Car's front engine at the time of my inspection. The Motor Car was observed to have sustained damage at its engine oil cooler (circled) and there was engine oil leakage as a result of the accident.

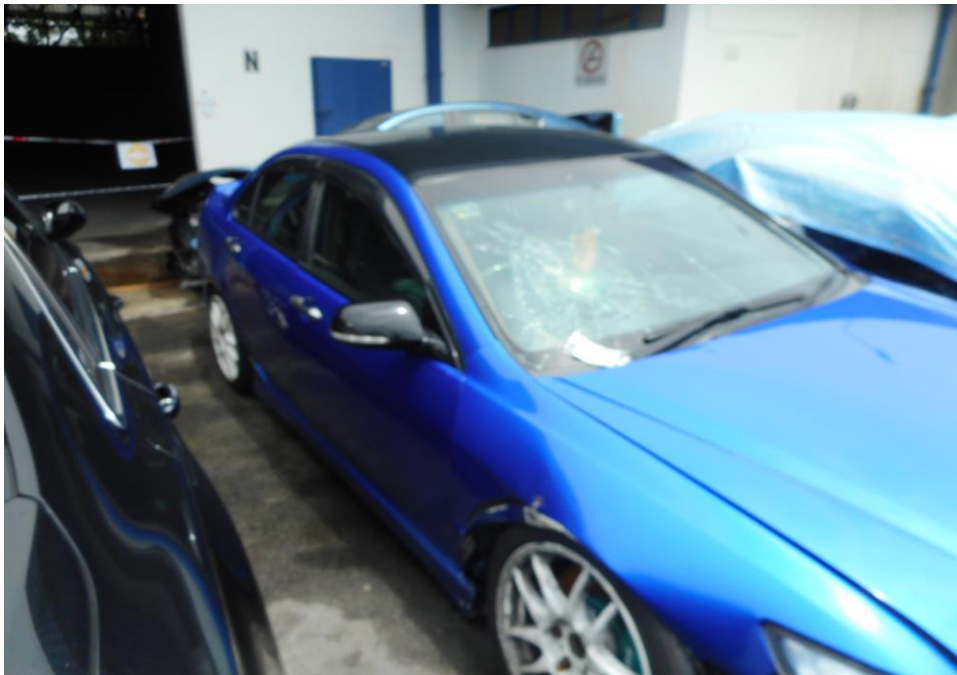
**Photo 11** shows a general view of the Motor Car's right body at the time of my inspection. The right portion of the Motor Car was observed to have been unaffected by the accident.

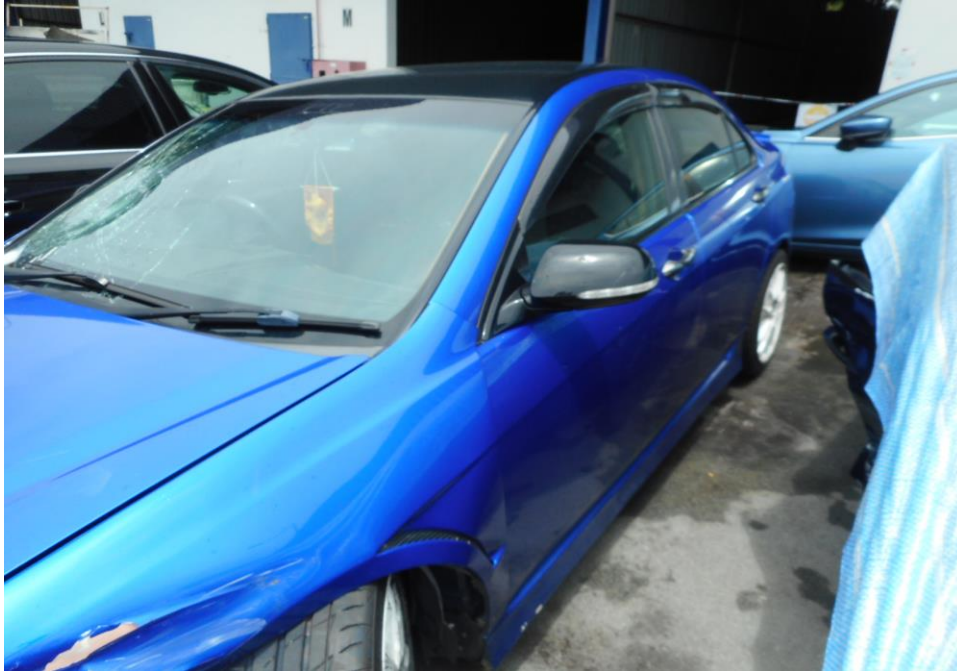
**Photo 12** shows a general view of the Motor Car's left body at the time of my inspection. The left portion of the Motor Car was observed to have been unaffected by the accident.

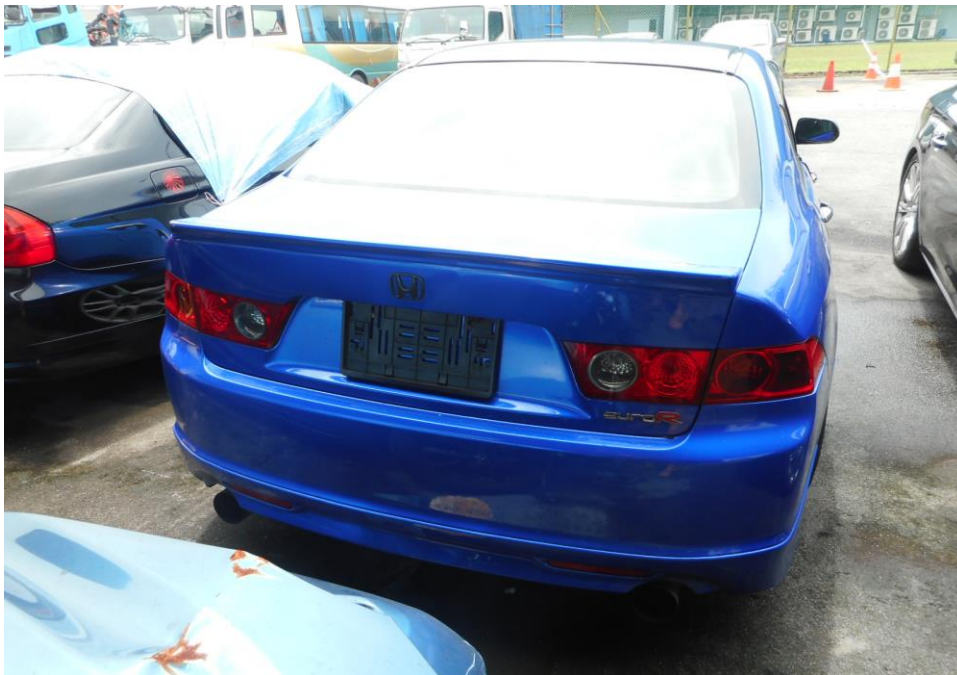
**Photo 13** shows the general view of the Motor Car's rear body at the time of my inspection. The Motor Car rear was observed to be unaffected by the accident.

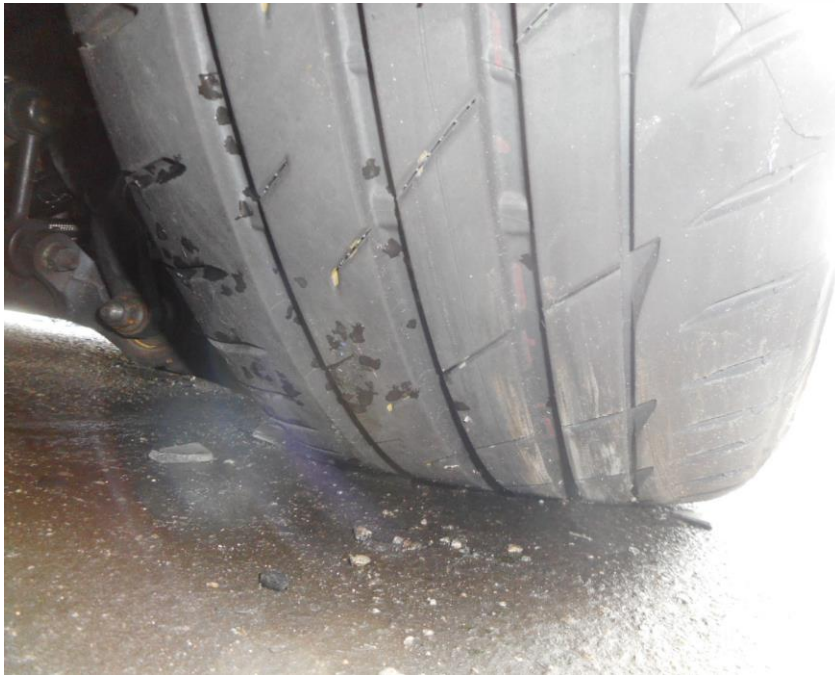
**Photo 14** shows the condition of the front right tyre of the Motor Car, which was observed to be in serviceable condition with remaining tread depth of approximately 6.4mm. The tyre was sufficiently inflated for vehicular operation with no tear, cut or burst mark(s) on the outer and the inner sidewalls as well as across the tread. The 4 tyres of the Motor Car were wrapped around alloy wheel rims without any damage.

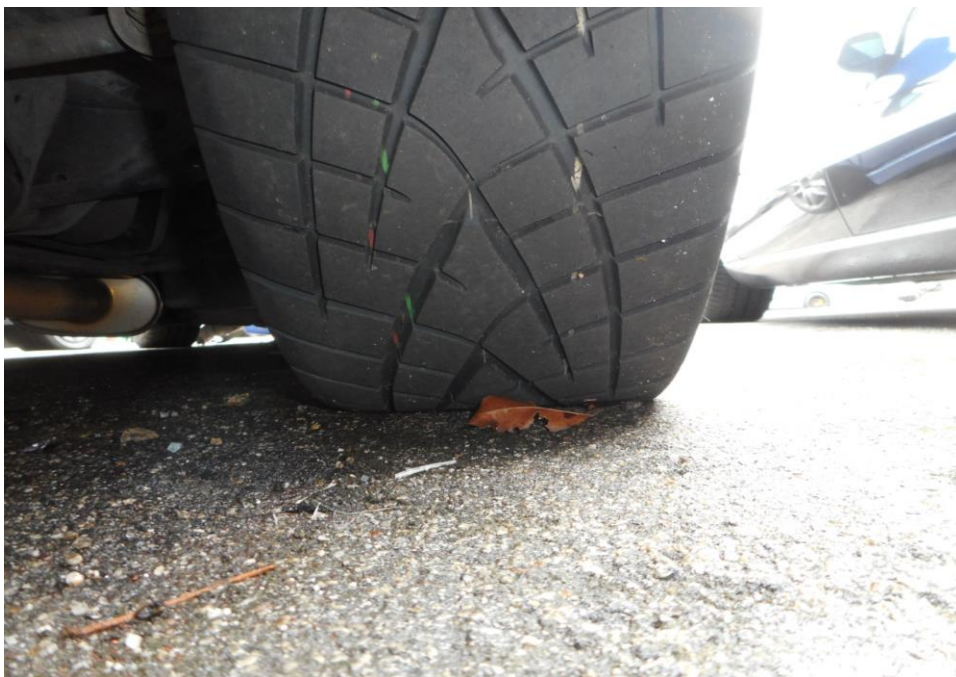
**Photo 15** shows the condition of the rear right tyre of the Motor Car, which was observed to be in serviceable condition with remaining tread depth of approximately 4.6mm. The tyre was also observed to be sufficiently inflated for vehicular operation with no tear, cut or burst mark(s).

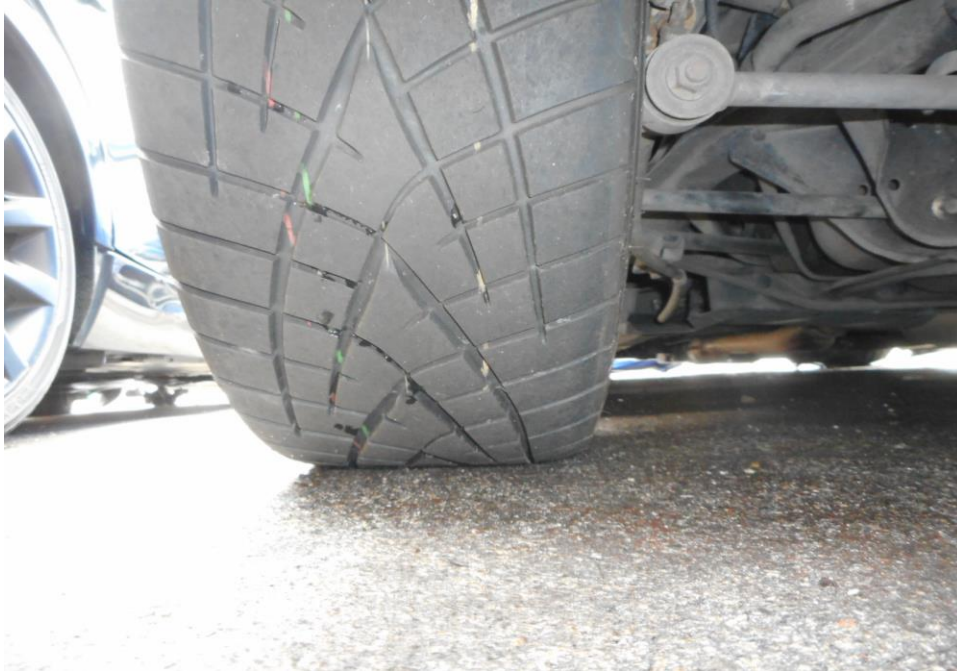
**Photo 16** shows the condition of the rear left tyre of the Motor Car, which was observed to be in serviceable condition with remaining tread depth of approximately 4.9mm. The tyre, which was wrapped around alloy wheel rim, was also observed to be sufficiently inflated for vehicular operation. The 4 tyres of the Motor Car were wrapped around standard steel wheel rims.

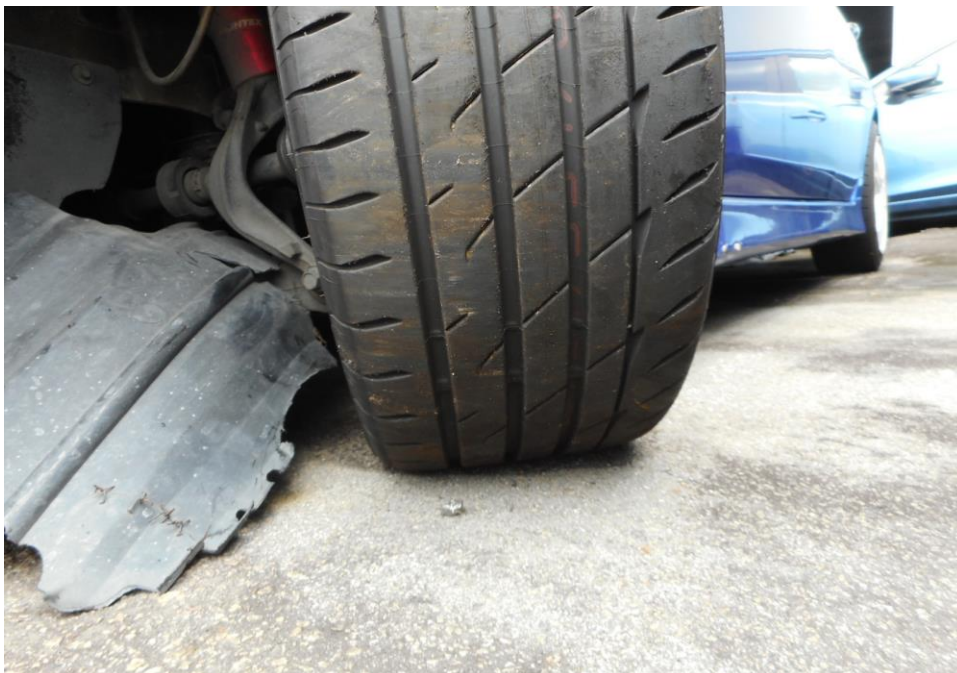
**Photo 17** shows the condition of the front left tyre of the Motor Car, which was observed to be in serviceable condition with remaining tread depth of approximately 6.7mm. There was also no tear, cut or burst mark(s) on the outer and the inner sidewalls as well as across the tread of the Motor Car's 4 tyres.

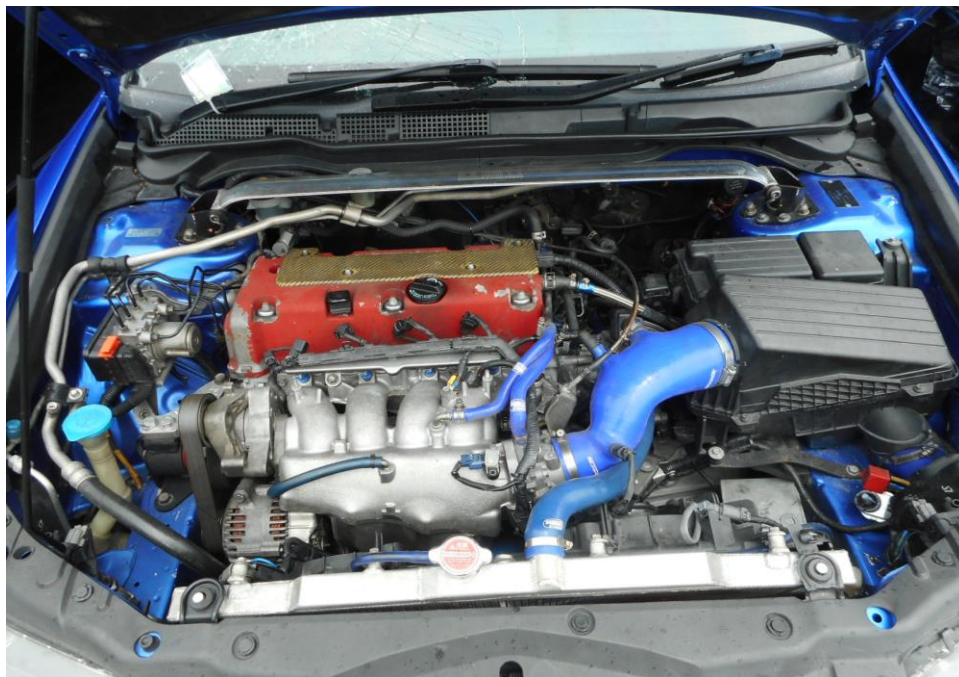
**Photo 18** shows a general view of the Motor Car's engine compartment. The various parts and components inside the engine compartment were unaffected by the accident. There was also no sign(s) or indication(s) of fluid leakage and/or fluid stain within the engine compartment.

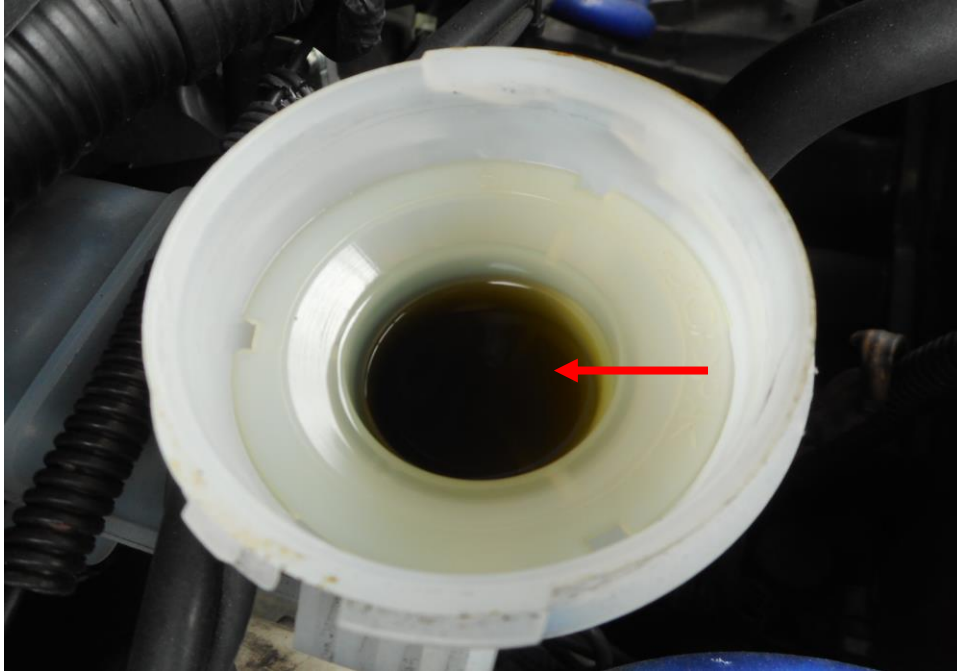
**Photo 19** shows the brake fluid reservoir of the Motor Car at the time of my inspection. The brake fluid was observed to be of sufficient level (arrowed) and without any visible contamination.

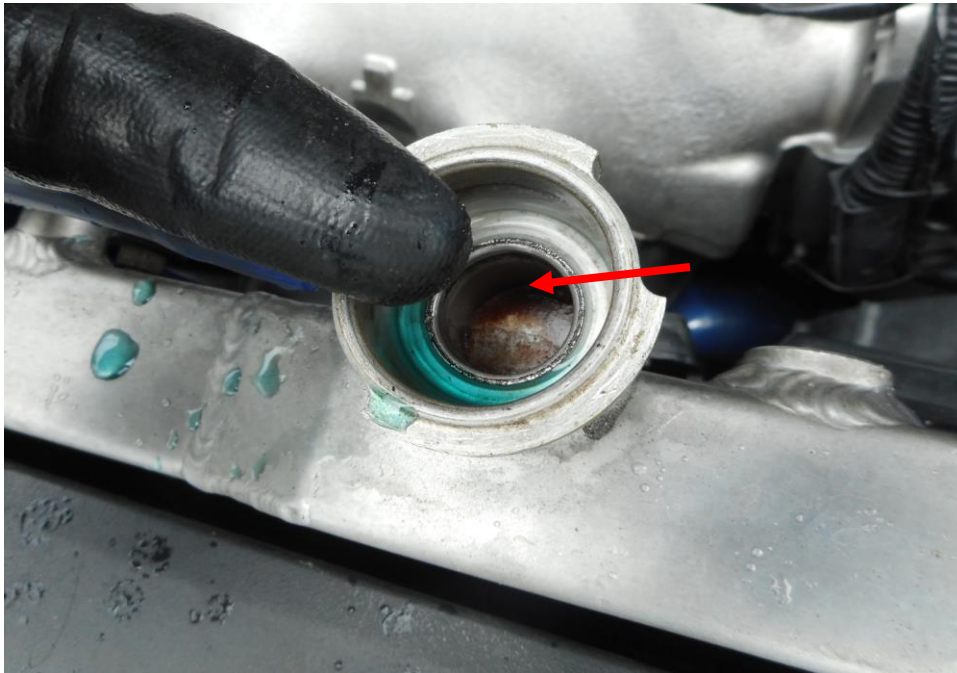
**Photo 20** shows checks being carried out to the engine coolant of the Motor Car at the time of my inspection. The engine coolant was observed to be of insufficient level (arrowed) as there was a leakage from the damaged engine coolant radiator.

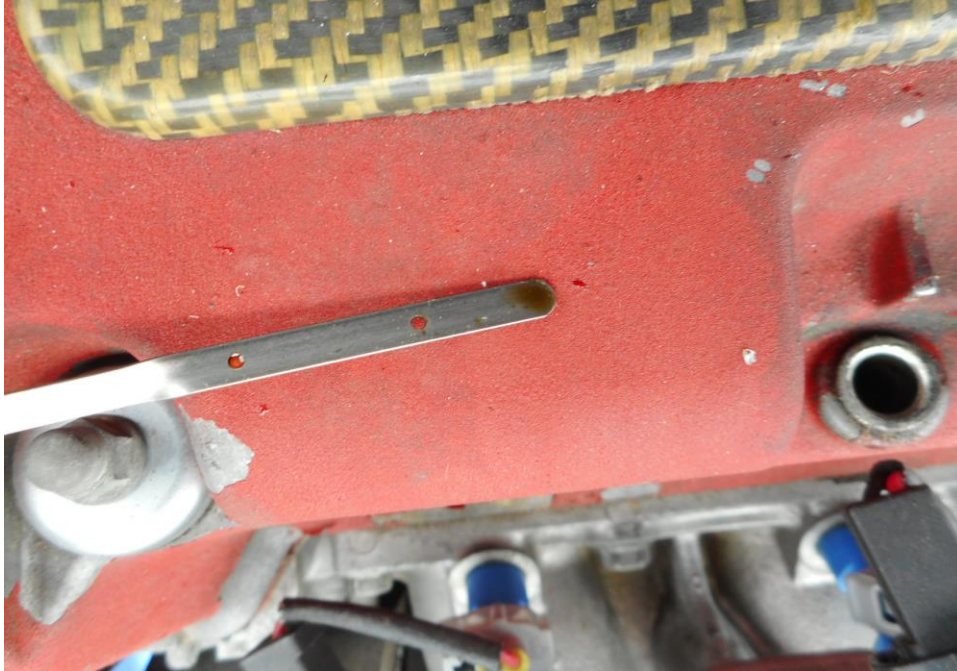
**Photo 21** shows the engine oil dip stick of the Motor Car at the time of my inspection. The engine oil was observed to be of insufficient level as there was a leakage from the damaged engine oil cooler.

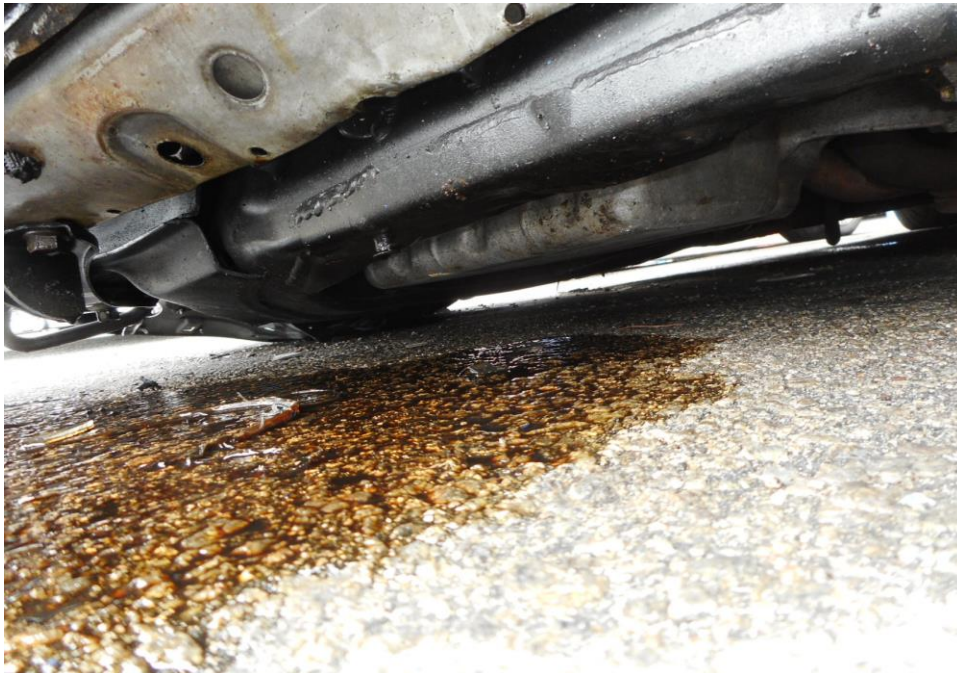
**Photo 22** shows the undercarriage of the Motor Car, at the area where the engine housing and transmission housing are located. I did observed fluid leak) on the underside of the Motor Car, this leakage came from the damaged engine oil cooler as a result of the accident.

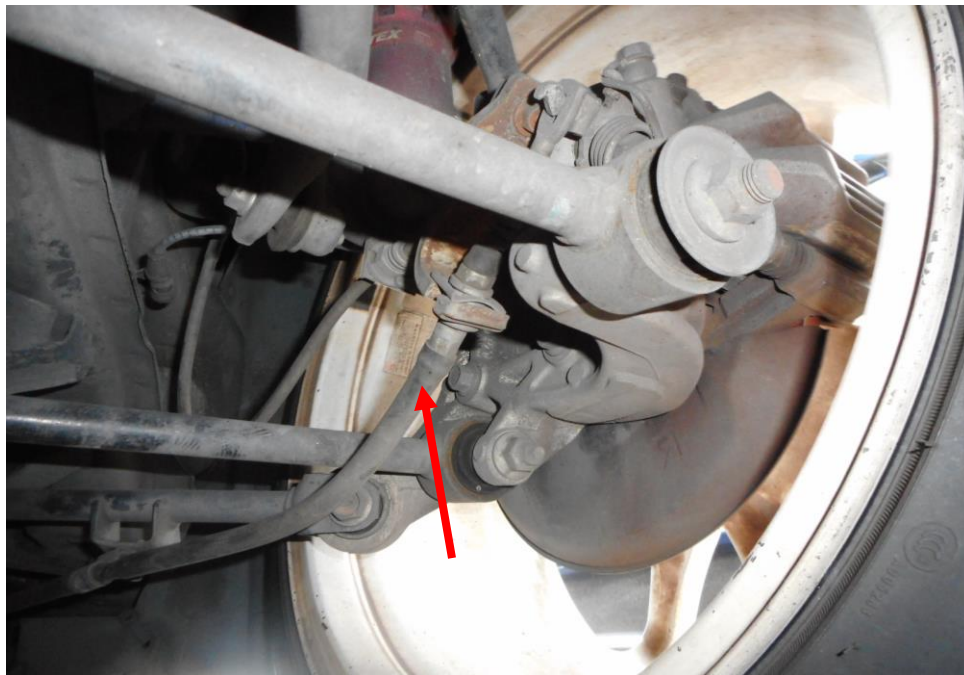
**Photo 23** shows the brake hose/pipe (arrowed) at the rear right wheel of the Motor Car. No leakage of brake fluid was observed. Visual examination of the various components of the braking system like the drum brake, brake booster, brake pedal etc. had revealed all to be intact and without visible damage.

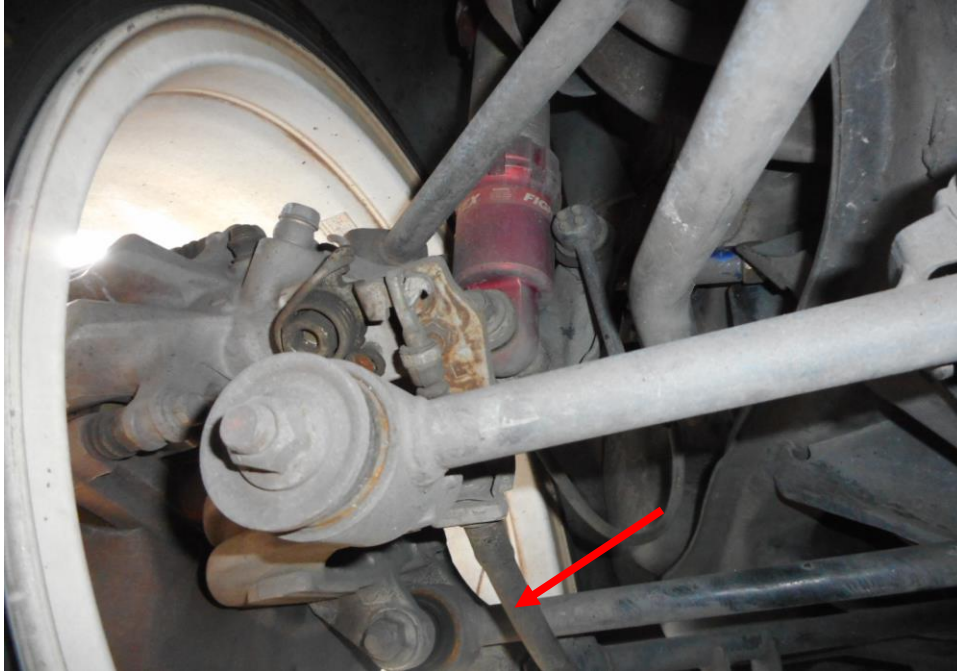
**Photo 24** shows the brake hose/pipe (arrowed) at the rear left wheel of the Motor Car. I did not observe any leakage of brake fluid at the time of my inspection of the Motor Car. Static tests of the Motor Car's braking system had indicated that there was no internal leakage of pressure/vacuum. The undercarriage components of the Motor Car were also all found to be intact and without any visible damage.

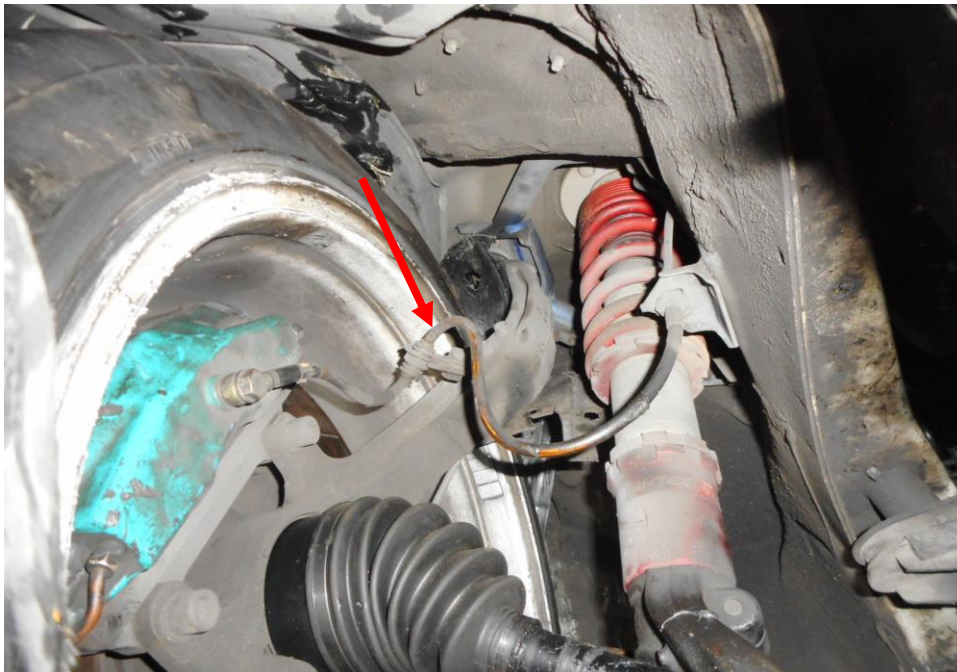
**Photo 25** shows the brake hose/pipe (arrowed) at the front right wheel of the Motor Car. I did not observe any leakage of brake fluid at the time of my inspection of the Motor Car. Static tests of the Motor Car's braking system had indicated that there was no internal leakage of pressure/vacuum. The undercarriage components of the Motor Car were also all found to be intact and without any visible damage.

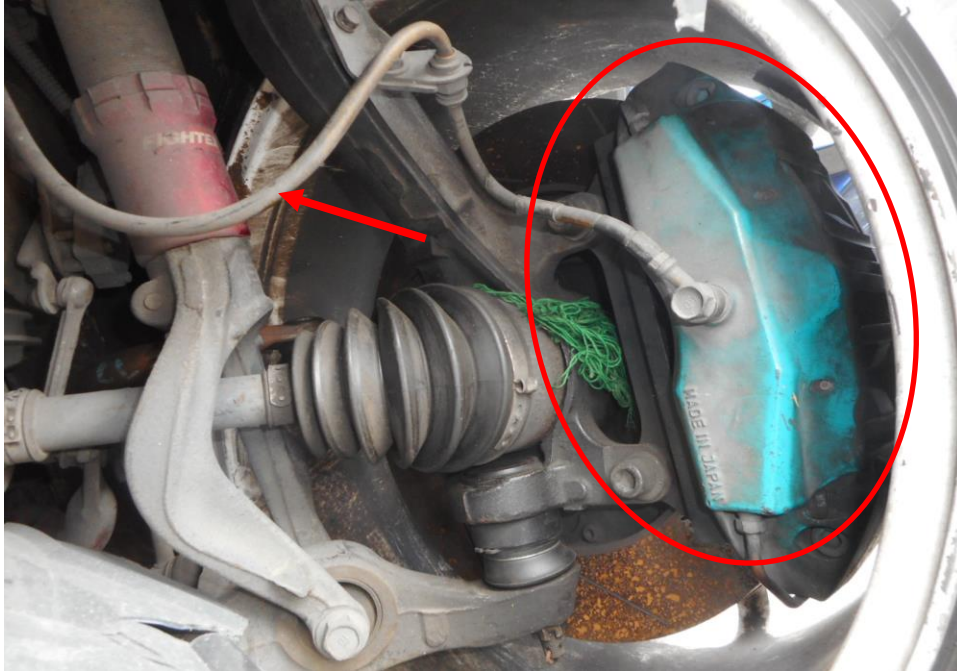
**Photo 26** shows the brake hose/pipe (arrowed) at the front left wheel of the Motor Car. No leakage of brake fluid was observed. Visual examination of the various components of the braking system like the brake caliper (circled), brake booster, brake pedal etc had revealed all to be intact and without visible damage.

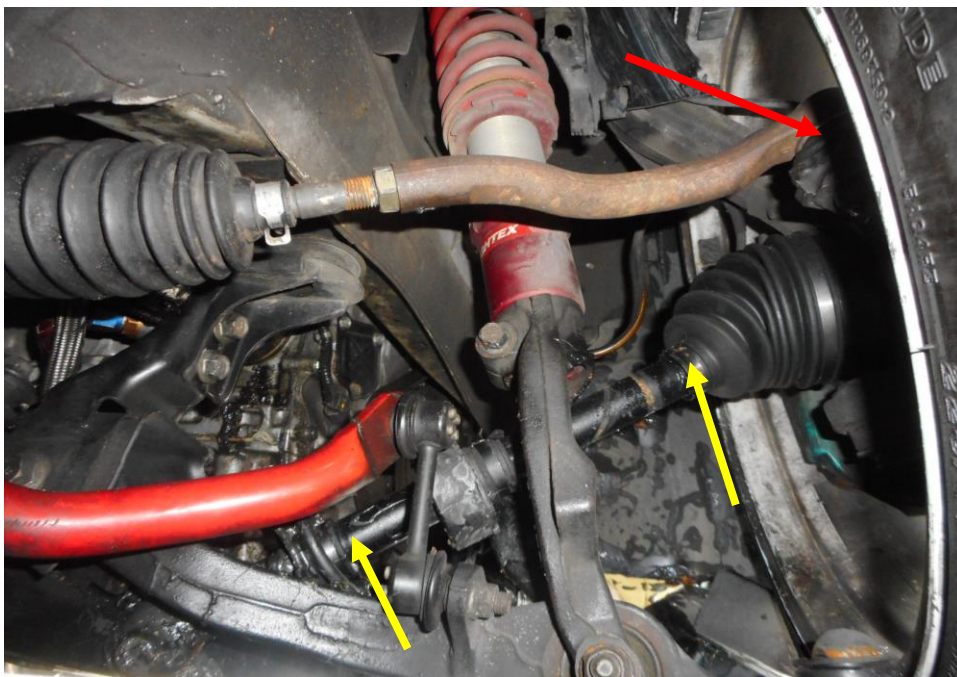
**Photo 27** shows the various undercarriage components at the front right wheel of the Motor Car, in particular the steering tie rod (red arrow). The various steering components were all found to be intact, suggesting that the steering system of the Motor Car was likely to be in serviceable condition at the material time of accident. However, the front right drive shaft of the Motor Car was observed to be damaged as a result of the accident (yellow arrow).

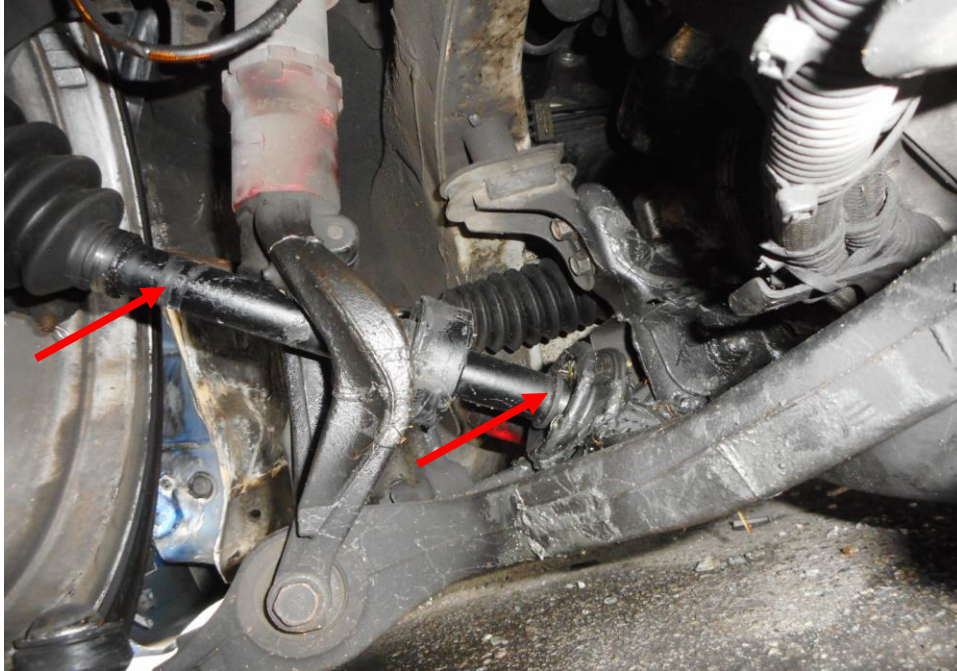
**Photo 28** shows the driveshaft of the front right wheel of the Motor Car, it was observed to be damaged as a result of the accident (arrowed).

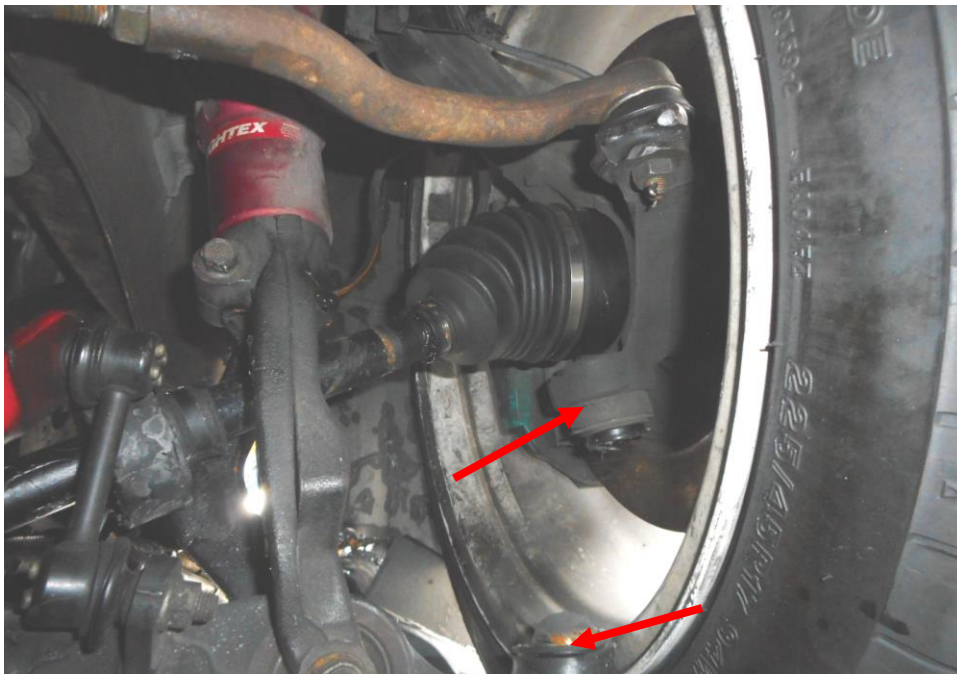
**Photo 29** shows the control arm of the front right wheel of the Motor Car, it was observed to be damaged and broken off as a result of the accident (arrowed).

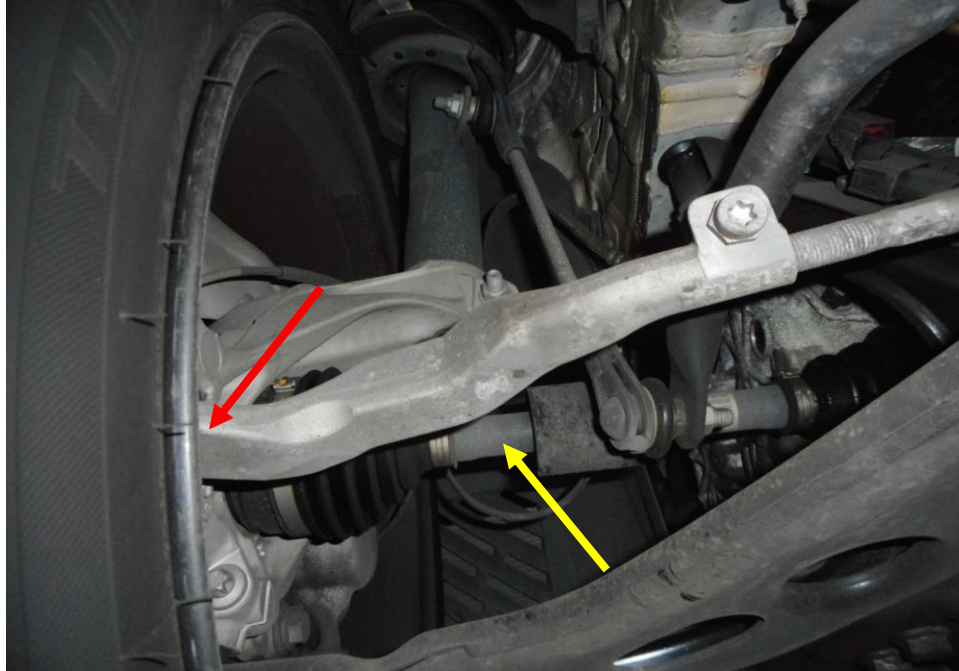
**Photo 30** shows the various undercarriage components at the front left wheel of the Motor Car, which had included the steering tie rod (red arrowed) and the driveshaft (yellow arrowed). The various undercarriage components of the Motor Car were all found to be intact without any visible damage.

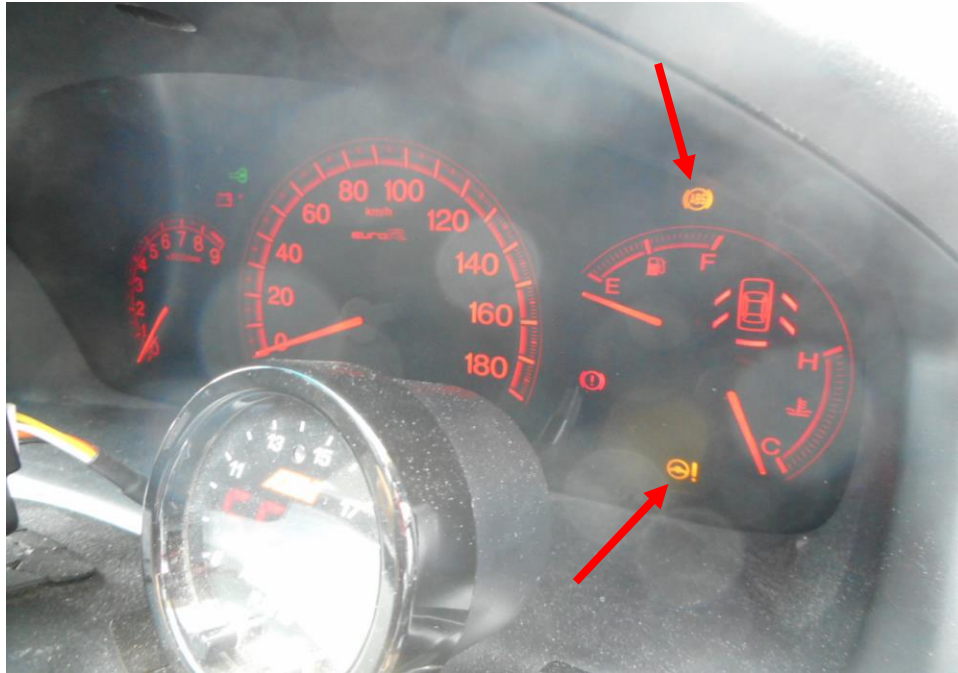
**Photo 31** shows the warning light for Anti-Lock Brake System (ABS) and Electric Power Steering System (EPS) (arrowed) appearing on the instrument panel of the Motor Car during the self-test of its various electronic operating systems when its engine was cranked.

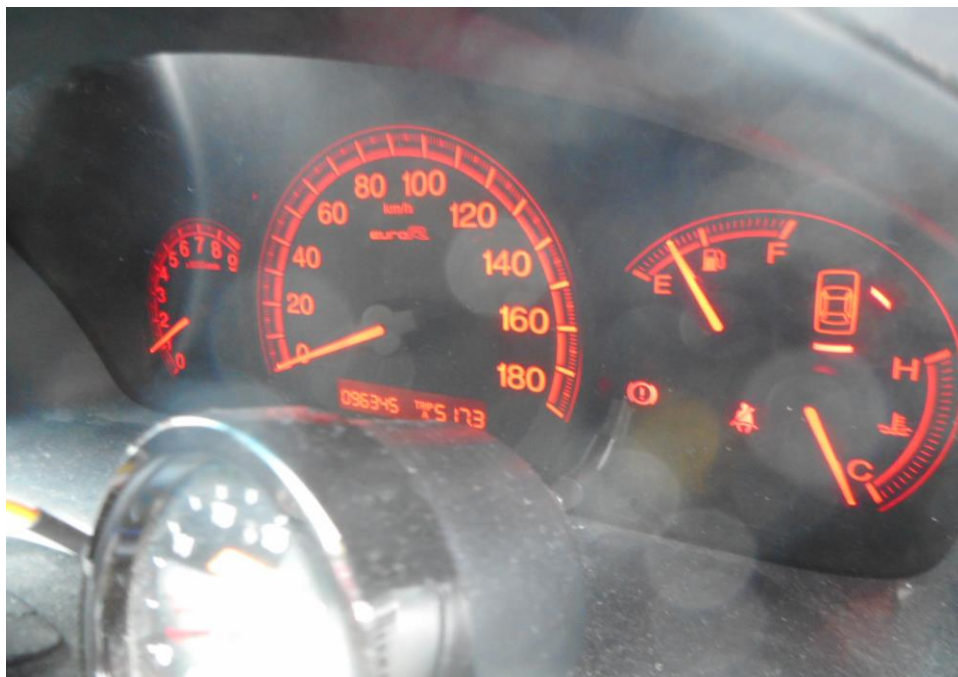
**Photo 32** shows no warning lights illuminated on the instrument panel of the Motor Car after the engine was cranked. This would suggest that there was no abnormality to the electronic operating system of the Motor Car, like the ABS, EPS and etc.
