Your Ref: TP/IP/12995/2021
Our Ref : CI/TPD21003847/P

12th April 2021

MECHANICAL INSPECTION REPORT OF MOTOR LORRY YP 9680Y

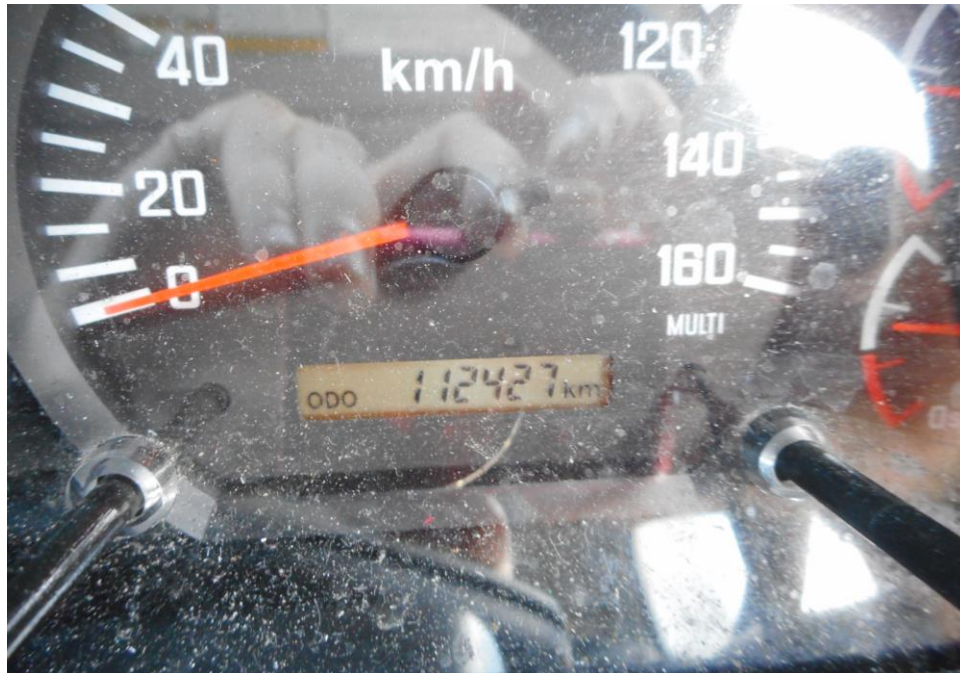
Photo 1 shows a general view of the instrument cluster of the Motor Lorry at the time of my inspection. The mileage of the Motor Lorry was 112,427 km

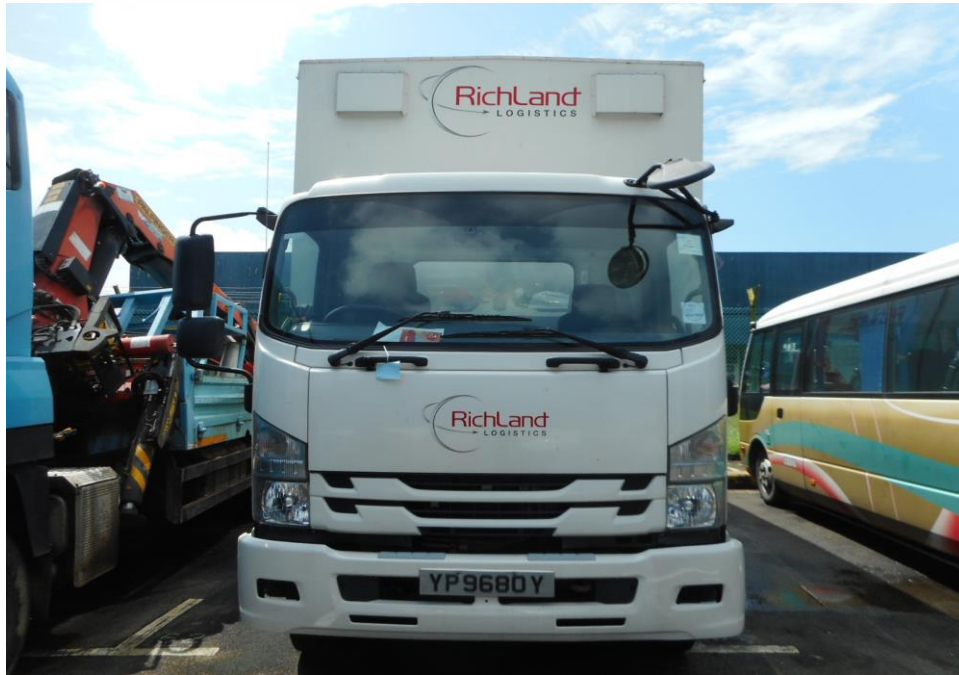
Photo 2 shows a general view of the Motor Lorry's frontal portion at the time of my inspection. The Motor Lorry front was observed to be intact and unaffected by the accident.

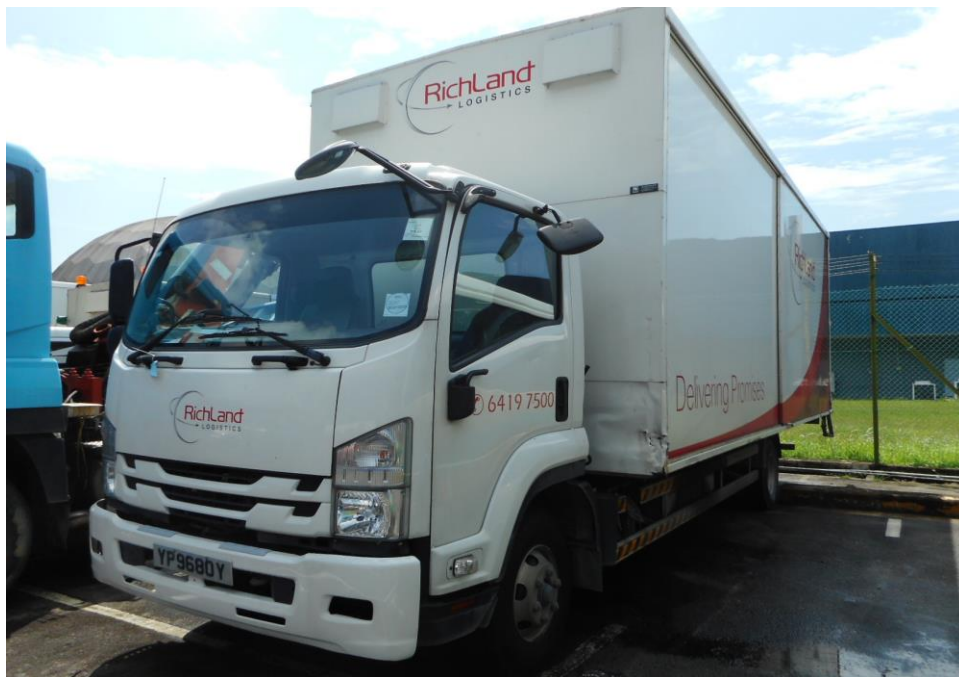
Photo 3 shows a general view of the Motor Lorry's left portion at the time of my inspection. It appeared to have sustained damage at its left portion. Its left rear view mirror and left body panels was damage at the time of my inspection.

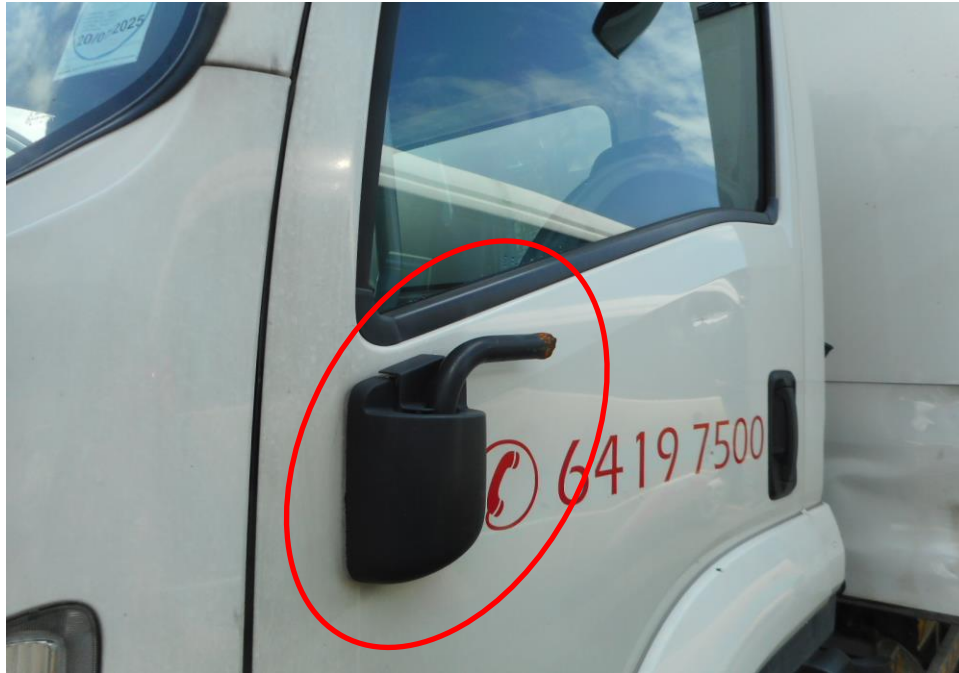
Photo 4 shows a close up view of the Motor Lorry's left portion at the time of my inspection. It appeared to have sustained damage at its left portion. Its left rear view mirror (red circle) was damage at the time of my inspection as a result of the accident.

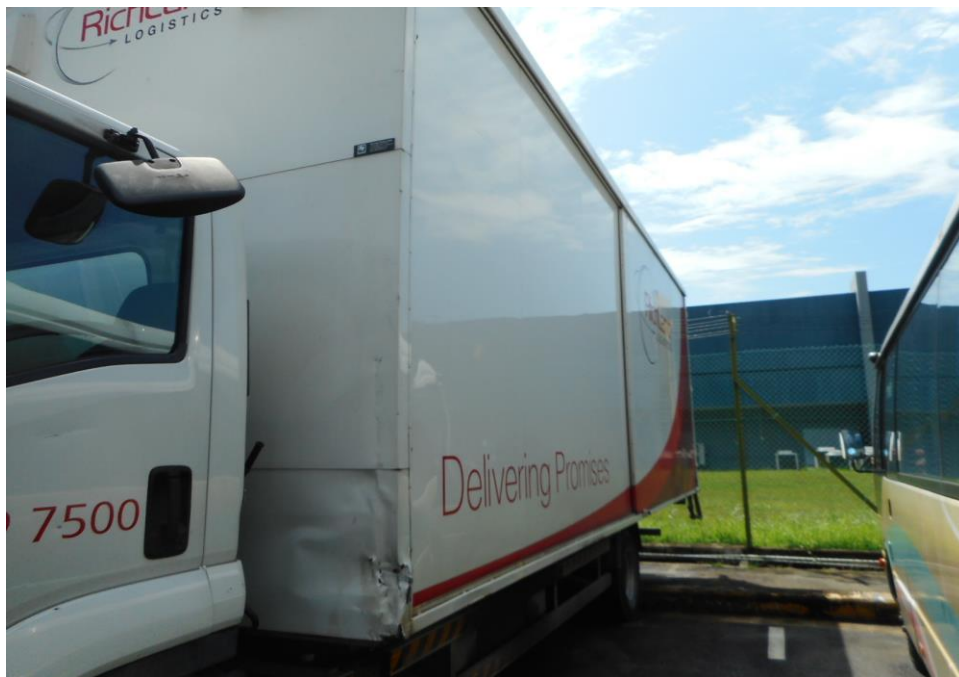
Photo 5 shows a general view of the Motor Lorry's left portion at the time of my inspection. It appeared to have sustained damage at its left portion. Its left body panel was damage at the time of my inspection as a result of the accident.

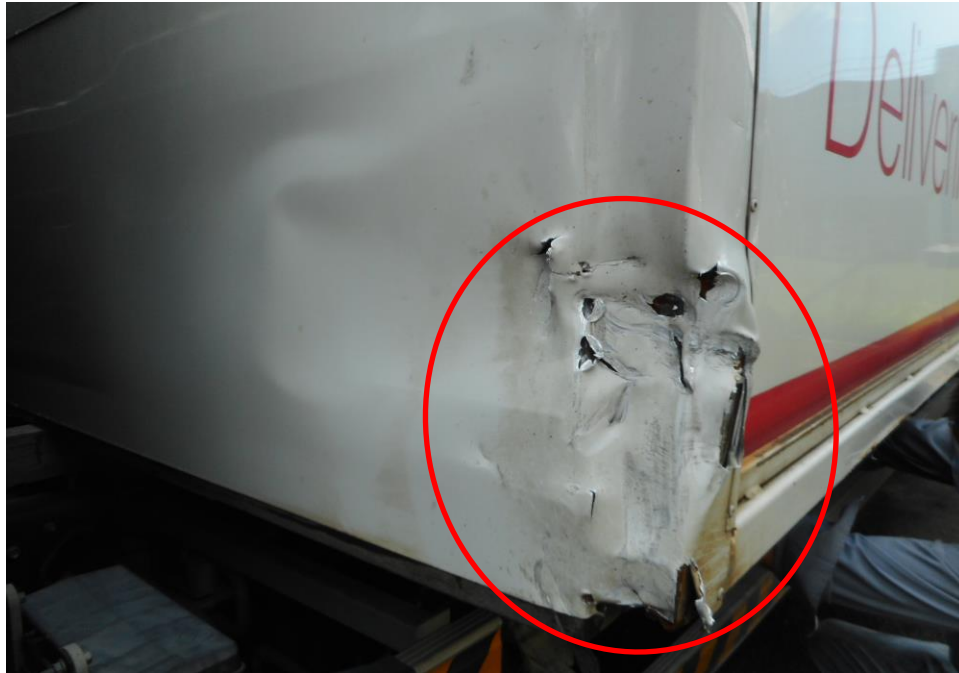
Photo 6 shows a close up view of the Motor Lorry's left portion at the time of my inspection. It appeared to have sustained damage at its left portion. Its left body panel (circled) was damage at the time of my inspection as a result of the accident.

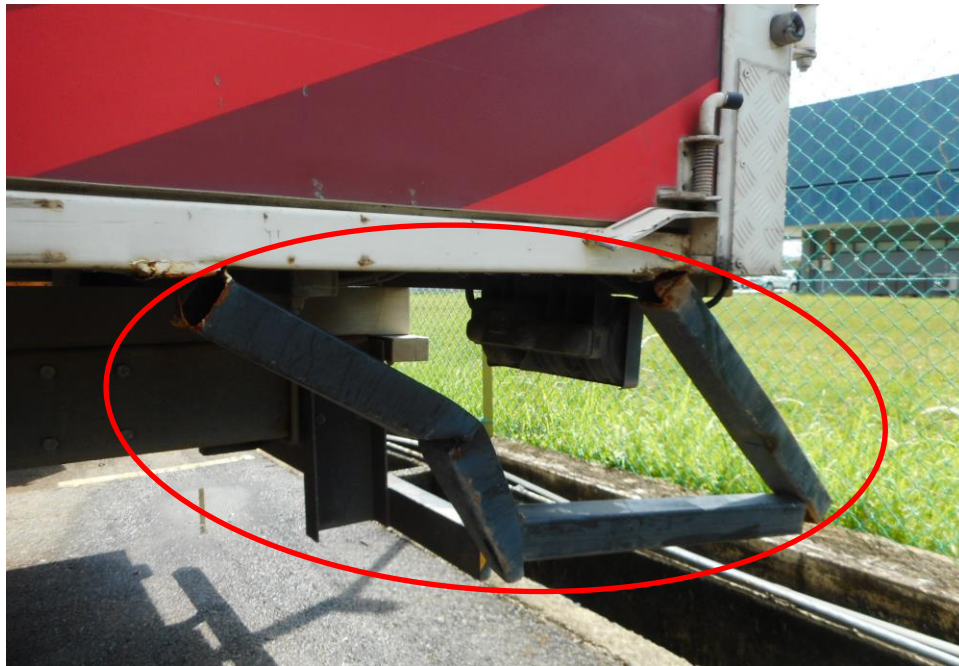
Photo 7 shows a close up view of the Motor Lorry's left portion at the time of my inspection. It appeared to have sustained damage at its left portion. Its left body panel (circled) was damage at the time of my inspection as a result of the accident.

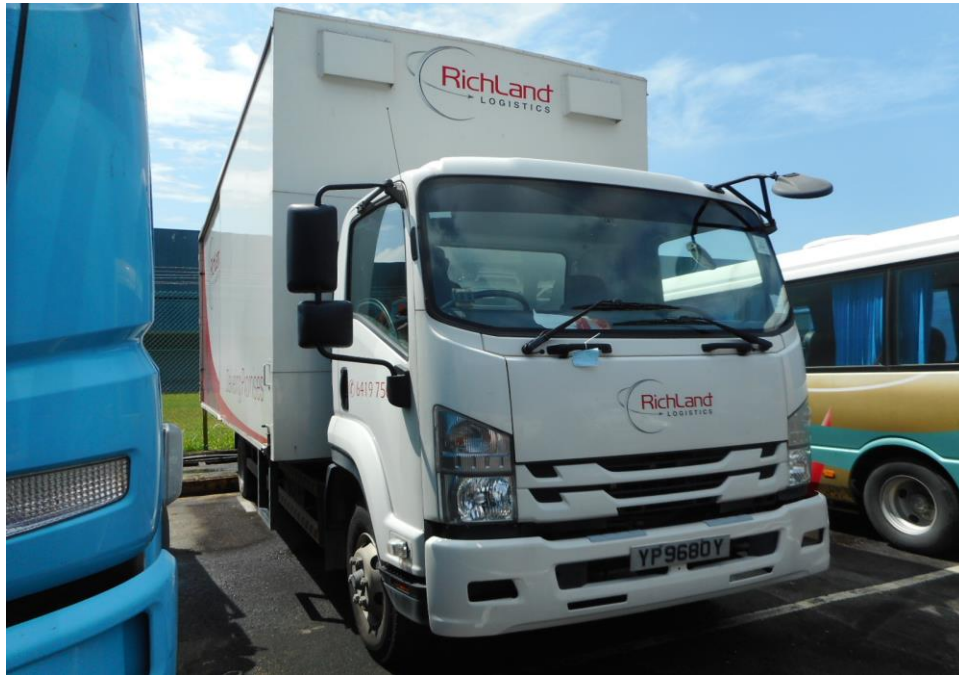
Photo 8 shows a general view of the right body of the Motor Lorry at the time of my inspection. The Motor Lorry was observed to be intact and unaffected by the accident.

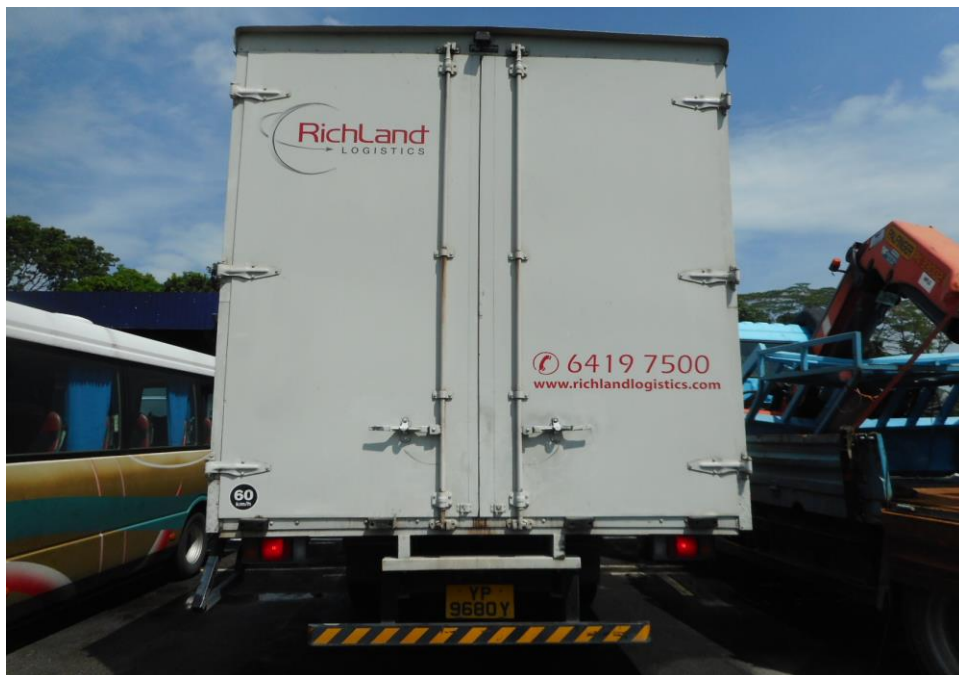
Photo 9 shows a general view of the rear body of the Motor Lorry at the time of my inspection. The Motor Lorry was observed to be intact and unaffected by the accident.

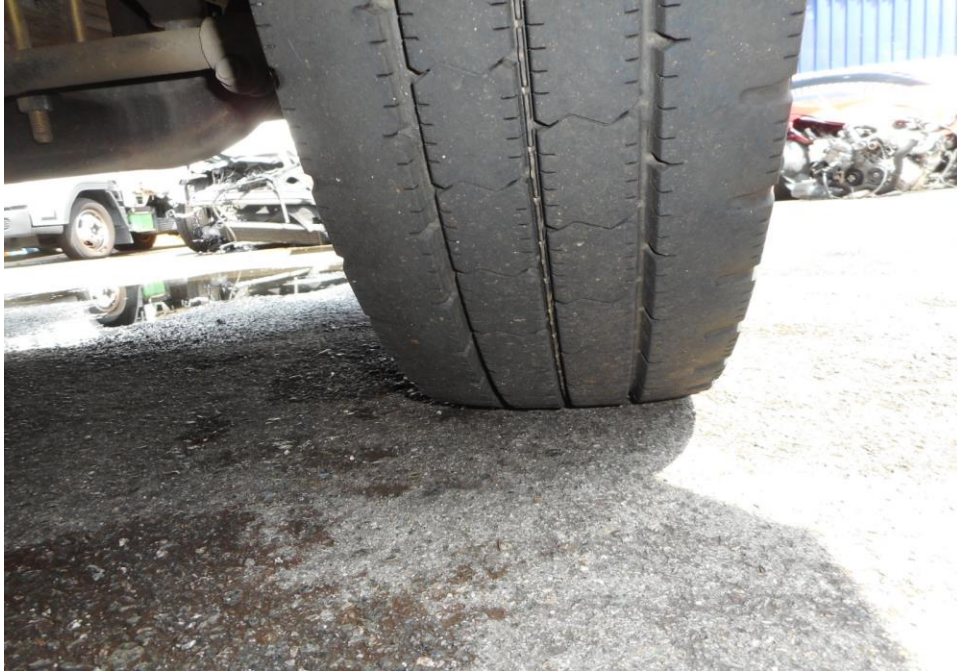
Photo 10 shows the condition of the front right tyre of the Motor Lorry, which was observed to be in serviceable condition with remaining tread depth of approximately 7.2mm. The tyre, which was wrapped around standard steel wheel rim, was also observed to be sufficiently inflated for vehicular operation. There was no tear, cut or burst mark(s) on the outer and the inner sidewalls as well as across the tread of the 6 tyres that were fitted on the Motor Lorry.

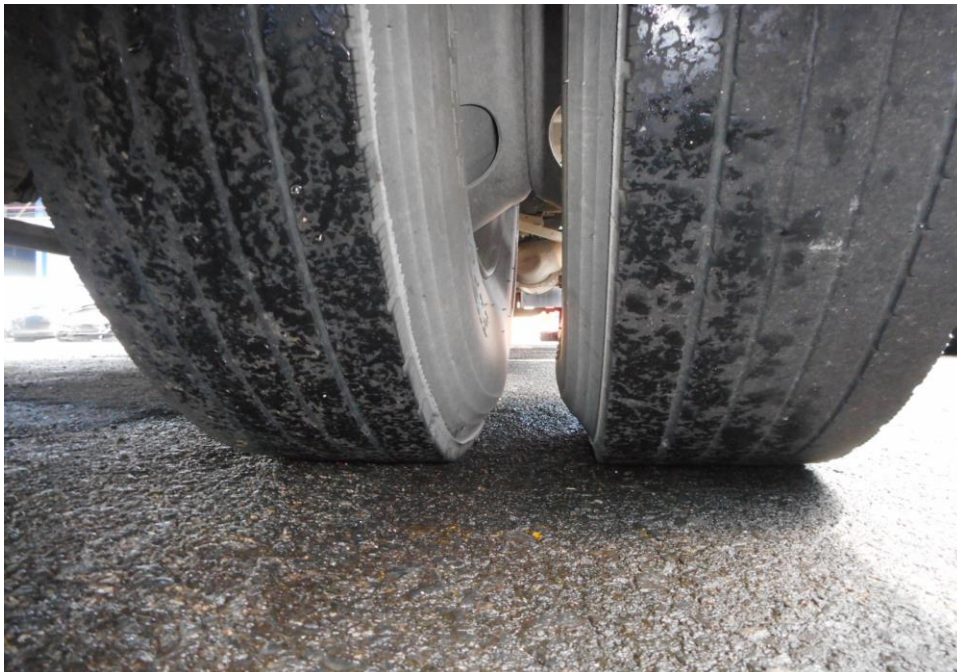
Photo 11 shows the condition of the rear right tyre of the Motor Lorry, which was observed to be in serviceable condition with remaining tread depth of approximately 2.7mm. The tyre, which was wrapped around standard steel wheel rim, it was observed to be sufficiently inflated for vehicular operation.

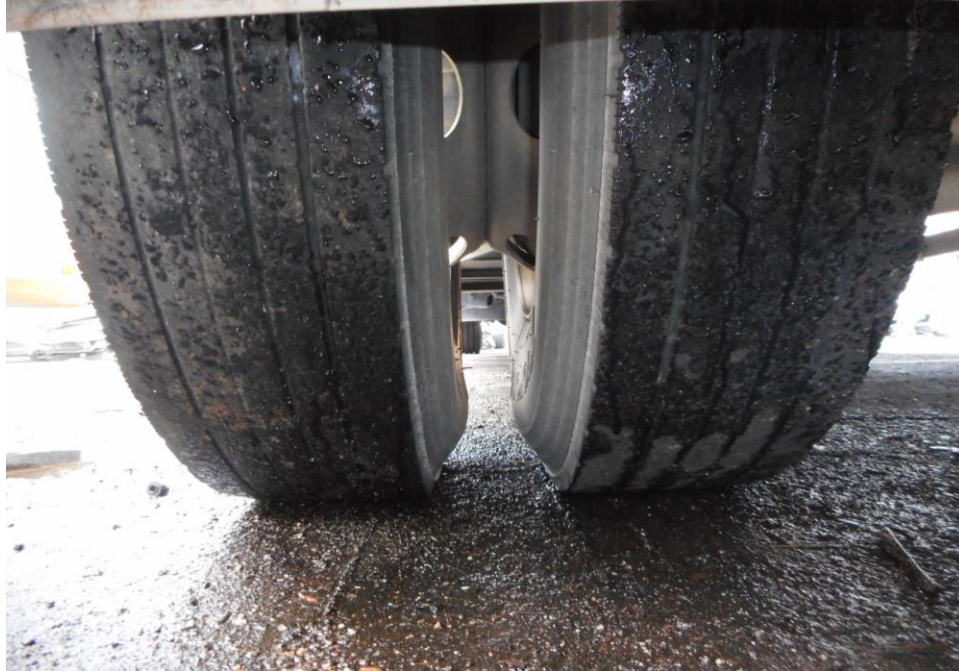
Photo 12 shows the condition of the rear left tyres of the Motor Lorry, which was observed to be in serviceable condition with remaining tread depth of approximately 1.7mm. The tyres, which were wrapped around standard steel wheel rim, were also observed to be sufficiently inflated for vehicular operation. There was also no damage found on all 6 steel wheel rims of the Motor Lorry.

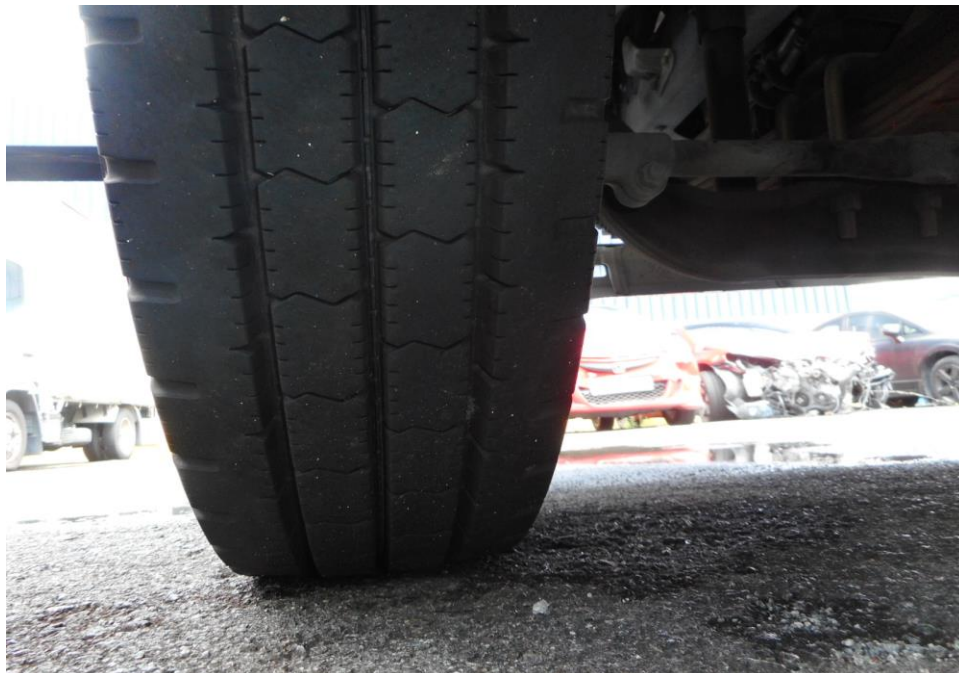
Photo 13 shows the condition of the rear right tyres of the Motor Lorry, which were observed to be in serviceable condition with remaining, tread depth of approximately 9.6mm. There was also no tear, cut or burst mark(s) on the outer and the inner sidewalls as well as across the tread of the 6 tyres that were fitted on the Motor Lorry.

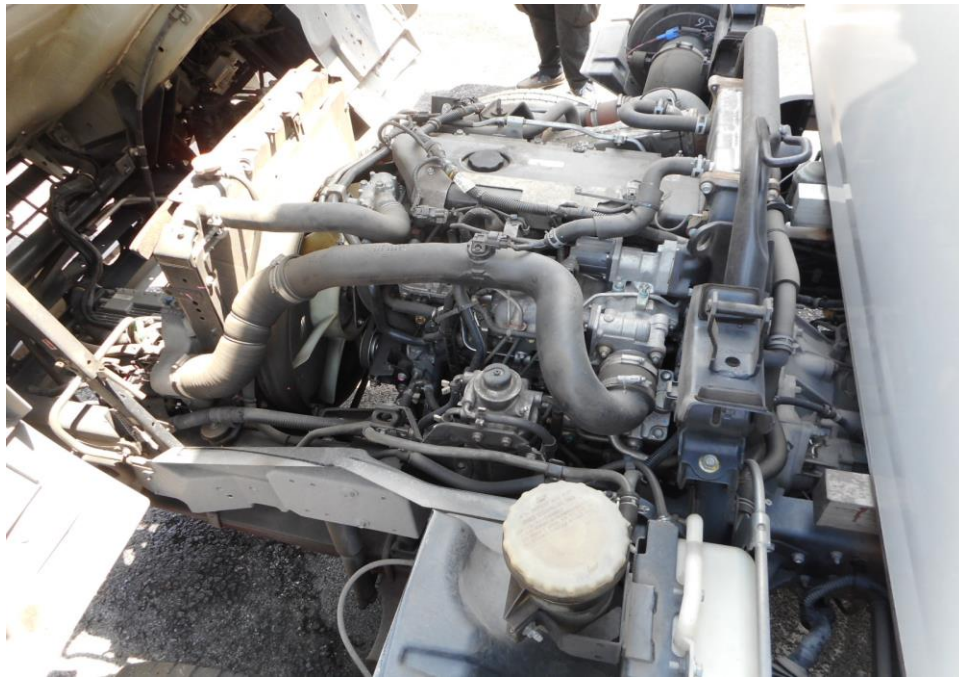
Photo 14 shows a general view of the Motor Lorry's engine compartment, which was accessed by lifting the front cabin of the Motor Lorry. The various parts and components inside the engine compartment were unaffected by the accident. There was also no sign(s) or indication(s) of fresh fluid leakage and/or fluid stain within the engine compartment

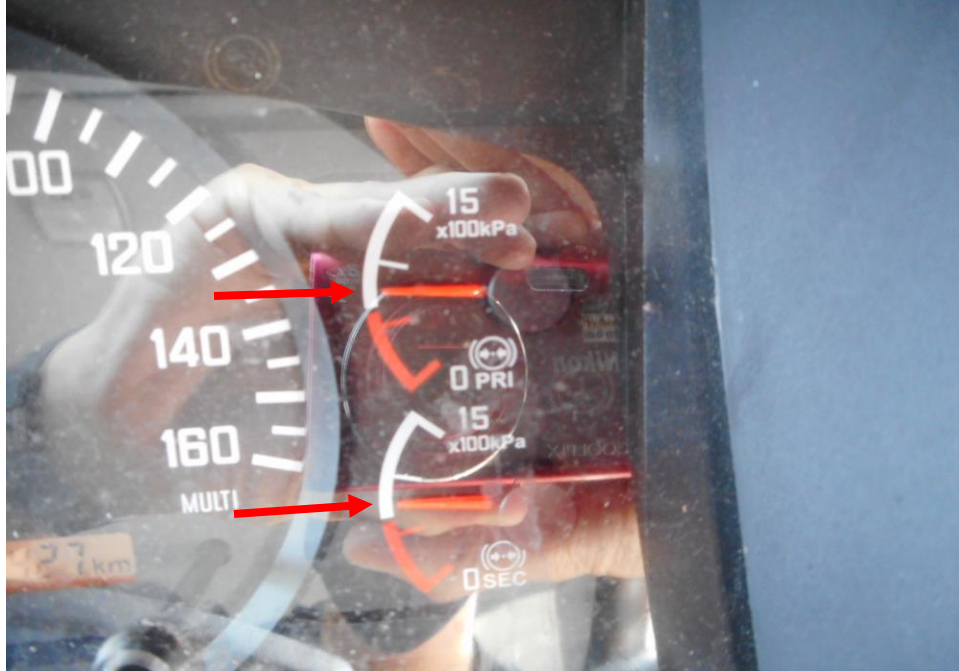
Photo 15 shows the air in the air brake cylinder of the Motor Bus at the time of my inspection. The air in the cylinder was observed to be of sufficient level & serviceable at the time of the accident.

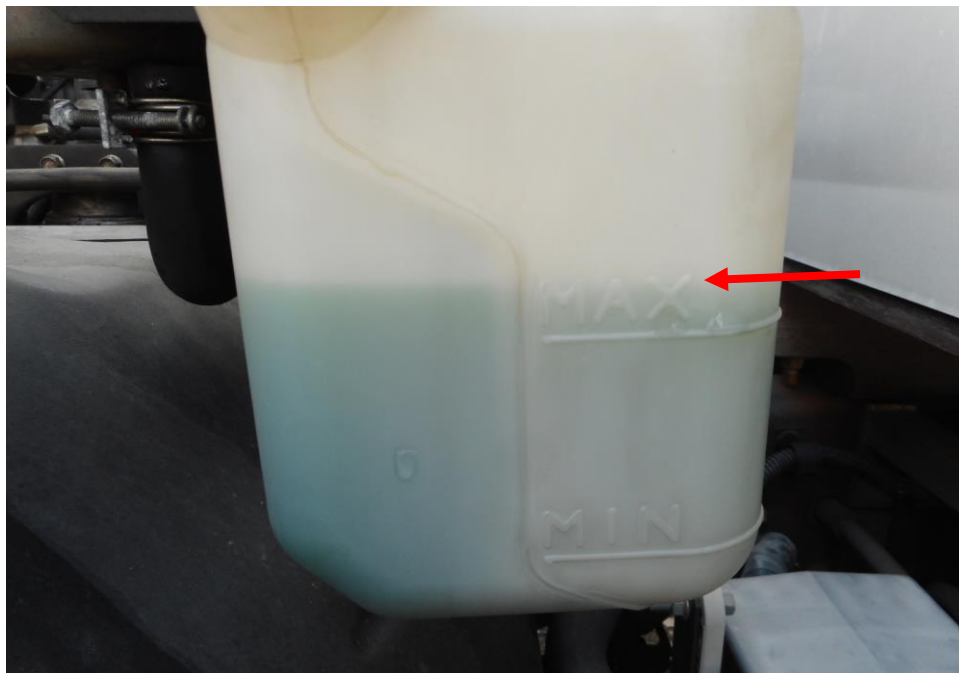
Photo 16 shows the engine coolant reservoir of the Motor Lorry at the time of my inspection. The engine coolant was observed to be of sufficient level (arrowed) and without any visible contamination.

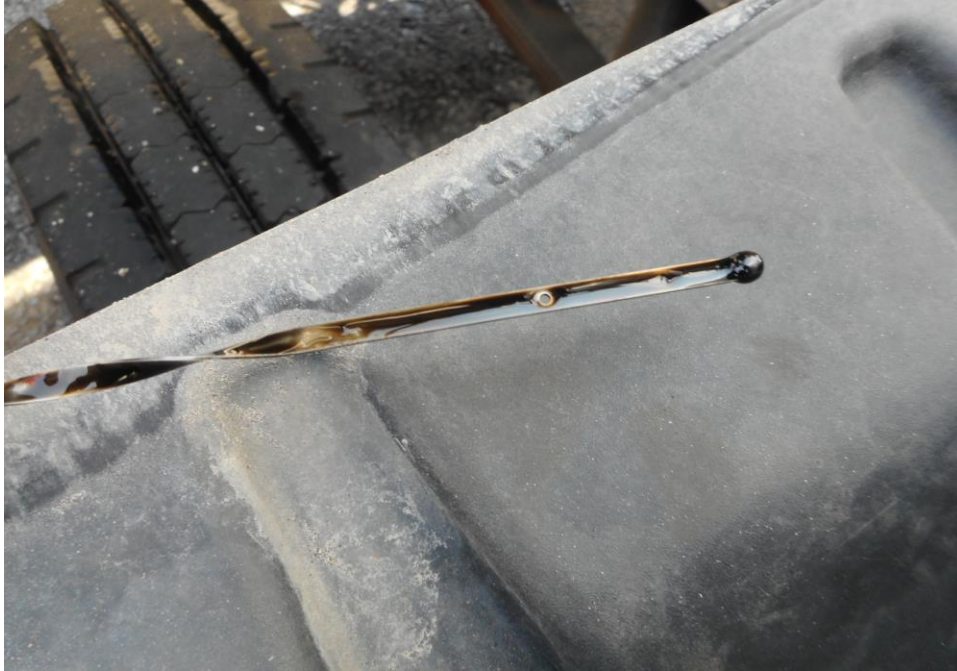
Photo 17 shows the engine oil dip stick of the Motor Lorry at the time of my inspection. The engine oil was observed to be of sufficient level and without any visible contamination.

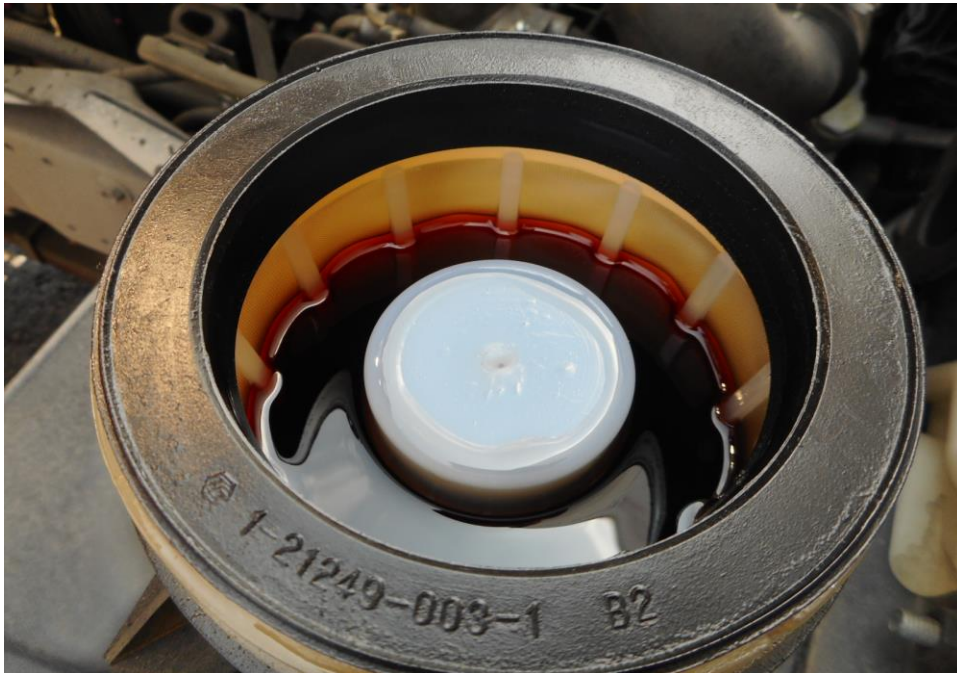
Photo 18 shows the power steering fluid reservoir of the Motor Lorry at the time of my inspection. The power steering fluid was observed to be of sufficient level (arrowed) and without any visible contamination.

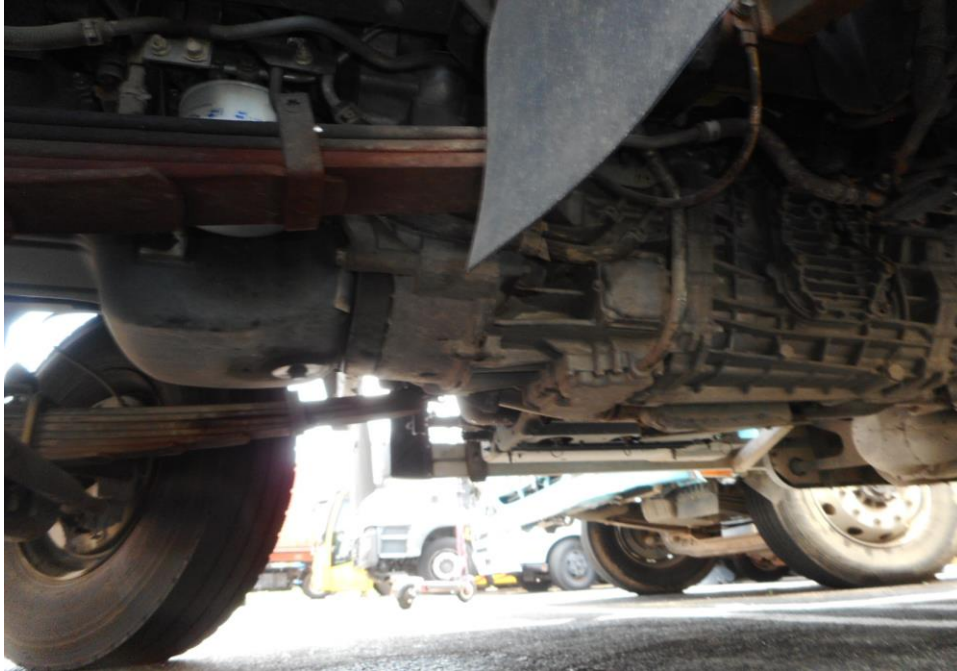
Photo 19 shows the undercarriage of the Motor Lorry, at the area where the engine housing and transmission housing are located. I did not find any sign(s) or indication(s) of fluid leak and/or fluid stain(s) on the underside of the Motor Lorry.

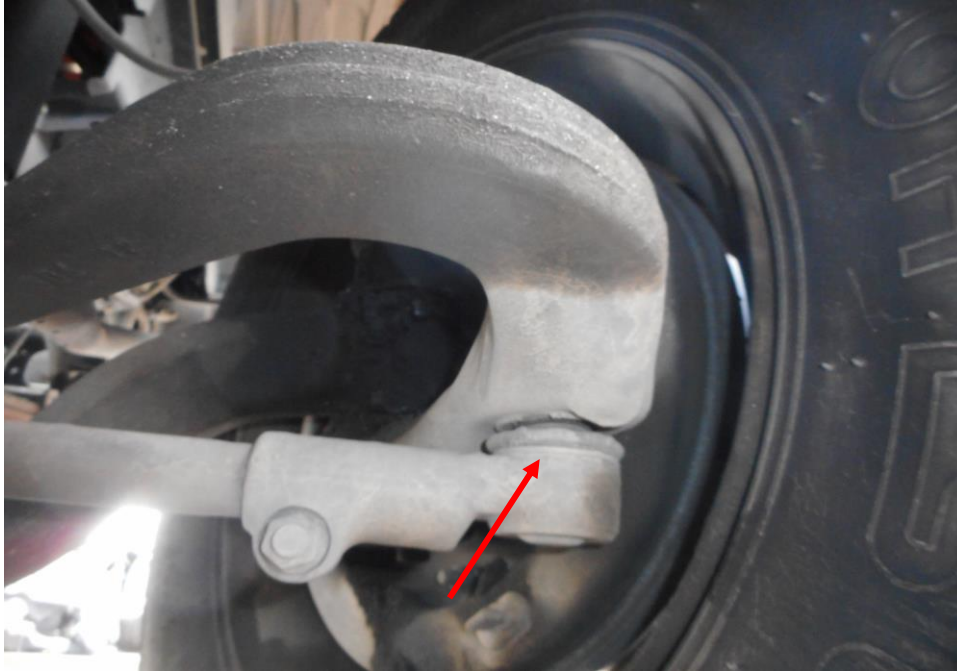
Photo 20 shows the various undercarriage components at the front right wheel of the Motor Lorry, in particular the steering tie rod end (arrowed). The various steering components were all found to be intact, suggesting that the steering system of the Motor Lorry was likely to be in serviceable condition at the material time of accident. There was also no sign of fluid stain(s) observed on the various undercarriage components.

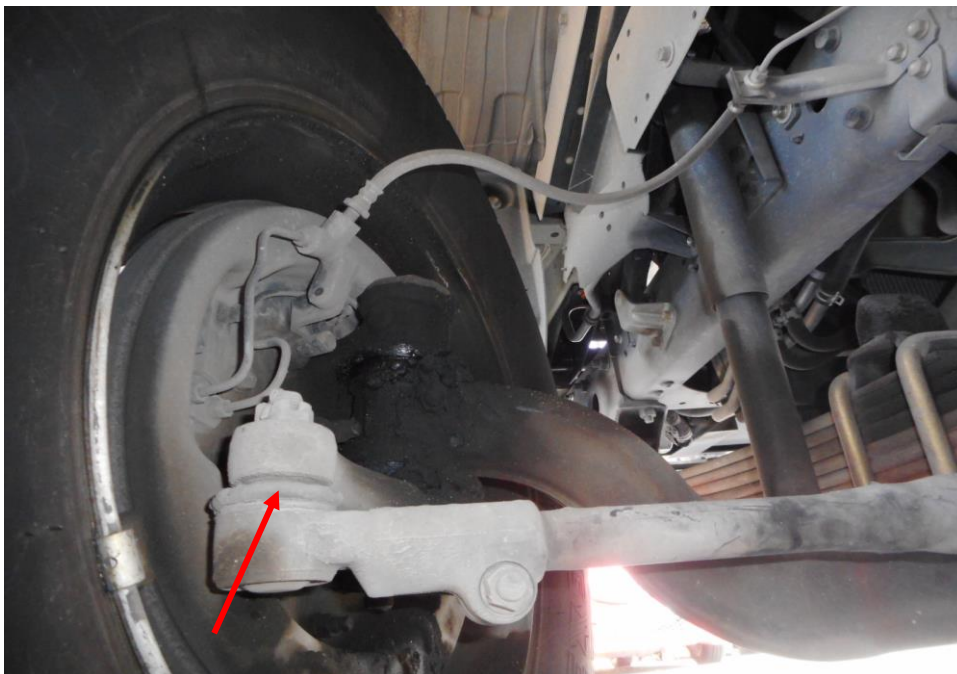
Photo 21 shows the various undercarriage components at the front left wheel of the Motor Lorry, in particular the steering tie rod end (arrowed). The various undercarriage components of the Motor Lorry were all found to be intact without any visible damage. There was also no sign of fluid stain(s) observed on the various undercarriage components.

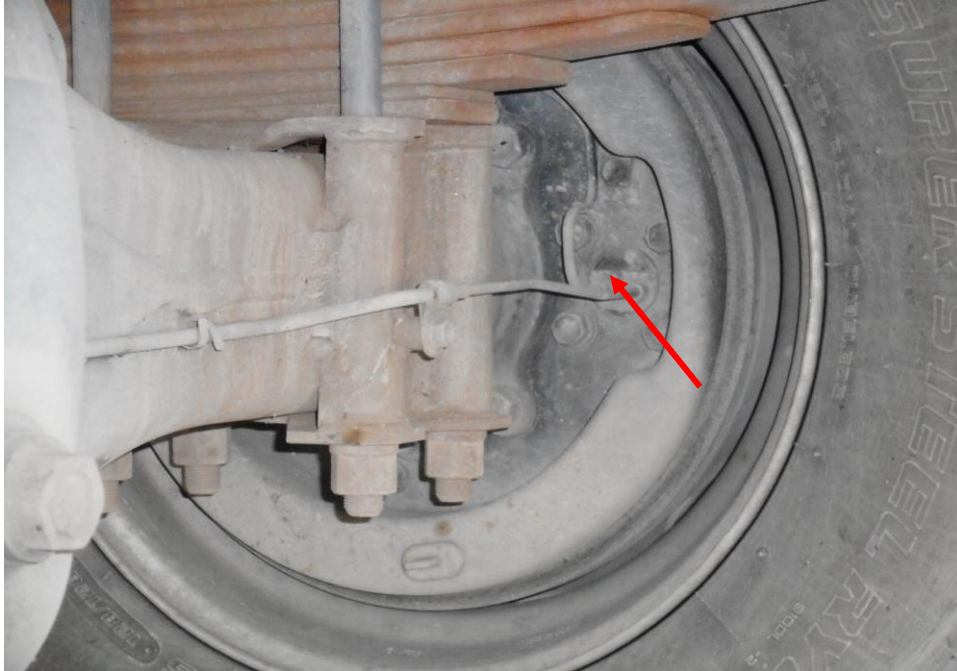
Photo 22 shows the brake pipe (arrowed) at the rear right wheel of the Motor Lorry. I did not observe any leakage of brake fluid at the time of my inspection of the Motor Lorry. My static tests of the Motor Lorry's braking system, along with my visual examination of the various mechanical components in the braking system, had indicated that there was no internal leakage of pressure/vacuum. Hence the braking system of the Motor Lorry was likely to be in serviceable condition at the material time of accident.

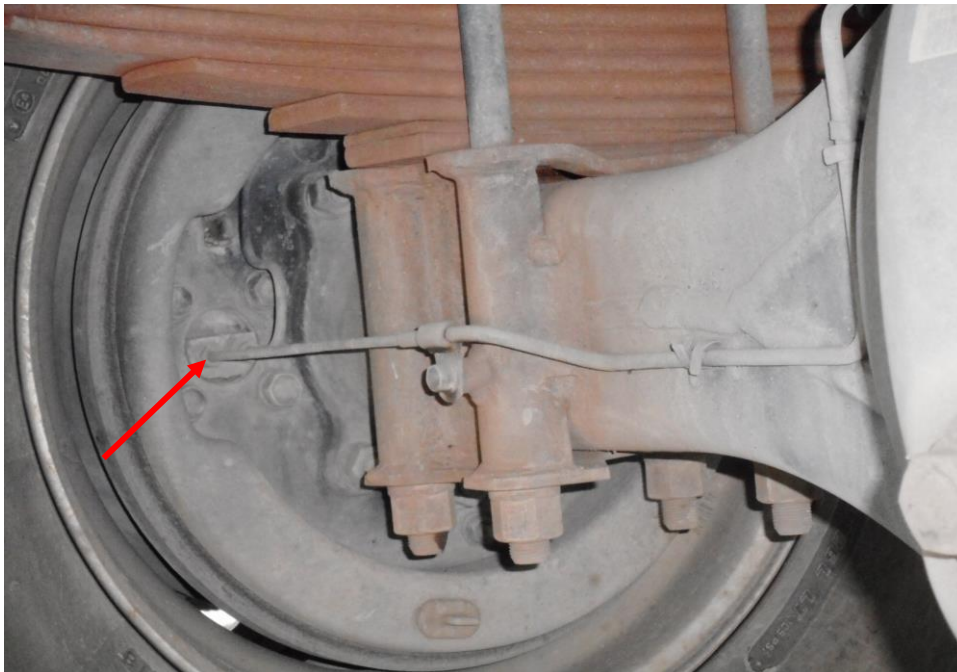
Photo 23 shows the brake pipe (arrowed) at the rear left wheel of the Motor Lorry. I did not observe any leakage of brake fluid at the time of my inspection of the Motor Lorry. My static tests of the Motor Lorry's braking system, along with my visual examination of the various mechanical components in the braking system had indicated that there was no internal leakage of pressure/vacuum. Hence the braking system of the Motor Lorry was likely to be in serviceable condition at the material time of accident.

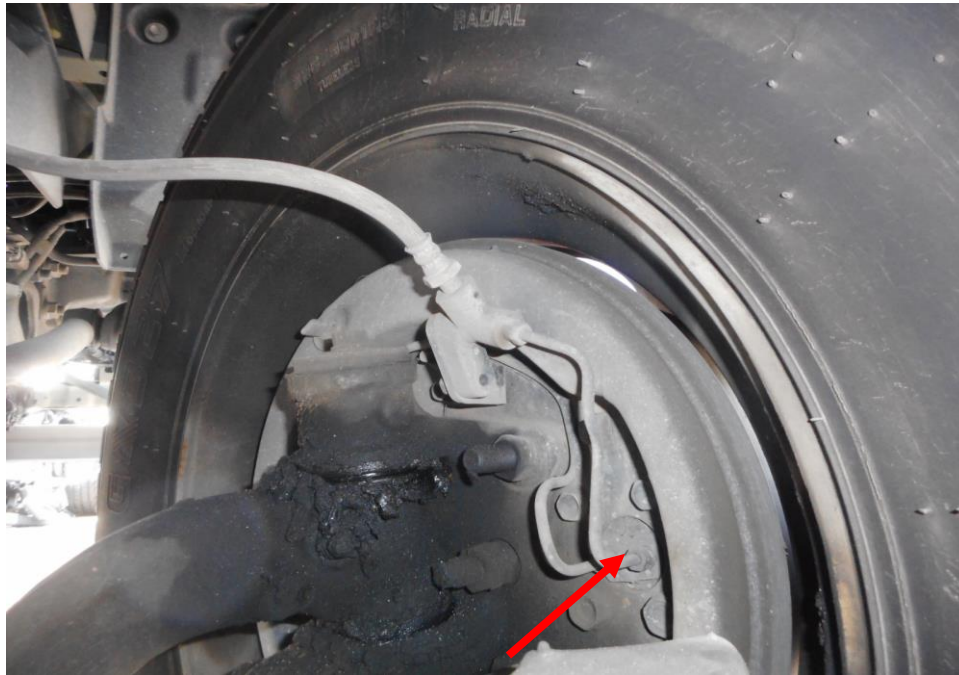
Photo 24 shows the brake hose/pipe (arrowed) at the front right wheel of the Motor Lorry. My static tests of the Motor Bus's braking system, along with my visual examination of the various mechanical components in the braking system had indicated that there was no internal leakage of pressure/vacuum. Hence the braking system of the Motor Bus was likely to be in serviceable condition at the material time of accident.

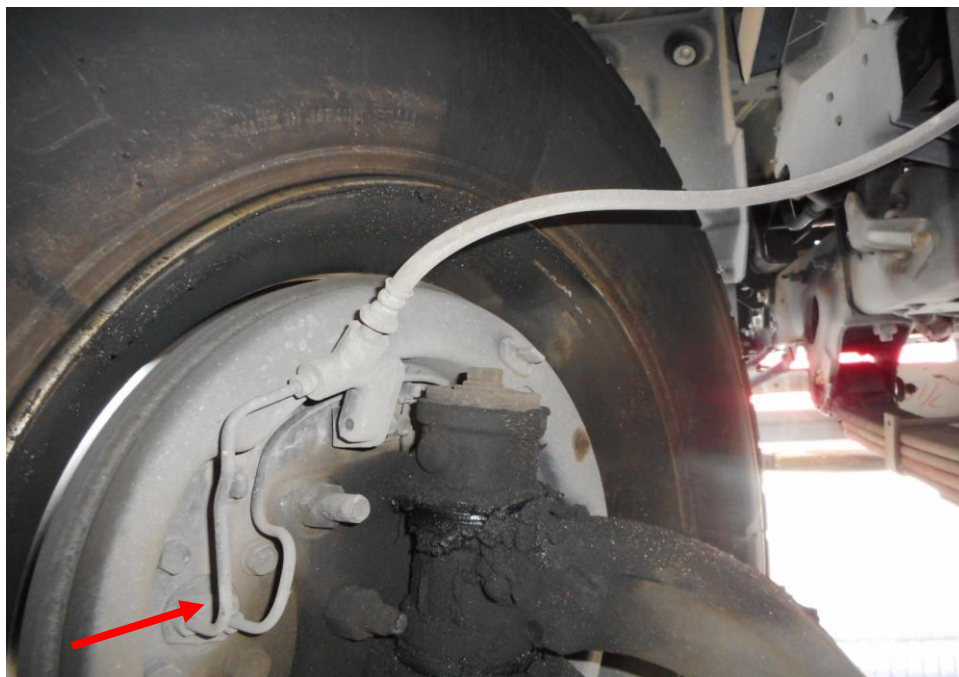
Photo 25 shows the brake hose/pipe (arrowed) at the front left wheel of the Motor Lorry. My static tests of the Motor Bus's braking system, along with my visual examination of the various mechanical components in the braking system had indicated that there was no internal leakage of pressure/vacuum. Hence the braking system of the Motor Bus was likely to be in serviceable condition at the material time of accident.

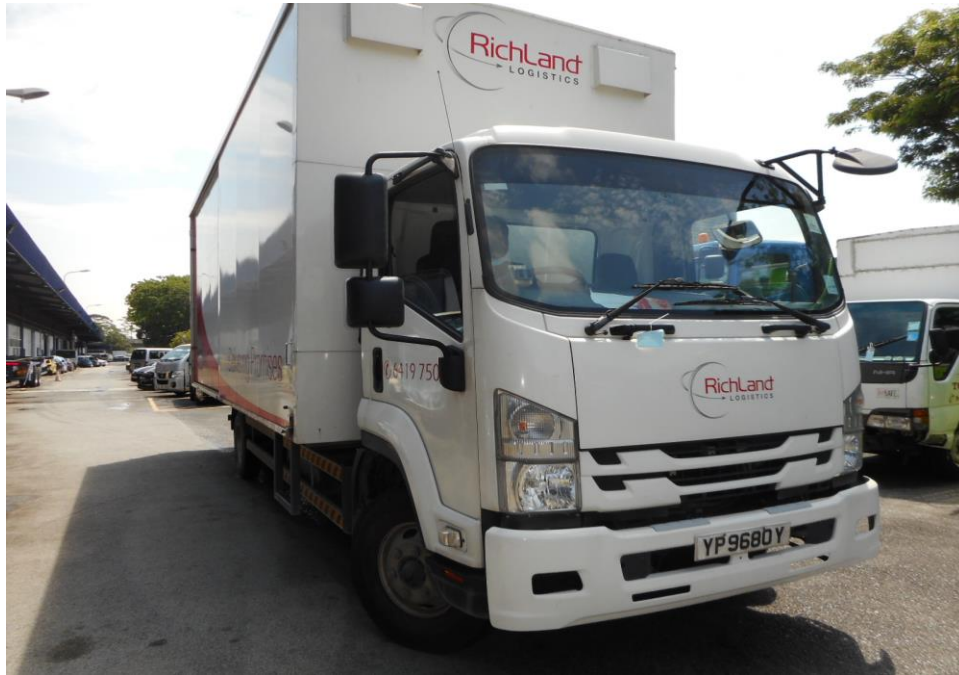
Photo 26 shows the front right wheel of the Motor Lorry turned to its full left. During my steering system test, I did not experience any abnormal free play and/or resistance when I had turned the steering wheel towards full left and full right. This would suggest that the steering system of the Motor Lorry was likely to be in serviceable condition at the material time of accident.
