Your Ref: TP/IP/12995/2021  
Our Ref : CI/TPD21003848/P

29<sup>th</sup> March 2021

**MECHANICAL INSPECTION REPORT OF MOTOR LORRY GBF 6933M**

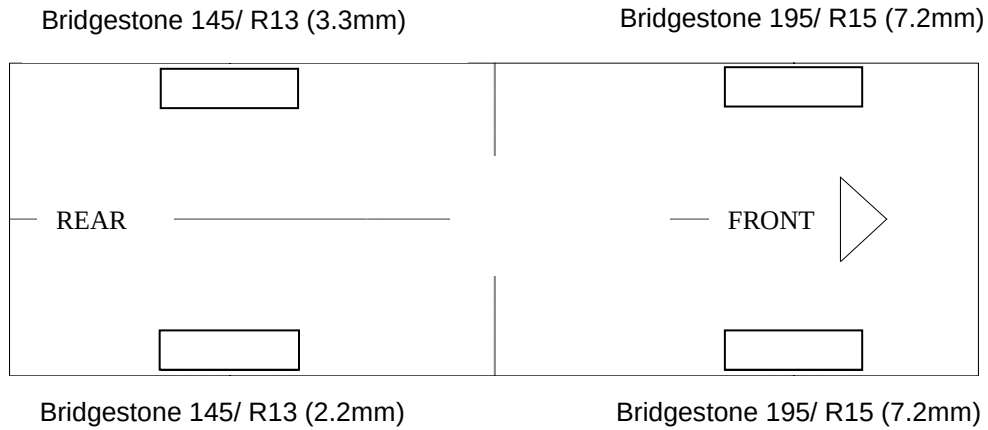
6. The 4 tyres of the Motor Lorry were observed to be in serviceable condition and sufficiently inflated for vehicular operation. I did not find any tear, cut or burst mark(s) on the outer and the inner sidewalls as well as across the tread of the 4 tyres. The tyre brand, tyre size and remaining tread depth of the 4 tyres of the Motor Lorry were recorded as follows:-

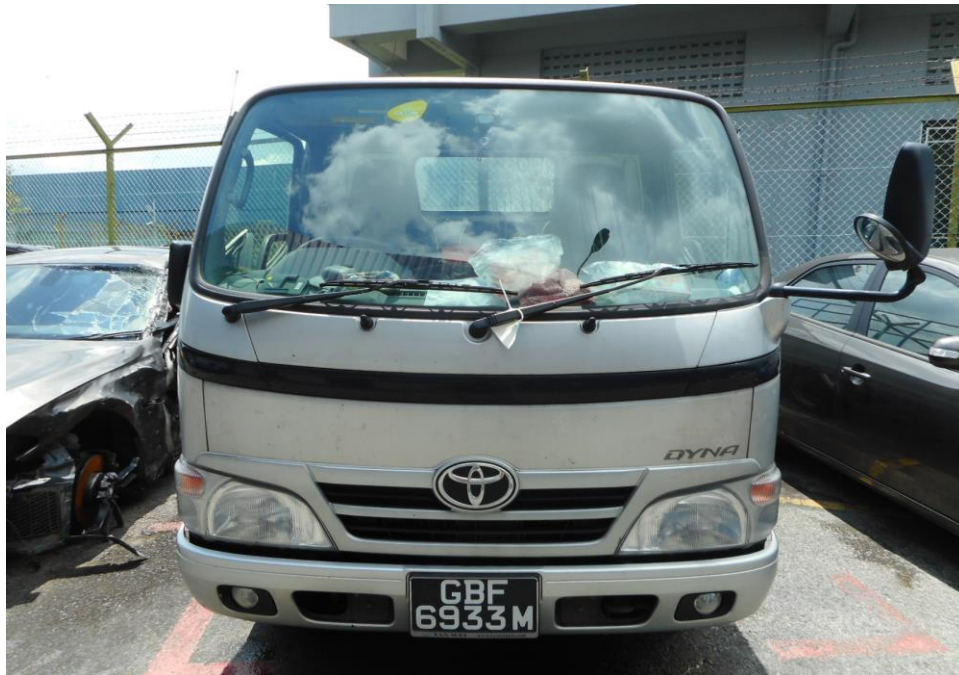
**Photo 1** shows a general view of the Motor Lorry's frontal portion at the time of my inspection. The Motor Lorry front portion was observed to be intact and unaffected by the accident.

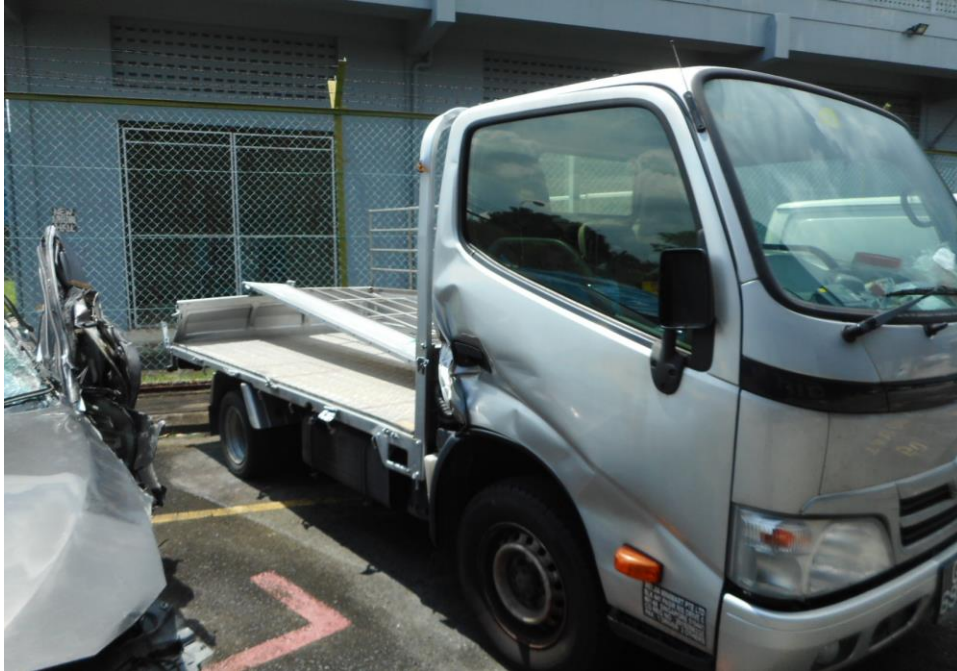
**Photo 2** shows general view of the Motor Lorry's right portion at the time of my inspection. It appeared to have sustained damage at its right portion. Its right door were damage at the time of my inspection as result of the accident.

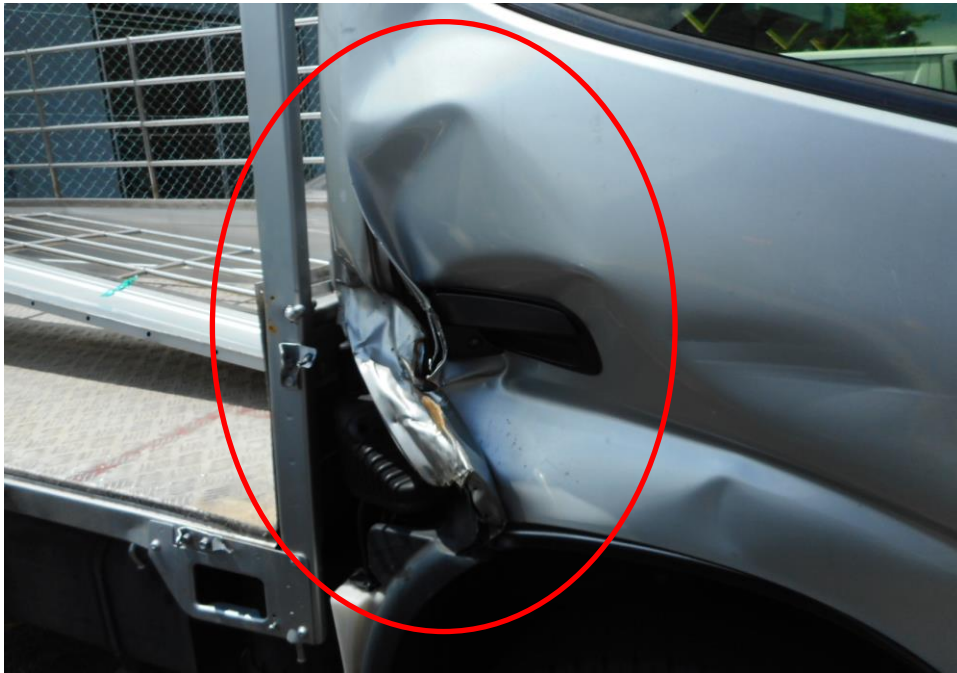
**Photo 3** shows close up view of the Motor Lorry's right portion at the time of my inspection. It appeared to have sustained damage at its right portion. Its right door (circled) were damage at the time of my inspection as result of the accident.

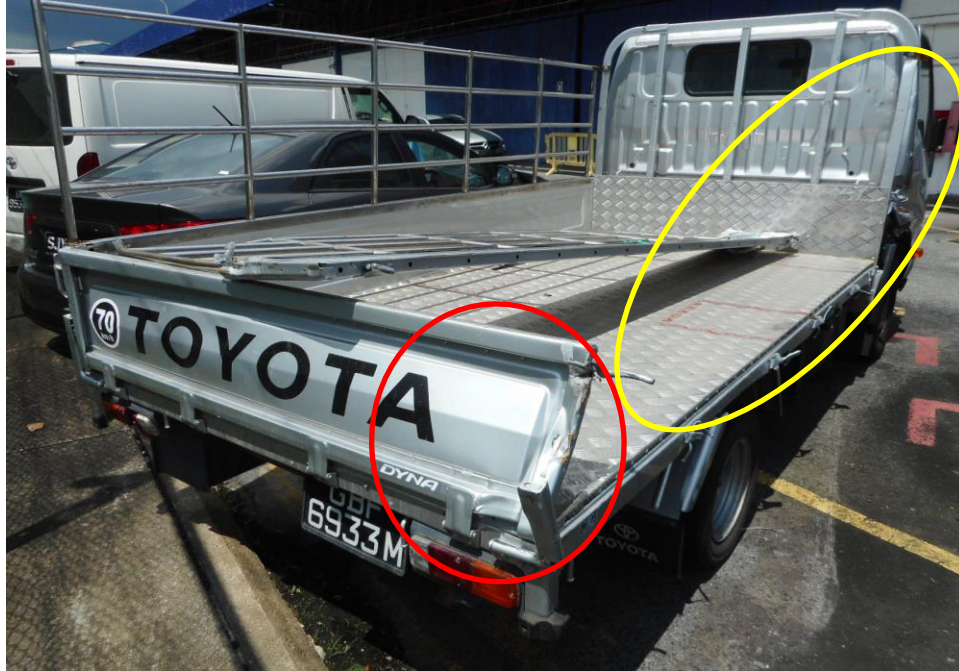
**Photo 4** shows close up view of the Motor Lorry's right and rear portion at the time of my inspection. It appeared to have sustained damage at its left portion. Its rear body panel (red circle) and right body panel (yellow circle) were damaged at the time of my inspection as result of the accident.

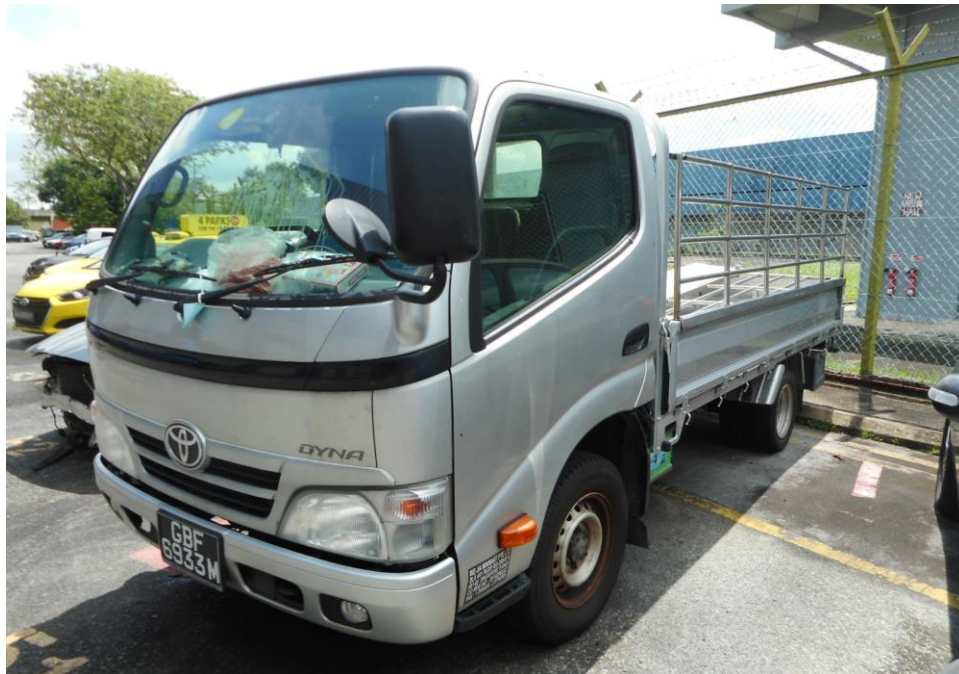
**Photo 5** shows a general view of the left body of the Motor Lorry at the time of my inspection. The Motor Lorry was observed to be intact and unaffected by the accident.

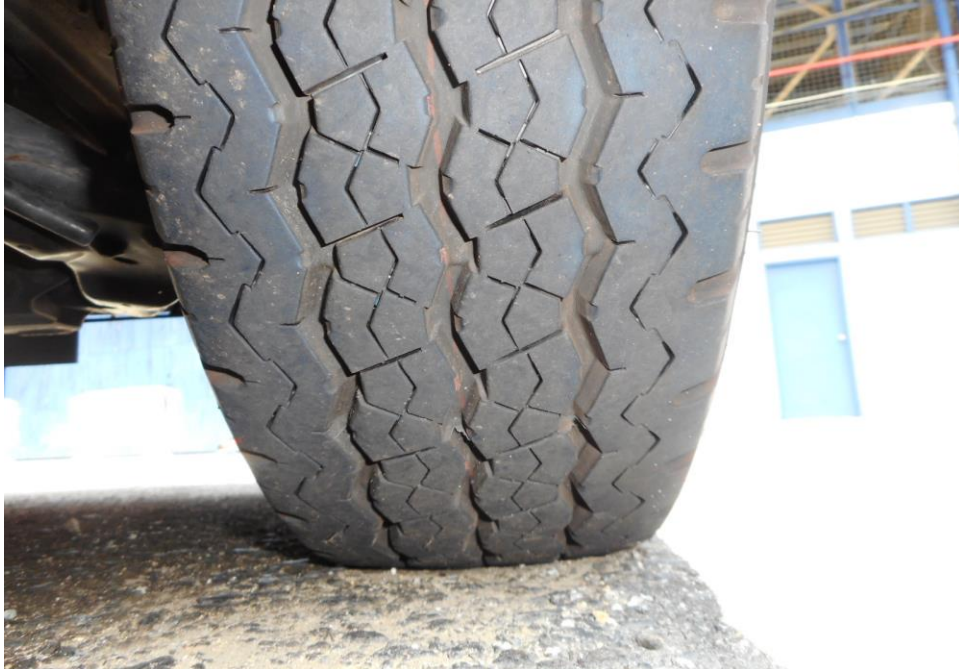
**Photo 6** shows the condition of the front right tyre of the Motor Lorry, which was observed to be in serviceable condition with remaining tread depth of approximately 7.2mm. The tyre, which was wrapped around standard steel wheel rim, was also observed to be sufficiently inflated for vehicular operation. There was no tear, cut or burst mark(s) on the outer and the inner sidewalls as well as across the tread of the 4 tyres that were fitted on the Motor Lorry.

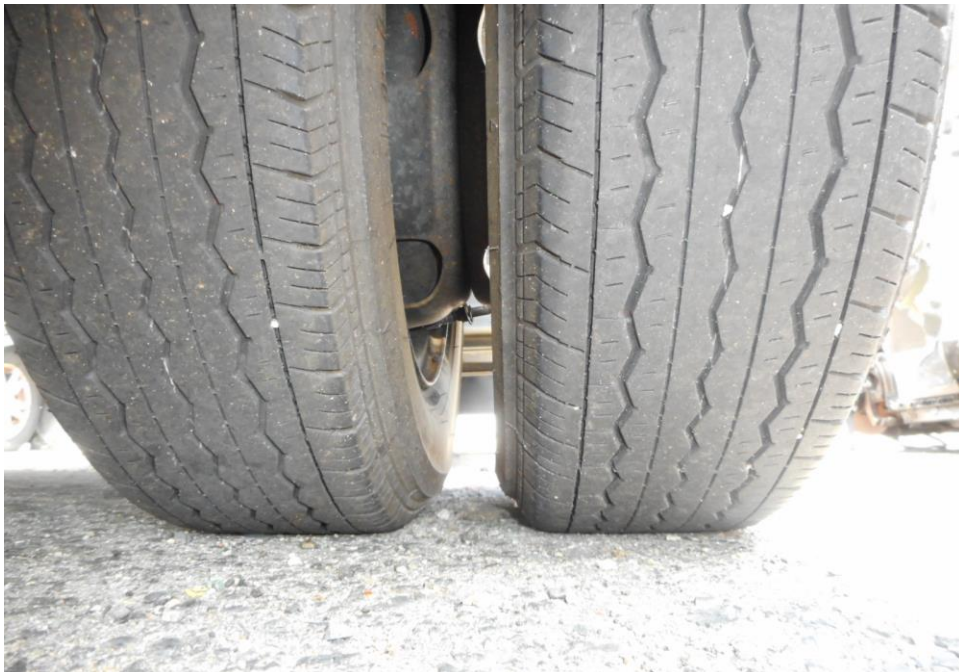
**Photo 7** shows the condition of the rear right tyre of the Motor Lorry, which was observed to be in serviceable condition with remaining tread depth of approximately 2.2mm. The tyre, which was wrapped around standard steel wheel rim, it was observed to be sufficiently inflated for vehicular operation.

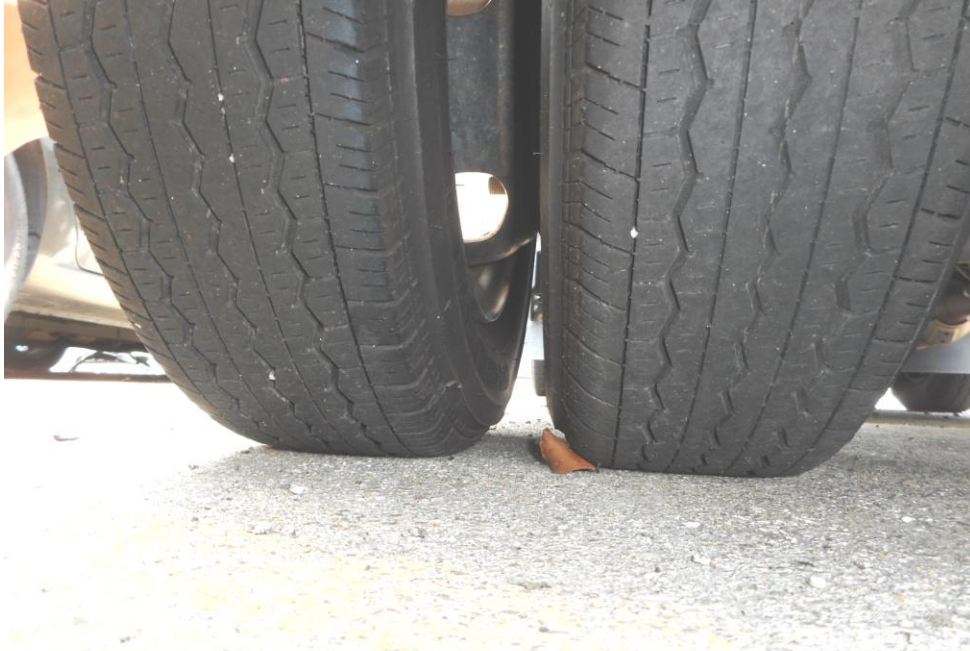
**Photo 8** shows the condition of the rear left tyres of the Motor Lorry, which was observed to be in serviceable condition with remaining tread depth of approximately 3.3mm. The tyres, which were wrapped around standard steel wheel rim, were also observed to be sufficiently inflated for vehicular operation. There was also no damage found on all 4 steel wheel rims of the Motor Lorry.

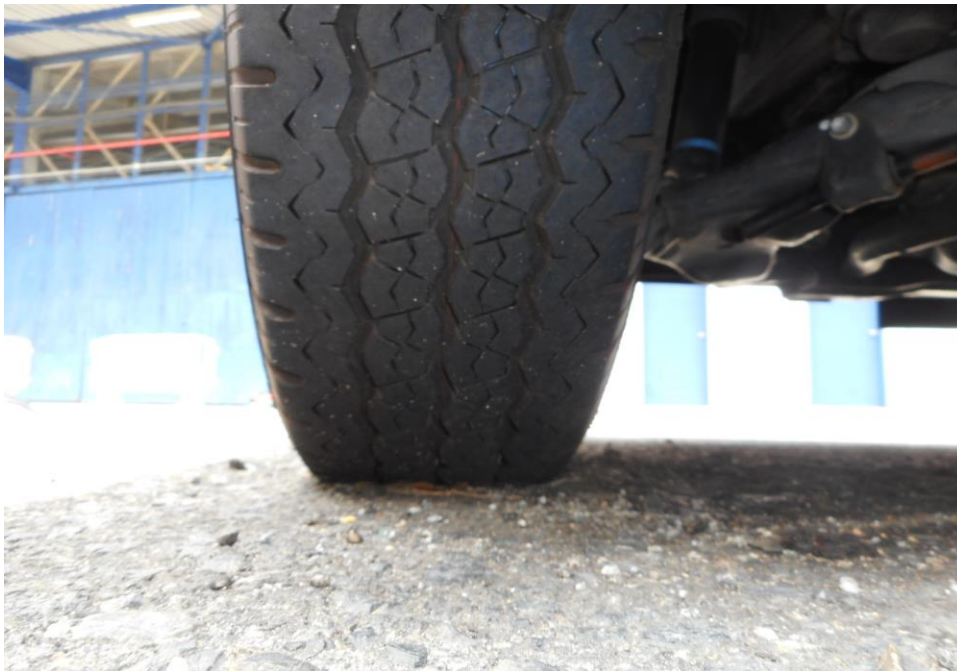
**Photo 9** shows the condition of the rear right tyres of the Motor Lorry, which were observed to be in serviceable condition with remaining, tread depth of approximately 7.2mm. There was also no tear, cut or burst mark(s) on the outer and the inner sidewalls as well as across the tread of the 4 tyres that were fitted on the Motor Lorry.

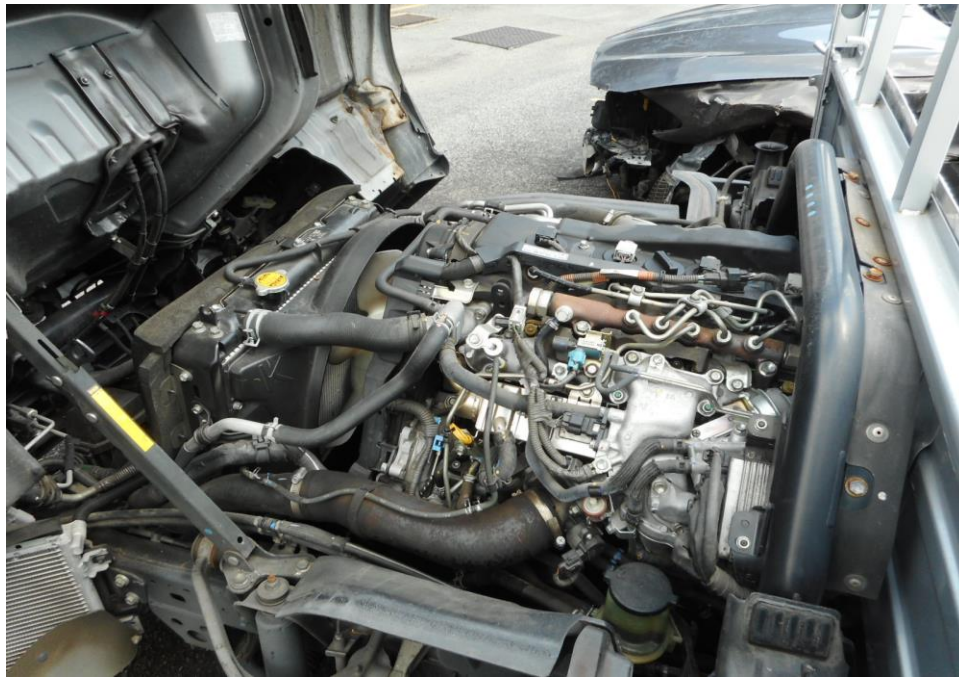
**Photo 10** shows a general view of the Motor Lorry's engine compartment, which was accessed by lifting the front cabin of the Motor Lorry. The various parts and components inside the engine compartment were unaffected by the accident. There was also no sign(s) or indication(s) of fresh fluid leakage and/or fluid stain within the engine compartment

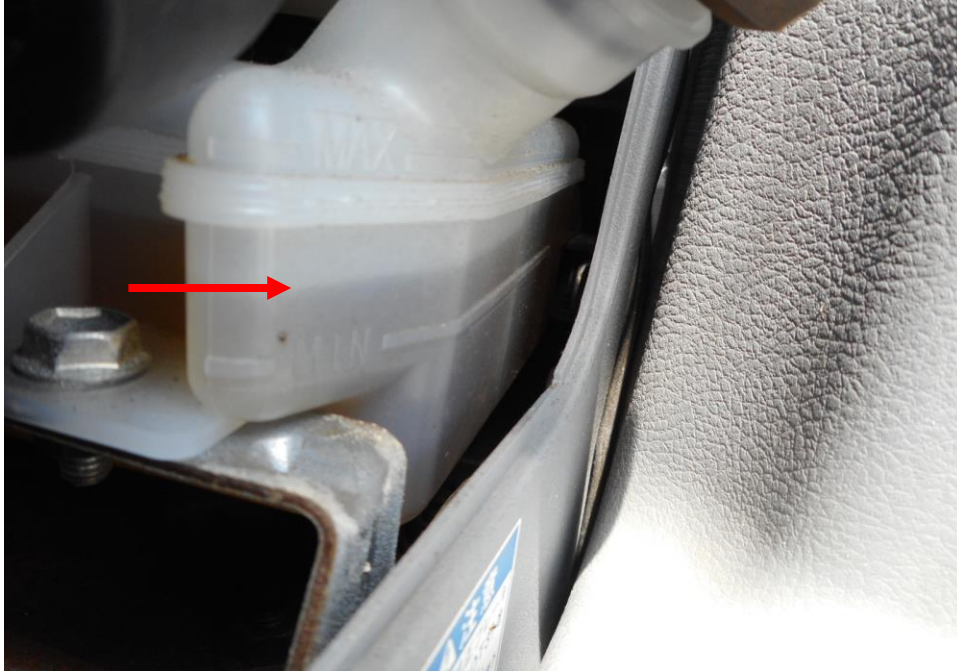
**Photo 11** shows the brake fluid reservoir of the Motor Lorry at the time of my inspection. The brake fluid was observed to be of sufficient level (arrowed) and without any visible contamination.

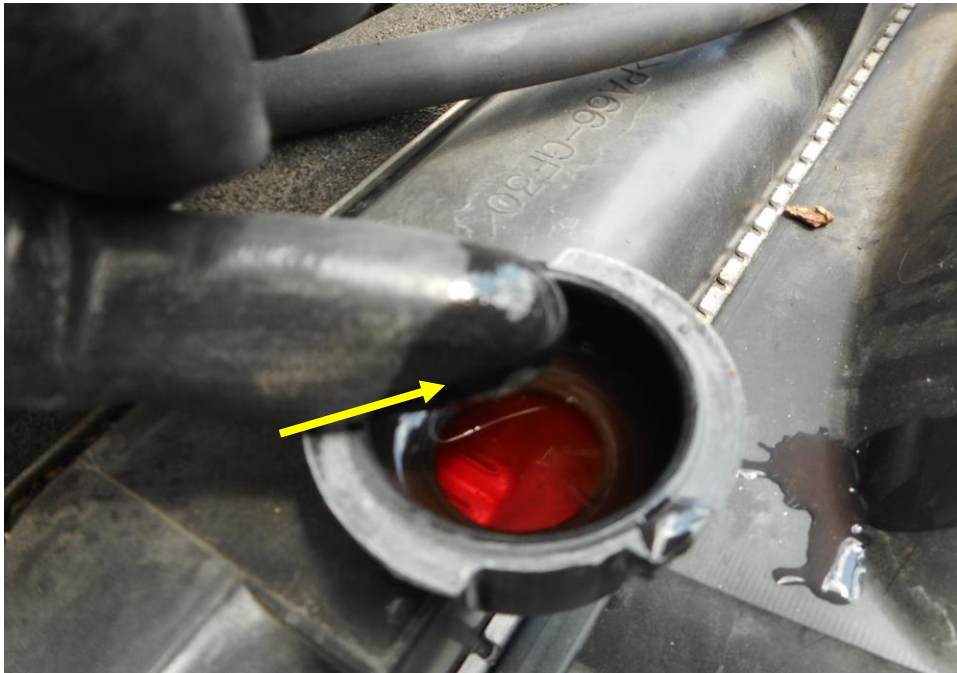
**Photo 12** shows the engine coolant reservoir of the Motor Lorry at the time of my inspection. The engine coolant was observed to be of sufficient level (arrowed) and without any visible contamination.

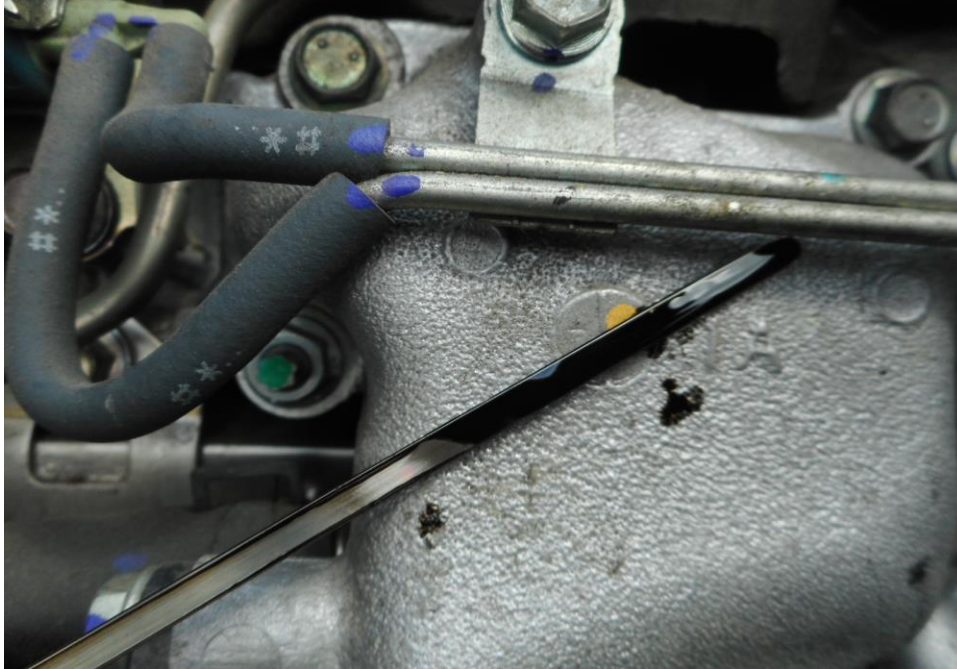
**Photo 13** shows the engine oil dip stick of the Motor Lorry at the time of my inspection. The engine oil was observed to be of sufficient level and without any visible contamination.

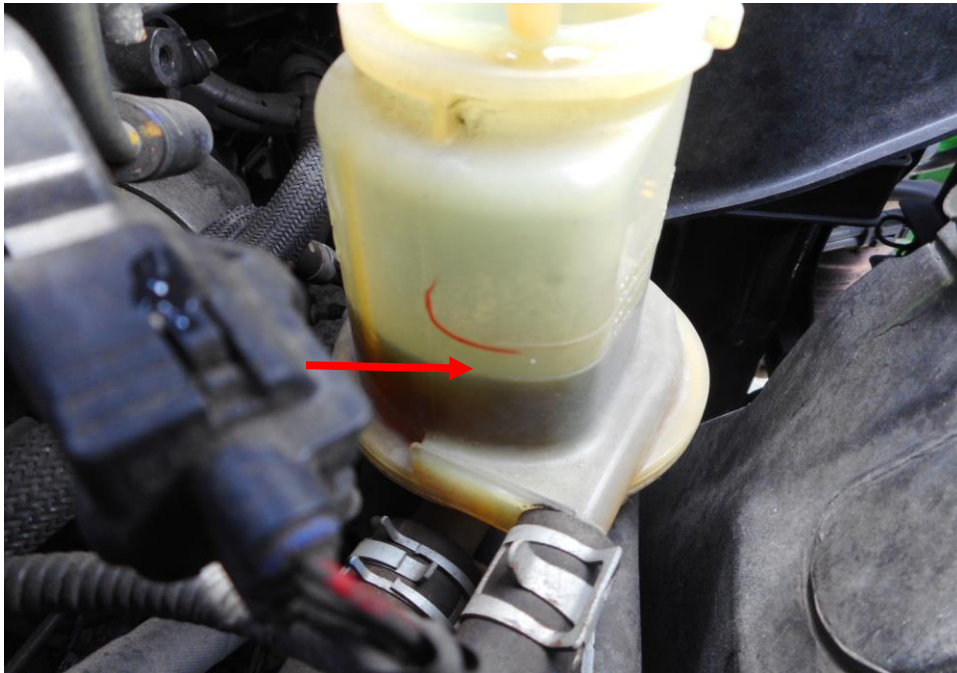
**Photo 14** shows the power steering fluid reservoir of the Motor Lorry at the time of my inspection. The power steering fluid was observed to be of sufficient level (arrowed) and without any visible contamination.

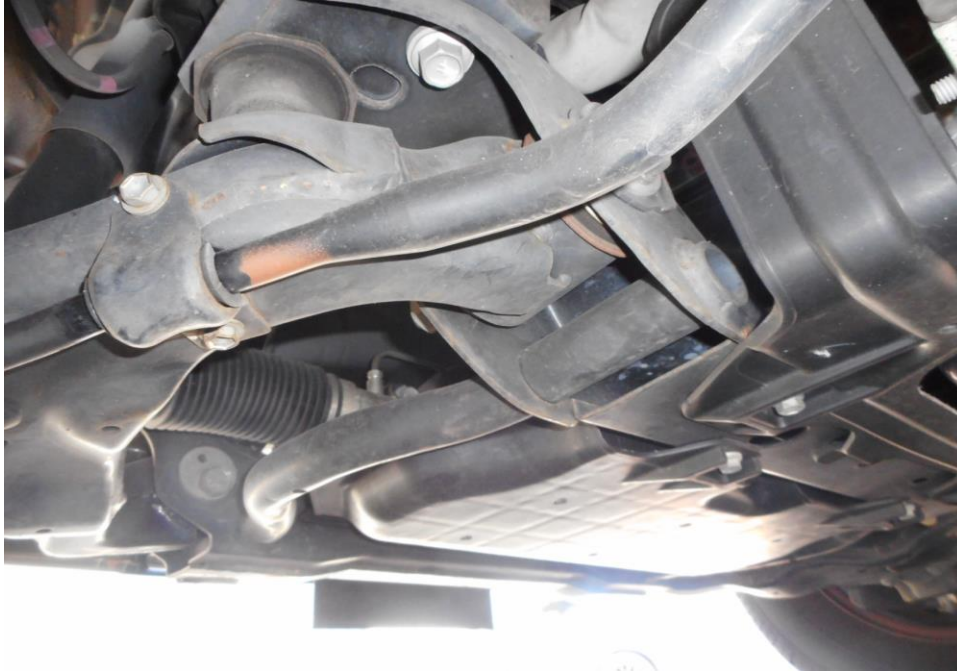
**Photo 15** shows the undercarriage of the Motor Lorry, at the area where the engine housing and transmission housing are located. I did not find any sign(s) or indication(s) of fluid leak and/or fluid stain(s) on the underside of the Motor Lorry.

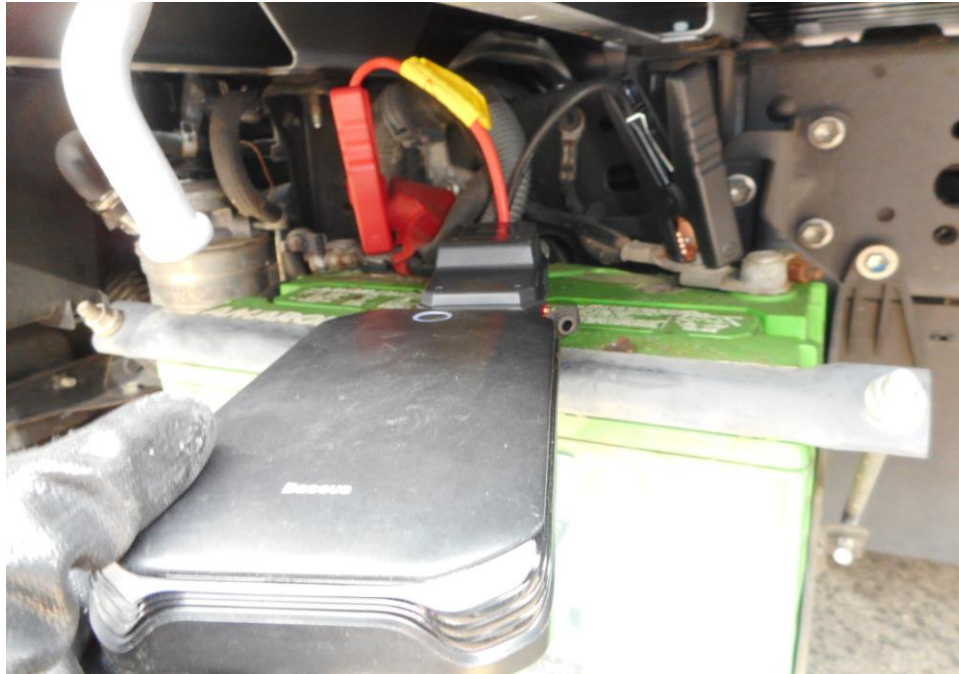
**Photo 16** shows the jumpstarting process of the Motor Lorry's engine. The engine of the Motor Lorry was unable to be jumpstarted up despite multiple attempts in starting it.

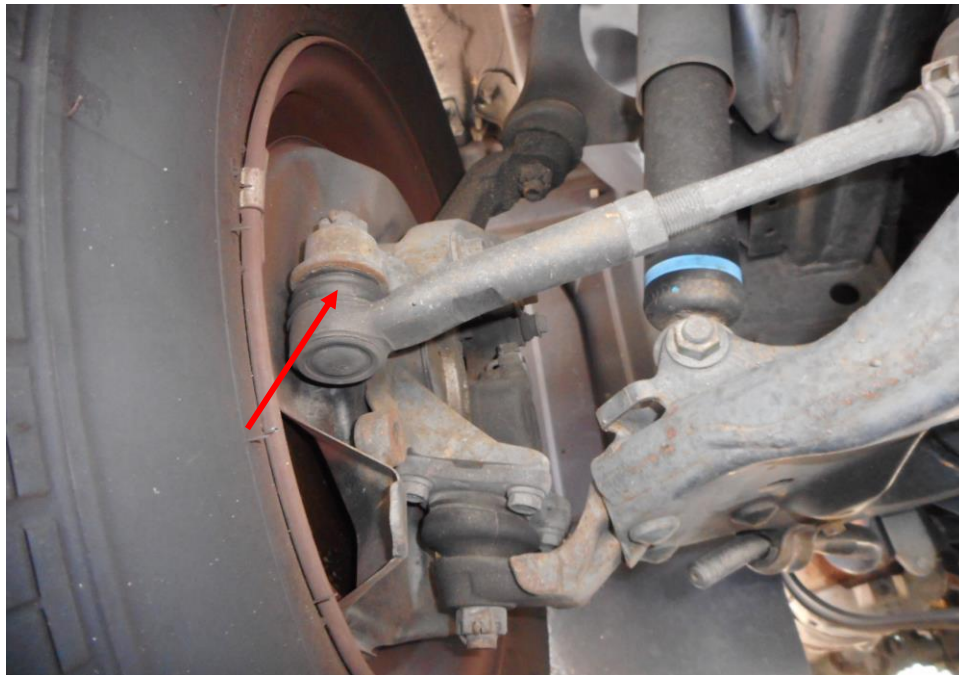
**Photo 17** shows the various undercarriage components at the front right wheel of the Motor Lorry, in particular the steering tie rod end (arrowed). The various steering components were all found to be intact, suggesting that the steering system of the Motor Lorry was likely to be in serviceable condition at the material time of accident. There was also no sign of fluid stain(s) observed on the various undercarriage components.

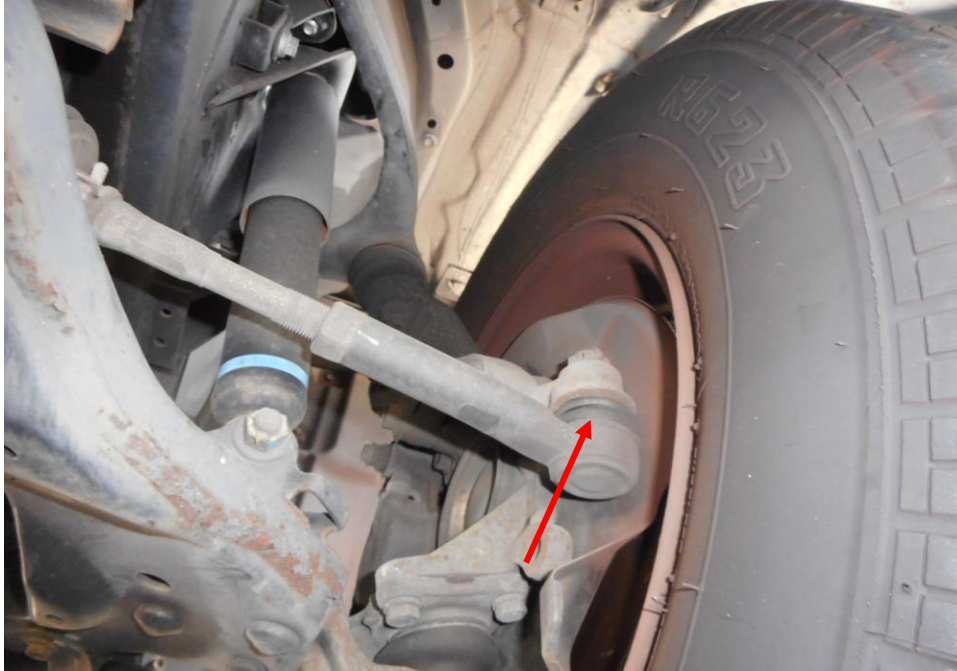
**Photo 18** shows the various undercarriage components at the front left wheel of the Motor Lorry, in particular the steering tie rod end (arrowed). The various undercarriage components of the Motor Lorry were all found to be intact without any visible damage. There was also no sign of fluid stain(s) observed on the various undercarriage components.

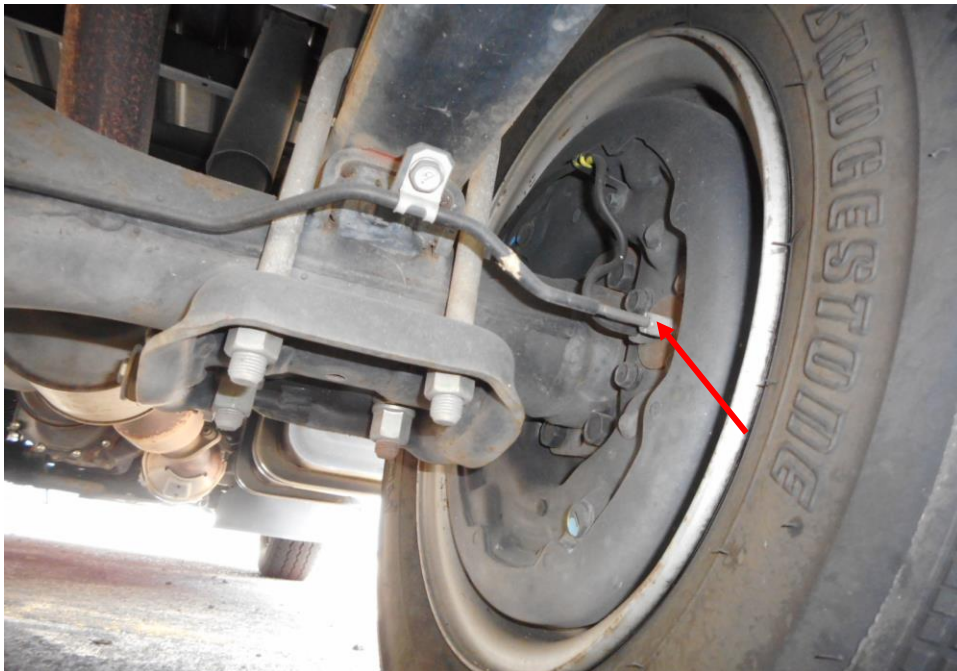
**Photo 19** shows the brake pipe (arrowed) at the rear right wheel of the Motor Lorry. I did not observe any leakage of brake fluid at the time of my inspection of the Motor Lorry. My static tests of the Motor Lorry's braking system, along with my visual examination of the various mechanical components in the braking system, had indicated that there was no internal leakage of pressure/vacuum. Hence the braking system of the Motor Lorry was likely to be in serviceable condition at the material time of accident.

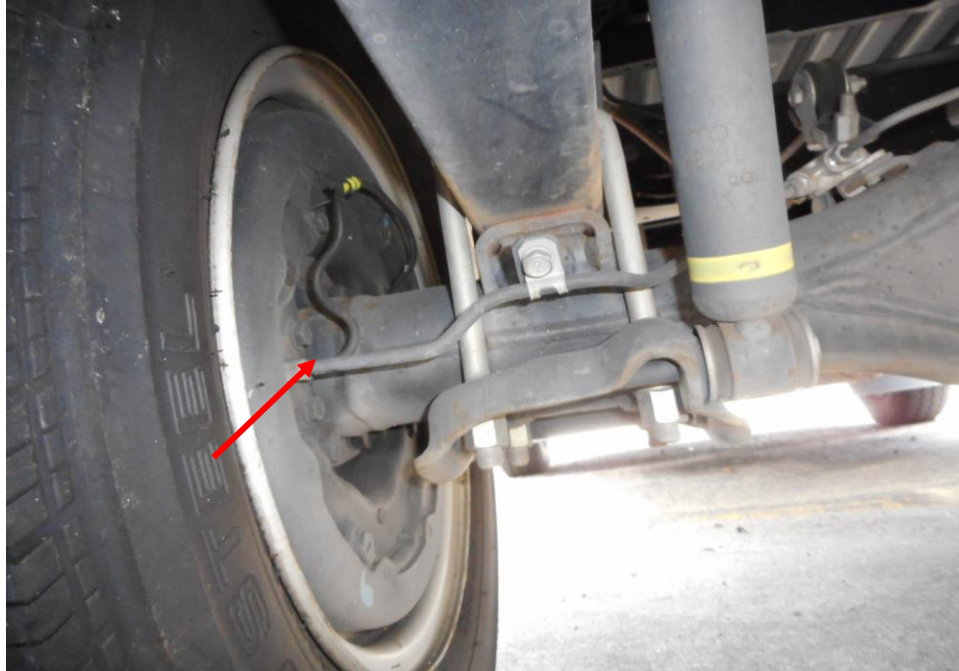
**Photo 20** shows the brake pipe (arrowed) at the rear left wheel of the Motor Lorry. I did not observe any leakage of brake fluid at the time of my inspection of the Motor Lorry. My static tests of the Motor Lorry's braking system, along with my visual examination of the various mechanical components in the braking system had indicated that there was no internal leakage of pressure/vacuum. Hence the braking system of the Motor Lorry was likely to be in serviceable condition at the material time of accident.

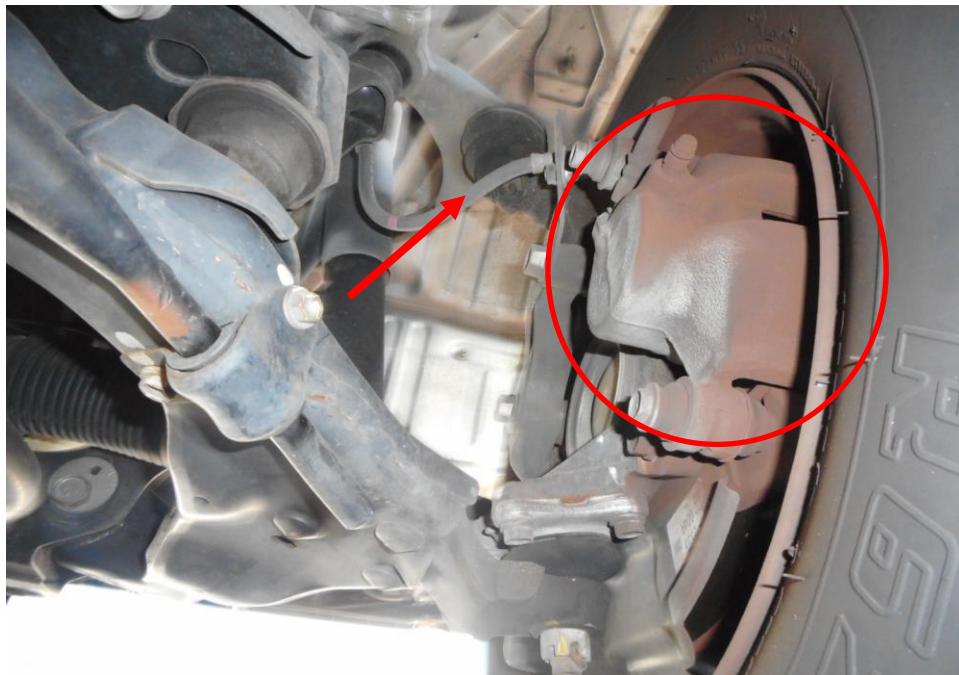
**Photo 21** shows the brake hose/pipe (arrowed) at the front right wheel of the Motor Lorry. No leakage of brake fluid was observed. Visual examination of the various components of the braking system like the brake caliper (circled), brake booster, brake pedal etc had revealed all to be intact and without visible damage at the time of accident. There was also no sign of fluid stain(s) observed on the various undercarriage components.

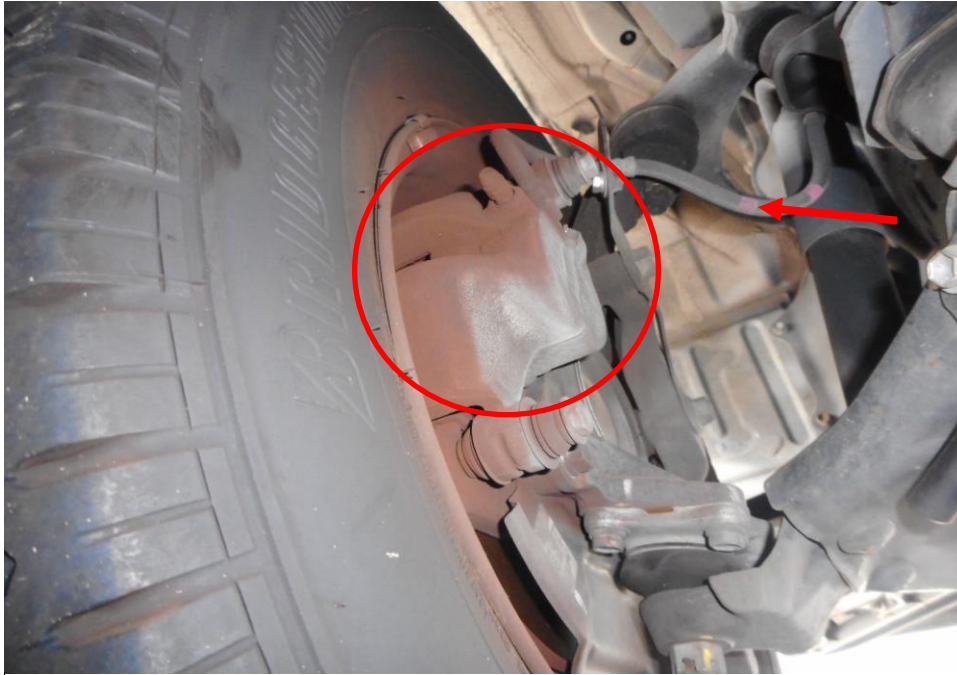
**Photo 22** shows the brake hose/pipe (arrowed) at the front left wheel of the Motor Lorry. No leakage of brake fluid was observed. Visual examination of the various components of the braking system like the brake caliper (circled), brake booster, brake pedal etc had revealed all to be intact and without visible damage at the time of accident. There was also no sign of fluid stain(s) observed on the various undercarriage components.
