Your Ref: TP/IP/14151/2021  
Our Ref : CI/TPD21003849/P

**MECHANICAL INSPECTION REPORT OF MOTOR BUS SBS 8595Z**

1. I refer to your request on 25<sup>th</sup> March 2021 to conduct a physical inspection of a Motor Bus bearing registration number SBS 8595Z (herein referred to as "**Motor Bus**"), which was involved in a fatal road traffic accident on 19<sup>th</sup> March 2021.
2. The objective of this inspection is to determine if there was any possible mechanical failure to the Motor Bus that may have contributed to the accident.
3. Following the request, I had carried out a physical inspection of the Motor Bus on 12<sup>th</sup> April 2021 at the premises of Traffic Police vehicle pound, 517 Airport Road Singapore 539942. I now set out below my observations and comments with respect to this inspection.

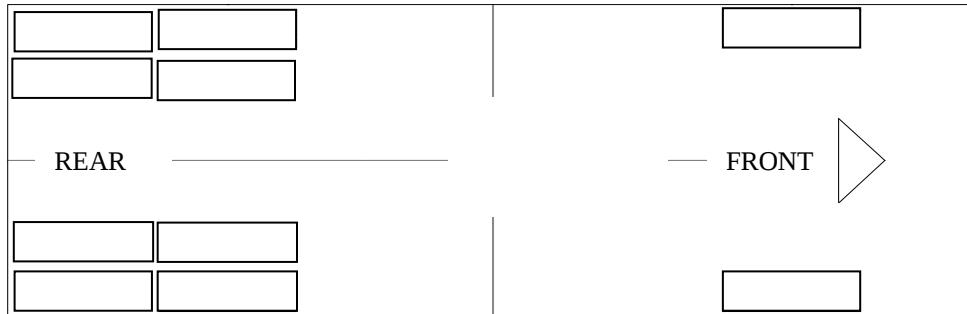
Bridgestone 275/70R22.5 (13.8mm)

Bridgestone 275/70R22.5 (13mm)

Bridgestone 275/70R22.5 (6.5mm)

Bridgestone 275/70R22.5 (9.9mm)

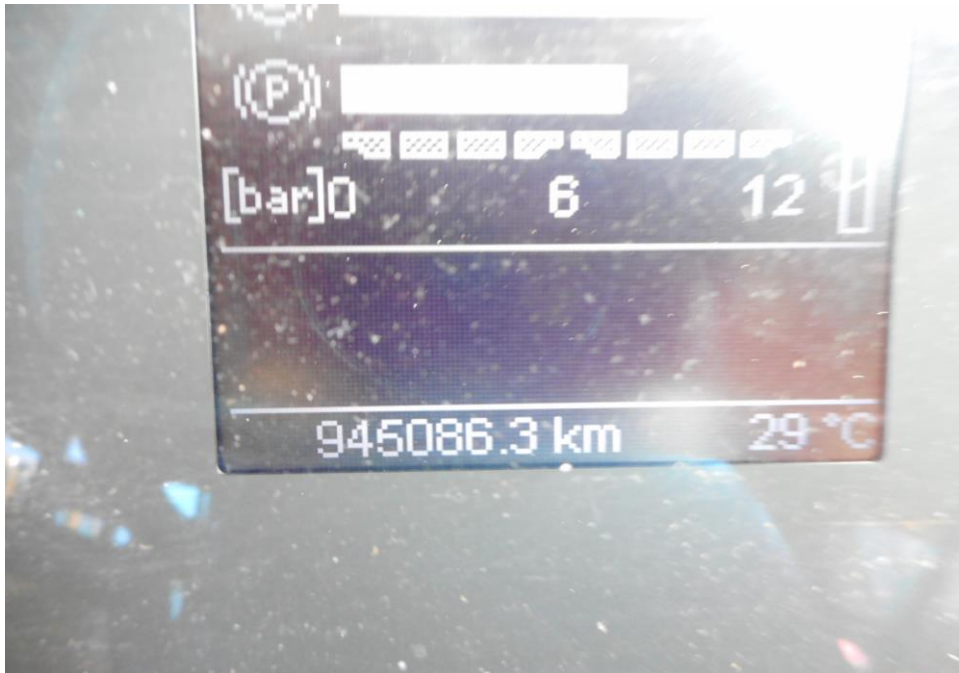
4. The mileage of the Motor Bus at the time of my inspection was 945,086km.
5. There was no visible damage observed on the Motor Bus at the time of my inspection.

**Photo 1** shows a general view of the instrument cluster of the Motor Bus at the time of my inspection. The mileage of the Motor Bus was 945,086km

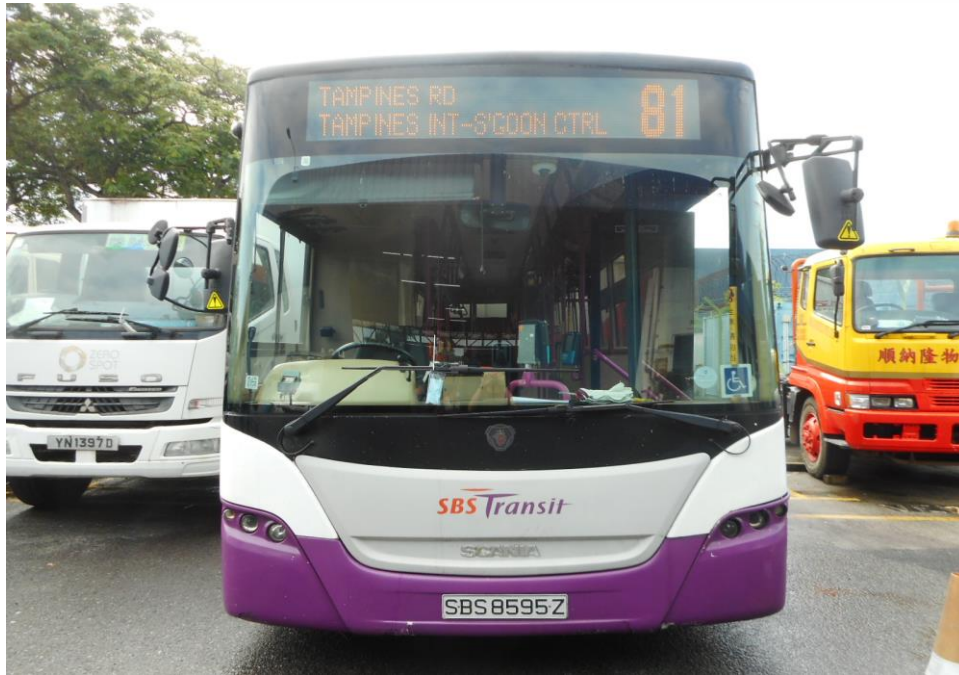
**Photo 2** shows a general view of the front body of the Motor Bus at the time of my inspection. The Motor Bus was observed to be intact and unaffected by the accident.

14. A short operational test to the Motor Bus, to primarily determine whether there was any abnormality to its various operating systems like its engine system, its transmission system, steering system and braking system was subsequently carried out. The test was conducted by driving the Motor Bus forward, stopping, before reversing and coming to a stop again.
15. During the operational test, the various transmission gears of the Motor Bus were able to be engage without any difficulty by stepping on the clutch pedal and manually shifting the gear lever. There were no abnormal sounds heard and/or abnormal behaviour of the Motor Bus's engine system. It was able to move forward and backward normally. The braking system was also found to be in working condition as the Motor Bus was able to slow down and come to a complete stop upon depressing of the brake pedal. Refer to photo 2 and 23.

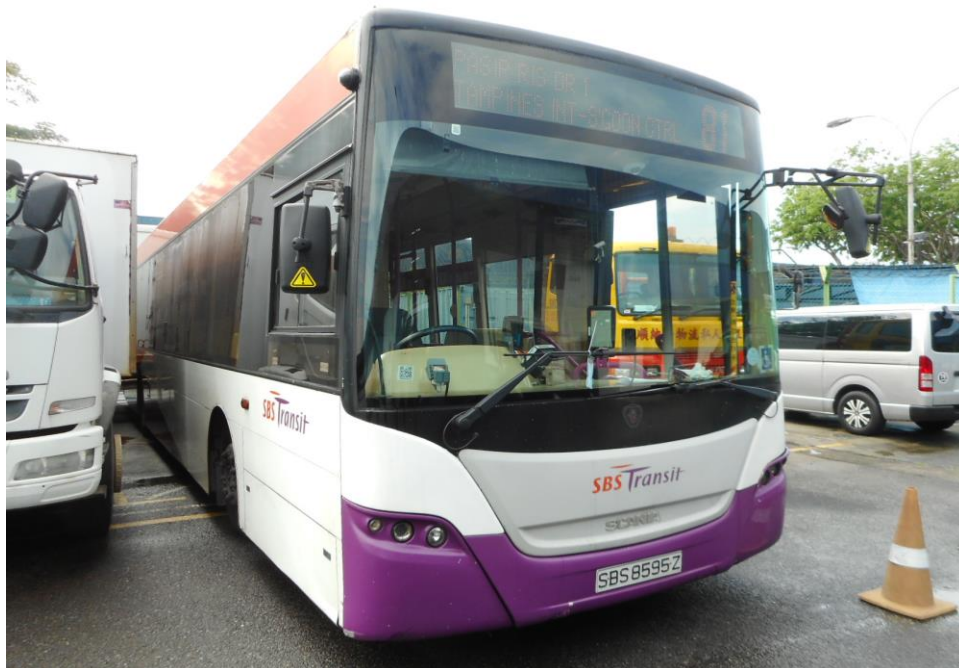
**Photo 3** shows a general view of the right body of the Motor Bus at the time of my inspection. The Motor Bus was observed to be intact and unaffected by the accident.

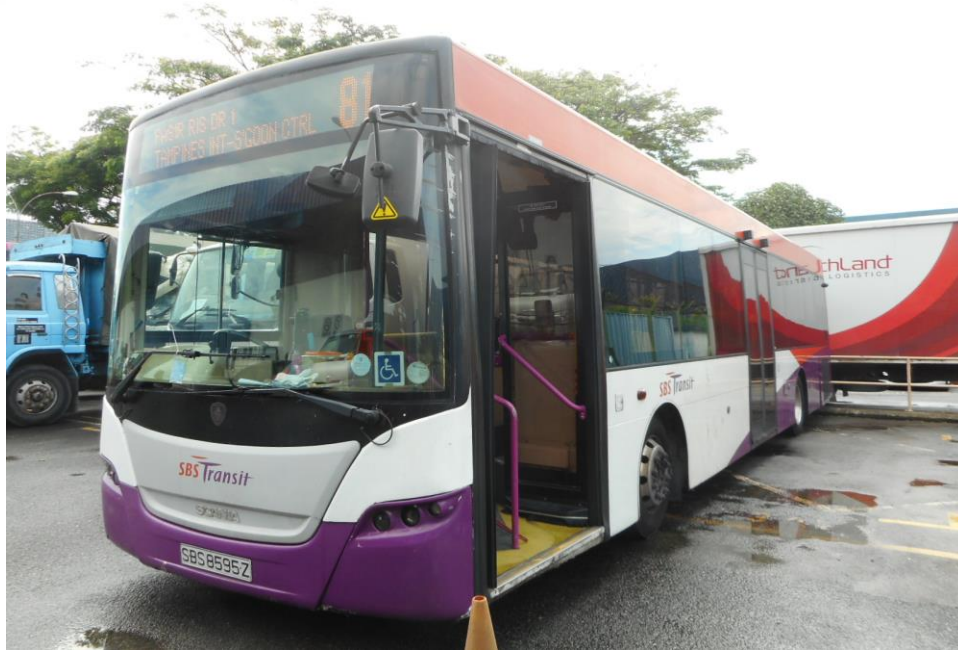
**Photo 4** shows a general view of the left body of the Motor Bus at the time of my inspection. The Motor Bus was observed to be intact and unaffected by the accident.

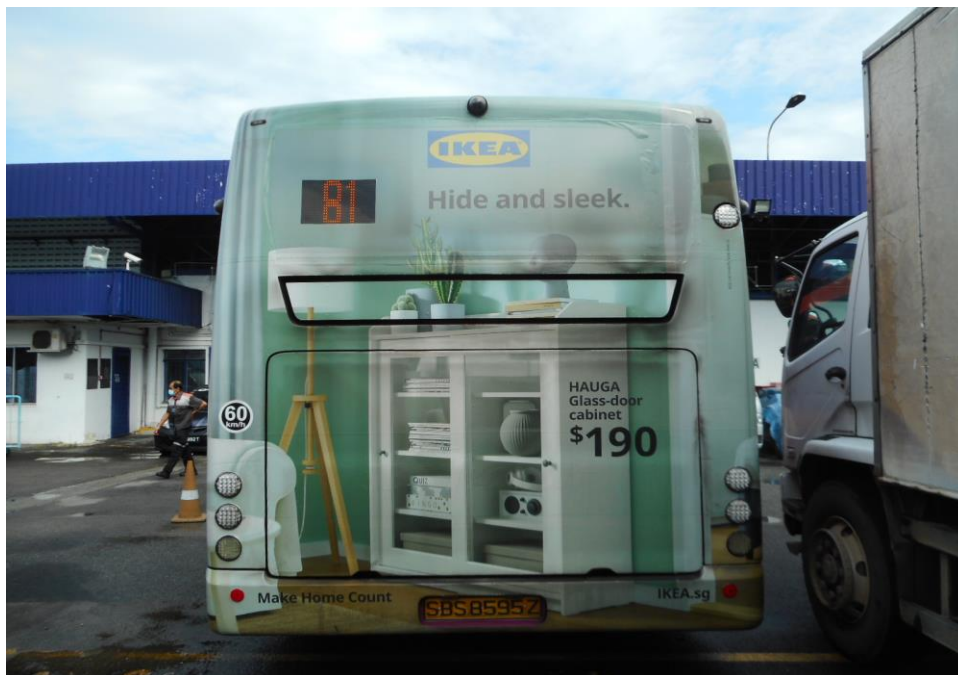
**Photo 5** shows a general view of the Motor Bus's rear body at the time of my inspection. The Motor Bus was observed to be intact and unaffected to by the accident.

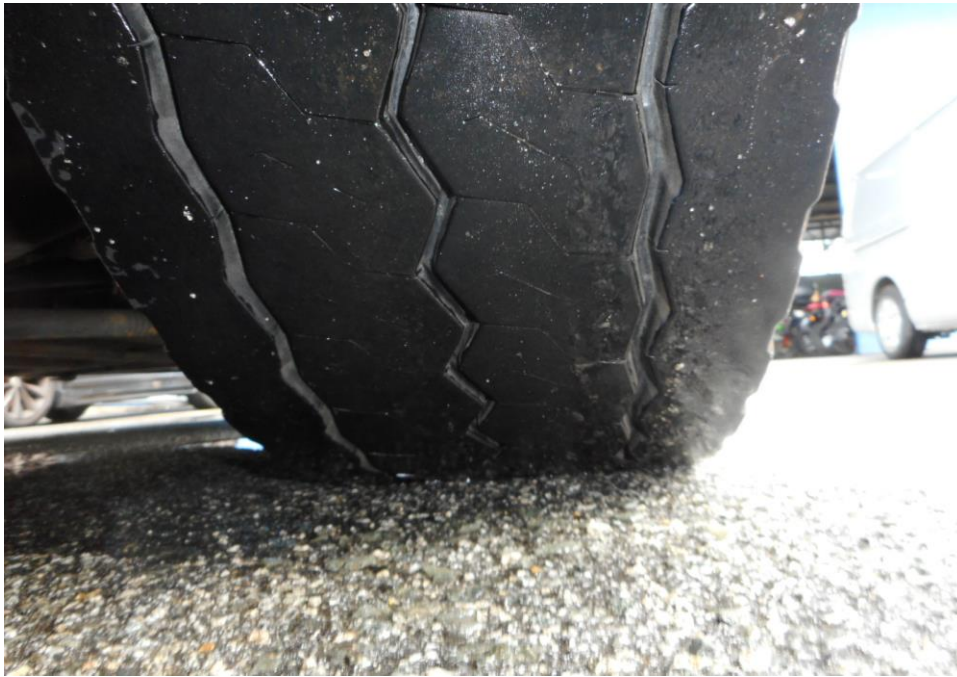
**Photo 6** shows the condition of the front right tyre of the Motor Bus, which was observed to be in serviceable condition with remaining tread depth of approximately 9.9mm. The tyre, which was wrapped around standard steel wheel rim, was also observed to be sufficiently inflated for vehicular operation. There was no tear, cut or burst mark(s) on the outer and the inner sidewalls as well as across the tread of the 6 tyres that were fitted on the Motor Bus.

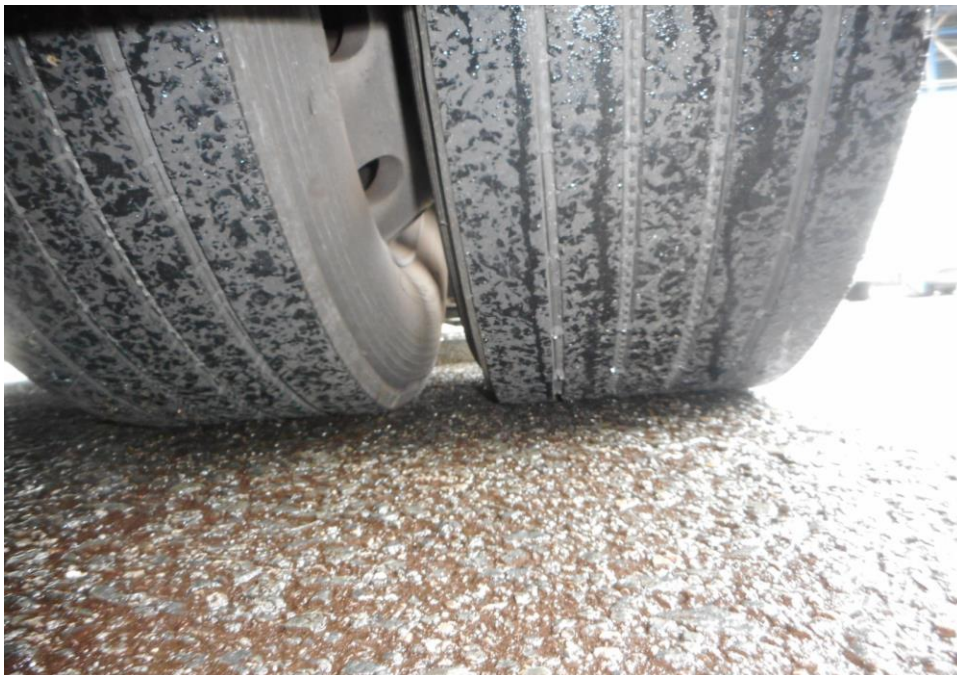
**Photo 7** shows the condition of the rear right tyre of the Motor Bus, which was observed to be in serviceable condition with remaining tread depth of approximately 6.5mm. The tyre, which was wrapped around standard steel wheel rim, was also observed to be sufficiently inflated for vehicular operation.

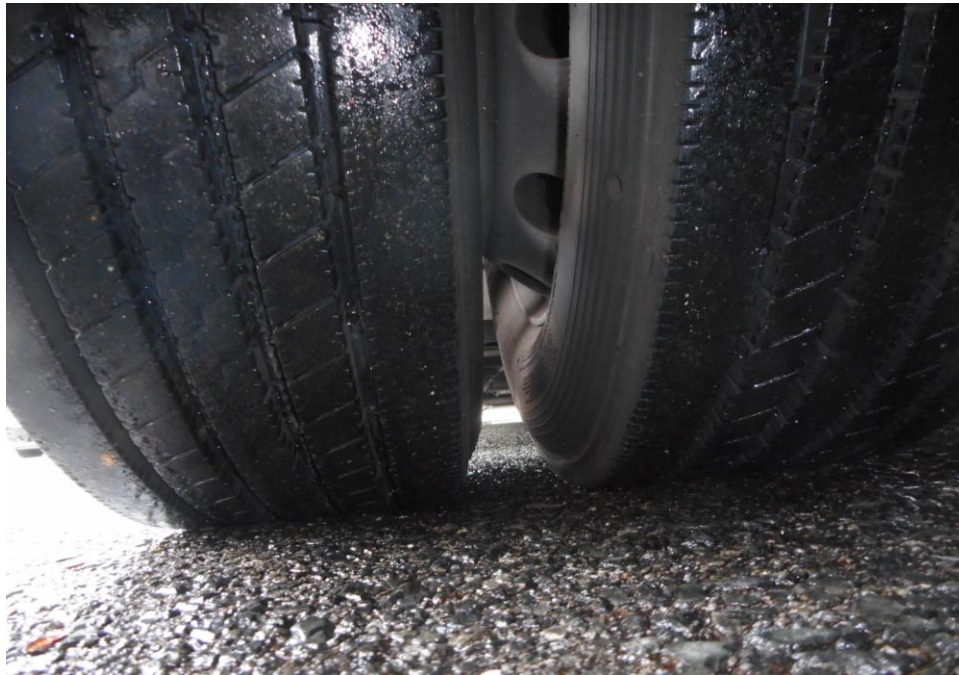
**Photo 8** shows the condition of the rear left tyres of the Motor Bus, which was observed to be in serviceable condition with remaining tread depth of approximately 13.8mm. The tyres, which were wrapped around standard steel wheel rim, were also observed to be sufficiently inflated for vehicular operation. There was also no damage found on all 6 steel wheel rims of the Motor Bus.

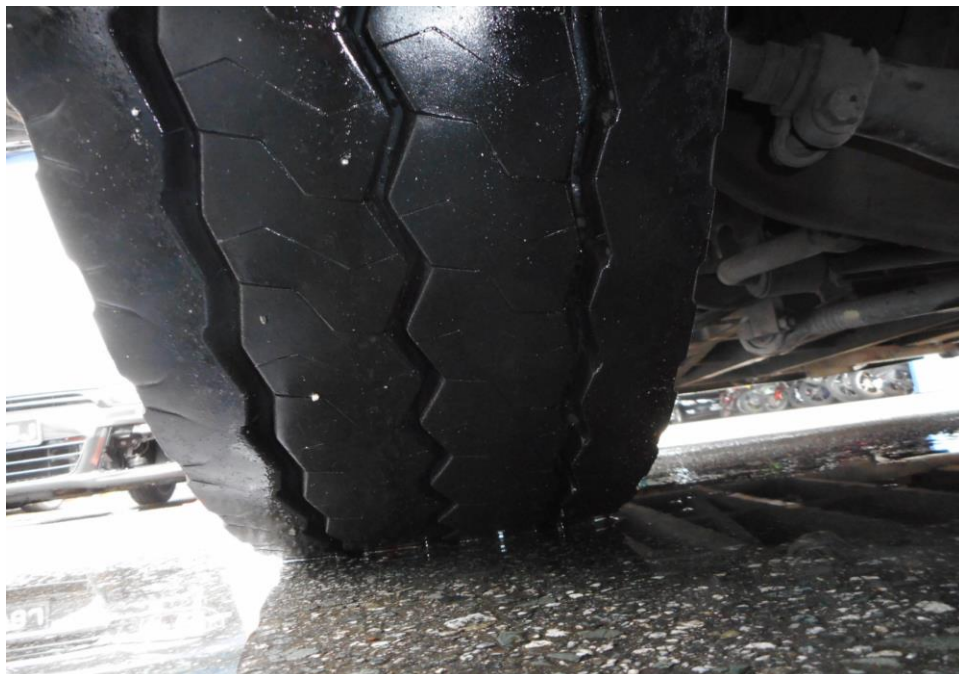
**Photo 9** shows the condition of the front left tyres of the Motor Bus, which were observed to be in serviceable condition with remaining tread depth of approximately 13mm. There was also no tear, cut or burst mark(s) on the outer and the inner sidewalls as well as across the tread of the 6 tyres that were fitted on the Motor Bus.

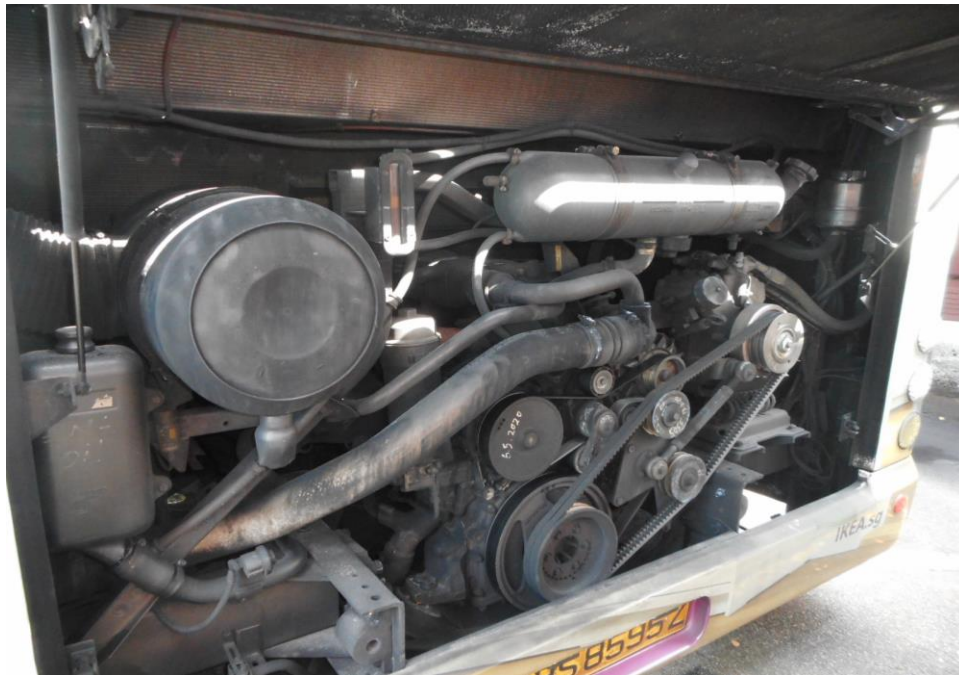
**Photo 10** shows a general view of the Motor Bus's engine compartment, which was accessed by lifting the rear of the Motor Bus. The various parts and components inside the engine compartment were unaffected by the accident. There was also no sign(s) or indication(s) of fresh fluid leakage and/or fluid stain within the engine compartment

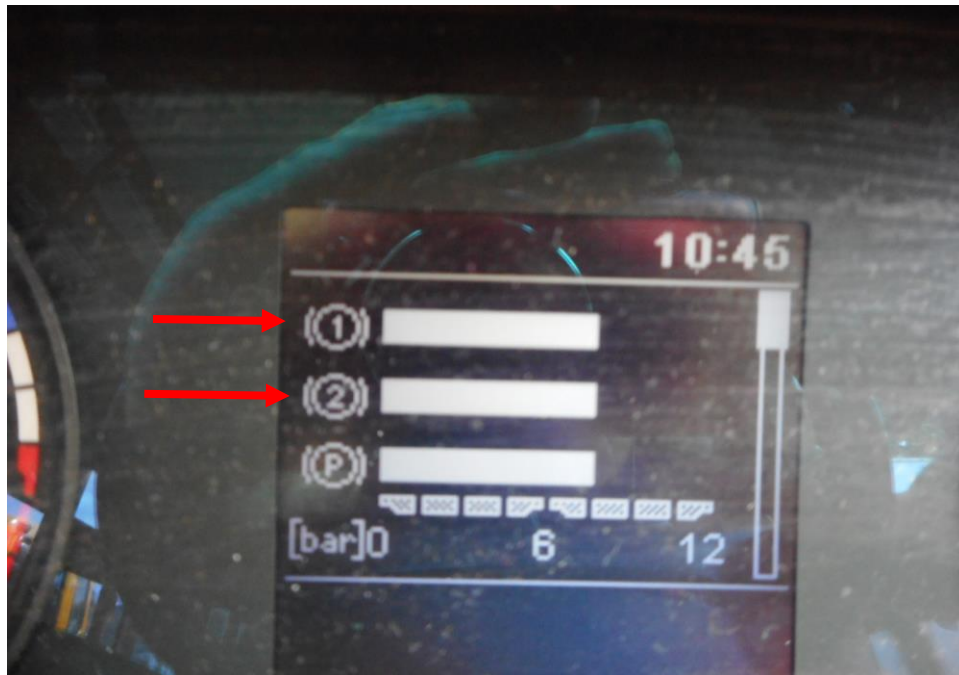
**Photo 11** shows the air in the air brake cylinder of the Motor Bus at the time of my inspection. The air in the cylinder was observed to be of sufficient level & serviceable at the time of the accident.

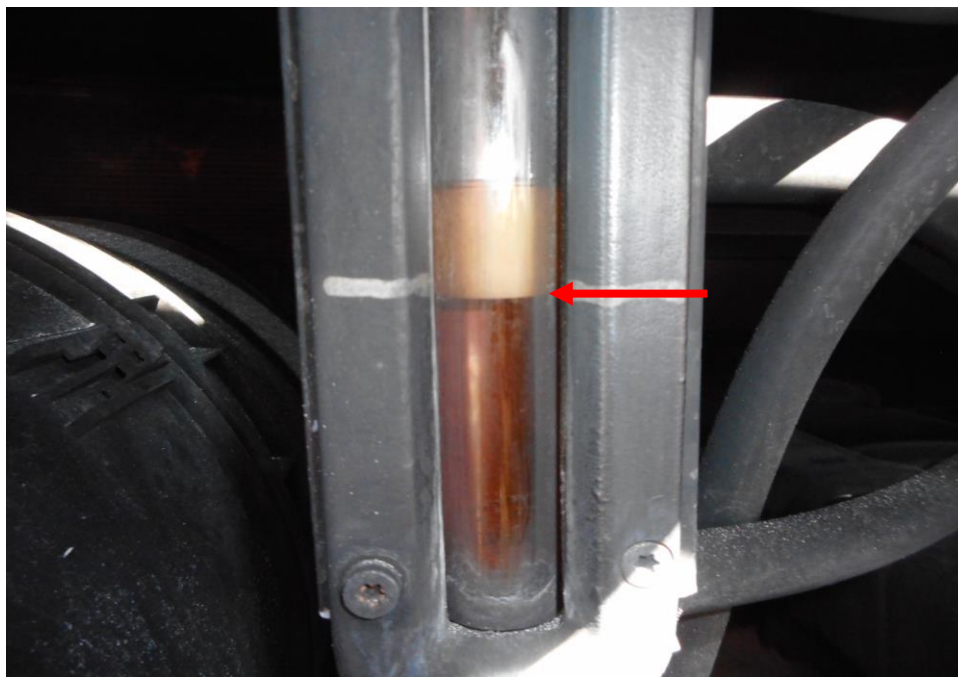
**Photo 12** shows the engine coolant reservoir of the Motor Bus at the time of my inspection. The engine coolant was observed to be of sufficient level (arrowed) and without any visible contamination.

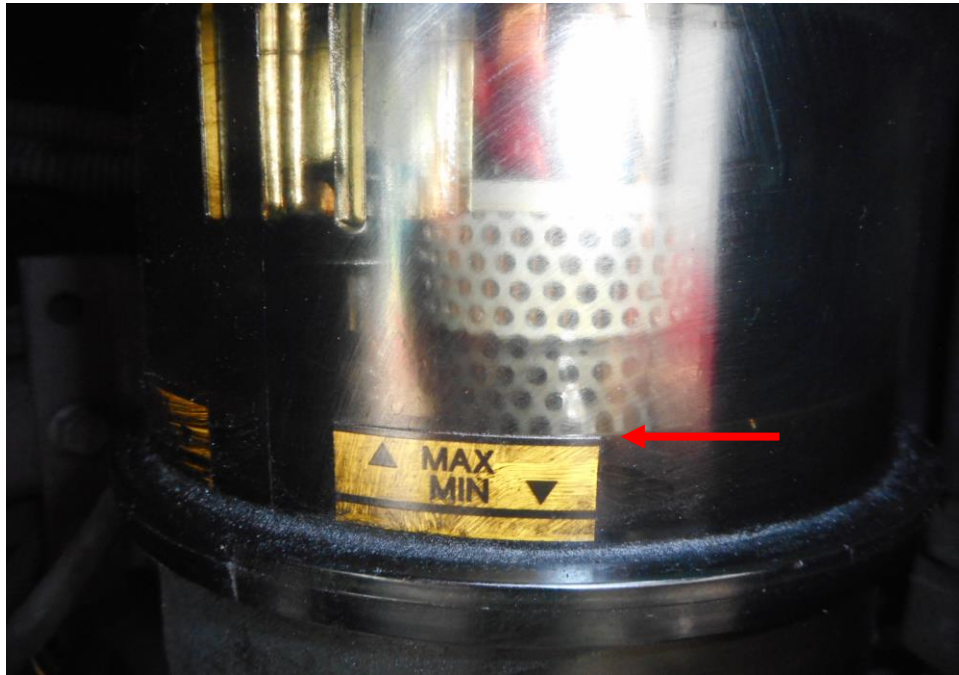
**Photo 13** shows the power steering fluid reservoir of the Motor Bus at the time of my inspection. The power steering fluid was observed to be of sufficient level and without any visible contamination.

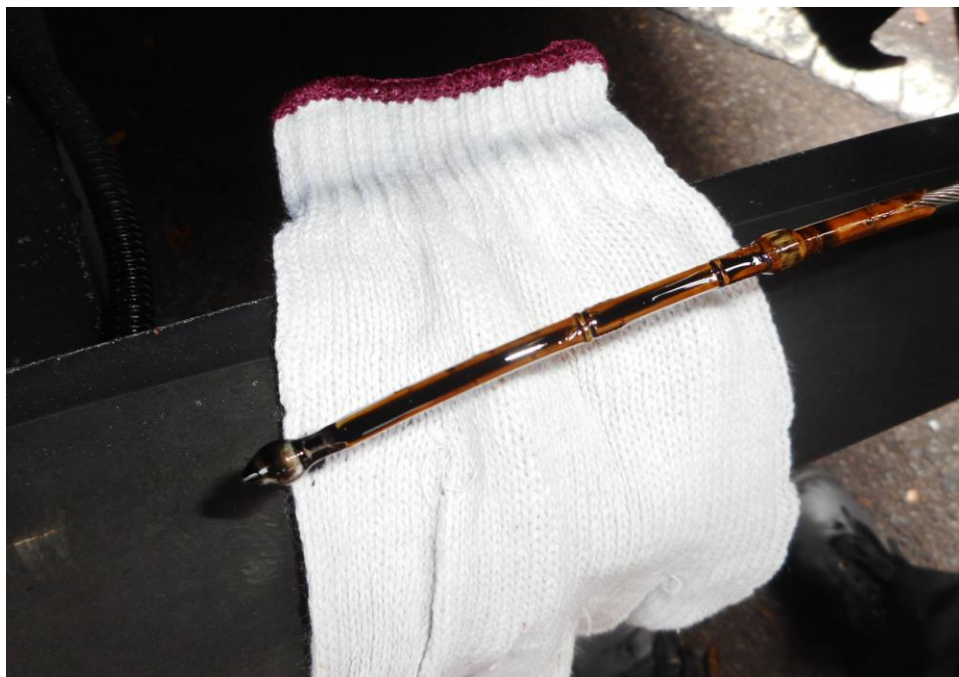
**Photo 14** shows the engine oil dip stick system of the Motor Bus at the time of my inspection. The engine oil was observed to be sufficient for operation and without any visible contamination.

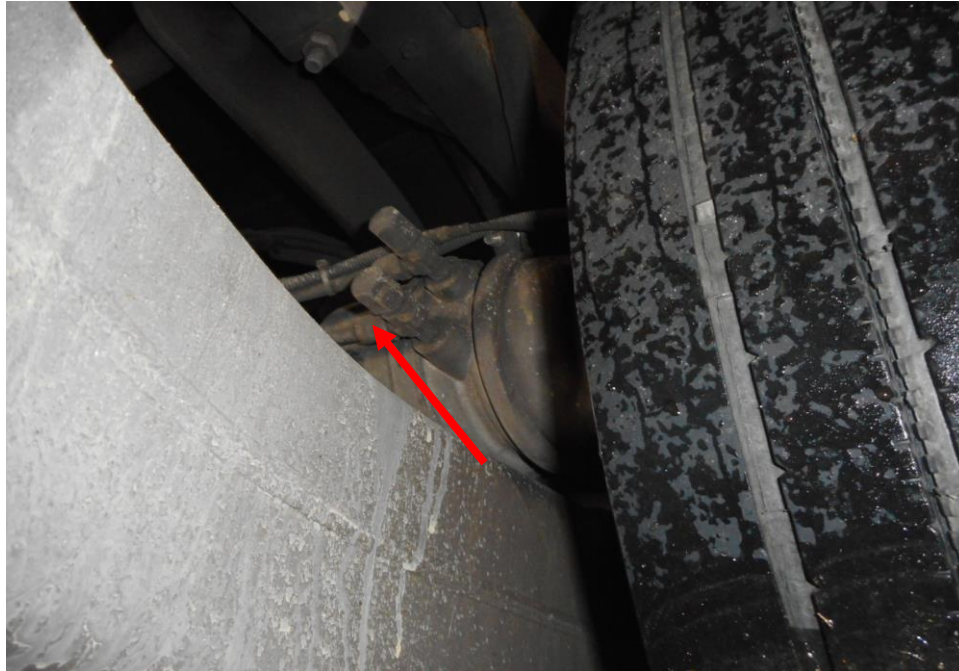
**Photo 15** shows the brake pipe (arrowed) at the rear right wheel of the Motor Bus. I did not observe any leakage of brake fluid at the time of my inspection of the Motor Bus. My static tests of the Motor Bus's braking system, along with my visual examination of the various mechanical components in the braking system, had indicated that there was no internal leakage of pressure/vacuum. Hence the braking system of the Motor Bus was likely to be in serviceable condition at the material time of accident.

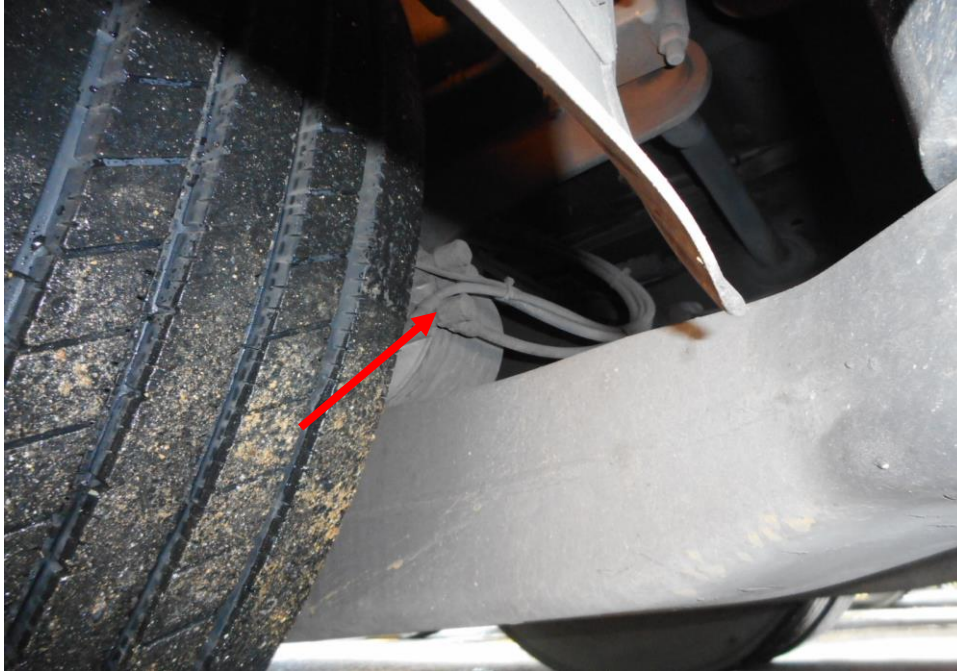
**Photo 16** shows the brake pipe (arrowed) at the rear left wheel of the Motor Bus. I did not observe any leakage of brake fluid at the time of my inspection of the Motor Bus. My static tests of the Motor Bus's braking system, along with my visual examination of the various mechanical components in the braking system, had indicated that there was no internal leakage of pressure/vacuum. Hence the braking system of the Motor Bus was likely to be in serviceable condition at the material time of accident.

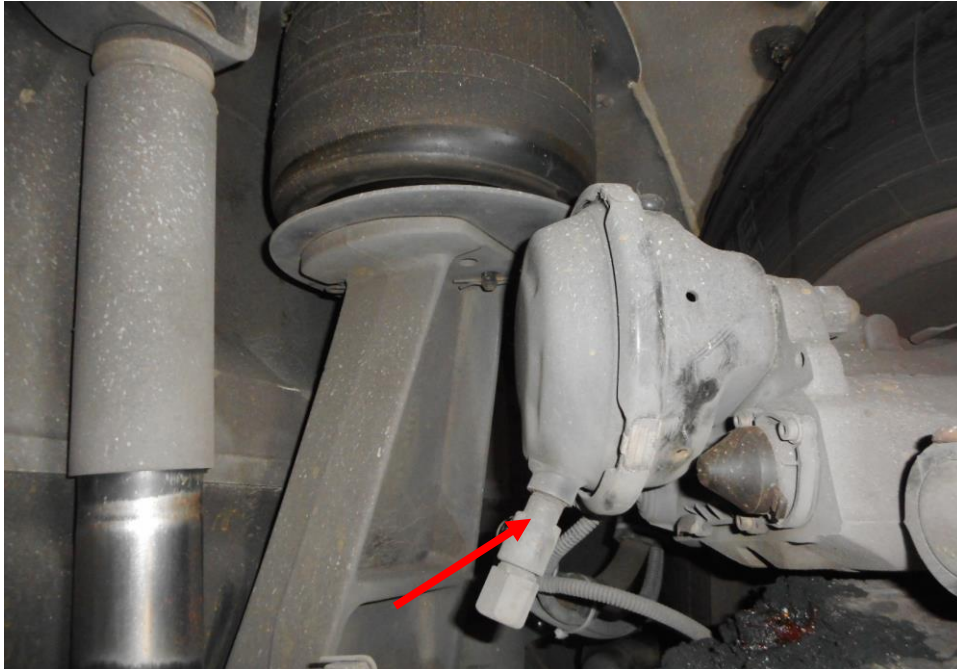
**Photo 17** shows the brake pipe (arrowed) at the front right wheel of the Motor Bus. I did not observe any leakage of brake fluid at the time of my inspection of the Motor Bus. My static tests of the Motor Bus's braking system, along with my visual examination of the various mechanical components in the braking system, had indicated that there was no internal leakage of pressure/vacuum. Hence the braking system of the Motor Bus was likely to be in serviceable condition at the material time of accident.

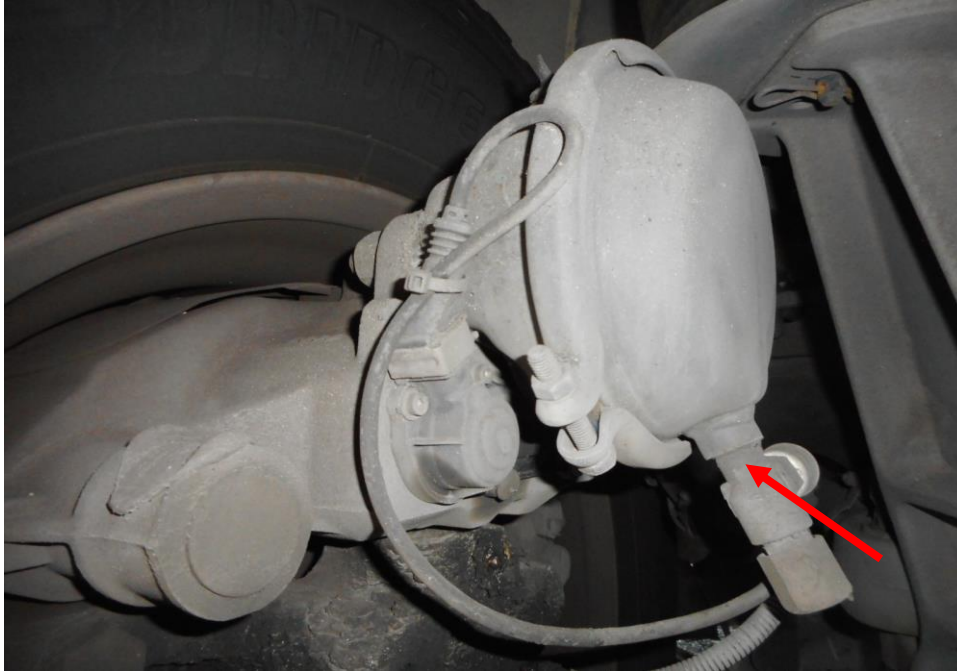
**Photo 18** shows the brake pipe (arrowed) at the front left wheel of the Motor Bus. I did not observe any leakage of brake fluid at the time of my inspection of the Motor Bus. My static tests of the Motor Bus's braking system, along with my visual examination of the various mechanical components in the braking system had indicated that there was no internal leakage of pressure/vacuum. Hence the braking system of the Motor Bus was likely to be in serviceable condition at the material time of accident.

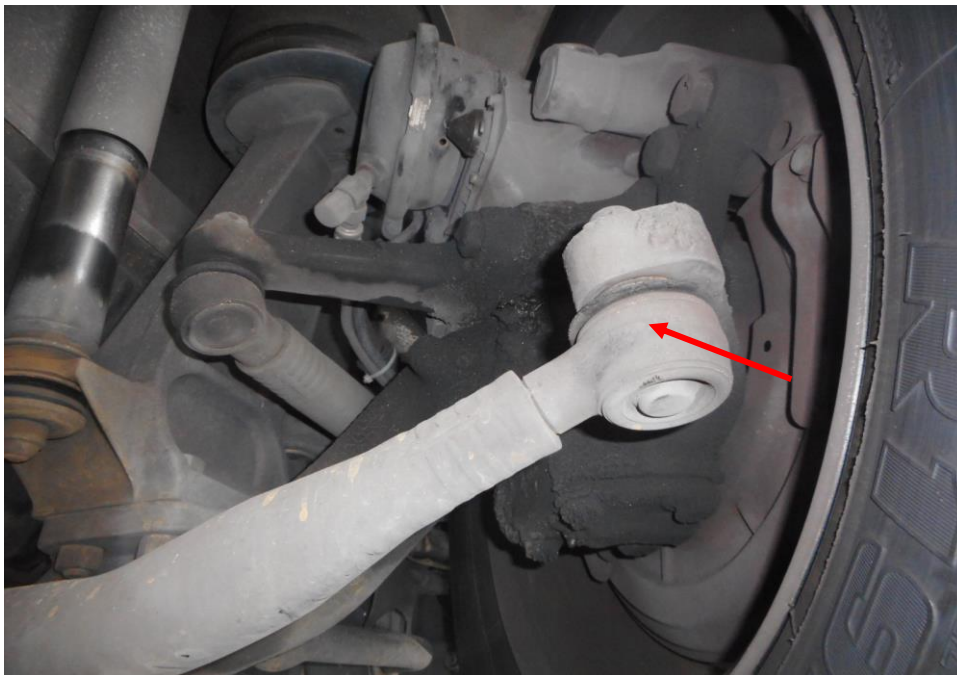
**Photo 19** shows the various undercarriage components at the front right wheel of the Motor Bus, in particular the steering tie rod end (arrowed). The various steering components were all found to be intact, suggesting that the steering system of the Motor Bus was likely to be in serviceable condition at the material time of accident. There was also no sign of fluid stain(s) observed on the various undercarriage components.

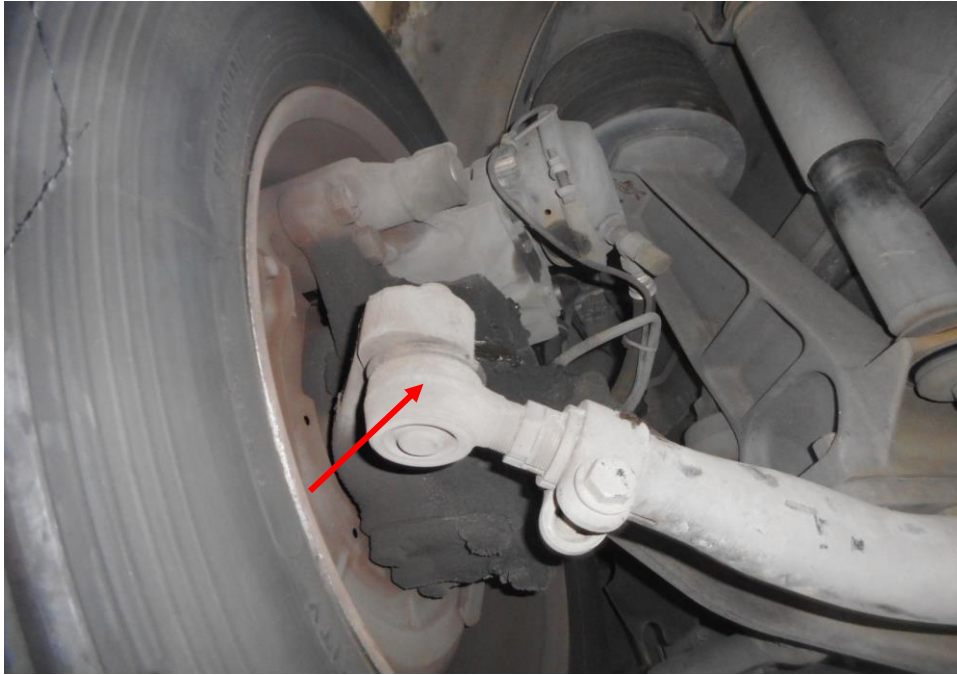
**Photo 20** shows the various undercarriage components at the front left wheel of the Motor Bus, in particular the steering tie rod end (arrowed). The various undercarriage components of the Motor Bus were all found to be intact without any visible damage. There was also no sign of fluid stain(s) observed on the various undercarriage components.

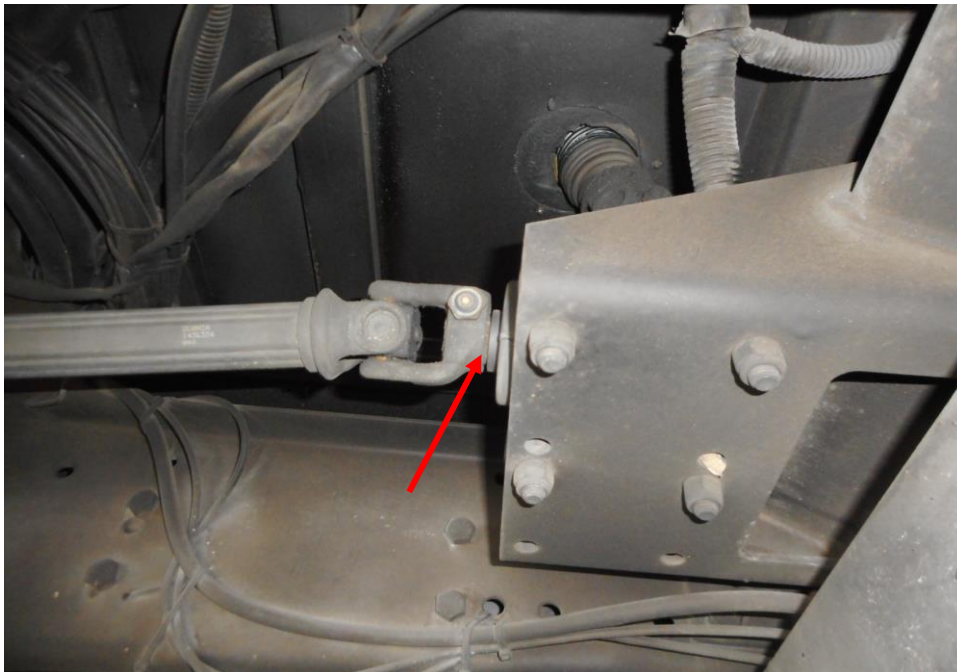
**Photo 21** shows the steering box component (arrowed) at the undercarriage of the Motor Bus was found to be intact without any visible damage. There was also no sign of fluid stain(s) observed on the various undercarriage components.

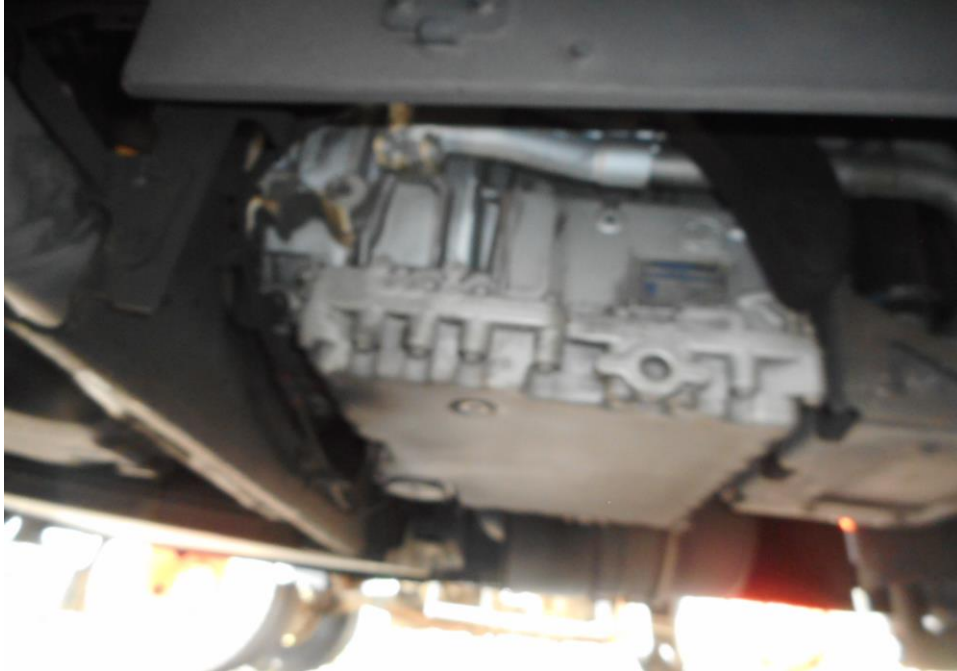
**Photo 22** shows the undercarriage of the Motor Bus, at the area where the engine housing and transmission housing are located. I did not find any sign(s) or indication(s) of fluid leak and/or fluid stain(s) on the underside of the Motor Bus.

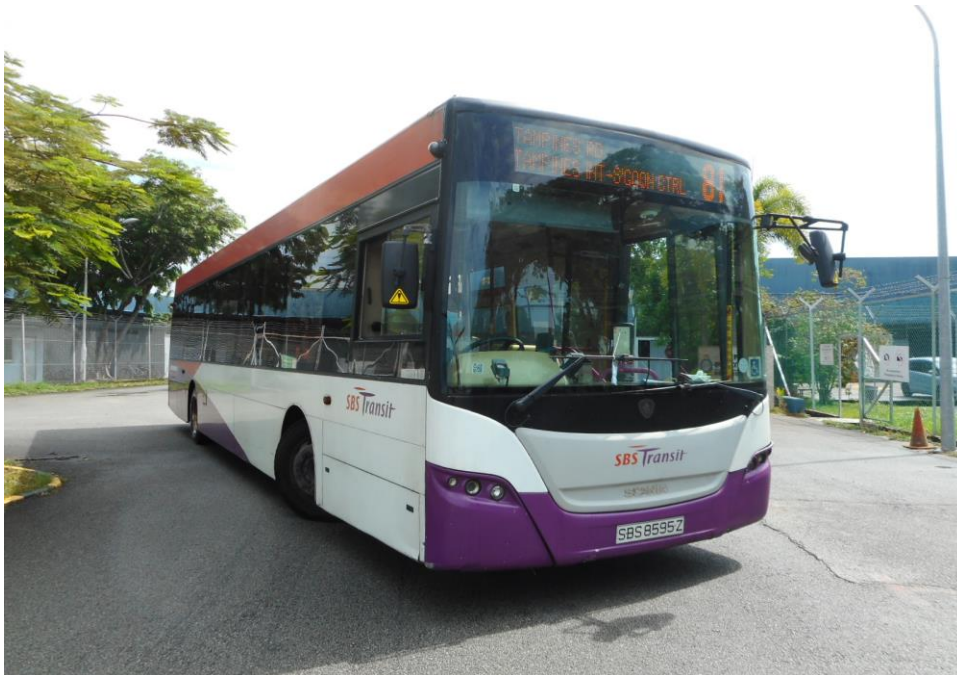
**Photo 23** shows the front right wheel of the Motor Bus turned to its full left. During my steering system test, I did not experience any abnormal free play and/or resistance when I had turned the steering wheel towards full left and full right. This would suggest that the steering system of the Motor Bus was likely to be in serviceable condition at the material time of accident.

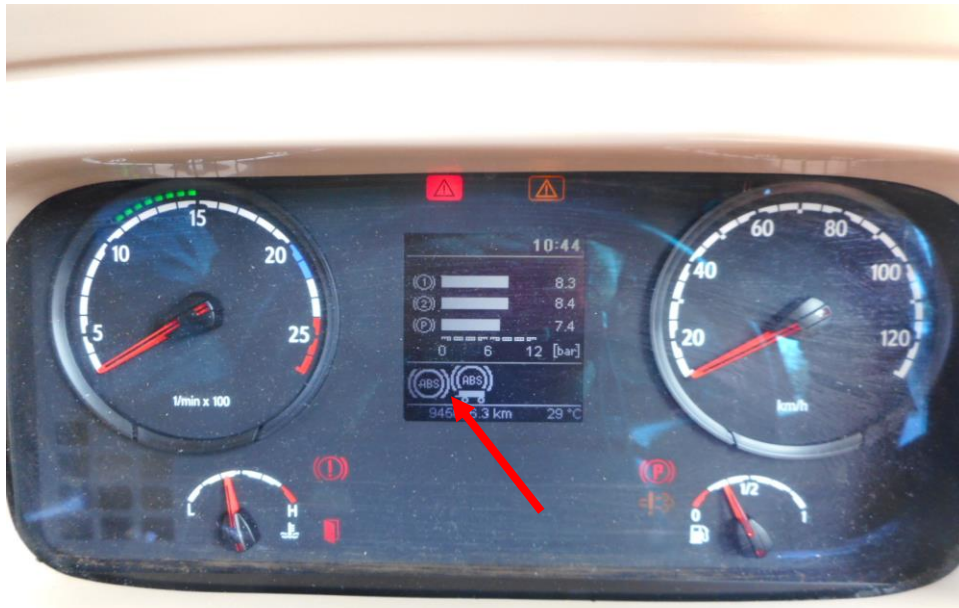
**Photo 24** shows the warning light for Anti-Lock Brake System (ABS) appearing on the instrument panel of the Motor Bus during the self-test of its various electronic operating systems when its engine was cranked.

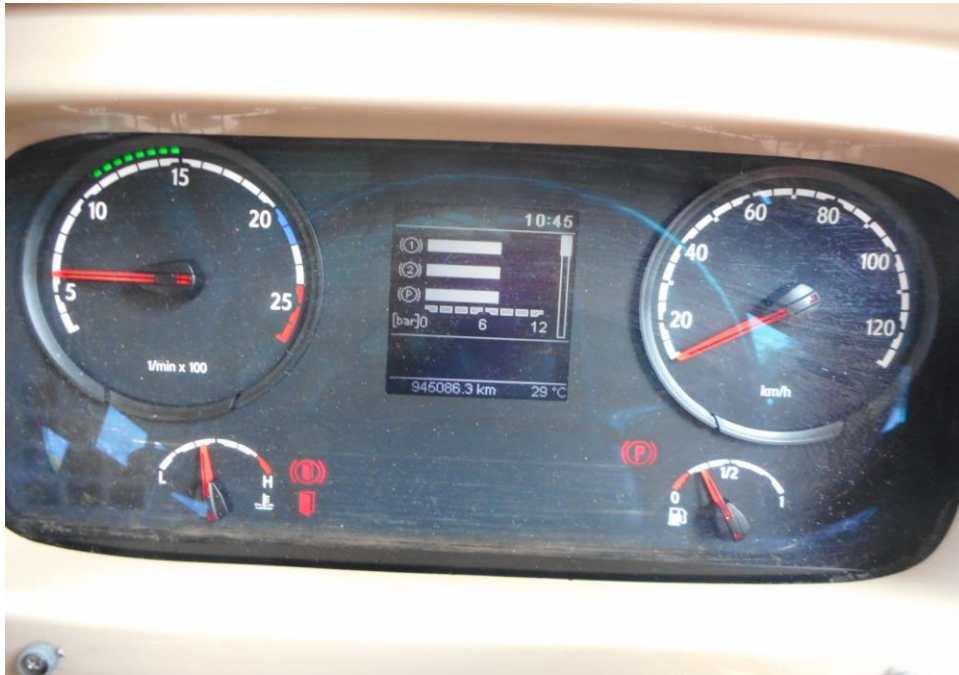
**Photo 25** shows no warning lights illuminated on the instrument panel of the Motor Bus after the engine was cranked. This would suggest that there was no abnormality to the various electronic operating systems of the Motor Bus, like the ABS
