Your Ref: TP/IP/12091/2021  
Our Ref : CI/TPD21003850/P

29<sup>th</sup> March 2021

**MECHANICAL INSPECTION REPORT OF MOTOR CAR SLF 8012P**

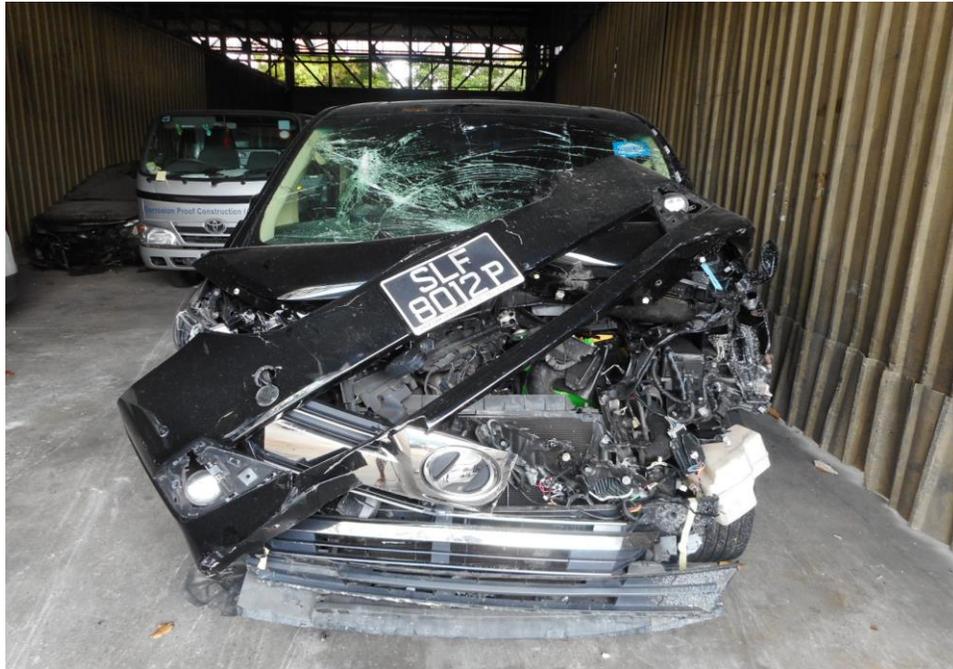
**Photo 1** shows a general view of the Motor Car's front body at the time of my inspection. The Motor car was observed to have sustained extensive damage at its front portion. Its front windscreen, front bonnet, front bumper, front left fender was amongst the body parts and various components in the engine compartments were also damaged as a result of the accident

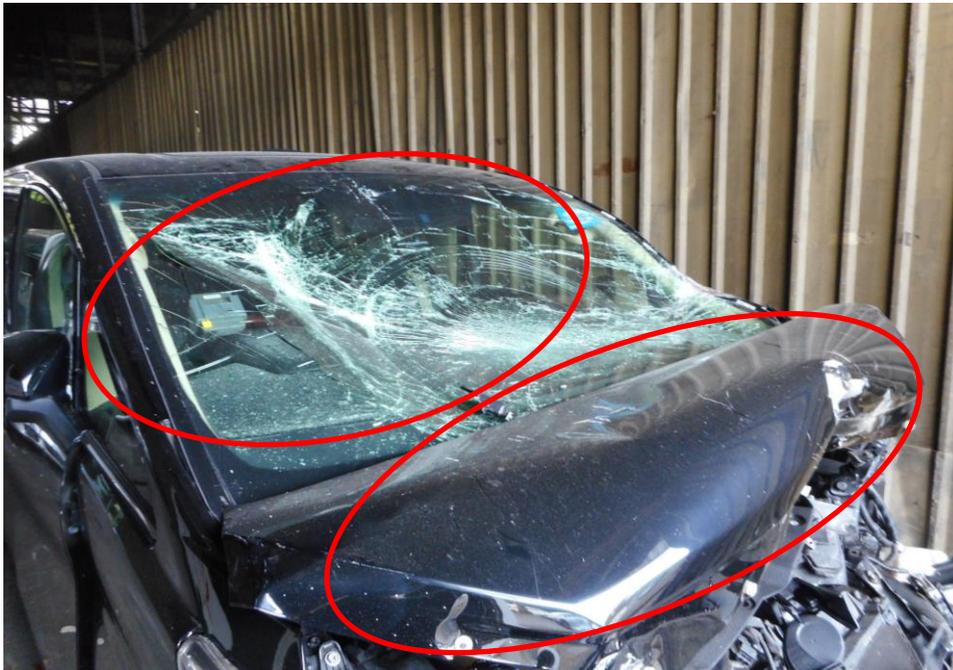
**Photo 2** shows the close up view of the Motor Car's front body at the time of my inspection. The Motor car was observed to have sustained damage at its front portion. Its front windscreen (red circle) and front bonnet (yellow circle) was amongst the body parts and various components in the engine compartments were also damaged as a result of the accident.

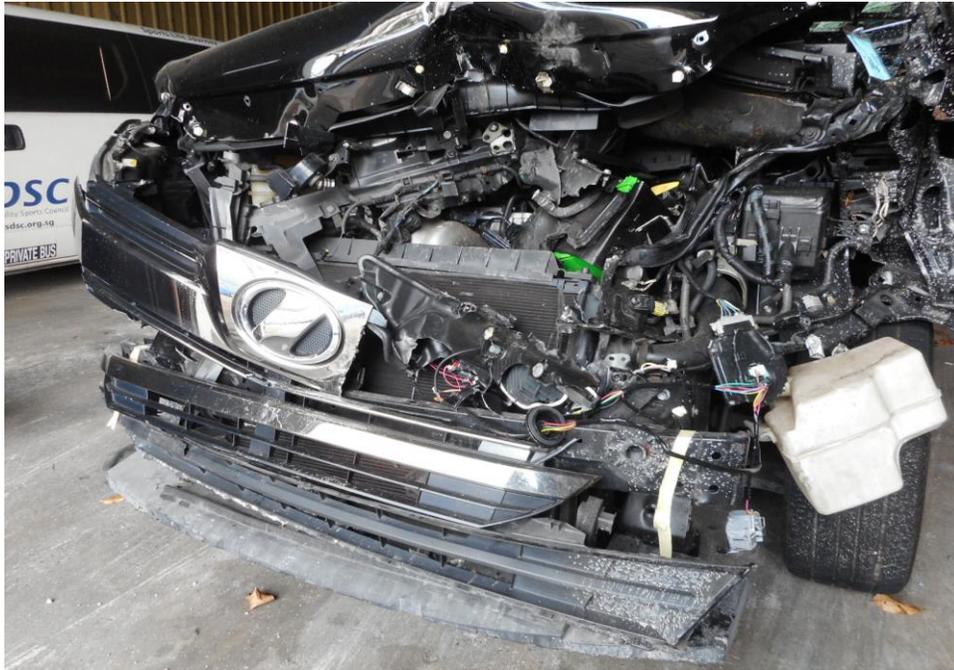
**Photo 3** shows the general view of the Motor Car's front body at the time of my inspection. The Motor car was observed to have sustained damage at its front portion. Its engine and its ignition system was amongst the various components in the engine compartments were also damaged as a result of the accident.

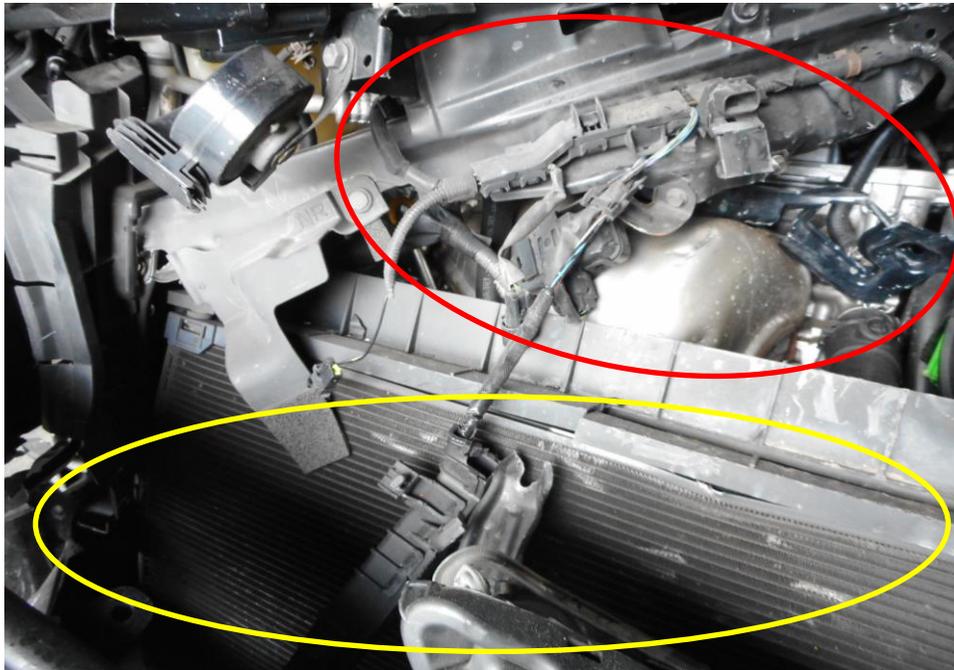
**Photo 4** shows the close up view of the Motor Car's front body at the time of my inspection. The Motor car was observed to have sustained damage at its front portion. Its engine (red circle) and engine radiator (yellow circle) was amongst the various components in the engine compartments were also damaged as a result of the accident.

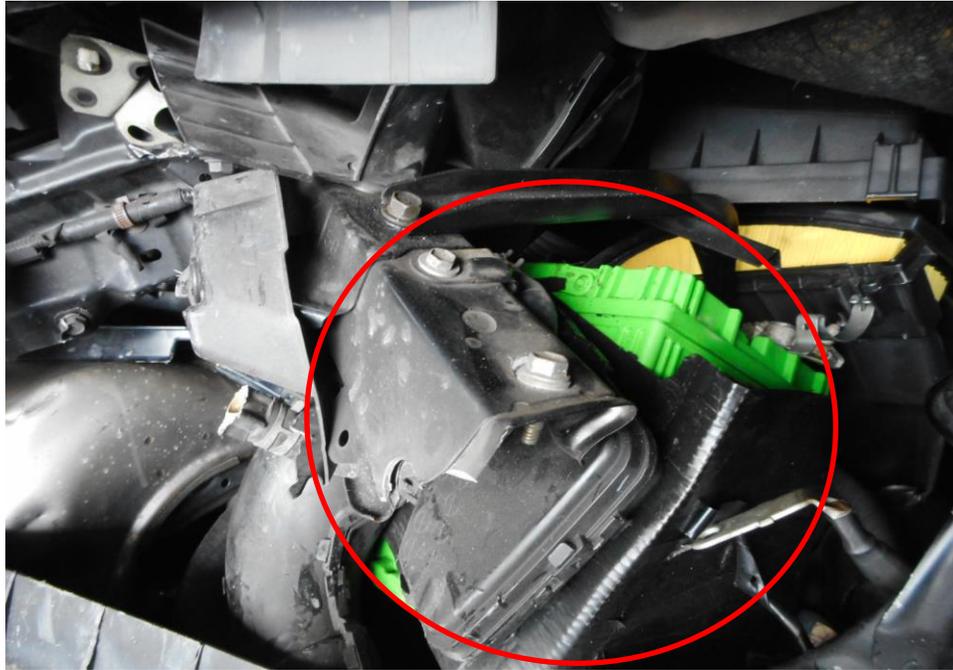
**Photo 5** shows the close up view of the Motor Car's front body at the time of my inspection. The Motor car ignition system (circled) was amongst the various components in the engine compartments were also damaged as a result of the accident.

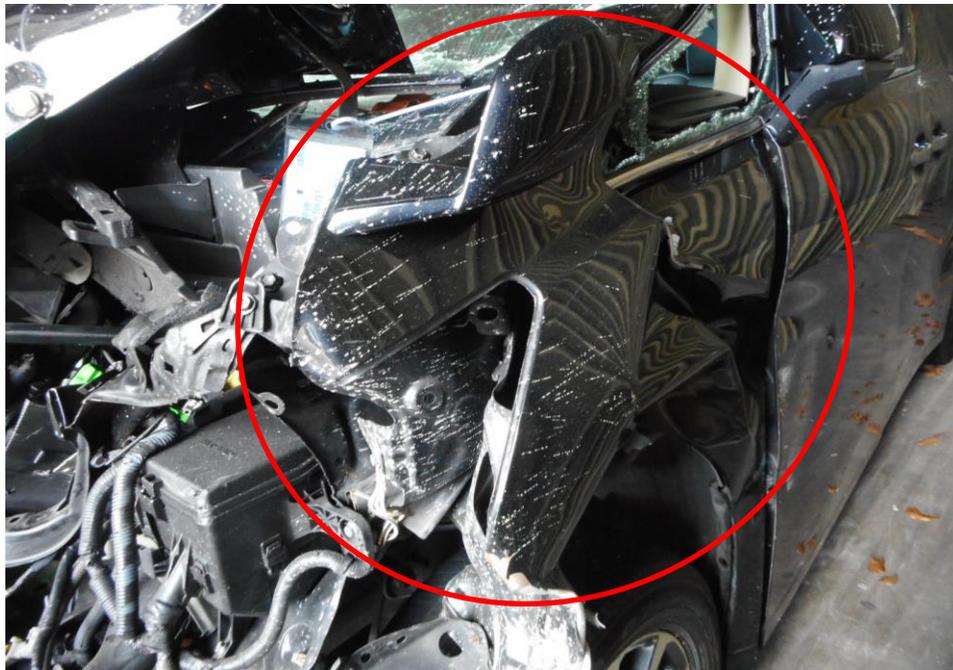
**Photo 6** shows the close up view of the Motor Car's right body at the time of my inspection. The Motor car was observed to have sustained damage at its fright portion. Its front left fender (circled) was damaged as a result of the accident.

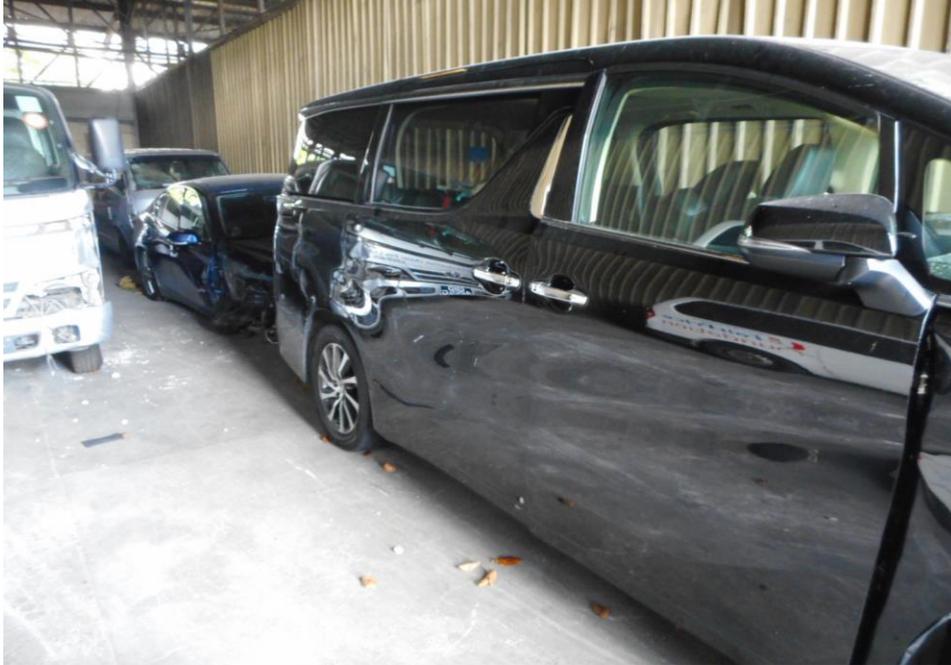
**Photo 7** shows a general view of the Motor Car's right body at the time of my inspection. The right portion of the Motor Car was observed to have been undamaged by the accident.

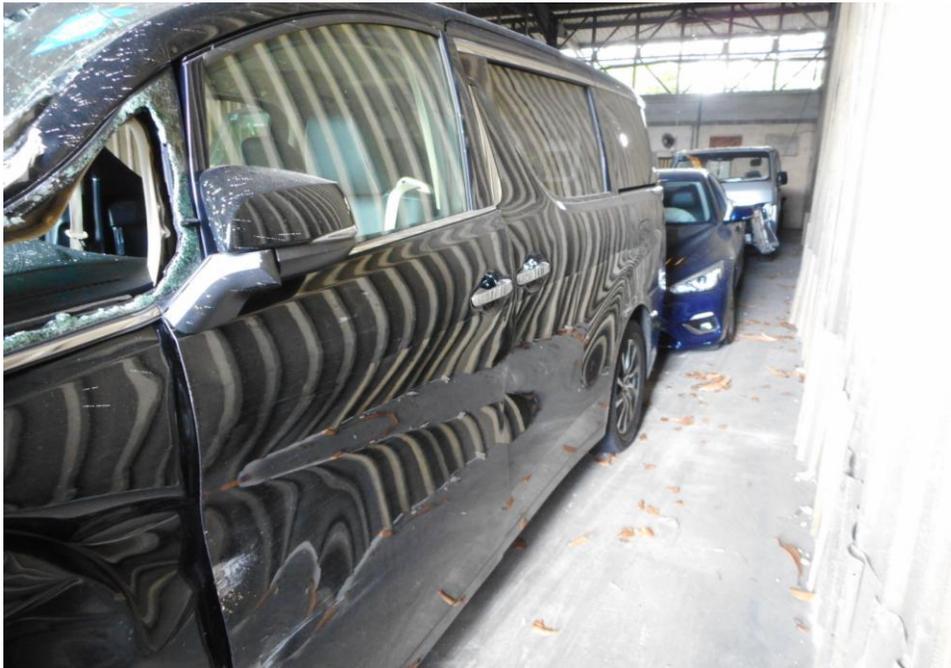
**Photo 8** shows a general view of the Motor Car's left body at the time of my inspection. The left portion of the Motor Car was observed to have been undamaged by the accident.

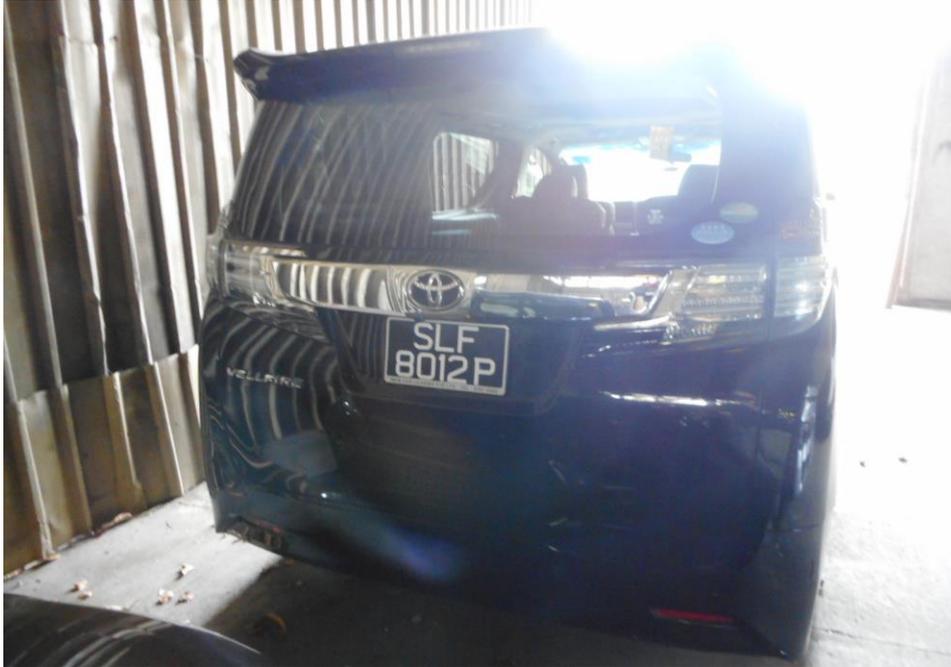
**Photo 9** shows a general view of the Motor Car's rear body at the time of my inspection. The rear portion of the Motor Car was observed to have been undamaged by the accident.

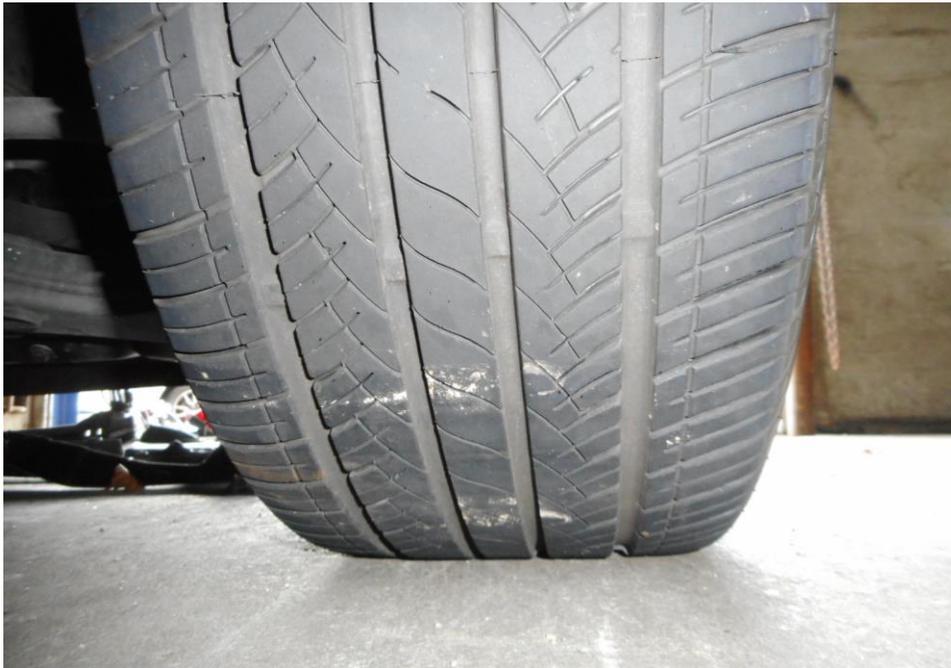
**Photo 10** shows the condition of the front right tyre of the Motor Car, which was observed to be in serviceable condition with remaining tread depth of approximately 5.1mm. The tyre was also observed to be sufficiently inflated for vehicular operation with no tear, cut or burst mark(s).

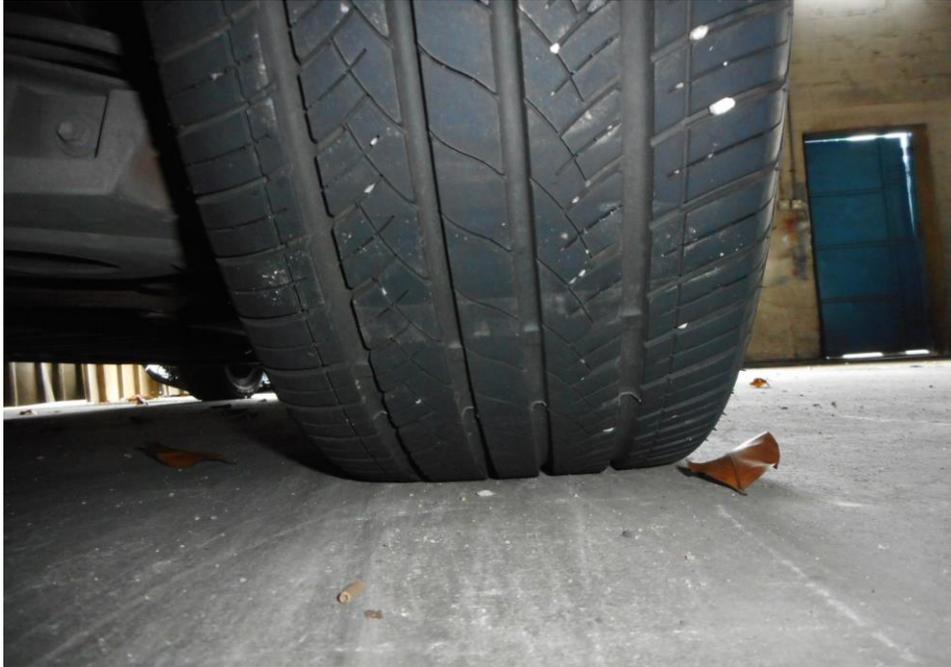
**Photo 11** shows the condition of the rear right tyre of the Motor Car, which was observed to be in serviceable condition with remaining tread depth of approximately 6.1mm. The tyre was also observed to be sufficiently inflated for vehicular operation with no tear, cut or burst mark(s).

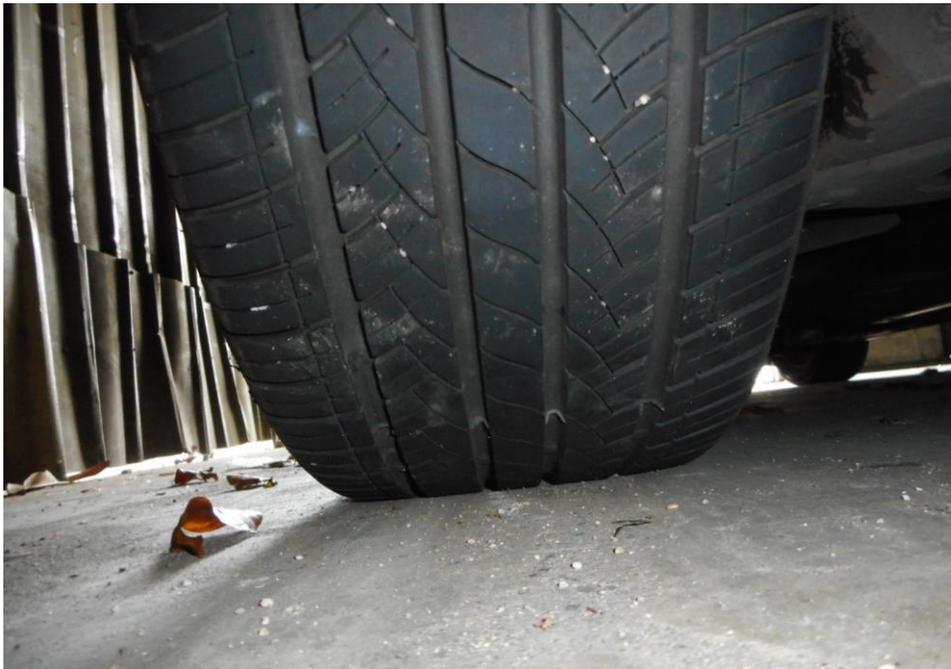
**Photo 12** shows the condition of the rear left tyre of the Motor Car, which was observed to be in serviceable condition with remaining tread depth of approximately 6.1mm. The tyre was also observed to be sufficiently inflated for vehicular operation with no tear, cut or burst mark(s).

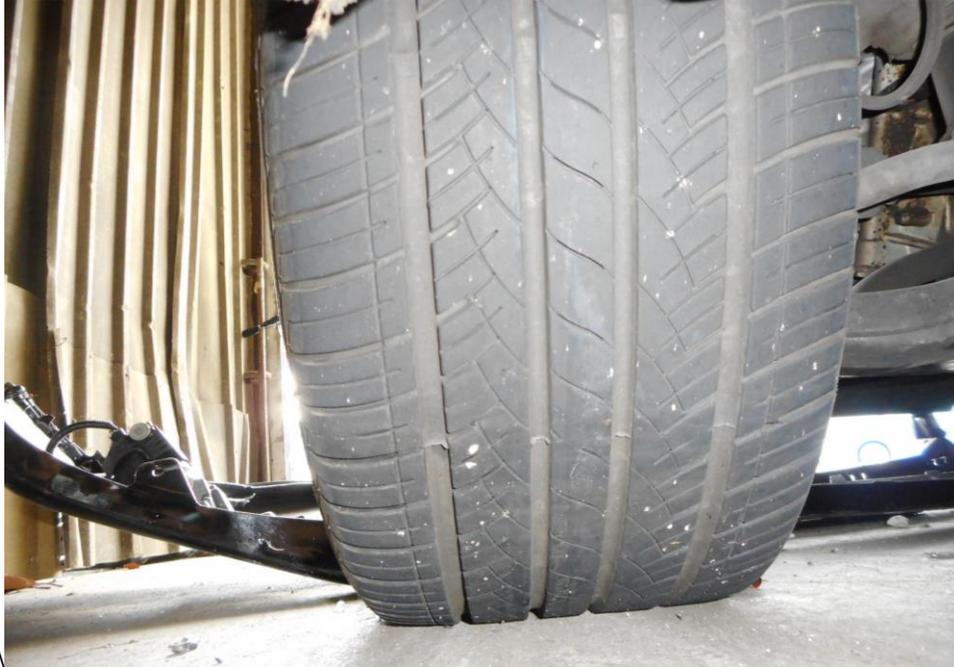
**Photo 13** shows the condition of the front left tyre of the Motor Car, which was observed to be in serviceable condition with remaining tread depth of approximately 5.3mm. The tyre was also observed to be sufficiently inflated for vehicular operation with no tear, cut or burst mark(s).

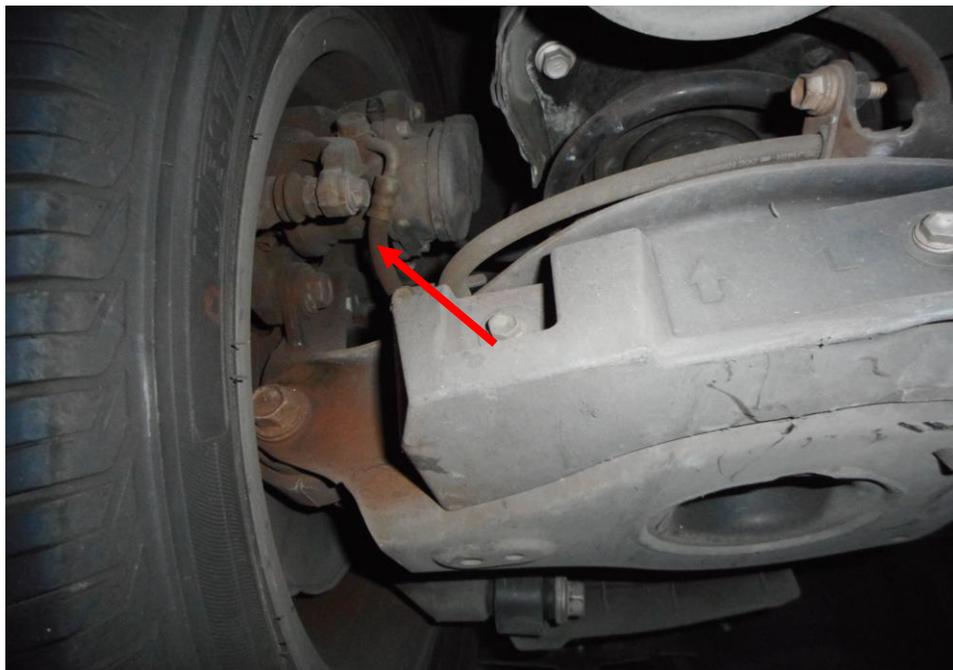
**Photo 14** shows the brake hose/pipe (arrowed) at the rear left wheel of the Motor Car. I did not observe any leakage of brake fluid at the time of my inspection of the Motor Car. Static tests of the Motor Car's braking system had indicated that there was no internal leakage of pressure/vacuum. The undercarriage components of the Motor Car were also all found to be intact and without any visible damage.

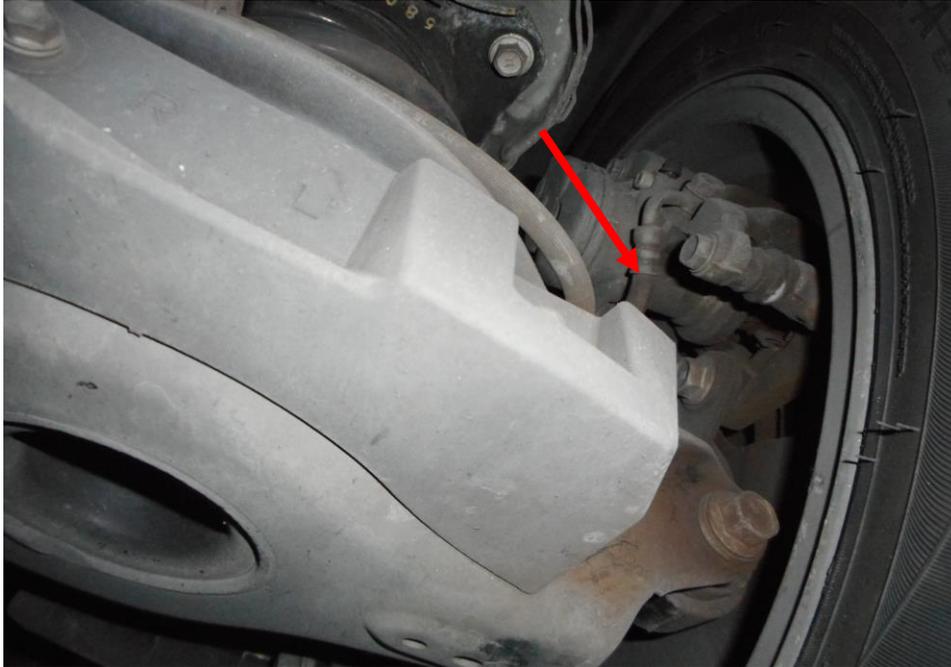
**Photo 15** shows the brake hose/pipe (arrowed) at the front right wheel of the Motor Car. I did not observe any leakage of brake fluid at the time of my inspection of the Motor Car. Static tests of the Motor Car's braking system had indicated that there was no internal leakage of pressure/vacuum. The undercarriage components of the Motor Car were also all found to be intact and without any visible damage.

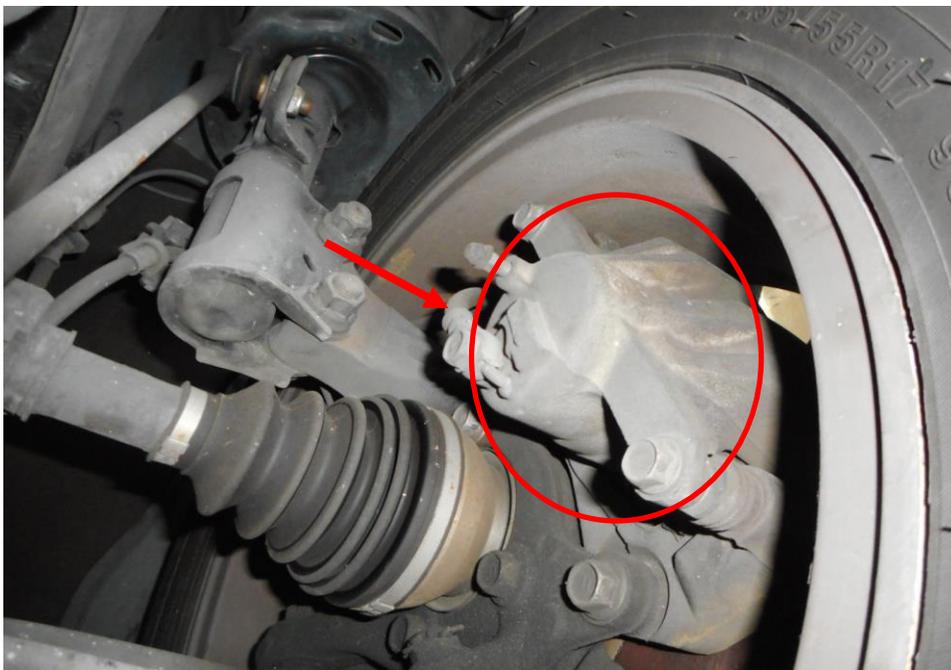
**Photo 16** shows the brake hose/pipe (arrowed) at the front right wheel of the Motor Car. No leakage of brake fluid was observed. Visual examination of the various components of the braking system like the brake caliper (circled) brake pedal etc had revealed all to be intact and without visible damage at the time of accident. There was also no sign of fluid stain(s) observed on the various undercarriage components.

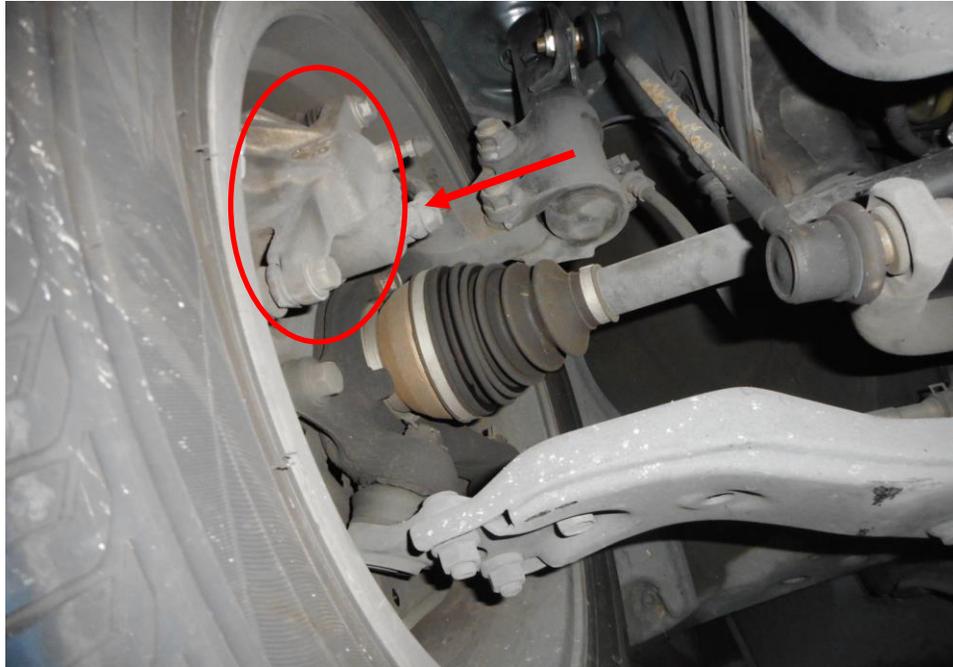
**Photo 17** shows the brake hose/pipe (arrowed) at the front left wheel of the Motor Car. No leakage of brake fluid was observed. Visual examination of the various components of the braking system like the brake caliper (circled), brake pedal etc had revealed all to be intact and without visible damage at the time of accident. There was also no sign of fluid stain(s) observed on the various undercarriage components.

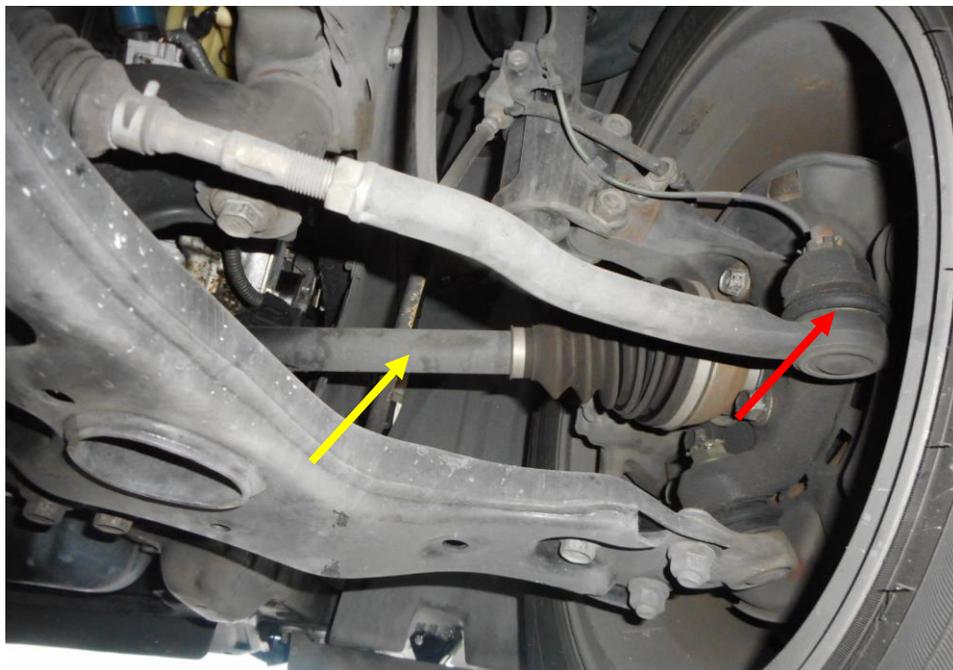
**Photo 18** shows the various undercarriage components at the front right wheel of the Motor Car, in particular the steering tie rod end (arrowed) and drive shaft (yellow arrow). The various steering components were all found to be intact, suggesting that the steering system of the Motor Car was likely to be in serviceable condition at the material time of accident. There was also no sign of fluid stain(s) observed on the various undercarriage components.

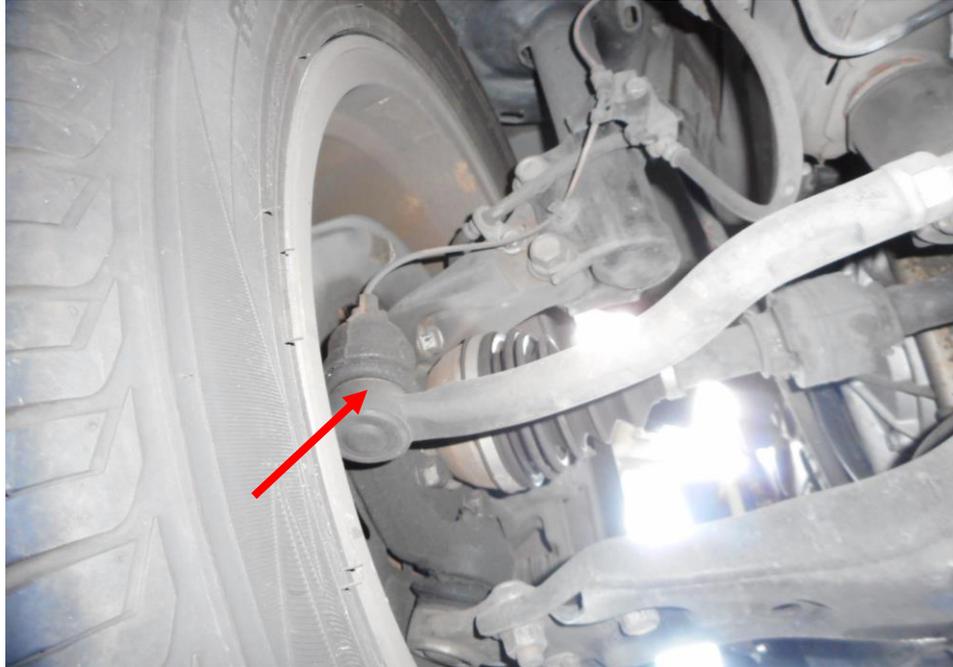
**Photo 19** shows the various undercarriage components at the front left wheel of the Motor Car, in particular the steering tie rod end (arrowed). The various steering components were all found to be intact, suggesting that the steering system of the Motor Car was likely to be in serviceable condition at the material time of accident. There was also no sign of fluid stain(s) observed on the various undercarriage components.
