Your Ref: TP/IP/00085/20201  
Our Ref : CI/TPD21003851/P

### **Fatal Accident Investigation Team**

### **MECHANICAL INSPECTION REPORT OF MOTOR VAN GBK 5366E**

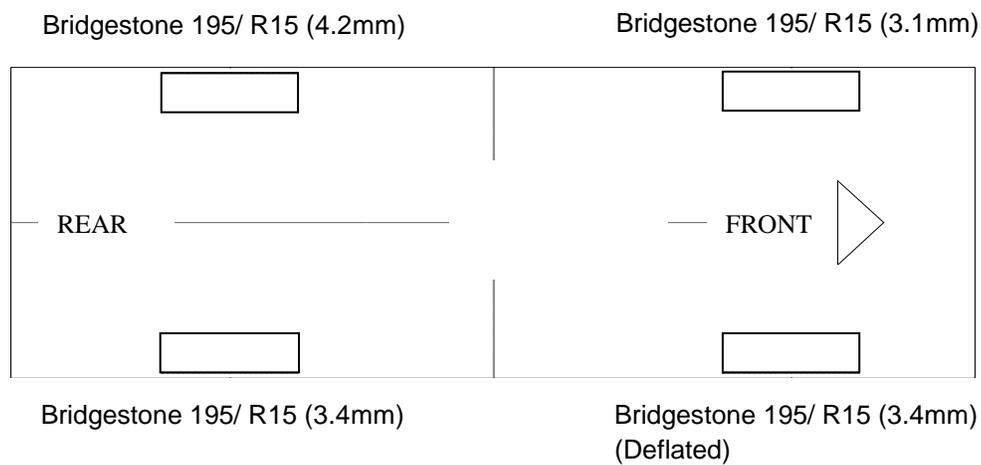
6. The front right tyre was observed to be deflated as a result of the accident. However, the other 3 tyres of the Motor Van were observed to be in serviceable condition and sufficiently inflated for vehicular operation. I did not find any tear, cut or burst mark(s) on the outer and the inner sidewalls as well as across the tread of the 4 tyres. The tyre brand, tyre size and remaining tread depth of the 4 tyres of the Motor Van were recorded as follows:-

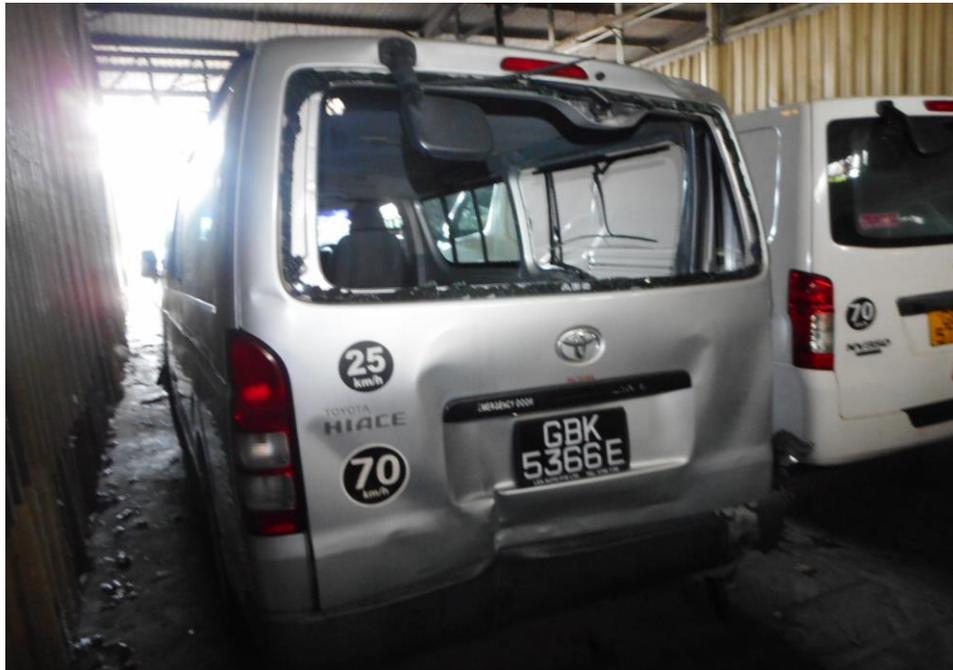
**Photo 1** shows a general view of the rear body of the Motor Van at the time of my inspection. It appeared to have sustained damage at its rear portion. Its rear windscreen and rear body panel were damaged at the time of my inspection as a result of the accident.

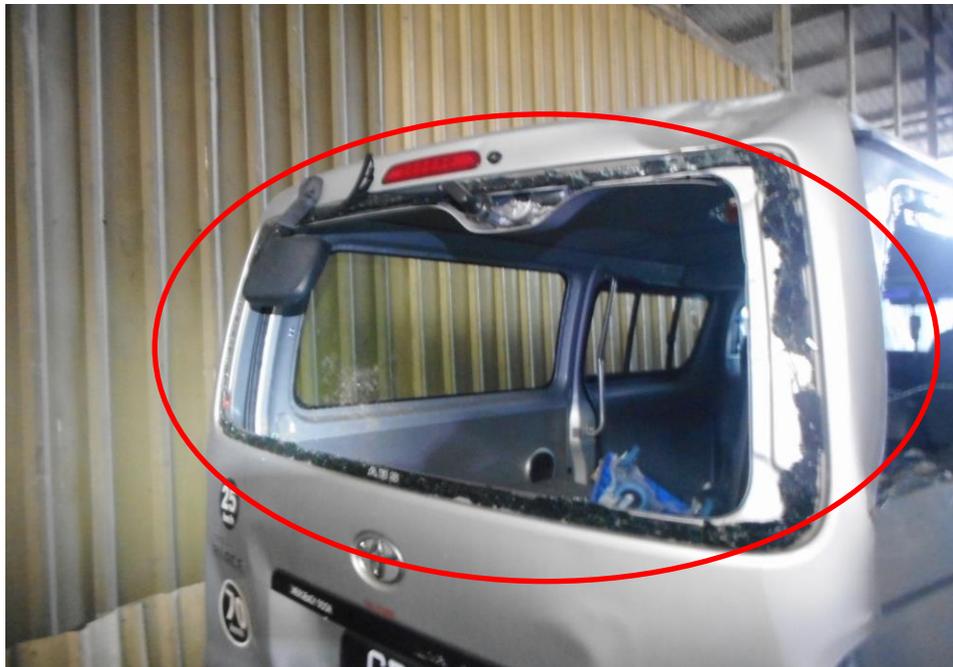
**Photo 2** shows a close up view of the rear body of the Motor Van at the time of my inspection. It appeared to have sustained damage at its rear portion. Its rear windscreen (circled) were damaged at the time of my inspection as a result of the accident.

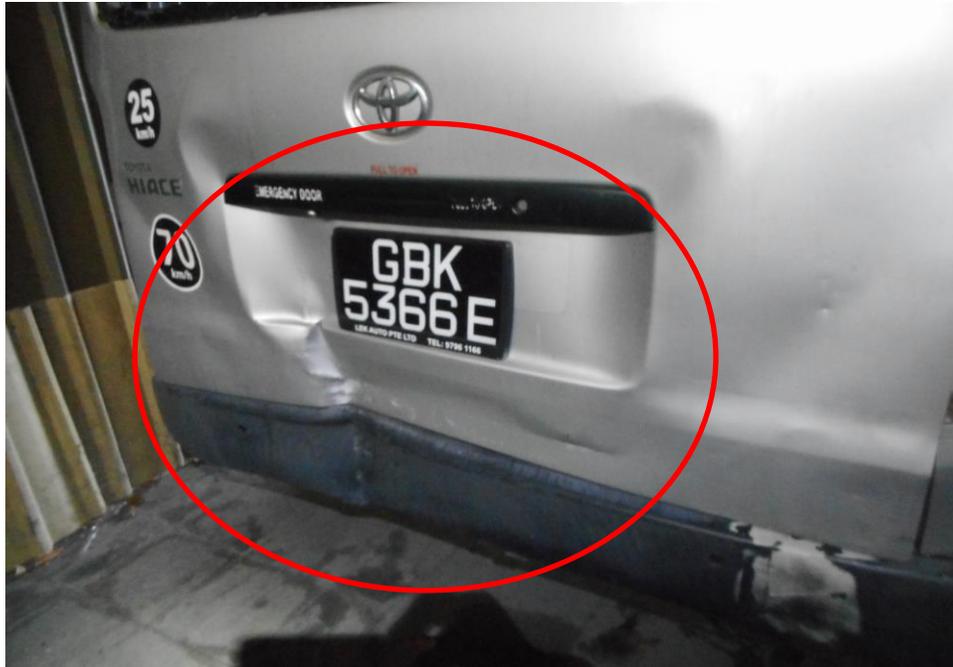
**Photo 3** shows a general view of the rear body of the Motor Van at the time of my inspection. It appeared to have sustained damage at its rear portion. Its rear body panel (circled) were damage at the time of my inspection as a result of the accident.

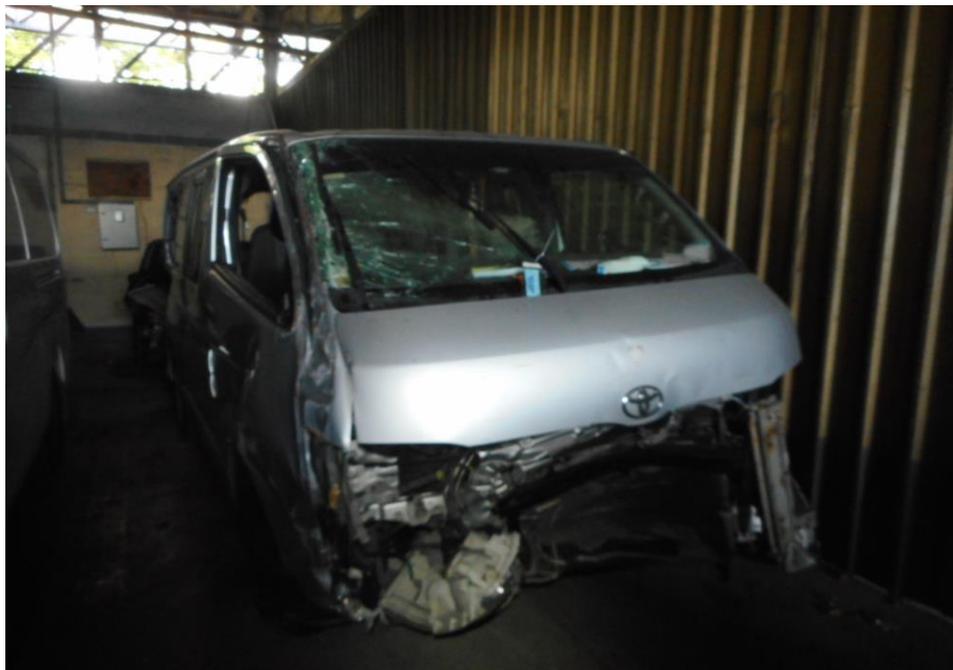
**Photo 4** shows a general view of the Motor Van's frontal portion at the time of my inspection. Its front windscreen, front body panel and front engine radiator were damaged as a result of the accident.

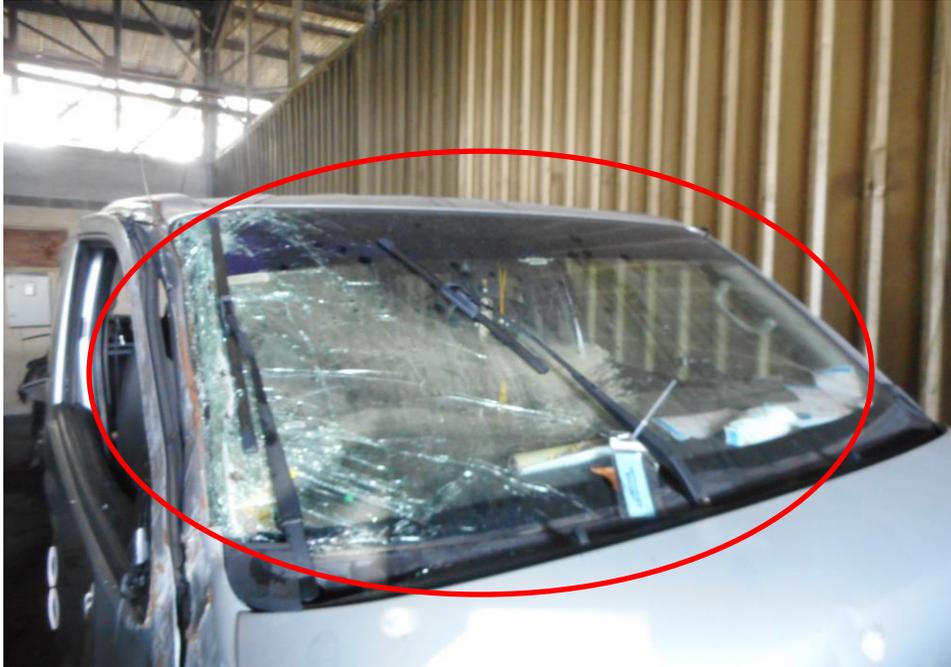
**Photo 5** shows a close up view of the Motor Van's frontal portion at the time of my inspection. It appeared to have sustained damage at its frontal portion. Its front windscreen (circled) was damage at the time of my inspection as a result of the accident.

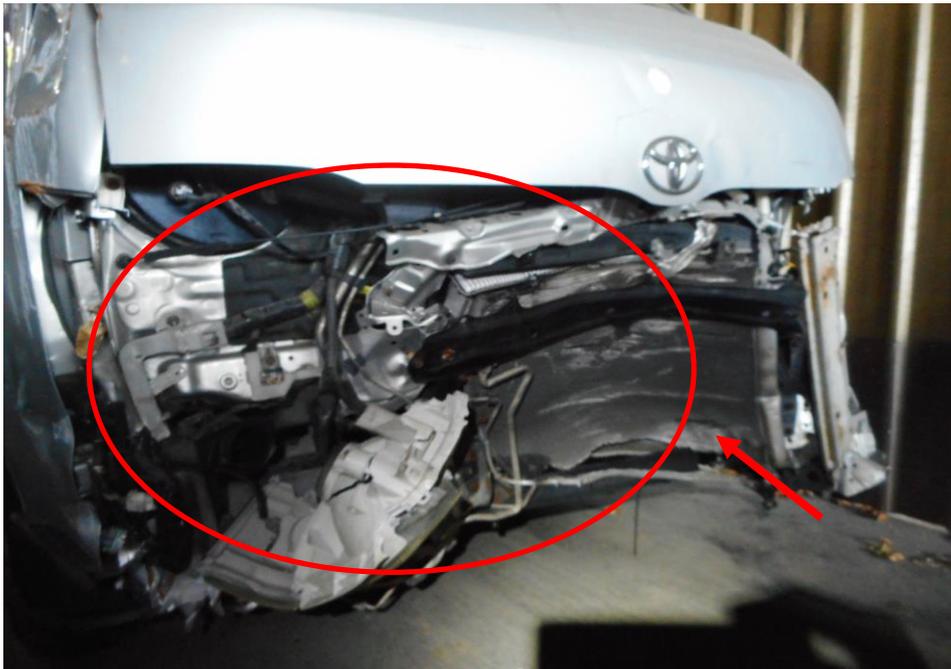
**Photo 6** shows a close up view of the Motor Van's frontal portion at the time of my inspection. It appeared to have sustained damage at its frontal portion. Its front body panel (circled) and engine radiator (arrowed) was damage at the time of my inspection as a result of the accident.

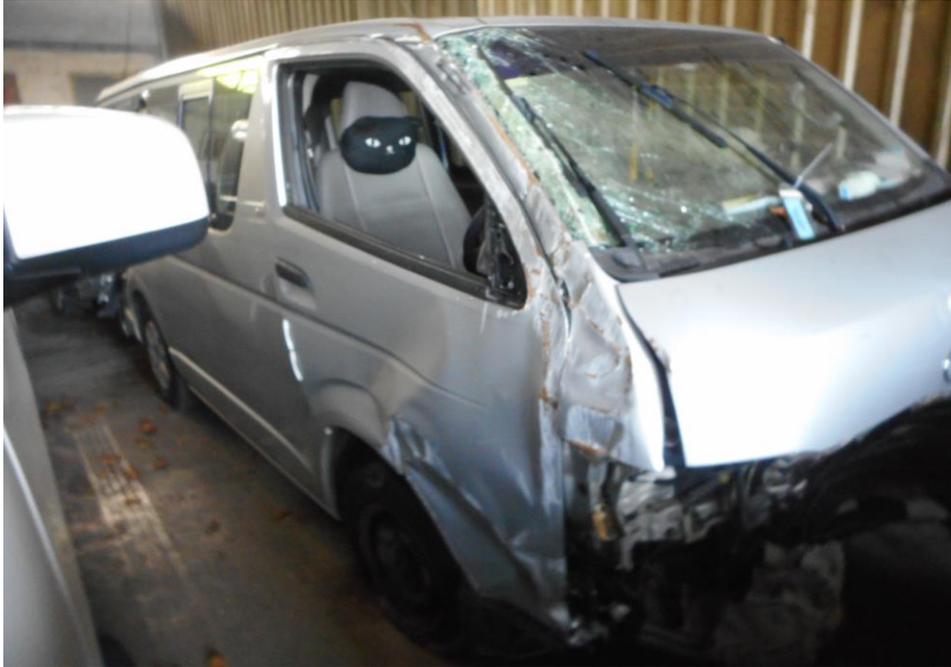
**Photo 7** shows a general view of the right body of the Motor Van at the time of my inspection. Its right door and right body panel were damaged as a result of the accident.

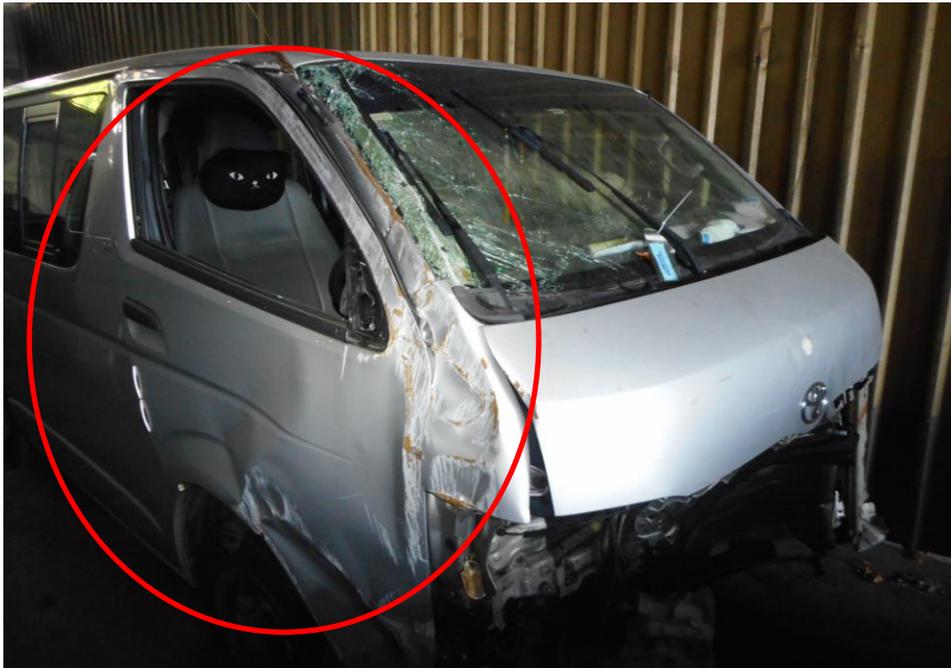
**Photo 8** shows a close up view of the right body of the Motor Van at the time of my inspection. Its right door (circled) were damaged as a result of the accident.

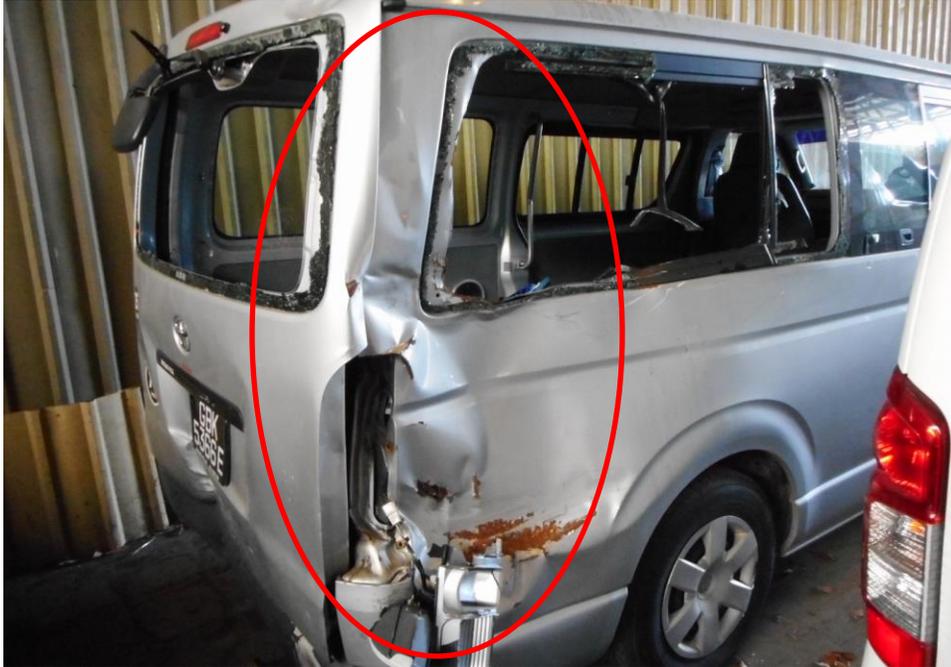
**Photo 9** shows a close up view of the right body of the Motor Van at the time of my inspection. Its right body panel (circled) were damaged as a result of the accident.

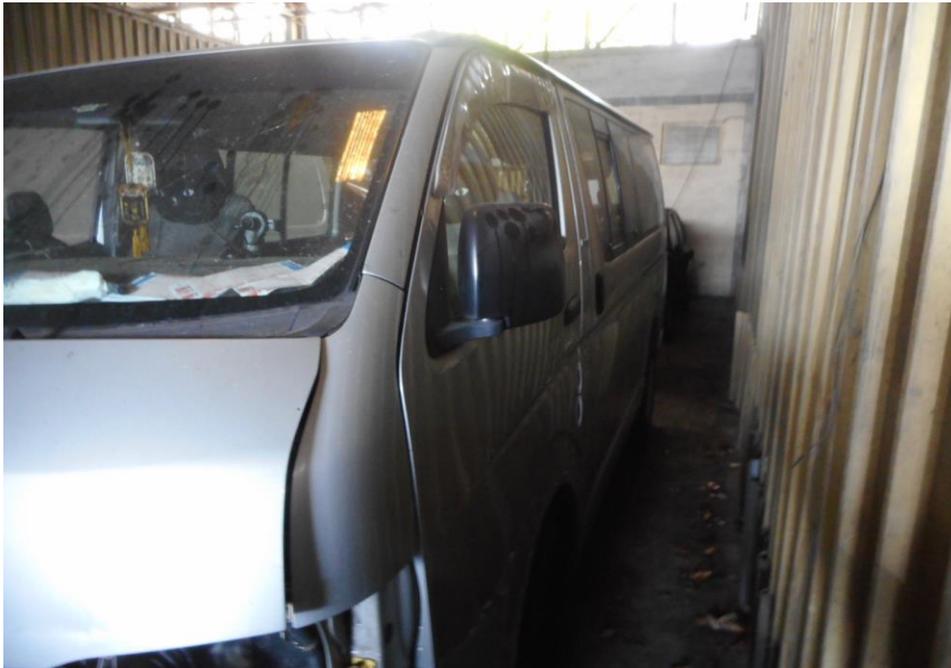
**Photo 10** shows a general view of the left body of the Motor Van at the time of my inspection. The Motor Van was observed to be intact and unaffected by the accident.

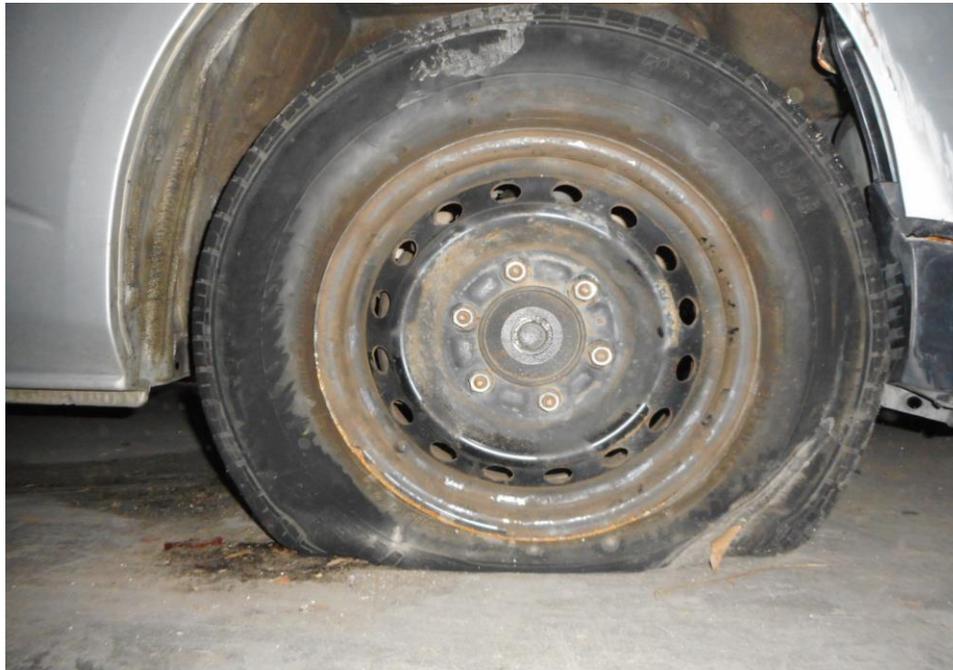
**Photo 11** shows the condition of the front right tyre of the Motor Van, which was observed to be deflated as a result of the accident with remaining tread depth of approximately 3.4mm. There was no tear, cut or burst mark(s) on the outer and the inner sidewalls as well as across the tread of the 4 tyres that were fitted on the Motor Van.

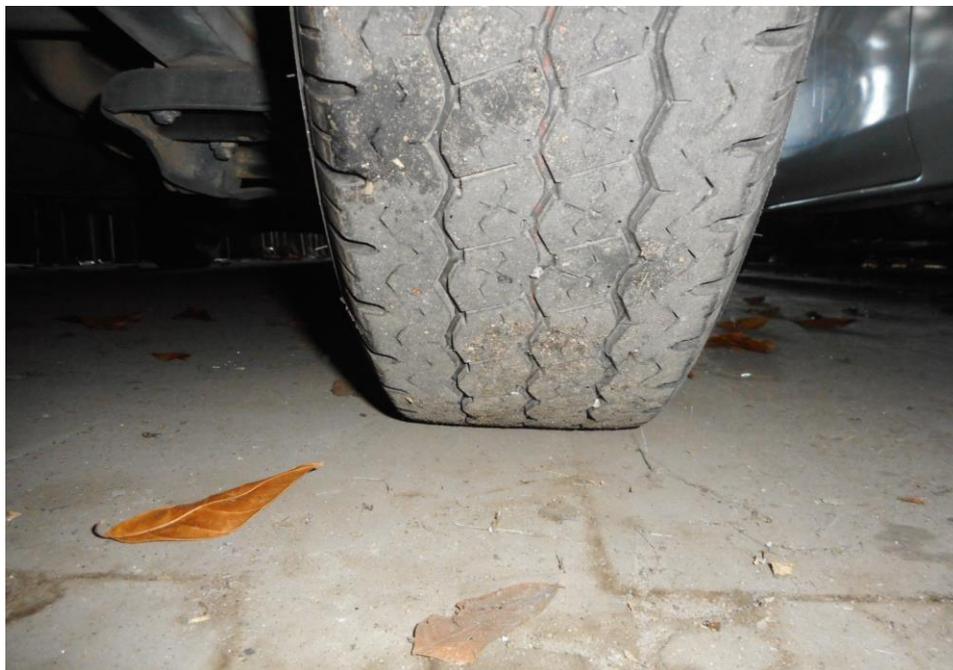
**Photo 12** shows the condition of the rear right tyre of the Motor Van, which was observed to be in serviceable condition with remaining tread depth of approximately 3.4mm. The tyre, which was wrapped around standard steel wheel rim, it was observed to be sufficiently inflated for vehicular operation.

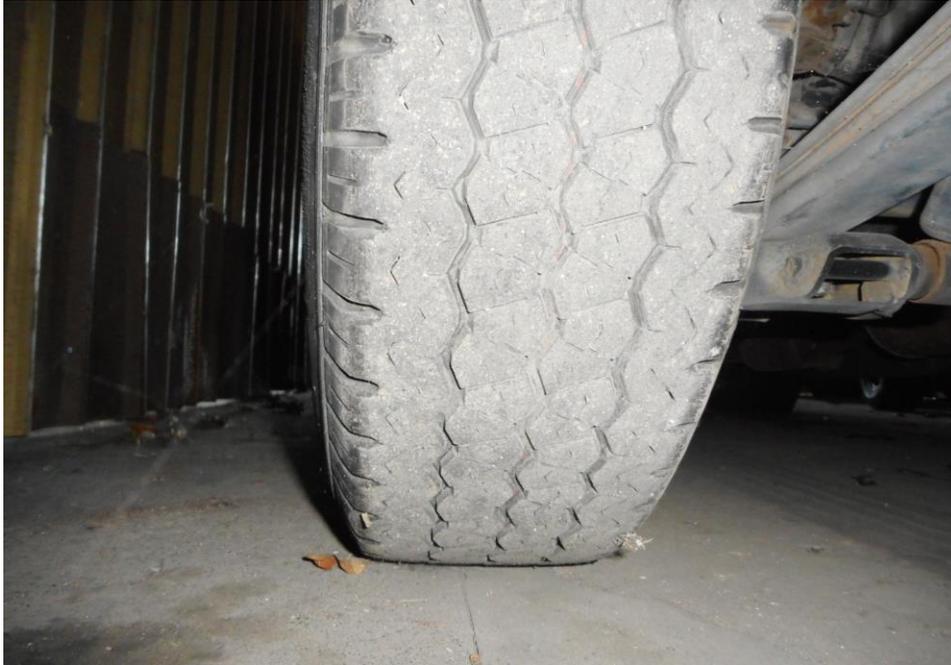
**Photo 13** shows the condition of the rear left tyres of the Motor Van, which was observed to be in serviceable condition with remaining tread depth of approximately 4.2mm. The tyres, which were wrapped around standard steel wheel rim, were also observed to be sufficiently inflated for vehicular operation. There was also no damage found on all 4 steel wheel rims of the Motor Van.

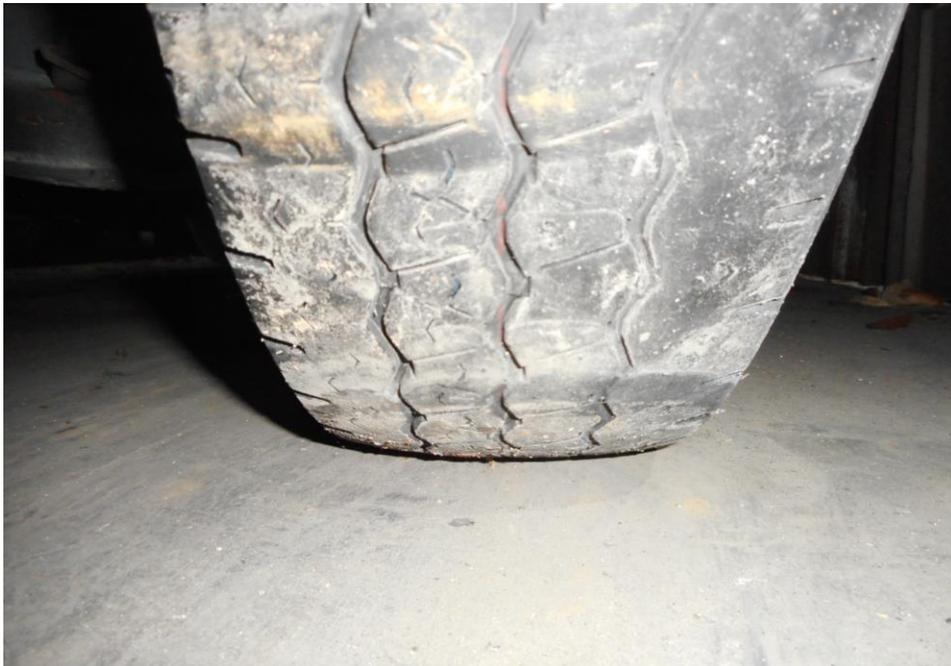
**Photo 14** shows the condition of the rear right tyres of the Motor Van, which were observed to be in serviceable condition with remaining tread depth of approximately 3.1mm. There was also no tear, cut or burst mark(s) on the outer and the inner sidewalls as well as across the tread of the 4 tyres that were fitted on the Motor Van.

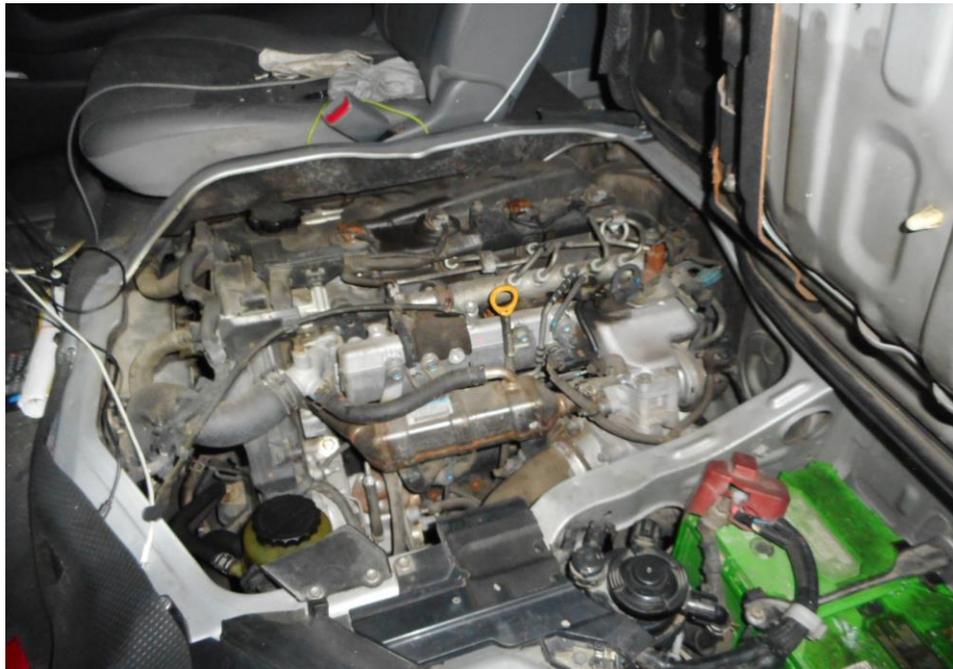
**Photo 15** shows a general view of the Motor Van's engine compartment, which was accessed by lifting the front cabin of the Motor Van. The various parts and components inside the engine compartment were unaffected by the accident. There was also no sign(s) or indication(s) of fresh fluid leakage and/or fluid stain within the engine compartment

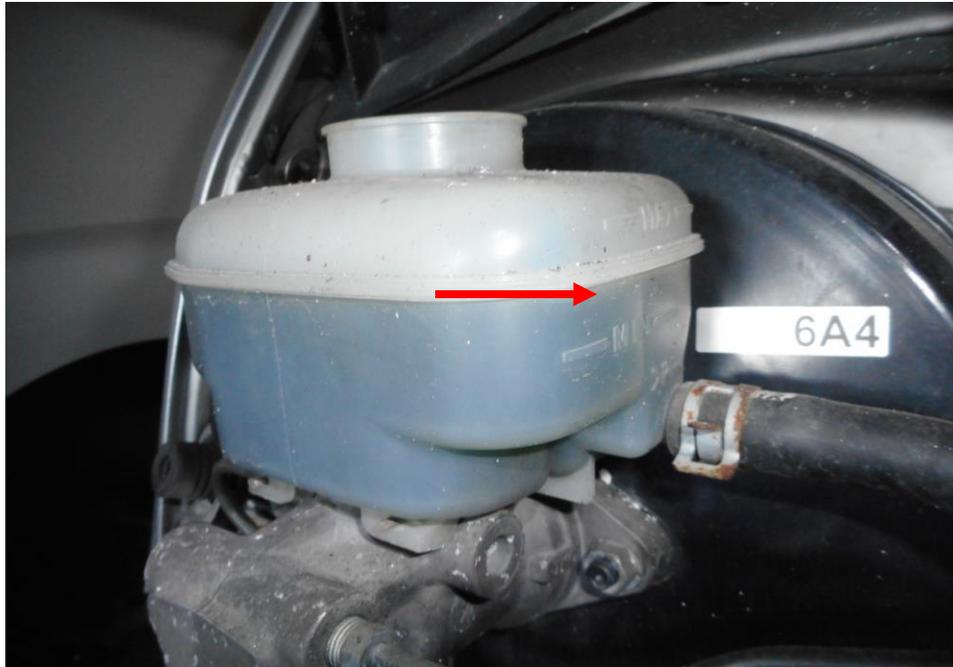
**Photo 16** shows the brake fluid reservoir of the Motor Van at the time of my inspection. The brake fluid was observed to be of sufficient level (arrowed) and without any visible contamination.

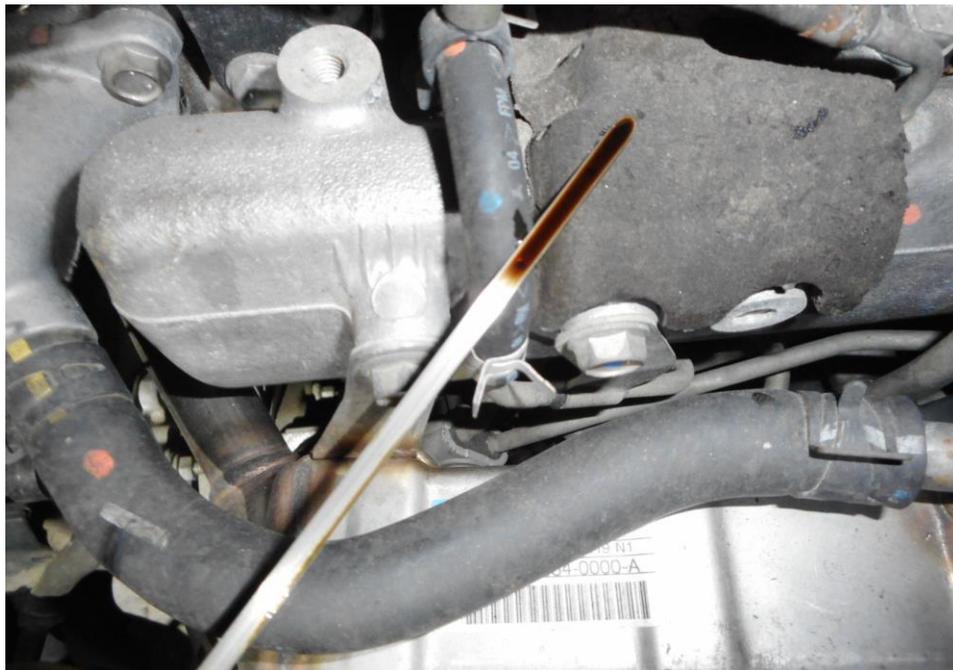
**Photo 17** shows the engine oil dip stick of the Motor Van at the time of my inspection. The engine oil was observed to be of sufficient level and without any visible contamination.

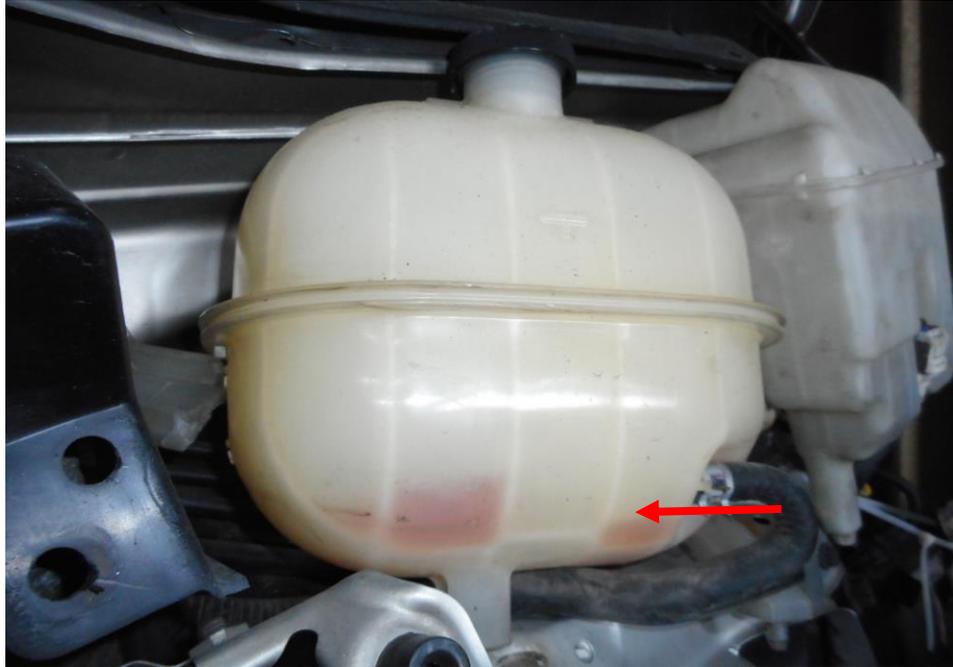
**Photo 18** shows the engine coolant reservoir of the Motor Van at the time of my inspection. The engine coolant was observed to be of insufficient level (arrowed) as the engine radiator had been damaged by the accident which caused a leakage of engine coolant.

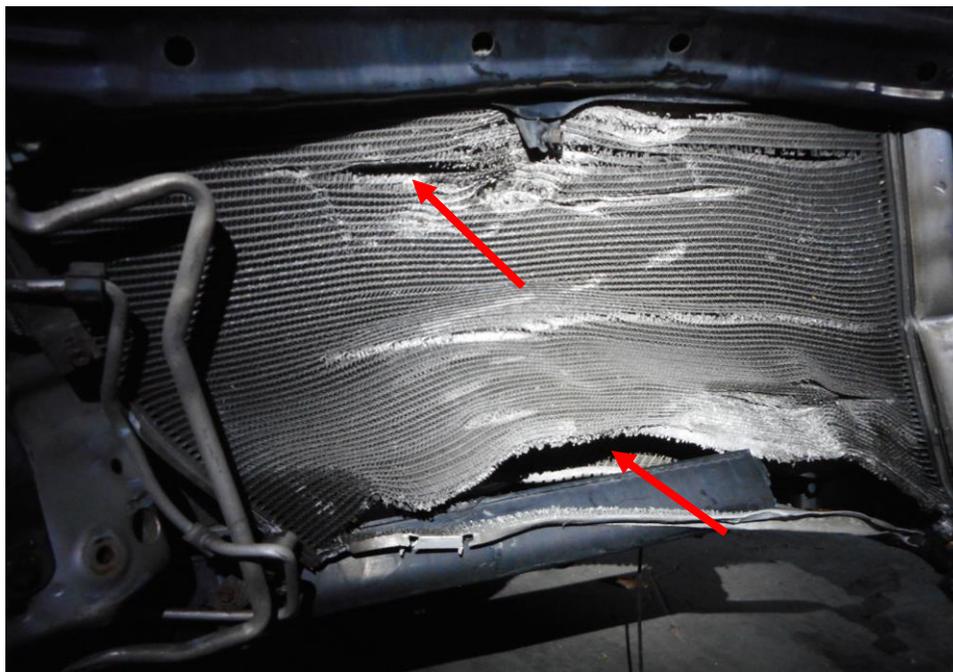
**Photo 19** shows the engine radiator of the Motor Van at the time of my inspection. The engine coolant was observed to be leaked out from the radiator (arrowed) as the engine radiator had been damaged by the accident.

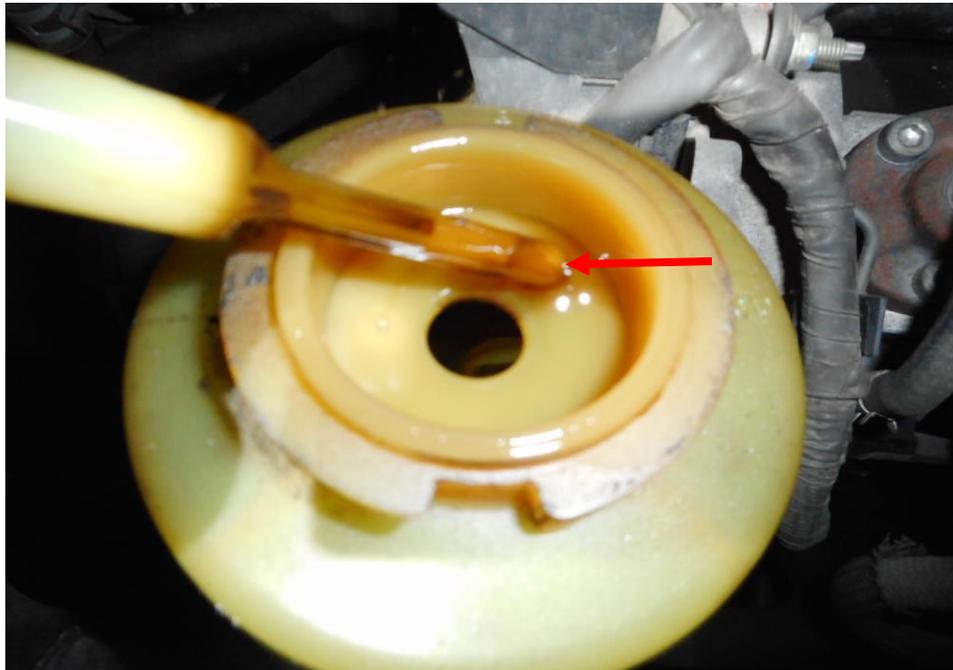
**Photo 20** shows the power steering fluid of the Motor Van at the time of my inspection. The power steering fluid (arrowed) was observed to be of sufficient level and without any visible contamination.

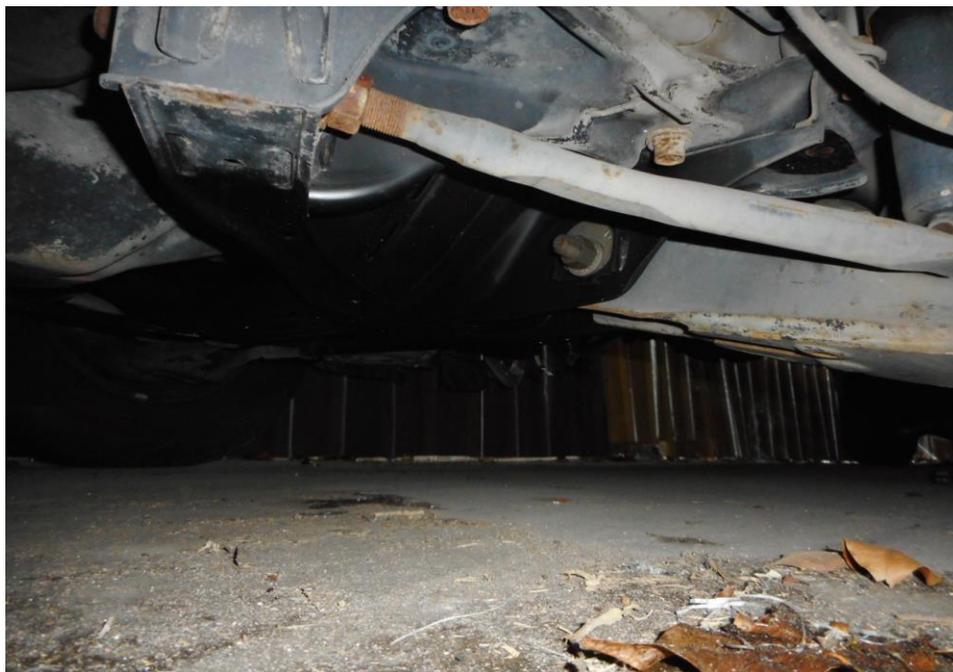
**Photo 21** shows the undercarriage of the Motor Van, at the area where the engine housing and transmission housing are located. . I did not find any sign(s) or indication(s) of fluid leak and/or fluid stain(s) on the underside of the Motor Van.

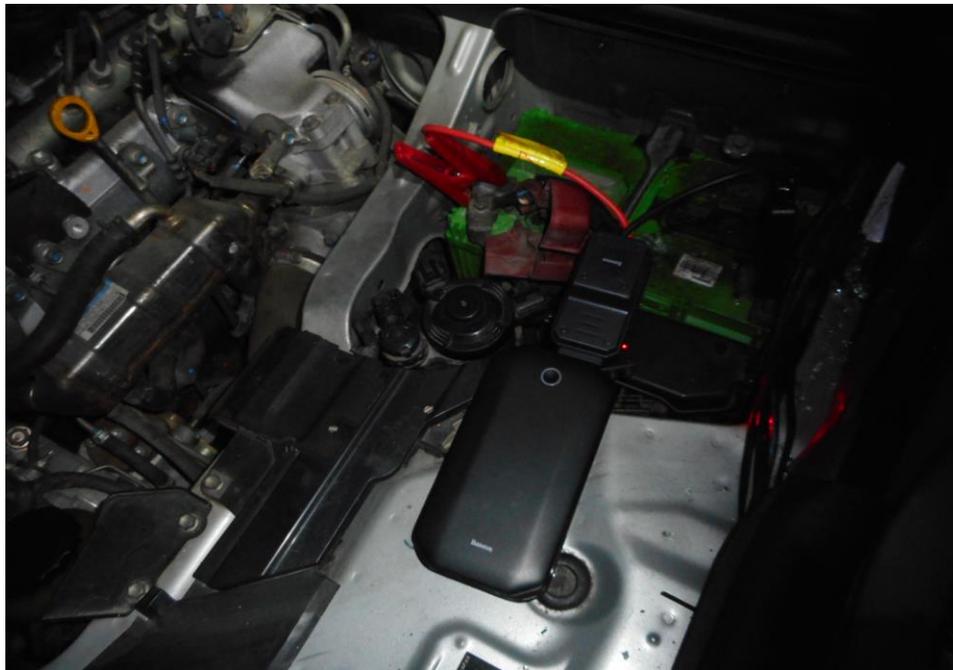
**Photo 22** shows the jumpstarting process of the Motor Van's engine. The engine of the Motor Van was unable to be jumpstarted up despite multiple attempts in starting it.

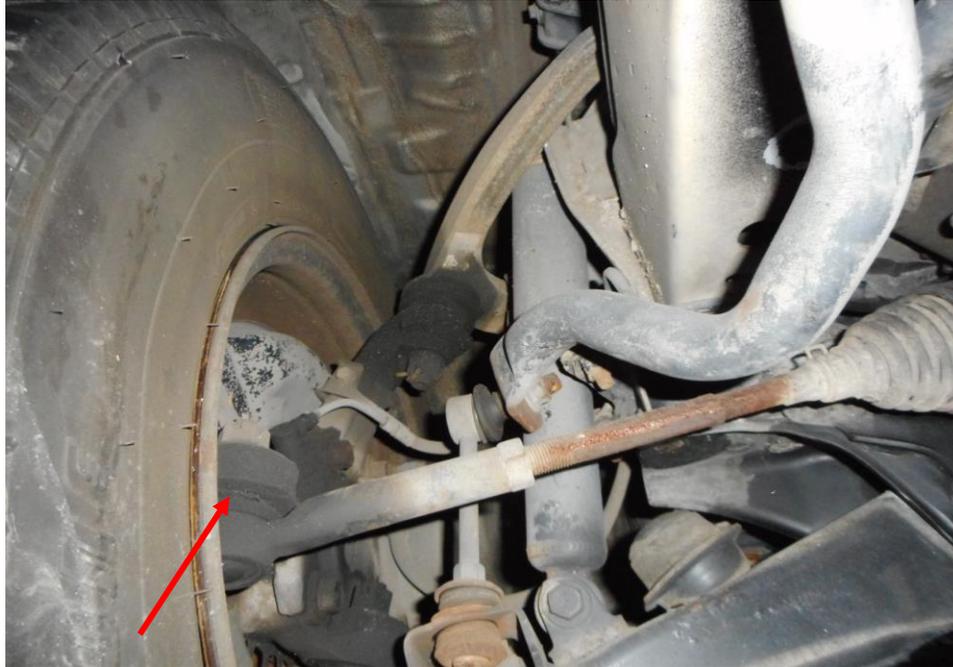
**Photo 23** shows the various undercarriage components at the front right wheel of the Motor Van, in particular the steering tie rod end (arrowed). The various steering components were all found to be intact, suggesting that the steering system of the Motor Van was likely to be in serviceable condition at the material time of accident. There was also no sign of fluid stain(s) observed on the various undercarriage components.

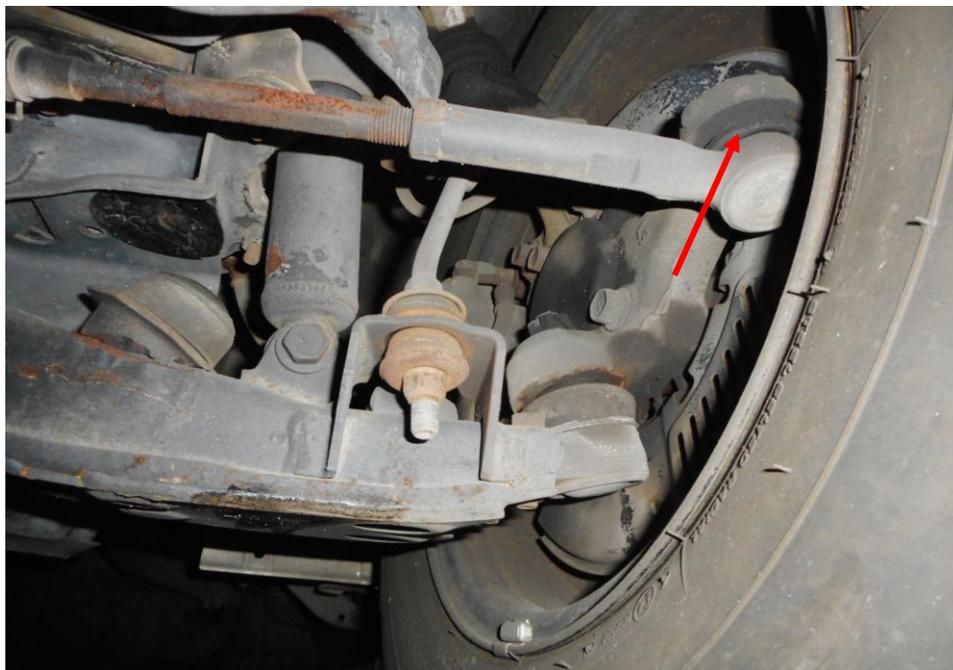
**Photo 24** shows the various undercarriage components at the front left wheel of the Motor Van, in particular the steering tie rod end (arrowed). The various undercarriage components of the Motor Van were all found to be intact without any visible damage. There was also no sign of fluid stain(s) observed on the various undercarriage components.

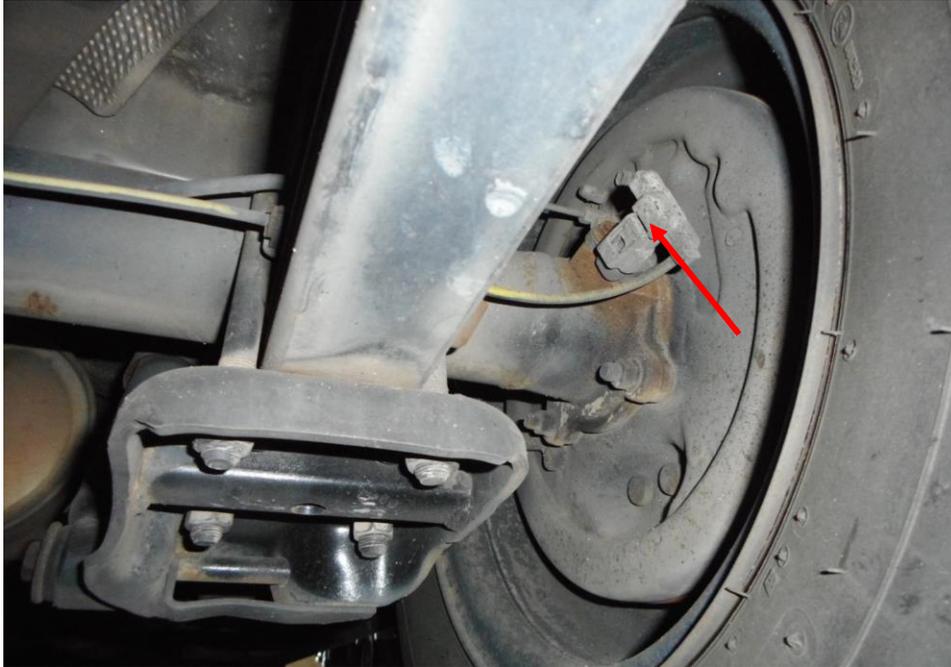
**Photo 25** shows the brake pipe (arrowed) at the rear right wheel of the Motor Van. I did not observe any leakage of brake fluid at the time of my inspection of the Motor Van. My static tests of the Motor Van's braking system, along with my visual examination of the various mechanical components in the braking system, had indicated that there was no internal leakage of pressure/vacuum. Hence the braking system of the Motor Van was likely to be in serviceable condition at the material time of accident.

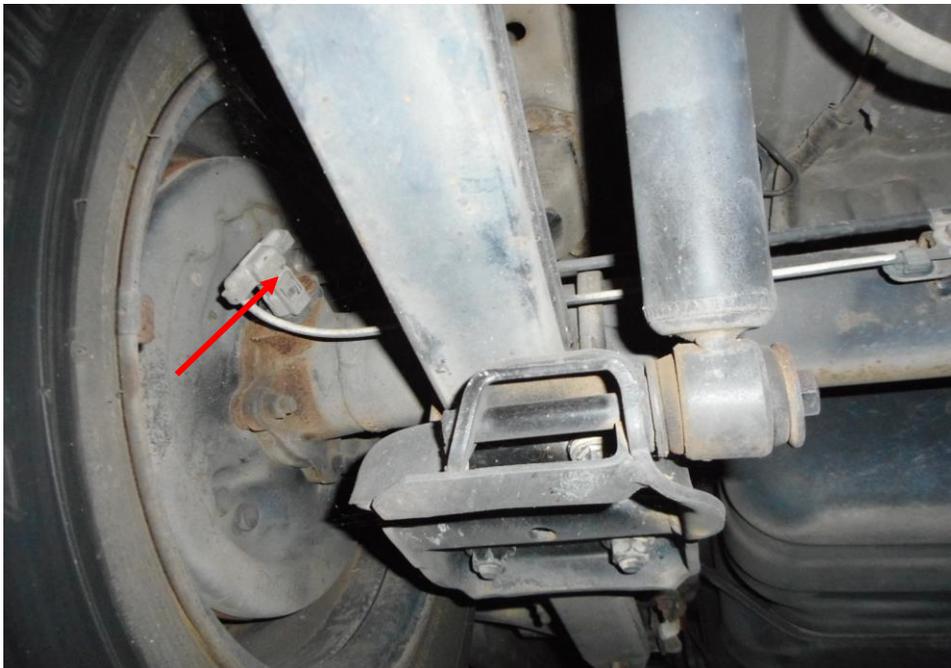
**Photo 26** shows the brake pipe (arrowed) at the rear left wheel of the Motor Van. I did not observe any leakage of brake fluid at the time of my inspection of the Motor Van. My static tests of the Motor Van's braking system, along with my visual examination of the various mechanical components in the braking system had indicated that there was no internal leakage of pressure/vacuum. Hence the braking system of the Motor Van was likely to be in serviceable condition at the material time of accident.

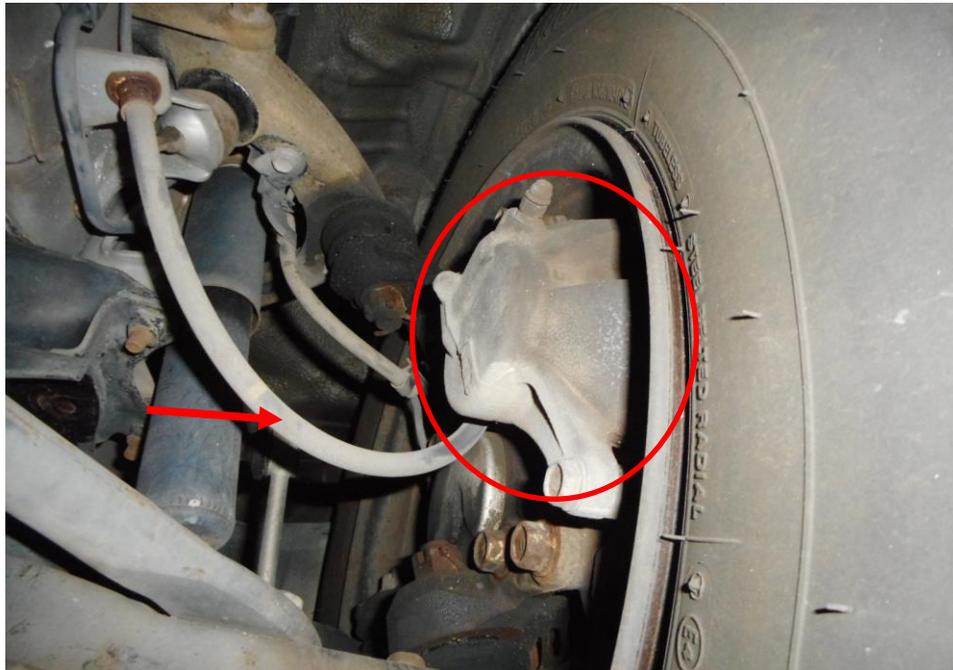
**Photo 27** shows the brake hose/pipe (arrowed) at the front right wheel of the Motor Van. No leakage of brake fluid was observed. Visual examination of the various components of the braking system like the brake caliper (circled), brake booster, brake pedal etc had revealed all to be intact and without visible damage at the time of accident. There was also no sign of fluid stain(s) observed on the various undercarriage components.

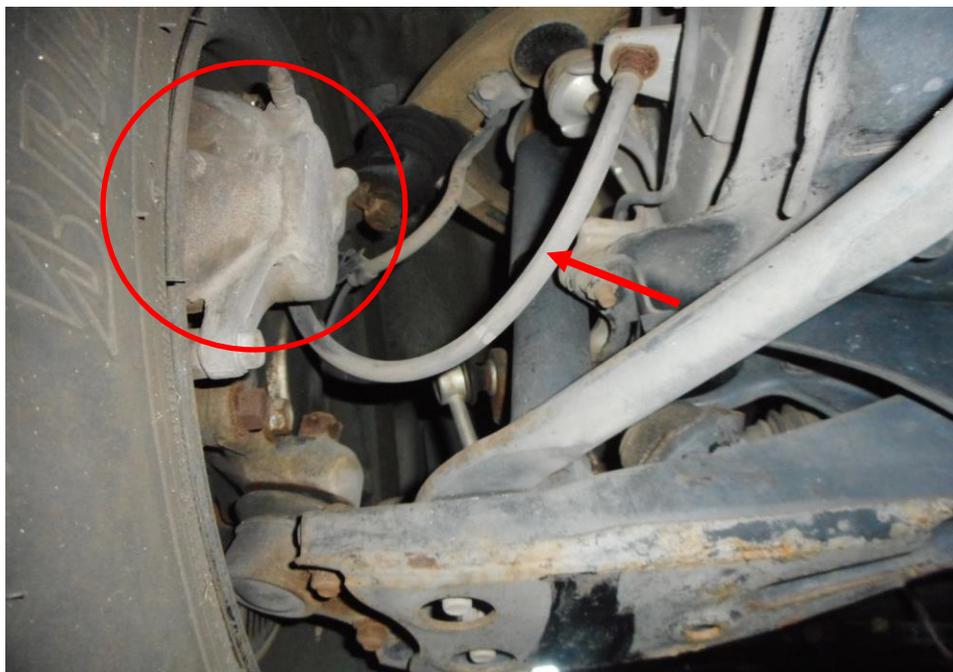
**Photo 28** shows the brake hose/pipe (arrowed) at the front left wheel of the Motor Van. No leakage of brake fluid was observed. Visual examination of the various components of the braking system like the brake caliper (circled), brake booster, brake pedal etc had revealed all to be intact and without visible damage at the time of accident. There was also no sign of fluid stain(s) observed on the various undercarriage components.
