Your Ref: TP/IP/09011/2021
Our Ref : CI/TPD21003853/P

MECHANICAL INSPECTION REPORT OF MOTOR CAR SGJ 4056C

1. I refer to your request on 25th March 2021 to conduct a physical inspection of a Motor car bearing registration number SGJ 4056C (herein referred to as "**Motor Car**"), which was involved in a road traffic accident on 20th February 2021.
2. The objective of the inspection is to determine if there was any possible mechanical failure to the Motor car that may have contributed to the accident.
3. Following the request, I had carried out a physical inspection of the Motor Car on 30th March 2021 at the premises of Traffic Police vehicle pound, 517 Airport Road Singapore 539942. I now set out below my observations and comments with respect to this inspection.

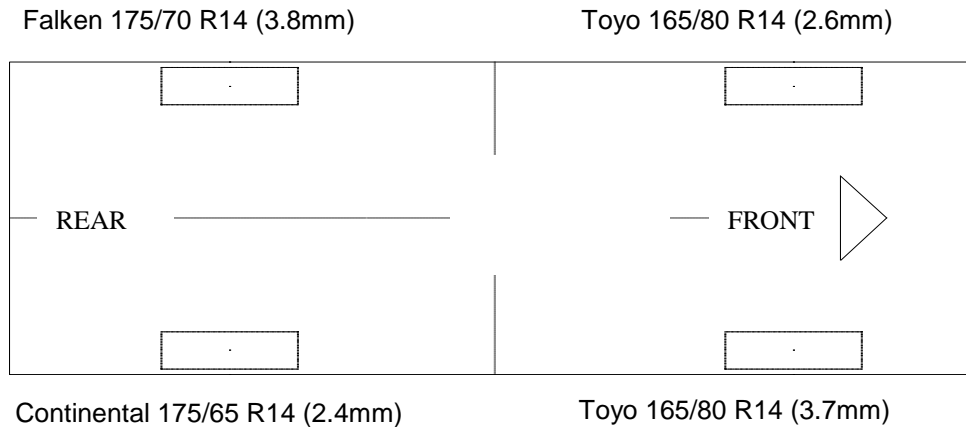
6. The condition of the Motor Car's 4 tyres was observed to be in serviceable condition. I did not find any tear, cut or burst mark(s) on the outer and the inner sidewalls as well as across the tread of the 4 tyres. The 4 tyres were also observed to be sufficiently inflated for vehicular operation. The tyre brand, tyre size and remaining tread depth of the 4 tyres were recorded as follows:-

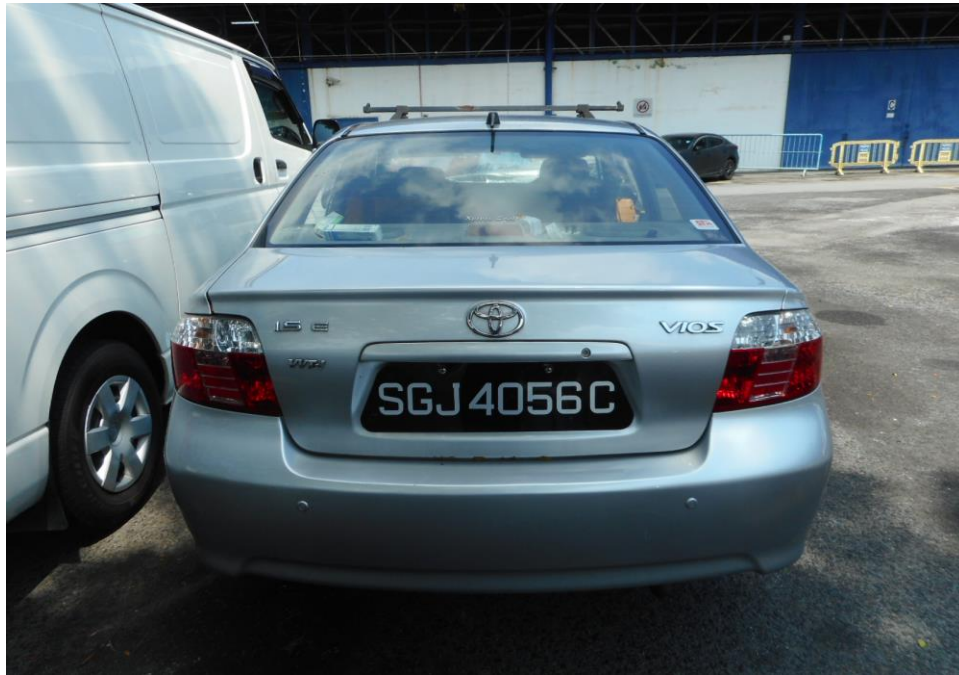
Photo 1 shows a general view of the Motor Car's rear body at the time of my inspection. The rear portion of the Motor Car was observed to have been undamaged by the accident.

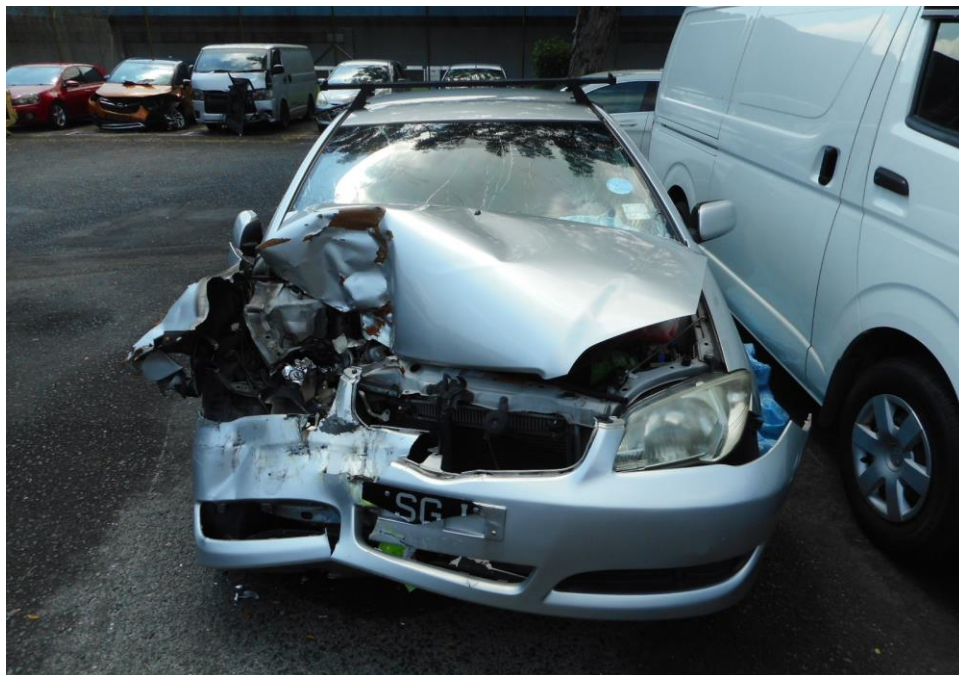
4. The mileage of the Motor car was not recorded due to damage to the ignition system and engine system as a result of the accident.
5. The Motor car was observed to have sustained extensive damage at its front portion. Its front windscreen, front bonnet, front bumper, front right fender was amongst the body parts and various components in the engine compartments were also damaged as a result of the accident. The Supplemental Restraint System (SRS) was activated as a result of the accident.

Photo 2 shows a general view of the Motor Car's front body at the time of my inspection. The Motor car was observed to have sustained damage at its front portion. Its front windscreen, front bonnet, front bumper, front right fender was amongst the body parts and various components in the engine compartments were also damaged as a result of the accident. The Supplemental Restraint System (SRS) was activated as a result of the accident.

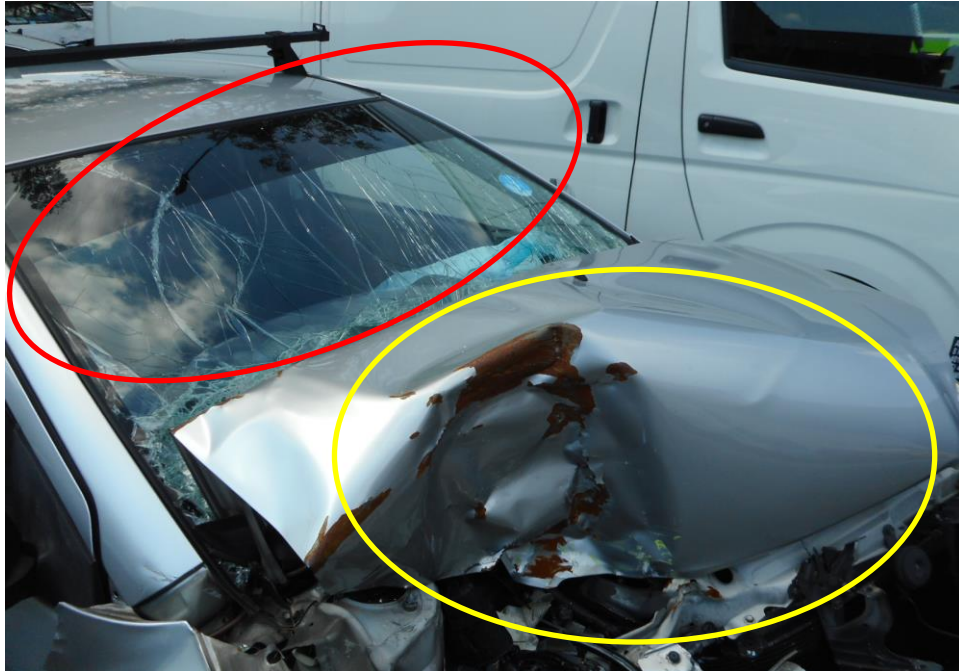
Photo 3 shows the close up view of the Motor Car's front body at the time of my inspection. The Motor car was observed to have sustained damage at its front portion. Its front windscreen (red circle) and front bonnet (red circle) was damaged as a result of the accident.

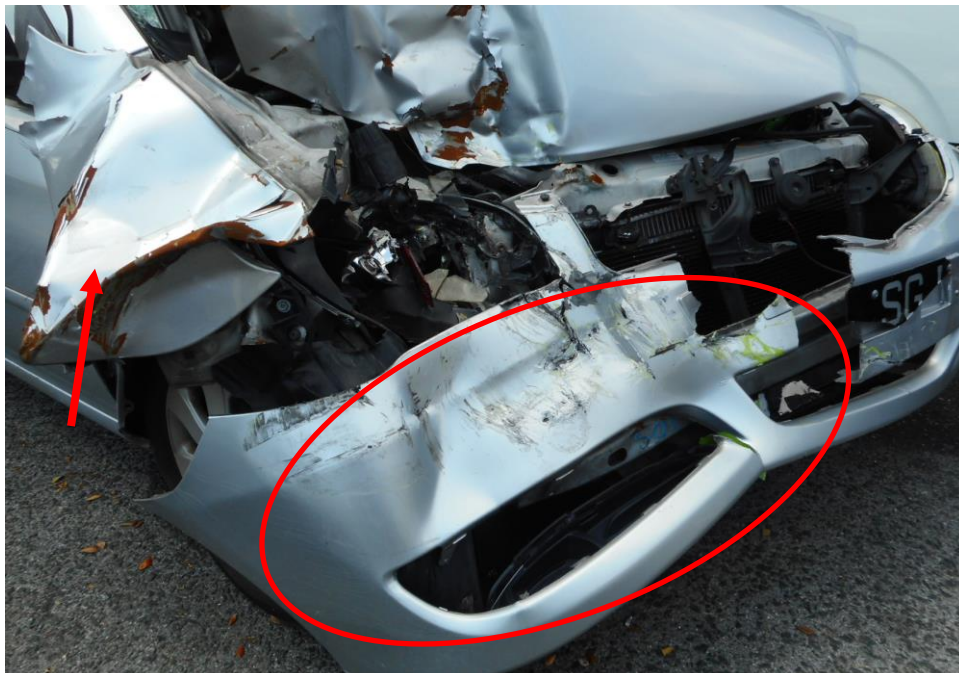
Photo 4 shows the close up view of the Motor Car's front body at the time of my inspection. The Motor car was observed to have sustained damage at its front portion. Its front bumper (circled) and front right fender (arrowed) was amongst the body parts and various components in the engine compartments were also damaged as a result of the accident.

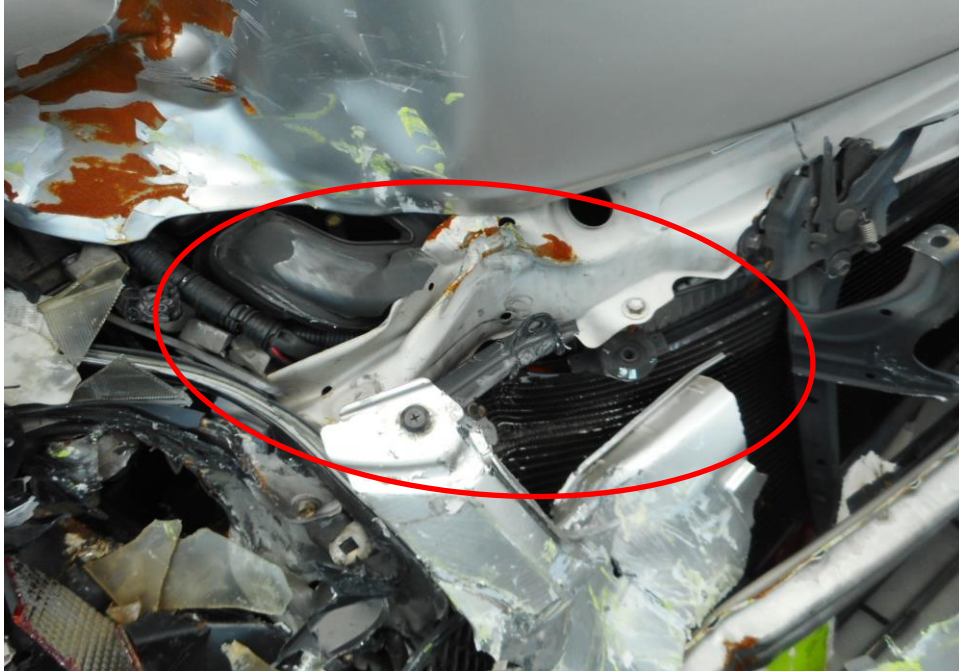
Photo 5 shows the close up view of the Motor Car's front body at the time of my inspection. The Motor car was observed to have sustained damage at its front portion. Its engine (circled) was damaged as a result of the accident.

8. We were unable conduct check on the engine compartment and operating fluids as this components were all damaged as a result of the accident at the time of our inspection.

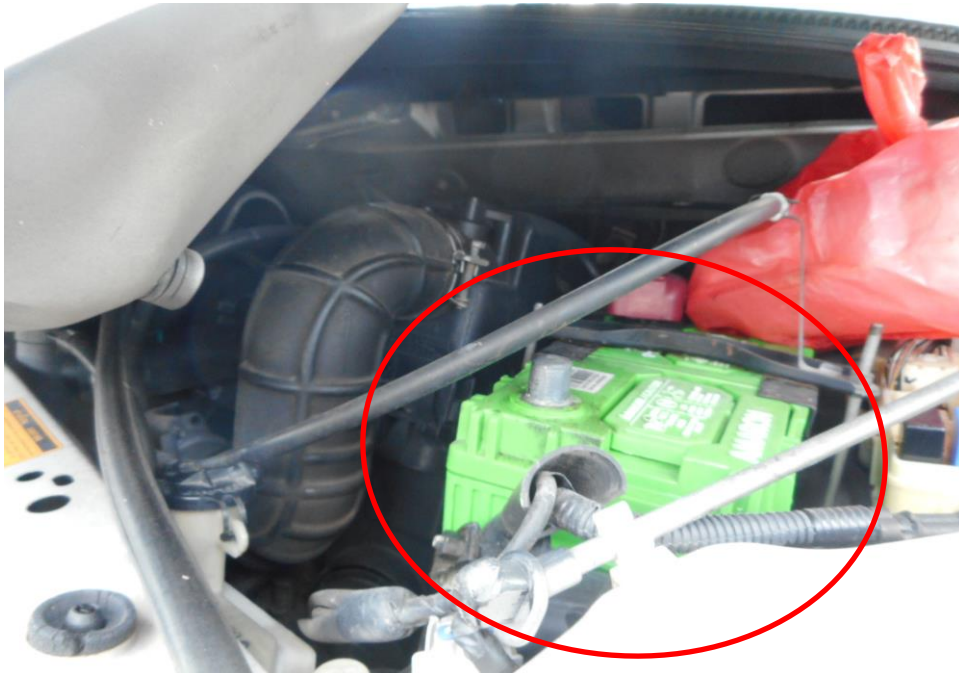
Photo 6 shows the close up view of the Motor Car's front body at the time of my inspection. The Motor car was observed to have sustained damage at its front portion. Its ignition system (circled) was damaged as a result of the accident.

12. The Motor Car's automatic self-test of the functionality of its various electronic operating systems was not able to be conducted as there was damaged ignition system and engine system as a result of the accident. (unable to be started)

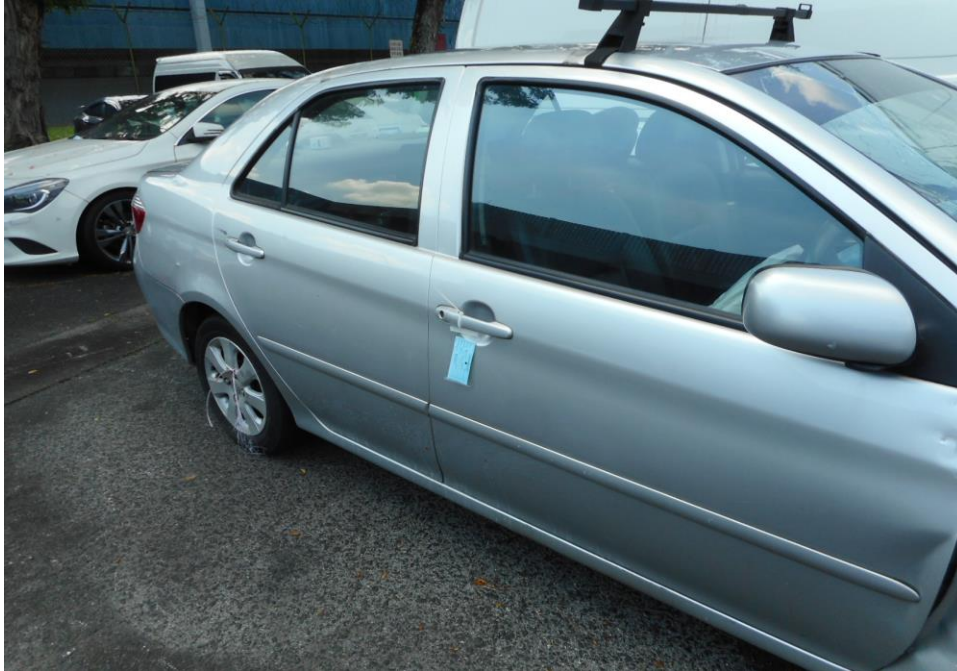
Photo 7 shows a general view of the Motor Car's right body at the time of my inspection. The right portion of the Motor Car was observed to have been undamaged by the accident.

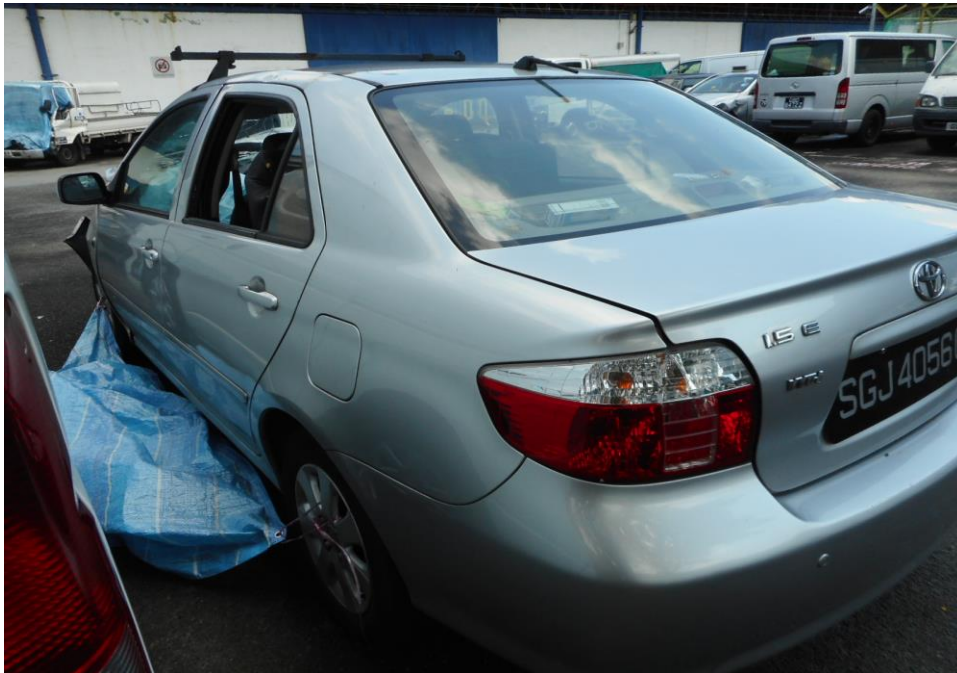
Photo 8 shows a general view of the Motor Car's left body at the time of my inspection. The left portion of the Motor Car was observed to have been undamaged by the accident.

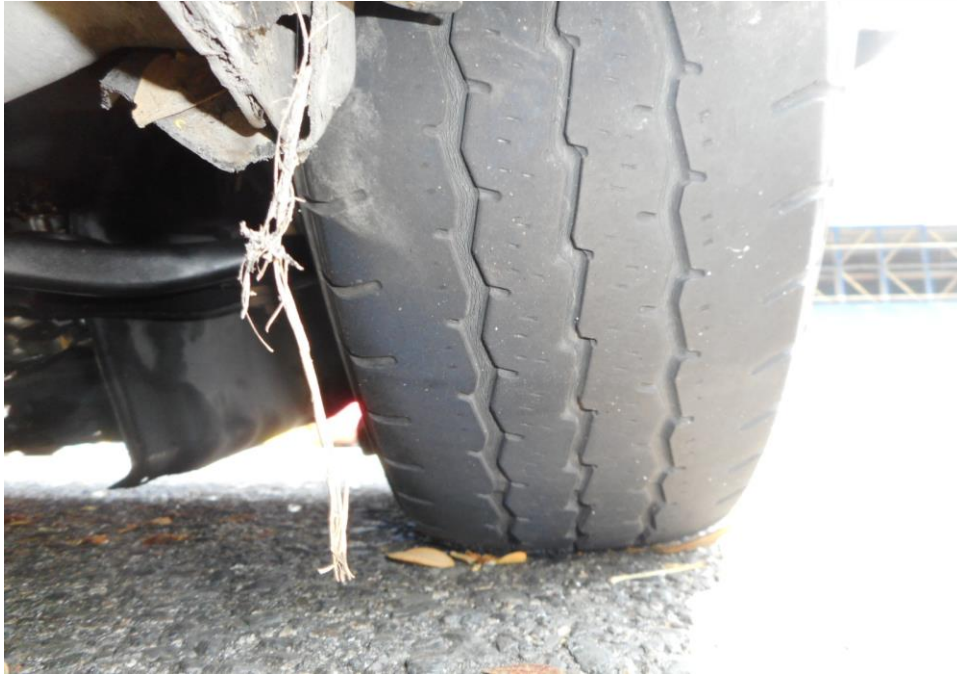
Photo 9 shows the condition of the front right tyre of the Motor Car, which was observed to be in serviceable condition with remaining tread depth of approximately 3.7mm. The tyre, which was wrapped around alloy wheel rim, was also observed to be sufficiently inflated for vehicular operation.

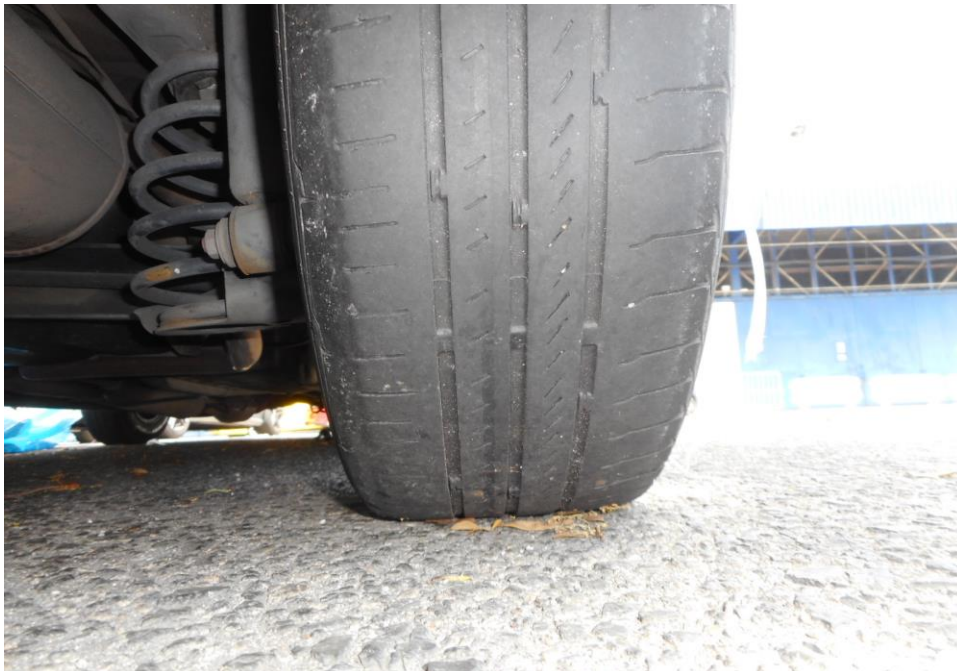
Photo 10 shows the condition of the rear right tyre of the Motor Car, which was observed to be in serviceable condition with remaining tread depth of approximately 2.4mm. The tyre was also observed to be sufficiently inflated for vehicular operation with no tear, cut or burst mark(s).

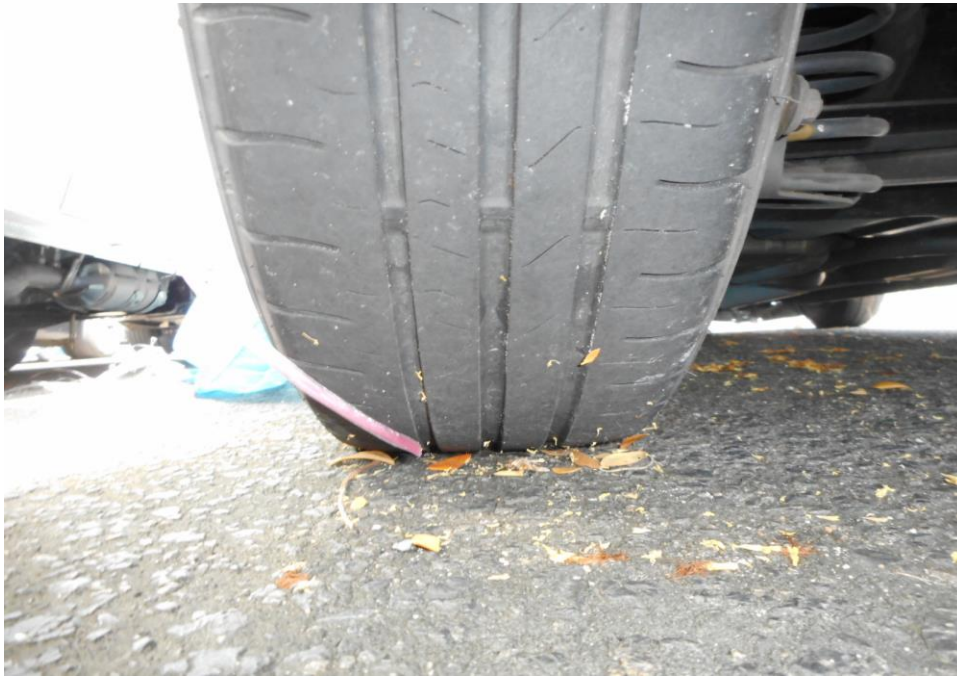
Photo 11 shows the condition of the rear left tyre of the Motor Car, which was observed to be in serviceable condition with remaining tread depth of approximately 3.8mm. The tyre was also observed to be sufficiently inflated for vehicular operation with no tear, cut or burst mark(s).

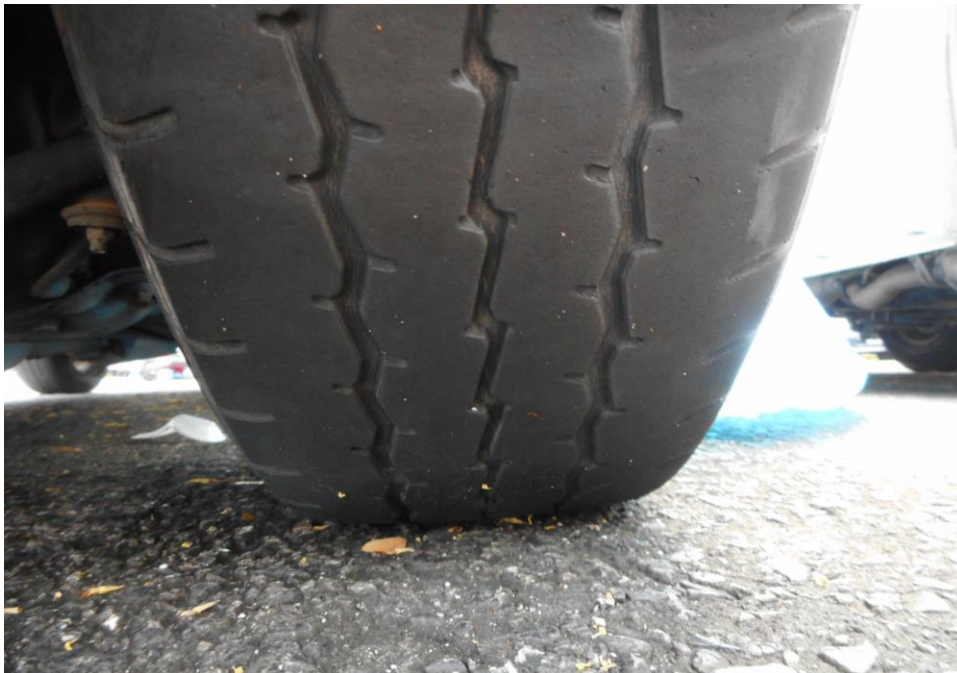
Photo 12 shows the condition of the front left tyre of the Motor Car, which was observed to be in serviceable condition with remaining tread depth of approximately 2.8mm. The tyre was also observed to be sufficiently inflated for vehicular operation with no tear, cut or burst mark(s).

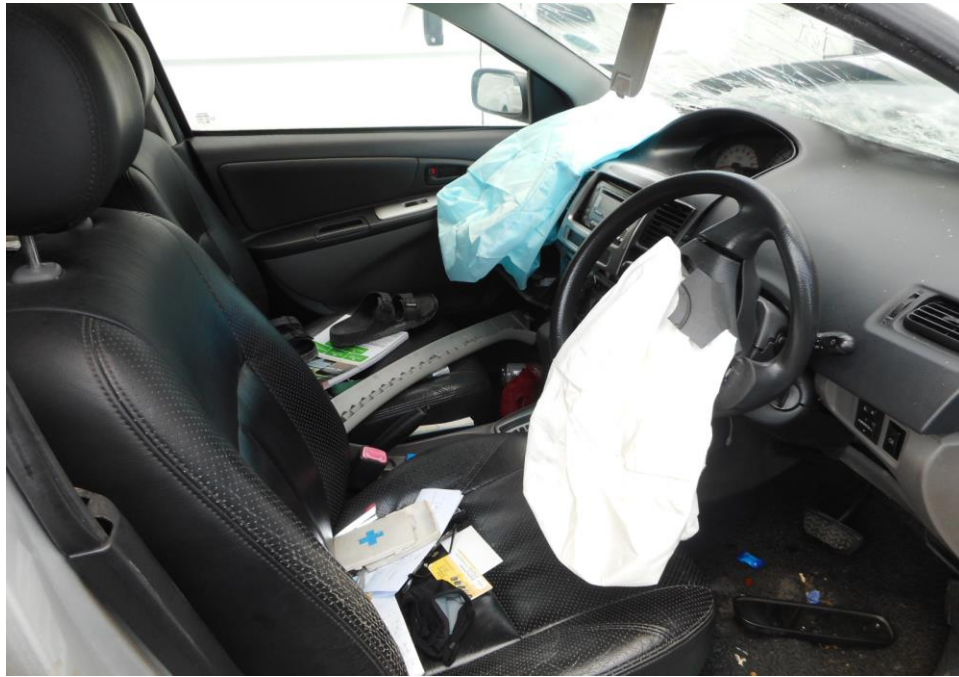
Photo 13 shows the deployment of the Supplemental Restraint System (SRS) airbag in the Motor Car as a result of the accident.

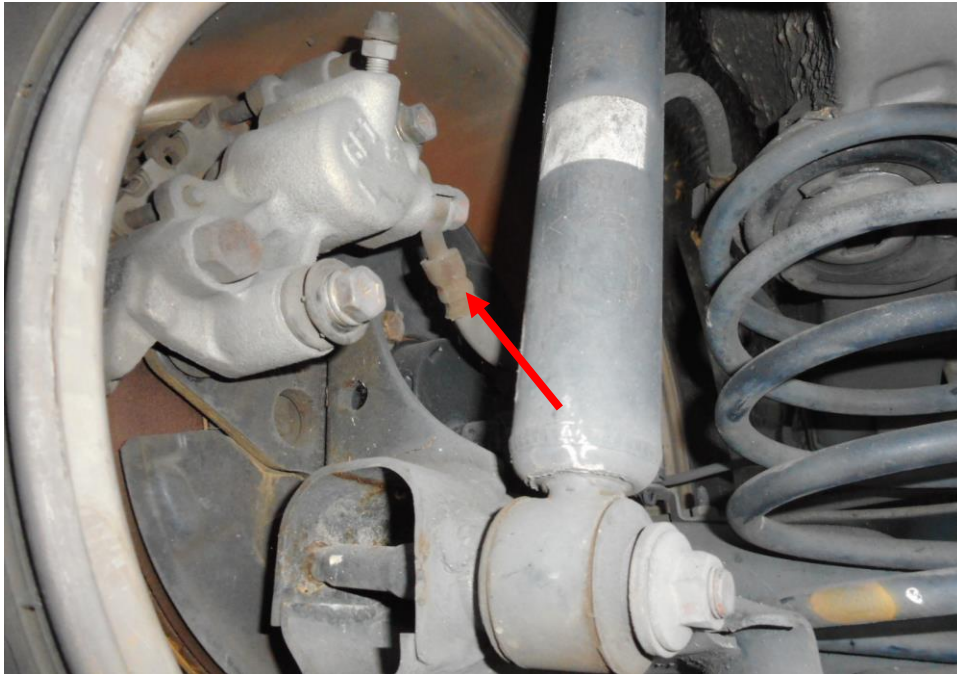
Photo 14 shows the brake hose/pipe (arrowed) at the rear left wheel of the Motor Car. No leakage of brake fluid was observed. Visual examination of the various components of the braking system like the drum brake, brake booster, brake pedal etc. had revealed all to be intact and without visible damage.

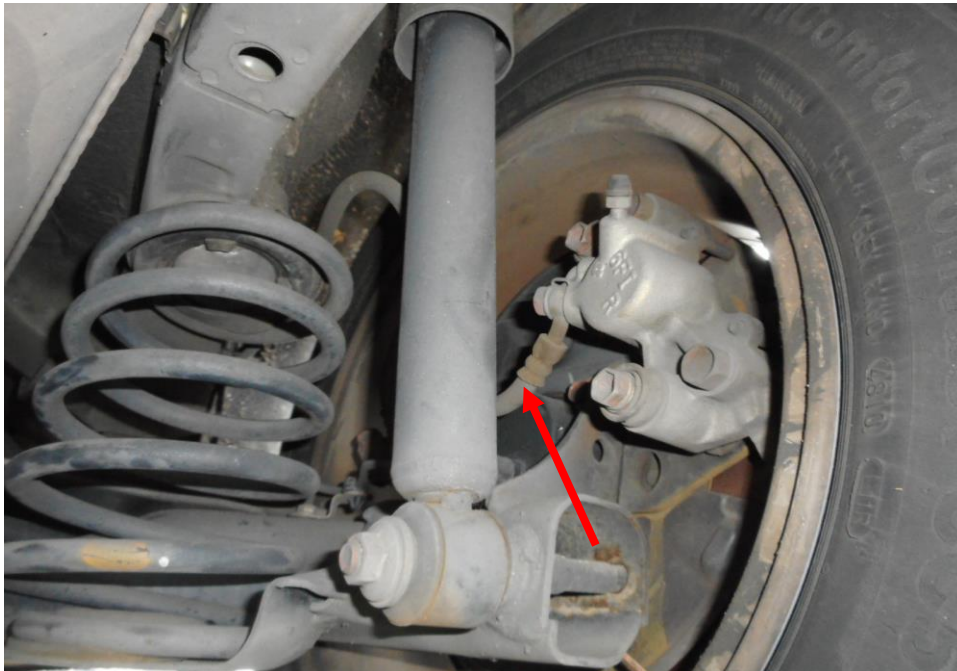
Photo 15 shows the brake hose/pipe (arrowed) at the rear right wheel of the Motor Car. No leakage of brake fluid was observed. Visual examination of the various components of the braking system like the drum brake, brake booster, brake pedal etc. had revealed all to be intact and without visible damage.

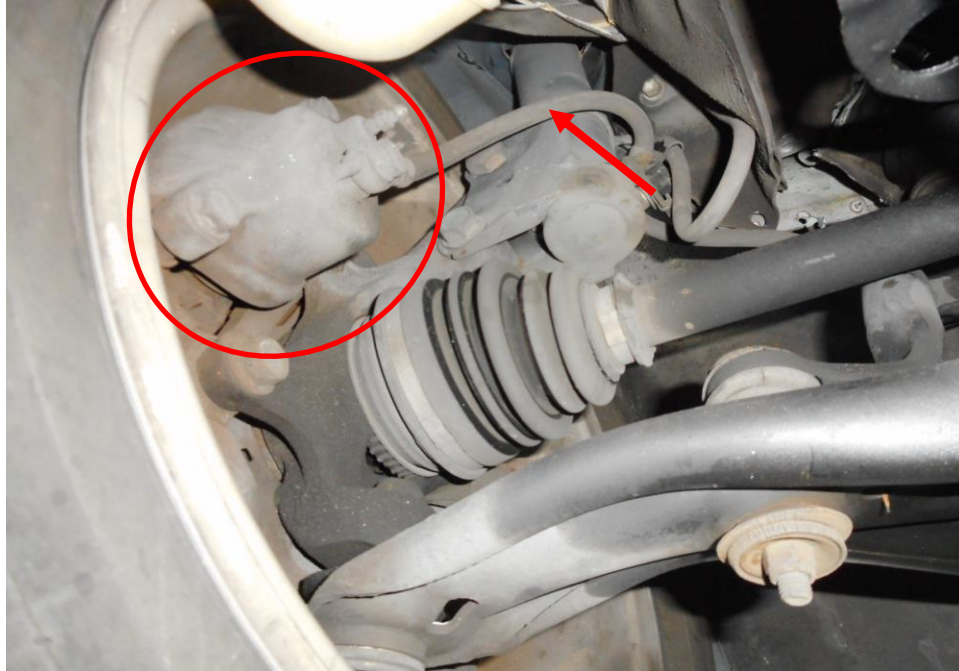
Photo 16 shows the brake hose/pipe (arrowed) at the front right wheel of the Motor Car. No leakage of brake fluid was observed. Visual examination of the various components of the braking system like the brake caliper (circled), brake booster, brake pedal etc had revealed all to be intact and without visible damage at the time of accident. There was also no sign of fluid stain(s) observed on the various undercarriage components.

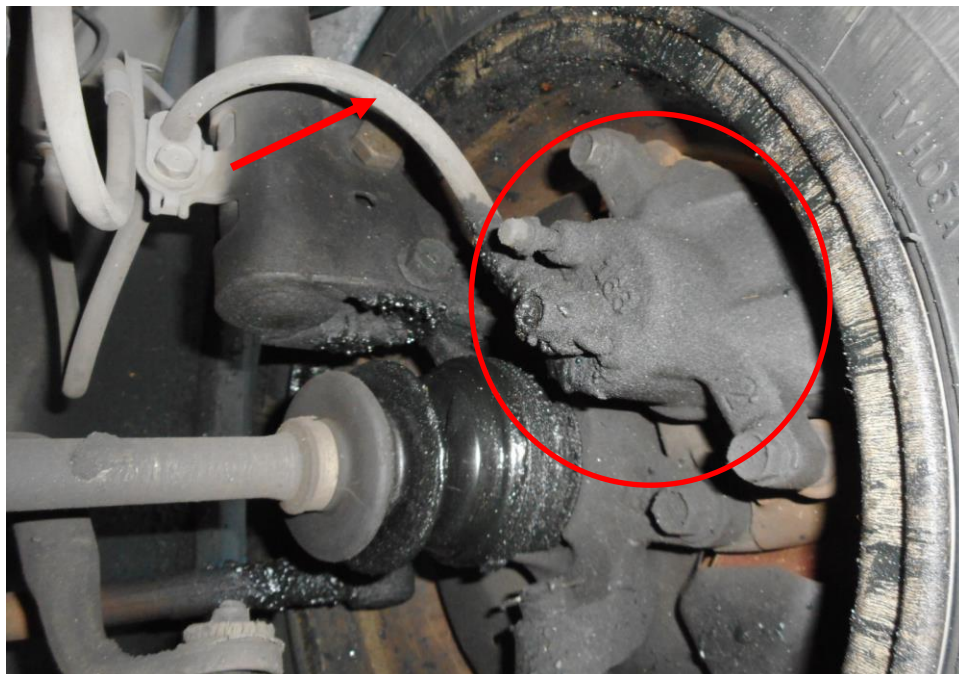
Photo 17 shows the brake hose/pipe (arrowed) at the front left wheel of the Motor Car. No leakage of brake fluid was observed. Visual examination of the various components of the braking system like the brake caliper (circled), brake booster, brake pedal etc had revealed all to be intact and without visible damage at the time of accident. There was also no sign of fluid stain(s) observed on the various undercarriage components. However, observed was old grease stains around the surroundings.

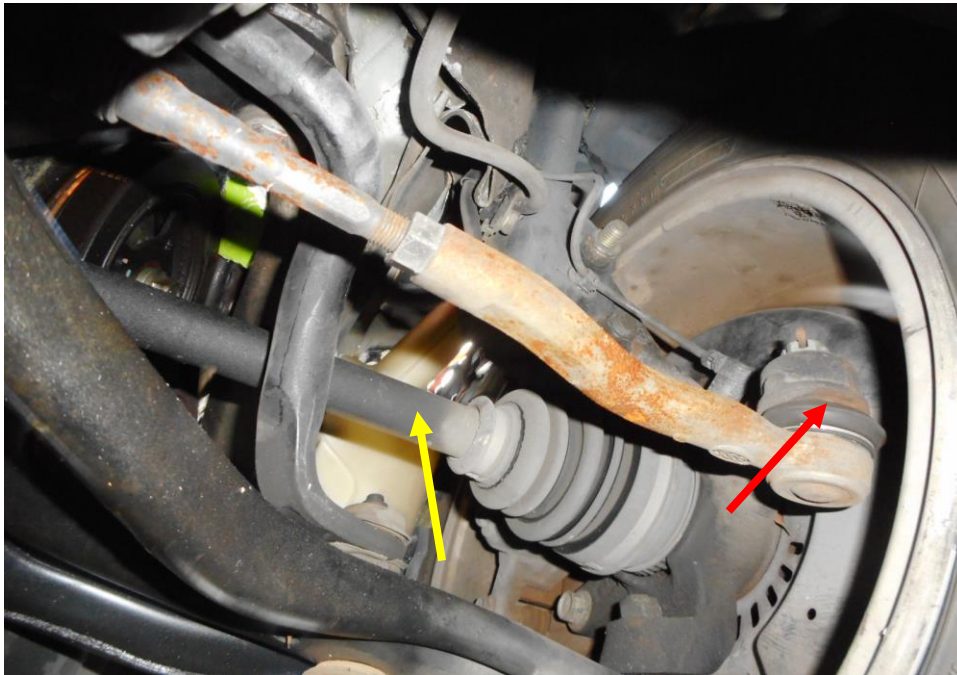
Photo 18 shows the various undercarriage components at the front right wheel of the Motor Car, in particular the steering tie rod end (arrowed) and drive shaft (yellow arrow). The various steering components were all found to be intact, suggesting that the steering system of the Motor Car was likely to be in serviceable condition at the material time of accident. There was also no sign of fluid stain(s) observed on the various undercarriage components.

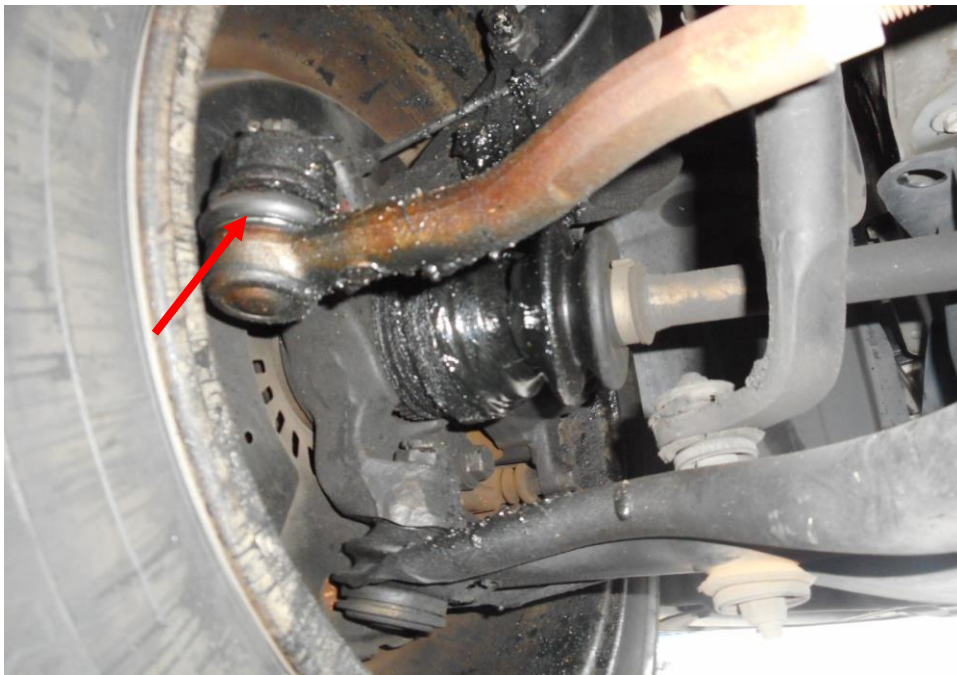
Photo 19 shows the various undercarriage components at the front left wheel of the Motor Car, in particular the steering tie rod end (arrowed). The various Undercarriage components of the Motor Car were all found to be intact without any visible damage. There was also no sign of fluid stain(s) observed on the various undercarriage components. However, observed was old grease stains around the surroundings.

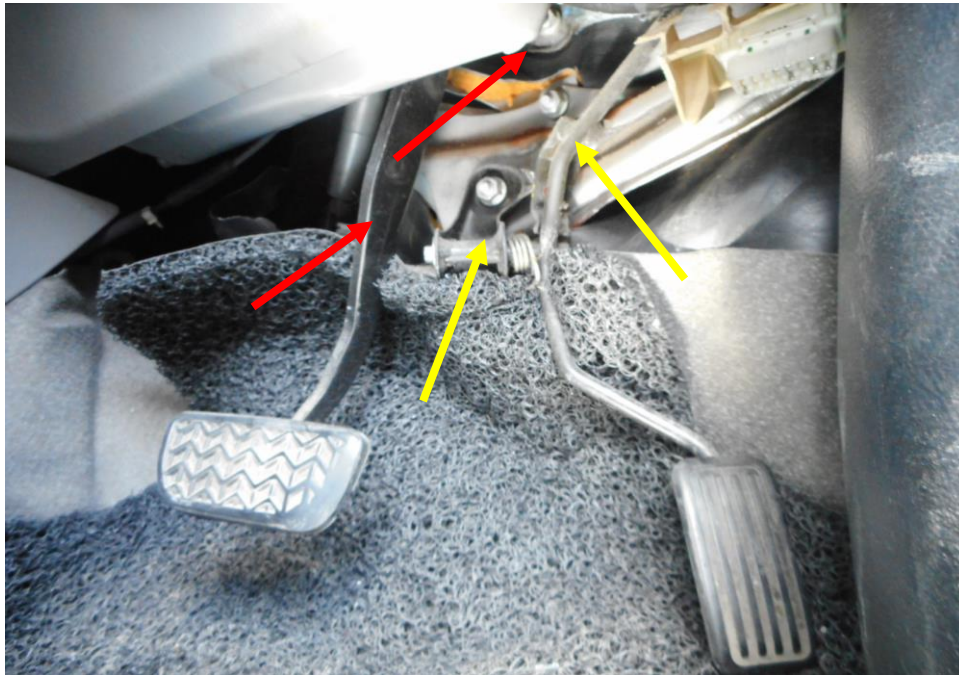
Photo 20 shows the close up view of the Motor Car's brake pedal and brake booster at the time of my inspection. Its brake pedal, brake pedal (red arrowed) and accelerator pedal (yellow arrow) was observed to be damaged as a result of the induced impact from the accident.

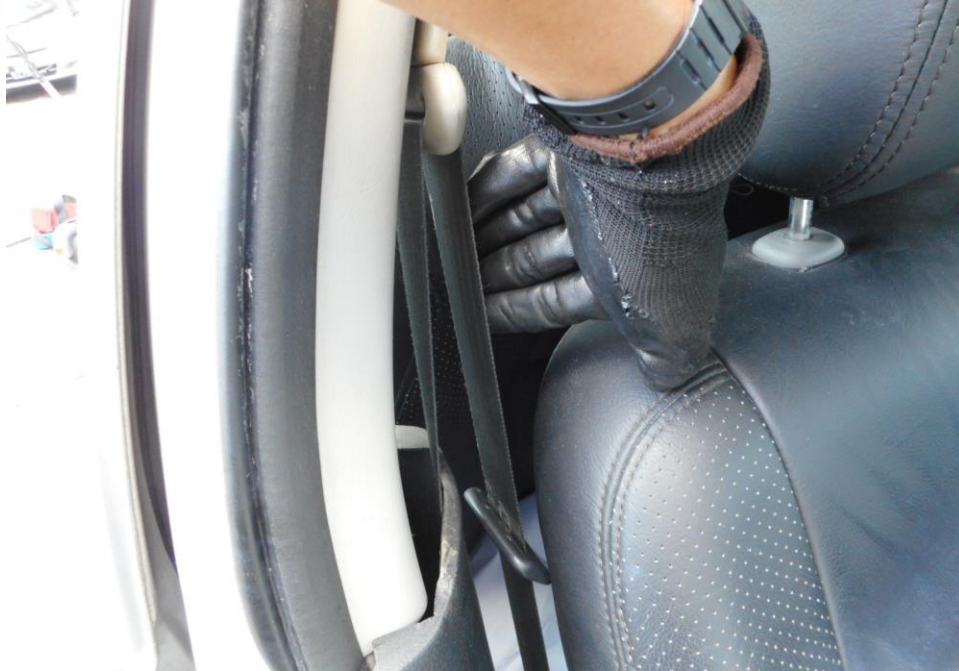
13. The front right and left seat belt of the "Motor Car" was not worn at the material time of accident as the respective pre-tensioners that were fitted at the side of each seat was activated upon the material time. See photo 21 and 22 below.

Photo 21 shows that the seat belt on the right seat was not worn at the material time of accident as the safety pre-tensioners was activated at the moment of impact and caused the seat belt to be locked into the last position.

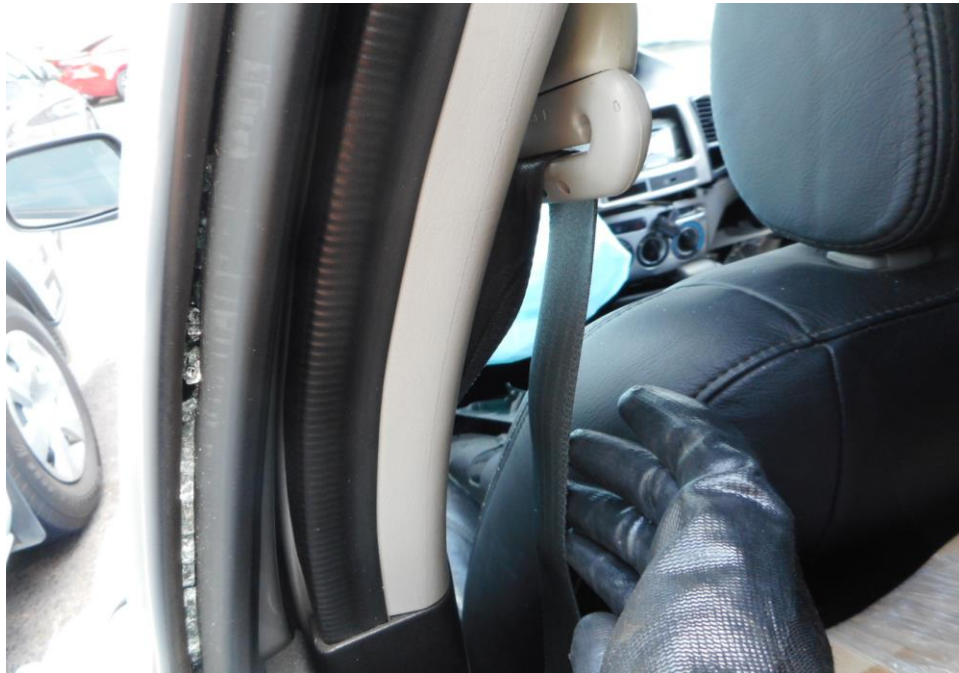
Photo 22 shows that the seat belt on the left seat was not worn at the material time of accident as the safety pre-tensioners was activated at the moment of impact and caused the seat belt to be locked into the last position.
