Your Ref: TP/IP/09011/2021  
Our Ref : CI/TPD21003854/P

**Fatal Accident Investigation Team**

**MECHANICAL INSPECTION REPORT OF MOTOR BUS SG 1849A**

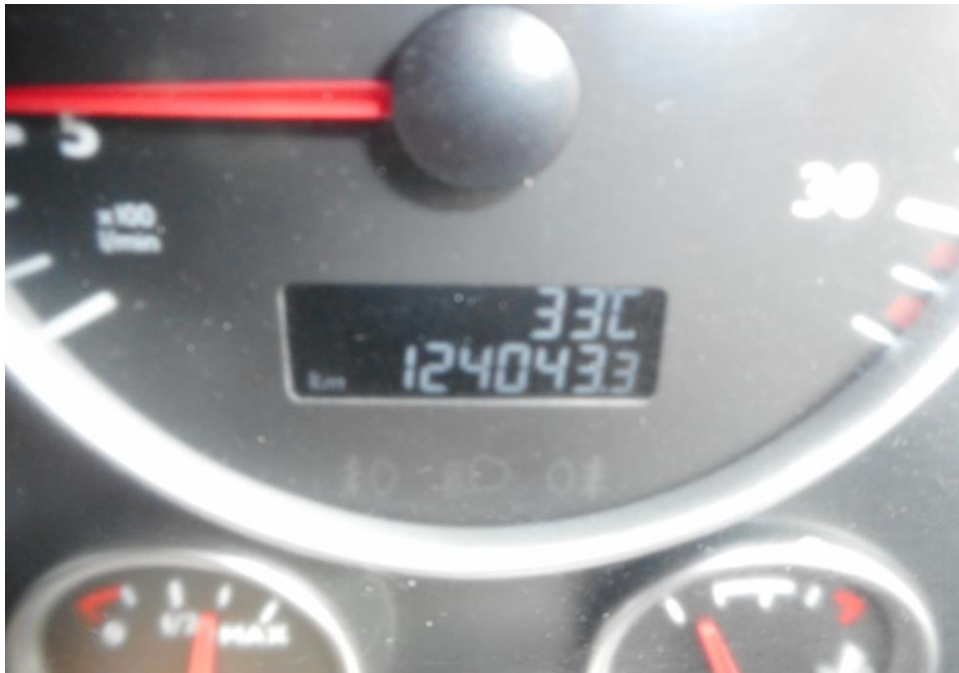
4. The mileage of the Motor Bus at the time of my inspection was 124,043km.
5. The Motor Bus was observed to sustained damage at its rear portion. Its rear left brake lamp and its rear body panel were damage at the time of my inspection.

**Photo 1** shows a general view of the instrument cluster of the Motor Bus at the time of my inspection. The mileage of the Motor Bus was 124,043km

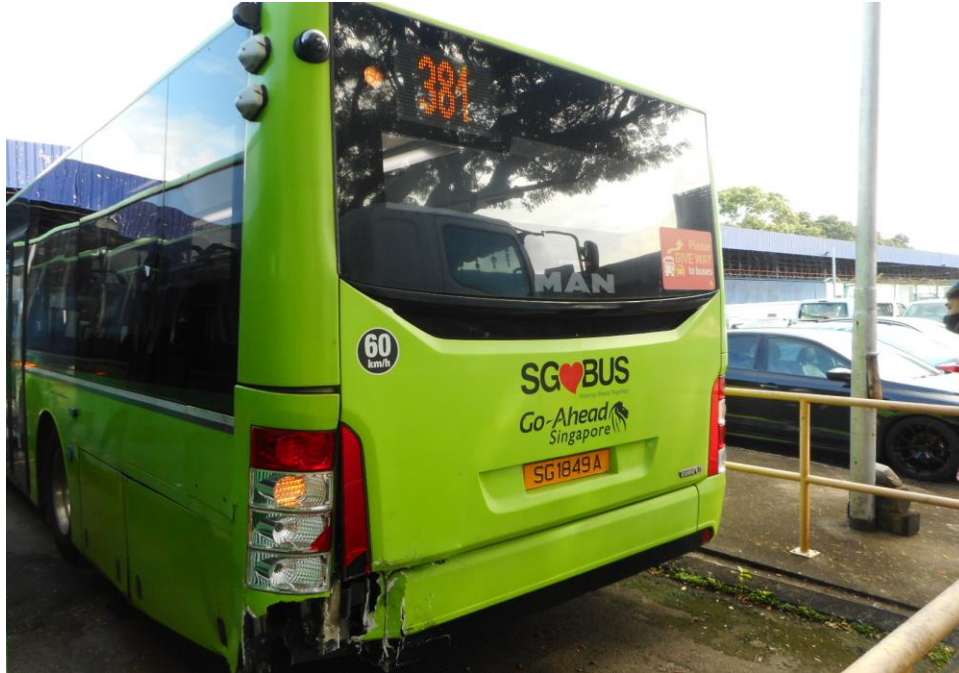
**Photo 2** shows a general view of the Motor Bus's rear body at the time of my inspection. It appeared to have sustained damage at its rear left portion. Its rear brake lamp and rear body panel were damage at the time of my inspection.

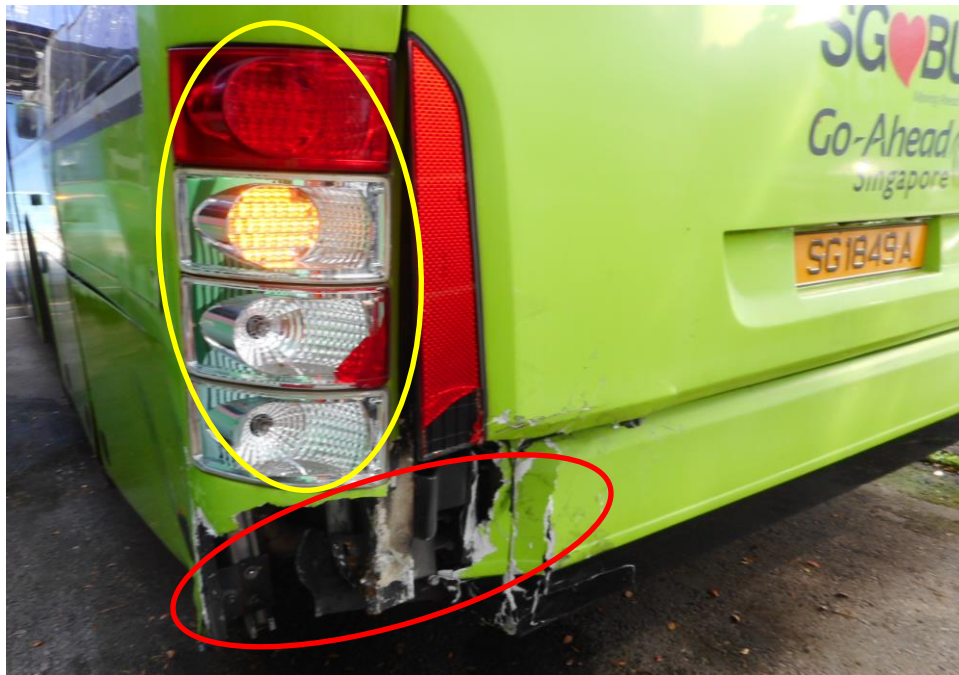
**Photo 3** shows a close up view of the Motor Bus's rear body at the time of my inspection. It appeared to have sustained damage at its rear left portion. Its rear brake lamp (yellow circle) and rear body panel (red circle) were damage at the time of my inspection.

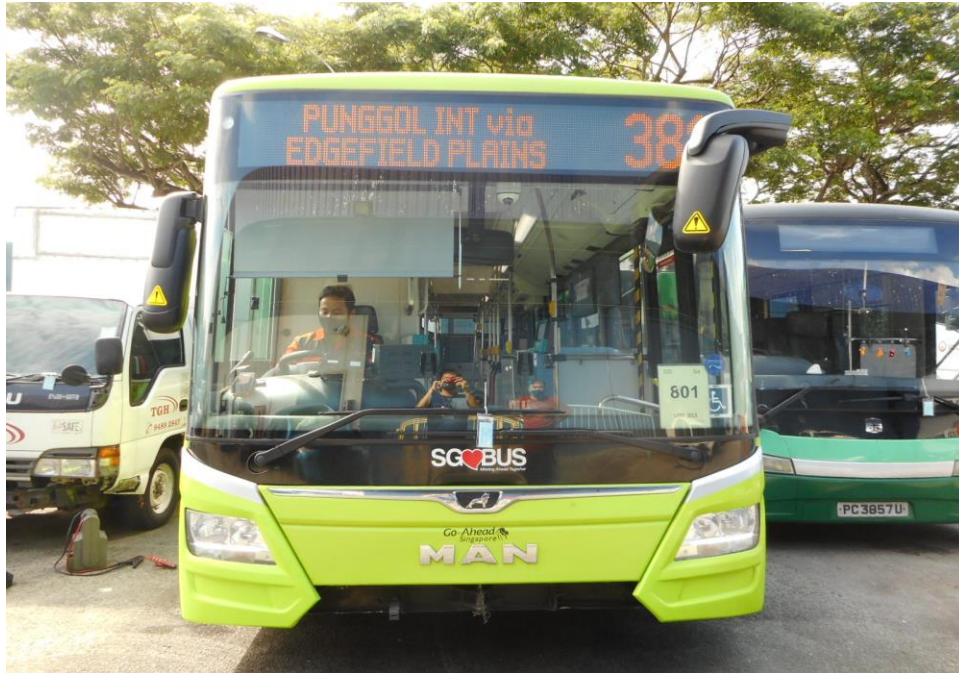
**Photo 4** shows a general view of the front body of the Motor Bus at the time of my inspection. The Motor Bus was observed to be intact and unaffected by the accident.

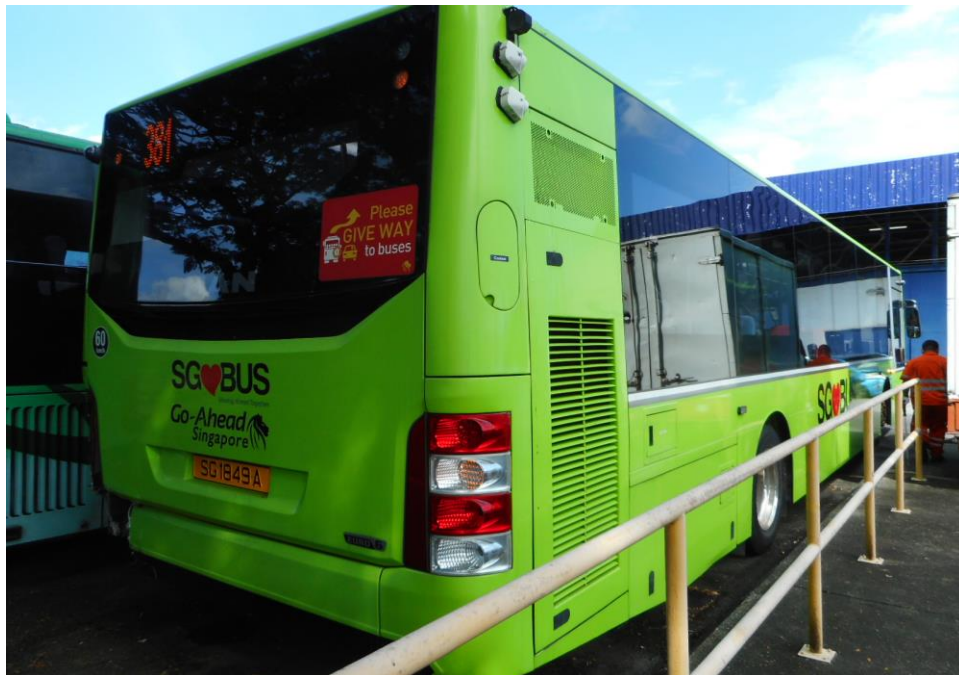
**Photo 5** shows a general view of the right body of the Motor Bus at the time of my inspection. The Motor Bus was observed to be intact and unaffected by the accident.

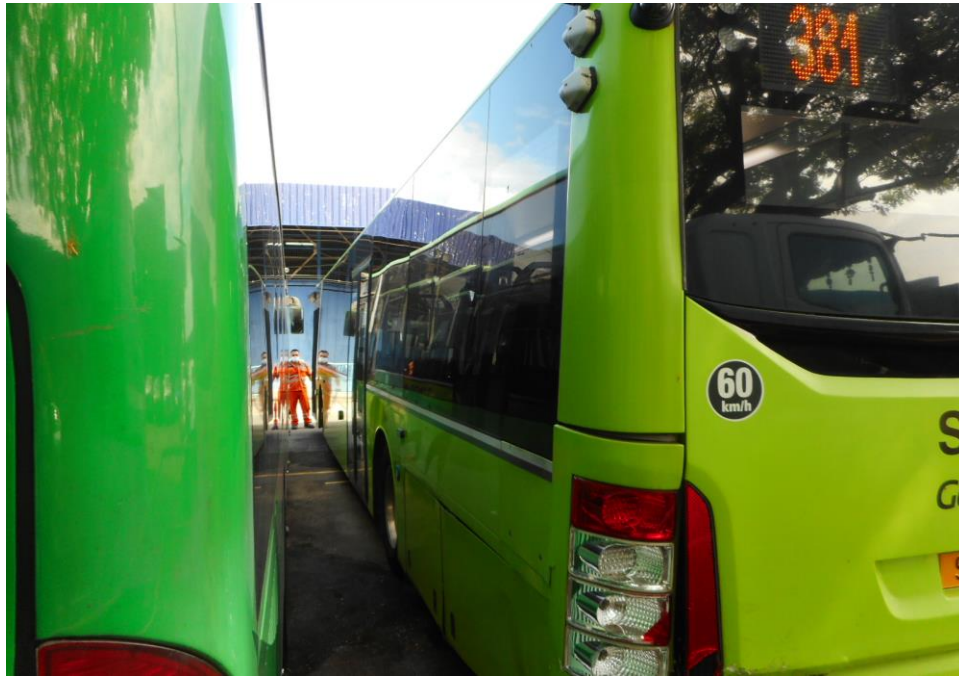
**Photo 6** shows a general view of the left body of the Motor Bus at the time of my inspection. The Motor Bus was observed to be intact and unaffected by the accident.

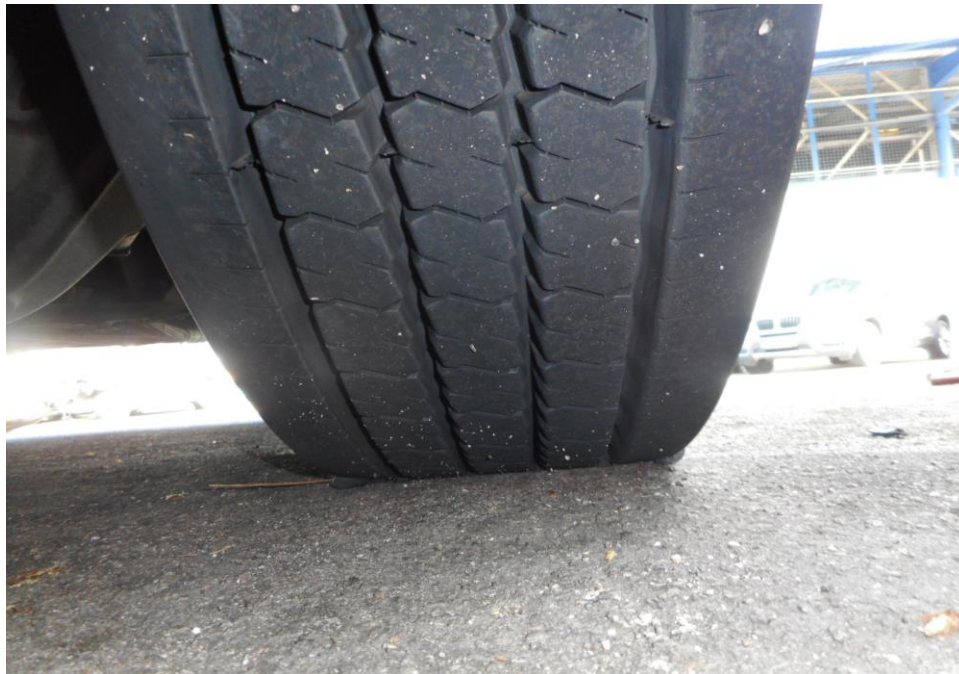
**Photo 7** shows the condition of the front right tyre of the Motor Bus, which was observed to be in serviceable condition with remaining tread depth of approximately 12.2mm. The tyre, which was wrapped around standard steel wheel rim, was also observed to be sufficiently inflated for vehicular operation. There was no tear, cut or burst mark(s) on the outer and the inner sidewalls as well as across the tread of the 6 tyres that were fitted on the Motor Bus.

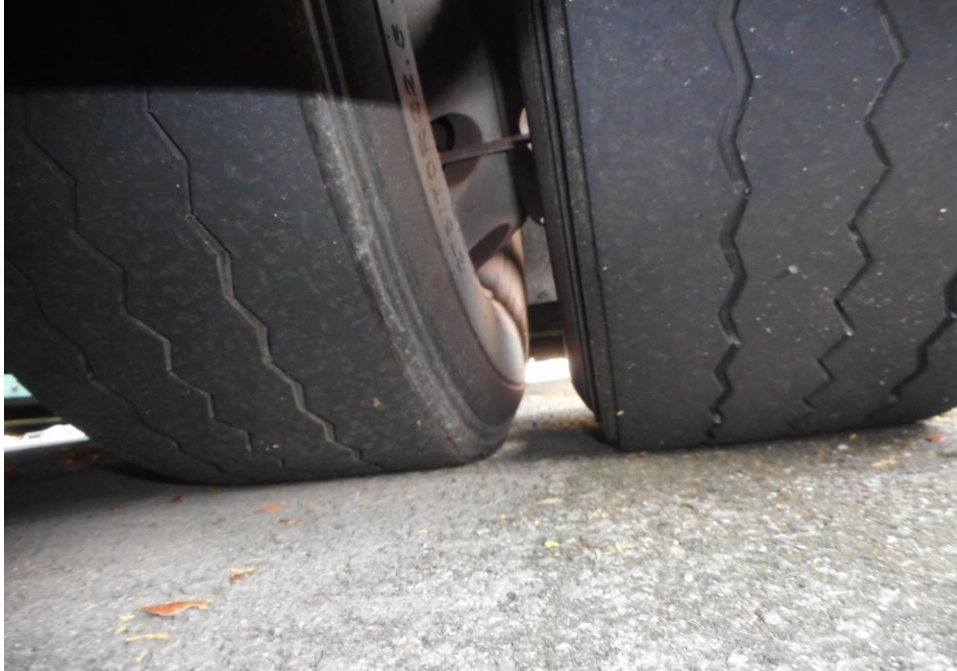
**Photo 8** shows the condition of the rear right tyre of the Motor Bus, which was observed to be in serviceable condition with remaining tread depth of approximately 2.8mm. The tyre, which was wrapped around standard steel wheel rim, was also observed to be sufficiently inflated for vehicular operation.

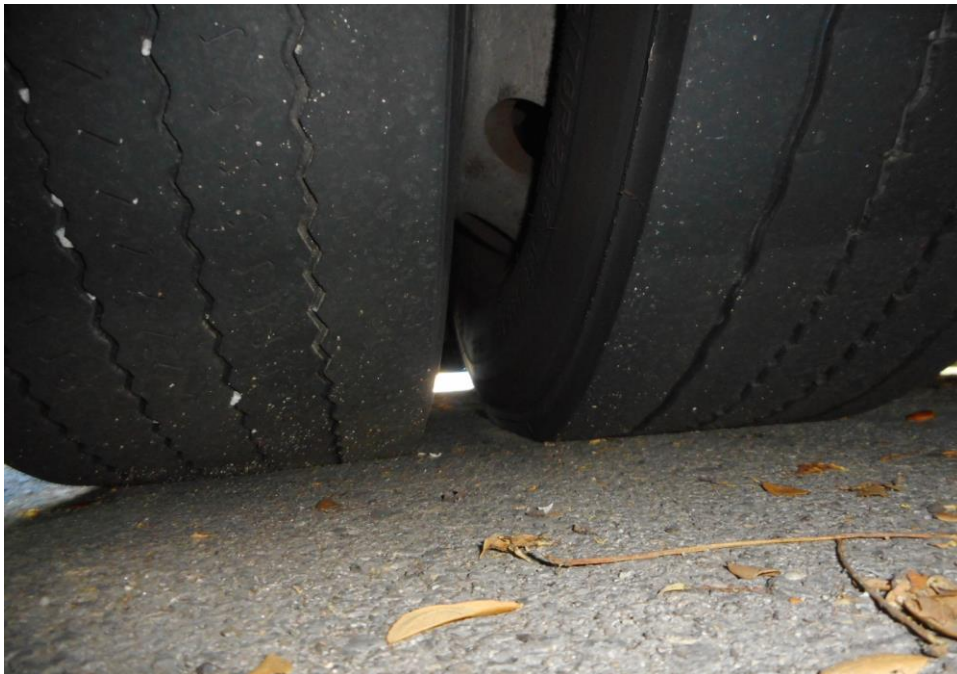
**Photo 9** shows the condition of the rear left tyres of the Motor Bus, which was observed to be in serviceable condition with remaining tread depth of approximately 6.4mm. The tyres, which were wrapped around standard steel wheel rim, were also observed to be sufficiently inflated for vehicular operation. There was also no damage found on all 6 steel wheel rims of the Motor Bus.

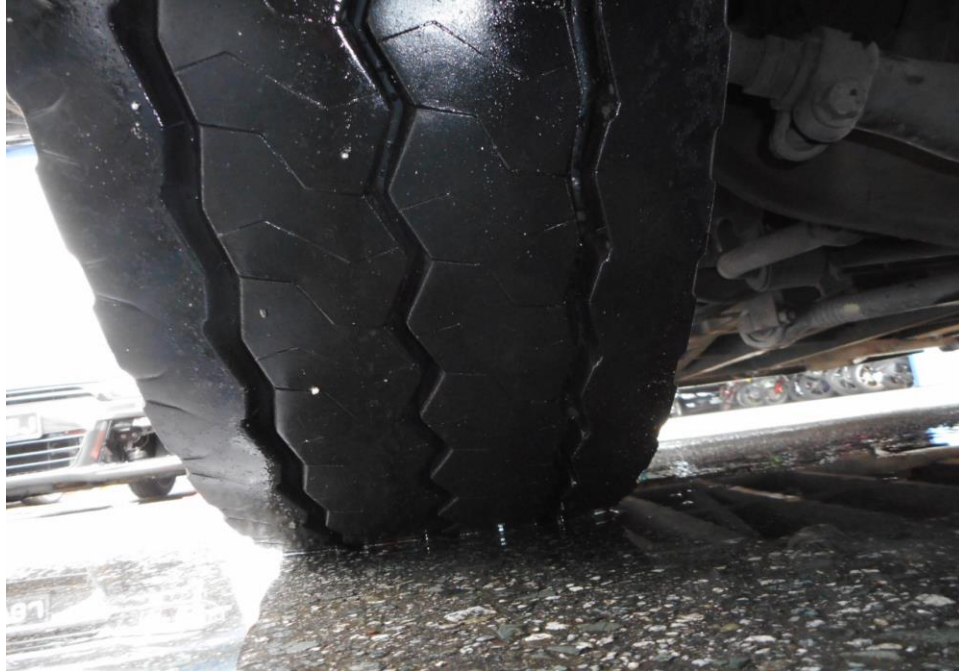
**Photo 10** shows the condition of the front left tyres of the Motor Bus, which were observed to be in serviceable condition with remaining tread depth of approximately 13.8mm. There was also no tear, cut or burst mark(s) on the outer and the inner sidewalls as well as across the tread of the 6 tyres that were fitted on the Motor Bus.

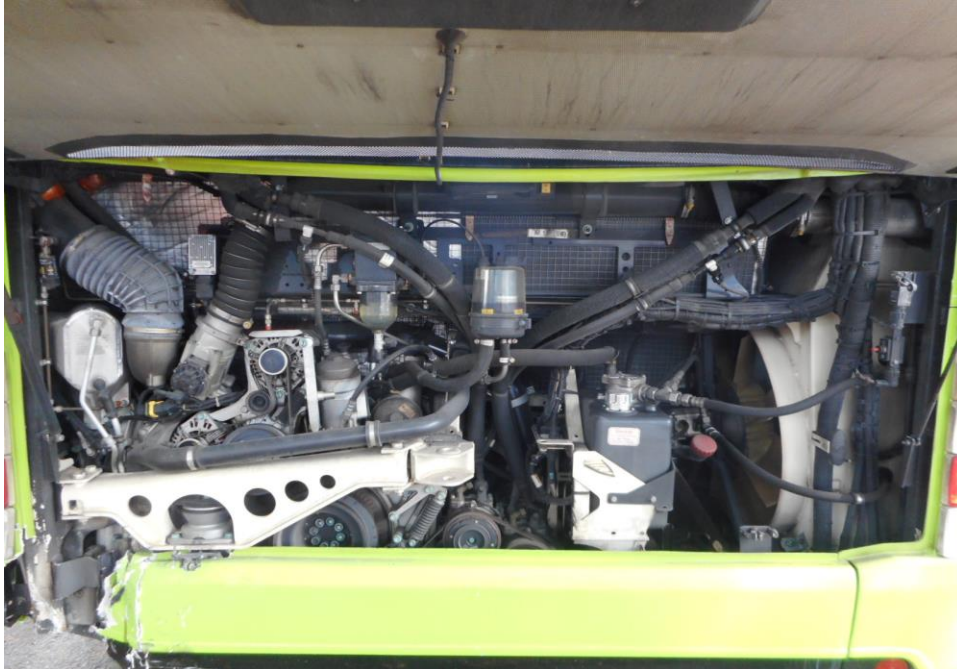
**Photo 11** shows a general view of the Motor Bus's engine compartment, which was accessed by lifting the rear of the Motor Bus. The various parts and components inside the engine compartment were unaffected by the accident. There was also no sign(s) or indication(s) of fresh fluid leakage and/or fluid stain within the engine compartment

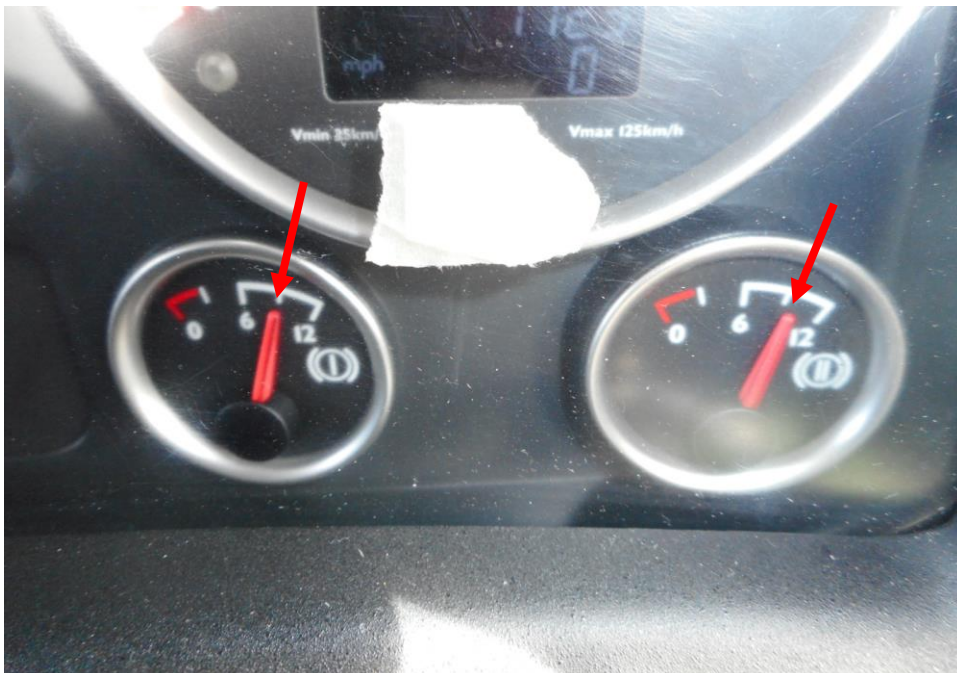
**Photo 12** shows the air in the air brake cylinder of the Motor Bus at the time of my inspection. The air in the cylinder was observed to be of sufficient level & serviceable at the time of the accident.

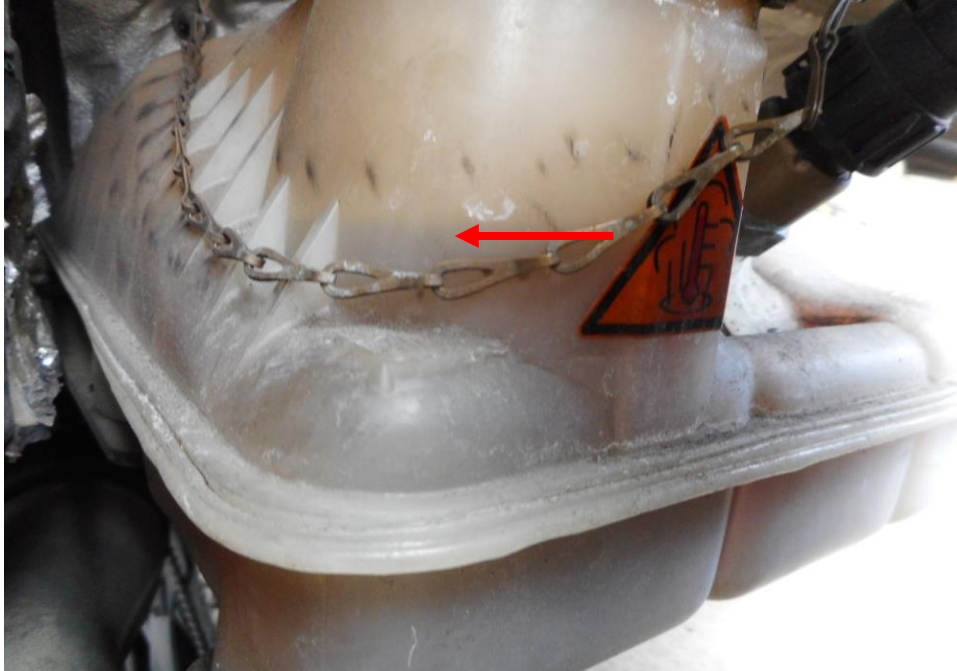
**Photo 13** shows the engine coolant reservoir of the Motor Bus at the time of my inspection. The engine coolant was observed to be of sufficient level (arrowed) and without any visible contamination.

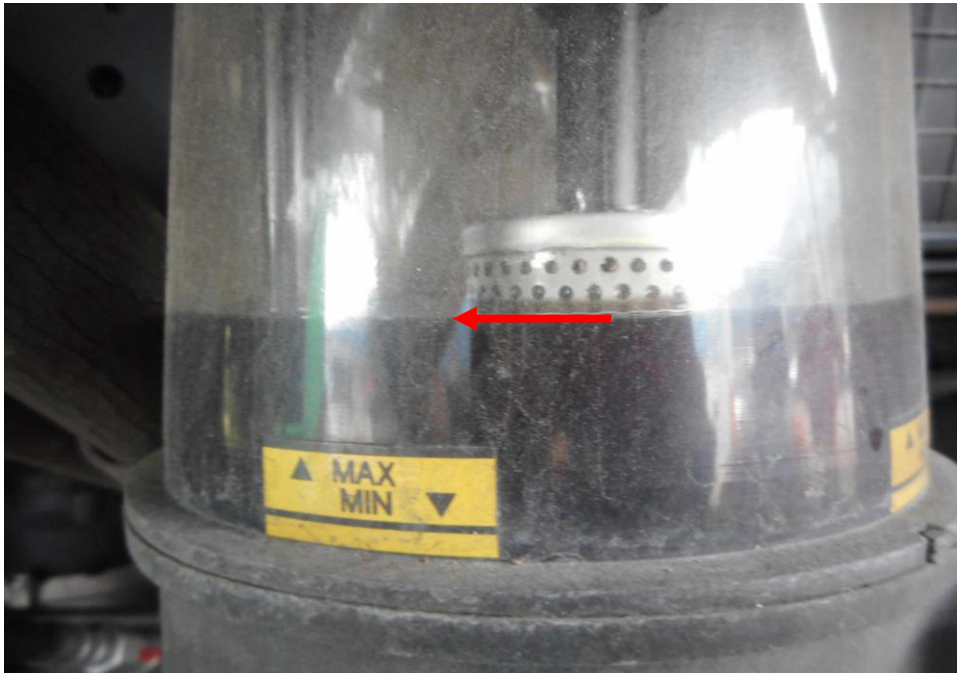
**Photo 14** shows the power steering fluid reservoir of the Motor Bus at the time of my inspection. The power steering fluid was observed to be of sufficient level and without any visible contamination.

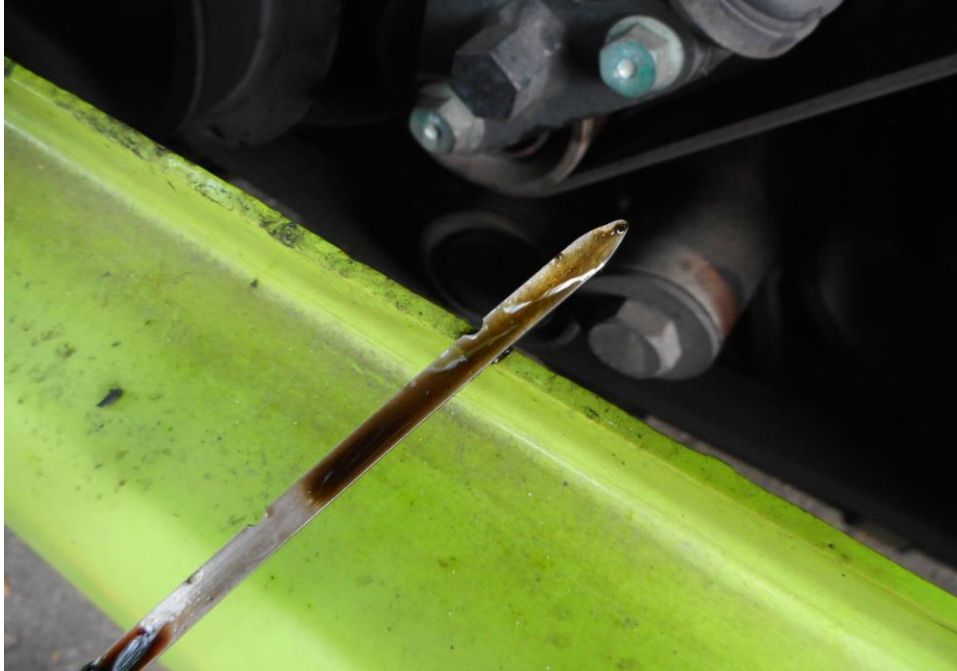
**Photo 15** shows the engine oil dip stick system of the Motor Bus at the time of my inspection. The engine oil was observed to be sufficient for operation and without any visible contamination.

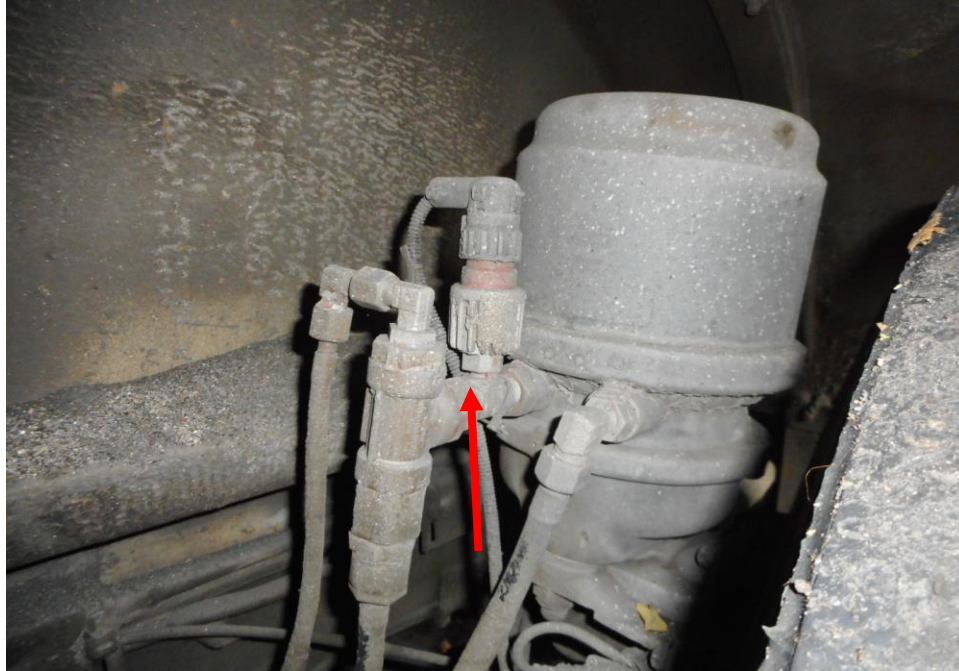
**Photo 16** shows the brake pipe (arrowed) at the rear right wheel of the Motor Bus. I did not observe any leakage of brake fluid at the time of my inspection of the Motor Bus. My static tests of the Motor Bus's braking system, along with my visual examination of the various mechanical components in the braking system, had indicated that there was no internal leakage of pressure/vacuum. Hence the braking system of the Motor Bus was likely to be in serviceable condition at the material time of accident.

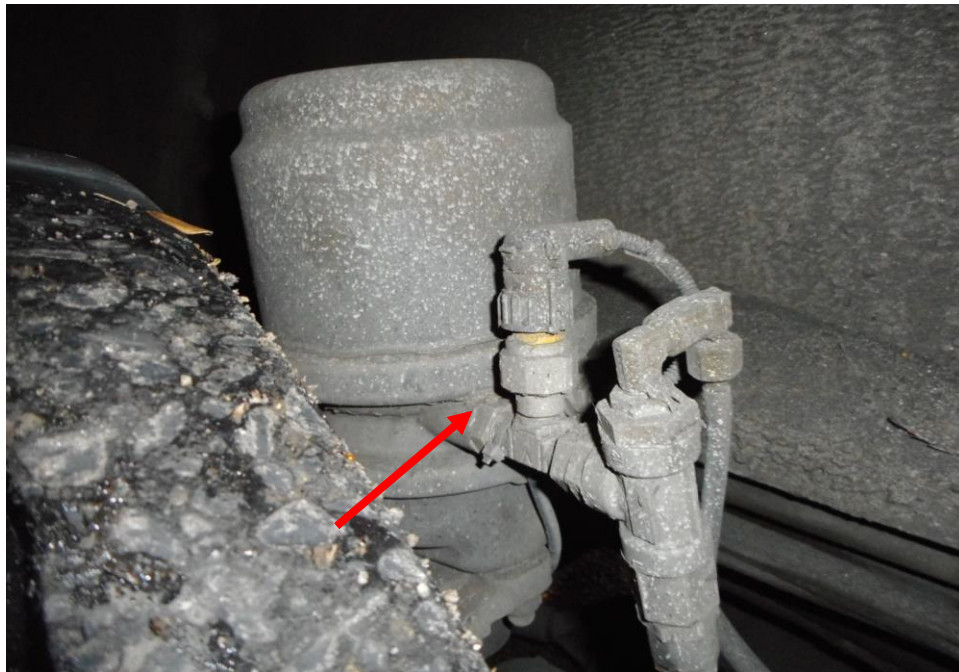
**Photo 17** shows the brake pipe (arrowed) at the rear left wheel of the Motor Bus. I did not observe any leakage of brake fluid at the time of my inspection of the Motor Bus. My static tests of the Motor Bus's braking system, along with my visual examination of the various mechanical components in the braking system, had indicated that there was no internal leakage of pressure/vacuum. Hence the braking system of the Motor Bus was likely to be in serviceable condition at the material time of accident.

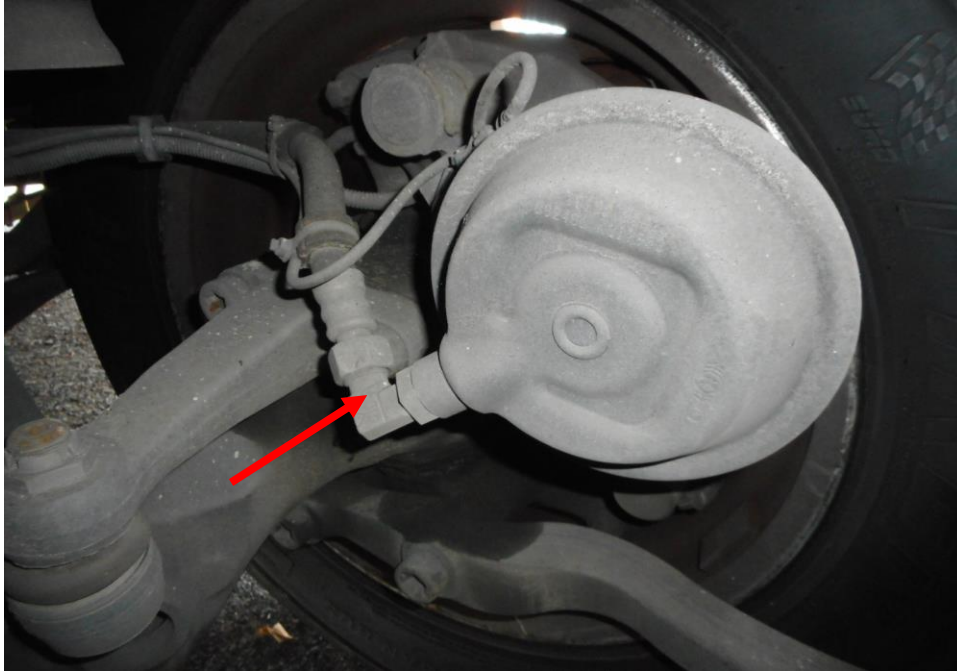
**Photo 18** shows the brake pipe (arrowed) at the front right wheel of the Motor Bus. I did not observe any leakage of brake fluid at the time of my inspection of the Motor Bus. My static tests of the Motor Bus's braking system, along with my visual examination of the various mechanical components in the braking system, had indicated that there was no internal leakage of pressure/vacuum. Hence the braking system of the Motor Bus was likely to be in serviceable condition at the material time of accident.

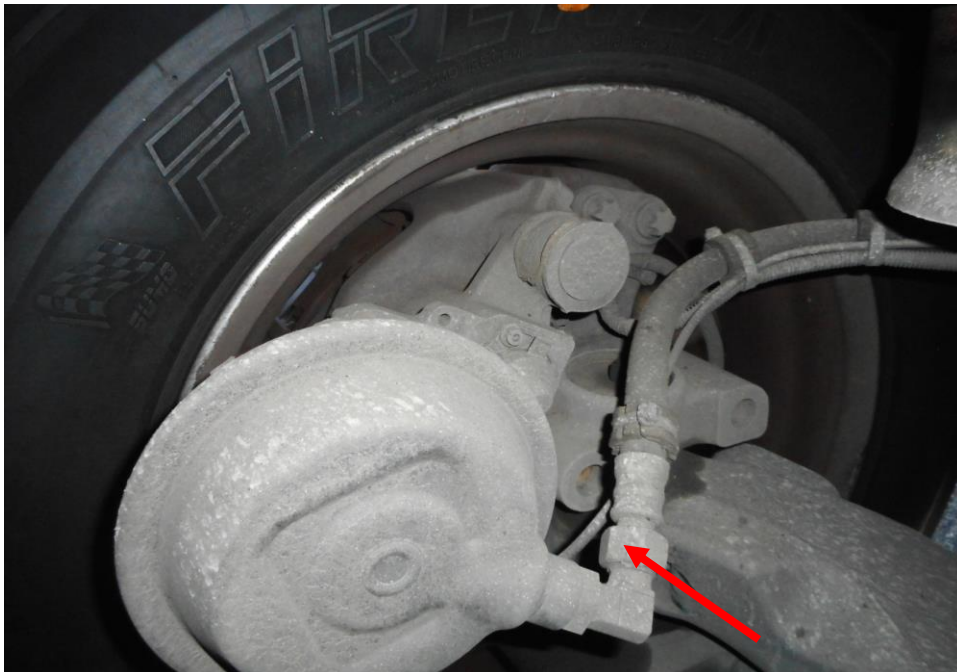
**Photo 19** shows the brake pipe (arrowed) at the front left wheel of the Motor Bus. I did not observe any leakage of brake fluid at the time of my inspection of the Motor Bus. My static tests of the Motor Bus's braking system, along with my visual examination of the various mechanical components in the braking system had indicated that there was no internal leakage of pressure/vacuum. Hence the braking system of the Motor Bus was likely to be in serviceable condition at the material time of accident.

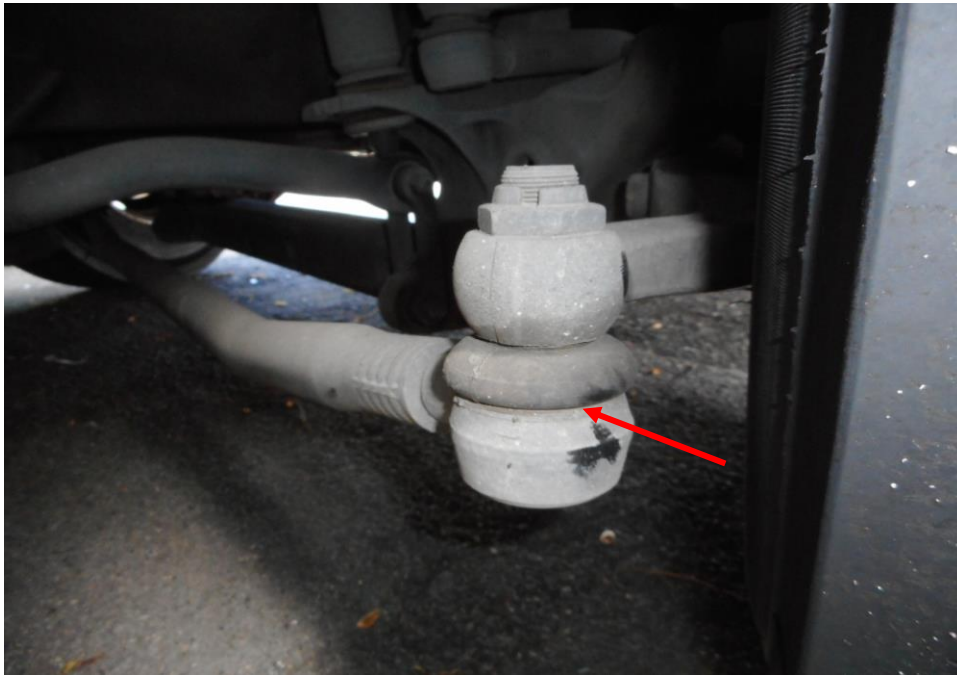
**Photo 20** shows the various undercarriage components at the front right wheel of the Motor Bus, in particular the steering tie rod end (arrowed). The various steering components were all found to be intact, suggesting that the steering system of the Motor Bus was likely to be in serviceable condition at the material time of accident. There was also no sign of fluid stain(s) observed on the various undercarriage components.

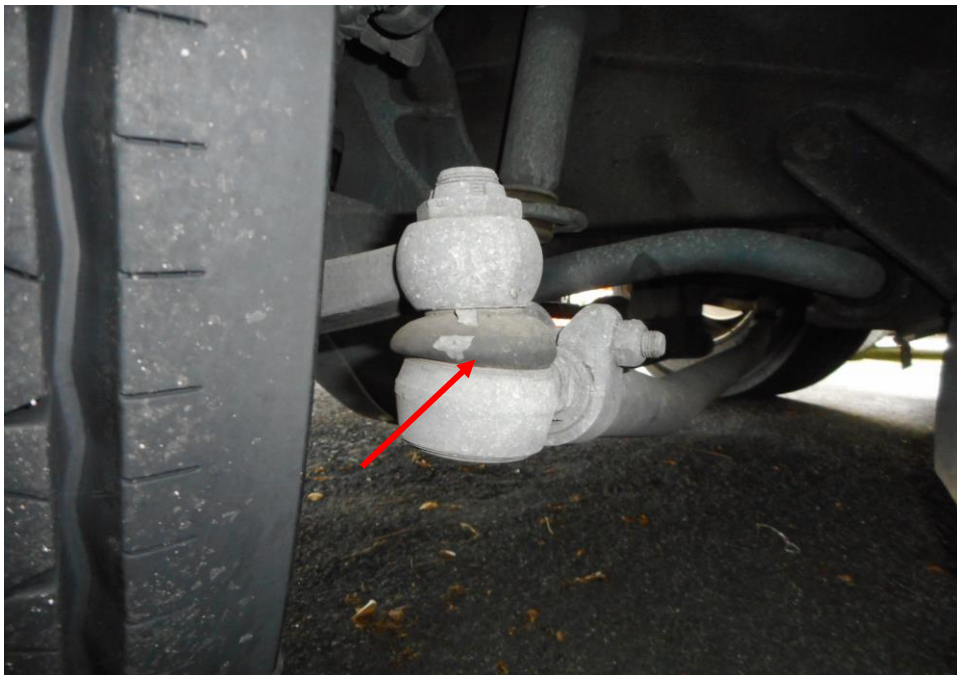
**Photo 21** shows the various undercarriage components at the front left wheel of the Motor Bus, in particular the steering tie rod end (arrowed). The various undercarriage components of the Motor Bus were all found to be intact without any visible damage. There was also no sign of fluid stain(s) observed on the various undercarriage components.

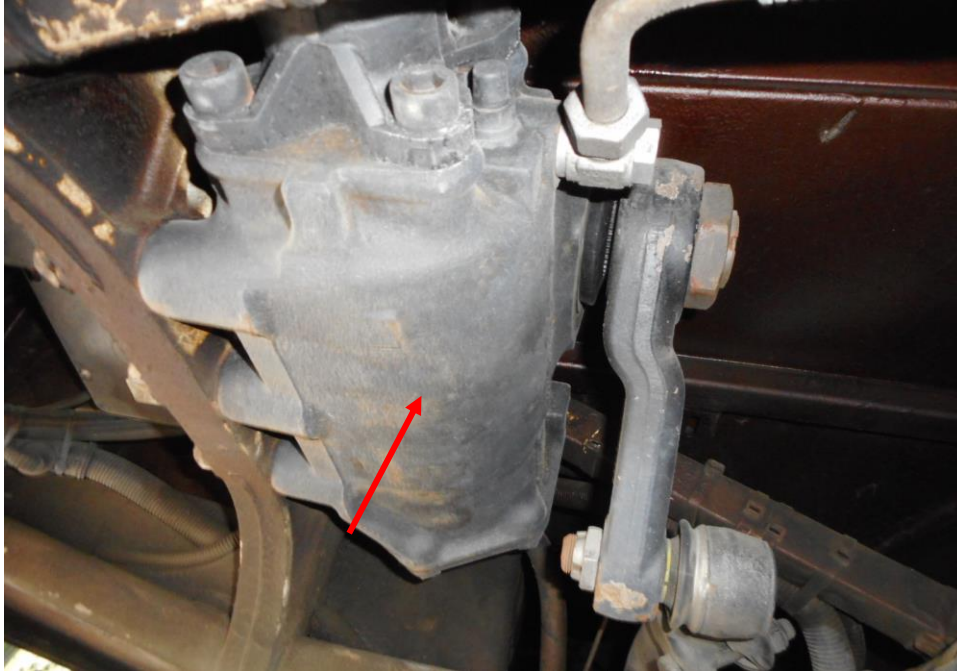
**Photo 22** shows the steering box component (arrowed) at the undercarriage of the Motor Bus was found to be intact without any visible damage. There was also no sign of fluid stain(s) observed on the various undercarriage components.

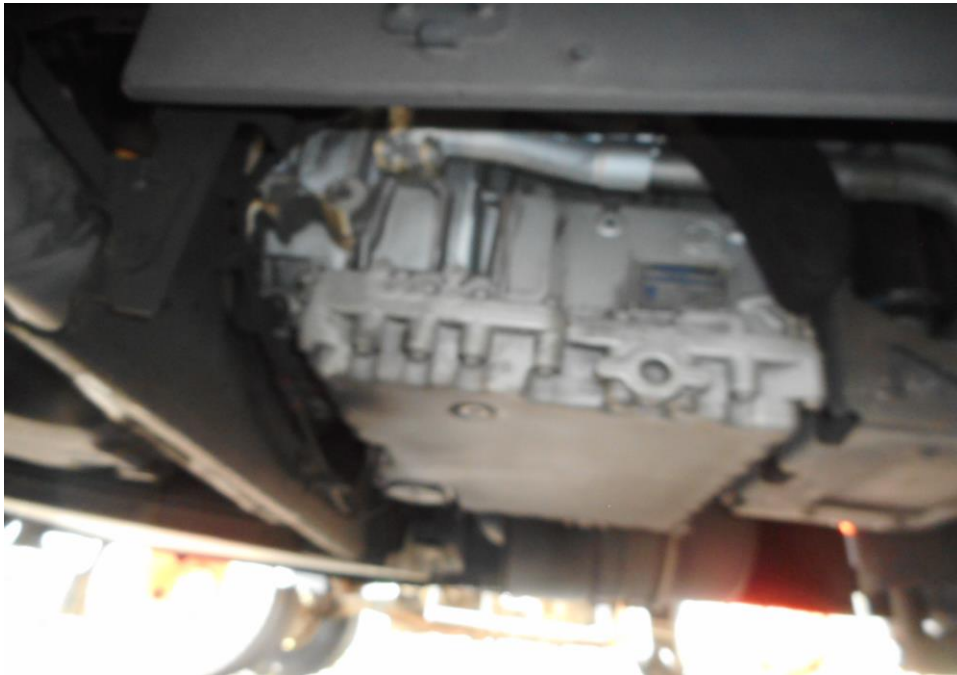
**Photo 23** shows the undercarriage of the Motor Bus, at the area where the engine housing and transmission housing are located. I did not find any sign(s) or indication(s) of fluid leak and/or fluid stain(s) on the underside of the Motor Bus.

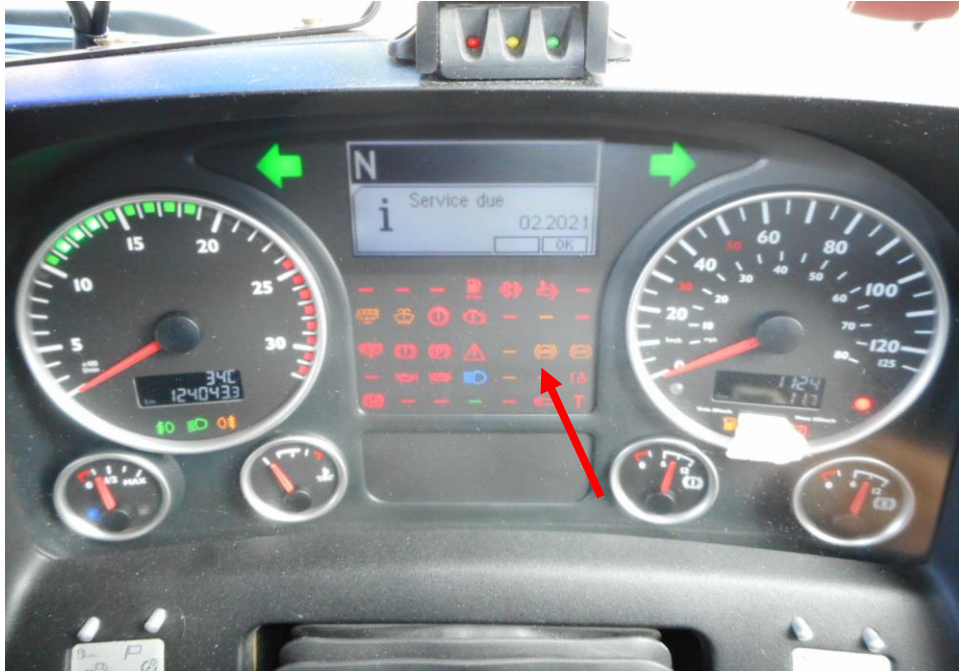
**Photo 25** shows the warning light for Anti-Lock Brake System (ABS) appearing on the instrument panel of the Motor Bus during the self-test of its various electronic operating systems when its engine was cranked.

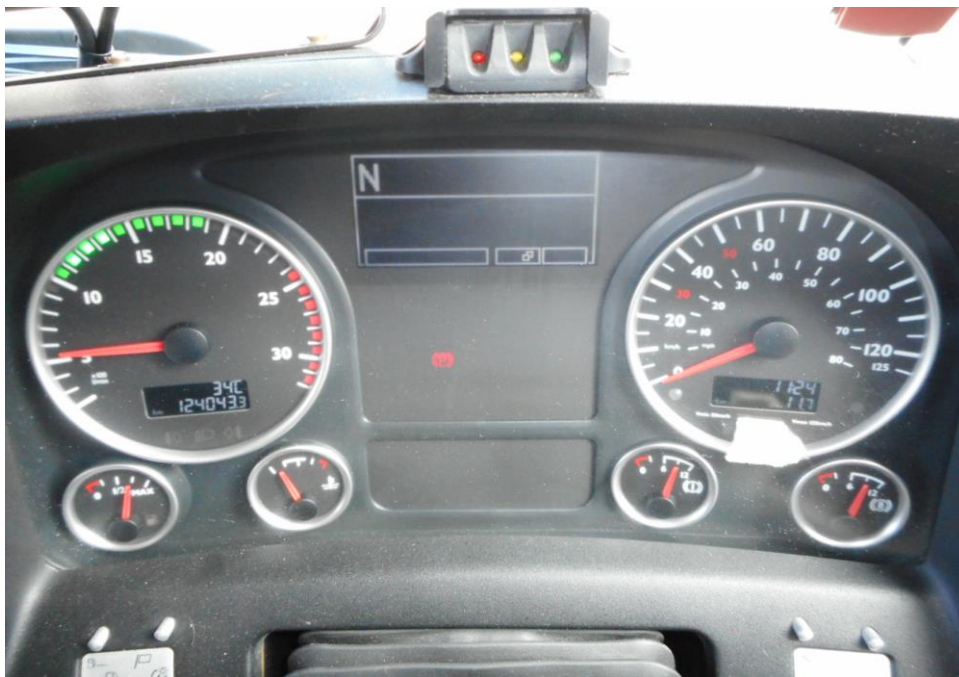
**Photo 26** shows no warning lights illuminated on the instrument panel of the Motor Bus after the engine was cranked. This would suggest that there was no abnormality to the various electronic operating systems of the Motor Bus, like the ABS
