Your Ref: TP/IP/10833/2021
Our Ref: CI/TPD21003855/P

Fatal Accident Investigation Team

MECHANICAL INSPECTION REPORT OF MOTOR LORRY GV 8094C

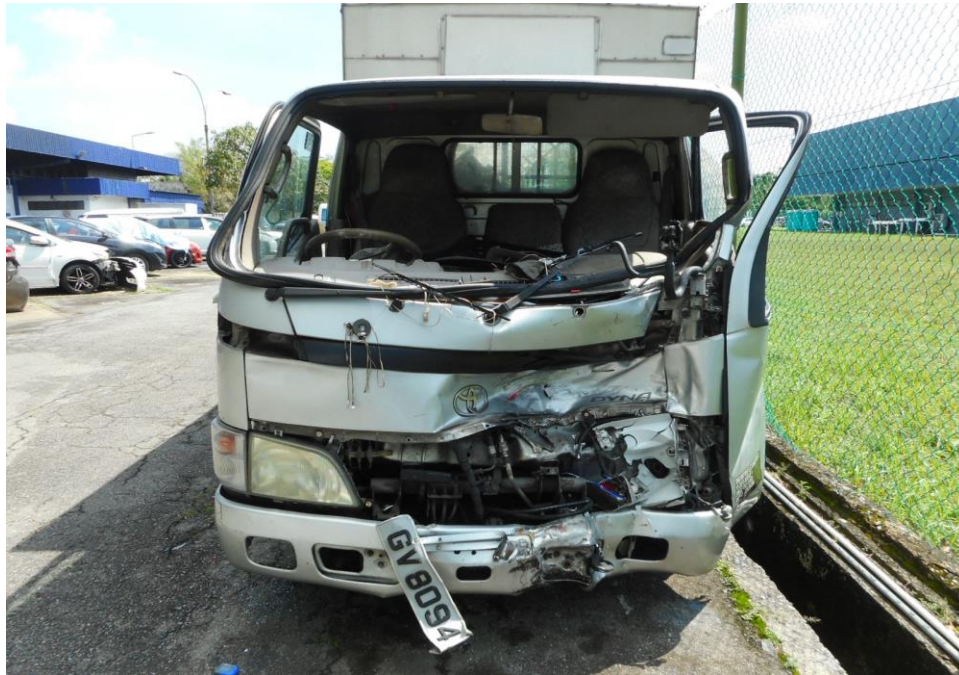
Photo 1 shows a general view of the front windscreen and body panel of the Motor Lorry at the time of our inspection. The Motor Lorry was observed sustained major damages to its frontal due to the accident.

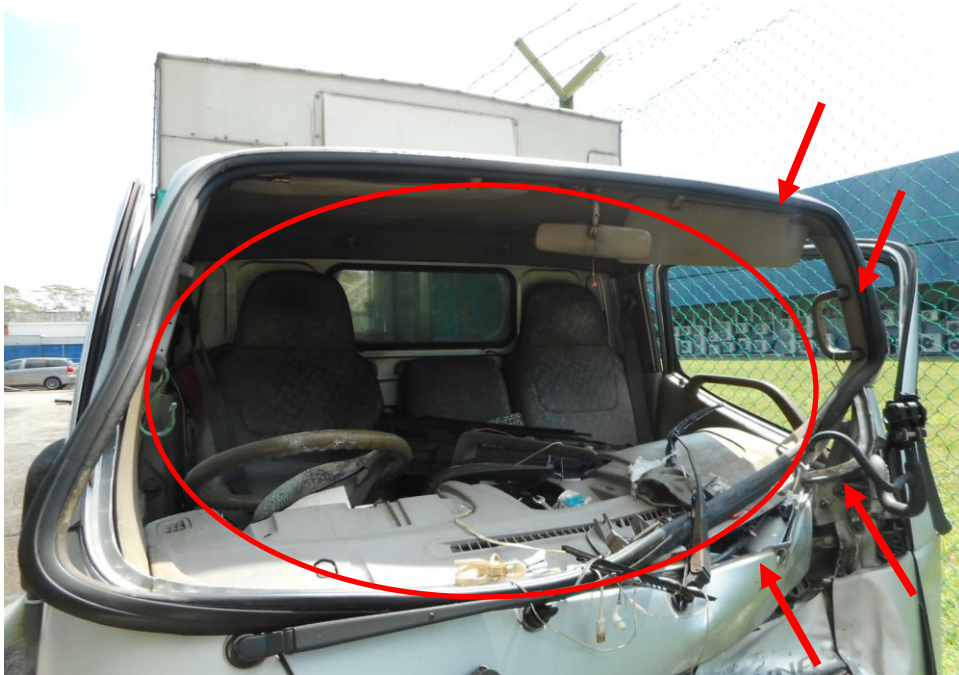
Photo 2 shows the close up view of the front portion of the Motor Lorry at the time of our inspection. The Motor Lorry was observed to have sustained major damages to its front windscreen (circled) and its front cabin (arrowed) that was crushed due to the accident's impact.

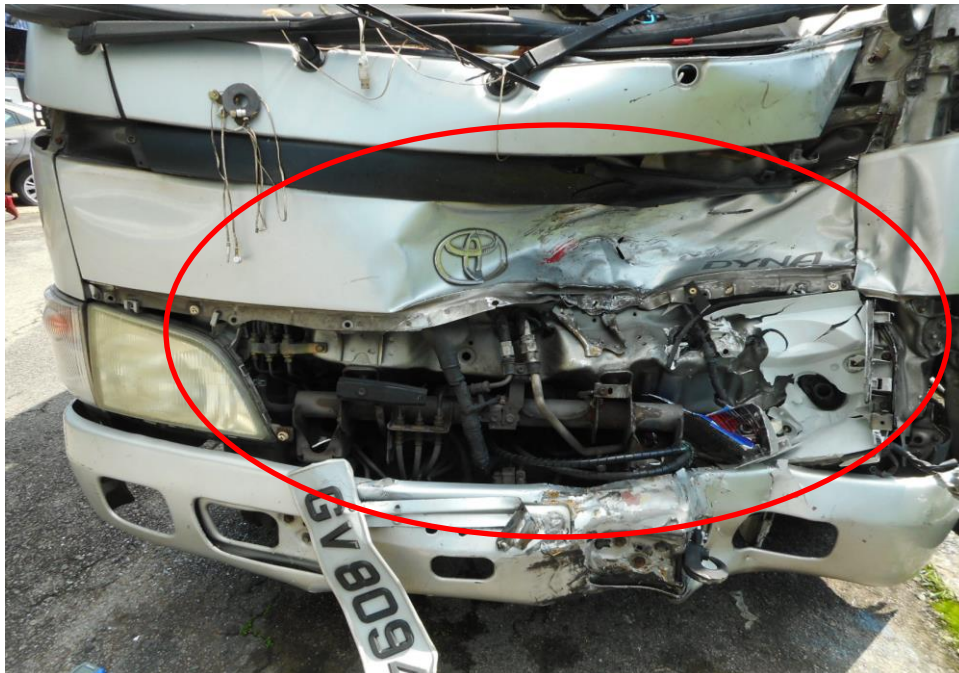
Photo 3 shows the close up view of the front portion of the Motor Lorry at the time of our inspection. The Motor Lorry was observed to have sustained major damages to its front body panel (circled) that was damaged as a result of the accident's impact.

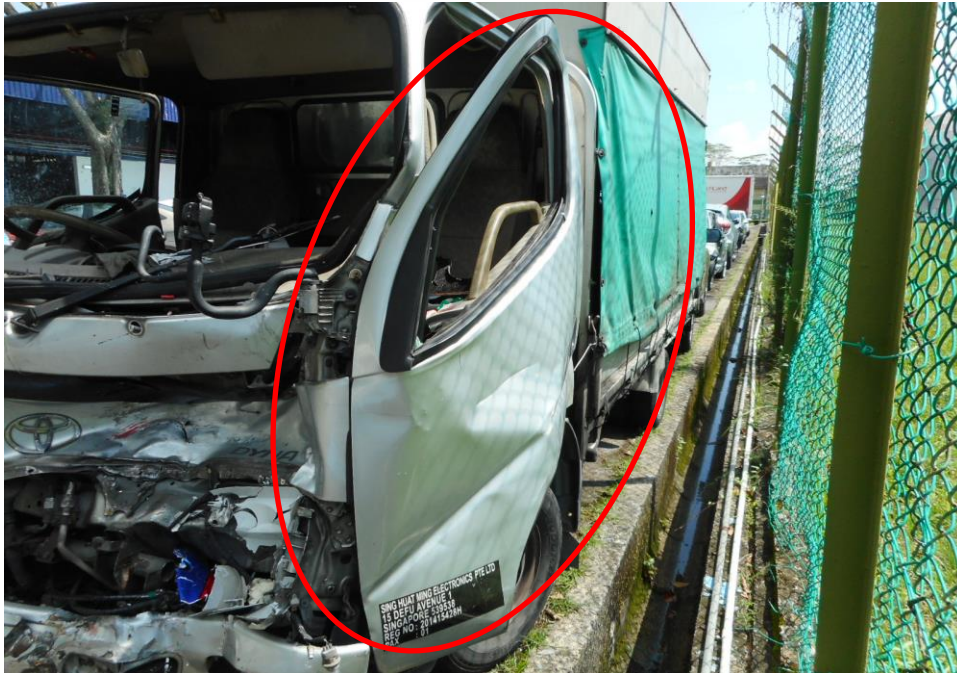
Photo 4 shows the close up view of the left door of the Motor Lorry at the time of our inspection. The Motor Lorry was observed to have sustained damages to its left door (circled) as a result of the accident.

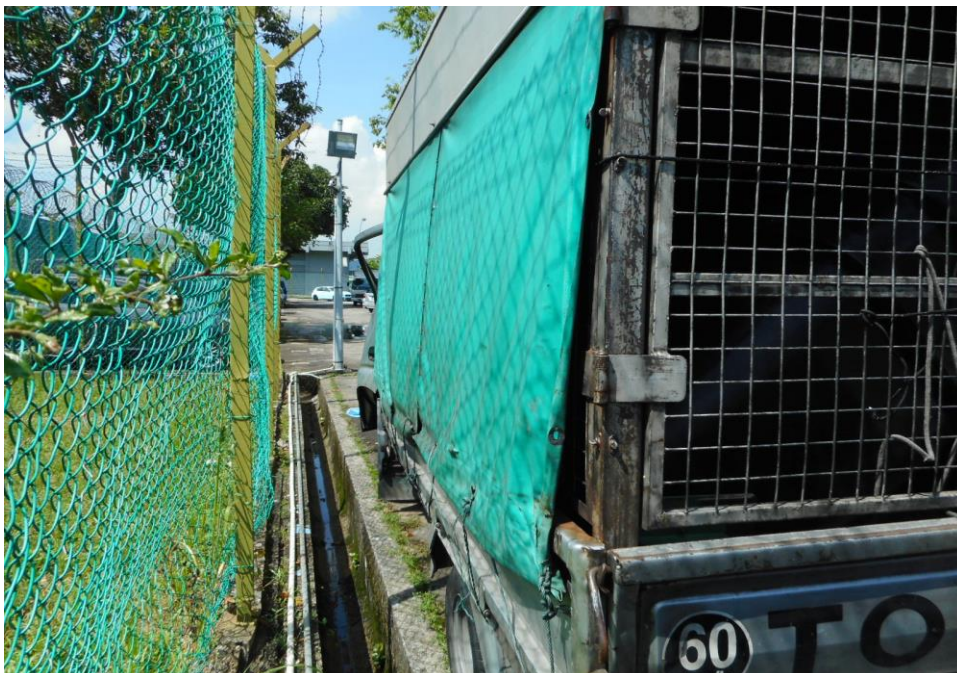
Photo 5 shows a general view of the Motor Lorry's left body at the time of my inspection. The left portion of the Motor Lorry was observed to have been unaffected by the accident.

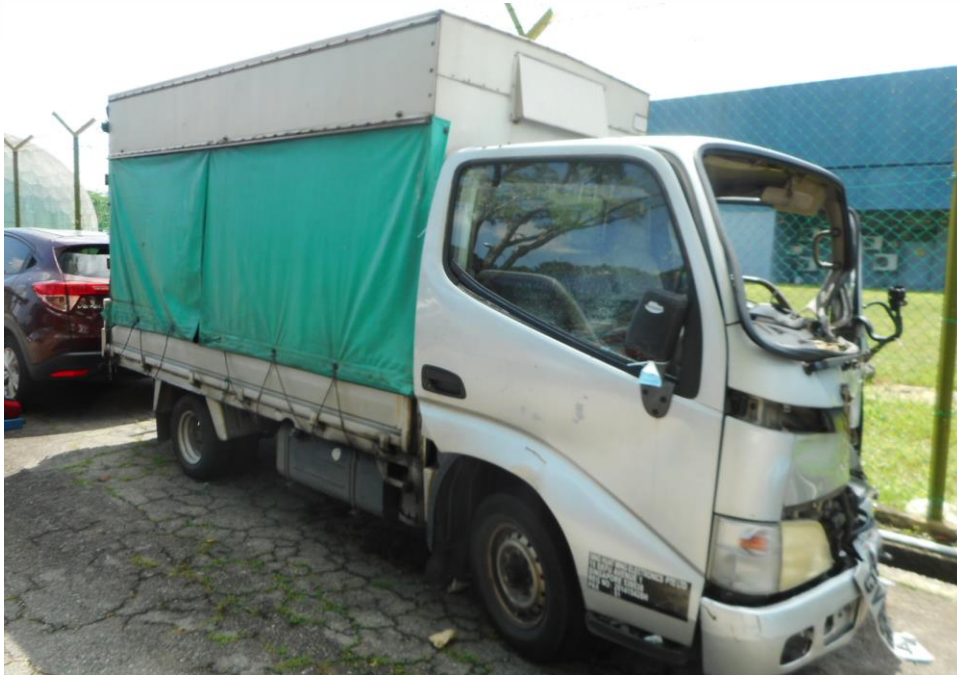
Photo 6 shows a general view of the Motor Lorry's right body at the time of my inspection. The right portion of the Motor Lorry was observed to have been unaffected by the accident.

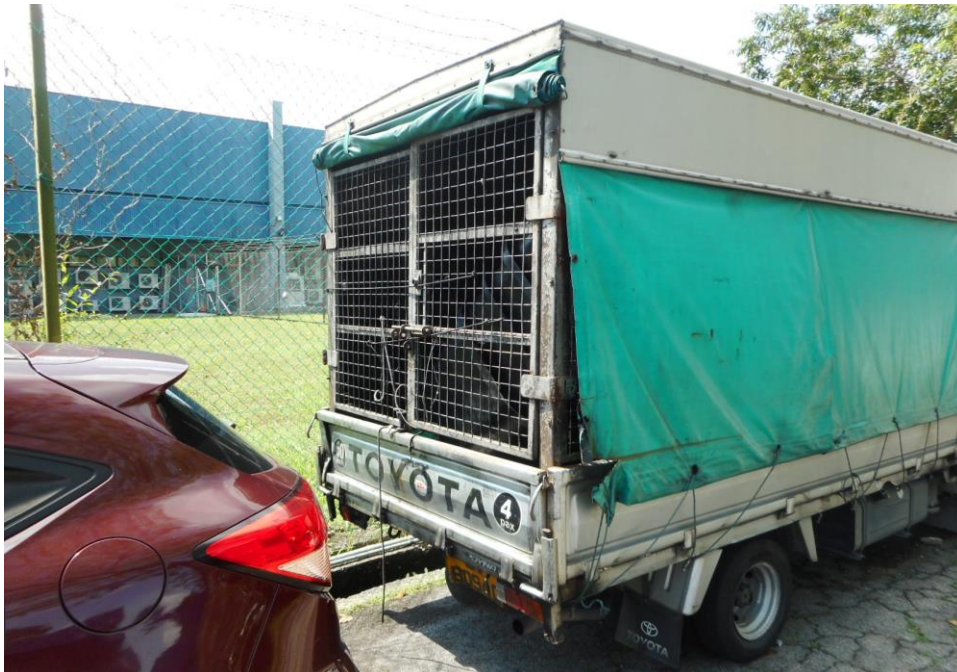
Photo 7 shows the general view of the Motor Lorry's rear body at the time of my inspection. The Motor Lorry rear was observed to be unaffected by the accident.

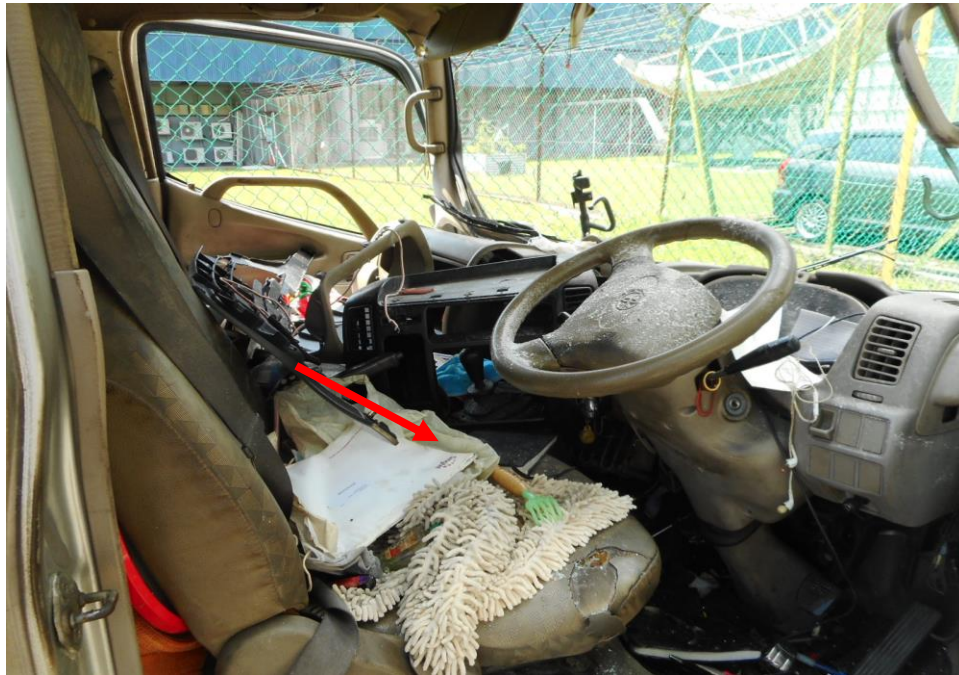
Photo 8 shows the close up view of the interior cabin of the Motor Lorry. It was observed to have sustained extensive induced damages to the dashboard as a result of the accident.

12. The static test of the Motor Lorry electronic safety system could not be inspected as the instrument cluster was damaged due to the induce impact from the accident.

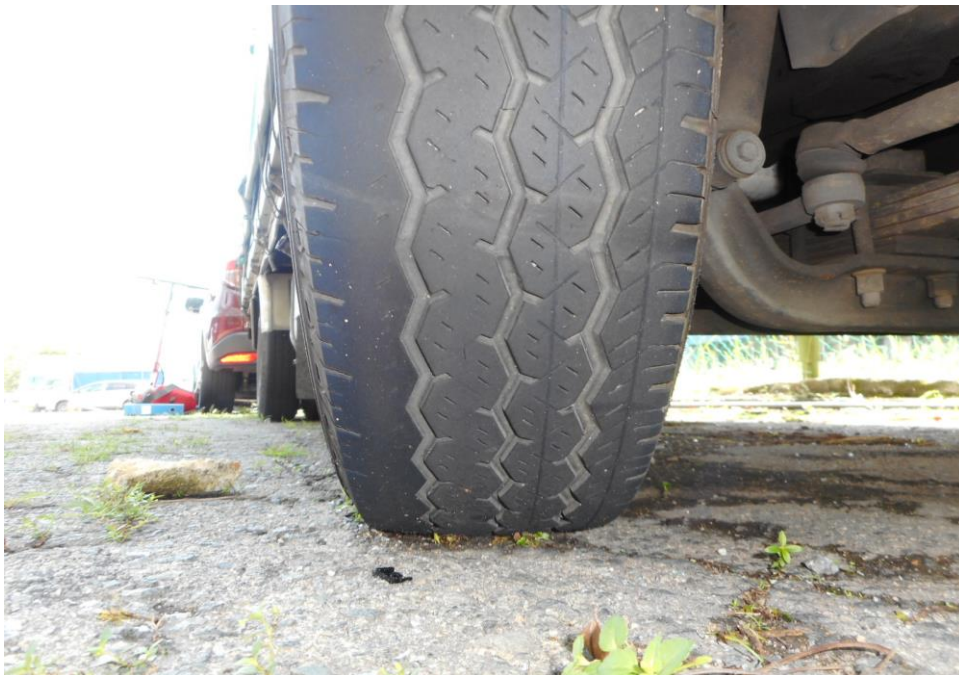
Westlake 185/ R15 (3mm)

Photo 9 shows the condition of the front right tyre of the Motor Lorry, which was observed to be in serviceable condition with remaining tread depth of approximately 3mm. The tyre, which was wrapped around standard steel wheel rim, was also observed to be sufficiently inflated for vehicular operation.

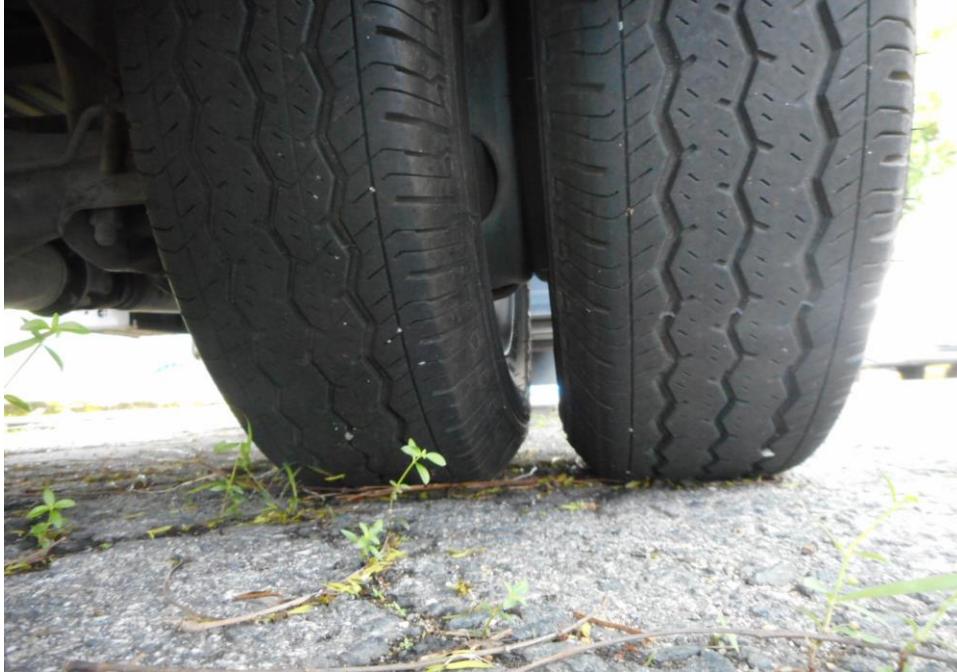
Westlake 155/ R12 (4.1mm)

Photo 10 shows the condition of the rear right tyres of the Motor Lorry, which observed to be in serviceable condition with remaining tread depth of approximately 4.1mm. The tyres, which were wrapped around standard steel wheel rim, were also observed to be sufficiently inflated for vehicular operation.

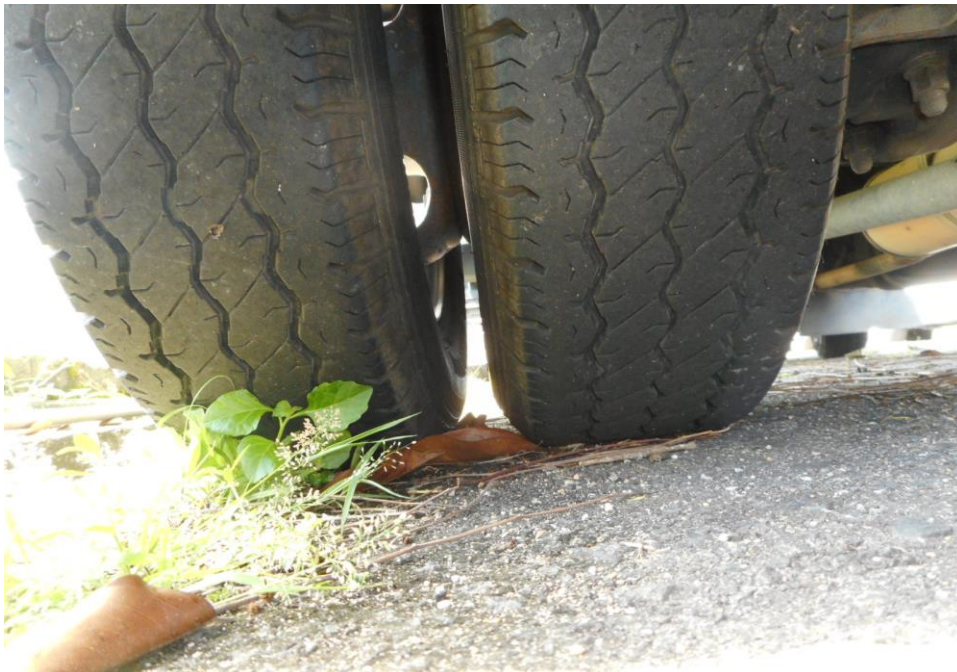
Westlake 155/ R12 (3.8mm)

Photo 11 shows the condition of the rear left tyres of the Motor Lorry, which were observed to be in serviceable condition with remaining, tread depth of approximately 3.8mm. See above.

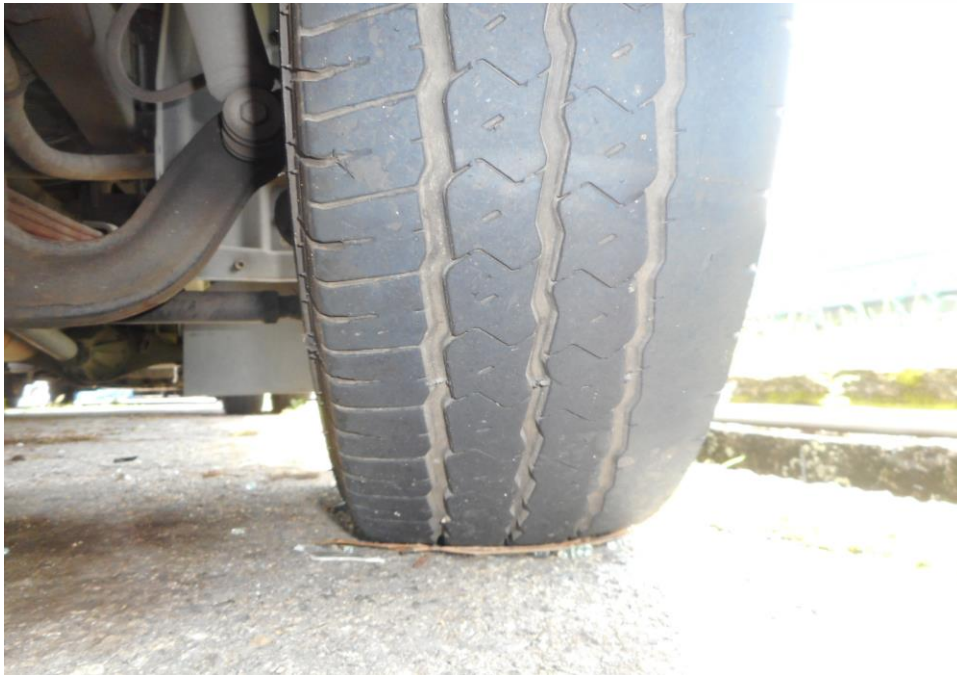
Good ride 185/ R15 (5.5mm)

Photo 12 shows the condition of the front right tyre of the Motor Lorry, which was observed to be in serviceable condition with remaining tread depth of approximately 5.5mm. The tyre, which was wrapped around standard steel wheel rim, was also observed to be sufficiently inflated for vehicular operation.

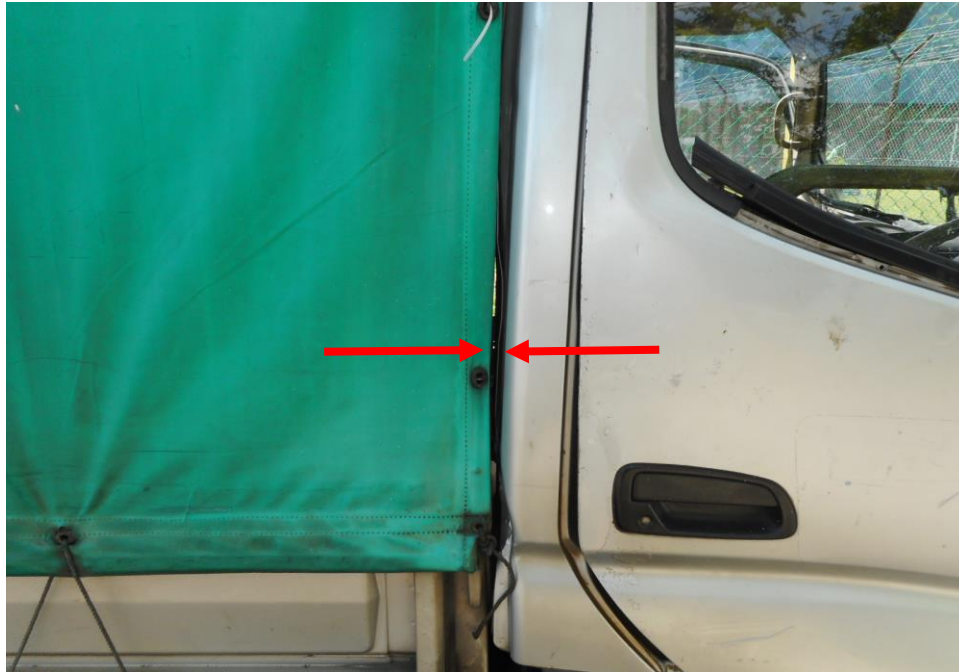
8. Upon examination of the Motor Lorry's engine compartment, we had observed that all the parts, components and fluids could not be inspected as due to the damage induced has crushed and deformed the cabin of the Motor Lorry which immobilized its opening and viewing, however we are able to observe the brake fluid of the Motor Lorry and was observed to be sufficient level without any visible contamination.
9. Our subsequent checks on the underside of the Motor Lorry also revealed no fluid stain. Visually, the various undercarriage components of the Motor Lorry were all observed to be intact and without any visible damage. See photo 13 – 15 below.

Photo 13 shows the induced damage to the cabin (arrowed) of the Motor Lorry's which immobilised the opening and viewing of the various parts and components inside the engine compartment, a result of the accident.

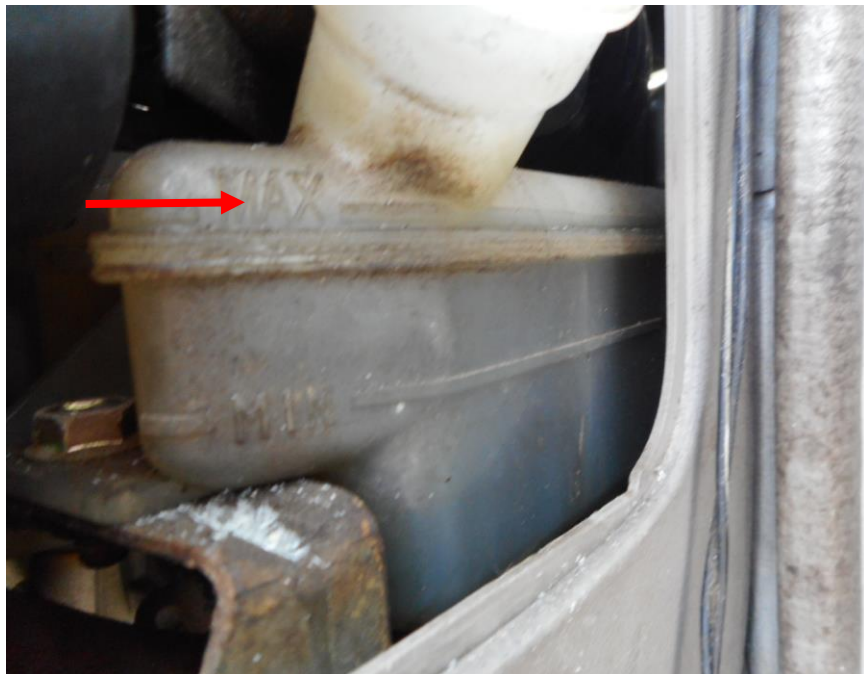
Photo 14 shows the brake fluid reservoir of the Motor Lorry at the time of our inspection. The brake fluid was observed to be of sufficient level and without any visible contamination (arrowed).

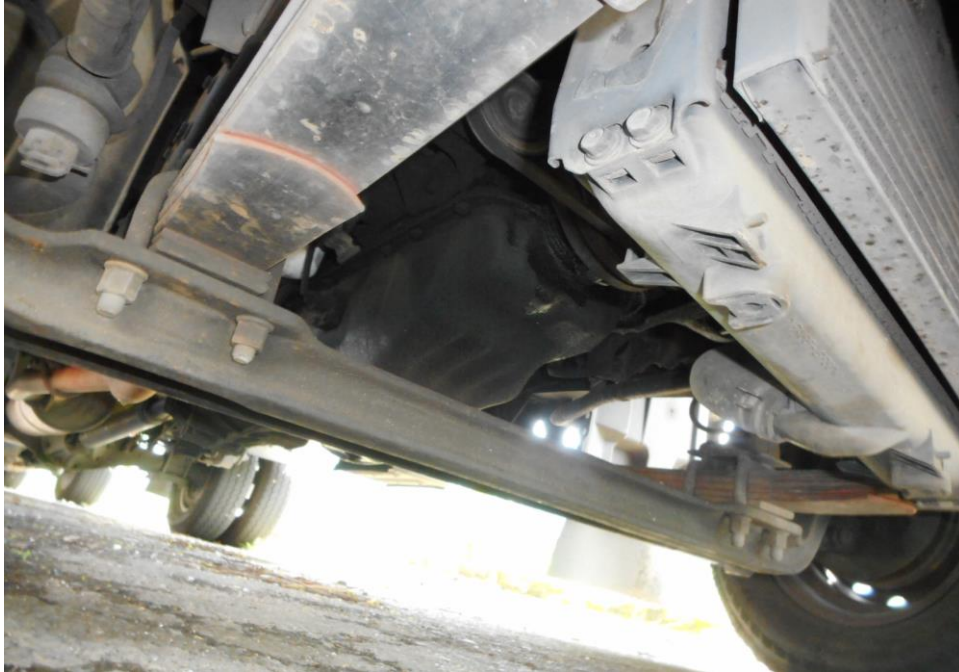
Photo 15 shows the undercarriage of the engine of the Motor Lorry at the time of our inspection. There was also sign(s) and indication(s) of old fluid stain within the engine undercarriage area.

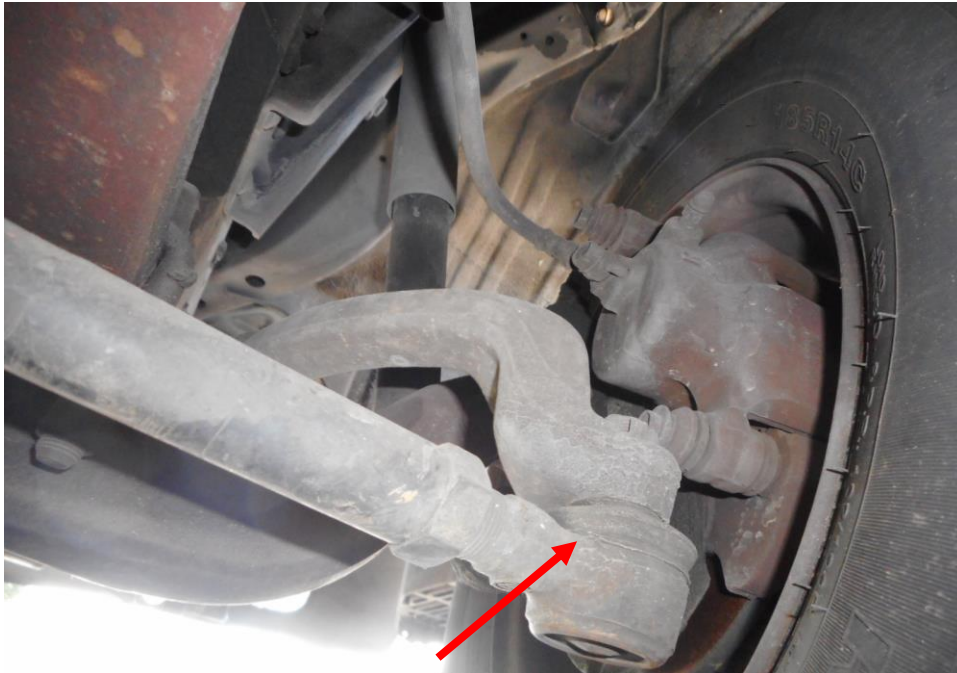
Photo 16 shows the various undercarriage components at the front right wheel of the Motor Lorry, in particular the steering tie rod end and ball joints (arrowed). The various undercarriage components of the Motor Lorry were all found to be intact without any visible damage. There was also no sign of fluid stain(s) observed on the various undercarriage components.

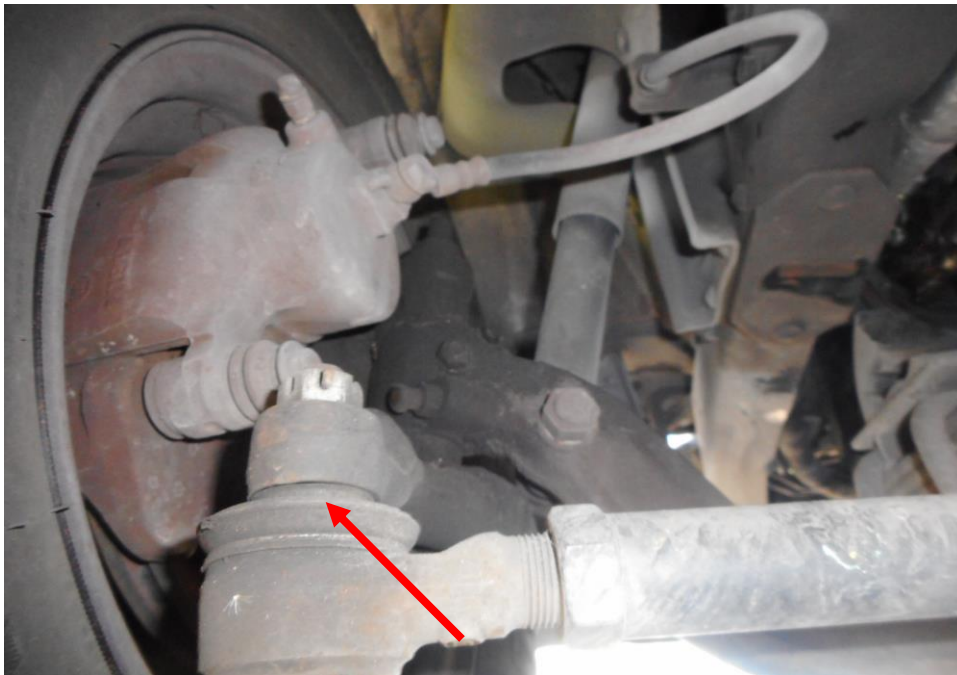
Photo 17 shows the various undercarriage components at the front left wheel of the Motor Lorry, in particular the steering tie rod end and ball joints (arrowed) were observed to be damaged.

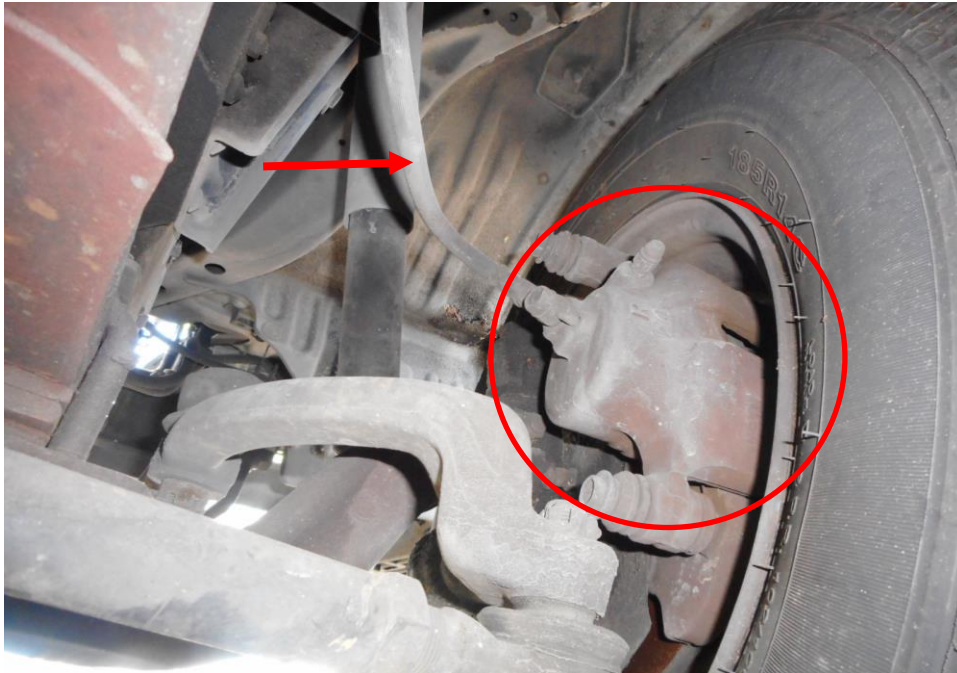
Photo 18 shows the various undercarriage components at the front right wheel of the Motor Lorry, in particular the brake hose (arrowed) and callipers (circled). The various undercarriage components of the Motor Lorry were all found to be intact without any visible damage. There was also no sign of fluid stain(s) observed on the various undercarriage components.

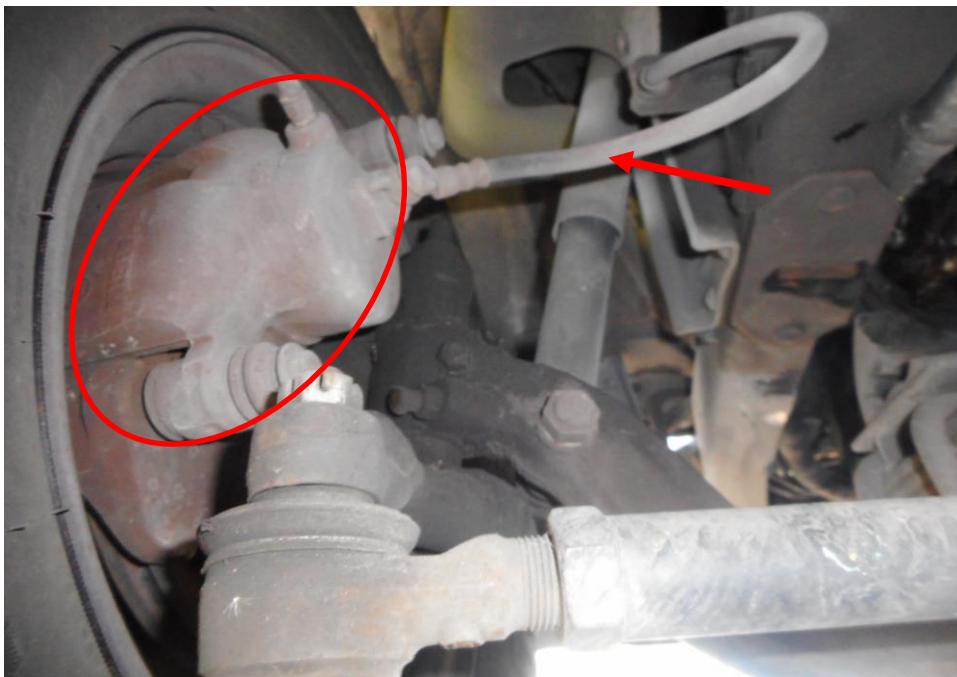
Photo 19 shows the various undercarriage components at the front left wheel of the Motor Lorry, in particular the brake hose (arrowed) and callipers (circled). The various undercarriage components of the Motor Lorry were all found to be intact without any visible damage. There was also no sign of fluid stain(s) observed on the various undercarriage components.

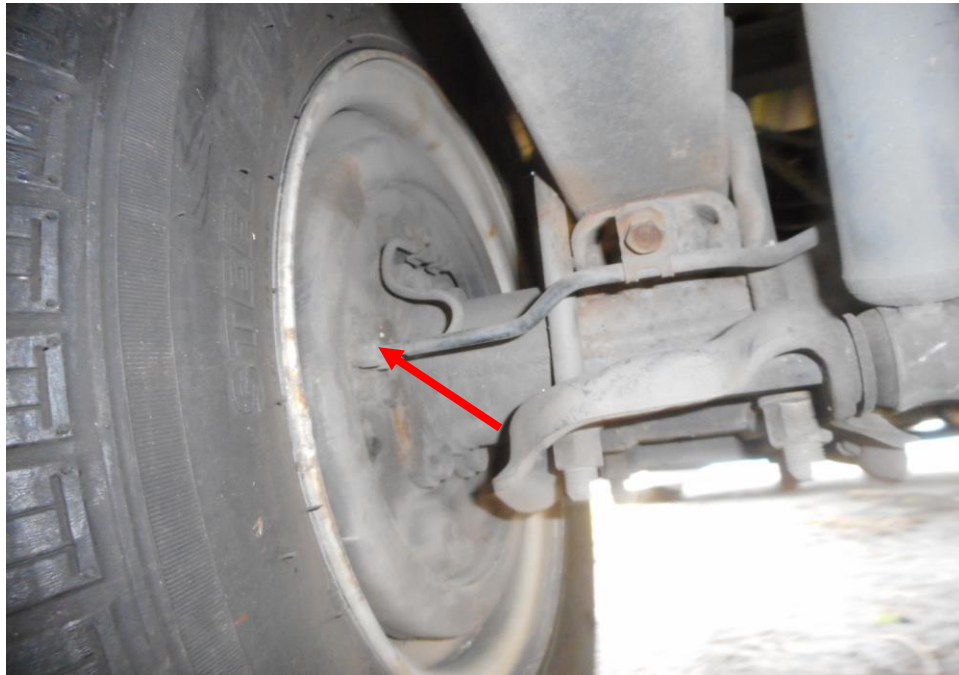
Photo 20 shows the various undercarriage components at the rear left wheel of the Motor Lorry, in particular the brake hose and drum brake (arrowed). The various undercarriage components of the Motor Lorry were all found to be intact without any visible damage. There was also no sign of fluid stain(s) observed on the various undercarriage components.

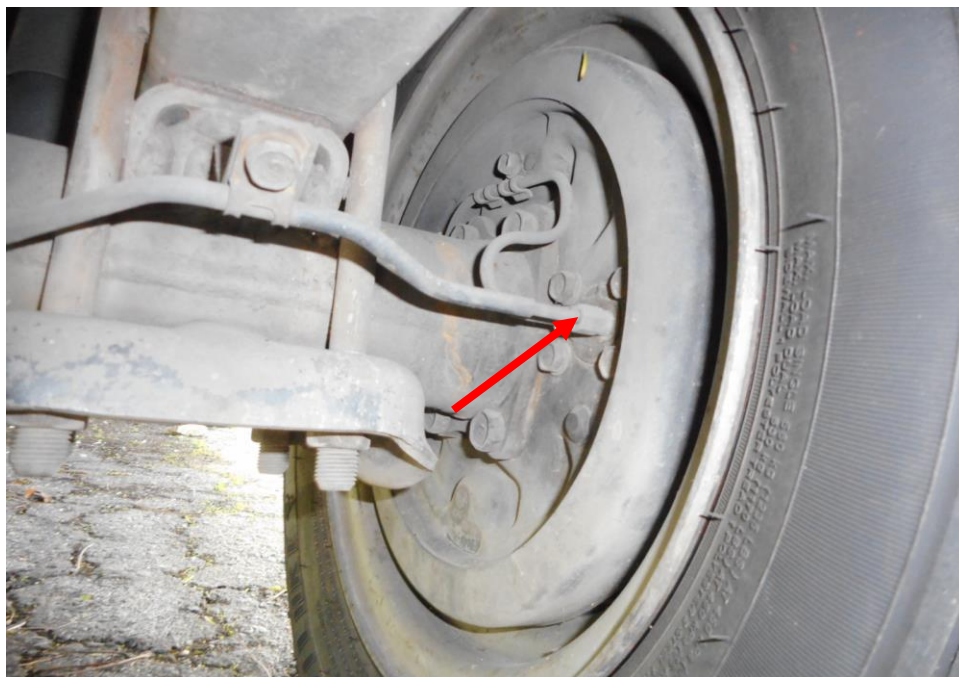
Photo 21 shows the various undercarriage components at the rear right wheel of the Motor Lorry, in particular the brake hose and drum brake (arrowed). The various undercarriage components of the Motor Lorry were all found to be intact without any visible damage. There was also no sign of fluid stain(s) observed on the various undercarriage components.
