Your Ref: Mercedes Benz GLE 43  
(chassis number WDC2923642A149013)  
Our Ref : CI/TP21003933/D

**INSPECTION REPORT OF AN UNREGISTERD MERCEDES BENZ GLE 43  
MOTOR CAR WITH CHASSIS NUMBER WDC2923642A149013**

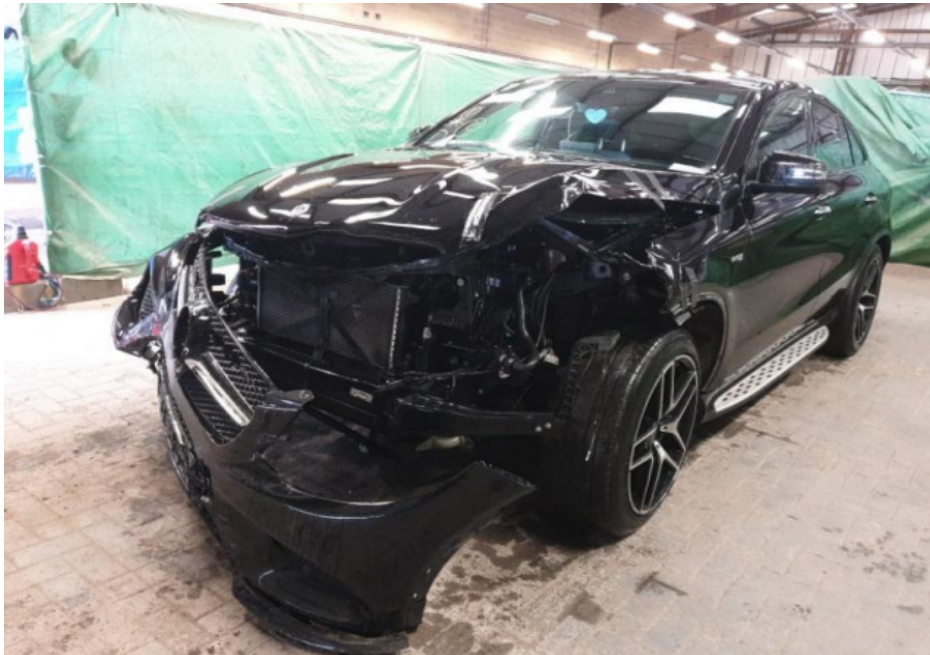
**Photo 1** shows the front left body of the Motor Car (photograph provided to me). The Motor Car was observed to have sustained damage at its frontal portion. The front bumper, front bumper reinforcement, front left headlamp, front left fender, front left fender wheel arc garnish and front bonnet were amongst the parts that were observed to have been damaged.

22. The body parts at the frontal portion of the Motor Car were visually examined and it was noted that the repair/restoration works carried out to the damaged area of the Motor Car (refer to photograph 1 to 4 above) were reasonably adequate and in order.

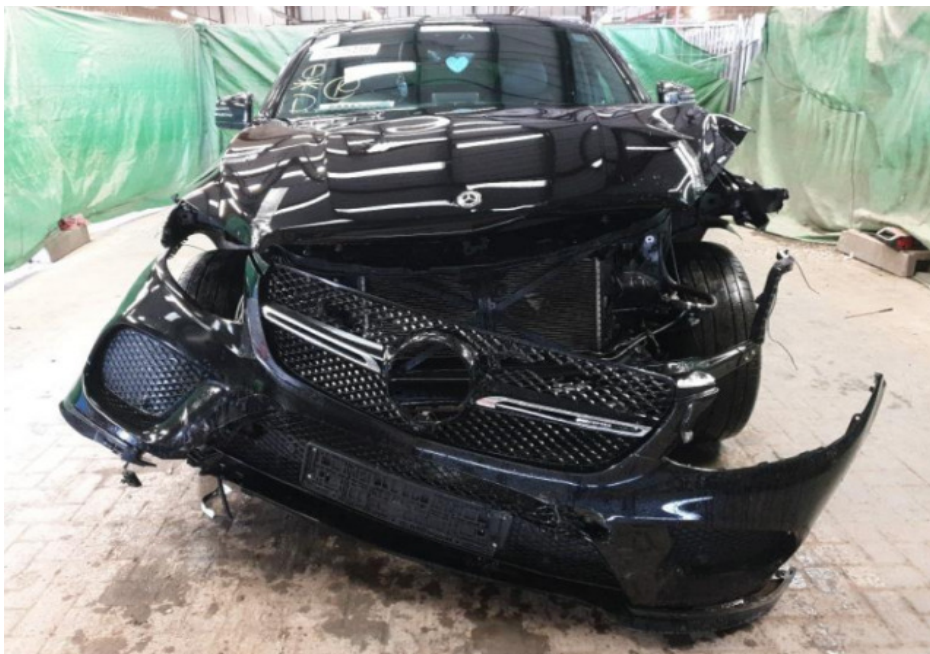
**Photo 2** shows the frontal body of the Motor Car (photograph provided to me). The Motor Car was observed to have sustained damage at its frontal portion. The front bumper, front bumper centre lower grille, radiator grille, radiator grille emblem, front headlamps and front bonnet were amongst the parts that were observed to have been damaged.

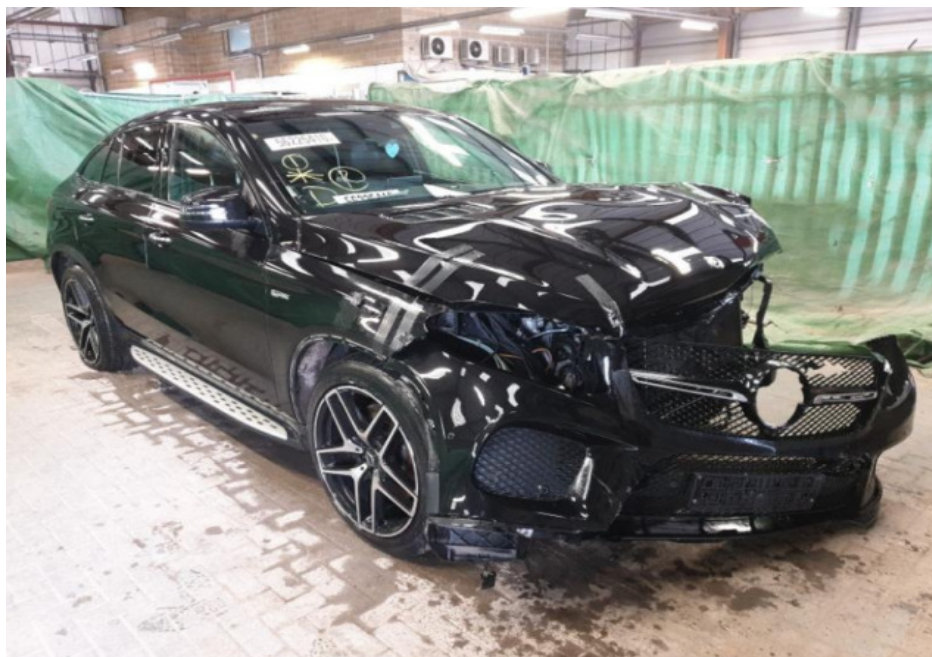
**Photo 3** shows the front right body of the Motor Car (photograph provided to me). The Motor Car was observed to have sustained damage at its frontal portion. The front bumper, radiator grille, radiator grille emblem, front bonnet, front right headlamp, and front right fender were amongst the parts that were observed to have been damaged.

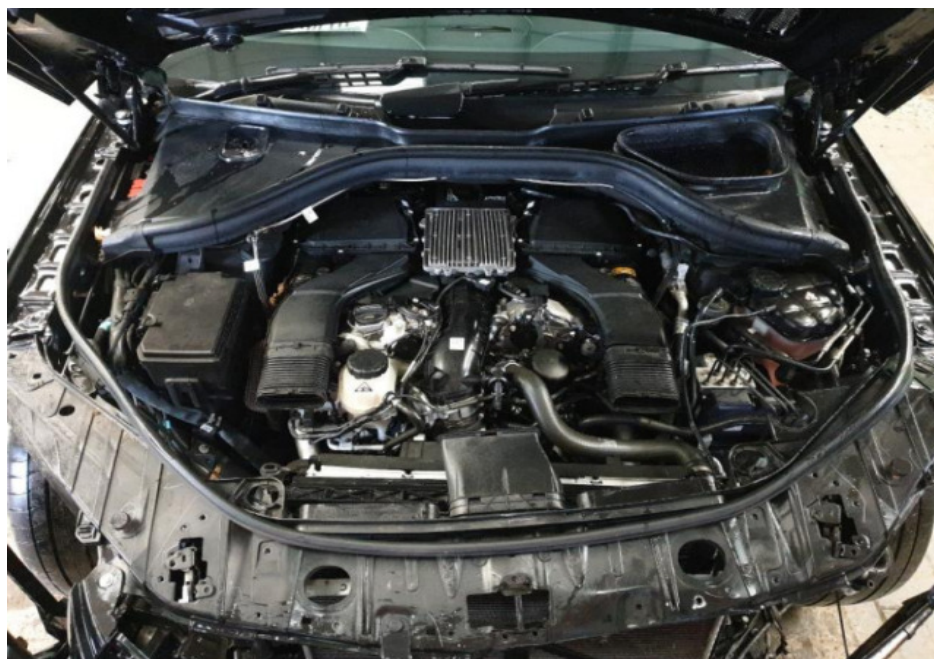
**Photo 4** shows the engine compartment of the Motor Car (photograph provided to me). The front support panel and front support panel top cover were observed to be damaged however parts within the engine compartment were unaffected as seen from the photograph.

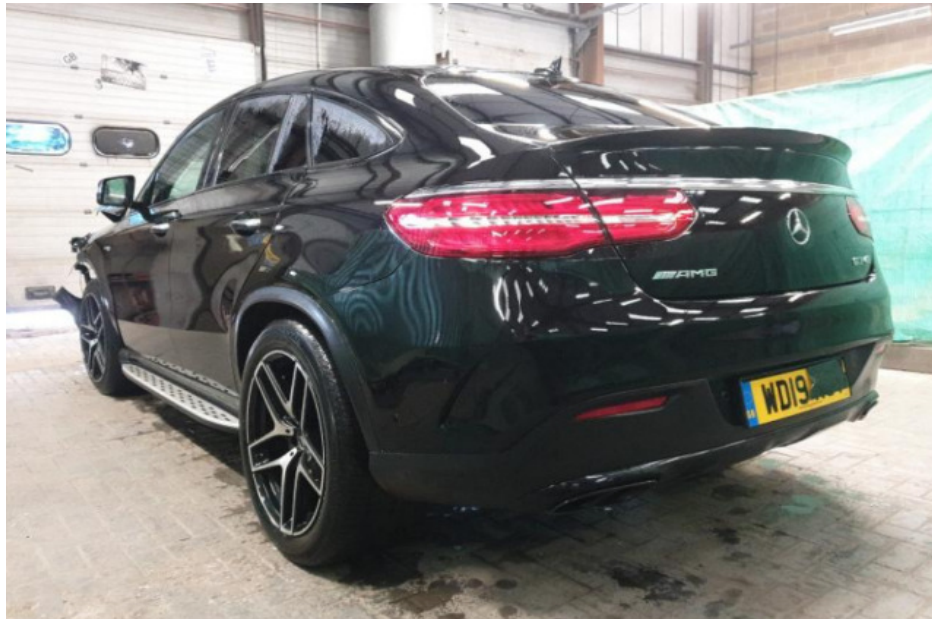
**Photo 5** shows the rear left body of the Motor Car (photograph provided to me). Apart for the frontal portion, there was no physical damage seen to other areas of the Motor Car.

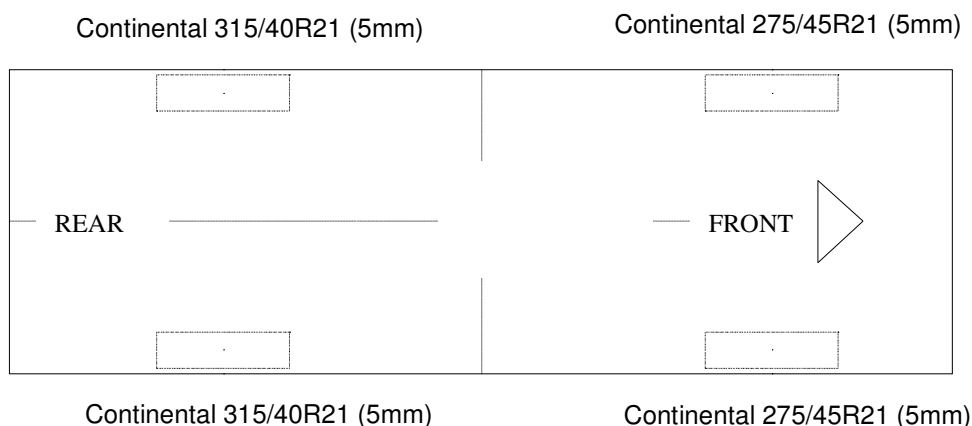
8. It was fitted with 21inch sport wheel rims that were wrapped with tyres that were observed to be of serviceable condition. The tyres were also sufficiently inflated for vehicular operation. The tyre brand, tyre size and approximate remaining tread depth of the 4 tyres of the Motor Car were recorded as follows: -

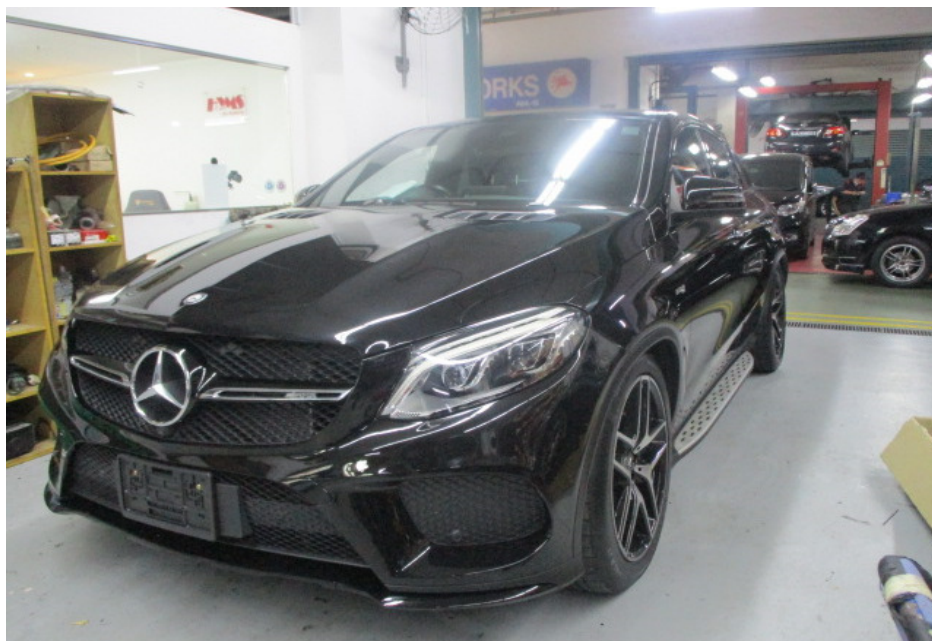
**Photo 6** shows a general view of the front left body of the Motor Car at the time of my inspection. The Motor Car was observed to be in a relatively good general condition with no loose exterior fittings observed. The body parts at the frontal portion of the Motor Car were visually examined and it was observed that the repair/restoration works carried out to the damaged area of the Motor Car (refer to photograph 1 & 2 above) were reasonably adequate and in order.

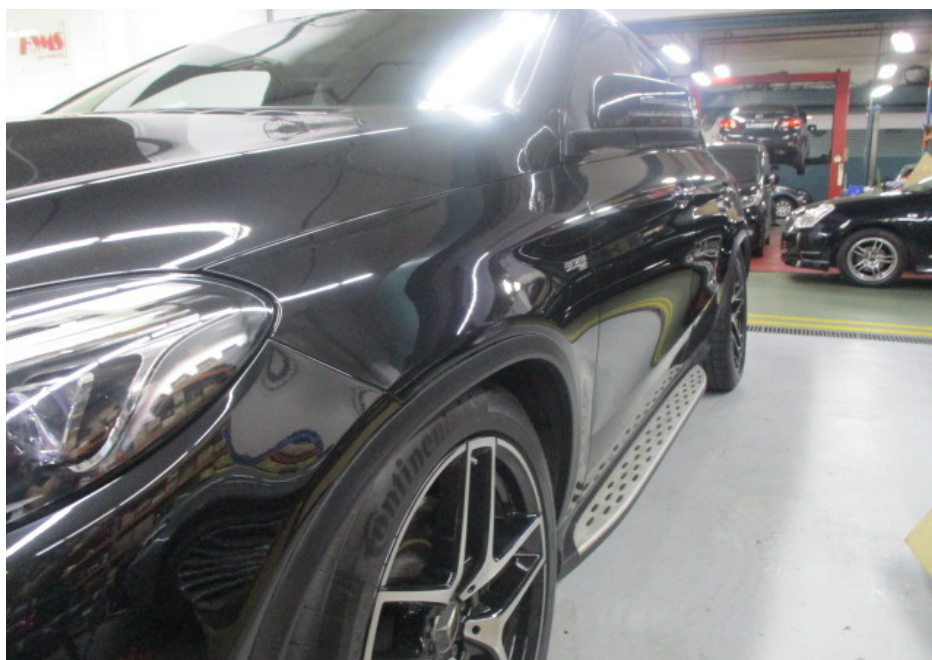
**Photo 7** shows a closer view of the front bumper, front left headlamp, front left fender and front left fender wheel arc garnish of the Motor Car. The body parts at the frontal portion of the Motor Car were visually examined and it was observed that the repair/restoration works carried out to the damaged area of the Motor Car (refer to photograph 1 & 2 above) were reasonably adequate and in order.

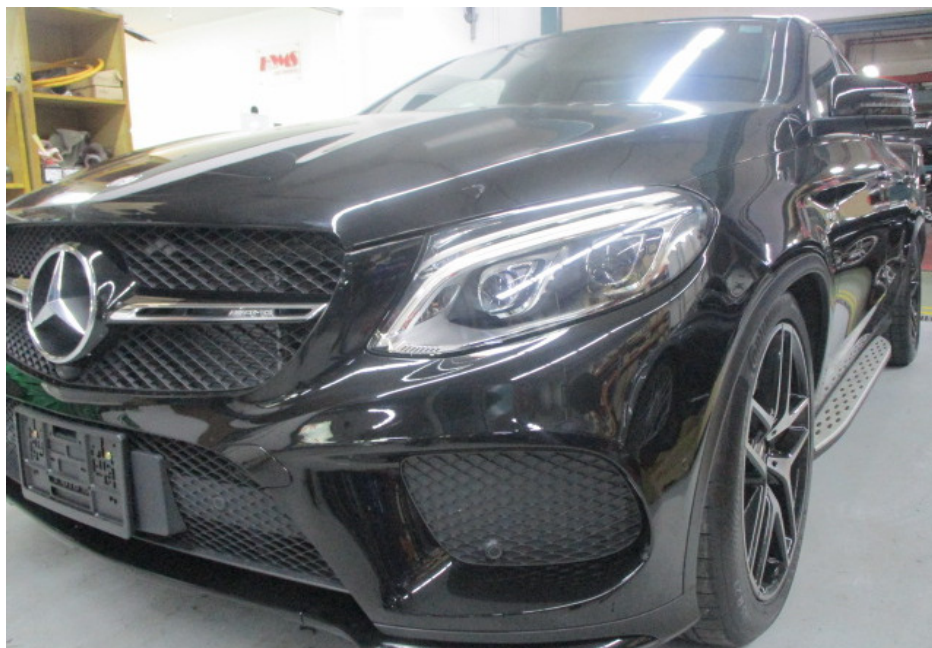
**Photo 8** shows a closer view of the front bumper, front bumper centre lower grille, front bonnet, radiator grille, radiator grille emblem and front left headlamp of the Motor Car at the time of my inspection. The body parts at the frontal portion of the Motor Car were visually examined and it was observed that the repair/restoration works carried out to the damaged area of the Motor Car (refer to photograph 1 & 2 above) were reasonably adequate and in order.

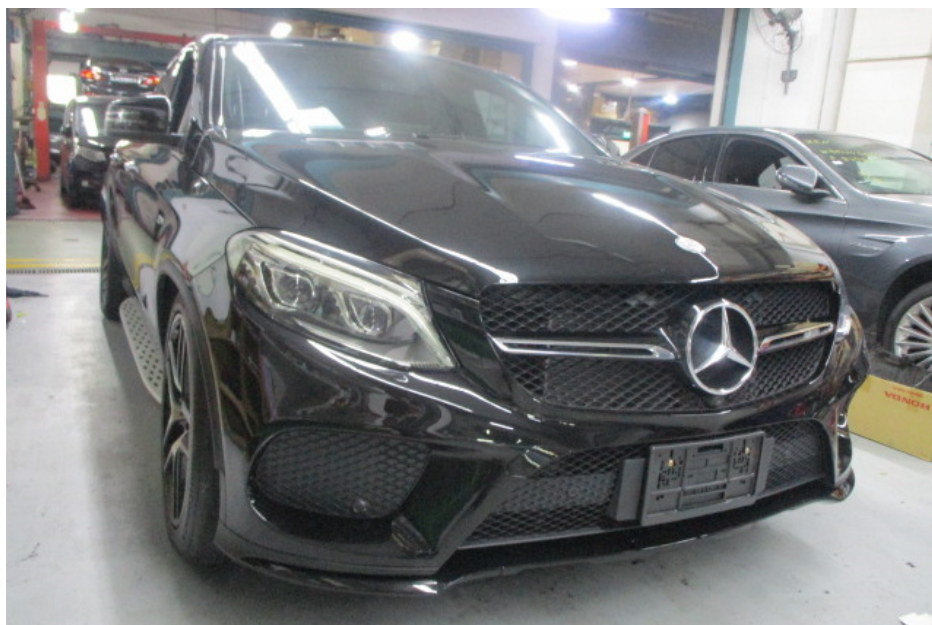
**Photo 9** shows a general view of the front right body of the Motor Car at the time of my inspection. The Motor Car was observed to be in a relatively good general condition with no loose exterior fittings observed. The body parts at the frontal portion of the Motor Car were visually examined and it was observed that the repair/restoration works carried out to the damaged area of the Motor Car (refer to photograph 2 & 3 above) were reasonably adequate and in order.

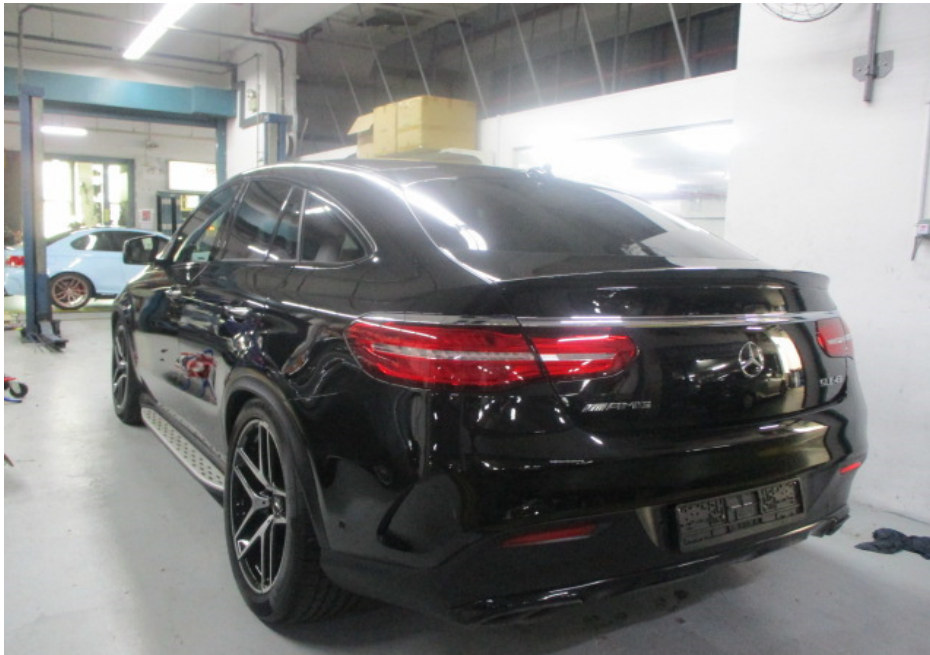
**Photo 10** shows a general view of the rear left body of the Motor Car at the time of my inspection. The Motor Car was observed to be in a relatively good general condition with no loose exterior fittings observed. The mileage of the Motor Car recorded at the time of my inspection was 48,555km.

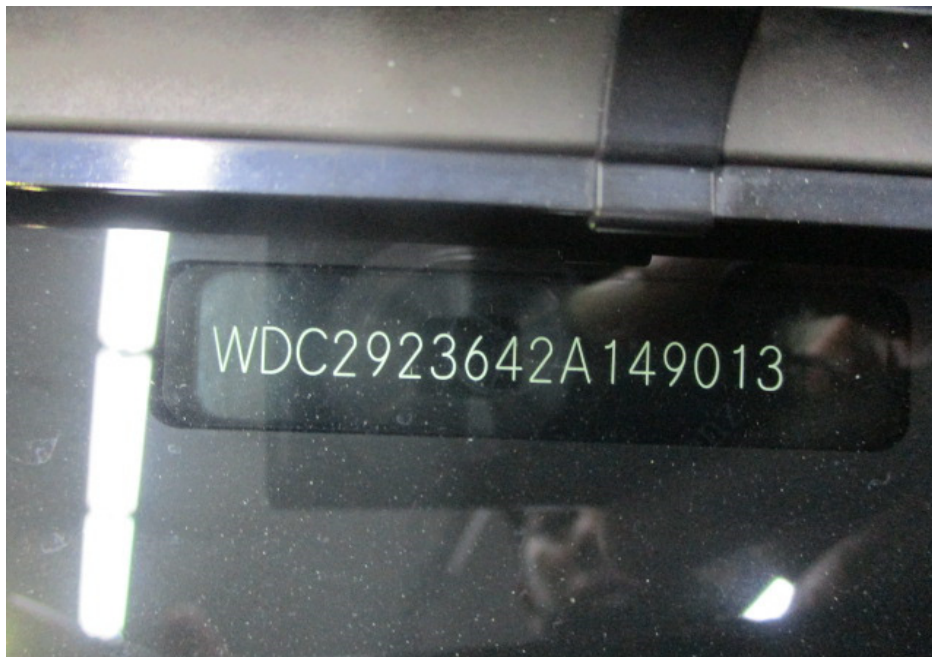
**Photo 11** shows the chassis number of the Motor Car. The chassis number recorded was WDC2923642A149013.

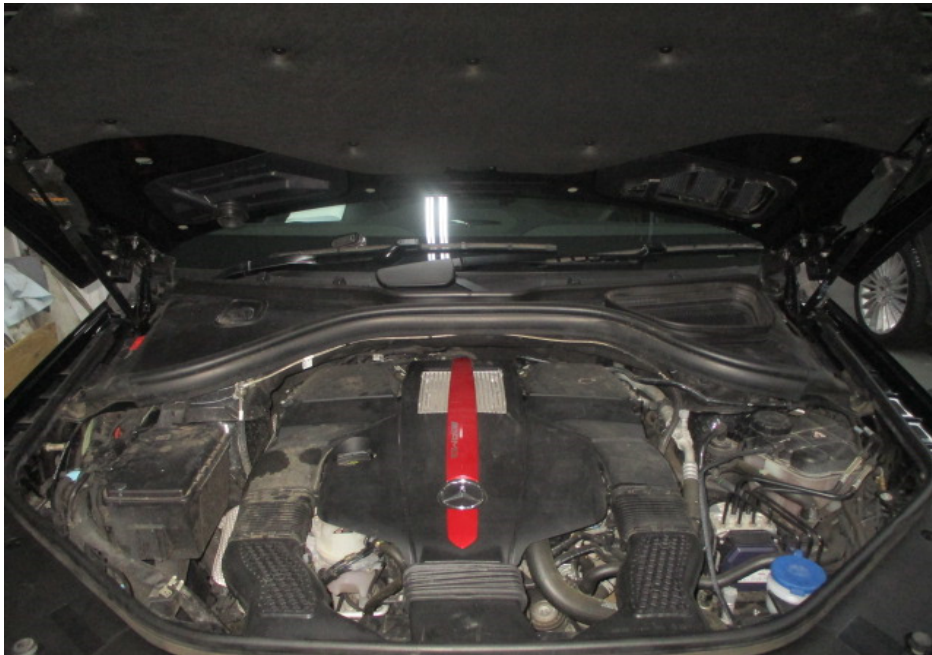
**Photo 12** shows a general view of the engine compartment of the Motor Car at the time of my inspection. The various parts and components inside the engine compartment were all observed to be intact and properly fitted. There was also no sign(s) or indication(s) of fluid leak and/or fluid stain found inside the engine compartment.

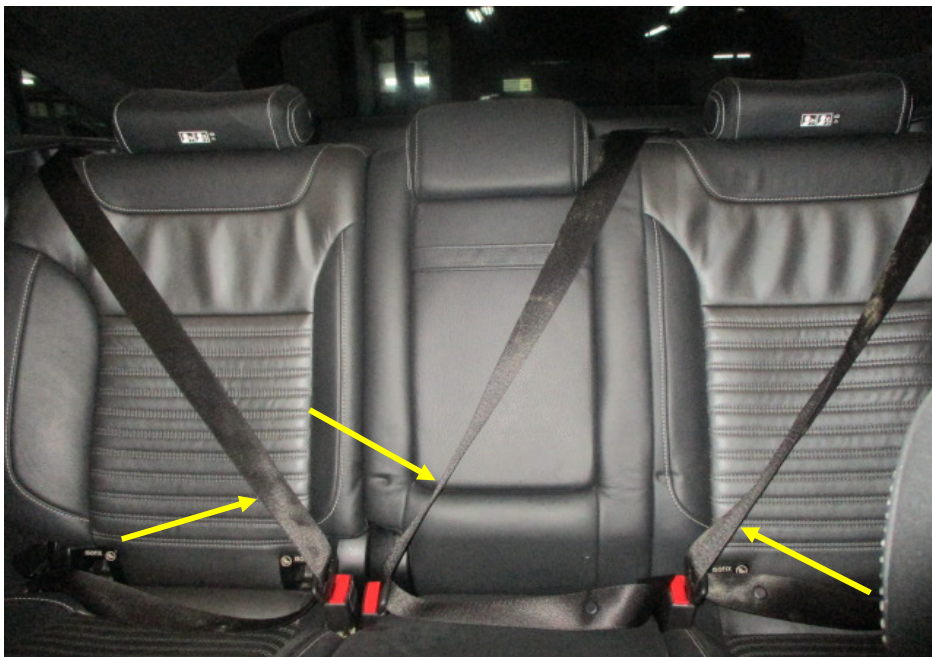
**Photo 13** shows the rear seats of the Motor Car. All the seats of the Motor Car were secured via seat rails to the floorboard. They were also fitted with a retractable seat belt reel and a pre-tensioner. The seat belts (arrowed) were tested and were able to be fastened into the respective pre-tensions that were fitted on the side of each individual seat.

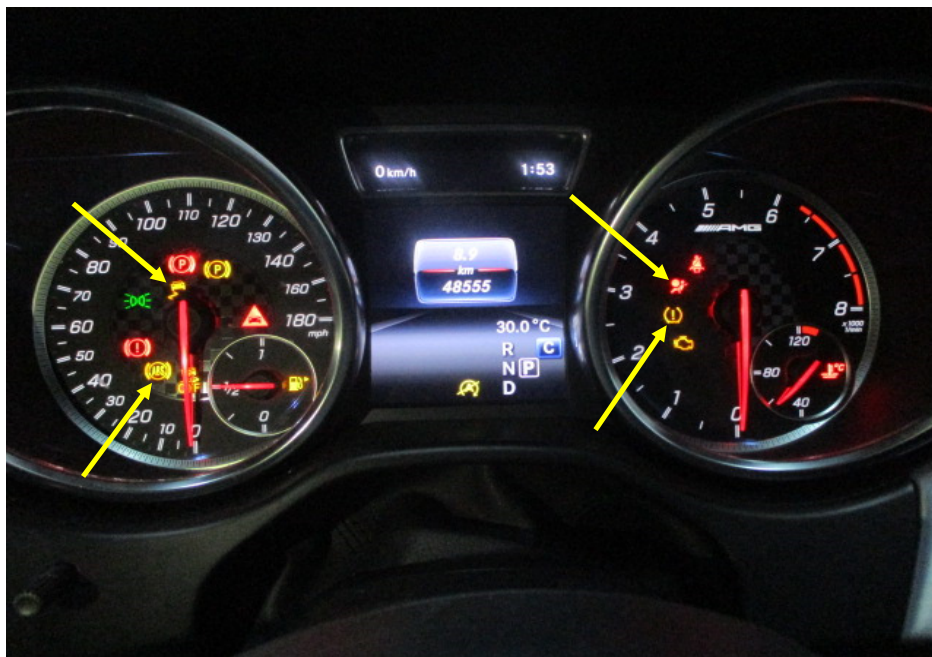
**Photo 14** shows the warning lights for the various electronic safety features appearing on the instrument panel of the Motor Car during its self-test when the engine is cranked, in particular the ABS, SRS, TPM and TCS lights (arrowed).

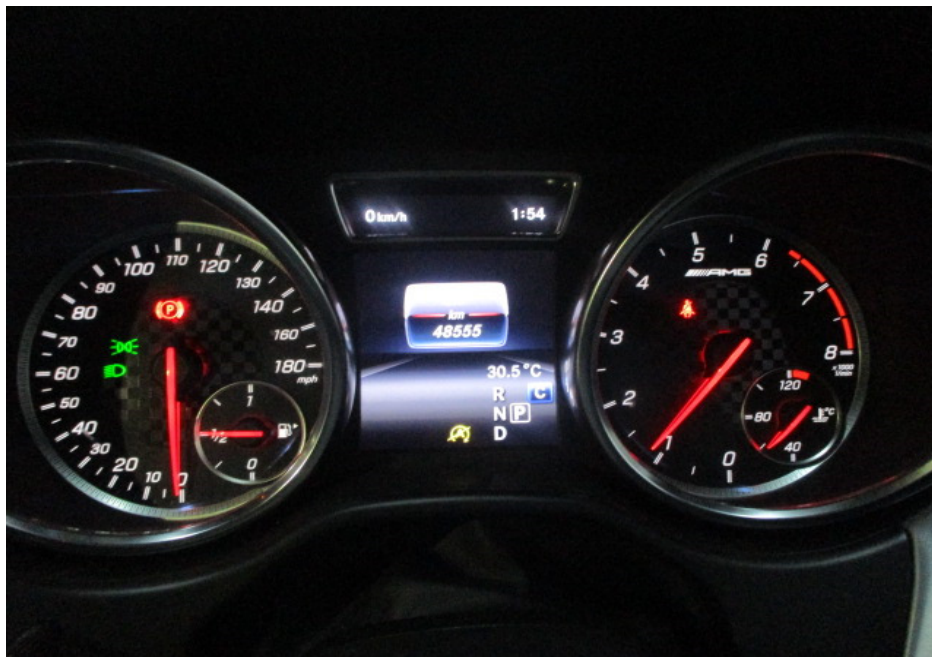
**Photo 15** shows the respective warning lights no longer illuminated, indicating that there is no fault detected to the ABS, SRS, TPM and TCS systems of the Motor Car during the self-test. These electronic systems were hence in working condition at the time of my inspection.

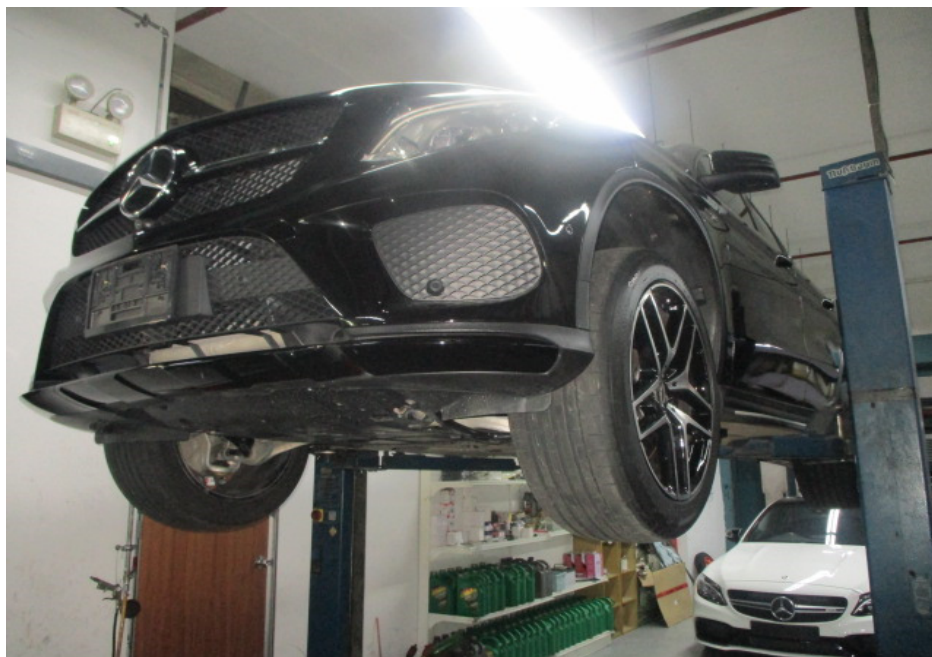
**Photo 16** shows the Motor Car hoisted up for checks on its undercarriage. There was no sign(s) or indication(s) of fluid leakage and/or fluid stain(s) on the underside of the Motor Car. The undercarriage components of the Motor Car were also all observed to be intact and secured in an appropriate manner.

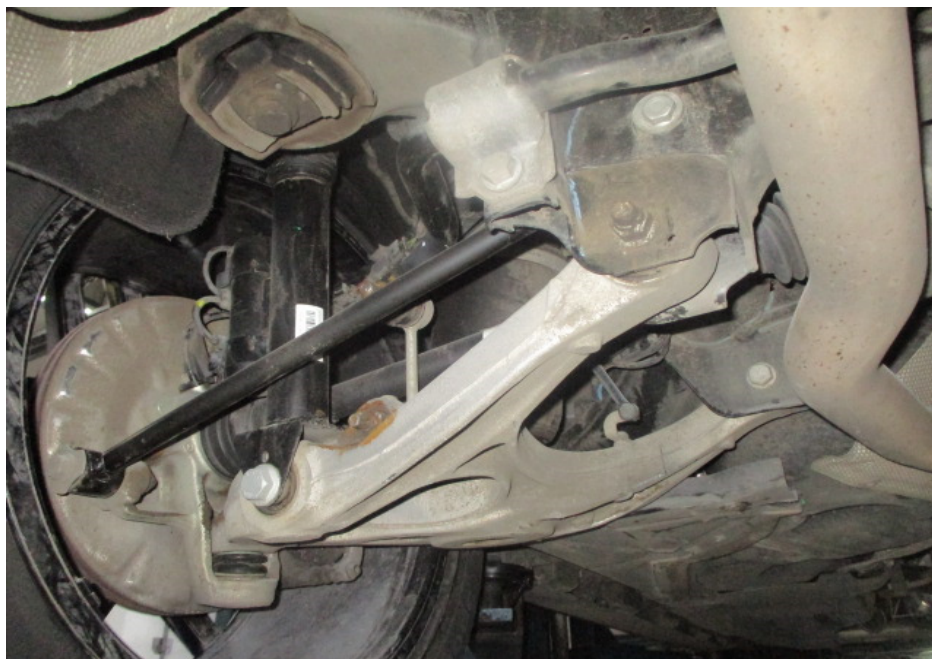
**Photo 17** shows a general view of the control arms and linkages at the rear left wheel of the Motor Car. I did not observe any fluid leak and/or fluid stain on the underside of the Motor Car. All of the Motor Car's undercarriage components were observed to be intact and secured in an appropriate manner.

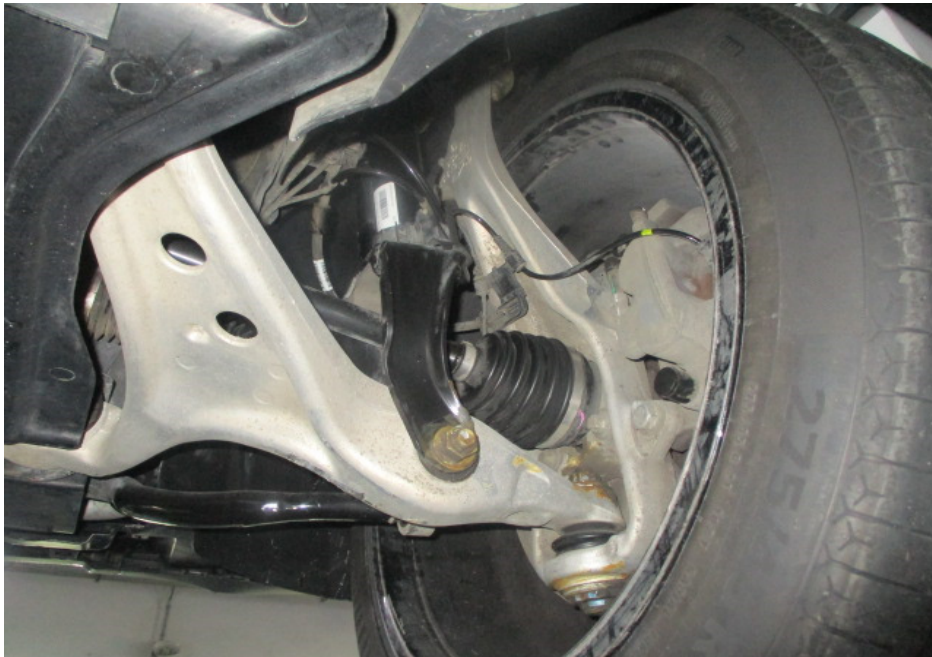
**Photo 18** shows the various undercarriage components at the front right wheel of the Motor Car. The mechanical components, control arms and linkages were all found to be intact and secured in an appropriate manner.

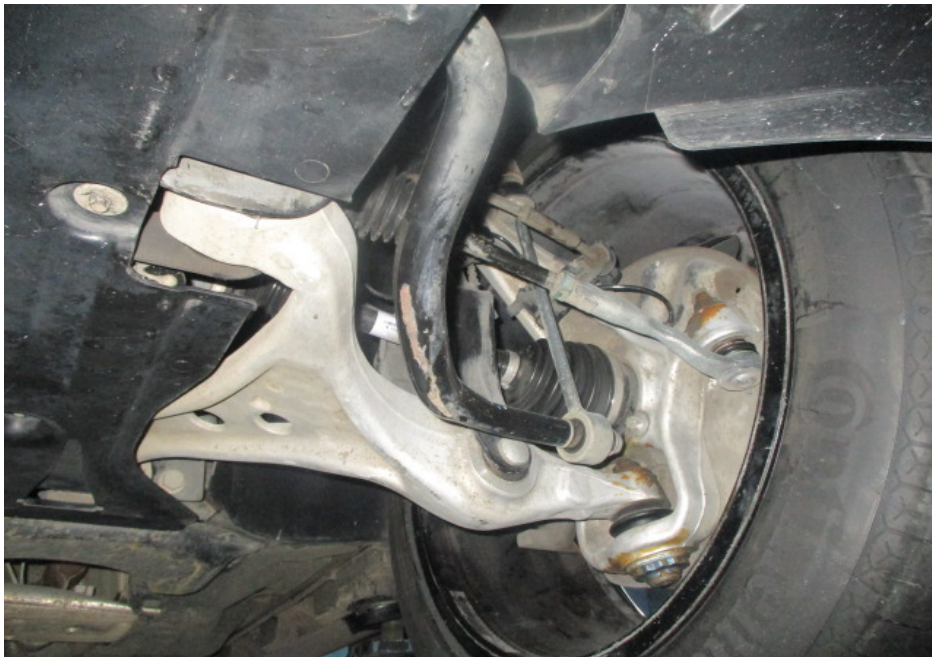
**Photo 19** shows the various undercarriage components at the front left wheel of the Motor Car. The mechanical components, control arms and linkages were all found to be intact and secured in an appropriate manner. I also did not observe any fluid leak and/or fluid stain on the underside of the Motor Car.

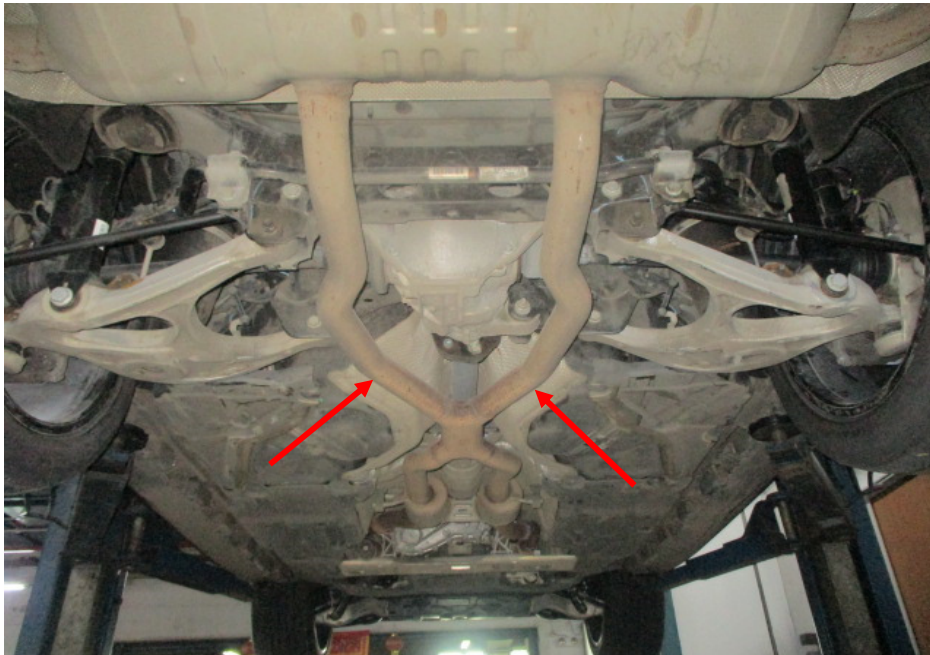
**Photo 20** shows a general view of the Motor Car's exhaust system (arrowed). My examination of the Motor Car's exhaust system revealed no sign(s) or indication(s) of any cut or weld marks along its catalytic converters, exhaust pipes and on its rear muffler.

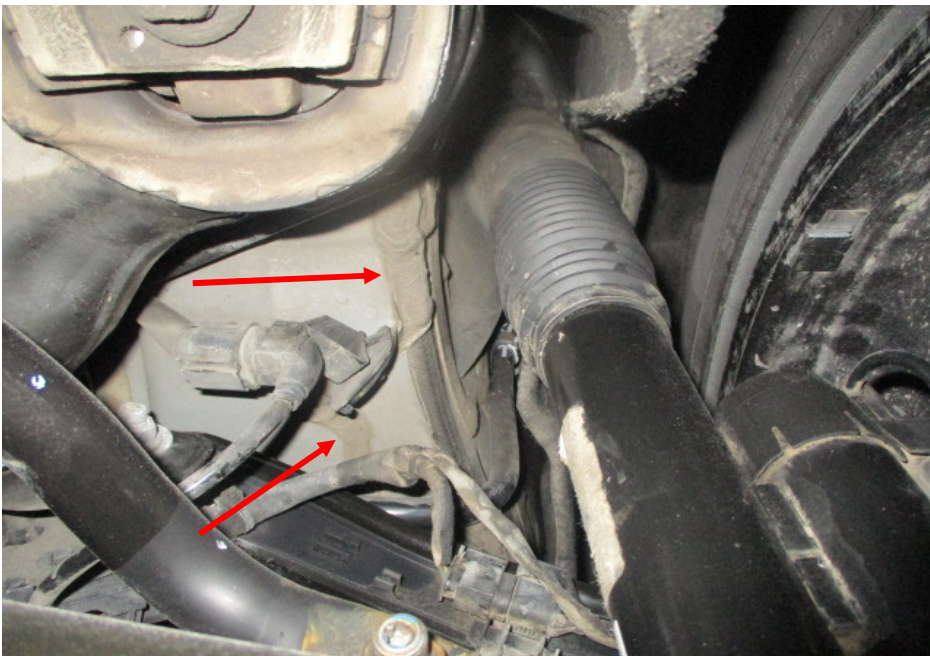
**Photo 21** shows the chassis/structural body at the underside rear right of the Motor Car. I did not find any weld marks other than original spot weld marks on the chassis/structural body of the Motor Car. The original factory sealant (arrowed) at the joints along the chassis/structural body was also untouched, indicating no work was done on the chassis/structural body of the Motor Car and that the chassis/structural body was originally fitted.

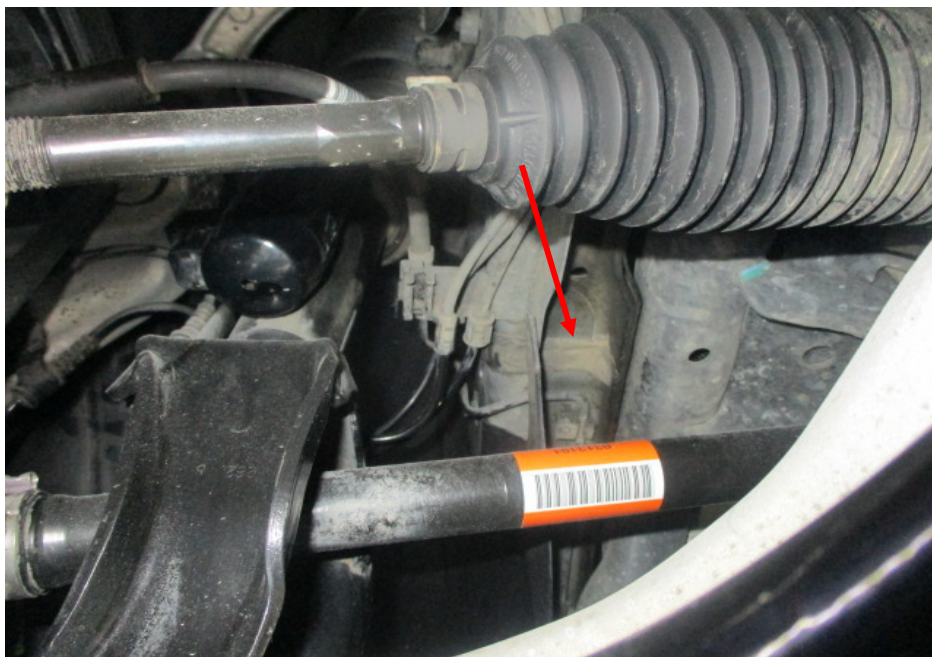
**Photo 22** shows the chassis/structural body at the underside front right of the Motor Car. I did not find any weld marks other than original spot weld marks on the chassis/structural body of the Motor Car. The original factory sealant (arrowed) at the joints along the chassis/structural body was also untouched, indicating no work was done on the chassis/structural body of the Motor Car and that the chassis/structural body was originally fitted.

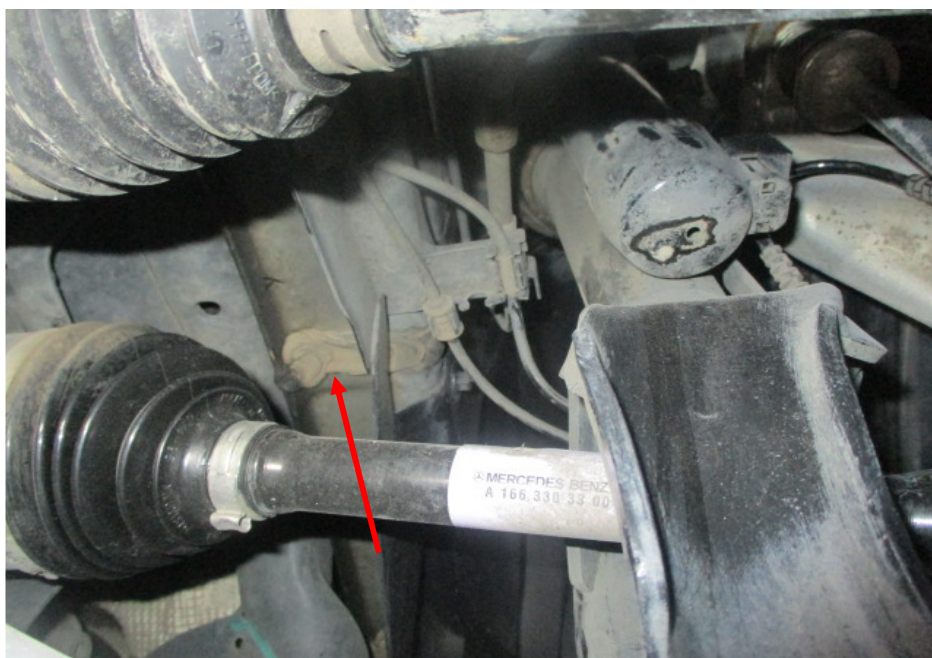
**Photo 23** shows the chassis/structural body at the underside front left of the Motor Car. The original factory sealant (arrowed) at the joints along the chassis/structural body was observed to be untouched. In general, I had found no work was carried out on the chassis/structural body of the Motor Car. The chassis/structural body of the Motor Car was originally fitted.

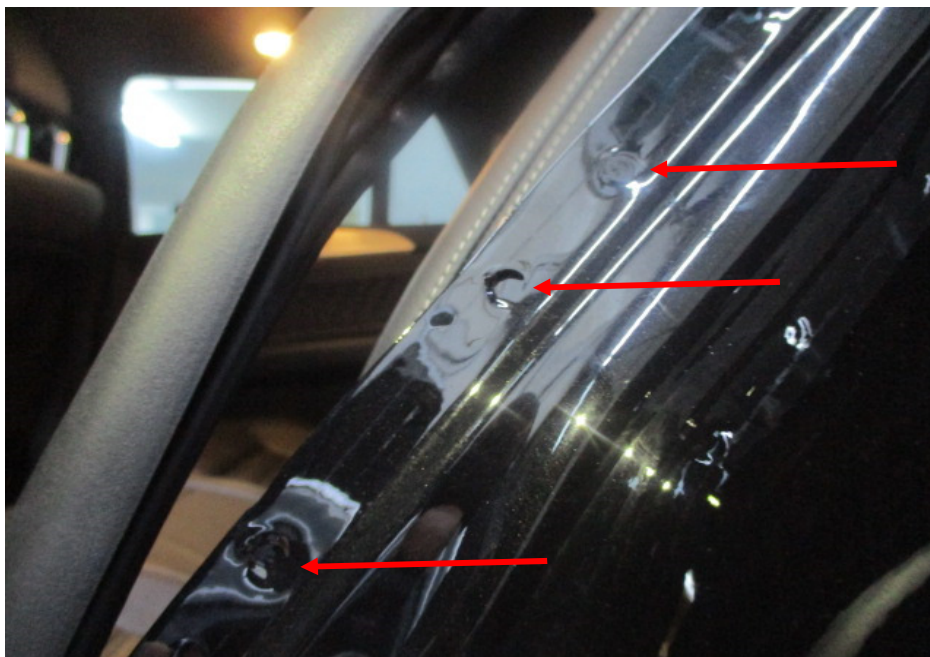
**Photo 24** shows the left side "C" pillar of the Motor Car. I did not find any weld marks other than original spot weld marks (arrowed) on the left side "C" pillar of the Motor Car which, indicates that there was no re-welding works carried out. In general, I had found all the non-detachable body panels of the Motor Car to be originally fitted at the time of my inspection.
