SURVEY OF VEHICLE NO. JTR 9191

AUTOMOBILE ASSESSMENT REPORT

Assessment of Vehicle No : **JTR 9191**
Date of Accident : **11-February-2020**
Date of Inspection : **13-February-2020**
Address of Inspection : **1 Kaki Bukit Ave 6 #02-34 S'417883**

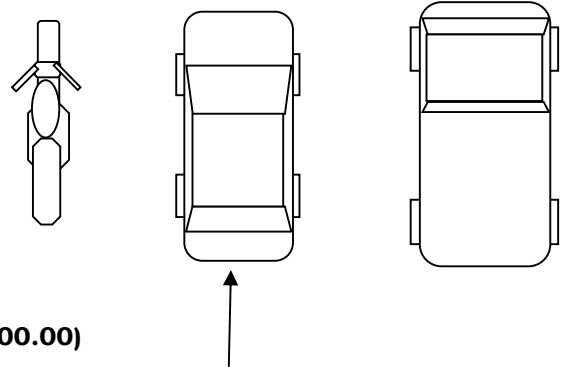
At the time of inspection, this vehicle sustained damages to the **Rear** portion. Please see attached scheduled for details.
