**Re: Third Party Claim / Workshop :- Precise Auto Service**  
**Vehicle Regn. No. : JTR 9191**

## VEHICLE INSPECTION REPORT

**SURVEY OF VEHICLE NO. JTR 9191**

## AUTOMOBILE ASSESSMENT REPORT

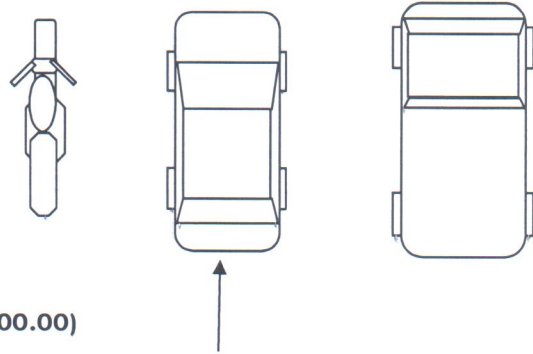
At the time of inspection, this vehicle sustained damages to the **Rear** portion. Please see attached scheduled for details.
