Sincere Appraisal Services

VEHICLE DAMAGE INSPECTION REPORT

Our Ref: 226/TP/2016

Reg No:	SKT1456B	Make &	Toyota
Reg date:	25/5/2015	Model	Estima Aeras Premium 2.4
Colour:	Silver	Engine No:	2AZJ137879
Type:	Motor Car	Chassis No:	ACR500188296
Type of Claims:	Third Party	Odometer No:	22665km
		Engine Cap:	2362cc

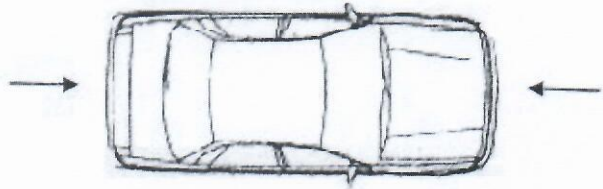
POINT OF IMPACT

Damaged at the front and rear portion

Our visual inspection of the vehicle revealed that the damages noted are at the front and rear portion.

We have inspected the actual damages found on the vehicle and recommend the replacement of parts and repairs accordingly. The estimated repair cost is \$25,146.60. The repairer has agreed to undertake the repairs at our adjusted lump sum amount of \$18,000.
