### VEHICLE DAMAGE INSPECTION REPORT

Our Ref: 226/TP/2016

Reg No:	SKT1456B	Make &	Toyota
Reg date:	25/5/2015	Model	Estima Aeras Premium 2.4
Colour:	Silver	Engine No:	2AZJ137879
Type:	Motor Car	Chassis No:	ACR500188296
Type of Claims:	Third Party	Odometer No:	22665km
		Engine Cap:	2362cc

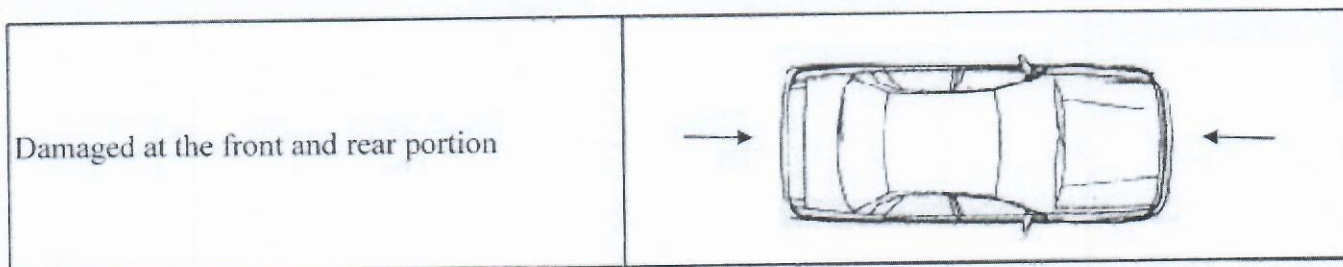
### POINT OF IMPACT

Our visual inspection of the vehicle revealed that the damages noted are at the front and rear portion.
