VEHICLE DAMAGE INSPECTION REPORT

Our Ref: 226/TP/2016

Reg No:	SKT1456B	Make &	Toyota
Reg date:	25/5/2015	Model	Estima Aeras Premium 2.4
Colour:	Silver	Engine No:	2AZJ137879
Type:	Motor Car	Chassis No:	ACR500188296
Type of Claims:	Third Party	Odometer No:	22665km
		Engine Cap:	2362cc

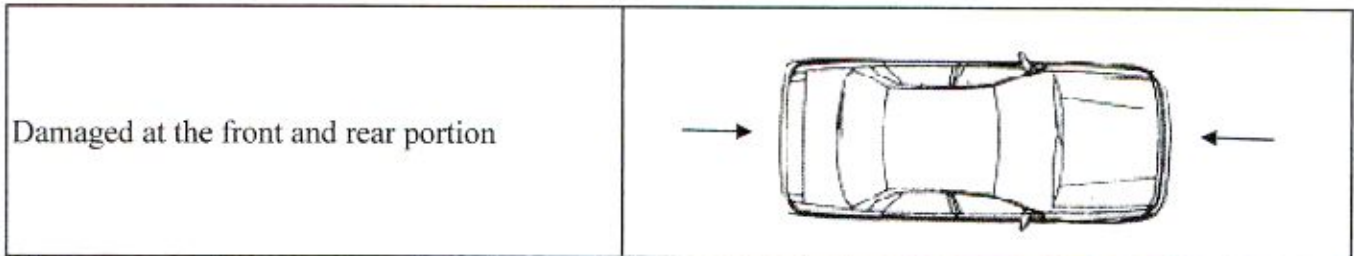
POINT OF IMPACT

Our visual inspection of the vehicle revealed that the damages noted are at the front and rear portion.

We have inspected the actual damages found on the vehicle and recommend the replacement of parts and repairs accordingly. The estimated repair cost is \$25,146.60. The repairer has agreed to undertake the repairs at our adjusted lump sum amount of \$18,000.
