Your Ref: Mercedes Benz C63  
(chassis number WDD2050862R393434)  
Our Ref : CI/TP21003963/D

**INSPECTION REPORT OF AN UNREGISTERD MERCEDES BENZ C63  
MOTOR CAR WITH CHASSIS NUMBER WDD2050862R393434**

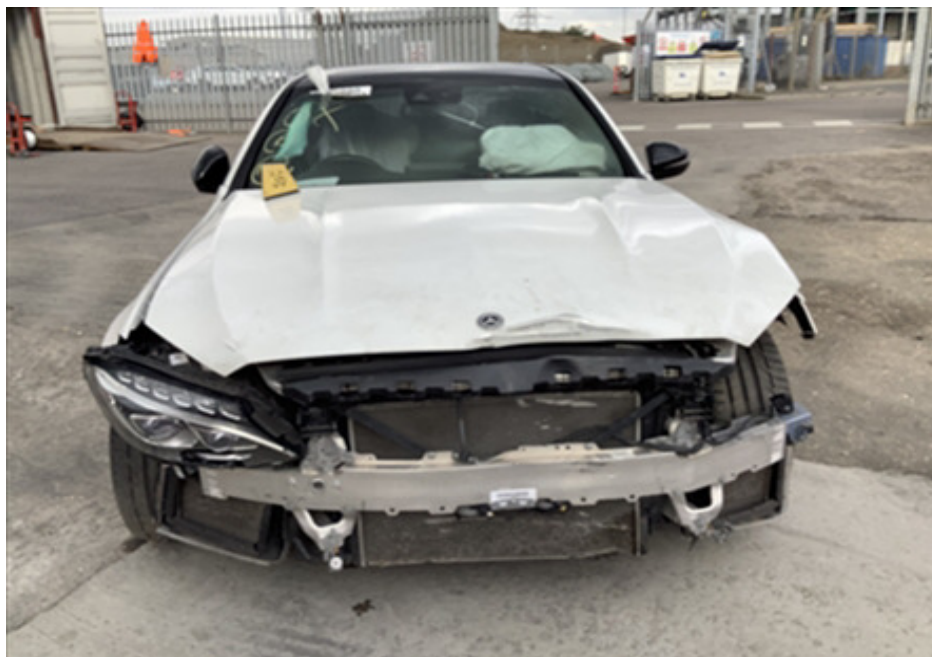
**Photo 1** shows the frontal body of the Motor Car (photograph provided to me). The Motor Car was observed to have sustained damage at its frontal portion. The front bumper and all its related attachments and fittings, front bumper reinforcement, radiator grille, front headlamps, front fender inner shields, front bonnet, front bonnet lock, aircon condenser, radiator, radiator air guide, front support panel and front support panel top garnish were amongst the parts that were observed to have been damaged.

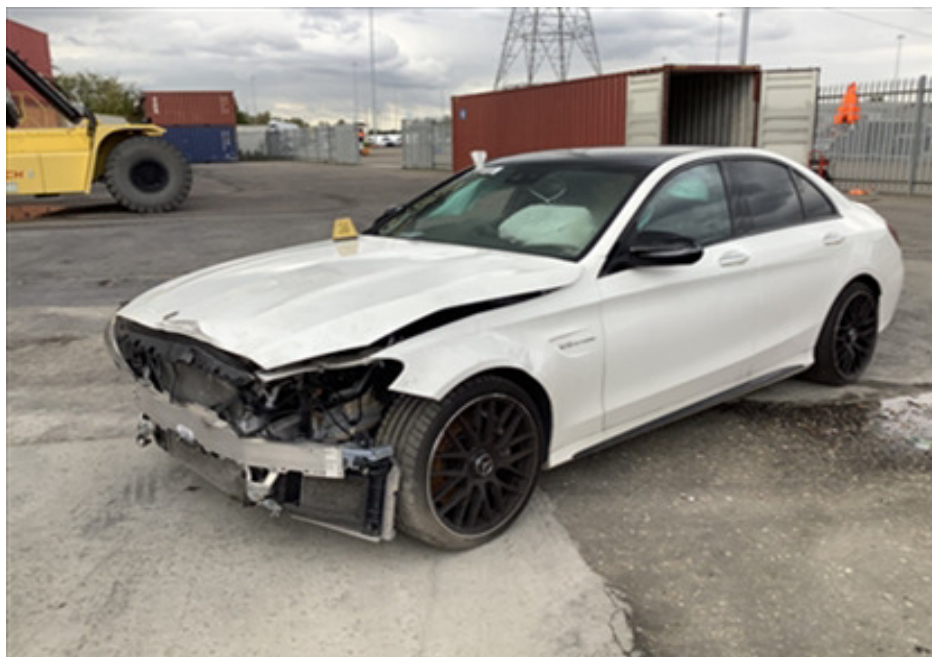
**Photo 2** shows the front left body of the Motor Car (photograph provided to me). The Motor Car was observed to have sustained damage at its frontal portion. The front left passenger airbag and left curtain airbag were activated.

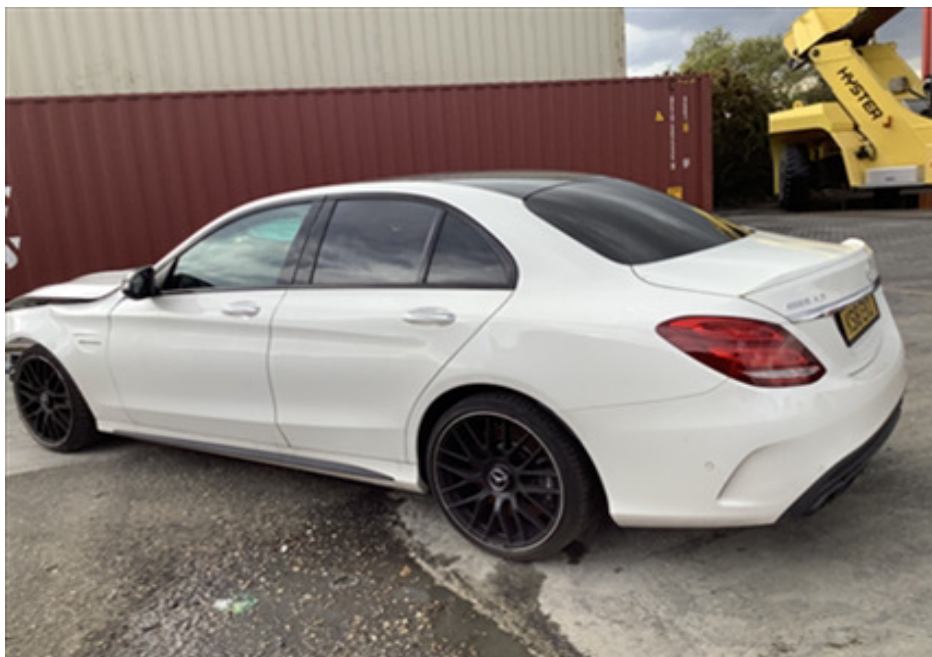
**Photo 3** shows the rear left body of the Motor Car (photograph provided to me). Apart for the frontal portion, there was no physical damage seen to other areas of the Motor Car.

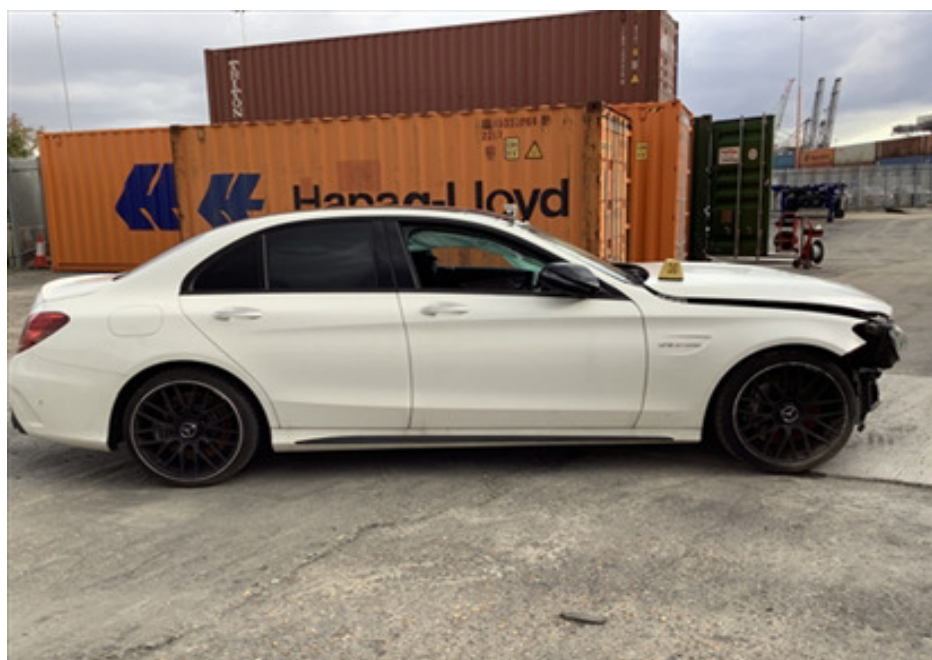
**Photo 4** shows the right body of the Motor Car (photograph provided to me). Apart for the frontal portion, there was no physical damage seen to other areas of the Motor Car.

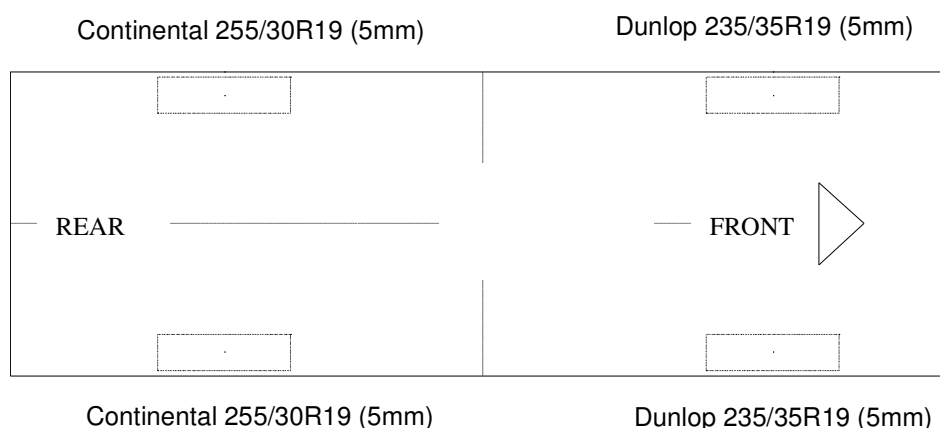
8. It was fitted with 19inch sport wheel rims that were wrapped with tyres that were observed to be of serviceable condition. The tyres were also sufficiently inflated for vehicular operation. The tyre brand, tyre size and approximate remaining tread depth of the 4 tyres of the Motor Car were recorded as follows: -

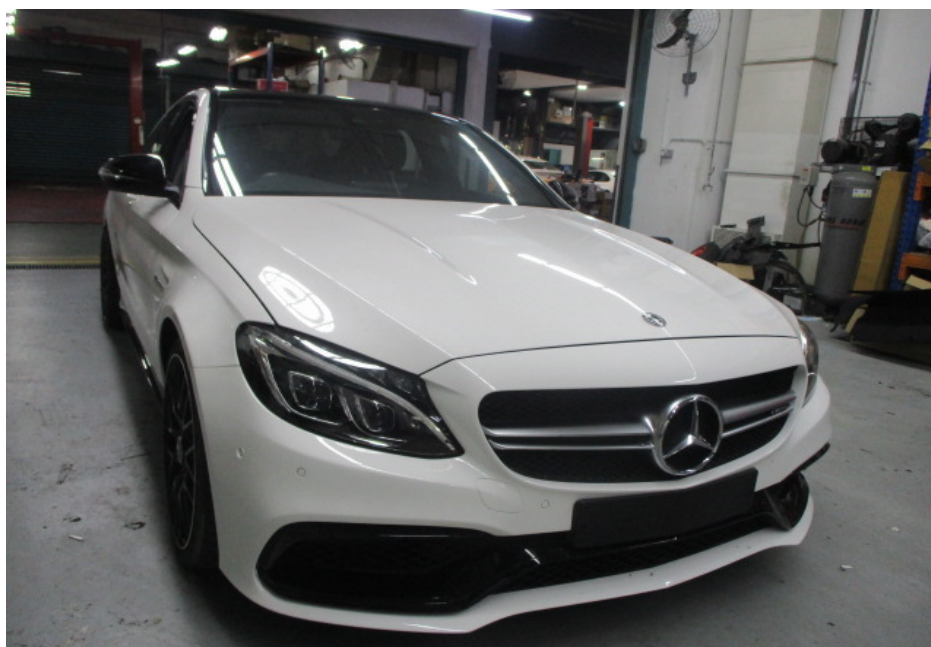
**Photo 5** shows a general view of the front right body of the Motor Car at the time of my inspection. The Motor Car was observed to be in a relatively good general condition with no loose exterior fittings observed. The body parts at the frontal portion of the Motor Car were visually examined and it was observed that the repair/restoration works carried out to the damaged area of the Motor Car (refer to photograph 1 above) were reasonably adequate and in order.

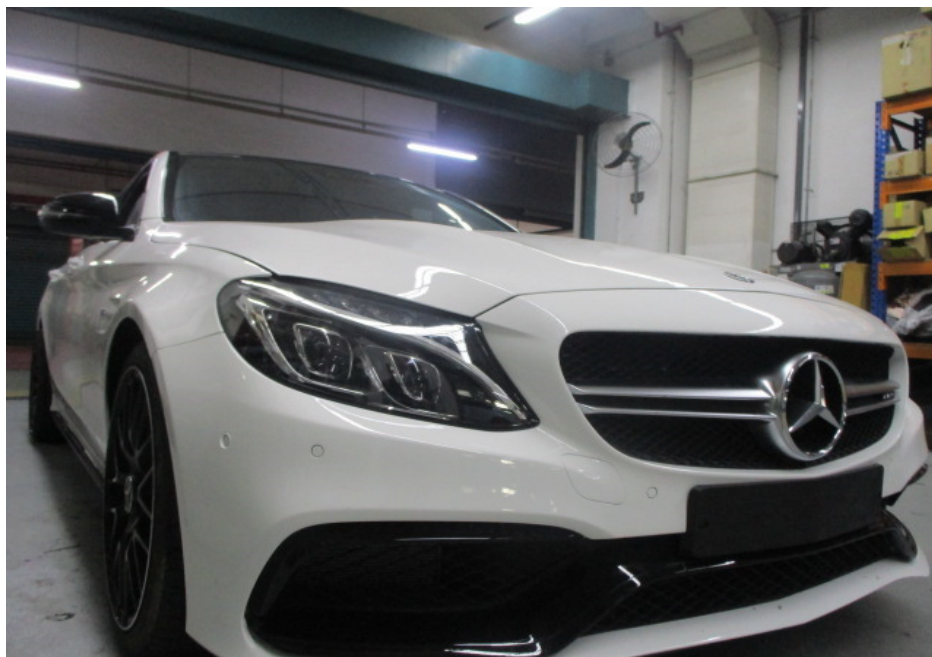
**Photo 6** shows a closer view of the front bumper, front bumper lower grille, front bumper lower garnish, front number plate garnish and front right headlamp of the Motor Car at the time of my inspection. The body parts at the frontal portion of the Motor Car were visually examined and it was observed that the repair/restoration works carried out to the damaged area of the Motor Car (refer to photograph 1 above) were reasonably adequate and in order.

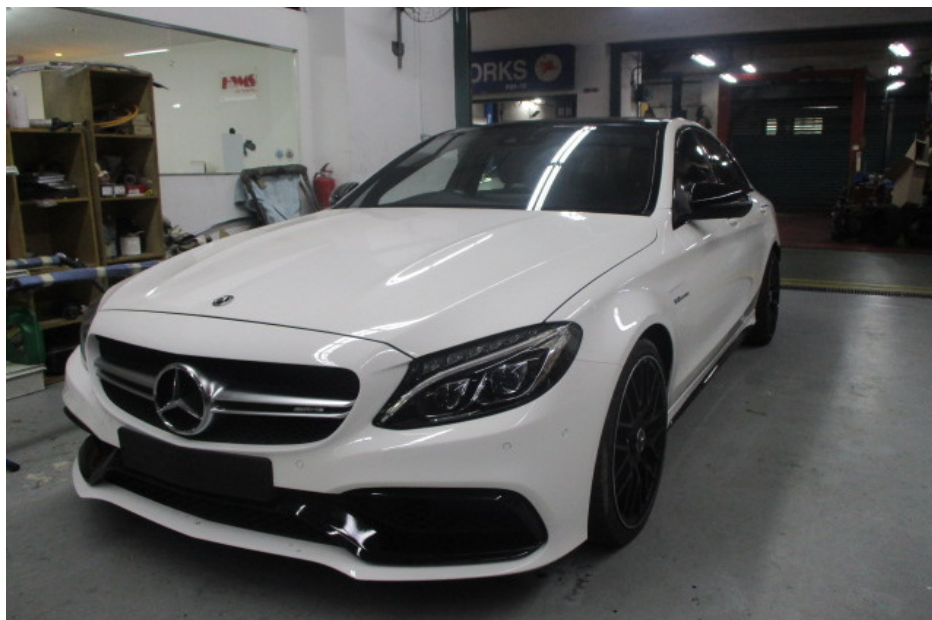
**Photo 7** shows a general view of the front left body of the Motor Car at the time of my inspection. The Motor Car was observed to be in a relatively good general condition with no loose exterior fittings observed. The body parts at the frontal portion of the Motor Car were visually examined and it was observed that the repair/restoration works carried out to the damaged area of the Motor Car (refer to photograph 1 & 2 above) were reasonably adequate and in order.

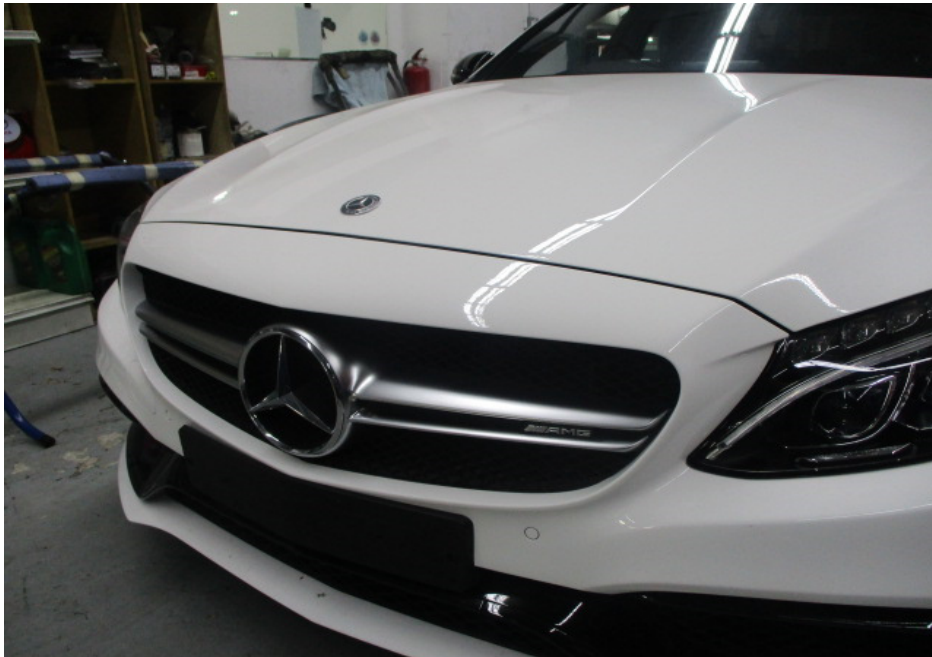
**Photo 8** shows a closer view of the front bumper, front bonnet, radiator grille and front left headlamp of the Motor Car at the time of my inspection. The body parts at the frontal portion of the Motor Car were visually examined and it was observed that the repair/restoration works carried out to the damaged area of the Motor Car (refer to photograph 1 & 2 above) were reasonably adequate and in order.

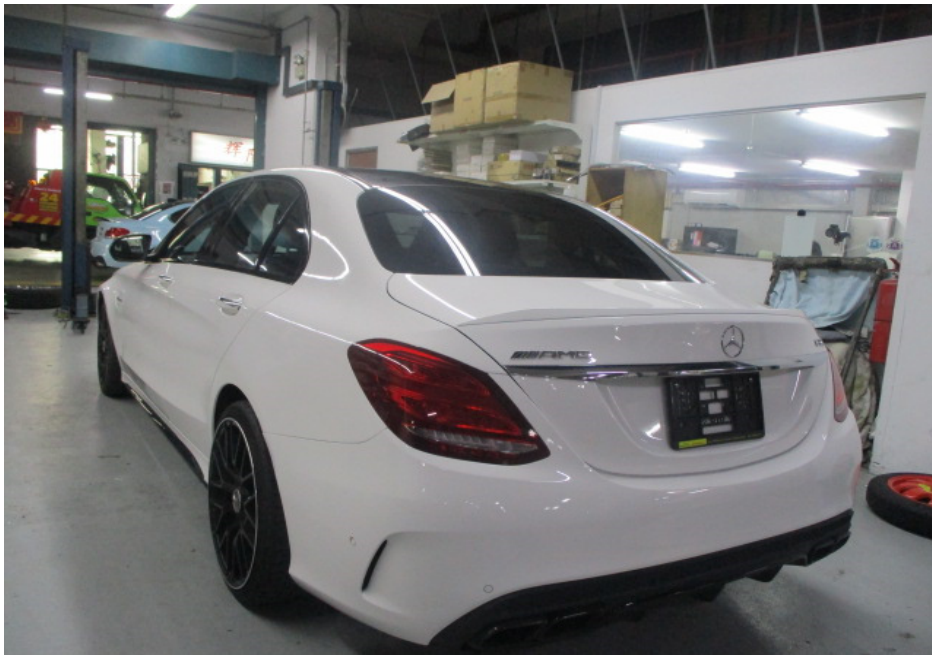
**Photo 9** shows a general view of the rear left body of the Motor Car at the time of my inspection. The Motor Car was observed to be in a relatively good general condition with no loose exterior fittings observed. The mileage of the Motor Car recorded at the time of my inspection was 32,153km.

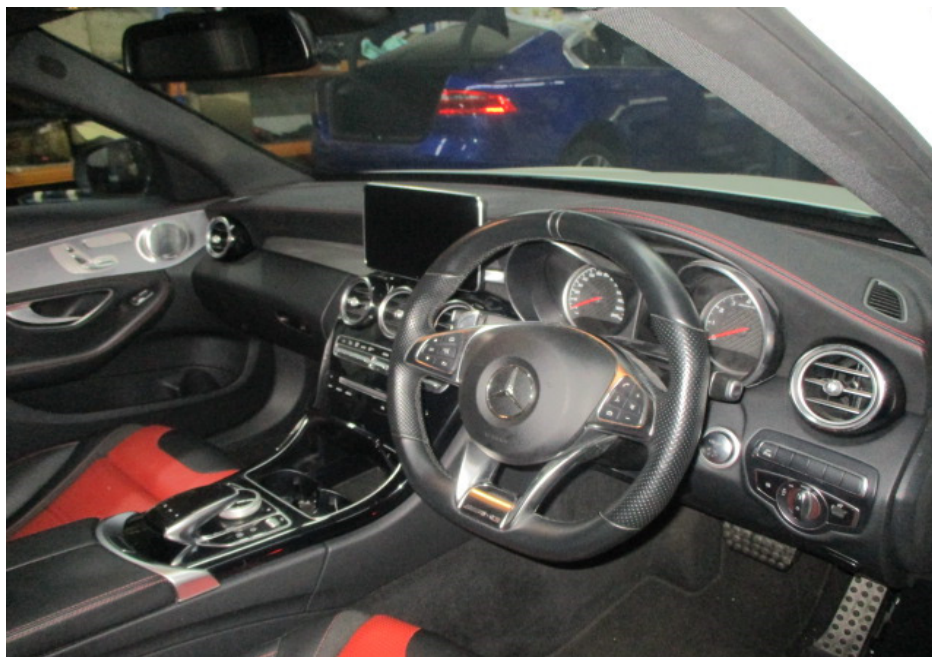
**Photo 10** shows a general view of the dashboard panel of the Motor Car. The steering wheel (driver's airbag) and dashboard panel (front left passenger airbag) were checked, and it was observed that the repair/restoration works carried out to parts damaged by the activation of the driver's airbag and front left passenger airbag were reasonably adequate and in order.

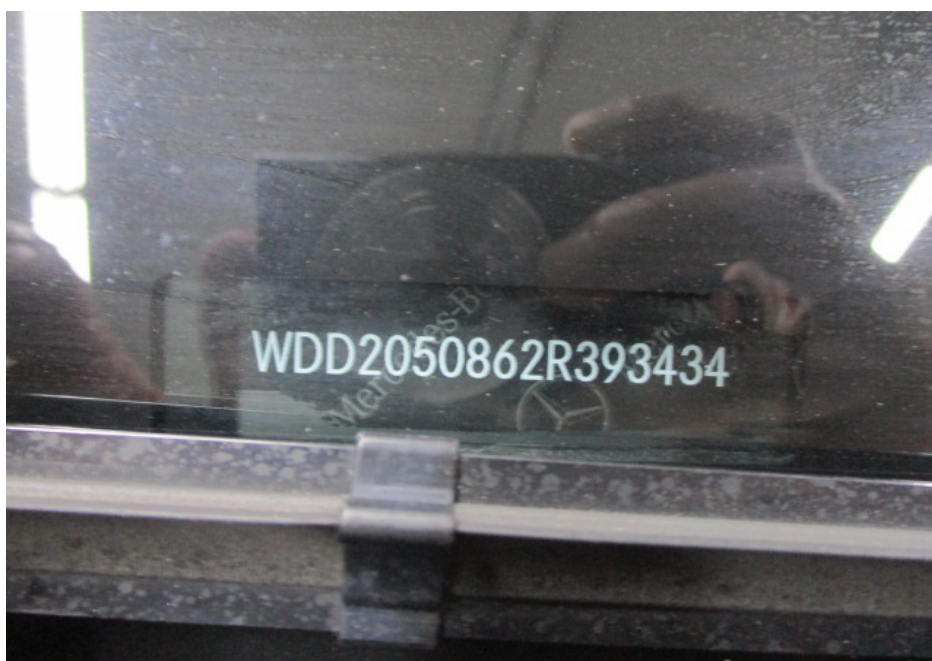
**Photo 11** shows the chassis number of the Motor Car. The chassis number recorded was WDD2050862R393434.

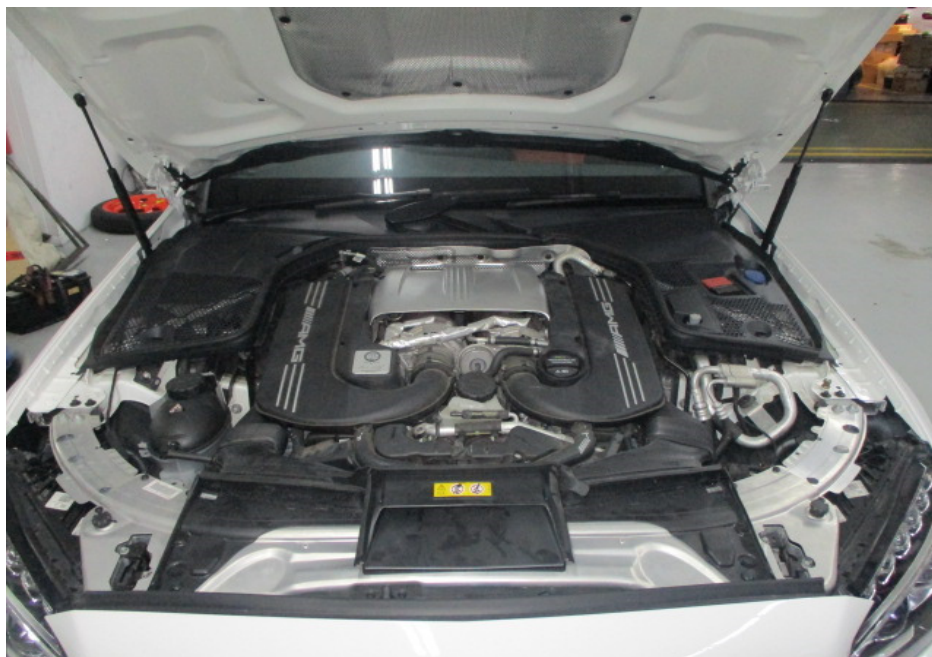
**Photo 12** shows a general view of the engine compartment of the Motor Car at the time of my inspection. The various parts and components inside the engine compartment were all observed to be intact and properly fitted. There was also no sign(s) or indication(s) of fluid leak and/or fluid stain found inside the engine compartment.

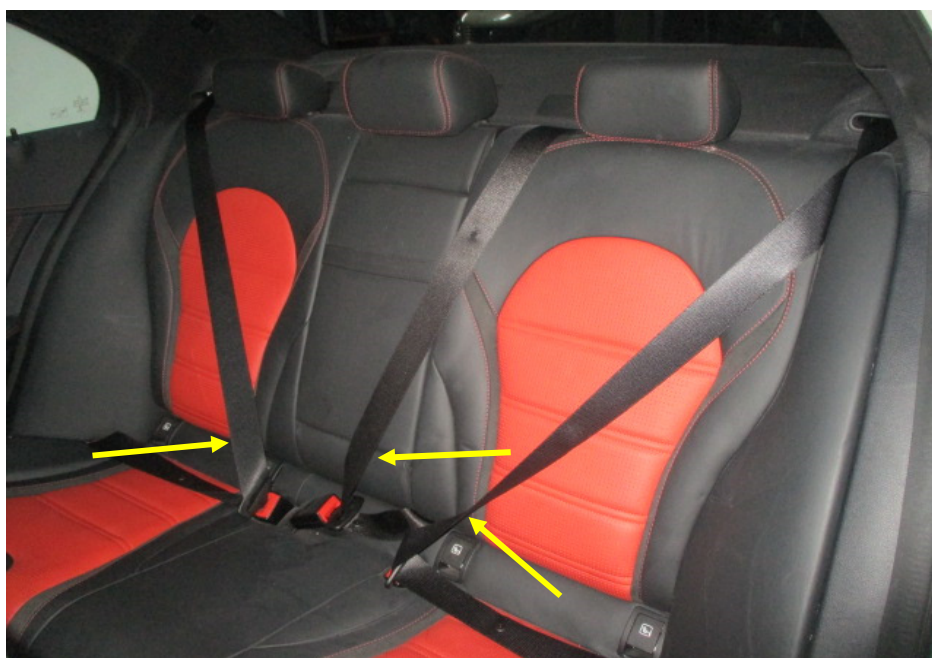
**Photo 13** shows the rear seats of the Motor Car. All the seats of the Motor Car were secured via seat rails to the floorboard. They were also fitted with a retractable seat belt reel and a pre-tensioner. The seat belts (arrowed) were tested and were able to be fastened into the respective pre-tensions that were fitted on the side of each individual seat.

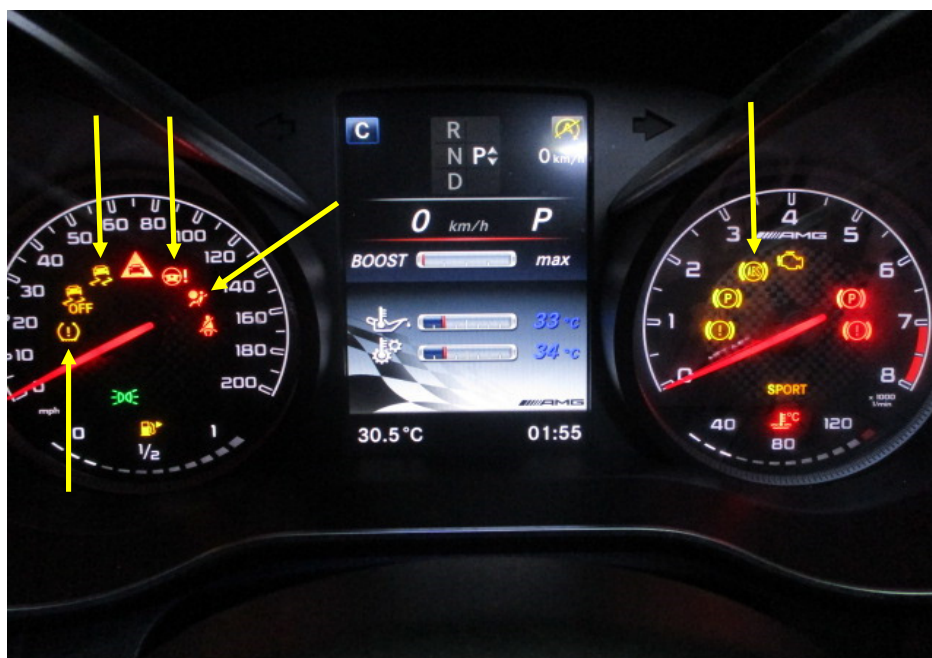
**Photo 14** shows the warning lights for the various electronic safety features appearing on the instrument panel of the Motor Car during its self-test when the engine is cranked, in particular the ABS, SRS, EPS, TPM and TCS lights (arrowed).

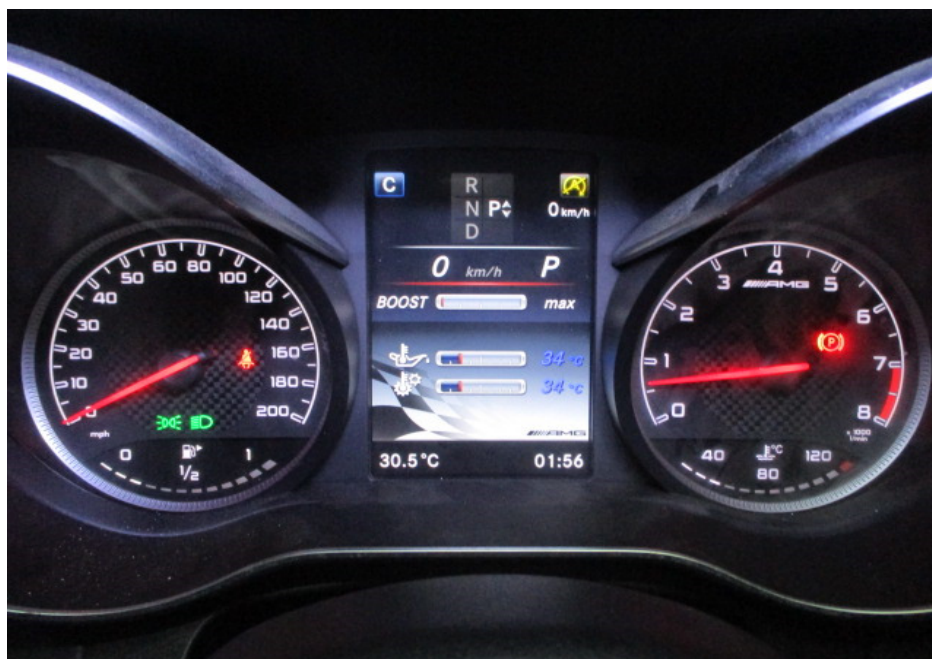
**Photo 15** shows the respective warning lights no longer illuminated, indicating that there is no fault detected to the ABS, SRS, EPS, TPM and TCS systems of the Motor Car during the self-test. These electronic systems were hence in working condition at the time of my inspection.

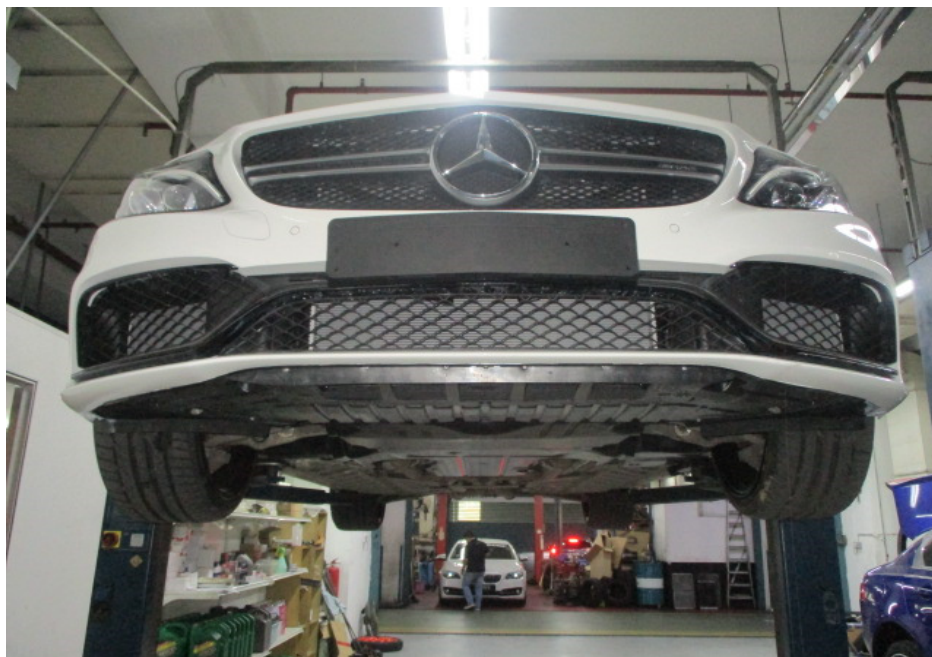
**Photo 16** shows the Motor Car hoisted up for checks on its undercarriage. There was no sign(s) or indication(s) of fluid leakage and/or fluid stain(s) on the underside of the Motor Car. The undercarriage components of the Motor Car were also all observed to be intact and secured in an appropriate manner.

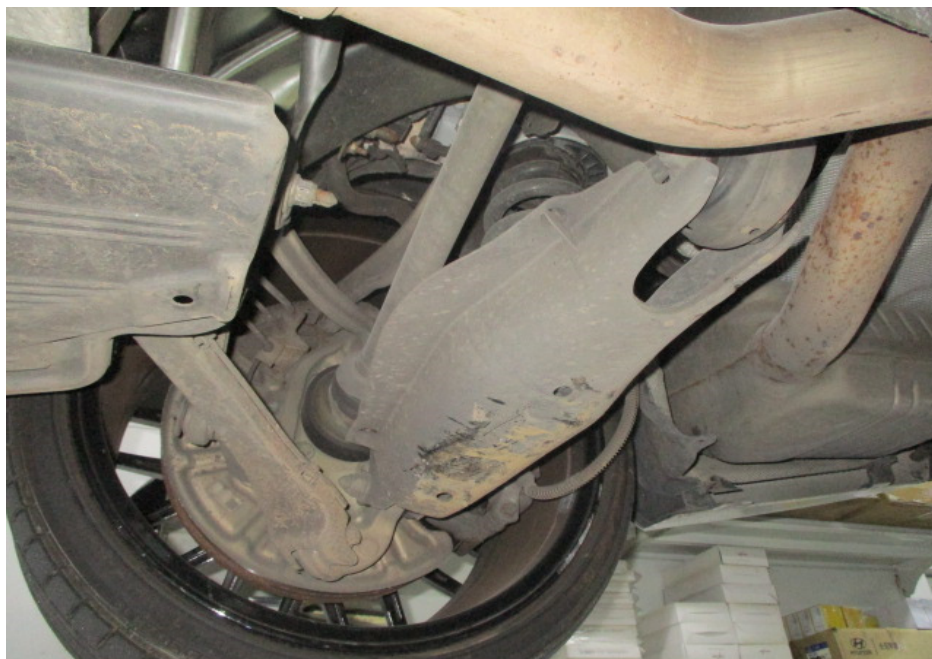
**Photo 17** shows a general view of the control arms and linkages at the rear left wheel of the Motor Car. I did not observe any fluid leak and/or fluid stain on the underside of the Motor Car. All of the Motor Car's undercarriage components were observed to be intact and secured in an appropriate manner.

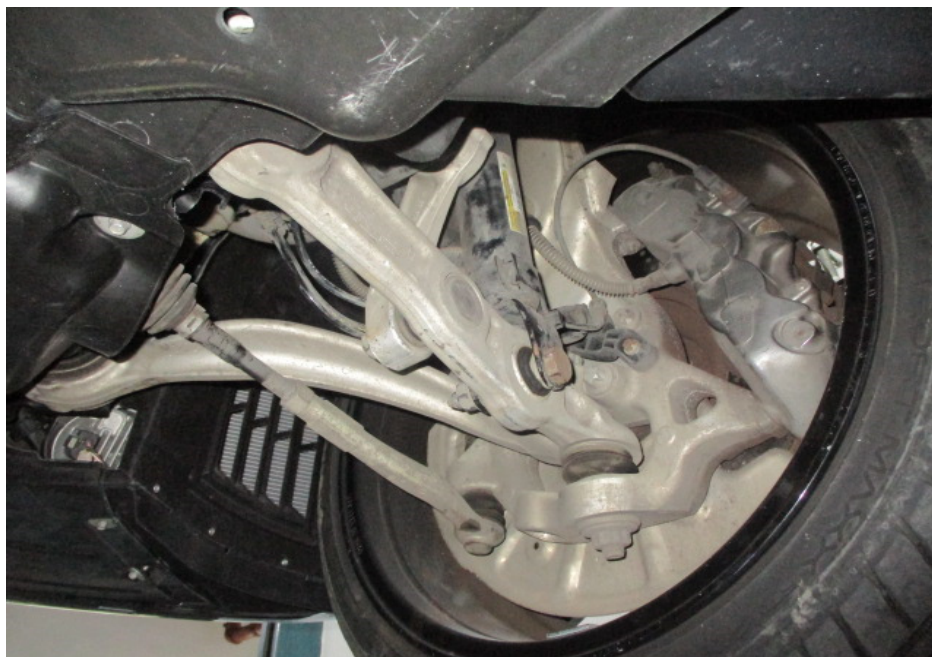
**Photo 18** shows the various undercarriage components at the front right wheel of the Motor Car. The mechanical components, control arms and linkages were all found to be intact and secured in an appropriate manner.

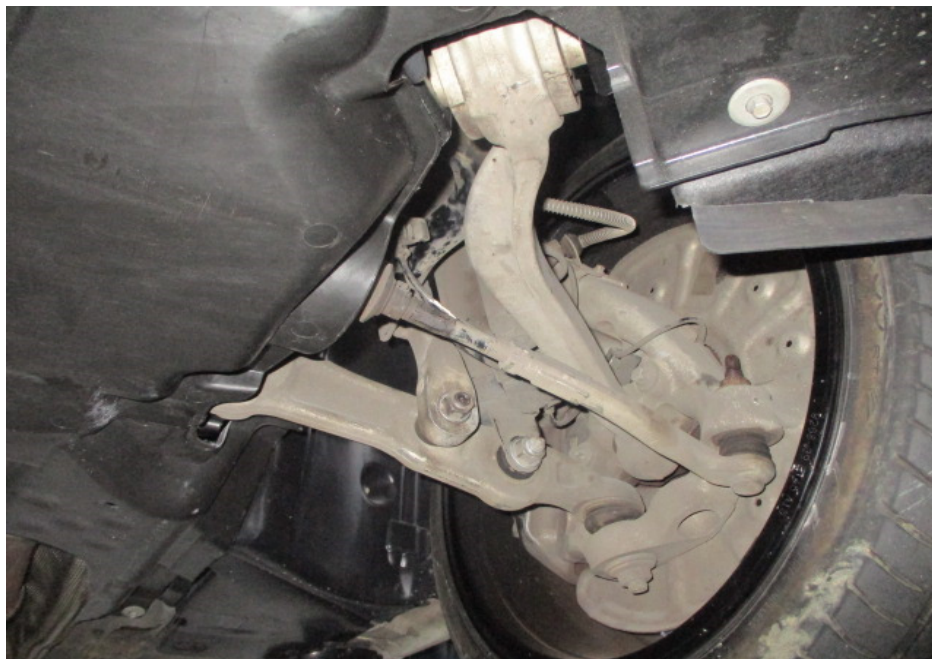
**Photo 19** shows the various undercarriage components at the front left wheel of the Motor Car. The mechanical components, control arms and linkages were all found to be intact and secured in an appropriate manner. I also did not observe any fluid leak and/or fluid stain on the underside of the Motor Car.

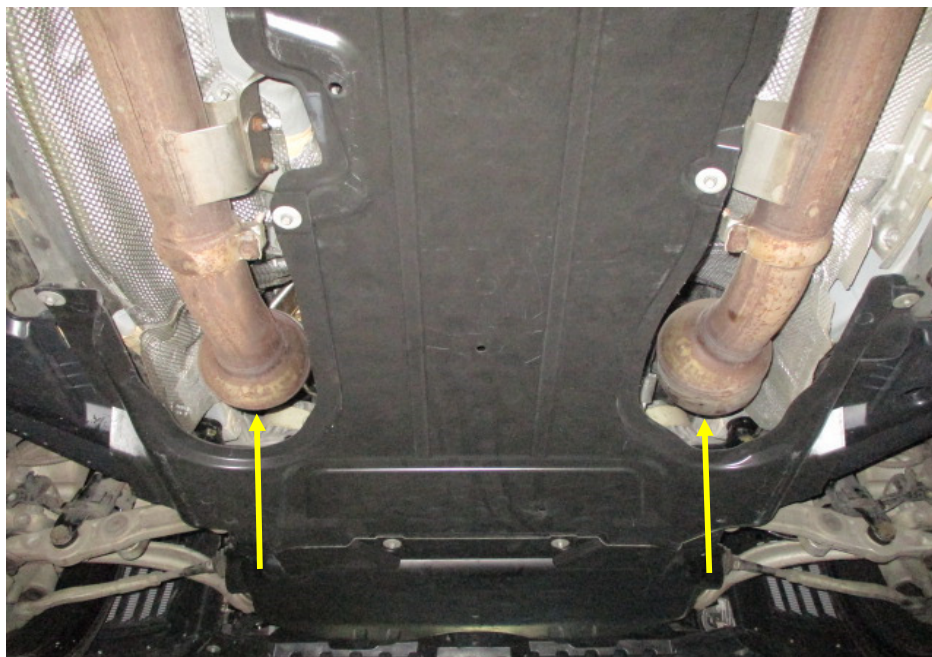
**Photo 20** shows the Motor Car's catalytic converters (arrowed). My examination of the Motor Car's exhaust system revealed no sign(s) or indication(s) of any cut or weld marks along its exhaust pipes and on its rear mufflers.

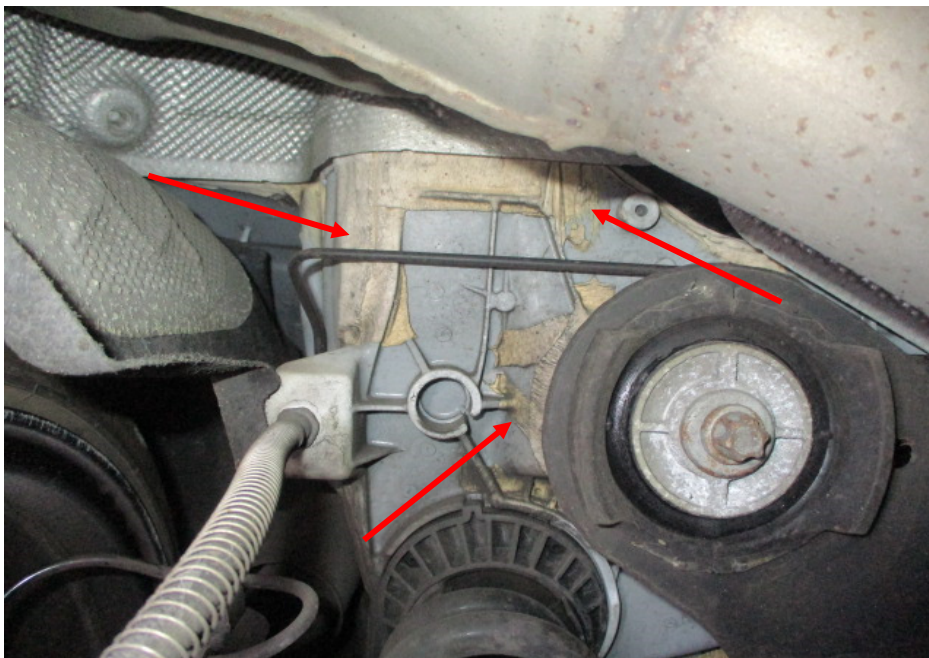
**Photo 21** shows the chassis/structural body at the underside rear left of the Motor Car. I did not find any weld marks other than original spot weld marks on the chassis/structural body of the Motor Car. The original factory sealant (arrowed) at the joints along the chassis/structural body was also untouched, indicating no work was done on the chassis/structural body of the Motor Car and that the chassis/structural body was originally fitted.

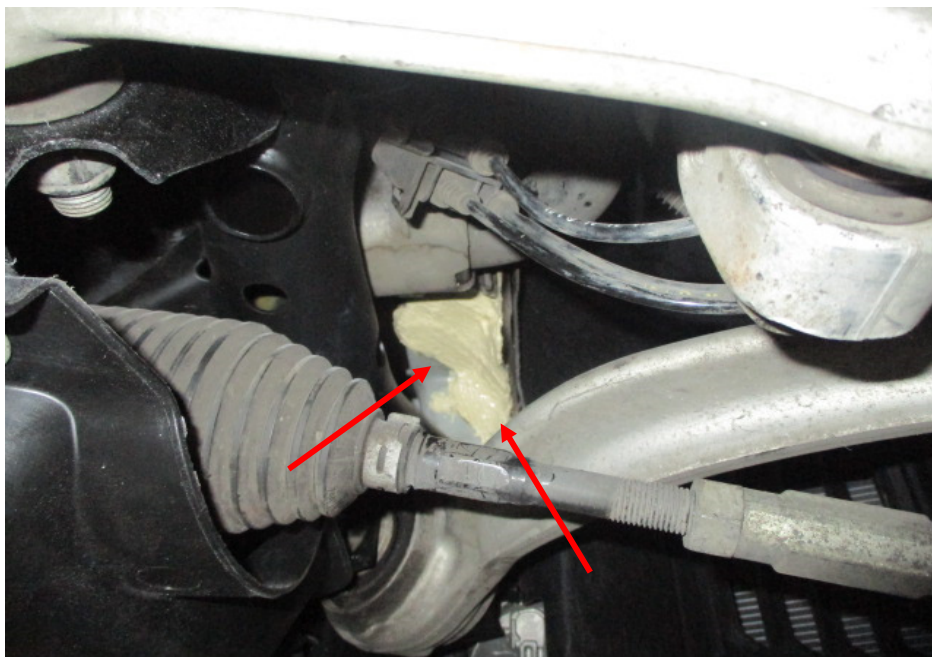
**Photo 22** shows the chassis/structural body at the underside front right of the Motor Car. The original factory sealant (arrowed) at the joints along the chassis/structural body was observed to be untouched. In general, I had found no work was carried out on the chassis/structural body of the Motor Car. The chassis/structural body of the Motor Car was originally fitted.

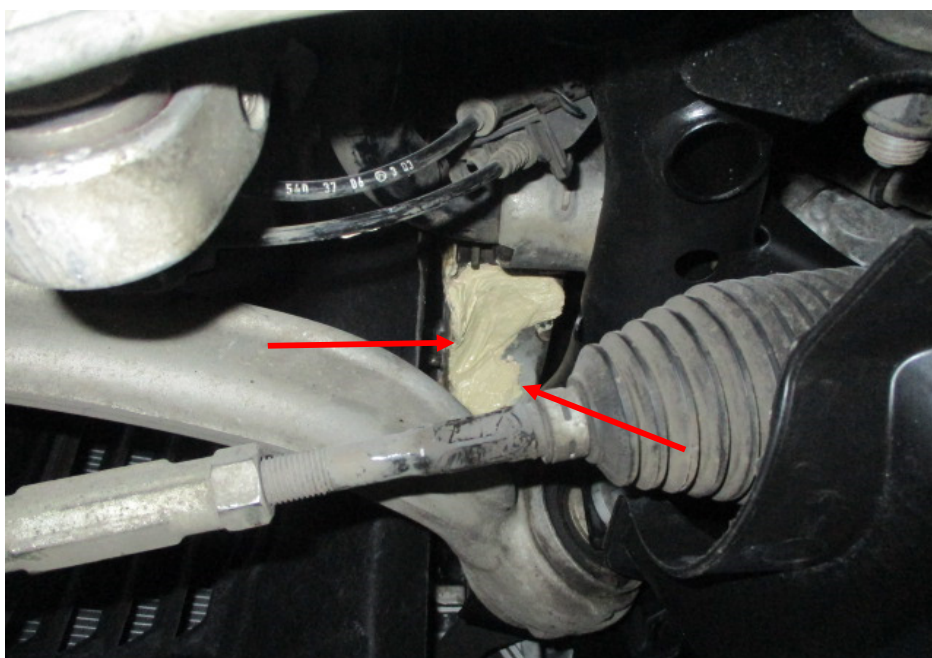
**Photo 23** shows the chassis/structural body at the underside front left of the Motor Car. The original factory sealant (arrowed) at the joints along the chassis/structural body was observed to be untouched. In general, I had found no work was carried out on the chassis/structural body of the Motor Car. The chassis/structural body of the Motor Ca was originally fitted.

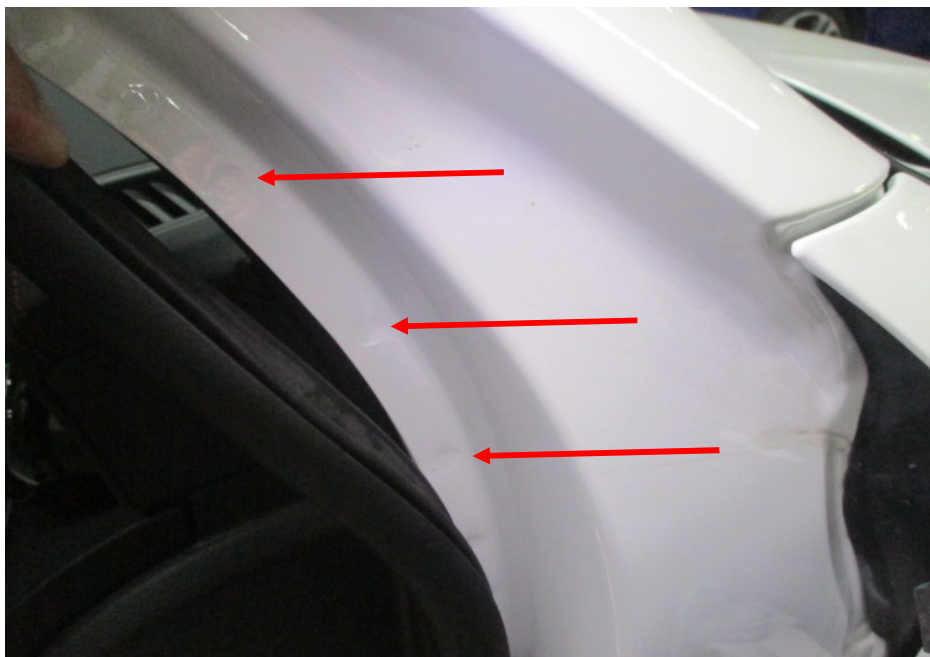
**Photo 24** shows the right side "A" pillar of the Motor Car. I did not find any weld marks other than original spot weld marks (arrowed) on the right side "A" pillar of the Motor Car which, indicates that there was no re-welding works carried out. In general, I had found all the non-detachable body panels of the Motor Car to be originally fitted at the time of my inspection.
